**No. 96**  
(April  
2007)

**Double Hull Oil Tankers - Guidelines for Surveys,  
Assessment and Repair of Hull Structures**

## DOUBLE HULL OIL TANKERS

Guidelines for Surveys, Assessment and Repair  
of Hull Structures

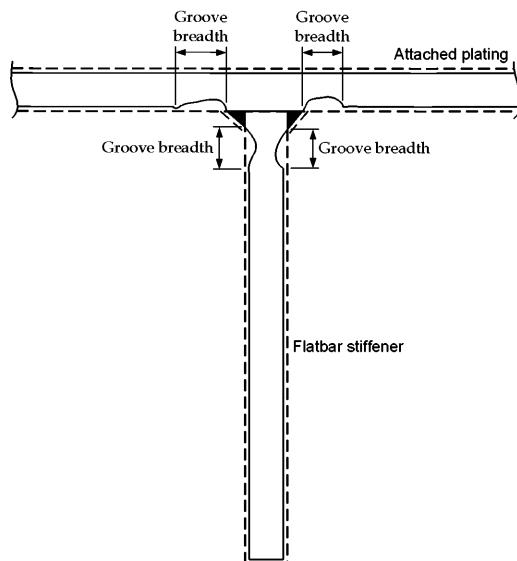
**Figure 8      Grooving Corrosion**

Grooving corrosion is often found in or beside welds, especially in the heat affected zone. This corrosion is sometimes referred to as 'inline pitting attack' and can also occur on vertical members and flush sides of bulkheads in way of flexing. The corrosion is caused by the galvanic current generated from the difference of the metallographic structure between the heat affected zone and base metal. Coating of the welds is generally less effective compared to other areas due to roughness of the surface, which exacerbates the corrosion. Grooving corrosion may lead to stress concentrations and further accelerate the corrosion process. Grooving corrosion may be found in the base material where coating has been scratched or the metal itself has been mechanically damaged. An example of grooving corrosion is shown in Figure 8.

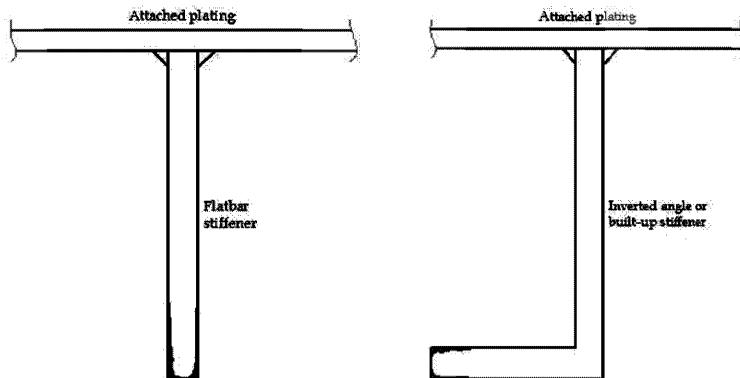
**Figure 9 Edge Corrosion**

Edge corrosion is defined as local corrosion at the free edges of plates, stiffeners, primary support members and around openings. An example of edge corrosion is shown in Figure 9.

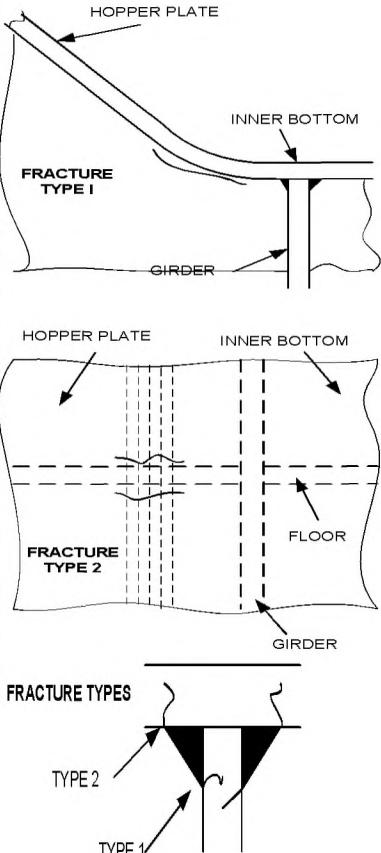
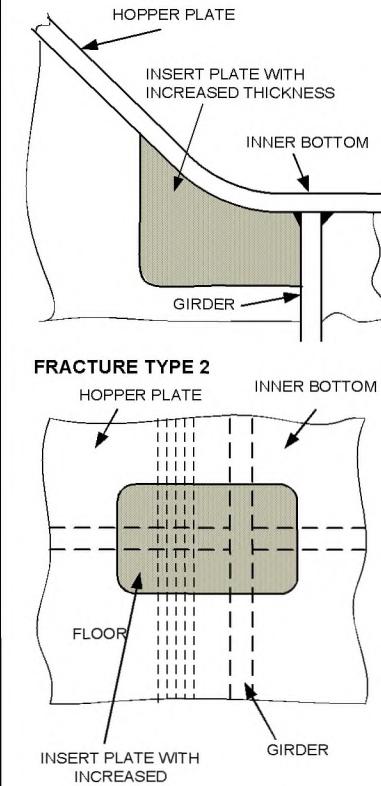
OIL Tankers		Guidelines for Surveys, Assessment and Repair of Hull Structure
Group 1	Cargo area	Example No.
	Hopper and double bottom ballast tank	5
Detail of damage	Fractured floor and inner bottom plate in way of juncture of inner bottom to hopper plate	
<b>Sketch of damage</b>

<b>Factors which may have caused damage</b> <ol style="list-style-type: none"> <li>1. Misalignment. The three mid-lines do not cross at the same joint. This misalignment produces an out-of-plane deformation of inner bottom plate in way of knuckle line.</li> <li>2. Stress concentration at connection between floor and inner bottom plate.</li> <li>3. Static and dynamic load of ballast water.</li> </ol>		
<b>Notes on repairs</b> See Sketch.

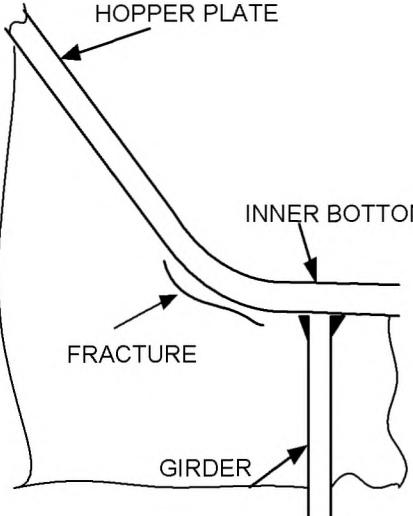
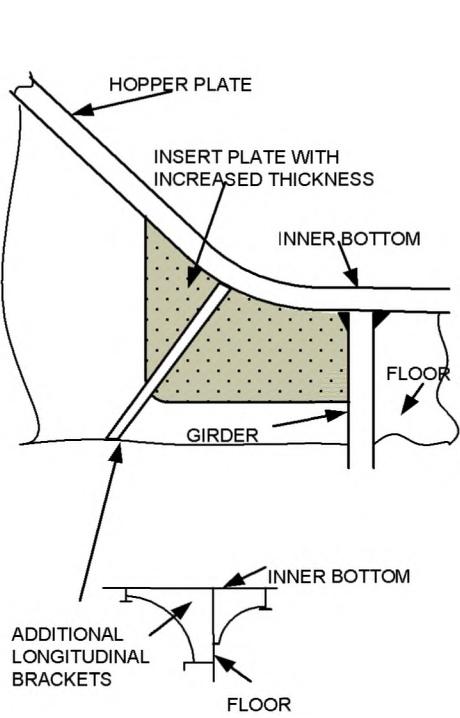
OIL Tankers		Guidelines for Surveys, Assessment and Repair of Hull Structure
Group 1	Cargo area	Example No.
	Hopper and double bottom ballast tank	6
Detail of damage	Fracture at connection of bilge hopper plate and web frame	
Sketch of damage

Factors which may have caused damage	<p>1. Stress concentration due to reduction of effective flange area at curved plate.</p>	
	<p>Notes on repairs See Sketch.</p>

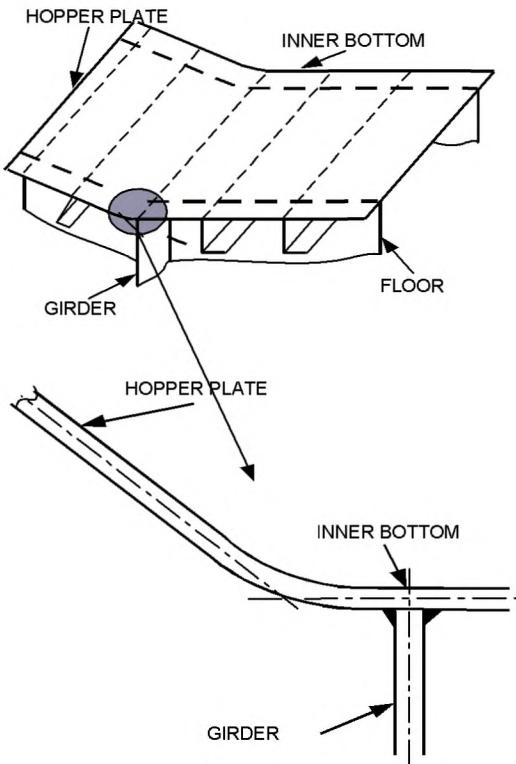
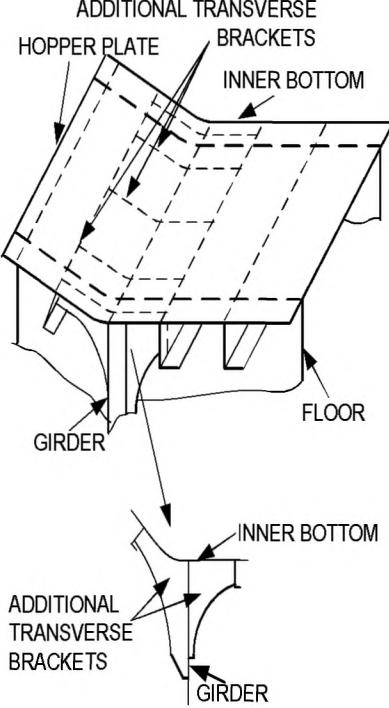
OIL Tankers		Guidelines for Surveys, Assessment and Repair of Hull Structure
Group 1	Cargo area	Example No.
	Hopper and double bottom ballast tank	7
Detail of damage	Rounded hopper plate deformation in way of the floor	
Sketch of damage

Factors which may have caused damage	<p>1. Misalignment. The three midlines do not cross at the same joint. This misalignment produces an out-of-plane deformation in knuckled plate in the vicinity of floor.</p> <p>2. Insufficient stiffening between floors.</p>	
	<p><b>Notes on repairs</b> See Sketch.</p>

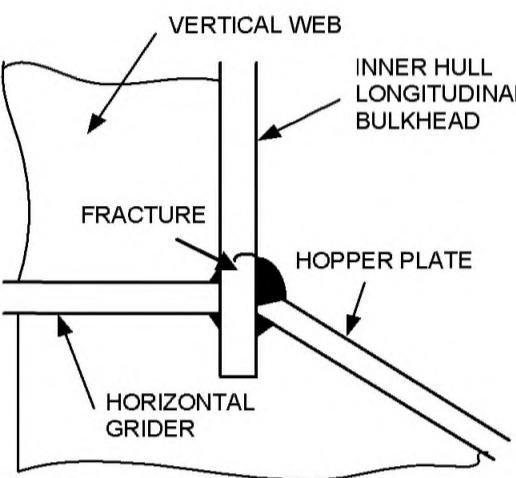
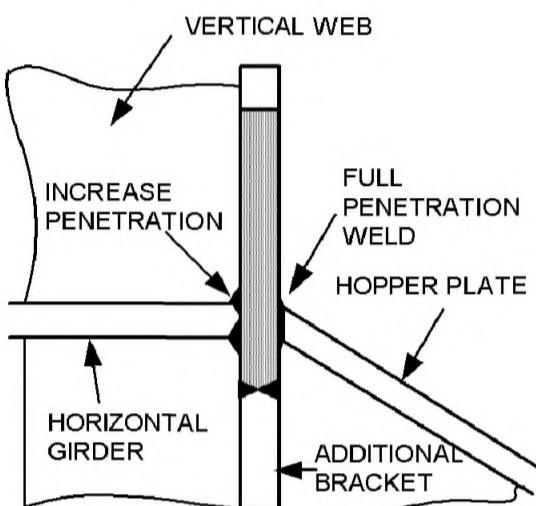
OIL Tankers		Guidelines for Surveys, Assessment and Repair of Hull Structure
Group 1	Cargo area	Example No.
	Wing cargo tank	8
Detail of damage	Fracture at the connection of hopper plate to outside longitudinal bulkhead.	
Sketch of damage

Factors which may have caused damage	<p>1. Stress concentration at junction of hopper plate to outside longitudinal bulkhead.</p> <p>2. Insufficient welding connection and/or incorrect shape of the weld toe.</p> <p>3. Misalignment between hopper plate, outside longitudinal bulkhead and side stringer.</p>	
Notes on repairs	<p>See Sketch.</p>

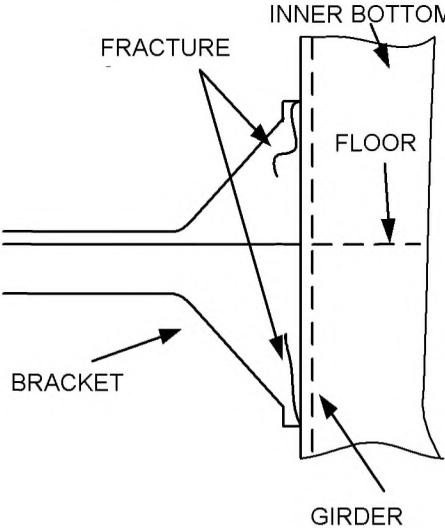
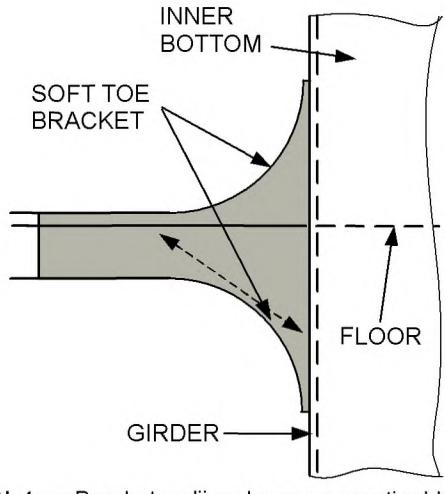
OIL Tankers		Guidelines for Surveys, Assessment and Repair of Hull Structure
Group 1	Cargo area	Example No.
	Hopper and double bottom ballast tank	9
Detail of damage	Fracture in gusset plate in line with inner bottom	
Sketch of damage

<p><b>Notes:</b> Bracket radii as large as practicable.            Bracket same thickness as inner bottom stiffener.            Toe height should be small as possible while still allowing return weld (wrapped weld).</p>	
Factors which may have caused damage	<ol style="list-style-type: none"> <li>1. Stress concentration due to small radius and abrupt toe.</li> <li>2. Insufficient welding.</li> <li>3. Insufficient sectional area (thickness x breadth) of the connecting bracket.</li> </ol>	
	<p><b>Notes on repairs</b>            See Sketch.</p>

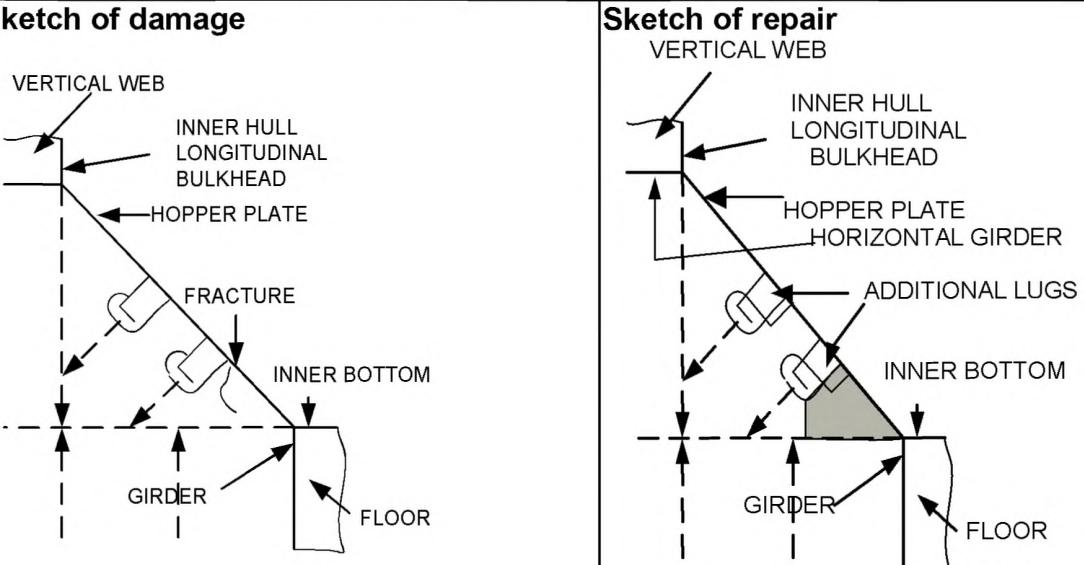
OIL Tankers Guidelines for Surveys, Assessment and Repair of Hull Structure	
Group 1	Cargo area
	Hopper ballast tank
Detail of damage	Fracture in way of cut-out in hopper plate
Sketch of damage	<p><b>Sketch of repair</b></p>

Factors which may have caused damage	<p>Notes on repairs</p> <p>See Sketch.</p>
1. Stress concentration due to no collar plate.

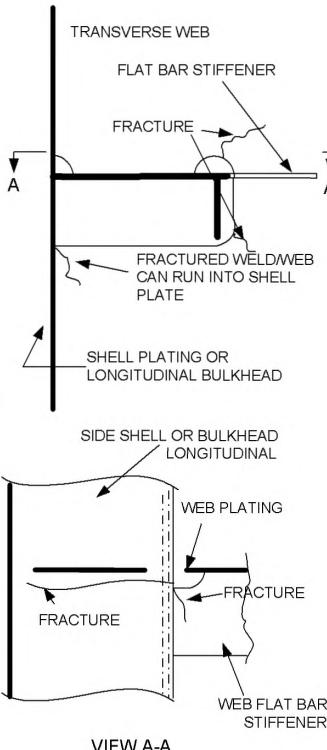
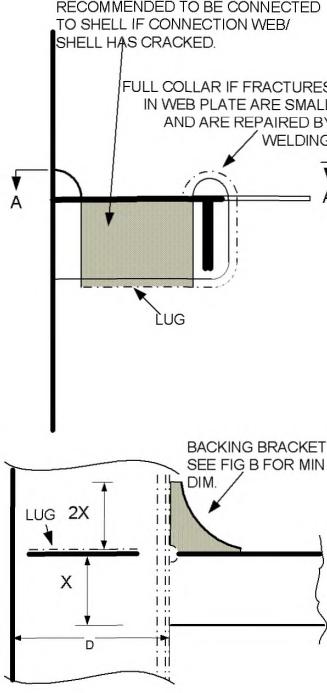
OIL Tankers Guidelines for Surveys, Assessment and Repair of Hull Structure	
Group 2	Cargo area
	Example No. 3
<b>Detail of damage</b>	Fracture in way of web and flat bar stiffener at cut outs for longitudinal stiffener connections.
<b>Sketch of damage</b>

<b>Factors which may have caused damage</b>	<p><b>Notes on repairs</b> See Sketch. May also fit a double bracket to avoid fracture from toe.</p>
<ol style="list-style-type: none"> <li>1. Asymmetrical connection of flat bar stiffener resulting in high peak stress at heel of the stiffener under fatigue loading.</li> <li>2. Insufficient area of connection of longitudinal to web plate.</li> <li>3. Defective weld at return around the plate thickness.</li> <li>4. High localized corrosion at areas of stress concentrations such as flat bar stiffener connections, corners of cut out for longitudinal and connection of web to shell at cut outs.</li> <li>5. High shear stress in web of the transverse.</li> <li>6. Dynamic seaway loads/motions.</li> </ol>

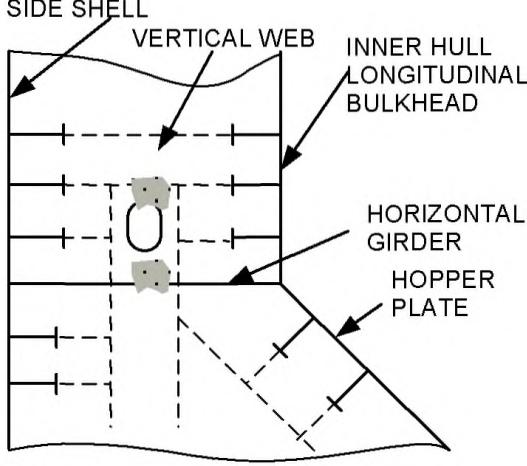
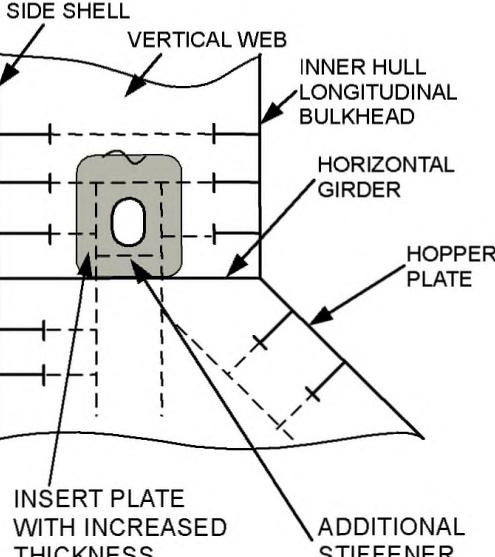
OIL Tankers Guidelines for Surveys, Assessment and Repair of Hull Structure	
Group 2	Cargo area
	Wing ballast tank
Detail of damage	Buckling in way of side web panels above hopper horizontal girder
Sketch of damage	Sketch of repair

Factors which may have caused damage	Notes on repairs See Sketch.
<ol style="list-style-type: none"> <li>1. High shear stress in the transverse web.</li> <li>2. Insufficient buckling strength.</li> </ol>

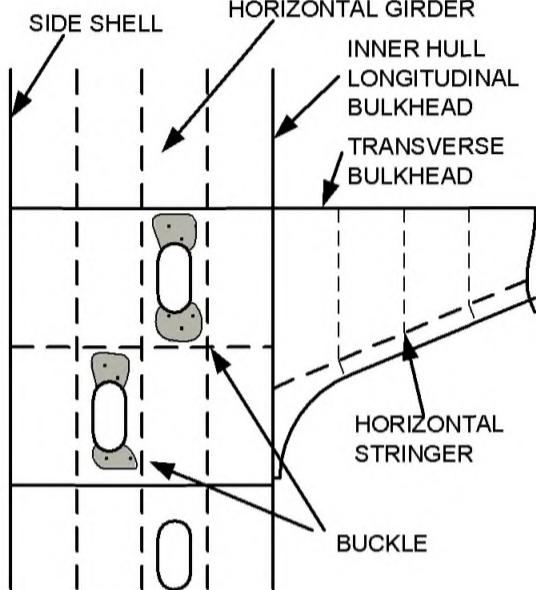
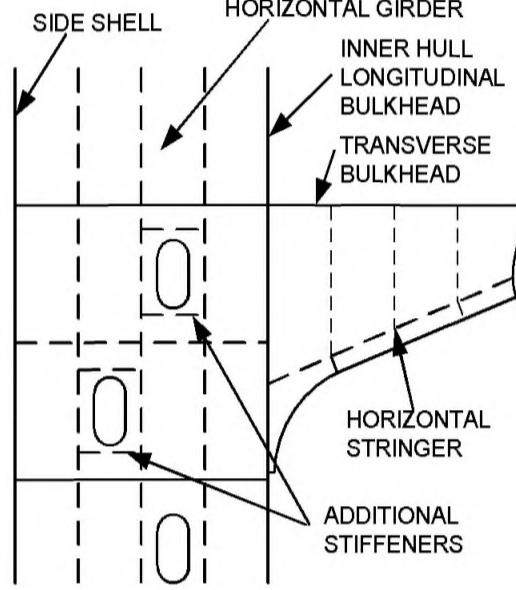
<b>Factors which may have caused damage</b> <ol style="list-style-type: none"> <li>1. High shear or compressive stress in the stringer.</li> <li>2. Insufficient buckling strength.</li> </ol>		<b>Notes on repairs</b> See Sketch.

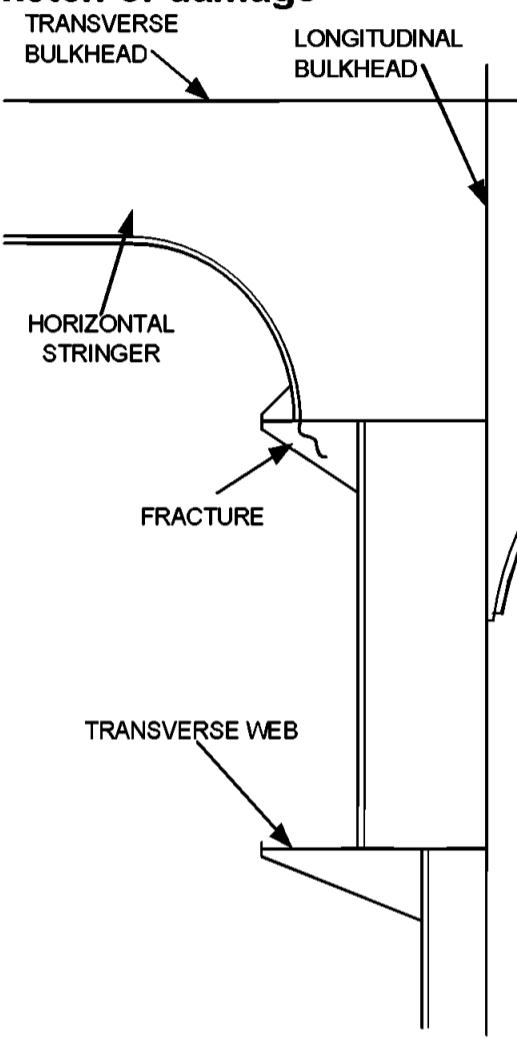
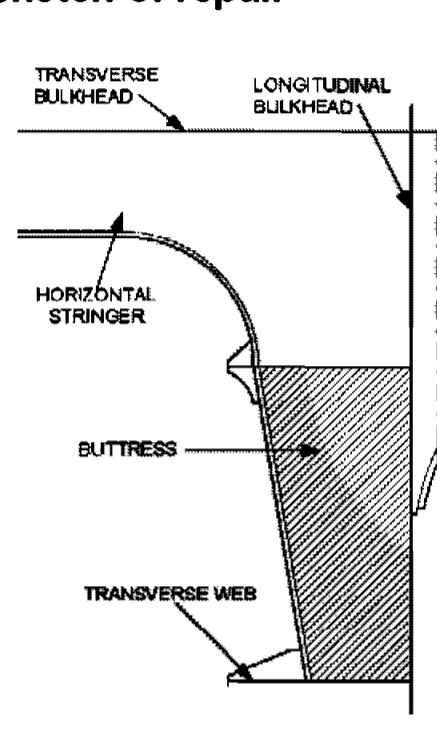
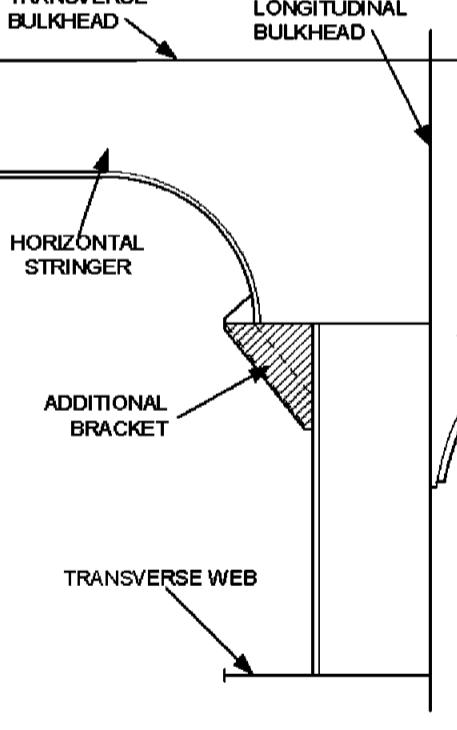
<b>Factors which may have caused damage</b>	<b>Notes on repairs</b>
<ol style="list-style-type: none"> <li>1. Stress concentration due to discontinuous structure.</li> <li>2. High shear stress in the horizontal stringer.</li> </ol>	See Sketch.

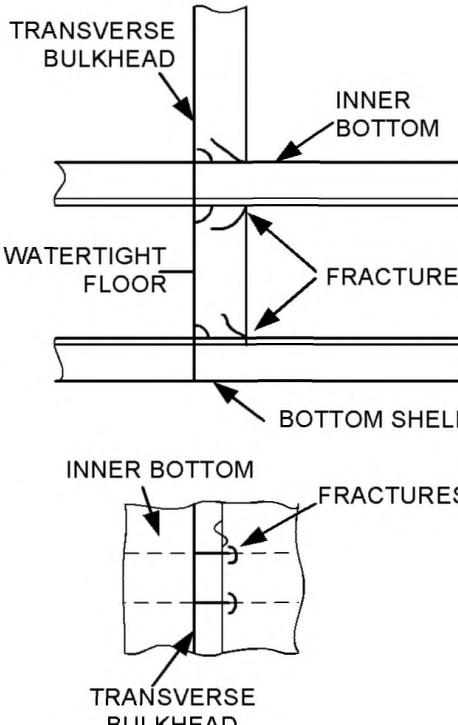
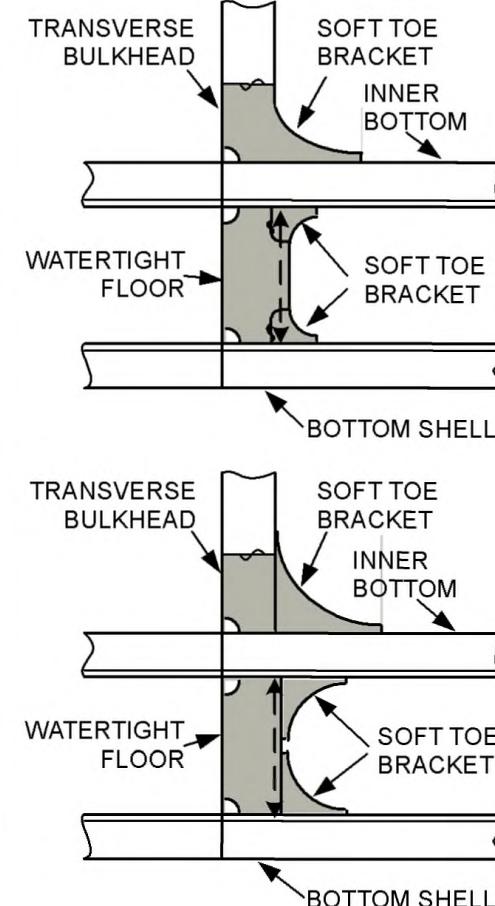
Factors which may have caused damage	Notes on repairs
<ol style="list-style-type: none"> <li>1. Misalignment between bulkhead stiffener and inner bottom longitudinal.</li> <li>2. High stress concentration.</li> </ol>	<p>See Sketch.</p> <ol style="list-style-type: none"> <li>1. If tank top plating is fractured, part crop and insert.</li> <li>2. Proper alignment between bulkhead stiffener and inner bottom longitudinal is critical for successful repair.</li> <li>3. Soft backing brackets may also be added.</li> </ol>

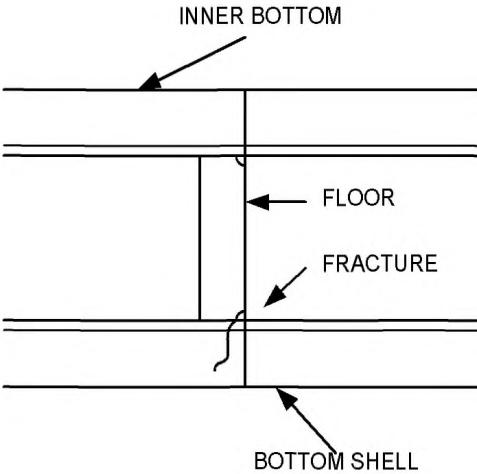
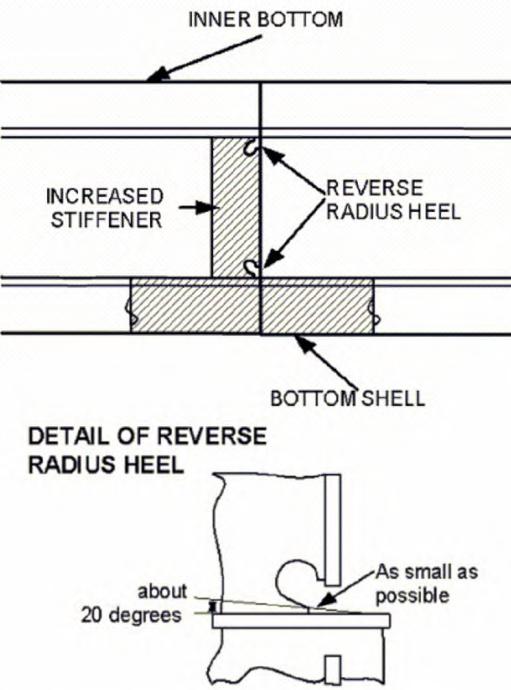
<b>Factors which may have caused damage</b>	<b>Notes on repairs</b> See Sketch.
<ol style="list-style-type: none"> <li>1. Asymmetrical connection.</li> <li>2. Relative deflection of adjacent floor to transverse bulkhead.</li> </ol>

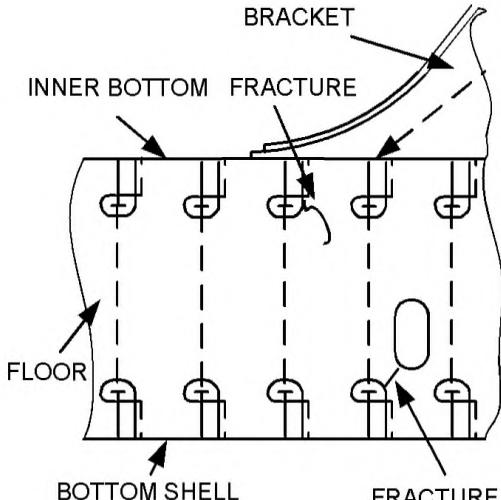
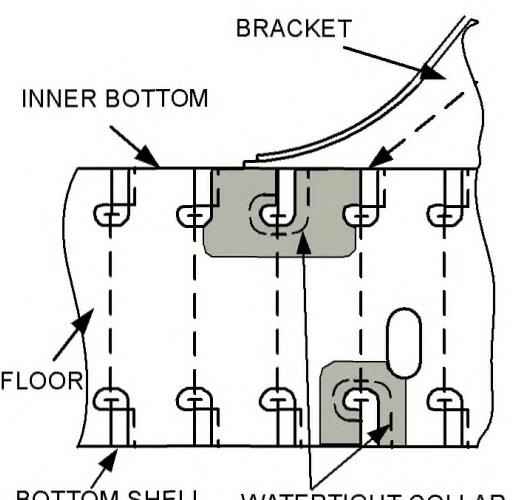
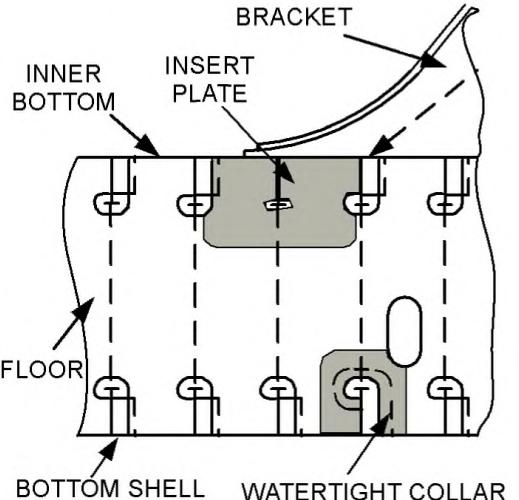
OIL Tankers Guidelines for Surveys, Assessment and Repair of Hull Structure	
Group 3	Cargo area
	Bottom ballast tank
Detail of damage Cut-outs on floors	
<b>Sketch of damage</b>

<b>Above method for larger fractures.</b>
<b>Factors which may have caused damage</b> <ol style="list-style-type: none"> <li>1. High stress in the vicinity of the transverse web frame bracket toe.</li> <li>2. Lack of material between manhole and cut-out for bottom longitudinals.</li> </ol>	<b>Notes on repairs</b> <ol style="list-style-type: none"> <li>1. Top sketch: Gouge and reweld fractures then fit WT collars.</li> <li>2. Bottom sketch: As an alternative to rewelding and fitting collar, crop and insert.</li> </ol>

<b>Above for relatively small fractures.</b>

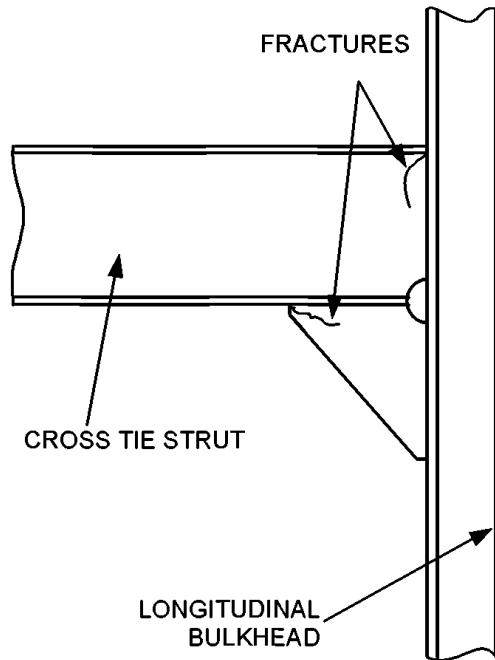
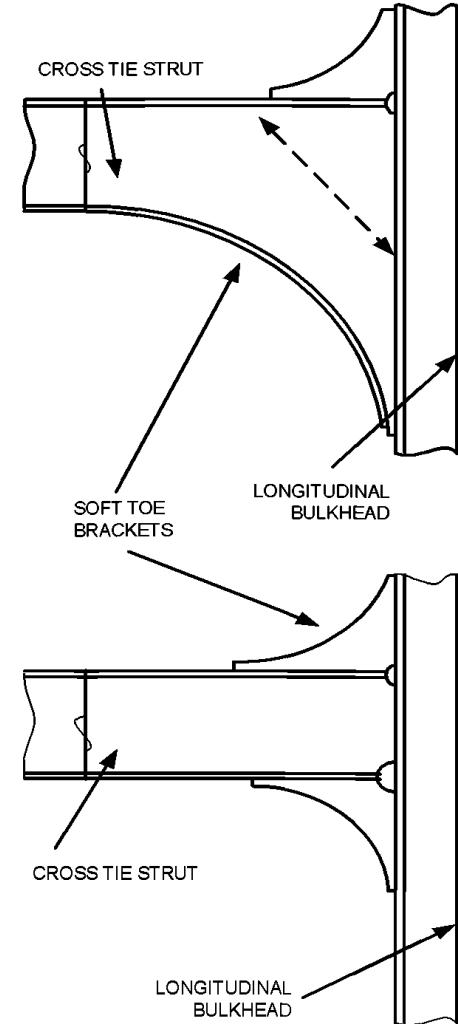
<b>Factors which may have caused damage</b> <ol style="list-style-type: none"> <li>1. Stress concentration due to unsuitable bracket shape at juncture of cross tie to longitudinal.</li> <li>2. Inadequate panel stiffening of web plate of cross-tie.</li> </ol>	<b>Notes on repairs</b> See Sketch.

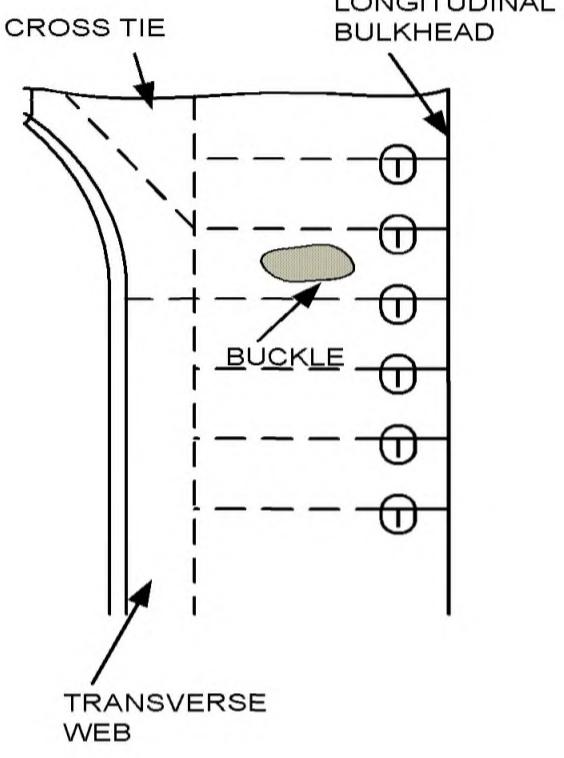
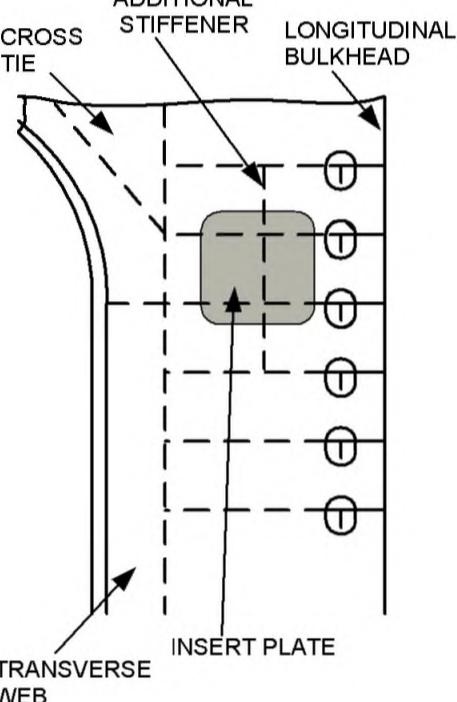
<p>CROSS TIE ADDITIONAL STIFFENER LONGITUDINAL BULKHEAD TRANSVERSE WEB INSERT PLATE</p>
Factors which may have caused damage	Notes on repairs
1. Insufficient panel stiffening on transverse web.	See Sketch. 1. Depending upon size of deformation, additional stiffeners may be sufficient.

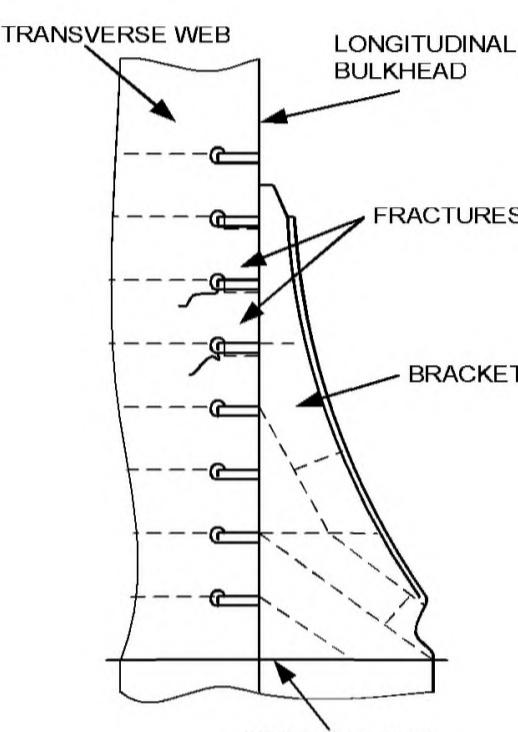
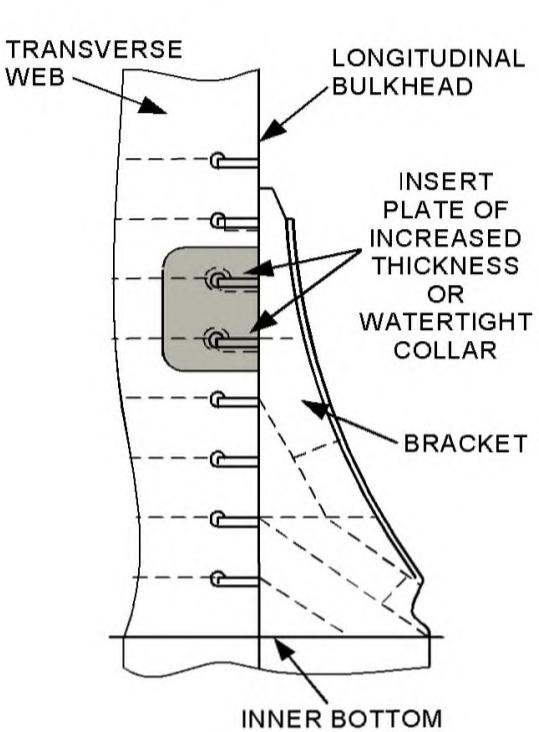
<p>TRANSVERSE WEB LONGITUDINAL BULKHEAD INSERT PLATE OF INCREASED THICKNESS OR WATERTIGHT COLLAR BRACKET INNER BOTTOM</p>
Factors which may have caused damage	Notes on repairs
<ol style="list-style-type: none"> <li>1. High stresses at toe of bottom transverse end bracket.</li> <li>2. Sharp corner at cut-out.</li> </ol>	See Sketch.

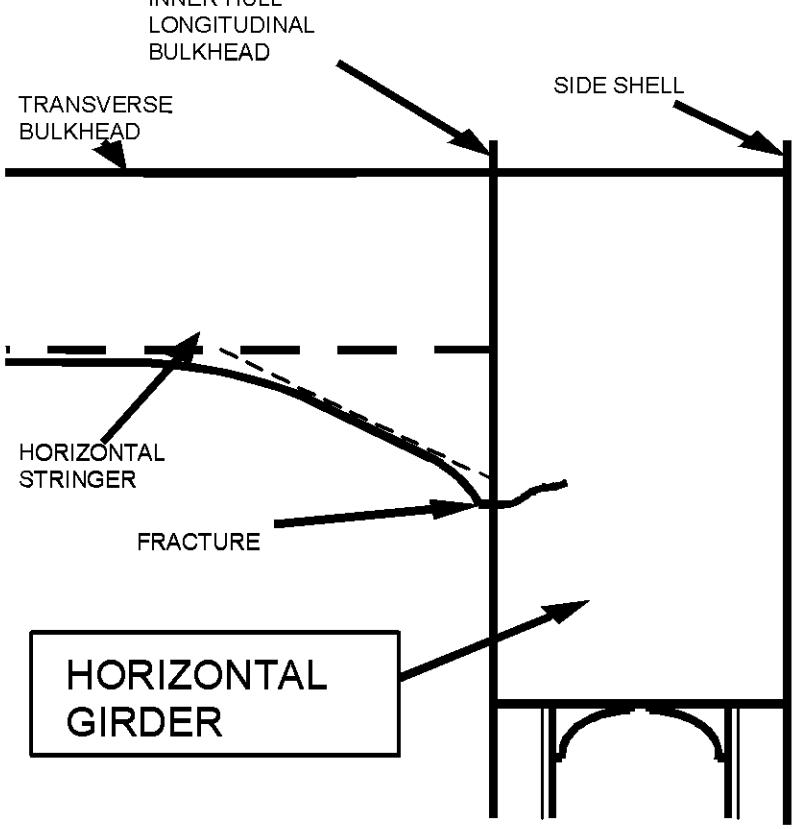
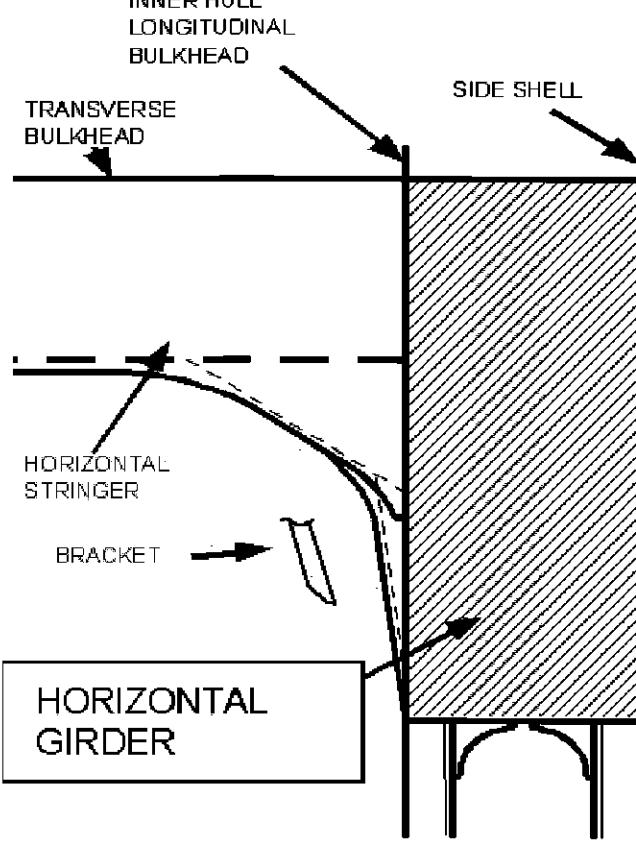
<p>INNER HULL LONGITUDINAL BULKHEAD TRANSVERSE BULKHEAD SIDE SHELL HORIZONTAL STRINGER BRACKET HORIZONTAL GIRDER</p>	
Factors which may have caused damage	<p>1. Misalignment between bracket end and side girder in wing tank.</p> <p>Notes on repairs See Sketch.</p>

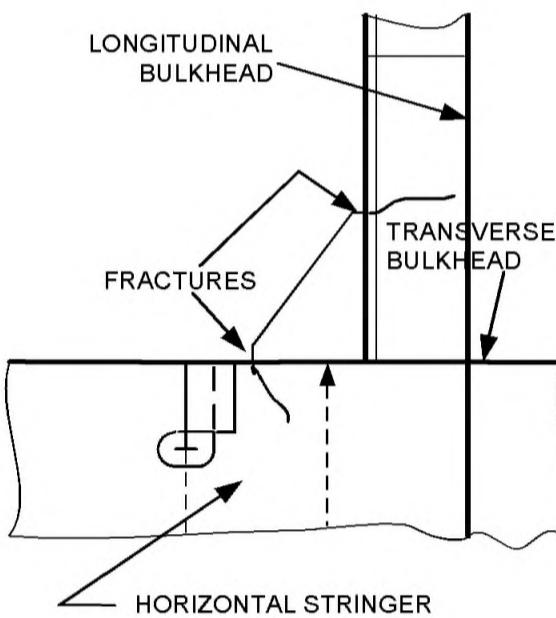
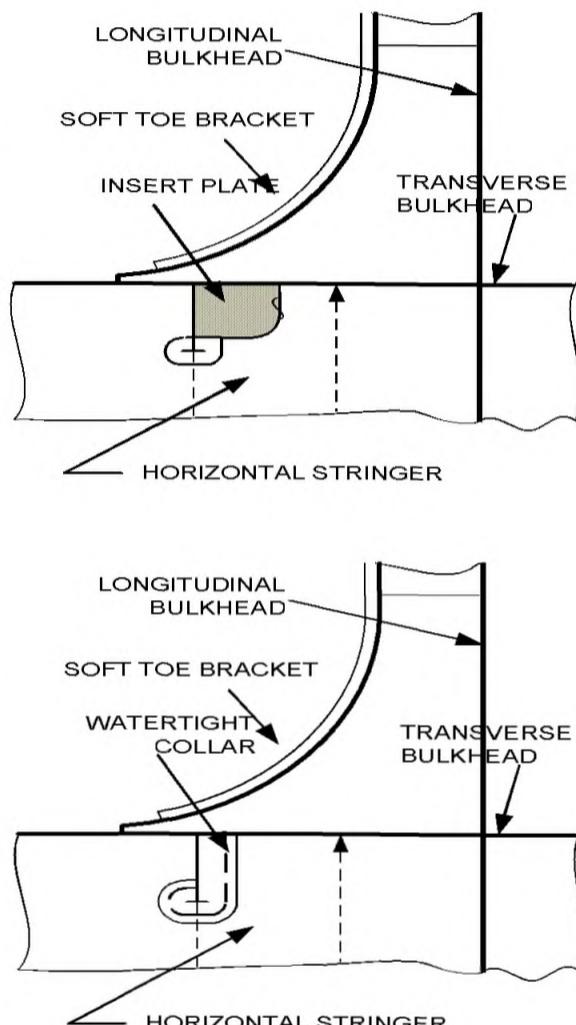
<b>Factors which may have caused damage</b> <ol style="list-style-type: none"> <li>1. Stress concentration due to inadequate shape of the bracket.</li> <li>2. Relative deflection of adjoining transverse web against transverse bulkhead.</li> </ol>	<b>Notes on repairs</b> See Sketch

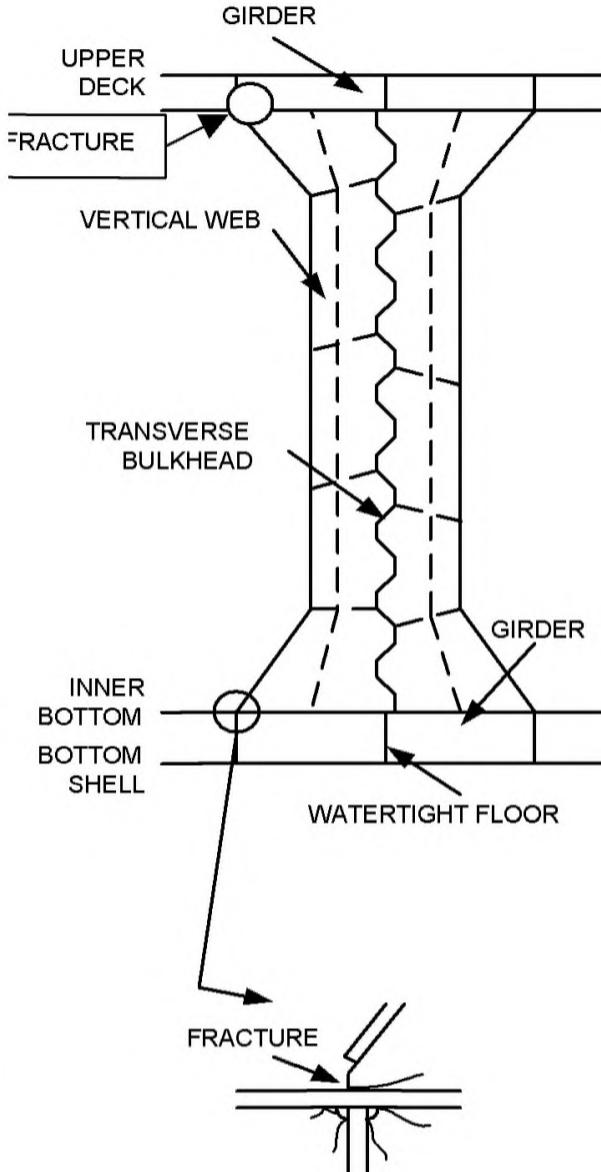
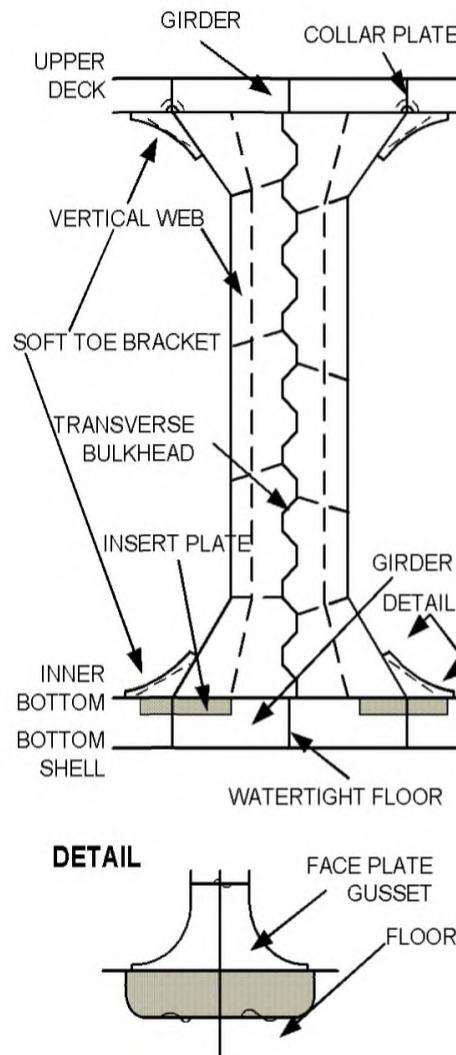
Factors which may have caused damage	<p>1. Stress concentration at toe of bracket due to sniped face plate and scallop in way.</p>	
	<p>Notes on repairs See Sketch.</p>

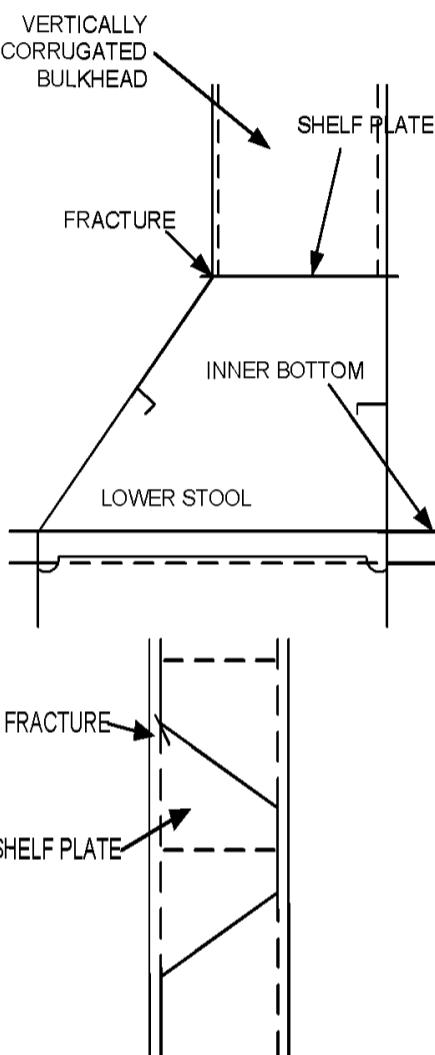
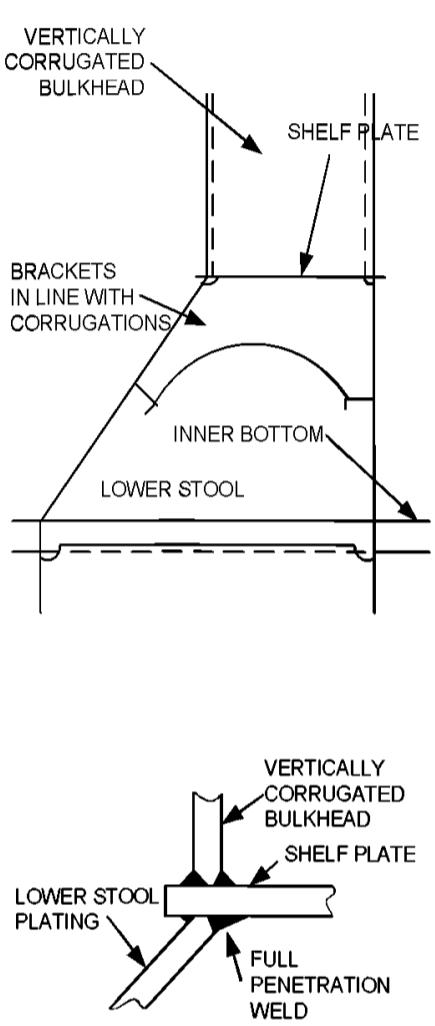
<b>Factors which may have caused damage</b>	<p>1. Stress concentration due to unsupported corrugation web.</p> <p>2. High through thickness stress, lamellar tearing.</p> <p>3. Weld details and dimensions.</p> <p>4. Misalignment.</p> <p>5. Insufficient thickness of stool side plating in relation to corrugation flange thickness.</p>	
	<p><b>Notes on repairs</b> See Sketch.</p>

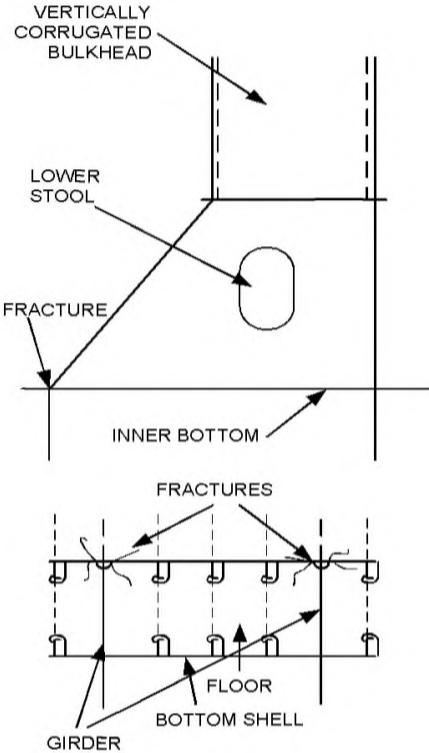
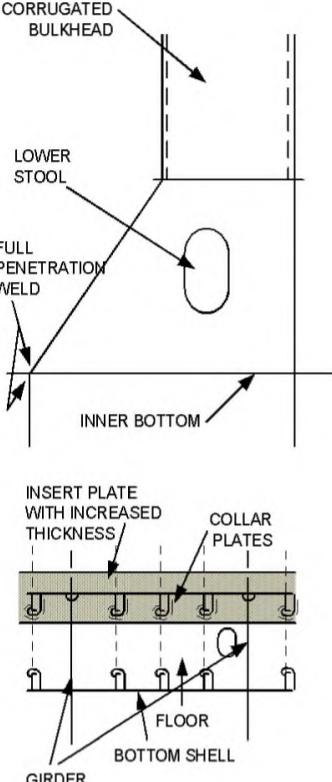
<b>Factors which may have caused damage</b>	<p>1. Misalignment between stool side plating and floor and/or stool webs and girders of double bottom.</p> <p>2. Insufficient thickness of floor compared to stool thickness.</p> <p>3. Scallops, cut-outs, air hole reducing the connecting area too much.</p> <p>4. Weld details and dimensions.</p> <p>5. Lamellar tearing of inner bottom plating.</p>	
	<b>Notes on repairs</b> See Sketch.

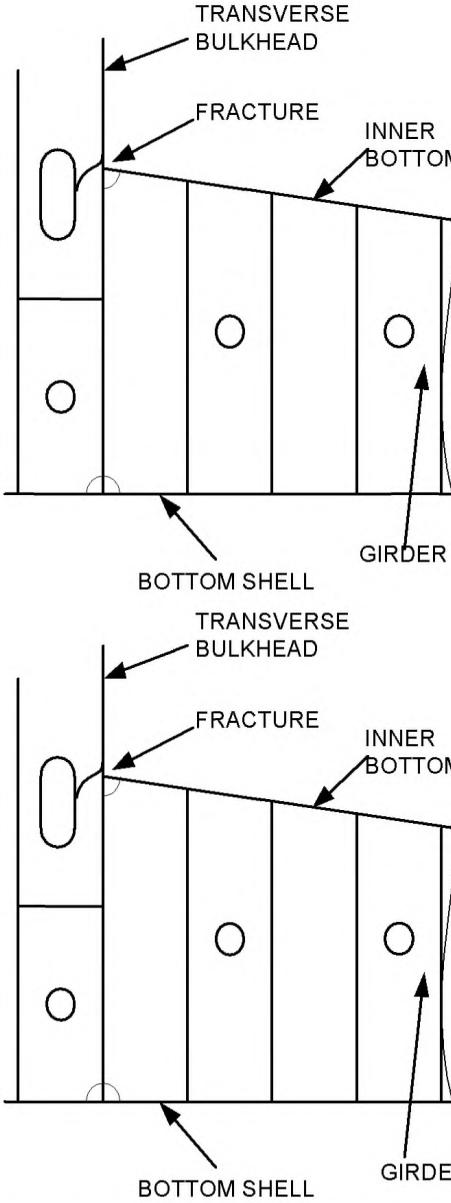
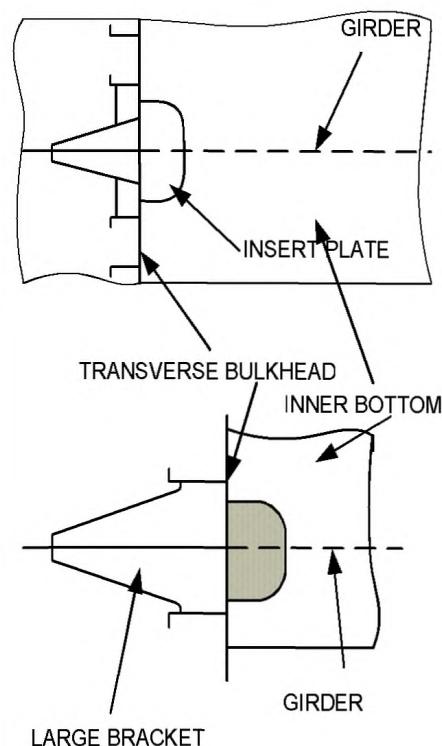
Factors which may have caused damage	<p>Notes on repairs See Sketch.</p>
<ol style="list-style-type: none"> <li>1. High stress concentration.</li> <li>2. Discontinuity of structural members at knuckle joint.</li> </ol>

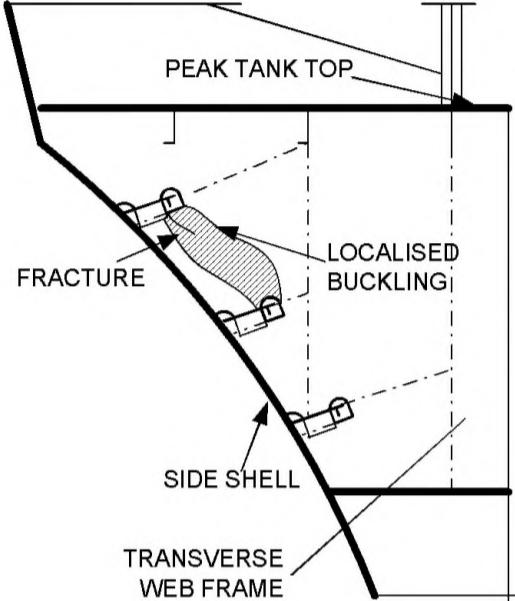
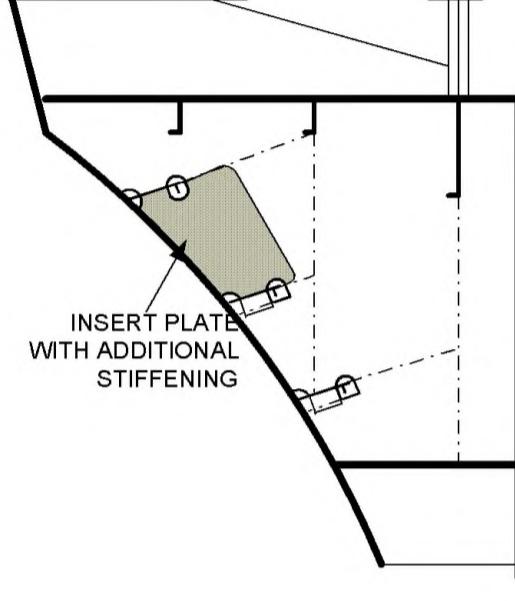
Factors which may have caused damage	<p>1. Localised thinning in way of coating failure at cut-outs and sharp edges due to working of the structure.</p> <p>2. Dynamic seaway loadings in way of bow flare.</p>	
Notes on repairs	<p>See Sketch.</p>

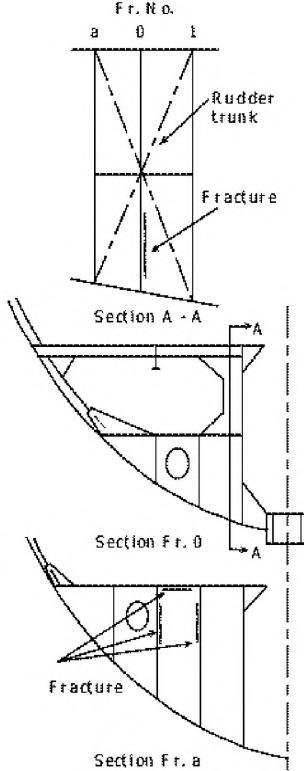
<b>Factors which may have caused damage</b>	<b>Notes on repairs</b>
1. Vibration.	1. The fractured plating should be cropped and renewed. 2. Natural frequency of the plate between stiffeners should be changed, e.g. reinforcement by additional stiffeners.

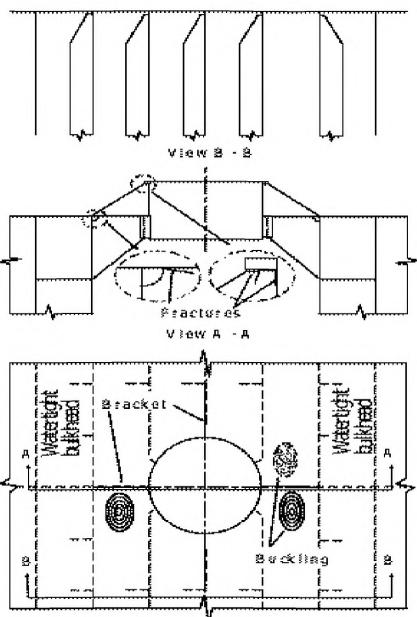
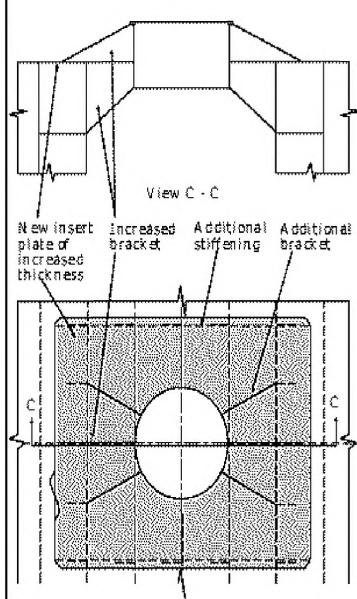
Factors which may have caused damage	<p>1. Insufficient deck strengthening (missing base plate).      2. Insufficient strengthening of steering gear foundation.      3. Bolts of steering gear were not sufficiently pre-loaded.</p>	
	<p><b>Notes on repairs</b></p> <ol style="list-style-type: none"> <li>1. New insert base plate of increased plate thickness.</li> <li>2. Additional longitudinal stiffening at base plate edges.</li> <li>3. Additional foundation brackets above and under deck (star configuration).</li> </ol>
