No.55 GENERAL CARGO SHIPS - Guidelines For
(March
1999)
Surveys, Assessment and Repair of Hull
Structure

GENERAL CARGO SHIPS

Guidelines for Surveys,
Assessment and Repair
of Hull Structure

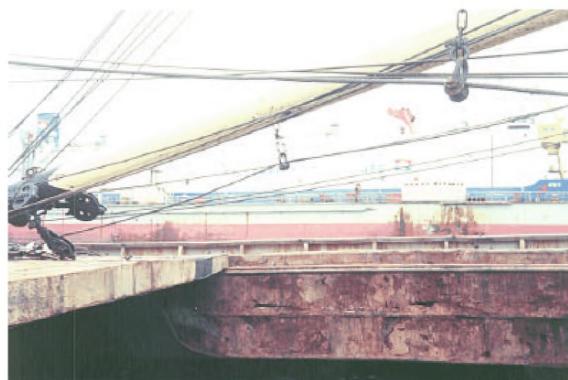
3.1.2 Severe corrosion of the hatch coaming from inside and of under deck girders may occur due to difficult access for maintenance of the protective coating. This may in turn lead to fractures (See **Photograph 1**).

Photograph 1 Heavy corrosion of hatch coaming

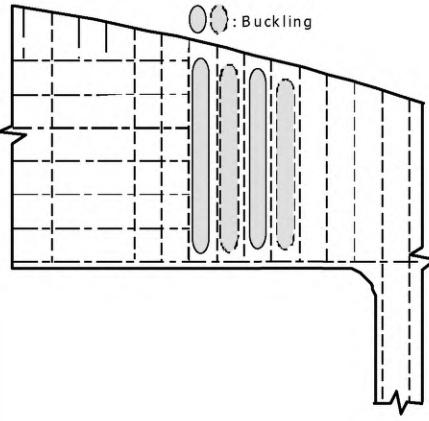
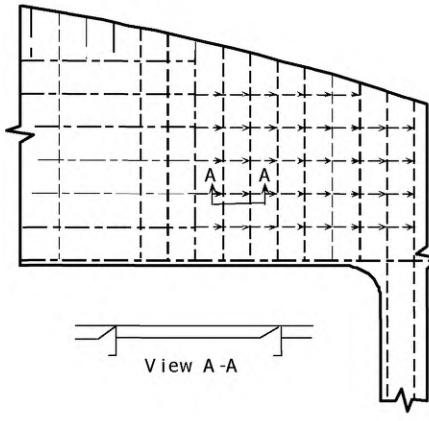
GENERAL CARGO SHIPS		Guidelines for Surveys, Assessment and Repair of Hull Structure
Part 1	Cargo hold region	Example No.
Area 1	Upper deck structure	1
Detail of damage	Buckling of deck plating of transverse framing system	
Sketch of damage

Notes on possible cause of damage	<p>1. Excessive compressive stress due to slamming or bow flare effect.</p> <p>2. Insufficient longitudinal stiffening of deck plating.</p>	
	<p>Notes on repairs</p> <p>1. Buckled plating should be cropped and renewed. Longitudinal internal stiffeners should be provided. (Instead of longitudinal stiffeners, renewal by thicker deck plating can be accepted.)</p> <p>2. Stress concentration may occur at the end of sniped stiffener resulting in fatigue fracture. For locations where high cyclic stress may occur, appropriate connection such as lug-connection should be considered.</p>

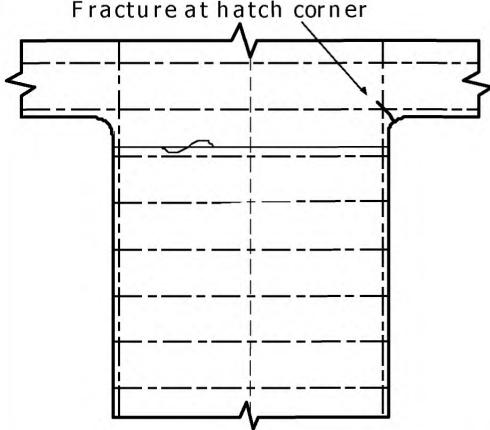
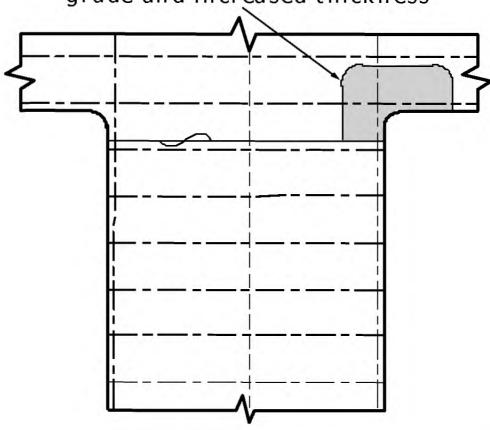
GENERAL CARGO SHIPS		Guidelines for Surveys, Assessment and Repair of Hull Structure
Part 1	Cargo hold region	Example No.
Area 1	Upper deck structure	2
Detail of damage	Fractures at main cargo hatch corner	
Sketch of damage

Notes on possible cause of damage	<p>1. Stress concentration at hatch corners, i.e. radius of corner. 2. Welded attachment of shedder plate close to edge of hatch corner. 3. Wire rope groove.</p>	
Notes on repairs	<p>1. The corner plating in way of the fracture is to be cropped and renewed. If stress concentration is primary cause, insert plate should be of increased thickness, enhanced steel grade and/or improved geometry. Insert plate should be continued beyond the longitudinal and transverse extent of the hatch corner radius ellipse or parabola, and the butt welds to the adjacent deck plating should be located well clear of the butts in the hatch coaming. It is recommended that the edges of the insert plate and the butt welds connecting the insert plates to the surrounding deck plating be made smooth by grinding. In this respect caution should be taken to ensure that the micro grooves of the grinding are parallel to the plate edge. 2. If the cause of fracture is welded attachment of shedder plate, the deck connection should be left unwelded. 3. If the cause of the fracture is wire rope groove, replacement to the original design can be accepted.</p>

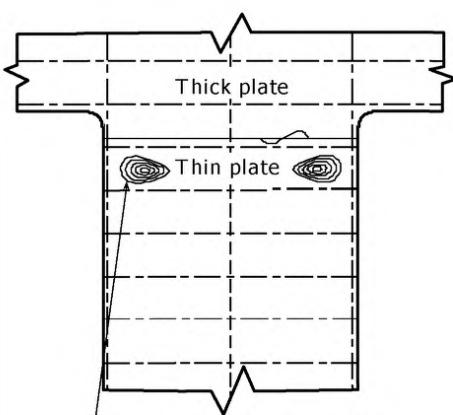
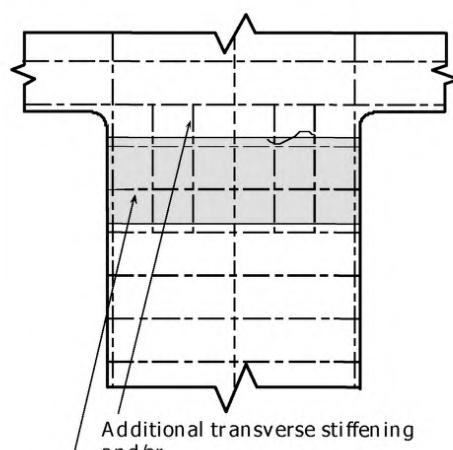
GENERAL CARGO SHIPS		Guidelines for Surveys, Assessment and Repair of Hull Structure
Part 1	Cargo hold region	Example No.
Area 1	Upper deck structure	3-b
Detail of damage	Plate buckling in thin plate near thick plate at cross deck	
Sketch of damage

Notes on possible cause of damage	<p>1. In-plane bending of cross deck strip due to torsional (longitudinal) movement of ship sides, often in combination with 2. corrosion.</p> <p>Insufficient transverse stiffening.</p>	
	<p>Notes on repairs</p> <p>1. Transverse stiffeners extending from hatch sides towards centerline at least 10% of breadth of hatch, and/or increased plate thickness in the same area.</p>

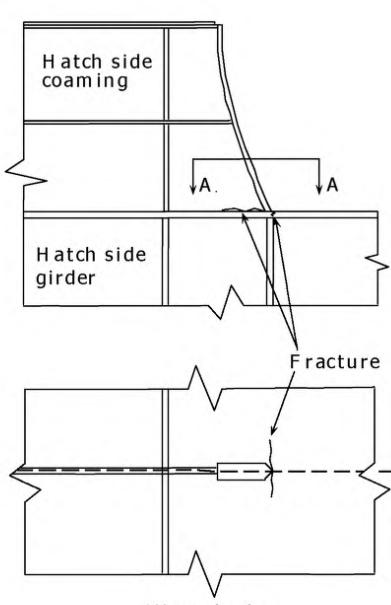
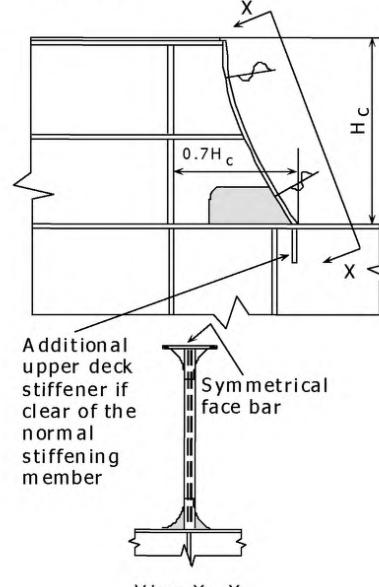
Notes on possible cause of damage <ol style="list-style-type: none"> 1. This damage is caused by stress concentrations attributed to the design of the bracket. 		
Notes on repairs <ol style="list-style-type: none"> 1. The design of the bracket can be altered as shown above, however, it is to be ensured that an additional under deck stiffener is provided at the toe of the termination bracket, where the toe is clear of the normal stiffening member. 2. Full penetration weld for a distance of 0.15 Hc from toe of side coaming termination bracket and for connection of athwartship gusset bracket to deck. 3. The fracture in deck plating to be vee'd-out and rewelded or deck plating cropped and part renewed as appropriate, using low hydrogen electrodes for welding.

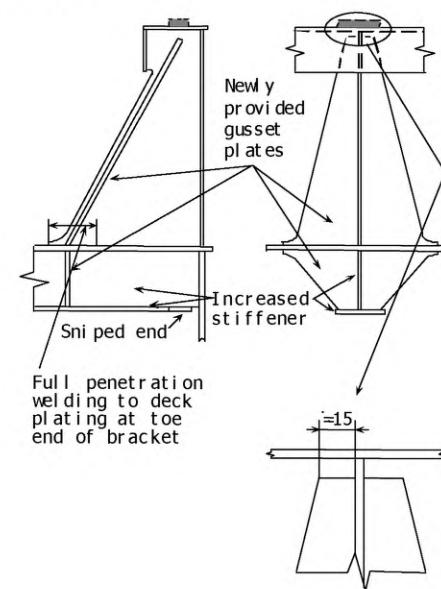
Notes on possible cause of damage	<p>1. Insufficient consideration of the horizontal friction forces in way of the resting pads for hatch cover.</p>	
Notes on repairs	<ol style="list-style-type: none"> 1. Modification of the design of the hatch coaming stay. 2. Full penetration welding between gusset plates and deck plating. 3. Strengthening and continuation of the structure below the deck. 4. Use pads with smaller coefficient of friction.

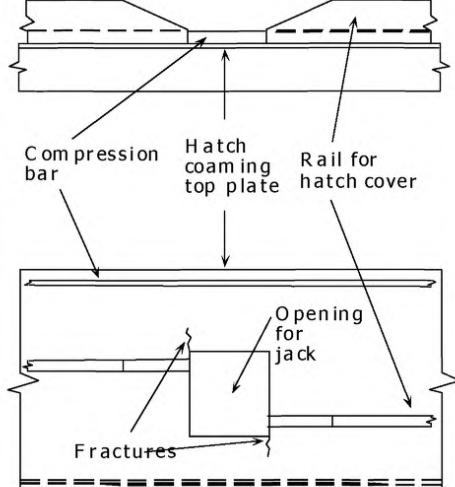
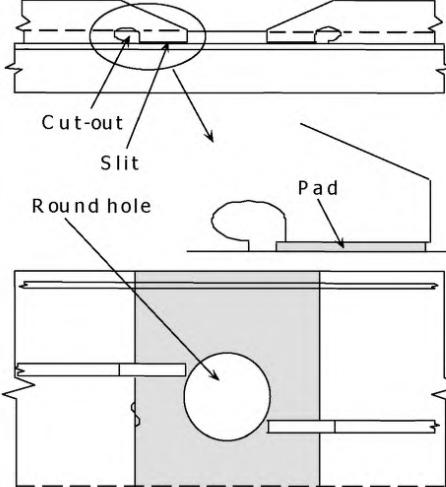
GENERAL CARGO SHIPS		Guidelines for Surveys, Assessment and Repair of Hull Structure
Part 1	Cargo hold region	Example No.
Area 1	Upper deck structure	7-b
Detail of damage	Fractures in hatch coaming top plate at the termination of rail for hatch cover	
Sketch of damage

Notes on possible cause of damage	<p>1. Stress concentration at the termination of the rail for hatch cover.</p>	
Notes on repairs	<p>1. Fractured plate is to be cropped and part renewed.</p> <p>2. Thicker insert plate and/or reduction of stress concentration adopting large radius should be considered. Or cut-out in the rail and detachment of the welds as shown in the above drawing should be considered in order to reduce the stress of the corner of the opening.</p>

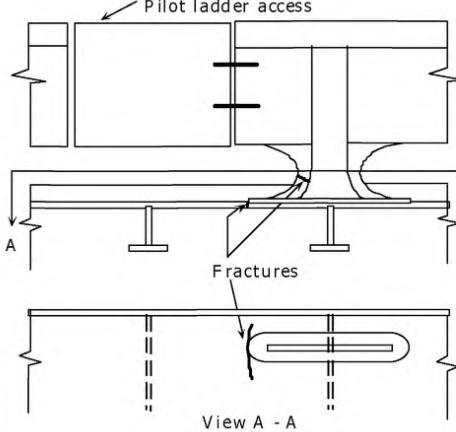
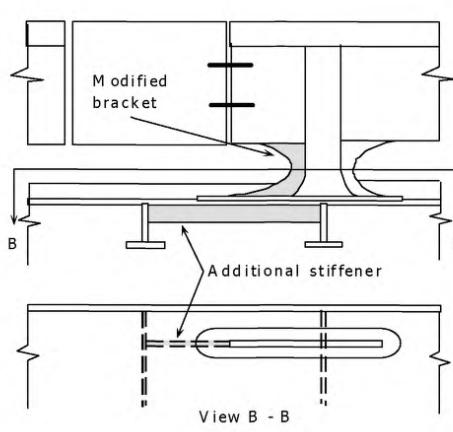
GENERAL CARGO SHIPS		Guidelines for Surveys, Assessment and Repair of Hull Structure
Part 1	Cargo hold region	Example No.
Area 1	Upper deck structure	9
Detail of damage	Fracture in deck plating at the pilot ladder access of bulwarks	
Sketch of damage

Notes on possible cause of damage	<p>1. Stress concentration at the termination of bulwarks.</p>	
	<p>Notes on repairs</p> <ol style="list-style-type: none"> 1. Fractured deck plating should be cropped and part renewed. 2. Reduction of stress concentration should be considered. In the above figure gusset plate was replaced with soft type for the fracture in gusset plate and pad plate was increased. Additional stiffeners were provided for the fracture in deck plating.

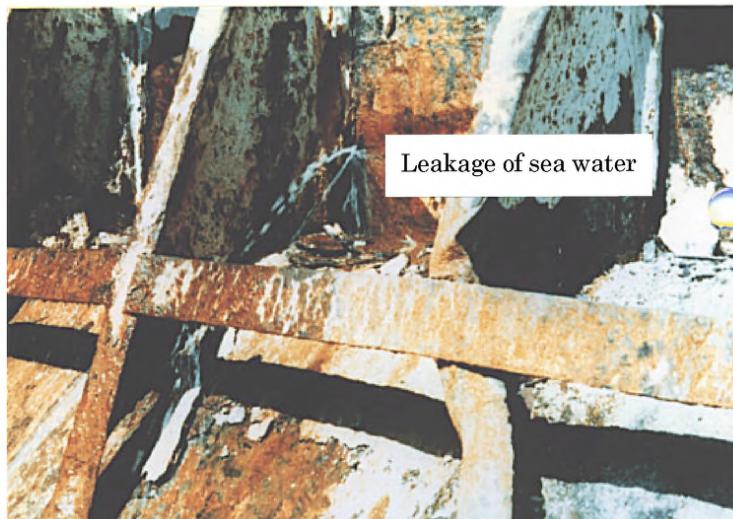
Photograph Leakage from side shell plating due to heavy corrosion

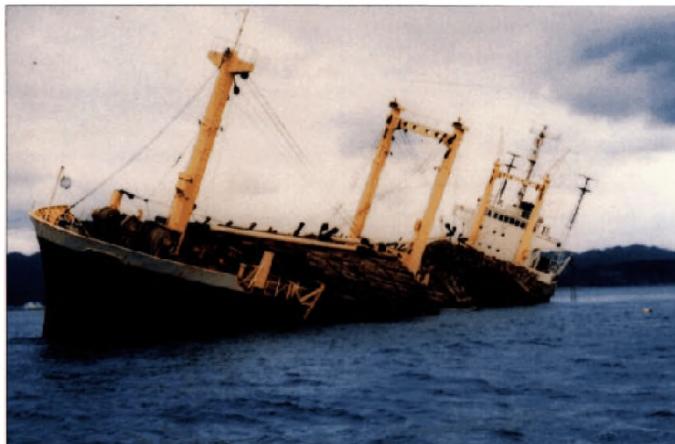
Photograph 2 Timber carrier listing due to ingress of water

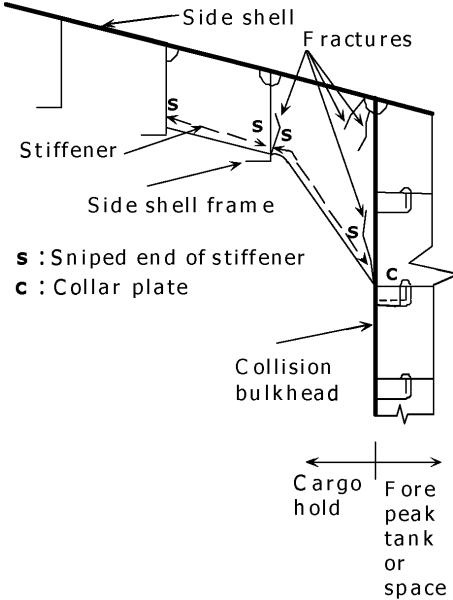
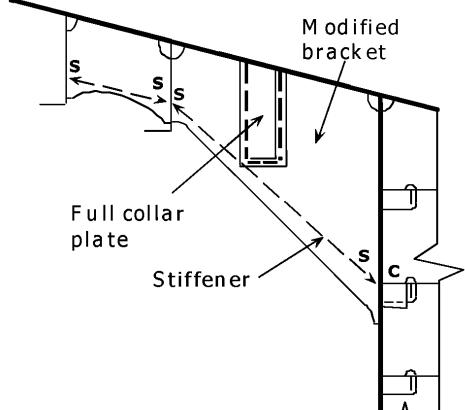
Notes on possible cause of damage	<p>1. Insufficient bracket size resulting in high stress due to load cantilevered from side frame.</p> <p>2. Stress concentration at toe of bracket and misalignment between bracket and stringer in fore peak tank or space.</p>	
	<p>Notes on repairs</p> <ol style="list-style-type: none"> 1. The extended bracket arm connection to the collision bulkhead is to have a soft toe, and any cut-outs for stiffeners in the fore peak tank or space are to be collared when situated in the vicinity of the bracket toe. 2. When fractures have extended into the side shell or bulkhead plating, the plating is to be cropped and part renewed.

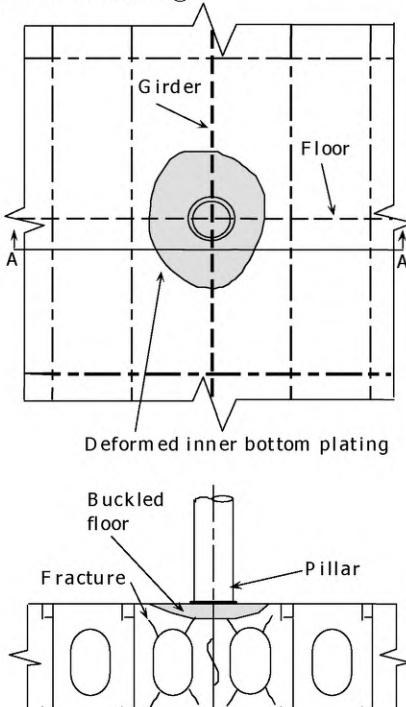
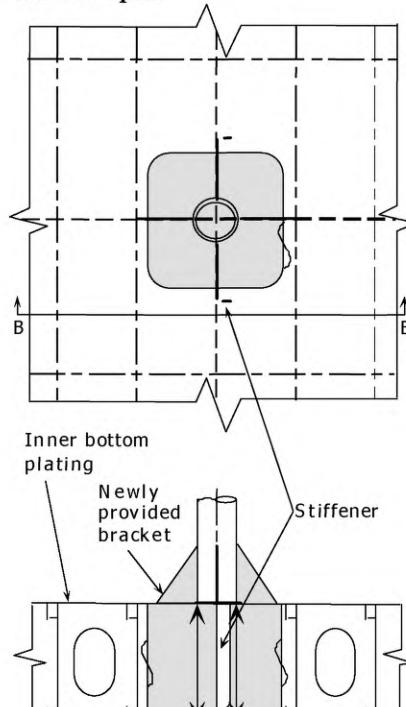
Notes on possible cause of damage <ol style="list-style-type: none"> 1. Inadequate arrangement and/or reinforcement of access holes. 2. Excessive deck-loading on tween deck. 		Notes on repairs <ol style="list-style-type: none"> 1. Dented inner bottom plating is to be cropped and part renewed. 2. The fractured floor is to be cropped and part renewed. 3. Access holes should be closed by insert plates. 4. Stiffener on floor/girder and/or brackets should be considered. (Fitting of brackets in the hold is subject to the agreement of the owner.)

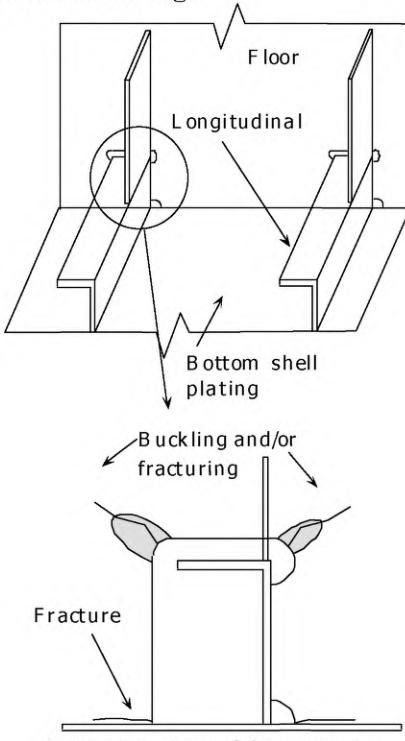
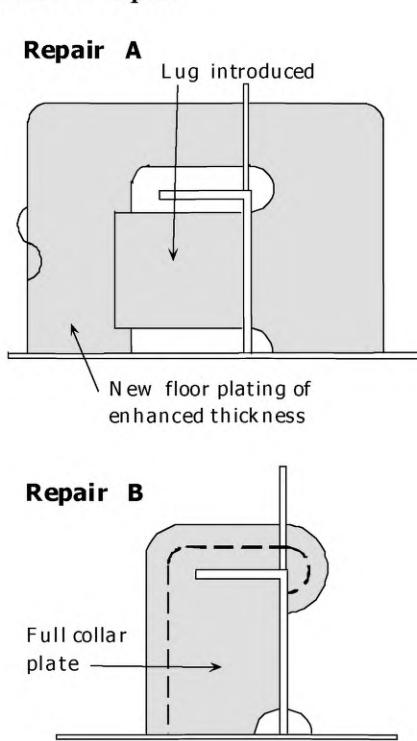
<p>Repair A Lug introduced New floor plating of enhanced thickness</p> <p>Repair B Full collar plate</p>
Notes on possible cause of damage		Notes on repairs
<p>1. Damage can be caused by general levels of corrosion and presence of stress concentration associated with the presence of a cut-out.</p>		<p>1. If fractures are significant then crop and part renew the floor plating otherwise the fracture can be vee'd-out and welded provided the plating is not generally corroded.</p> <p>2. Repair B is to be incorporated if the lug proves to be ineffective.</p>

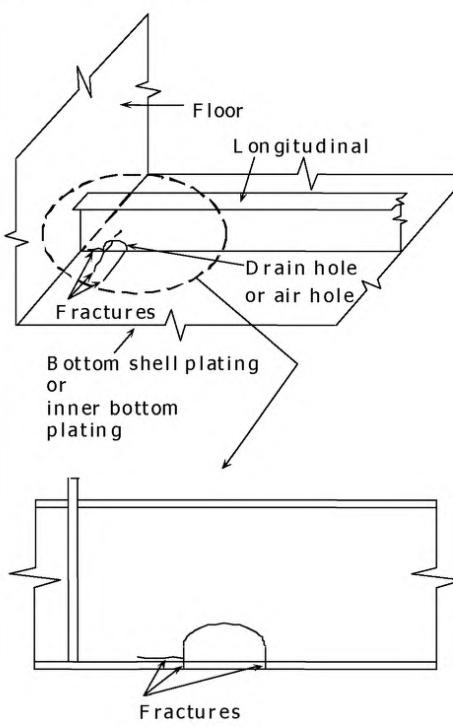
Notes on possible cause of damage	<p>1. Stress concentration and/or corrosion due to stress concentration at the corner of drain hole/air hole.</p>	
Notes on repairs	<ol style="list-style-type: none"> 1. Fractured plating should be cropped and part renewed. 2. If fatigue life is to be improved, change of drain hole/air hole shape is to be considered.

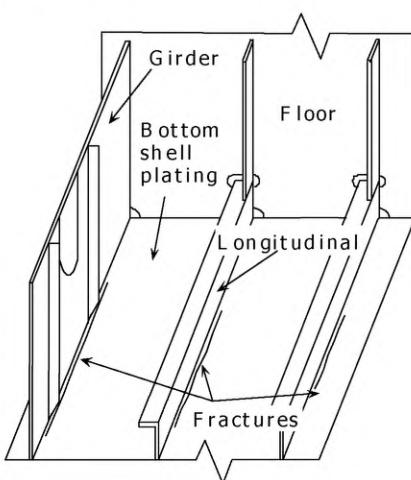
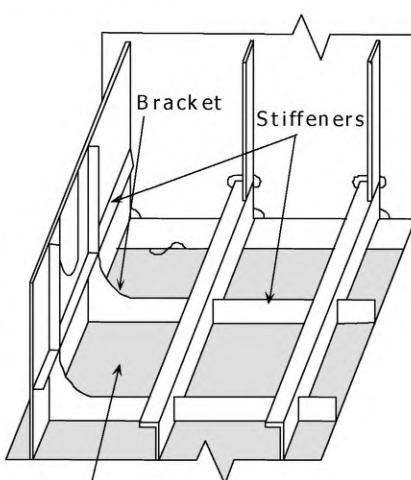
Renewed bottom shell plating
Notes on possible cause of damage 1. Vibration.		Notes on repairs 1. Fractured bottom shell plating should be cropped and renewed. 2. Natural frequency of the panel should be changed, e.g. reinforcement by additional stiffener/bracket.

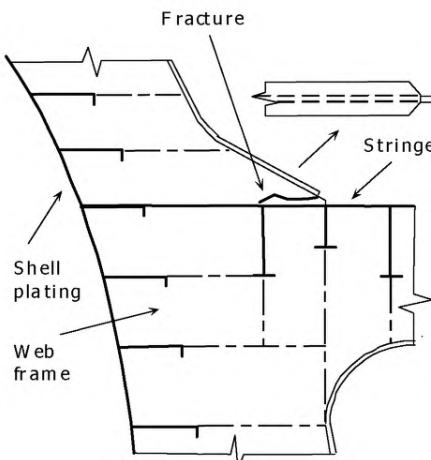
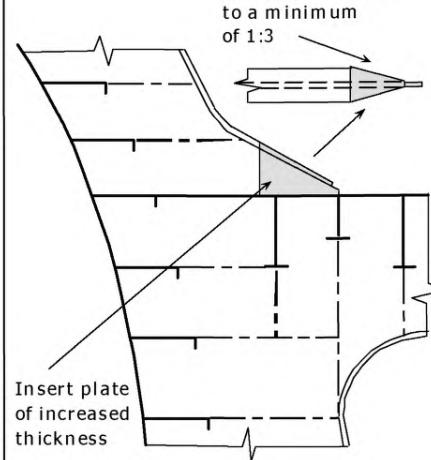
Notes on possible cause of damage	<p>1. Inadequate bracket forming the web frame connection to the stringer.</p> <p>2. Localized material wastage in way of coating failure at bracket due to flexing of the structure.</p> <p>3. Dynamic seaway loading in way of bow flare.</p>	
	<p>Notes on repairs</p> <p>1. Adequate soft nose bracket endings with a face plate taper of at least 1 : 3 to be provided.</p>

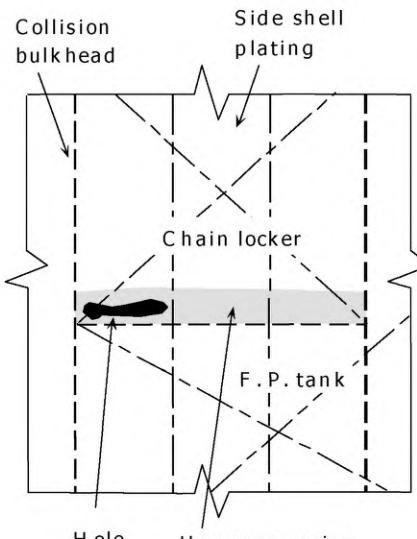
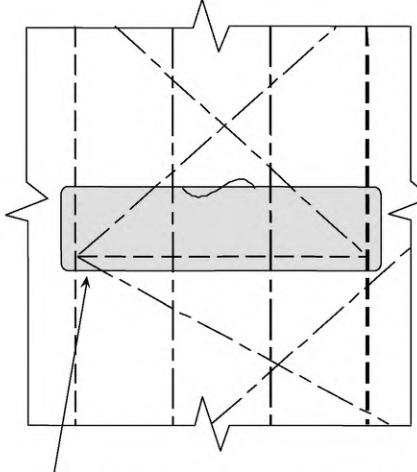
<p>Renewal of shell plating including internals as found necessary</p>	
Notes on possible cause of damage	<p>1. Heavy corrosion in region where mud is accumulated.</p>	
Notes on repairs	<ol style="list-style-type: none"> 1. Corroded plating should be cropped and renewed. 2. Protective coating should be applied.

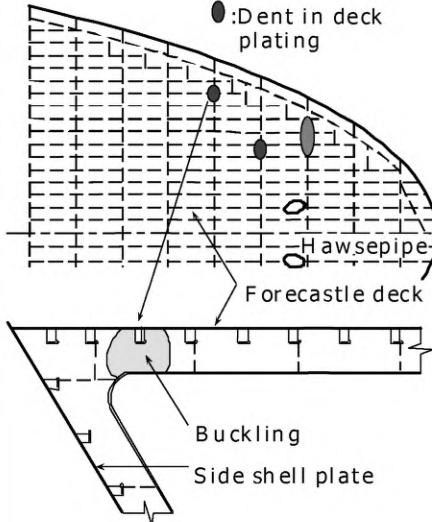
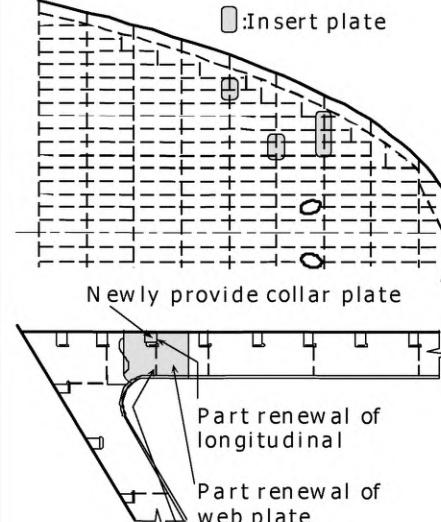
<p>Insert plate</p> <p>Newly provide collar plate</p> <p>Part renewal of longitudinal</p> <p>Part renewal of web plate</p> <p>Newly provided stiffener</p>	
Notes on possible cause of damage	<p>Notes on repairs</p> <ol style="list-style-type: none"> 1. Green sea on deck. 2. Insufficient strength. <ol style="list-style-type: none"> 1. Deformed structure should be cropped and renewed. 2. Additional stiffeners on web of beam should be considered for reinforcement.

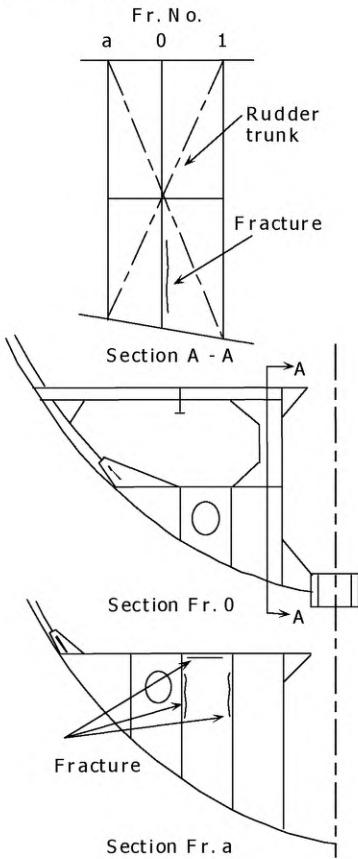
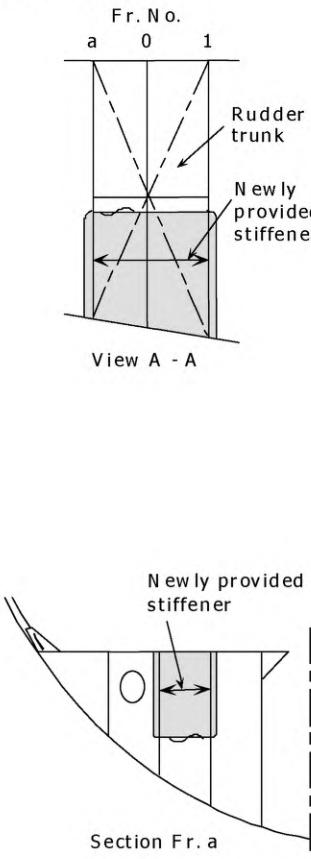
Notes on possible cause of damage <ol style="list-style-type: none"> 1. Vibration. 		Notes on repairs <ol style="list-style-type: none"> 1. The fractured plating should be cropped and renewed. 2. Natural frequency of the plate between stiffeners should be changed, e.g. reinforcement by additional stiffeners.

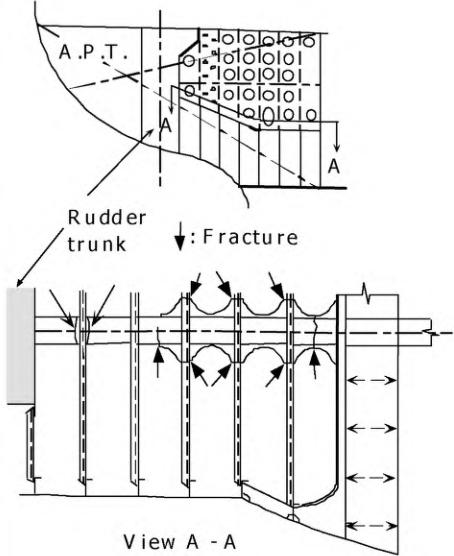
Notes on possible cause of damage		Notes on repairs
1. Vibration.		<ol style="list-style-type: none"> 1. The fractured plating should be cropped and renewed. 2. Natural frequency of the panel should be changed, e.g. reinforcement by additional strut.

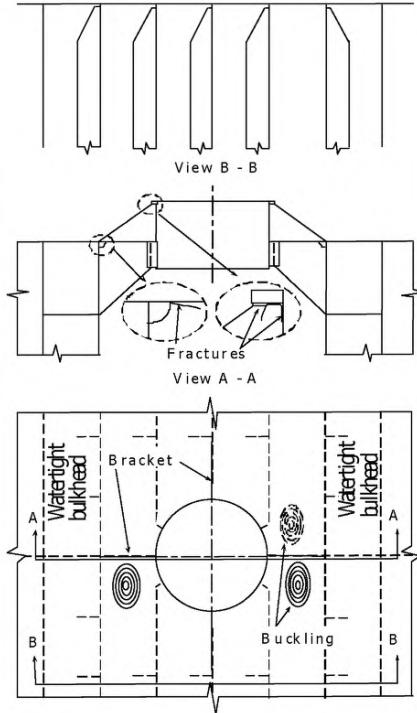
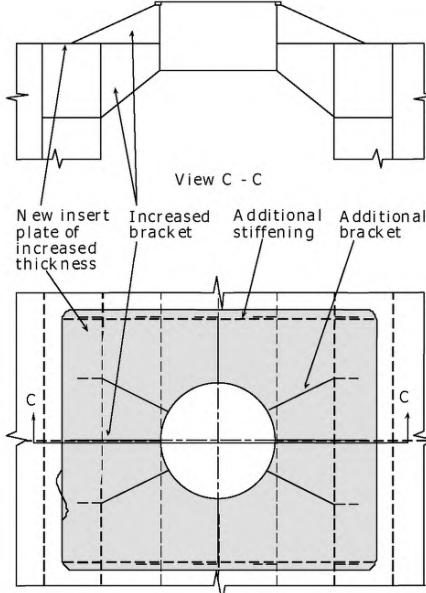
Sketch of repair
Notes on possible cause of damage <ol style="list-style-type: none"> 1. Insufficient deck strengthening (missing base plate). 2. Insufficient strengthening of steering gear foundation. 3. Bolts of steering gear were not sufficiently pre-loaded. 		Notes on repairs <ol style="list-style-type: none"> 1. New insert base plate of increased plate thickness. 2. Additional longitudinal stiffening at base plate edges. 3. Additional foundation brackets above and under deck (star configuration).

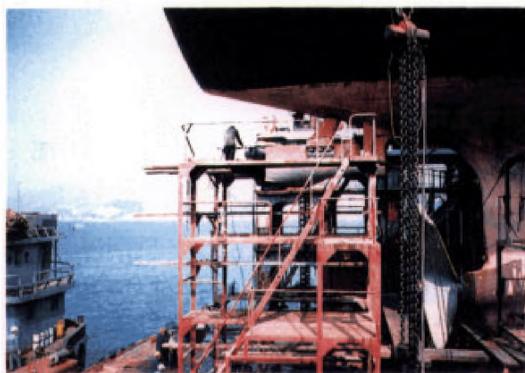
Photograph 1
Fractured rudder due to corrosion in rudder plating

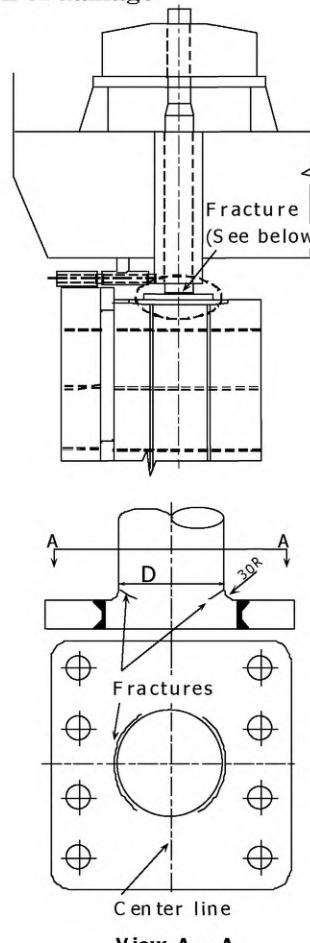
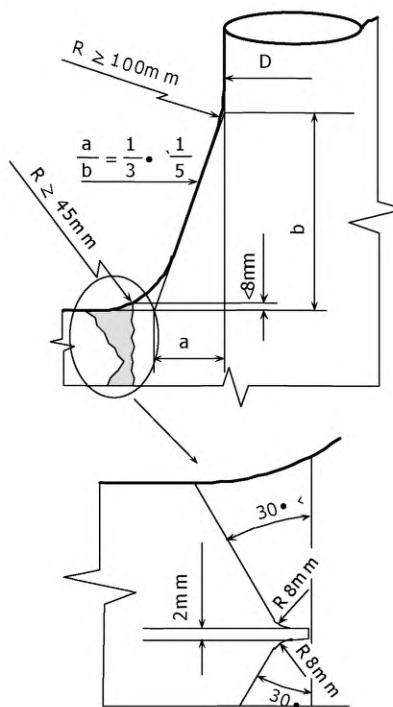
Notes on possible cause of damage	<p>1. Inadequate design for stress concentration in rudder stock.</p>	
Notes on repairs	<p>1. Modification of detail design of rudder stock to reduce the stress concentration.</p>

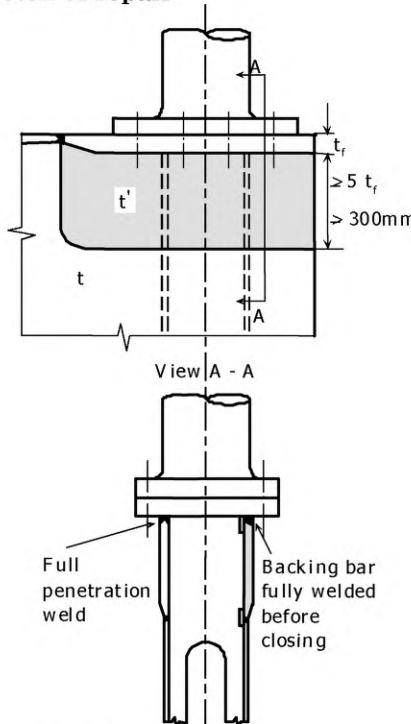
Notes on possible cause of damage	<p>1. Inadequate connection between palm plate and rudder blade plating (insufficient plating thickness and/or insufficient fillet weld).</p>	
	<p>Notes on repairs</p> <p>1. Modification of detail design of the connection by increasing the plate thickness and full penetration welding.</p>

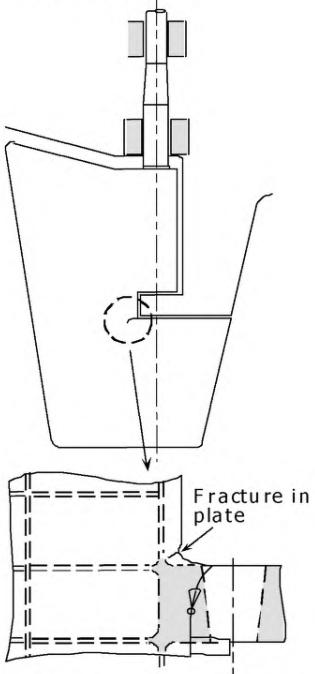
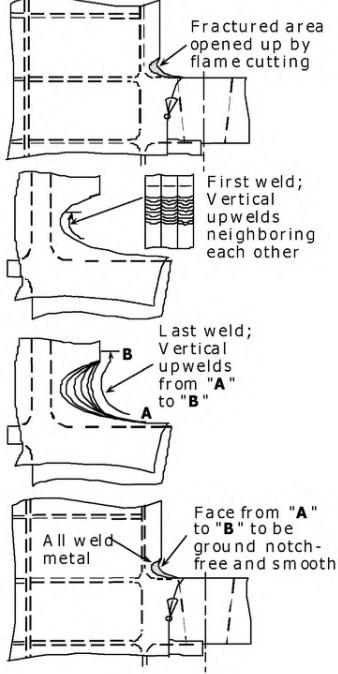
Notes on possible cause of damage	<p>1. Stress concentration due to inadequate local design and/or fabrication notches in way of the butt weld between cast piece and plating.</p>	
Notes on repairs	<ol style="list-style-type: none"> 1. Grooving-out and welding of the fracture is not always adequate (metallurgical notch in way of a high stressed area). 2. In the proposed repair procedure the metallurgical notches are shifted into a zone exposed to lower stresses. 3. After welding a modification of the radius according to the proposal in Example 5 is to be carried out. 4. In case of very small crack it can be ground off by increasing the radius.

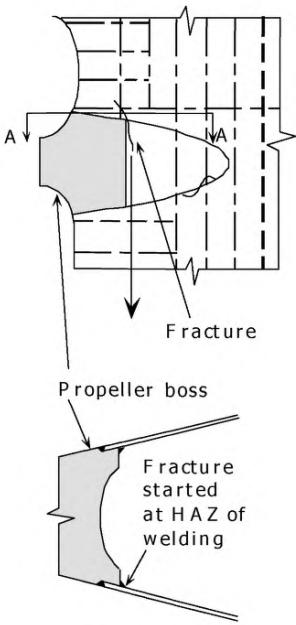
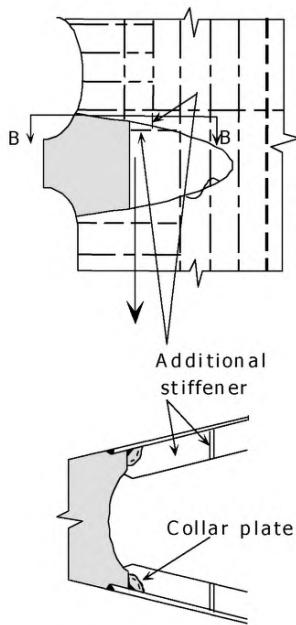
<p>Enlarged View B - B</p>
Notes on possible cause of damage 1. Fatigue fracture due to vibration.		Notes on repairs 1. Fractured side shell plating is to be cropped and part renewed. 2. Additional stiffeners are to be provided. 3. Collar plate is to be provided.

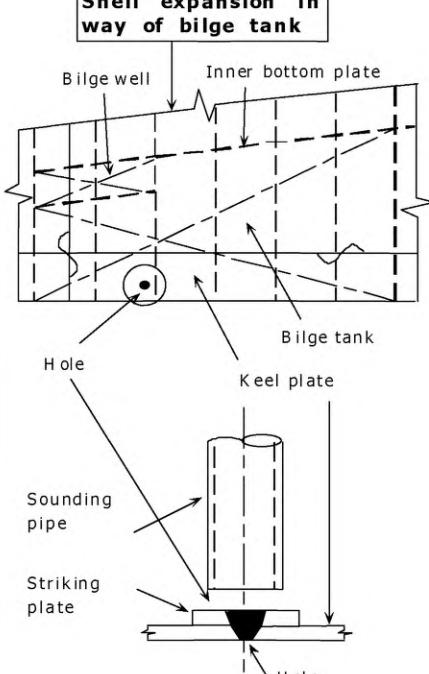
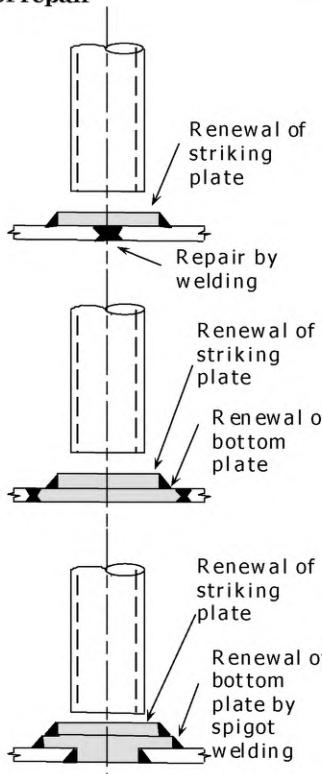
Notes on possible cause of damage <ol style="list-style-type: none"> 1. Heavy corrosion of bottom plating under sounding pipe. 		
Notes on repairs <ol style="list-style-type: none"> 1. Corroded striking plating should be renewed. 2. Bottom plate should be repaired depending on the condition of corrosion. (Note) Repair by spigot welding can be applied to the structure only when the stress level is considerably low. Generally this procedure cannot be applied to the repair of bottom plating of ballast tanks in cargo hold region.

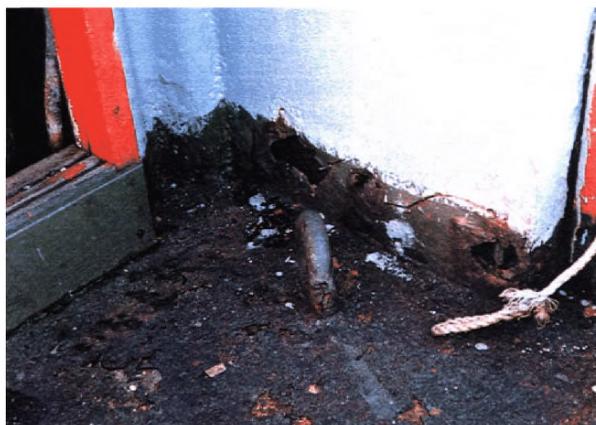
Photograph 1 Corroded accommodation house structure
