**No. 96**

**Double Hull Oil Tankers** - Guidelines for Surveys,  
Assessment and Repair of Hull Structures

# IACS

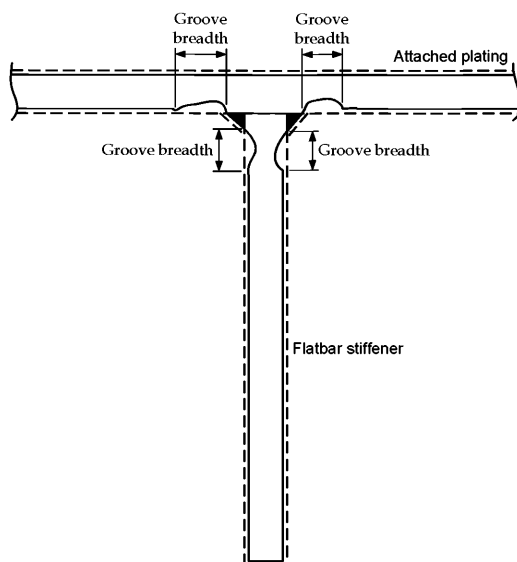
**Figure 8 Grooving Corrosion**

Grooving corrosion is often found in or beside welds, especially in the heat affected zone. This corrosion is sometimes referred to as 'inline pitting attack' and can also occur on vertical members and flush sides of bulkheads in way of flexing. The corrosion is caused by the galvanic current generated from the difference of the metallographic structure between the heat affected zone and base metal. Coating of the welds is generally less effective compared to other areas due to roughness of the surface, which exacerbates the corrosion. Grooving corrosion may lead to stress concentrations and further accelerate the corrosion process. Grooving corrosion may be found in the base material where coating has been scratched or the metal itself has been mechanically damaged. An example of grooving corrosion is shown in Figure 8.

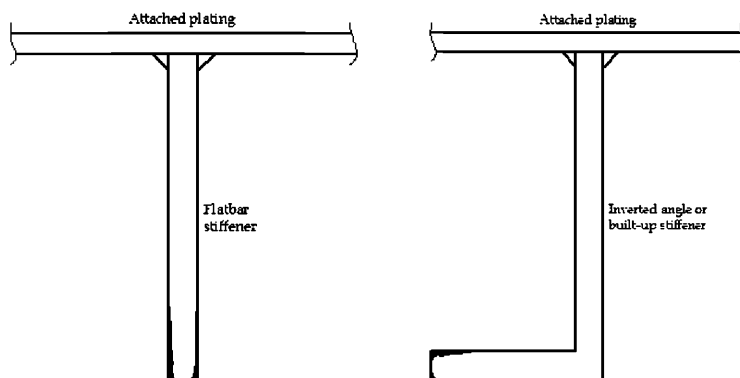
**Figure 9      Edge Corrosion**

Edge corrosion is defined as local corrosion at the free edges of plates, stiffeners, primary support members and around openings. An example of edge corrosion is shown in Figure 9.

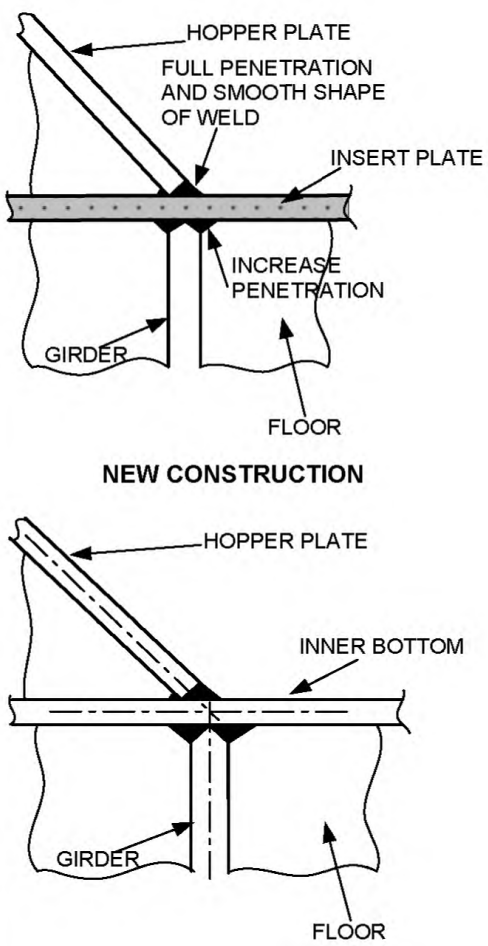
| OIL Tankers | | Guidelines for Surveys, Assessment and Repair of Hull Structure |
|---|---|---|
| <b>Factors which may have caused damage</b> <ol style="list-style-type: none"> <li>1. Stress concentration at juncture of hopper plate to inner bottom.</li> <li>2. Insufficient welding connection.</li> <li>3. Misalignment between hopper plate, inner bottom and girder.</li> </ol> | | <b>Notes on repairs</b><br>See Sketch. |

| OIL Tankers | | Guidelines for Surveys, Assessment and Repair of Hull Structure |
|---|---|---|
| | | <p><b>Notes:</b> Plate midlines intersect</p> |

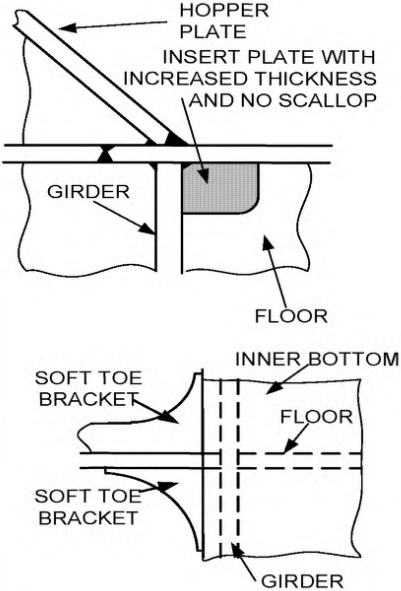
| OIL Tankers | | Guidelines for Surveys, Assessment and Repair of Hull Structure | |
|---|---|---|--|
| Detail of damage | | Fracture at connection of bilge hopper plate and inner bottom | |
| <b>Factors which may have caused damage</b><br>1. Stress concentration at the knuckle. | | <b>Notes on repairs</b><br>See Sketch. | |

| OIL Tankers | | Guidelines for Surveys, Assessment and Repair of Hull Structure | |
|---|---|---|--|
| <b>Sketch of damage</b> | | <b>Sketch of repair</b> <p><b>Notes:</b> Plate midlines intersect</p> | |

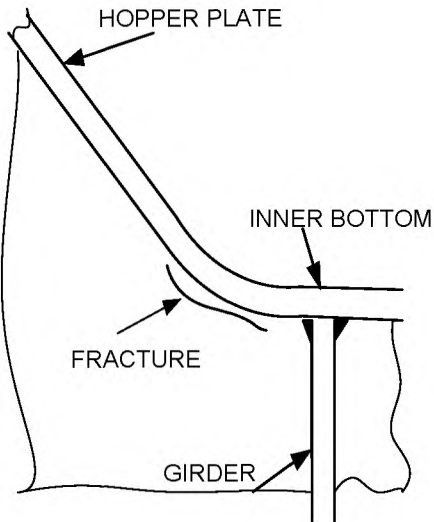
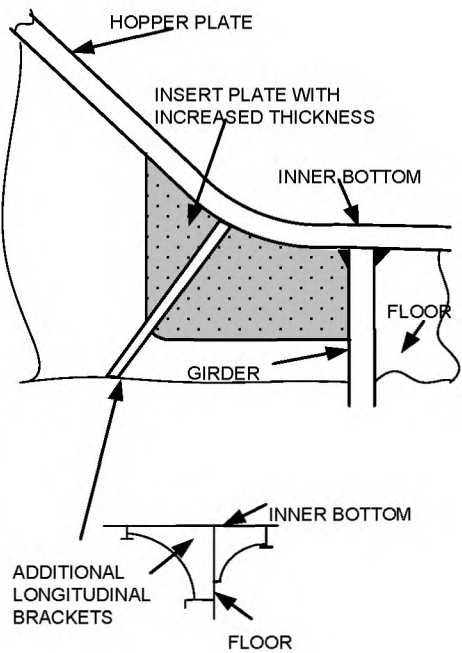
| OIL Tankers | | Guidelines for Surveys, Assessment and Repair of Hull Structure |
|---|---|---|
| Detail of damage | Fracture at connection of bilge hopper plate and web frame | |
| <b>Factors which may have caused damage</b><br>1. Stress concentration due to reduction of effective flange area at curved plate. | | <b>Notes on repairs</b><br>See Sketch. |

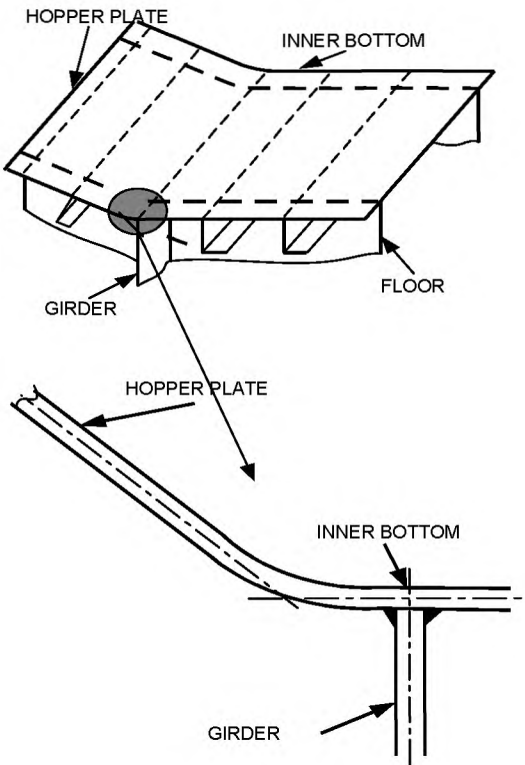
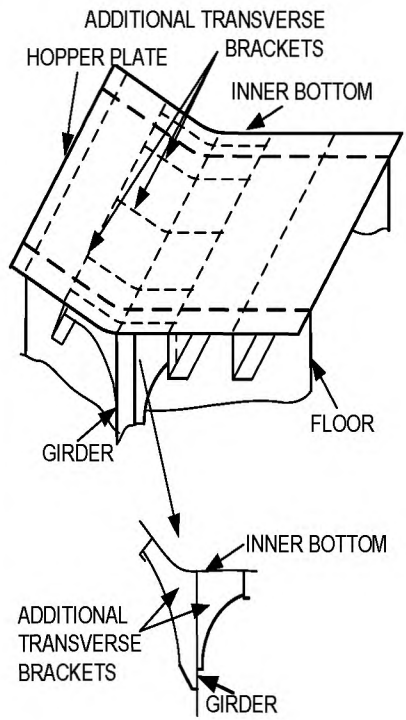
| OIL Tankers | | Guidelines for Surveys, Assessment and Repair of Hull Structure |
|---|---|---|
| Detail of damage | | Rounded hopper plate deformation in way of the floor |
| <b>Factors which may have caused damage</b> <ol style="list-style-type: none"> <li>1. Misalignment. The three midlines do not cross at the same joint. This misalignment produces an out-of-plane deformation in knuckled plate in the vicinity of floor.</li> <li>2. Insufficient stiffening between floors.</li> </ol> | | <b>Notes on repairs</b><br>See Sketch. |

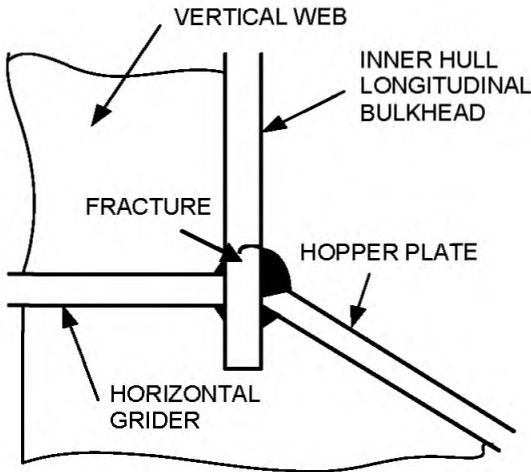
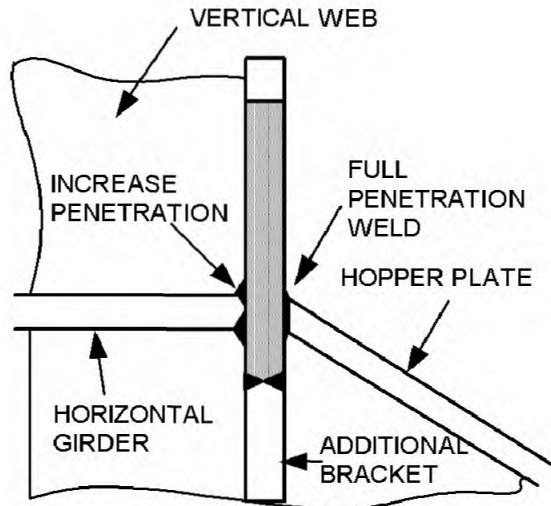
| OIL Tankers | | Guidelines for Surveys, Assessment and Repair of Hull Structure |
|---|---|---|
| <b>Factors which may have caused damage</b> <ol style="list-style-type: none"> <li>1. Stress concentration at junction of hopper plate to outside longitudinal bulkhead.</li> <li>2. Insufficient welding connection and/or incorrect shape of the weld toe.</li> <li>3. Misalignment between hopper plate, outside longitudinal bulkhead and side stringer.</li> </ol> | | <b>Notes on repairs</b><br>See Sketch. |

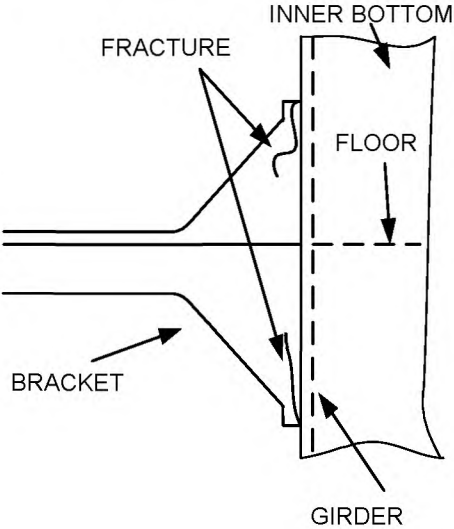
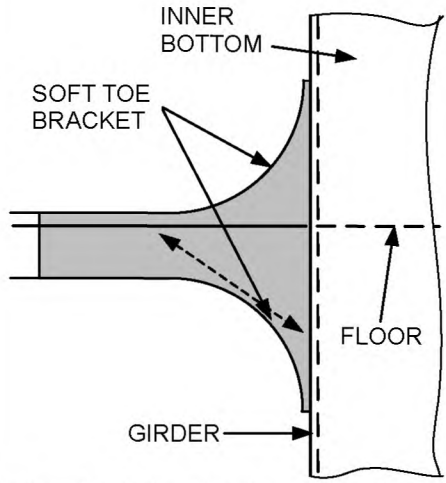
| OIL Tankers | | Guidelines for Surveys, Assessment and Repair of Hull Structure |
|---|---|---|
| Detail of damage | | Fracture in gusset plate in line with inner bottom |
| <b>Factors which may have caused damage</b> <ol style="list-style-type: none"> <li>1. Stress concentration due to small radius and abrupt toe.</li> <li>2. Insufficient welding.</li> <li>3. Insufficient sectional area (thickness x breadth) of the connecting bracket.</li> </ol> | | <b>Notes on repairs</b><br>See Sketch. |

| OIL Tankers | | Guidelines for Surveys, Assessment and Repair of Hull Structure |
|---|---|---|
| <b>Sketch of damage</b> | | <b>Sketch of repair</b> <p><b>Notes:</b> Bracket radii as large as practicable.<br/>Bracket same thickness as inner bottom stiffener.<br/>Toe height should be small as possible while still allowing return weld (wrapped weld).</p> |

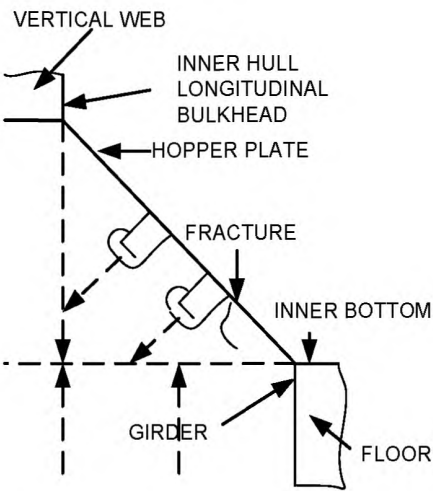
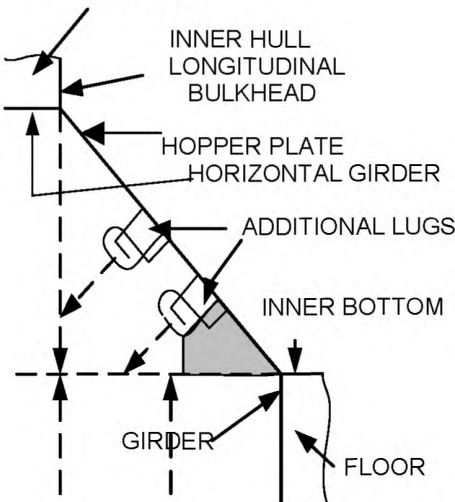
| OIL Tankers | | Guidelines for Surveys, Assessment and Repair of Hull Structure |
|---|---|---|
| Detail of damage | | Fracture in way of cut-out in hopper plate |
| <b>Factors which may have caused damage</b><br>1. Stress concentration due to no collar plate. | | <b>Notes on repairs</b><br>See Sketch. |

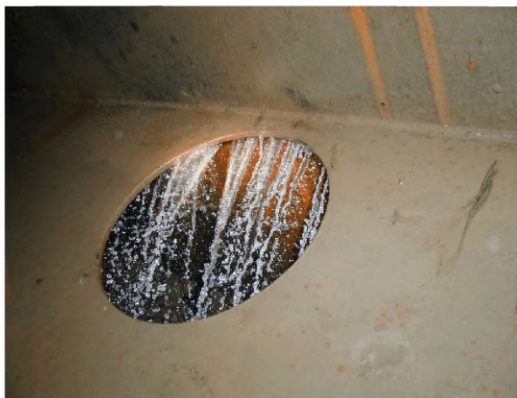
**Photograph 1 Side shell fracture in way of horizontal stringer weld**

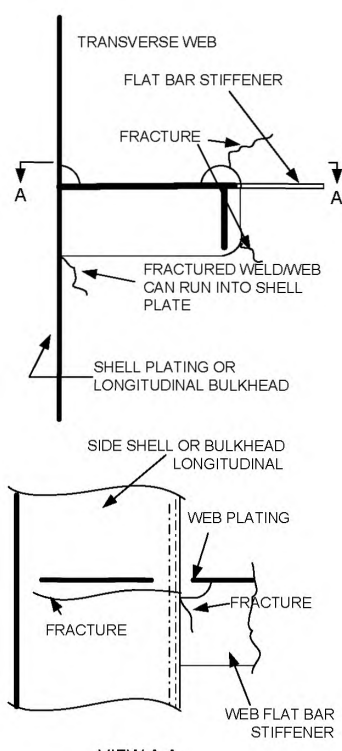
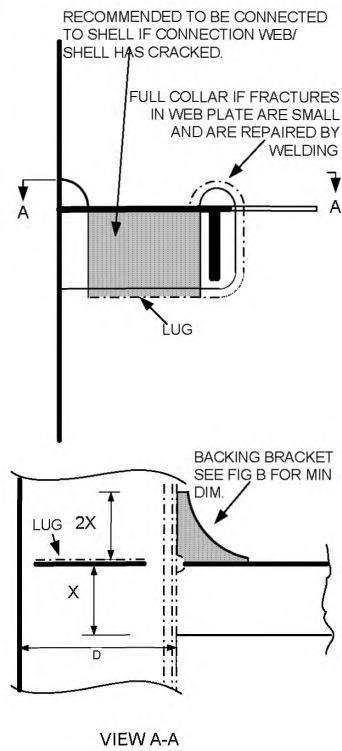
| OIL Tankers | | Guidelines for Surveys, Assessment and Repair of Hull Structure | |
|---|---|---|--|
| <b>Factors which may have caused damage</b> <ol style="list-style-type: none"> <li>1. Asymmetrical connection of flat bar stiffener resulting in high peak stress at heel of the stiffener under fatigue loading.</li> <li>2. Insufficient area of connection of longitudinal to web plate.</li> <li>3. Defective weld at return around the plate thickness.</li> <li>4. High localized corrosion at areas of stress concentrations such as flat bar stiffener connections, corners of cut out for longitudinal and connection of web to shell at cut outs.</li> <li>5. High shear stress in web of the transverse.</li> <li>6. Dynamic seaway loads/motions.</li> </ol> | | <b>Notes on repairs</b><br>See Sketch.<br>May also fit a double bracket to avoid fracture from toe. | |

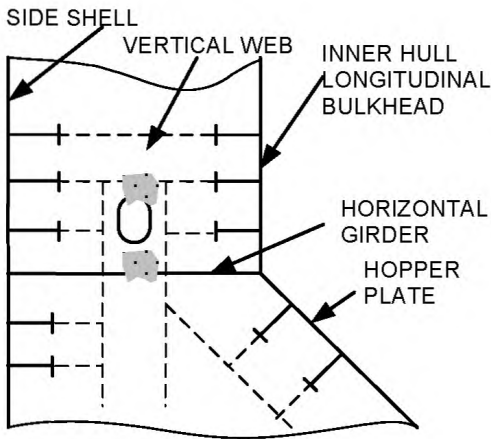
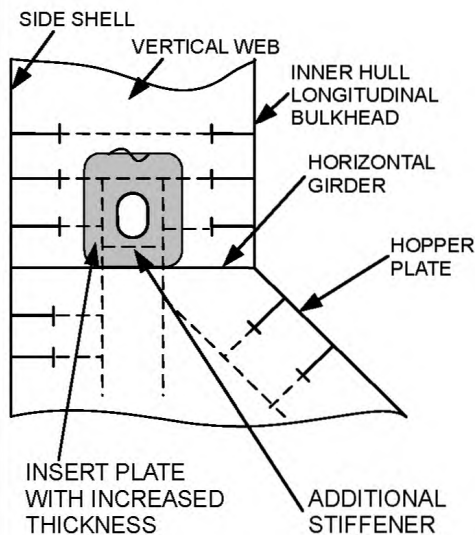
| OIL Tankers | | Guidelines for Surveys, Assessment and Repair of Hull Structure | |
|---|---|---|--|
| <b>Factors which may have caused damage</b><br>1. High shear stress in the transverse web.<br>2. Insufficient buckling strength. | | <b>Notes on repairs</b><br>See Sketch. | |

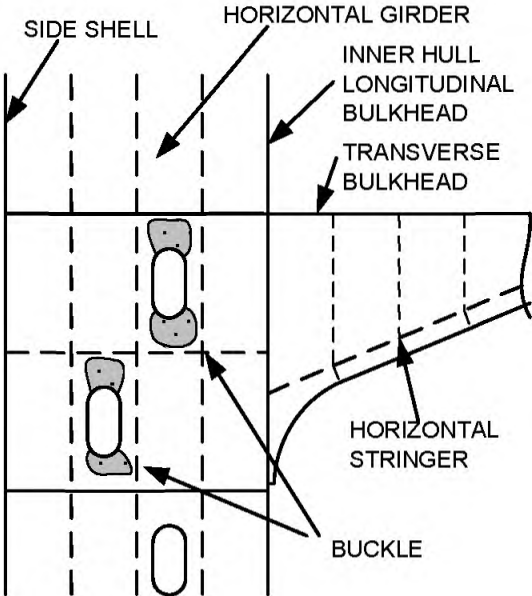
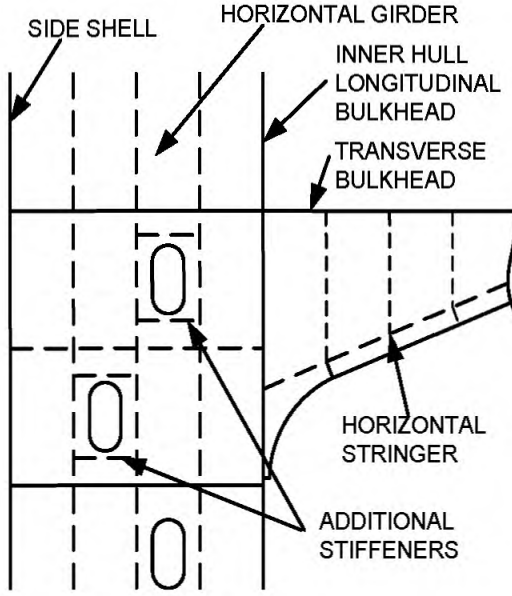
| OIL Tankers | | Guidelines for Surveys, Assessment and Repair of Hull Structure | |
|---|---|---|--|
| Detail of damage | | Panels of side horizontal girders in way of transverse bulkhead | |
| <b>Factors which may have caused damage</b> <ol style="list-style-type: none"> <li>1. High shear or compressive stress in the stringer.</li> <li>2. Insufficient buckling strength.</li> </ol> | | <b>Notes on repairs</b><br>See Sketch. | |

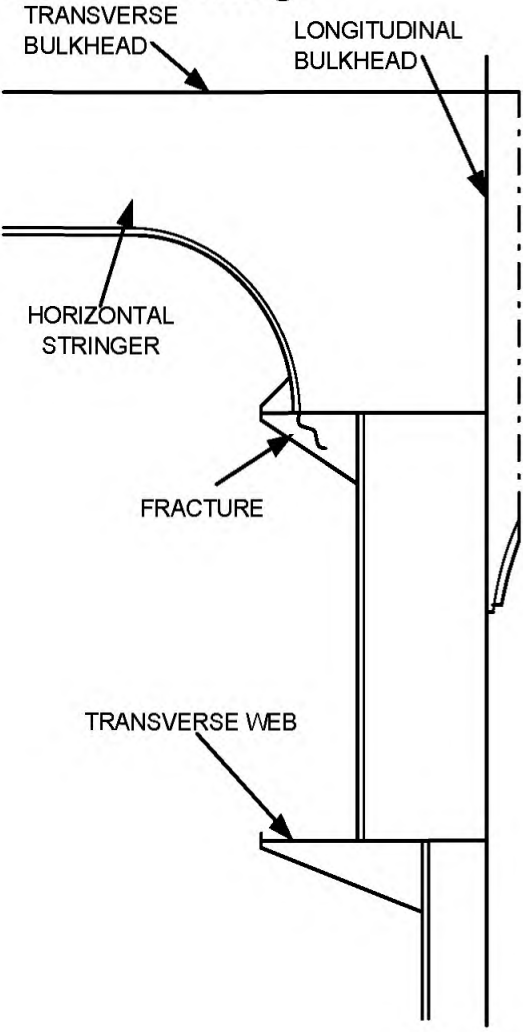
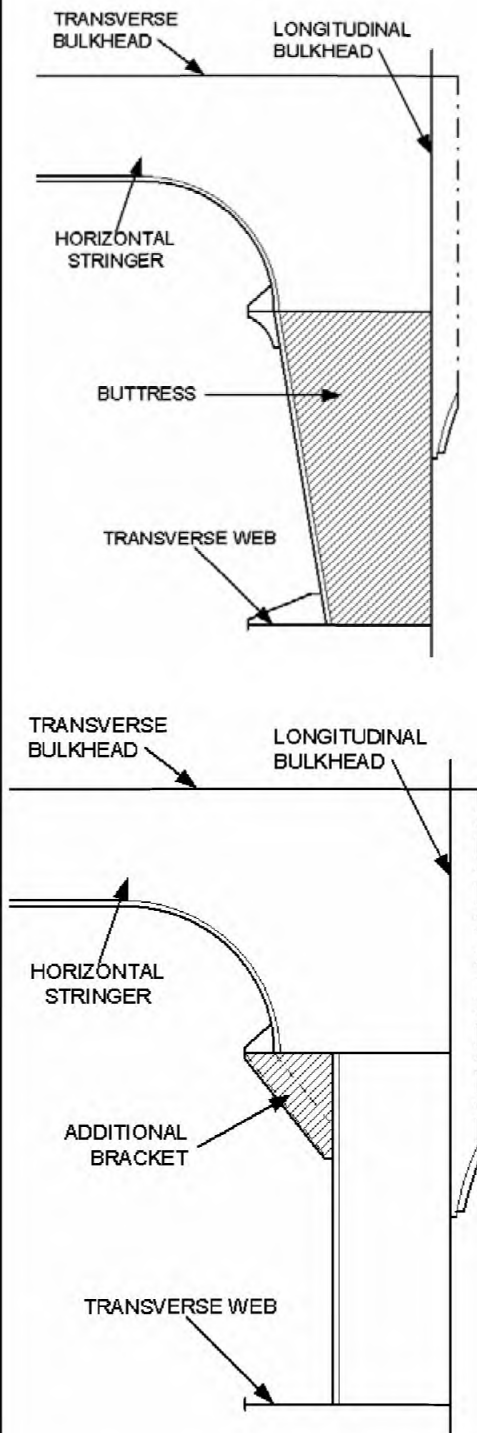
| OIL Tankers | | Guidelines for Surveys, Assessment and Repair of Hull Structure |
|---|---|---|
| Detail of damage | | Fracture at connection of horizontal stringers to transverse web frames and horizontal girders |
| <b>Factors which may have caused damage</b><br>1. Stress concentration due to discontinuous structure.<br>2. High shear stress in the horizontal stringer. | | <b>Notes on repairs</b><br>See Sketch. |

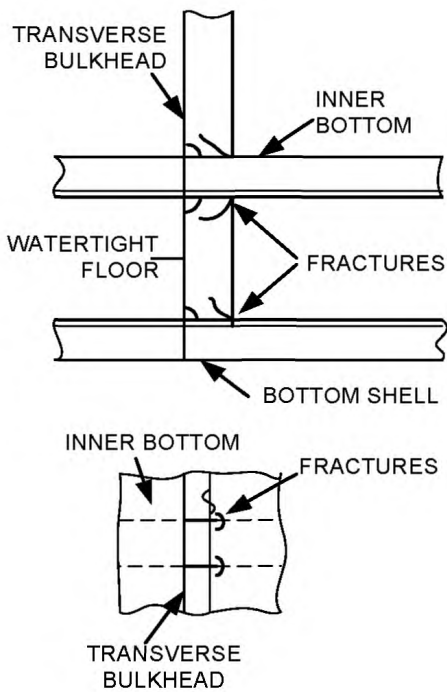
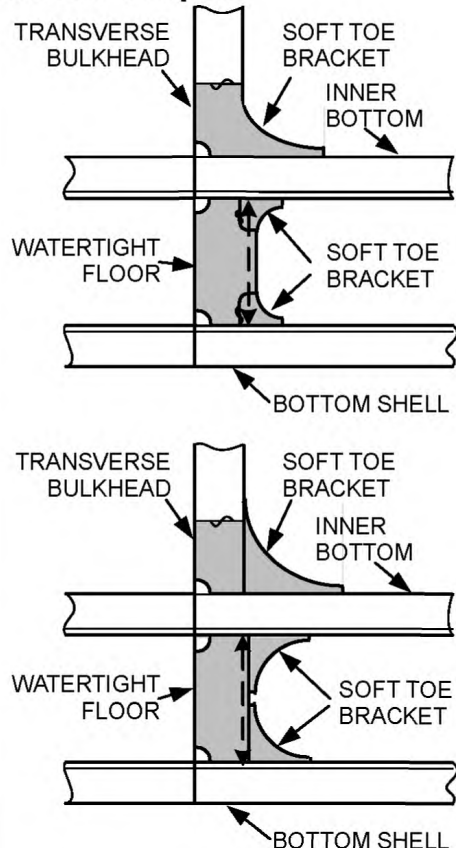
| OIL Tankers | | Guidelines for Surveys, Assessment and Repair of Hull Structure | |
|---|---|---|--|
| <b>Factors which may have caused damage</b> <ol style="list-style-type: none"> <li>1. Misalignment between bulkhead stiffener and inner bottom longitudinal.</li> <li>2. High stress concentration.</li> </ol> | | <b>Notes on repairs</b> <p>See Sketch.</p> <ol style="list-style-type: none"> <li>1. If tank top plating is fractured, part crop and insert.</li> <li>2. Proper alignment between bulkhead stiffener and inner bottom longitudinal is critical for successful repair.</li> <li>3. Soft backing brackets may also be added.</li> </ol> | |

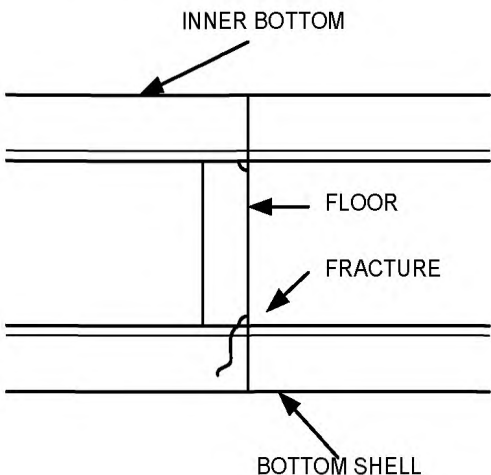
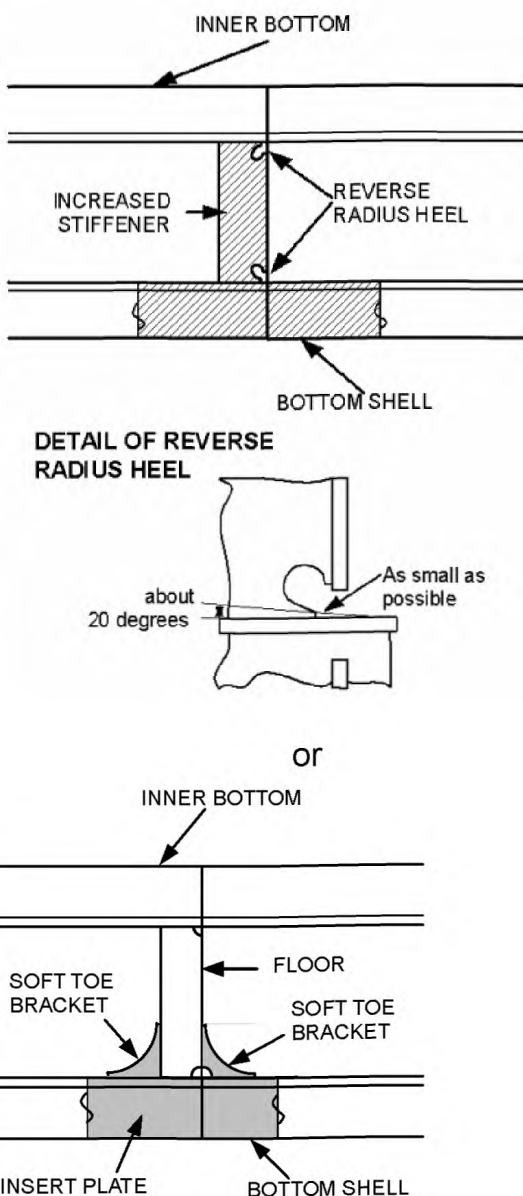
| OIL Tankers | | Guidelines for Surveys, Assessment and Repair of Hull Structure | |
|---|---|---|--|
| <b>Factors which may have caused damage</b> <ol style="list-style-type: none"> <li>1. Asymmetrical connection.</li> <li>2. Relative deflection of adjacent floor to transverse bulkhead.</li> </ol> | | <b>Notes on repairs</b><br>See Sketch. | |

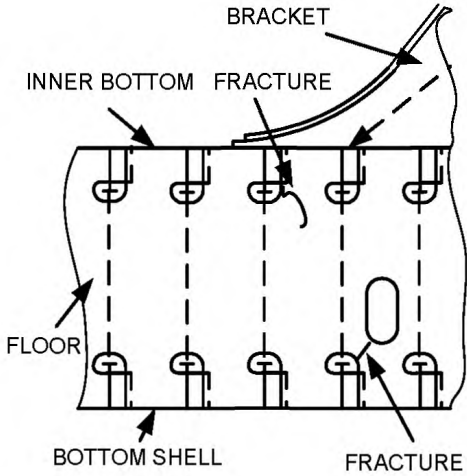
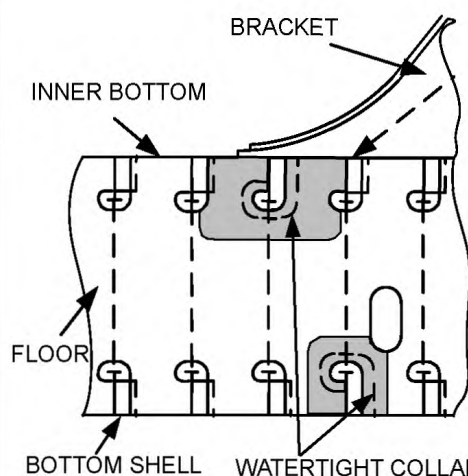
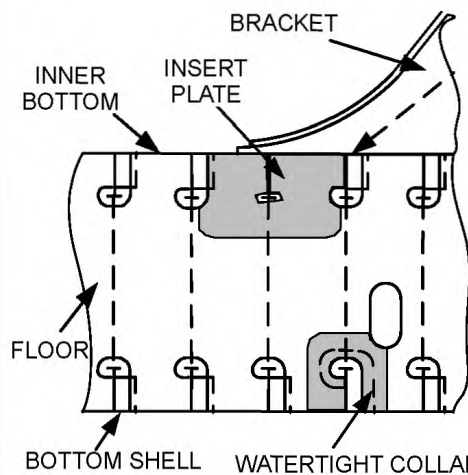
| OIL Tankers | | Guidelines for Surveys, Assessment and Repair of Hull Structure | |
|---|---|---|--|
| <b>Factors which may have caused damage</b> <ol style="list-style-type: none"> <li>1. High stress in the vicinity of the transverse web frame bracket toe.</li> <li>2. Lack of material between manhole and cut-out for bottom longitudinals.</li> </ol> | | <b>Notes on repairs</b> <ol style="list-style-type: none"> <li>1. Top sketch: Gouge and reweld fractures then fit WT collars.</li> <li>2. Bottom sketch: As an alternative to rewelding and fitting collar, crop and insert.</li> </ol> | |

| OIL Tankers | | Guidelines for Surveys, Assessment and Repair of Hull Structure | |
|---|---|---|--|
| | | <p><b>Above for relatively small fractures.</b></p> <p><b>Above method for larger fractures.</b></p> | |

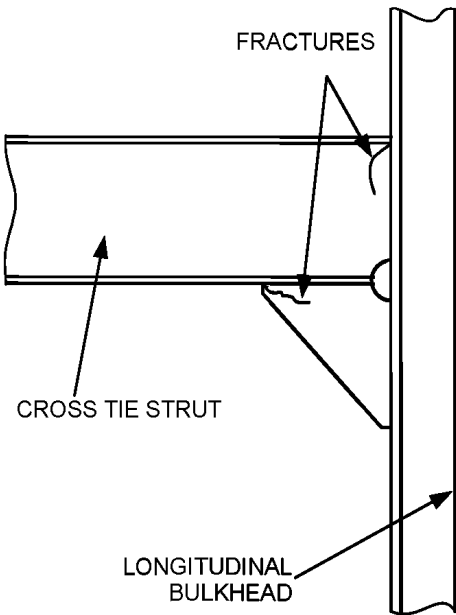
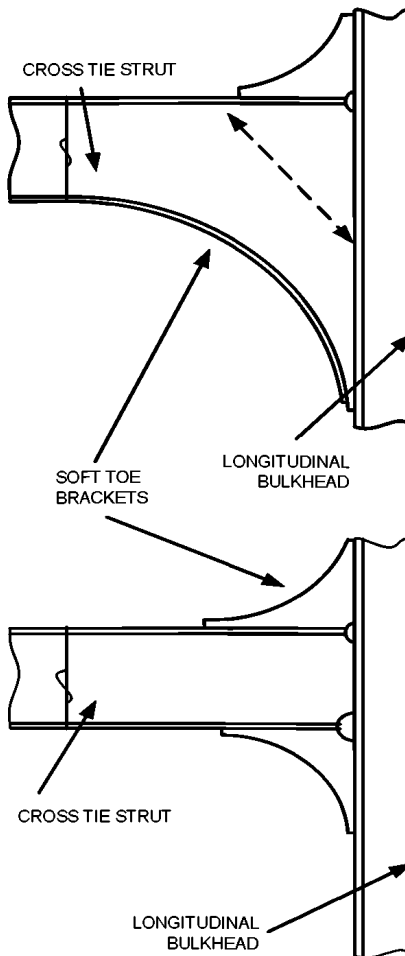
| OIL Tankers | | Guidelines for Surveys, Assessment and Repair of Hull Structure | |
|---|---|---|--|
| <b>Factors which may have caused damage</b> <ol style="list-style-type: none"> <li>1. Stress concentration due to unsuitable bracket shape at juncture of cross tie to longitudinal.</li> <li>2. Inadequate panel stiffening of web plate of cross-tie.</li> </ol> | | <b>Notes on repairs</b><br>See Sketch. | |

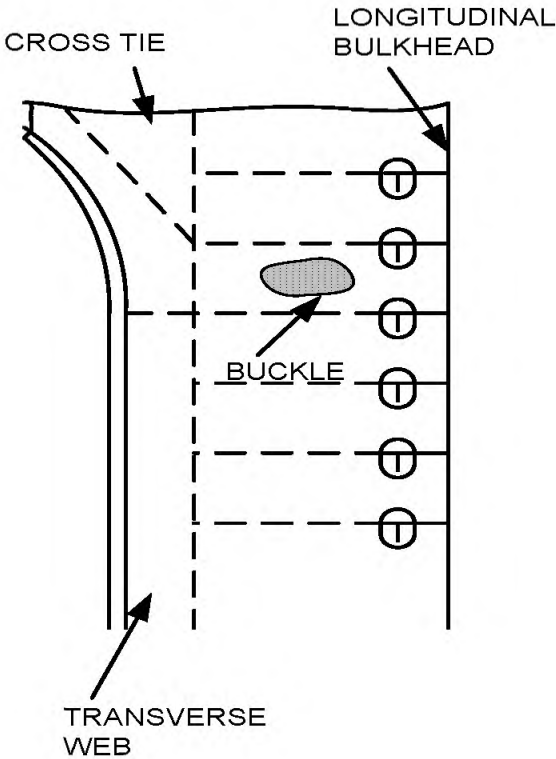
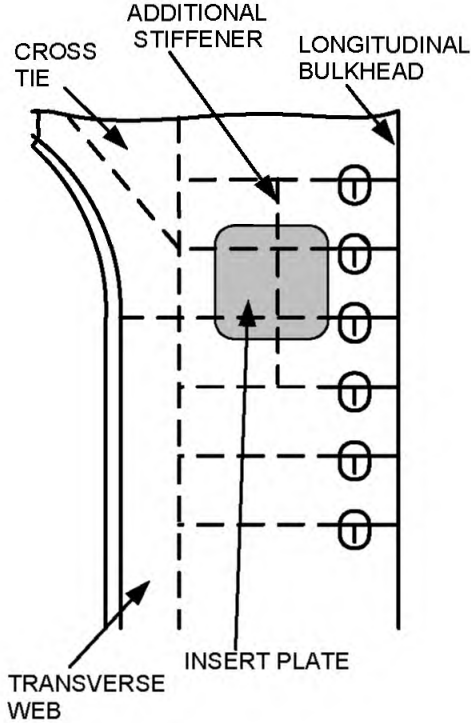
| OIL Tankers | | Guidelines for Surveys, Assessment and Repair of Hull Structure | |
|---|---|---|--|
| Detail of damage | | Buckled transverse web plates in way of cross tie. | |
| <b>Factors which may have caused damage</b><br>1. Insufficient panel stiffening on transverse web. | | <b>Notes on repairs</b><br>See Sketch.<br>1. Depending upon size of deformation, additional stiffeners may be sufficient. | |

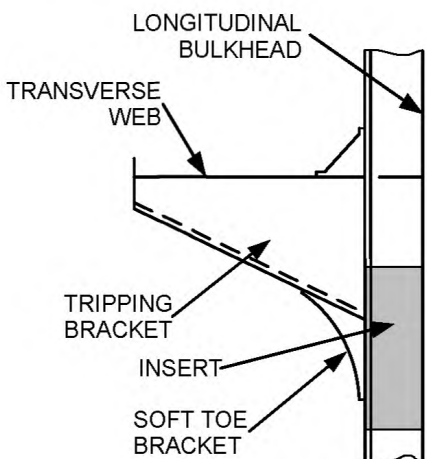
| OIL Tankers | | Guidelines for Surveys, Assessment and Repair of Hull Structure | |
|---|---|---|--|
| <b>Factors which may have caused damage</b> <ol style="list-style-type: none"> <li>1. Stress concentrations at toe of bracket.</li> <li>2. High stress in longitudinal.</li> </ol> | | <b>Notes on repairs</b> <p>See Sketch.</p> <ol style="list-style-type: none"> <li>1. Soft bracket may be added on upper side of web, to avoid fracture at the heel.</li> </ol> | |

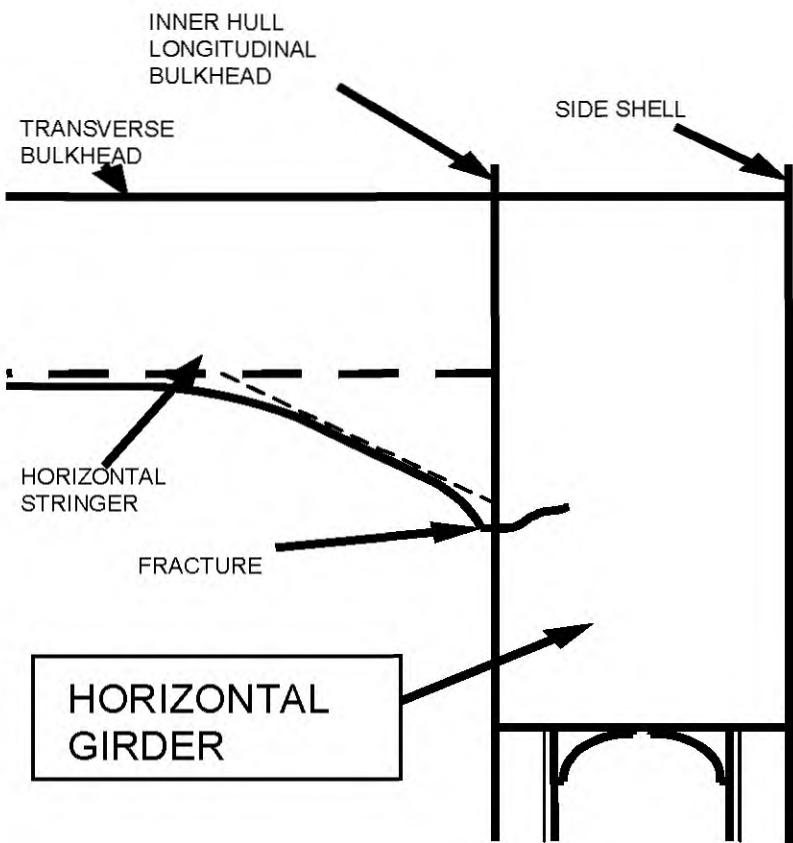
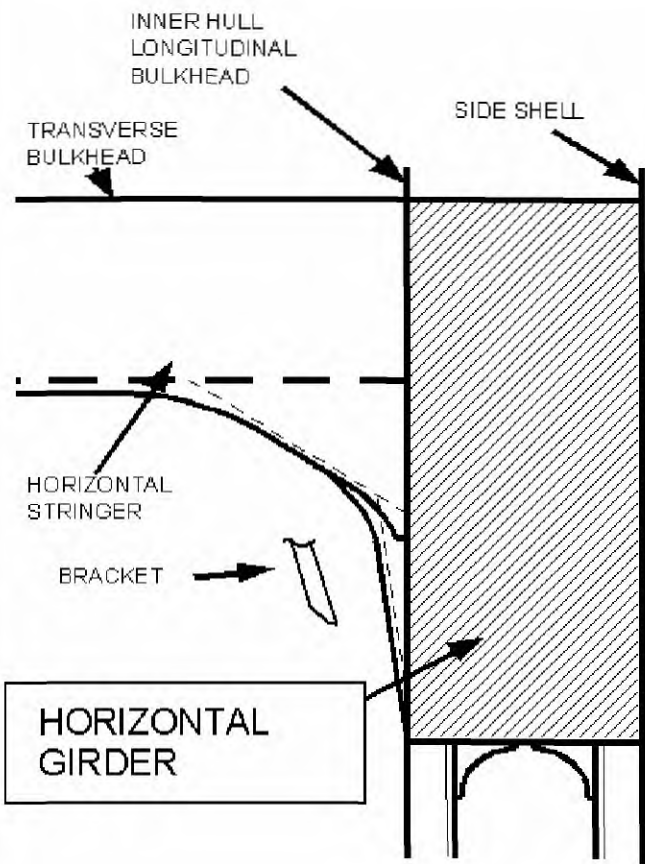
| OIL Tankers | | Guidelines for Surveys, Assessment and Repair of Hull Structure | |
|---|---|---|--|
| Detail of damage | | Horizontal stringer in way of longitudinal BHD cracked | |
| <b>Factors which may have caused damage</b><br>1. Misalignment between bracket end and side girder in wing tank. | | <b>Notes on repairs</b><br>See Sketch. | |

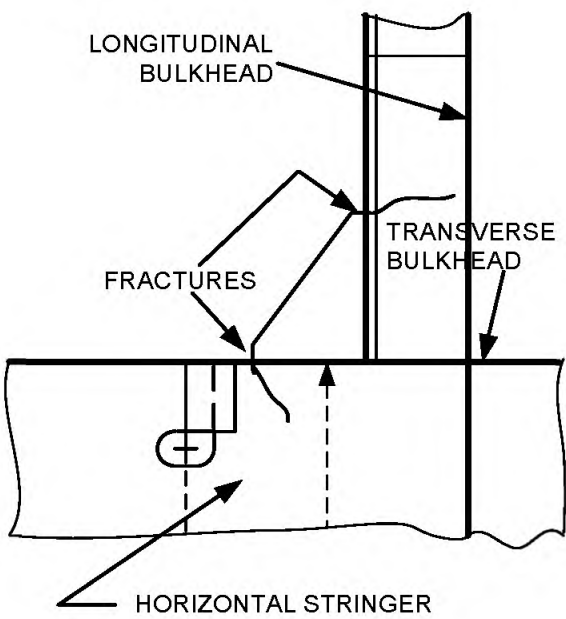
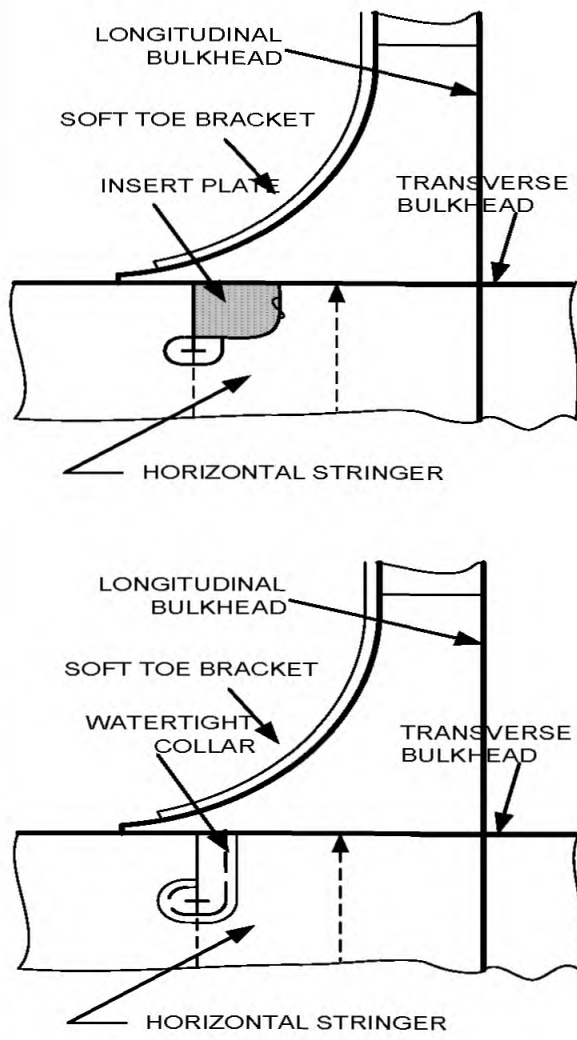
| OIL Tankers | | Guidelines for Surveys, Assessment and Repair of Hull Structure | |
|---|---|---|--|
| Detail of damage | | Connection of longitudinals to horizontal stringers. | |
| <b>Factors which may have caused damage</b> <ol style="list-style-type: none"> <li>1. Stress concentration due to inadequate shape of the bracket.</li> <li>2. Relative deflection of adjoining transverse web against transverse bulkhead.</li> </ol> | | <b>Notes on repairs</b><br>See Sketch | |

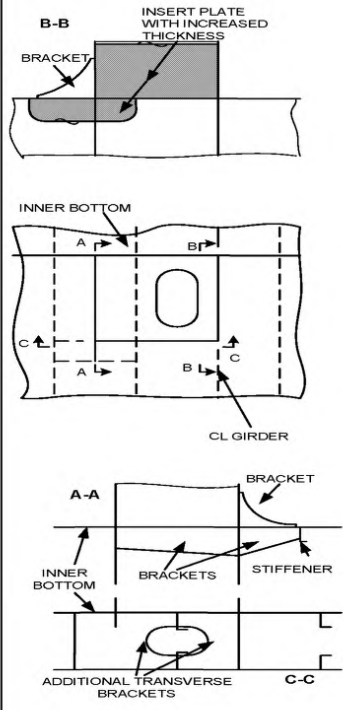
| OIL Tankers | | Guidelines for Surveys, Assessment and Repair of Hull Structure | |
|---|---|---|--|
| Detail of damage | | Fractured inner bottom plate at the connection to access trunk wall | |
| <b>Factors which may have caused damage</b> <ol style="list-style-type: none"> <li>1. Stress concentration at the connection of trunk wall to inner bottom plate.</li> <li>2. Relative deformation between horizontal stringer fitted on transverse bulkhead and inner bottom plate.</li> <li>3. Static and dynamic load of cargo liquid.</li> </ol> | | <b>Notes on repairs</b><br>See Sketch. | |

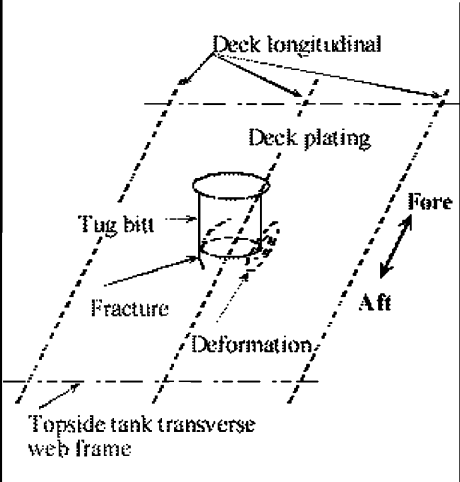
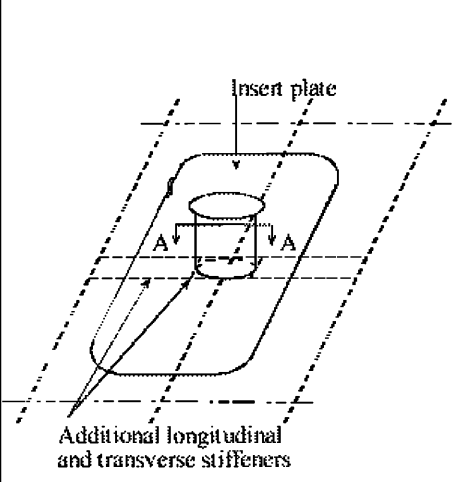
| OIL Tankers | | Guidelines for Surveys, Assessment and Repair of Hull Structure |
|---|---|---|
| <b>Detail of damage</b> | Deformed and fractured deck plating around tug bitt | |
| <b>Factors which may have caused damage</b> | <b>Notes on repairs</b> <ol style="list-style-type: none"> <li>1. Insufficient strength</li> <li>1. Fractured/deformed deck plating should be cropped and part renewed.</li> <li>2. Reinforcement by stiffeners should be considered.</li> </ol> | |

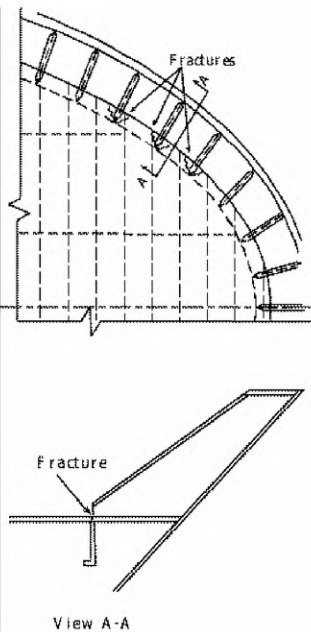
| OIL Tankers | | Guidelines for Surveys, Assessment and Repair of Hull Structure |
|---|---|---|
| <b>Factors which may have caused damage</b> <ol style="list-style-type: none"> <li>1. Bow Flare effect in heavy weather.</li> <li>2. Stress concentration due to poor design.</li> </ol> | | <b>Notes on repairs</b> <ol style="list-style-type: none"> <li>1. Fractured deck plating should be cropped and renewed.</li> <li>2. Bracket in line with the bulwark stay to be fitted to reduce stress concentration.</li> </ol> |

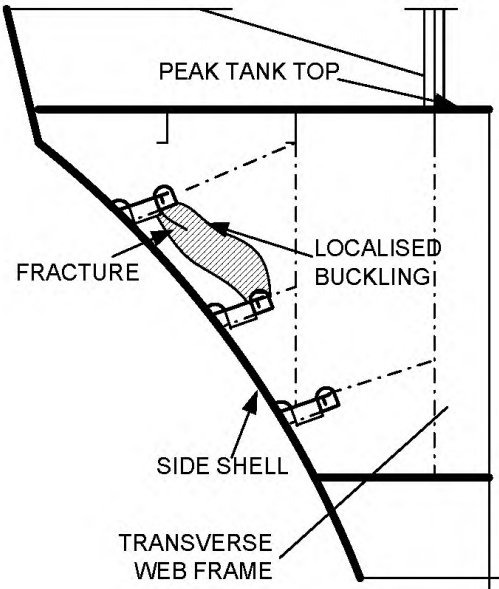
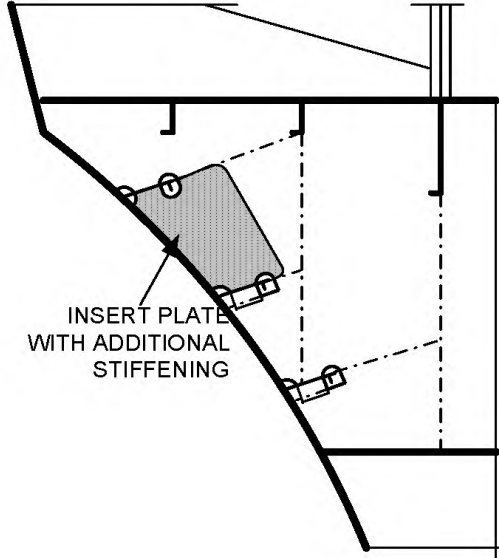
| OIL Tankers | | Guidelines for Surveys, Assessment and Repair of Hull Structure |
|---|---|---|
| <b>Factors which may have caused damage</b> <ol style="list-style-type: none"> <li>1. Localised thinning in way of coating failure at cut-outs and sharp edges due to working of the structure.</li> <li>2. Dynamic seaway loadings in way of bow flare.</li> </ol> | | <b>Notes on repairs</b><br>See Sketch. |

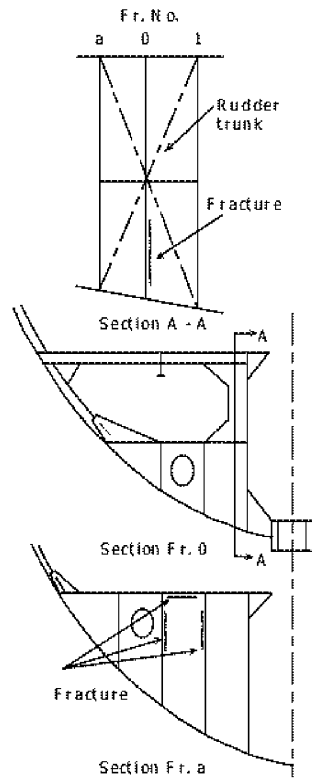
| OIL Tankers | | Guidelines for Surveys, Assessment and Repair of Hull Structure | |
|---|---|---|--|
| <b>Factors which may have caused damage</b><br>1. Vibration. | | <b>Notes on repairs</b><br>1. The fractured plating should be cropped and renewed.<br>2. Natural frequency of the plate between stiffeners should be changed, e.g. reinforcement by additional stiffeners. | |

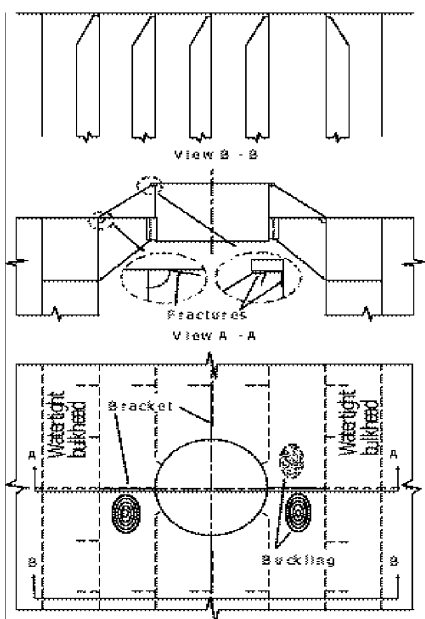
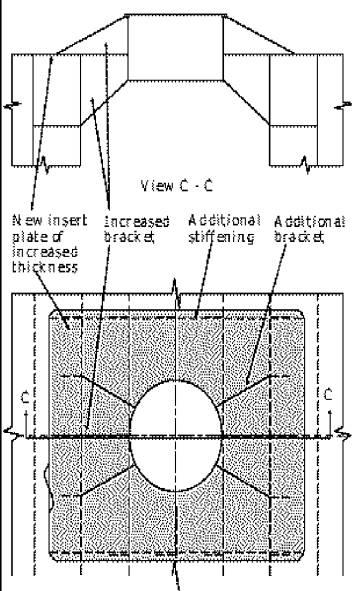
| OIL Tankers Guidelines for Surveys, Assessment and Repair of Hull Structure | | |
|---|---|---|
| Factors which may have caused damage | <ol style="list-style-type: none"> <li>1. Insufficient deck strengthening (missing base plate).</li> <li>2. Insufficient strengthening of steering gear foundation.</li> <li>3. Bolts of steering gear were not sufficiently pre-loaded.</li> </ol> | |

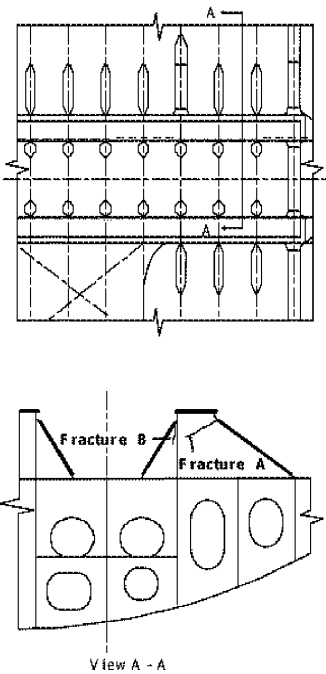
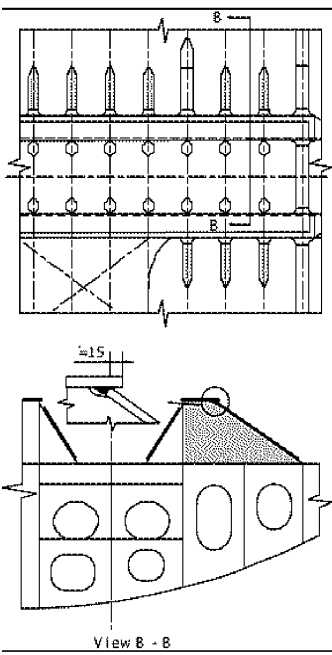
| OIL Tankers | | Guidelines for Surveys, Assessment and Repair of Hull Structure |
|---|---|---|
| <b>Factors which may have caused damage</b> <ol style="list-style-type: none"> <li>1. Vibration of main engine.</li> <li>2. Insufficient strength of brackets at main engine foundation.</li> <li>3. Insufficient pre-load of the bolts.</li> </ol> | | <b>Notes on repairs</b> <ol style="list-style-type: none"> <li>1. Fractures may be veed-out and rewelded.</li> <li>2. New modified brackets at main engine foundation.</li> <li>3. Or insert pieces and additional flanges to increase section modulus of the brackets.</li> </ol> |

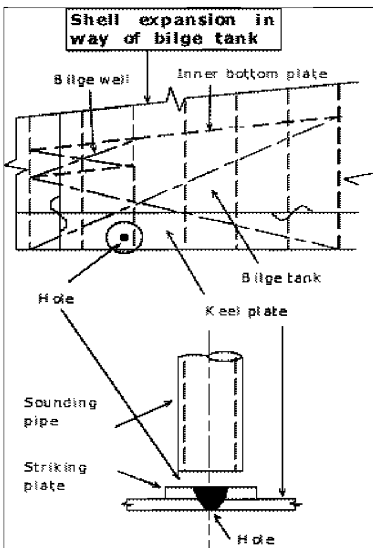
| OIL Tankers | | Guidelines for Surveys, Assessment and Repair of Hull Structure |
|---|---|---|
| <b>Factors which may have caused damage</b><br>1. Heavy corrosion of bottom plating under sounding pipe. | | <b>Notes on repairs</b><br>1. Corroded striking plating should be renewed.<br>2. Bottom plate should be repaired depending on the condition of corrosion.<br><br><i>(Note):</i><br>Repair by spigot welding can be applied to the structure only when the stress level is considerably low. Generally this procedure cannot be applied to the repair of bottom plating of ballast tanks in cargo tank region. |
