**No.76 IACS Guidelines for Surveys, Assessment and
(1994) Repair of Hull Structure – Bulk Carriers**

BULK CARRIERS

Guidelines for Surveys, Assessment and Repair of Hull
Structure

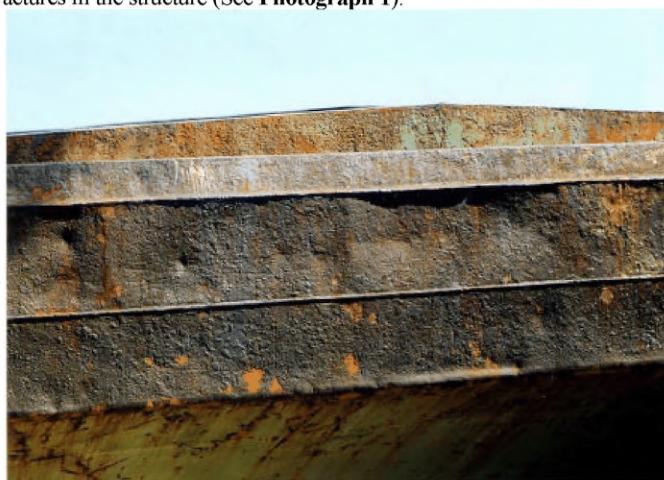
3.1.2 Severe corrosion of the hatch coaming plating inside cargo hold and topside tank plating vertical strake may occur due to difficult access for the maintenance of the protective coating. This may lead to fractures in the structure (See **Photograph 1**).

Photograph 1 **Heavy corrosion of hatch coaming and topside tank plating vertical strake**

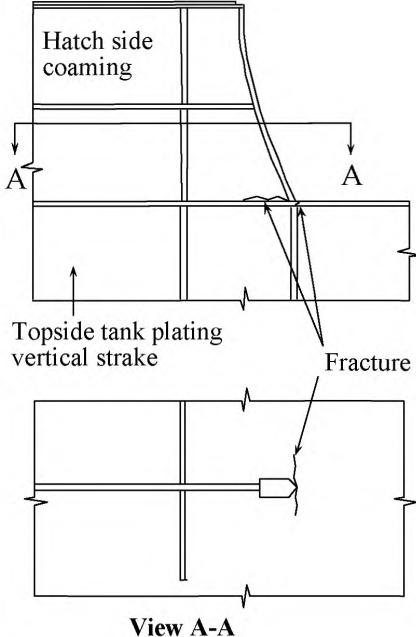
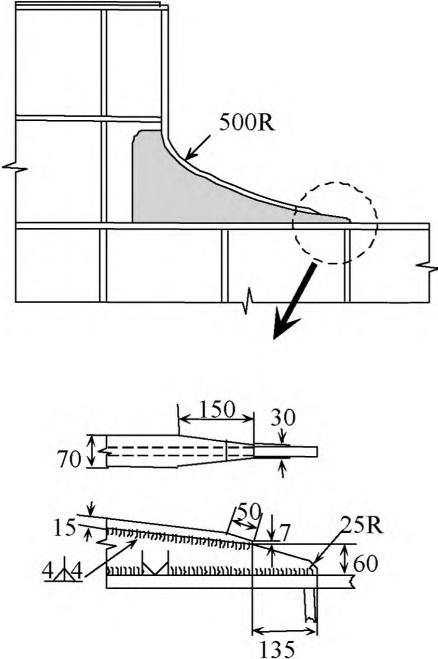
BULK CARRIERS		Guidelines for Surveys, Assessment and Repair of Hull Structure
Part 1	Cargo hold region	Example No.
Area 1	Deck structure	3-b
Detail of damage		Fractures in the web or in the deck at the toes of the longitudinal hatch coaming termination bracket
Sketch of damage		Sketch of repair

Notes on possible cause of damage		Notes on repairs
<p>1. This damage is caused by stress concentrations attributed to the design of the bracket.</p>		<p>1. The design of the bracket can be altered as shown above, however, it is to be ensured that an additional under deck stiffener is provided at the toe of the termination bracket, where the toe is clear of the normal stiffening member.</p> <p>2. The fracture in deck plating to be vee'd-out and rewelded or deck plating cropped and part renewed as appropriate, using low hydrogen electrodes for welding.</p>

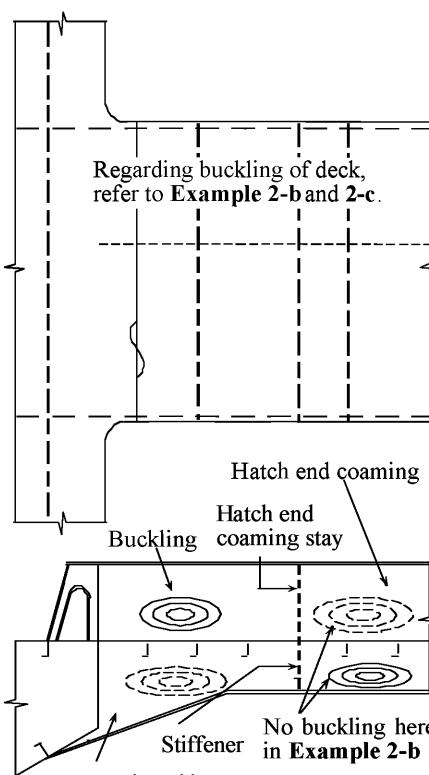
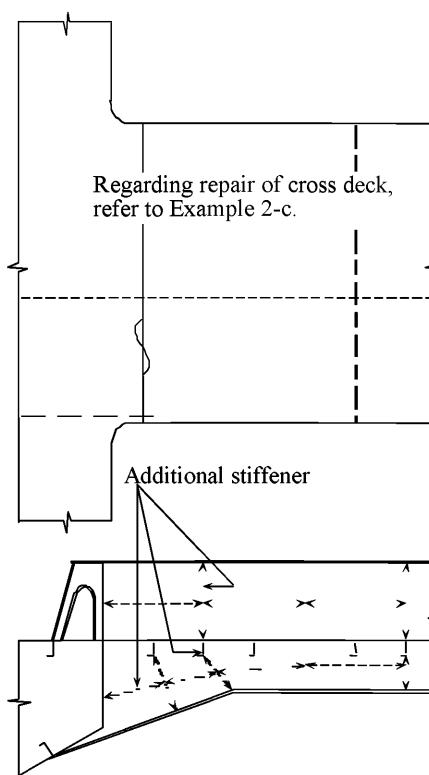
BULK CARRIERS		Guidelines for Surveys, Assessment and Repair of Hull Structure
Part 1	Cargo hold region	Example No.
Area 1	Deck structure	7-a
Detail of damage		Buckling of hatch coaming and hatch end beam
Sketch of damage

Notes on possible cause of damage <ol style="list-style-type: none"> 1. Additional transverse forces due to heavy seas, and torsional loading. 2. Inadvertent overloading of cargo spaces. 		Notes on repairs <ol style="list-style-type: none"> 1. If buckling is due to loss in strength induced by corrosion, the buckled zone to be cropped and renewed as necessary. 2. If buckling results from inadequate strength, stiffeners should be fitted in addition to cropping and renewal of buckled zone.

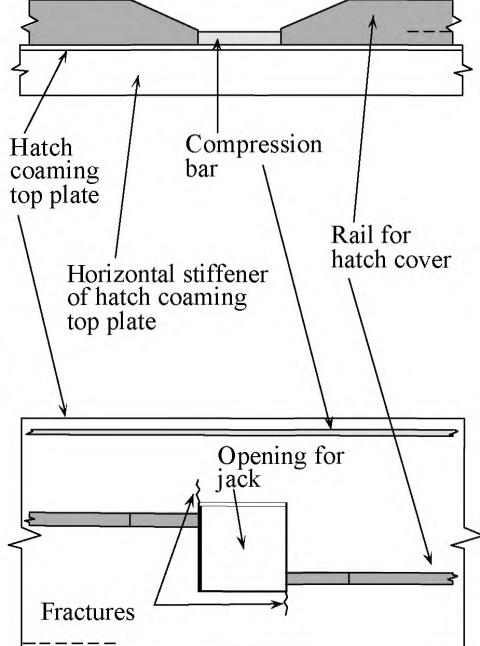
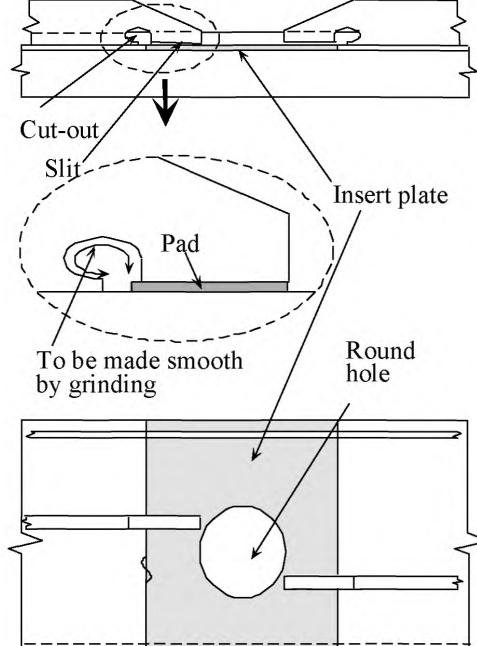
BULK CARRIERS		Guidelines for Surveys, Assessment and Repair of Hull Structure
Part 1	Cargo hold region	Example No.
Area 1	Deck structure	10-b
Detail of damage		Fractures in hatch coaming top plate at the termination of rail for hatch cover
Sketch of damage

Notes on possible cause of damage		
1. Stress concentration at the termination of the rail for hatch cover due to poor design of opening.		
		Notes on repairs
1. Fractured plate is to be cropped and part renewed.		
2. Thicker insert plate and/or reduction of stress concentration adopting large radius should be considered. Or cut-out in the rail and detachment of the welds as shown in the above drawing should be considered in order to reduce the stress of the corner of the opening.

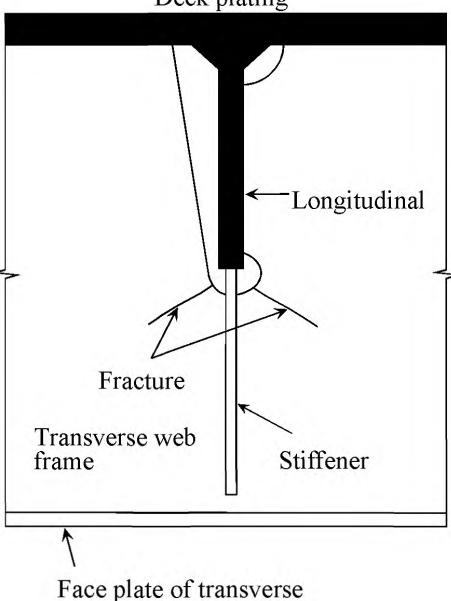
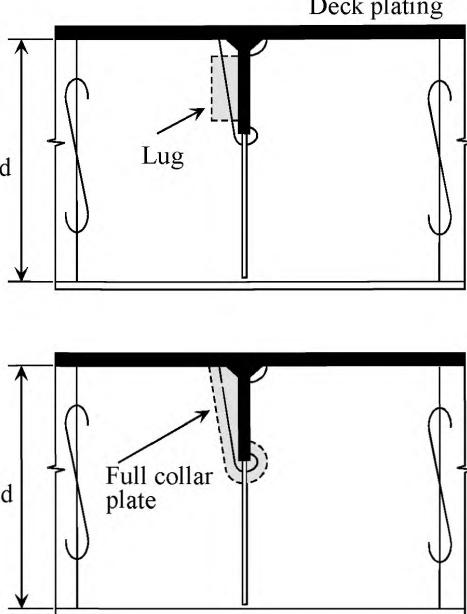
BULK CARRIERS		Guidelines for Surveys, Assessment and Repair of Hull Structure
Part 1	Cargo hold region	Example No.
Area 2	Topside tank structure	4-a
Detail of damage		Fractures at slots in way of transverse web frame
Sketch of damage

<p>(Note) Full collar plate where the depth of cut-out is more than 0.4 times the depth of web frame (0.4d) and in an areas of high shear stress</p>		
Notes on possible cause of damage <ol style="list-style-type: none"> 1. Damage may be created by local shear stress concentrations due to large cut-outs for notch. 2. Also deficient welds (fillet welds between deck longitudinal and stiffener). 	Notes on repairs <ol style="list-style-type: none"> 1. Crop and part renew the web plating. 2. Close the cut-out by introducing a lug or alternatively fit a full collar plate.

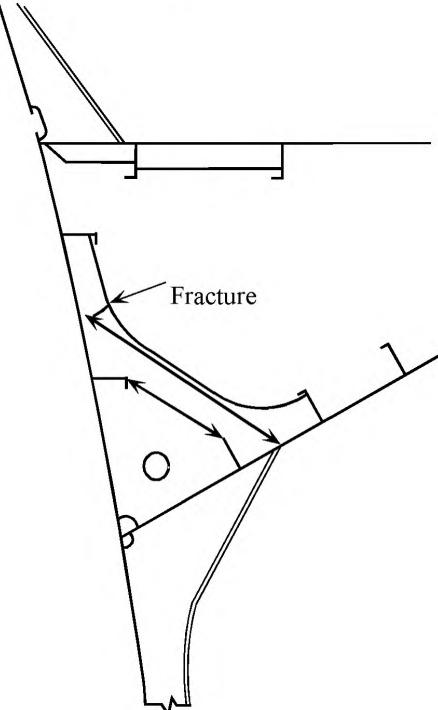
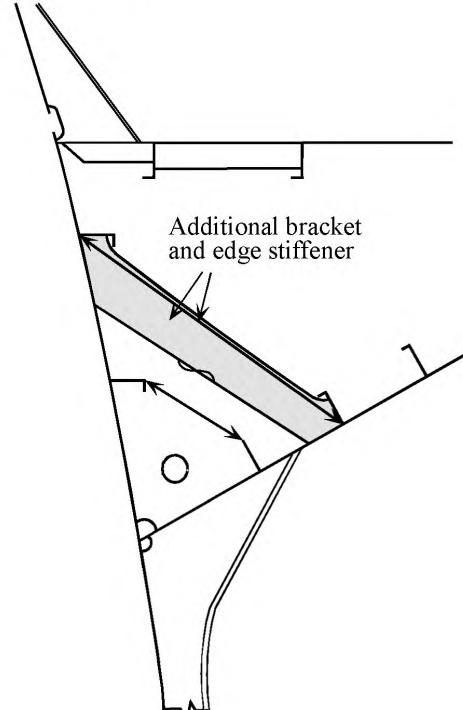
BULK CARRIERS	Guidelines for Surveys, Assessment and Repair of Hull Structure	
Part 1	Cargo hold region	Example No.
Area 2	Topsides tank structure	7-b
Detail of damage	Fractures in transverse bracket	
Sketch of damage

Notes on possible cause of damage	<p>1. Insufficient strength. 2. Corrosion.</p>	
	<p>Notes on repairs</p> <ol style="list-style-type: none"> Fractured part to be cropped and renewed. If the fractured part is free from corrosion, increased size and thickness should be considered. Partial renewal of the bracket may be accepted depending on the nature of the fracture.

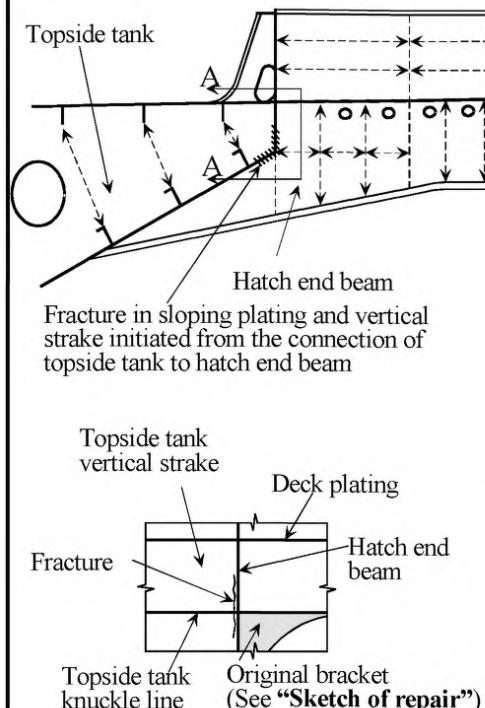
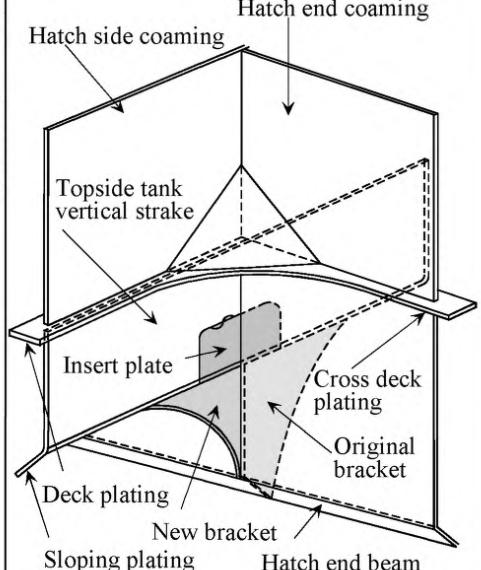
<p>Fracture in sloping plating and vertical strake initiated from the connection of topside tank to hatch end beam</p> <p>View A-A</p>		
		Sketch of repair

<p>Notes on possible cause of damage</p> <ol style="list-style-type: none"> 1. Stress concentration at the connection of hatch end beam to topside tank. 		<p>Notes on repairs</p> <ol style="list-style-type: none"> 1. Fractured part to be cropped and renewed with increased thickness. 2. Additional bracket should be considered for reinforcement.

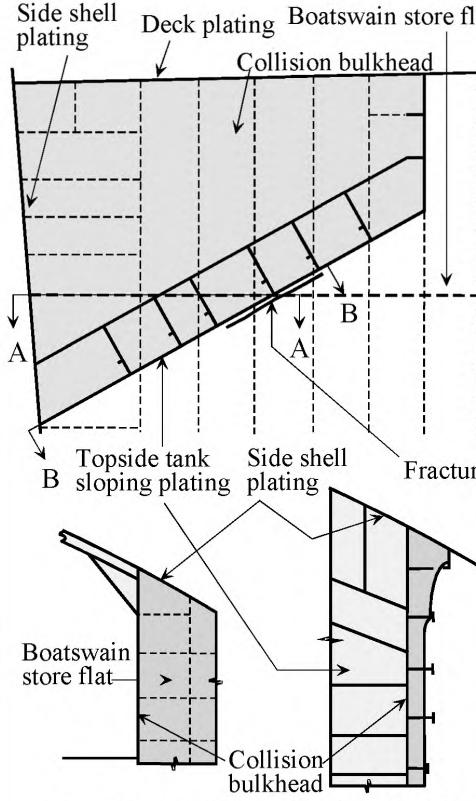
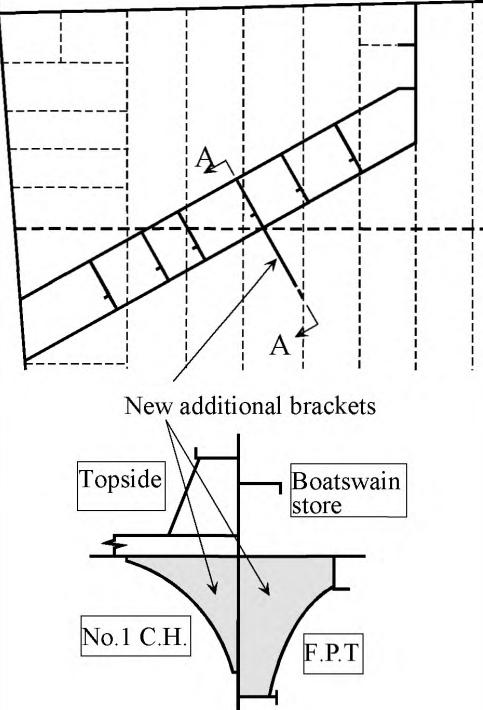
Notes on possible cause of damage <ol style="list-style-type: none"> 1. Damage caused by hard spot at intersection of the topside tank sloping plating and boatswain's store deck plating (fore peak tank top plating). 		Notes on repairs <ol style="list-style-type: none"> 1. Fractured plates to be cropped and renewed. 2. Stress concentration should be considered (Brackets were fitted on both sides for reinforcement).

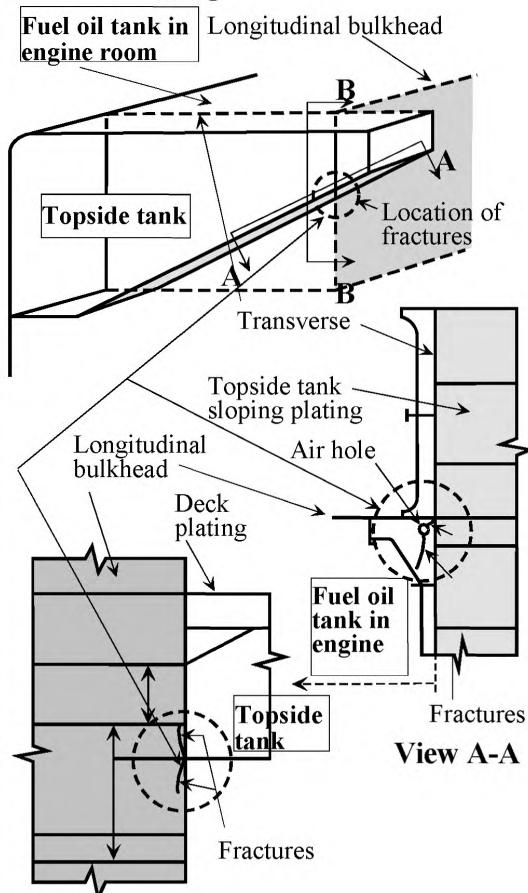
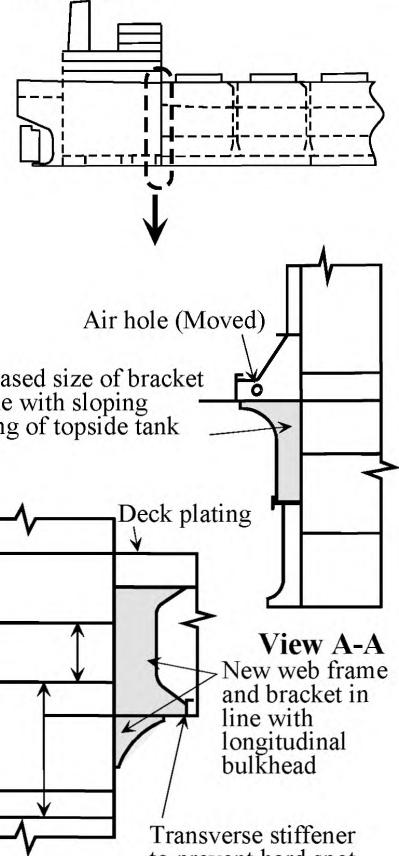
Notes on possible cause of damage 1. Damage caused by hard spot at intersection of the topside tank sloping plating and longitudinal bulkhead of the fuel oil tank in engine room.		
Notes on repairs 1. Fractured plates to be cropped and renewed as necessary and reinforcement fitted as shown shaded above. The position of the air-hole to be relocated.

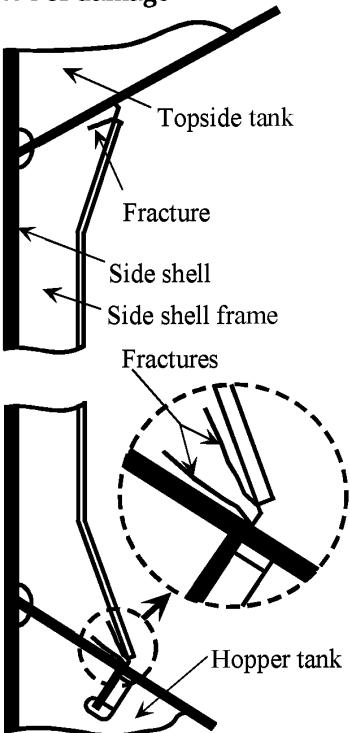
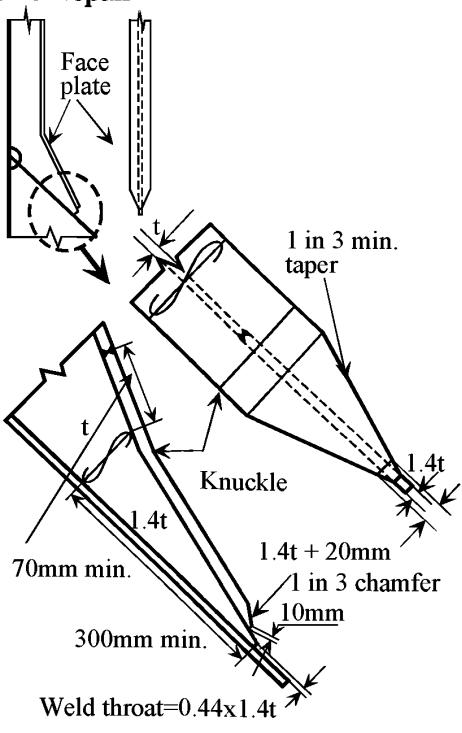
Notes on possible cause of damage <ol style="list-style-type: none"> 1. This type of damage is caused due to stress concentration. 		Notes on repairs <ol style="list-style-type: none"> 1. Repair is to incorporate a design similar to the one shown on the sketch and in addition: <ol style="list-style-type: none"> 1.1. The arm of the bracket along the hopper/ topside plating should be increased by altering the angle of the bracket face plate. A face plate taper of 1 in 3 should be arranged. 1.2. The local thickness of the bracket web plating over the length of the new face plate taper should be increased by about 40% above that originally fitted. 1.3. The face plate thickness should be chamfered 1 in 3 to a thickness at its extremity. 1.4. Welding of the new bracket toe should be based on a weld factor of 0.44 applied to the increased thickness. 2. Attention to be given to the structure in wing tanks in way of the extended bracket arm. i.e. reinforcement provided in line with the bracket.

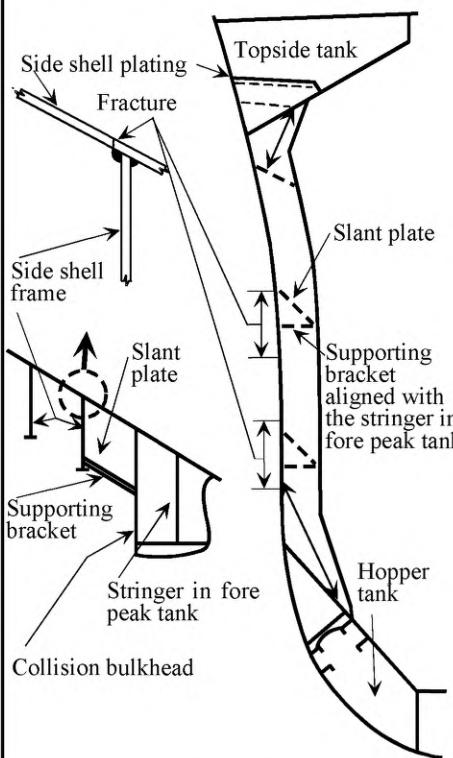
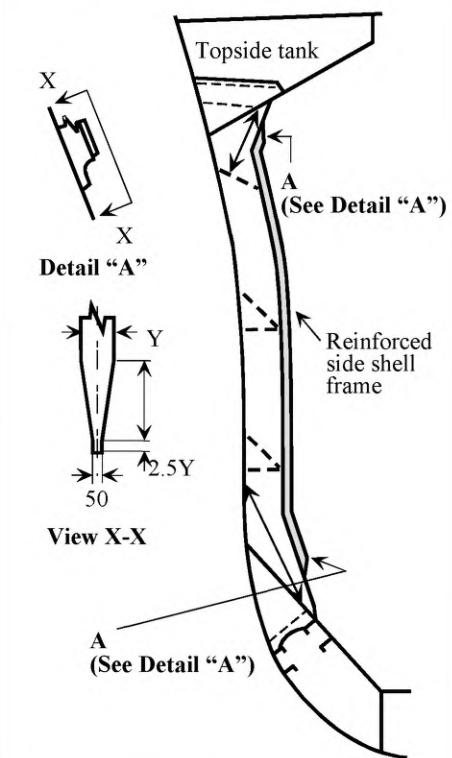
Notes on possible cause of damage <ol style="list-style-type: none"> 1. Damage caused by stress concentration leading to fatigue fracture in side shell. This has been exacerbated because of the greater flexibility of the hold structure in relation to the structure forward of the collision bulkhead. 		Notes on repairs <ol style="list-style-type: none"> 1. Fractured shell plates to be cropped and part renewed, and side shell frame/frames in the vicinity of the damage to be reinforced as required by the relevant Classification Society.

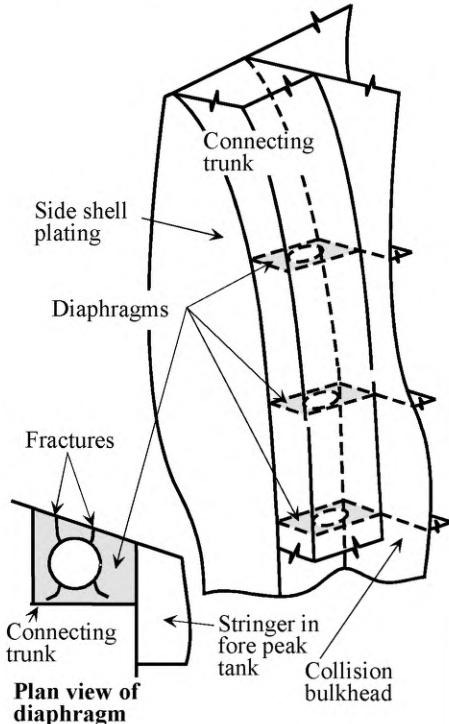
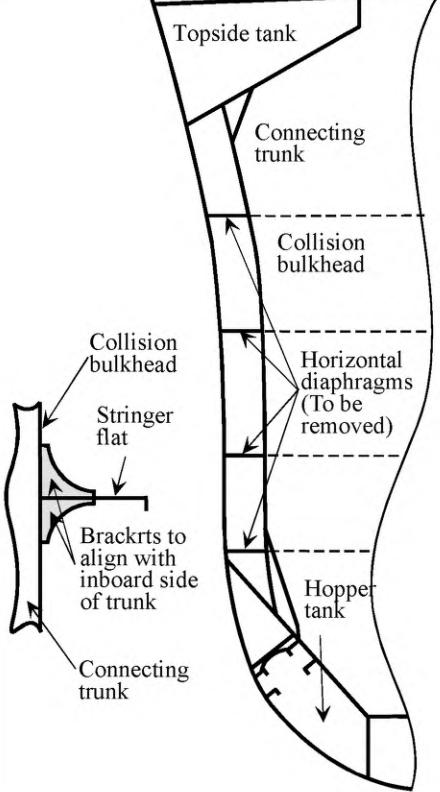
Notes on possible cause of damage	<p>1. Damage caused by stress concentration resulting from the discontinuity created by the trunk and diaphragm structure. This has been exacerbated because of the greater flexibility of the hold structure in relation to the trunk and structure forward of the collision bulkhead.</p>	
Notes on repairs	<p>1. Diaphragm to be removed permanently and fractured shell plated cropped and part renewed, or veed and weld as necessary in way of damage. Brackets with softened toes are to be fitted on forward side of collision bulkhead in way of stringers/flats to align with inboard side of trunk in order to remove hard-spots.</p>

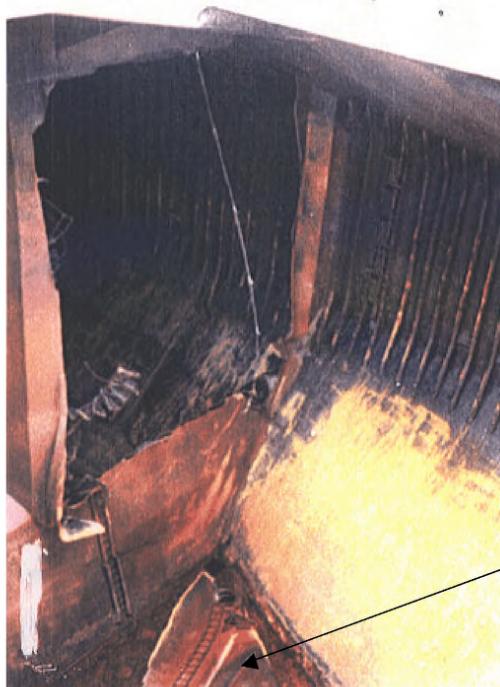
Photograph 1
Collapsed and detached
transverse bulkhead

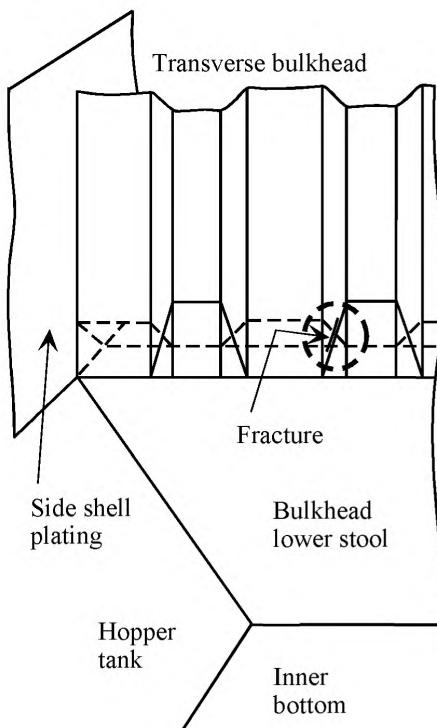
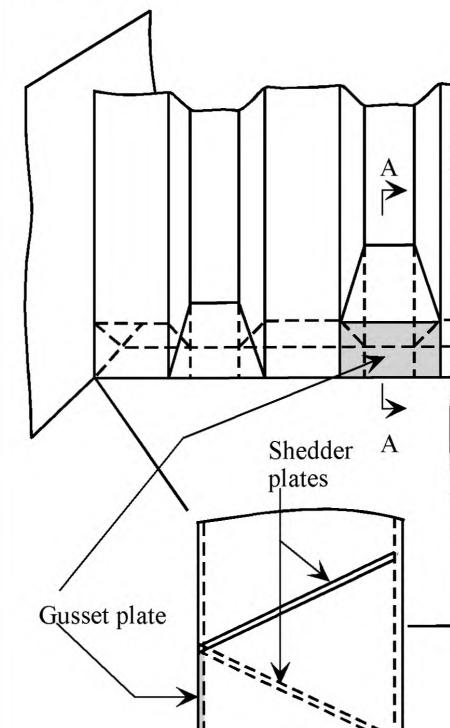
Notes on possible cause of damage <ol style="list-style-type: none"> 1. Damage due to stress concentrations at intersection of shedder plates. This can be exacerbated by corrosion and reduction in thickness of the corrugation web plating. 		Notes on repairs <ol style="list-style-type: none"> 1. If due to wastage, corrugation plating and shedder plates to be part renewed/renewed as necessary. 2. Where renewals are being carried out it may be prudent to fit the extension pieces shown above to change the location of the point of intersection, and hence reduce the stress concentration.

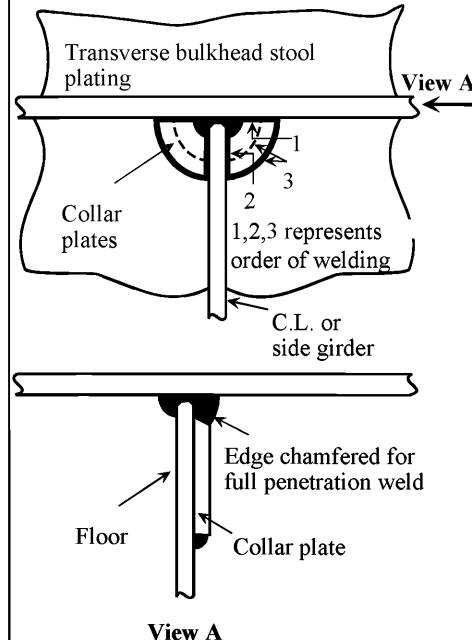
Notes on possible cause of damage	<p>1. Stress concentration at the welds due to scallops.</p>	
	<p>Notes on repairs</p> <p>1. The scallops will require to be fitted with welded collar plates to reduce stresses in the area.</p>

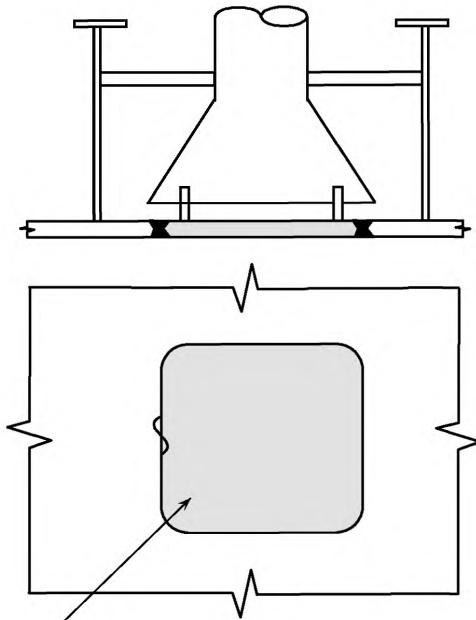
Notes on possible cause of damage <ol style="list-style-type: none"> 1. High flow rate associated with insufficient corrosion prevention system. 2. Galvanic action between dissimilar metals. 		Notes on repairs <ol style="list-style-type: none"> 1. Insert to have round corners 2. Non-destructive examination to be applied after welding based on the Society's rules

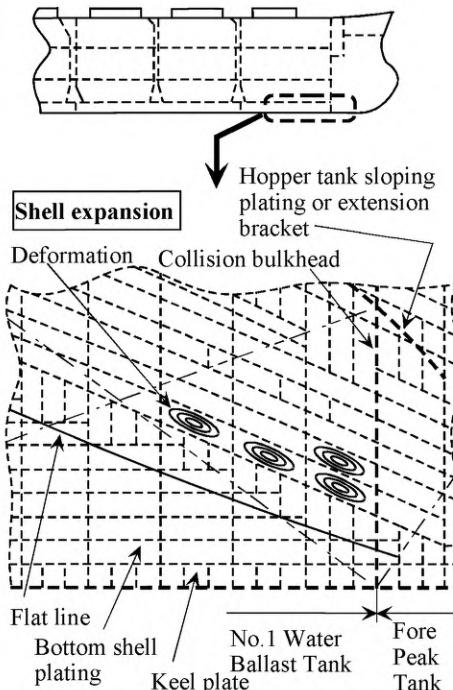
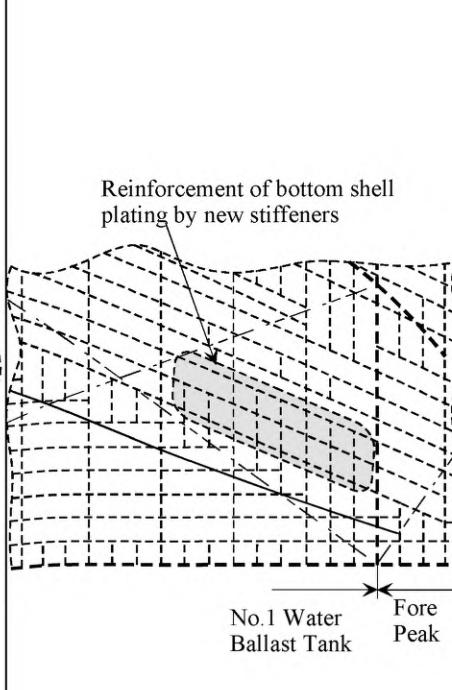
Notes on possible cause of damage <ol style="list-style-type: none"> 1. Heavy weather. 2. Poor design for slamming. 3. Poor operation, i.e. negligence of heavy ballast. 		Notes on repairs <ol style="list-style-type: none"> 1. Deformed bottom shell plating should be faired in place, or partly cropped and renewed if considered necessary. 2. Bottom shell plating should be reinforced by stiffeners.

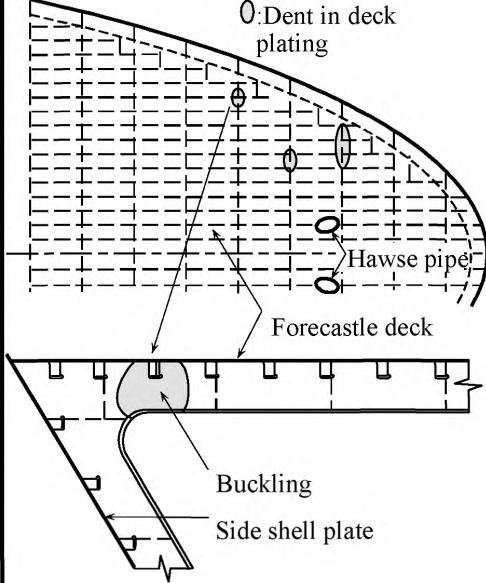
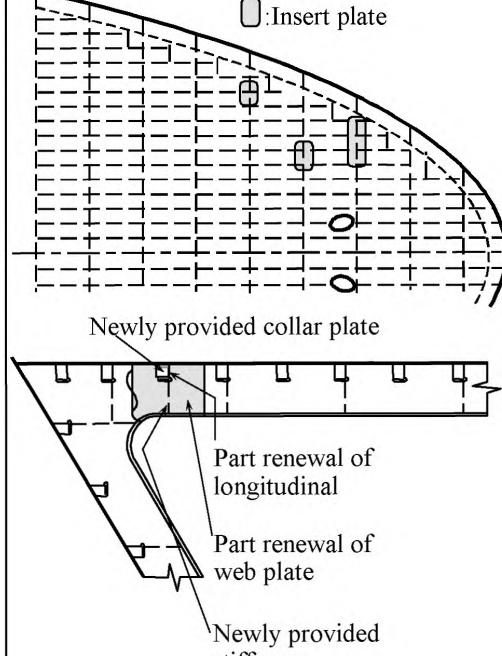
Notes on possible cause of damage <ol style="list-style-type: none"> 1. Green sea on deck. 2. Insufficient strength. 		Notes on repairs <ol style="list-style-type: none"> 1. Deformed structure should be cropped and renewed. 2. Additional stiffeners on web of beam should be considered for reinforcement.

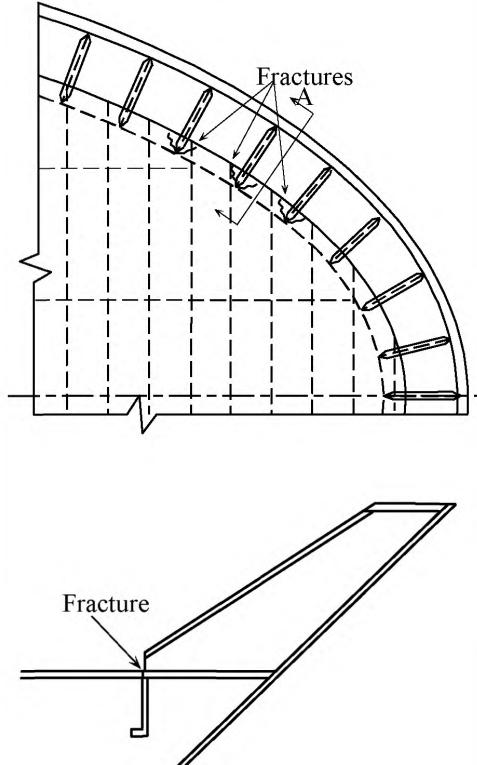
Notes on possible cause of damage	<p>1. Bow flare effect in heavy weather. 2. Stress concentration due to poor design.</p>	
	<p>Notes on repairs</p> <ol style="list-style-type: none"> 1. Fractured deck plating should be cropped and renewed. 2. Bracket in line with the bulwark stay to be fitted to reduce stress concentration.

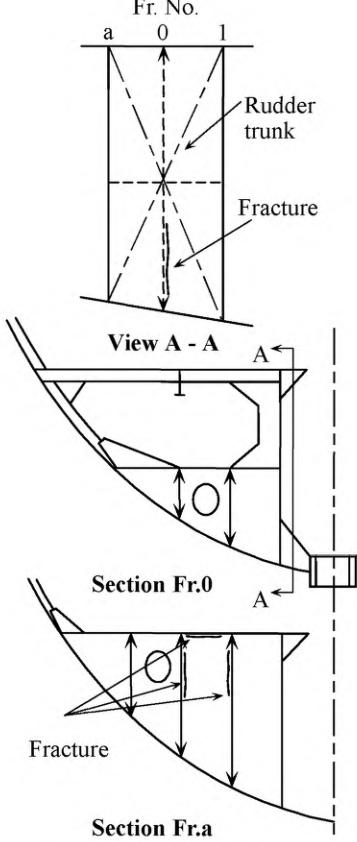
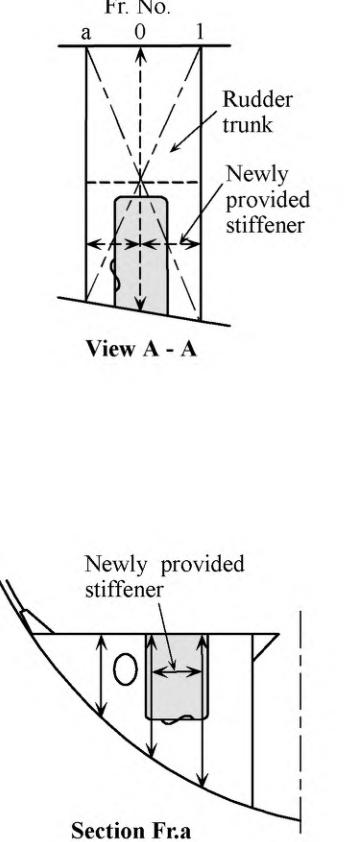
Notes on possible cause of damage 1. Vibration.		Notes on repairs 1. The fractured plating should be cropped and renewed. 2. Natural frequency of the plate between stiffeners should be changed, e.g. reinforcement by additional stiffeners.

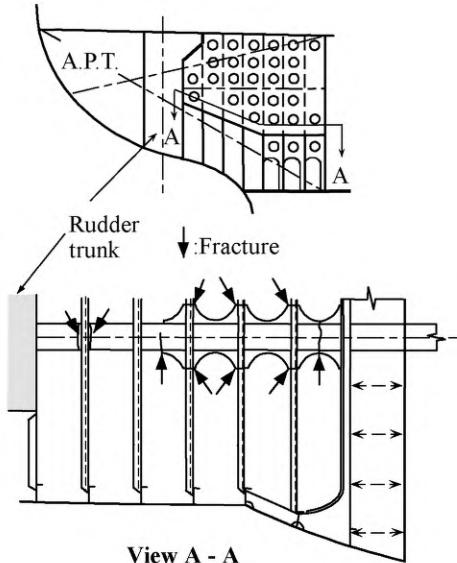
Notes on possible cause of damage		Notes on repairs
1. Vibration.		<ol style="list-style-type: none"> 1. The fractured plating should be cropped and renewed. 2. Natural frequency of the panel should be changed, e.g. reinforcement by additional strut.

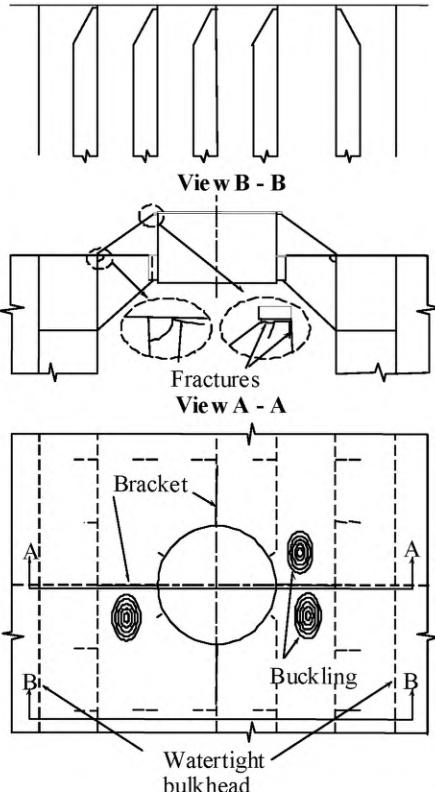
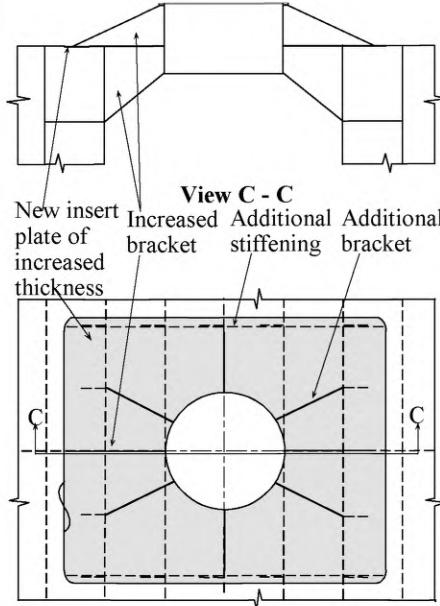
Notes on possible cause of damage	<ol style="list-style-type: none"> 1. Insufficient deck strengthening (missing base plate). 2. Insufficient strengthening of steering gear foundation. 3. Bolts of steering gear were not sufficiently pre-loaded. 	
	Notes on repairs	
	<ol style="list-style-type: none"> 1. New insert base plate of increased plate thickness. 2. Additional longitudinal stiffening at base plate edges. 3. Additional foundation brackets above and under deck (star configuration).

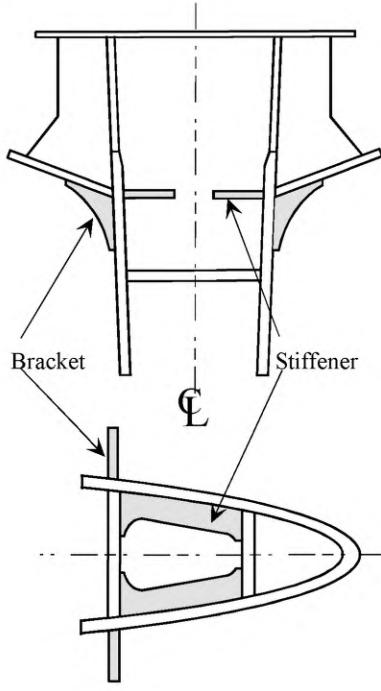
Notes on possible cause of damage <ol style="list-style-type: none"> 1. Insufficient strength due to poor design. 		Notes on repairs <ol style="list-style-type: none"> 1. Fractured plating to be veed-out and rewelded. 2. Fractured plating to be cropped and renewed if considered necessary. 3. Reinforcement should be considered if considered necessary.

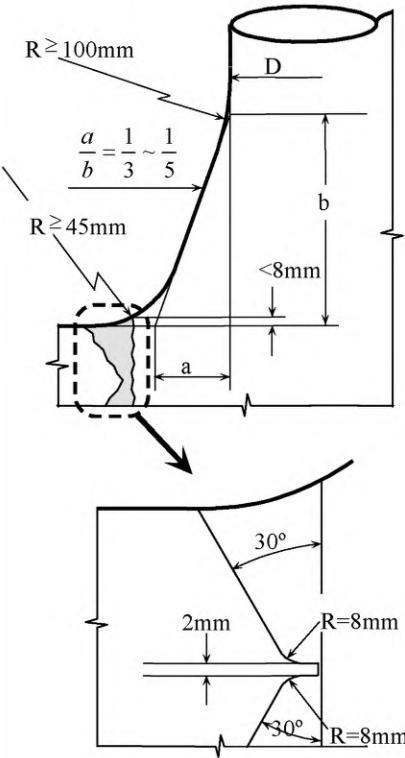
Notes on possible cause of damage <ol style="list-style-type: none"> 1. Inadequate design for stress concentration in rudder stock. 		Notes on repairs <ol style="list-style-type: none"> 1. Modification of detail design of rudder stock to reduce the stress concentration.

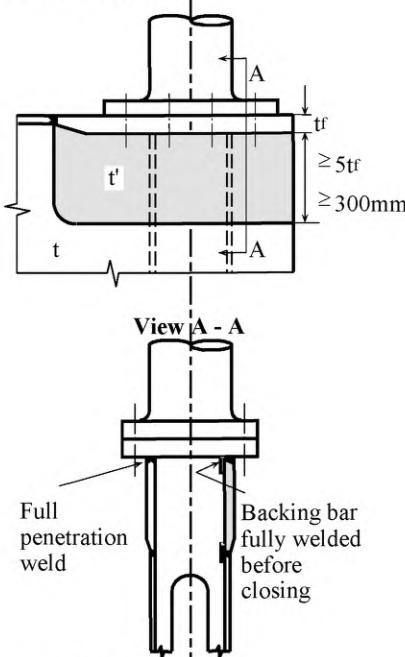
<p> t = plate thickness, mm tf = actual flange thickness, mm $t = \frac{tf}{3} + 5$, mm, where $tf \leq 50$mm $t = 3\sqrt{tf}$, mm, where $tf \geq 50$mm </p>
Notes on possible cause of damage <ol style="list-style-type: none"> Inadequate connection between palm plate and rudder blade plating (insufficient plating thickness and/or insufficient fillet weld). 		Notes on repairs <ol style="list-style-type: none"> Modification of detail design of the connection by increasing the plate thickness and full penetration welding.

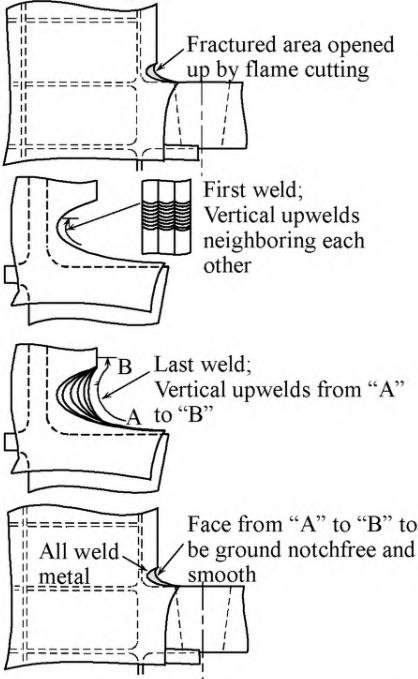
Notes on possible cause of damage		Notes on repairs
<ol style="list-style-type: none"> 1. Stress concentration due to inadequate local design and/or fabrication notches in way of the butt weld between cast piece and plating. 		<ol style="list-style-type: none"> 1. Grooving-out and welding of the fracture is not always adequate (metallurgical notch in way of a high stressed area). 2. In the proposed repair procedure the metallurgical notches are shifted into a zone exposed to lower stresses. 3. After welding a modification of the radius according to the proposal in Example 5 is to be carried out. 4. In case of very small crack it can be ground off by increasing the radius.

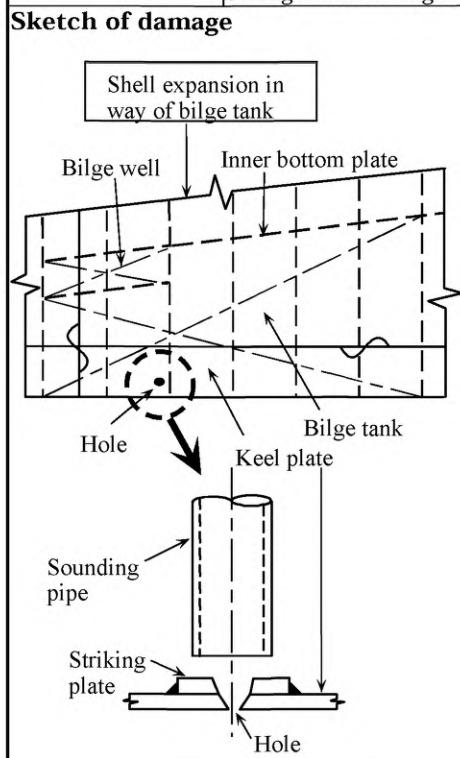
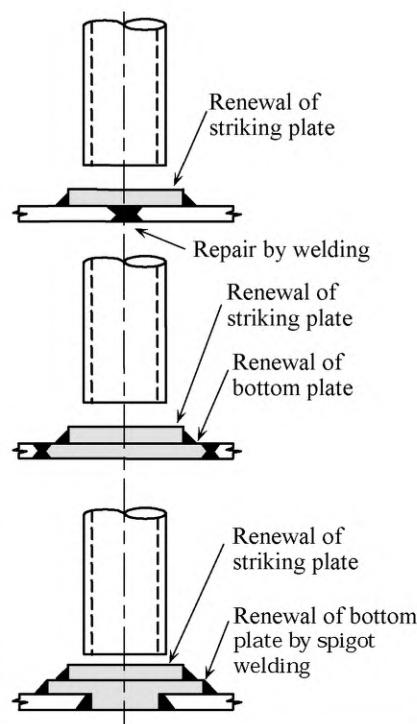
Notes on possible cause of damage	<ol style="list-style-type: none"> 1. Heavy corrosion of bottom plating under sounding pipe. 	
	Notes on repairs <ol style="list-style-type: none"> 1. Corroded striking plating should be renewed. 2. Bottom plate should be repaired depending on the condition of corrosion. (Note) Repair by spigot welding can be applied to the structure only when the stress level is considerably low. Generally this procedure cannot be applied to the repair of bottom plating of ballast tanks in cargo hold region.

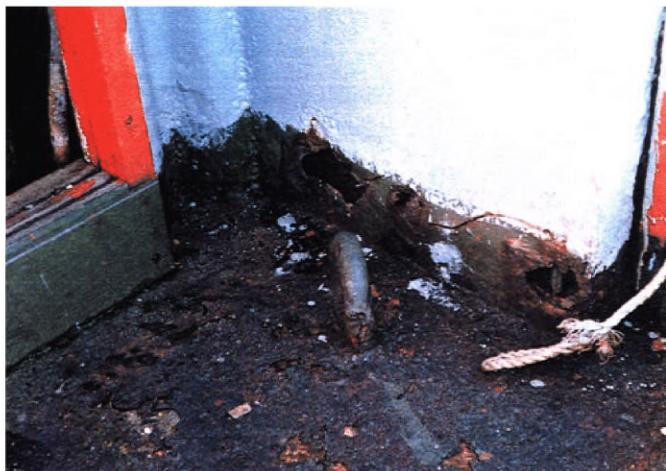
Photograph 1 Corroded accommodation house side structure
