No. 96 (April 2007) **Double Hull Oil Tankers -** Guidelines for Surveys, Assessment and Repair of Hull Structures

DOUBLE HULL OIL TANKERS

Guidelines for Surveys, Assessment and Repair of Hull Structures

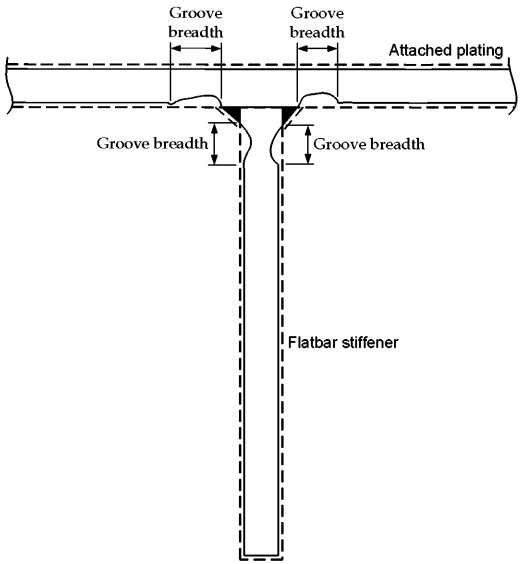
Figure 8 Grooving Corrosion

Grooving corrosion is often found in or beside welds, especially in the heat affected zone. This corrosion is sometimes referred to as 'inline pitting attack' and can also occur on vertical members and flush sides of bulkheads in way of flexing. The corrosion is caused by the galvanic current generated from the difference of the metallographic structure between the heat affected zone and base metal. Coating of the welds is generally less effective compared to other areas due to roughness of the surface, which exacerbates the corrosion. Grooving corrosion may lead to stress concentrations and further accelerate the corrosion process. Grooving corrosion may be found in the base material where coating has been scratched or the metal itself has been mechanically damaged. An example of grooving corrosion is shown in Figure 8.

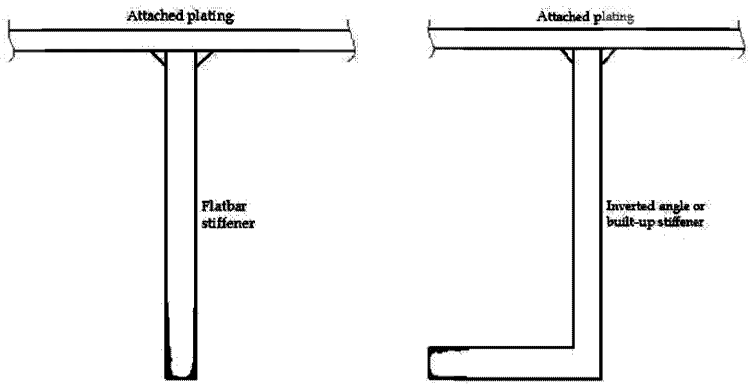
Figure 9 Edge Corrosion

Edge corrosion is defined as local corrosion at the free edges of plates, stiffeners, primary support members and around openings. An example of edge corrosion is shown in Figure 9.

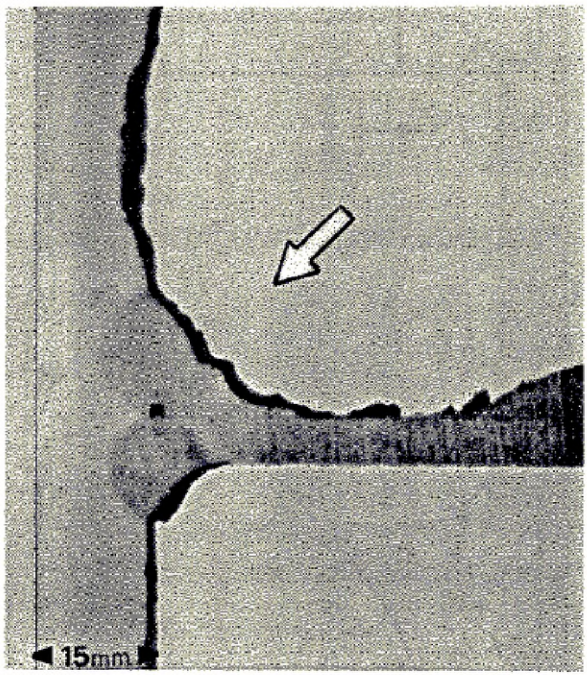
Figure 10 Detail of Necking Effect

- Necking occurs at the junction of the longitudinal bulkhead plating and longitudinals. The deflection of the bulkhead plating and longitudinals due to reverse, cyclic loading from cargo oil and water ballast plus the accumulated mixtures of water, mud and scale at their junctures accelerates the corrosion rate. As the steel thins and weakens, the flexing consequently increases and hence corrosion accelerates (see Figure 10). The similar necking effect could also occur in the transverse bulkhead plating and stiffeners, or in the inner bottom plating and longitudinals inside the double bottom space. In the coated water ballast tanks, the plating is the principally affected area due to local corrosion in way of coating failure.

One of the best methods of preventing corrosion within these spaces is that protective coatings be applied to the underdeck and inner bottom plating areas. In addition to

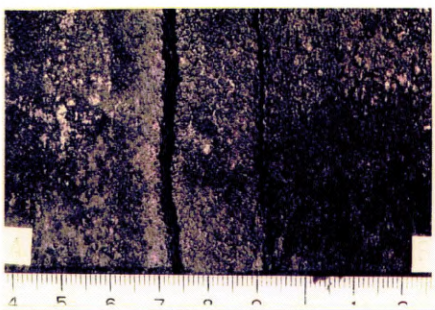
4.1.2 Severe grooving along welding of bottom plating is often found (See **Photographs 1** and **2**). This grooving can be accelerated by poor maintenance of the protective coating and/or sacrificial anodes fitted to the bottom plating.

Photograph 1
Grooving corrosion of welding of bottom plating

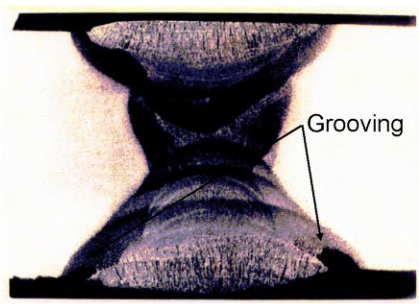
Photograph 2
Section of the grooving shown in Photograph 1

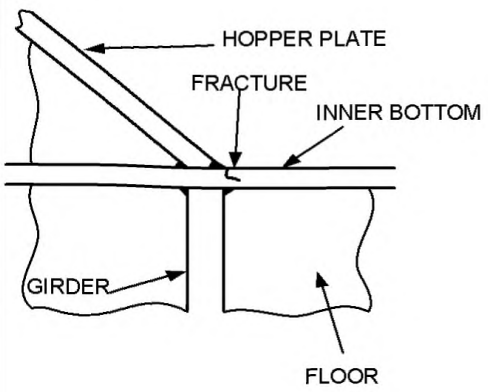
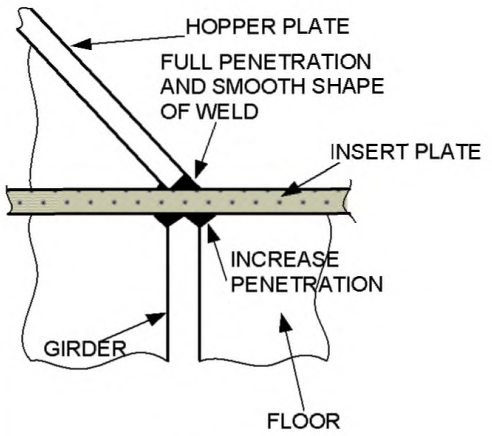
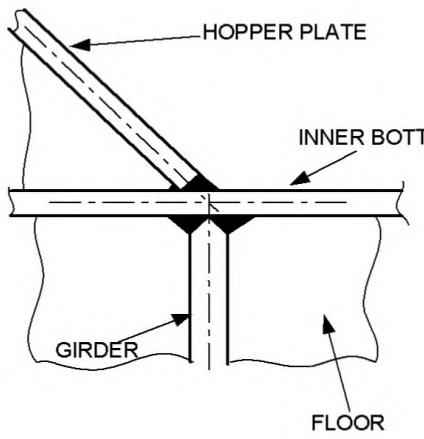
OIL Tankers	Guidelines for Surveys, Assessment and Repair of Hull Structure	
Group 1	Cargo area	Example No.
	Hopper and double bottom ballast tank	1
Detail of damage	Fracture on the inner bottom plating at the connection of hopper plate to inner bottom

Notes: Plate midlines intersect

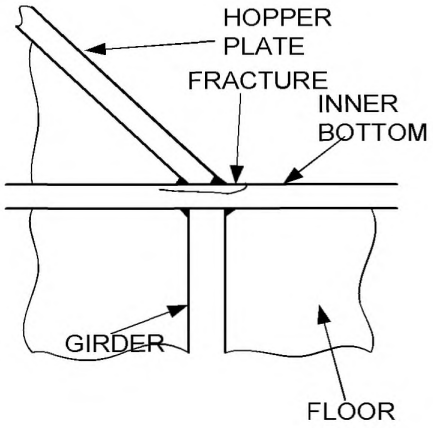
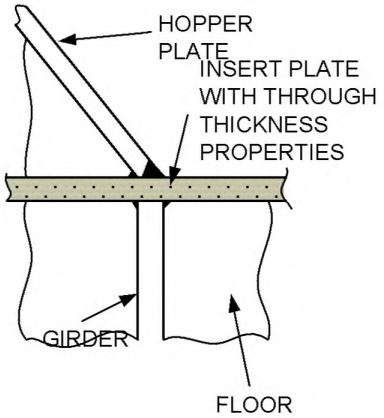
OIL Tankers	Guidelines for Surveys, Assessment and Repair of Hull Structure	
Group 1	Cargo area	Example No.
	Hopper and double bottom ballast tank	2
Detail of damage	Fracture at connection of bilge hopper plate and inner bottom

Notes: Plate midlines intersect

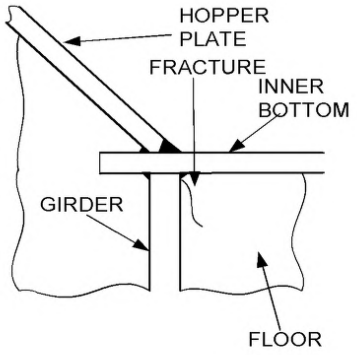
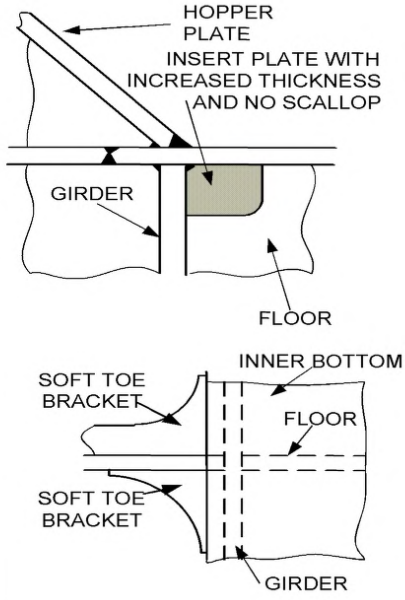
OIL Tankers	Guidelines for Surveys, Assessment and Repair of Hull Structure	
Group 1	Cargo area	Example No.
	Hopper and double bottom ballast tank	3
Detail of damage	Fracture at connection of bilge hopper plate and inner bottom

Factors which may have caused damage	**Notes on repairs**
1. Stress concentration at the knuckle.	See Sketch.

Notes: Plate midlines intersect

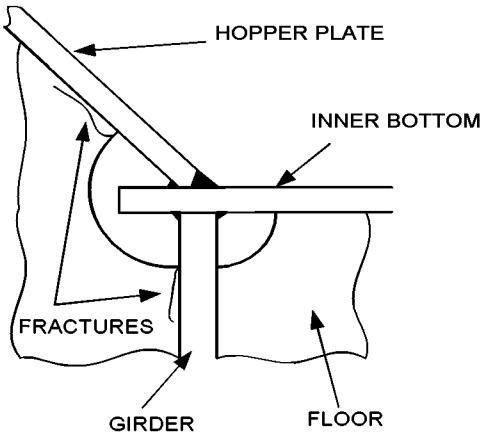
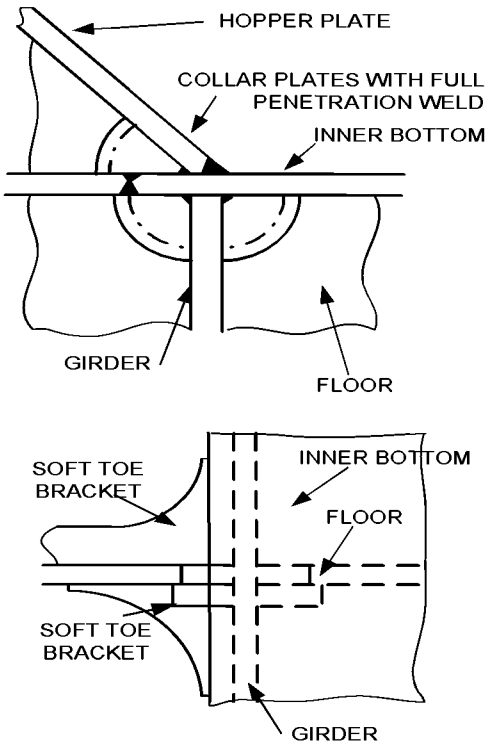
OIL Tankers	Guidelines for Surveys, Assessment and Repair of Hull Structure	
Group 1	Cargo area	Example No.
	Hopper and double bottom ballast tank	4
Detail of damage	Fracture at connection of bilge hopper plate and inner bottom

Notes: Plate midlines intersect

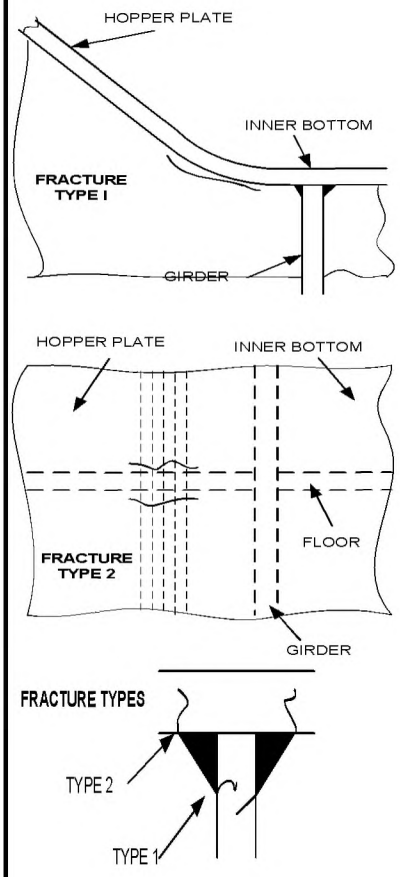
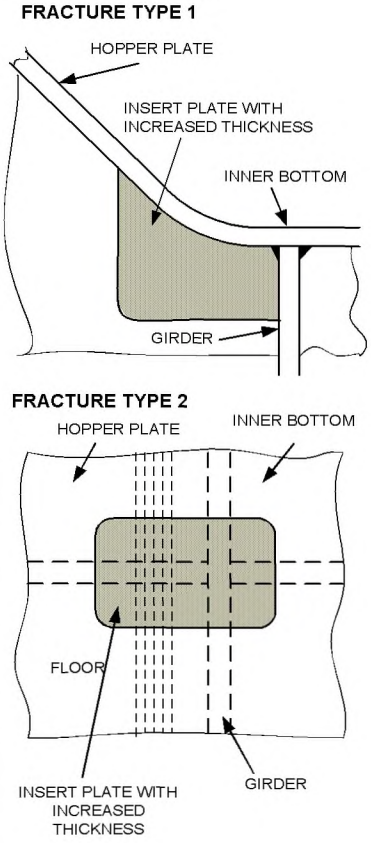
OIL Tankers	Guidelines for Surveys, Assessment and Repair of Hull Structure	
Group 1	Cargo area	Example No.
	Hopper and double bottom ballast tank	5
Detail of damage	Fractured floor and inner bottom plate in way of juncture of inner bottom to hopper plate

1. Misalignment. The three mid-lines do not cross at the same joint. This misalignment produces an out-of-plane deformation of inner bottom plate in way of knuckle line.
2. Stress concentration at connection between floor and inner bottom plate.
3. Static and dynamic load of ballast water.

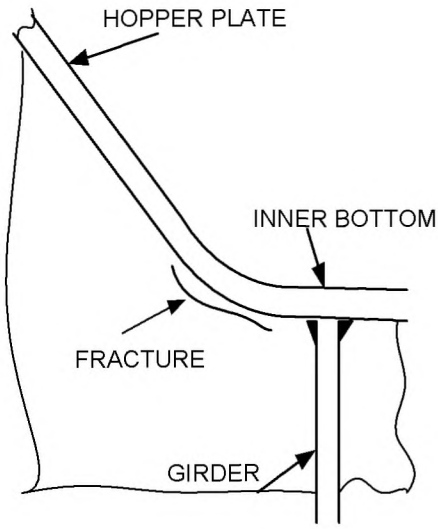
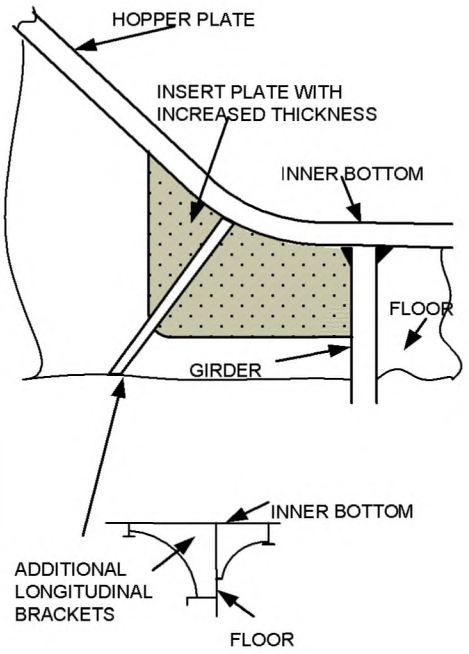
OIL Tankers	Guidelines for Surveys, Assessment and Repair of Hull Structure	
Group 1	Cargo area	Example No.
	Hopper and double bottom ballast tank	6
Detail of damage	Fracture at connection of bilge hopper plate and web frame

1. Stress concentration due to reduction of effective flange area at curved plate.

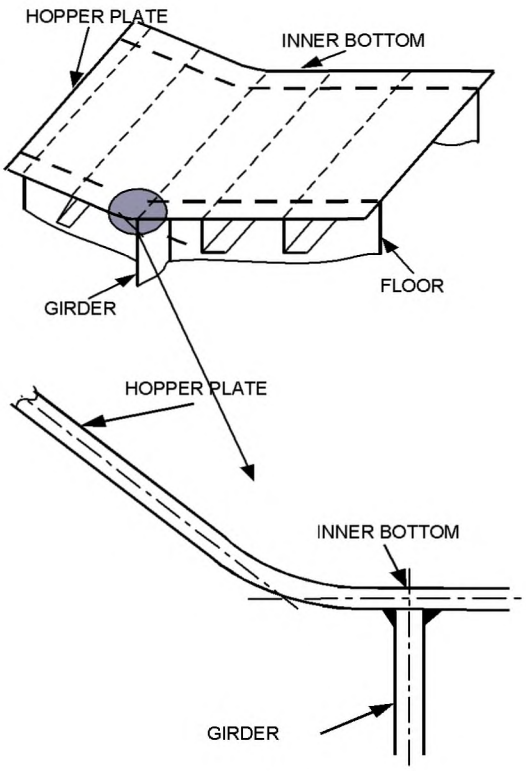
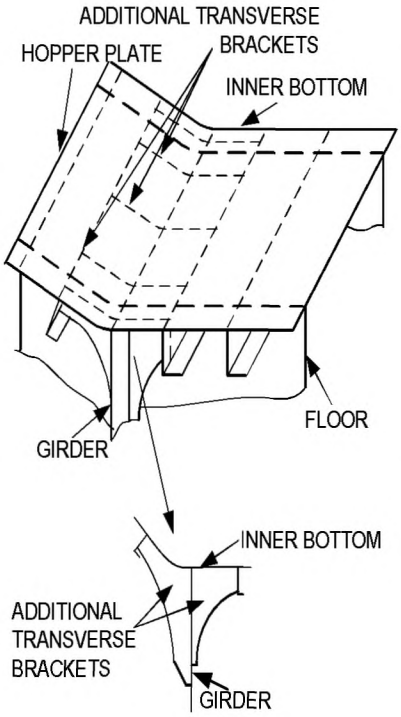
OIL Tankers	Guidelines for Surveys, Assessment and Repair of Hull Structure	
Group 1	Cargo area	Example No.
	Hopper and double bottom ballast tank	7
Detail of damage	Rounded hopper plate deformation in way of the floor

1. Misalignment. The three midlines do not cross at the same joint. This misalignment produces an out-of-plane deformation in knuckled plate in the vicinity of floor.
2. Insufficient stiffening between floors.

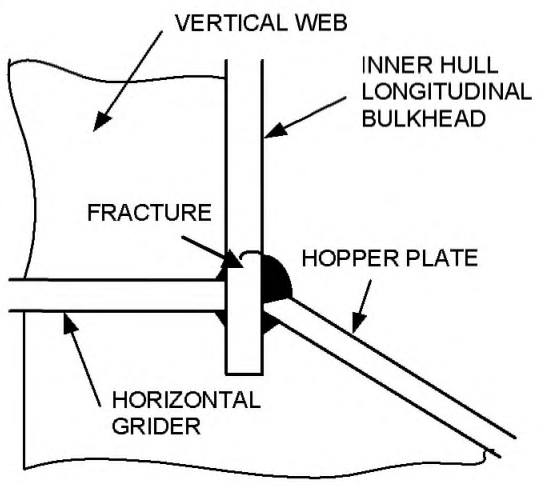
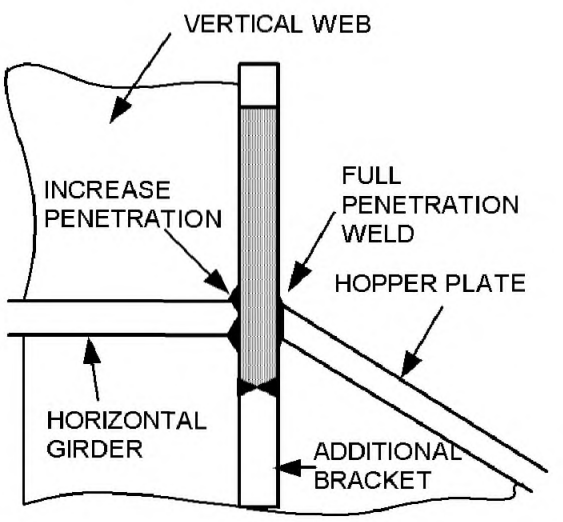
1. Stress concentration at junction of hopper plate to outside longitudinal bulkhead.
2. Insufficient welding connection and/or incorrect shape of the weld toe.
3. Misalignment between hopper plate, outside longitudinal bulkhead and side stringer.

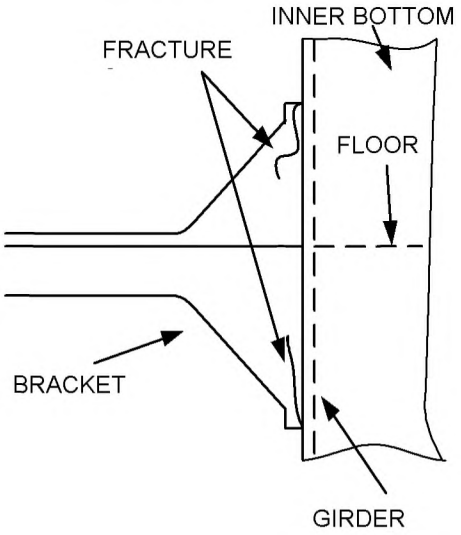
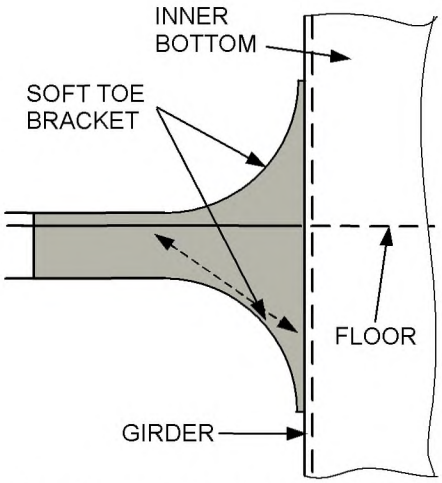
OIL Tankers	Guidelines for Surveys, Assessment and Repair of Hull Structure	
Group 1	Cargo area	Example No.
	Hopper and double bottom ballast tank	9
Detail of damage	Fracture in gusset plate in line with inner bottom

Notes: Bracket radii as large as practicable.
Bracket same thickness as inner bottom stiffener.
Toe height should be small as possible while still allowing return weld (wrapped weld).

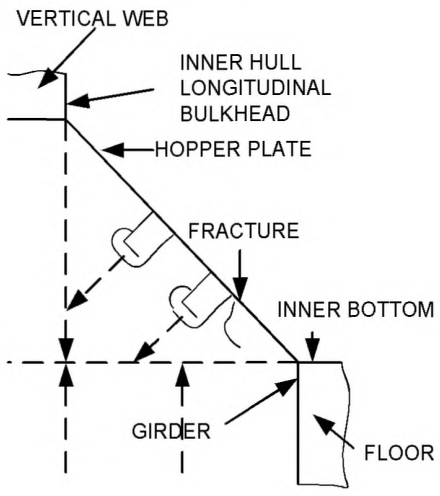
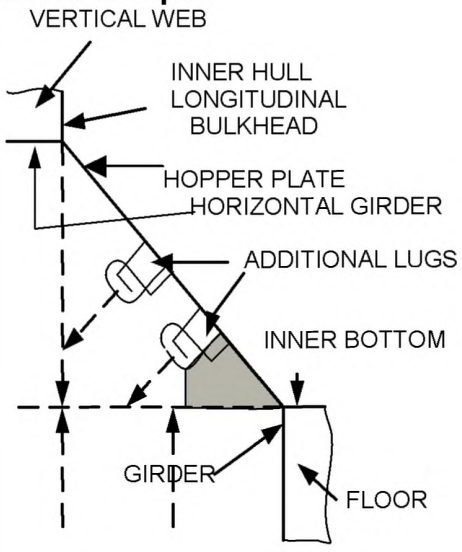
1. Stress concentration due to no collar plate.

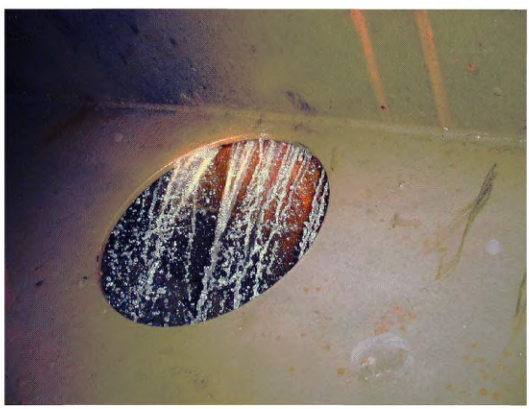
Photograph 1 Side shell fracture in way of horizontal stringer weld

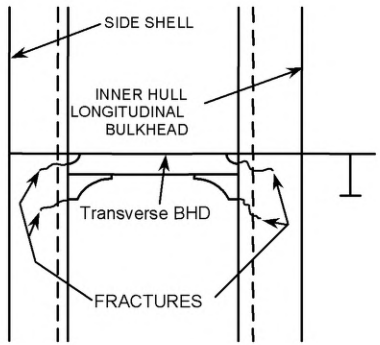
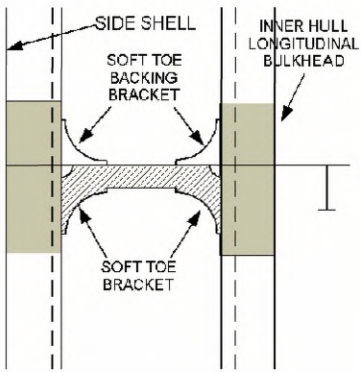
OIL Tankers	Guidelines for Surveys, Assessment and Repair of Hull Structure	
Group 2	Cargo area	Example No.
	Wing ballast tank	1
Detail of damage	Crack in way of connection of longitudinals to transverse bulkhead

1. Asymmetrical connection of bracket without backing bracket.
2. Relative deflection of adjoining transverse web against transverse bulkhead.
3. Additional biaxial bending stresses due to asymmetry of the angle bar longitudinal instead of symmetric T section.
4. Dynamic load in the vicinity of the water line.
5. Large upstand at bracket toe.

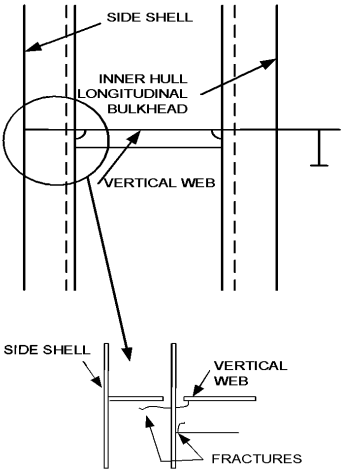
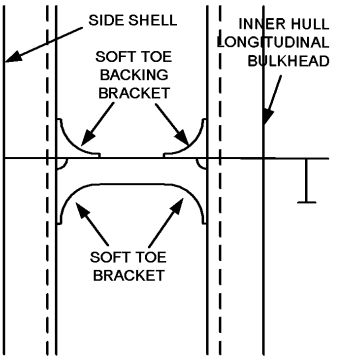
OIL Tankers	Guidelines for Surveys, Assessment and Repair of Hull Structure	
Group 2	Cargo area	Example No.
	Wing ballast tank	2
Detail of damage	Crack in way of connection of longitudinals to transverse webs

1. Asymmetrical connection of flat bar stiffener resulting in high peak stresses at the heel of the stiffener.
2. Insufficient area of connection of longitudinal to web.
3. High bending stresses in the longitudinal.
4. Additional biaxial bending stresses due to asymmetry of the longitudinal (angle bar instead of symmetric T bar).
5. Stress concentration at the square angles at heel and toe of the connections.
6. High shear stress in the transverse web.

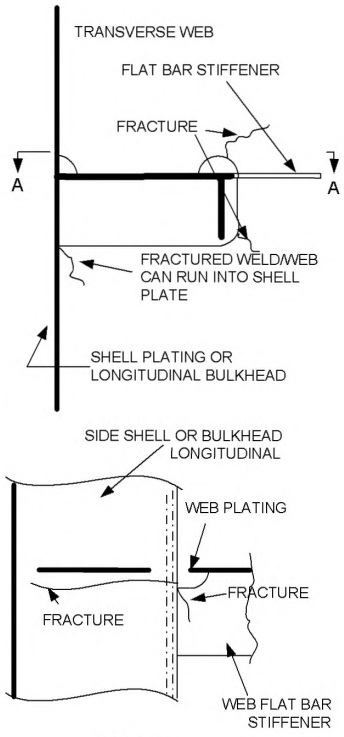
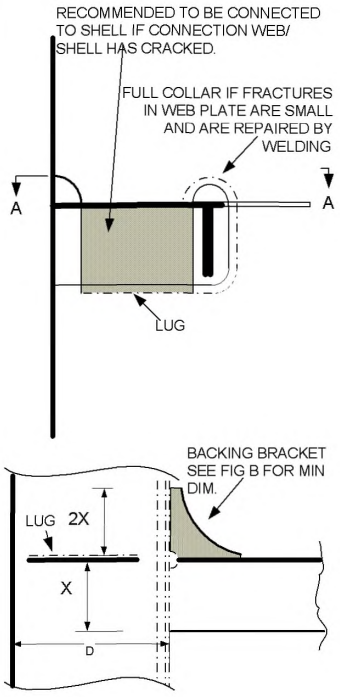
OIL Tankers	Guidelines for Surveys, Assessment and Repair of Hull Structure	
Group 2	Cargo area	Example No.
	Wing ballast tank	3
Detail of damage	Fracture in way of web and flat bar stiffener at cut outs for longitudinal stiffener connections.

1. Asymmetrical connection of flat bar stiffener resulting in high peak stress at heel of the stiffener under fatigue loading.
2. Insufficient area of connection of longitudinal to web plate.
3. Defective weld at return around the plate thickness.
4. High localized corrosion at areas of stress concentrations such as flat bar stiffener connections, corners of cut out for longitudinal and connection of web to shell at cut outs.
5. High shear stress in web of the transverse.
6. Dynamic seaway loads/motions.

Insert longitudinal.

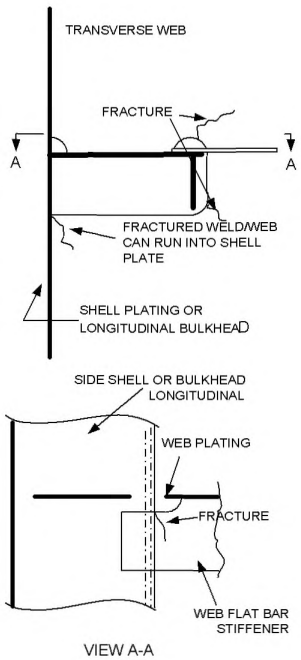
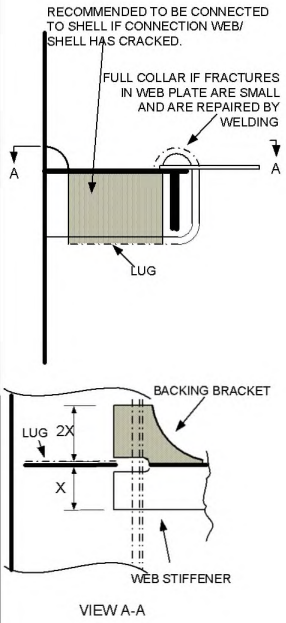
Detail of damage Fracture in way of web and flat bar stiffener at cut outs for longitudinal stiffener connections as Example 3 but with faceplate attached to underside of web. Flat bar lap welded.

1. Asymmetrical connection of flat bar stiffener resulting in high peak stress at heel of the stiffener under fatigue loading.
2. Fabricated longitudinal with welding onto exposed edge of the web resulting in poor fatigue strength of the connection of the longitudinal to the flat bar.
3. Insufficient area of connection of longitudinal to web plate.
4. Defective weld at return around the plate thickness.
5. High localized corrosion at areas of stress concentrations such as flat bar stiffener connections, corners of cut out for longitudinal and connection of lug to shell at cut outs.
6. High shear stress in web of the transverse.
7. Dynamic seaway loads/motions.

Insert web plate.

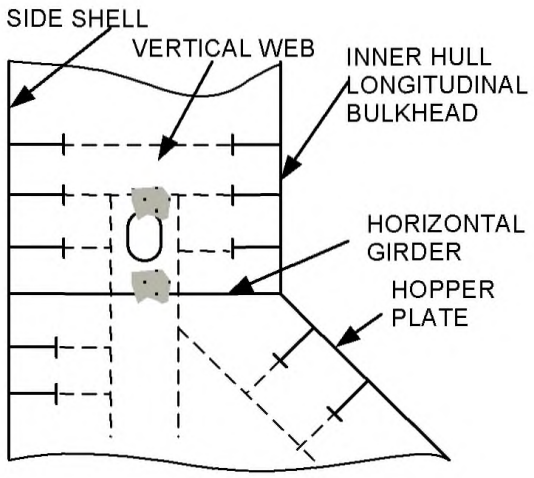
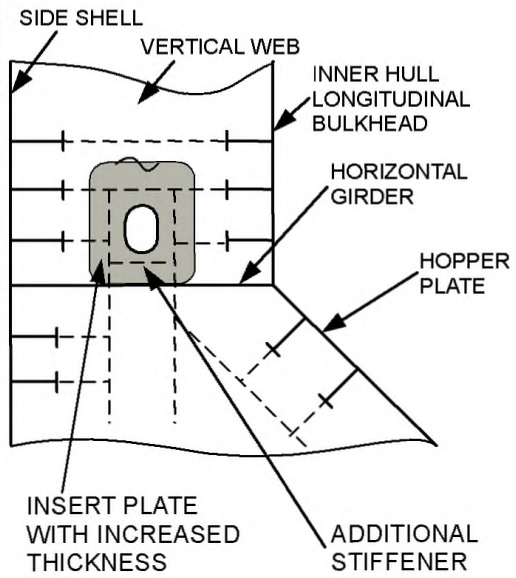
1. High shear stress in the transverse web.
2. Insufficient buckling strength.

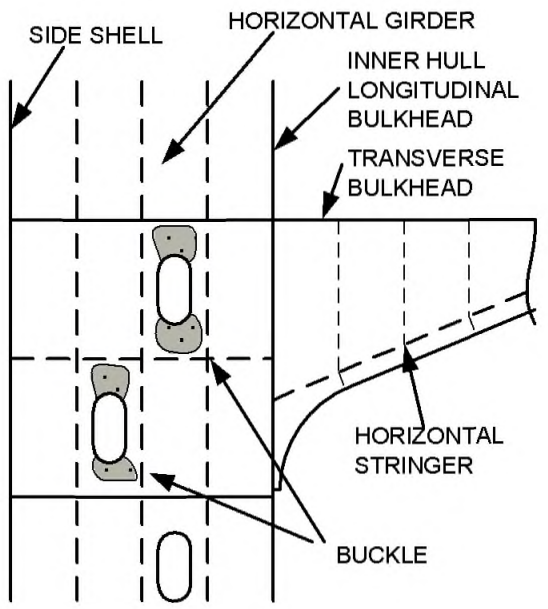
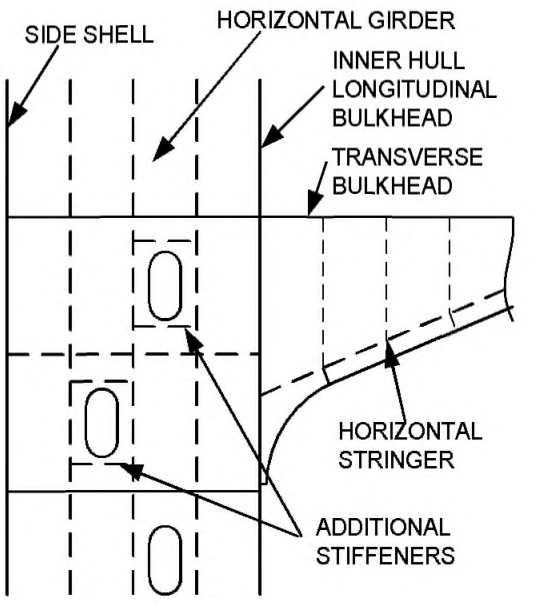
1. High shear or compressive stress in the stringer.
2. Insufficient buckling strength.

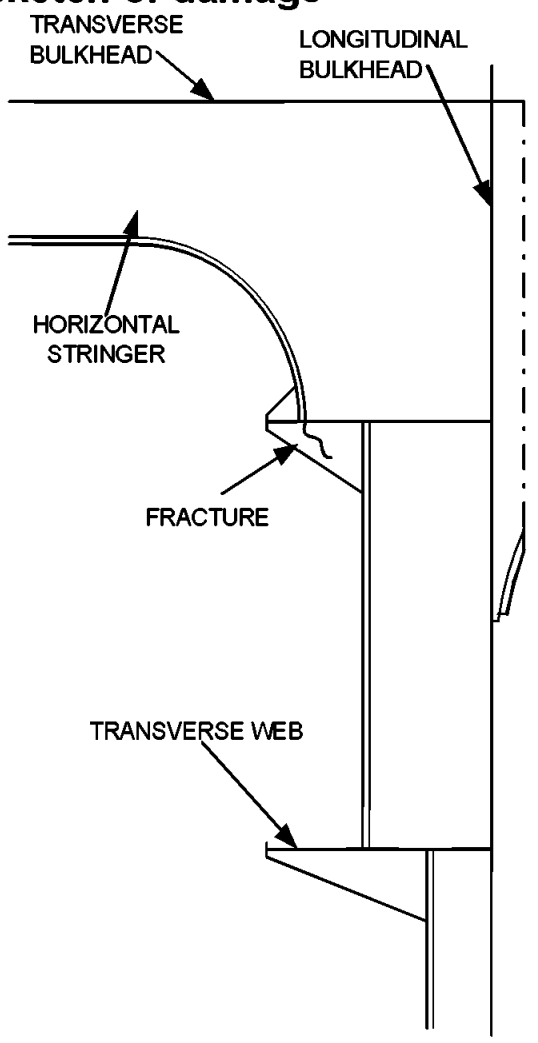
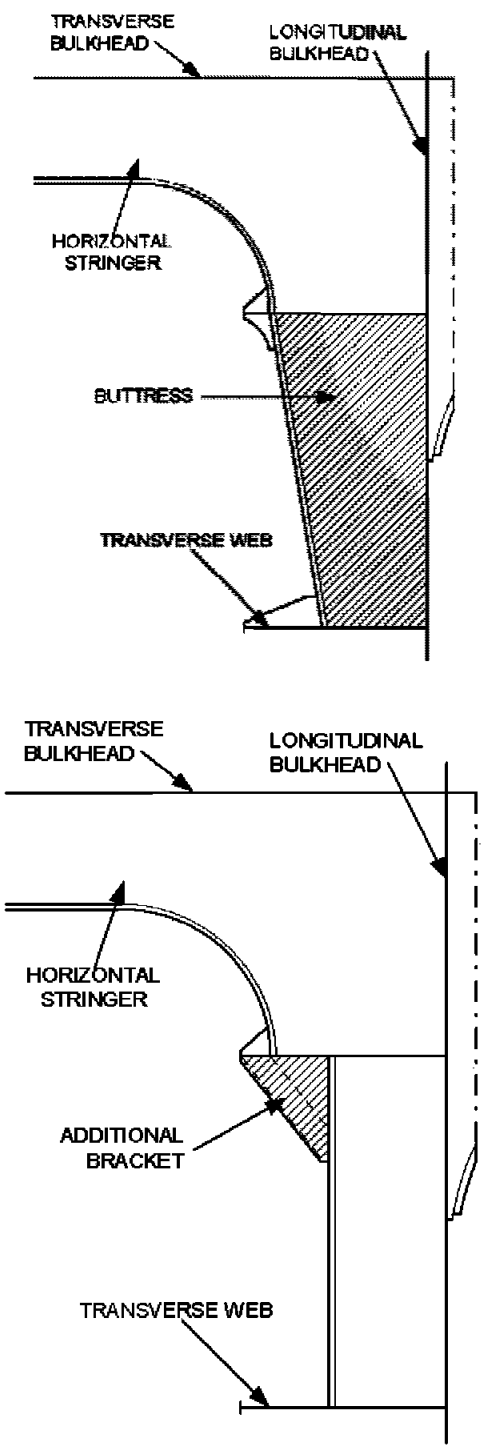
1. Stress concentration due to discontinuous structure.
2. High shear stress in the horizontal stringer.

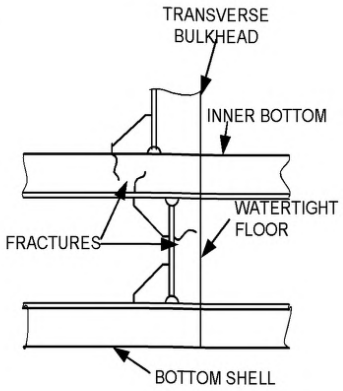
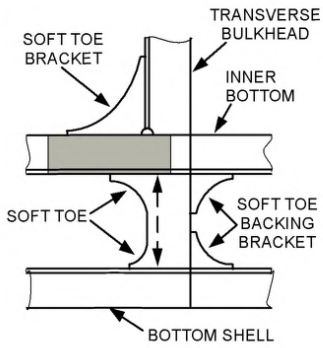
OIL Tankers	Guidelines for Surveys, Assessment and Repair of Hull Structure	
Group 3	Cargo area	Example No.
	Bottom ballast tank	1
Detail of damage	Cracks in way of longitudinals connected to watertight floors

1. Asymmetrical connection of bracket in association with a backing bracket, which is too small.
2. Relative deflection between adjacent floor and transverse bulkhead.
3. Inadequate shape of the brackets.
4. High stresses in the inner bottom longitudinal and the floor stiffener.

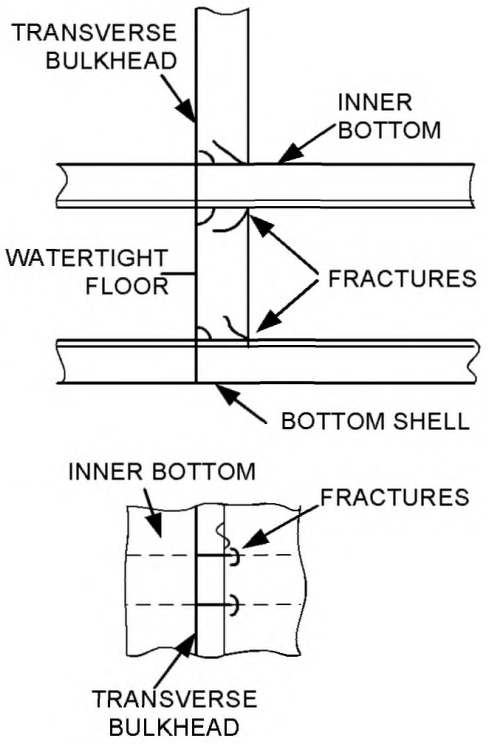
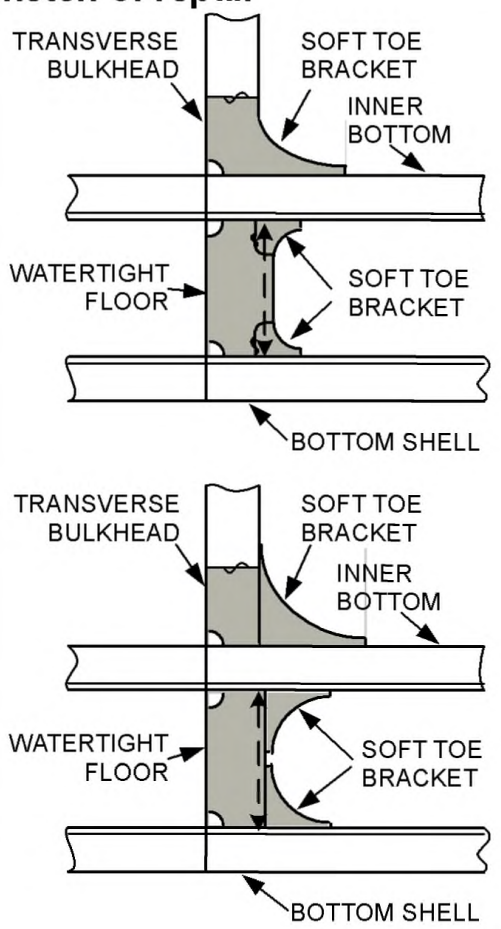
Factors which may have caused damage	Notes on repairs
1. Misalignment between bulkhead stiffener and inner bottom longitudinal. 2. High stress concentration.	See Sketch. 1. If tank top plating is fractured, part crop and insert. 2. Proper alignment between bulkhead stiffener and inner bottom longitudinal is critical for successful repair. 3. Soft backing brackets may also be added.

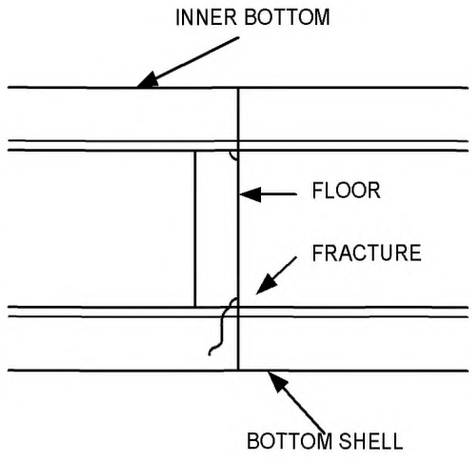
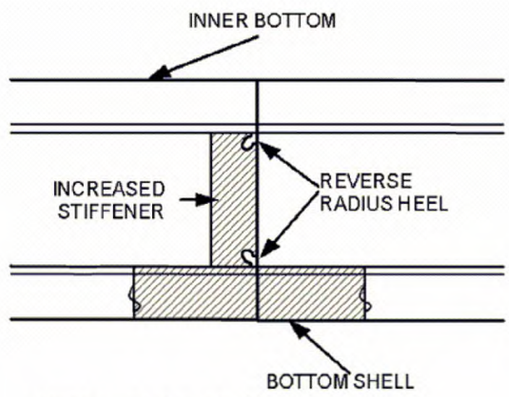
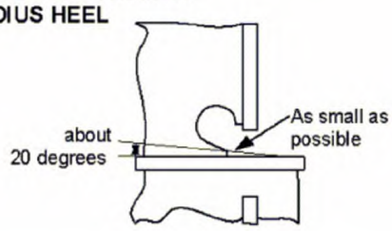
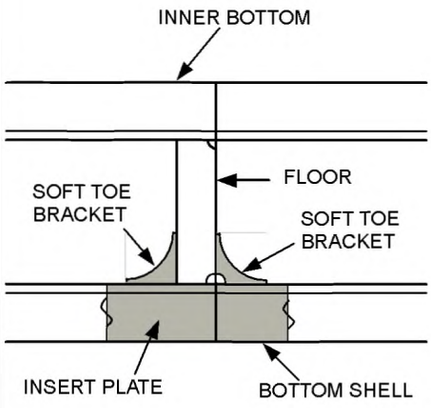
OIL Tankers	Guidelines for Surveys, Assessment and Repair of Hull Structure	
Group 3	Cargo area	Example No.
	Bottom ballast tank	3
Detail of damage	Connection of longitudinals to ordinary floors.

1. Asymmetrical connection.
2. Relative deflection of adjacent floor to transverse bulkhead.

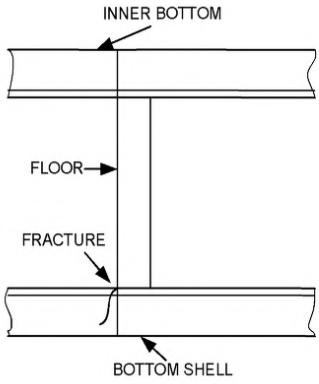
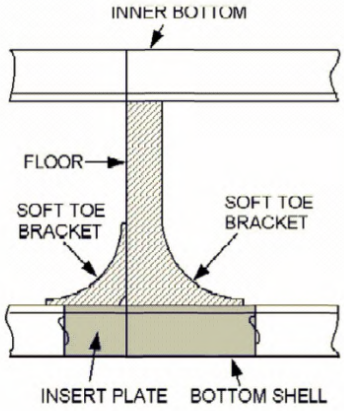
OIL Tankers	Guidelines for Surveys, Assessment and Repair of Hull Structure	
Group 3	Cargo area	Example No.
	Bottom ballast tank	4
Detail of damage	Connection of longitudinals to ordinary floors

1. Stress concentration at the connection of bottom longitudinal and stiffener on floor.

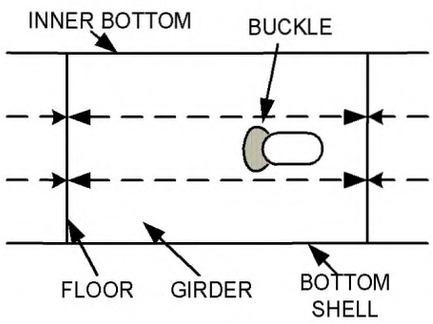
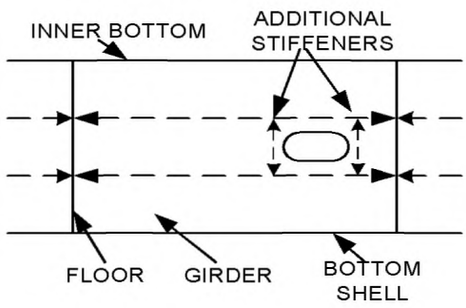
OIL Tankers	Guidelines for Surveys, Assessment and Repair of Hull Structure	
Group 3	Cargo area	Example No.
	Bottom ballast tank	5
Detail of damage	Panels of bottom girders in way of openings.

1. High shear or compressive stress in the side girder.
2. Insufficient buckling strength.

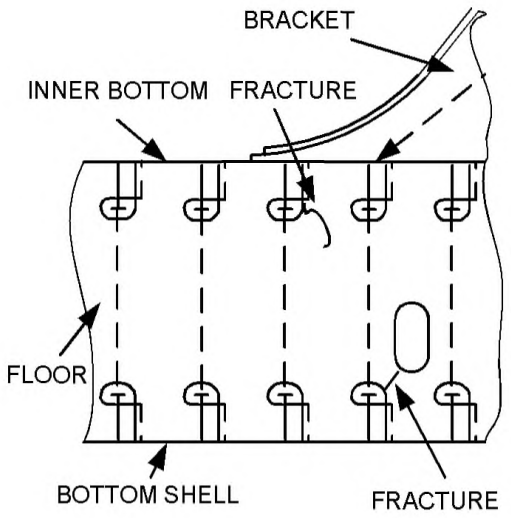
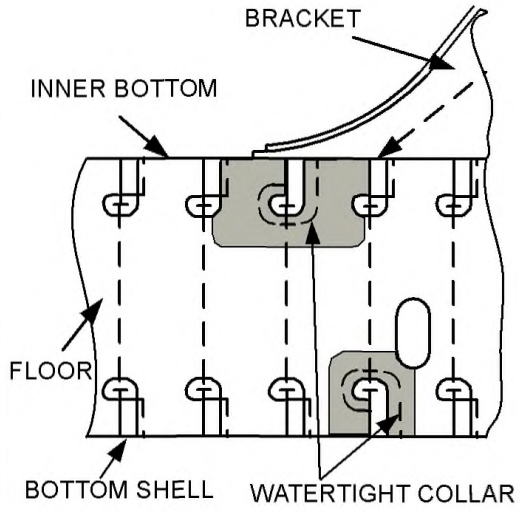
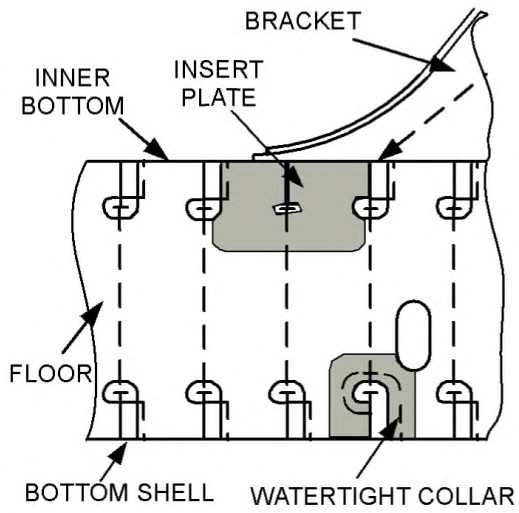
OIL Tankers	Guidelines for Surveys, Assessment and Repair of Hull Structure	
Group 3	Cargo area	Example No.
	Bottom ballast tank	6
Detail of damage	Cut-outs on floors

Above for relatively small fractures.

Above method for larger fractures.

1. Top sketch: Gouge and reweld fractures then fit WT collars.
2. Bottom sketch: As an alternative to rewelding and fitting collar, crop and insert.

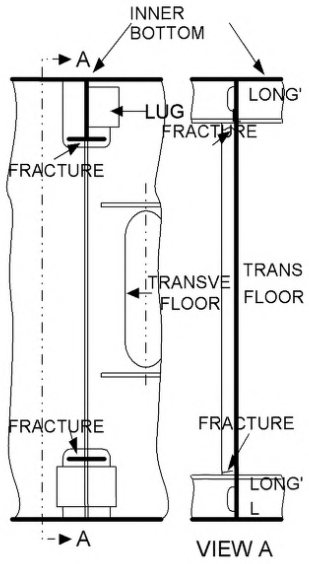
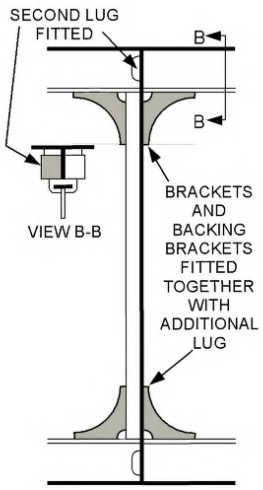
OIL Tankers	Guidelines for Surveys, Assessment and Repair of Hull Structure	
Group 3	Cargo area	Example No.
	Bottom ballast tank	7
Detail of damage	Fractured stiffener connection to bottom and inner bottom longitudinals.

1. Asymmetric connection leading to high local stresses at the connection of vertical stiffeners of the transverse floors to the inner and outer bottom longitudinals.
2. Wide slot for longitudinal leads to inefficient lug connection.
3. Sharp corners or flame-cut edges producing a notch effect.
4. Incomplete/defective weld at stiffener connection to the longitudinals.
5. Dynamic sea way loads/ship motions.

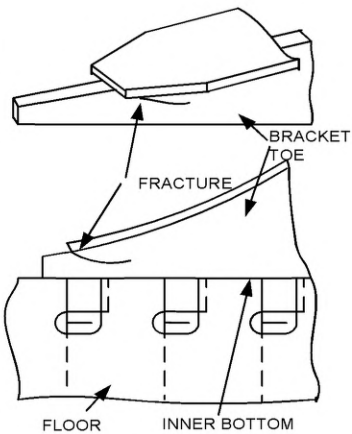
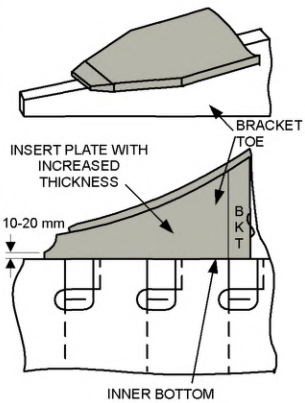
OIL Tankers	Guidelines for Surveys, Assessment and Repair of Hull Structure	
Group 4	Cargo area	Example No.
	Web Frame in cargo tank	1
Detail of damage	Fracture at toe of web frame bracket connection to inner bottom.

1. Inadequate tapering the toe end.
2. Insufficient tapering of flange.
3. Lateral flexing of the bracket.

Modify Face Taper

1. Breadth taper 20 degrees.
2. Breadth at toe as small as practical.
3. Thickness taper 1 in 3 to 10mm.

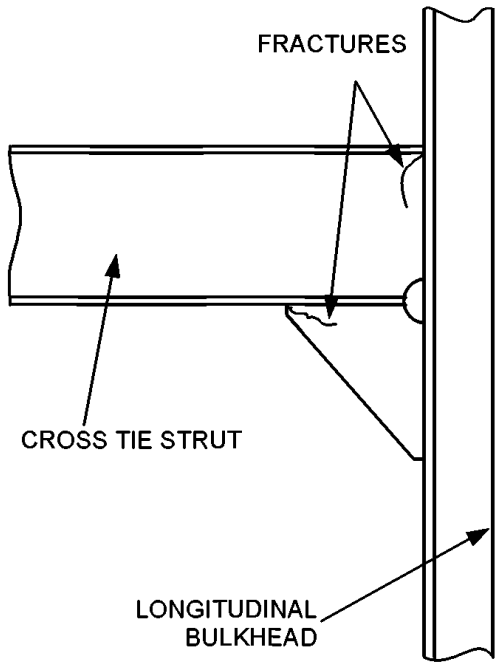
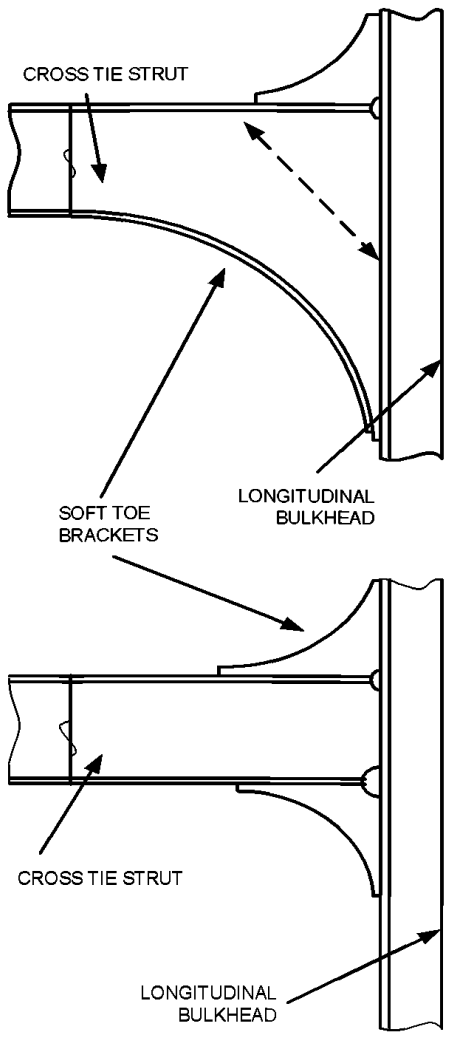
1. Stress concentration due to unsuitable bracket shape at juncture of cross tie to longitudinal.
2. Inadequate panel stiffening of web plate of cross-tie.

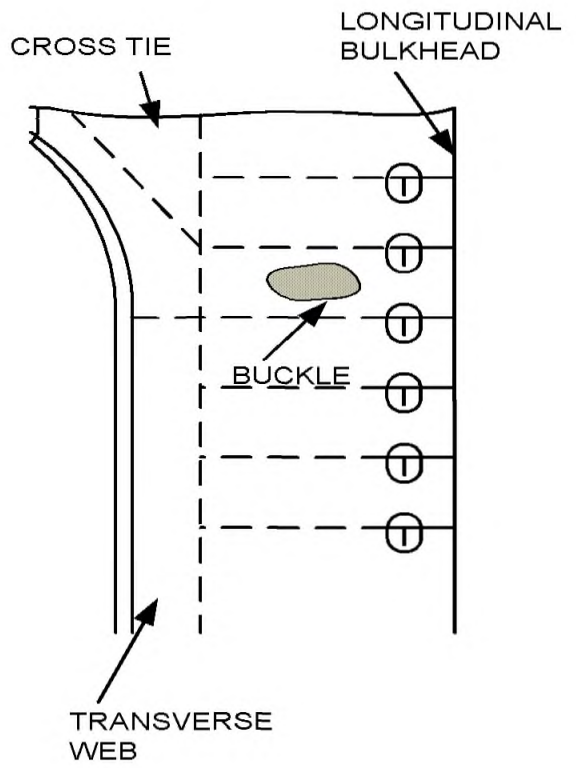
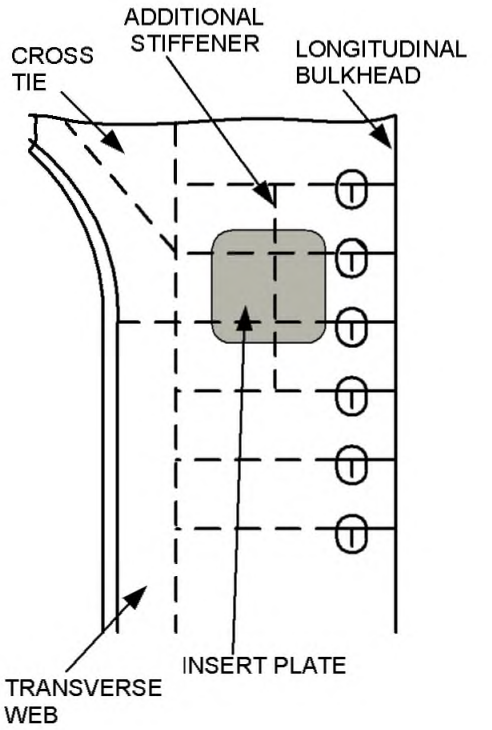
1. Insufficient panel stiffening on transverse web.

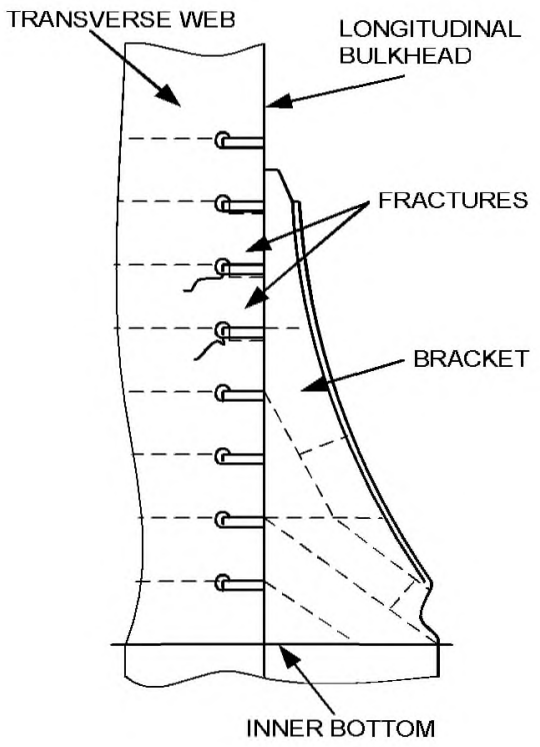
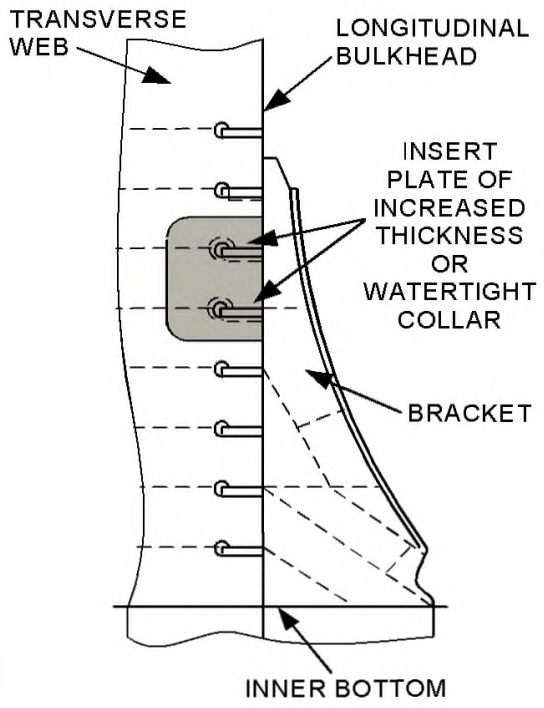
1. High stresses at toe of bottom transverse end bracket.
2. Sharp corner at cut-out.

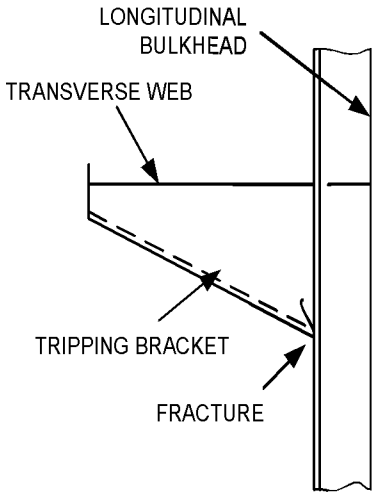
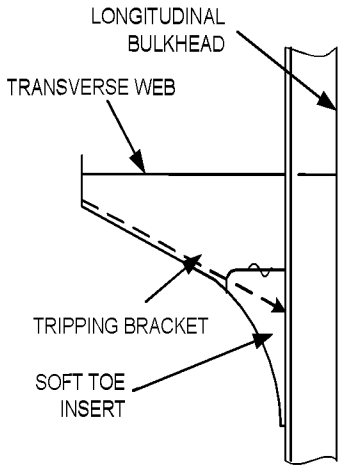
OIL Tankers	Guidelines for Surveys, Assessment and Repair of Hull Structure	
Group 4	Cargo area	Example No.
	Web Frame in cargo tank	5
Detail of damage	Fracture in way of connection of transverse web tripping brackets to longitudinal

1. Hard spot at the toe of bracket.
2. Vibration.

1. Soft bracket may be added on upper side of web, to avoid fracture at the heel.

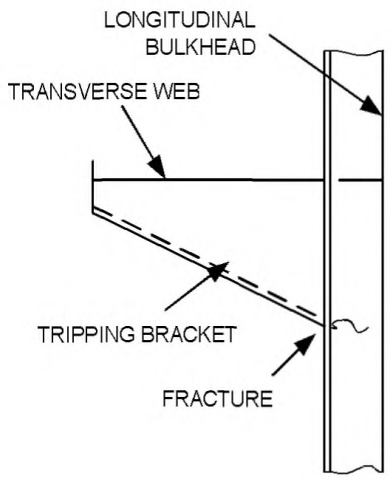
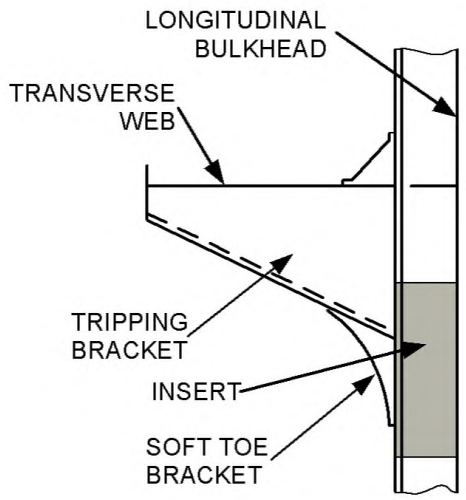
OIL Tankers	Guidelines for Surveys, Assessment and Repair of Hull Structure	
Group 4	Cargo area	Example No.
	Web Frame in cargo tank	6
Detail of damage	Tripping brackets modification of the bracket toe.

1. Stress concentrations at toe of bracket.
2. High stress in longitudinal.

1. Soft bracket may be added on upper side of web, to avoid fracture at the heel.

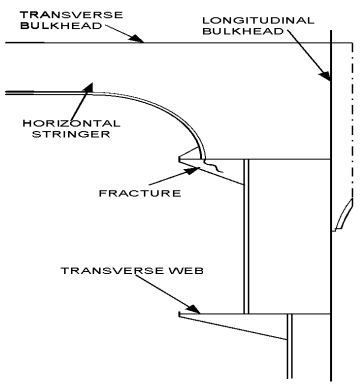
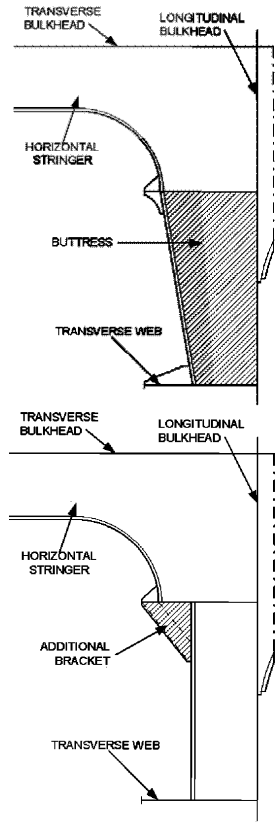
OIL Tankers	Guidelines for Surveys, Assessment and Repair of Hull Structure	
Group 5	Cargo area	Example No.
	Transverse Bulkhead in cargo tank	1
Detail of damage	Fracture in way of connection of transverse bulkhead stringer to transverse web frames and longitudinal bulkhead stringer

1. Stress concentration due to discontinuous structure.
2. High shear stress in the horizontal stringer.

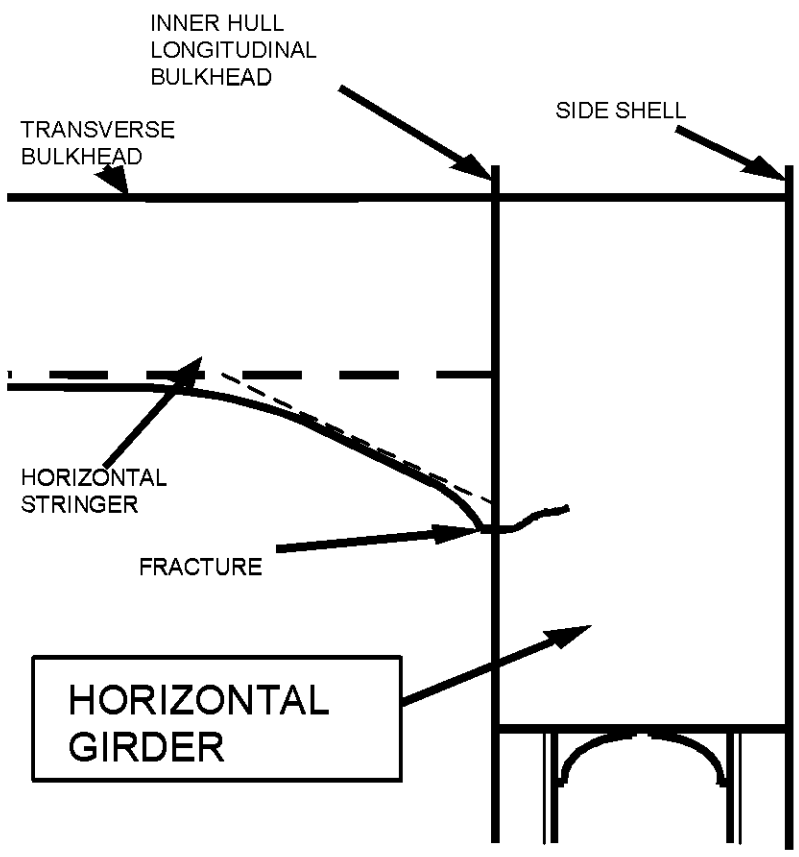
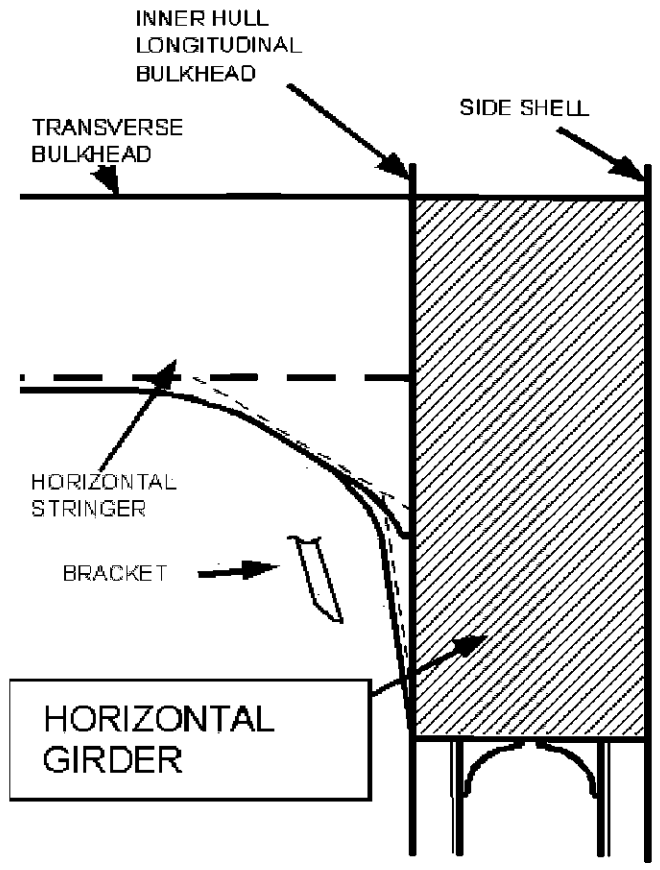
1. Misalignment between bracket end and side girder in wing tank.
