No. 96 (April 2007) **Double Hull Oil Tankers -** Guidelines for Surveys, Assessment and Repair of Hull Structures

DOUBLE HULL OIL TANKERS

Guidelines for Surveys, Assessment and Repair of Hull Structures

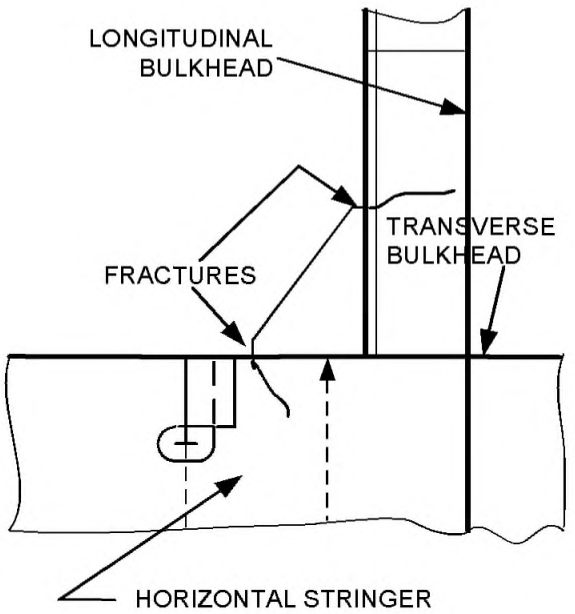
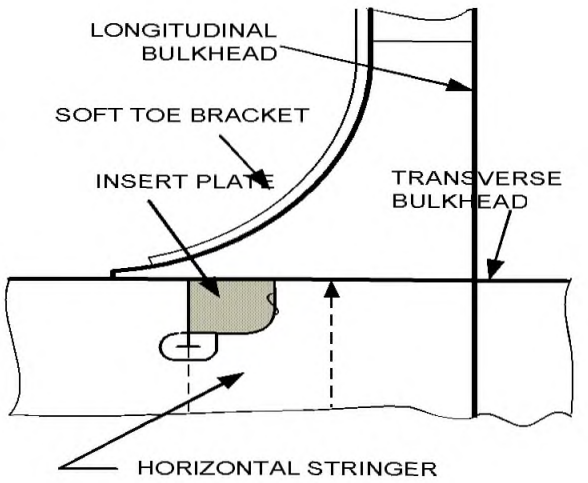
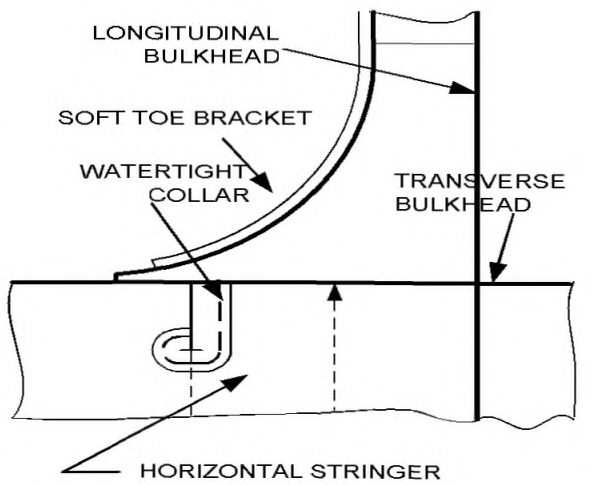
1. Stress concentration due to inadequate shape of the bracket.
2. Relative deflection of adjoining transverse web against transverse bulkhead.

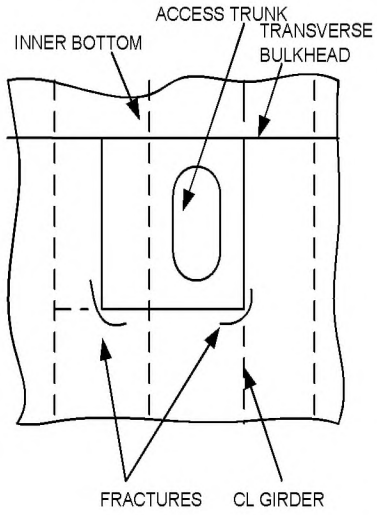
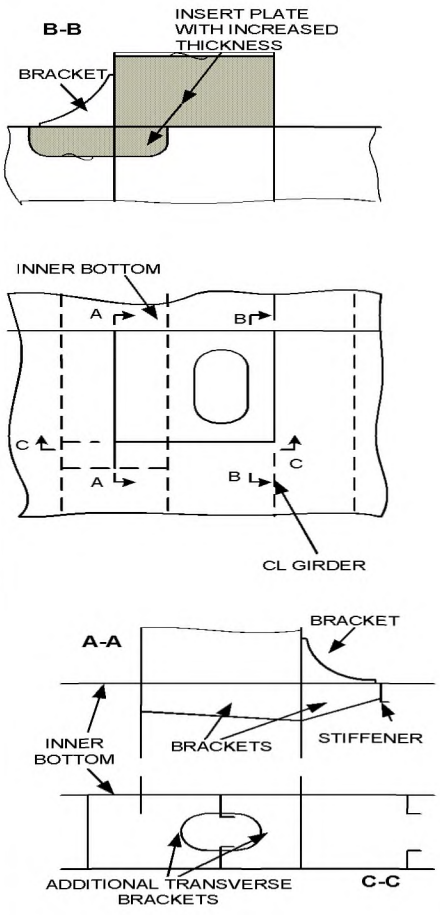
OIL Tankers	Guidelines for Surveys, Assessment and Repair of Hull Structure	
Group 5	Cargo area	Example No.
	Transverse Bulkhead in cargo tank	4
Detail of damage	Fractured inner bottom plate at the connection to access trunk wall

1. Stress concentration at the connection of trunk wall to inner bottom plate.
2. Relative deformation between horizontal stringer fitted on transverse bulkhead and inner bottom plate.
3. Static and dynamic load of cargo liquid.

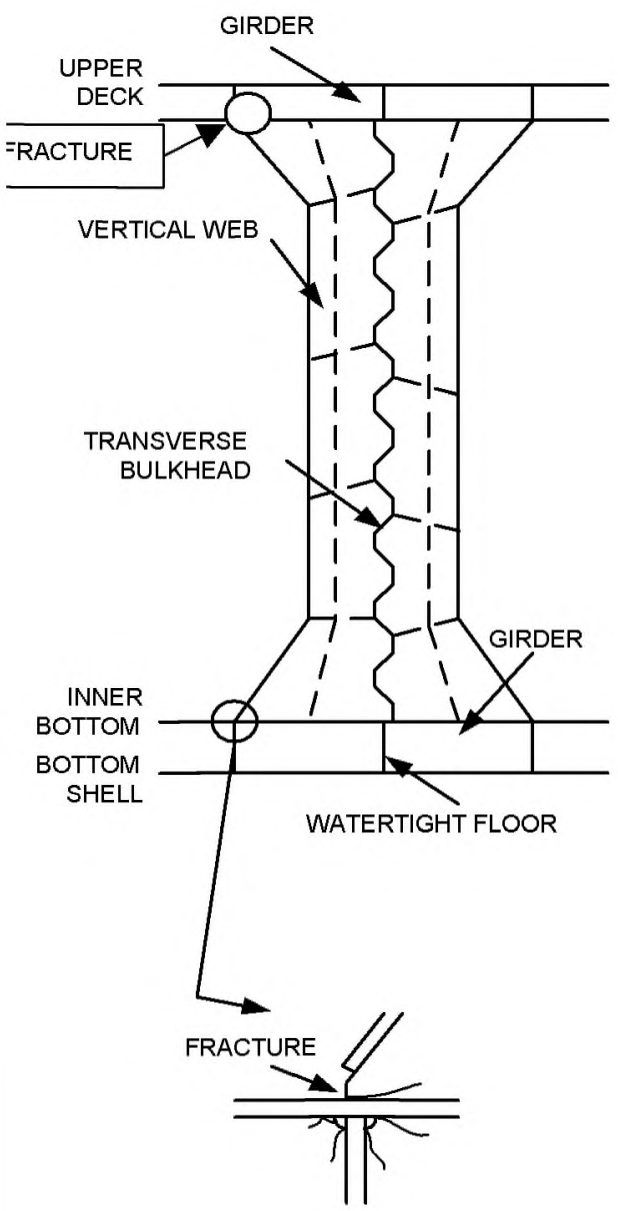
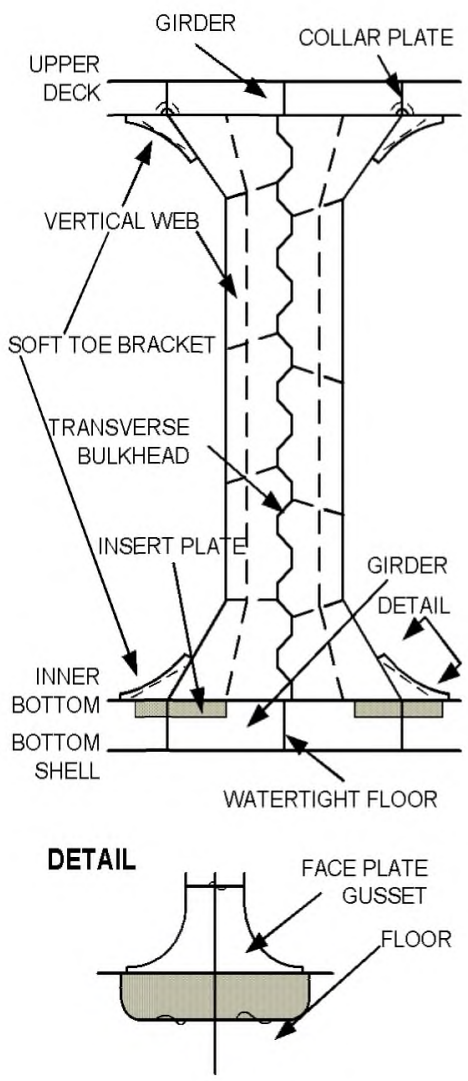
1. Stress concentration at toe of bracket due to sniped face plate and scallop in way.

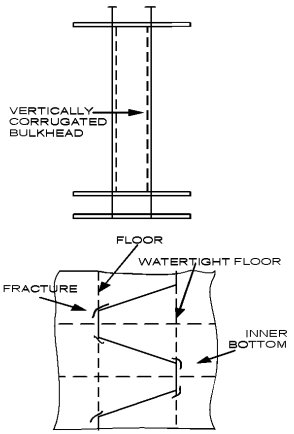
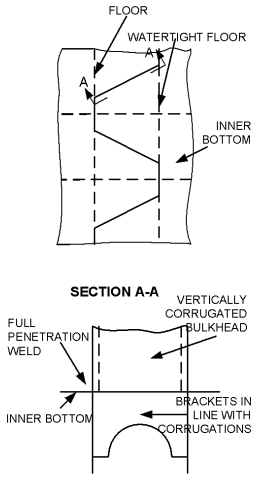
OIL Tankers	Guidelines for Surveys, Assessment and Repair of Hull Structure	
Group 5	Cargo area	Example No.
	Transverse Bulkhead in cargo tank	6
Detail of damage	Vertically corrugated bulkhead without stool, connection to deck and inner bottom

1. Stress concentration due to unsupported corrugation web.
2. High through thickness stress, lamellar tearing.
3. Weld details and dimensions.
4. Misalignment between face of corrugation and floor underneath.
5. Cut-outs and scallops or air holes increasing the stress in the floor.
6. Insufficient through thickness properties of inner bottom plate.

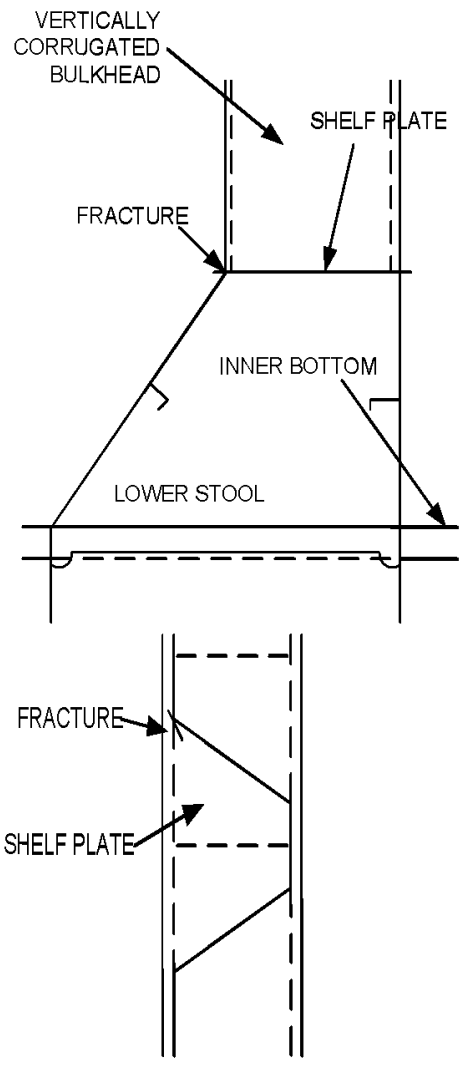
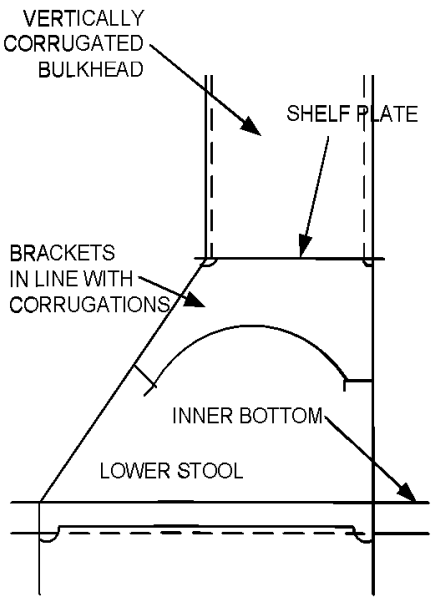
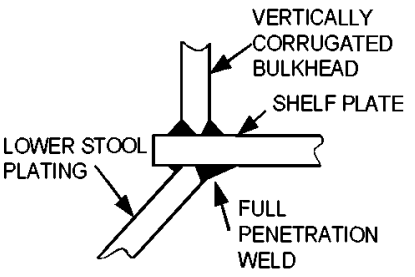
OIL Tankers	Guidelines for Surveys, Assessment and Repair of Hull Structure	
Group 5	Cargo area	Example No.
	Transverse Bulkhead in cargo tank	7
Detail of damage	Fracture at connection of vertically corrugated transverse bulkhead with stool to shelf plate and lower stool plate.

1. Stress concentration due to unsupported corrugation web.
2. High through thickness stress, lamellar tearing.
3. Weld details and dimensions.
4. Misalignment.
5. Insufficient thickness of stool side plating in relation to corrugation flange thickness.

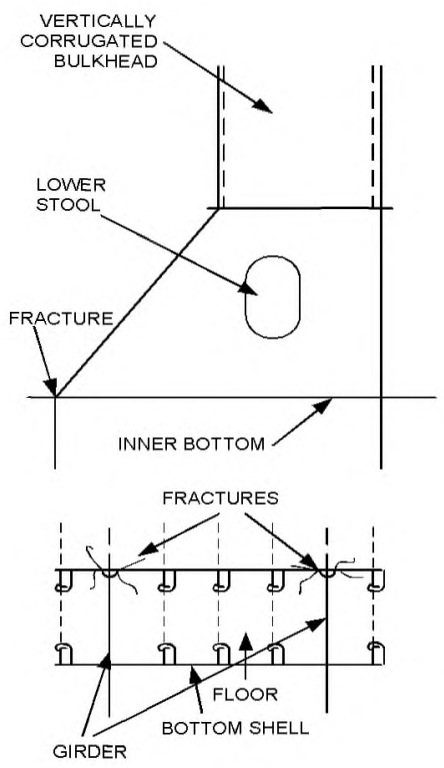
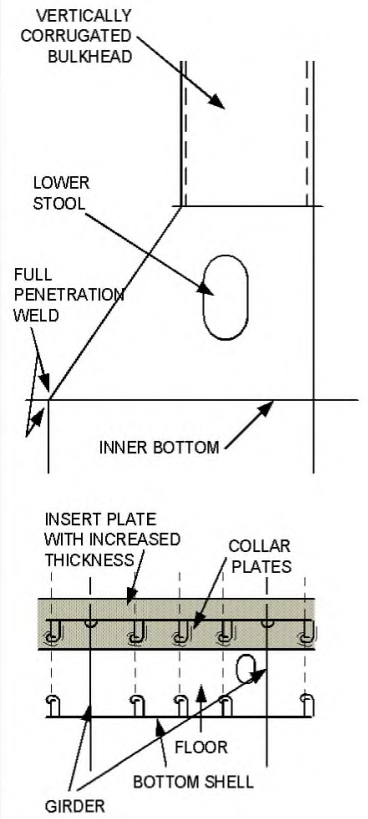
1. Misalignment between stool side plating and floor and/or stool webs and girders of double bottom.
2. Insufficient thickness of floor compared to stool thickness.
3. Scallops, cut-outs, air hole reducing the connecting area too much.
4. Weld details and dimensions.
5. Lamellar tearing of inner bottom plating.

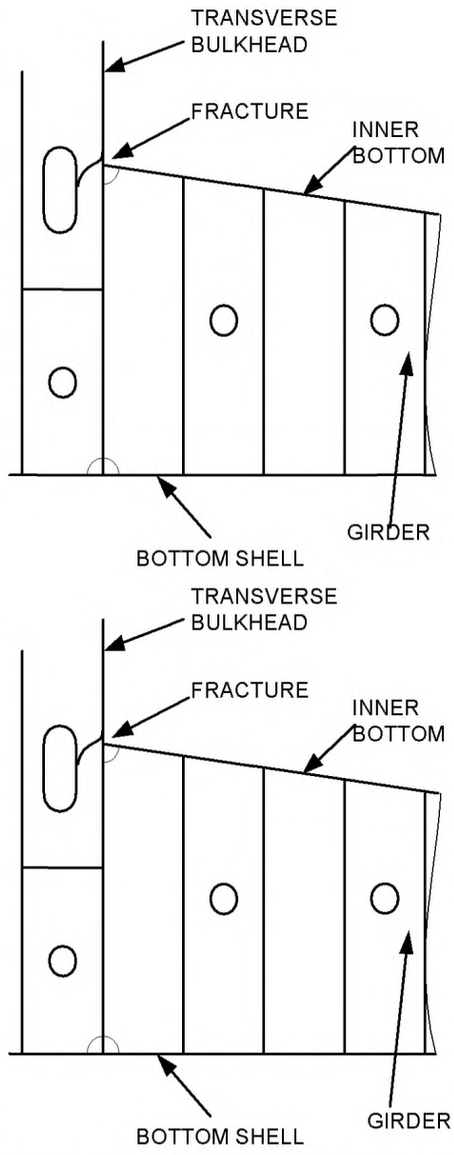
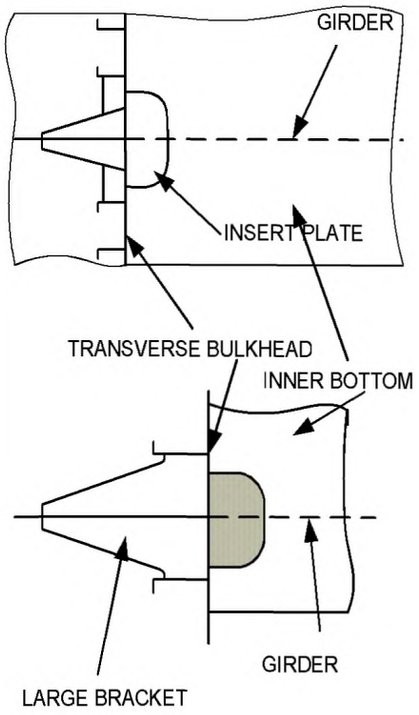
1. High stress concentration.
2. Discontinuity of structural members at knuckle joint.

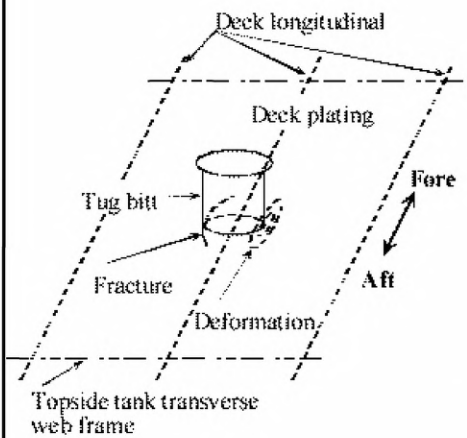
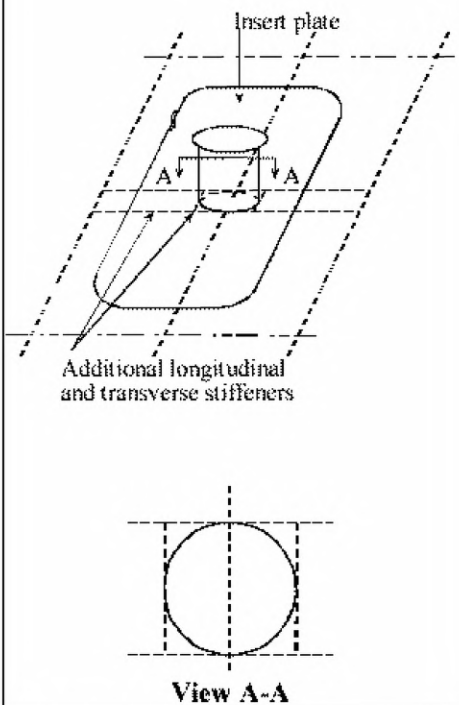
OIL Tankers	Guidelines for Surveys, Assessment and Repair of Hull Structure	
Group 6	Deck Structure	Example No.
		1
Detail of damage	Deformed and fractured deck plating around tug bitt

1. Insufficient strength

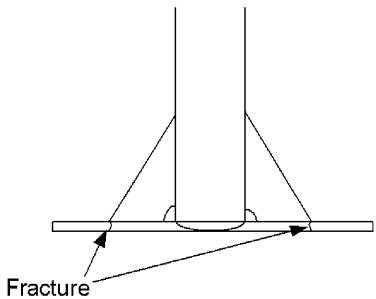
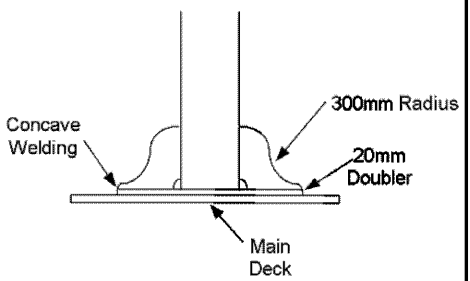
OIL Tankers	Guidelines for Surveys, Assessment and Repair of Hull Structure	
Group 6	Deck Structure	Example No. 5
Detail of damage	Fractured deck plating in way of deck pipe support stanchions (midships)

1. Stanchions experience more severe relative displacements from hull girder bending.

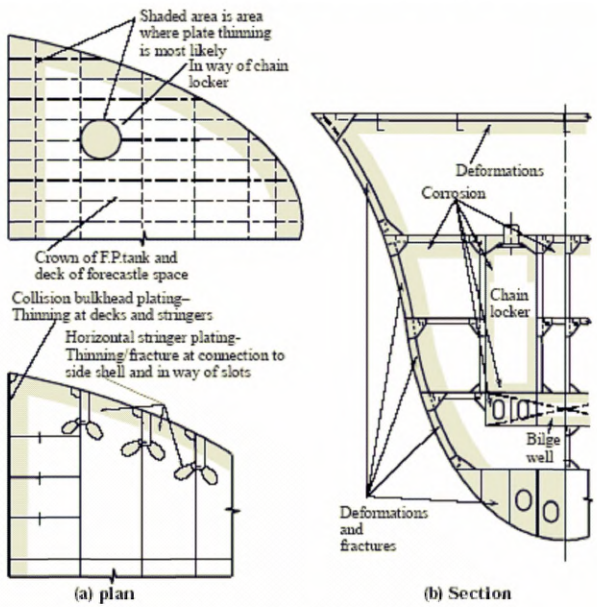
Fig 1 Fore end structure - Potential problem areas

2.3.2 Fractures are often found in transition region and reference should be made to examples provided in the other Groups.

2.3.3 Fractures that extend through the thickness of the plating or through the boundary welds may be observed during pressure testing of tanks.

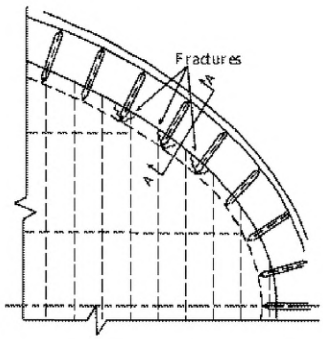
OIL Tankers	Guidelines for Surveys, Assessment and Repair of Hull Structure	
Group 7	Fore region	Example No.
Area 1	Forecastle	1
Detail of damage	Fracture in forecastle deck plating at bulwark

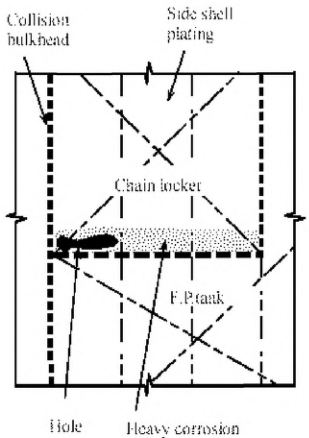
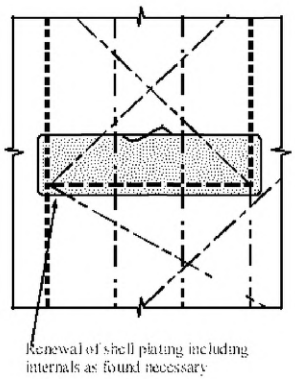
OIL Tankers	Guidelines for Surveys, Assessment and Repair of Hull Structure	
Group 7	Fore region	Example No.
Area 1	Chain locker	2
Detail of damage	Fractures in side shell plating in way of chain locker

1. Heavy corrosion in region where mud is accumulated.

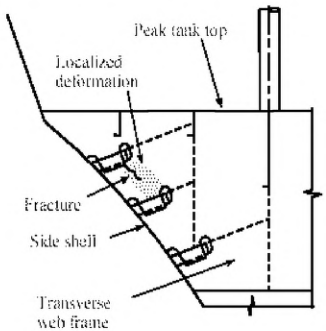
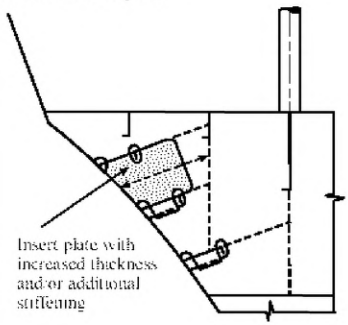
OIL Tankers	Guidelines for Surveys, Assessment and Repair of Hull Structure	
Group 7	Fore region	Example No.
Area 1	Forepeak ballast tank	3
Detail of damage	Fractures and deformation of bow transverse webs in way of cut-outs for side longitudinals

1. Localized material wastage in way of coating failure at cut-outs and sharp edges due to working of the structure.
2. Dynamic seaway loading in way of bow flare.

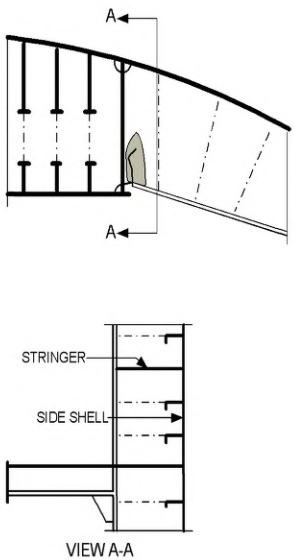
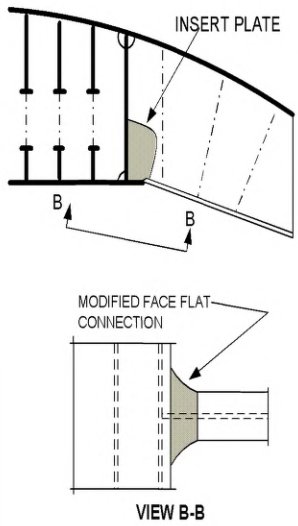
OIL Tankers	Guidelines for Surveys, Assessment and Repair of Hull Structure	
Group 7	Fore region	Example No.
Area 1	Forepeak ballast tank	5
Detail of damage	Fractured stringer end connection in way of the parabolic bow structure

1. High stress concentration of stringer to stiff girder/deep web intersection due to discontinuity of faceplate.
2. Localised thinning in way of coating failure at stringer connection due to flexing of the structure.
3. Dynamic seaway loadings at bow causing flexing in way of detail.

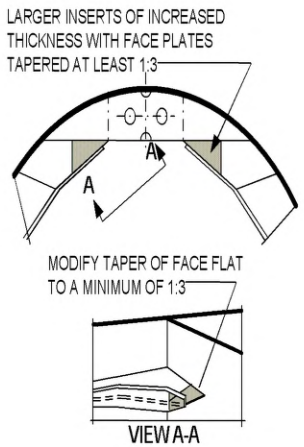
1. Inadequate brackets forming the longitudinal endings at bow structure.
2. Localised thinning in way of coating failure at longitudinal endings due to flexing of the structure.
3. Dynamic seaway loadings at bow causing flexing at longitudinal endings.

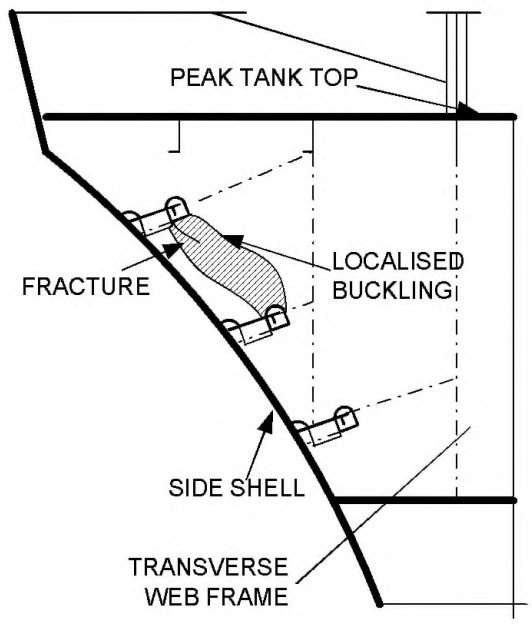
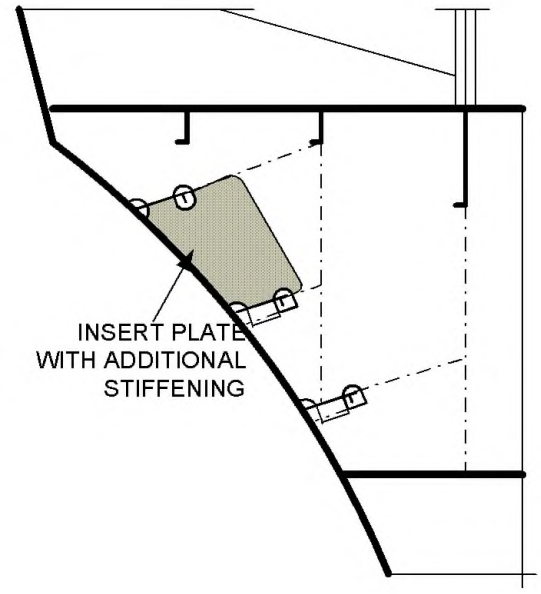
1. Localised thinning in way of coating failure at cut-outs and sharp edges due to working of the structure.
2. Dynamic seaway loadings in way of bow flare.

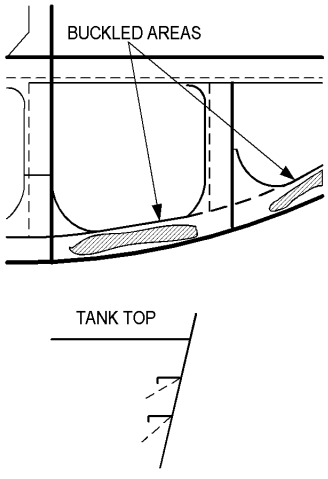
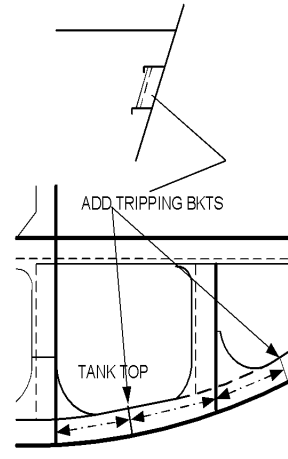
OIL Tankers	Guidelines for Surveys, Assessment and Repair of Hull Structure	
Group 7	Fore region	Example No.
Area 1	Fore peak ballast tank	8
Detail of damage	Buckled and tripped breasthooks

1. Bow impact load.
2. Low buckling resistance.

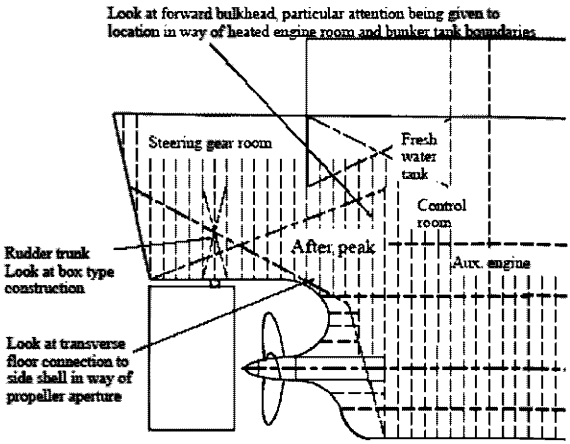
Figure 1 Aft end structure - Potential problem areas

2.3.1 Fractures in weld at floor connections and other locations in the aft peak tank and rudder trunk space can normally only be found by close-up survey.

2.3.2 The structure supporting the rudder carrier may fracture and/or deform due to excessive load on the rudder. Bolts connecting the rudder carrier to the steering gear flat may also suffer damage under such load.

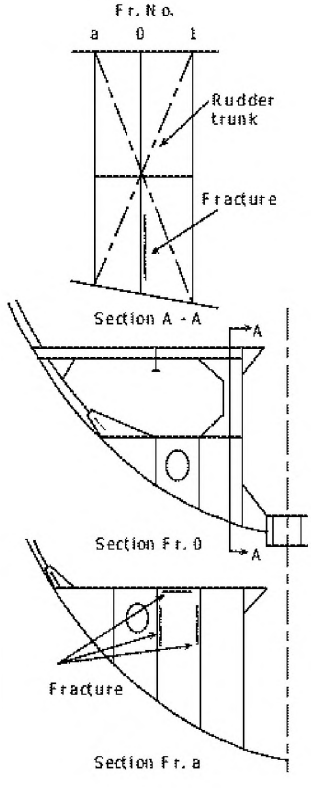
OIL Tankers	Guidelines for Surveys, Assessment and Repair of Hull Structure	
Group 7	**Aft region**	**Example No.**
Area 2	**Aft peak ballast tank**	**9**
Detail of damage	Fractures in bulkhead in way of rudder trunk

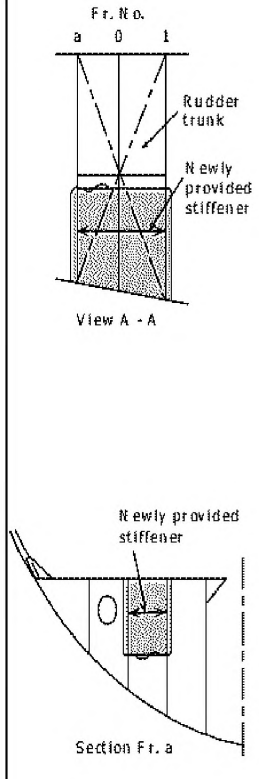
Sketch of repair

1. Vibration.

1. The fractured plating should be cropped and renewed.
2. Natural frequency of the plate between stiffeners should be changed, e.g. reinforcement by additional stiffeners.

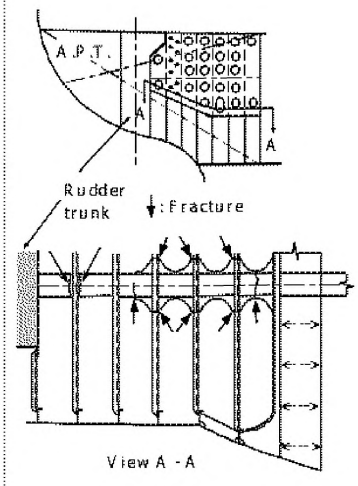
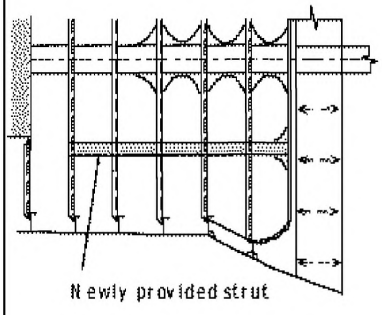
OIL Tankers	Guidelines for Surveys, Assessment and Repair of Hull Structure	
Group 7	Aft region	Example No.
Area 2	Aft peak ballast tank	10
Detail of damage	Fractures at the connection of floors and girders/side brackets

1. Vibration.

1. The fractured plating should be cropped and renewed.
2. Natural frequency of the panel should be changed, e.g. reinforcement by additional strut.

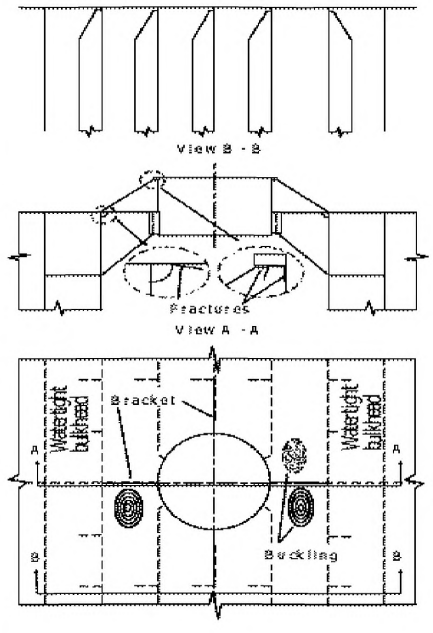
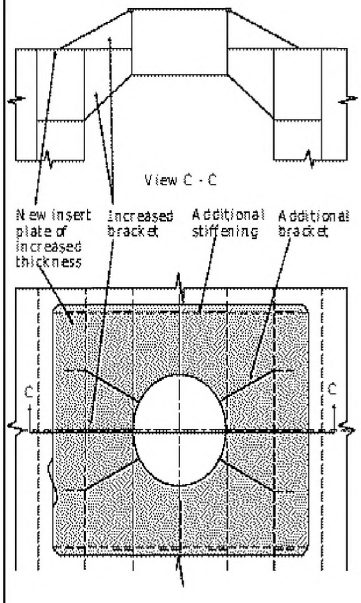
1. Insufficient deck strengthening (missing base plate).
2. Insufficient strengthening of steering gear foundation.
3. Bolts of steering gear were not sufficiently pre-loaded.

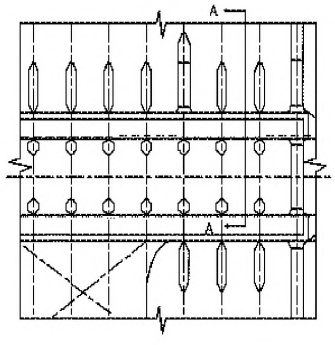
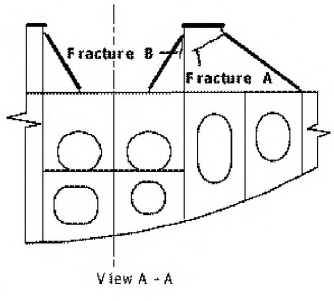
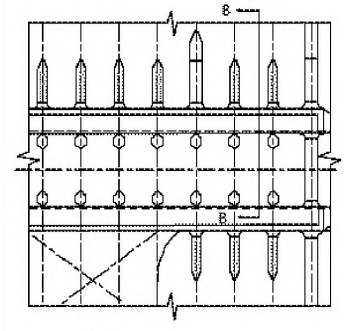
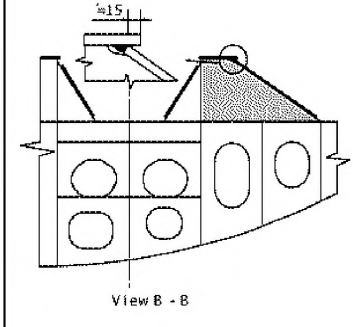
OIL Tankers	Guidelines for Surveys, Assessment and Repair of Hull Structure	
Group 8	Machinery and accommodation spaces	Example No.
Area 1	Engine room	1
Detail of damage	Fractures in brackets at main engine foundation

1. Vibration of main engine.
2. Insufficient strength of brackets at main engine foundation.
3. Insufficient pre-load of the bolts.

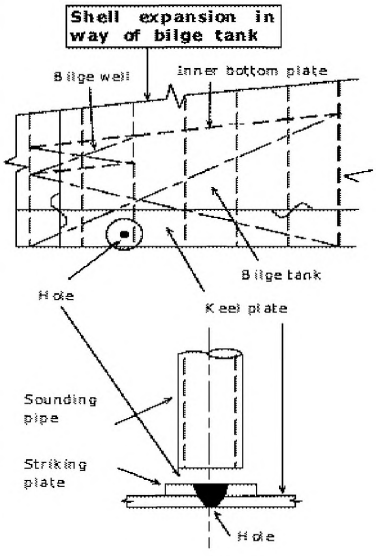
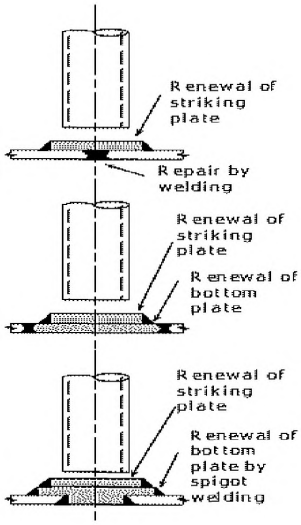
OIL Tankers	Guidelines for Surveys, Assessment and Repair of Hull Structure	
Group 8	Machinery and accommodation spaces	Example No.
Area 1	Engine room	2
Detail of damage	Corrosion in bottom plating under sounding pipe in way of bilge storage tank in engine room

1. Heavy corrosion of bottom plating under sounding pipe.

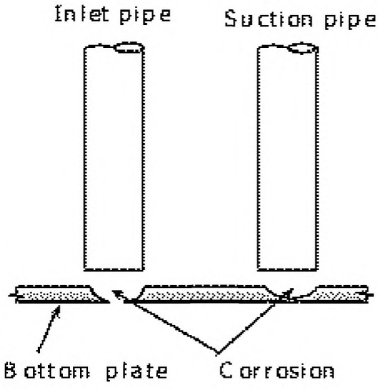
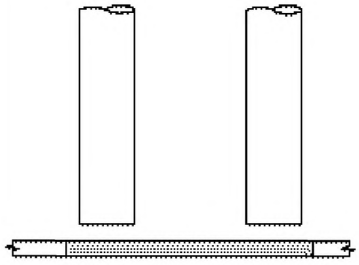
OIL Tankers	Guidelines for Surveys, Assessment and Repair of Hull Structure	
Group 8	Machinery and accommodation spaces	Example No.
Area 1	Engine room	3
Detail of damage	Corrosion in bottom plating under inlet/suction/pipe in way of bilge tank in engine room

1. Heavy corrosion of bottom plating under the inlet/suction pipe.
