**No. 96**  
(April  
2007)

**Double Hull Oil Tankers - Guidelines for Surveys,  
Assessment and Repair of Hull Structures**

## DOUBLE HULL OIL TANKERS

Guidelines for Surveys, Assessment and Repair  
of Hull Structures

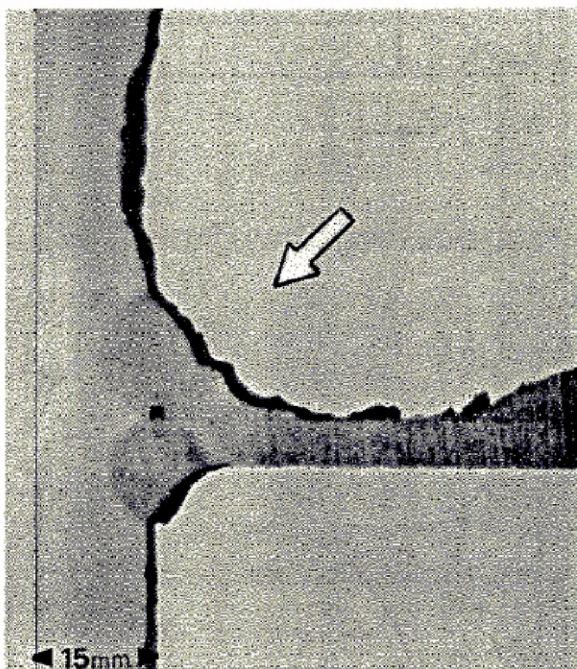
- Necking occurs at the junction of the longitudinal bulkhead plating and longitudinals. The deflection of the bulkhead plating and longitudinals due to reverse, cyclic loading from cargo oil and water ballast plus the accumulated mixtures of water, mud and scale at their junctures accelerates the corrosion rate. As the steel thins and weakens, the flexing consequently increases and hence corrosion accelerates (see Figure 10). The similar necking effect could also occur in the transverse bulkhead plating and stiffeners, or in the inner bottom plating and longitudinals inside the double bottom space. In the coated water ballast tanks, the plating is the principally affected area due to local corrosion in way of coating failure.

**Figure 10 Detail of Necking Effect**

One of the best methods of preventing corrosion within these spaces is that protective coatings be applied to the underdeck and inner bottom plating areas. In addition to

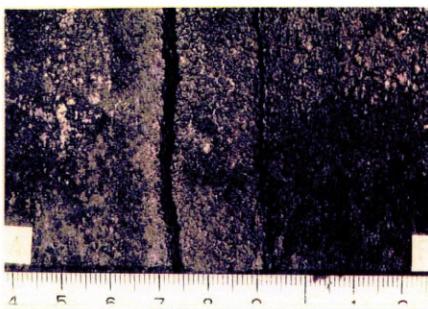
**4.1.2** Severe grooving along welding of bottom plating is often found (See **Photographs 1 and 2**). This grooving can be accelerated by poor maintenance of the protective coating and/or sacrificial anodes fitted to the bottom plating.

**Photograph 1**  
Grooving corrosion of welding of bottom plating

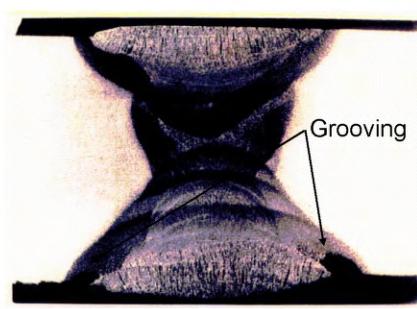
**Photograph 2**  
Section of the grooving shown in Photograph 1

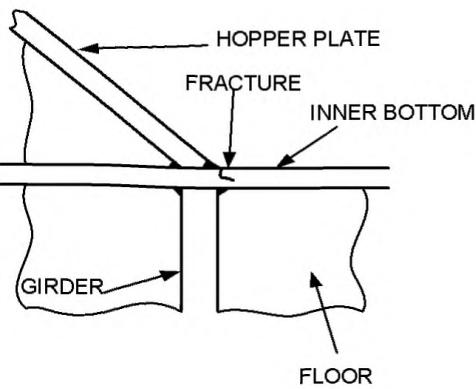
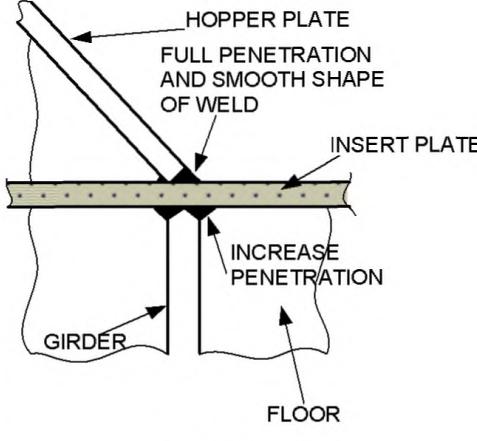
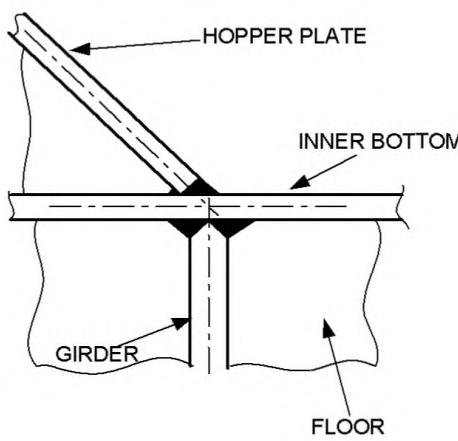
OIL Tankers Guidelines for Surveys, Assessment and Repair of Hull Structure	
Group 1	Cargo area
	<b>Hopper and double bottom ballast tank</b>
<b>Detail of damage</b>	Fracture on the inner bottom plating at the connection of hopper plate to inner bottom
<b>Sketch of damage</b>

<b>Factors which may have caused damage</b>	<p><b>Notes:</b> Plate midlines intersect</p>
<ol style="list-style-type: none"> <li>1. Stress concentration at juncture of hopper plate to inner bottom.</li> <li>2. Insufficient welding connection.</li> <li>3. Misalignment between hopper plate, inner bottom and girder.</li> </ol>	<p><b>Notes on repairs</b> See Sketch.</p>

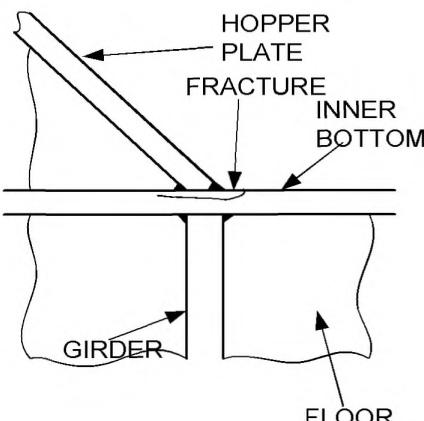
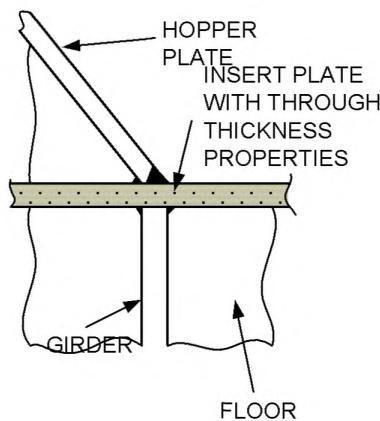
OIL Tankers		Guidelines for Surveys, Assessment and Repair of Hull Structure
Group 1	Cargo area	Example No.
	Hopper and double bottom ballast tank	2
Detail of damage	Fracture at connection of bilge hopper plate and inner bottom	
Sketch of damage

<p><b>Notes:</b> Plate midlines intersect</p>	
Factors which may have caused damage	<p>1. Stress concentration at the knuckle.</p> <p>Notes on repairs See Sketch.</p>

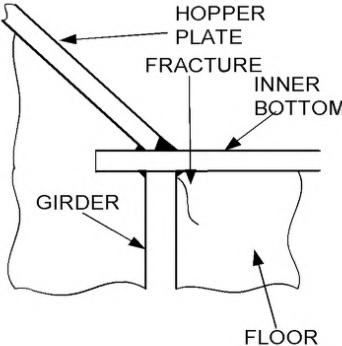
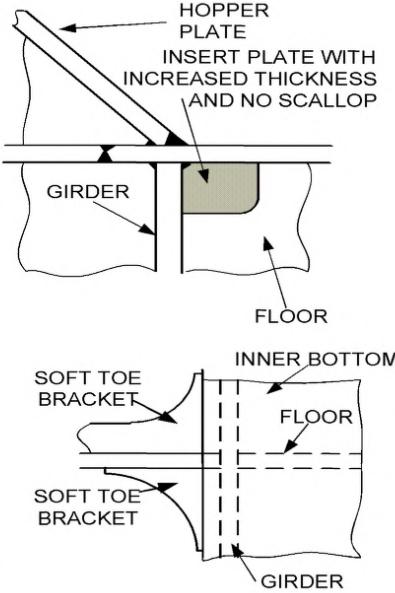
OIL Tankers		Guidelines for Surveys, Assessment and Repair of Hull Structure
Group 1	Cargo area	Example No.
<b>Hopper and double bottom ballast tank</b>		3
<b>Detail of damage</b> Fracture at connection of bilge hopper plate and inner bottom		
<b>Sketch of damage</b>

<b>Notes:</b> Plate midlines intersect		
<b>Factors which may have caused damage</b> 1. Stress concentration at the knuckle.		<b>Notes on repairs</b> See Sketch.

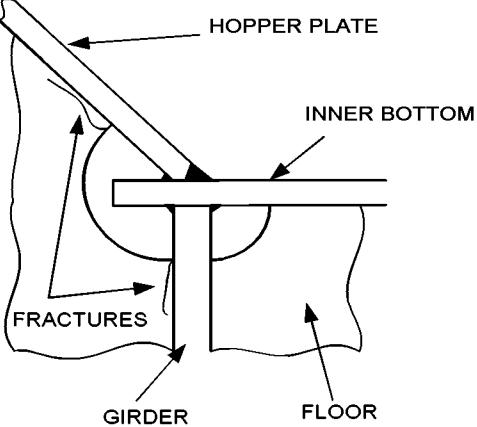
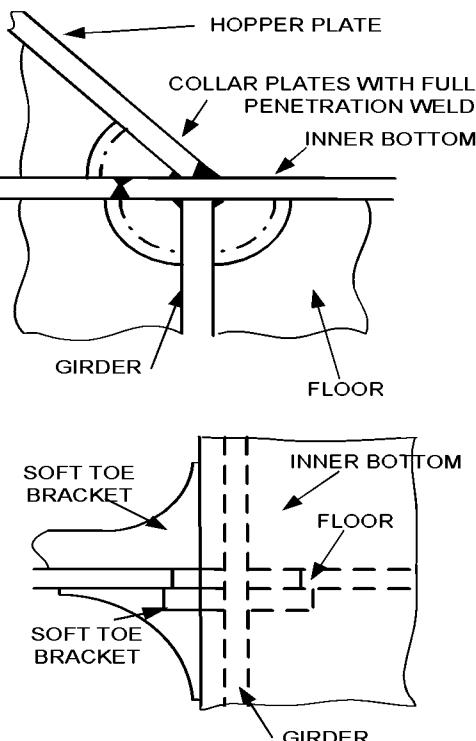
OIL Tankers   Guidelines for Surveys, Assessment and Repair of Hull Structure	
Group 1   Cargo area	Example No.
<b>Hopper and double bottom ballast tank</b>	4
<b>Detail of damage</b>	Fracture at connection of bilge hopper plate and inner bottom
<b>Sketch of damage</b>	<b>Sketch of repair</b>

<p>HOPPER PLATE INNER BOTTOM FRACTURES GIRDER FLOOR</p>

<p>HOPPER PLATE COLLAR PLATES WITH FULL PENETRATION WELD INNER BOTTOM GIRDER FLOOR</p> <p>INNER BOTTOM FLOOR SOFT TOE BRACKET GIRDER</p>
	<p><b>Notes:</b> Plate midlines intersect</p>
<b>Factors which may have caused damage</b>	<b>Notes on repairs</b>
1. Stress concentration at the knuckle.	See Sketch.

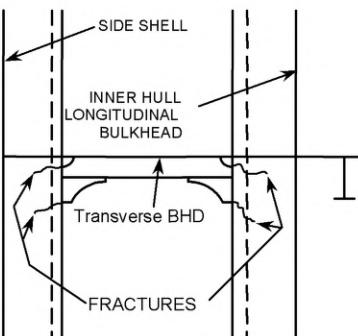
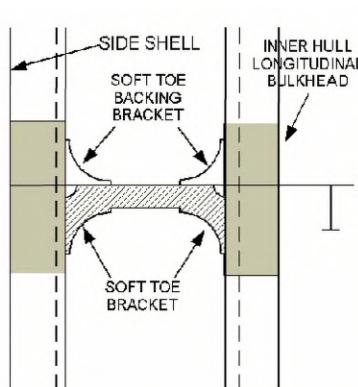
OIL Tankers		Guidelines for Surveys, Assessment and Repair of Hull Structure
Group 2	Cargo area	Example No.
	Wing ballast tank	1
Detail of damage		Crack in way of connection of longitudinals to transverse bulkhead
<b>Sketch of damage</b>

<b>Factors which may have caused damage</b> <ol style="list-style-type: none"> <li>1. Asymmetrical connection of bracket without backing bracket.</li> <li>2. Relative deflection of adjoining transverse web against transverse bulkhead.</li> <li>3. Additional biaxial bending stresses due to asymmetry of the angle bar longitudinal instead of symmetric T section.</li> <li>4. Dynamic load in the vicinity of the water line.</li> <li>5. Large upstand at bracket toe.</li> </ol>		<b>Notes on repairs</b> See Sketch.

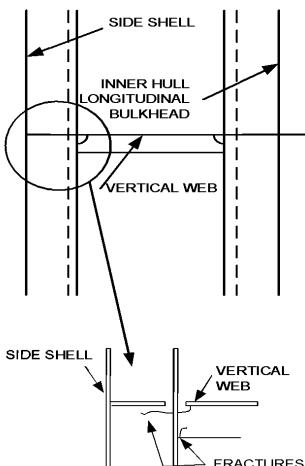
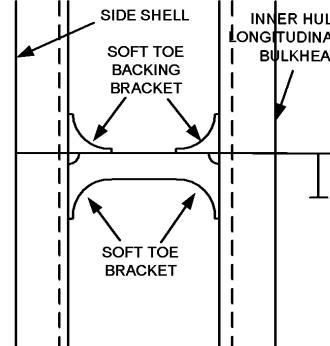
OIL Tankers		Guidelines for Surveys, Assessment and Repair of Hull Structure
Group 2	Cargo area	Example No.
	Wing ballast tank	2
Detail of damage		Crack in way of connection of longitudinals to transverse webs
<b>Sketch of damage</b>

<b>Factors which may have caused damage</b> <ol style="list-style-type: none"> <li>1. Asymmetrical connection of flat bar stiffener resulting in high peak stresses at the heel of the stiffener.</li> <li>2. Insufficient area of connection of longitudinal to web.</li> <li>3. High bending stresses in the longitudinal.</li> <li>4. Additional biaxial bending stresses due to asymmetry of the longitudinal (angle bar instead of symmetric T bar).</li> <li>5. Stress concentration at the square angles at heel and toe of the connections.</li> <li>6. High shear stress in the transverse web.</li> </ol>		<b>Notes on repairs</b> See Sketch.

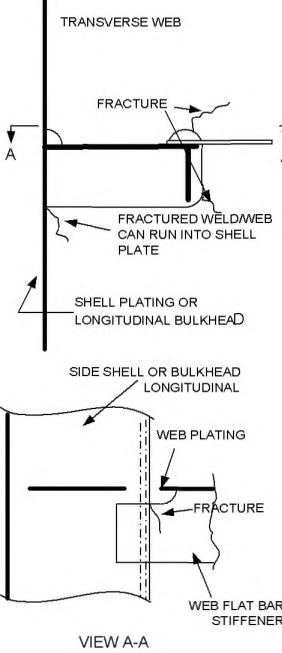
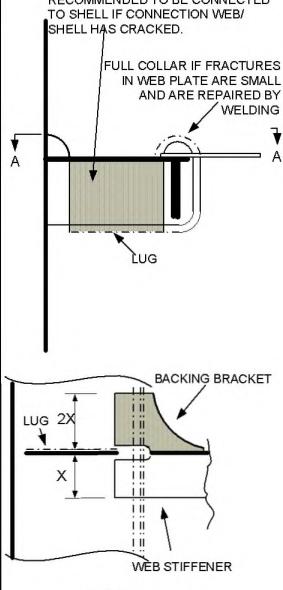
OIL Tankers   Guidelines for Surveys, Assessment and Repair of Hull Structure		
Group 2	Cargo area	Example No.
	Wing ballast tank	4
<b>Detail of damage</b>	Fracture in way of web and flat bar stiffener at cut outs for longitudinal stiffener connections as Example 3 but with faceplate attached to underside of web. Flat bar lap welded.	
<b>Sketch of damage</b>

<p>Insert web plate.</p>	
<b>Factors which may have caused damage</b>	<p>1. Asymmetrical connection of flat bar stiffener resulting in high peak stress at heel of the stiffener under fatigue loading.</p> <p>2. Fabricated longitudinal with welding onto exposed edge of the web resulting in poor fatigue strength of the connection of the longitudinal to the flat bar.</p> <p>3. Insufficient area of connection of longitudinal to web plate.</p> <p>4. Defective weld at return around the plate thickness.</p> <p>5. High localized corrosion at areas of stress concentrations such as flat bar stiffener connections, corners of cut out for longitudinal and connection of lug to shell at cut outs.</p> <p>6. High shear stress in web of the transverse.</p> <p>7. Dynamic seaway loads/motions.</p>

<b>Notes on repairs</b>	<p>See Sketch.</p> <p>1. May also fit a double bracket to avoid fracture from toe.</p>

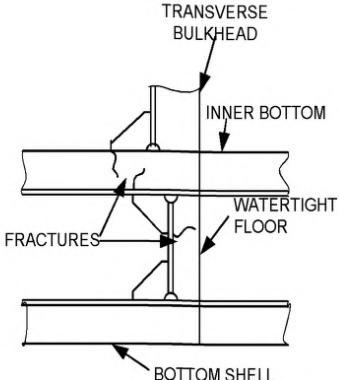
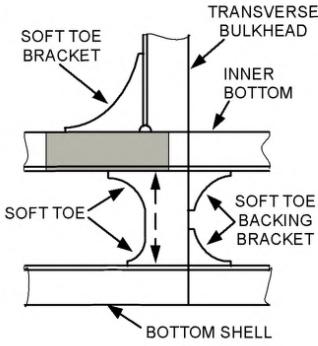
OIL Tankers		Guidelines for Surveys, Assessment and Repair of Hull Structure
Group 3	Cargo area	Example No.
	Bottom ballast tank	1
Detail of damage		Cracks in way of longitudinals connected to watertight floors
<b>Sketch of damage</b>

<b>Factors which may have caused damage</b> <ol style="list-style-type: none"> <li>1. Asymmetrical connection of bracket in association with a backing bracket, which is too small.</li> <li>2. Relative deflection between adjacent floor and transverse bulkhead.</li> <li>3. Inadequate shape of the brackets.</li> <li>4. High stresses in the inner bottom longitudinal and the floor stiffener.</li> </ol>		<b>Notes on repairs</b> See Sketch.

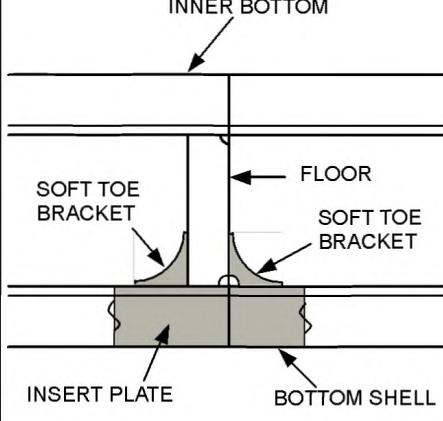
OIL Tankers Guidelines for Surveys, Assessment and Repair of Hull Structure	
Group 3	Cargo area
	<b>Bottom ballast tank</b>
<b>Detail of damage</b>	Connection of longitudinals to ordinary floors.
<b>Sketch of damage</b>	<b>Sketch of repair</b>

<b>Factors which may have caused damage</b>	<b>Notes on repairs</b> See Sketch.
<ol style="list-style-type: none"> <li>1. Asymmetrical connection.</li> <li>2. Relative deflection of adjacent floor to transverse bulkhead.</li> </ol>

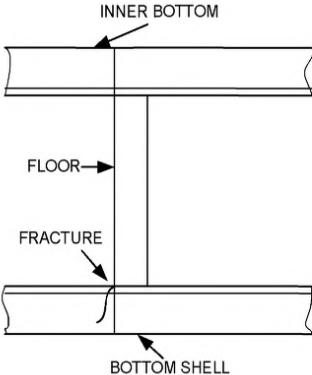
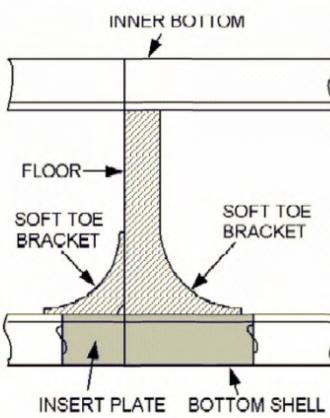
OIL Tankers		Guidelines for Surveys, Assessment and Repair of Hull Structure
Group 3	Cargo area	Example No.
Bottom ballast tank		4
Detail of damage		Connection of longitudinals to ordinary floors
<b>Sketch of damage</b>

<b>Factors which may have caused damage</b> 1. Stress concentration at the connection of bottom longitudinal and stiffener on floor.		<b>Notes on repairs</b> See Sketch. 1. Butt welds in bottom longitudinal should be kept clear of the soft toe bracket toes. 2. If possible soft toe bracket and vertical stiffener should be integral.

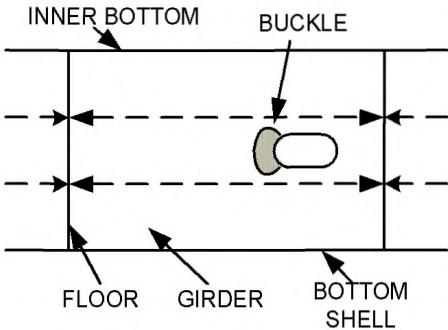
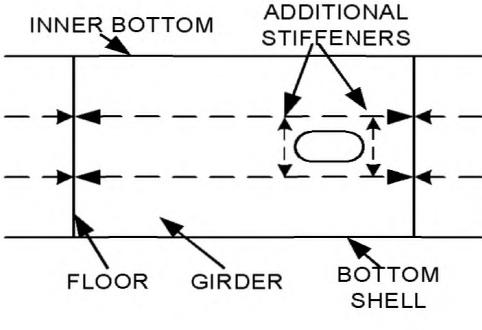
OIL Tankers Guidelines for Surveys, Assessment and Repair of Hull Structure	
Group 3	Cargo area
	<b>Bottom ballast tank</b>
<b>Detail of damage</b>	Panels of bottom girders in way of openings.
<b>Sketch of damage</b>	<b>Sketch of repair</b>

<b>Factors which may have caused damage</b>	<b>Notes on repairs</b> See Sketch.
<ol style="list-style-type: none"> <li>1. High shear or compressive stress in the side girder.</li> <li>2. Insufficient buckling strength.</li> </ol>

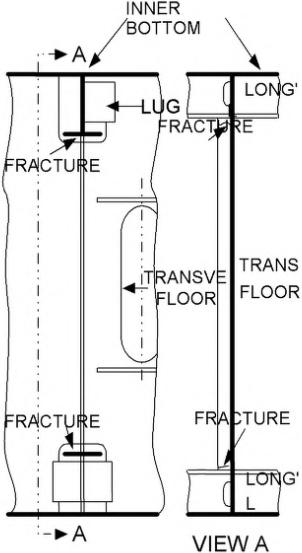
OIL Tankers		Guidelines for Surveys, Assessment and Repair of Hull Structure
Group 3	Cargo area	Example No.
Bottom ballast tank		7
Detail of damage	Fractured stiffener connection to bottom and inner bottom longitudinals.	
Sketch of damage

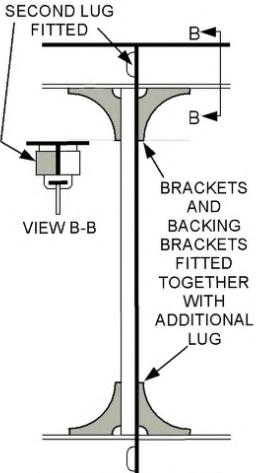
Sketch of repair

Factors which may have caused damage	<ol style="list-style-type: none"> <li>1. Asymmetric connection leading to high local stresses at the connection of vertical stiffeners of the transverse floors to the inner and outer bottom longitudinals.</li> <li>2. Wide slot for longitudinal leads to inefficient lug connection.</li> <li>3. Sharp corners or flame-cut edges producing a notch effect.</li> <li>4. Incomplete/defective weld at stiffener connection to the longitudinals.</li> <li>5. Dynamic sea way loads/ship motions.</li> </ol>	
Notes on repairs	<p>See Sketch.</p>

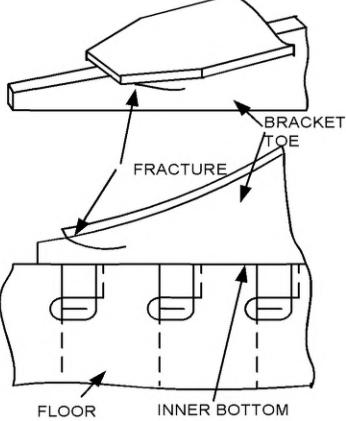
OIL Tankers	Guidelines for Surveys, Assessment and Repair of Hull Structure	
Group 4	Cargo area	Example No.
	Web Frame in cargo tank	1
<b>Detail of damage</b> Fracture at toe of web frame bracket connection to inner bottom.		
<b>Sketch of damage</b>

<b>Factors which may have caused damage</b> <ol style="list-style-type: none"> <li>1. Inadequate tapering the toe end.</li> <li>2. Insufficient tapering of flange.</li> <li>3. Lateral flexing of the bracket.</li> </ol>		<b>Notes on repairs</b> See Sketch.

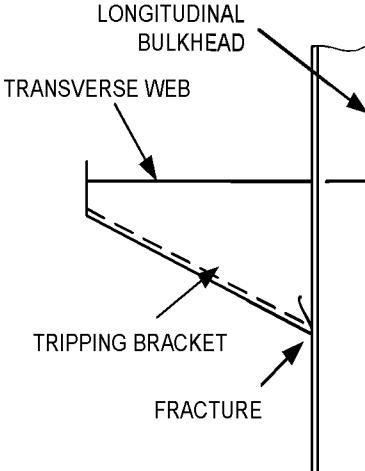
OIL Tankers		Guidelines for Surveys, Assessment and Repair of Hull Structure
Group 4	Cargo area	Example No.
Web Frame in cargo tank		5
Detail of damage		Fracture in way of connection of transverse web tripping brackets to longitudinal
<b>Sketch of damage</b>

<b>Factors which may have caused damage</b> 1. Hard spot at the toe of bracket. 2. Vibration.		<b>Notes on repairs</b> See Sketch. 1. Soft bracket may be added on upper side of web, to avoid fracture at the heel.

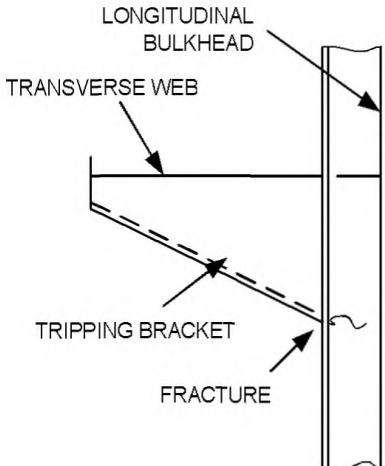
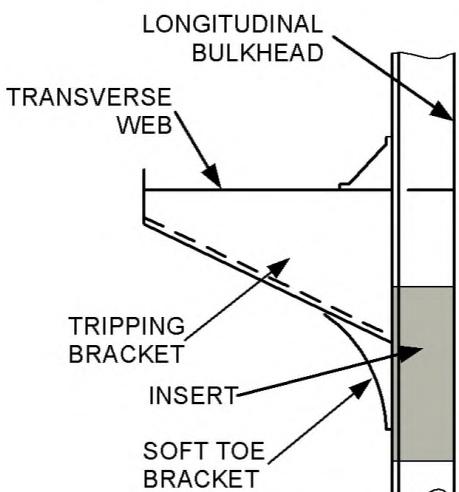
OIL Tankers Guidelines for Surveys, Assessment and Repair of Hull Structure	
Group 4	Cargo area
	Web Frame in cargo tank
<b>Detail of damage</b>	Tripping brackets modification of the bracket toe.
<b>Sketch of damage</b>	<b>Sketch of repair</b>

<b>Factors which may have caused damage</b>	<b>Notes on repairs</b>
<ol style="list-style-type: none"> <li>1. Stress concentrations at toe of bracket.</li> <li>2. High stress in longitudinal.</li> </ol>	<p>See Sketch.</p> <ol style="list-style-type: none"> <li>1. Soft bracket may be added on upper side of web, to avoid fracture at the heel.</li> </ol>

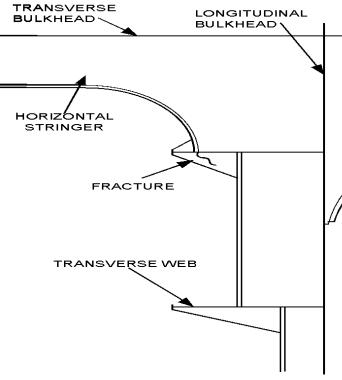
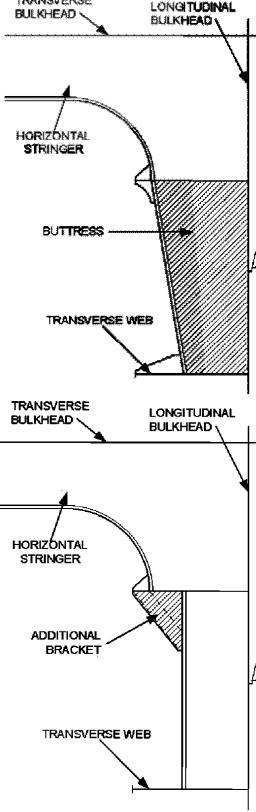
OIL Tankers		Guidelines for Surveys, Assessment and Repair of Hull Structure
Group 5	Cargo area	Example No.
	Transverse Bulkhead in cargo tank	1
Detail of damage	Fracture in way of connection of transverse bulkhead stringer to transverse web frames and longitudinal bulkhead stringer	
Sketch of damage

Factors which may have caused damage	<p>1. Stress concentration due to discontinuous structure. 2. High shear stress in the horizontal stringer.</p>	
	<p><b>Notes on repairs</b> See Sketch.</p>

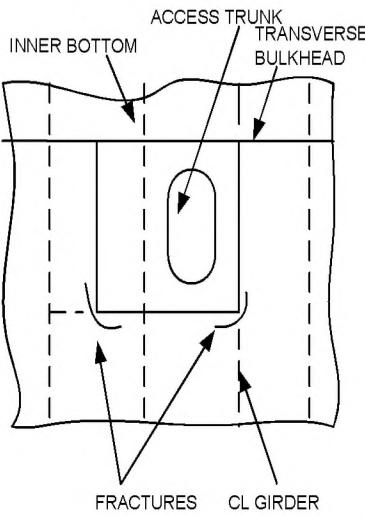
OIL Tankers   Guidelines for Surveys, Assessment and Repair of Hull Structure	
Group 5   Cargo area	Example No. 4
<b>Transverse Bulkhead in cargo tank</b>	<b>Detail of damage</b>   Fractured inner bottom plate at the connection to access trunk wall
<b>Sketch of damage</b>

<b>Factors which may have caused damage</b> 1. Stress concentration at the connection of trunk wall to inner bottom plate. 2. Relative deformation between horizontal stringer fitted on transverse bulkhead and inner bottom plate. 3. Static and dynamic load of cargo liquid.	<b>Notes on repairs</b> See Sketch.

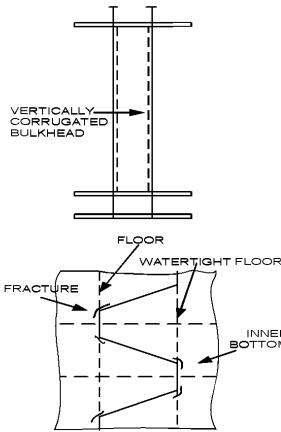
OIL Tankers		Guidelines for Surveys, Assessment and Repair of Hull Structure
Group 5	Cargo area	Example No. 6
	Transverse Bulkhead in cargo tank	
Detail of damage	Vertically corrugated bulkhead without stool, connection to deck and inner bottom	
<b>Sketch of damage</b>

<b>Factors which may have caused damage</b> <ol style="list-style-type: none"> <li>1. Stress concentration due to unsupported corrugation web.</li> <li>2. High through thickness stress, lamellar tearing.</li> <li>3. Weld details and dimensions.</li> <li>4. Misalignment between face of corrugation and floor underneath.</li> <li>5. Cut-outs and scallops or air holes increasing the stress in the floor.</li> <li>6. Insufficient through thickness properties of inner bottom plate.</li> </ol>		<b>Notes on repairs</b> See Sketch.

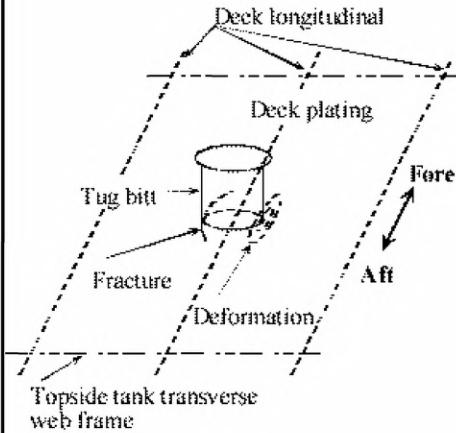
OIL Tankers		Guidelines for Surveys, Assessment and Repair of Hull Structure
Group 6	Deck Structure	Example No.
		1
<b>Detail of damage</b>	Deformed and fractured deck plating around tug bitt	
<b>Sketch of damage</b>

<b>Factors which may have caused damage</b>	<p>1. Insufficient strength</p>	
	<p><b>Notes on repairs</b></p> <ol style="list-style-type: none"> <li>Fractured/deformed deck plating should be cropped and part renewed.</li> <li>Reinforcement by stiffeners should be considered.</li> </ol>

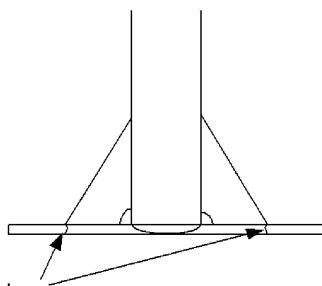
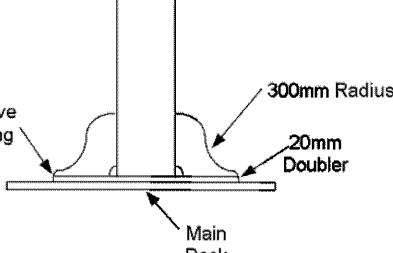
OIL Tankers Guidelines for Surveys, Assessment and Repair of Hull Structure	
Group 6 Deck Structure	Example No. 5
<b>Detail of damage</b> Fractured deck plating in way of deck pipe support stanchions (midships)	
<b>Sketch of damage</b>	<b>Sketch of repair</b>

<b>Factors which may have caused damage</b> 1. Stanchions experience more severe relative displacements from hull girder bending.	<b>Notes on repairs</b> See Sketch.

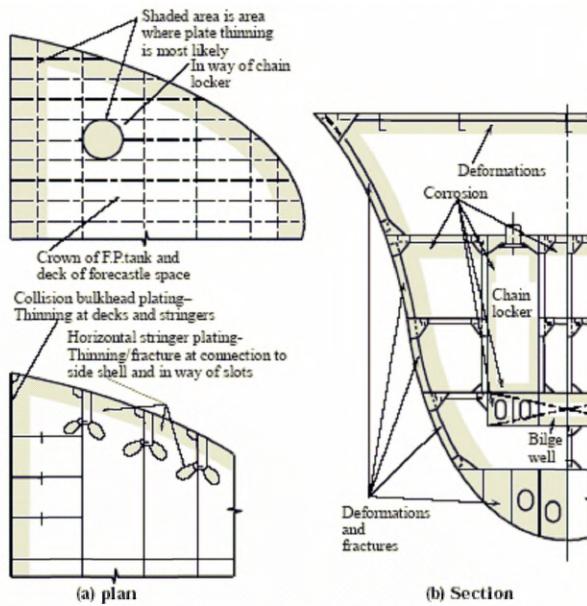
Fig 1 Fore end structure - Potential problem areas

**2.3.2** Fractures are often found in transition region and reference should be made to examples provided in the other Groups.

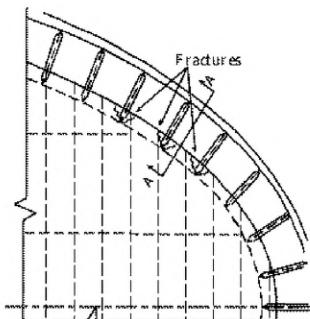
OIL Tankers		Guidelines for Surveys, Assessment and Repair of Hull Structure
Group 7	Fore region	Example No.
Area 1	Forecastle	1
Detail of damage	Fracture in forecastle deck plating at bulwark	
Sketch of damage

Bracket in line with bulwark stay	
<b>Factors which may have caused damage</b> <ol style="list-style-type: none"> <li>1. Bow Flare effect in heavy weather.</li> <li>2. Stress concentration due to poor design.</li> </ol>	<b>Notes on repairs</b> <ol style="list-style-type: none"> <li>1. Fractured deck plating should be cropped and renewed.</li> <li>2. Bracket in line with the bulwark stay to be fitted to reduce stress concentration.</li> </ol>

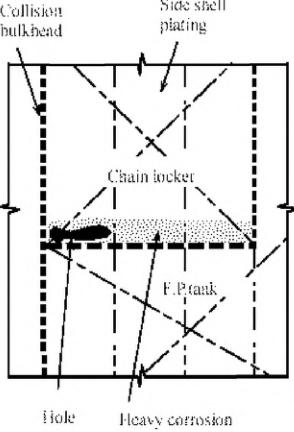
OIL Tankers		Guidelines for Surveys, Assessment and Repair of Hull Structure
Group 7	Fore region	Example No.
Area 1	Chain locker	2
<b>Detail of damage</b> Fractures in side shell plating in way of chain locker		
<b>Sketch of damage</b>

<b>Factors which may have caused damage</b> <ol style="list-style-type: none"> <li>1. Heavy corrosion in region where mud is accumulated.</li> </ol>		<b>Notes on repairs</b> <ol style="list-style-type: none"> <li>1. Corroded plating should be cropped and renewed.</li> <li>2. Protective coating should be applied.</li> </ol>

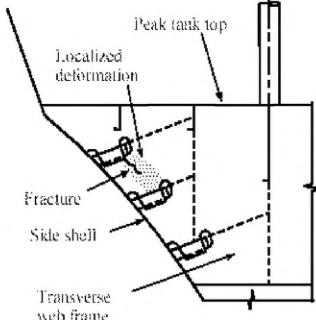
OIL Tankers		Guidelines for Surveys, Assessment and Repair of Hull Structure
Group 7	Fore region	Example No.
Area 1	Forepeak ballast tank	3
Detail of damage	Fractures and deformation of bow transverse webs in way of cut-outs for side longitudinals	
Sketch of damage

<p>Peak tank top Localized deformation Fracture Side shell Transverse web frame</p>

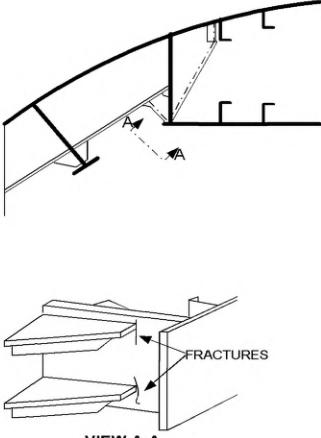
OIL Tankers		Guidelines for Surveys, Assessment and Repair of Hull Structure
Group 7	Fore region	Example No.
Area 1	Forepeak ballast tank	4
<b>Detail of damage</b>		Fractured vertical web at the longitudinal stiffener ending in way of the parabolic bow structure.
<b>Sketch of damage</b>

<b>Factors which may have caused damage</b> <ol style="list-style-type: none"> <li>1. Stress concentrations at bracket ending due to inadequate support at bracket toes in way of connection to web frame members.</li> <li>2. Localised thinning in way of coating failure at bracket endings due to flexing of the structure.</li> <li>3. Dynamic seaway loadings at bow causing flexing at bracket endings.</li> </ol>		<b>Notes on repairs</b> See Sketch.

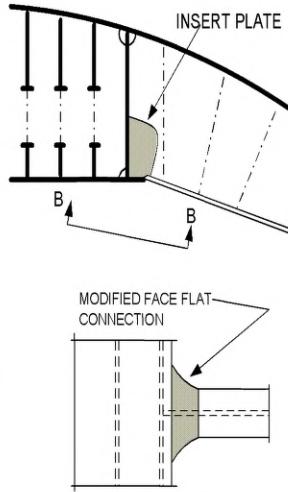
OIL Tankers Guidelines for Surveys, Assessment and Repair of Hull Structure	
Group 7 Fore region	Example No.
Area 1 Forepeak ballast tank	5
Detail of damage	Fractured stringer end connection in way of the parabolic bow structure
Sketch of damage	Sketch of repair

VIEW B-B
Factors which may have caused damage	Notes on repairs See Sketch.
<ol style="list-style-type: none"> <li>1. High stress concentration of stringer to stiff girder/deep web intersection due to discontinuity of faceplate.</li> <li>2. Localised thinning in way of coating failure at stringer connection due to flexing of the structure.</li> <li>3. Dynamic seaway loadings at bow causing flexing in way of detail.</li> </ol>

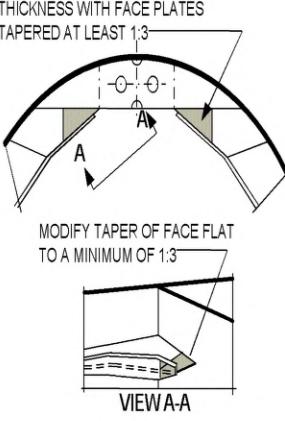
<b>Sketch of repair</b>

OIL Tankers		Guidelines for Surveys, Assessment and Repair of Hull Structure
Group 7	Fore region	Example No.
Area 1	Forepeak ballast tank	6
Detail of damage		Fracture at end of longitudinal at bow structure.
<b>Sketch of damage</b>

<b>Factors which may have caused damage</b> <ol style="list-style-type: none"> <li>1. Inadequate brackets forming the longitudinal endings at bow structure.</li> <li>2. Localised thinning in way of coating failure at longitudinal endings due to flexing of the structure.</li> <li>3. Dynamic seaway loadings at bow causing flexing at longitudinal endings.</li> </ol>		<b>Notes on repairs</b> See Sketch.

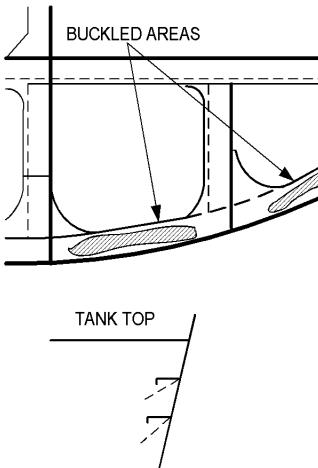
OIL Tankers		Guidelines for Surveys, Assessment and Repair of Hull Structure
Group 7	Fore region	Example No.
Area 1	Fore peak ballast tank	8
<b>Detail of damage</b> Buckled and tripped breasthooks		
<b>Sketch of damage</b>

<b>Factors which may have caused damage</b> 1. Bow impact load. 2. Low buckling resistance.		<b>Notes on repairs</b> See Sketch.

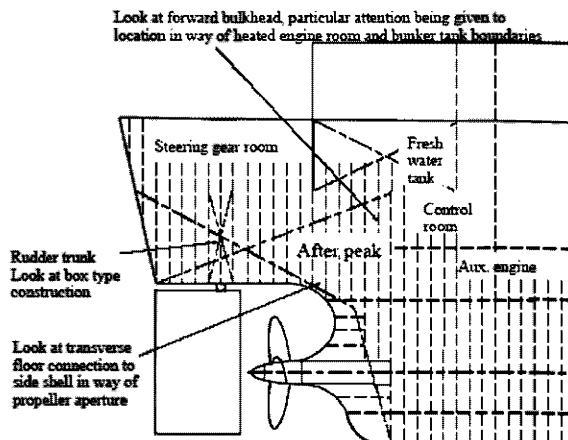
Figure 1 Aft end structure - Potential problem areas

2.3.1 Fractures in weld at floor connections and other locations in the aft peak tank and rudder trunk space can normally only be found by close-up survey.

2.3.2 The structure supporting the rudder carrier may fracture and/or deform due to excessive load on the rudder. Bolts connecting the rudder carrier to the steering gear flat may also suffer damage under such load.

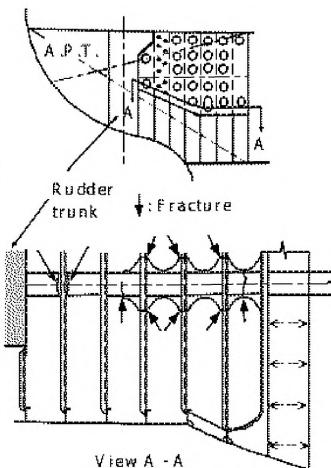
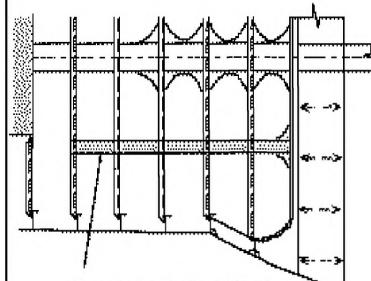
OIL Tankers Guidelines for Surveys, Assessment and Repair of Hull Structure	
Group 7	Aft region
Area 2	Aft peak ballast tank
Detail of damage	Fractures at the connection of floors and girders/side brackets
Sketch of damage	Sketch of repair

<p>View A - A</p>

<p>Newly provided strut</p>
Factors which may have caused damage	Notes on repairs
1. Vibration.	1. The fractured plating should be cropped and renewed. 2. Natural frequency of the panel should be changed, e.g. reinforcement by additional strut.

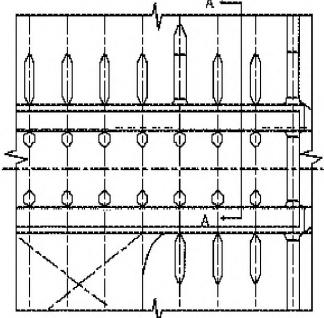
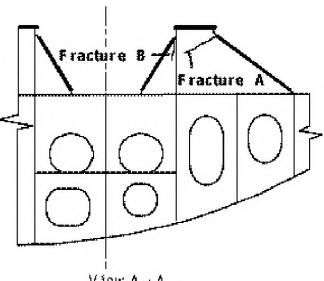
OIL Tankers		Guidelines for Surveys, Assessment and Repair of Hull Structure
Group 8	Machinery and accommodation spaces	Example No.
Area 1	Engine room	1
Detail of damage	Fractures in brackets at main engine foundation	
Sketch of damage

Factors which may have caused damage	<p>1. Vibration of main engine.  2. Insufficient strength of brackets at main engine foundation.  3. Insufficient pre-load of the bolts.</p>	
Notes on repairs	<p>1. Fractures may be vee'd-out and rewelded.  2. New modified brackets at main engine foundation.  3. Or insert pieces and additional flanges to increase section modulus of the brackets.</p>

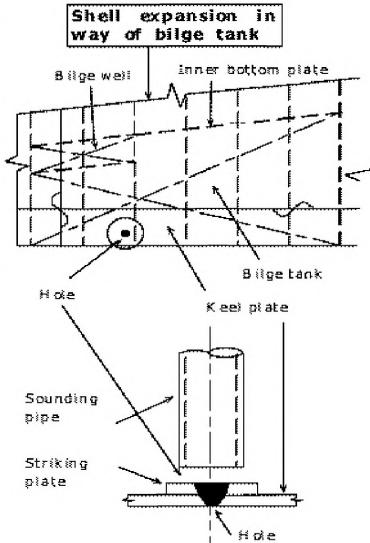
OIL Tankers		Guidelines for Surveys, Assessment and Repair of Hull Structure
Group 8	Machinery and accommodation spaces	Example No.
Area 1	Engine room	2
Detail of damage	Corrosion in bottom plating under sounding pipe in way of bilge storage tank in engine room	
Sketch of damage

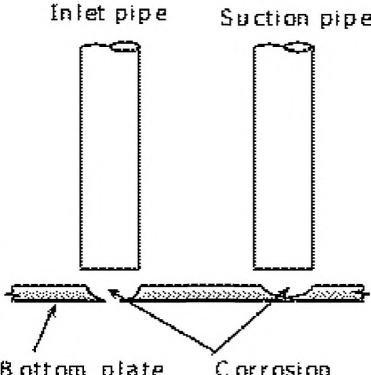
OIL Tankers		Guidelines for Surveys, Assessment and Repair of Hull Structure
Group 8	Machinery and accommodation spaces	Example No.
Area 1	Engine room	3
Detail of damage	Corrosion in bottom plating under inlet/suction/pipe in way of bilge tank in engine room	
Sketch of damage

Factors which may have caused damage	<p>1. Heavy corrosion of bottom plating under the inlet/suction pipe.</p>	
Notes on repairs	<ol style="list-style-type: none"> <li>1. Corroded bottom plate is to be cropped and part renewed. Thicker plate is preferable.</li> <li>2. Replacement of pipe end by enlarged conical opening (similar to suction head in ballast tank) is preferable.</li> </ol>

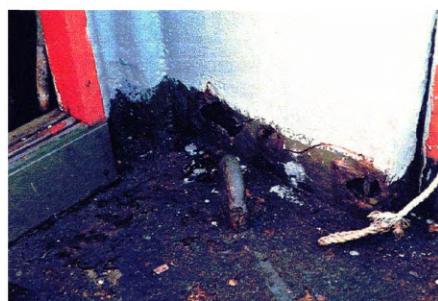
Severe corrosion may be found in exposed deck plating and deck house side structure adjacent to the deck plating where water is liable to accumulate (See **Photograph 1**). Corrosion may also be found in accommodation bulkheads around cut-out for fittings, such as doors, side scuttles, ventilators, etc., where proper maintenance of the area is relatively difficult. Deterioration of the bulkheads including fittings may impair the integrity of weathertightness.

**Photograph 1 Corroded accommodation house side structure**
