No.55 GENERAL CARGO SHIPS - Guidelines For
(March
1999)
Surveys, Assessment and Repair of Hull
Structure

GENERAL CARGO SHIPS

Guidelines for Surveys,
Assessment and Repair
of Hull Structure

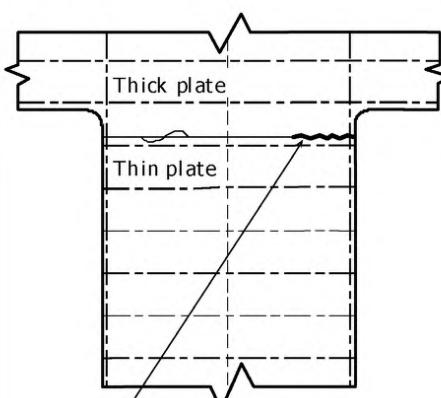
GENERAL CARGO SHIPS		Guidelines for Surveys, Assessment and Repair of Hull Structure
Part 1	Cargo hold region	Example No.
Area 1	Upper deck structure	3-a
Detail of damage	Fracture of welded seam between thick plate and thin plate at cross deck	
Sketch of damage

<p>Fracture at welded seam</p>		Sketch of repair

<p>Insert plate of suitable intermediate thickness</p>
Notes on possible cause of damage <ol style="list-style-type: none"> 1. Stress concentration created by abrupt change in deck plating thickness. 2. In-plane bending in cross deck strip due to torsional (longitudinal) movements of ship sides. 3. Welded seam not clear of tangent point of hatch corner. 		Notes on repairs <ol style="list-style-type: none"> 1. Insert plate of intermediate thickness is recommended. 2. Smooth transition between plates (beveling) should be considered.

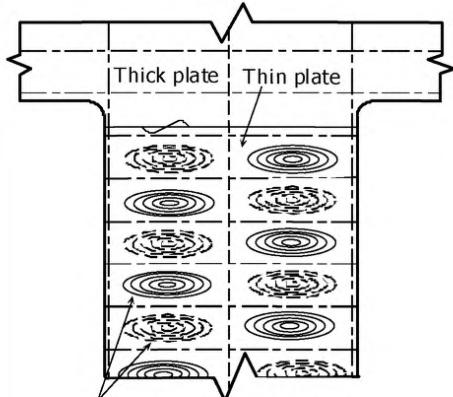
GENERAL CARGO SHIPS		Guidelines for Surveys, Assessment and Repair of Hull Structure
Part 1	Cargo hold region	Example No.
Area 1	Upper deck structure	3-c
Detail of damage	Overall buckling of cross deck plating	
Sketch of damage

<p>Buckling of cross deck plating</p>

<p>Repair B Insertion of plate of increased thickness</p>
Notes on possible cause of damage	<p>1. Transverse compression of deck due to sea load. 2. Insufficient transverse stiffening.</p>	
	<p>Notes on repairs</p> <ol style="list-style-type: none"> Repair A Plating of original thickness in combination with additional transverse stiffening. Repair B Insertion of plating of increased thickness.

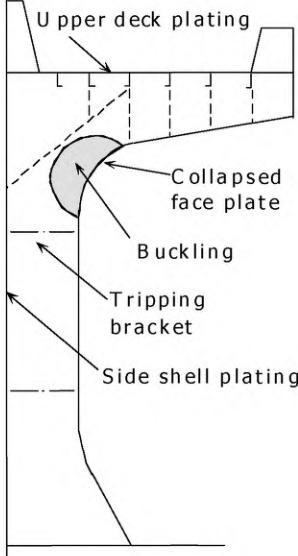
GENERAL CARGO SHIPS		Guidelines for Surveys, Assessment and Repair of Hull Structure
Part 1	Cargo hold region	Example No.
Area 1	Upper deck structure	4
Detail of damage	Buckling of web beam	
Sketch of damage

Notes on possible cause of damage <ol style="list-style-type: none"> 1. Overloading by green sea on deck or by excessive deck cargo. 2. Excessive corrosion. 3. Insufficient/improper web stiffening. 		Notes on repairs <ol style="list-style-type: none"> 1. Buckled part is to be cropped and renewed. 2. If corrosion is not the cause, renewal by thicker plate (web and/or face) and/or reinforcement by stiffener and tripping bracket should be considered.

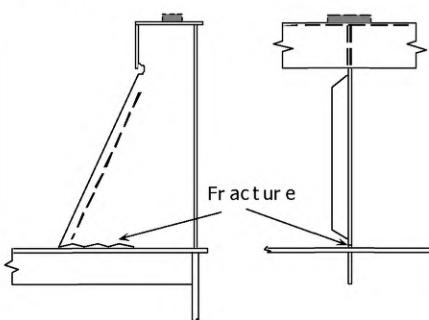
GENERAL CARGO SHIPS		Guidelines for Surveys, Assessment and Repair of Hull Structure
Part 1	Cargo hold region	Example No.
Area 1	Upper deck structure	6
Detail of damage	Fractures in web of transverse hatch coaming stay	
Sketch of damage

Notes on possible cause of damage	<p>1. Insufficient consideration of the horizontal friction forces in way of the resting pads for hatch cover.</p>	
Notes on repairs	<ol style="list-style-type: none"> 1. Modification of the design of the hatch coaming stay. 2. Full penetration welding between gusset plates and deck plating. 3. Strengthening and continuation of the structure below the deck. 4. Use pads with smaller coefficient of friction.

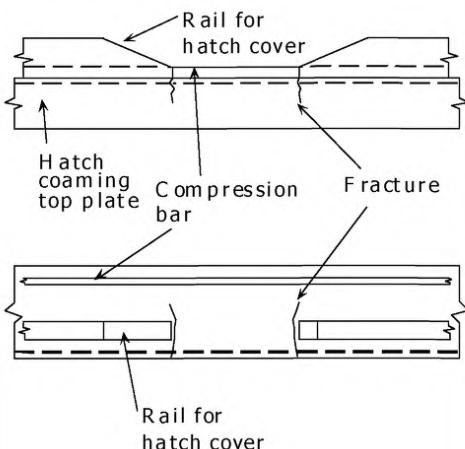
GENERAL CARGO SHIPS		Guidelines for Surveys, Assessment and Repair of Hull Structure
Part 1	Cargo hold region	Example No.
Area 1	Upper deck structure	7-a
Detail of damage	Fractures in hatch coaming top plate at the termination of rail for hatch cover	
Sketch of damage

Notes on possible cause of damage	<p>1. Stress concentration at the termination of the rail for hatch cover.</p>	
	<p>Notes on repairs</p> <ol style="list-style-type: none"> 1. Fractured plate is to be cropped and part renewed. 2. Thicker insert plate and/or reinforcement by additional stiffener under the top plate should be considered. Also refer to Example 7-b.

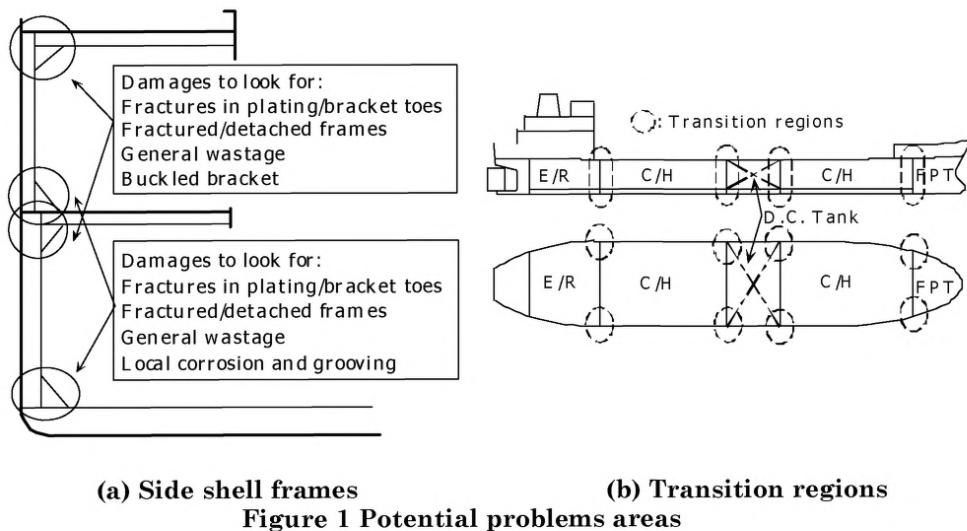
Figure 1 Potential problems areas

- 1.5 The transition regions are subject to stress concentrations due to structural discontinuities. The side shell plating in fore and aft transition regions is also subject to panting. The lack of continuity of the longitudinal structure, and the greater slenderness and flexibility of the side structure near the more rigid end structures, can result in damages.

- 1.6 A summary of potential problem areas is shown in **Figures 1 (a) and (b)**. Serious consequences of damaged ship sides are illustrated in **Photographs 1 and 2**.

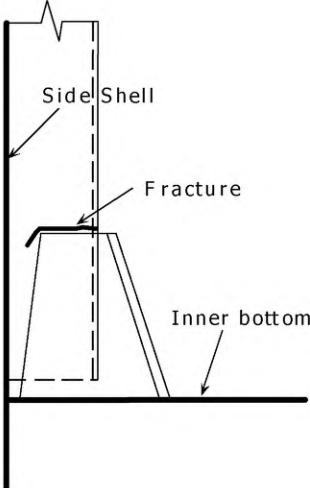
GENERAL CARGO SHIPS		Guidelines for Surveys, Assessment and Repair of Hull Structure
Part 1	Cargo hold region	Example No.
Area 2	Side structure	1
Detail of damage	Fracture in side shell frame at lower bracket	
Sketch of damage

Notes on possible cause of damage	<p>1. This type of damage is caused due to stress concentration.</p>	
Notes on repairs	<ol style="list-style-type: none"> 1. For small fractures, e. g. hairline fractures, the fracture can be vee'd-out, welded up, ground, examined by NDT for fractures, and rewelded. 2. For larger/significant fractures consideration is to be given to cropping and partly renewing/ renewing the frame brackets. If renewing the brackets, end of frames can be sniped to soften them. 3. If felt prudent, soft toes are to be incorporated at the boundaries of the bracket to the inner bottom plating.

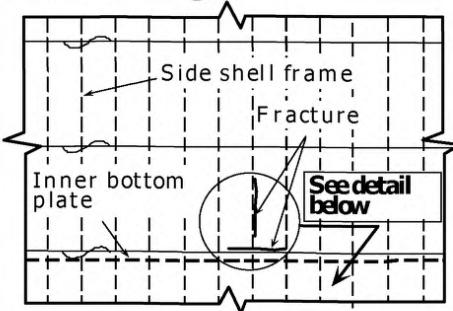
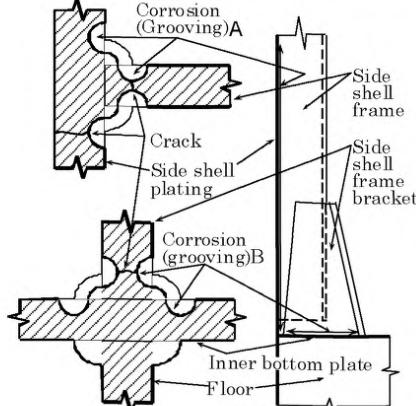
GENERAL CARGO SHIPS		Guidelines for Surveys, Assessment and Repair of Hull Structure
Part 1	Cargo hold region	Example No.
Area 2	Side structure	2
Detail of damage	Fractures in side shell frame/lower bracket and side shell plating near tank top	
Sketch of damage

Notes on possible cause of damage <ol style="list-style-type: none"> Fracture in side shell plating along side shell frame: Heavy corrosion (grooving) along side shell frame (See A). Fracture in side shell plating along tank top: Heavy corrosion (grooving) along tank top (See B) resulting detachment of side shell frame bracket from inner bottom plating. 		Notes on repairs <ol style="list-style-type: none"> Sketch of repair applies when damage extends over several frames. Isolated fractures may be repaired by veeing-out and rewelding. Isolated cases of grooving may be repaired by build up of welding.

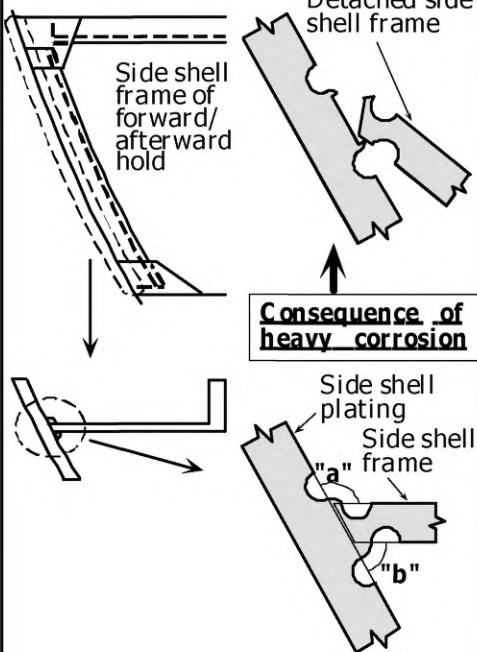
GENERAL CARGO SHIPS		Guidelines for Surveys, Assessment and Repair of Hull Structure
Part 1	Cargo hold region	Example No.
Area 2	Side structure	3
Detail of damage	Adverse effect of corrosion on the frame of forward/afterward hold	
Sketch of damage

Notes on possible cause of damage 1. Heavy corrosion (grooving) of side shell frame along side shell plating and difference of throat thickness "a" from "b". (Since original throat thickness of "a" is usually smaller than that of "b", if same welding procedure is applied, the same corrosion has a more severe effect on "a", and may cause collapse and/or detachment of side shell frame.)		Notes on repairs 1. Sketch of repair applies when damage extends over several frames. 2. Isolated fractures may be repaired by veeing-out and rewelding. 3. Isolated cases of grooving may be repaired by build up of welding.

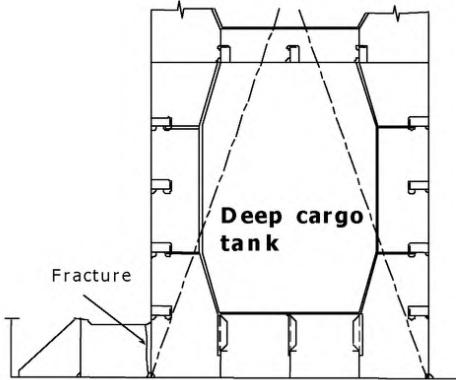
GENERAL CARGO SHIPS		Guidelines for Surveys, Assessment and Repair of Hull Structure
Part 1	Cargo hold region	Example No.
Area 2	Side structure	6
Detail of damage	Fractures in way of continuation/extension brackets at the end of deep cargo tank	
Sketch of damage

Notes on possible cause of damage	<p>1. Damage caused by stress concentration leading to fatigue fracture on side shell. This will be exacerbated because of the greater flexibility of the ordinary hold structure in relation to the deep cargo tank structure.</p>	
Notes on repairs	<p>1. The fractured shell plate is to be cropped and part renewed as necessary. 2. Brackets should be modified.</p>

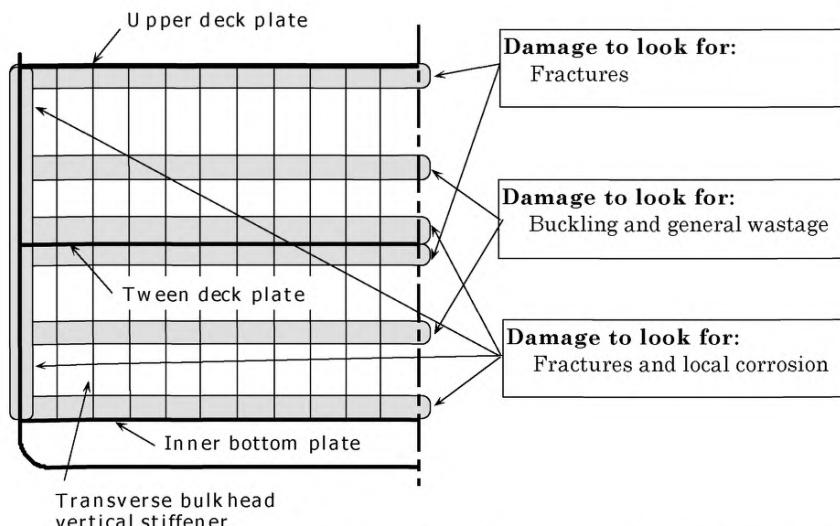
Figure 1 Transverse bulkhead - potential problem areas

1.3 Deformation of the plating may lead to the failure and collapse of the bulkhead under water pressure in an emergency situation.

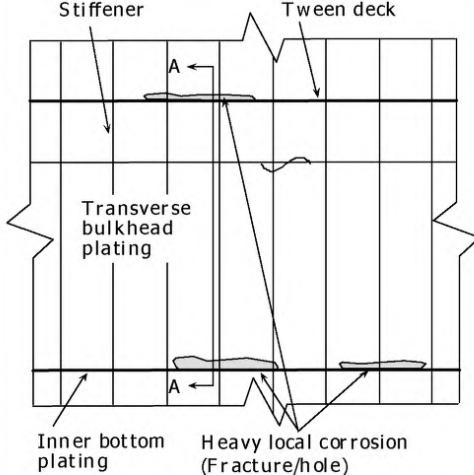
GENERAL CARGO SHIPS		Guidelines for Surveys, Assessment and Repair of Hull Structure
Part 1	Cargo hold region	Example No.
Area 3	Transverse bulkhead structure	1
Detail damage	of Corrosion along inner bottom or tween deck plating	
Sketch of damage

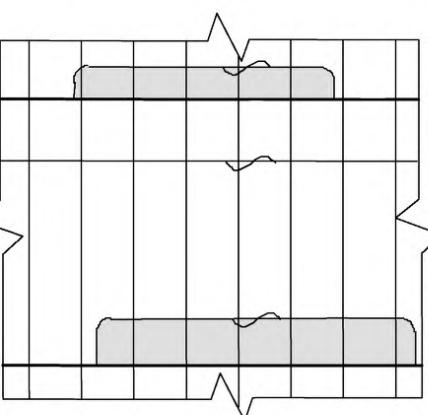
<p>Note: Regarding "View A-A", refer to Example 2 of Area 2 of this part</p>		
Notes on possible cause of damage 1. Heavy corrosion including grooving along inner bottom plating or tween deck due to poor drainage.		Notes on repairs 1. The extent of the renewal should be determined carefully. If the renewal plate (original thickness) is welded to thin plate (corroded plate), it may cause stress concentration and cause fracture. 2. Protective coating should be applied.

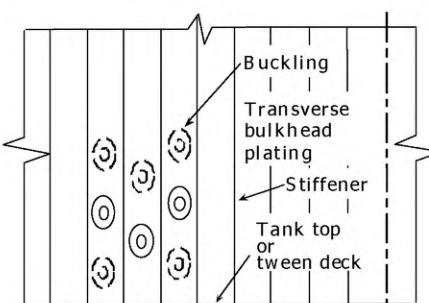
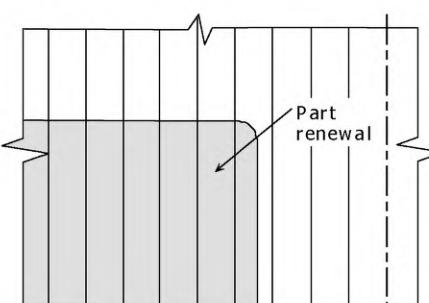
GENERAL CARGO SHIPS		Guidelines for Surveys, Assessment and Repair of Hull Structure
Part 1	Cargo hold region	Example No.
Area 3	Transverse bulkhead structure	2
Detail of damage	Buckling in transverse bulkhead	
Sketch of damage

Notes on possible cause of damage 1. Heavy general corrosion.		Notes on repairs 1. The extent of the renewal should be determined carefully. If the renewal plating (original thickness) is welded to thin plating (corroded plating), it may cause stress concentration and fracture. 2. Protective coating should be applied.

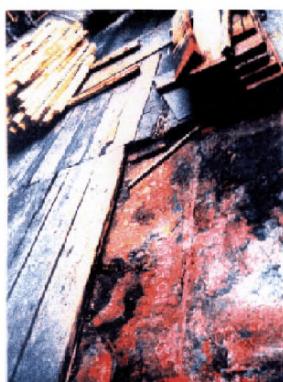
2.1.2 When the tank top plating has been covered with dunnage or ceiling the plating may have suffered heavy corrosion, due to high humidity, and lack of proper maintenance (See **Photograph 1**).

Photograph 1
Fractured inner bottom plating due to heavy corrosion on both sides

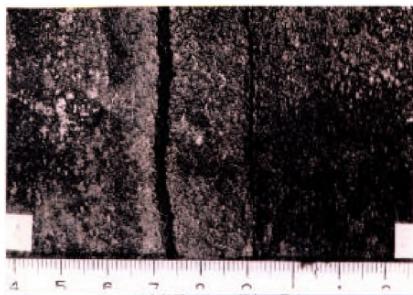
4.1.2 Severe grooving along welding of bottom plating is often found (See **Photographs 2** and **3**). This grooving can be accelerated by poor maintenance of the protective coating and/or sacrificial anodes fitted to the bottom plating.

Photograph 2
Grooving corrosion of welding
of bottom plating

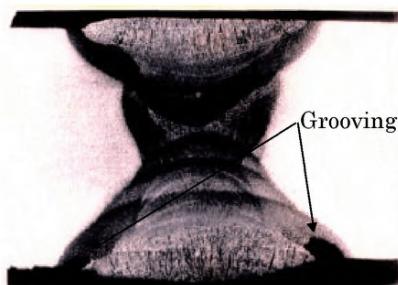
Photograph 3
Section of the grooving shown
in Photograph 2

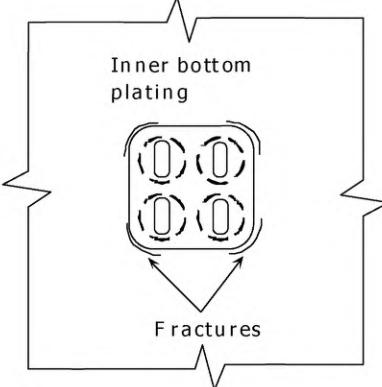
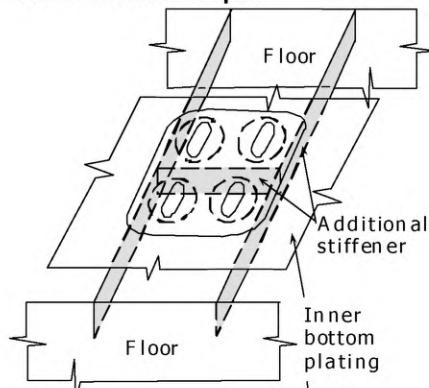
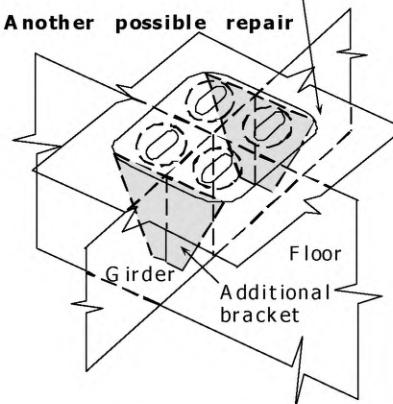
GENERAL CARGO SHIPS		Guidelines for Surveys, Assessment and Repair of Hull Structure
Part 1	Cargo hold region	Example No.
Area 5	Double bottom structure	1
Detail of damage		Fractures in inner bottom plating around container bottom pocket
Sketch of damage		Sketch of repair

Notes on possible cause of damage <ol style="list-style-type: none"> 1. Pocket is not supported correctly by floor, longitudinal and/or stiffener. 		Notes on repairs <ol style="list-style-type: none"> 1. Fractured plating should be cropped and part renewed. 2. Adequate reinforcement should be considered.

<p>Most common repair</p>

<p>Another possible repair</p>

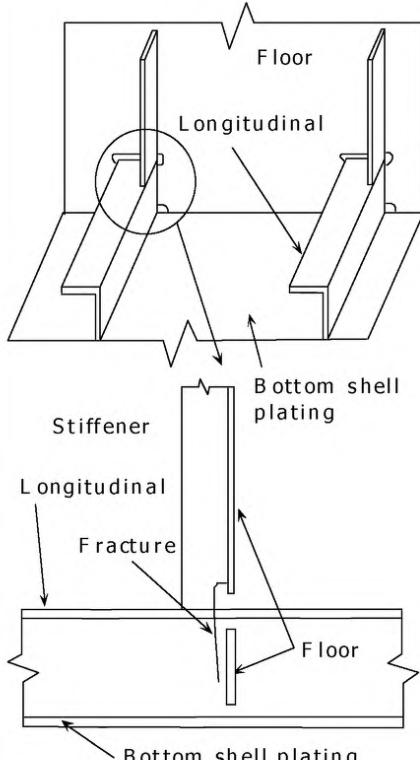
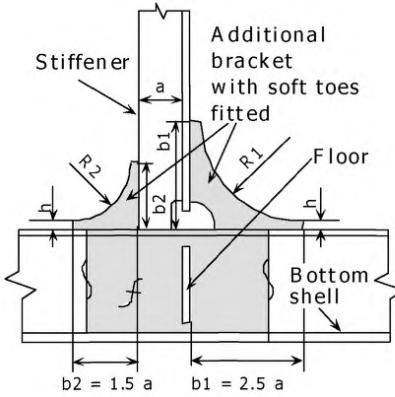
GENERAL CARGO SHIPS		Guidelines for Surveys, Assessment and Repair of Hull Structure
Part 1	Cargo hold region	Example No.
Area 5	Double bottom structure	3-a
Detail of damage	Fractures at the connection of bottom/inner bottom longitudinal to floor stiffener	
Sketch of damage

<p>Note: same damage may occur at similar connection to inner bottom plating</p>

Notes on possible cause of damage	<p>1. Damage can be caused by stress concentrations leading to accelerated fatigue in this region.</p>	
	<p>Notes on repairs</p> <ol style="list-style-type: none"> 1. If fracture extends to over one third of the depth of the longitudinal, then crop and part renew. Otherwise the fracture can be vee'd-out and welded.

<p>f: Where required, the longitudinal to be cropped and part renewed</p> <ol style="list-style-type: none"> 1. For a slope at toes max. 1 : 3, $R1 = (b1-h) \times 1.6$ and $R2 = (b2-h) \times 1.6$ 2. Soft toe bracket to be welded first to longitudinal 3. Scallop in bracket to be as small as possible, recommended max. 35 mm 4. If toes of brackets are ground smooth, full penetration welds in way to be provided 5. Maximum length to thickness ratio = 50 : 1 for unstiffened bracket edge 6. Toe height, h, to be as small as possible (10- 15 mm)

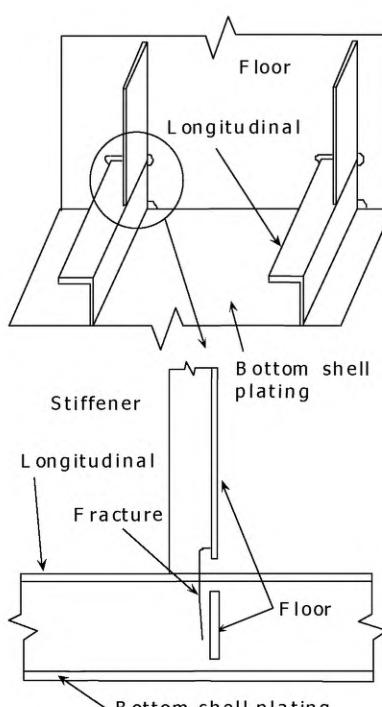
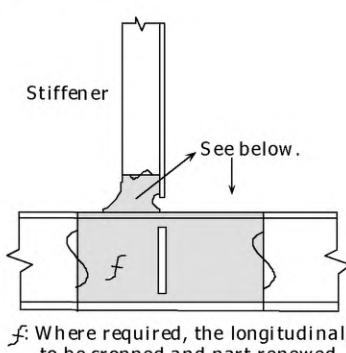
GENERAL CARGO SHIPS		Guidelines for Surveys, Assessment and Repair of Hull Structure
Part 1	Cargo hold region	Example No.
Area 5	Double bottom structure	3-b
Detail of damage	Fractures at the connection of bottom/inner bottom longitudinal to floor stiffener	
Sketch of damage

<p>Note: same damage may occur at similar connection to inner bottom plating</p>	
	Sketch of repair

<p>Where required, the longitudinal to be cropped and part renewed</p>

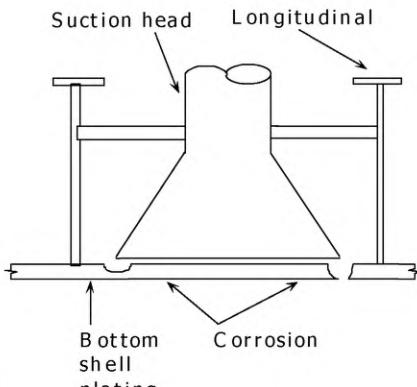
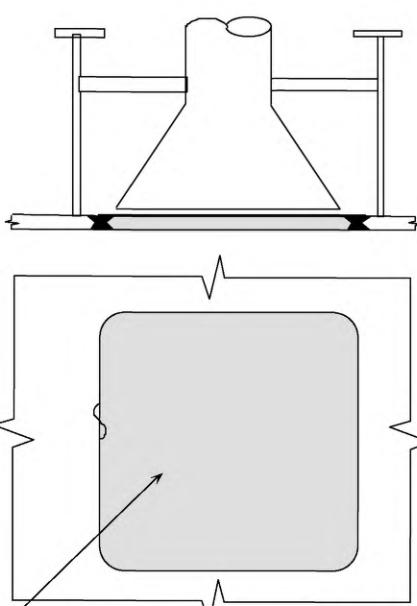
GENERAL CARGO SHIPS		Guidelines for Surveys, Assessment and Repair of Hull Structure
Part 1	Cargo hold region	Example No.
Area 5	Double bottom structure	7
Detail of damage		Corrosion in bottom plating below suction head
Sketch of damage		Sketch of repair

<p>1. Insert to have round corners 2. Non-destructive examination to be applied after welding based on the Society's rules</p>
Notes on possible cause of damage <ol style="list-style-type: none"> 1. High flow rate associated with insufficient corrosion prevention system. 2. Galvanic action between dissimilar metals 		Notes on repairs <ol style="list-style-type: none"> 1. Affected plating should be cropped and part renewed. Thicker plate and suitable beveling should be considered. 2. If the corrosion is limited to a small area, i.e. pitting corrosion, repair by welding is acceptable.

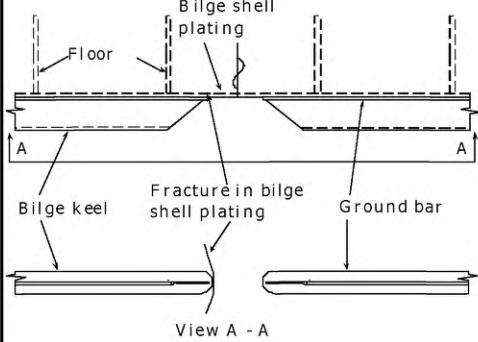
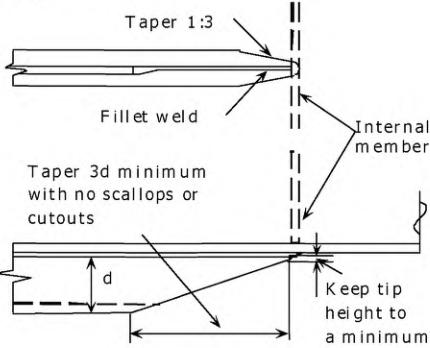
GENERAL CARGO SHIPS		Guidelines for Surveys, Assessment and Repair of Hull Structure
Part 1	Cargo hold region	Example No.
Area 5	Double bottom structure	8
Detail of damage		Fracture in shell plating at the termination of bilge keel
Sketch of damage		Sketch of repair

<p>Repair A</p>

<p>Repair B</p>

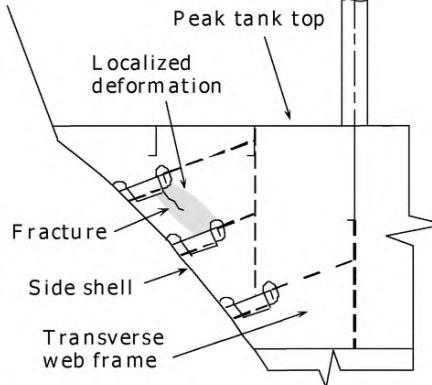
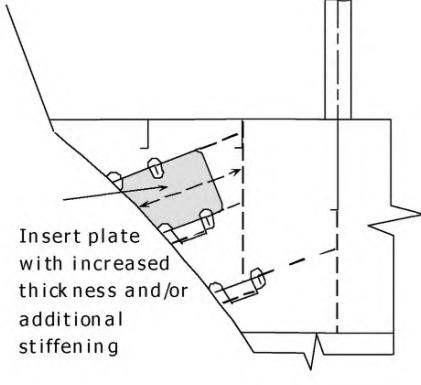
GENERAL CARGO SHIPS		Guidelines for Surveys, Assessment and Repair of Hull Structure
Part 2	Fore and aft end regions	Example No.
Area 1	Fore end structure	1
Detail of damage	Fracture and deformation of bow transverse web in way of cut-outs for side longitudinals	
Sketch of damage

<p>Insert plate with increased thickness and/or additional stiffening</p>
Notes on possible cause of damage <ol style="list-style-type: none"> Localized material wastage in way of coating failure at cut-outs and sharp edges due to working of the structure. Dynamic seaway loading in way of bow flare. 		Notes on repairs <ol style="list-style-type: none"> Sufficient panel strength to be provided to absorb the dynamic loads enhanced by bow flare shape.

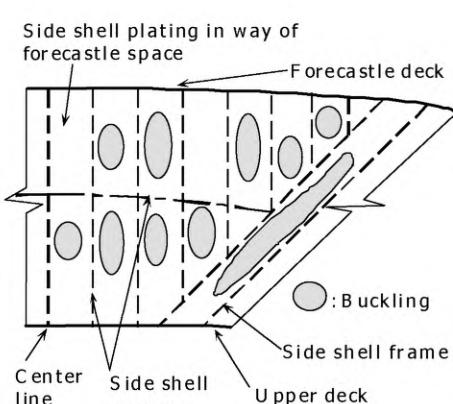
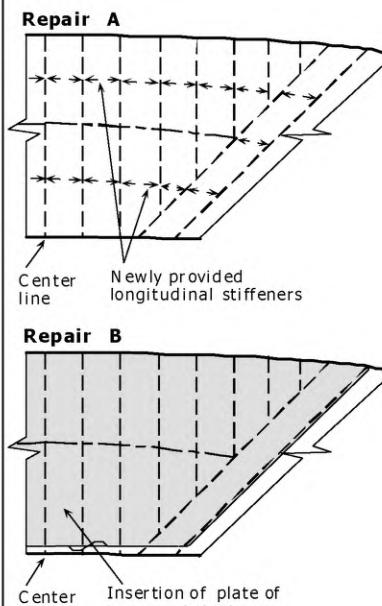
GENERAL CARGO SHIPS		Guidelines for Surveys, Assessment and Repair of Hull Structure
Part 2	Fore and aft end regions	Example No.
Area 1	Fore end structure	5
Detail of damage	Deformation of side shell plating in way of forecastle space	
Sketch of damage

Notes on possible cause of damage <ol style="list-style-type: none"> 1. Heavy weather. 2. Insufficient strength. 		
Notes on repairs <ol style="list-style-type: none"> 1. Deformed part should be cropped and part renewed. 2. Repair A Additional stiffeners between existing stiffeners should be considered. <p>Repair B Insertion of plate of increased thickness with additional stiffeners</p>

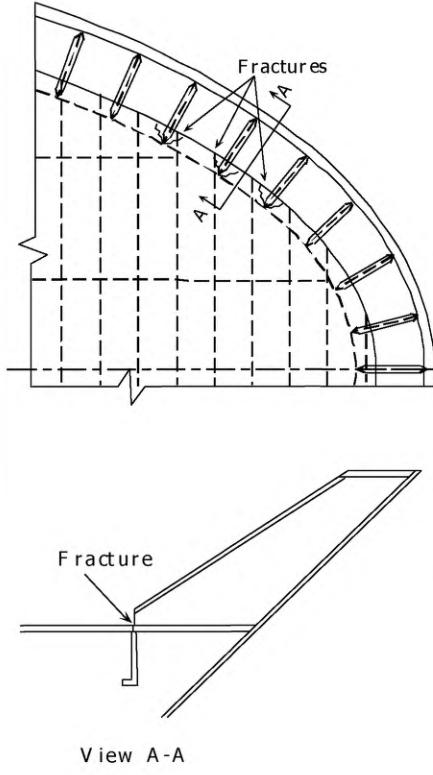
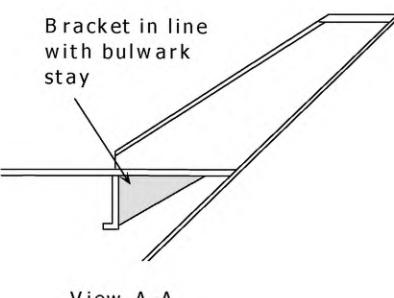
GENERAL CARGO SHIPS		Guidelines for Surveys, Assessment and Repair of Hull Structure
Part 2	Fore and aft end regions	Example No.
Area 1	Fore end structure	6
Detail of damage	Fracture in forecastle deck plating at bulwark	
Sketch of damage

Notes on possible cause of damage	<p>Notes on possible cause of damage</p> <ol style="list-style-type: none"> 1. Bow flare effect in heavy weather. 2. Stress concentration due to poor design. 	
	<p>Notes on repairs</p> <ol style="list-style-type: none"> 1. Fractured deck plating should be cropped and renewed. 2. Bracket in line with the bulwark stay to be fitted to reduce stress concentration.

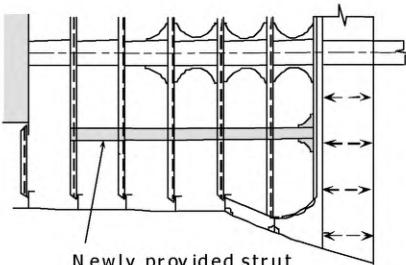
GENERAL CARGO SHIPS		Guidelines for Surveys, Assessment and Repair of Hull Structure
Part 2	Fore and aft end regions	Example No.
Area 2	Aft end structure	2
Detail of damage		Fractures at the connection of floors and girders/side brackets
Sketch of damage		Sketch of repair

Notes on possible cause of damage		Notes on repairs
1. Vibration.		<ol style="list-style-type: none"> 1. The fractured plating should be cropped and renewed. 2. Natural frequency of the panel should be changed, e.g. reinforcement by additional strut.

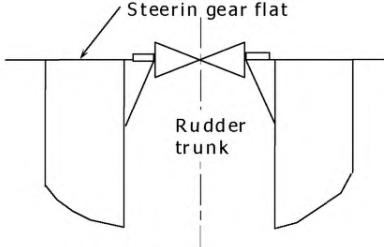
GENERAL CARGO SHIPS		Guidelines for Surveys, Assessment and Repair of Hull Structure
Part 2	Fore and aft end regions	Example No.
Area 2	Aft end structure	3-a
Detail of damage	Fracture in flat where rudder carrier is installed in steering gear room	
Sketch of damage

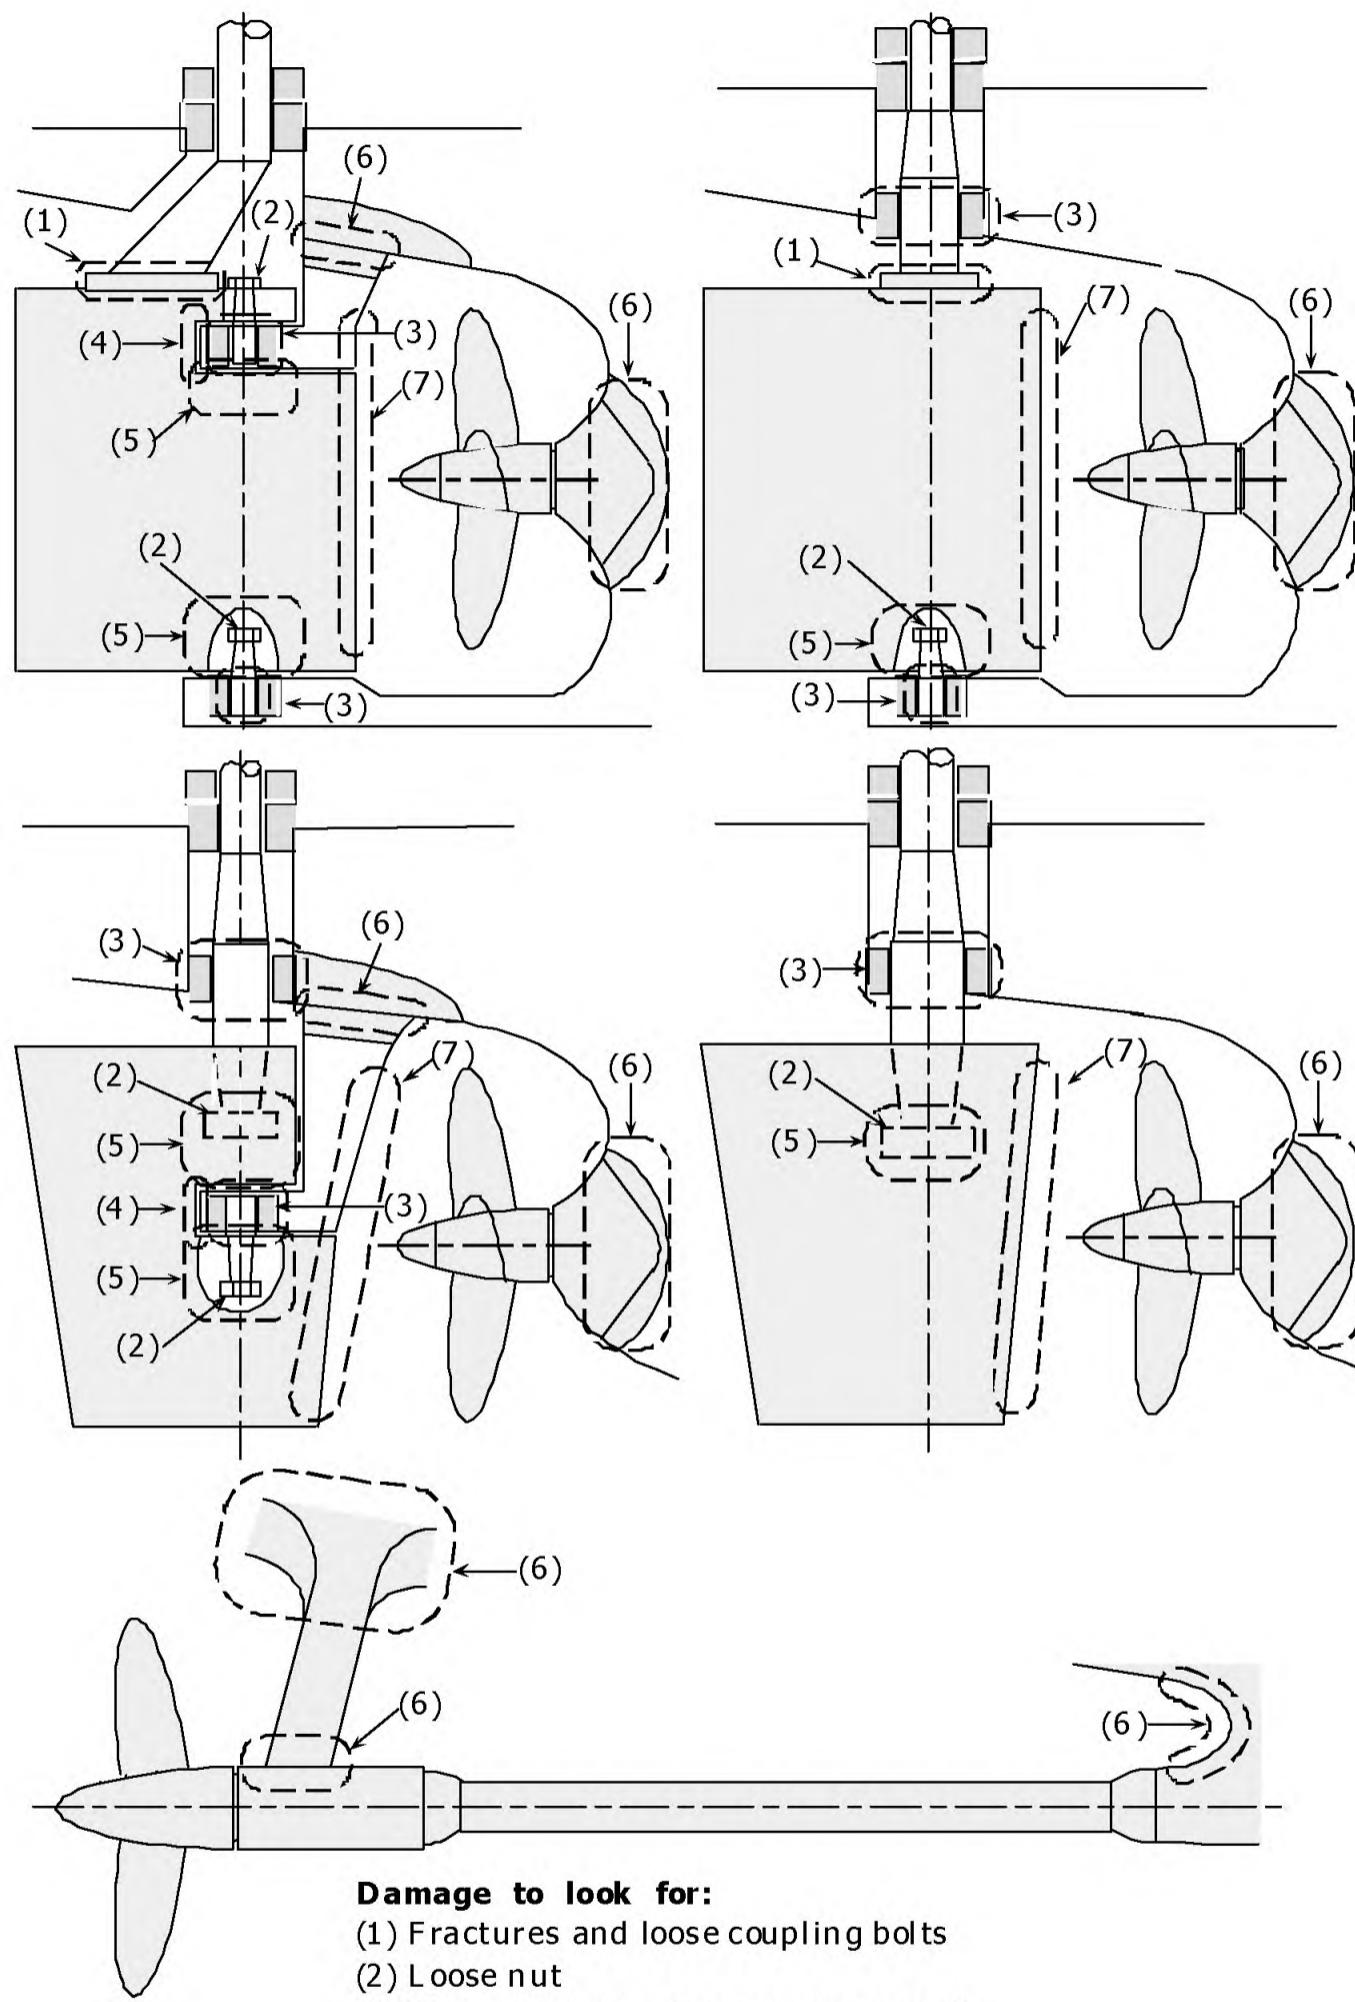
Figure 2 Potential problem areas

- 1.6 Pre-existing manufacturing internal defects in cast pieces may lead to fatigue cracking.
- 1.7 A summary of potential problem areas is shown in **Figure 2**.

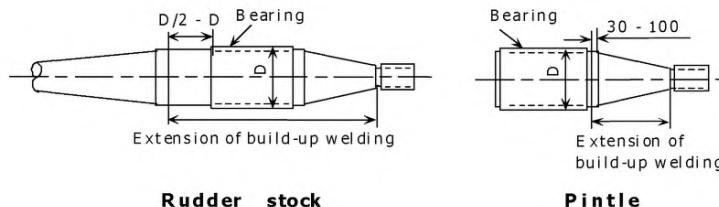
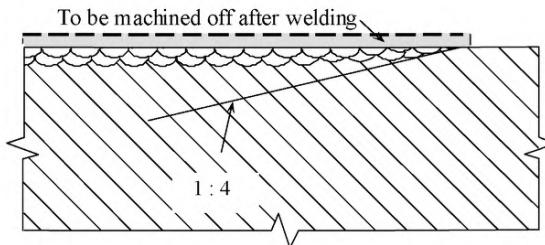
Figure 3 Rudder stock repair by welding

Rudder stocks and/or pintles may be repaired by welding replacing wasted material by similar weld material. After removal of the wasted area (corrosion, scratches, etc.) by machining and/or grinding the build-up welding has to be carried out by an automatic spiral welding according to an approved welding procedure. The welding has to be extended over the area of large bending moments (rudder stocks). In special cases post weld heat treatment has to be carried out according to the requirements of the Classification Society. After final machining, a sufficient number of layers of welding material have to remain on the rudder stock/pintle. A summary of the most important steps and conditions of this repair is shown in the **Figure 3**.

Replacing wasted material by similar ordinary weld material

- Removal of the wasted area by machining and/or grinding, non-destructive examination for fractures (magnetic particle inspection preferred)
- Build-up welding by automatic spiral welding (turning device) according to an approved welding procedure (weld process, preheating, welding consumables, etc.)
- Extension of build-up welding over the area of **large bending moments (shafts)** according to the sketch

- Sufficient number of weld layers to compensate removed material, at least one layer in excess (heat treatment of the remaining layer)
- Transition at the end of the build-up welding according to the following sketch

- Post weld heat treatment if required in special cases (never for stainless steel cladding on ordinary steel)
- Final machining, at least two layers of welding material have to remain on the rudder stock (See the above sketch)
- Non-destructive fracture examination

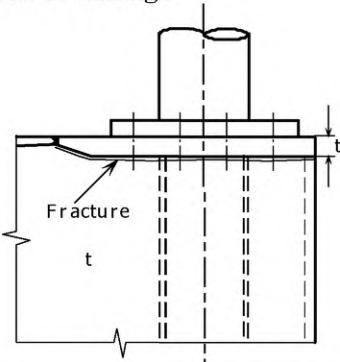
GENERAL CARGO SHIPS		Guidelines for Surveys, Assessment and Repair of Hull Structure
Part 2	Fore and aft end regions	Example No.
Area 3	Stern frame, rudder arrangement and propeller shaft support	2
Detail of damage	Fracture in connection of palm plate to rudder blade	
Sketch of damage

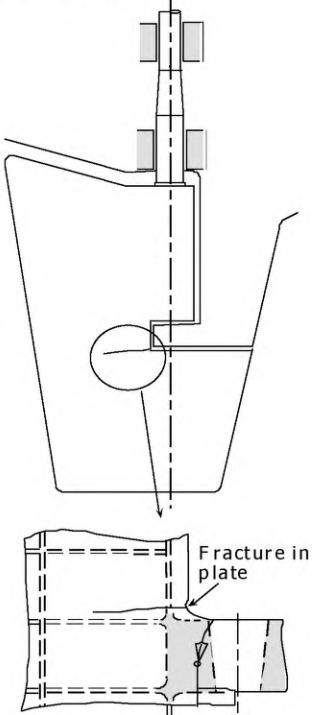
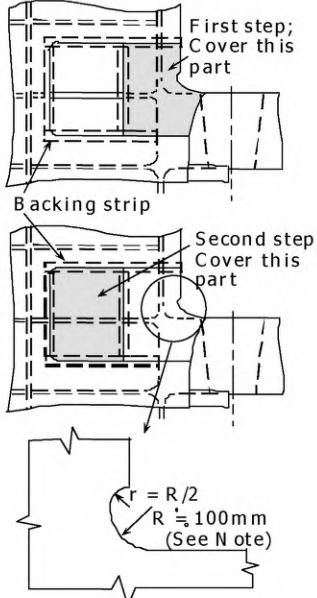
GENERAL CARGO SHIPS		Guidelines for Surveys, Assessment and Repair of Hull Structure
Part 2	Fore and aft end regions	Example No.
Area 3	Stern frame, rudder arrangement and propeller shaft support	4
Detail of damage	Fracture in rudder plating of semi-spa de rudder extending beyond the vertical web	
Sketch of damage

In case of longer fatigue fractures starting in the lower and/or upper corners of the pintle recess of semi-spade rudders that propagate over a longer distance into the plating, thorough check of the internal structures has to be carried out. The fractured parts of the plating and internal structures, if necessary, have to be replaced by insert plates. A proper welding connection between the insert plate and the internal stiffening structure is very important (See **Examples 4** and **5**).

<p>First step; Cover this part</p> <p>Backing strip</p> <p>Second step; Cover this part</p> <p>$r = R/2$ $R = 100\text{ mm}$ (See Note)</p> <p>Note: R should be considered according to local detail</p>
Notes on possible cause of damage	1. Stress concentration due to inadequate local design and/or fabrication notches in way of the butt weld between cast piece and plating.	Notes on repairs
		<ol style="list-style-type: none"> 1. Fractured plating is to be cut-out. 2. Internal structures are to be checked. 3. Cut-out is to be closed by an insert plating according to the sketch (welding only from one side is demonstrated). 4. Modification of the radius. 5. In case of a new cast piece, connection with the plating is to be shifted outside the high stress area.

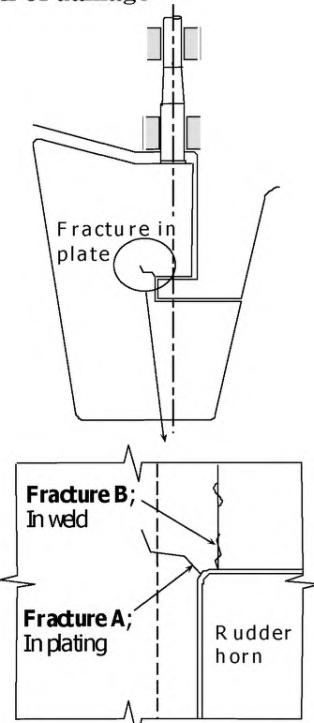
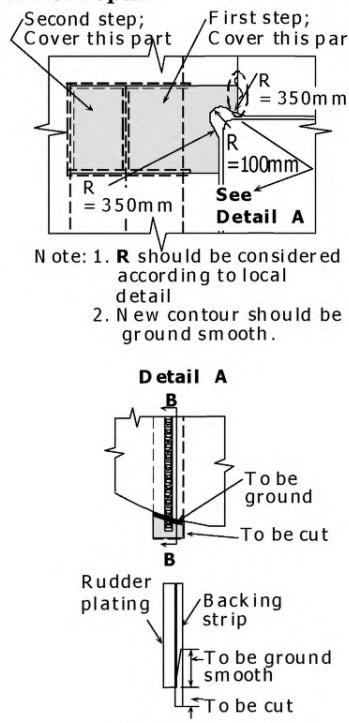
GENERAL CARGO SHIPS		Guidelines for Surveys, Assessment and Repair of Hull Structure
Part 2	Fore and aft end regions	Example No.
Area 3	Stern frame, rudder arrangement and propeller shaft support	5
Detail of damage	Fracture in rudder plating of semi-spade rudder in way of pintle cutout	
Sketch of damage

The area of the pintle recess corners has to be ground smooth after the repair. In many cases a modification of the radius, an increased thickness of plating and an enhanced steel quality may be necessary.

<p>Second step; Cover this part</p> <p>First step; Cover this part</p> <p>$R = 100\text{mm}$</p> <p>$R = 350\text{mm}$</p> <p>See Detail A</p> <p>Note: 1. R should be considered according to local detail 2. New contour should be ground smooth.</p> <p>Detail A</p> <p>B</p> <p>To be ground</p> <p>To be cut</p> <p>Rudder plating</p> <p>Backing strip</p> <p>To be ground smooth</p> <p>To be cut</p> <p>View B - B</p>
Notes on possible cause of damage <ol style="list-style-type: none"> 1. Inadequate design for stress concentration in way of pintle bearing 2. (Fracture A). Imperfection in welding seam (Fracture B). 		Notes on repairs <ol style="list-style-type: none"> 1. Fractured part to be cropped off. 2. Repair by two insert plates of modified, stress releasing contour. For the vertical seam no backing strip is used 100mm off contour, welding from both sides, to be ground after welding. 3. Variant (See Detail A): Repair as mentioned under 2 with the use of backing strip for the complete vertical seam. After welding backing strip partly removed by grinding.

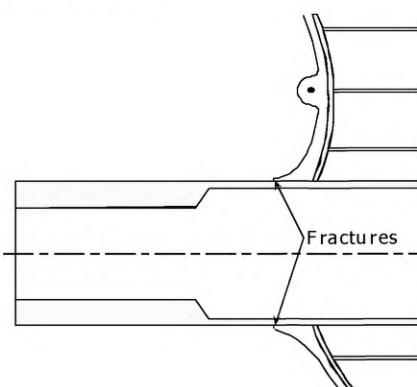
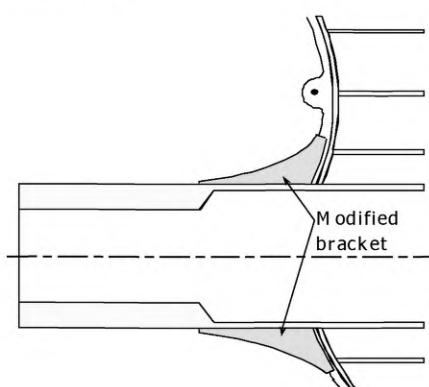
GENERAL CARGO SHIPS		Guidelines for Surveys, Assessment and Repair of Hull Structure
Part 2	Fore and aft end regions	Example No.
Area 3	Stern frame, rudder arrangement and propeller shaft support	7
Detail of damage		Fracture in stern tube at the connection to stern frame
Sketch of damage

Notes on possible cause of damage 1. Fatigue fracture due to vibration.		Notes on repairs 1. Fractured tube is to be welded from both sides. 2. Brackets are to be replaced by modified brackets with soft transition.

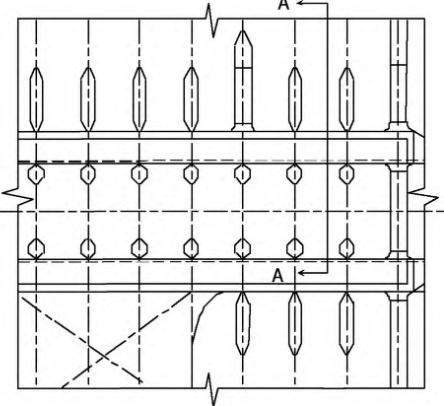
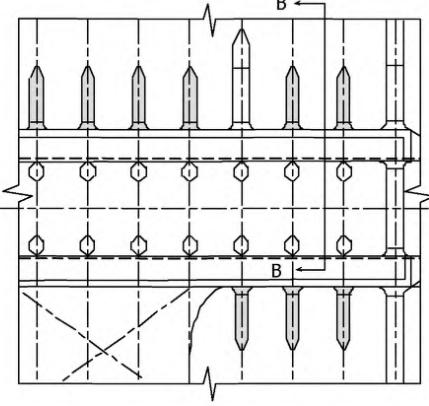
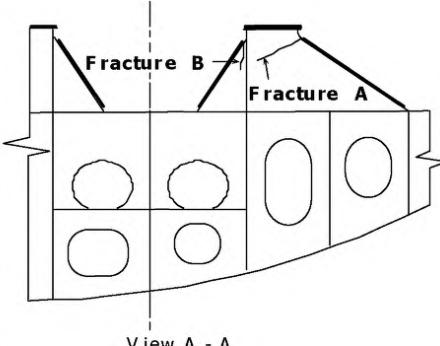
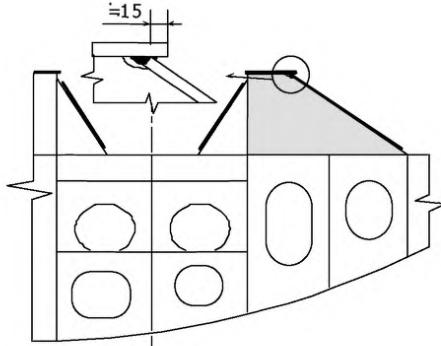
GENERAL CARGO SHIPS		Guidelines for Surveys, Assessment and Repair of Hull Structure
Part 3	Machinery and accommodation spaces	Example No.
Area 1	Engine room structure	1
Detail of damage		Fractures in brackets at main engine foundation
Sketch of damage

Notes on possible cause of damage <ol style="list-style-type: none"> 1. Vibration of main engine. 2. Insufficient strength of brackets at main engine foundation. 3. Insufficient pre-load of the bolts. 		Notes on repairs <ol style="list-style-type: none"> 1. Fractures may be veed-out and 2. rewelded. <p>New modified brackets at main engine foundation. Or insert pieces and additional flanges to increase section modulus of the brackets.</p>

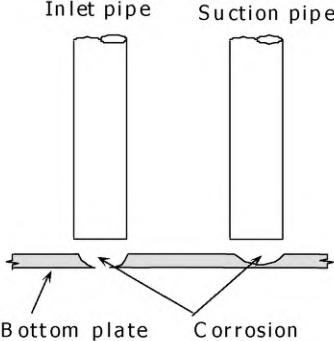
GENERAL CARGO SHIPS		Guidelines for Surveys, Assessment and Repair of Hull Structure
Part 3	Machinery and accommodation spaces	Example No.
Area 1	Engine room structure	3
Detail of damage	Corrosion in bottom plating under inlet/suction/pipe in way of bilge tank in engine room	
Sketch of damage
