**No. 96**

**Double Hull Oil Tankers** - Guidelines for Surveys,  
Assessment and Repair of Hull Structures

# IACS

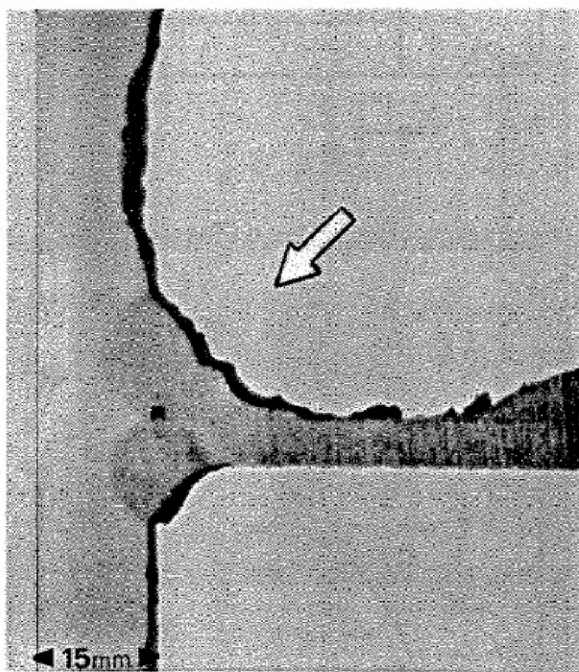
- Necking occurs at the junction of the longitudinal bulkhead plating and longitudinals. The deflection of the bulkhead plating and longitudinals due to reverse, cyclic loading from cargo oil and water ballast plus the accumulated mixtures of water, mud and scale at their junctures accelerates the corrosion rate. As the steel thins and weakens, the flexing consequently increases and hence corrosion accelerates (see Figure 10). The similar necking effect could also occur in the transverse bulkhead plating and stiffeners, or in the inner bottom plating and longitudinals inside the double bottom space. In the coated water ballast tanks, the plating is the principally affected area due to local corrosion in way of coating failure.

**Figure 10** Detail of Necking Effect

One of the best methods of preventing corrosion within these spaces is that protective coatings be applied to the underdeck and inner bottom plating areas. In addition to

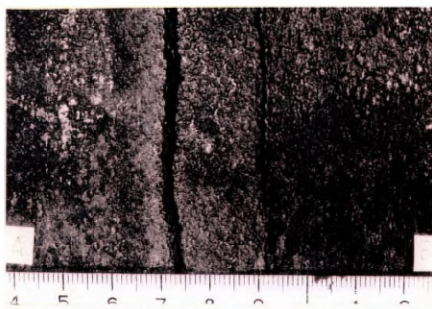
**4.1.2** Severe grooving along welding of bottom plating is often found (See **Photographs 1** and **2**). This grooving can be accelerated by poor maintenance of the protective coating and/or sacrificial anodes fitted to the bottom plating.

**Photograph 1**  
Grooving corrosion of welding of bottom plating

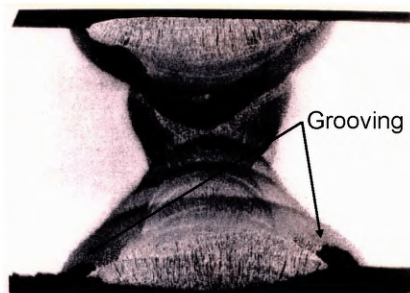
**Photograph 2**  
Section of the grooving shown in Photograph 1

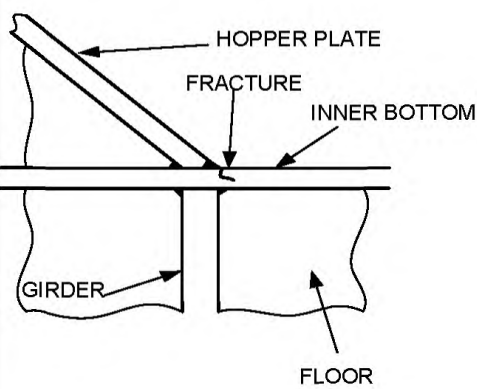
| OIL Tankers | | Guidelines for Surveys, Assessment and Repair of Hull Structure |
|---|---|---|
| Detail of damage | | Fracture on the inner bottom plating at the connection of hopper plate to inner bottom |
| <b>Factors which may have caused damage</b> <ol style="list-style-type: none"> <li>1. Stress concentration at juncture of hopper plate to inner bottom.</li> <li>2. Insufficient welding connection.</li> <li>3. Misalignment between hopper plate, inner bottom and girder.</li> </ol> | | <b>Notes on repairs</b><br>See Sketch. |

| OIL Tankers | | Guidelines for Surveys, Assessment and Repair of Hull Structure |
|---|---|---|
| | | <p><b>Notes:</b> Plate midlines intersect</p> |

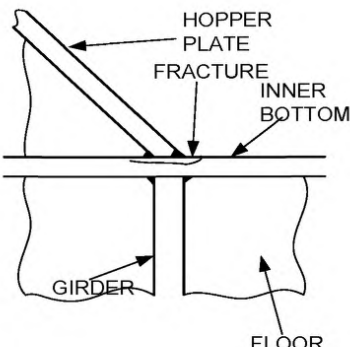
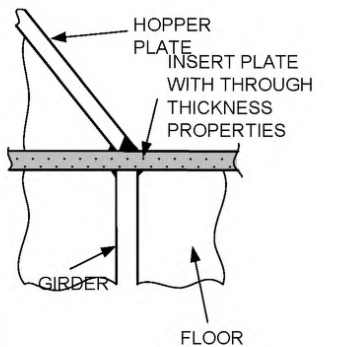
| OIL Tankers | | Guidelines for Surveys, Assessment and Repair of Hull Structure | |
|---|---|---|--|
| Detail of damage | | Fracture at connection of bilge hopper plate and inner bottom | |
| <b>Factors which may have caused damage</b><br>1. Stress concentration at the knuckle. | | <b>Notes on repairs</b><br>See Sketch. | |

| OIL Tankers | | Guidelines for Surveys, Assessment and Repair of Hull Structure | |
|---|---|---|--|
| | | <p><b>Notes:</b> Plate midlines intersect</p> | |

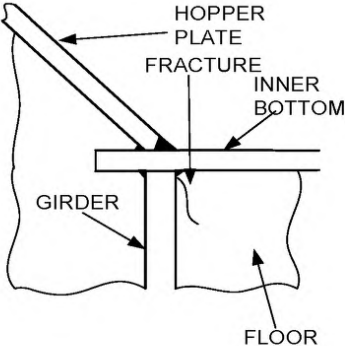
| OIL Tankers | | Guidelines for Surveys, Assessment and Repair of Hull Structure | |
|---|---|---|--|
| Detail of damage | | Fracture at connection of bilge hopper plate and inner bottom | |
| <b>Factors which may have caused damage</b><br>1. Stress concentration at the knuckle. | | <b>Notes on repairs</b><br>See Sketch. | |

| OIL Tankers | | Guidelines for Surveys, Assessment and Repair of Hull Structure | |
|---|---|---|--|
| <b>Sketch of damage</b> | | <b>Sketch of repair</b> <p><b>Notes:</b> Plate midlines intersect</p> | |

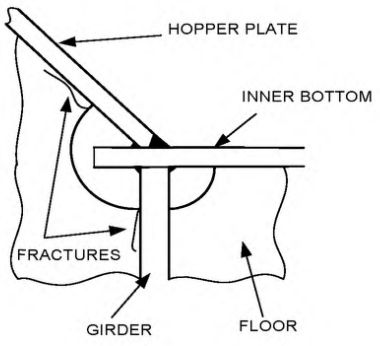
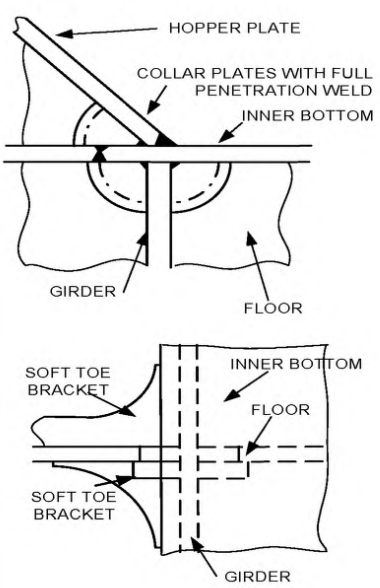
| OIL Tankers | | Guidelines for Surveys, Assessment and Repair of Hull Structure | |
|---|---|---|--|
| Detail of damage | | Fracture at connection of bilge hopper plate and inner bottom | |
| 1. Stress concentration at the knuckle. | | See Sketch. | |

| OIL Tankers | | Guidelines for Surveys, Assessment and Repair of Hull Structure | |
|---|---|---|--|
| | | <p>Notes: Plate midlines intersect</p> | |

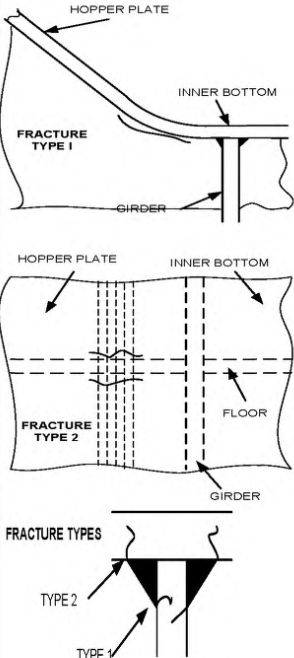
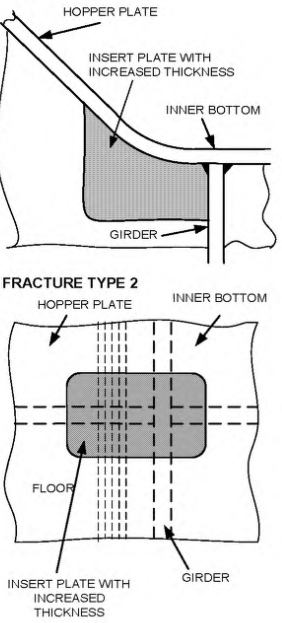
| OIL Tankers | | Guidelines for Surveys, Assessment and Repair of Hull Structure | |
|---|---|---|--|
| Detail of damage | | Fractured floor and inner bottom plate in way of juncture of inner bottom to hopper plate | |
| <ol style="list-style-type: none"> <li>1. Misalignment. The three mid-lines do not cross at the same joint. This misalignment produces an out-of-plane deformation of inner bottom plate in way of knuckle line.</li> <li>2. Stress concentration at connection between floor and inner bottom plate.</li> <li>3. Static and dynamic load of ballast water.</li> </ol> | | See Sketch. | |

| OIL Tankers | | Guidelines for Surveys, Assessment and Repair of Hull Structure | |
|---|---|---|--|
| <p>Sketch of damage showing Fracture Type 1 and Fracture Type 2. Fracture Type 1 shows a hopper plate, inner bottom, and girder with a fracture line. Fracture Type 2 shows a hopper plate, inner bottom, floor, and girder with a fracture line. A legend shows Fracture Types 1 and 2.</p> | | <p>Sketch of repair showing Fracture Type 1 and Fracture Type 2. Fracture Type 1 shows a hopper plate, inner bottom, and girder with an insert plate with increased thickness. Fracture Type 2 shows a hopper plate, inner bottom, floor, and girder with an insert plate with increased thickness.</p> | |

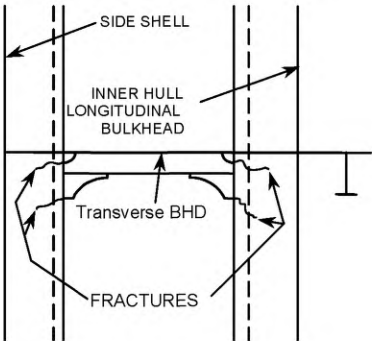
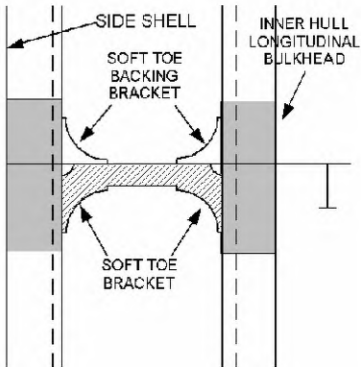
| OIL Tankers | | Guidelines for Surveys, Assessment and Repair of Hull Structure | |
|---|---|---|--|
| Detail of damage | | Crack in way of connection of longitudinals to transverse bulkhead | |
| <b>Factors which may have caused damage</b> <ol style="list-style-type: none"> <li>1. Asymmetrical connection of bracket without backing bracket.</li> <li>2. Relative deflection of adjoining transverse web against transverse bulkhead.</li> <li>3. Additional biaxial bending stresses due to asymmetry of the angle bar longitudinal instead of symmetric T section.</li> <li>4. Dynamic load in the vicinity of the water line.</li> <li>5. Large upstand at bracket toe.</li> </ol> | | <b>Notes on repairs</b><br>See Sketch. | |

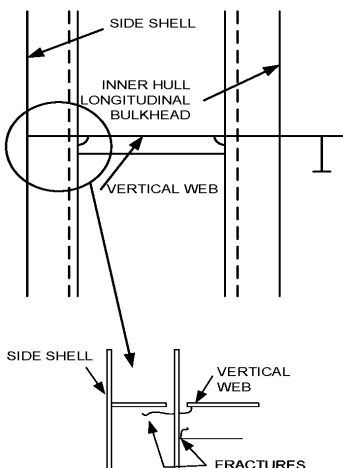
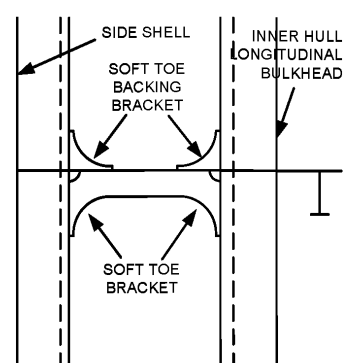
| OIL Tankers | | Guidelines for Surveys, Assessment and Repair of Hull Structure |
|---|---|---|
| Detail of damage | Crack in way of connection of longitudinals to transverse webs | |
| <b>Factors which may have caused damage</b> <ol style="list-style-type: none"> <li>1. Asymmetrical connection of flat bar stiffener resulting in high peak stresses at the heel of the stiffener.</li> <li>2. Insufficient area of connection of longitudinal to web.</li> <li>3. High bending stresses in the longitudinal.</li> <li>4. Additional biaxial bending stresses due to asymmetry of the longitudinal (angle bar instead of symmetric T bar).</li> <li>5. Stress concentration at the square angles at heel and toe of the connections.</li> <li>6. High shear stress in the transverse web.</li> </ol> | <b>Notes on repairs</b><br>See Sketch. | |

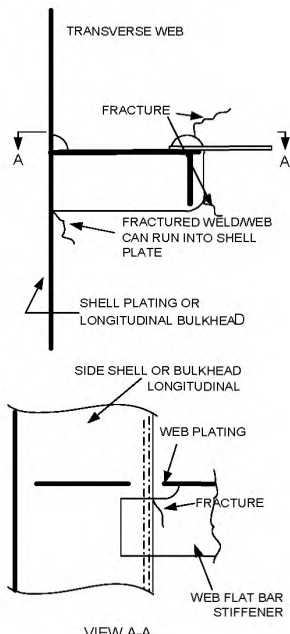
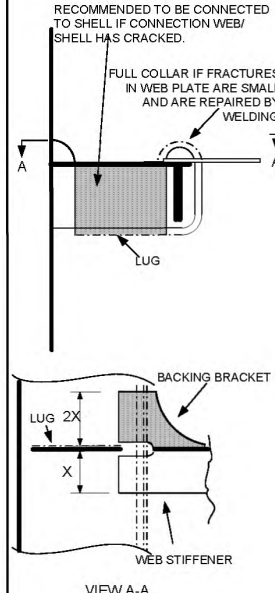
| OIL Tankers | | Guidelines for Surveys, Assessment and Repair of Hull Structure | |
|---|---|---|--|
| Detail of damage | | Fracture in way of web and flat bar stiffener at cut outs for longitudinal stiffener connections as Example 3 but with faceplate attached to underside of web. Flat bar lap welded. | |
| <b>Factors which may have caused damage</b> <ol style="list-style-type: none"> <li>1. Asymmetrical connection of flat bar stiffener resulting in high peak stress at heel of the stiffener under fatigue loading.</li> <li>2. Fabricated longitudinal with welding onto exposed edge of the web resulting in poor fatigue strength of the connection of the longitudinal to the flat bar.</li> <li>3. Insufficient area of connection of longitudinal to web plate.</li> <li>4. Defective weld at return around the plate thickness.</li> <li>5. High localized corrosion at areas of stress concentrations such as flat bar stiffener connections, corners of cut out for longitudinal and connection of lug to shell at cut outs.</li> <li>6. High shear stress in web of the transverse.</li> <li>7. Dynamic seaway loads/motions.</li> </ol> | | <b>Notes on repairs</b><br>See Sketch. <ol style="list-style-type: none"> <li>1. May also fit a double bracket to avoid fracture from toe.</li> </ol> | |

| OIL Tankers | | Guidelines for Surveys, Assessment and Repair of Hull Structure | |
|---|---|---|--|
| | | <p>Insert web plate.</p> | |

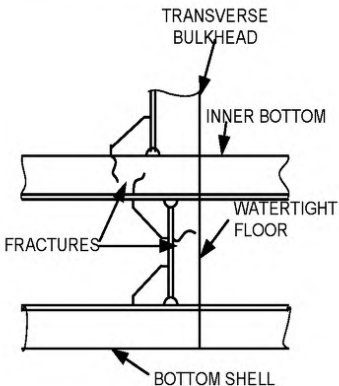
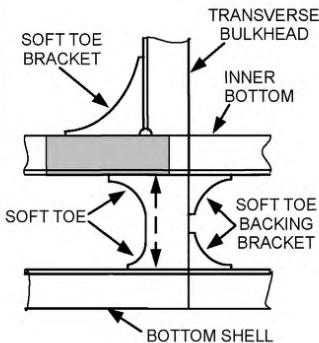
| OIL Tankers | | Guidelines for Surveys, Assessment and Repair of Hull Structure |
|---|---|---|
| Detail of damage | | Cracks in way of longitudinals connected to watertight floors |
| <b>Factors which may have caused damage</b> <ol style="list-style-type: none"> <li>1. Asymmetrical connection of bracket in association with a backing bracket, which is too small.</li> <li>2. Relative deflection between adjacent floor and transverse bulkhead.</li> <li>3. Inadequate shape of the brackets.</li> <li>4. High stresses in the inner bottom longitudinal and the floor stiffener.</li> </ol> | | <b>Notes on repairs</b><br>See Sketch. |

| OIL Tankers | | Guidelines for Surveys, Assessment and Repair of Hull Structure |
|---|---|---|
| <p>TRANSVERSE BULKHEAD</p> <p>INNER BOTTOM</p> <p>WATERTIGHT FLOOR</p> <p>FRACTURES</p> <p>BOTTOM SHELL</p> | | <p>SOFT TOE BRACKET</p> <p>TRANSVERSE BULKHEAD</p> <p>INNER BOTTOM</p> <p>SOFT TOE</p> <p>SOFT TOE BACKING BRACKET</p> <p>BOTTOM SHELL</p> |

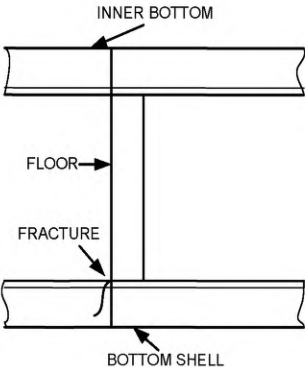
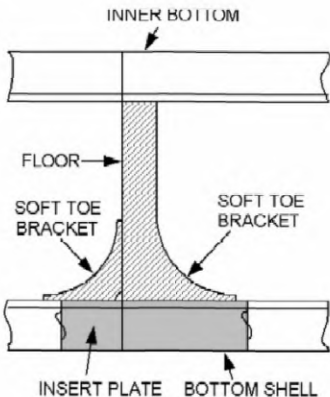
| OIL Tankers Guidelines for Surveys, Assessment and Repair of Hull Structure | | |
|---|---|---|
| Detail of damage | Connection of longitudinals to ordinary floors | |

| OIL Tankers Guidelines for Surveys, Assessment and Repair of Hull Structure | | |
|---|---|---|
| Factors which may have caused damage | <p><b>Notes on repairs</b></p> <p>See Sketch.</p> <ol style="list-style-type: none"> <li>Butt welds in bottom longitudinal should be kept clear of the soft toe bracket toes.</li> <li>If possible soft toe bracket and vertical stiffener should be integral.</li> </ol> | |

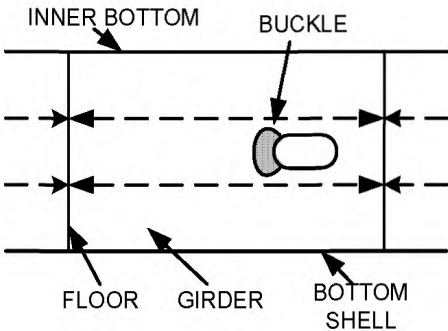
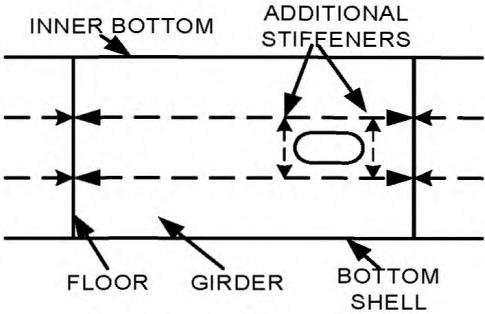
| OIL Tankers | | Guidelines for Surveys, Assessment and Repair of Hull Structure | |
|---|---|---|--|
| Detail of damage | | Panels of bottom girders in way of openings. | |
| <b>Factors which may have caused damage</b><br>1. High shear or compressive stress in the side girder.<br>2. Insufficient buckling strength. | | <b>Notes on repairs</b><br>See Sketch. | |

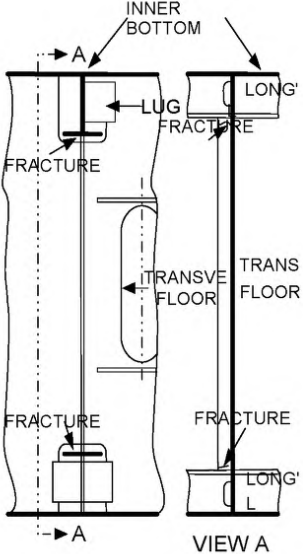
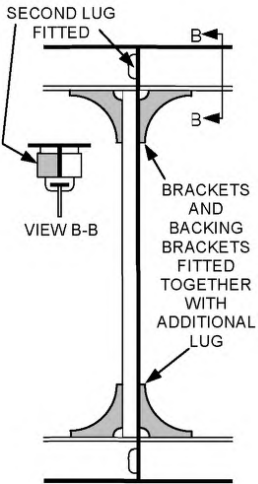
| OIL Tankers | | Guidelines for Surveys, Assessment and Repair of Hull Structure |
|---|---|---|
| <b>Detail of damage</b> | | Fractured stiffener connection to bottom and inner bottom longitudinals. |
| <ol style="list-style-type: none"> <li>1. Asymmetric connection leading to high local stresses at the connection of vertical stiffeners of the transverse floors to the inner and outer bottom longitudinals.</li> <li>2. Wide slot for longitudinal leads to inefficient lug connection.</li> <li>3. Sharp corners or flame-cut edges producing a notch effect.</li> <li>4. Incomplete/defective weld at stiffener connection to the longitudinals.</li> <li>5. Dynamic sea way loads/ship motions.</li> </ol> | | See Sketch. |

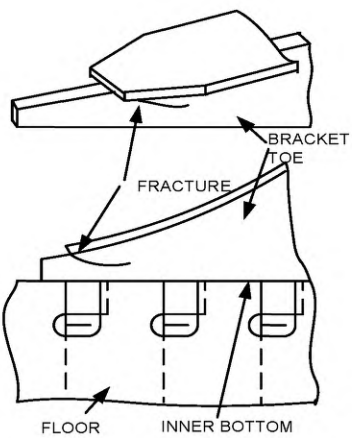
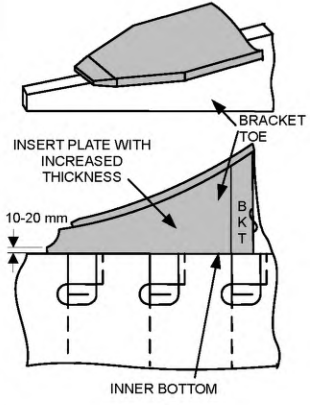
| OIL Tankers | | Guidelines for Surveys, Assessment and Repair of Hull Structure |
|---|---|---|
| Detail of damage | | Fracture at toe of web frame bracket connection to inner bottom. |
| 1. Inadequate tapering the toe end.<br>2. Insufficient tapering of flange.<br>3. Lateral flexing of the bracket. | | See Sketch. |

| OIL Tankers | | Guidelines for Surveys, Assessment and Repair of Hull Structure |
|---|---|---|
| Sketch of damage | | <p><b>Sketch of repair</b><br/> Modify Face Taper<br/> 1. Breadth taper 20 degrees.<br/> 2. Breadth at toe as small as practical.<br/> 3. Thickness taper 1 in 3 to 10mm.</p> |

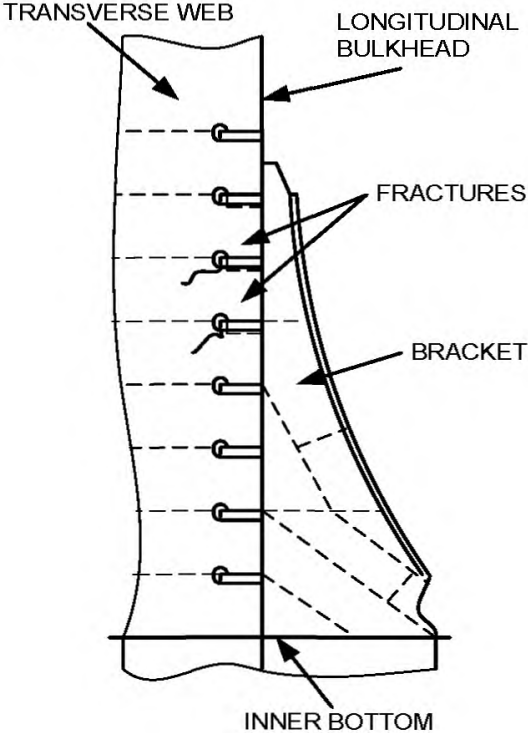
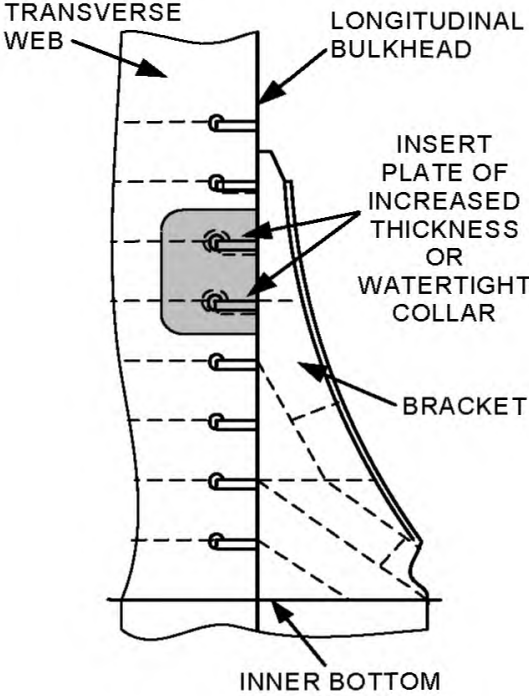
| Detail of damage | | Cut-outs around transverse bracket end. | |
| 1. High stresses at toe of bottom transverse end bracket.<br>2. Sharp corner at cut-out. | | See Sketch. | |

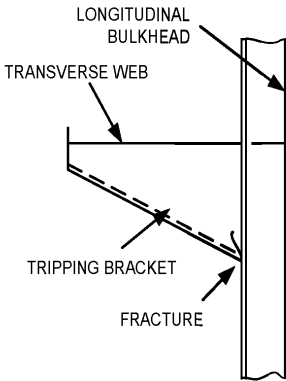
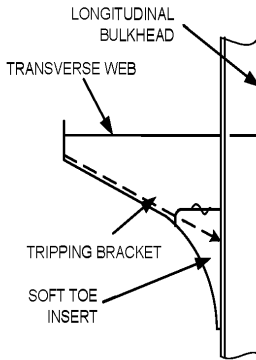
| OIL Tankers | | Guidelines for Surveys, Assessment and Repair of Hull Structure | |
|---|---|---|--|
| Detail of damage | | Fracture in way of connection of transverse web tripping brackets to longitudinal | |
| <ol style="list-style-type: none"> <li>1. Hard spot at the toe of bracket.</li> <li>2. Vibration.</li> </ol> | | <p>See Sketch.</p> <ol style="list-style-type: none"> <li>1. Soft bracket may be added on upper side of web, to avoid fracture at the heel.</li> </ol> | |

| OIL Tankers | | Guidelines for Surveys, Assessment and Repair of Hull Structure | |
|---|---|---|--|
| <p>LONGITUDINAL BULKHEAD</p> <p>TRANSVERSE WEB</p> <p>TRIPPING BRACKET</p> <p>FRACTURE</p> | | <p>LONGITUDINAL BULKHEAD</p> <p>TRANSVERSE WEB</p> <p>TRIPPING BRACKET</p> <p>SOFT TOE INSERT</p> | |

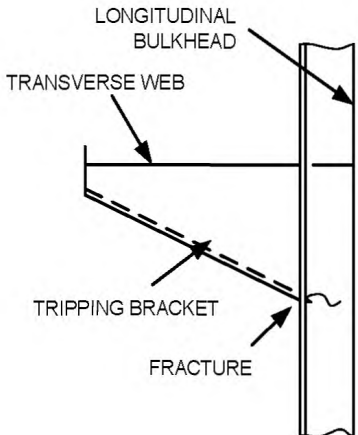
| OIL Tankers | | Guidelines for Surveys, Assessment and Repair of Hull Structure | |
|---|---|---|--|
| Detail of damage | | Tripping brackets modification of the bracket toe. | |
| <b>Factors which may have caused damage</b> <ol style="list-style-type: none"> <li>1. Stress concentrations at toe of bracket.</li> <li>2. High stress in longitudinal.</li> </ol> | | <b>Notes on repairs</b> <p>See Sketch.</p> <ol style="list-style-type: none"> <li>1. Soft bracket may be added on upper side of web, to avoid fracture at the heel.</li> </ol> | |

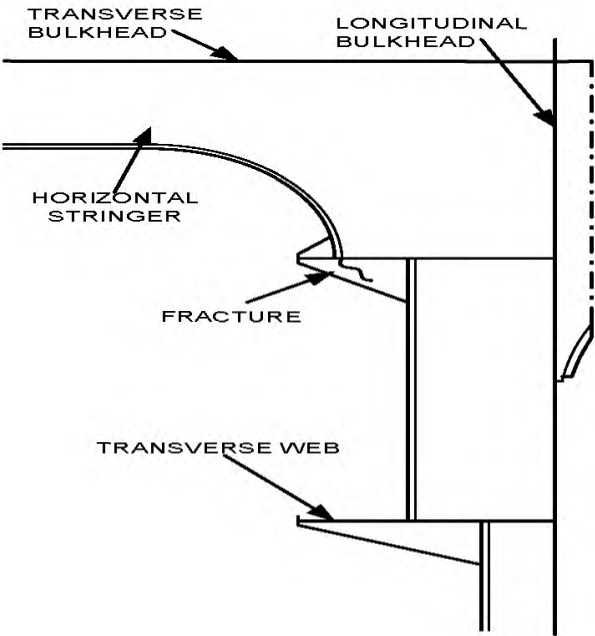
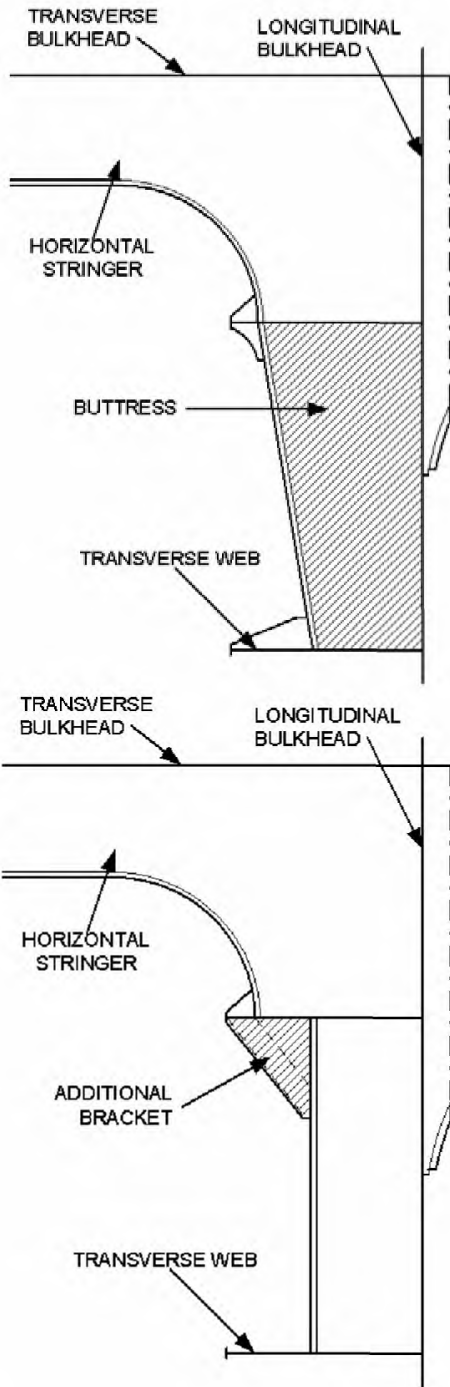
| Detail of damage | | Fracture in way of connection of transverse bulkhead stringer to transverse web frames and longitudinal bulkhead stringer | |
| 1. Stress concentration due to discontinuous structure.<br>2. High shear stress in the horizontal stringer. | | See Sketch. | |

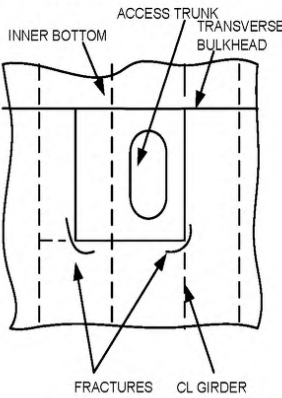
| OIL Tankers | | Guidelines for Surveys, Assessment and Repair of Hull Structure | |
|---|---|---|--|
| Detail of damage | | Fractured inner bottom plate at the connection to access trunk wall | |
| <b>Factors which may have caused damage</b> <ol style="list-style-type: none"> <li>1. Stress concentration at the connection of trunk wall to inner bottom plate.</li> <li>2. Relative deformation between horizontal stringer fitted on transverse bulkhead and inner bottom plate.</li> <li>3. Static and dynamic load of cargo liquid.</li> </ol> | | <b>Notes on repairs</b><br>See Sketch. | |

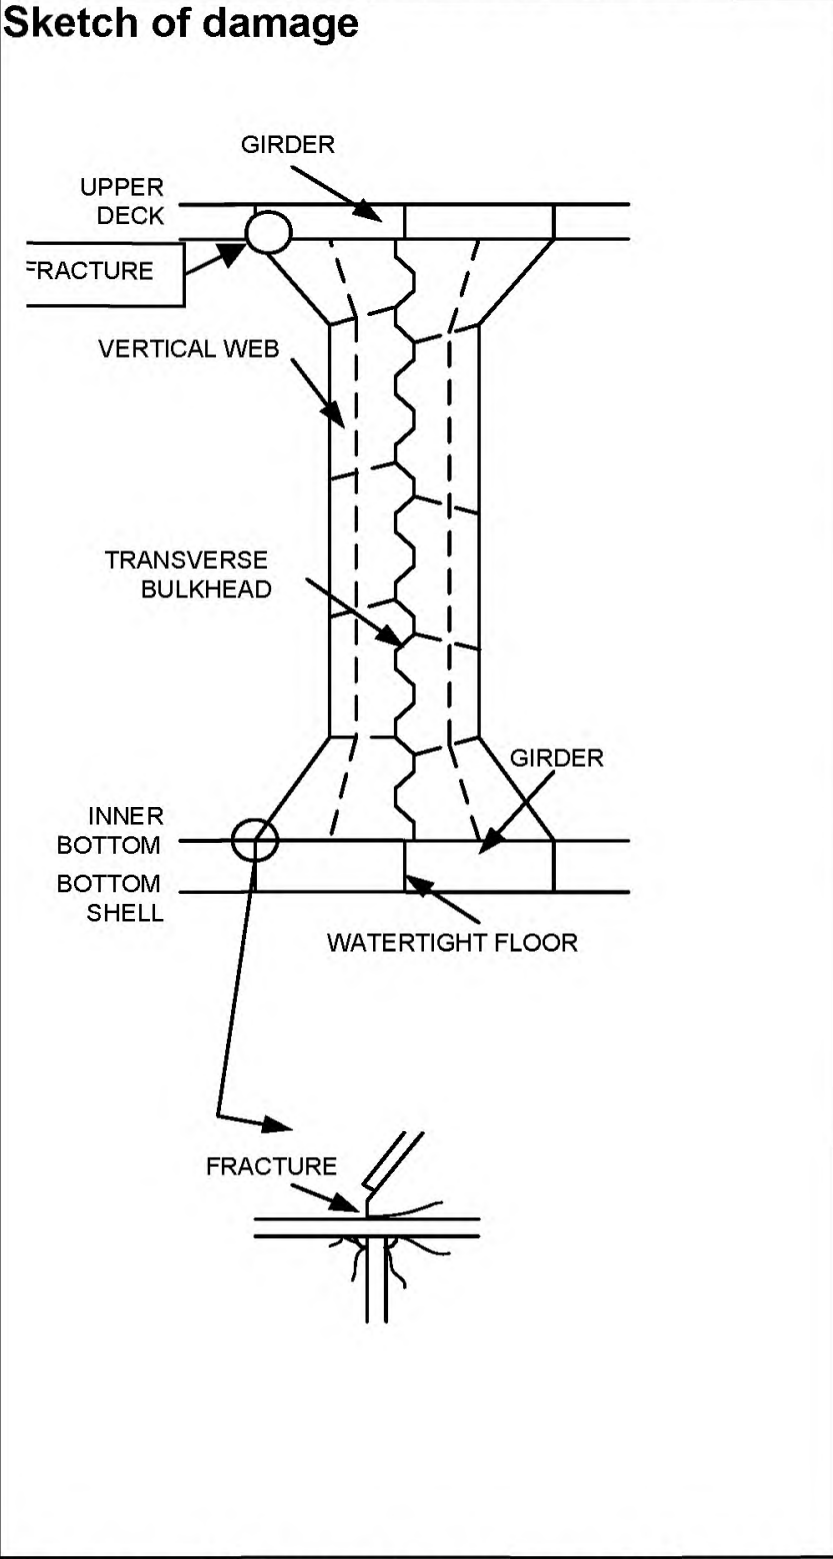
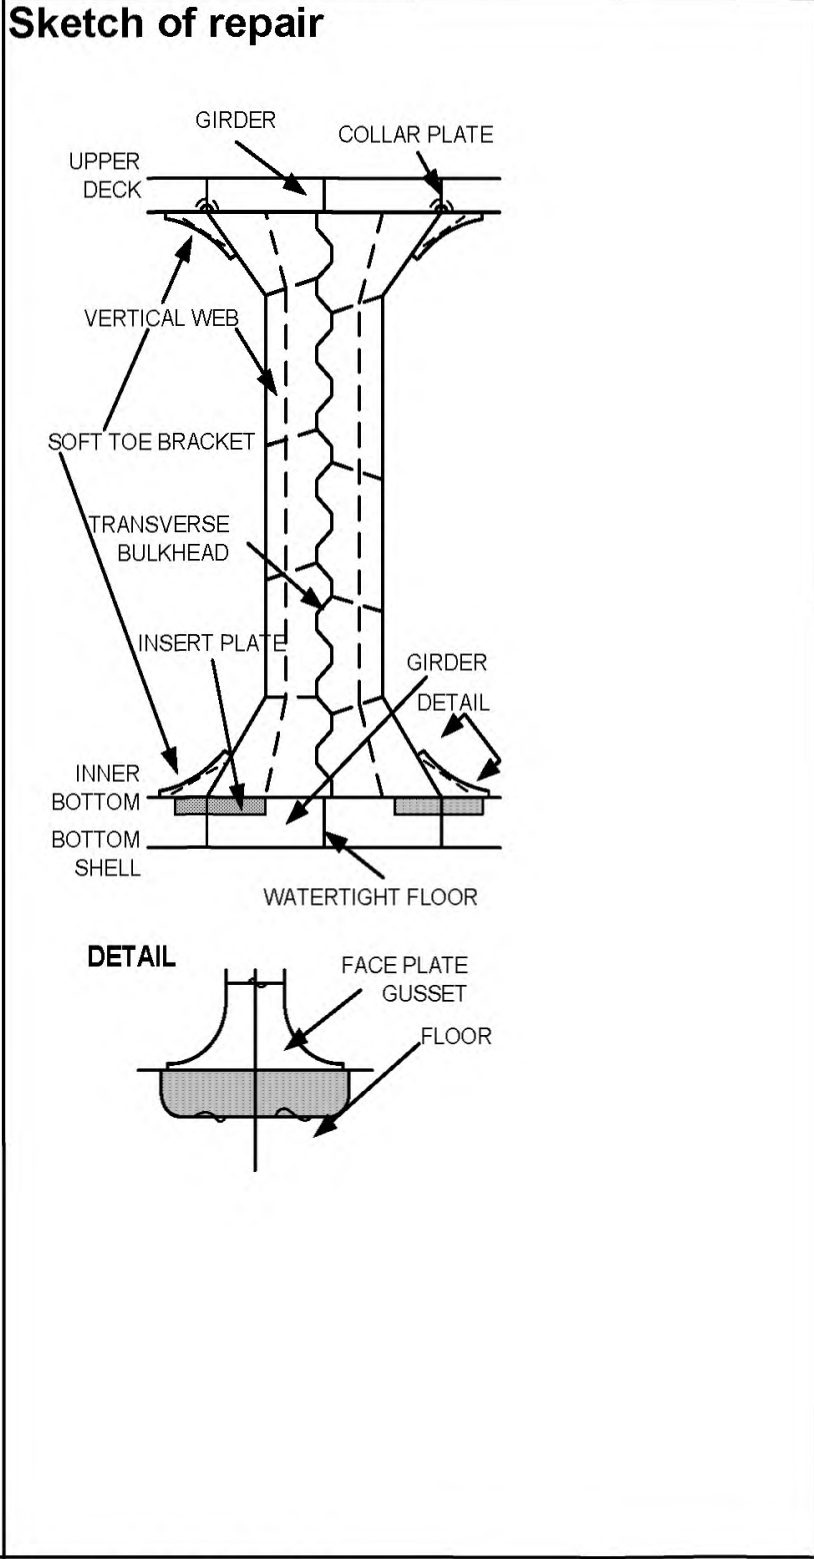
| Detail of damage | | Bulkhead vertical web to deck and inner bottom | |
| 1. Stress concentration at toe of bracket due to sniped face plate and scallop in way. | | See Sketch. | |

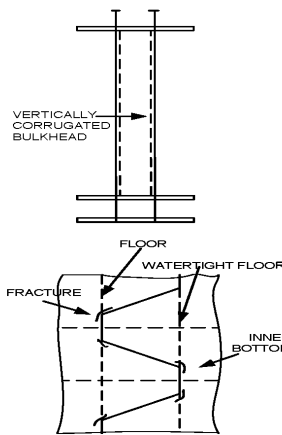
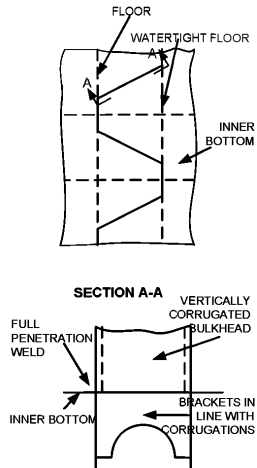
| OIL Tankers | | Guidelines for Surveys, Assessment and Repair of Hull Structure | |
|---|---|---|--|
| Detail of damage | Vertically corrugated bulkhead without stool, connection to deck and inner bottom | | |
| Factors which may have caused damage | <div>1. Stress concentration due to unsupported corrugation web.</div> <div>2. High through thickness stress, lamellar tearing.</div> <div>3. Weld details and dimensions.</div> <div>4. Misalignment between face of corrugation and floor underneath.</div> <div>5. Cut-outs and scallops or air holes increasing the stress in the floor.</div> <div>6. Insufficient through thickness properties of inner bottom plate.</div> | | |

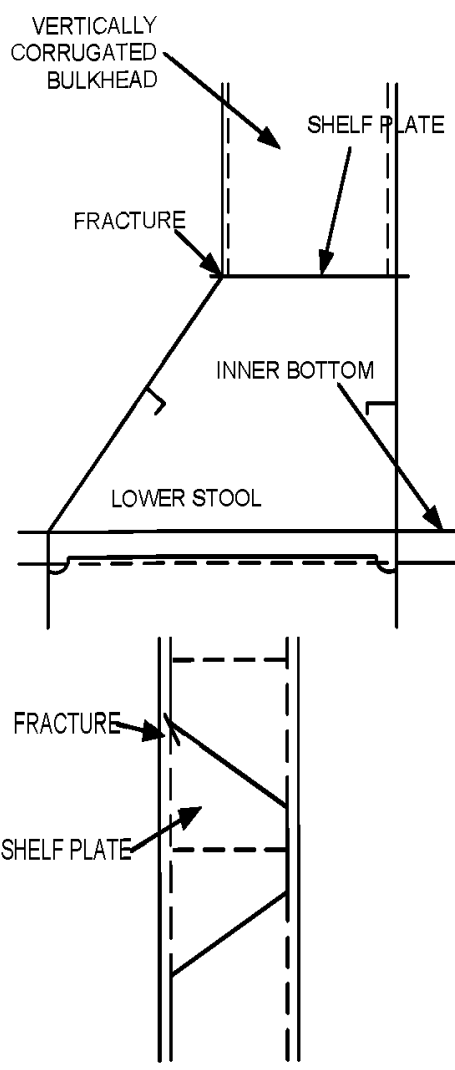
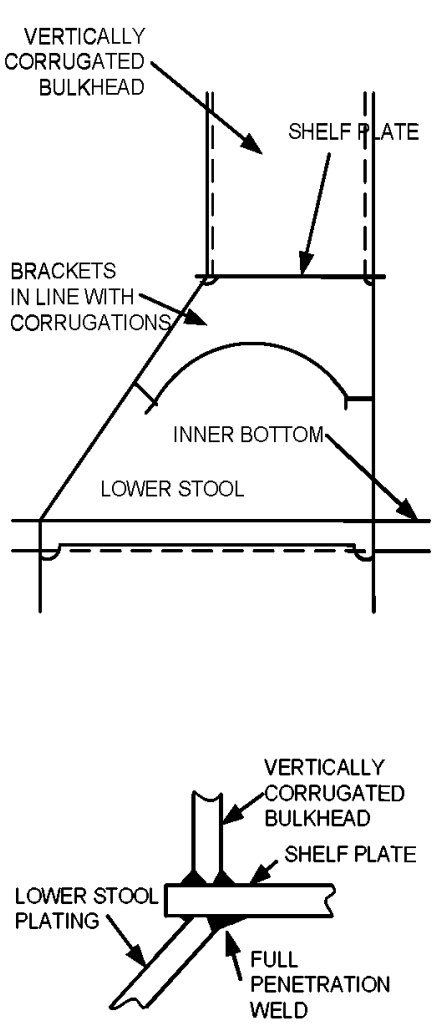
**3.2.1** Fractures observed at the connection between lower stool and corrugated bulkhead during stool survey may have initiated at the weld connection of the inside diaphragms (See **Example 7**).

| Detail of damage | Fracture at connection of vertically corrugated transverse bulkhead with stool to shelf plate and lower stool plate. | | |
| <div>1. Stress concentration due to unsupported corrugation web.</div> <div>2. High through thickness stress, lamellar tearing.</div> <div>3. Weld details and dimensions.</div> <div>4. Misalignment.</div> <div>5. Insufficient thickness of stool side plating in relation to corrugation flange thickness.</div> | | <div>See Sketch.</div> | |

(a) Fractures in the weld connections of the stool plating to the shelf plate in way of the scallops in the stool's internal structure. The scallops should be closed by fitting lapped collar plates and the stool weld connections repaired as indicated in **4.3.1**. The lapped collar plates should have a full penetration weld connection to the stool and shelf plate and should be completed using low hydrogen electrodes prior to welding the collar to the stool diaphragm/bracket.

(b) Fractures in the weld connections of the corrugations and/or stool plate to the shelf plate resulting from misalignment of the stool plate and the flange of the corrugation (Similarly misalignment of the stool plate with the double bottom floor).

It is recommended that the structure be cut free, the misalignment rectified, and the stool, floor and corrugation weld connection appropriately repaired as indicated in **4.3.1**. Other remedies to such damages include fitting of brackets in the stool in line with the webs of the corrugations. In such cases both the webs of the corrugations and the brackets underneath are to have full penetration welds and the brackets are to be arranged without scallops. However, in many cases this may prove difficult to attain.

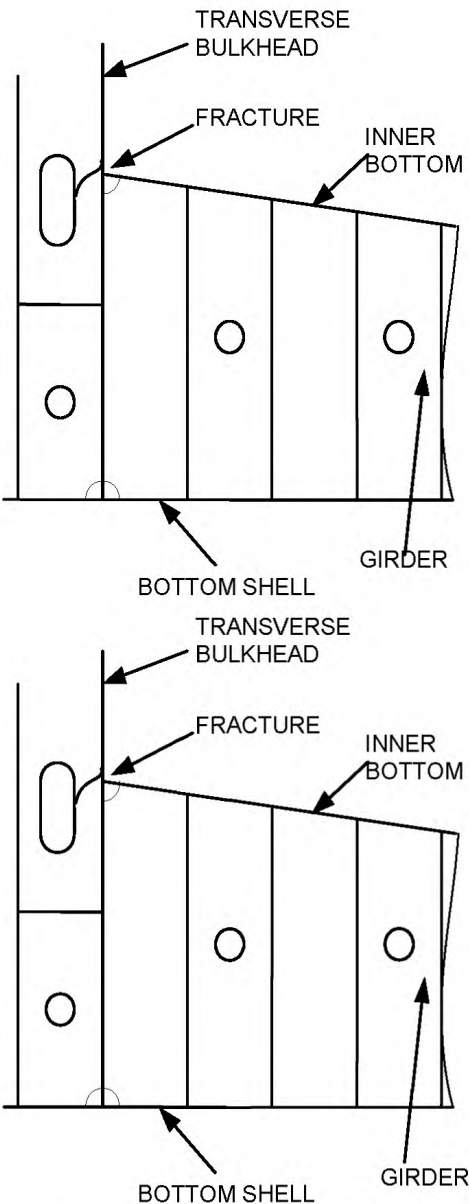
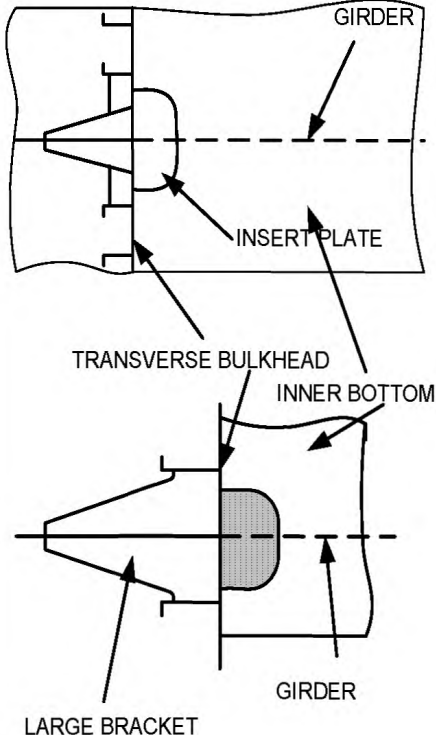
| OIL Tankers | | Guidelines for Surveys, Assessment and Repair of Hull Structure | |
|---|---|---|--|
| Detail of damage | | Fracture at connection of transverse bulkhead to knuckle inner bottom/girder | |
| <ol style="list-style-type: none"> <li>1. High stress concentration.</li> <li>2. Discontinuity of structural members at knuckle joint.</li> </ol> | | See Sketch. | |

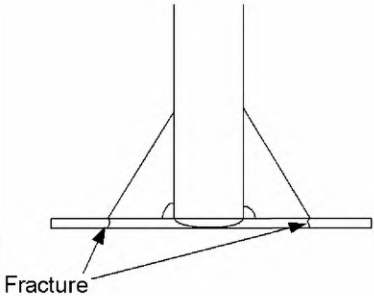
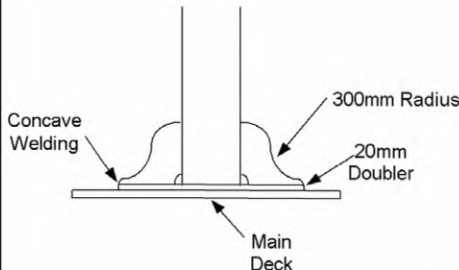
| OIL Tankers | | Guidelines for Surveys, Assessment and Repair of Hull Structure |
|---|---|---|
| <b>Detail of damage</b> | Fractured deck plating in way of deck pipe support stanchions (midships) | |
| <b>Factors which may have caused damage</b> | <p>1. Stanchions experience more severe relative displacements from hull girder bending.</p> | |

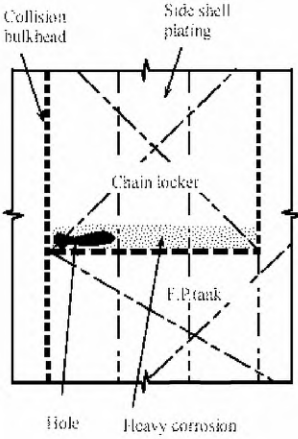
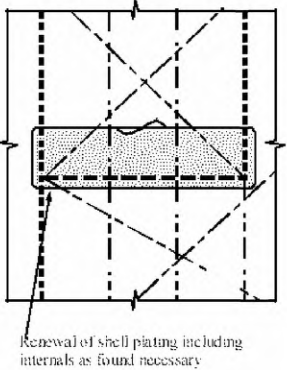
| OIL Tankers Guidelines for Surveys, Assessment and Repair of Hull Structure | | |
|---|---|---|
| Detail of damage Fractures in side shell plating in way of chain locker | | |
| <b>Factors which may have caused damage</b><br>1. Heavy corrosion in region where mud is accumulated. | | <b>Notes on repairs</b><br>1. Corroded plating should be cropped and renewed.<br>2. Protective coating should be applied. |

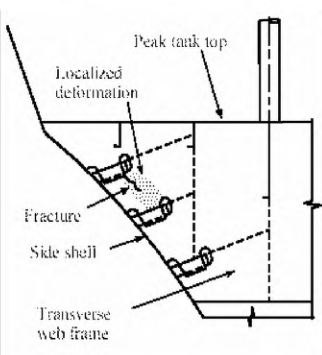
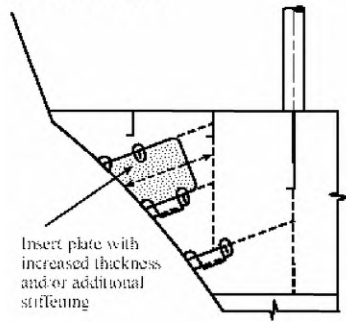
| OIL Tankers Guidelines for Surveys, Assessment and Repair of Hull Structure | | |
|---|---|---|
| Detail of damage | Fractures and deformation of bow transverse webs in way of cut-outs for side longitudinals | |
| <b>Factors which may have caused damage</b> <ol style="list-style-type: none"> <li>1. Localized material wastage in way of coating failure at cut-outs and sharp edges due to working of the structure.</li> <li>2. Dynamic seaway loading in way of bow flare.</li> </ol> | | <b>Notes on repairs</b> <ol style="list-style-type: none"> <li>1. Sufficient panel strength to be provided to absorb the dynamic loads enhanced by bow flare shape.</li> </ol> |

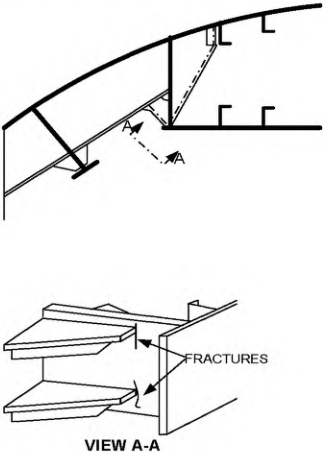
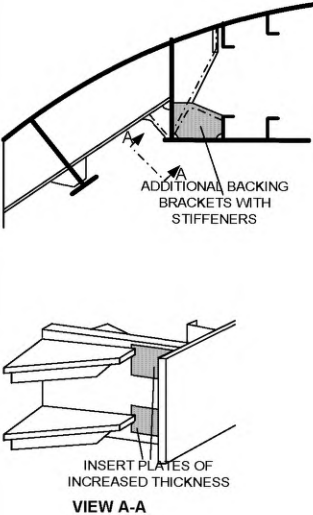
| OIL Tankers | | Guidelines for Surveys, Assessment and Repair of Hull Structure |
|---|---|---|
| Detail of damage | Fractured vertical web at the longitudinal stiffener ending in way of the parabolic bow structure. | |
| <b>Factors which may have caused damage</b> <ol style="list-style-type: none"> <li>1. Stress concentrations at bracket ending due to inadequate support at bracket toes in way of connection to web frame members.</li> <li>2. Localised thinning in way of coating failure at bracket endings due to flexing of the structure.</li> <li>3. Dynamic seaway loadings at bow causing flexing at bracket endings.</li> </ol> | | <b>Notes on repairs</b><br>See Sketch. |

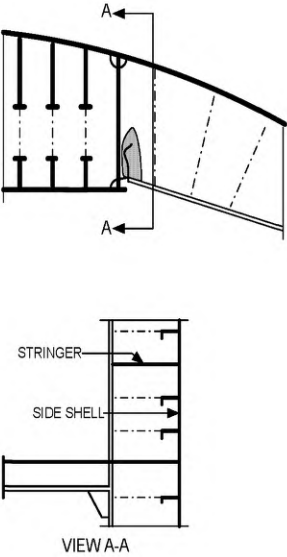
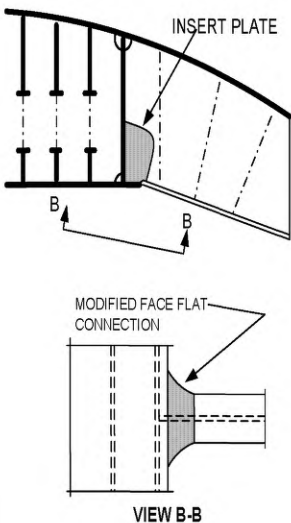
| OIL Tankers Guidelines for Surveys, Assessment and Repair of Hull Structure | | |
|---|---|---|
| Detail of damage | Fractured stringer end connection in way of the parabolic bow structure | |
| <b>Factors which may have caused damage</b> <ol style="list-style-type: none"> <li>1. High stress concentration of stringer to stiff girder/deep web intersection due to discontinuity of faceplate.</li> <li>2. Localised thinning in way of coating failure at stringer connection due to flexing of the structure.</li> <li>3. Dynamic seaway loadings at bow causing flexing in way of detail.</li> </ol> | | <b>Notes on repairs</b><br>See Sketch. |

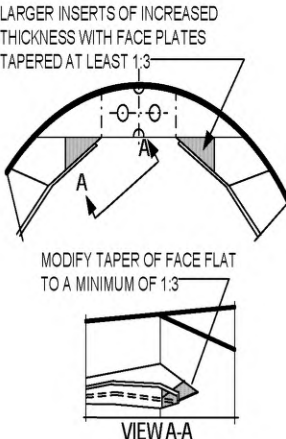
| OIL Tankers | | Guidelines for Surveys, Assessment and Repair of Hull Structure |
|---|---|---|
| Detail of damage | Fracture at end of longitudinal at bow structure. | |
| <b>Factors which may have caused damage</b> <ol style="list-style-type: none"> <li>1. Inadequate brackets forming the longitudinal endings at bow structure.</li> <li>2. Localised thinning in way of coating failure at longitudinal endings due to flexing of the structure.</li> <li>3. Dynamic seaway loadings at bow causing flexing at longitudinal endings.</li> </ol> | | <b>Notes on repairs</b><br>See Sketch. |

| OIL Tankers | | Guidelines for Surveys, Assessment and Repair of Hull Structure |
|---|---|---|
| <b>Sketch of damage</b><br> | | <b>Sketch of repair</b><br><p>LARGER INSERTS OF INCREASED THICKNESS WITH FACE PLATES TAPERED AT LEAST 1:3</p> <p>VIEW A-A</p> |

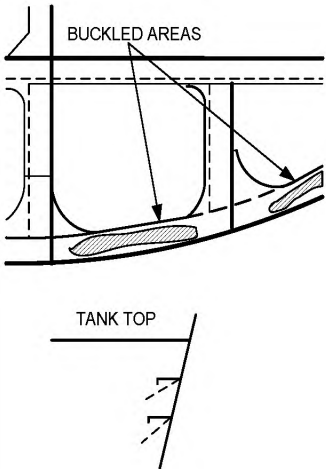
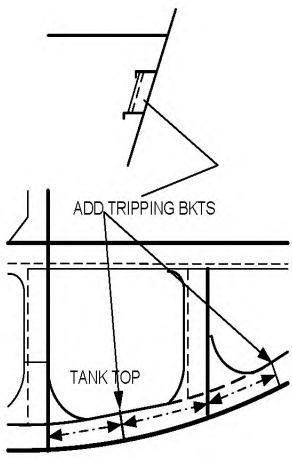
| OIL Tankers Guidelines for Surveys, Assessment and Repair of Hull Structure | | |
|---|---|---|
| Detail of damage | Buckled and tripped breathhooks | |
| <b>Factors which may have caused damage</b><br>1. Bow impact load.<br>2. Low buckling resistance. | | <b>Notes on repairs</b><br>See Sketch. |

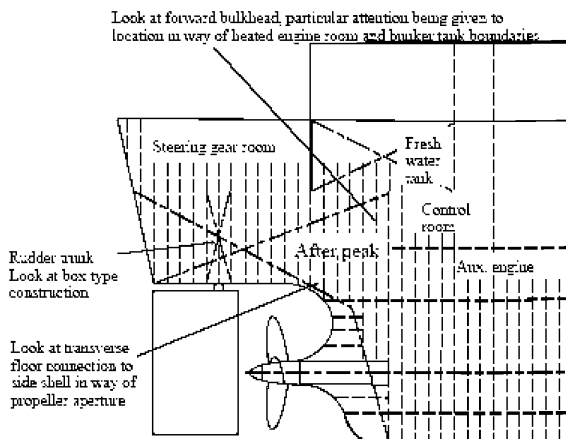
Figure 1 Aft end structure - Potential problem areas

**2.3.2** The structure supporting the rudder carrier may fracture and/or deform due to excessive load on the rudder. Bolts connecting the rudder carrier to the steering gear flat may also suffer damage under such load.

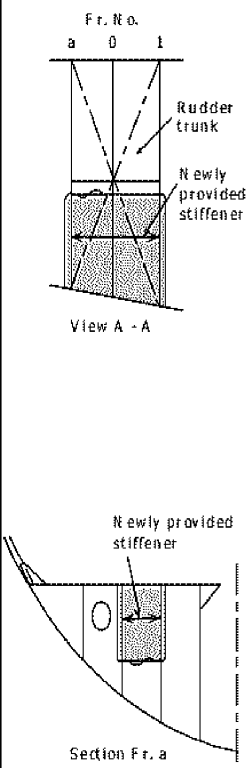
| OIL Tankers | | Guidelines for Surveys, Assessment and Repair of Hull Structure | |
|---|---|---|--|
| Detail of damage | | Fractures in bulkhead in way of rudder trunk | |
| <b>Factors which may have caused damage</b><br>1. Vibration. | | <b>Notes on repairs</b><br>1. The fractured plating should be cropped and renewed.<br>2. Natural frequency of the plate between stiffeners should be changed, e.g. reinforcement by additional stiffeners. | |

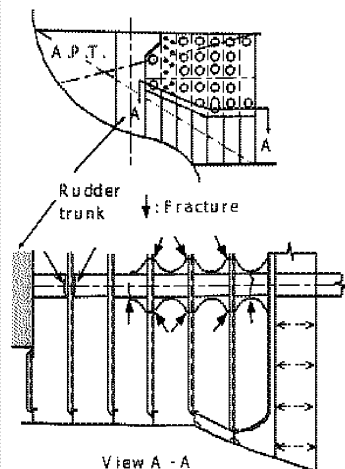
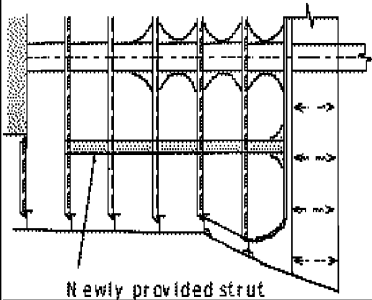
| OIL Tankers | | Guidelines for Surveys, Assessment and Repair of Hull Structure |
|---|---|---|
| Detail of damage | Fractures at the connection of floors and girders/side brackets | |

| OIL Tankers | | Guidelines for Surveys, Assessment and Repair of Hull Structure |
|---|---|---|
| Factors which may have caused damage | <b>Notes on repairs</b> <ol style="list-style-type: none"> <li>1. The fractured plating should be cropped and renewed.</li> <li>2. Natural frequency of the panel should be changed, e.g. reinforcement by additional strut.</li> </ol> | |

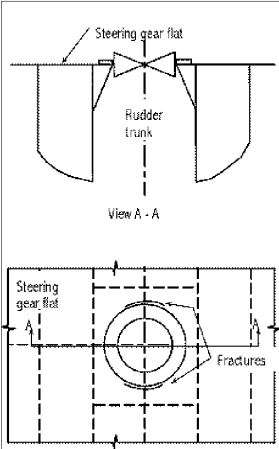
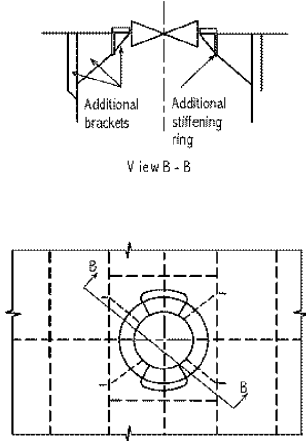
| OIL Tankers Guidelines for Surveys, Assessment and Repair of Hull Structure | | |
|---|---|---|
| Detail of damage | Fractures in flat where rudder carrier is installed in steering gear room | |
| <b>Factors which may have caused damage</b><br>1. Inadequate design. | | <b>Notes on repairs</b><br>1. Fractured plating should be cropped and renewed.<br>2. Additional brackets and stiffening ring should be fitted for reinforcement. |

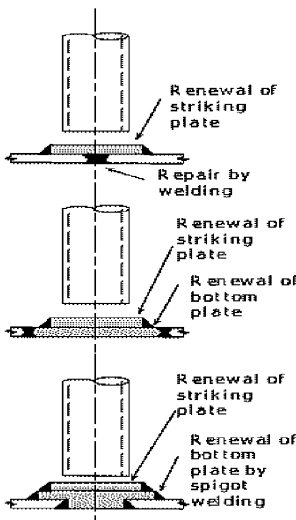
| OIL Tankers | | Guidelines for Surveys, Assessment and Repair of Hull Structure |
|---|---|---|
| Detail of damage | | Corrosion in bottom plating under sounding pipe in way of bilge storage tank in engine room |
| <b>Factors which may have caused damage</b><br>1. Heavy corrosion of bottom plating under sounding pipe. | | <b>Notes on repairs</b><br>1. Corroded striking plating should be renewed.<br>2. Bottom plate should be repaired depending on the condition of corrosion.<br><br><i>(Note):</i><br>Repair by spigot welding can be applied to the structure only when the stress level is considerably low. Generally this procedure cannot be applied to the repair of bottom plating of ballast tanks in cargo tank region. |

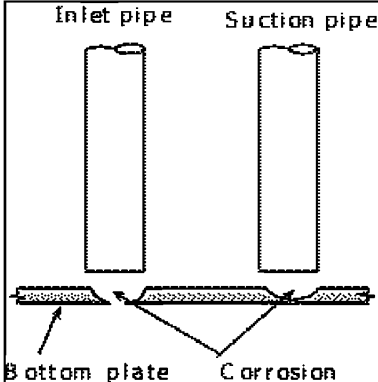
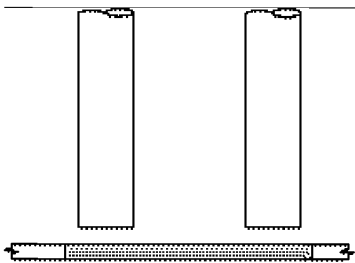
| OIL Tankers | | Guidelines for Surveys, Assessment and Repair of Hull Structure |
|---|---|---|
| Detail of damage | | Corrosion in bottom plating under inlet/suction/pipe in way of bilge tank in engine room |
| 1. Heavy corrosion of bottom plating under the inlet/suction pipe. | | 1. Corroded bottom plate is to be cropped and part renewed. Thicker plate is preferable.<br>2. Replacement of pipe end by enlarged conical opening (similar to suction head in ballast tank) is preferable. |

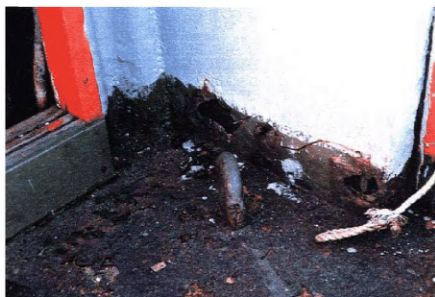
Severe corrosion may be found in exposed deck plating and deck house side structure adjacent to the deck plating where water is liable to accumulate (See **Photograph 1**). Corrosion may also be found in accommodation bulkheads around cut-out for fittings, such as doors, side scuttles, ventilators, etc., where proper maintenance of the area is relatively difficult. Deterioration of the bulkheads including fittings may impair the integrity of weathertightness.

**Photograph 1 Corroded accommodation house side structure**
