**No.76 IACS Guidelines for Surveys, Assessment and
(1994) Repair of Hull Structure – Bulk Carriers**

BULK CARRIERS

Guidelines for Surveys, Assessment and Repair of Hull
Structure

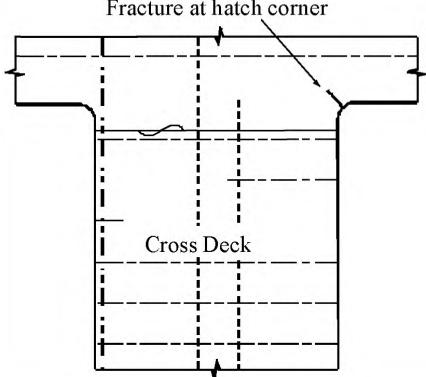
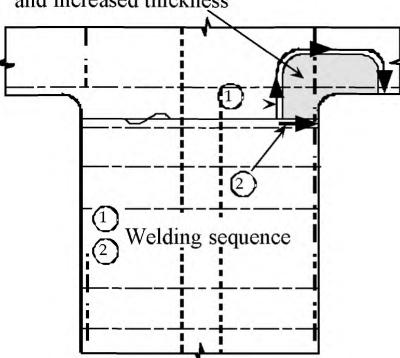
BULK CARRIERS		Guidelines for Surveys, Assessment and Repair of Hull Structure
Part 1	Cargo hold region	Example No.
Area 1	Deck structure	1
Detail of damage		Fractures at main cargo hatch corner
Sketch of damage

Notes on possible cause of damage <ol style="list-style-type: none"> 1. Stress concentration at hatch corners, i.e. radius of corner. 2. Welded attachment of shedder plate close to edge of hatch corner. 3. Wire rope groove. 		Notes on repairs <ol style="list-style-type: none"> 1. The corner plating in way of the fracture is to be cropped and renewed. If stress concentration is primary cause, insert plate should be increased thickness, enhanced steel grade and/or improved geometry. Insert plate should be continued beyond the longitudinal and transverse extent of the hatch corner radius ellipse or parabola, and the butt welds to the adjacent deck plating should be located well clear of the butts in the hatch coaming. It is recommended that the edges of the insert plate and the butt welds connecting the insert plates to the surrounding deck plating be made smooth by grinding. In this respect caution should be taken to ensure that the micro grooves of the grinding are parallel to the plate edge. 2. If the cause of fracture is welded attachment of shedder plate, the deck connection should be left unwelded. 3. If the cause of the fracture is wire rope groove, replacement to the original design can be accepted.

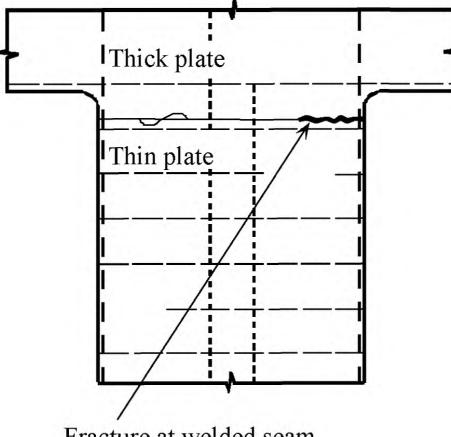
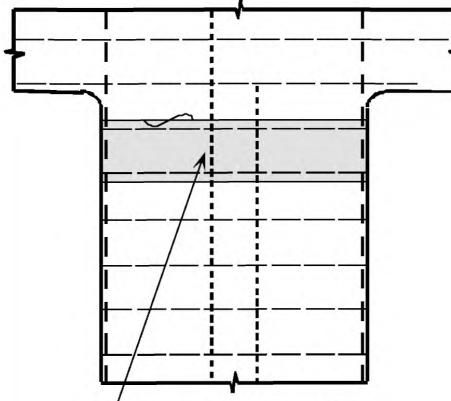
BULK CARRIERS		Guidelines for Surveys, Assessment and Repair of Hull Structure
Part 1	Cargo hold region	Example No.
Area 1	Deck structure	2-a
Detail of damage	Fractures of welded seam between thick plate and thin plate at cross deck	
Sketch of damage

Notes on possible cause of damage	<p>1. Stress concentration created by abrupt change in deck plating thickness.</p> <p>2. In-plane bending in cross deck strip due to torsional (longitudinal) movements of ship sides.</p> <p>3. Welded seam not clear of tangent point of hatch corner.</p>	
	Notes on repairs <ol style="list-style-type: none"> 1. Insert plate of intermediate thickness is recommended. 2. Smooth transition between plates (beveling) should be considered.

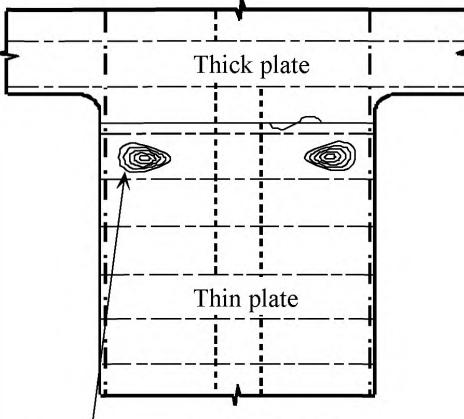
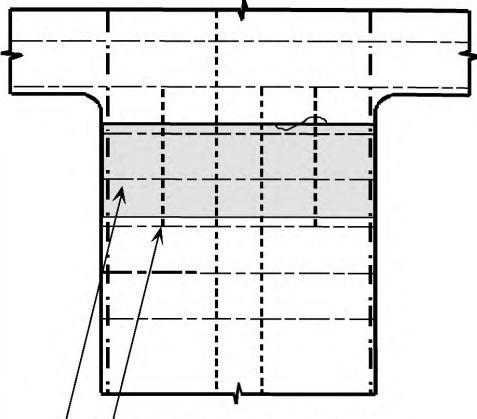
BULK CARRIERS		Guidelines for Surveys, Assessment and Repair of Hull Structure
Part 1	Cargo hold region	Example No.
Area 1	Deck structure	2-b
Detail of damage		Plate buckling in thin plate near thick plate at cross deck
Sketch of damage		Sketch of repair

<p>Buckling of cross deck plating (Buckling of hatch end structure should be examined. Refer to Example 7-a.)</p>

<p>Additional transverse stiffening and/or insertion of plate with suitable intermediate thickness</p>
Notes on possible cause of damage		Notes on repairs
<ol style="list-style-type: none"> 1. In-plane bending of cross deck strip due to torsional (longitudinal) movement of ship sides, often in combination with corrosion. 2. Insufficient plate thickness and/or transverse stiffening. 		<ol style="list-style-type: none"> 1. Transverse stiffeners extending from hatch sides towards centerline at least 10% of breadth of hatch, and/or increased plate thickness in the same area.

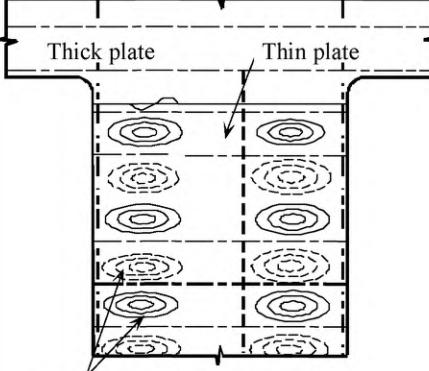
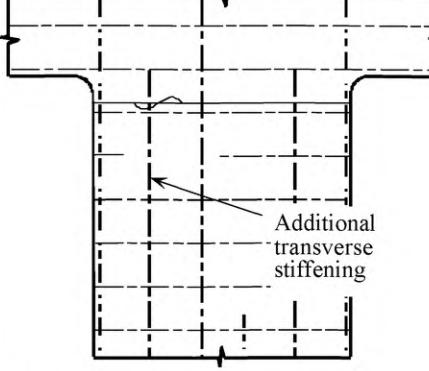
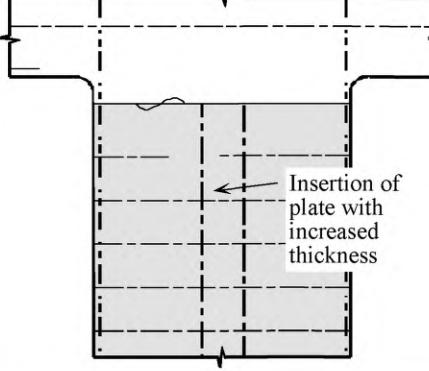
BULK CARRIERS		Guidelines for Surveys, Assessment and Repair of Hull Structure
Part 1	Cargo hold region	Example No.
Area 1	Deck structure	2-c
Detail of damage		Overall buckling of cross deck plating
Sketch of damage		Sketch of repair

<p>Buckling of cross deck plating (Buckling of hatch end structure should be examined. Refer to Example 7-a.)</p>		<p>Repair A</p>

<p>Additional transverse stiffening</p> <p>Repair B</p>

<p>Insertion of plate with increased thickness</p>
<p>Notes on possible cause of damage</p> <ol style="list-style-type: none"> 1. Transverse compression of deck due to sea load. 2. Transverse compression of deck due to excessive loading in two adjacent holds. 3. Insufficient plate thickness and/or transverse stiffening. 		<p>Notes on repairs</p> <ol style="list-style-type: none"> 1. Repair A Plating of original thickness in combination with additional transverse stiffening. 2. Repair B Insertion of plating of increased thickness.

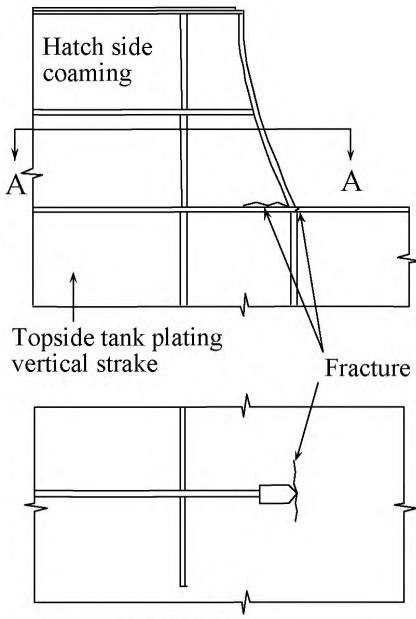
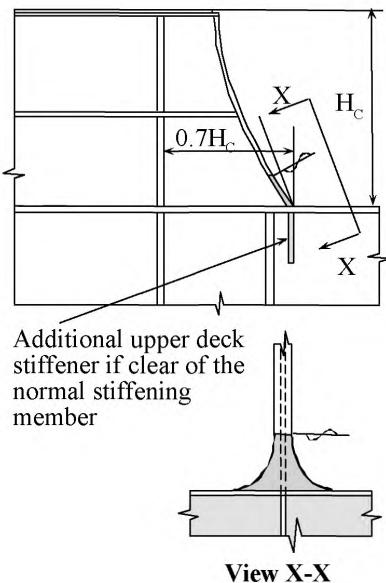
BULK CARRIERS		Guidelines for Surveys, Assessment and Repair of Hull Structure
Part 1	Cargo hold region	Example No.
Area 1	Deck structure	3-a
Detail of damage	Fractures in the web or in the deck at the toes of the longitudinal hatch coaming termination bracket	
Sketch of damage

Notes on possible cause of damage <ol style="list-style-type: none"> 1. This damage is caused by stress concentrations attributed to the design of the bracket. 		Notes on repairs <ol style="list-style-type: none"> 1. The design of the bracket can be altered as shown above, however, it is to be ensured that an additional under deck stiffener is provided at the toe of the termination bracket, where the toe is clear of the normal stiffening member. 2. Full penetration weld for a distance of $0.15 H_c$ from toe of side coaming termination bracket and for connection of athwartship gusset bracket to deck. 3. The fracture in deck plating to be vee'd-out and rewelded or deck plating cropped and part renewed as appropriate, using low hydrogen electrodes for welding.

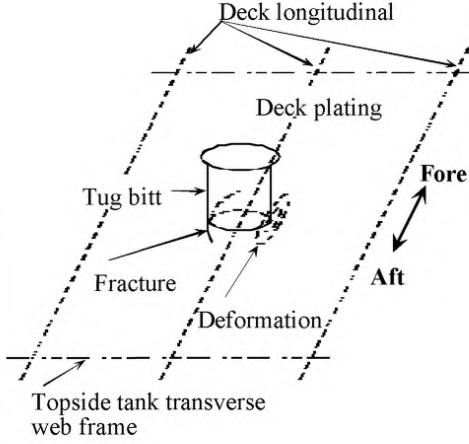
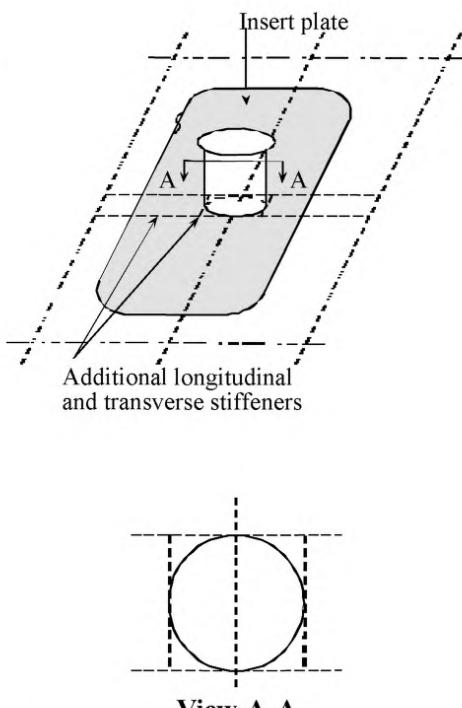
BULK CARRIERS		Guidelines for Surveys, Assessment and Repair of Hull Structure
Part 1	Cargo hold region	Example No.
Area 1	Deck structure	5
Detail of damage	Deformed and fractured deck plating around tug bitt	
Sketch of damage

Notes on possible cause of damage	<p>1. Insufficient strength</p>	
	Notes on repairs <ol style="list-style-type: none"> 1. Fractured/deformed deck plating should be cropped and part renewed. 2. Reinforcement by stiffeners should be considered.

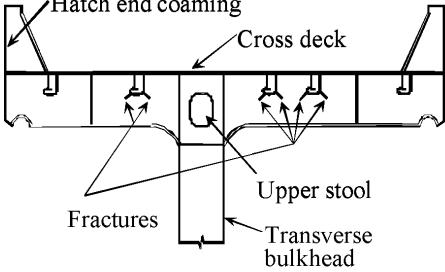
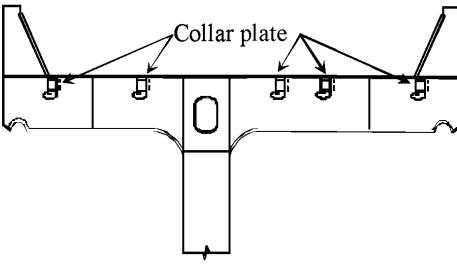
BULK CARRIERS		Guidelines for Surveys, Assessment and Repair of Hull Structure
Part 1	Cargo hold region	Example No.
Area 1	Deck structure	6
Detail of damage		Fractures around cut-outs in cross deck girder
Sketch of damage

Notes on possible cause of damage <ol style="list-style-type: none"> 1. Stress concentration at the cut-outs in cross deck girder. 		Notes on repairs <ol style="list-style-type: none"> 1. Fractured web plate of cross deck girder to be cropped and part renewed. 2. Collar plates to be provided.

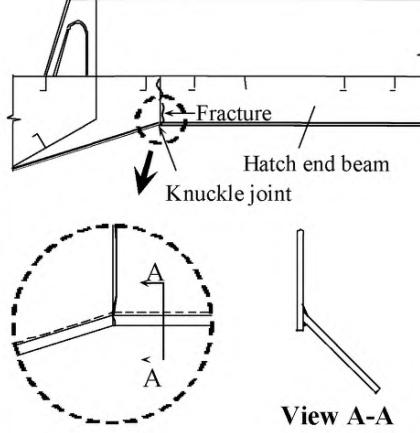
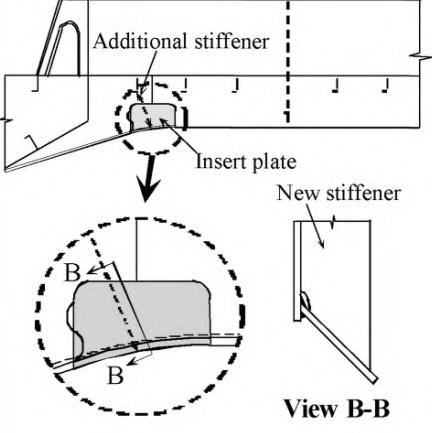
BULK CARRIERS		Guidelines for Surveys, Assessment and Repair of Hull Structure
Part 1	Cargo hold region	Example No.
Area 1	Deck structure	7-b
Detail of damage	Fractures in hatch end beam at knuckle joint	
Sketch of damage

<p>Notes on possible cause of damage</p> <ol style="list-style-type: none"> 1. Stress concentration at knuckle joint. 	<p>Notes on repairs</p> <ol style="list-style-type: none"> 1. Fractured part to be cropped and renewed. 2. Improvement to avoid stress concentration at knuckle joint should be considered.

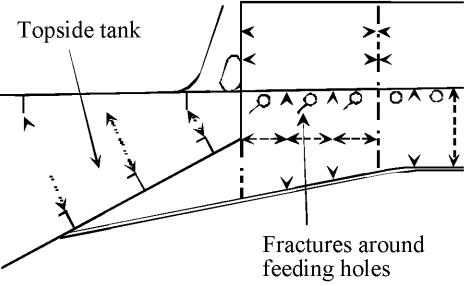
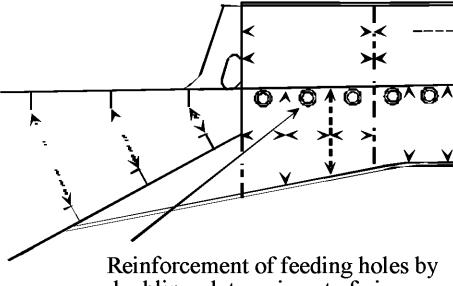
BULK CARRIERS		Guidelines for Surveys, Assessment and Repair of Hull Structure
Part 1	Cargo hold region	Example No.
Area 1	Deck structure	9
Detail of damage		Fractures in hatch end beam around feeding holes
Sketch of damage

Reinforcement of feeding holes by doubling plate or insert of pipe. See "Detail" below.
Notes on possible cause of damage <ol style="list-style-type: none"> 1. Inadequate reinforcement around feeding hole. 2. Corrosion. 		Notes on repairs <ol style="list-style-type: none"> 1. Fractured part to be vee'd-out or cropped and renewed. 2. If the fractured part is free from corrosion, reinforcement should be considered.

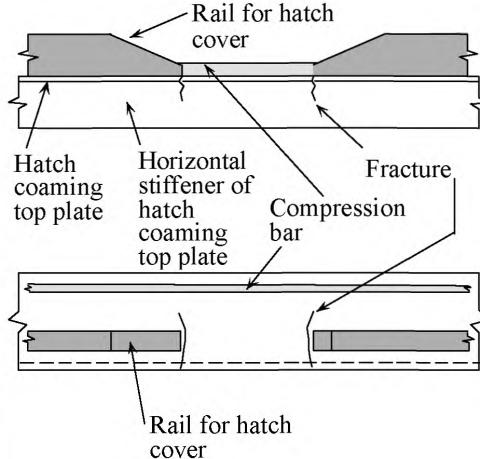
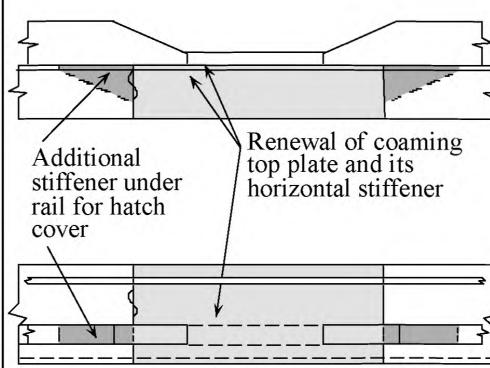
BULK CARRIERS		Guidelines for Surveys, Assessment and Repair of Hull Structure
Part 1	Cargo hold region	Example No.
Area 1	Deck structure	10-a
Detail of damage		Fractures in hatch coaming top plate at the termination of rail for hatch cover
Sketch of damage

Notes on possible cause of damage 1. Stress concentration at the termination of the rail for hatch cover due to poor design.		Notes on repairs 1. Fractured plate is to be cropped and part renewed. 2. Thicker insert plate and/or reinforcement by additional stiffener under the top plate should be considered. Also refer to Example 10-b .

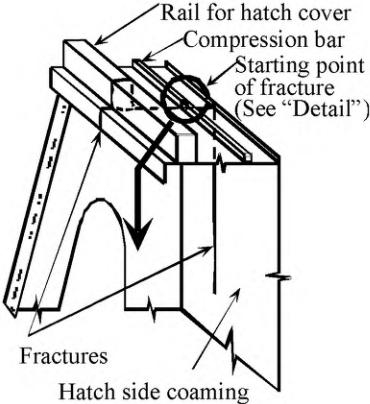
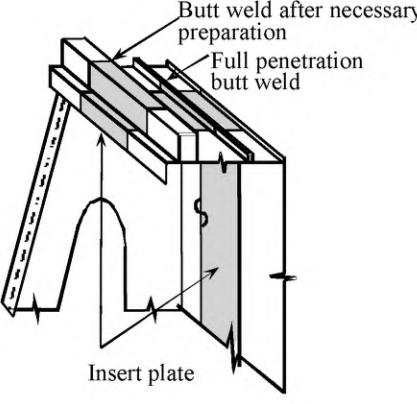
BULK CARRIERS		Guidelines for Surveys, Assessment and Repair of Hull Structure
Part 1	Cargo hold region	Example No.
Area 1	Deck structure	11
Detail of damage		Fractures in hatch coaming top plate initiated from butt weld of compression bar
Sketch of damage

<p>Butt weld after necessary preparation Full penetration butt weld Insert plate</p>		
Notes on possible cause of damage <ol style="list-style-type: none"> 1. Heavy weather 2. Insufficient preparation of weld of compression bar and/or rail (Although the compression bar and rail are not longitudinal strength members, they subject same longitudinal stress as longitudinal members) 3. Crack may initiate from insufficient penetration of weld of rail for hatch cover. 	Notes on repairs <ol style="list-style-type: none"> 1. Loading condition of the ship and proper welding procedure should be carefully considered. 2. Fractured structure is to be cropped and renewed if considered necessary. (Small fracture may be vee'd-out and rewelded.) 3. Full penetration welding should be applied to the butt weld of compression bar and rail.

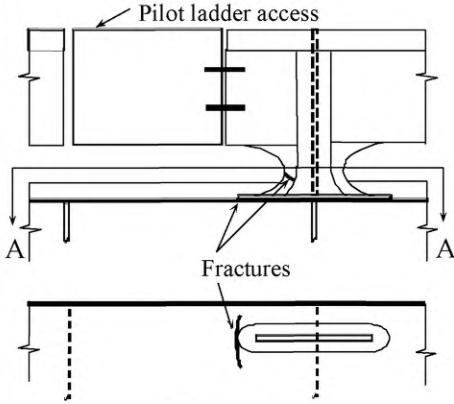
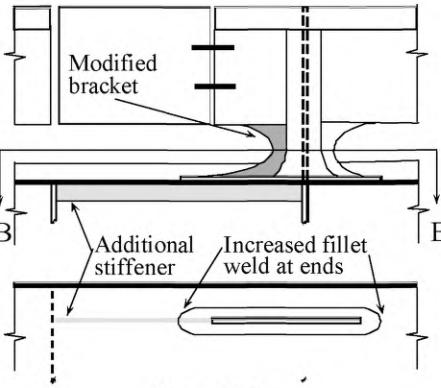
BULK CARRIERS		Guidelines for Surveys, Assessment and Repair of Hull Structure
Part 1	Cargo hold region	Example No.
Area 1	Deck structure	12
Detail of damage		Fractures in deck plating at the pilot ladder access of bulwarks
Sketch of damage		Sketch of repair

<p>View B-B</p>
Notes on possible cause of damage <ol style="list-style-type: none"> 1. Stress concentration at the termination of bulwarks. 		Notes on repairs <ol style="list-style-type: none"> 1. Fractured deck plating should be cropped and part renewed. 2. Reduction of stress concentration should be considered. In the above figure gusset plate was replaced with soft type for the fracture in gusset plate and pad plate was increased. Additional stiffeners were provided for the fracture in deck plating.

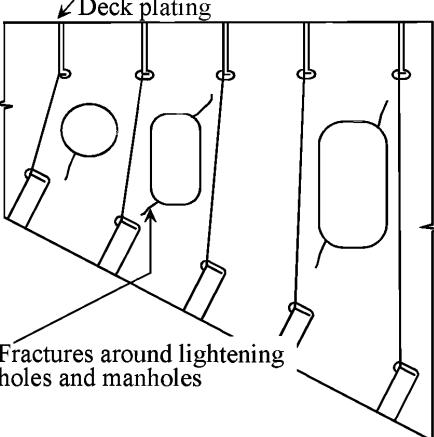
BULK CARRIERS		Guidelines for Surveys, Assessment and Repair of Hull Structure
Part 1	Cargo hold region	Example No.
Area 2	Topside tank structure	1
Detail of damage	Fractures around unstiffened lightening holes and manholes in wash bulkhead	
Sketch of damage

<p>Deck plating</p> <p>Fractures around lightening holes and manholes</p>		Sketch of repair Repair A

<p>New face plates around holes</p>
Notes on possible cause of damage <ol style="list-style-type: none"> General levels of corrosion and presence of stress concentration. 		Notes on repairs <ol style="list-style-type: none"> Corroded/fractured plate should be cropped and renewed with plating of enhanced thickness. Reinforcement should be considered.

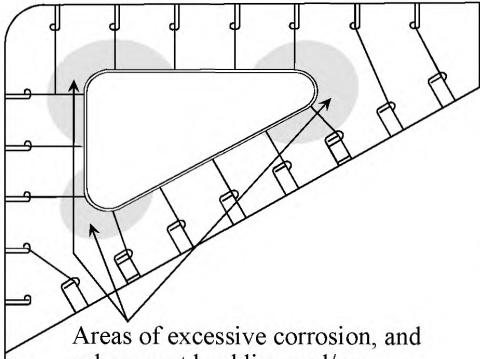
BULK CARRIERS		Guidelines for Surveys, Assessment and Repair of Hull Structure
Part 1	Cargo hold region	Example No.
Area 2	Topside tank structure	2-a
Detail of damage	Thinning and subsequent buckling of web plating in the vicinity of the radii of the opening	
Sketch of damage

<p>Areas of excessive corrosion, and subsequent buckling and/or</p>		Sketch of repair

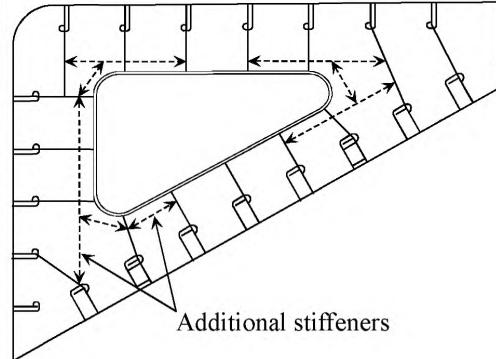
<p>Additional stiffeners</p>
Notes on possible cause of damage <ol style="list-style-type: none"> 1. Insufficient buckling strength. 2. Corrosion due to stress concentration at corners. 		Notes on repairs <ol style="list-style-type: none"> 1. Buckled plating is to be cropped and parts renewed, if necessary. 2. Additional stiffeners as shown above and/or renewal with plating of increased thickness should be considered.

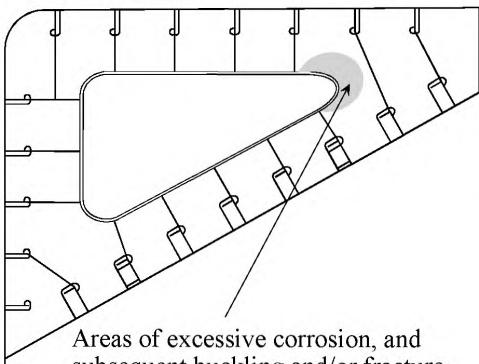
BULK CARRIERS		Guidelines for Surveys, Assessment and Repair of Hull Structure
Part 1	Cargo hold region	Example No.
Area 2	Topside tank structure	2-b
Detail of damage		Thinning and subsequent buckling of web plating in the vicinity of the radii of the opening
Sketch of damage

Notes on possible cause of damage <ol style="list-style-type: none"> 1. Corrosion caused by stress concentration at the corner due to insufficient radius for the opening. 		Notes on repairs <ol style="list-style-type: none"> 1. Corroded/buckled plating is to be cropped and parts renewed with plating of increased thickness and additional stiffeners are preferable to minimize deflection. 2. An attempt should be made to improve the design of the radius if felt necessary.

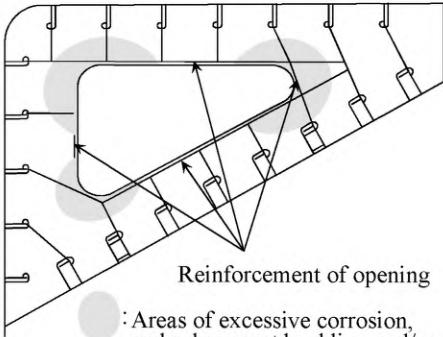
BULK CARRIERS	Guidelines for Surveys, Assessment and Repair of Hull Structure	
Part 1	Cargo hold region	Example No.
Area 2	Topside tank structure	2-c
Detail of damage	Thinning and subsequent buckling of web plating in the vicinity of the radii of the opening	
Sketch of damage

Notes on possible cause of damage 1. Additional stresses at the free edge of transverse web. (In Example 2-a - 2-c face plate is provided for the reinforcement of the opening.)		Notes on repairs 1. Corroded/buckled plating is to be cropped and part renewed with plating of increased thickness.

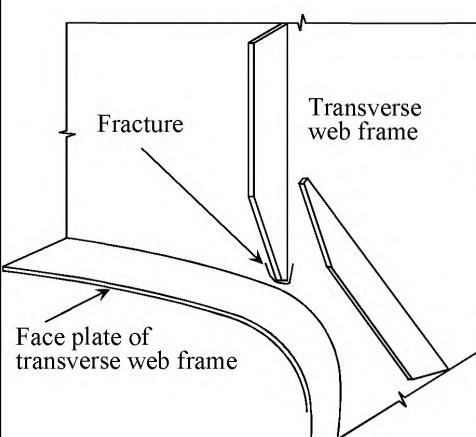
BULK CARRIERS		Guidelines for Surveys, Assessment and Repair of Hull Structure
Part 1	Cargo hold region	Example No.
Area 2	Topside tank structure	3
Detail of damage		Fractures in transverse web at sniped end of stiffener
Sketch of damage

Notes on possible cause of damage 1. Stress concentration.		Notes on repairs 1. Fracture can be veed-out and welded provided the plating is not generally corroded. If necessary, fractured plating should be cropped and renewed. 2. Excessive stress concentration at the end of stiffener should be avoided.

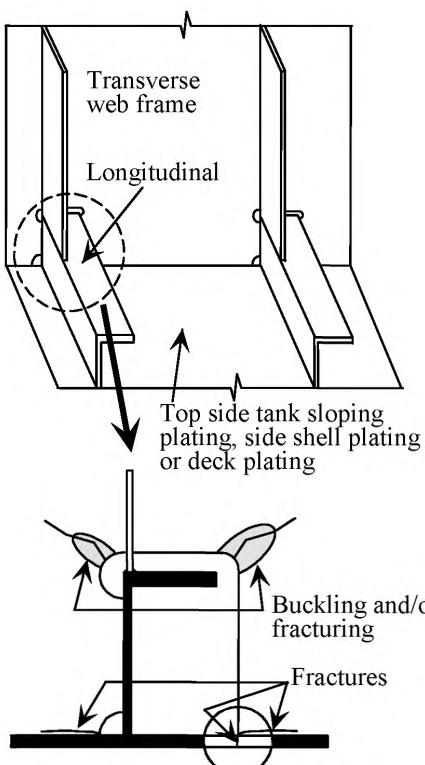
BULK CARRIERS		Guidelines for Surveys, Assessment and Repair of Hull Structure
Part 1	Cargo hold region	Example No.
Area 2	Topside tank structure	4-b
Detail of damage		Fractures and buckling at slots in way of transverse web frame
Sketch of damage

Notes on possible cause of damage <ol style="list-style-type: none"> 1. Damage can be caused by general levels of corrosion and presence of stress concentration associated with the presence of a cut-out. 		Notes on repairs <ol style="list-style-type: none"> 1. If fractures are significant then crop and part renew the plating otherwise the fracture can be vee'd-out and welded provided the plating is not generally corroded. 2. Repair A Lug should be considered. 3. Repair B Full collar plate should be considered where the depth of cut-out is more than 0.4 times the depth of web frame and in an area of high shear stress or the existing lug proves to be ineffective.

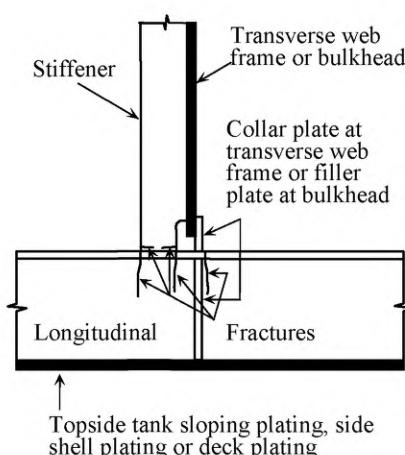
BULK CARRIERS		Guidelines for Surveys, Assessment and Repair of Hull Structure
Part 1	Cargo hold region	Example No.
Area 2	Topside tank structure	5
Detail of damage Fractures in longitudinal at transverse web frame or bulkhead		
Sketch of damage

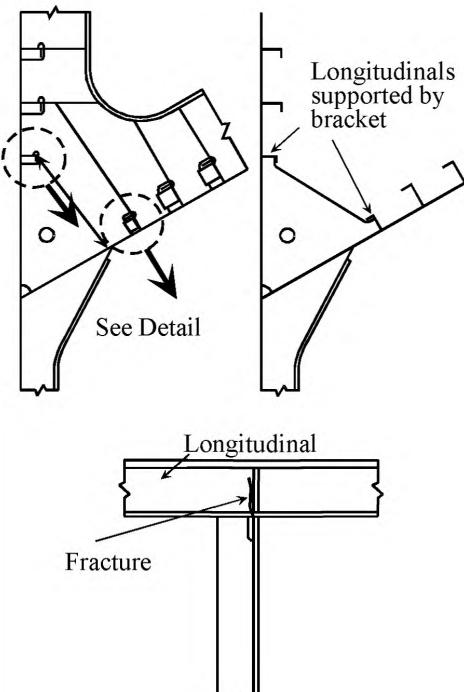
BULK CARRIERS		Guidelines for Surveys, Assessment and Repair of Hull Structure
Part 1	Cargo hold region	Example No.
Area 2	Topside tank structure	6
Detail of damage Fractures in the lowest longitudinal at transverse web frame		
Sketch of damage

<p>Longitudinals supported by bracket</p> <p>See Detail</p> <p>Longitudinal</p> <p>Fracture</p> <p>Detail</p>

<p>Increased bracket</p>
Notes on possible cause of damage <ol style="list-style-type: none"> 1. Insufficient scantling for torsional rigidity (The lowest longitudinal is usually supported by bracket(s) as shown in the above and smaller scantling may be adopted. However, the lowest longitudinal undergoes torsion from side shell frame through bracket(s) and may suffer fracture.) 		Notes on repairs <ol style="list-style-type: none"> 1. Fractured part to be cropped and renewed. 2. Size of bracket should be increased

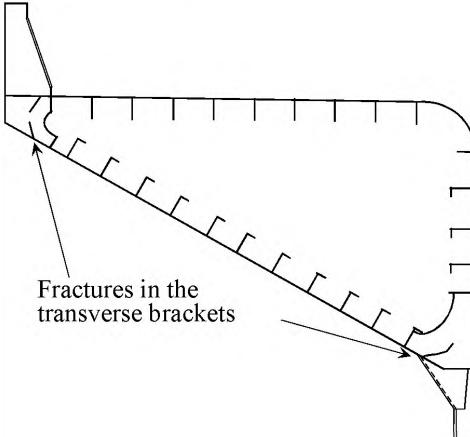
BULK CARRIERS		Guidelines for Surveys, Assessment and Repair of Hull Structure
Part 1	Cargo hold region	Example No.
Area 2	Topsides tank structure	7-a
Detail of damage		Fractures in transverse brackets
Sketch of damage

<p>Fractures in the transverse brackets</p>		Sketch of repair

<p>Larger brackets inserted, cutouts for longitudinals closed by lugs or collar plates and additional stiffening added. For lower bracket alternatively increase the thickness</p>
Notes on possible cause of damage <ol style="list-style-type: none"> 1. General levels of corrosion and presence of stress concentrations. 2. Misalignment of the brackets with adjoining structure, e.g. side shell frame brackets and/or coaming brackets. 3. High shear stresses due to insufficient bracket size. 4. Inadvertent overloading. 		Notes on repairs <ol style="list-style-type: none"> 1. If the damage is caused by misalignment with the side shell frame brackets or the hatch coaming brackets the misalignment is to be rectified and the replacement by larger brackets incorporated only if considered necessary.

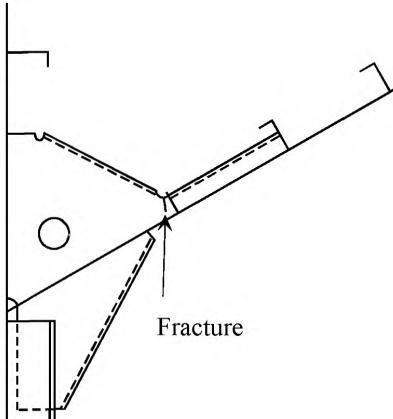
BULK CARRIERS	Guidelines for Surveys, Assessment and Repair of Hull Structure	
Part 1	Cargo hold region	Example No.
Area 2	Topside tank structure	7-c
Detail of damage	Fractures at toes of transverse bracket	
Sketch of damage

Notes on possible cause of damage	<p>1. Stress concentration due to the shape of the bracket.</p>	
	Notes on repairs <p>1. Cracked weld to be vee'd-out and rewelded.</p>

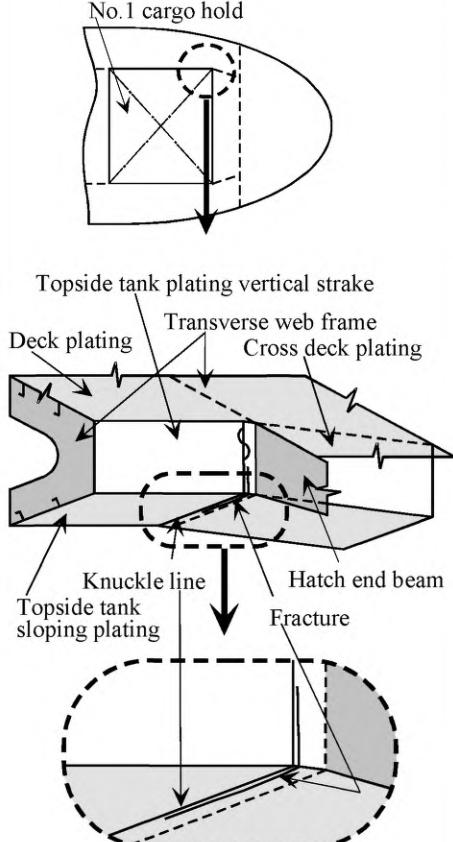
BULK CARRIERS		Guidelines for Surveys, Assessment and Repair of Hull Structure
Part 1	Cargo hold region	Example No.
Area 2	Topside tank structure	9
Detail of damage	Fractures in sloping plating at knuckle	
Sketch of damage

<p>View A-A</p> <p>Insert plates should be assembled where welding is easy to be performed before inserted in topside tank for quality of butt welded joint and the joint should be grounded.</p>	
Notes on possible cause of damage	<ol style="list-style-type: none"> 1. Insufficient strength. 2. Additional stress induced by knuckle. 	
Notes on repairs	<ol style="list-style-type: none"> 1. Knuckle part should be reinforced appropriately.

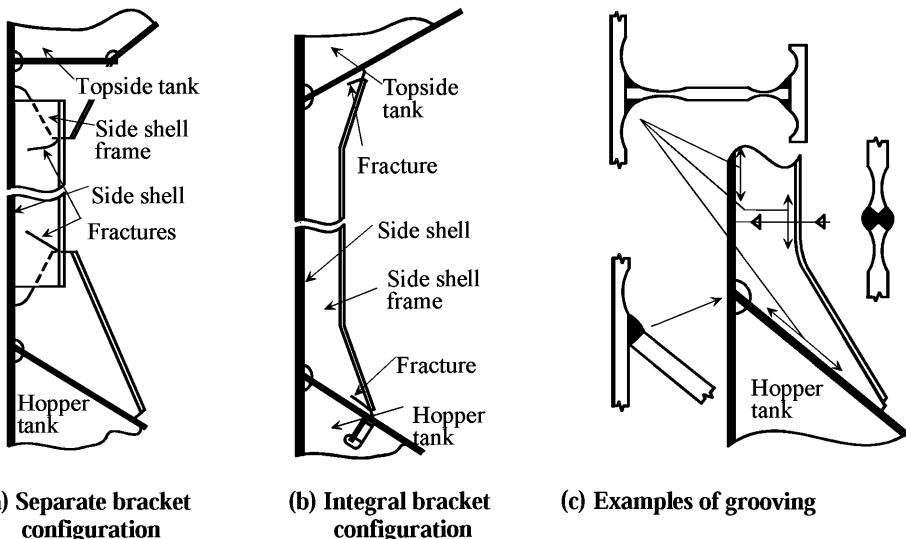
Figure 2 **Damages to side shell frame - Potential problem areas**

(Note) The type of bracket configuration used will, to a large extent, dictate the location and extent of fracture. Where separate brackets are employed, the fracture location is normally at the bracket toe position on the frames, whereas with integral brackets the location is at the toe position on the hopper and topside tank.

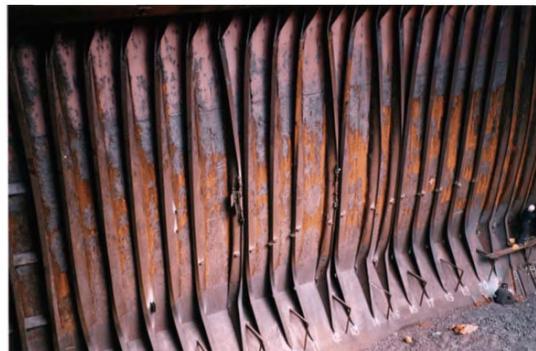
Photograph 1 Collapsed side shell frames (See Example 4)

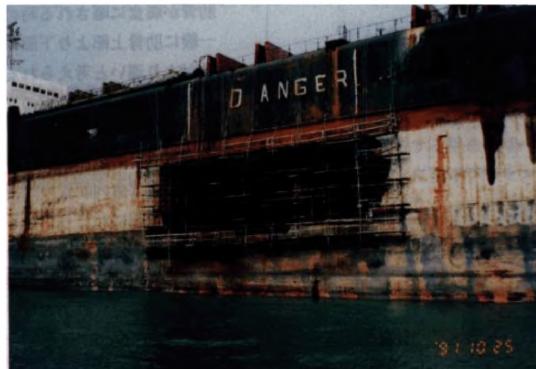
Photograph 2 Missing side shell structure (See Examples 4 and 5)

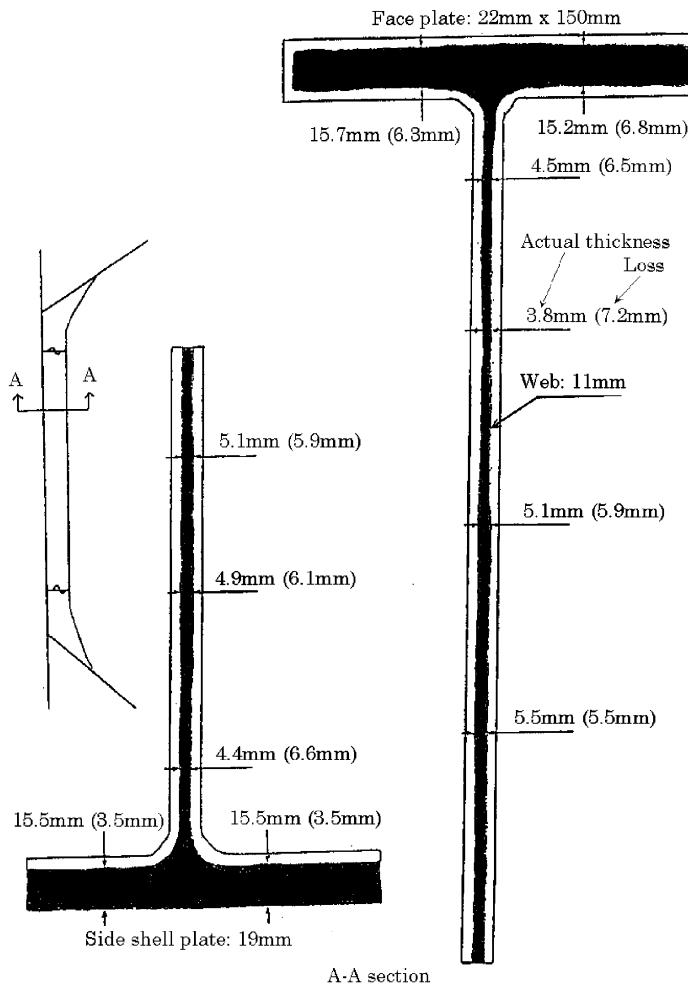
2.1.1 Attention is drawn to the fact that side shell frames may be significantly weakened by loss of thickness although diminution and deformations may not be apparent. Inspection should be made after the removal of any scale or rust deposit. Thickness measurements may be necessary, particularly if the corrosion is smooth and uniform, to determine the condition of the structure (See **Figure 5**).

Figure 5 Uniform corrosion of side shell frame

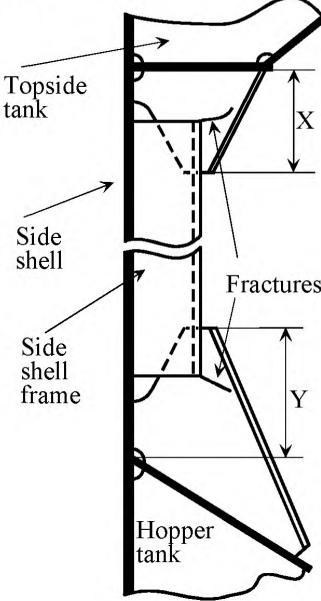
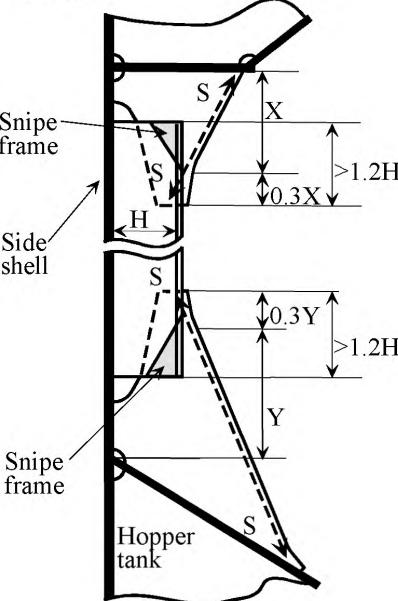
BULK CARRIERS		Guidelines for Surveys, Assessment and Repair of Hull Structure
Part 1	Cargo hold region	Example No.
Area 3	Cargo hold side structure	1-a
Detail of damage		Fractures in brackets at termination of frame
Sketch of damage

<p>S=Snipped end</p>
Notes on possible cause of damage <ol style="list-style-type: none"> 1. This type of damage is caused due to stress concentration. 		Notes on repairs <ol style="list-style-type: none"> 1. For small fractures, e. g. hairline fractures, the fracture can be veed-out, ground, examined by NDT for fractures, and rewelded. 2. For larger/significant fractures consideration is to be given to cropping and partly renewing/renewing the frame brackets. If renewing the brackets, end of frames can be sniped to soften them. 3. If felt prudent, soft toes are to be incorporated at the boundaries of the bracket to the hopper plating. 4. Attention to be given to the structure in wing tanks in way of the extended bracket arm. i.e. reinforcement provided in line with the bracket.

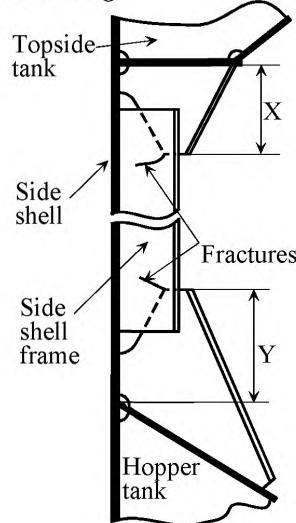
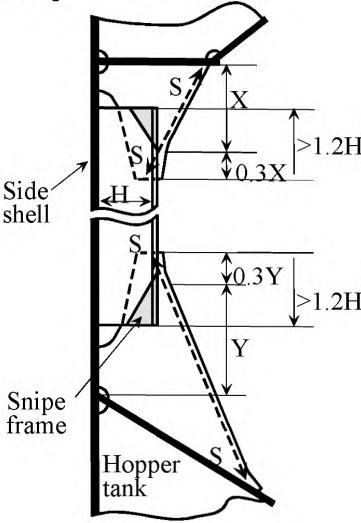
BULK CARRIERS		Guidelines for Surveys, Assessment and Repair of Hull Structure
Part 1	Cargo hold region	Example No.
Area 3	Cargo hold side structure	1-b
Detail of damage		Fractures in side shell frame at bracket's toe
Sketch of damage

<p>Snipped end</p>
Notes on possible cause of damage <ol style="list-style-type: none"> 1. This type of damage is caused due to stress concentration. 		Notes on repairs <ol style="list-style-type: none"> 1. For small fractures, e. g. hairline fractures, the fracture can be vee'd-out, welded up, ground, examined by NDT for fractures, and rewelded. 2. For larger/significant fractures consideration is to be given to cropping and partly renewing/renewing the frame brackets. If renewing the brackets, end of frames can be sniped to soften them. 3. If felt prudent, soft toes are to be incorporated at the boundaries of the bracket to the hopper plating. 4. Attention to be given to the structure in wing tanks in way of the extended bracket arm. i.e. reinforcement provided in line with the bracket.

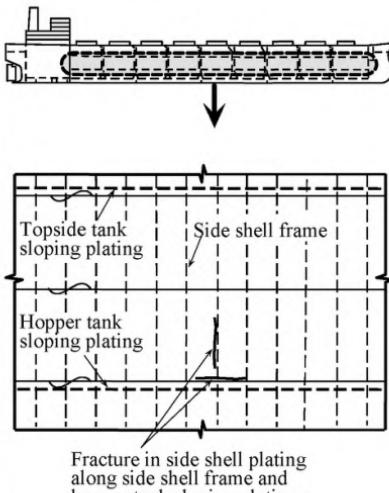
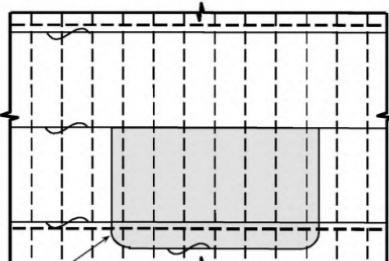
BULK CARRIERS		Guidelines for Surveys, Assessment and Repair of Hull Structure
Part 1	Cargo hold region	Example No.
Area 3	Cargo hold side structure	3
Detail of damage		Fractures in side shell frame/lower bracket and side shell plating near hopper
Sketch of damage		Sketch of repair

<p>Fracture in side shell plating along side shell frame and hopper tank sloping plating</p>

<p>Part renewal including side shell frames and hopper sloping plating, as found necessary</p>
Notes on possible cause of damage <ol style="list-style-type: none"> 1. Heavy corrosion (grooving). Refer to Figure 2 (c). 		Notes on repairs <ol style="list-style-type: none"> 1. Sketch of repair applies when damage extends over several frames. 2. Isolated fractures may be repaired by veeing-out and rewelding. 3. Isolated cases of grooving may be repaired by build up of welding.

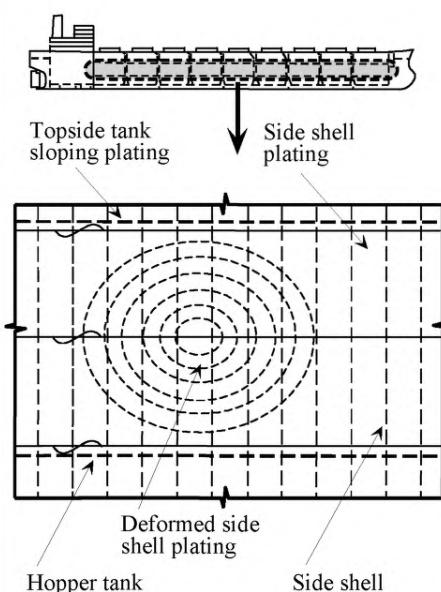
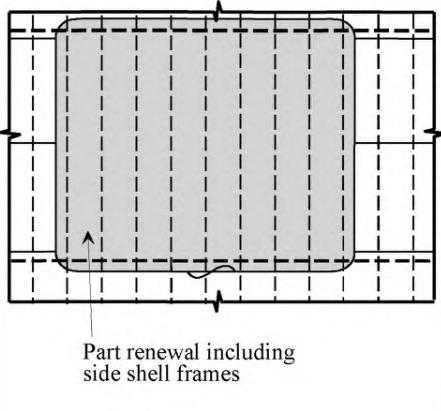
BULK CARRIERS		Guidelines for Surveys, Assessment and Repair of Hull Structure
Part 1	Cargo hold region	Example No.
Area 3	Cargo hold side structure	4
Detail of damage	Deformation of side shell plating	
Sketch of damage

Notes on possible cause of damage	<p>1. Insufficient stiffness of side shell frames due to buckling and/or detachment of side shell frames due to corrosion.</p> <p>2. Heavy weather.</p>	
	Notes on repairs	
	<p>1. Deformed side shell plating including side shell frames should be cropped and renewed.</p>

<p>The diagram shows the proposed repair. The deformed section of the side shell plating is highlighted in grey, and the entire area is labeled 'Part renewal including side shell frames'. This indicates that the damaged section will be removed and replaced with new plating and frames.</p>

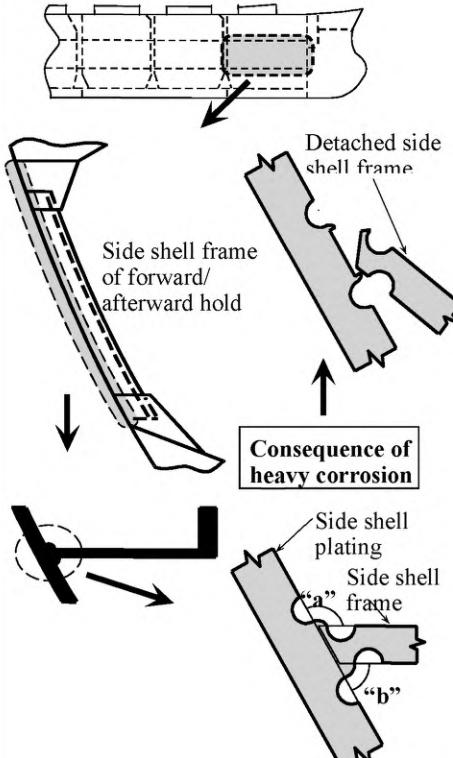
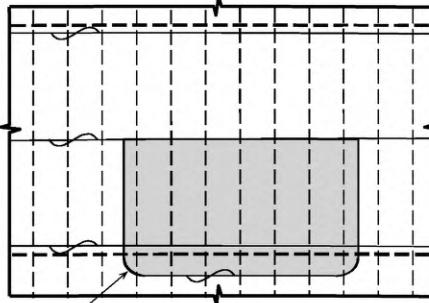
BULK CARRIERS		Guidelines for Surveys, Assessment and Repair of Hull Structure
Part 1	Cargo hold region	Example No.
Area 3	Cargo hold side structure	5
Detail of damage		Adverse effect of corrosion on the frame of forward/afterward hold
Sketch of damage		Sketch of repair

<ol style="list-style-type: none"> 1. Part renewal including side shell frames and hopper plating, as found necessary 2. Deep penetration welding at the connections of side shell frames to side shell plating
Notes on possible cause of damage <ol style="list-style-type: none"> 1. Heavy corrosion (grooving) of side shell frame along side shell plating and difference of throat thickness "a" from "b". (Since original throat thickness of "a" is usually smaller than that of "b", if same welding procedure is applied, the same corrosion has a more severe effect on "a", and may cause collapse and/or detachment of side shell frame.) 		Notes on repairs <ol style="list-style-type: none"> 1. Sketch of repair applies when damage extends over several frames. 2. Isolated fractures may be repaired by veeing-out and rewelding. 3. Isolated cases of grooving may be repaired by build up of welding.

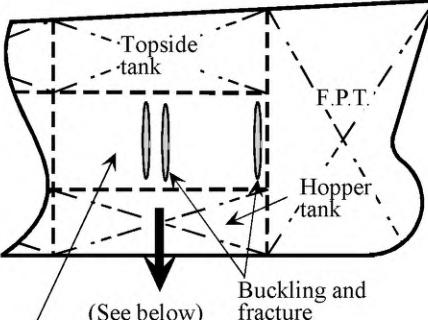
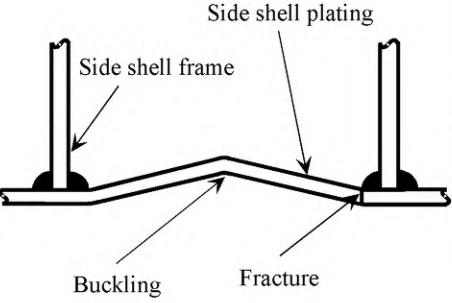
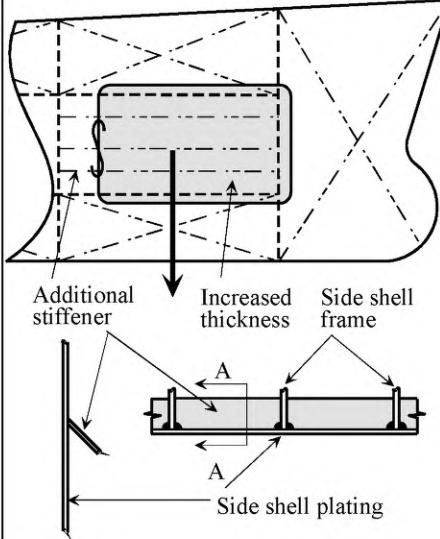
BULK CARRIERS		Guidelines for Surveys, Assessment and Repair of Hull Structure	
Part 1	Cargo hold region	Example No.	
Area 3	Cargo hold side structure	6	
Detail of damage	Buckling and fractures of side shell plating in foremost cargo hold		
Sketch of damage		Sketch of repair

<p>Buckling and fracture points are indicated.</p>

<p>Additional stiffener, Increased thickness, Side shell frame</p> <p>View A-A</p>	
<p>Notes on possible cause of damage</p> <ol style="list-style-type: none"> 1. Heavy weather. 2. Insufficient buckling strength due to high tensile steel or heavy uniform corrosion. 3. Inadequate transition structure. 		<p>Notes on repairs</p> <ol style="list-style-type: none"> 1. Buckled/fractured side shell plating is to be cropped and renewed. 2. Reinforcement by thicker side shell plating and/or additional stiffeners should be considered.

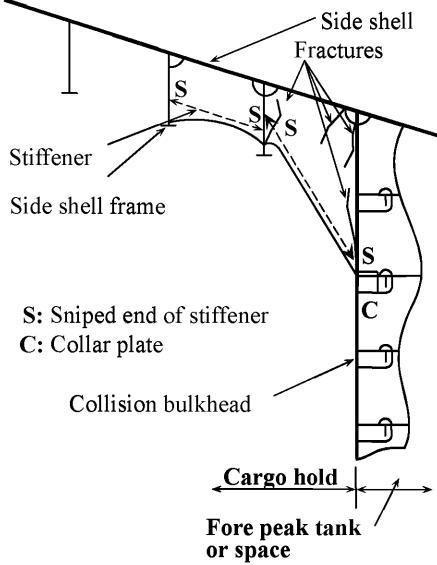
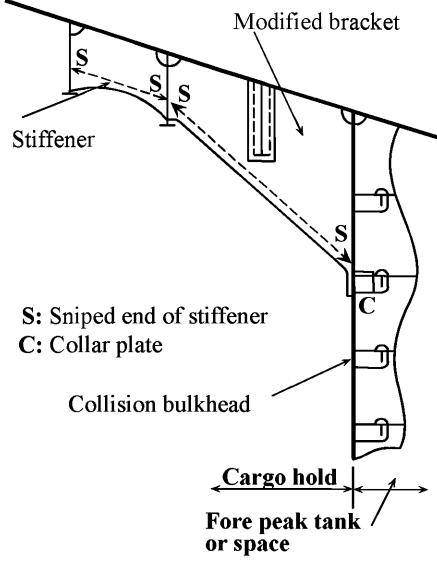
BULK CARRIERS		Guidelines for Surveys, Assessment and Repair of Hull Structure
Part 1	Cargo hold region	Example No.
Area 3	Cargo hold side structure	7
Detail of damage Fractures at the supporting brackets in way of the collision bulkhead		
Sketch of damage

Notes on possible cause of damage <ol style="list-style-type: none"> 1. Insufficient bracket size resulting in high stress due to load cantilevered from side frame. 2. Stress concentration at toe of bracket and misalignment between bracket and stringer in fore peak tank or space. 		Notes on repairs <ol style="list-style-type: none"> 1. The extended bracket arm connection to the collision bulkhead is to have a soft toe, and any cut-outs for stiffeners in the fore peak tank or space are to be collared when situated in the vicinity of the bracket toe. 2. When fractures have extended into the side shell or bulkhead plating, the plating is to be cropped and part renewed.

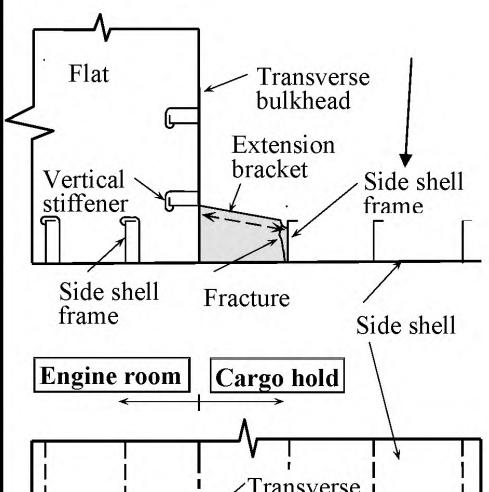
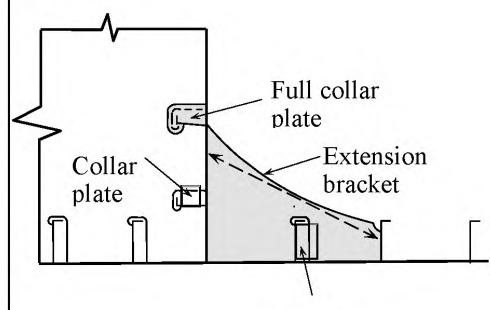
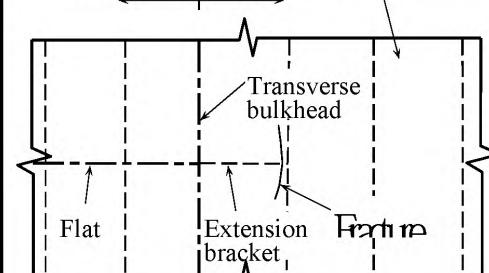
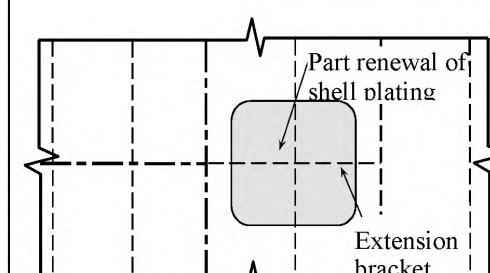
BULK CARRIERS		Guidelines for Surveys, Assessment and Repair of Hull Structure
Part 1	Cargo hold region	Example No.
Area 3	Cargo hold side structure	10
Detail of damage		Fractures in way of continuation/extension brackets in aftermost hold at the engine room bulkhead
Sketch of damage

Notes on possible cause of damage <ol style="list-style-type: none"> 1. Damage caused by stress concentration leading to fatigue fracture on side shell. This will be exacerbated because of the greater flexibility of the hold structure in relation to the engine room structure. 		Notes on repairs <ol style="list-style-type: none"> 1. The fractured shell plating is to be cropped and part renewed as necessary. 2. Extension bracket is to be modified and collar plates to cut-outs in engine room flat are to be installed.

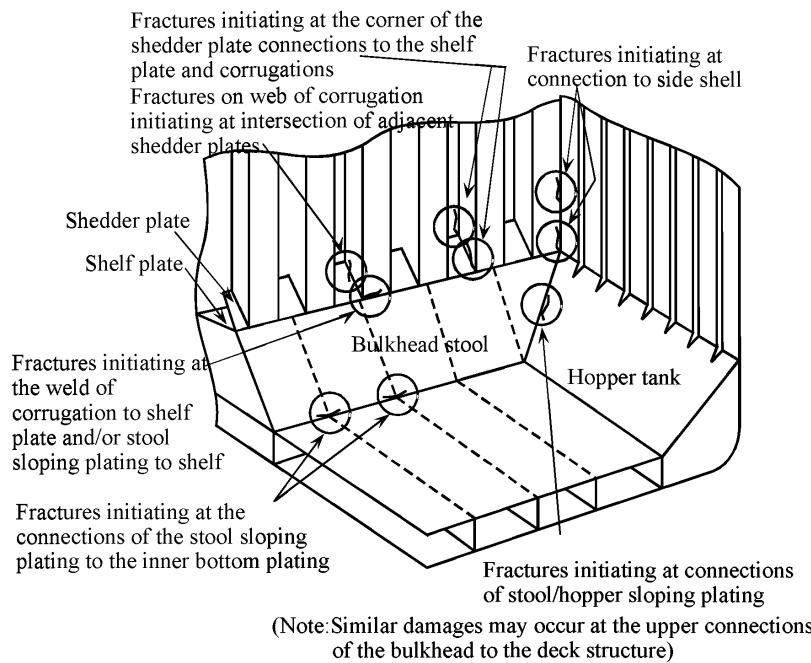
Figure 2 Typical fracturing at the connection of transverse bulkhead structure

2.3.1 Fractures usually occur at the boundaries of corrugations and bulkhead stools particularly in way of shelf plates, shedder plates, deck, inner bottom, etc. (See **Figure 2**).

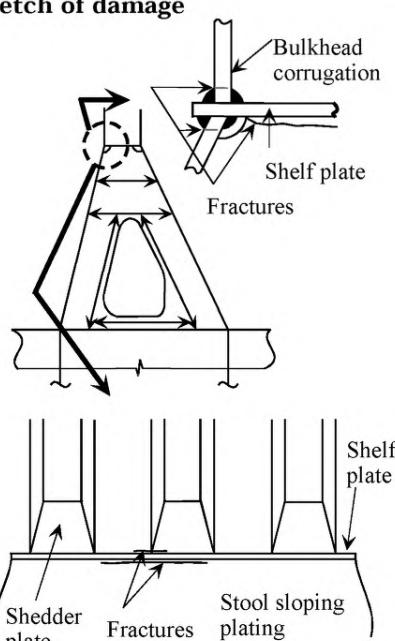
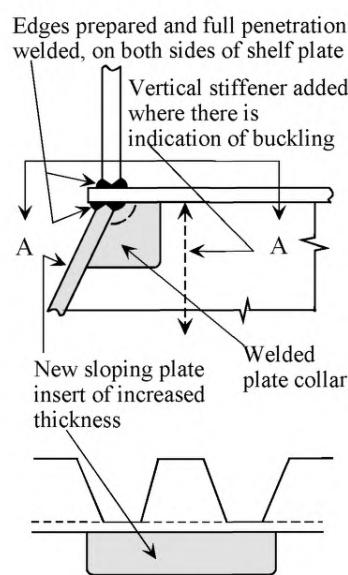
BULK CARRIERS		Guidelines for Surveys, Assessment and Repair of Hull Structure
Part 1	Cargo hold region	Example No.
Area 4	Transverse bulkhead and associated structure in cargo hold	1-a
Detail of damage		Fractures at weld connections to stool shelf plate
Sketch of damage

Notes on possible cause of damage <ol style="list-style-type: none"> 1. Stress concentrations at welds adjacent to the scallops. 2. Inadequate welding area connecting corrugation flange to shelf plate or similarly sloping stool plating to shelf plate. 3. Inadequate thickness of sloping plating in relation to corrugation flange thickness. 4. Stress concentration at knuckle of corrugation where web is not supported by bracket inside the stool. 		Notes on repairs <ol style="list-style-type: none"> 1. Fractures to be bevelled and rewelded. 2. Reductions in stress concentration by fitting welded plate collars in way of the scallop. 3. Where necessary an insert plate to be arranged in stool plating and/or diaphragm.

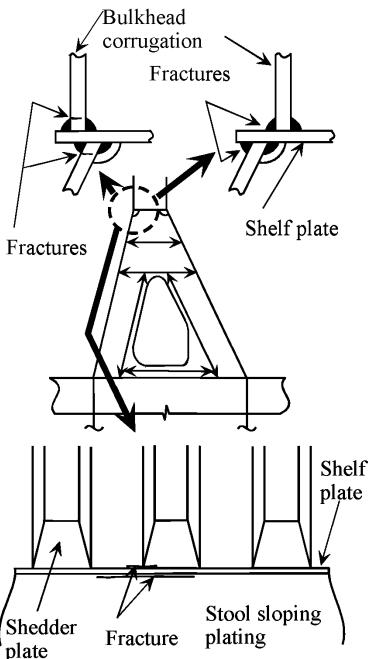
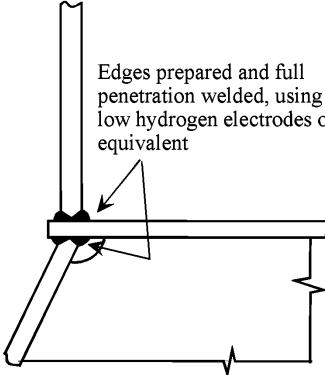
BULK CARRIERS		Guidelines for Surveys, Assessment and Repair of Hull Structure
Part 1	Cargo hold region	Example No.
Area 4	Transverse bulkhead and associated structure in cargo hold	1-b
Detail of damage		Fractures at weld connections to stool shelf plate
Sketch of damage		Sketch of repair

<p>Edges prepared and full penetration welded, using low hydrogen electrodes or equivalent</p>
Notes on possible cause of damage <ol style="list-style-type: none"> 1. Misalignment between corrugation flange and sloping stool plating. 2. Inadequate welding area connecting corrugation flange to shelf plate or similarly sloping stool plating to shelf plate. 		Notes on repairs <ol style="list-style-type: none"> 1. Fractures to be vee'd-out and rewelded. 2. Structure to be released and misalignment rectified. 3. Edge of the corrugated bulkhead and the stool plating on both sides of shelf plate to have full penetration welds. 4. Where necessary an insert plate to be arranged in stool plating.

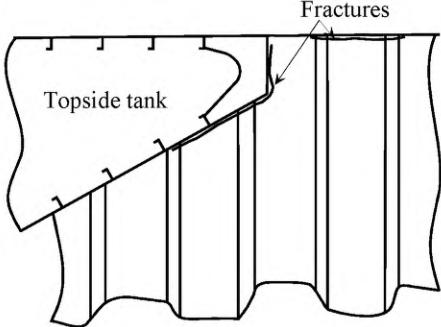
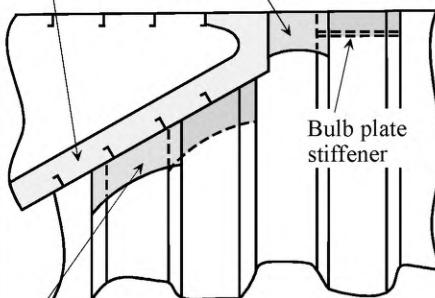
BULK CARRIERS		Guidelines for Surveys, Assessment and Repair of Hull Structure
Part 1	Cargo hold region	Example No.
Area 4	Transverse bulkhead and associated structure in cargo hold	2
Detail of damage Fractures at the upper boundaries to topside tanks		
Sketch of damage

Notes on possible cause of damage <ol style="list-style-type: none"> 1. Damage due to poor design and/or defective welds. 		Notes on repairs <ol style="list-style-type: none"> 1. Fractures may be bevelled and rewelded. If necessary corrugated plating cropped and renewed. 2. It is recommended that reinforcement as shown above be incorporated, giving due consideration to the following criteria: <ol style="list-style-type: none"> 2.1 It is important to have the gusset plates well aligned with the transverse structure inside the tank. Gusset plates may be joggled to obtain this alignment. 2.2 If there is no transverse web already existing inside the topside tank and in line with the flanges of corrugation or gusset plates, reinforcement as shown above to be fitted.

Sketch of repair <p>Continuous or intercostal reinforcement in line with flanges or gussets where not already fitted</p> <p>Adjacent to the topside tank either a gusset to a bulb plate stiffener may be</p>
