**No.76 IACS Guidelines for Surveys, Assessment and
(1994) Repair of Hull Structure – Bulk Carriers**

BULK CARRIERS

Guidelines for Surveys, Assessment and Repair of Hull
Structure

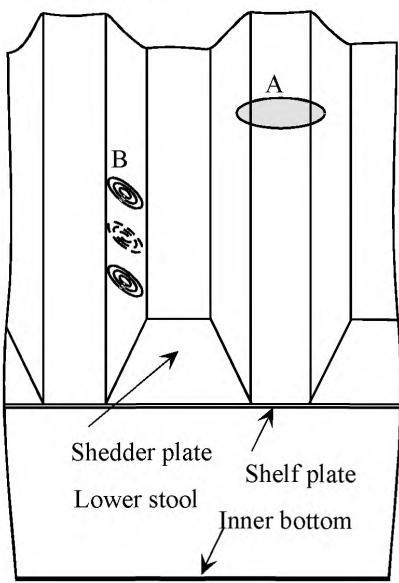
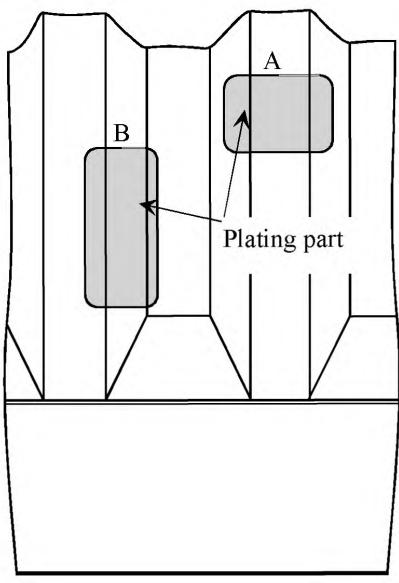
BULK CARRIERS		Guidelines for Surveys, Assessment and Repair of Hull Structure
Part 1	Cargo hold region	Example No.
Area 4	Transverse bulkhead and associated structure in cargo hold	3
Detail of damage		Indentation and buckling of vertical corrugation
Sketch of damage		Sketch of repair

Notes on possible cause of damage		Notes on repairs
<ol style="list-style-type: none"> 1. Damages by mechanical abuse during cargo handling e.g. grab damage. 2. Damage resulting from thickness reduction by corrosion. 3. Buckling caused by bending or shear, see locations A and B respectively above, with a minimum reduction in thickness could be caused by underdesign or overloading. If this cause is suspected, the Classification Society concerned shall be contacted before proceeding with repairs. 		<ol style="list-style-type: none"> 1. Damage by mechanical abuse If the indentation/buckling is local and of a minor nature, the plating can be faired in place. If the deformation is more pronounced and/or in association with a generalized reduction in thickness the plating is to be cropped and renewed, as shown at locations A and B above. 2. Damage resulting from corrosion In this case thickness measurements are to be taken at mid-span and top and bottom of corrugations, and corrugations renewed or part renewed as necessary. Particular attention is to be given to the fit and alignment at corners of flanged corrugations when being partly renewed.

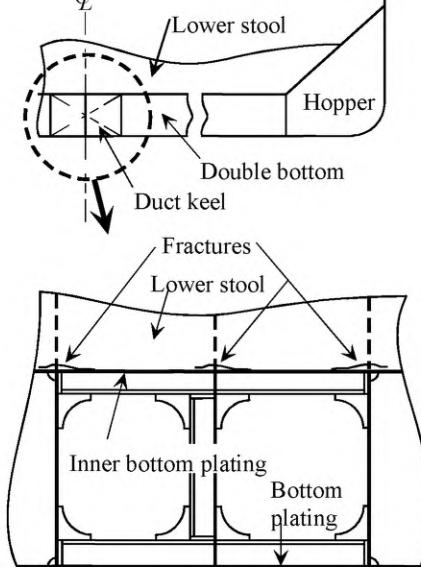
BULK CARRIERS		Guidelines for Surveys, Assessment and Repair of Hull Structure
Part 1	Cargo hold region	Example No.
Area 4	Transverse bulkhead and associated structure in cargo hold	5
Detail of damage		Fractures at weld connection of lower stool plating to inner bottom in way of duct keel
Sketch of damage

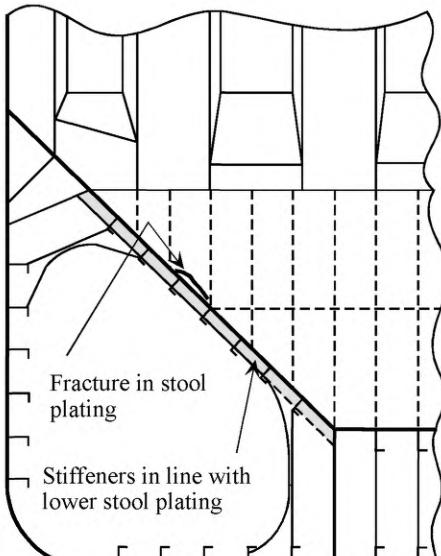
BULK CARRIERS		Guidelines for Surveys, Assessment and Repair of Hull Structure
Part 1	Cargo hold region	Example No.
Area 4	Transverse bulkhead and associated structure in cargo hold	6
Detail of damage		Fractures at the connection of lower stool to hopper
Sketch of damage

Notes on possible cause of damage <ol style="list-style-type: none"> 1. Insufficient strength of the connection 2. Corrosion 		Notes on repairs <ol style="list-style-type: none"> 1. Fractured stool plating should be partly cropped and renewed (thicker plate) if considered necessary. 2. If the damage occurred due to insufficient strength, stiffeners in line with stool plating should be increased.

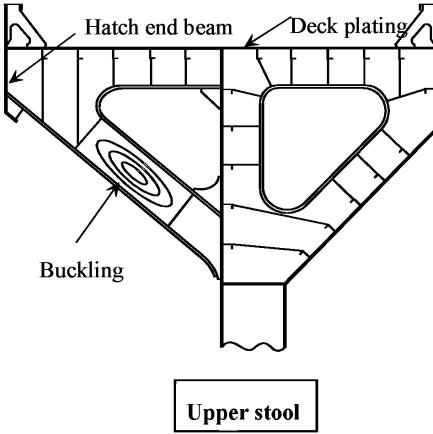
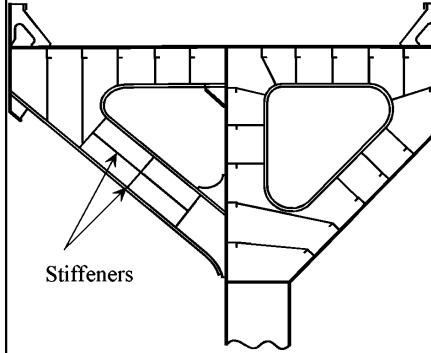
BULK CARRIERS		Guidelines for Surveys, Assessment and Repair of Hull Structure
Part 1	Cargo hold region	Example No.
Area 4	Transverse bulkhead and associated structure in cargo hold	7
Detail of damage		Buckling of strut supporting hatch end beam
Sketch of damage		Sketch of repair

Notes on possible cause of damage		Notes on repairs
<ol style="list-style-type: none"> 1. Insufficient strength 2. Partial ballast loading in ballast cargo hold (sloshing) 3. Corrosion 		<ol style="list-style-type: none"> 1. Deformed part to be cropped and renewed if considered necessary. 2. If the damage occurred due to insufficient strength, appropriate reinforcement is to be considered (thicker plate/additional stiffener(s)).

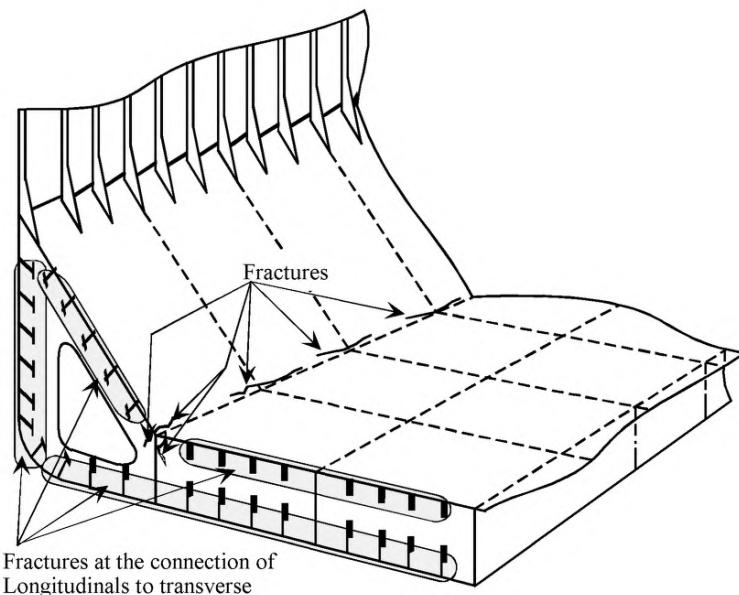
Figure 1 Typical fractures in the connection of hopper sloping plating to inner bottom (tank top) and longitudinals to transverse (or transverse bulkhead)

extend through the thickness of the plating or through the welds may be observed during pressure testing of the double bottom tanks (See **Figure 1** and **2** of **Area 4**).

3.3.2 Fractures may occur in way of the welded or radiused knuckle between the inner bottom and hopper sloping plating if the side girder in the double bottom is not in line with the knuckle and also when the floors below have a large spacing, or when corner scallops are created for ease of fabrication. The local stress variations due to the loading and subsequent deflection may lead to the development of fatigue fractures which can be categorised as follows (See **Figure 1**).

3.3.3 The fractures in way of connection of inner bottom plating/hopper sloping plating to stool may be caused by the cyclic deflection of the inner bottom induced by repeated loading from the sea or due to poor "through-thickness" properties of the inner bottom plating. Scallops in the underlying girders can create stress concentrations which further increase the risk of fractures. These can be categorised as follows (See **Figure 1 and Examples**).

and hopper sloping plating should be repaired as follows.

- (a) Where the fracture is confined to the weld, the weld is to be veed-out and renewed using full penetration welding, with low hydrogen electrodes or equivalent.

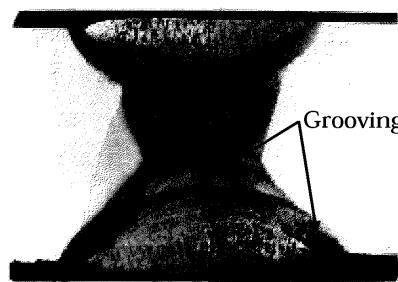
Photograph 2
Section of the grooving shown in Photograph 1

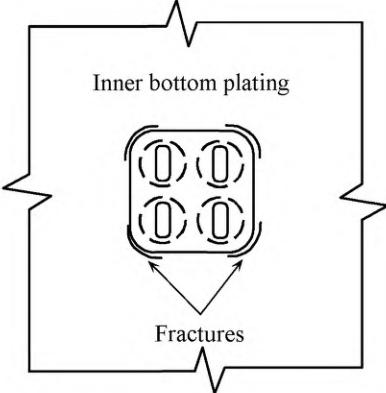
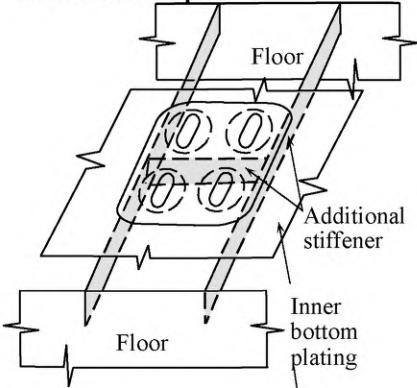
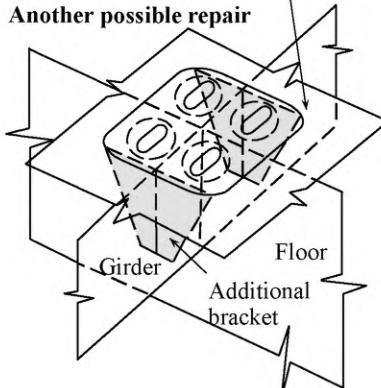
BULK CARRIERS		Guidelines for Surveys, Assessment and Repair of Hull Structure
Part 1	Cargo hold region	Example No.
Area 5		Double bottom structure including hopper
Detail of damage		Fractures in inner bottom plating around container bottom pocket
Sketch of damage		Sketch of repair

Notes on possible cause of damage		Notes on repairs
<ol style="list-style-type: none"> 1. Pocket is not supported correctly by floor, longitudinal and/or stiffener. 		<ol style="list-style-type: none"> 1. Fractured plating should be cropped and part renewed. 2. Adequate reinforcement should be considered.

<p>Most common repair</p>

<p>Another possible repair</p>

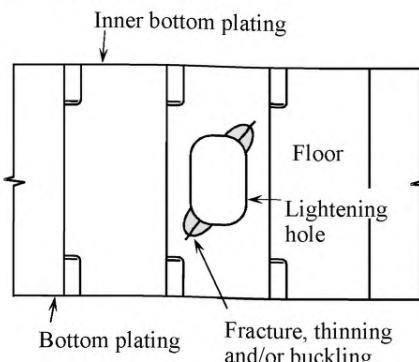
BULK CARRIERS		Guidelines for Surveys, Assessment and Repair of Hull Structure
Part 1	Cargo hold region	Example No.
Area 5	Double bottom structure including hopper	2
Detail of damage	Fractures, corrosion and/or buckling of floor/girder around lightening hole	
Sketch of damage

<p>Face plate</p> <p>Section A-A</p>
Notes on possible cause of damage <ol style="list-style-type: none"> 1. Insufficient strength due to lightening hole. 2. Fracture, corrosion and/or buckling around lightening hole due to high stress. 		Notes on repairs <ol style="list-style-type: none"> 1. Fractured, corroded and/or buckled plating should be cropped and renewed if considered necessary. 2. Appropriate reinforcement should be considered.

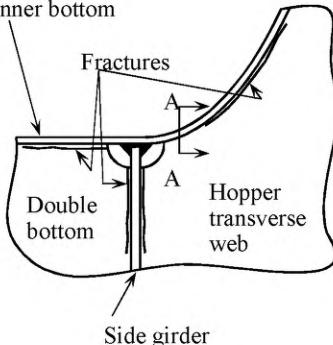
BULK CARRIERS		Guidelines for Surveys, Assessment and Repair of Hull Structure
Part 1	Cargo hold region	Example No.
Area 5	Double bottom tank structure including hopper	3
Detail of damage		Fractures at weld connections of floors in way of hopper/inner bottom interface (radiused knuckle)
Sketch of damage

<p>View A - A Transverse fractures in hopper web plating into possibly extending into the hopper sloping plating

<p>Reinforcement Insert plate of increased thickness Additional stiffeners</p>		
Notes on possible cause of damage <ol style="list-style-type: none"> 1. The damage is partly due to stress concentrations at the edges of the weld created by the presence of cut-outs and local stress variations caused by the deflections in the inner bottom/hopper plating.

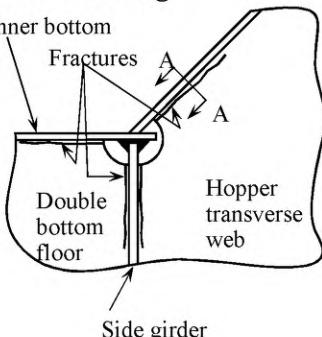
BULK CARRIERS		Guidelines for Surveys, Assessment and Repair of Hull Structure
Part 1	Cargo hold region	Example No.
Area 5	Double bottom tank structure including hopper	4
Detail of damage		Fractures at weld connections of floors in way of hopper/inner bottom interface (welded knuckle)
Sketch of damage

View A - A <p>Transverse fractures in hopper web plating into possibly extending into the hopper sloping plating</p>

Notes on possible cause of damage <ol style="list-style-type: none"> 1. The damage is partly due to stress concentration at the edges of the weld created by the presence of the deflections in the inner bottom/hopper plating. 		Notes on repairs <ol style="list-style-type: none"> 1. The fracture in the weld and/or plating is veed-out/cropped and renewed as appropriate. 2. The cut-outs are eliminated by introducing suitable collar plates with emphasis on edge preparation and sequence of welding as shown above. 3. Further reinforcements may be incorporated as shown above and depending on the judged cause of damage.

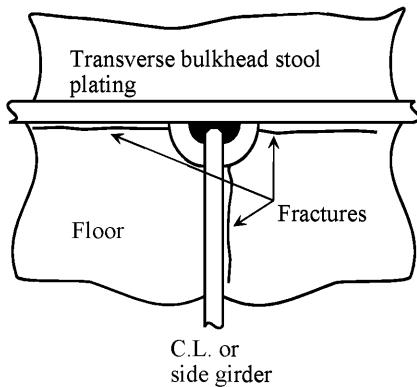
BULK CARRIERS		Guidelines for Surveys, Assessment and Repair of Hull Structure
Part 1	Cargo hold region	Example No.
Area 5	Double bottom tank structure including hopper	5
Detail of damage	Fractures at weld connections of floors in way of inner bottom and side girders, and plating of bulkhead stool	
Sketch of damage

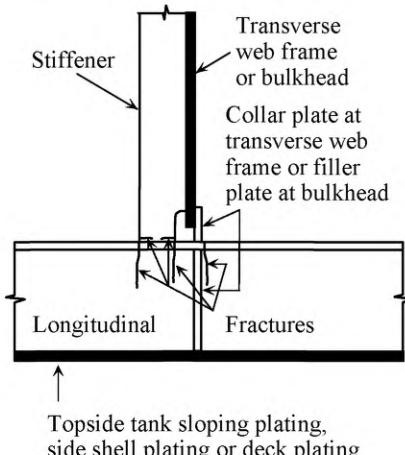
BULK CARRIERS		Guidelines for Surveys, Assessment and Repair of Hull Structure
Part 1	Cargo hold region	Example No.
Area 5	Double bottom tank structure including hopper	7
Detail of damage		Fractures in longitudinal at floor/transverse web frame or bulkhead
Sketch of damage

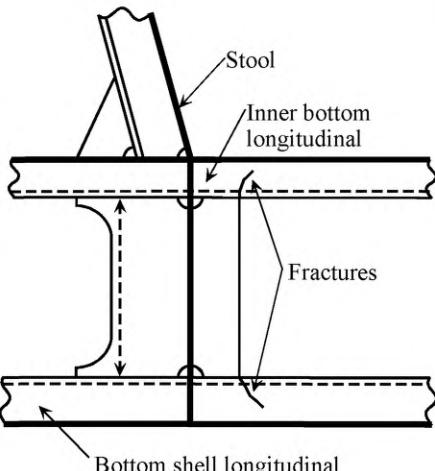
BULK CARRIERS		Guidelines for Surveys, Assessment and Repair of Hull Structure
Part 1	Cargo hold region	Example No.
Area 5	Double bottom tank structure including hopper	8
Detail of damage		Fractures in bottom and inner bottom longitudinals in way of inner bottom and bulkhead stool boundaries
Sketch of damage

<p>f : Where required the longitudinal to be cropped and part renewed</p>
Notes on possible cause of damage <ol style="list-style-type: none"> 1. Damage can be caused by stress concentration leading to accelerated fatigue in this region. 		Notes on repairs <ol style="list-style-type: none"> 1. If fractures are not extensive e.g. hairline fractures then these can be veed-out and welded. 2. If fracture extended to over one third of the depth of the longitudinal depth then crop and part renew.

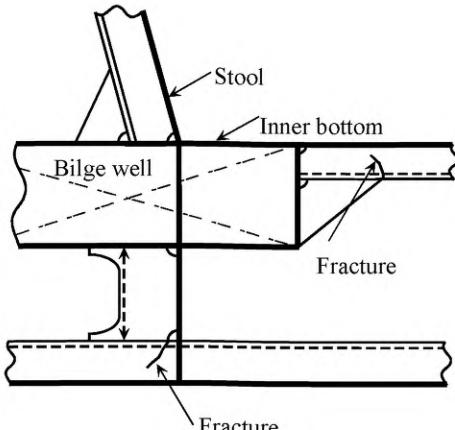
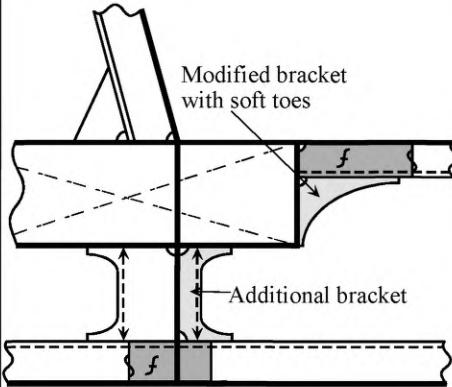
BULK CARRIERS		Guidelines for Surveys, Assessment and Repair of Hull Structure
Part 1	Cargo hold region	Example No.
Area 5	Double bottom tank structure including hopper	9
Detail of damage		Fractures in longitudinal in way of bilge well
Sketch of damage		Sketch of repair

<p><i>f</i>: Where required the longitudinals to be cropped and part renewed</p>
Notes on possible cause of damage		Notes on repairs
<ol style="list-style-type: none"> 1. Damage can be caused by stress concentrations leading to accelerated fatigue in this region. 		<ol style="list-style-type: none"> 1. If fractures are not extensive e.g. hairline fractures then these can be vee'd-out and welded. 2. If the fracture extended to over one third of the depth of the longitudinal then crop and part renew.

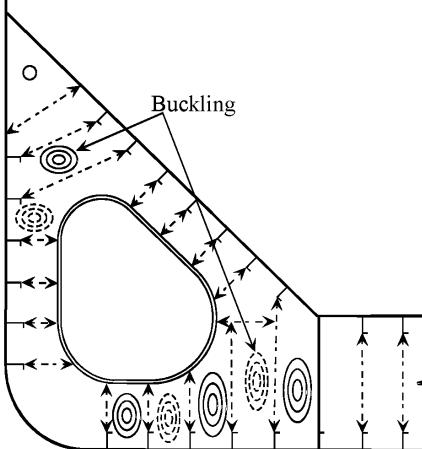
BULK CARRIERS		Guidelines for Surveys, Assessment and Repair of Hull Structure
Part 1	Cargo hold region	Example No.
Area 5	Double bottom tank structure including hopper	10
Detail of damage		Buckling of transverse web
Sketch of damage

Notes on possible cause of damage <ol style="list-style-type: none"> 1. Insufficient buckling strength of transverse web plating. 2. Corrosion of high stress area. 		Notes on repairs <ol style="list-style-type: none"> 1. If the buckling occurred without significant corrosion, adequate reinforcement is to be carried out. 2. If the buckling occurred due to corrosion of high stress (shear stress) area, damaged area is to be cropped and part renewed. Adequate reinforcement and protective measures should be considered.

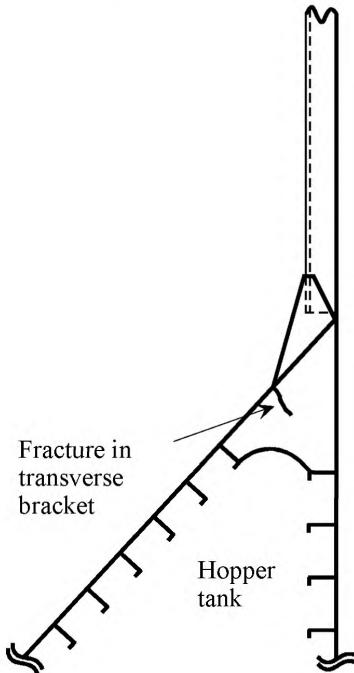
BULK CARRIERS		Guidelines for Surveys, Assessment and Repair of Hull Structure
Part 1	Cargo hold region	Example No.
Area 5	Double bottom tank structure including hopper	11
Detail of damage		Fractures at weld connection of transverse brackets
Sketch of damage

Notes on possible cause of damage <ol style="list-style-type: none"> 1. General levels of corrosion and presence of stress concentration. 2. Misalignment of the brackets with adjoining structure e.g. frame brackets. 3. High shear stresses due to insufficient bracket. 4. Inadvertent overloading. 		Notes on repairs <ol style="list-style-type: none"> 1. If the damage is caused by misalignment with the frame bracket above, the misalignment is to be rectified. 2. Replacement by a bracket of increased thickness or size should be considered.

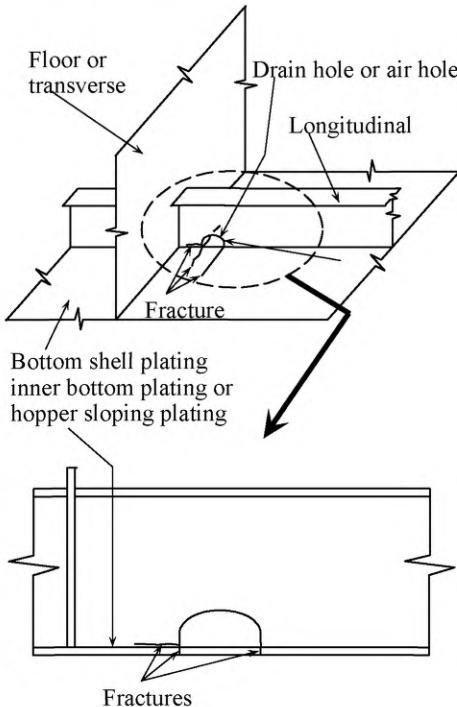
BULK CARRIERS		Guidelines for Surveys, Assessment and Repair of Hull Structure
Part 1	Cargo hold region	Example No.
Area 5	Double bottom tank structure including hopper	12
Detail of damage		Fractures in bottom shell/side shell/hopper sloping plating at the corner drain hole/air hole in longitudinal
Sketch of damage

Notes on possible cause of damage <ol style="list-style-type: none"> 1. Stress concentration and/or corrosion due to stress concentration at the corner of drain hole/air hole. 		Notes on repairs <ol style="list-style-type: none"> 1. Fractured plating should be cropped and part renewed. 2. If fatigue life is to be improved, change of drain hole/air hole shape is to be considered.

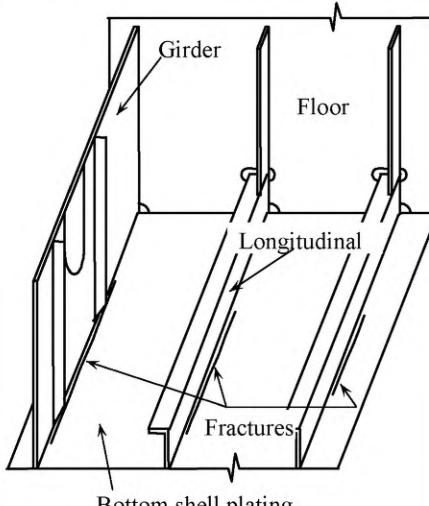
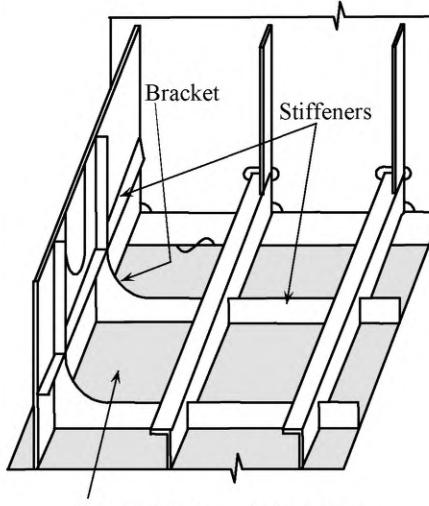
BULK CARRIERS		Guidelines for Surveys, Assessment and Repair of Hull Structure
Part 1	Cargo hold region	Example No.
Area 5	Double bottom tank structure including hopper	13
Detail of damage		Fractures in bottom plating along side girder and/or bottom longitudinal
Sketch of damage		Sketch of repair

Notes on possible cause of damage		Notes on repairs
1. Vibration.		1. Fractured bottom shell plating should be cropped and renewed. 2. Natural frequency of the panel should be changed, e.g. reinforcement by additional stiffener/bracket.

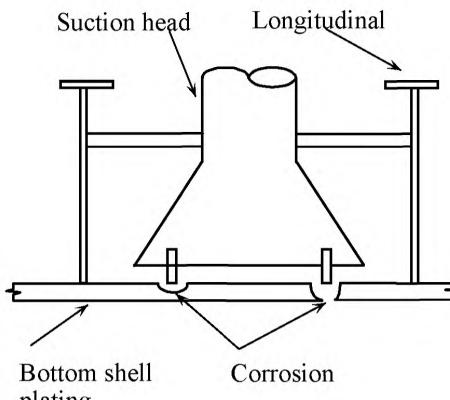
BULK CARRIERS		Guidelines for Surveys, Assessment and Repair of Hull Structure
Part 1	Cargo hold region	Example No.
Area 5	Double bottom tank structure including hopper	14
Detail of damage		Corrosion in bottom plating below suction head
Sketch of damage

Notes on possible cause of damage <ol style="list-style-type: none"> 1. High flow rate associated with insufficient corrosion prevention system. 2. Galvanic action between dissimilar metals. 		Notes on repairs <ol style="list-style-type: none"> 1. Insert to have round corners 2. Non-destructive examination to be applied after welding based on the Society's rules

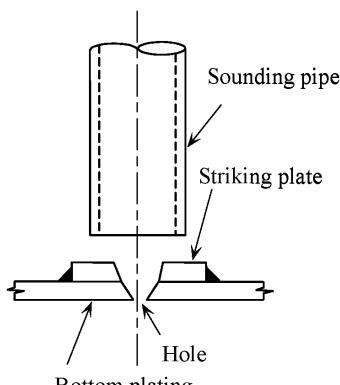
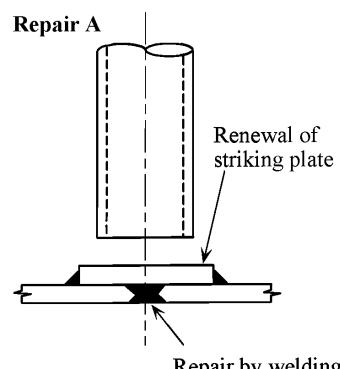
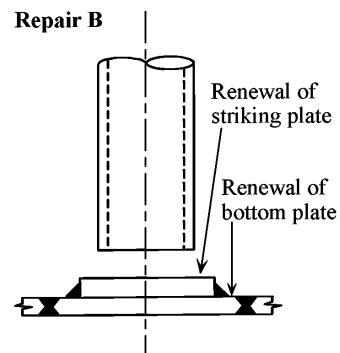
BULK CARRIERS		Guidelines for Surveys, Assessment and Repair of Hull Structure
Part 1	Cargo hold region	Example No.
Area 5	Double bottom tank structure including hopper	15
Detail of damage		Corrosion in bottom plating below sounding pipe
Sketch of damage

<p>Repair B</p> <p>Renewal of striking plate</p> <p>Renewal of bottom plate</p>
Notes on possible cause of damage		Notes on repairs
<ol style="list-style-type: none"> Accelerated corrosion of striking plate by the striking of the weight of the sounding tape. 		<ol style="list-style-type: none"> Corroded bottom plating should be welded or partly cropped and renewed if considered necessary. Corroded striking plate should be renewed.

<p>Repair A</p> <p>Renewal of striking plate</p> <p>Repair by welding</p>

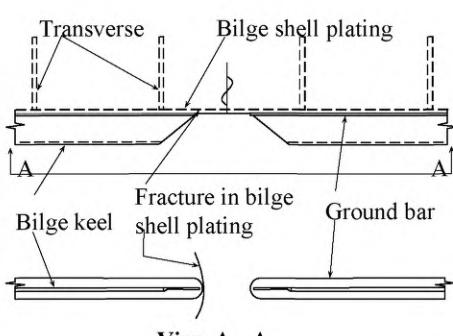
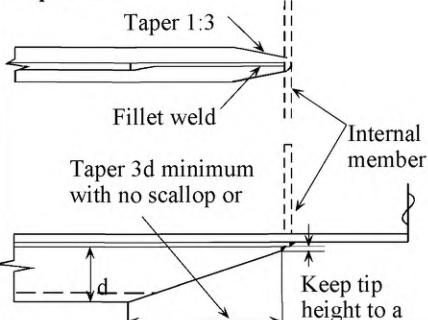
BULK CARRIERS		Guidelines for Surveys, Assessment and Repair of Hull Structure
Part 1	Cargo hold region	Example No.
Area 5		Double bottom structure including hopper
Detail of damage		Fractures in shell plating at the termination of bilge keel
Sketch of damage		Sketch of repair

<p>Newly provided stiffeners</p>
Notes on possible cause of damage		Notes on repairs
<ol style="list-style-type: none"> 1. Poor design causing stress concentration. 		<ol style="list-style-type: none"> 1. Fractured plating is to be cropped and renewed. 2. Reduction of stress concentration of the bilge keel end should be considered. <p>Repair A: Modification of the detail of end</p> <p>Repair B: New internal stiffeners</p> <p>Repair C: Continuous ground bar (in connection with Repair A)</p> <ol style="list-style-type: none"> 3. Instead of Repair A or B continuous ground bar and bilge keel should be considered.

<p>View A - A</p>		<p>Repair A</p>

<p>Taper 1:3</p> <p>Fillet weld</p> <p>Internal member</p> <p>Taper 3d minimum with no scallop or</p> <p>Keep tip height to a</p> <p>Repair B</p>

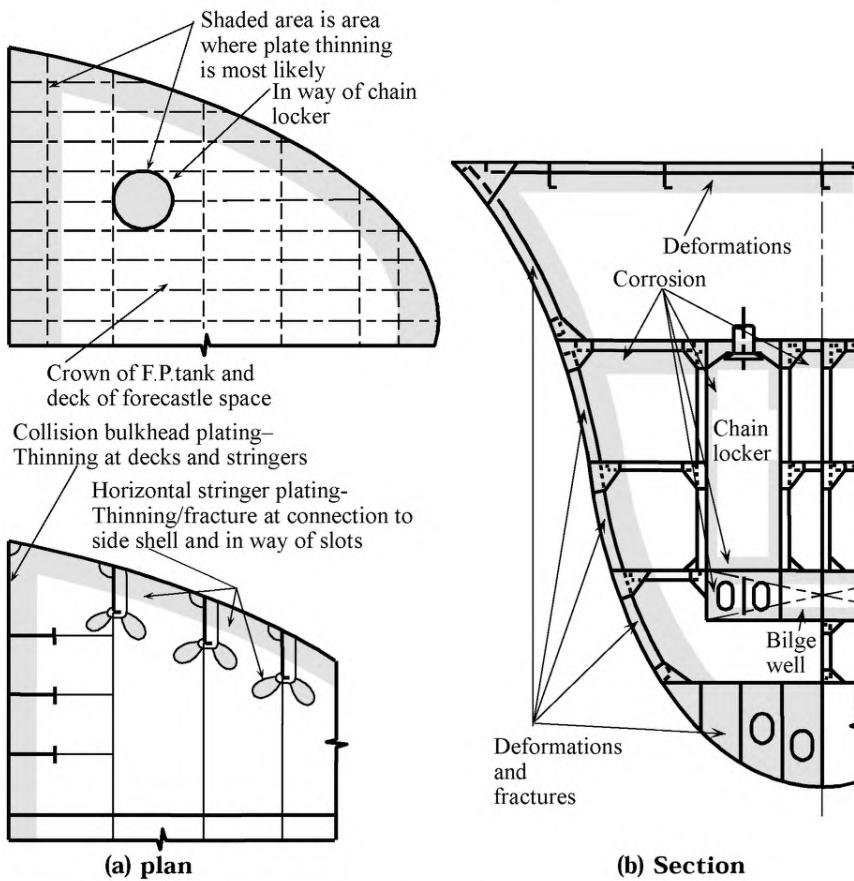
Fig 1 Fore end structure - Potential problem areas

- 2.1.1** Wastage (and possible subsequent fractures) is more likely to be initiated at the locations as indicated in **Figure 1** and particular attention should be given to these areas. A close-up inspection should be carried out with selection of representative thickness measurements to determine the extent of corrosion.
- 2.1.2** Structure in chain locker is liable to have heavy corrosion due to mechanical damage to the protective coating caused by the action of anchor chains. In some ships, especially smaller ships, the side shell plating may form boundaries of the chain locker and heavy corrosion may consequently result in holes in the side shell plating.

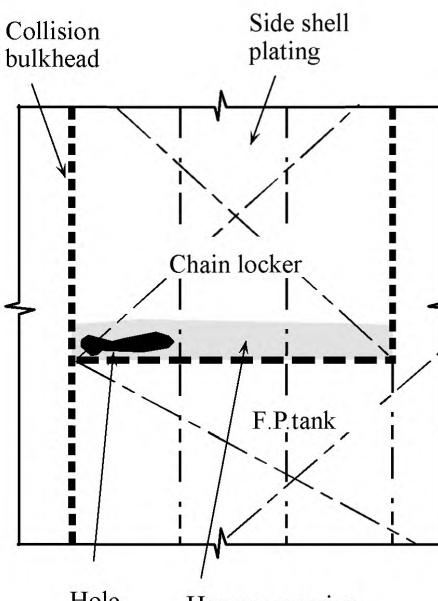
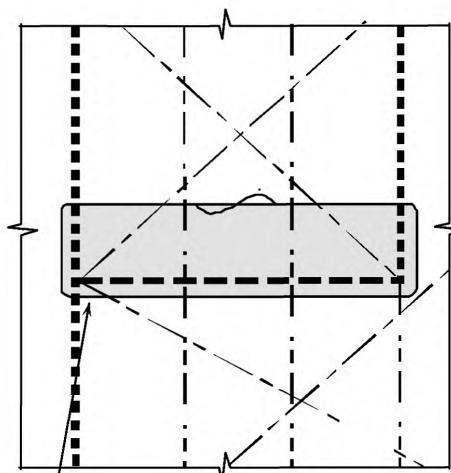
BULK CARRIERS		Guidelines for Surveys, Assessment and Repair of Hull Structure
Part 2	Fore and aft end regions	Example No.
Area 1	Fore end structure	3
Detail of damage Fractures in side shell plating in way of chain locker		
Sketch of damage

Notes on possible cause of damage <ol style="list-style-type: none"> 1. Heavy corrosion in region where mud is accumulated. 		Notes on repairs <ol style="list-style-type: none"> 1. Corroded plating should be cropped and renewed. 2. Protective coating should be applied.

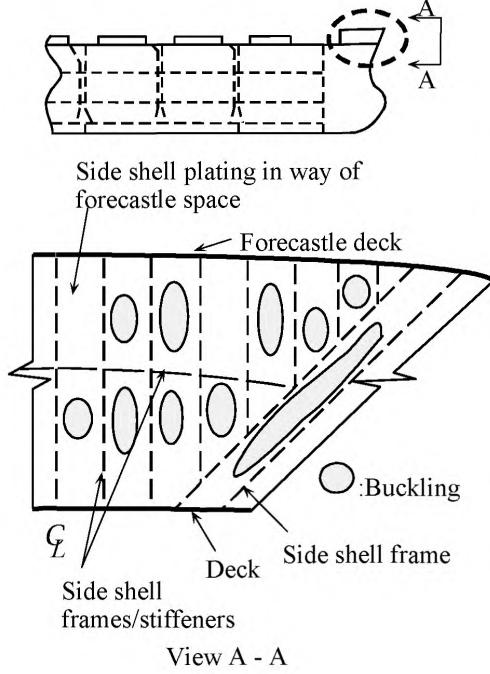
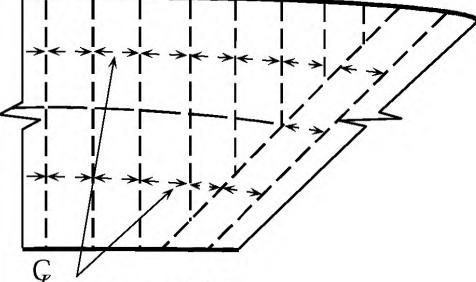
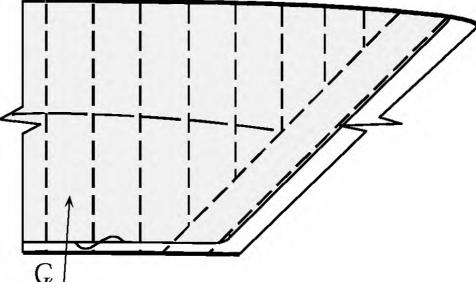
BULK CARRIERS		Guidelines for Surveys, Assessment and Repair of Hull Structure
Part 2	Fore and aft end regions	Example No.
Area 1	Fore end structure	4
Detail of damage		Deformation of side shell plating in way of forecastle space
Sketch of damage		Sketch of repair

<p>Insertion of plate of</p>
Notes on possible cause of damage		Notes on repairs
<ol style="list-style-type: none"> 1. Heavy weather. 2. Insufficient strength. 		<ol style="list-style-type: none"> 1. Deformed part should be cropped and part renewed. 2. Repair A Additional stiffeners between existing stiffeners should be considered. Repair B Insertion of plate of increased thickness with additional stiffeners.

<p>Newly provided intercostal stiffeners</p> <p>Repair B</p>

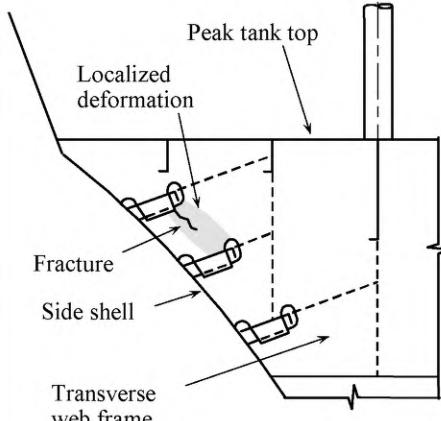
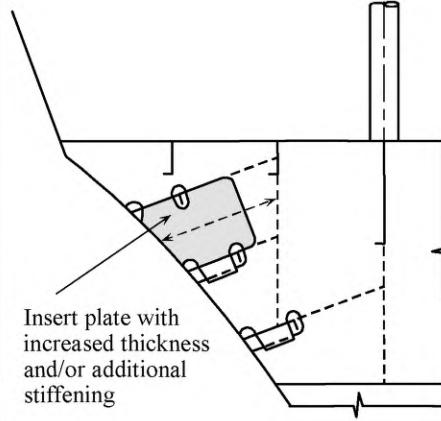
BULK CARRIERS		Guidelines for Surveys, Assessment and Repair of Hull Structure
Part 2	Fore and aft end regions	Example No.
Area 1	Fore end structure	5
Detail of damage	Fracture and deformation of bow transverse web in way of cut-outs for side longitudinals	
Sketch of damage

<p>Peak tank top Localized deformation Fracture Side shell Transverse web frame</p>		Sketch of repair

<p>Insert plate with increased thickness and/or additional stiffening</p>
Notes on possible cause of damage <ol style="list-style-type: none"> Localized material wastage in way of coating failure at cut-outs and sharp edges due to working of the structure. Dynamic seaway loading in way of bow flare. 		Notes on repairs <ol style="list-style-type: none"> Sufficient panel strength to be provided to absorb the dynamic loads enhanced by bow flare shape.

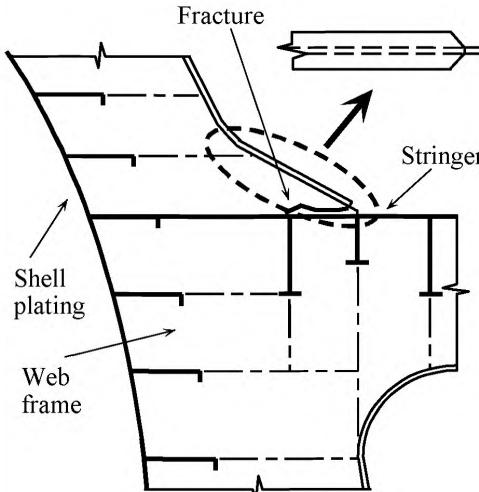
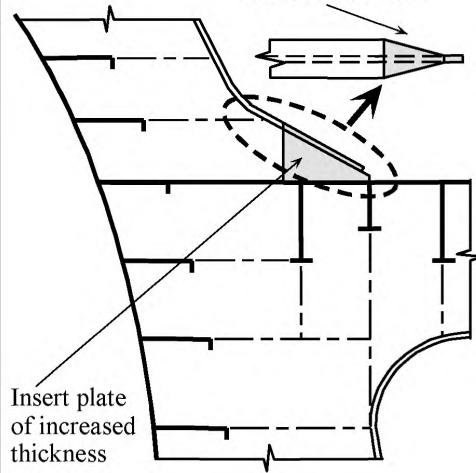
BULK CARRIERS		Guidelines for Surveys, Assessment and Repair of Hull Structure
Part 2	Fore and aft end regions	Example No.
Area 1	Fore end structure	6
Detail of damage	Fractures at toe of web frame bracket connection to stringer platform bracket	
Sketch of damage

Notes on possible cause of damage <ol style="list-style-type: none"> 1. Inadequate bracket forming the web frame connection to the stringer. 2. Localized material wastage in way of coating failure at bracket due to flexing of the structure. 3. Dynamic seaway loading in way of bow flare. 		Notes on repairs <ol style="list-style-type: none"> 1. Adequate soft nose bracket endings with a face plate taper of at least 1 : 3 to be provided.

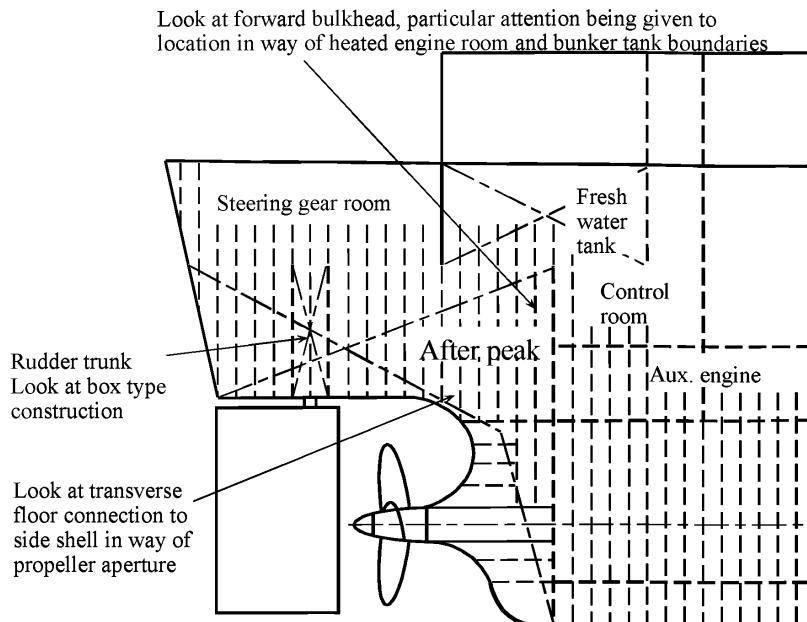
Figure 1 Aft end structure - Potential problem areas

- 2.1.1** Wastage (and possible subsequent fractures) is more likely to be initiated at in the locations as indicated in **Figure 1**. A close-up inspection should be carried out with selection of representative thickness measurements to determine the extent of corrosion. Particular attention should be given to bunker tank boundaries and spaces adjacent to heated engine room.

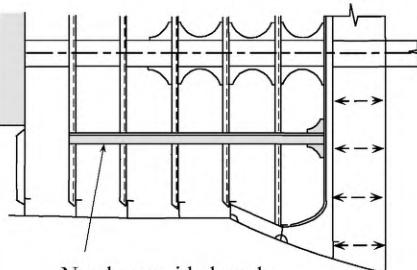
BULK CARRIERS		Guidelines for Surveys, Assessment and Repair of Hull Structure
Part 2	Fore and aft end regions	Example No.
Area 2	Aft end structure	2
Detail of damage		Fractures at the connection of floors and girders/side brackets
Sketch of damage		Sketch of repair

Notes on possible cause of damage		Notes on repairs
1. Vibration.		<ol style="list-style-type: none"> 1. The fractured plating should be cropped and renewed. 2. Natural frequency of the panel should be changed, e.g. reinforcement by additional strut.

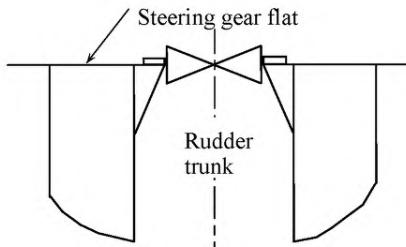
BULK CARRIERS		Guidelines for Surveys, Assessment and Repair of Hull Structure
Part 2	Fore and aft end regions	Example No.
Area 2	Aft end structure	3-a
Detail of damage	Fractures in flat where rudder carrier is installed in steering gear room	
Sketch of damage

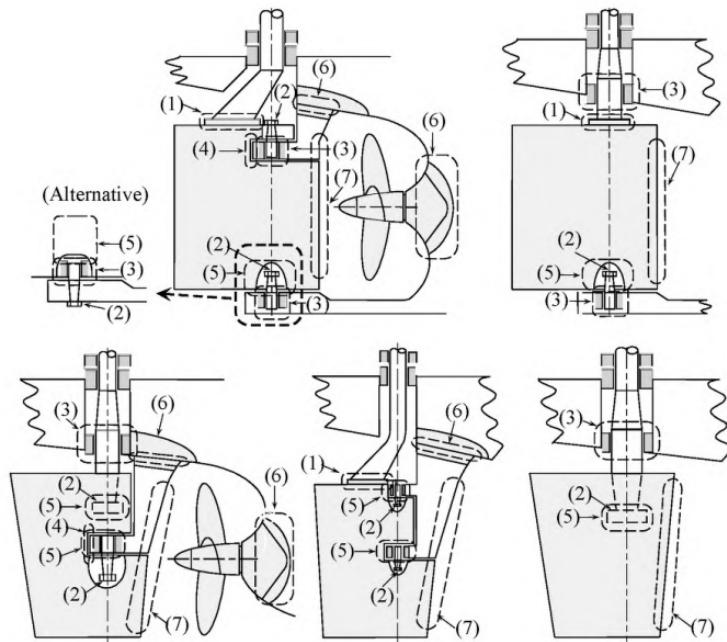
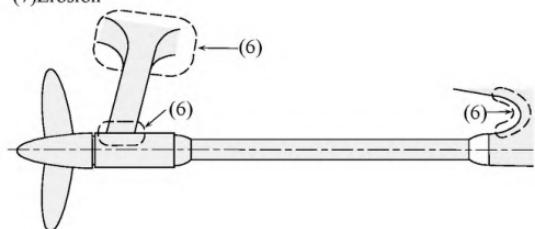
Figure 2 Potential problem areas

Damage to look for:

- (1) Fractures and loose coupling bolts
- (2) Loose nut
- (3) Wear(excessive bearing clearance)
- (4) Fractures in way of pintle cutout
- (5) Fractures in way of removable access plate
- (6) Fractures
- (7) Erosion

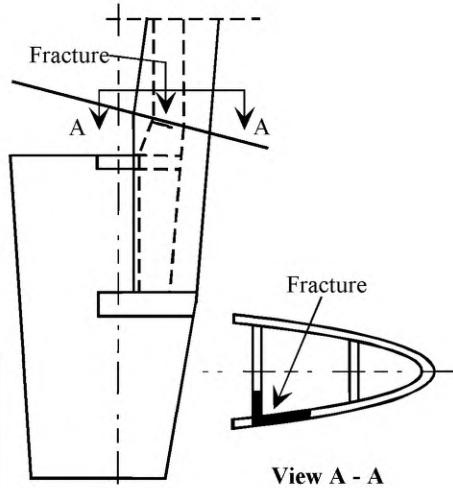
BULK CARRIERS		Guidelines for Surveys, Assessment and Repair of Hull Structure
Part 2	Fore and aft end regions	Example No.
Area 3	Stern frame, rudder arrangement and propeller shaft support	1
Detail of damage		Fractures in rudder horn along bottom shell plating
Sketch of damage

Notes on possible cause of damage <ol style="list-style-type: none"> 1. Insufficient strength due to poor design. 		Notes on repairs <ol style="list-style-type: none"> 1. Fractured plating to be veed-out and rewelded. 2. Fractured plating to be cropped and renewed if considered necessary. 3. Reinforcement should be considered if considered necessary.

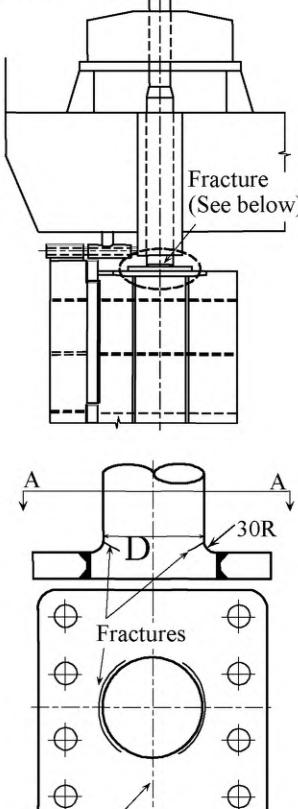
BULK CARRIERS		Guidelines for Surveys, Assessment and Repair of Hull Structure
Part 2	Fore and aft end regions	Example No.
Area 3	Stern frame, rudder arrangement and propeller shaft support	2
Detail of damage		Fractures in rudder stock
Sketch of damage

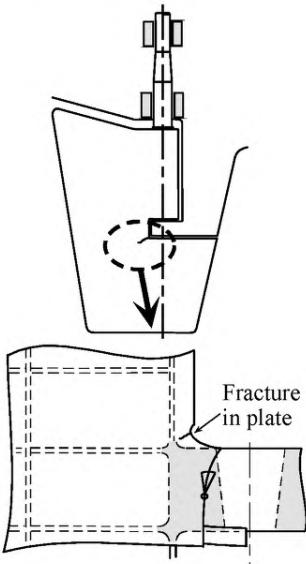
BULK CARRIERS		Guidelines for Surveys, Assessment and Repair of Hull Structure
Part 2	Fore and aft end regions	Example No.
Area 3	Stern frame, rudder arrangement and propeller shaft support	4
Detail of damage		Fractures in rudder plating of semi-spa ^d e rudder (short fracture with end located forward of the vertical web)
Sketch of damage

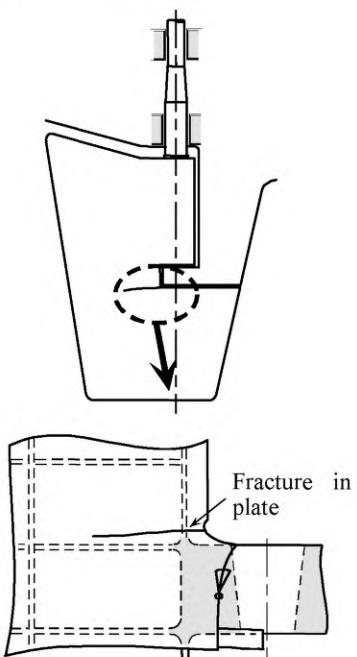
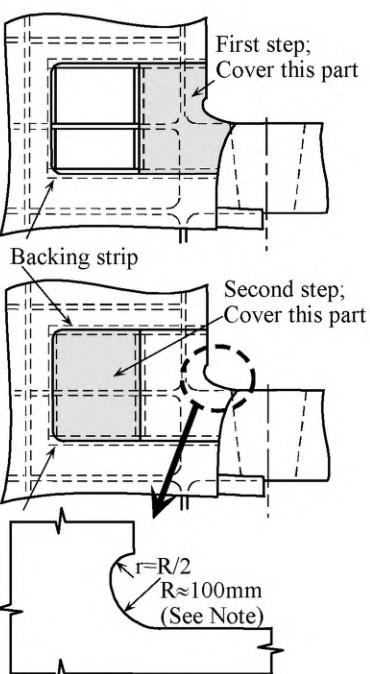
GENERAL CARGO SHIPS		Guidelines for Surveys, Assessment and Repair of Hull Structure
Part 2	Fore and aft end regions	Example No.
Area 3	Stern frame, rudder arrangement and propeller shaft support	5
Detail of damage		Fractures in rudder plating of semi-spaide rudder extending beyond the vertical web
Sketch of damage

<p>First step; Cover this part</p> <p>Backing strip</p> <p>Second step; Cover this part</p> <p>$r=R/2$ $R\approx100\text{mm}$ (See Note)</p> <p>Note: R should be considered according to local detail</p>
Notes on possible cause of damage <ol style="list-style-type: none"> 1. Stress concentration due to inadequate local design and/or fabrication notches in way of the butt weld between cast piece and plating. 		Notes on repairs <ol style="list-style-type: none"> 1. Fractured plating is to be cut-out. 2. Internal structures are to be checked. 3. Cut-out is to be closed by an insert plating according to the sketch (welding only from one side is demonstrated). 4. Modification of the radius. 5. In case of a new cast piece, connection with the plating is to be shifted outside the high stress area.

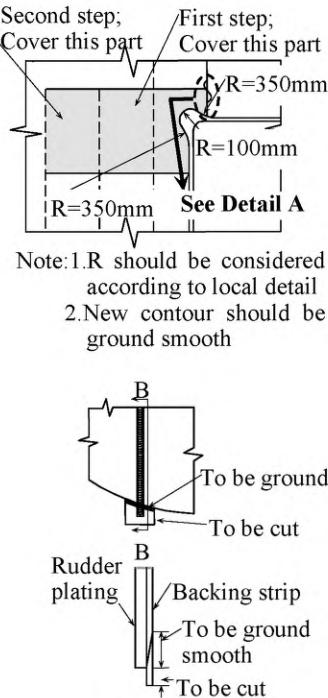
BULK CARRIERS		Guidelines for Surveys, Assessment and Repair of Hull Structure
Part 2	Fore and aft end regions	Example No.
Area 3	Stern frame, rudder arrangement and propeller shaft support	6
Detail of damage		Fractures in rudder plating of semi-spaide rudder in way of pintle cutout
Sketch of damage

<p>Second step; Cover this part</p> <p>First step; Cover this part</p> <p>$R=350\text{mm}$</p> <p>$R=100\text{mm}$</p> <p>See Detail A</p> <p>Note: 1. R should be considered according to local detail 2. New contour should be ground smooth</p> <p>View B - B</p>
Notes on possible cause of damage		<ol style="list-style-type: none"> 1. Inadequate design for stress concentration in way of pintle bearing (Fracture A). 2. Imperfection in welding seam (Fracture B).
Notes on repairs		<ol style="list-style-type: none"> 1. Fractured part to be cropped off. 2. Repair by two insert plates of modified, stress releasing contour. For the vertical seam no backing strip is used 100mm off contour, welding from both sides, to be ground after welding. 3. Variant (See Detail A): Repair as mentioned under 2 with the use of backing strip for the complete vertical seam. After welding backing strip partly removed by grinding.

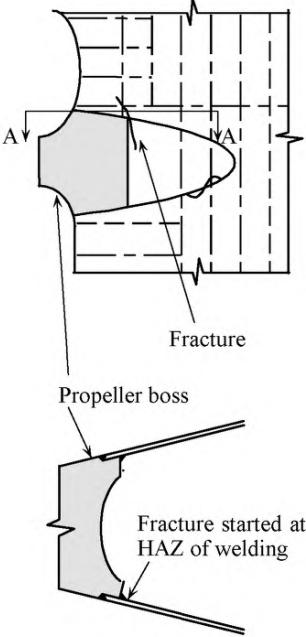
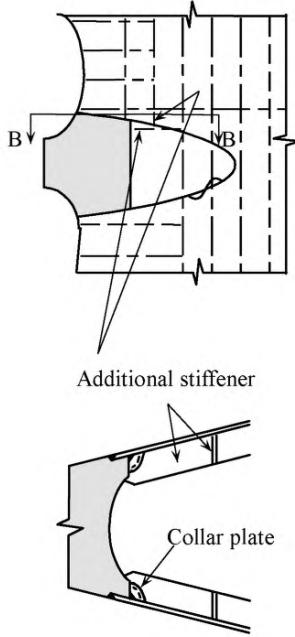
BULK CARRIERS		Guidelines for Surveys, Assessment and Repair of Hull Structure
Part 2	Fore and aft end regions	Example No.
Area 3	Stern frame, rudder arrangement and propeller shaft support	7
Detail of damage		Fractures in side shell plating at the connection to propeller boss
Sketch of damage

Notes on possible cause of damage 1. Fatigue fracture due to vibration.		Notes on repairs 1. Fractured side shell plating is to be cropped and part renewed. 2. Additional stiffeners are to be provided. 3. Collar plate is to be provided.

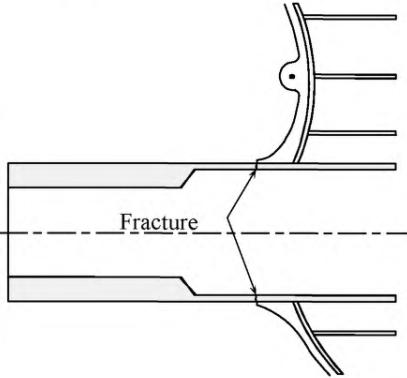
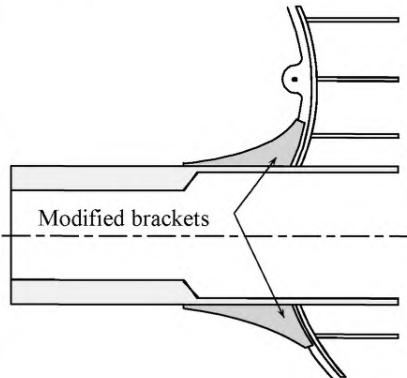
BULK CARRIERS		Guidelines for Surveys, Assessment and Repair of Hull Structure
Part 2	Fore and aft end regions	Example No.
Area 3	Stern frame, rudder arrangement and propeller shaft support	8
Detail of damage		Fractures in stern tube at the connection to stern frame
Sketch of damage

Notes on possible cause of damage 1. Fatigue fracture due to vibration.		Notes on repairs 1. Fractured tube is to be vee'd-out and welded from both sides. 2. Brackets are to be replaced by modified brackets with soft transition.

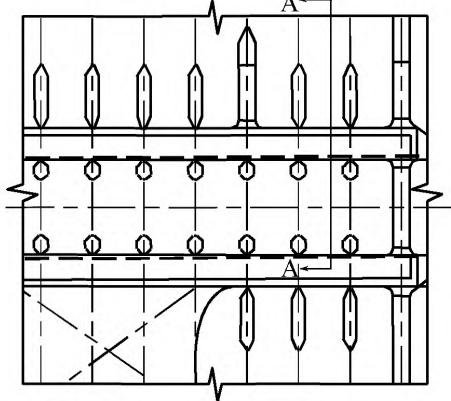
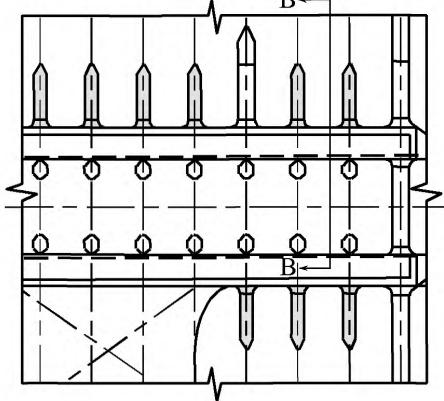
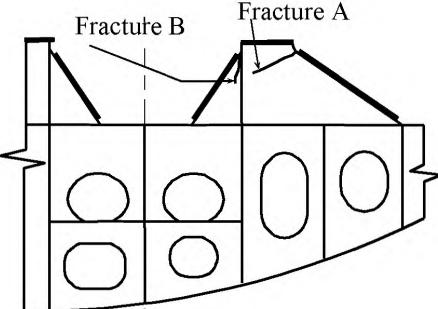
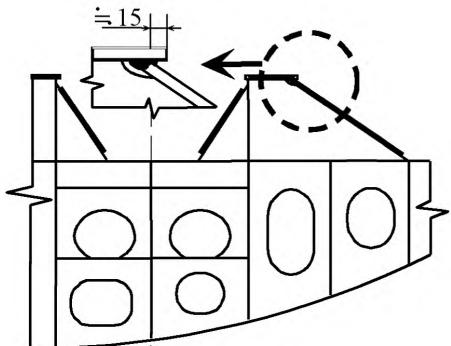
BILK CARRIERS		Guidelines for Surveys, Assessment and Repair of Hull Structure
Part 3	Machinery and accommodation spaces	Example No.
Area 1	Engine room structure	1
Detail of damage		Fractures in brackets at main engine foundation
Sketch of damage

<p>View B - B</p>
Notes on possible cause of damage <ol style="list-style-type: none"> 1. Vibration of main engine. 2. Insufficient strength of brackets at main engine foundation. 3. Insufficient pre-load bolts. 		Notes on repairs <ol style="list-style-type: none"> 1. Fractures are to be vee'd-out and re-welded. 2. New modified brackets at main engine foundation. 3. Or insert pieces and additional flanges to increase section modulus of the brackets.

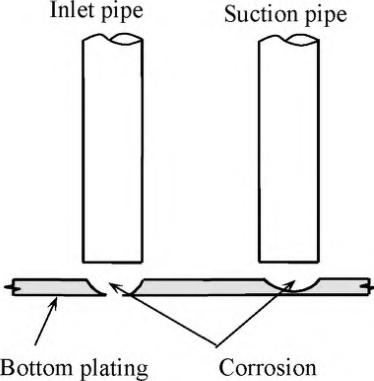
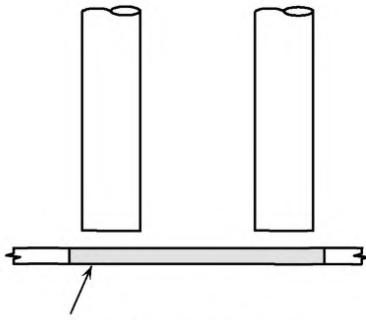
BULK CARRIERS		Guidelines for Surveys, Assessment and Repair of Hull Structure
Part 3	Machinery and accommodation spaces	Example No.
Area 1	Engine room structure	3
Detail of damage		Corrosion in bottom plating under inlet/suction/pipe in way of bilge tank in engine room
Sketch of damage

Notes on possible cause of damage <ol style="list-style-type: none"> 1. Heavy corrosion of bottom plating under the inlet/suction pipe. 		Notes on repairs <ol style="list-style-type: none"> 1. Corroded bottom plating is to be cropped and part renewed. Thicker plate is preferable. 2. Replacement of pipe end by enlarged conical opening (similar to suction head in ballast tank) is preferable.
