**РОССИЙСКИЙ МОРСКОЙ РЕГИСТР СУДОХОДСТВА
RUSSIAN MARITIME REGISTER OF SHIPPING**

**ПРИЛОЖЕНИЕ К ПРАВИЛАМ И РУКОВОДСТВАМ
РОССИЙСКОГО МОРСКОГО РЕГИСТРА СУДОХОДСТВА**

**SUPPLEMENT TO RULES AND GUIDELINES
OF RUSSIAN MARITIME REGISTER OF SHIPPING**

**IACS PROCEDURAL REQUIREMENTS,
UNIFIED REQUIREMENTS,
UNIFIED INTERPRETATIONS
AND RECOMMENDATIONS**

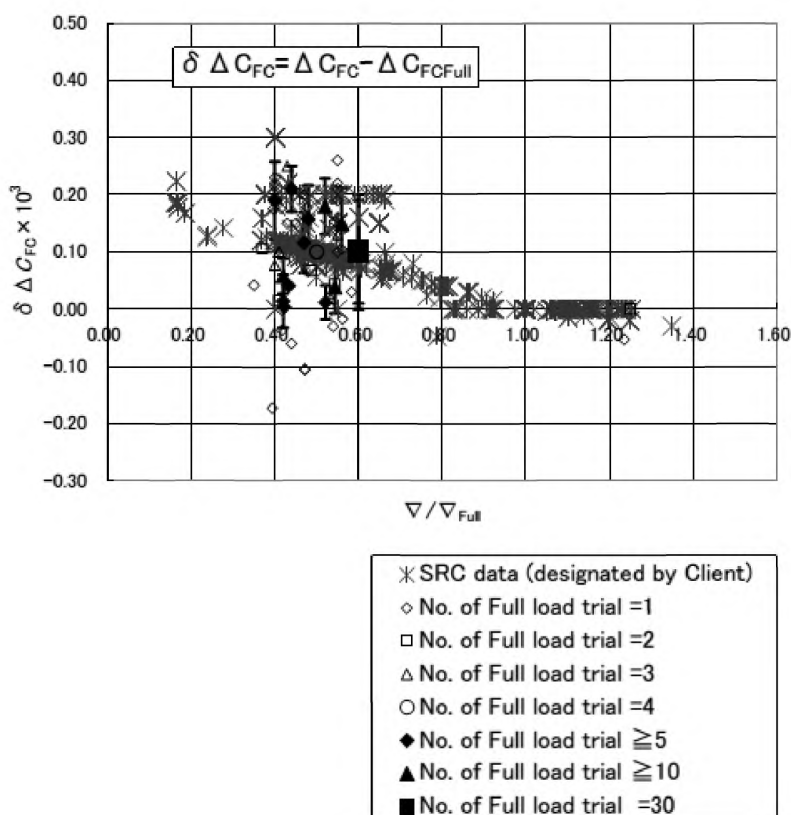
Figure 3.2: Variation of ΔC_{FC} as a function of the displacement ratio

NB: The trends in Figures 3.1 and 3.2 are based on limited data and may be revised in the future. The displayed trends depend on the method used to analyze the model tests behind the data including the form factor and other correlation factor relations. Other values may be accepted if based on sufficient number of data.

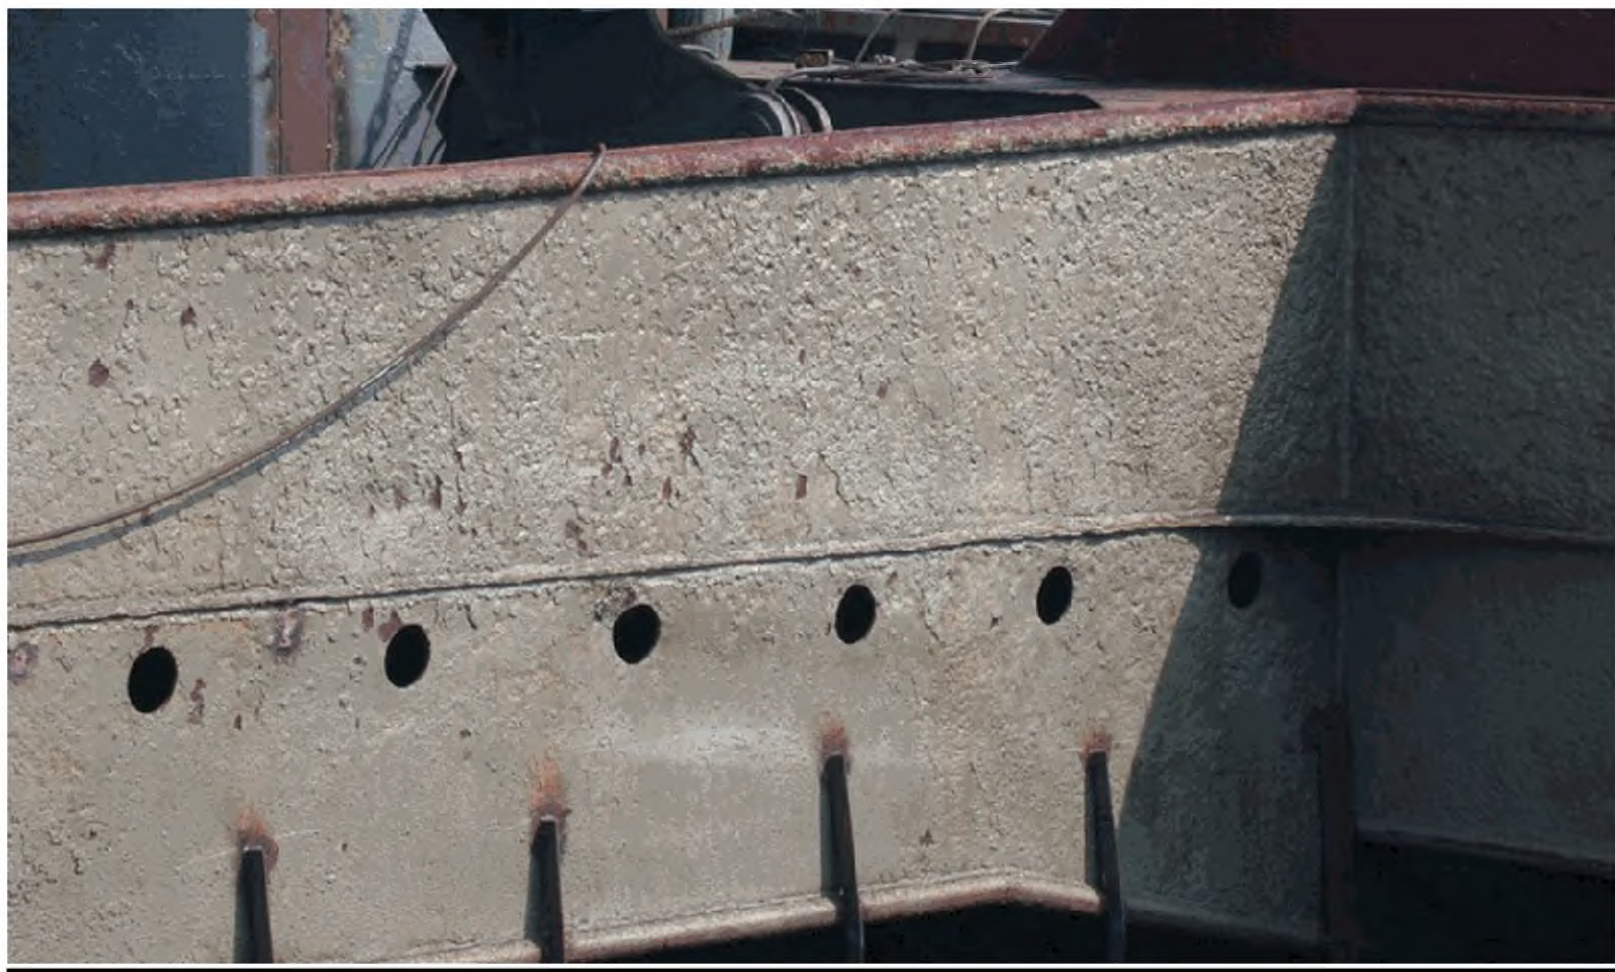
Photograph 1 Heavy corrosion of hatch coaming

- 3.1.1** The level of wastage of under-deck stiffeners/structures may have to be established by means of thickness measurements. As mentioned previously the combination of the effects from the marine environment and the local atmosphere will give rise to high corrosion rates.
- 3.1.2** Severe corrosion of the hatch coaming from inside and of under deck girders may occur due to difficult access for maintenance of the protective coating. This may in turn lead to fractures (See **Photograph 1**).

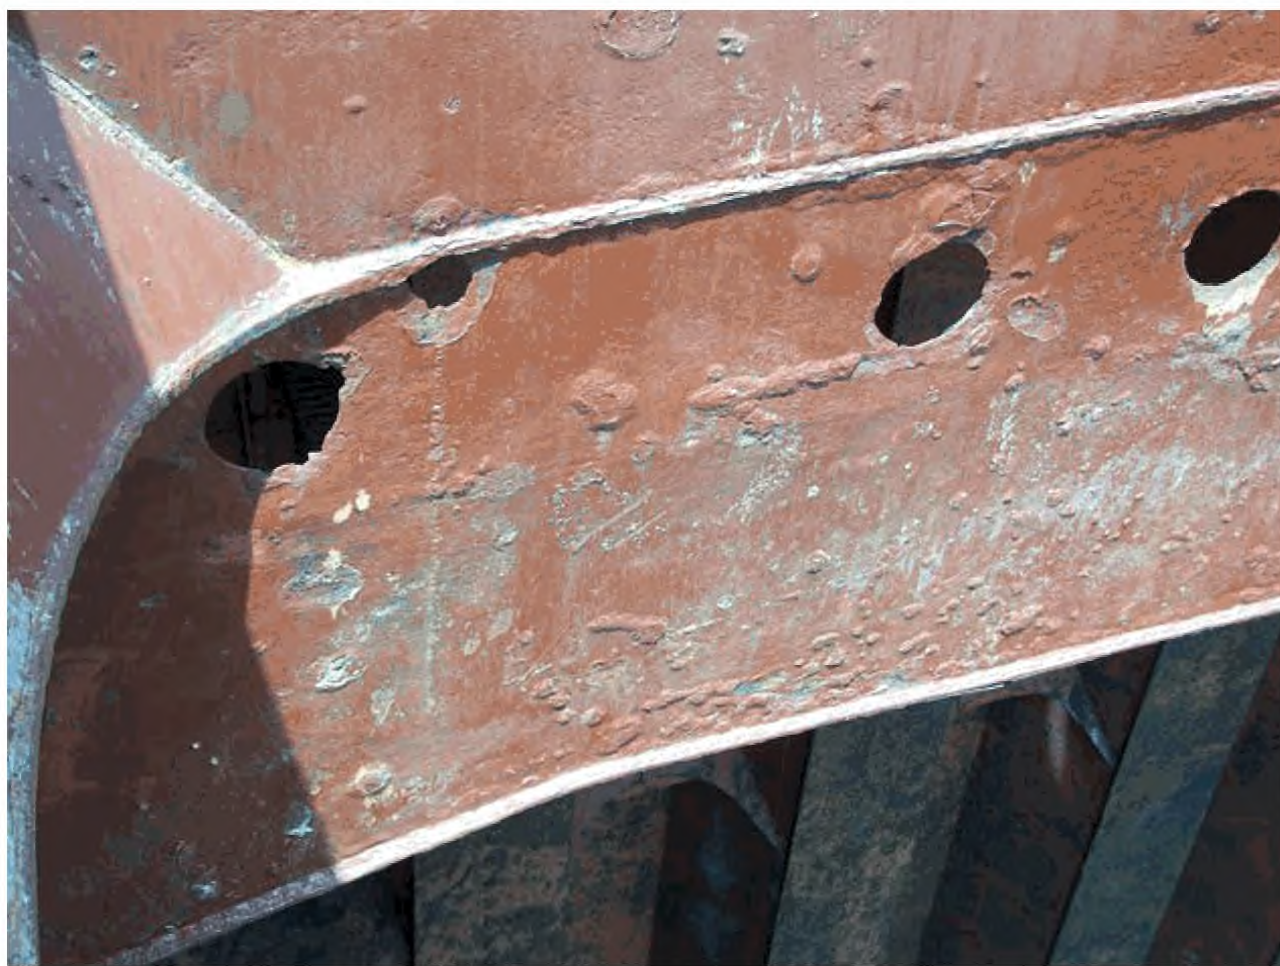
Photograph 2 Heavy corrosion of hatch coaming

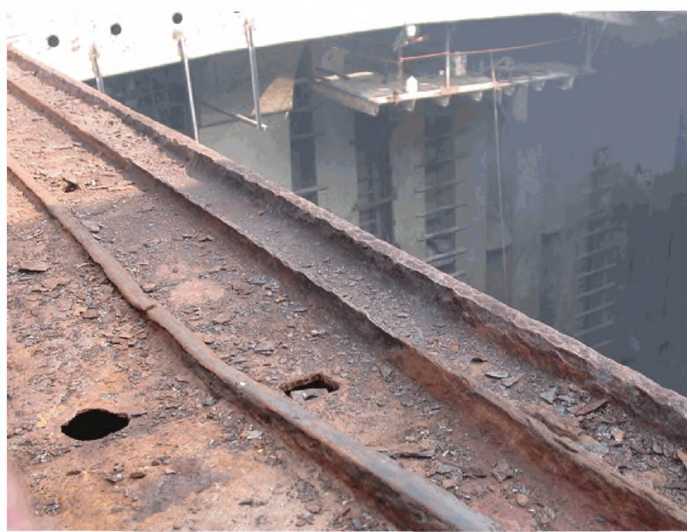
Photograph 4 Corrosion at the top of the hatch coaming

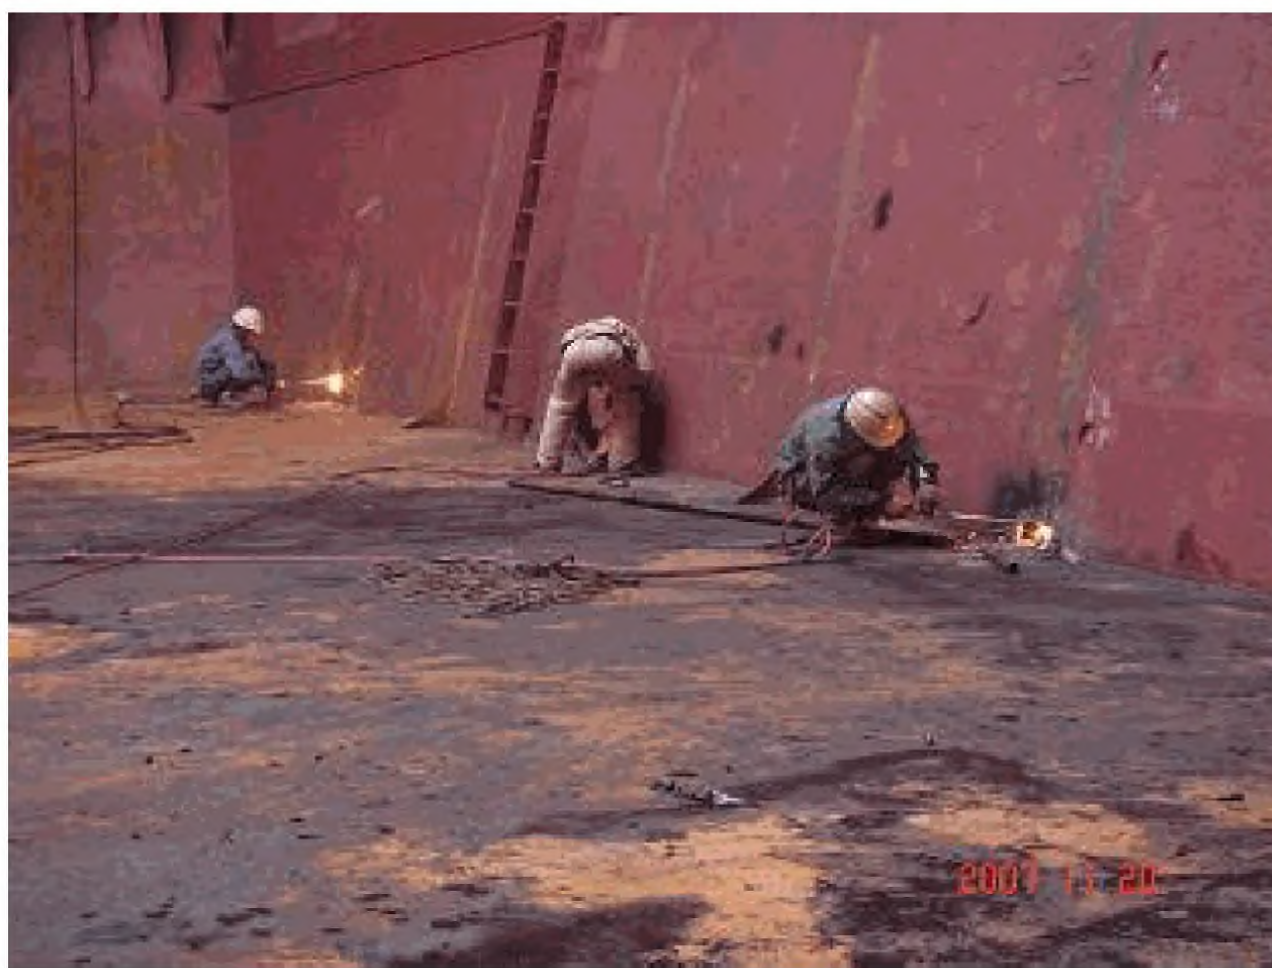
Photograph 1 Heavy corrosion affecting inner bottom plating

- 2.1.2 When the tank top plating has been covered with dunnage or ceiling the plating may have suffered heavy corrosion, due to high humidity, and lack of proper maintenance (See **Photograph 1**).

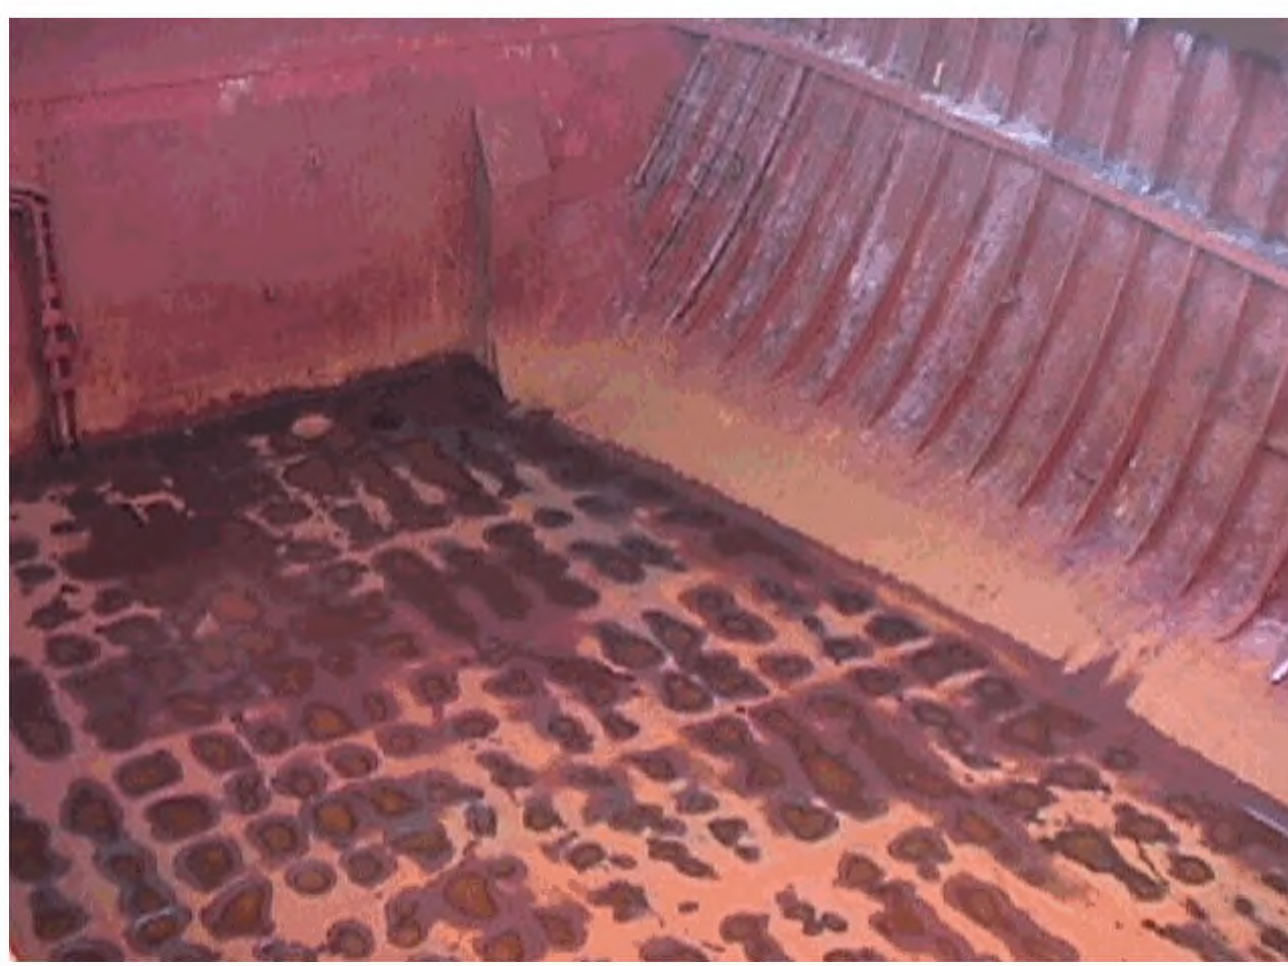
Photograph 2 Damaged inner bottom plating

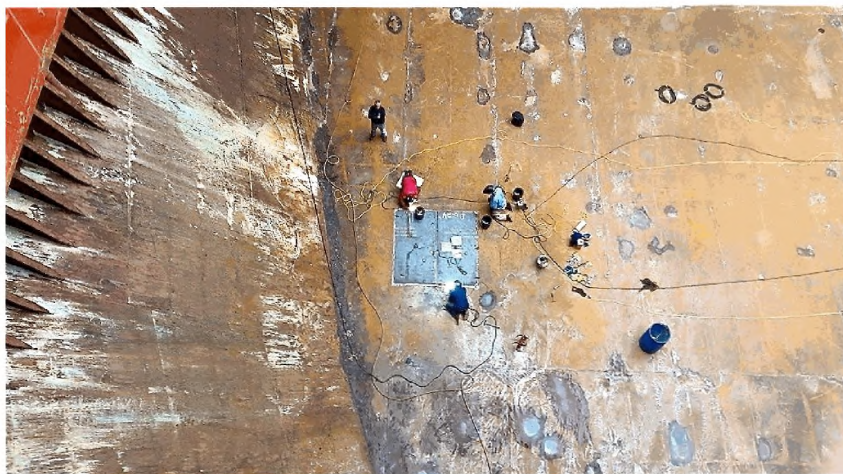
Photograph 3 Repairs of damaged inner bottom plating

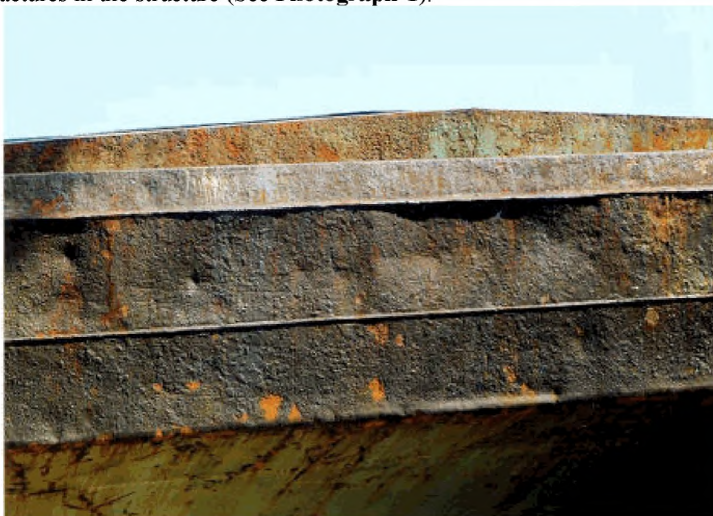
Photograph 1 **Heavy corrosion of hatch coaming and topside tank plating vertical strake**

- 3.1.1 The level of wastage of under-deck stiffeners/structure in cross deck may have to be established by means of thickness measurements. The combined effect of the marine environment and the high humidity atmosphere within cargo hold s will give rise to a high corrosion rate.
- 3.1.2 Severe corrosion of the hatch coaming plating inside cargo hold and topside tank plating vertical strake may occur due to difficult access for the maintenance of the protective coating. This may lead to fractures in the structure (See **Photograph 1**).

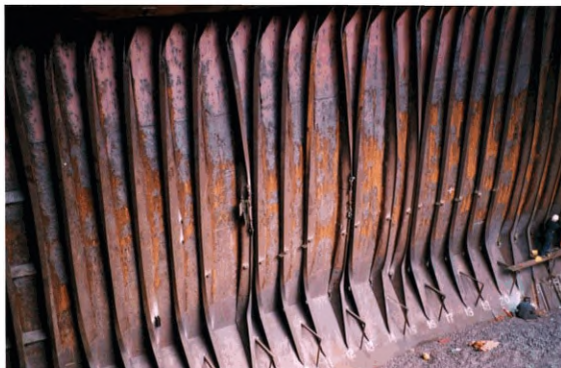
Photograph 1 Collapsed side shell frames (See Example 4)

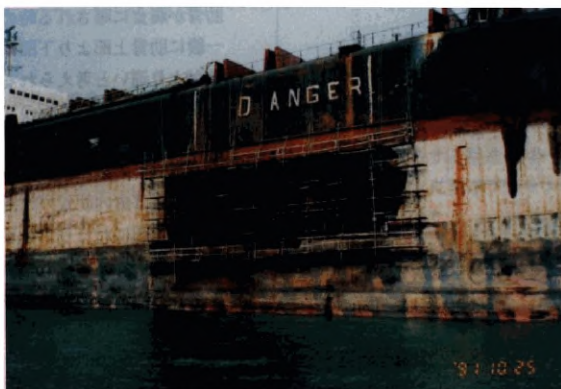
Photograph 2 Missing side shell structure (See Examples 4 and 5)

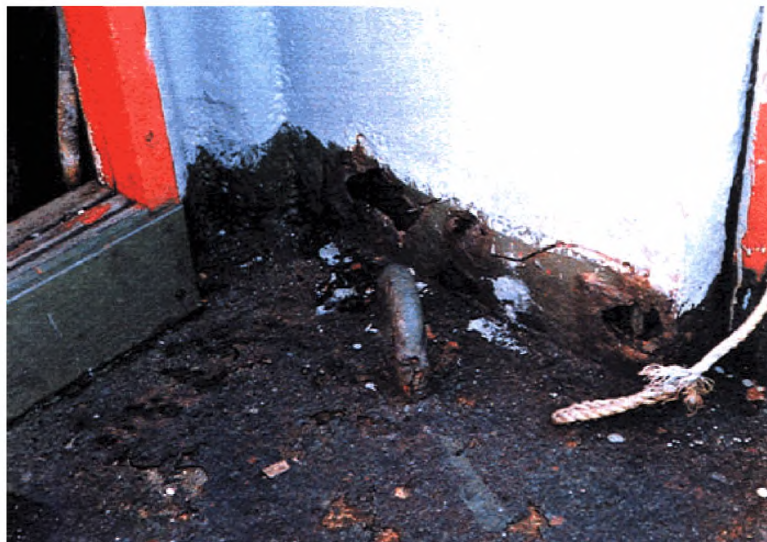
Photograph 1 Corroded accommodation house side structure

Severe corrosion may be found in exposed deck plating and deck house side structure adjacent to the deck plating where water is liable to accumulate (See **Photograph 1**). Corrosion may also be found in accommodation bulkheads around cutout for fittings, such as doors, side scuttles, ventilators, etc., where proper maintenance of the area is relatively difficult. Deterioration of the bulkheads including fittings may impair the integrity of weathertightness.

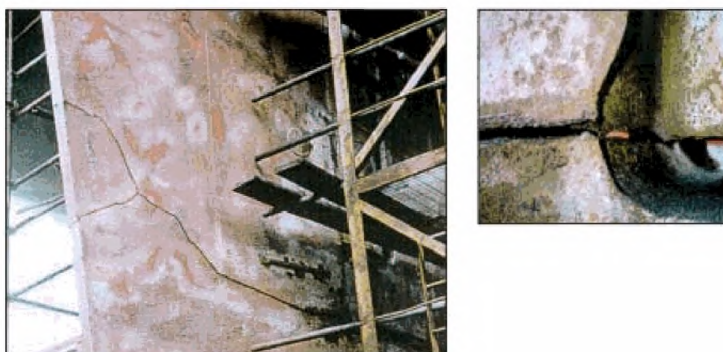
Photograph 1 Fractured rudder

2.3.1 Corrosion/erosion (such as deep pitting corrosion) should be looked for in rudder/rudder horn plating, especially in welds. In extreme cases the corrosion /erosion may cause a large fracture as shown in

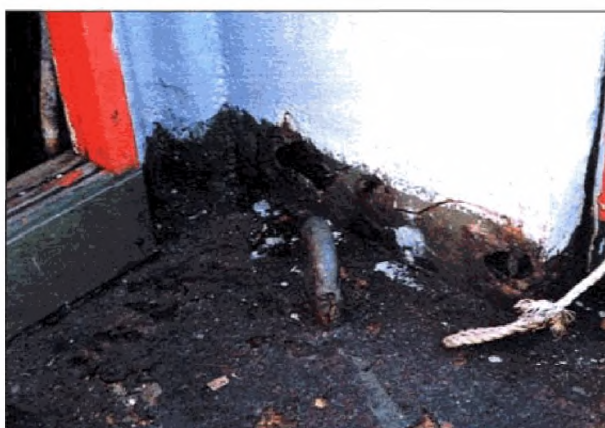
Photograph 1 Corroded accommodation house side structure

Severe corrosion may be found in exposed deck plating and the deck house side structure adjacent to the deck plating where water is liable to accumulate (See **Photograph 1**). Corrosion may also be found in accommodation bulkheads around the cutout for fittings, such as doors, side scuttles, ventilators, etc., where proper maintenance of the area is relatively difficult. Deterioration of the bulkheads including fittings may impair the integrity of weathertightness.

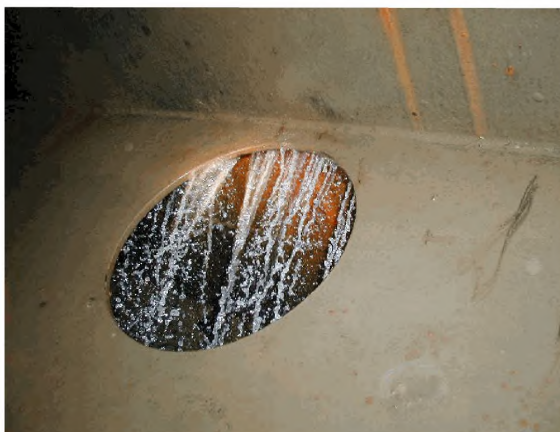
Photograph 1 Side shell fracture in way of horizontal stringer weld

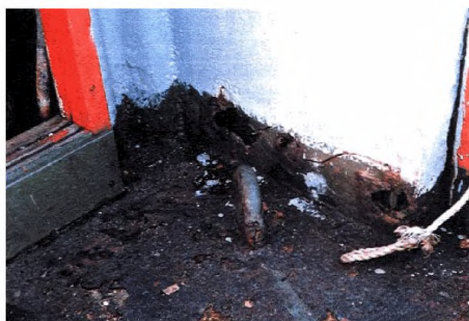
Photograph 1 Corroded accommodation house side structure

Severe corrosion may be found in exposed deck plating and deck house side structure adjacent to the deck plating where water is liable to accumulate (See **Photograph 1**). Corrosion may also be found in accommodation bulkheads around cut-out for fittings, such as doors, side scuttles, ventilators, etc., where proper maintenance of the area is relatively difficult. Deterioration of the bulkheads including fittings may impair the integrity of weathertightness.
