**РОССИЙСКИЙ МОРСКОЙ РЕГИСТР СУДОХОДСТВА**  
**RUSSIAN MARITIME REGISTER OF SHIPPING**

**IACS PROCEDURAL REQUIREMENTS,  
UNIFIED INTERPRETATIONS  
AND RECOMMENDATIONS**

## **GENERAL DRY CARGO SHIPS**

Guidelines for  
Surveys, Assessment and Repair  
of Hull Structure

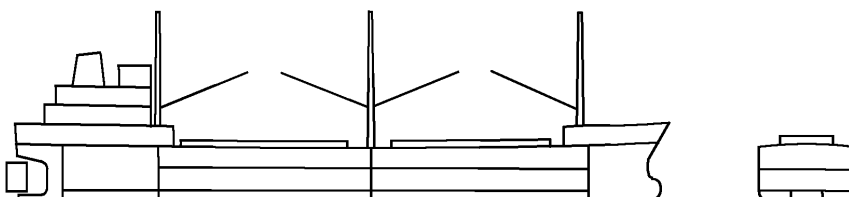
**Figure 1** shows a typical general arrangement of a general dry cargo ship with single tween deck.

**Figure 1** General view of a typical general dry cargo ship

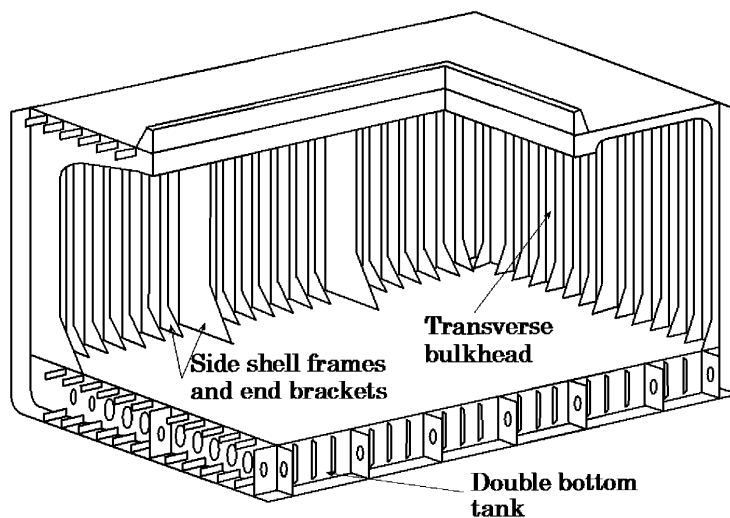
(a) Single deck ship

**Figures 2 (a) and (b)** show cargo hold structural configurations for general dry cargo ships. As

Figure 2 Cargo hold structural configurations for general dry cargo ships

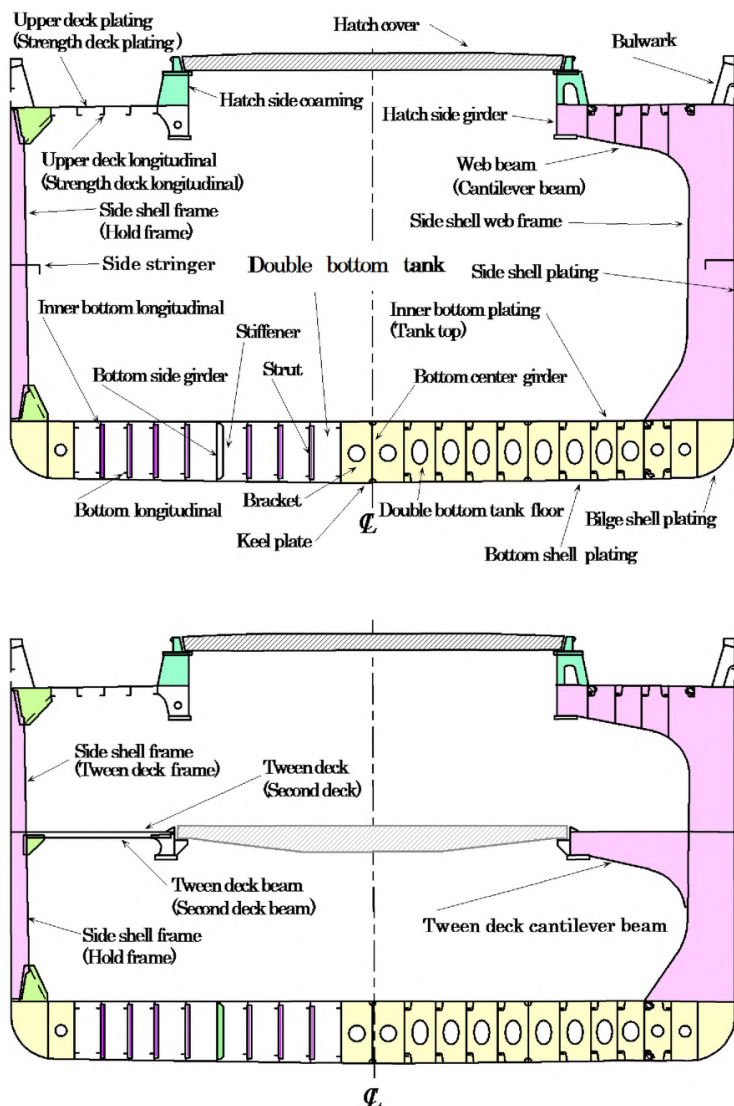
Figure 3 (a) Nomenclature for typical transverse section in way of cargo hold

- 3.2.1 For clarity of definition and reporting of survey data, it is recommended that standard nomenclature for structural elements be adopted. Typical sections in way of cargo holds are illustrated in **Figures 3 (a) and (b)**. These figures show the generally accepted nomenclature.

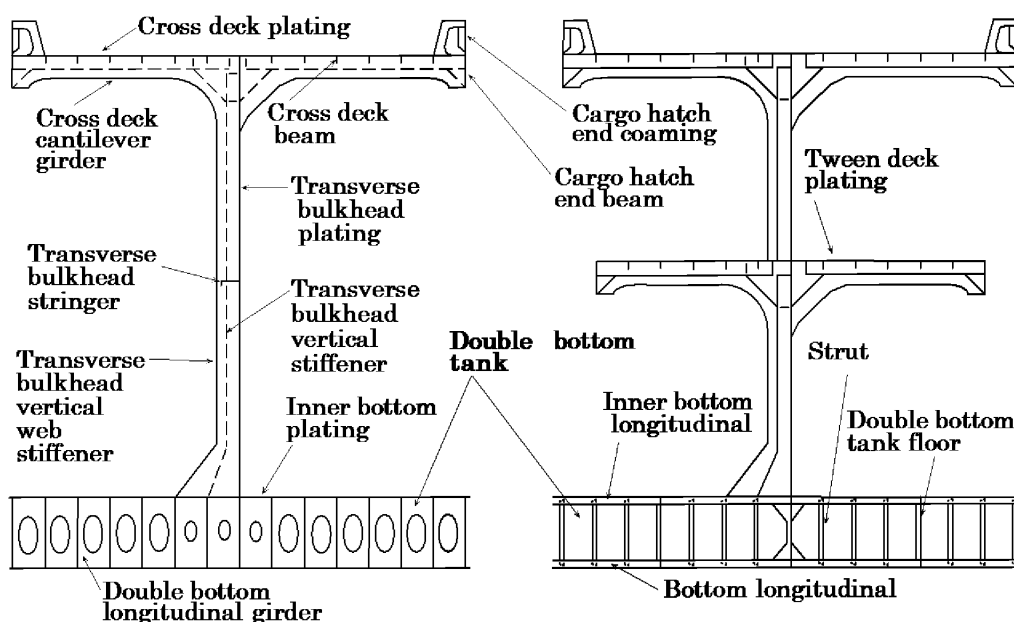
Figure 3 (b) Nomenclature for typical watertight bulkhead

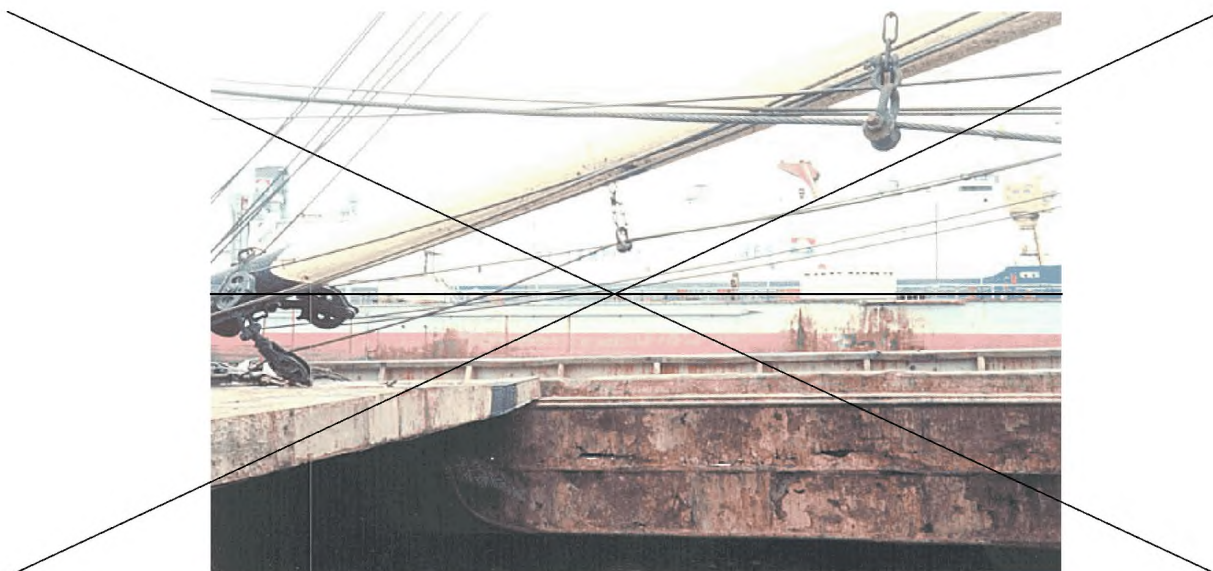
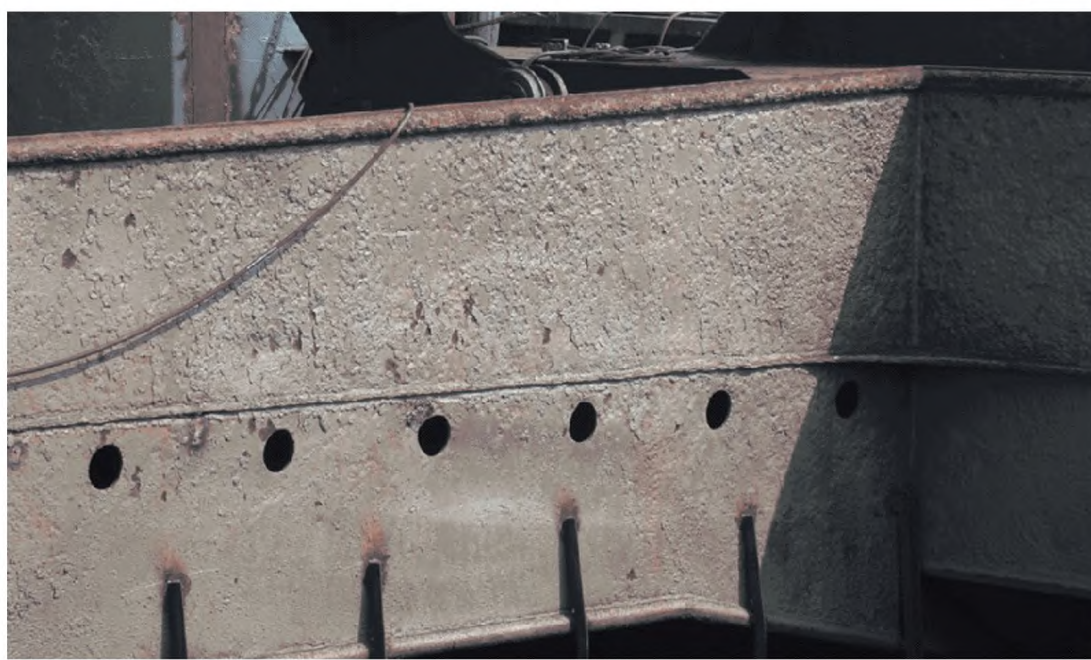
**Photograph 1 Heavy corrosion of hatch coaming**

**3.1.2** Severe corrosion of the hatch coaming from inside and of under deck girders may occur due to difficult access for maintenance of the protective coating. This may in turn lead to fractures (See **Photograph 1**).

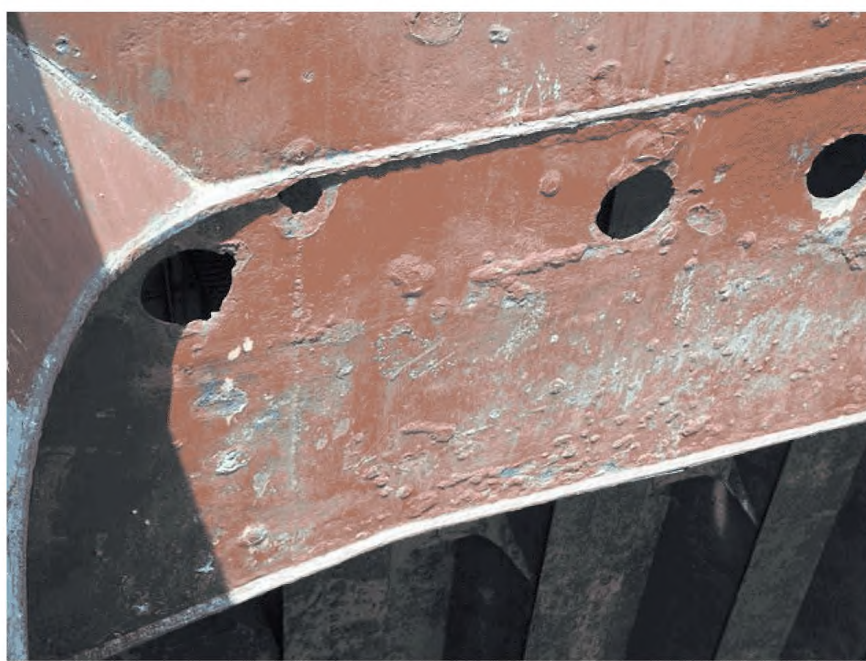
**Photograph 2 Heavy corrosion of hatch coaming**

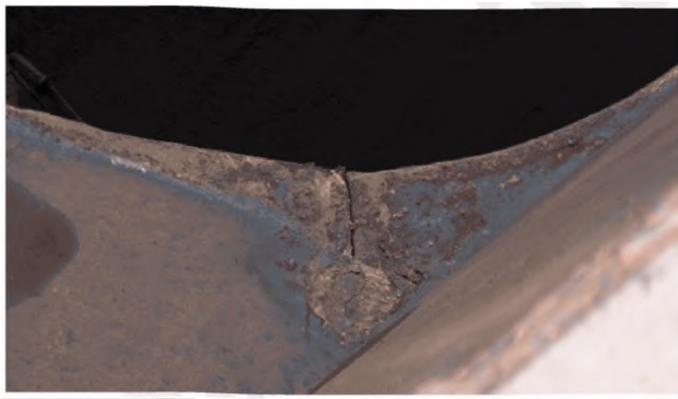
**Photograph 3**    **Fractures at the hatch corner**

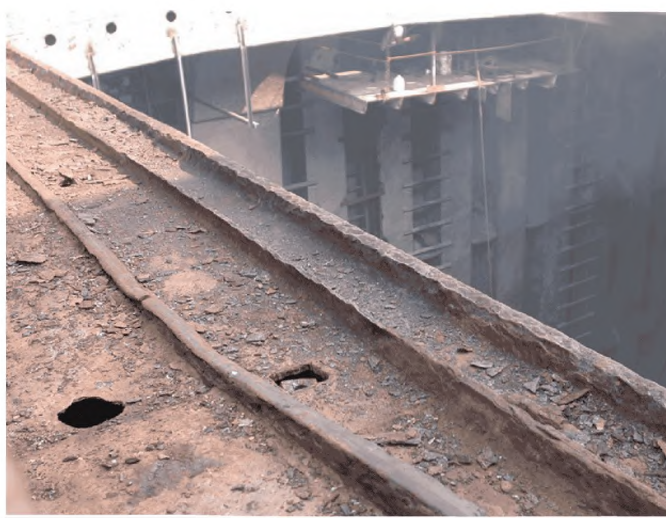
**Photograph 4**    **Corrosion at the top of the hatch coaming**

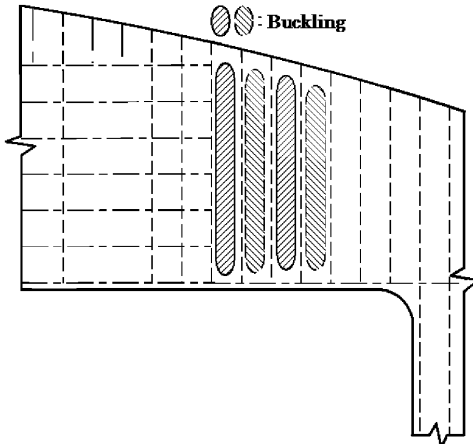
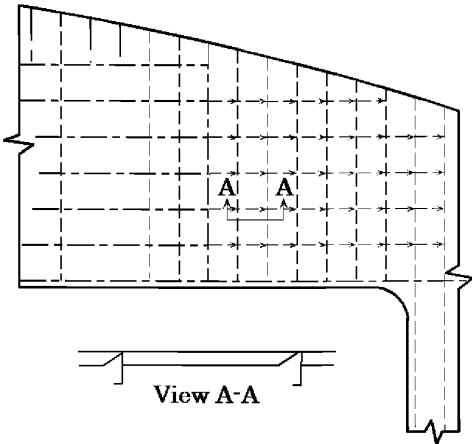
GENERAL DRY CARGO SHIPS		Guidelines for Surveys, Assessment and Repair of Hull Structure
Part 1	Cargo hold region	Example No.
Area 1	Upper deck structure	1
Detail of damage	Buckling of deck plating of transverse framing system	
Sketch of damage		Sketch of repair

<b>Notes on possible cause of damage</b> <ol style="list-style-type: none"> <li>Excessive compressive stress due to slamming or bow flare effect.</li> <li>Insufficient longitudinal stiffening of deck plating.</li> </ol>		<b>Notes on repairs</b> <ol style="list-style-type: none"> <li>Buckled plating should be cropped and renewed. Longitudinal internal stiffeners should be provided. (Instead of longitudinal stiffeners, renewal by thicker deck plating can be accepted.)</li> <li>Stress concentration may occur at the end of sniped stiffener resulting in fatigue fracture. For locations where high cyclic stress may occur, appropriate connection such as lug-connection should be considered.</li> </ol>

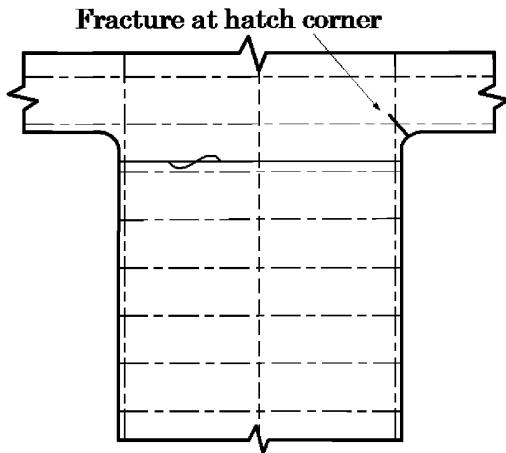
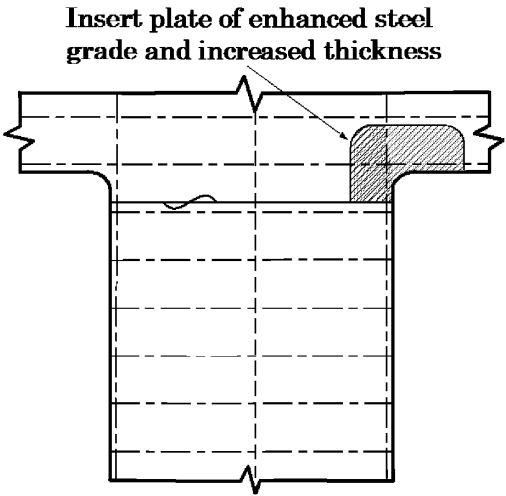
GENERAL DRY CARGO SHIPS		Guidelines for Surveys, Assessment and Repair of Hull Structure
Part 1	Cargo hold region	Example No.
Area 1	Upper deck structure	2
Detail of damage	Fractures at main cargo hatch corner	
<b>Sketch of damage</b>

<b>Notes on possible cause of damage</b> <ol style="list-style-type: none"> <li>1. Stress concentration at hatch corners, i.e. radius of corner.</li> <li>2. Welded attachment of shedder plate close to edge of hatch corner.</li> <li>3. Wire rope groove.</li> </ol>		<b>Notes on repairs</b> <ol style="list-style-type: none"> <li>1. The corner plating in way of the fracture is to be cropped and renewed. If stress concentration is primary cause, insert plate should be of increased thickness, enhanced steel grade and/or improved geometry. Insert plate should be continued beyond the longitudinal and transverse extent of the hatch corner radius ellipse or parabola, and the butt welds to the adjacent deck plating should be located well clear of the butts in the hatch coaming. It is recommended that the edges of the insert plate and the butt welds connecting the insert plates to the surrounding deck plating be made smooth by grinding. In this respect caution should be taken to ensure that the micro grooves of the grinding are parallel to the plate edge.</li> <li>2. If the cause of fracture is welded attachment of shedder plate, the deck connection should be left unwelded.</li> <li>3. If the cause of the fracture is wire rope groove, replacement to the original design can be accepted.</li> </ol>

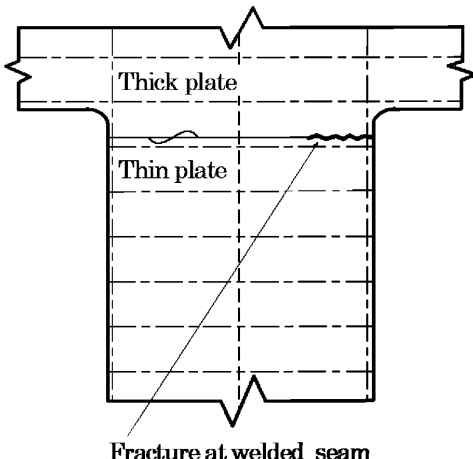
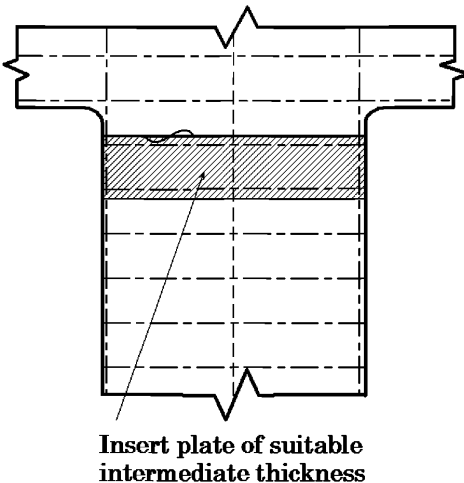
GENERAL DRY CARGO SHIPS		Guidelines for Surveys, Assessment and Repair of Hull Structure
Part 1	Cargo hold region	Example No.
Area 1	Upper deck structure	3-a
Detail of damage	Fracture of welded seam between thick plate and thin plate at cross deck	
Sketch of damage		Sketch of repair

<p>Thick plate</p> <p>Thin plate</p> <p>Fracture at welded seam</p>

<p>Insert plate of suitable intermediate thickness</p>
<b>Notes on possible cause of damage</b> <ol style="list-style-type: none"> <li>1. Stress concentration created by abrupt change in deck plating thickness.</li> <li>2. In-plane bending in cross deck strip due to torsional (longitudinal) movements of ship sides.</li> <li>3. Welded seam not clear of tangent point of hatch corner.</li> </ol>		<b>Notes on repairs</b> <ol style="list-style-type: none"> <li>1. Insert plate of intermediate thickness is recommended.</li> <li>2. Smooth transition between plates (beveling) should be considered.</li> </ol>

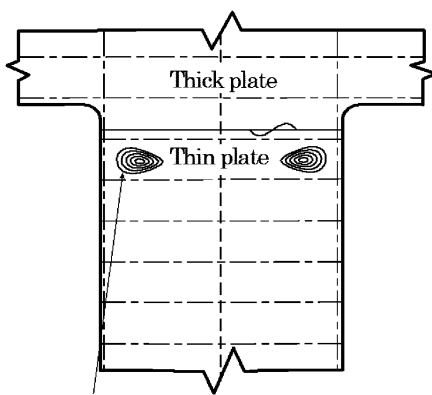
GENERAL DRY CARGO SHIPS		Guidelines for Surveys, Assessment and Repair of Hull Structure
Part 1	Cargo hold region	Example No.
Area 1	Upper deck structure	3-b
Detail of damage	Plate buckling in thin plate near thick plate at cross deck	
Sketch of damage		Sketch of repair

<p>Buckling of cross deck plating</p>

<p>Additional transverse stiffening and/or insertion of plate with suitable intermediate thickness</p>
<b>Notes on possible cause of damage</b> <ol style="list-style-type: none"> <li>1. In-plane bending of cross deck strip due to torsional (longitudinal) movement of ship sides, often in combination with corrosion.</li> <li>2. Insufficient transverse stiffening.</li> </ol>		<b>Notes on repairs</b> <ol style="list-style-type: none"> <li>1. Transverse stiffeners extending from hatch sides towards centerline at least 10% of breadth of hatch, and/or increased plate thickness in the same area.</li> </ol>

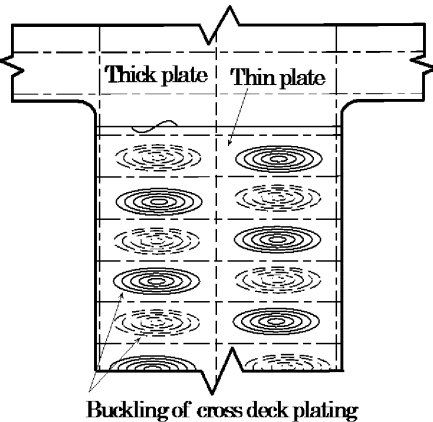
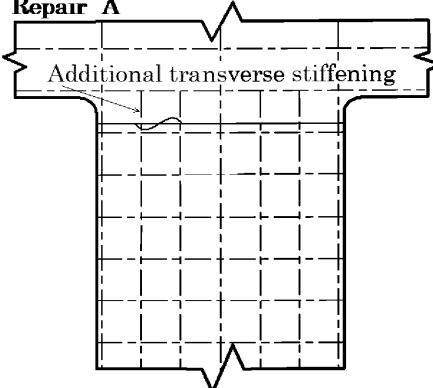
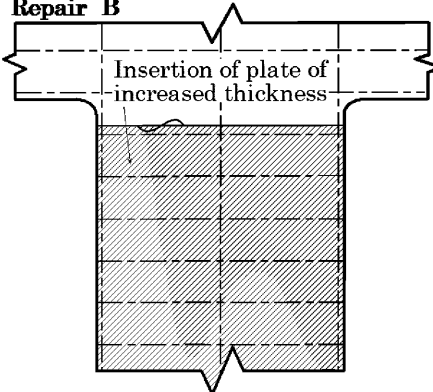
GENERAL DRY CARGO SHIPS		Guidelines for Surveys, Assessment and Repair of Hull Structure
Part 1	Cargo hold region	Example No.
Area 1	Upper deck structure	3-c
Detail of damage	Overall buckling of cross deck plating	
Sketch of damage		Sketch of repair

<p>Buckling of cross deck plating</p>		<p><b>Repair A</b></p>

<p><b>Repair B</b></p>

<b>Notes on possible cause of damage</b> <ol style="list-style-type: none"> <li>1. Transverse compression of deck due to sea load.</li> <li>2. Insufficient transverse stiffening.</li> </ol>		<b>Notes on repairs</b> <ol style="list-style-type: none"> <li>1. <b>Repair A</b> Plating of original thickness in combination with additional transverse stiffening.</li> <li>2. <b>Repair B</b> Insertion of plating of increased thickness.</li> </ol>

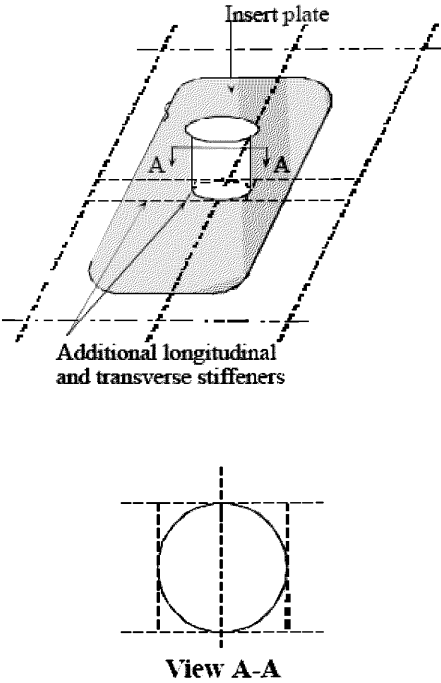
GENERAL DRY CARGO SHIPS		Guidelines for Surveys, Assessment and Repair of Hull Structure
Part 1	Cargo hold region	Example No.
Area 1	Upper deck structure	3-d
Detail of damage		Deformed and fractured deck plating around tug bitt
Sketch of damage		Sketch of repair

Notes on possible cause of damage		Notes on repairs
1. <u>Insufficient strength.</u>		1. <u>Fractured/deformed deck plating should be cropped and part renewed.</u>
		2. <u>Reinforcement by stiffeners should be considered.</u>

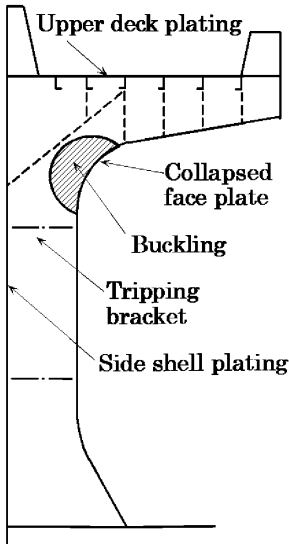
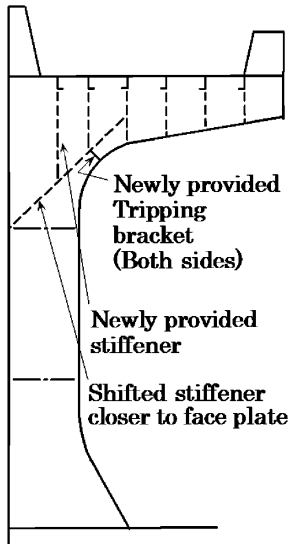
GENERAL DRY CARGO SHIPS		Guidelines for Surveys, Assessment and Repair of Hull Structure
Part 1	Cargo hold region	Example No.
Area 1	Upper deck structure	4
Detail of damage		Buckling of web beam
<b>Sketch of damage</b>

<b>Notes on possible cause of damage</b> <ol style="list-style-type: none"> <li>1. Overloading by green sea on deck or by excessive deck cargo.</li> <li>2. Excessive corrosion.</li> <li>3. Insufficient/improper web stiffening.</li> </ol>		<b>Notes on repairs</b> <ol style="list-style-type: none"> <li>1. Buckled part is to be cropped and renewed.</li> <li>2. If corrosion is not the cause, renewal by thicker plate (web and/or face) and/or reinforcement by stiffener and tripping bracket should be considered.</li> </ol>

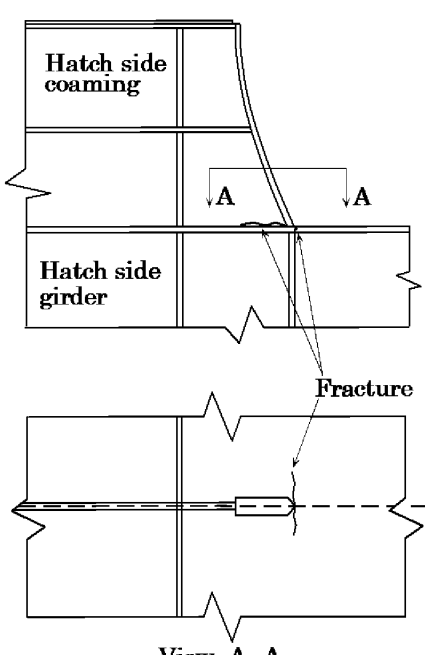
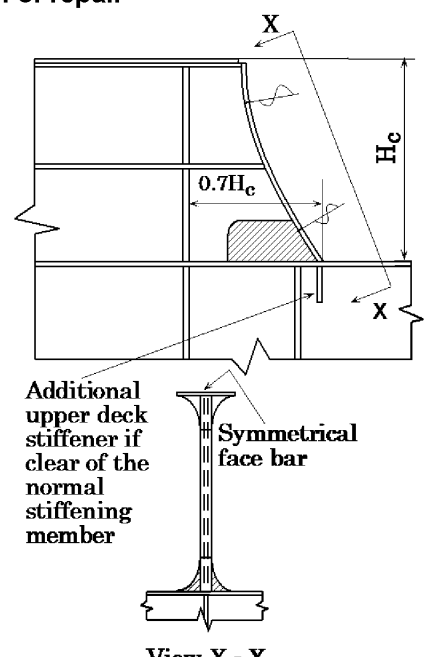
GENERAL DRY CARGO SHIPS		Guidelines for Surveys, Assessment and Repair of Hull Structure
Part 1	Cargo hold region	Example No.
Area 1	Upper deck structure	5-a
Detail of damage	Fractures in the web or in the deck at the toes of the longitudinal hatch coaming termination bracket (discontinuous longitudinal hatch coaming)	
<b>Sketch of damage</b>

<b>Notes on possible cause of damage</b> 1. This damage is caused by stress concentrations attributed to the design of the bracket.		<b>Notes on repairs</b> 1. The design of the bracket can be altered as shown above, however, it is to be ensured that an additional under deck stiffener is provided at the toe of the termination bracket, where the toe is clear of the normal stiffening member. Full penetration weld for a distance of $0.15 H_c$ 2. from toe of side coaming termination bracket and for connection of athwartship gusset bracket to deck. The fracture in deck plating to be veed-out and 3. rewelded or deck plating cropped and part renewed as appropriate, using low hydrogen electrodes for welding.

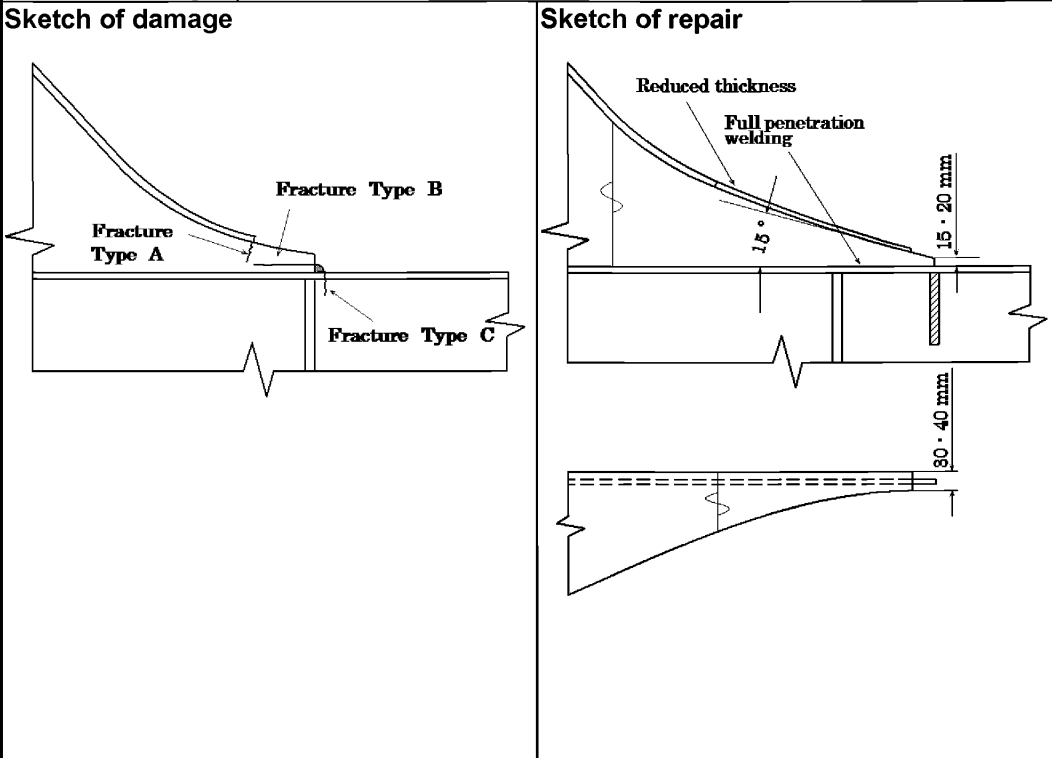
GENERAL DRY CARGO SHIPS		Guidelines for Surveys, Assessment and Repair of Hull Structure
Part 1	Cargo hold region	Example No.
Area 1	Upper deck structure	5-b
Detail of damage	Fractures in continuous longitudinal hatch coaming extension bracket	
Sketch of damage

<p>The sketch of damage shows three fracture types: Fracture Type A (in the web), Fracture Type B (in the web at the undercut or HAZ of the fillet weld), and Fracture Type C (in the deck plating). The sketch of repair shows the same structure with 'Reduced thickness' and 'Full penetration welding' indicated. Dimensions include a 15° angle, 15 · 20 mm, and 80 · 40 mm.</p>	
Notes on possible cause of damage	Notes on repairs	
<ol style="list-style-type: none"> <li>1. Flange force at the end of the flange too high due to insufficient tapering (<b>Fracture Type A</b>, propagating in the web).</li> <li>2. Shear force in the web plate too high due to insufficient reduction of the web height at the end (<b>Fracture Type B</b>, propagating in the web at the undercut or HAZ of the fillet weld). Insufficient support of the extension bracket below the deck (<b>Fracture Type C</b>, starting from undercut or HAZ of the fillet weld and propagating in the deck plating).</li> </ol>		<ol style="list-style-type: none"> <li>1. Extend the extension bracket as long as possible to arrange a gradual transition.</li> <li>2. Reduce the web height at the end of the bracket; in case of high stress areas grind smooth the transition to the deck plating welding.</li> <li>3. Reduce the cross sectional area of the flange at the end as far as possible.</li> <li>4. Provide longitudinal structure in way of the web of the extension bracket to the next transverse structure or provide a new transverse structure.</li> </ol>

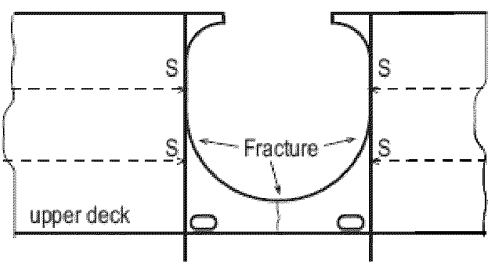
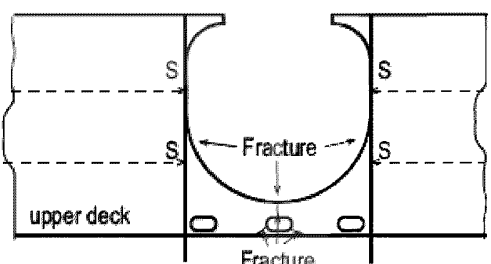
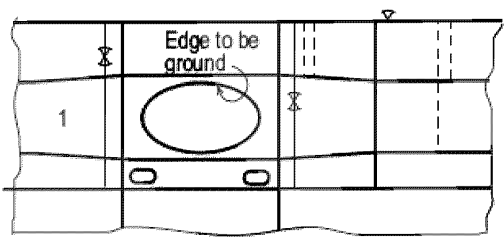
GENERAL DRY CARGO SHIPS		Guidelines for Surveys, Assessment and Repair of Hull Structure
Part 1	Cargo hold region	Example No.
Area 1	Upper deck structure	5-c
Detail of damage	Fracture in access hole of longitudinal hatch coaming	
Sketch of damage		Sketch of repair

<b>Notes on possible cause of damage</b> <u>1. Coincidence of maximum increased stress due to the reduction of the hatch coaming with the metallurgical notches due to the welding seams in web and flat bar located at the same position. Insufficient transverse stiffening.</u>		<b>Notes on repairs</b> <u>1. Hatch coaming to be continuous.</u> <u>2. Access opening to be provided.</u> <u>3. Drain holes to be elliptical and located above fillet weld to deck.</u> <u>4. Hatch coaming stiffeners of same material as coaming.</u>

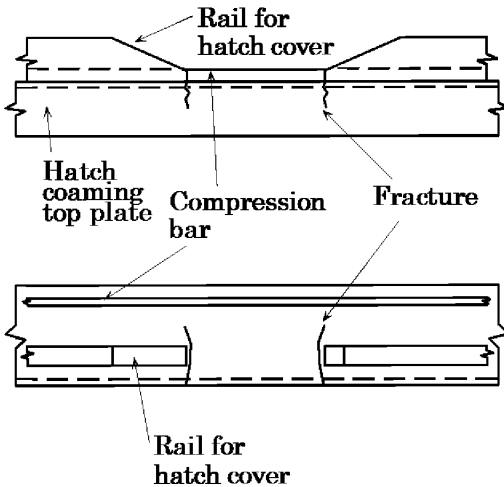
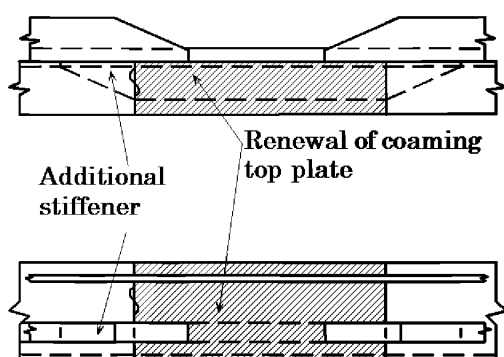
GENERAL DRY CARGO SHIPS		Guidelines for Surveys, Assessment and Repair of Hull Structure
Part 1	Cargo hold region	Example No.
Area 1	Upper deck structure	7-a
Detail of damage	Fractures in hatch coaming top plate at the termination of rail for hatch cover	
<b>Sketch of damage</b>

<b>Notes on possible cause of damage</b> 1. Stress concentration at the termination of the rail for hatch cover.		<b>Notes on repairs</b> 1. Fractured plate is to be cropped and part renewed. 2. Thicker insert plate and/or reinforcement by additional stiffener under the top plate should be considered. Also refer to <b>Example 7-b</b> .

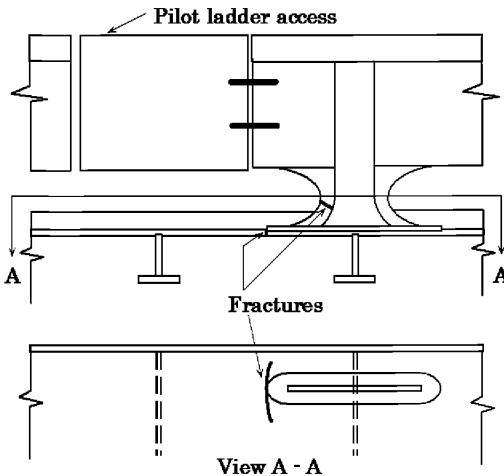
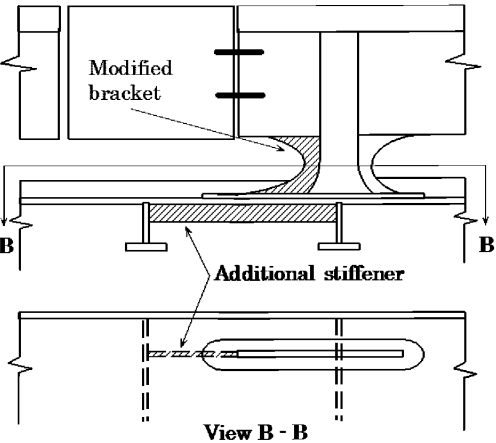
<b>GENERAL DRY CARGO SHIPS</b>		<b>Guidelines for Surveys, Assessment and Repair of Hull Structure</b>
<b>Part 1</b>	<b>Cargo hold region</b>	<b>Example No.</b>
<b>Area 1</b>	<b>Upper deck structure</b>	<b>9</b>
<b>Detail of damage</b> Fracture in deck plating at the pilot ladder access of bulwarks		
<b>Sketch of damage</b>		<b>Sketch of repair</b>

<b>Notes on possible cause of damage</b>		<b>Notes on repairs</b>
<ol style="list-style-type: none"> <li>1. Stress concentration at the termination of bulwarks.</li> </ol>		<ol style="list-style-type: none"> <li>1. Fractured deck plating should be cropped and part renewed.</li> <li>2. Reduction of stress concentration should be considered. In the above figure gusset plate was replaced with soft type for the fracture in gusset plate and pad plate was increased. Additional stiffeners were provided for the fracture in deck plating.</li> </ol>

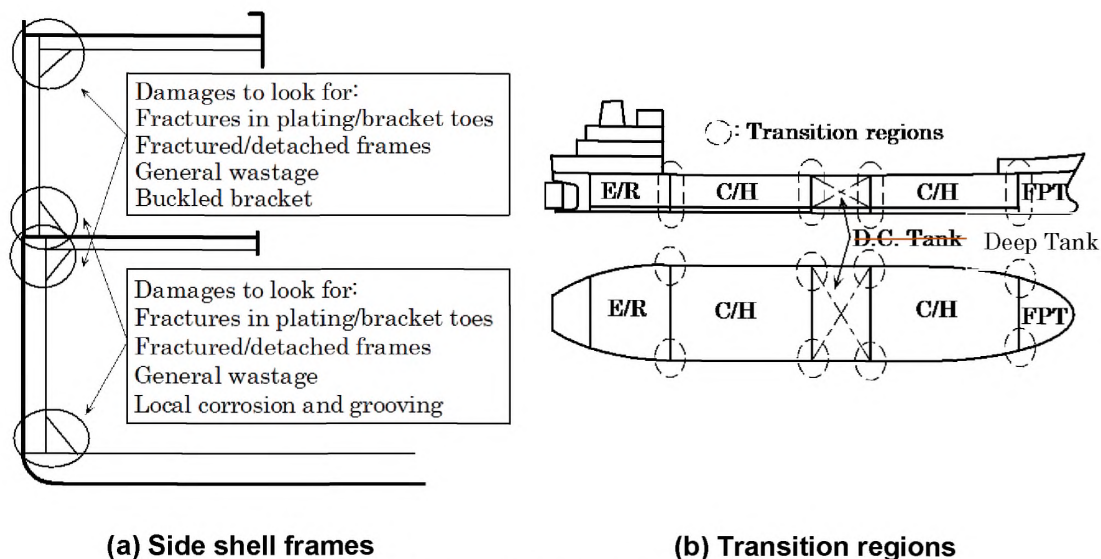
Figure 1 Potential problem problems areas

- 1.6 A summary of potential problem areas is shown in **Figures 1 (a) and (b)**. Serious consequences of damaged ship sides are illustrated in **Photographs 1 and 2**.

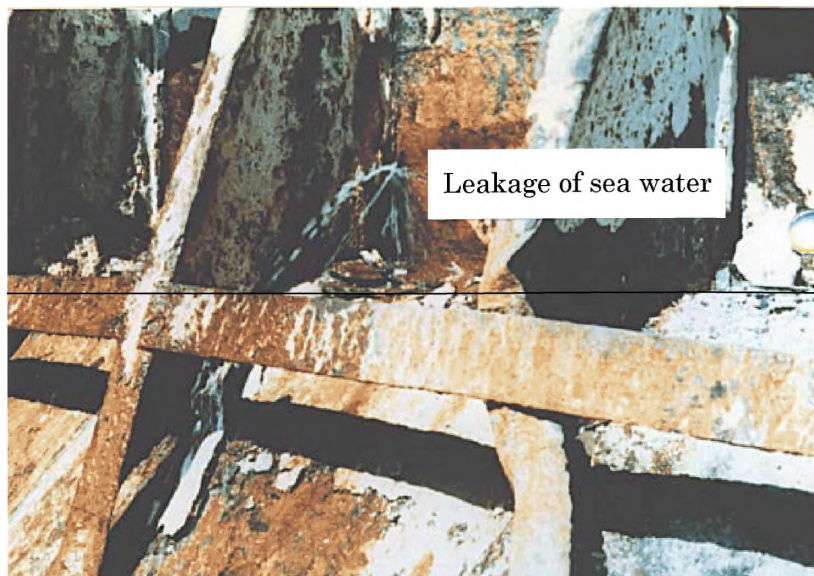
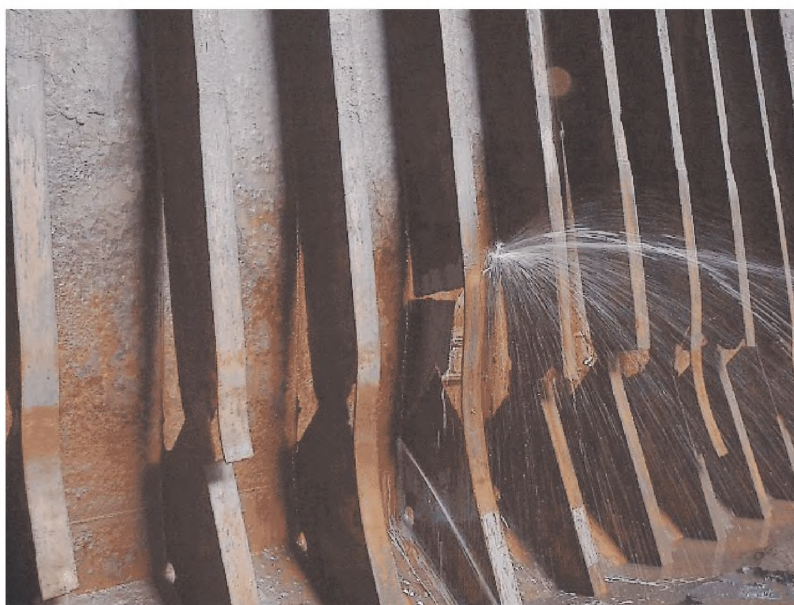
**Photograph 1**      Leakage from side shell plating due to heavy corrosion

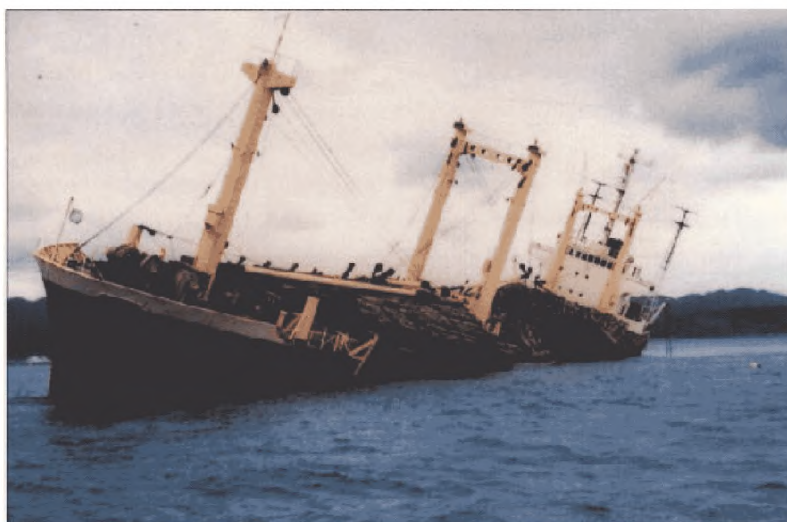
**Photograph 2**      Timber carrier listing due to ingress of water

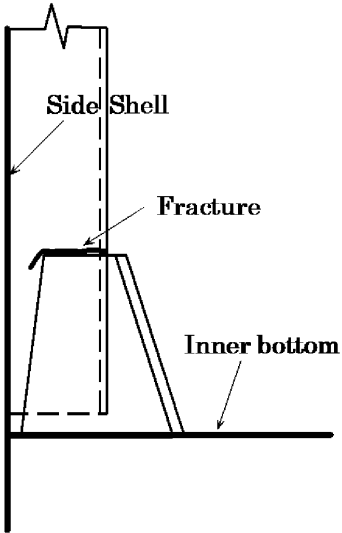
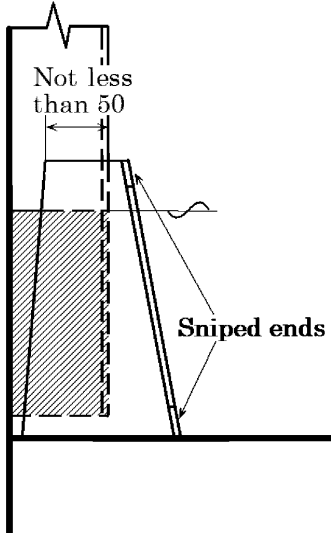
GENERAL DRY CARGO SHIPS		Guidelines for Surveys, Assessment and Repair of Hull Structure
Part 1	Cargo hold region	Example No.
Area 2	Side structure	1
Detail of damage		Fracture in side shell frame at lower bracket
Sketch of damage		Sketch of repair

Notes on possible cause of damage		Notes on repairs
<p>1. This type of damage is caused due to stress concentration.</p>		<p>1. For small fractures, e. g. hairline fractures, the fracture can be veed-out, welded up, ground, examined by NDT for fractures, and rewelded. For larger/significant fractures consideration is</p> <p>2. to be given to cropping and partly renewing/ renewing the frame brackets. If renewing the brackets, end of frames can be sniped to soften them.</p> <p>If felt prudent, soft toes are to be incorporated</p> <p>3. at the boundaries of the bracket to the inner bottom plating.</p>

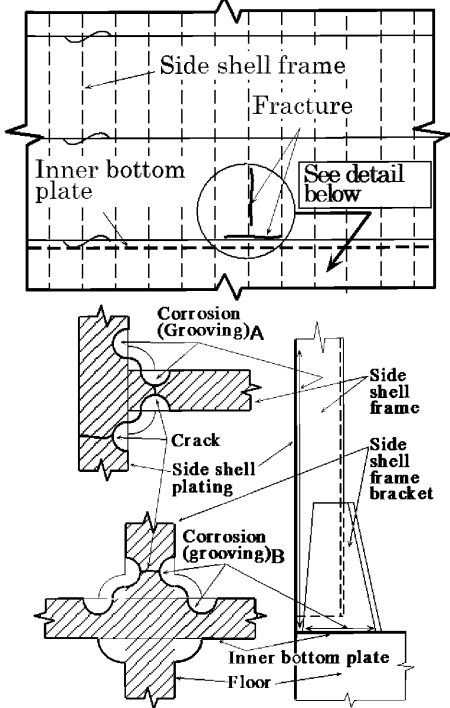
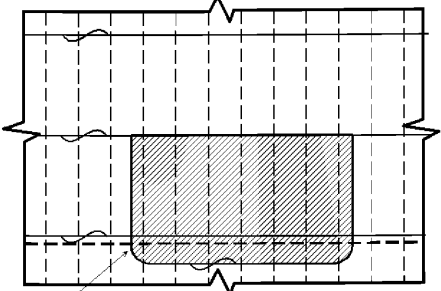
GENERAL DRY CARGO SHIPS		Guidelines for Surveys, Assessment and Repair of Hull Structure
Part 1	Cargo hold region	Example No.
Area 2	Side structure	2
Detail of damage	Fractures in side shell frame/lower bracket and side shell plating near tank top	
<b>Sketch of damage</b>

Part renewal including side shell frames and inner bottom plating, as found necessary
<b>Notes on possible cause of damage</b> <ol style="list-style-type: none"> <li>1. Fracture in side shell plating along side shell frame: Heavy corrosion (grooving) along side shell frame (See A).</li> <li>2. Fracture in side shell plating along tank top: Heavy corrosion (grooving) along tank top (See B) resulting detachment of side shell frame bracket from inner bottom plating.</li> </ol>		<b>Notes on repairs</b> <ol style="list-style-type: none"> <li>1. Sketch of repair applies when damage extends over several frames.</li> <li>2. Isolated fractures may be repaired by veeing-out and rewelding.</li> <li>3. Isolated cases of grooving may be repaired by build up of welding.</li> </ol>

- 2.1.1 Heavy wastage along the boundaries at ship's sides and at transverse bulkheads may occur as a result of seawater accumulated from wet cargo due to poor drainage. Such damages are related to those suffered at the lower end of side structures and transverse bulkhead structures (See **Area 2, Example 2** and **Area 3, Example 1**).

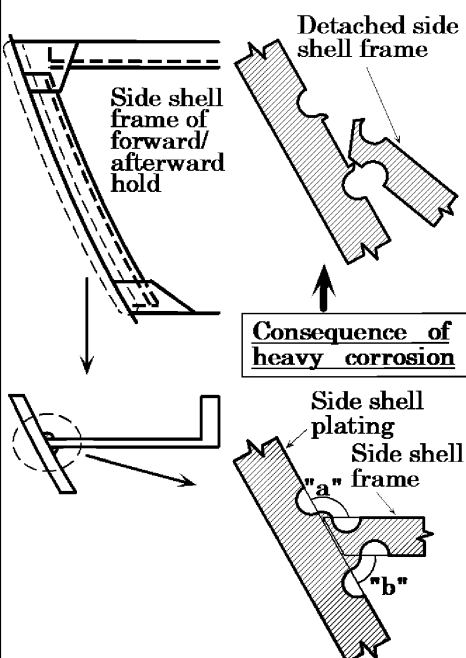
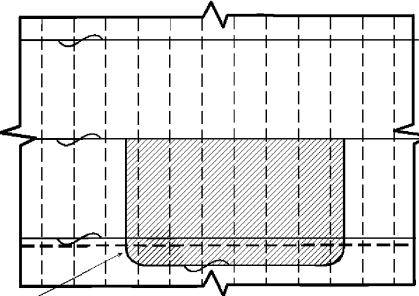
GENERAL DRY CARGO SHIPS		Guidelines for Surveys, Assessment and Repair of Hull Structure
Part 1	Cargo hold region	Example No.
Area 2	Side structure	3
Detail of damage	Adverse effect of corrosion on the frame of forward/afterward hold	
Sketch of damage		Sketch of repair

<p>Side shell frame of forward/afterward hold</p> <p>Detached side shell frame</p> <p>Consequence of heavy corrosion</p> <p>Side shell plating</p> <p>Side shell "a" frame</p> <p>"b"</p>

<ol style="list-style-type: none"> <li>1. Part renewal including side shell frames and inner bottom plating, as found necessary</li> <li>2. Deep penetration welding at the connections of side shell frames to side shell plating</li> </ol>
<b>Notes on possible cause of damage</b> <ol style="list-style-type: none"> <li>1. Heavy corrosion (grooving) of side shell frame along side shell plating and difference of throat thickness "a" from "b". (Since original throat thickness of "a" is usually smaller than that of "b", if same welding procedure is applied, the same corrosion has a more severe effect on "a", and may cause collapse and/or detachment of side shell frame.)</li> </ol>		<b>Notes on repairs</b> <ol style="list-style-type: none"> <li>1. Sketch of repair applies when damage extends over several frames.</li> <li>2. Isolated fractures may be repaired by veeing-out and rewelding.</li> <li>3. Isolated cases of grooving may be repaired by build up of welding.</li> </ol>

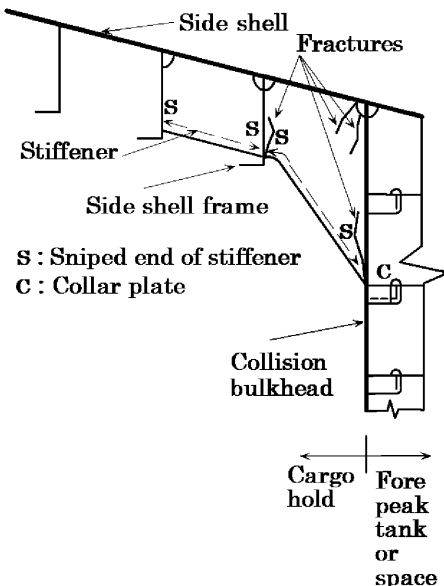
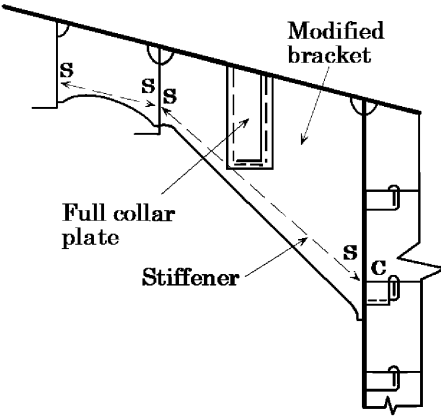
GENERAL DRY CARGO SHIPS		Guidelines for Surveys, Assessment and Repair of Hull Structure
Part 1	Cargo hold region	Example No.
Area 2	Side structure	4
Detail of damage	Fractures at the supporting brackets in way of the collision bulkhead, (with no side shell panting stringers fitted in hold)	
<b>Sketch of damage</b>

<p>S : Sniped end of stiffener C : Collar plate</p>		<b>Sketch of repair</b>

<b>Notes on possible cause of damage</b> <ol style="list-style-type: none"> <li>1. Insufficient bracket size resulting in high stress due to load cantilevered from side frame.</li> <li>2. Stress concentration at toe of bracket and misalignment between bracket and stringer in fore peak tank or space.</li> </ol>		<b>Notes on repairs</b> <ol style="list-style-type: none"> <li>1. The extended bracket arm connection to the collision bulkhead is to have a soft toe, and any cut-outs for stiffeners in the fore peak tank or space are to be collared when situated in the vicinity of the bracket toe. When fractures have extended into the side</li> <li>2. shell or bulkhead plating, the plating is to be cropped and part renewed.</li> </ol>

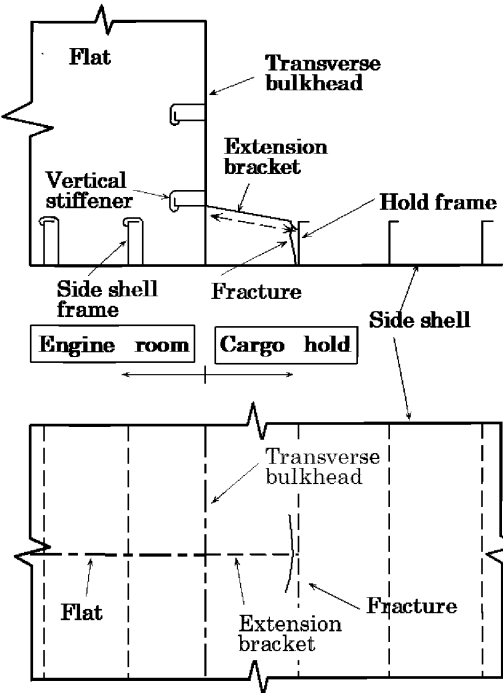
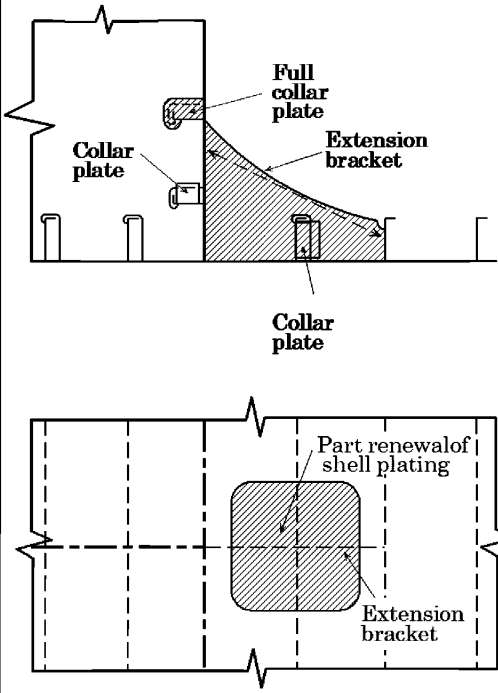
GENERAL DRY CARGO SHIPS		Guidelines for Surveys, Assessment and Repair of Hull Structure
Part 1	Cargo hold region	Example No.
Area 2	Side structure	5
Detail of damage	Fractures in way of continuation /extension brackets in aftermost hold at the engine room bulkhead	
<b>Sketch of damage</b>

<b>Notes on possible cause of damage</b> 1. Damage caused by stress concentration leading to fatigue fracture on side shell. This will be exacerbated because of the greater flexibility of the hold structure in relation to the engine room structure.		<b>Notes on repairs</b> 1. The fractured shell plating is to be cropped and part renewed as necessary. 2. Extension bracket is to be modified and collar plates to cut-outs in engine room flat are to be installed.

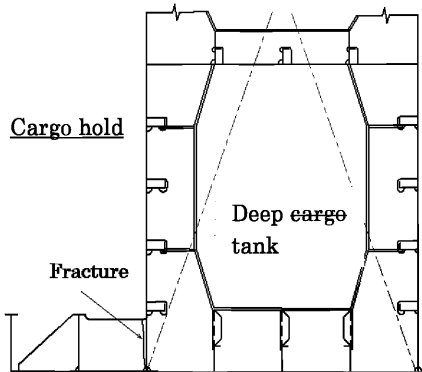
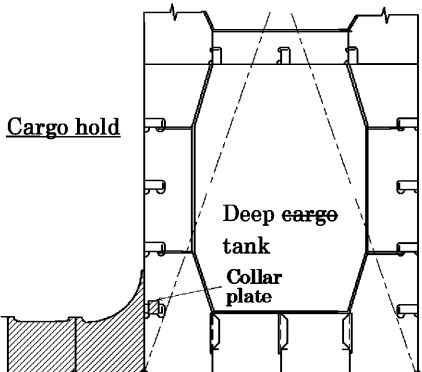
GENERAL DRY CARGO SHIPS		Guidelines for Surveys, Assessment and Repair of Hull Structure
Part 1	Cargo hold region	Example No.
Area 2	Side structure	6
Detail of damage	Fractures in way of continuation/extension brackets at the end of deep cargo tank	
<b>Sketch of damage</b>

<b>Notes on possible cause of damage</b> 1. Damage caused by stress concentration leading to fatigue fracture on side shell. This will be exacerbated because of the greater flexibility of the ordinary hold structure in relation to the deep cargo tank structure.		<b>Notes on repairs</b> 1. The fractured shell plate is to be cropped and part renewed as necessary. 2. Brackets should be modified.

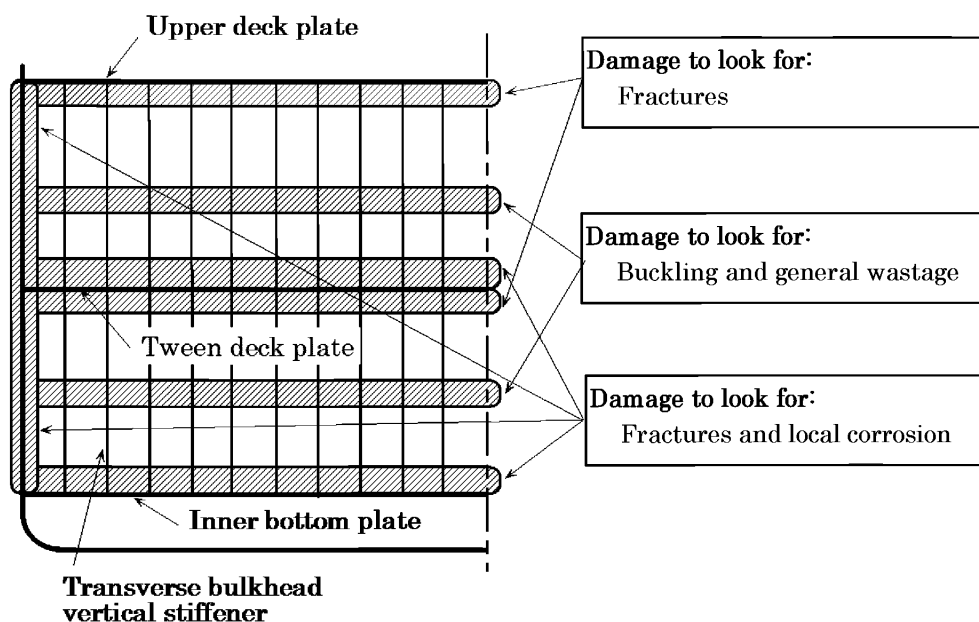
**Figure 1 Transverse bulkhead - potential problem areas**

- The structure may sometimes appear to be in good condition when it is in fact excessively corroded. In view of this, appropriate access arrangements as indicated in **Chapter 4 Survey planning, preparation and execution** of the Guidelines guidelines, should be provided to enable a proper close-up inspection and thickness measurement (See **Figure 1**).

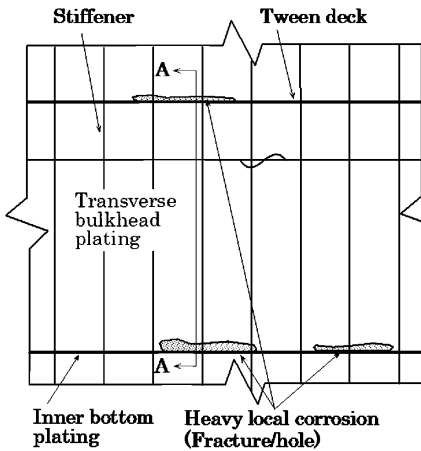
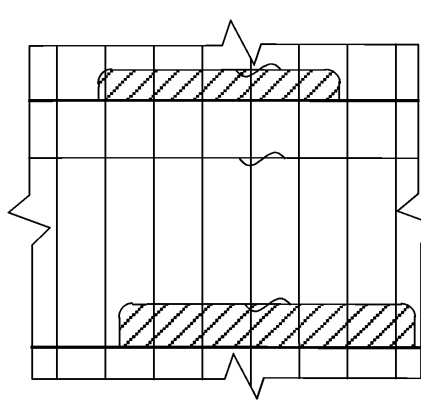
GENERAL DRY CARGO SHIPS		Guidelines for Surveys, Assessment and Repair of Hull Structure
Part 1	Cargo hold region	Example No.
Area 3	Transverse bulkhead structure	1
Detail of damage	Corrosion along inner bottom or tween deck plating	
<b>Sketch of damage</b>

<p>Note: Regarding "View A-A", refer to Example 2 of Area 2 of this part</p>		<b>Sketch of repair</b>

<b>Notes on possible cause of damage</b> 1. Heavy corrosion including grooving along inner bottom plating or tween deck due to poor drainage.		<b>Notes on repairs</b> 1. The extent of the renewal should be determined carefully. If the renewal plate (original thickness) is welded to thin plate (corroded plate), it may cause stress concentration and cause fracture. 2. Protective coating should be applied.

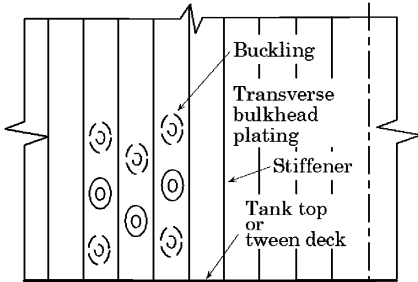
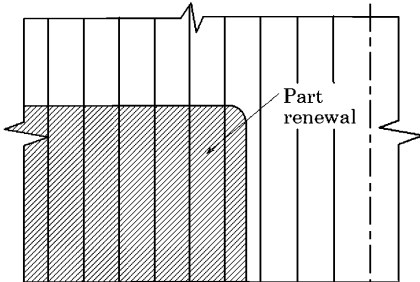
GENERAL DRY CARGO SHIPS		Guidelines for Surveys, Assessment and Repair of Hull Structure
Part 1	Cargo hold region	Example No.
Area 3	Transverse bulkhead structure	2
Detail of damage <u>Shear B</u> buckling in transverse bulkhead		
Sketch of damage		Sketch of repair

Notes on possible cause of damage		Notes on repairs
1. Heavy general corrosion.		1. The extent of the renewal should be determined carefully. If the renewal plating (original thickness) is welded to thin plating (corroded plating), it may cause stress concentration and fracture. 2. Protective coating should be applied.

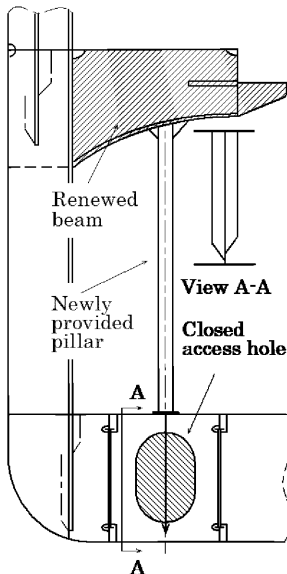
GENERAL DRY CARGO SHIPS		Guidelines for Surveys, Assessment and Repair of Hull Structure
Part 1	Cargo hold region	Example No.
Area 4	Tween deck structure	1
Detail of damage	Sagging of deck panel/buckling of cantilever beam	
Sketch of damage	Sketch of repair

<p>Buckled cantilever beam</p>	<div style="display: flex; justify-content: space-around;"> <div style="text-align: center;"> <p><b>Repair A</b></p>

<p>Newly provided bracket/stiffener</p> <p>Increased thickness and height of web plate</p> <p>Increased thickness and breadth of face plate</p> </div> <div style="text-align: center;"> <p><b>Repair B</b></p>

<p>Renewed beam</p> <p>Newly provided pillar</p> <p>View A-A</p> <p>Closed access hole</p> </div> </div>	
<b>Notes on possible cause of damage</b> 1. Poor design, overloading and/or excessive inertia force caused in heavy weather.		<b>Notes on repairs</b> 1. The affected structures are to be cropped and renewed. 2. <b>Repair A:</b> Reinforcement should be considered by increased scantlings of beam and/or additional stiffeners. 3. <b>Repair B:</b> Pillars may be provided for reinforcement subject to the approval of the owner. In such a case, reinforcement of the floor under the pillar should be considered. (In the above example, access hole was closed.)

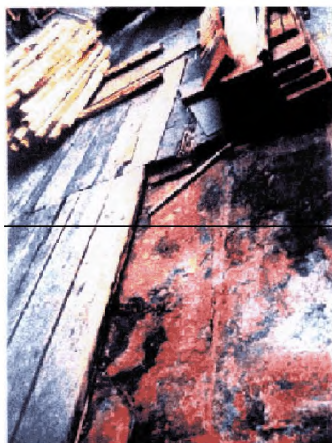
**Photograph 1**  
**Fractured inner bottom plating due to heavy corrosion on both sides**

- 2.1.2 When the tank top plating has been covered with dunnage or ceiling the plating may have suffered heavy corrosion, due to high humidity, and lack of proper maintenance (See **Photograph 1**).
