**РОССИЙСКИЙ МОРСКОЙ РЕГИСТР СУДОХОДСТВА**  
**RUSSIAN MARITIME REGISTER OF SHIPPING**

**IACS PROCEDURAL REQUIREMENTS,  
UNIFIED INTERPRETATIONS  
AND RECOMMENDATIONS**

## **GENERAL DRY CARGO SHIPS**

Guidelines for  
Surveys, Assessment and Repair  
of Hull Structure

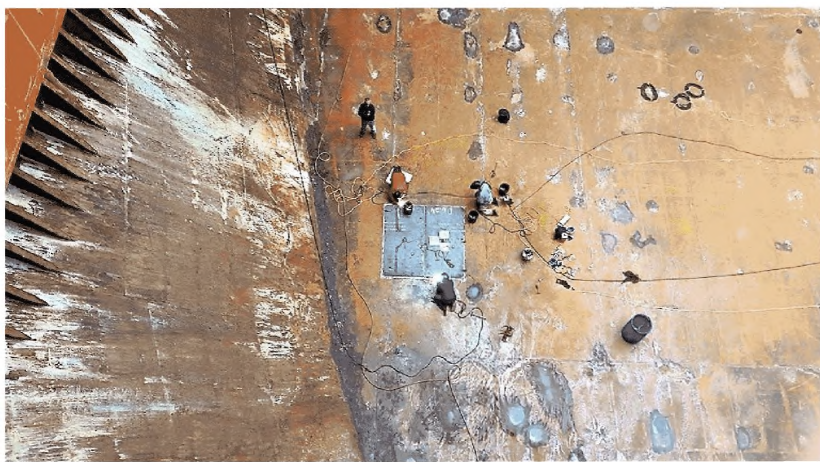
**Photograph 3 Repairs of damaged inner bottom plating**

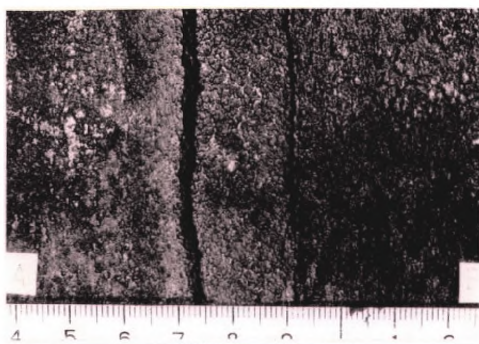
**Photograph 24**  
Grooving corrosion of welding of bottom plating

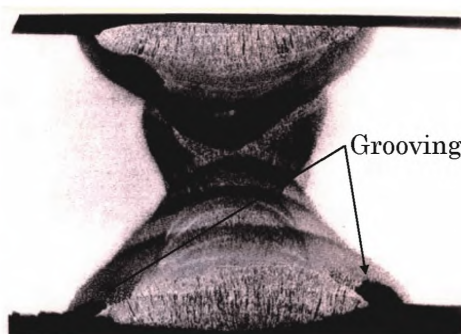
**Photograph 35**  
Section of the grooving shown in Photograph 24

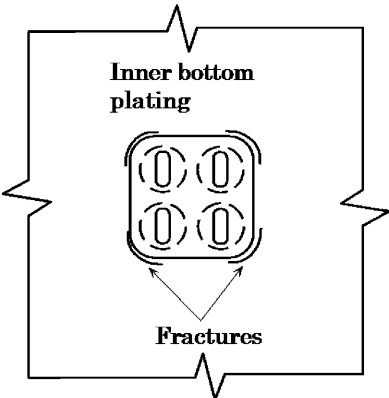
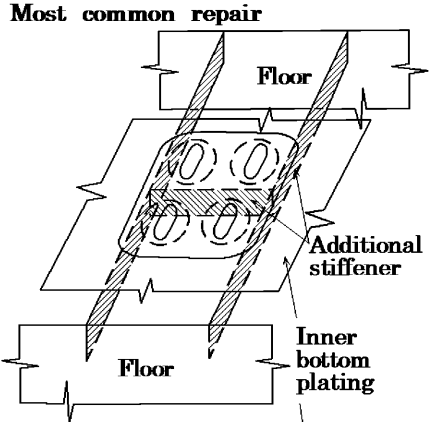
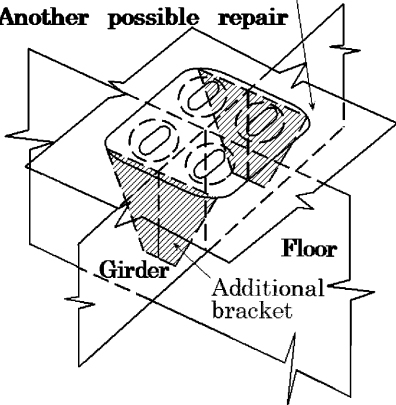
<b>GENERAL DRY CARGO SHIPS</b>		<b>Guidelines for Surveys, Assessment and Repair of Hull Structure</b>
<b>Part 1</b>	<b>Cargo hold region</b>	<b>Example No.</b>
<b>Area 5</b>	<b>Double bottom structure</b>	<b>1</b>
<b>Detail of damage</b>	Fractures in inner bottom plating around container bottom pocket	
<b>Sketch of damage</b>	<div style="display: flex; justify-content: space-between;"> <div style="width: 48%;">

<p style="text-align: center;"><b>Inner bottom plating</b></p> <p style="text-align: center;"><b>Fractures</b></p> </div> <div style="width: 48%;"> <p><b>Most common repair</b></p>

<p style="text-align: center;"><b>Another possible repair</b></p>

</div> </div>	
<b>Notes on possible cause of damage</b>	<b>Notes on repairs</b> 1. Pocket is not supported correctly by floor, longitudinal and/or stiffener. 1. Fractured plating should be cropped and part renewed. 2. Adequate reinforcement should be considered.

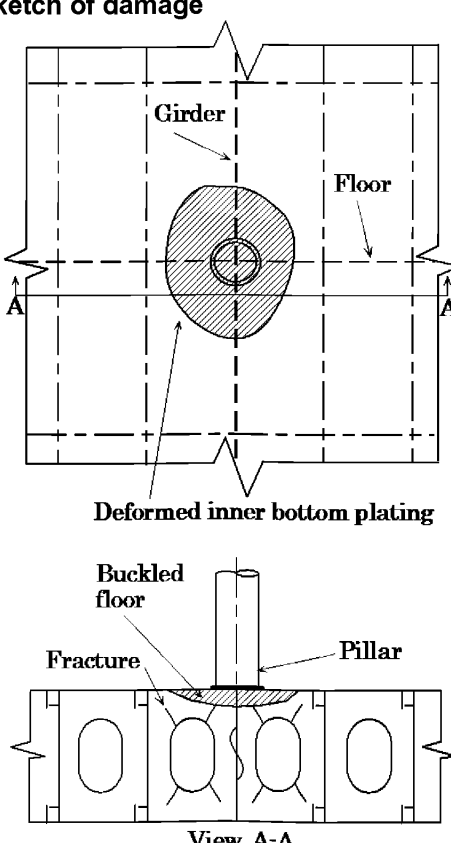
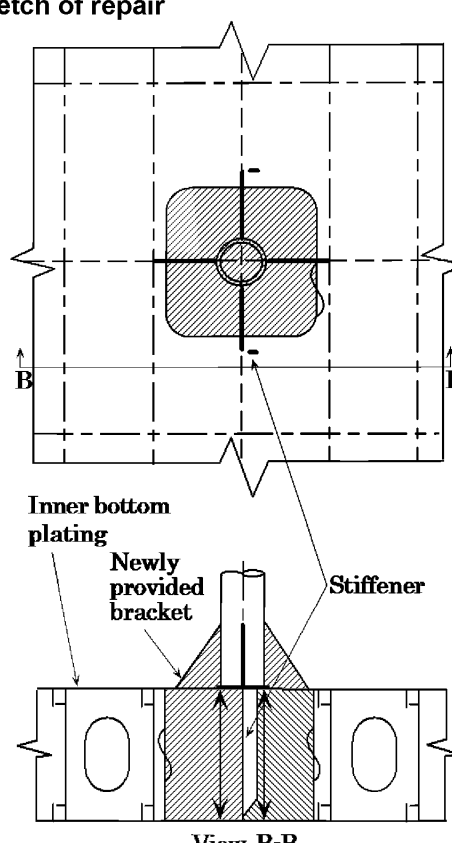
<b>GENERAL DRY CARGO SHIPS</b>		<b>Guidelines for Surveys, Assessment and Repair of Hull Structure</b>
<b>Part 1</b>	<b>Cargo hold region</b>	<b>Example No.</b>
<b>Area 5</b>	<b>Double bottom structure</b>	<b>2</b>
<b>Detail of damage</b>	Dented inner bottom plating and buckled/fractured floor under pillar	
<b>Sketch of damage</b>		<b>Sketch of repair</b>

<p>View A-A</p>

<p>View B-B</p>
<b>Notes on possible cause of damage</b>		<b>Notes on repairs</b>
<ol style="list-style-type: none"> <li>1. Inadequate arrangement and/or reinforcement of access holes.</li> <li>2. Excessive deck-loading on tween deck.</li> </ol>		<ol style="list-style-type: none"> <li>1. Dented inner bottom plating is to be cropped and part renewed.</li> <li>2. The fractured floor is to be cropped and part renewed.</li> <li>3. Access holes should be closed by insert plates.</li> <li>4. Stiffener on floor/girder and/or brackets should be considered. (Fitting of brackets in the hold is subject to the agreement of the owner.)</li> </ol>

- 2.2.1 Deformed structure may be observed near hatch openings where cargo and/ or hatch cover pontoons may have bumped into the structure during lift on or lift off operations.
- 2.2.2 Sagging of plate panels may be caused by lateral overloading as a consequence of excessive cargo loads, improper distribution /support of cargo loads, excessive inertia forces imposed by the cargo in extreme weather conditions, or a combination of these causes. It is essential that an under-deck inspection also be carried out to assess the extent of such damage (See **Example 1**). If the tween deck is supported by pillars, excessive loads could be transmitted to the double bottom structure (inner bottom plating, floors, girders) which could be damaged. Therefore inspection of double bottom tanks may be necessary (See **Area 5, Example 2**).

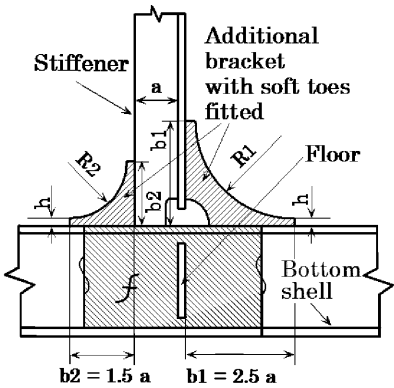
<p><math>f</math>: Where required, the longitudinal to be cropped and part renewed</p> <ol style="list-style-type: none"> <li>1. For a slope at toes max. 1 : 3,  <math>R1 = (b1-h) \times 1.6</math> and <math>R2 = (b2-h) \times 1.6</math></li> <li>2. Soft toe bracket to be welded first to longitudinal</li> <li>3. Scallop in bracket to be as small as possible, recommended max. 35 mm</li> <li>4. If toes of brackets are ground smooth, full penetration welds in way to be provided</li> <li>5. Maximum length to thickness ratio = 50 : 1 for unstiffened bracket edge</li> <li>6. Toe height, <math>h</math>, to be as small as possible (10- 15 mm)</li> </ol>

<p><b>Notes on possible cause of damage</b></p> <ol style="list-style-type: none"> <li>1. Damage can be caused by stress concentrations leading to accelerated fatigue in this region.</li> </ol>		<p><b>Notes on repairs</b></p> <ol style="list-style-type: none"> <li>1. If fracture extends to over one third of the depth of the longitudinal, then crop and part renew. Otherwise the fracture can be vee-out and welded.</li> </ol>

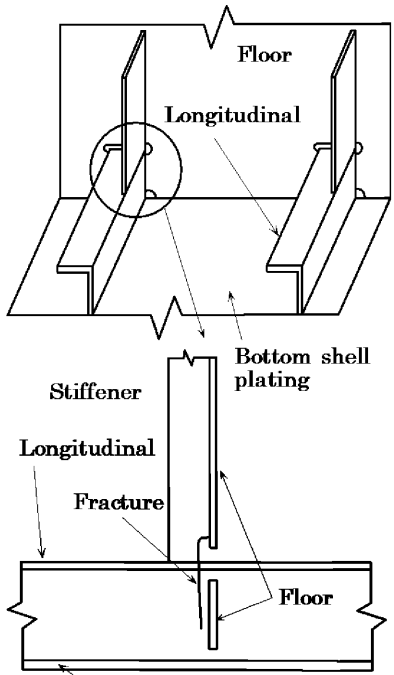
GENERAL DRY CARGO SHIPS		Guidelines for Surveys, Assessment and Repair of Hull Structure
Part 1	Cargo hold region	Example No.
Area 5	Double bottom structure	3-b
Detail of damage	Fractures at the connection of bottom/inner bottom longitudinal to floor stiffener	
<p><b>Sketch of damage</b></p>

<p>Note: same damage may occur at similar connection to inner bottom plating</p>		<p><b>Sketch of repair</b></p>

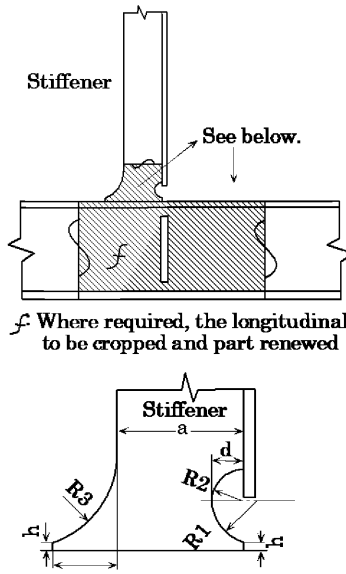
<p>Where required, the longitudinal to be cropped and part renewed</p> <p>Various cut-out shapes have been developed. The following is one example.</p> <ol style="list-style-type: none"> <li>1. Toe height as small as possible (<math>h = 10 - 15 \text{ mm}</math>)</li> <li>2. Depth "d" of key hole notch as small as possible, max. 30 mm</li> <li>3. For a slope at toe max. 1 : 3</li> <li>4. <math>R1 = 1.5d</math>, <math>R2 = d</math> and <math>R3 = 1.5c</math></li> </ol>
<p><b>Notes on possible cause of damage</b></p> <ol style="list-style-type: none"> <li>1. Damage can be caused by stress concentrations leading to accelerated fatigue in this region.</li> </ol>		<p><b>Notes on repairs</b></p> <ol style="list-style-type: none"> <li>1. If fracture extends to over one third of the depth of the longitudinal, then crop and part renew. Otherwise the fracture can be vee-out and welded.</li> </ol>

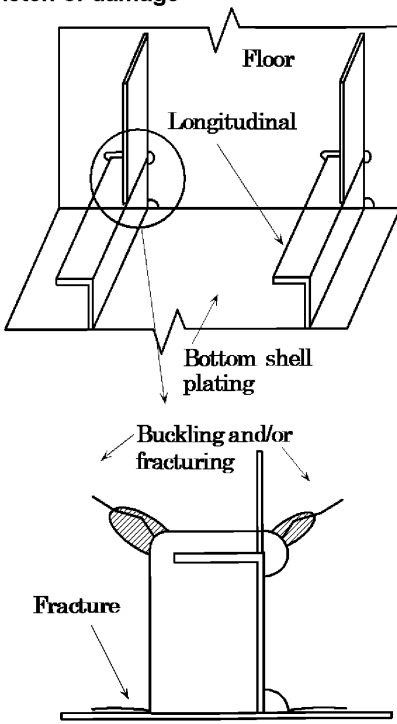
GENERAL DRY CARGO SHIPS		Guidelines for Surveys, Assessment and Repair of Hull Structure
Part 1	Cargo hold region	Example No.
Area 5	Double bottom structure	4
Detail of damage	Fractures and buckling in way of a cut-out for the passage of a longitudinal through a transverse primary member	
<b>Sketch of damage</b>

<p><b>Note:</b> same type of damage may occur at similar connections to inner bottom</p>		<b>Sketch of repair</b> <p><b>Repair A</b></p>

<b>Notes on possible cause of damage</b> 1. Damage can be caused by general levels of corrosion and presence of stress concentration associated with the presence of a cut-out.		<b>Notes on repairs</b> 1. If fractures are significant then crop and part renew the floor plating otherwise the fracture can be veed-out and welded provided the plating is not generally corroded. <b>Repair B</b> is to be incorporated if the lug proves to be ineffective.

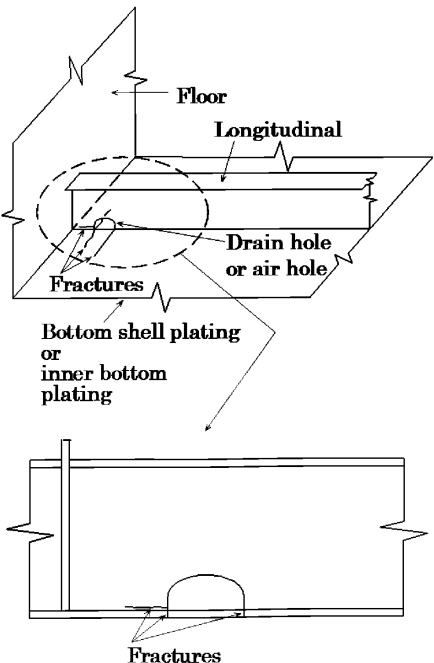
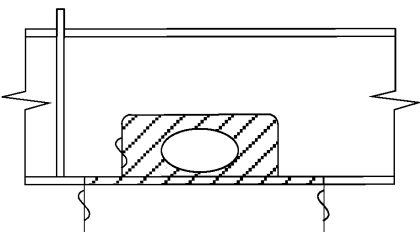
GENERAL DRY CARGO SHIPS		Guidelines for Surveys, Assessment and Repair of Hull Structure	
Part 1	Cargo hold region	Example No.	
Area 5	Double bottom structure	5	
Detail of damage	Fractures in bottom shell plating/inner bottom plating at the corner drain hole/air hole in longitudinal		
Sketch of damage		Sketch of repair

Notes on possible cause of damage		Notes on repairs	
1. Stress concentration and/or corrosion due to stress concentration at the corner of drain hole/air hole.		1. Fractured plating should be cropped and part renewed. 2. If fatigue life is to be improved, change of drain hole/air hole shape is to be considered.

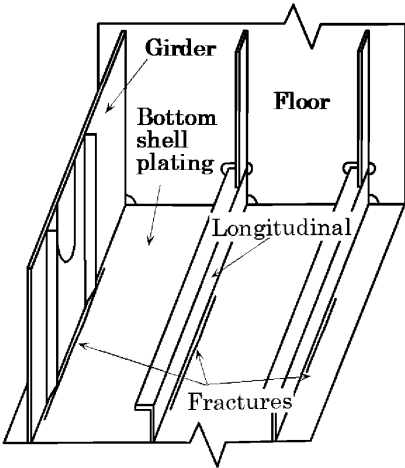
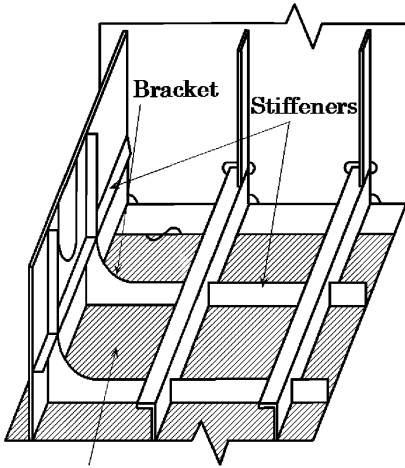
<b>GENERAL DRY CARGO SHIPS</b>		<b>Guidelines for Surveys, Assessment and Repair of Hull Structure</b>
<b>Part 1</b>	<b>Cargo hold region</b>	<b>Example No.</b>
<b>Area 5</b>	<b>Double bottom structure</b>	<b>6</b>
<b>Detail of damage</b>	Fracture in bottom shell plating along side girder and/or bottom longitudinal	
<b>Sketch of damage</b>		<b>Sketch of repair</b>

<p><b>Renewed bottom shell plating</b></p>
<b>Notes on possible cause of damage</b>		<b>Notes on repairs</b>
1. Vibration.		1. Fractured bottom shell plating should be cropped and renewed. 2. Natural frequency of the panel should be changed, e.g. reinforcement by additional stiffener/bracket.

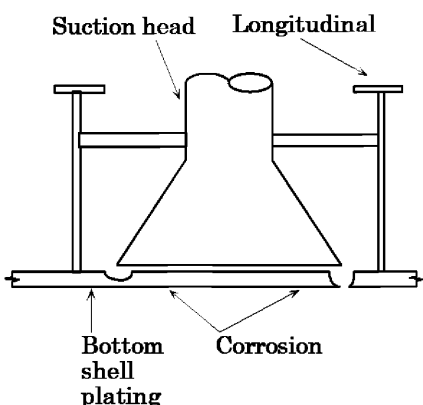
GENERAL DRY CARGO SHIPS		Guidelines for Surveys, Assessment and Repair of Hull Structure
Part 1	Cargo hold region	Example No.
Area 5	Double bottom structure	7
Detail of damage	Corrosion in bottom plating below suction head	
Sketch of damage		Sketch of repair

<p>Suction head      Longitudinal</p> <p>Bottom shell plating      Corrosion</p>

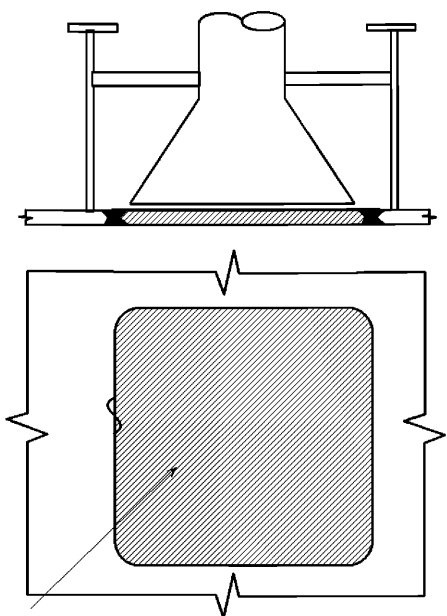
<p>1. Insert to have round corners</p> <p>2. Non-destructive examination to be applied after welding based on the Society's rules</p>
<b>Notes on possible cause of damage</b> <ol style="list-style-type: none"> <li>1. High flow rate associated with insufficient corrosion prevention system.</li> <li>2. Galvanic action between dissimilar metals</li> </ol>		<b>Notes on repairs</b> <ol style="list-style-type: none"> <li>1. Affected plating should be cropped and part renewed. Thicker plate and suitable beveling should be considered.</li> <li>2. If the corrosion is limited to a small area, i.e. pitting corrosion, repair by welding is acceptable.</li> </ol>

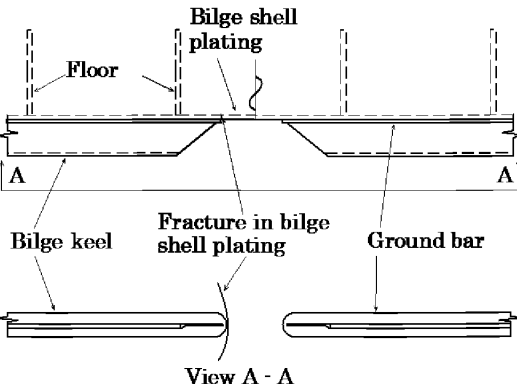
GENERAL DRY CARGO SHIPS		Guidelines for Surveys, Assessment and Repair of Hull Structure
Part 1	Cargo hold region	Example No.
Area 5	Double bottom structure	8
Detail of damage	Fracture in shell plating at the termination of bilge keel	
Sketch of damage		Sketch of repair

<b>Notes on possible cause of damage</b> 1. Poor design causing stress concentration.		<b>Notes on repairs</b> 1. Fractured plating is to be cropped and renewed. 2. Reduction of stress concentration of the bilge keel end should be considered. <b>Repair A:</b> Modification of the detail of end <b>Repair B:</b> New internal stiffeners Instead of <b>Repair A</b> or <b>B</b> continuous ground bar and bilge keel should be considered. 3.

- 5.3.5** Ends of bilge keels require internal support. This should be taken into account when cropping a damaged part of a bilge keel (See **Example 8**).

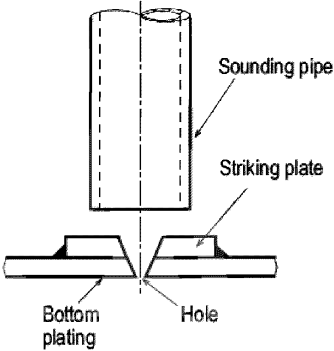
GENERAL DRY CARGO SHIPS		Guidelines for Surveys, Assessment and Repair of Hull Structure
Part 1	Cargo hold region	Example No.
Area 5	Double bottom structure	9
Detail of damage		Corrosion in bottom plating below sounding pipe
Sketch of damage		Sketch of repair

<b>Notes on possible cause of damage</b> 1. Accelerated corrosion of striking plate by the striking of the weight of the sounding tape.		<b>Notes on repairs</b> 1. Corroded bottom plating should be welded or partly cropped and renewed if considered necessary. 2. Corroded striking plate should be renewed.

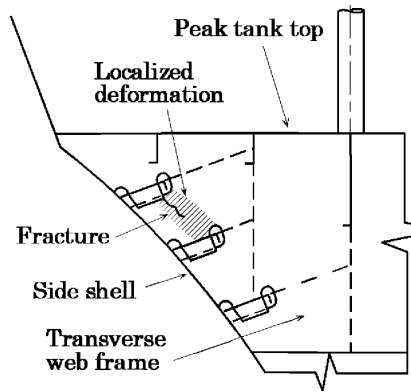
GENERAL DRY CARGO SHIPS		Guidelines for Surveys, Assessment and Repair of Hull Structure
Part 2	Fore and aft end regions	Example No.
Area 1	Fore end structure	1
Detail of damage	Fracture and deformation of bow transverse web in way of cut-outs for side longitudinals	
<b>Sketch of damage</b>

<b>Notes on possible cause of damage</b> <ol style="list-style-type: none"> <li>1. Localized material wastage in way of coating failure at cut-outs and sharp edges due to working of the structure.</li> <li>2. Dynamic seaway loading in way of bow flare.</li> </ol>		<b>Notes on repairs</b> <ol style="list-style-type: none"> <li>1. Sufficient panel strength to be provided to absorb the dynamic loads enhanced by bow flare shape.</li> </ol>

- 3.3.1 In the case of fractures caused by sea-loads the structure should be cropped and renewed. Increased thickness of plating and/or design modification to reduce stress concentrations should be considered (See **Examples 1, 2 and 6**).

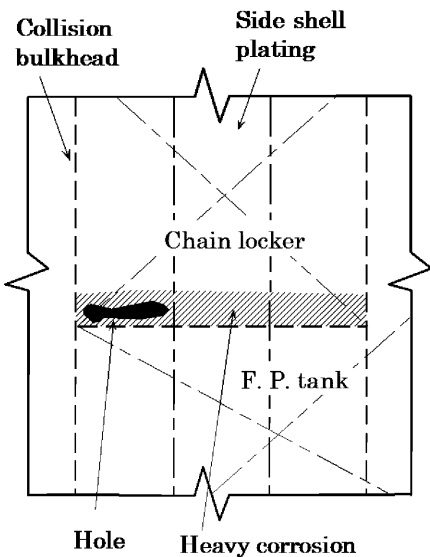
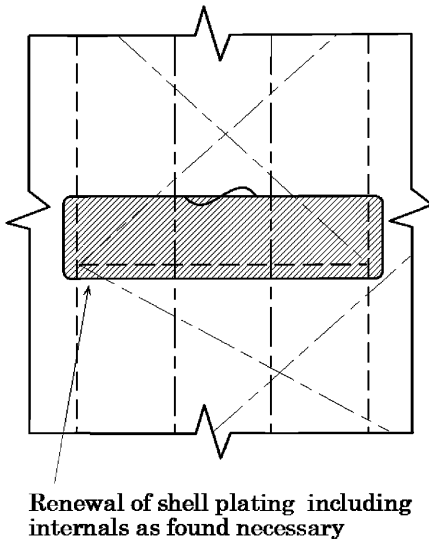
<b>GENERAL DRY CARGO SHIPS</b>		<b>Guidelines for Surveys, Assessment and Repair of Hull Structure</b>
<b>Part 2</b>	<b>Fore and aft end regions</b>	<b>Example No.</b>
<b>Area 1</b>	<b>Fore end structure</b>	<b>3</b>
<b>Detail of damage</b>	Fracture in side shell plating in way of chain locker	
<b>Sketch of damage</b>		<b>Sketch of repair</b>

<b>Notes on possible cause of damage</b>		<b>Notes on repairs</b>
<ol style="list-style-type: none"> <li>1. Heavy corrosion in region where mud is accumulated.</li> </ol>		<ol style="list-style-type: none"> <li>1. Corroded plating should be cropped and renewed.</li> <li>2. Protective coating should be applied.</li> </ol>

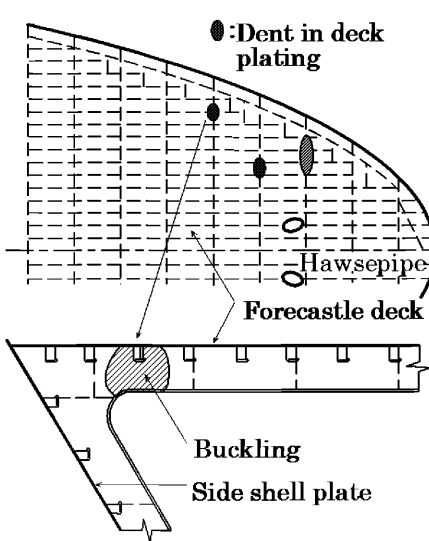
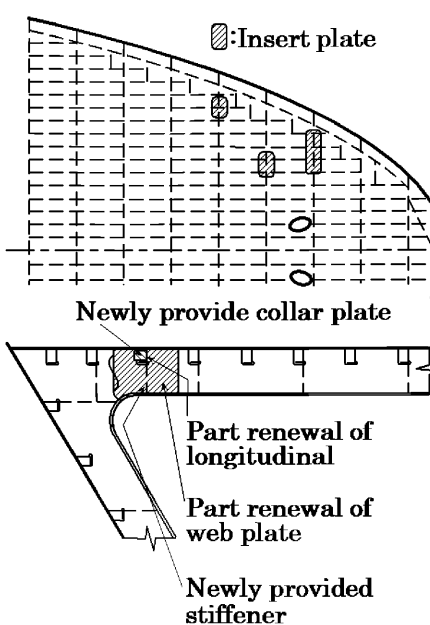
GENERAL DRY CARGO SHIPS		Guidelines for Surveys, Assessment and Repair of Hull Structure
Part 2	Fore and aft end regions	Example No.
Area 1	Fore end structure	4
Detail of damage	Deformation of forecastle deck	
Sketch of damage		Sketch of repair

<b>Notes on possible cause of damage</b> <ol style="list-style-type: none"> <li>1. Green sea on deck.</li> <li>2. Insufficient strength.</li> </ol>		<b>Notes on repairs</b> <ol style="list-style-type: none"> <li>1. Deformed structure should be cropped and renewed.</li> <li>2. Additional stiffeners on web of beam should be considered for reinforcement.</li> </ol>

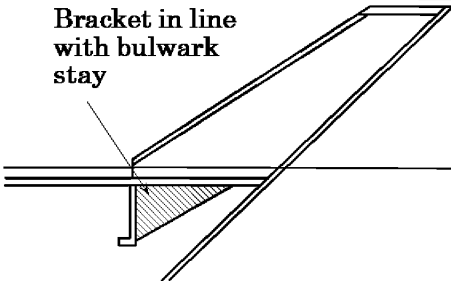
GENERAL DRY CARGO SHIPS		Guidelines for Surveys, Assessment and Repair of Hull Structure
Part 2	Fore and aft end regions	Example No.
Area 1	Fore end structure	6
Detail of damage	Fracture in forecastle deck plating at bulwark	
Sketch of damage	<div data-bbox="134 320 507 669"> <p>Fractures</p> <p>A/A</p> </div> <div data-bbox="134 728 507 946"> <p>Fracture</p> </div> <div data-bbox="186 960 290 990">View A-A</div>	
Sketch of repair	<div data-bbox="631 320 839 684"> </div> <div data-bbox="538 771 932 1019"> <p>Bracket in line with bulwark stay</p> <p><math>\alpha \leq 10^\circ</math></p> </div> <div data-bbox="600 1019 714 1062">View A-A</div>

<p>Bracket in line with bulwark stay</p> <p>View A-A</p>
<p><b>Notes on possible cause of damage</b></p> <ol style="list-style-type: none"> <li>1. Bow flare effect in heavy weather.</li> <li>2. Stress concentration due to poor design.</li> </ol>	<p><b>Notes on repairs</b></p> <ol style="list-style-type: none"> <li>1. Fractured deck plating should be cropped and renewed.</li> <li>2. Bracket in line with the bulwark stay to be fitted to reduce stress concentration.</li> <li>3. <u>The lower end of the bulwark bracket flange to be reshaped in order to avoid the sniper end.</u></li> </ol>

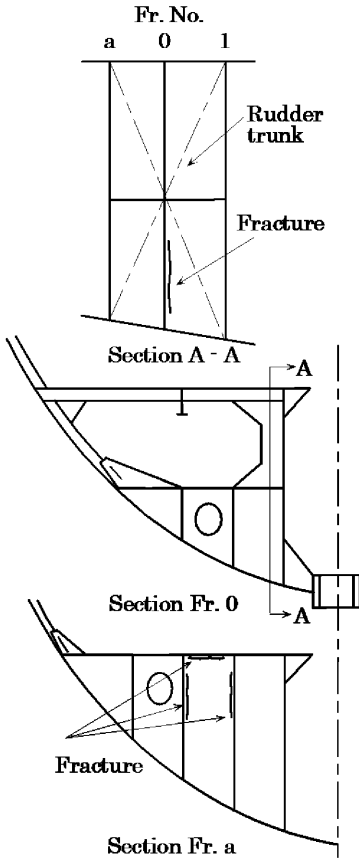
GENERAL DRY CARGO SHIPS		Guidelines for Surveys, Assessment and Repair of Hull Structure
Part 2	Fore and aft end regions	Example No.
Area 2	Aft end structure	1
Detail of damage	Fractures in <u>longitudinal</u> bulkhead in way of rudder trunk	
<b>Sketch of damage</b>

<b>Notes on possible cause of damage</b> 1. Vibration.		<b>Notes on repairs</b> 1. The fractured plating should be cropped and renewed. 2. Natural frequency of the plate between stiffeners should be changed, e.g. reinforcement by additional stiffeners.

- 3.3.1 Repairs of main engines and propeller excited vibration damage should be made by returning the structure to its original condition. In order to prevent recurrence of the damage the cause of the vibration should be ascertained and additional reinforcements provided as found necessary (See **Examples 1 and 2**).
- 3.3.2 Fractured structure which supports the rudder carrier is to be cropped and renewed, and may have to be reinforced (See **Example 3**).

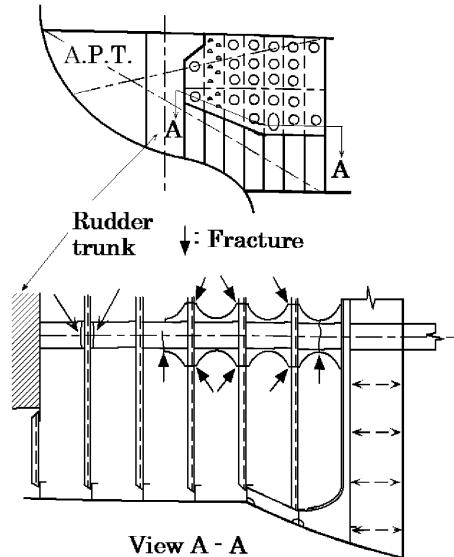
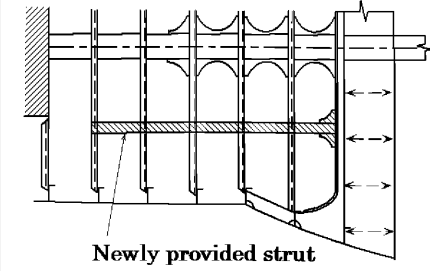
<b>GENERAL DRY CARGO SHIPS</b>		<b>Guidelines for Surveys, Assessment and Repair of Hull Structure</b>
<b>Part 2</b>	<b>Fore and aft end regions</b>	<b>Example No.</b>
<b>Area 2</b>	<b>Aft end structure</b>	<b>2</b>
<b>Detail of damage</b>		Fractures at the connection of floors and girders/side brackets
<b>Sketch of damage</b>

<p>View A - A</p>		<b>Sketch of repair</b>

<p>Newly provided strut</p>
<b>Notes on possible cause of damage</b> 1. Vibration.		<b>Notes on repairs</b> 1. The fractured plating should be cropped and renewed. 2. Natural frequency of the panel should be changed, e.g. reinforcement by additional strut.

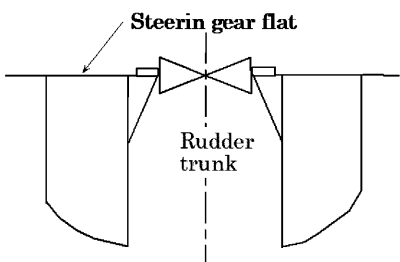
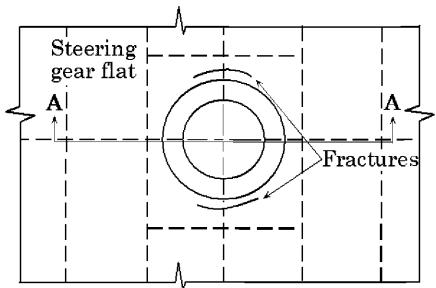
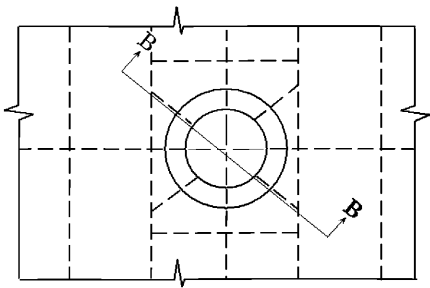
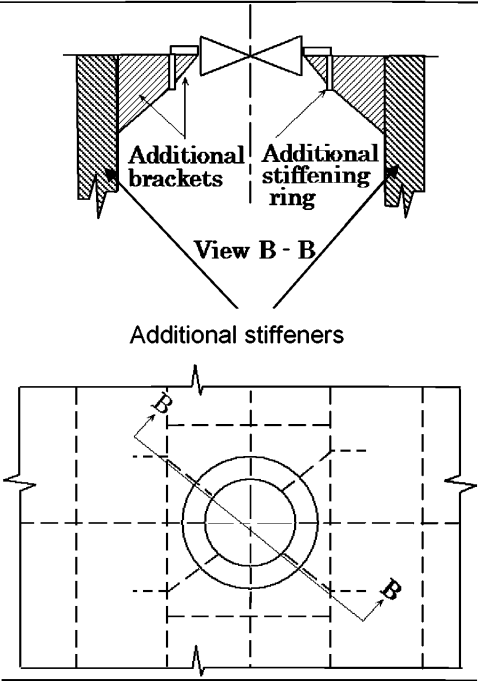
GENERAL DRY CARGO SHIPS		Guidelines for Surveys, Assessment and Repair of Hull Structure
Part 2	Fore and aft end regions	Example No.
Area 2	Aft end structure	3-a
Detail of damage	Fractures in flat where rudder carrier is installed in steering gear room	
Sketch of damage		Sketch of repair

<p>View A - A</p>

<p>View B - B</p>

<p><b>View B - B</b></p> <p>Additional brackets</p> <p>Additional stiffening ring</p> <p>Additional stiffeners</p>
<p><b>Notes on possible cause of damage</b></p> <ol style="list-style-type: none"> <li>1. Inadequate design.</li> </ol>	<p><b>Notes on repairs</b></p> <ol style="list-style-type: none"> <li>1. Fractured plating should be cropped and renewed.</li> <li>2. Additional brackets, <u>stiffeners</u> and stiffening ring should be fitted for reinforcement.</li> </ol>

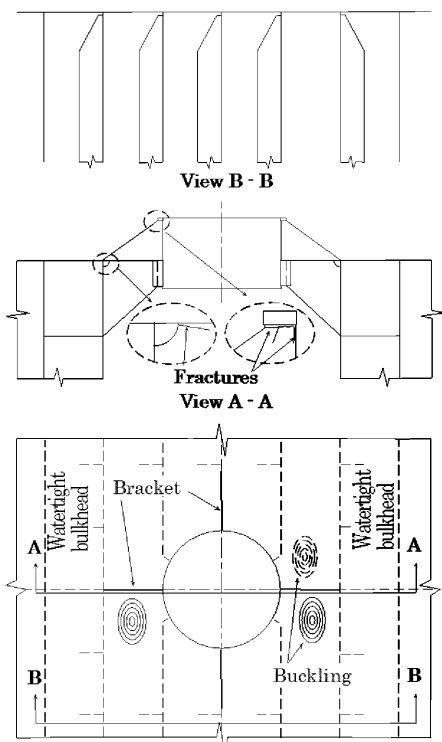
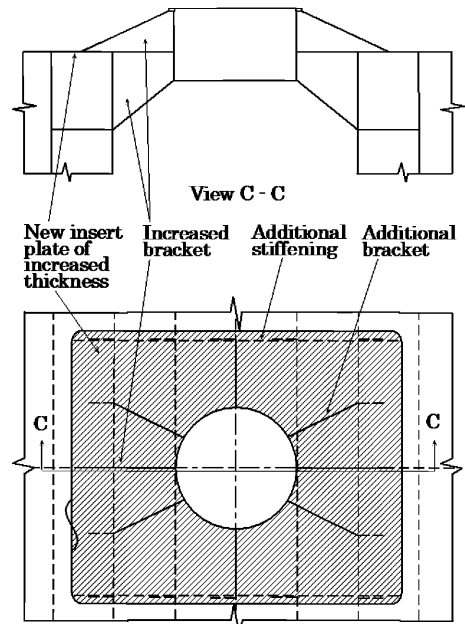
GENERAL DRY CARGO SHIPS		Guidelines for Surveys, Assessment and Repair of Hull Structure
Part 2	Fore and aft end regions	Example No.
Area 2	Aft end structure	3-b
Detail of damage	Fractures in steering gear foundation brackets and deformed deck plate	
Sketch of damage		Sketch of repair

<p>View B - B</p> <p>Fractures</p> <p>View A - A</p> <p>Watertight bulkhead</p> <p>Bracket</p> <p>Buckling</p>

<p>View C - C</p> <p>New insert plate of increased thickness</p> <p>Increased bracket</p> <p>Additional stiffening</p> <p>Additional bracket</p>
<b>Notes on possible cause of damage</b> <ol style="list-style-type: none"> <li>1. Insufficient deck strengthening (missing base plate).</li> <li>2. Insufficient strengthening of steering gear foundation.</li> <li>3. Bolts of steering gear were not sufficiently pre-loaded.</li> </ol>		<b>Notes on repairs</b> <ol style="list-style-type: none"> <li>1. New insert base plate of increased plate thickness.</li> <li>2. Additional longitudinal stiffening at base plate edges.</li> <li>3. Additional foundation brackets above and under deck (star configuration).</li> </ol>

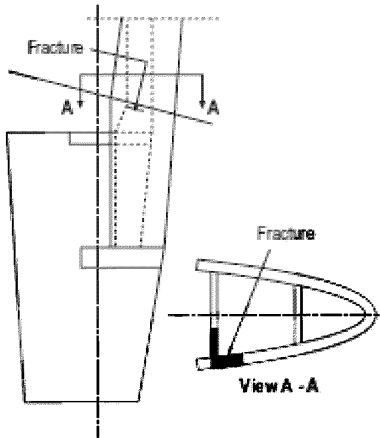
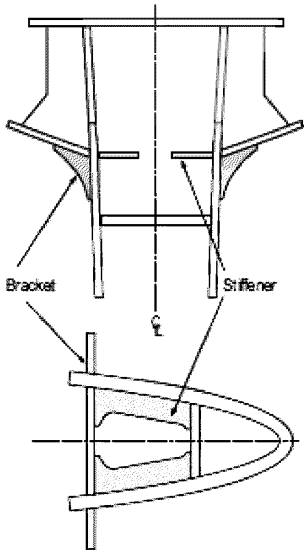
GENERAL DRY CARGO SHIPS		Guidelines for Surveys, Assessment and Repair of Hull Structure
Part 2	Fore and aft end regions	Example No.
Area 2	Aft end structure	3-c
Detail of damage Stern frame, rudder arrangement and propeller shaft support		
Sketch of damage		Sketch of repair

Notes on possible cause of damage		Notes on repairs
<u>1. Insufficient strength due to poor design.</u>		<u>1. Fractured plating to be veed-out and re-welded.</u> <u>2. Fractured plating to be cropped and renewed if considered necessary.</u> <u>3. Reinforcement should be considered if deemed necessary.</u>

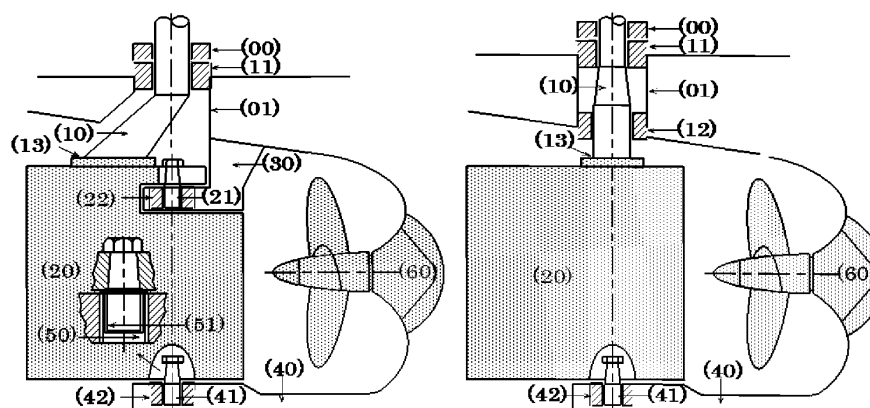
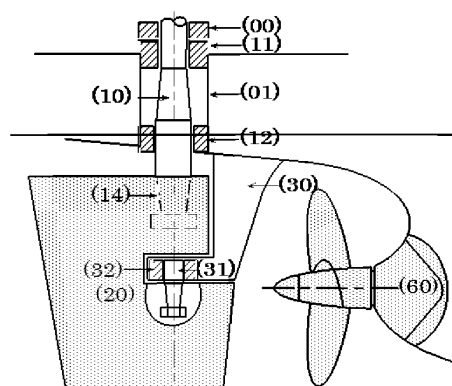
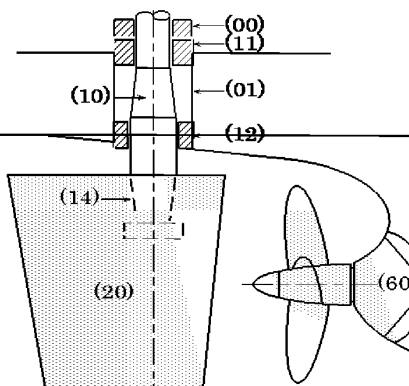
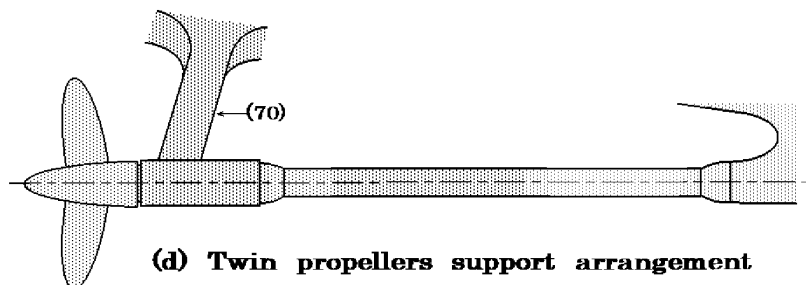
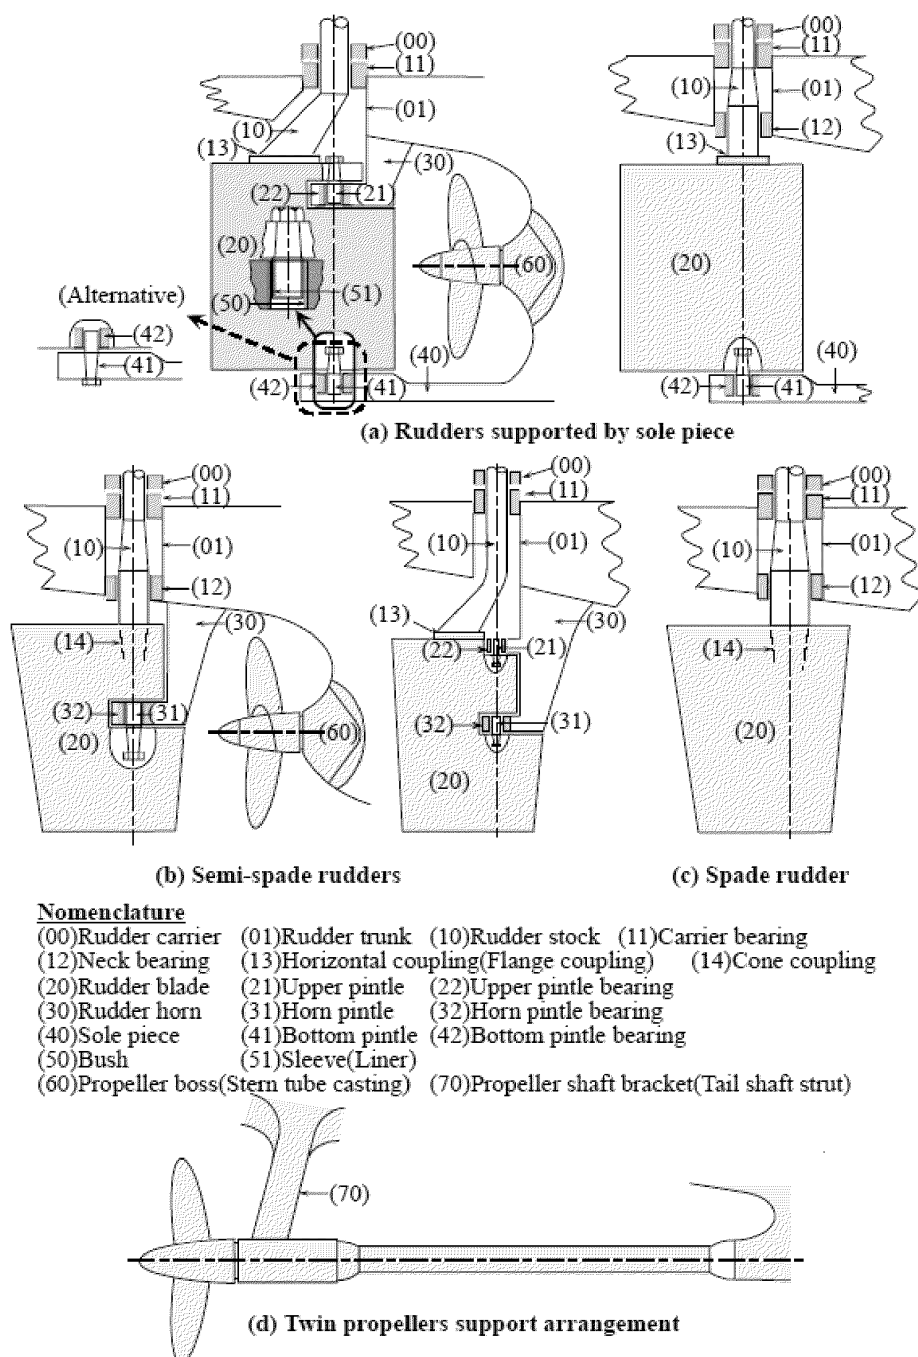
**Figure 1** Nomenclature for stern frame, rudder arrangement and propeller shaft support

(a) Rudders supported by sole piece

- (00) Rudder carrier
- (01) Rudder trunk
- (10) Rudder stock
- (11) Carrier bearing
- (12) Neck bearing
- (13) Horizontal coupling (Flange coupling)
- (14) Cone coupling
- (20) Rudder blade
- (21) Upper pintle
- (22) Upper pintle bearing
- (30) Rudder horn
- (31) Horn pintle
- (32) Horn pintle bearing
- (40) Sole piece
- (41) Bottom pintle
- (42) Bottom pintle bearing
- (50) Bush
- (51) Sleeve (Liner)
- (60) Propeller boss (Stern tube casting)
- (70) Propeller shaft bracket (Tail shaft strut)

(b) Semi-spade rudder (or Mariner rudder)

(c) Spade rudder

(d) Twin propellers support arrangement

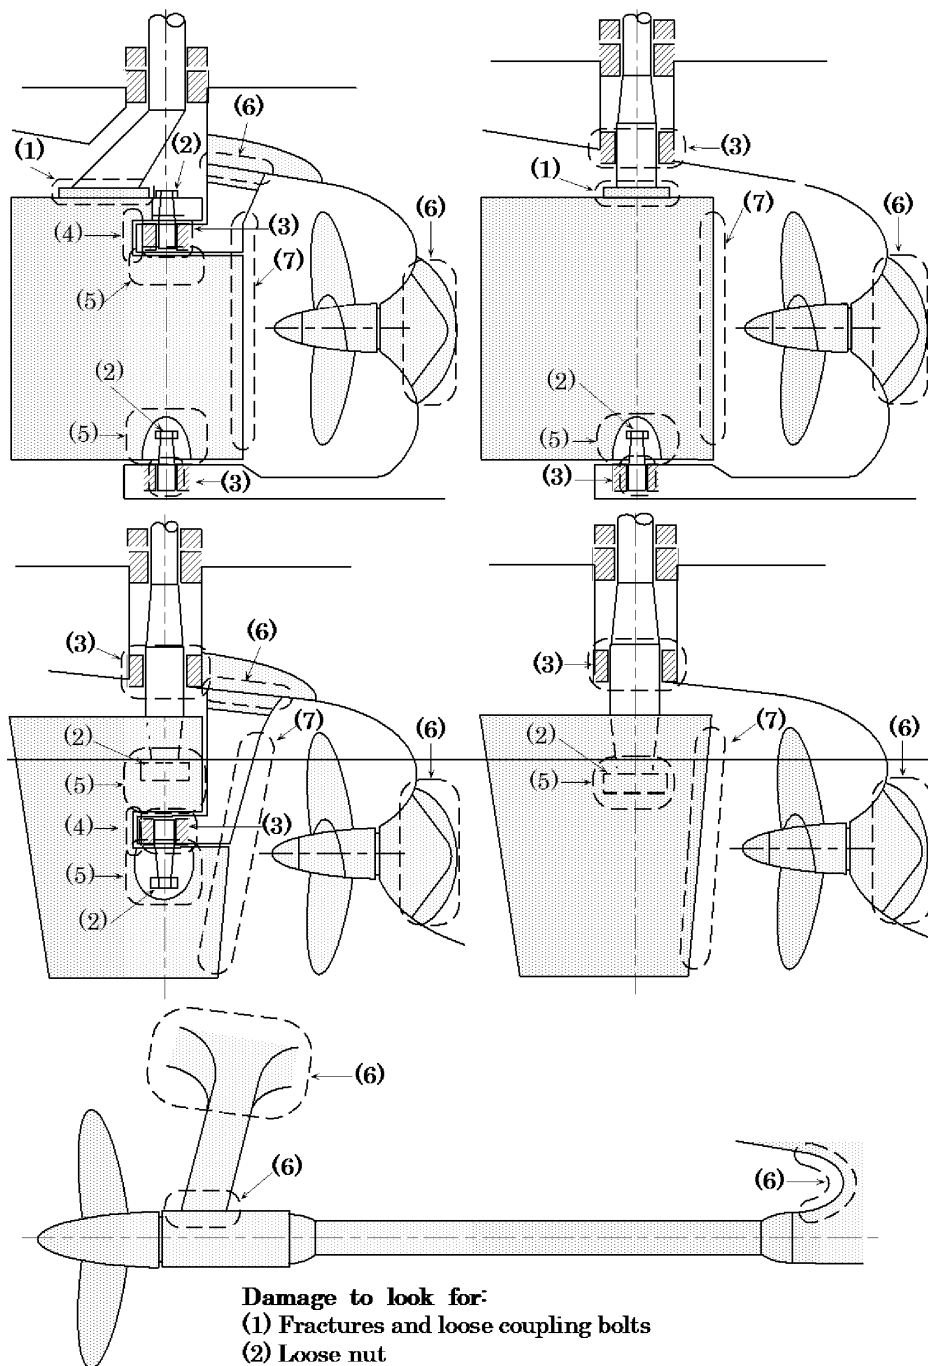
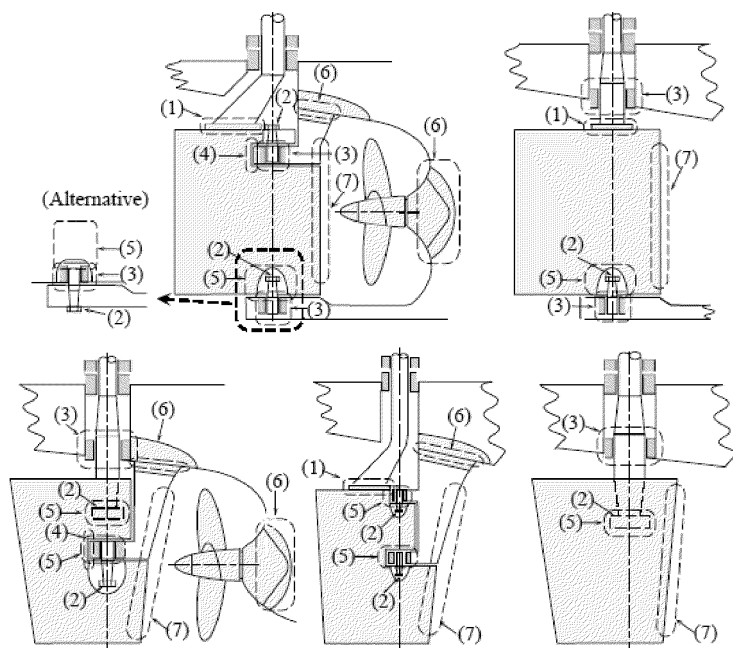
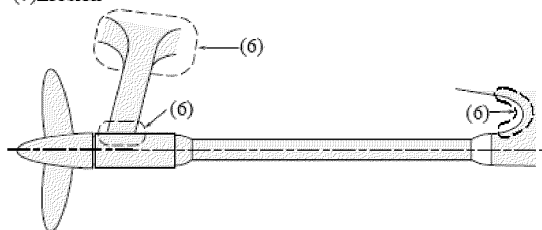
**Figure 2 Potential problem areas**

**Damage to look for:**

- (1) Fractures and loose coupling bolts
- (2) Loose nut
- (3) Wear (excessive bearing clearance)
- (4) Fractures in way of pintle cutout
- (5) Fractures in way of removable access plate
- (6) Fractures
- (7) Erosion

- 1.6 Pre-existing manufacturing internal defects in cast pieces may lead to fatigue cracking.
- 1.7 A summary of potential problem areas is shown in **Figure 2**.

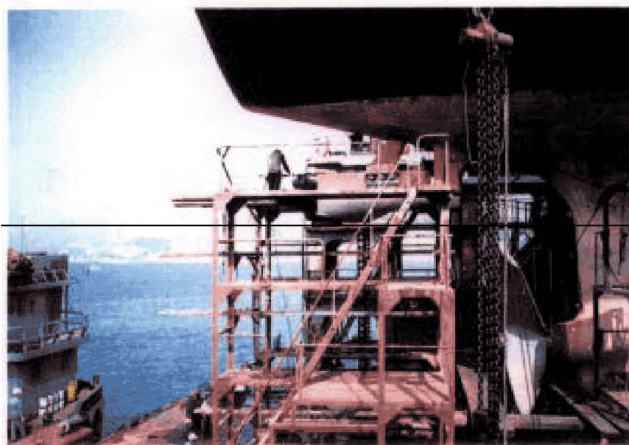
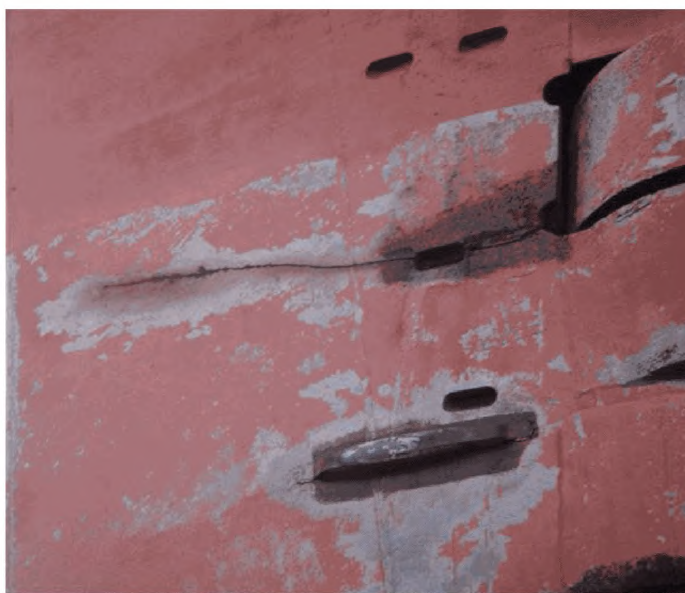
**Photograph 1**  
**Fractured rudder due to corrosion in rudder plating**

**Photograph 1 Fractured rudder due to corrosion in rudder plating**

Corrosion/erosion (such as deep pitting corrosion) should be looked for in rudder/rudder horn, especially in welds. In extreme cases the corrosion /erosion may cause a large fracture as shown in **Photograph 1**.

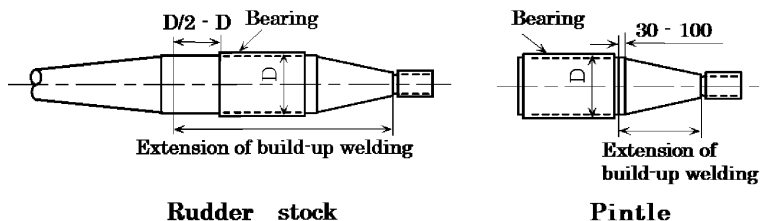
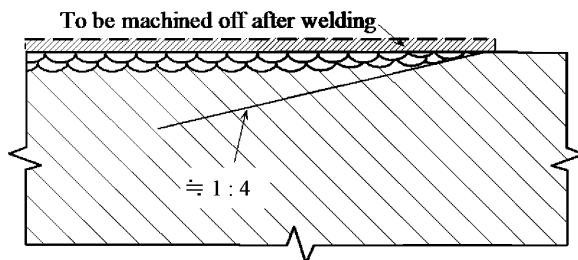
**Figure 3 Rudder stock repair by welding**

- Removal of the wasted area by machining and/or grinding, non-destructive examination for fractures (magnetic particle inspection preferred)
- Build-up welding by automatic spiral welding (turning device) according to an approved welding procedure (weld process, preheating, welding consumables, etc.)
- Extension of build-up welding over the area of **large bending moments (shafts)** according to the sketch

- Sufficient number of weld layers to compensate removed material, at least one layer in excess (heat treatment of the remaining layer)
- Transition at the end of the build-up welding according to the following sketch

- Post weld heat treatment if required in special cases (never for stainless steel cladding on ordinary steel)
- Final machining, at least two layers of welding material have to remain on the rudder stock (See the above sketch)
- Non-destructive fracture examination

Rudder stocks and/or pintles may be repaired by welding replacing wasted material by similar weld material. After removal of the wasted area (corrosion, scratches, etc.) by machining and/or grinding the build-up welding has to be carried out by an automatic spiral welding according to an approved welding procedure. The welding has to be extended over the area of large bending moments (rudder stocks). In special cases post weld heat treatment has to be carried out according to the requirements of the Classification Society. After final machining, a sufficient number of layers of welding material have to remain on the rudder stock/pintle. A summary of the most important steps and conditions of this repair is shown in the **Figure 3**.

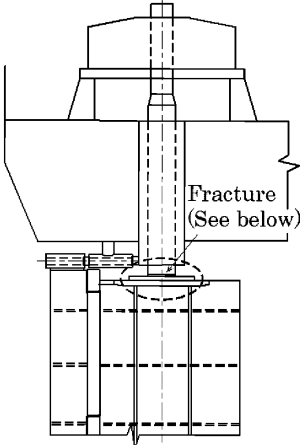
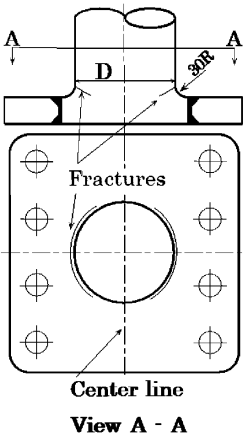
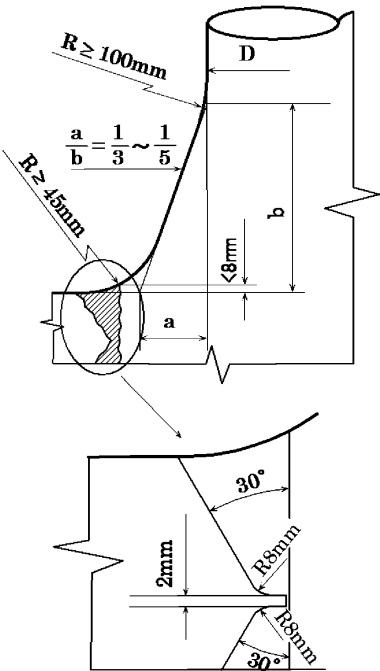
GENERAL DRY CARGO SHIPS		Guidelines for Surveys, Assessment and Repair of Hull Structure
Part 2	Fore and aft end regions	Example No.
Area 3	Stern frame, rudder arrangement and propeller shaft support	1
Detail of damage		Fracture in rudder stock
Sketch of damage		Sketch of repair

<p>Fracture (See below)</p> <p>Fractures</p> <p>Center line</p> <p>View A - A</p>

<p><math>R \geq 100\text{mm}</math></p> <p><math>\frac{a}{b} = \frac{1}{3} \sim \frac{1}{5}</math></p> <p><math>R \geq 45\text{mm}</math></p> <p>D</p> <p>b</p> <p><math>&lt; 8\text{mm}</math></p> <p>a</p> <p>30°</p> <p>2mm</p> <p>R8mm</p> <p>R6mm</p> <p>30°</p>
Notes on possible cause of damage		Notes on repairs
1. Inadequate design for stress concentration in rudder stock.		1. Modification of detail design of rudder stock to reduce the stress concentration.

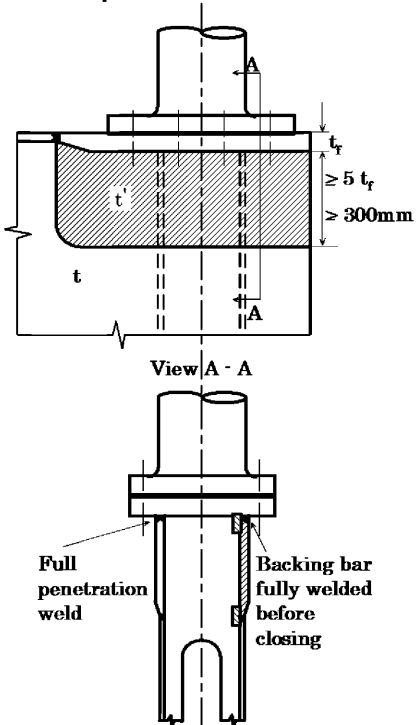
GENERAL DRY CARGO SHIPS		Guidelines for Surveys, Assessment and Repair of Hull Structure
Part 2	Fore and aft end regions	Example No.
Area 3	Stern frame, rudder arrangement and propeller shaft support	2
Detail of damage		Fracture in connection of palm plate to rudder blade
Sketch of damage		Sketch of repair

<p>View A - A</p> <p>Full penetration weld</p> <p>Backing bar fully welded before closing</p> <p><math>t</math> = plate thickness, mm  <math>t_r</math> = actual flange thickness, mm  <math>t' = \frac{t_r}{3} + 5</math>, mm, where <math>t_r &lt; 50</math>mm  <math>t' = 3 \sqrt{t_r}</math>, mm, where <math>t_r \geq 50</math>mm</p>
Notes on possible cause of damage		Notes on repairs

1. Inadequate connection between palm plate and rudder blade plating (insufficient plating thickness and/or insufficient fillet weld).		1. Modification of detail design of the connection by increasing the plate thickness and full penetration welding.

- 2.2.4 Fractures should be looked for at the transition radius between rudder stock and horizontal coupling (palm) plate, and the connection between horizontal coupling plate and rudder blade in case of horizontal coupling. Typical fractures are shown in **Examples 1 and 2**. Fatigue fractures should be looked for at the palm plate itself in case of loosened or lost coupling bolts.

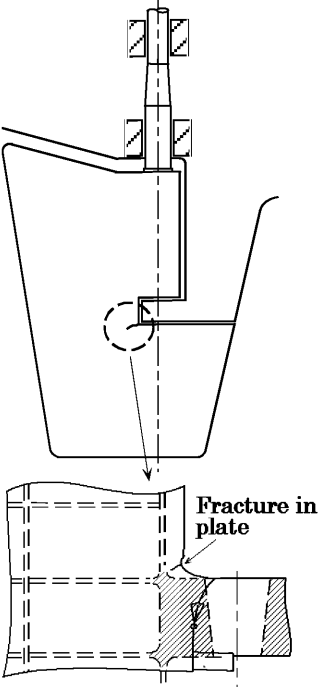
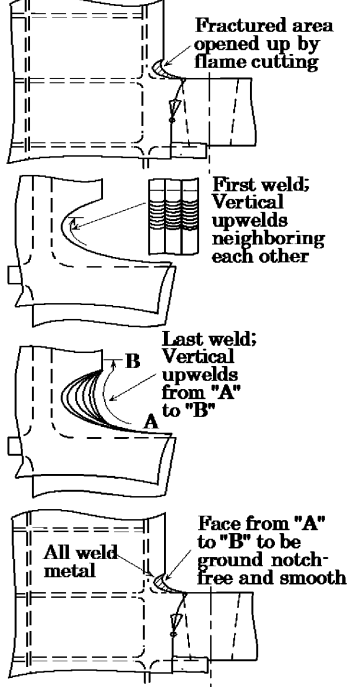
GENERAL DRY CARGO SHIPS		Guidelines for Surveys, Assessment and Repair of Hull Structure
Part 2	Fore and aft end regions	Example No.
Area 3	Stern frame, rudder arrangement and propeller shaft support	3
Detail of damage	Fracture in rudder plating of semi-spade rudder (short fracture with end located forward of the vertical web)	
<b>Sketch of damage</b>

<b>Notes on possible cause of damage</b> 1. Stress concentration due to inadequate local design and/or fabrication notches in way of the butt weld between cast piece and plating.		<b>Notes on repairs</b> 1. Grooving-out and welding of the fracture is not always adequate (metallurgical notch in way of a high stressed area). 2. In the proposed repair procedure the metallurgical notches are shifted into a zone exposed to lower stresses. 3. After welding a modification of the radius according to the proposal in <b>Example 5</b> is to be carried out. 4. In case of very small crack it can be ground off by increasing the radius.

- 2.2.2 Fractures should be looked for at weld connection between rudder horn, propeller boss and propeller shaft brackets, and stern frame.
- 2.2.3 Fractures should be looked for at the upper and lower corners in way of the pintle recess in case of semi-spade rudders. Typical fractures are shown in **Examples 3 to 5**.

- 3.2.1** Fatigue fractures in welding seams (butt welds) caused by welding failures (lack of fusion) can be gouged out and rewelded with proper root penetration.
- 3.2.2** In case of fractures, probably caused by (resonant) vibration, vibration analysis of the rudder plating has to be performed, and design modifications have to be carried out in order to change the natural frequency of the plate field.
- 3.2.3** Short fatigue fractures starting in the lower and/or upper corners of the pintle recess of semi-spade rudders that do not propagate into vertical or horizontal stiffening structures may be repaired by gouging out and welding. This procedure according to **Example 3** should be preferred.

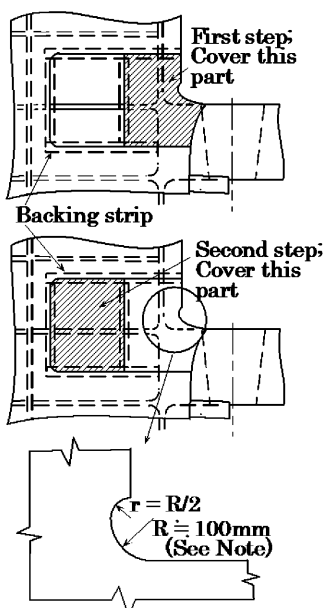
GENERAL DRY CARGO SHIPS		Guidelines for Surveys, Assessment and Repair of Hull Structure
Part 2	Fore and aft end regions	Example No.
Area 3	Stern frame, rudder arrangement and propeller shaft support	4
Detail of damage	Fracture in rudder plating of semi-spade rudder extending beyond the vertical web	
<b>Sketch of damage</b>

<p><b>Note:</b> R should be considered according to local detail</p>
<b>Notes on possible cause of damage</b> <ol style="list-style-type: none"> <li>1. Stress concentration due to inadequate local design and/or fabrication notches in way of the butt weld between cast piece and plating.</li> </ol>		<b>Notes on repairs</b> <ol style="list-style-type: none"> <li>1. Fractured plating is to be cut-out.</li> <li>2. Internal structures are to be checked.</li> <li>3. Cut-out is to be closed by an insert plating according to the sketch (welding only from one side is demonstrated).</li> <li>4. Modification of the radius.</li> <li>5. In case of a new cast piece, connection with the plating is to be shifted outside the high stress area.</li> </ol>

In case of longer fatigue fractures starting in the lower and/or upper corners of the pintle recess of semi-spade rudders that propagate over a longer distance into the plating, thorough check of the internal structures has to be carried out. The fractured parts of the plating and internal structures, if necessary, have to be replaced by insert plates. A proper welding connection between the insert plate and the internal stiffening structure is very important (See **Examples 4 and 5**).
