**РОССИЙСКИЙ МОРСКОЙ РЕГИСТР СУДОХОДСТВА**  
**RUSSIAN MARITIME REGISTER OF SHIPPING**

**IACS PROCEDURAL REQUIREMENTS,  
UNIFIED INTERPRETATIONS  
AND RECOMMENDATIONS**

## **GENERAL DRY CARGO SHIPS**

Guidelines for  
Surveys, Assessment and Repair  
of Hull Structure

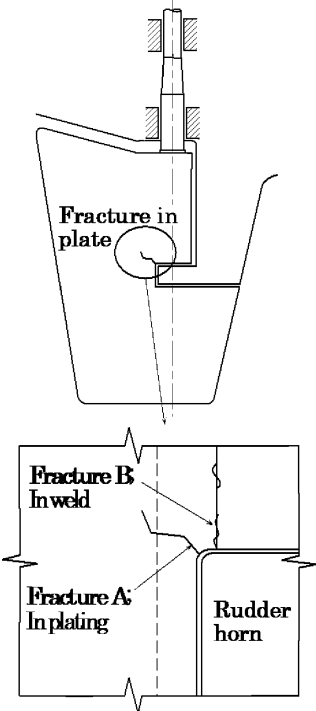
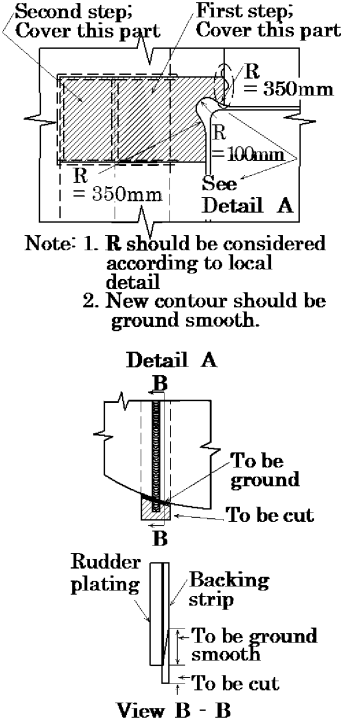
GENERAL DRY CARGO SHIPS		Guidelines for Surveys, Assessment and Repair of Hull Structure
Part 2	Fore and aft end regions	Example No.
Area 3	Stern frame, rudder arrangement and propeller shaft support	5
Detail of damage		Fracture in rudder plating of semi-spade rudder in way of pintle cutout
Sketch of damage		Sketch of repair

<p>Fracture in plate</p> <p>Fracture B In weld</p> <p>Fracture A In plating</p> <p>Rudder horn</p>

<p>Second step; Cover this part</p> <p>First step; Cover this part</p> <p><math>R = 350\text{mm}</math></p> <p><math>R = 100\text{mm}</math></p> <p>See Detail A</p> <p>Note: 1. <math>R</math> should be considered according to local detail 2. New contour should be ground smooth.</p> <p>Detail A</p> <p>To be ground</p> <p>To be cut</p> <p>Rudder plating</p> <p>Backing strip</p> <p>To be ground smooth</p> <p>To be cut</p> <p>View B - B</p>
Notes on possible cause of damage		Notes on repairs

<ol style="list-style-type: none"> <li>Inadequate design for stress concentration in way of pintle bearing (Fracture A).</li> <li>Imperfection in welding seam (Fracture B).</li> </ol>		<ol style="list-style-type: none"> <li>Fractured part to be cropped off.</li> <li>Repair by two insert plates of modified, stress releasing contour. For the vertical seam no backing strip is used 100mm off contour, welding from both sides, to be ground after welding.</li> <li>Variant (See Detail A): Repair as mentioned under 2 with the use of backing strip for the <del>complete</del> complete vertical seam. After welding backing strip partly removed by grinding.</li> </ol>

In case of longer fatigue fractures starting in the lower and/or upper corners of the pintle recess of semi-spade rudders that propagate over a longer distance into the plating, thorough check of the internal structures has to be carried out. The fractured parts of the plating and internal structures, if necessary, have to be replaced by insert plates. A proper welding connection between the insert plate and the internal stiffening structure is very important (See **Examples 4 and 5**).

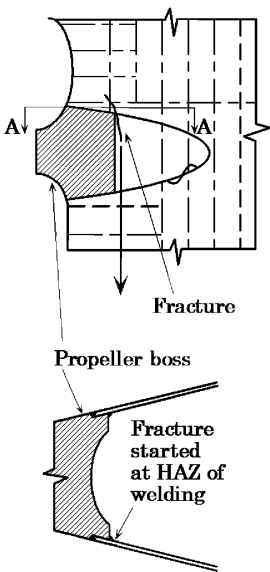
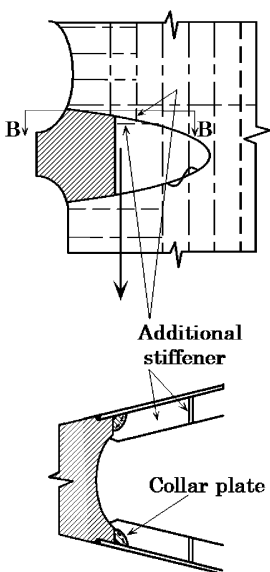
GENERAL DRY CARGO SHIPS		Guidelines for Surveys, Assessment and Repair of Hull Structure
Part 2	Fore and aft end regions	Example No.
Area 3	Stern frame, rudder arrangement and propeller shaft support	6
Detail of damage	Fracture in side shell plating at the connection to propeller boss	
Sketch of damage		Sketch of repair

<p>Fracture</p> <p>Propeller boss</p> <p>Fracture started at HAZ of welding</p> <p>Enlarged View A - A</p>

<p>Additional stiffener</p> <p>Collar plate</p> <p>Enlarged View B - B</p>
<b>Notes on possible cause of damage</b> 1. Fatigue fracture due to vibration.		<b>Notes on repairs</b> 1. Fractured side shell plating is to be cropped and part renewed. 2. Additional stiffeners are to be provided. 3. Collar plate is to be provided.

Repair examples for propeller boss and stern tube are shown in **Examples 6** and **7**. Regarding the welding reference is made to 3.1.2, 3.2.4 and 3.2.5.

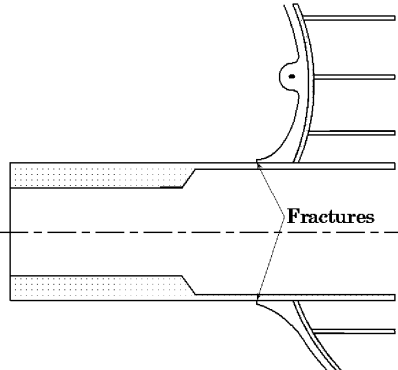
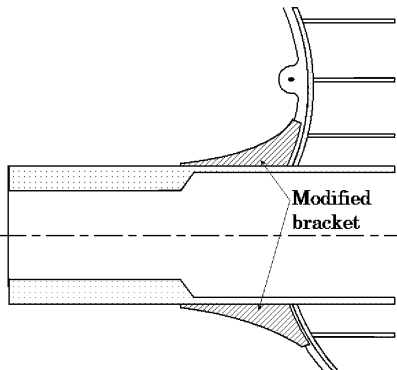
GENERAL DRY CARGO SHIPS		Guidelines for Surveys, Assessment and Repair of Hull Structure	
Part 2	Fore and aft end regions	Example No.	
Area 3	Stern frame, rudder arrangement and propeller shaft support	7	
Detail of damage	Fracture in stern tube at the connection to stern frame		
Sketch of damage		Sketch of repair

Notes on possible cause of damage		Notes on repairs	
1. Fatigue fracture due to vibration.		1. Fractured tube is to be welded from both sides. 2. Brackets are to be replaced by modified brackets with soft transition.

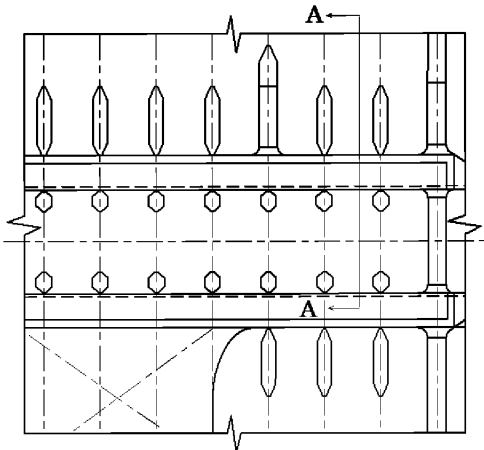
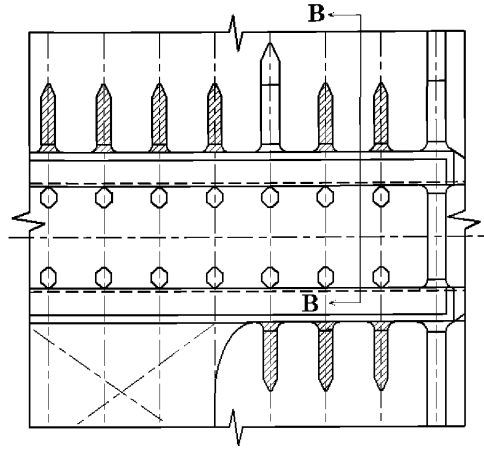
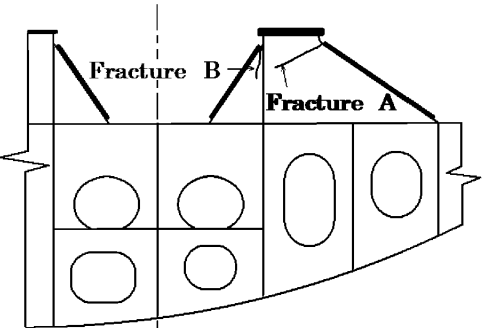
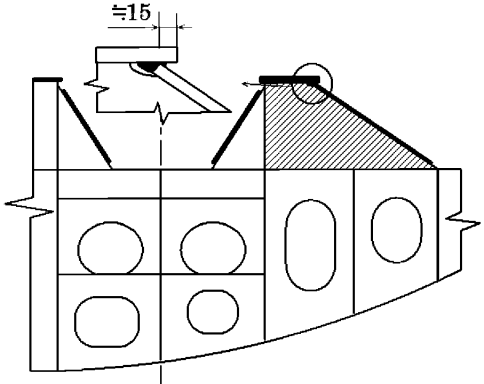
GENERAL DRY CARGO SHIPS		Guidelines for Surveys, Assessment and Repair of Hull Structure	
Part 3	Machinery and accommodation spaces	Example No.	
Area 1	Engine room structure	1	
Detail of damage	Fractures in brackets at main engine foundation		
Sketch of damage		Sketch of repair

View A - A		View B - B	
Notes on possible cause of damage		Notes on repairs	
<ol style="list-style-type: none"><li>1. Vibration of main engine.</li><li>2. Insufficient strength of brackets at main engine foundation.</li><li>3. Insufficient pre-load of the bolts.</li></ol>		<ol style="list-style-type: none"><li>1. Fractures may be veed-out and rewelded.</li><li>2. New modified brackets at main engine foundation. Or insert pieces and additional flanges to increase section modulus of the brackets.</li></ol>

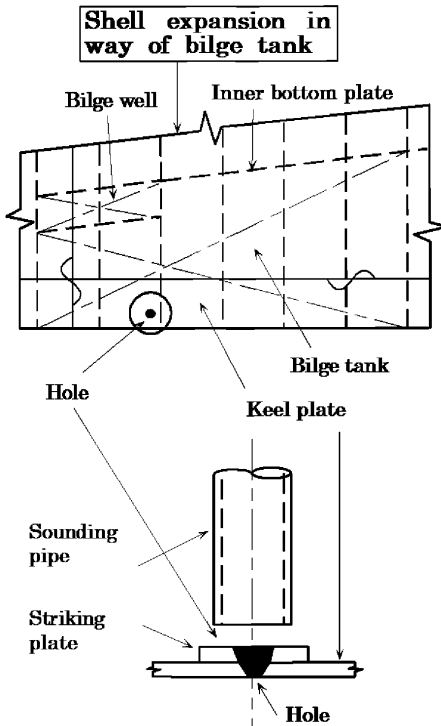
GENERAL DRY CARGO SHIPS		Guidelines for Surveys, Assessment and Repair of Hull Structure	
Part 3	Machinery and accommodation spaces		Example No.
Area 1	Engine room structure		2
Detail of damage	Corrosion in bottom plating under sounding pipe in way of bilge storage tank in engine room		
<b>Sketch of damage</b>

<b>Notes on possible cause of damage</b> 1. Heavy corrosion of bottom plating under sounding pipe.		<b>Notes on repairs</b> 1. Corroded striking plating should be renewed. Bottom plate should be repaired depending on the condition of corrosion. 2. (Note) Repair by spigot welding can be applied to the structure only when the stress level is considerably low. Generally this procedure cannot be applied to the repair of bottom plating of ballast tanks in cargo hold region.

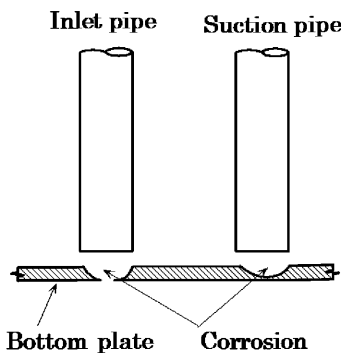
GENERAL DRY CARGO SHIPS		Guidelines for Surveys, Assessment and Repair of Hull Structure	
Part 3	Machinery and accommodation spaces		Example No.
Area 1	Engine room structure		3
Detail of damage	Corrosion in bottom plating under inlet/suction/pipe in way of bilge storage tank in engine room		
<b>Sketch of damage</b>

<b>Notes on possible cause of damage</b> <ol style="list-style-type: none"> <li>1. Heavy corrosion of bottom plating under the inlet/suction pipe.</li> </ol>		<b>Notes on repairs</b> <ol style="list-style-type: none"> <li>1. Corroded bottom plate is to be cropped and part renewed. Thicker plate is preferable.</li> <li>2. Replacement of pipe end by enlarged conical opening (similar to suction head in ballast tank) is preferable.</li> </ol>

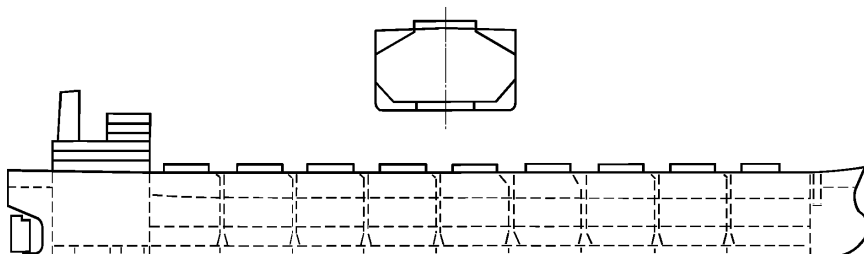
**Figure 1 General view of a typical single skin bulk carrier**

This manual gives guidelines for a bulk carrier type ship which is constructed with a single deck, single skin, double bottom, hopper side tanks and topside tanks in cargo spaces, and is intended primarily to carry dry cargo, including ore, in bulk. **Figure 1** shows the general view of a typical single skin bulk carrier with 9 cargo holds.

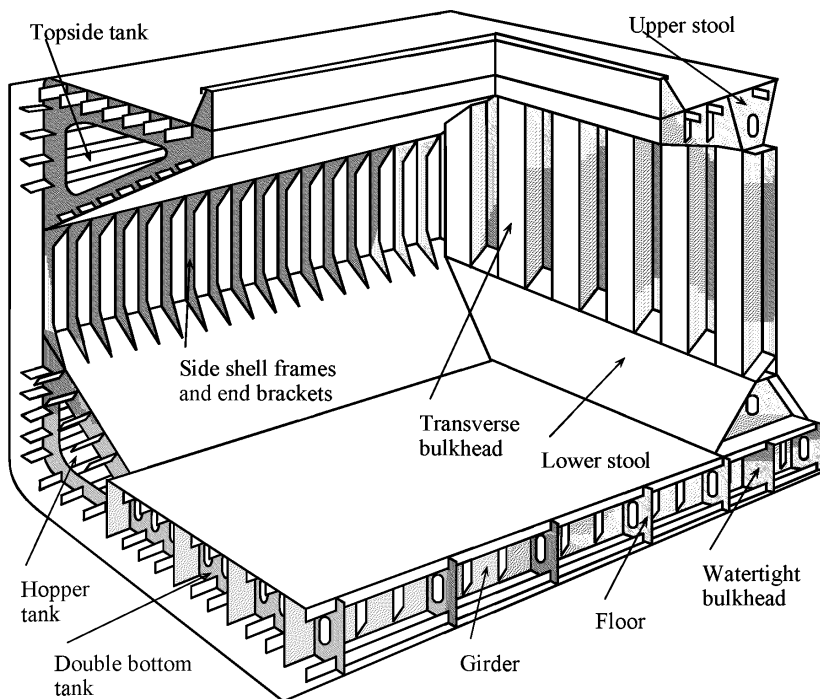
**Figure 2** Typical cargo hold configuration for a single skin bulk carrier

**Figure 2** shows a typical cargo hold structural arrangement in way of cargo hold region.

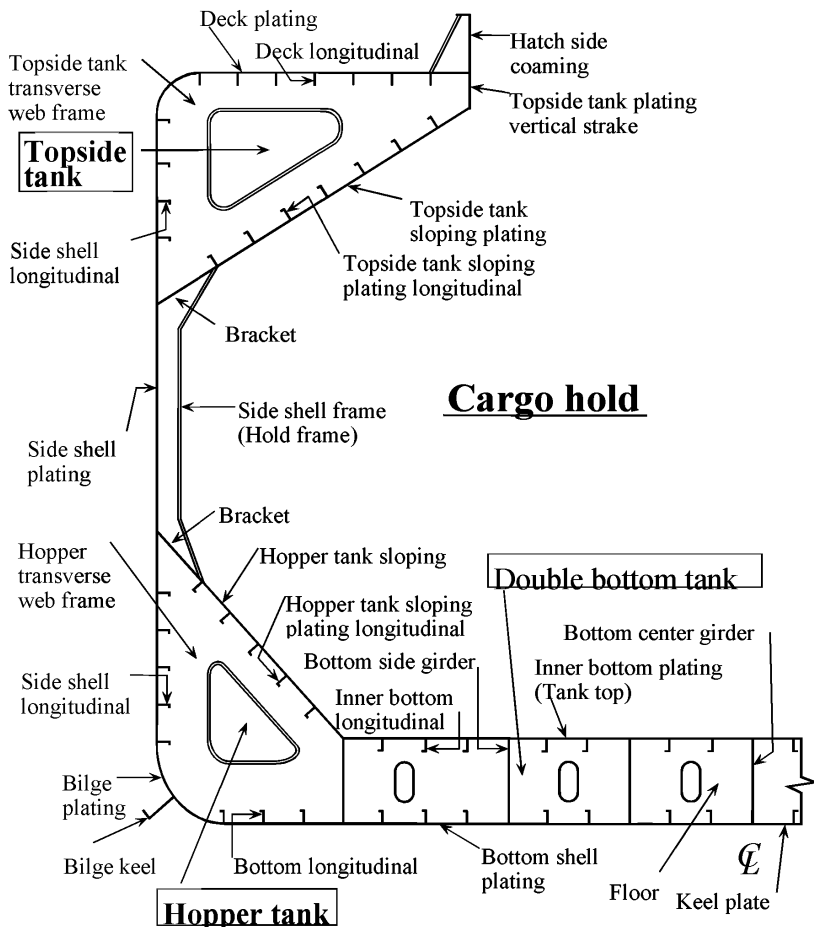
**Figure 3 (a) Nomenclature for typical transverse section in way of cargo hold**

**3.2.1** For clarity of definition and reporting of survey data, it is recommended that standard nomenclature for structural elements be adopted. Typical sections in way of cargo holds are illustrated in **Figures 3 (a)** and **(b)**. These figures show the generally accepted nomenclature.

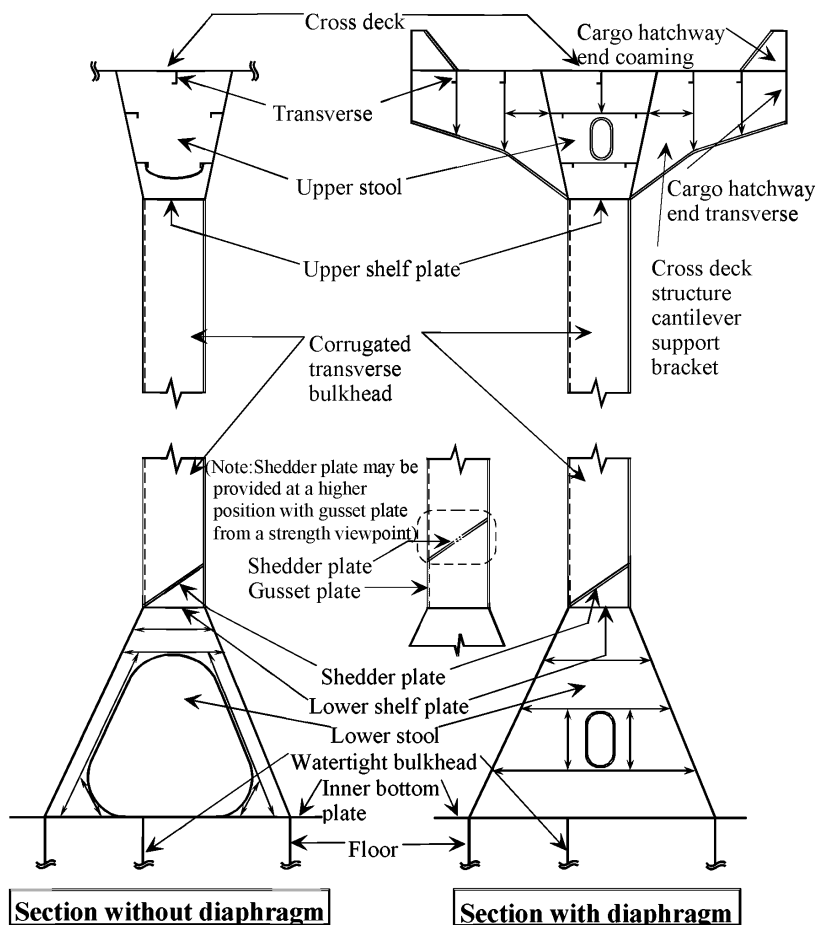
**Figure 3 (b) Nomenclature for typical watertight bulkhead**

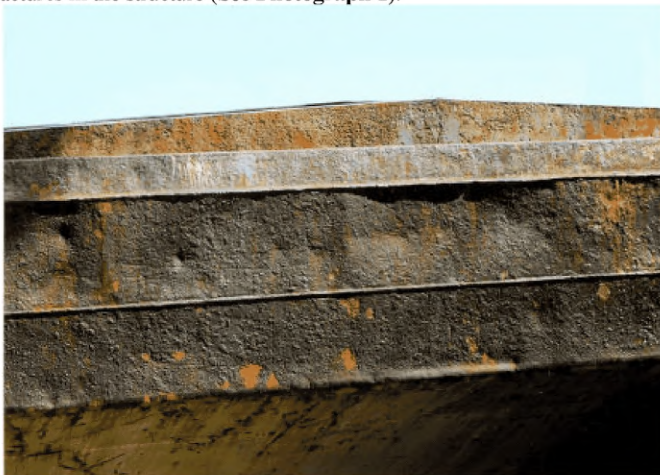
**Photograph 1**      **Heavy corrosion of hatch coaming and topside tank plating vertical strake**

- 3.1.1** The level of wastage of under-deck stiffeners/structure in cross deck may have to be established by means of thickness measurements. The combined effect of the marine environment and the high humidity atmosphere within cargo hold s will give rise to a high corrosion rate.
- 3.1.2** Severe corrosion of the hatch coaming plating inside cargo hold and topside tank plating vertical strake may occur due to difficult access for the maintenance of the protective coating. This may lead to fractures in the structure (See **Photograph 1**).

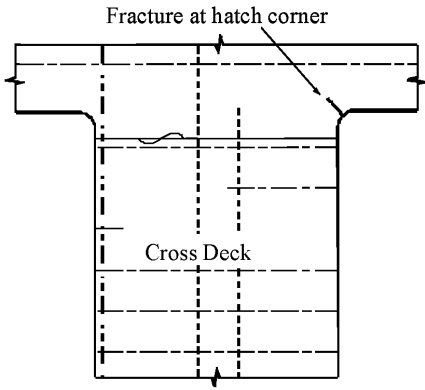
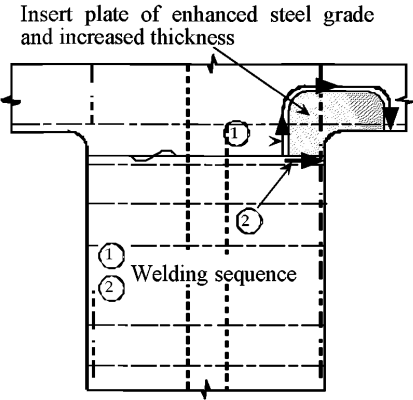
BULK CARRIERS		Guidelines for Surveys, Assessment and Repair of Hull Structure	
Part 1	Cargo hold region	Example No.	
Area 1	Deck structure	1	
Detail of damage		Fractures at main cargo hatch corner	
<b>Sketch of damage</b>

<b>Sketch of repair</b> Insert plate of enhanced steel grade and increased thickness

<b>Notes on possible cause of damage</b> <ol style="list-style-type: none"> <li>1. Stress concentration at hatch corners, i.e. radius of corner.</li> <li>2. Welded attachment of shedder plate close to edge of hatch corner.</li> <li>3. Wire rope groove.</li> </ol>		<b>Notes on repairs</b> <ol style="list-style-type: none"> <li>1. The corner plating in way of the fracture is to be cropped and renewed. If stress concentration is primary cause, insert plate should be increased thickness, enhanced steel grade and/or improved geometry. Insert plate should be continued beyond the longitudinal and transverse extent of the hatch corner radius ellipse or parabola, and the butt welds to the adjacent deck plating should be located well clear of the butts in the hatch coaming. It is recommended that the edges of the insert plate and the butt welds connecting the insert plates to the surrounding deck plating be made smooth by grinding. In this respect caution should be taken to ensure that the micro grooves of the grinding are parallel to the plate edge.</li> <li>2. If the cause of fracture is welded attachment of shedder plate, the deck connection should be left unwelded.</li> <li>3. If the cause of the fracture is wire rope groove, replacement to the original design can be accepted.</li> </ol>

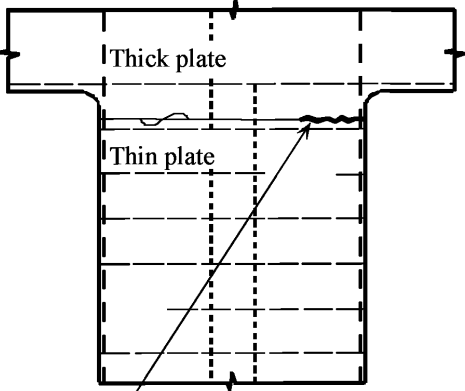
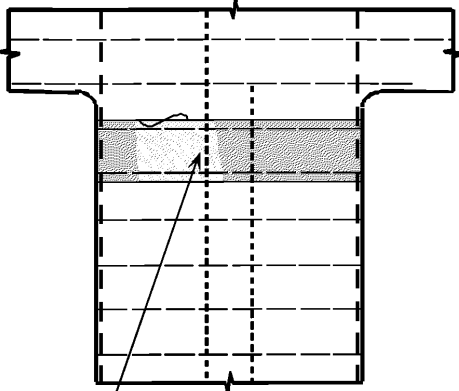
<b>BULK CARRIERS</b>		<b>Guidelines for Surveys, Assessment and Repair of Hull Structure</b>
<b>Part 1</b>	<b>Cargo hold region</b>	<b>Example No.</b>
<b>Area 1</b>	<b>Deck structure</b>	<b>2-a</b>
<b>Detail of damage</b>		Fractures of welded seam between thick plate and thin plate at cross deck
<b>Sketch of damage</b>

<p>Thick plate</p> <p>Thin plate</p> <p>Fracture at welded seam</p>		<b>Sketch of repair</b>

<p>Insert plate of suitable intermediate thickness</p>
<b>Notes on possible cause of damage</b> <ol style="list-style-type: none"> <li>1. Stress concentration created by abrupt change in deck plating thickness.</li> <li>2. In-plane bending in cross deck strip due to torsional (longitudinal) movements of ship sides.</li> <li>3. Welded seam not clear of tangent point of hatch corner.</li> </ol>		<b>Notes on repairs</b> <ol style="list-style-type: none"> <li>1. Insert plate of intermediate thickness is recommended.</li> <li>2. Smooth transition between plates (beveling) should be considered.</li> </ol>

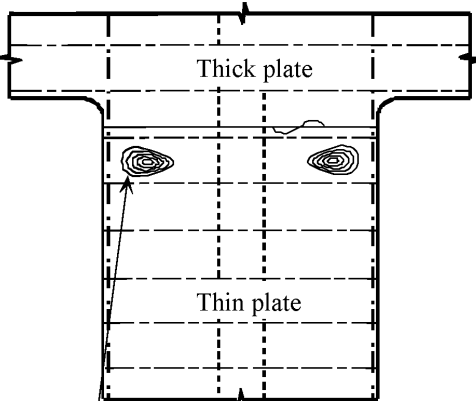
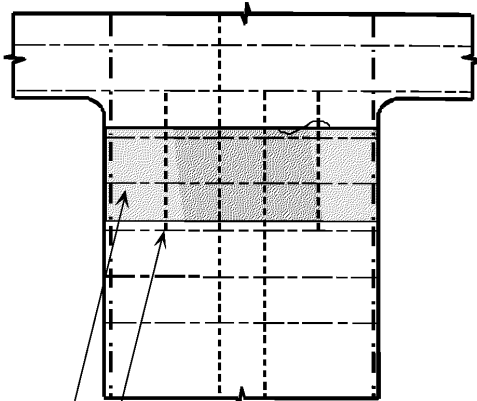
BULK CARRIERS		Guidelines for Surveys, Assessment and Repair of Hull Structure	
Part 1	Cargo hold region		Example No.
Area 1	Deck structure		2-b
Detail of damage		Plate buckling in thin plate near thick plate at cross deck	
<b>Sketch of damage</b>

<p>Buckling of cross deck plating (Buckling of hatch end structure should be examined. Refer to <b>Example 7-a.</b>)</p>		<b>Sketch of repair</b>

<p>Additional transverse stiffening and/or insertion of plate with suitable intermediate thickness</p>	
<b>Notes on possible cause of damage</b> <ol style="list-style-type: none"> <li>1. In-plane bending of cross deck strip due to torsional (longitudinal) movement of ship sides, often in combination with corrosion.</li> <li>2. Insufficient plate thickness and/or transverse stiffening.</li> </ol>		<b>Notes on repairs</b> <ol style="list-style-type: none"> <li>1. Transverse stiffeners extending from hatch sides towards centerline at least 10% of breadth of hatch, and/or increased plate thickness in the same area.</li> </ol>

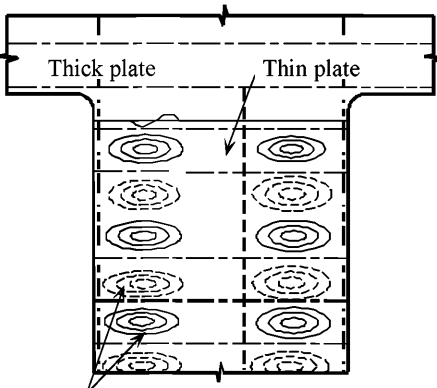
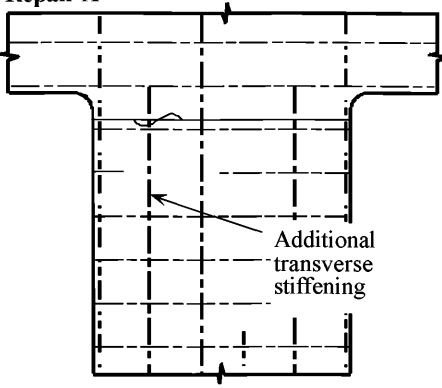
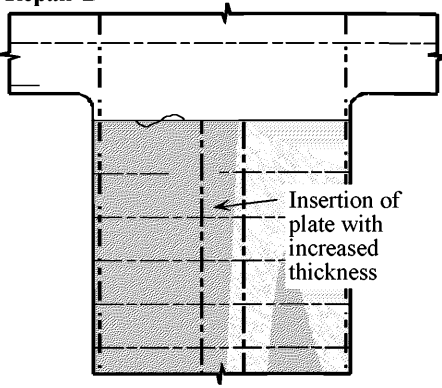
<b>BULK CARRIERS</b>		<b>Guidelines for Surveys, Assessment and Repair of Hull Structure</b>	
<b>Part 1</b>	<b>Cargo hold region</b>	<b>Example No.</b>	
<b>Area 1</b>	<b>Deck structure</b>	<b>2-c</b>	
<b>Detail of damage</b>		<b>Overall buckling of cross deck plating</b>	
<b>Sketch of damage</b>

<p>Buckling of cross deck plating (Buckling of hatch end structure should be examined. Refer to Example 7-a.)</p>		<b>Sketch of repair</b> <b>Repair A</b>

<p>Additional transverse stiffening</p> <b>Repair B</b>

<p>Insertion of plate with increased thickness</p>	
<b>Notes on possible cause of damage</b> <ol style="list-style-type: none"> <li>1. Transverse compression of deck due to sea load.</li> <li>2. Transverse compression of deck due to excessive loading in two adjacent holds.</li> <li>3. Insufficient plate thickness and/or transverse stiffening.</li> </ol>		<b>Notes on repairs</b> <ol style="list-style-type: none"> <li>1. <b>Repair A</b> Plating of original thickness in combination with additional transverse stiffening.</li> <li>2. <b>Repair B</b> Insertion of plating of increased thickness.</li> </ol>

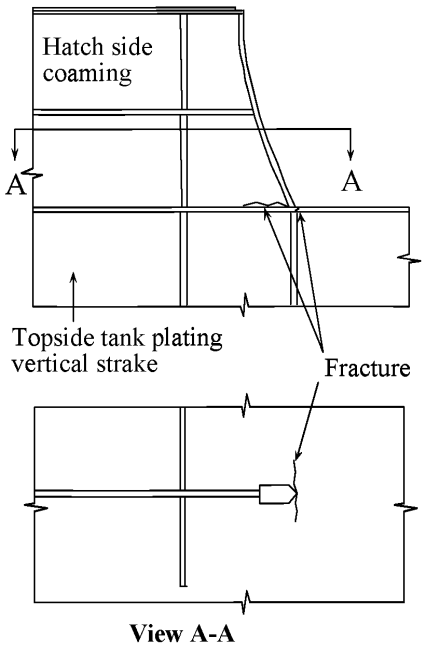
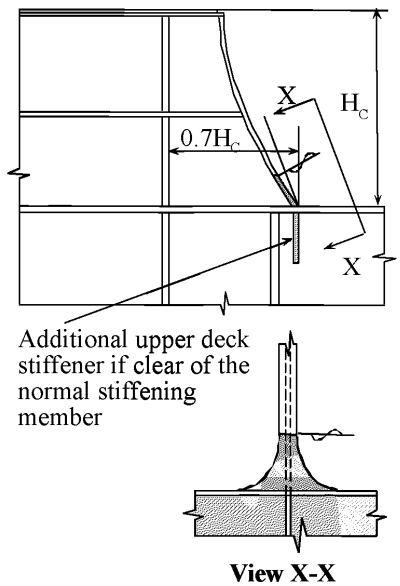
BULK CARRIERS		Guidelines for Surveys, Assessment and Repair of Hull Structure	
Part 1	Cargo hold region		Example No.
Area 1	Deck structure		3-a
Detail of damage		Fractures in the web or in the deck at the toes of the longitudinal hatch coaming termination bracket	
<b>Sketch of damage</b>

<b>Notes on possible cause of damage</b> 1. This damage is caused by stress concentrations attributed to the design of the bracket.		<b>Notes on repairs</b> 1. The design of the bracket can be altered as shown above, however, it is to be ensured that an additional under deck stiffener is provided at the toe of the termination bracket, where the toe is clear of the normal stiffening member. 2. Full penetration weld for a distance of $0.15 H_c$ from toe of side coaming termination bracket and for connection of athwartship gusset bracket to deck. 3. The fracture in deck plating to be veed-out and rewelded or deck plating cropped and part renewed as appropriate, using low hydrogen electrodes for welding.

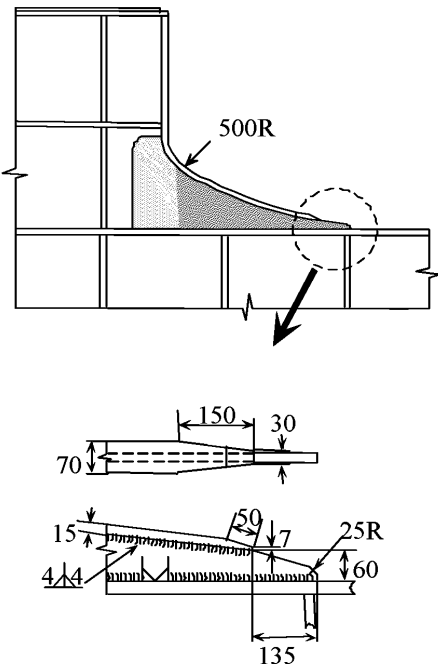
<b>BULK CARRIERS</b>		<b>Guidelines for Surveys, Assessment and Repair of Hull Structure</b>
<b>Part 1</b>	<b>Cargo hold region</b>	<b>Example No.</b>
<b>Area 1</b>	<b>Deck structure</b>	<b>3-b</b>
<b>Detail of damage</b>		Fractures in the web or in the deck at the toes of the longitudinal hatch coaming termination bracket
<b>Sketch of damage</b>

<p>Hatch side coaming</p> <p>Topside tank plating vertical strake</p> <p>Fracture</p> <p>View A-A</p>		<b>Sketch of repair</b>

<p>500R</p> <p>150 30 70 15 50 7 25R 60 135 4 4</p>
<b>Notes on possible cause of damage</b> 1. This damage is caused by stress concentrations attributed to the design of the bracket.		<b>Notes on repairs</b> 1. The design of the bracket can be altered as shown above, however, it is to be ensured that an additional under deck stiffener is provided at the toe of the termination bracket, where the toe is clear of the normal stiffening member. 2. The fracture in deck plating to be veed-out and rewelded or deck plating cropped and part renewed as appropriate, using low hydrogen electrodes for welding.

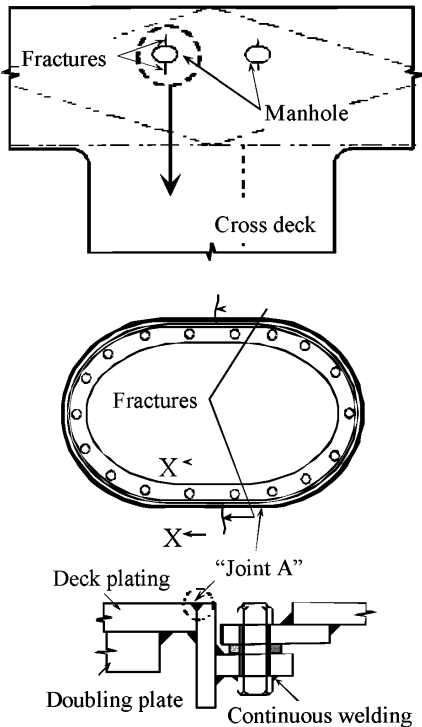
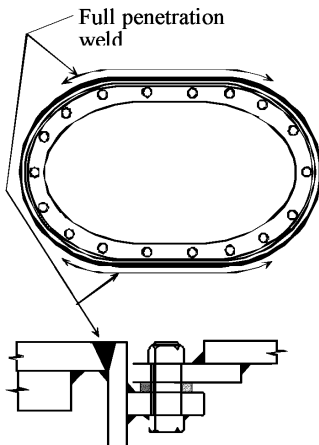
BULK CARRIERS		Guidelines for Surveys, Assessment and Repair of Hull Structure
Part 1	Cargo hold region	Example No.
Area 1	Deck structure	4
Detail of damage		Fractures in deck plating initiated from weld of access manhole
Sketch of damage		Sketch of repair

<p>Fractures</p> <p>Manhole</p> <p>Cross deck</p> <p>Fractures</p> <p>X-X</p> <p>Deck plating</p> <p>"Joint A"</p> <p>Doubling plate</p> <p>Continuous welding</p> <p><b>Section X-X</b></p>

<p>Full penetration weld</p>
<b>Notes on possible cause of damage</b> <ol style="list-style-type: none"> <li>1. Heavy weather.</li> <li>2. Improper welding of joint "A".</li> </ol>		<b>Notes on repairs</b> <ol style="list-style-type: none"> <li>1. The fracture in deck plating to be veed-out and rewelded, or deck plating cropped and part renewed if considered necessary.</li> <li>2. Full penetration of joint "A" should be considered.</li> </ol>

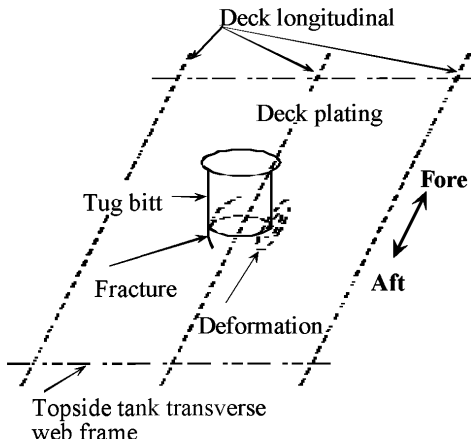
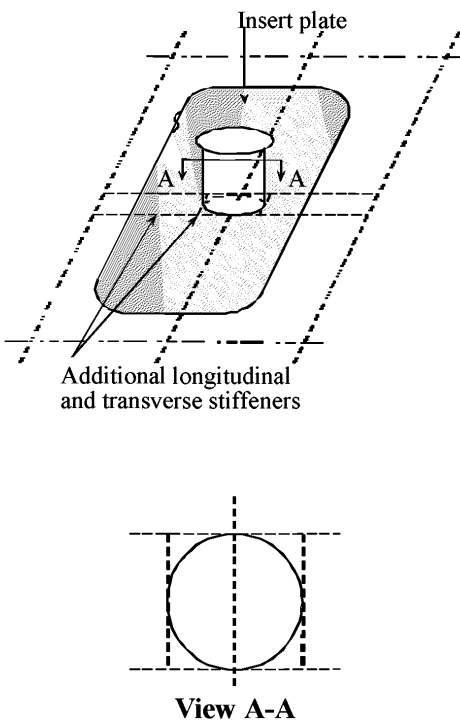
<b>BULK CARRIERS</b>		<b>Guidelines for Surveys, Assessment and Repair of Hull Structure</b>
<b>Part 1</b>	<b>Cargo hold region</b>	<b>Example No.</b>
<b>Area 1</b>	<b>Deck structure</b>	<b>5</b>
<b>Detail of damage</b>	Deformed and fractured deck plating around tug bitt	
<b>Sketch of damage</b>

<b>Notes on possible cause of damage</b> 1. Insufficient strength		<b>Notes on repairs</b> 1. Fractured/deformed deck plating should be cropped and part renewed. 2. Reinforcement by stiffeners should be considered.

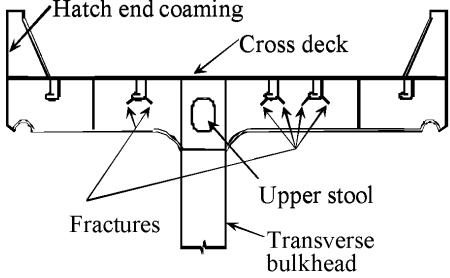
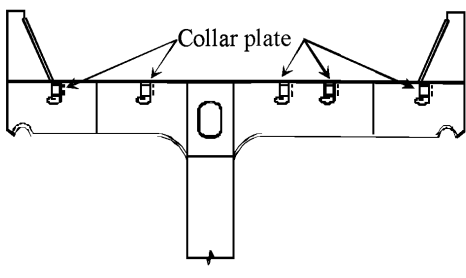
<b>BULK CARRIERS</b>		<b>Guidelines for Surveys, Assessment and Repair of Hull Structure</b>	
<b>Part 1</b>	<b>Cargo hold region</b>		<b>Example No.</b>
<b>Area 1</b>	<b>Deck structure</b>		<b>6</b>
<b>Detail of damage</b>		Fractures around cut-outs in cross deck girder	
<b>Sketch of damage</b>

<b>Notes on possible cause of damage</b> <ol style="list-style-type: none"> <li>1. Stress concentration at the cut-outs in cross deck girder.</li> </ol>		<b>Notes on repairs</b> <ol style="list-style-type: none"> <li>1. Fractured web plate of cross deck girder to be cropped and part renewed.</li> <li>2. Collar plates to be provided.</li> </ol>

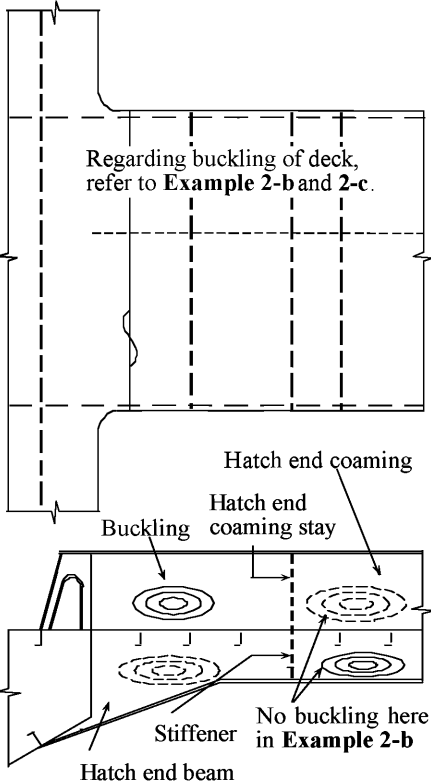
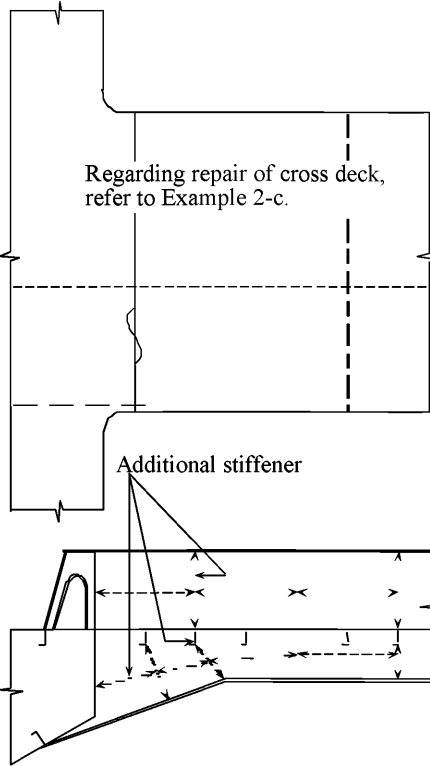
BULK CARRIERS		Guidelines for Surveys, Assessment and Repair of Hull Structure	
Part 1	Cargo hold region		Example No.
Area 1	Deck structure		7-a
Detail of damage		Buckling of hatch coaming and hatch end beam	
Sketch of damage		Sketch of repair	
<div>

</div>	
Notes on possible cause of damage		Notes on repairs	
<div><div>1.</div><div>Additional transverse forces due to heavy seas, and torsional loading.</div></div> <div><div>2.</div><div>Inadvertent overloading of cargo spaces.</div></div>		<div><div>1.</div><div>If buckling is due to loss in strength induced by corrosion, the buckled zone to be cropped and renewed as necessary.</div></div> <div><div>2.</div><div>If buckling results from inadequate strength, stiffeners should be fitted in addition to cropping and renewal of buckled zone.</div></div>

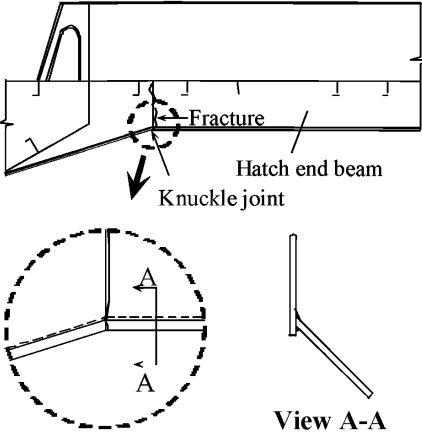
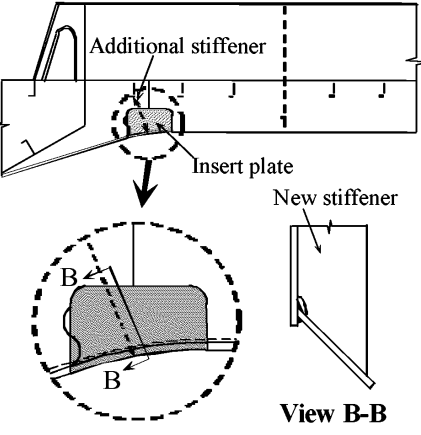
<b>BULK CARRIERS</b>		<b>Guidelines for Surveys, Assessment and Repair of Hull Structure</b>
<b>Part 1</b>	<b>Cargo hold region</b>	<b>Example No.</b>
<b>Area 1</b>	<b>Deck structure</b>	<b>7-b</b>
<b>Detail of damage</b>		Fractures in hatch end beam at knuckle joint
<b>Sketch of damage</b>

<b>Sketch of repair</b>

<b>Notes on possible cause of damage</b> 1. Stress concentration at knuckle joint.		<b>Notes on repairs</b> 1. Fractured part to be cropped and renewed. 2. Improvement to avoid stress concentration at knuckle joint should be considered.

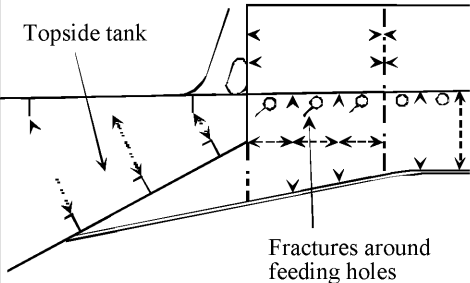
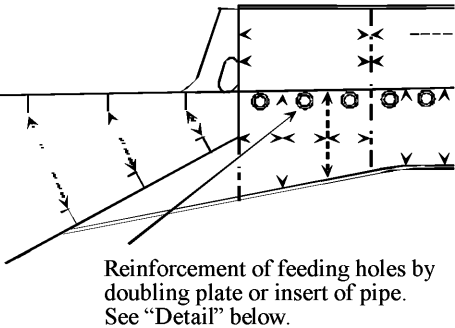
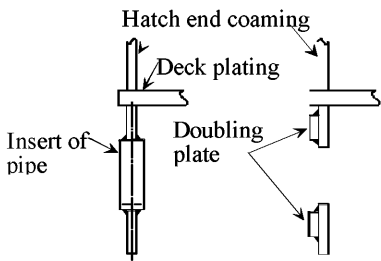
<b>BULK CARRIERS</b>		<b>Guidelines for Surveys, Assessment and Repair of Hull Structure</b>	
<b>Part 1</b>	<b>Cargo hold region</b>	<b>Example No.</b>	
<b>Area 1</b>	<b>Deck structure</b>	<b>9</b>	
<b>Detail of damage</b>		Fractures in hatch end beam around feeding holes	
<b>Sketch of damage</b>

<b>Sketch of repair</b>

<b>Notes on possible cause of damage</b> 1. Inadequate reinforcement around feeding hole. 2. Corrosion.		<b>Detail</b>

<b>Notes on repairs</b> 1. Fractured part to be vee-d-out or cropped and renewed. 2. If the fractured part is free from corrosion, reinforcement should be considered.

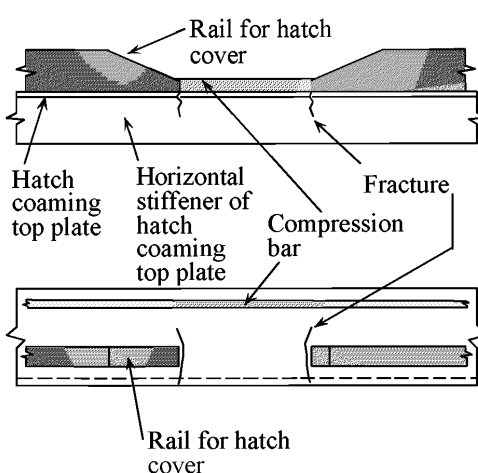
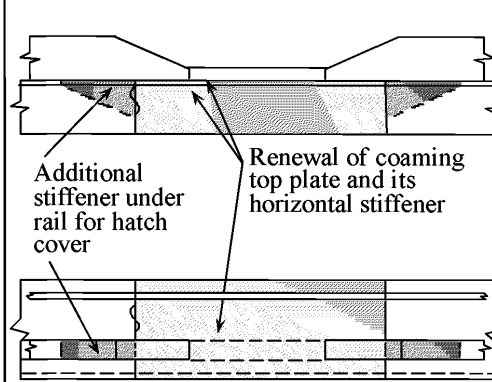
<b>BULK CARRIERS</b>		<b>Guidelines for Surveys, Assessment and Repair of Hull Structure</b>	
<b>Part 1</b>	<b>Cargo hold region</b>		<b>Example No.</b>
<b>Area 1</b>	<b>Deck structure</b>		<b>10-a</b>
<b>Detail of damage</b>		Fractures in hatch coaming top plate at the termination of rail for hatch cover	
<b>Sketch of damage</b>

<b>Sketch of repair</b>

<b>Notes on possible cause of damage</b> <ol style="list-style-type: none"> <li>1. Stress concentration at the termination of the rail for hatch cover due to poor design.</li> </ol>		<b>Notes on repairs</b> <ol style="list-style-type: none"> <li>1. Fractured plate is to be cropped and part renewed.</li> <li>2. Thicker insert plate and/or reinforcement by additional stiffener under the top plate should be considered. Also refer to <b>Example 10-b</b>.</li> </ol>

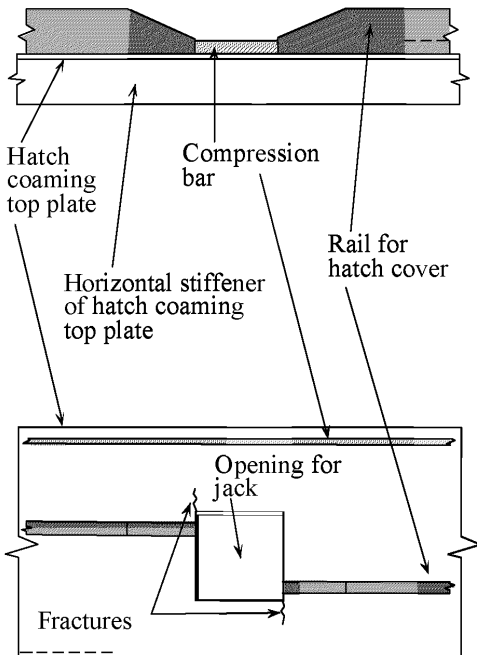
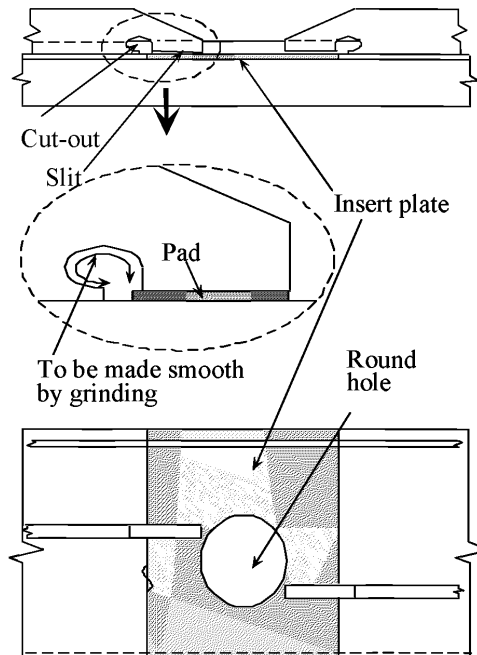
BULK CARRIERS		Guidelines for Surveys, Assessment and Repair of Hull Structure	
Part 1	Cargo hold region		Example No.
Area 1	Deck structure		10-b
Detail of damage		Fractures in hatch coaming top plate at the termination of rail for hatch cover	
<b>Sketch of damage</b>

<p>Hatch coaming top plate</p> <p>Horizontal stiffener of hatch coaming top plate</p> <p>Compression bar</p> <p>Rail for hatch cover</p> <p>Opening for jack</p> <p>Fractures</p>		<b>Sketch of repair</b>

<p>Cut-out</p> <p>Slit</p> <p>Insert plate</p> <p>Pad</p> <p>To be made smooth by grinding</p> <p>Round hole</p>	
<b>Notes on possible cause of damage</b> <ol style="list-style-type: none"> <li>1. Stress concentration at the termination of the rail for hatch cover due to poor design of opening.</li> </ol>		<b>Notes on repairs</b> <ol style="list-style-type: none"> <li>1. Fractured plate is to be cropped and part renewed.</li> <li>2. Thicker insert plate and/or reduction of stress concentration adopting large radius should be considered. Or cut-out in the rail and detachment of the welds as shown in the above drawing should be considered in order to reduce the stress of the corner of the opening.</li> </ol>

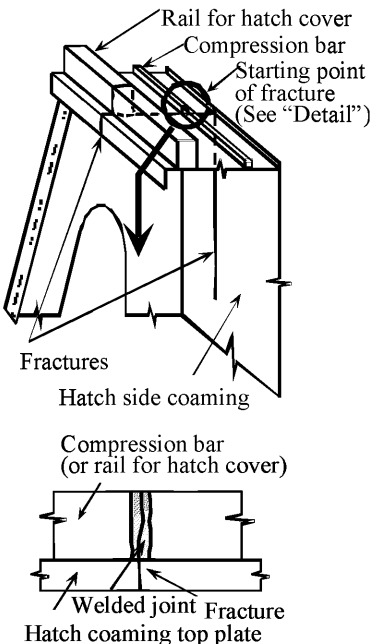
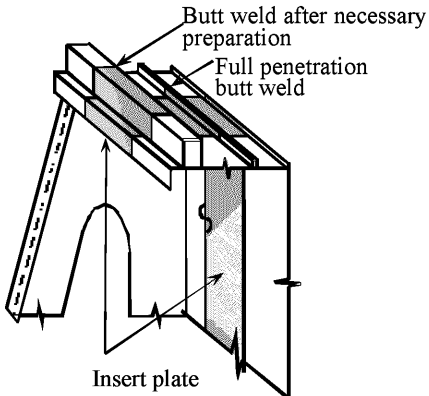
<b>BULK CARRIERS</b>		<b>Guidelines for Surveys, Assessment and Repair of Hull Structure</b>
<b>Part 1</b>	<b>Cargo hold region</b>	<b>Example No.</b>
<b>Area 1</b>	<b>Deck structure</b>	<b>11</b>
<b>Detail of damage</b>		Fractures in hatch coaming top plate initiated from butt weld of compression bar
<b>Sketch of damage</b>

<p>Rail for hatch cover Compression bar Starting point of fracture (See "Detail") Fractures Hatch side coaming Compression bar (or rail for hatch cover) Welded joint Fracture Hatch coaming top plate</p> <p><b>Detail</b></p>		<b>Sketch of repair</b>

<p>Butt weld after necessary preparation Full penetration butt weld Insert plate</p>
<b>Notes on possible cause of damage</b> <ol style="list-style-type: none"> <li>1. Heavy weather</li> <li>2. Insufficient preparation of weld of compression bar and/or rail (Although the compression bar and rail are not longitudinal strength members, they subject same longitudinal stress as longitudinal members)</li> <li>3. Crack may initiate from insufficient penetration of weld of rail for hatch cover.</li> </ol>		<b>Notes on repairs</b> <ol style="list-style-type: none"> <li>1. Loading condition of the ship and proper welding procedure should be carefully considered.</li> <li>2. Fractured structure is to be cropped and renewed if considered necessary. (Small fracture may be vee'd-out and rewelded.)</li> <li>3. Full penetration welding should be applied to the butt weld of compression bar and rail.</li> </ol>

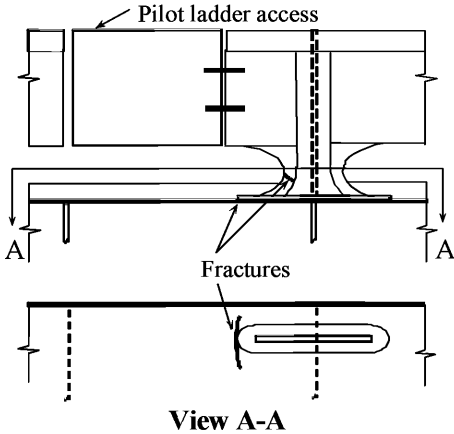
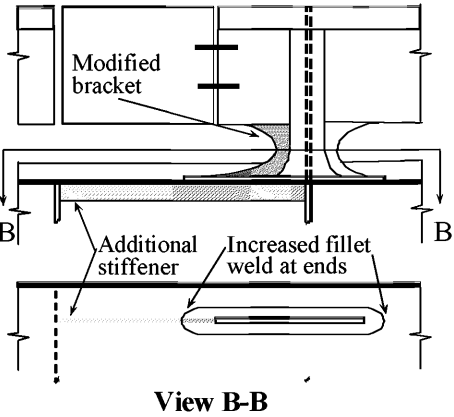
<b>BULK CARRIERS</b>		<b>Guidelines for Surveys, Assessment and Repair of Hull Structure</b>	
<b>Part 1</b>	<b>Cargo hold region</b>	<b>Example No.</b>	
<b>Area 1</b>	<b>Deck structure</b>	<b>12</b>	
<b>Detail of damage</b>		Fractures in deck plating at the pilot ladder access of bulwarks	
<b>Sketch of damage</b>

<p style="text-align: center;"><b>View A-A</b></p>		<b>Sketch of repair</b>

<p style="text-align: center;"><b>View B-B</b></p>	
<b>Notes on possible cause of damage</b> 1. Stress concentration at the termination of bulwarks.		<b>Notes on repairs</b> 1. Fractured deck plating should be cropped and part renewed. 2. Reduction of stress concentration should be considered. In the above figure gusset plate was replaced with soft type for the fracture in gusset plate and pad plate was increased. Additional stiffeners were provided for the fracture in deck plating.

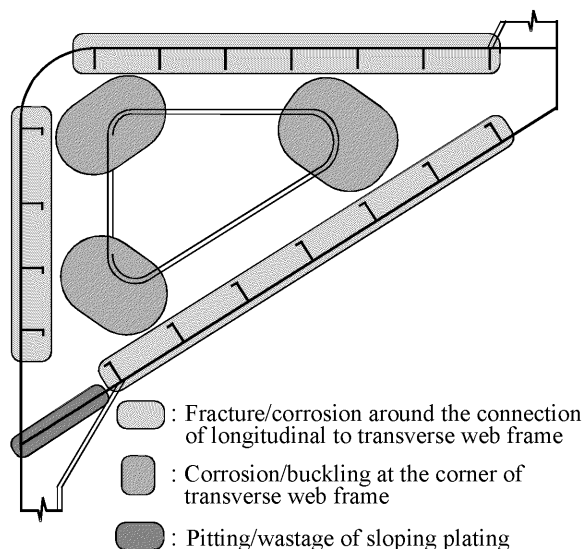
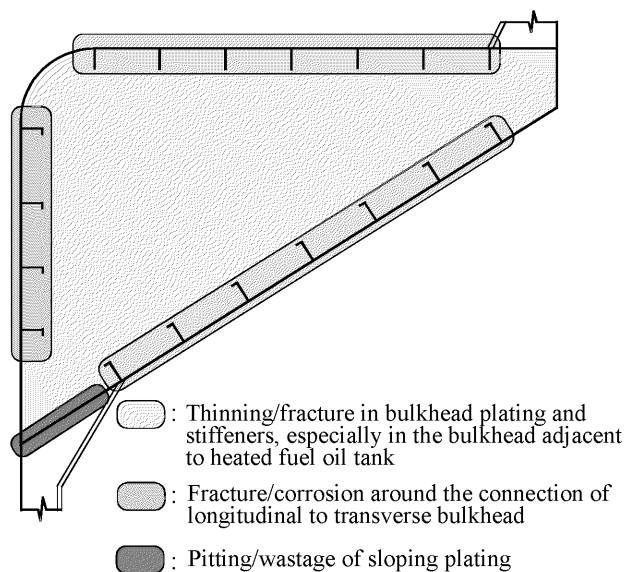
**Figure 1 Topside tank - Potential problem areas**

- (a) Structure in corrosive environment
    - Deck plating and deck longitudinal
    - Transverse bulkhead adjacent to heated fuel oil tank
    - Lowest part of sloping plating

- (b) Structure subject to high stress
    - Face plates and web plates of transverse at corners
    - Connection of side longitudinal to transverse
  - (c) Areas susceptible to coating breakdown

- Back side of face plate of longitudinal
    - Welded joint
    - Edge of access opening
  - (d) Areas subjected to poor drainage
    - Web of side and sloping longitudinals

**(a) Transverse web frame section**

**(b) Transverse bulkhead section**

- 2.1.2** Rate and extent of corrosion depends on the environmental conditions, and protective measures employed, such as coatings and sacrificial anodes. The following structures are generally susceptible to corrosion (See **Figure 1**).

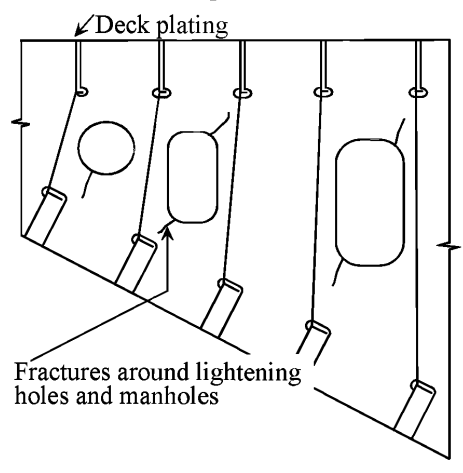
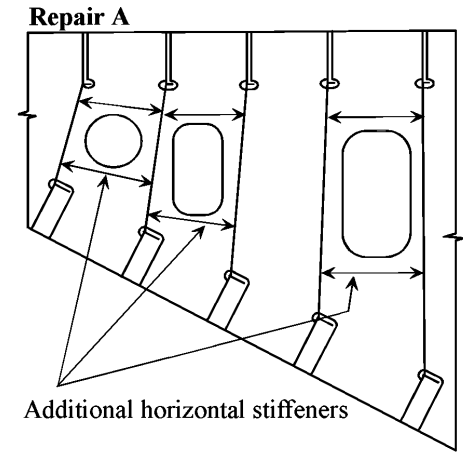
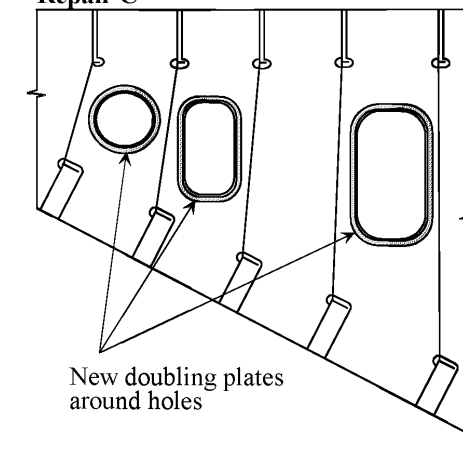
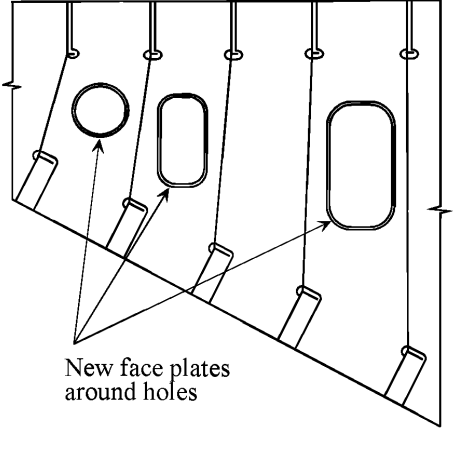
<b>BULK CARRIERS</b>		<b>Guidelines for Surveys, Assessment and Repair of Hull Structure</b>
<b>Part 1</b>	<b>Cargo hold region</b>	<b>Example No.</b>
<b>Area 2</b>	<b>Topside tank structure</b>	<b>1</b>
<b>Detail of damage</b>		Fractures around unstiffened lightening holes and manholes in wash bulkhead
<b>Sketch of damage</b>		<b>Sketch of repair</b>

<b>Notes on possible cause of damage</b>		<b>Notes on repairs</b>
<ol style="list-style-type: none"> <li>General levels of corrosion and presence of stress concentration.</li> </ol>		<ol style="list-style-type: none"> <li>Corroded/fractured plating should be cropped and renewed with plating of enhanced thickness.</li> <li>Reinforcement should be considered.</li> </ol>

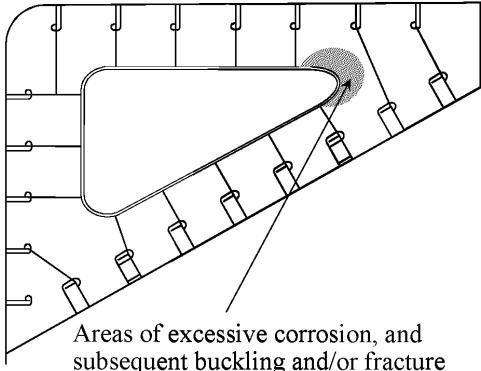
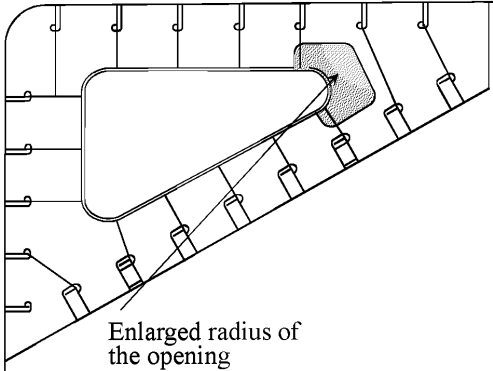
<b>BULK CARRIERS</b>		<b>Guidelines for Surveys, Assessment and Repair of Hull Structure</b>
<b>Part 1</b>	<b>Cargo hold region</b>	<b>Example No.</b>
<b>Area 2</b>	<b>Topside tank structure</b>	<b>2-b</b>
<b>Detail of damage</b>		Thinning and subsequent buckling of web plating in the vicinity of the radii of the opening
<b>Sketch of damage</b>		<b>Sketch of repair</b>

<p>Areas of excessive corrosion, and subsequent buckling and/or fracture</p>

<p>Enlarged radius of the opening</p>
<b>Notes on possible cause of damage</b>		<b>Notes on repairs</b>
<ol style="list-style-type: none"> <li>Corrosion caused by stress concentration at the corner due to insufficient radius for the opening.</li> </ol>		<ol style="list-style-type: none"> <li>Corroded/buckled plating is to be cropped and parts renewed with plating of increased thickness and additional stiffeners are preferable to minimize deflection.</li> <li>An attempt should be made to improve the design of the radius if felt necessary.</li> </ol>

<b>Notes on possible cause of damage</b> 1. Additional stresses at the free edge of transverse web. (In <b>Example 2-a - 2-c</b> face plate is provided for the reinforcement of the opening.)		<b>Notes on repairs</b> 1. Corroded/buckled plating is to be cropped and part renewed with plating of increased thickness.

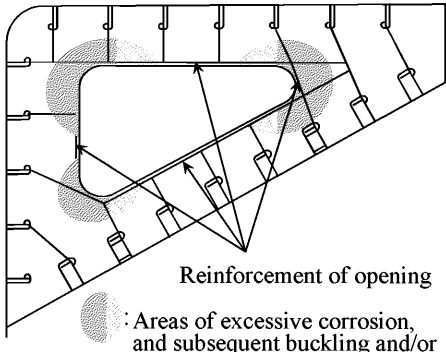
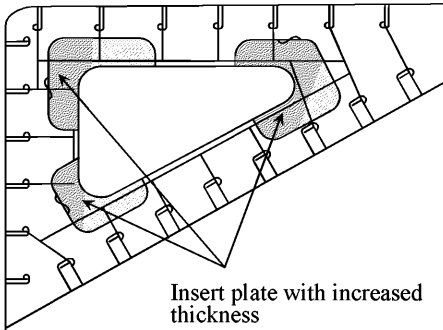
<b>BULK CARRIERS</b>		<b>Guidelines for Surveys, Assessment and Repair of Hull Structure</b>	
<b>Part 1</b>	<b>Cargo hold region</b>	<b>Example No.</b>	
<b>Area 2</b>	<b>Topside tank structure</b>	<b>2-c</b>	
<b>Detail of damage</b>		Thinning and subsequent buckling of web plating in the vicinity of the radii of the opening	
<b>Sketch of damage</b>		<b>Sketch of repair</b>

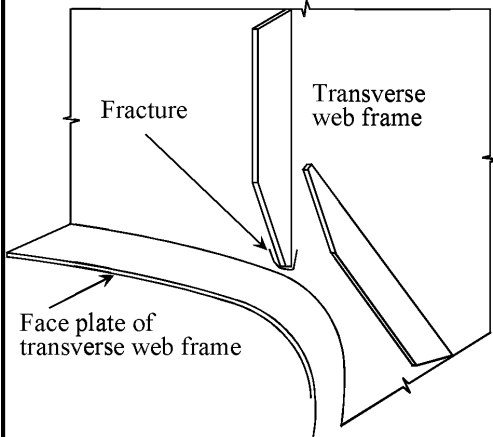
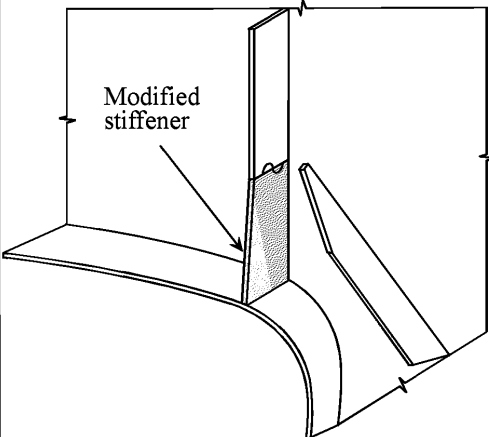
<b>BULK CARRIERS</b>		<b>Guidelines for Surveys, Assessment and Repair of Hull Structure</b>
<b>Part 1</b>	<b>Cargo hold region</b>	<b>Example No.</b>
<b>Area 2</b>	<b>Topside tank structure</b>	<b>3</b>
<b>Detail of damage</b>		Fractures in transverse web at sniped end of stiffener
<b>Sketch of damage</b>		<b>Sketch of repair</b>

<b>Notes on possible cause of damage</b>		<b>Notes on repairs</b>
<ol style="list-style-type: none"> <li>1. Stress concentration.</li> </ol>		<ol style="list-style-type: none"> <li>1. Fracture can be veed-out and welded provided the plating is not generally corroded. If necessary, fractured plating should be cropped and renewed.</li> <li>2. Excessive stress concentration at the end of stiffener should be avoided.</li> </ol>
