**РОССИЙСКИЙ МОРСКОЙ РЕГИСТР СУДОХОДСТВА**  
**RUSSIAN MARITIME REGISTER OF SHIPPING**

**IACS PROCEDURAL REQUIREMENTS,  
UNIFIED INTERPRETATIONS  
AND RECOMMENDATIONS**

## **GENERAL DRY CARGO SHIPS**

Guidelines for  
Surveys, Assessment and Repair  
of Hull Structure

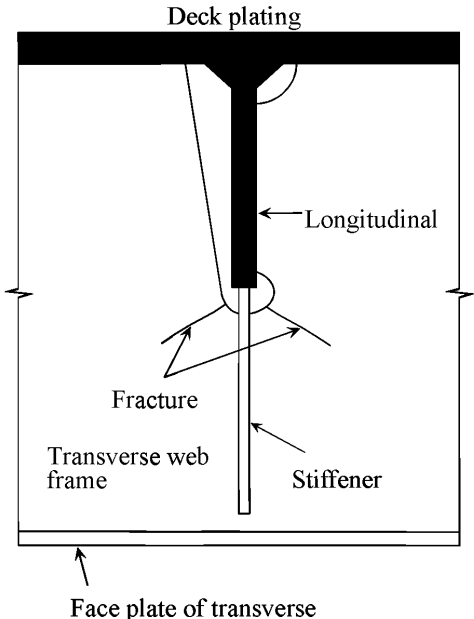
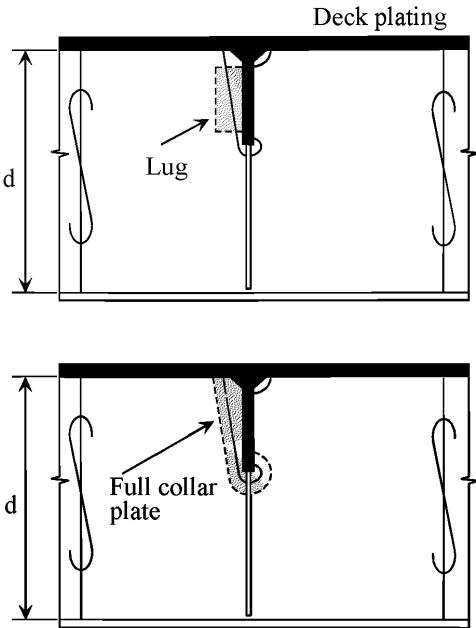
<b>BULK CARRIERS</b>		<b>Guidelines for Surveys, Assessment and Repair of Hull Structure</b>
<b>Part 1</b>	<b>Cargo hold region</b>	<b>Example No.</b>
<b>Area 2</b>	<b>Topside tank structure</b>	<b>4-a</b>
<b>Detail of damage</b>		Fractures at slots in way of transverse web frame
<b>Sketch of damage</b>

<b>Sketch of repair</b>

<p>(Note) Full collar plate where the depth of cut-out is more than 0.4 times the depth of web frame (<math>0.4d</math>) and in an areas of high shear stress</p>
<b>Notes on possible cause of damage</b> <ol style="list-style-type: none"> <li>1. Damage may be created by local shear stress concentrations due to large cut-outs for notch.</li> <li>2. Also deficient welds (fillet welds between deck longitudinal and stiffener).</li> </ol>		<b>Notes on repairs</b> <ol style="list-style-type: none"> <li>1. Crop and part renew the web plating.</li> <li>2. Close the cut-out by introducing a lug or alternatively fit a full collar plate.</li> </ol>

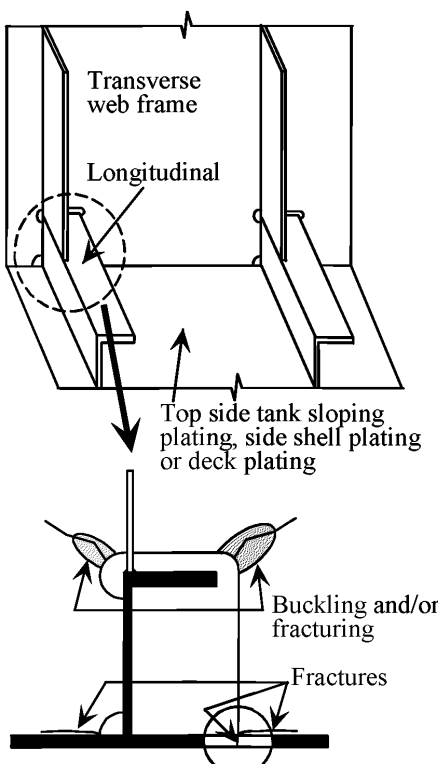
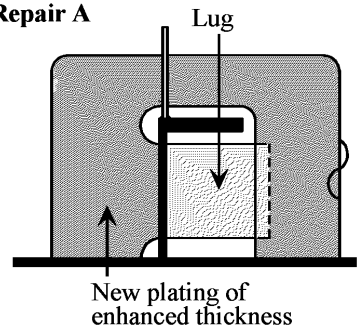
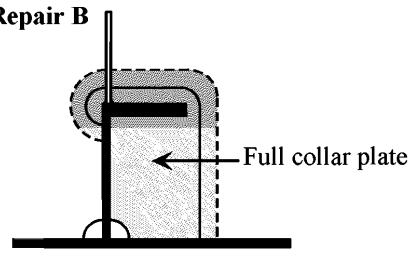
<b>BULK CARRIERS</b>		<b>Guidelines for Surveys, Assessment and Repair of Hull Structure</b>
<b>Part 1</b>	<b>Cargo hold region</b>	<b>Example No.</b>
<b>Area 2</b>	<b>Topside tank structure</b>	<b>4-b</b>
<b>Detail of damage</b>		Fractures and buckling at slots in way of transverse web frame
<b>Sketch of damage</b>		<b>Sketch of repair</b>

<p><b>Repair A</b></p>

<p><b>Repair B</b></p>

<b>Notes on possible cause of damage</b>		<b>Notes on repairs</b>
<p>1. Damage can be caused by general levels of corrosion and presence of stress concentration associated with the presence of a cut-out.</p>		<p>1. If fractures are significant then crop and part renew the plating otherwise the fracture can be veed-out and welded provided the plating is not generally corroded.</p> <p>2. <b>Repair A</b> Lug should be considered.</p> <p>3. <b>Repair B</b> Full collar plate should be considered where the depth of cut-out is more than 0.4 times the depth of web frame and in an area of high shear stress or the existing lug proves to be ineffective.</p>

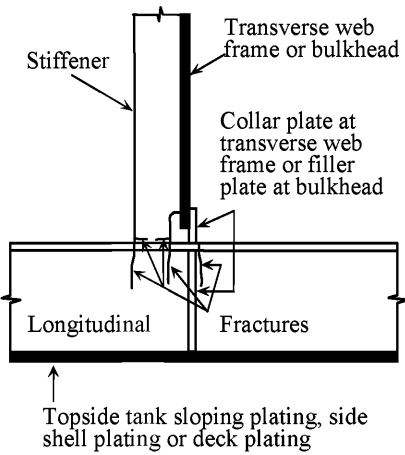
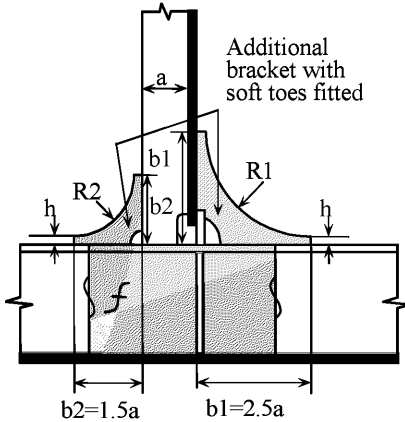
<b>BULK CARRIERS</b>		<b>Guidelines for Surveys, Assessment and Repair of Hull Structure</b>
<b>Part 1</b>	<b>Cargo hold region</b>	<b>Example No.</b>
<b>Area 2</b>	<b>Topside tank structure</b>	<b>5</b>
<b>Detail of damage</b>		Fractures in longitudinal at transverse web frame or bulkhead
<b>Sketch of damage</b>		<b>Sketch of repair</b>

<p><math>b2=1.5a</math>      <math>b1=2.5a</math></p> <p><math>f</math>: Where required, the longitudinal to be cropped and part renewed</p> <ol style="list-style-type: none"> <li>1. For a slope at toes max. 1:3, <math>R1=(b1-h) \times 1.6</math> and <math>R2=(b2-h) \times 1.6</math></li> <li>2. Soft toe bracket to be welded first to longitudinal</li> <li>3. Scallop in bracket to be as small as possible, recommended max. 35mm</li> <li>4. If toes of brackets are ground smooth, full penetration welds in way to be provided</li> <li>5. Maximum length to thickness ratio =50:1 for unstiffened bracket edge</li> <li>6. Toe height, <math>h</math>, to be as small as possible (10-15mm)</li> </ol>

<b>Notes on possible cause of damage</b>		<b>Notes on repairs</b>
<ol style="list-style-type: none"> <li>1. Damage can be caused by stress concentrations leading to accelerated fatigue in this region.</li> </ol>		<ol style="list-style-type: none"> <li>1. If fracture extends to over one third of the depth of the longitudinal, then crop and part renew. Otherwise the fracture can be veed-out and welded.</li> </ol>

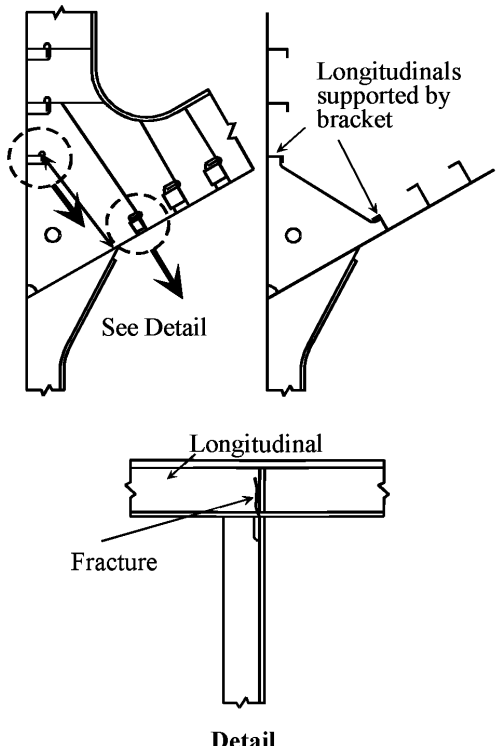
<b>BULK CARRIERS</b>		<b>Guidelines for Surveys, Assessment and Repair of Hull Structure</b>
<b>Part 1</b>	<b>Cargo hold region</b>	<b>Example No.</b>
<b>Area 2</b>	<b>Topside tank structure</b>	<b>6</b>
<b>Detail of damage</b>		Fractures in the lowest longitudinal at transverse web frame
<b>Sketch of damage</b>

<b>Notes on possible cause of damage</b> 1. Insufficient scantling for torsional rigidity (The lowest longitudinal is usually supported by bracket(s) as shown in the above and smaller scantling may be adopted. However, the lowest longitudinal undergoes torsion from side shell frame through bracket(s) and may suffer fracture.)		<b>Notes on repairs</b> 1. Fractured part to be cropped and renewed. 2. Size of bracket should be increased

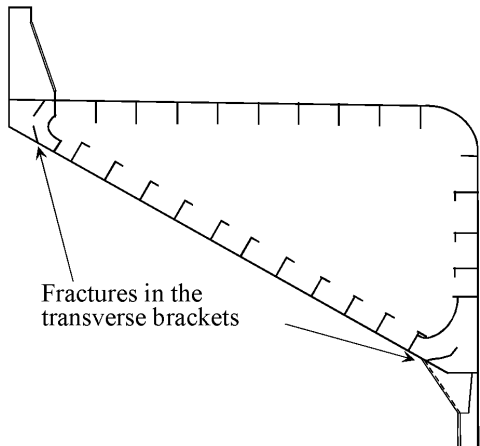
<b>BULK CARRIERS</b>		<b>Guidelines for Surveys, Assessment and Repair of Hull Structure</b>
<b>Part 1</b>	<b>Cargo hold region</b>	<b>Example No.</b>
<b>Area 2</b>	<b>Topside tank structure</b>	<b>7-a</b>
<b>Detail of damage</b> Fractures in transverse brackets		
<b>Sketch of damage</b>

<p>Fractures in the transverse brackets</p>		<b>Sketch of repair</b>

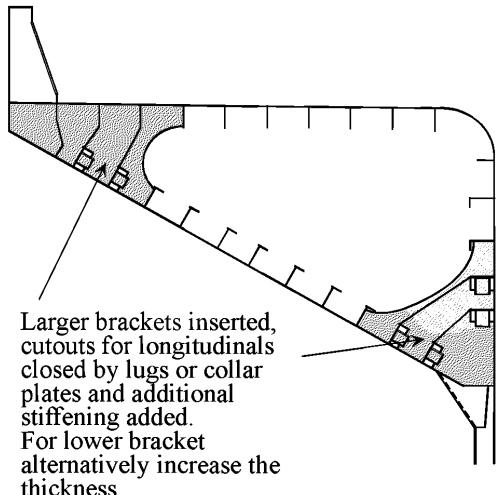
<p>Larger brackets inserted, cutouts for longitudinals closed by lugs or collar plates and additional stiffening added. For lower bracket alternatively increase the thickness</p>
<b>Notes on possible cause of damage</b> <ol style="list-style-type: none"> <li>1. General levels of corrosion and presence of stress concentrations.</li> <li>2. Misalignment of the brackets with adjoining structure, e.g. side shell frame brackets and/or coaming brackets.</li> <li>3. High shear stresses due to insufficient bracket size.</li> <li>4. Inadvertent overloading.</li> </ol>		<b>Notes on repairs</b> <ol style="list-style-type: none"> <li>1. If the damage is caused by misalignment with the side shell frame brackets or the hatch coaming brackets the misalignment is to be rectified and the replacement by larger brackets incorporated only if considered necessary.</li> </ol>

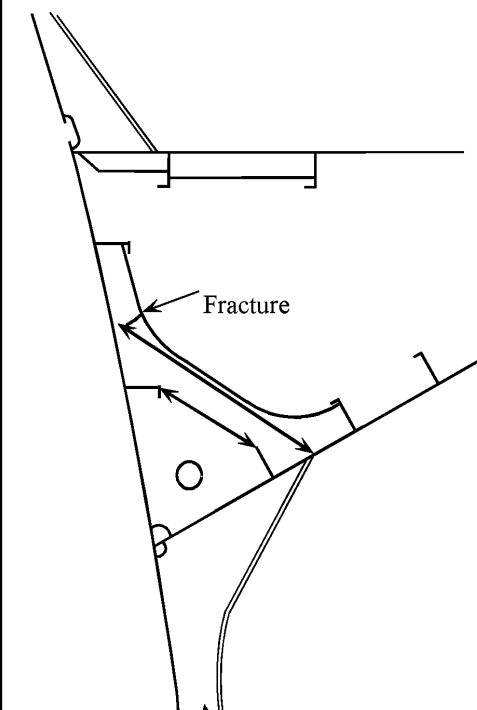
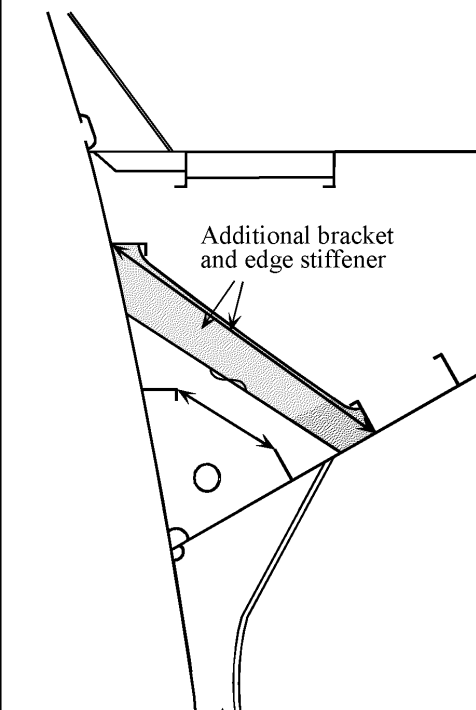
BULK CARRIERS		Guidelines for Surveys, Assessment and Repair of Hull Structure	
Part 1	Cargo hold region		Example No.
Area 2	Topside tank structure		7-b
Detail of damage		Fractures in transverse bracket	
Sketch of damage		Sketch of repair

Notes on possible cause of damage		Notes on repairs	
<ol style="list-style-type: none"><li>1. Insufficient strength.</li><li>2. Corrosion.</li></ol>		<ol style="list-style-type: none"><li>1. Fractured part to be cropped and renewed.</li><li>2. If the fractured part is free from corrosion, increased size and thickness should be considered. Partial renewal of the bracket may be accepted depending on the nature of the fracture.</li></ol>

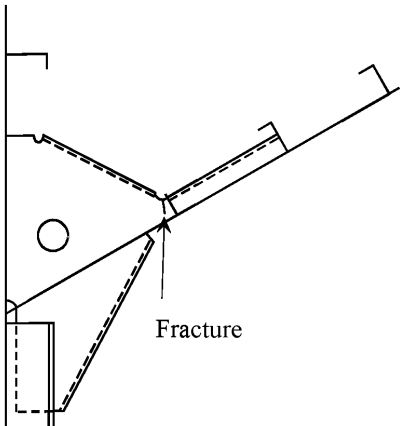
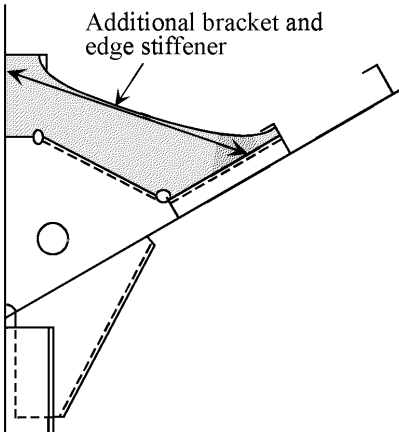
BULK CARRIERS		Guidelines for Surveys, Assessment and Repair of Hull Structure	
Part 1	Cargo hold region		Example No.
Area 2	Topside tank structure		7-c
Detail of damage		Fractures at toes of transverse bracket	
Sketch of damage		Sketch of repair

Notes on possible cause of damage		Notes on repairs	
1. Stress concentration due to the shape of the bracket.		1. Cracked weld to be veed-out and rewelded.

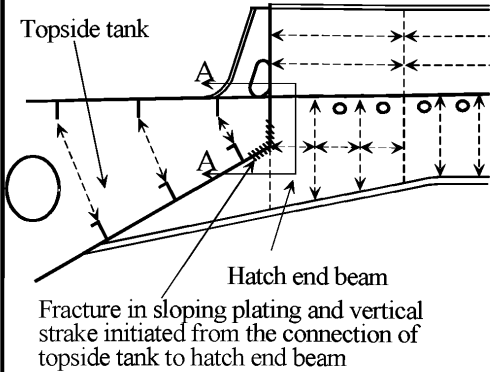
<b>BULK CARRIERS</b>		<b>Guidelines for Surveys, Assessment and Repair of Hull Structure</b>
<b>Part 1</b>	<b>Cargo hold region</b>	<b>Example No.</b>
<b>Area 2</b>	<b>Topside tank structure</b>	<b>8</b>
<b>Detail of damage</b>		Fractures in sloping plating and vertical strake initiated from the connection of topside tank to hatch end beam
<b>Sketch of damage</b>

<p>Topside tank</p> <p>Hatch end beam</p> <p>Fracture in sloping plating and vertical strake initiated from the connection of topside tank to hatch end beam</p>

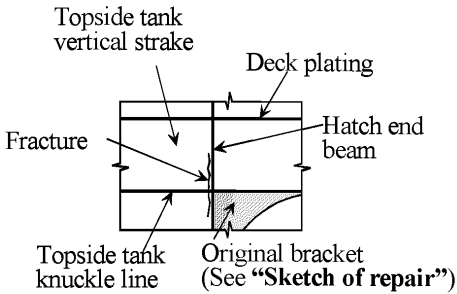
<p>Topside tank vertical strake</p> <p>Deck plating</p> <p>Fracture</p> <p>Hatch end beam</p> <p>Topside tank knuckle line</p> <p>Original bracket (See "Sketch of repair")</p> <p><b>View A-A</b></p>		<b>Sketch of repair</b>

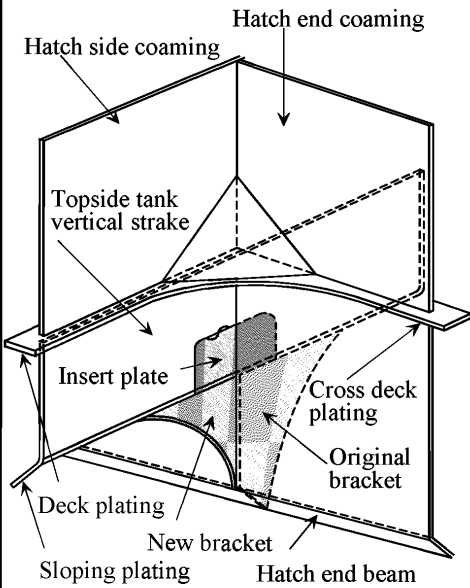
<p>Hatch end coaming</p> <p>Hatch side coaming</p> <p>Topside tank vertical strake</p> <p>Insert plate</p> <p>Cross deck plating</p> <p>Original bracket</p> <p>Deck plating</p> <p>New bracket</p> <p>Sloping plating</p> <p>Hatch end beam</p>

<b>Notes on possible cause of damage</b> 1. Stress concentration at the connection of hatch end beam to topside tank.		<b>Notes on repairs</b> 1. Fractured part to be cropped and renewed with increased thickness. 2. Additional bracket should be considered for reinforcement.

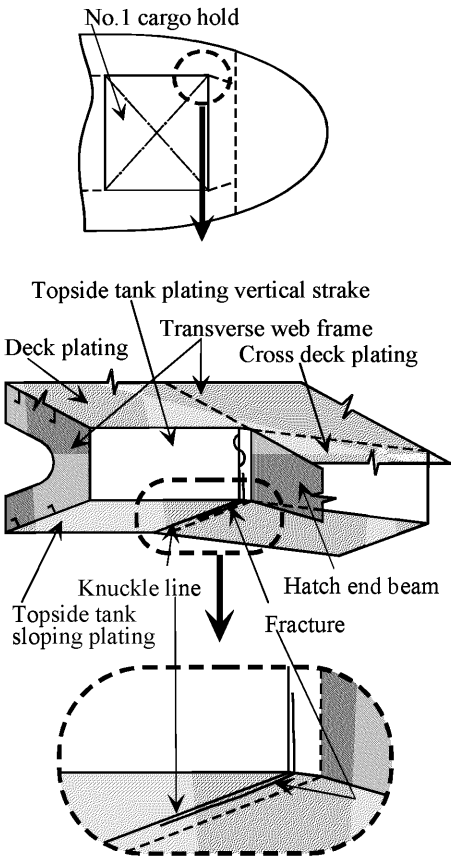
<b>BULK CARRIERS</b>		<b>Guidelines for Surveys, Assessment and Repair of Hull Structure</b>
<b>Part 1</b>	<b>Cargo hold region</b>	<b>Example No.</b>
<b>Area 2</b>	<b>Topside tank structure</b>	<b>9</b>
<b>Detail of damage</b>		Fractures in sloping plating at knuckle
<b>Sketch of damage</b>

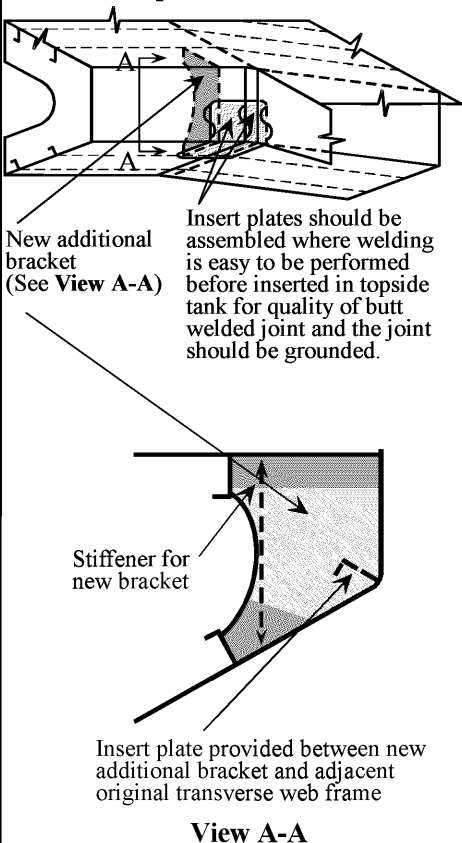
<b>Sketch of repair</b>

<b>Notes on possible cause of damage</b> 1. Insufficient strength. 2. Additional stress induced by knuckle.		<b>Notes on repairs</b> 1. Knuckle part should be reinforced appropriately.

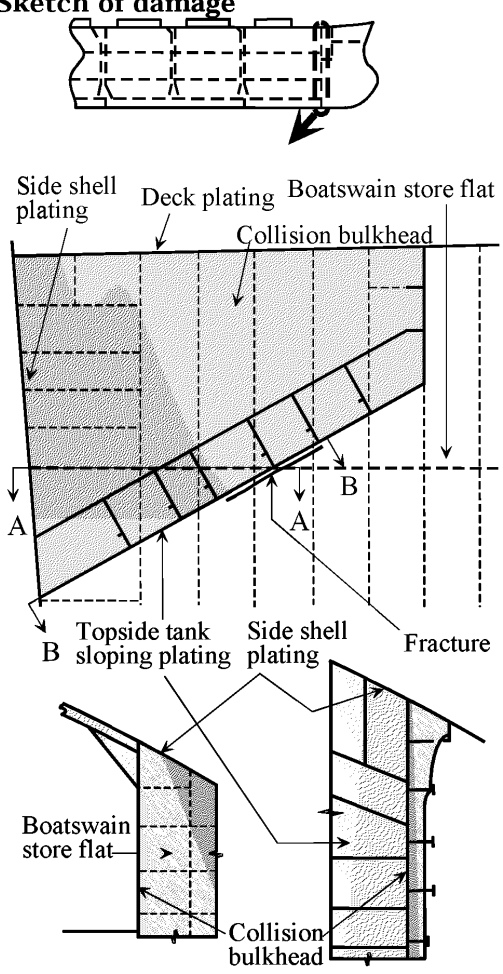
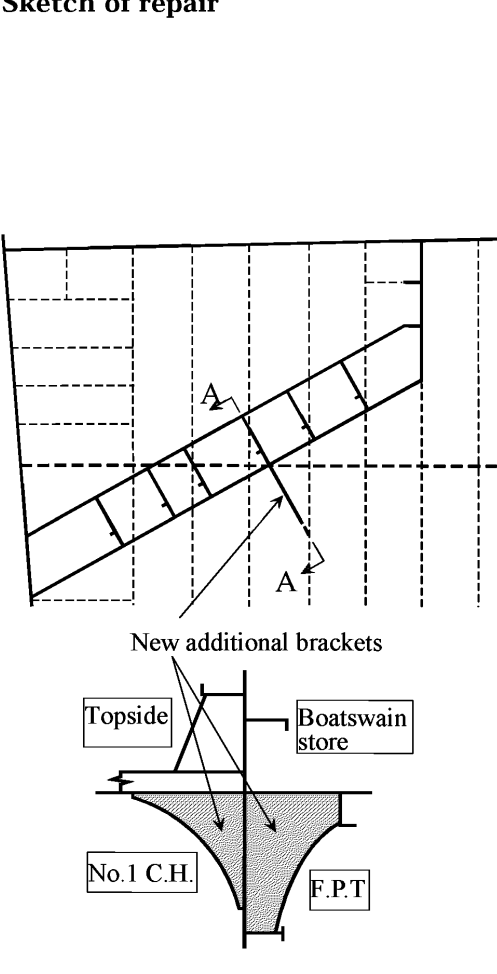
<b>BULK CARRIERS</b>		<b>Guidelines for Surveys, Assessment and Repair of Hull Structure</b>
<b>Part 1</b>	<b>Cargo hold region</b>	<b>Example No.</b>
<b>Area 2</b>	<b>Topside tank structure</b>	<b>10</b>
<b>Detail of damage</b>		Fractures in way of collision bulkhead at intersection with topside tank structure in foremost cargo hold
<b>Sketch of damage</b>		<b>Sketch of repair</b>

<p><b>Section A-A</b>      <b>Section B-B</b></p>

<p><b>Section A-A</b></p>
<b>Notes on possible cause of damage</b>		<b>Notes on repairs</b>
<ol style="list-style-type: none"> <li>Damage caused by hard spot at intersection of the topside tank sloping plating and boatswain's store deck plating (fore peak tank top plating).</li> </ol>		<ol style="list-style-type: none"> <li>Fractured plates to be cropped and renewed.</li> <li>Stress concentration should be considered (Brackets were fitted on both sides for reinforcement).</li> </ol>

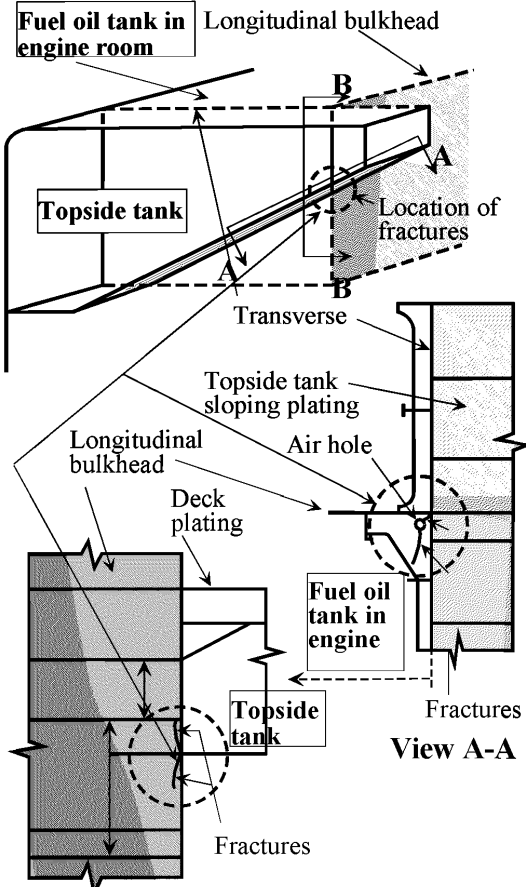
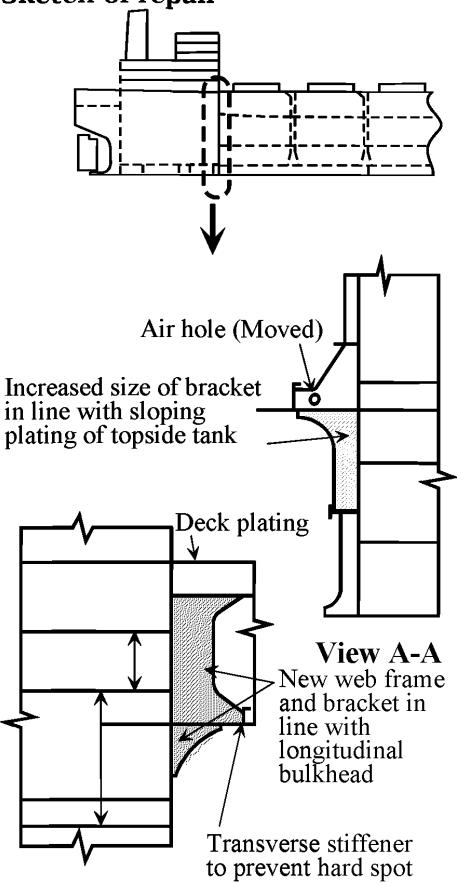
<b>BULK CARRIERS</b>		<b>Guidelines for Surveys, Assessment and Repair of Hull Structure</b>
<b>Part 1</b>	<b>Cargo hold region</b>	<b>Example No.</b>
<b>Area 2</b>	<b>Topside tank structure</b>	<b>11</b>
<b>Detail of damage</b> Fractures in way of engine room forward bulkhead at intersection with topside tank structure in aftermost cargo hold		
<b>Sketch of damage</b>		<b>Sketch of repair</b>

<b>Notes on possible cause of damage</b>		<b>Notes on repairs</b>
1. Damage caused by hard spot at intersection of the topside tank sloping plating and longitudinal bulkhead of the fuel oil tank in engine room.		1. Fractured plates to be cropped and renewed as necessary and reinforcement fitted as shown shaded above. The position of the air-hole to be relocated.

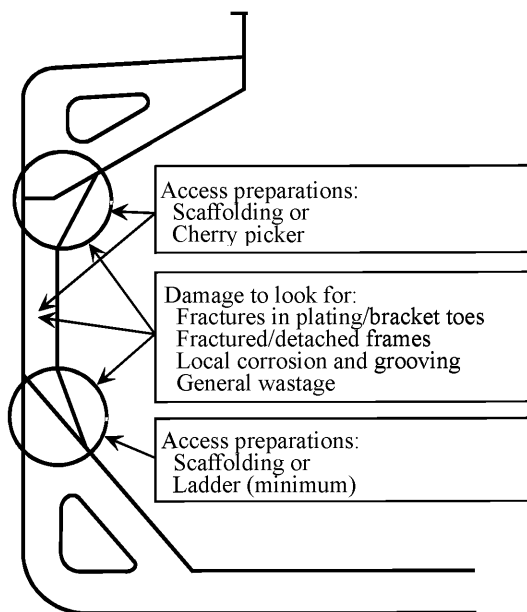
**Figure 1**  
Side shell frame - Potential problem areas

- 1.6 A summary of potential problem areas is shown in **Figures 1 - 4**. Examples of failure and damaged ship side structure are illustrated in **Photographs 1- 2**.

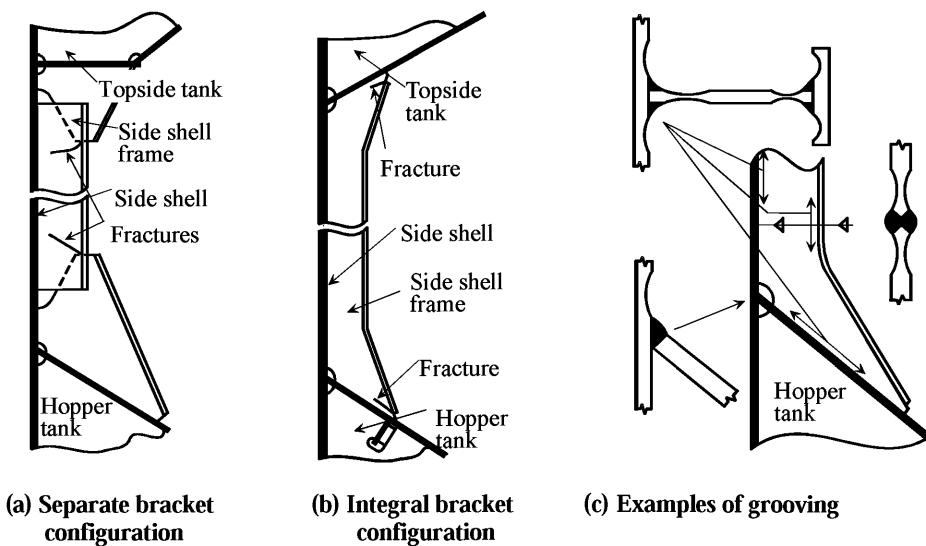
**Figure 2** Damages to side shell frame - Potential problem areas

(Note) The type of bracket configuration used will, to a large extent, dictate the location and extent of fracture. Where separate brackets are employed, the fracture location is normally at the bracket toe position on the frames, whereas with integral brackets the location is at the toe position on the hopper and topside tank.

<p>Part renewal including side shell frames and hopper sloping plating, as found necessary</p>
Notes on possible cause of damage		Notes on repairs
<ol style="list-style-type: none"> <li>Heavy corrosion (grooving). Refer to Figure 2 (c).</li> </ol>		<ol style="list-style-type: none"> <li>Sketch of repair applies when damage extends over several frames.</li> <li>Isolated fractures may be repaired by veeing-out and rewelding.</li> <li>Isolated cases of grooving may be repaired by build up of welding.</li> </ol>

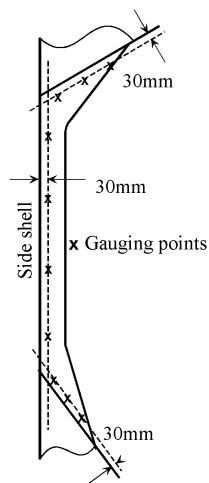
**Figure 3**  
Representative gauging locations on the side shell frame - Potential problem areas

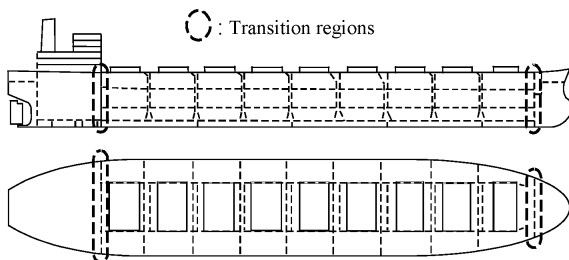
**Figure 4** Transition regions - Potential problem area

- 1.5 The structure at the transition regions at the fore and aft ends of the ship are subject to stress concentrations due to structural discontinuities. The side shell plating at the transition regions is also subject to panting. The lack of continuity of the longitudinal structure, and the increased slenderness and flexibility of the side structure, makes the structure at the transition regions more prone to fracture damages.

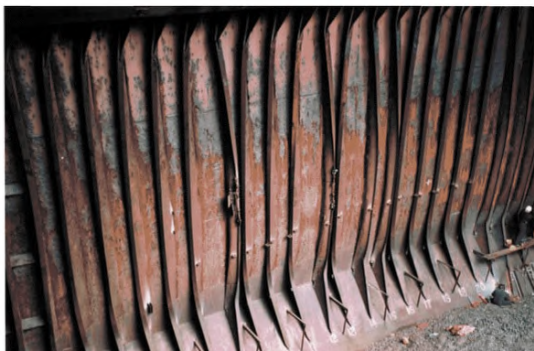
**Photograph 1**      **Collapsed side shell frames (See Example 4)**

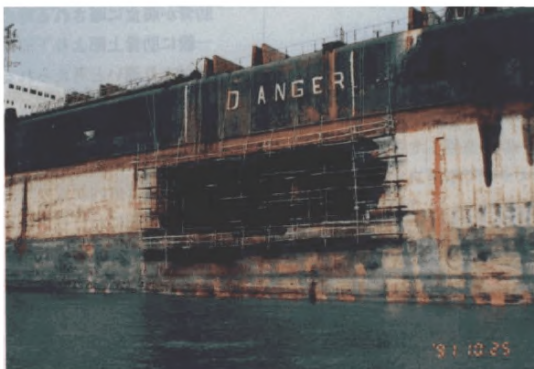
**Photograph 2**      **Missing side shell structure (See Examples 4 and 5)**

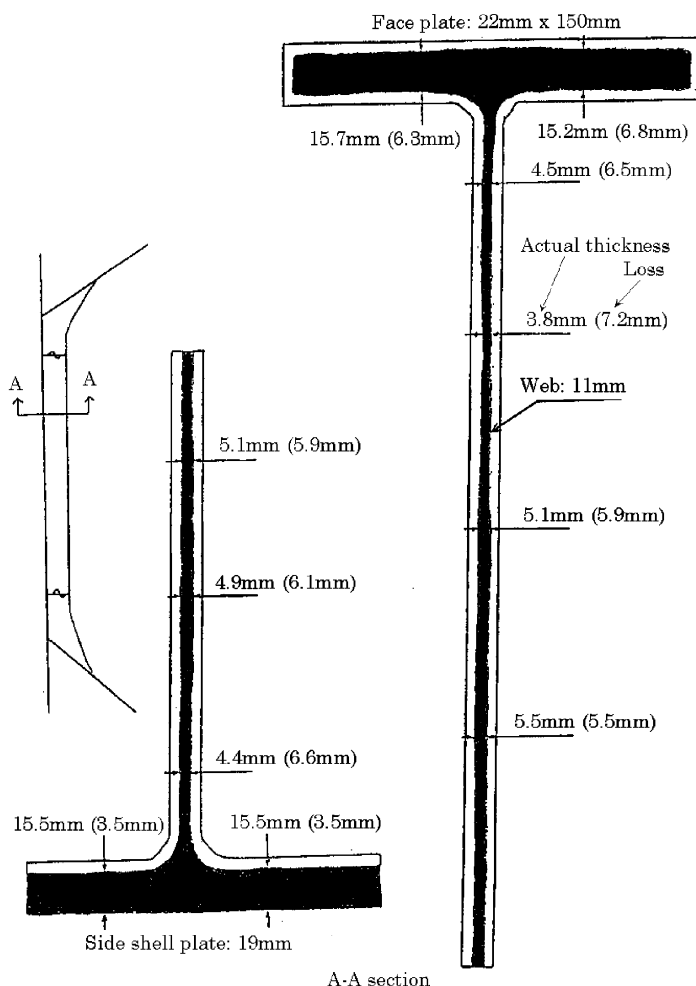
**Figure 5 Uniform corrosion of side shell frame**

- 2.1.1** Attention is drawn to the fact that side shell frames may be significantly weakened by loss of thickness although diminution and deformations may not be apparent. Inspection should be made after the removal of any scale or rust deposit. Thickness measurements may be necessary, particularly if the corrosion is smooth and uniform, to determine the condition of the structure (See **Figure 5**).

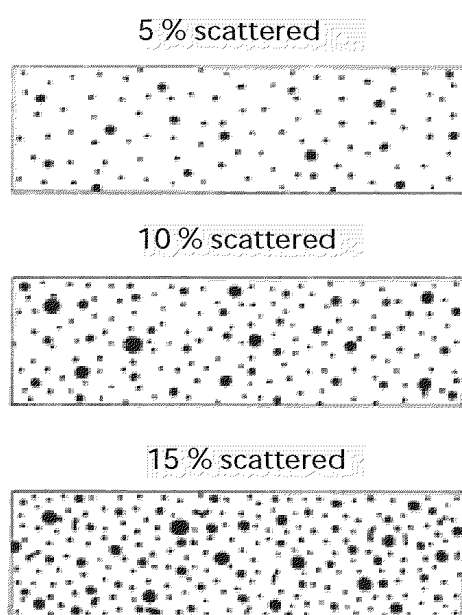
**Figure 6 Pitting intensity diagrams (from 5% to 15% intensity)**

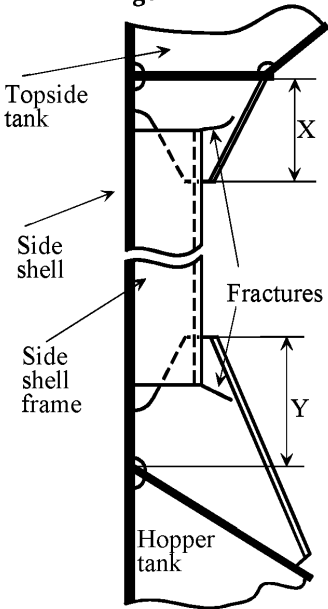
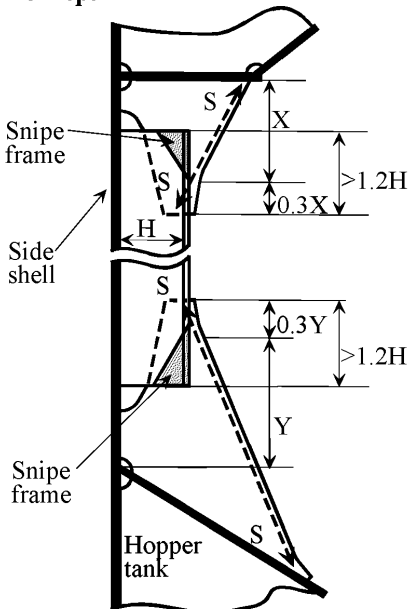
BULK CARRIERS		Guidelines for Surveys, Assessment and Repair of Hull Structure
Part 1	Cargo hold region	Example No.
Area 3	Cargo hold side structure	1-a
Detail of damage		Fractures in brackets at termination of frame
Sketch of damage		Sketch of repair

<p><b>Separate bracket configuration</b></p>

<p><b>S=Snipped end</b></p>
<b>Notes on possible cause of damage</b> 1. This type of damage is caused due to stress concentration.		<b>Notes on repairs</b> 1. For small fractures, e. g. hairline fractures, the fracture can be veed-out, ground, examined by NDT for fractures, and rewelded. 2. For larger/significant fractures consideration is to be given to cropping and partly renewing/renewing the frame brackets. If renewing the brackets, end of frames can be sniped to soften them. 3. If felt prudent, soft toes are to be incorporated at the boundaries of the bracket to the hopper plating. 4. Attention to be given to the structure in wing tanks in way of the extended bracket arm. i.e. reinforcement provided in line with the bracket.

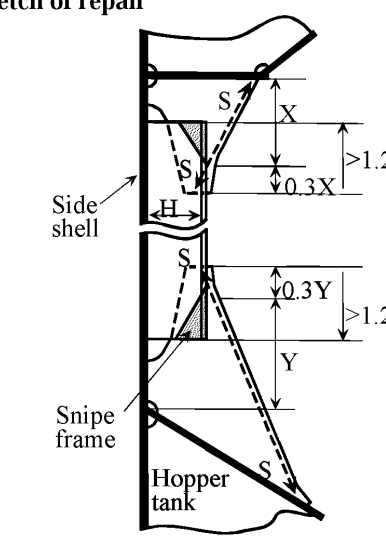
BULK CARRIERS		Guidelines for Surveys, Assessment and Repair of Hull Structure
Part 1	Cargo hold region	Example No.
Area 3	Cargo hold side structure	1-b
Detail of damage		Fractures in side shell frame at bracket's toe
<b>Sketch of damage</b>

<p>Separate bracket configuration</p>		<b>Sketch of repair</b>

<p>S=Snipped end</p>
<b>Notes on possible cause of damage</b> <ol style="list-style-type: none"> <li>1. This type of damage is caused due to stress concentration.</li> </ol>		<b>Notes on repairs</b> <ol style="list-style-type: none"> <li>1. For small fractures, e. g. hairline fractures, the fracture can be veed-out, welded up, ground, examined by NDT for fractures, and rewelded.</li> <li>2. For larger/significant fractures consideration is to be given to cropping and partly renewing/ renewing the frame brackets. If renewing the brackets, end of frames can be sniped to soften them.</li> <li>3. If felt prudent, soft toes are to be incorporated at the boundaries of the bracket to the hopper plating.</li> <li>4. Attention to be given to the structure in wing tanks in way of the extended bracket arm. i.e. reinforcement provided in line with the bracket.</li> </ol>

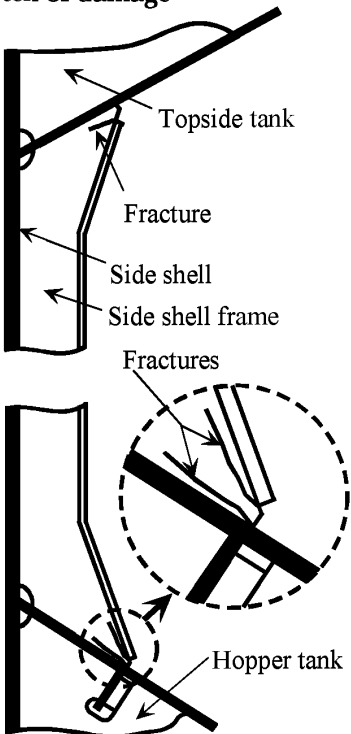
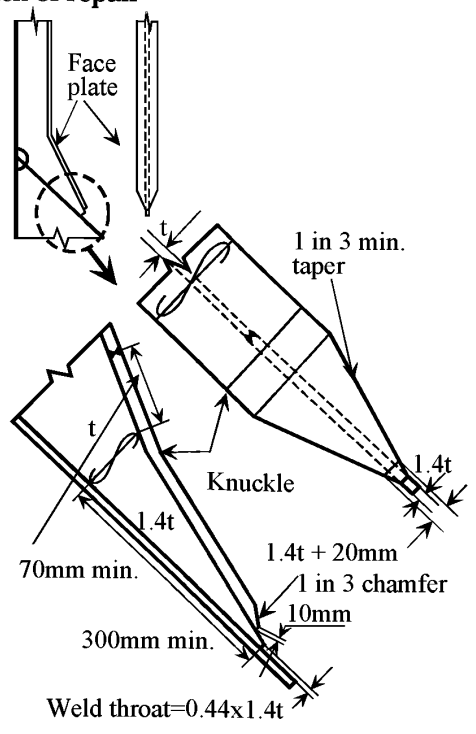
BULK CARRIERS		Guidelines for Surveys, Assessment and Repair of Hull Structure
Part 1	Cargo hold region	Example No.
Area 3	Cargo hold side structure	2
Detail of damage	Fractures in side shell frame at bracket's toe	
Sketch of damage

Notes on possible cause of damage	<p>1. This type of damage is caused due to stress concentration.</p>	
Notes on repairs	<p>1. Repair is to incorporate a design similar to the one shown on the sketch and in addition:-</p> <ol style="list-style-type: none"> <li>1.1. The arm of the bracket along the hopper/ topside plating should be increased by altering the angle of the bracket face plate. A face plate taper of 1 in 3 should be arranged.</li> <li>1.2. The local thickness of the bracket web plating over the length of the new face plate taper should be increased by about 40% above that originally fitted.</li> <li>1.3. The face plate thickness should be chamfered 1 in 3 to a thickness at its extremity.</li> <li>1.4. Welding of the new bracket toe should be based on a weld factor of 0.44 applied to the increased thickness.</li> </ol> <p>2. Attention to be given to the structure in wing tanks in way of the extended bracket arm. i.e. reinforcement provided in line with the bracket.</p>

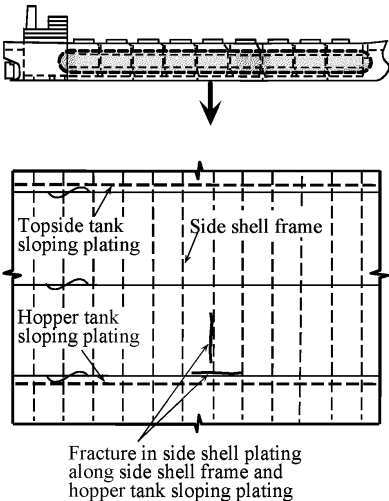
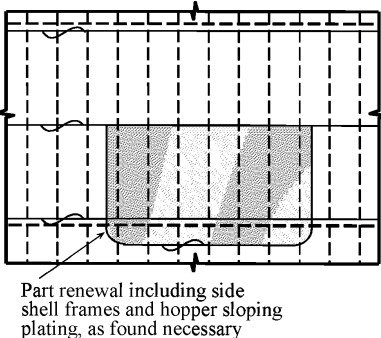
BULK CARRIERS		Guidelines for Surveys, Assessment and Repair of Hull Structure
Part 1	Cargo hold region	Example No.
Area 3	Cargo hold side structure	3
Detail of damage	Fractures in side shell frame/lower bracket and side shell plating near hopper	
Sketch of damage		Sketch of repair

<p>Topside tank sloping plating</p> <p>Side shell frame</p> <p>Hopper tank sloping plating</p> <p>Fracture in side shell plating along side shell frame and hopper tank sloping plating</p>

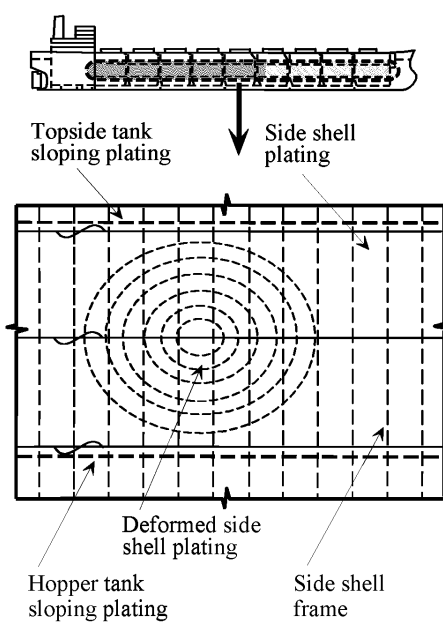
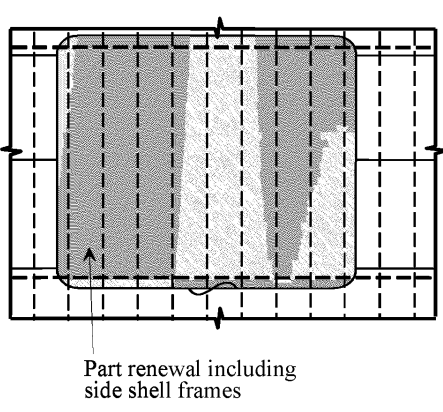
BULK CARRIERS		Guidelines for Surveys, Assessment and Repair of Hull Structure	
Part 1	Cargo hold region	Example No.	
Area 3	Cargo hold side structure	4	
Detail of damage		Deformation of side shell plating	
Sketch of damage		Sketch of repair

Notes on possible cause of damage		Notes on repairs	
<ol style="list-style-type: none"> <li>1. Insufficient stiffness of side shell frames due to buckling and/or detachment of side shell frames due to corrosion.</li> <li>2. Heavy weather.</li> </ol>		<ol style="list-style-type: none"> <li>1. Deformed side shell plating including side shell frames should be cropped and renewed.</li> </ol>

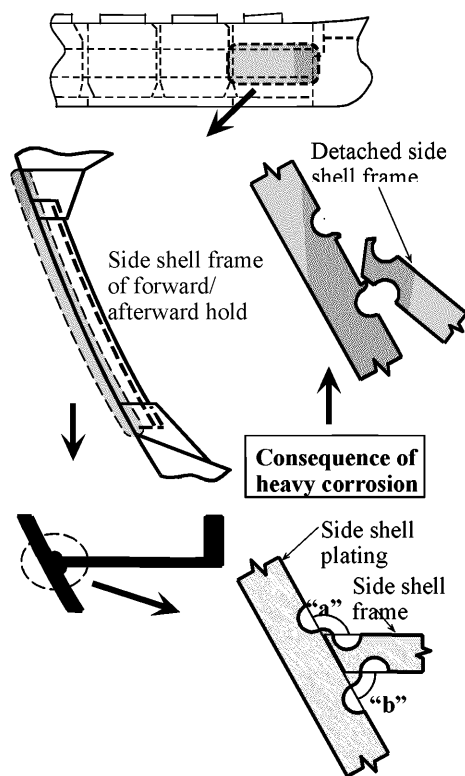
BULK CARRIERS		Guidelines for Surveys, Assessment and Repair of Hull Structure	
Part 1	Cargo hold region	Example No.	
Area 3	Cargo hold side structure	5	
Detail of damage		Adverse effect of corrosion on the frame of forward/afterward hold	
Sketch of damage		Sketch of repair

<p>Side shell frame of forward/afterward hold</p> <p>Detached side shell frame</p> <p>Consequence of heavy corrosion</p> <p>Side shell plating</p> <p>Side shell frame</p> <p>"a"</p> <p>"b"</p>

<ol style="list-style-type: none"> <li>1. Part renewal including side shell frames and hopper plating, as found necessary</li> <li>2. Deep penetration welding at the connections of side shell frames to side shell plating</li> </ol>	
<b>Notes on possible cause of damage</b> <ol style="list-style-type: none"> <li>1. Heavy corrosion (grooving) of side shell frame along side shell plating and difference of throat thickness "a" from "b". (Since original throat thickness of "a" is usually smaller than that of "b", if same welding procedure is applied, the same corrosion has a more severe effect on "a", and may cause collapse and/or detachment of side shell frame.)</li> </ol>		<b>Notes on repairs</b> <ol style="list-style-type: none"> <li>1. Sketch of repair applies when damage extends over several frames.</li> <li>2. Isolated fractures may be repaired by veeing-out and rewelding.</li> <li>3. Isolated cases of grooving may be repaired by build up of welding.</li> </ol>

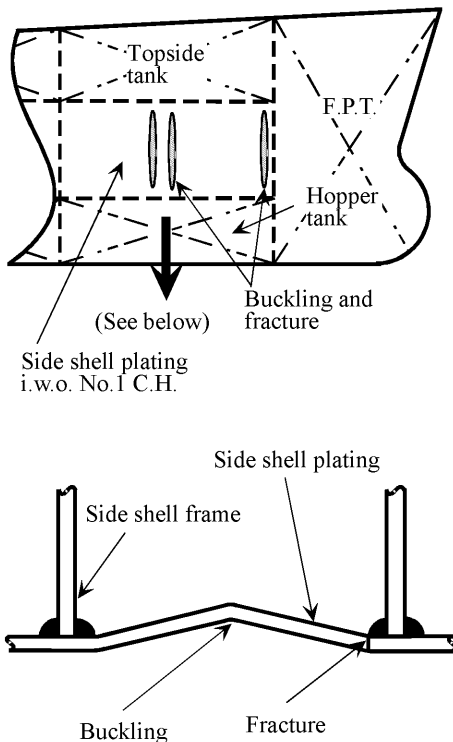
BULK CARRIERS		Guidelines for Surveys, Assessment and Repair of Hull Structure	
Part 1	Cargo hold region	Example No.	
Area 3	Cargo hold side structure	6	
Detail of damage		Buckling and fractures of side shell plating in foremost cargo hold	
Sketch of damage		Sketch of repair

<p>Topside tank</p> <p>F.P.T.</p> <p>Hopper tank</p> <p>(See below)</p> <p>Buckling and fracture</p> <p>Side shell plating i.w.o. No.1 C.H.</p> <p>Side shell frame</p> <p>Side shell plating</p> <p>Buckling</p> <p>Fracture</p>

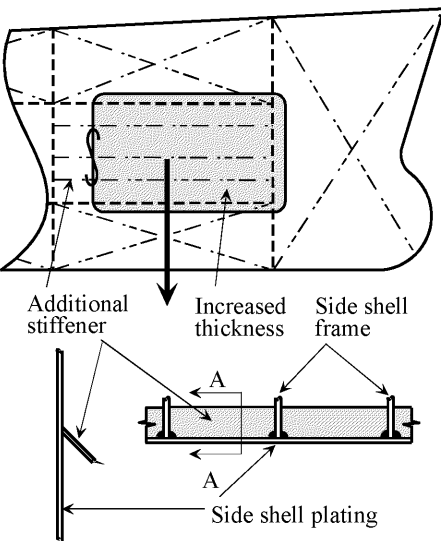
<p>Additional stiffener</p> <p>Increased thickness</p> <p>Side shell frame</p> <p>Side shell plating</p> <p>View A-A</p>	
<b>Notes on possible cause of damage</b> <ol style="list-style-type: none"> <li>1. Heavy weather.</li> <li>2. Insufficient buckling strength due to high tensile steel or heavy uniform corrosion.</li> <li>3. Inadequate transition structure.</li> </ol>		<b>Notes on repairs</b> <ol style="list-style-type: none"> <li>1. Buckled/fractured side shell plating is to be cropped and renewed.</li> <li>2. Reinforcement by thicker side shell plating and/or additional stiffeners should be considered.</li> </ol>

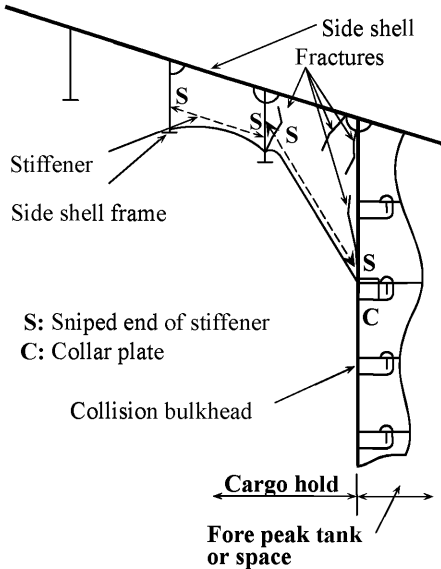
<p>Side shell Fractures Stiffener Side shell frame S: Sniped end of stiffener C: Collar plate Collision bulkhead Cargo hold Fore peak tank or space</p>		<b>Sketch of repair</b>

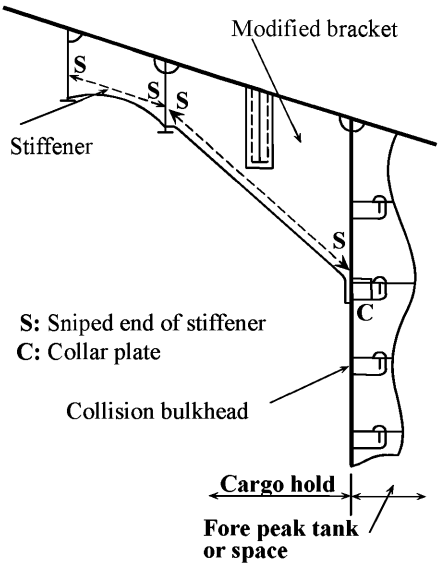
<p>Modified bracket Stiffener S: Sniped end of stiffener C: Collar plate Collision bulkhead Cargo hold Fore peak tank or space</p>
<b>Notes on possible cause of damage</b> <ol style="list-style-type: none"> <li>1. Insufficient bracket size resulting in high stress due to load cantilevered from side frame.</li> <li>2. Stress concentration at toe of bracket and misalignment between bracket and stringer in fore peak tank or space.</li> </ol>		<b>Notes on repairs</b> <ol style="list-style-type: none"> <li>1. The extended bracket arm connection to the collision bulkhead is to have a soft toe, and any cut-outs for stiffeners in the fore peak tank or space are to be collared when situated in the vicinity of the bracket toe.</li> <li>2. When fractures have extended into the side shell or bulkhead plating, the plating is to be cropped and part renewed.</li> </ol>

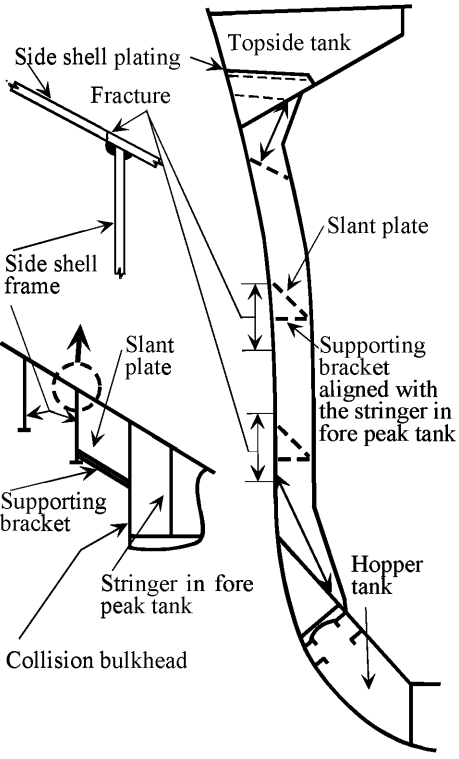
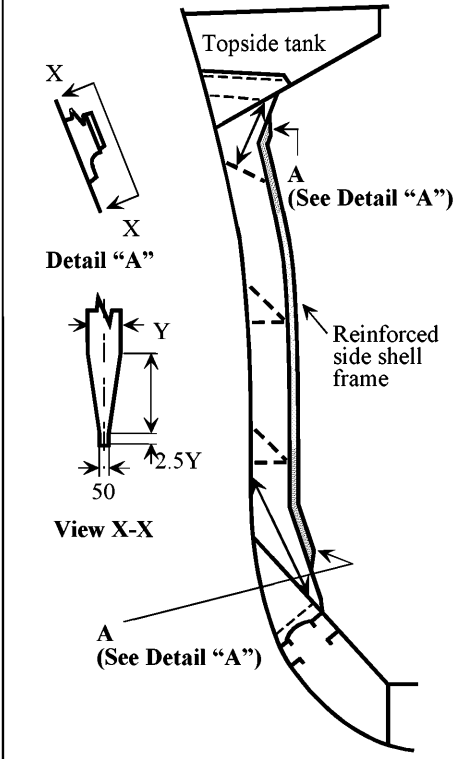
<b>Notes on possible cause of damage</b> 1. Damage caused by stress concentration leading to fatigue fracture in side shell. This has been exacerbated because of the greater flexibility of the hold structure in relation to the structure forward of the collision bulkhead.		<b>Notes on repairs</b> 1. Fractured shell plates to be cropped and part renewed, and side shell frame/frames in the vicinity of the damage to be reinforced as required by the relevant Classification Society.

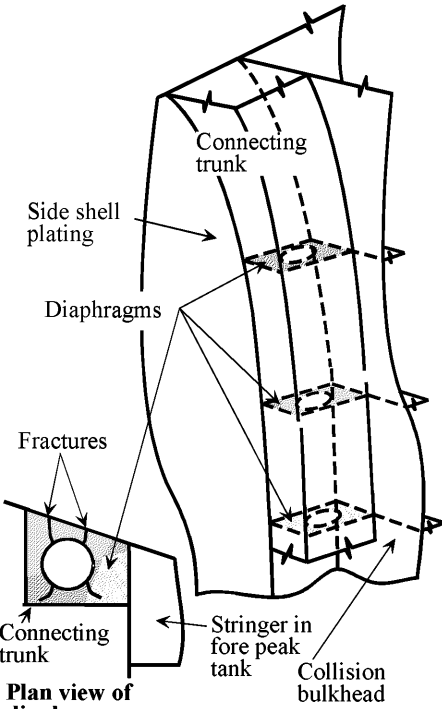
<b>Notes on possible cause of damage</b> 1. Damage caused by stress concentration resulting from the discontinuity created by the trunk and diaphragm structure. This has been exacerbated because of the greater flexibility of the hold structure in relation to the trunk and structure forward of the collision bulkhead.		<b>Notes on repairs</b> 1. Diaphragm to be removed permanently and fractured shell plated cropped and part renewed, or veed and weld as necessary in way of damage. Brackets with softened toes are to be fitted on forward side of collision bulkhead in way of stringers/flats to align with inboard side of trunk in order to remove hard-spots.

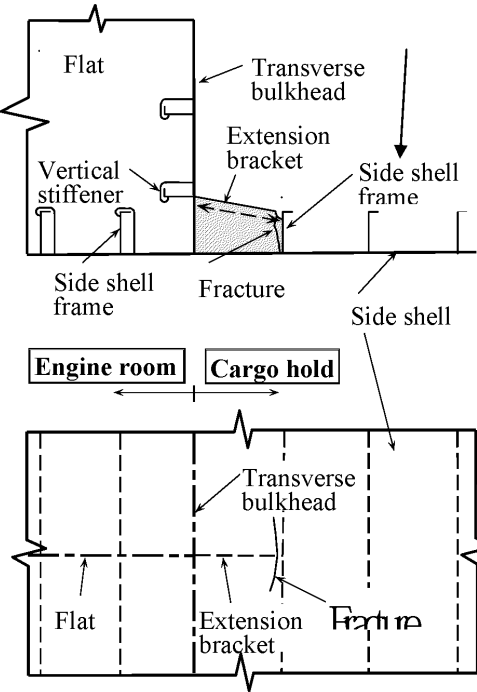
BULK CARRIERS		Guidelines for Surveys, Assessment and Repair of Hull Structure
Part 1	Cargo hold region	Example No.
Area 3	Cargo hold side structure	10
Detail of damage	Fractures in way of continuation/extension brackets in aftermost hold at the engine room bulkhead	
<b>Sketch of damage</b>

<b>Notes on possible cause of damage</b> 1. Damage caused by stress concentration leading to fatigue fracture on side shell. This will be exacerbated because of the greater flexibility of the hold structure in relation to the engine room structure.		<b>Notes on repairs</b> 1. The fractured shell plating is to be cropped and part renewed as necessary. 2. Extension bracket is to be modified and collar plates to cut-outs in engine room flat are to be installed.

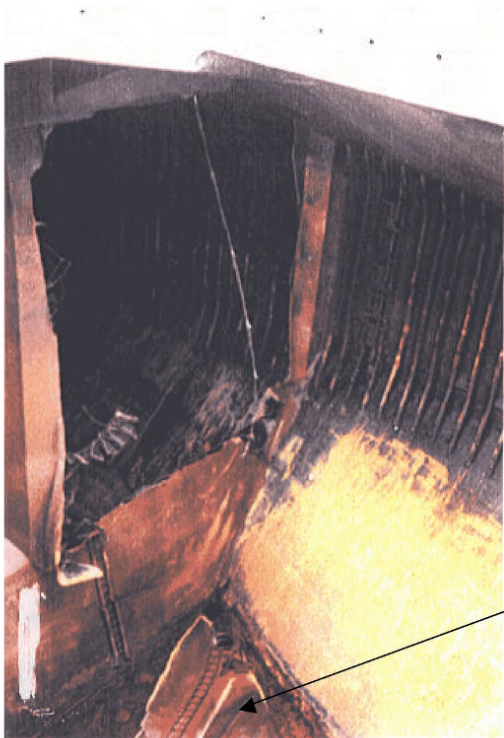
**Photograph 1**  
**Collapsed and detached**  
**transverse bulkhead**

Collapsed and detached transverse bulkhead on the tank top

- 1.4** Dry cargo holds, not designed as ballast holds, may sometimes be partially filled with water ballast in order to achieve a satisfactory air draught at the loading/discharging berths.  
The filling is restricted to a level that corresponds to the dry cargo hold scantlings, in particular the transverse bulkheads scantlings, and must only be carried out in port. In no case should these cargo holds be partially filled during voyage to save time at the berth. Such filling at sea may cause sloshing resulting in catastrophic failure such as indicated in **Photograph 1**.

- 1.5** Heavy corrosion may lead to collapse of the structure under extreme load, such as indicated in **Photograph 1** if it is not rectified properly.

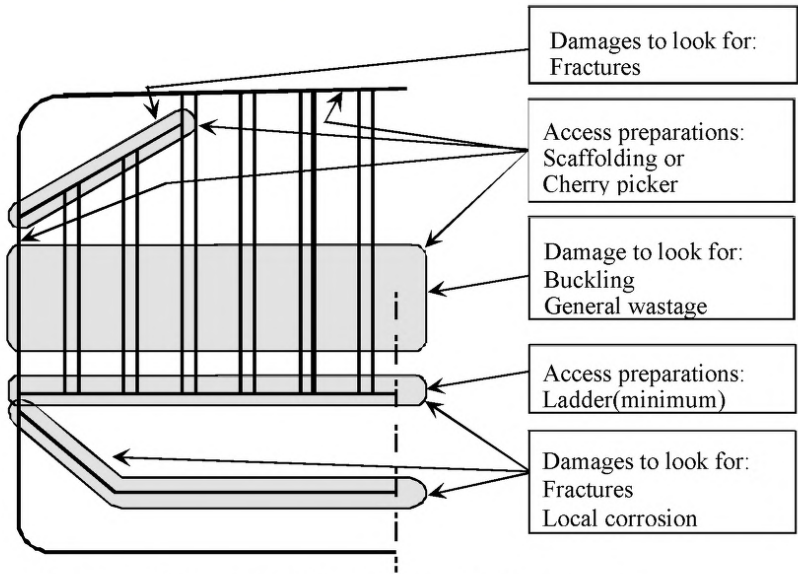
**Figure 1**      **Transverse bulkhead - Potential problem areas**

- 1.6** A summary of potential problem areas is shown in **Figure 1**. It is emphasised that appropriate access arrangement as indicated in **Chapter 4 Survey planning, preparation and execution** of the guidelines, should be provided to enable a proper close-up inspection and thickness measurement as necessary.

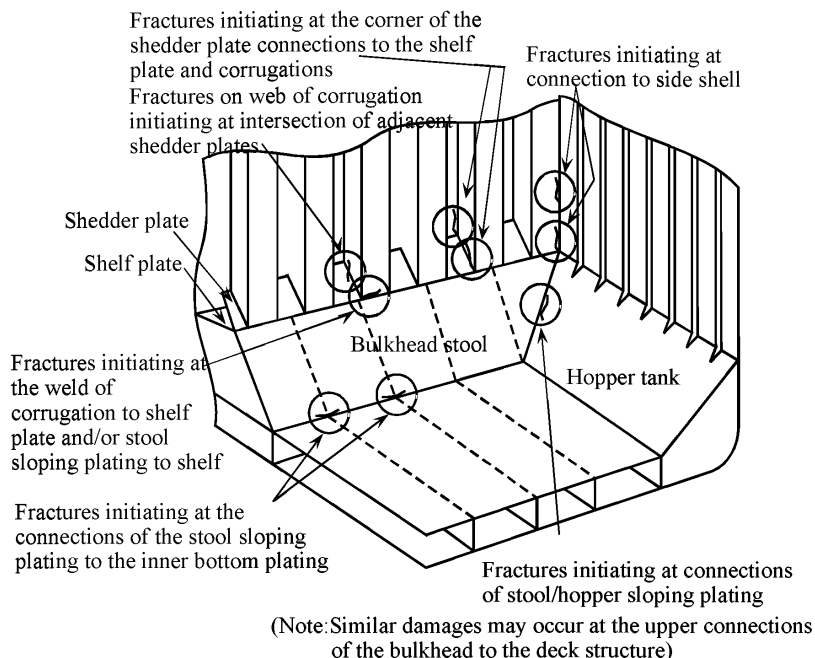
**Figure 2 Typical fracturing at the connection of transverse bulkhead structure**

**2.3.1** Fractures usually occur at the boundaries of corrugations and bulkhead stools particularly in way of shelf plates, shedder plates, deck, inner bottom, etc. (See **Figure 2**).

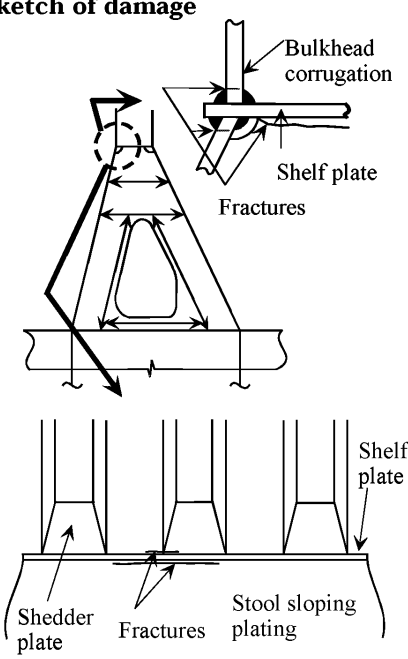
<p>The sketch shows two views of damage. The top view shows a bulkhead corrugation with a shelf plate attached. Arrows point to 'Bulkhead corrugation', 'Shelf plate', and 'Fractures' at the weld. The bottom view shows a shedder plate and stool sloping plating with 'Fractures' at the weld to the 'Shelf plate'.</p>		<b>Sketch of repair</b>

**3.3.1** Fractures observed at the connection between lower stool and corrugated bulkhead during hold inspection may have initiated at the weld connection of the inside diaphragms (See **Example 1**).

The scallops should be closed by fitting over-lap collar plates and the stool weld connections repaired as indicated in **4.3.1**. The over-lap collar should have a full penetration weld connection to the stool and shelf plate and should be completed using low hydrogen electrodes prior to welding the collar to the stool diaphragm/bracket.
