**РОССИЙСКИЙ МОРСКОЙ РЕГИСТР СУДОХОДСТВА**  
**RUSSIAN MARITIME REGISTER OF SHIPPING**

**IACS PROCEDURAL REQUIREMENTS,  
UNIFIED INTERPRETATIONS  
AND RECOMMENDATIONS**

## **GENERAL DRY CARGO SHIPS**

Guidelines for  
Surveys, Assessment and Repair  
of Hull Structure

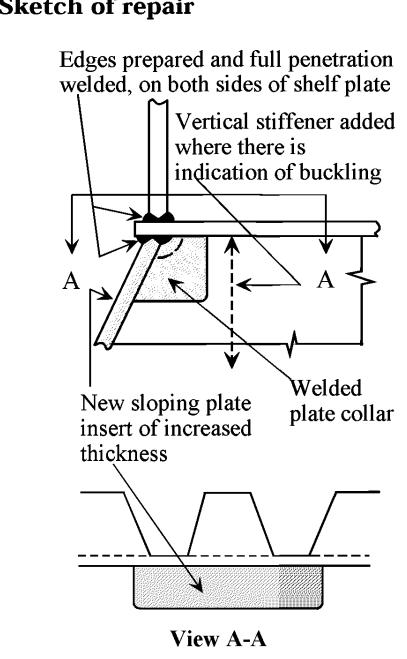
<p>The sketch shows two views of the repair. The top view shows 'Edges prepared and full penetration welded, on both sides of shelf plate', a 'Vertical stiffener added where there is indication of buckling', and a 'Welded plate collar'. Section lines A-A are indicated. The bottom view, labeled 'View A-A', shows a 'New sloping plate insert of increased thickness'.</p>

<b>Notes on possible cause of damage</b> <ol style="list-style-type: none"> <li>1. Stress concentrations at welds adjacent to the scallops.</li> <li>2. Inadequate welding area connecting corrugation flange to shelf plate or similarly sloping stool plating to shelf plate.</li> <li>3. Inadequate thickness of sloping plating in relation to corrugation flange thickness.</li> <li>4. Stress concentration at knuckle of corrugation where web is not supported by bracket inside the stool.</li> </ol>		<b>Notes on repairs</b> <ol style="list-style-type: none"> <li>1. Fractures to be veed-out and rewelded.</li> <li>2. Reductions in stress concentration by fitting welded plate collars in way of the scallop.</li> <li>3. Where necessary an insert plate to be arranged in stool plating and/or diaphragm.</li> </ol>

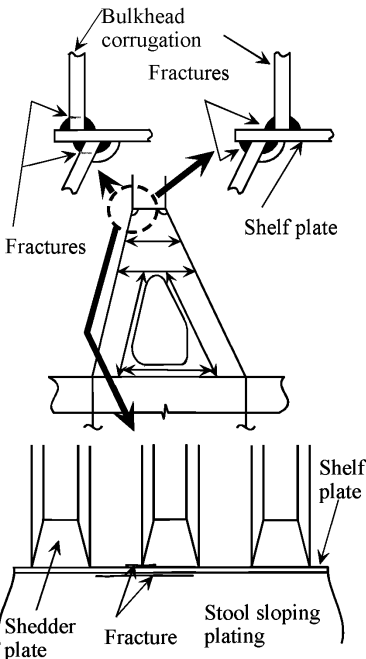
<b>Notes on possible cause of damage</b> <ol style="list-style-type: none"> <li>1. Misalignment between corrugation flange and sloping stool plating.</li> <li>2. Inadequate welding area connecting corrugation flange to shelf plate or similarly sloping stool plating to shelf plate.</li> </ol>		<b>Notes on repairs</b> <ol style="list-style-type: none"> <li>1. Fractures to be veed-out and rewelded.</li> <li>2. Structure to be released and misalignment rectified.</li> <li>3. Edge of the corrugated bulkhead and the stool plating on both sides of shelf plate to have full penetration welds.</li> <li>4. Where necessary an insert plate to be arranged in stool plating.</li> </ol>

**3.3.2** Misalignment between bulkhead corrugation flange and sloping stool plating may also cause fractures at the weld connection of the inside diaphragms (See **Example 2**).

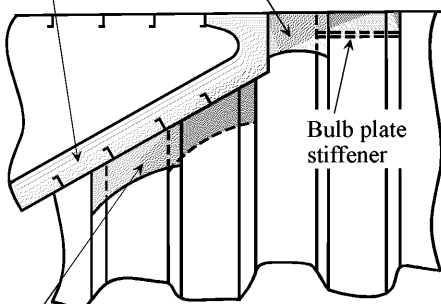
<b>Sketch of repair</b> <p>Continuous or intercostal reinforcement in line with flanges or gussets where not already fitted</p> <p>Adjacent to the topside tank either a gusset to a bulb plate stiffener may be</p>

<p>Gusset(similar gusset on the opposite)</p>
<b>Notes on possible cause of damage</b> 1. Damage due to poor design and/or defective welds.		<b>Notes on repairs</b> 1. Fractures may be veed-out and rewelded. If necessary corrugated plating cropped and renewed. 2. It is recommended that reinforcement as shown above be incorporated, giving due consideration to the following criteria: 2.1 It is important to have the gusset plates well aligned with the transverse structure inside the tank. Gusset plates may be joggled to obtain this alignment. 2.2 If there is no transverse web already existing inside the topside tank and in line with the flanges of corrugation or gusset plates, reinforcement as shown above to be fitted.

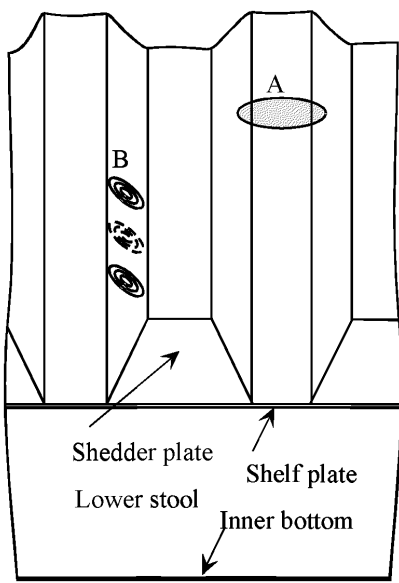
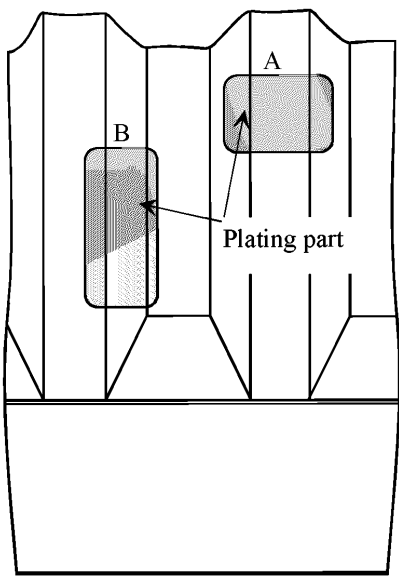
<b>Notes on possible cause of damage</b>		<b>Notes on repairs</b>
<ol style="list-style-type: none"> <li>1. Damages by mechanical abuse during cargo handling e.g. grab damage.</li> <li>2. Damage resulting from thickness reduction by corrosion.</li> <li>3. Buckling caused by bending or shear, see locations A and B respectively above, with a minimum reduction in thickness could be caused by underdesign or overloading. If this cause is suspected, the Classification Society concerned shall be contacted before proceeding with repairs.</li> </ol>		<ol style="list-style-type: none"> <li>1. Damage by mechanical abuse If the indentation/buckling is local and of a minor nature, the plating can be faired in place. If the deformation is more pronounced and/or in association with a generalized reduction in thickness the plating is to be cropped and renewed, as shown at locations A and B above.</li> <li>2. Damage resulting from corrosion In this case thickness measurements are to be taken at mid-span and top and bottom of corrugations, and corrugations renewed or part renewed as necessary. Particular attention is to be given to the fit and alignment at corners of flanged corrugations when being partly renewed.</li> </ol>

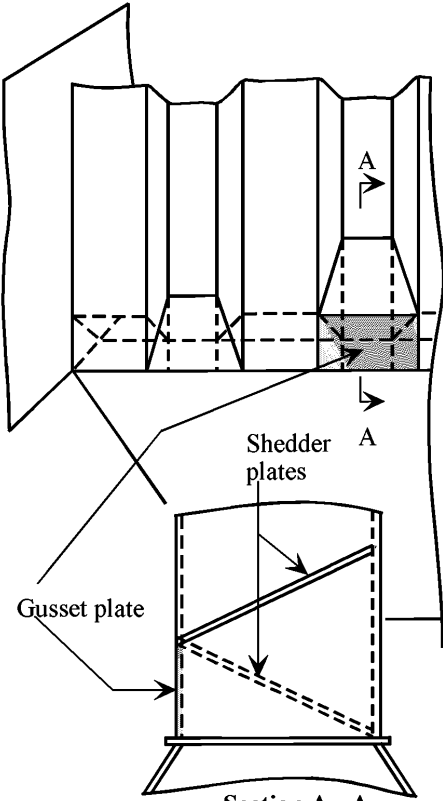
<p>Shedder plates</p> <p>Gusset plate</p> <p>Section A - A</p>
<b>Notes on possible cause of damage</b>		<b>Notes on repairs</b>
<p>1. Damage due to stress concentrations at intersection of shedder plates. This can be exacerbated by corrosion and reduction in thickness of the corrugation web plating.</p>		<p>1. If due to wastage, corrugation plating and shedder plates to be part renewed/renewed as necessary.</p> <p>2. Where renewals are being carried out it may be prudent to fit the extension pieces shown above to change the location of the point of intersection, and hence reduce the stress concentration.</p>

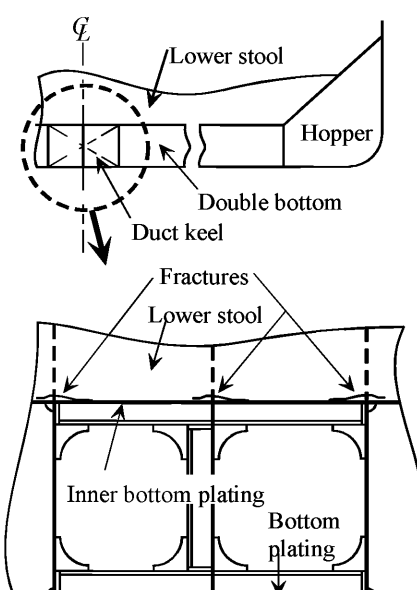
<p>Increased depth of stiffener to suit arrangement of pipes in duct keel</p> <p>Full penetration welds</p> <p>Lower stool space</p> <p>Plate collars</p> <p>Fillet weld of DB OT/WT girder to be made full penetration over length of stool space</p> <p><b>View A - A</b></p>
<b>Notes on possible cause of damage</b> <ol style="list-style-type: none"> <li>1. This type of failure is more likely to occur at the boundaries of the ballast hold.</li> <li>2. The fractures arise because of stress concentration in way of cut-outs and exacerbated by the flexibility of the inner bottom structure in way of the duct keel.</li> </ol>		<b>Notes on repairs</b> <ol style="list-style-type: none"> <li>1. In order to prevent recurrence of the damage, the additional reinforcement shown should be fitted.</li> </ol>

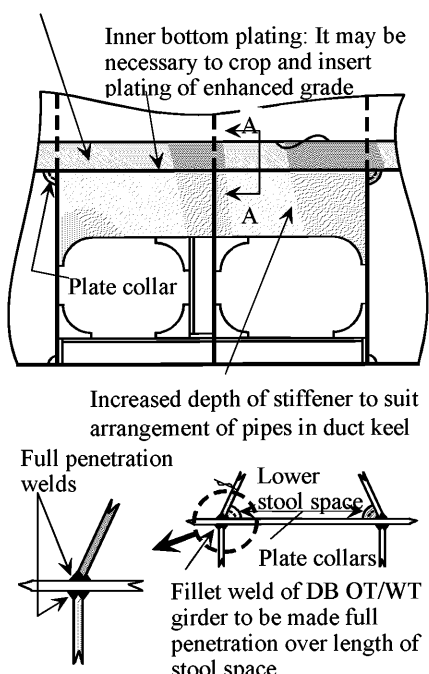
<b>Sketch of repair</b> <p>Lower stool: Insert plate of increased</p> <p>Inner bottom plating: It may be necessary to crop and insert plating of enhanced grade</p>

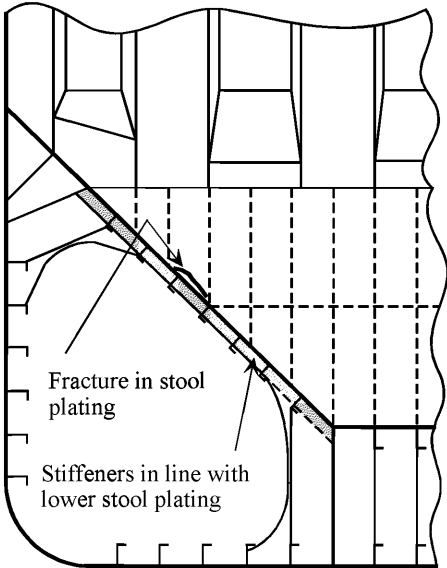
<b>BULK CARRIERS</b>		<b>Guidelines for Surveys, Assessment and Repair of Hull Structure</b>
<b>Part 1</b>	<b>Cargo hold region</b>	<b>Example No.</b>
<b>Area 4</b>	<b>Transverse bulkhead and associated structure in cargo hold</b>	<b>6</b>
<b>Detail of damage</b> Fractures at the connection of lower stool to hopper		
<b>Sketch of damage</b>		<b>Sketch of repair</b>

<p>Fracture in stool plating</p> <p>Stiffeners in line with lower stool plating</p>

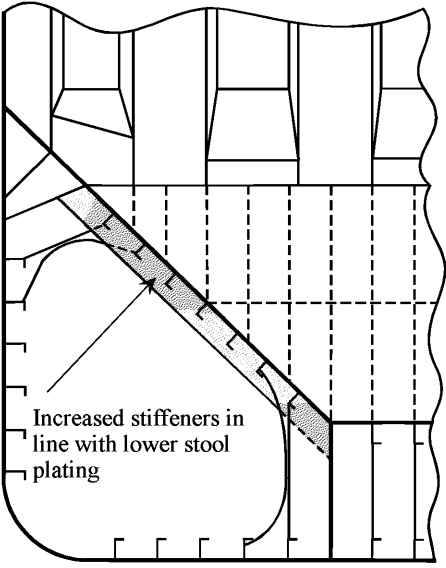
<p>Increased stiffeners in line with lower stool plating</p>
<b>Notes on possible cause of damage</b>		<b>Notes on repairs</b>
<ol style="list-style-type: none"> <li>1. Insufficient strength of the connection</li> <li>2. Corrosion</li> </ol>		<ol style="list-style-type: none"> <li>1. Fractured stool plating should be partly cropped and renewed (thicker plate) if considered necessary.</li> <li>2. If the damage occurred due to insufficient strength, stiffeners in line with stool plating should be increased.</li> </ol>

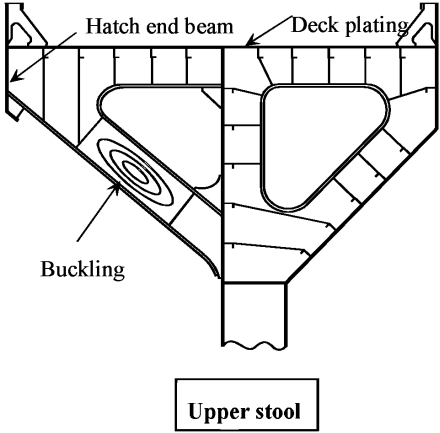
<b>BULK CARRIERS</b>		<b>Guidelines for Surveys, Assessment and Repair of Hull Structure</b>
<b>Part 1</b>	<b>Cargo hold region</b>	<b>Example No.</b>
<b>Area 4</b>	<b>Transverse bulkhead and associated structure in cargo hold</b>	<b>7</b>
<b>Detail of damage</b>		Buckling of strut supporting hatch end beam
<b>Sketch of damage</b>

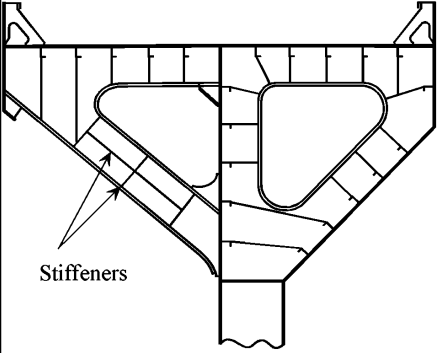
<b>Sketch of repair</b>

<b>Notes on possible cause of damage</b> <ol style="list-style-type: none"> <li>1. Insufficient strength</li> <li>2. Partial ballast loading in ballast cargo hold (sloshing)</li> <li>3. Corrosion</li> </ol>		<b>Notes on repairs</b> <ol style="list-style-type: none"> <li>1. Deformed part to be cropped and renewed if considered necessary.</li> <li>2. If the damage occurred due to insufficient strength, appropriate reinforcement is to be considered (thicker plate/additional stiffener(s)).</li> </ol>

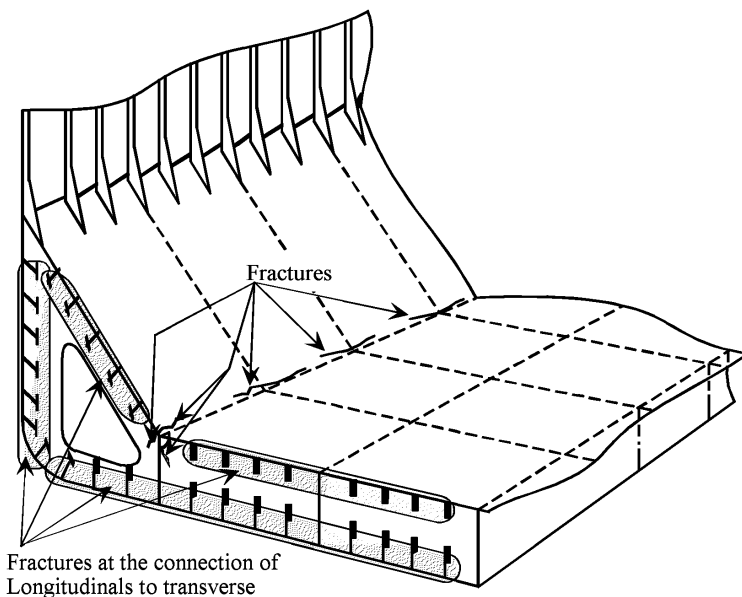
**Figure 1** Typical fractures in the connection of hopper sloping plating to inner bottom (tank top) and longitudinals to transverse (or transverse bulkhead)

**3.3.2** Fractures may occur in way of the welded or radiused knuckle between the inner bottom and hopper sloping plating if the side girder in the double bottom is not in line with the knuckle and also when the floors below have a large spacing, or when corner scallops are created for ease of fabrication. The local stress variations due to the loading and subsequent deflection may lead to the development of fatigue fractures which can be categorised as follows (See **Figure 1**).

**3.3.3** The fractures in way of connection of inner bottom plating/hopper sloping plating to stool may be caused by the cyclic deflection of the inner bottom induced by repeated loading from the sea or due to poor “through-thickness” properties of the inner bottom plating. Scallops in the underlying girders can create stress concentrations which further increase the risk of fractures. These can be categorised as follows (See **Figure 1** and **Examples**).

- (a) In way of the intersection between inner bottom and stool. These fractures often generate along the edge of the welded joint above the centre line girder, side girders, and sometimes along the duct keel sides.

- (b) Fractures in the inner bottom longitudinals and the bottom longitudinals in way of the intersection with the watertight floors below the transverse bulkhead stools in way of the ballast hold, especially in way of suction wells.

- (c) Fractures at the connection between the longitudinals and the vertical stiffeners or brackets on the floors, as well as at the corners of the duct keel.

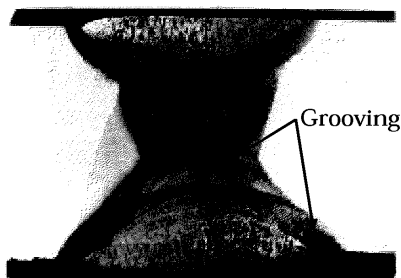
**Photograph 2**  
Section of the grooving shown in Photograph 1

**4.1.2** Severe grooving along welding of bottom plating is often found (See **Photographs 1** and **2**). This grooving can be accelerated by poor maintenance of the protective coating and/or sacrificial anodes fitted to the bottom plating.

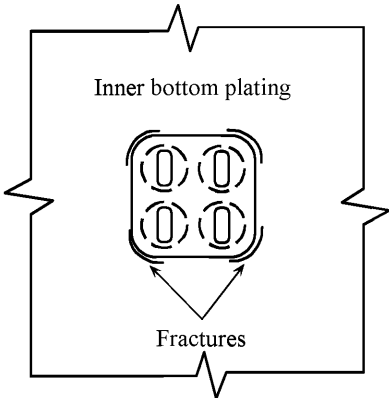
<b>BULK CARRIERS</b>	<b>Guidelines for Surveys, Assessment and Repair of Hull Structure</b>	
<b>Part 1</b>	<b>Cargo hold region</b>	<b>Example No.</b>
<b>Area 5</b>	<b>Double bottom structure including hopper</b>	<b>1</b>
<b>Detail of damage</b>	Fractures in inner bottom plating around container bottom pocket	
<b>Sketch of damage</b>

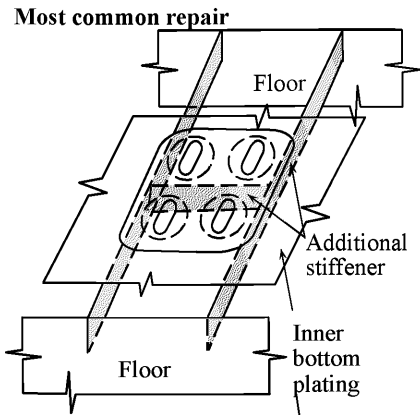
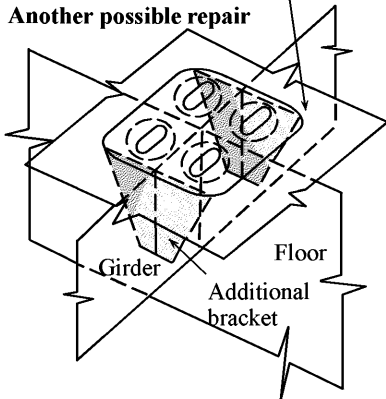
<b>Sketch of repair</b> <p><b>Most common repair</b></p>

<p><b>Another possible repair</b></p>

<b>Notes on possible cause of damage</b> 1. Pocket is not supported correctly by floor, longitudinal and/or stiffener.		<b>Notes on repairs</b> 1. Fractured plating should be cropped and part renewed. 2. Adequate reinforcement should be considered.

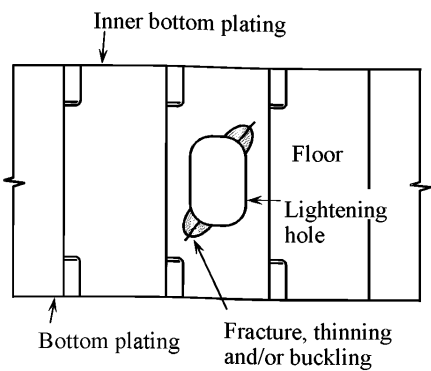
<b>BULK CARRIERS</b>		<b>Guidelines for Surveys, Assessment and Repair of Hull Structure</b>
<b>Part 1</b>	<b>Cargo hold region</b>	<b>Example No.</b>
<b>Area 5</b>	<b>Double bottom structure including hopper</b>	<b>2</b>
<b>Detail of damage</b> Fractures, corrosion and/or buckling of floor/girder around lightening hole		
<b>Sketch of damage</b>

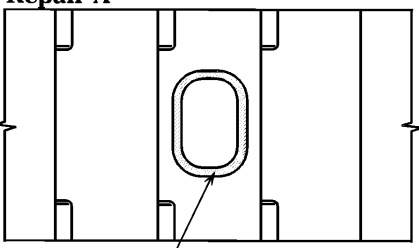
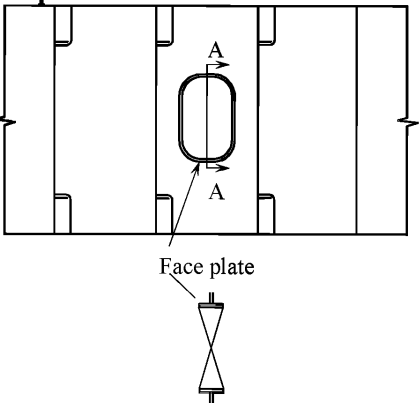
<b>Sketch of repair</b> <b>Repair A</b>

<b>Repair B</b>

<b>Section A-A</b>
<b>Notes on possible cause of damage</b> <ol style="list-style-type: none"> <li>1. Insufficient strength due to lightening hole.</li> <li>2. Fracture, corrosion and/or buckling around lightening hole due to high stress.</li> </ol>		<b>Notes on repairs</b> <ol style="list-style-type: none"> <li>1. Fractured, corroded and/or buckled plating should be cropped and renewed if considered necessary.</li> <li>2. Appropriate reinforcement should be considered.</li> </ol>

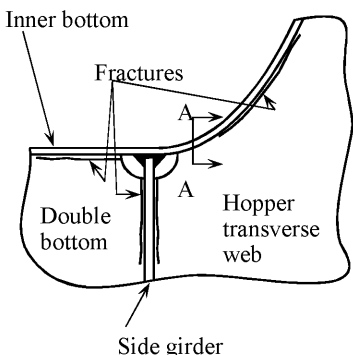
BULK CARRIERS		Guidelines for Surveys, Assessment and Repair of Hull Structure	
Part 1	Cargo hold region	Example No.	
Area 5	Double bottom tank structure including hopper	3	
Detail of damage		Fractures at weld connections of floors in way of hopper/inner bottom interface (radiused knuckle)	
Sketch of damage		Sketch of repair

<p><b>View A - A</b></p> <p>Transverse fractures in hopper web plating into possibly extending into the hopper sloping plating</p>

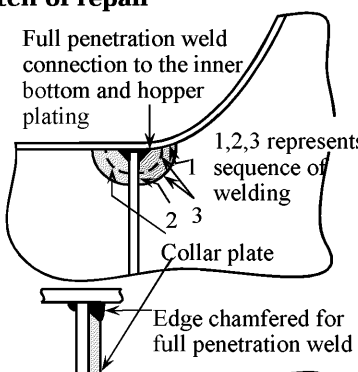
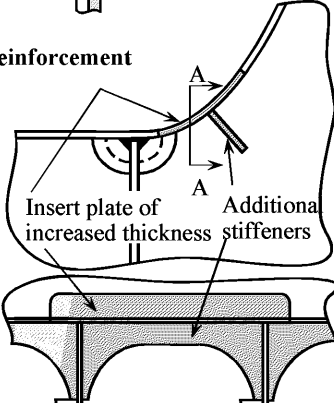
<p><b>Reinforcement</b></p>

1. The damage is partly due to stress concentrations at the edges of the weld created by the presence of cut-outs and local stress variations caused by the deflections in the inner bottom/hopper plating.		1. The fracture in the weld and/or plating is veed-out/cropped and renewed as appropriate.

2. The cut-outs are eliminated by introducing suitable collar plate with emphasis on edge preparation and sequence of welding as shown above.	
		3. Further reinforcements may need to be carried out as shown above, however, after consultation with the Classification Society concerned.

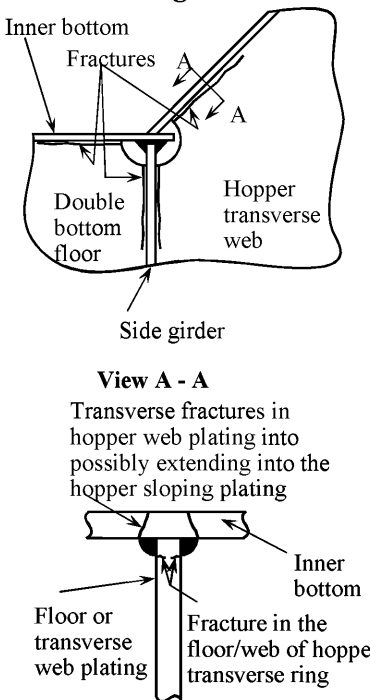
<b>BULK CARRIERS</b>	<b>Guidelines for Surveys, Assessment and Repair of Hull Structure</b>	
<b>Part 1</b>	<b>Cargo hold region</b>	<b>Example No.</b>
<b>Area 5</b>	<b>Double bottom tank structure including hopper</b>	<b>4</b>
<b>Detail of damage</b>		
Fractures at weld connections of floors in way of hopper/inner bottom interface (welded knuckle)		
<p><b>Sketch of damage</b></p>

<p><b>View A - A</b> Transverse fractures in hopper web plating into possibly extending into the hopper sloping plating</p> <p><b>View B - B</b> Fracture in the floor/web of hopper transverse ring</p>		
<p><b>Sketch of repair</b></p>

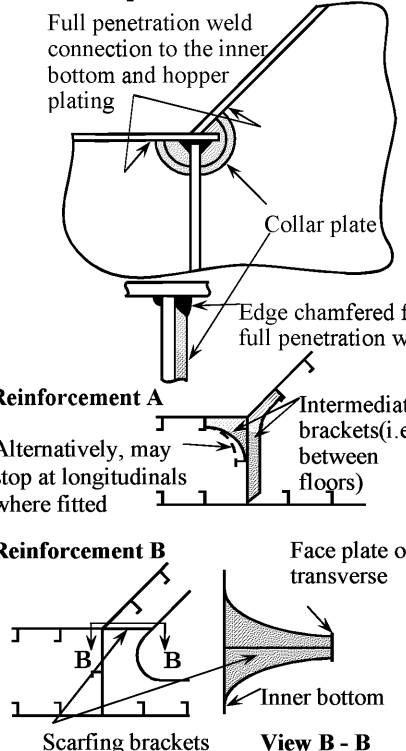
<p><b>Reinforcement A</b> Alternatively, may stop at longitudinals where fitted</p> <p><b>Reinforcement B</b> Face plate of transverse</p> <p><b>View B - B</b> Scarfing brackets</p>		
<b>Notes on possible cause of damage</b>		
<p>1. The damage is partly due to stress concentration at the edges of the weld created by the presence of the deflections in the inner bottom/hopper plating.</p>

<b>Notes on repairs</b>		
<p>1. The fracture in the weld and/or plating is veed-out/cropped and renewed as appropriate.</p> <p>2. The cut-outs are eliminated by introducing suitable collar plates with emphasis on edge preparation and sequence of welding as shown above.</p> <p>3. Further reinforcements may be incorporated as shown above and depending on the judged cause of damage.</p>

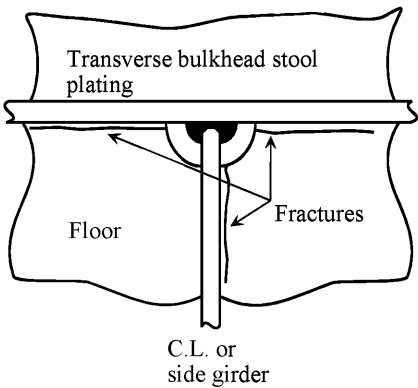
<b>BULK CARRIERS</b>		<b>Guidelines for Surveys, Assessment and Repair of Hull Structure</b>
<b>Part 1</b>	<b>Cargo hold region</b>	<b>Example No.</b>
<b>Area 5</b>	<b>Double bottom tank structure including hopper</b>	<b>5</b>
<b>Detail of damage</b>	Fractures at weld connections of floors in way of inner bottom and side girders, and plating of bulkhead stool	
<b>Sketch of damage</b>

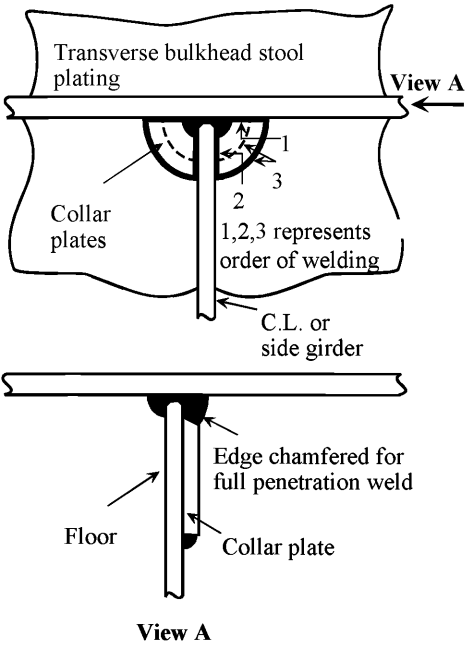
<b>Sketch of repair</b>

<b>Notes on possible cause of damage</b> 1. Stress concentration at the welds due to scallops.		<b>Notes on repairs</b> 1. The scallops will require to be fitted with welded collar plates to reduce stresses in the area.

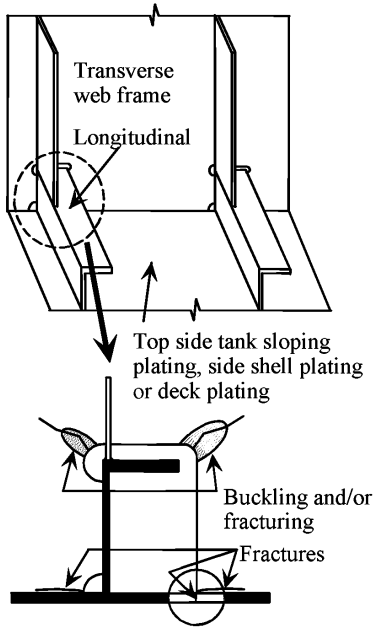
<b>BULK CARRIERS</b>		<b>Guidelines for Surveys, Assessment and Repair of Hull Structure</b>
<b>Part 1</b>	<b>Cargo hold region</b>	<b>Example No.</b>
<b>Area 5</b>	<b>Double bottom tank structure including hopper</b>	<b>6</b>
<b>Detail of damage</b>		Fractures and buckling in way of a cut-out for the passage of a longitudinal through a transverse primary member
<b>Sketch of damage</b>

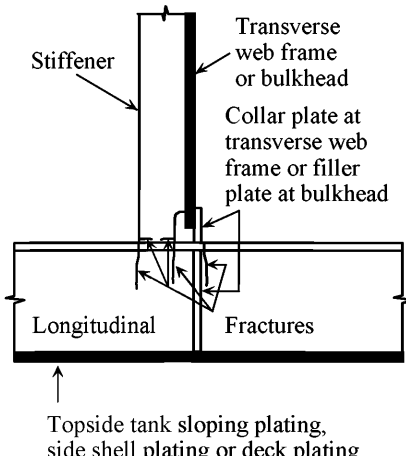
<b>BULK CARRIERS</b>		<b>Guidelines for Surveys, Assessment and Repair of Hull Structure</b>
<b>Part 1</b>	<b>Cargo hold region</b>	<b>Example No.</b>
<b>Area 5</b>	<b>Double bottom tank structure including hopper</b>	<b>7</b>
<b>Detail of damage</b>	Fractures in longitudinal at floor/transverse web frame or bulkhead	
<b>Sketch of damage</b>

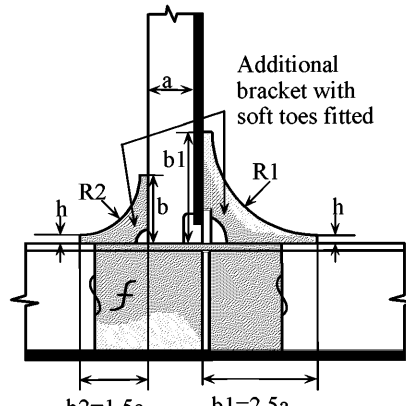
<b>Sketch of repair</b>

<p><math>f</math>: Where required, the longitudinal to be cropped and part renewed</p> <ol style="list-style-type: none"> <li>1. For a slope at toes max. 1:3,  <math>R1 = (b1 - h) \times 1.6</math> and <math>R2 = (b2 - h) \times 1.6</math></li> <li>2. Soft toe bracket to be welded first to longitudinal</li> <li>3. Scallop in bracket to be as small as possible, recommended max. 35mm</li> <li>4. If toes of brackets are ground smooth, full penetration welds in way to be provided</li> <li>5. Maximum length to thickness ratio = 50:1 for unstiffened bracket edge</li> <li>6. Toe height, <math>h</math>, to be as small as possible (10-15mm)</li> </ol>

<b>Notes on possible cause of damage</b> <ol style="list-style-type: none"> <li>1. Damage can be caused by stress concentrations leading to accelerated fatigue in this region.</li> </ol>		<b>Notes on repairs</b> <ol style="list-style-type: none"> <li>1. If fractures are not extensive e.g. hairline fractures, they can be veed-out and welded.</li> <li>2. If fracture extends to over one third of the depth of the longitudinal then crop and part renew.</li> </ol>

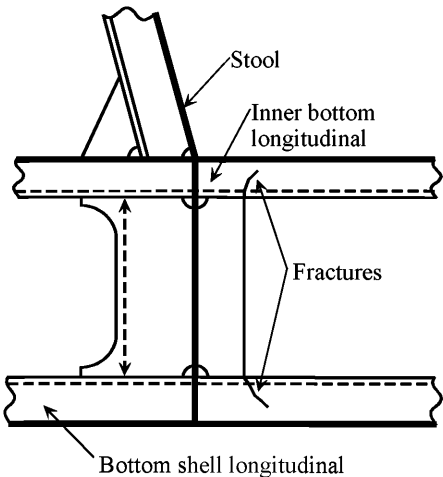
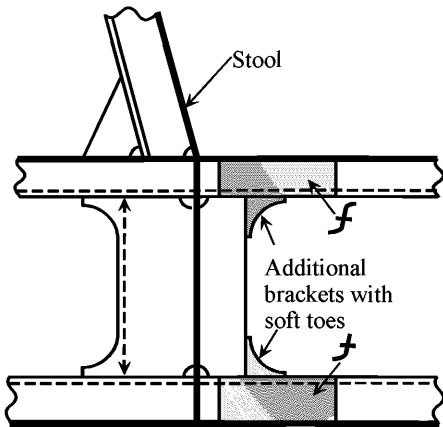
<b>BULK CARRIERS</b>		<b>Guidelines for Surveys, Assessment and Repair of Hull Structure</b>
<b>Part 1</b>	<b>Cargo hold region</b>	<b>Example No.</b>
<b>Area 5</b>	<b>Double bottom tank structure including hopper</b>	<b>8</b>
<b>Detail of damage</b>	Fractures in bottom and inner bottom longitudinals in way of inner bottom and bulkhead stool boundaries	
<b>Sketch of damage</b>		<b>Sketch of repair</b>

<p><b>f</b> :Where required the longitudinal to be cropped and part renewed</p>
<b>Notes on possible cause of damage</b>		<b>Notes on repairs</b>
<ol style="list-style-type: none"> <li>1. Damage can be caused by stress concentration leading to accelerated fatigue in this region.</li> </ol>		<ol style="list-style-type: none"> <li>1. If fractures are not extensive e.g. hairline fractures then these can be veed-out and welded.</li> <li>2. If fracture extended to over one third of the depth of the longitudinal depth then crop and part renew.</li> </ol>

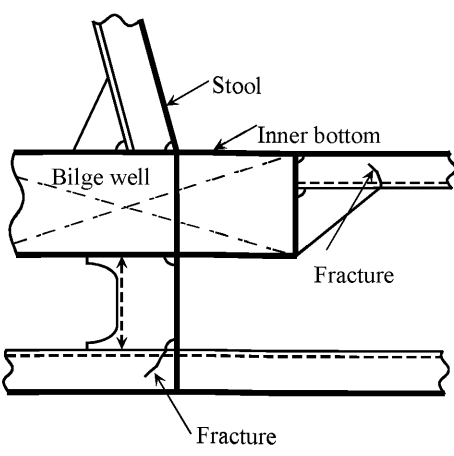
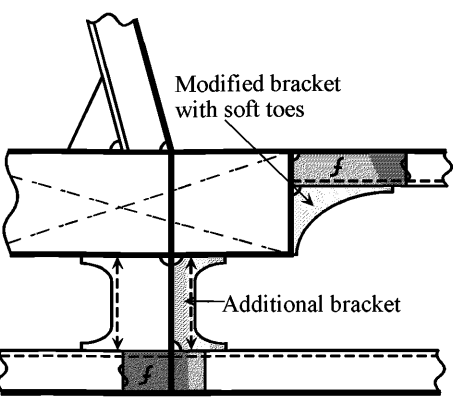
<b>BULK CARRIERS</b>		<b>Guidelines for Surveys, Assessment and Repair of Hull Structure</b>
<b>Part 1</b>	<b>Cargo hold region</b>	<b>Example No.</b>
<b>Area 5</b>	<b>Double bottom tank structure including hopper</b>	<b>9</b>
<b>Detail of damage</b>		Fractures in longitudinal in way of bilge well
<b>Sketch of damage</b>		<b>Sketch of repair</b>

<p><math>f</math>: Where required the longitudinals to be cropped and part renewed</p>
<b>Notes on possible cause of damage</b>		<b>Notes on repairs</b>
<ol style="list-style-type: none"> <li>Damage can be caused by stress concentrations leading to accelerated fatigue in this region.</li> </ol>		<ol style="list-style-type: none"> <li>If fractures are not extensive e.g. hairline fractures then these can be veed-out and welded.</li> <li>If the fracture extended to over one third of the depth of the longitudinal then crop and part renew.</li> </ol>

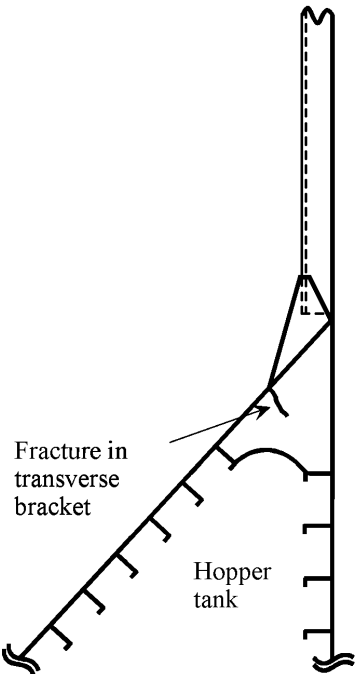
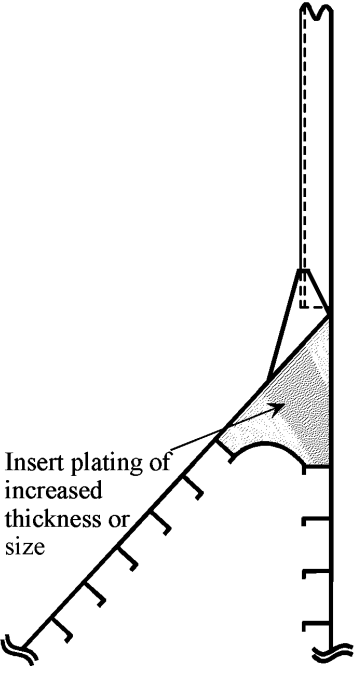
<b>BULK CARRIERS</b>		<b>Guidelines for Surveys, Assessment and Repair of Hull Structure</b>
<b>Part 1</b>	<b>Cargo hold region</b>	<b>Example No.</b>
<b>Area 5</b>	<b>Double bottom tank structure including hopper</b>	<b>11</b>
<b>Detail of damage</b>		Fractures at weld connection of transverse brackets
<b>Sketch of damage</b>		<b>Sketch of repair</b>

<b>Notes on possible cause of damage</b>		<b>Notes on repairs</b>
<ol style="list-style-type: none"> <li>1. General levels of corrosion and presence of stress concentration.</li> <li>2. Misalignment of the brackets with adjoining structure e.g. frame brackets.</li> <li>3. High shear stresses due to insufficient bracket.</li> <li>4. Inadvertent overloading.</li> </ol>		<ol style="list-style-type: none"> <li>1. If the damage is caused by misalignment with the frame bracket above, the misalignment is to be rectified.</li> <li>2. Replacement by a bracket of increased thickness or size should be considered.</li> </ol>

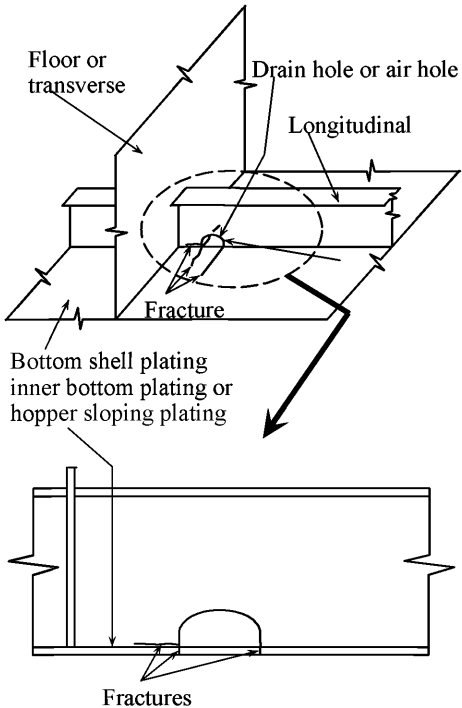
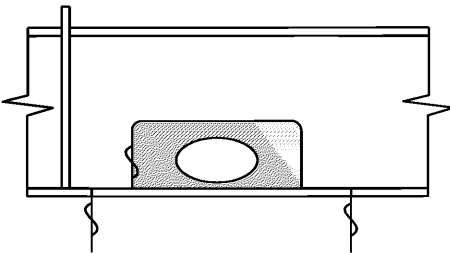
<b>BULK CARRIERS</b>		<b>Guidelines for Surveys, Assessment and Repair of Hull Structure</b>
<b>Part 1</b>	<b>Cargo hold region</b>	<b>Example No.</b>
<b>Area 5</b>	<b>Double bottom tank structure including hopper</b>	<b>12</b>
<b>Detail of damage</b>	Fractures in bottom shell/side shell/hopper sloping plating at the corner drain hole/air hole in longitudinal	
<b>Sketch of damage</b>

<b>Notes on possible cause of damage</b> 1. Stress concentration and/or corrosion due to stress concentration at the corner of drain hole/air hole.		<b>Notes on repairs</b> 1. Fractured plating should be cropped and part renewed. 2. If fatigue life is to be improved, change of drain hole/air hole shape is to be considered.

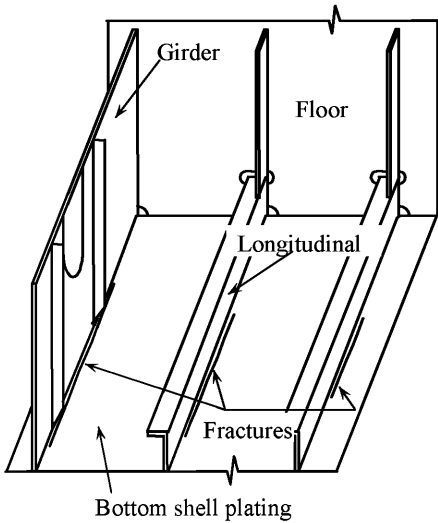
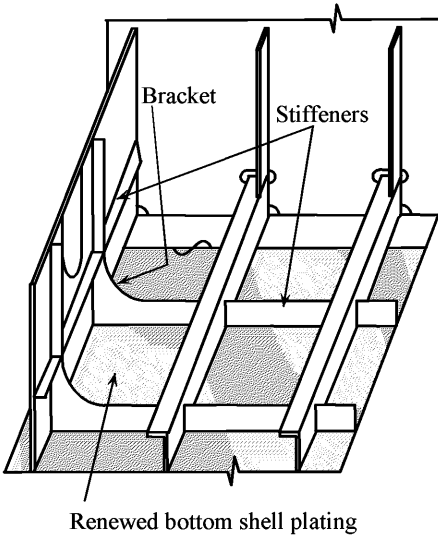
<b>BULK CARRIERS</b>		<b>Guidelines for Surveys, Assessment and Repair of Hull Structure</b>
<b>Part 1</b>	<b>Cargo hold region</b>	<b>Example No.</b>
<b>Area 5</b>	<b>Double bottom tank structure including hopper</b>	<b>13</b>
<b>Detail of damage</b>	Fractures in bottom plating along side girder and/or bottom longitudinal	
<b>Sketch of damage</b>

<b>Notes on possible cause of damage</b> 1. Vibration.		<b>Notes on repairs</b> 1. Fractured bottom shell plating should be cropped and renewed. 2. Natural frequency of the panel should be changed, e.g. reinforcement by additional stiffener/bracket.

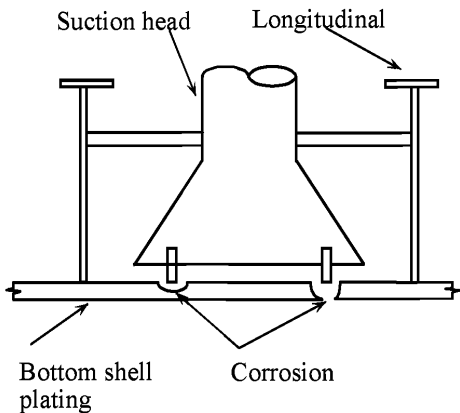
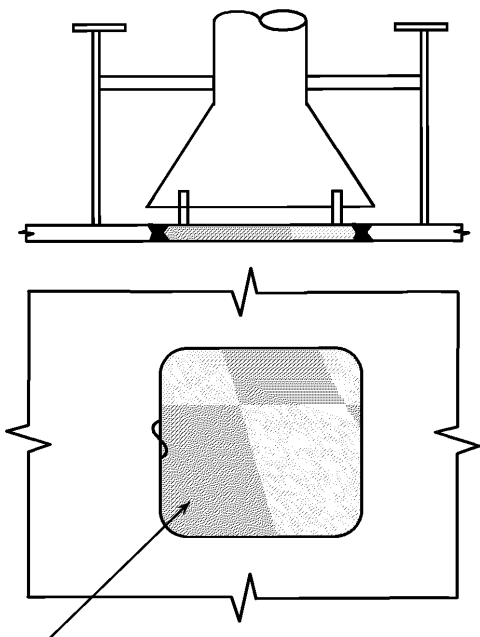
<b>BULK CARRIERS</b>		<b>Guidelines for Surveys, Assessment and Repair of Hull Structure</b>
<b>Part 1</b>	<b>Cargo hold region</b>	<b>Example No.</b>
<b>Area 5</b>	<b>Double bottom tank structure including hopper</b>	<b>14</b>
<b>Detail of damage</b>		Corrosion in bottom plating below suction head
<b>Sketch of damage</b>		<b>Sketch of repair</b>

<p>1. Insert to have round corners 2. Non-destructive examination to be applied after welding based on the Society's rules</p>
<b>Notes on possible cause of damage</b>		<b>Notes on repairs</b>
<ol style="list-style-type: none"> <li>1. High flow rate associated with insufficient corrosion prevention system.</li> <li>2. Galvanic action between dissimilar metals.</li> </ol>		<ol style="list-style-type: none"> <li>1. Affected plating should be cropped and part renewed. Thicker plate and suitable beveling should be considered.</li> <li>2. If the corrosion is limited to a small area, i. e. pitting corrosion, repair by welding is acceptable.</li> </ol>

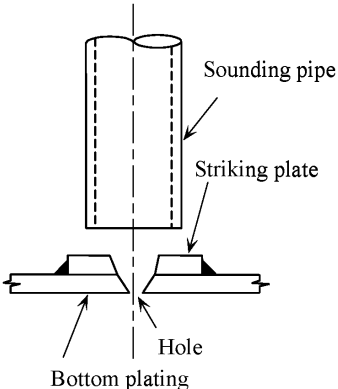
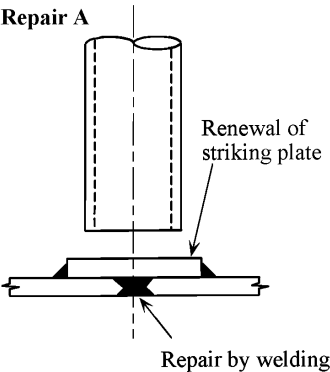
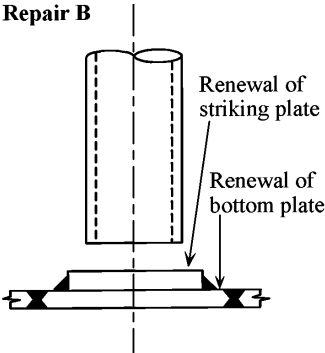
<b>BULK CARRIERS</b>		<b>Guidelines for Surveys, Assessment and Repair of Hull Structure</b>
<b>Part 1</b>	<b>Cargo hold region</b>	<b>Example No.</b>
<b>Area 5</b>	<b>Double bottom tank structure including hopper</b>	<b>15</b>
<b>Detail of damage</b> Corrosion in bottom plating below sounding pipe		
<b>Sketch of damage</b>

<b>Sketch of repair</b> <div style="margin-top: 20px;"> <b>Repair A</b>

</div> <div style="margin-top: 20px;"> <b>Repair B</b>

</div>
<b>Notes on possible cause of damage</b> <ol style="list-style-type: none"> <li>1. Accelerated corrosion of striking plate by the striking of the weight of the sounding tape.</li> </ol>		<b>Notes on repairs</b> <ol style="list-style-type: none"> <li>1. Corroded bottom plating should be welded or partly cropped and renewed if considered necessary.</li> <li>2. Corroded striking plate should be renewed.</li> </ol>

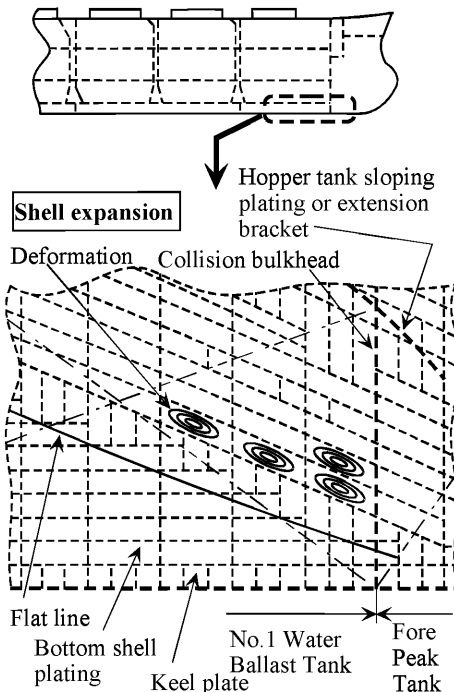
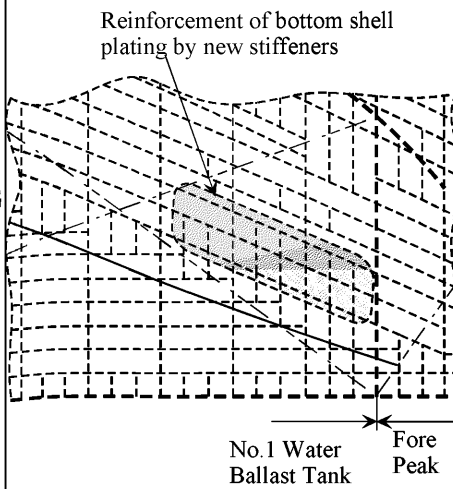
<b>BULK CARRIERS</b>		<b>Guidelines for Surveys, Assessment and Repair of Hull Structure</b>
<b>Part 1</b>	<b>Cargo hold region</b>	<b>Example No.</b>
<b>Area 5</b>	<b>Double bottom structure including hopper</b>	<b>16</b>
<b>Detail of damage</b>		Deformation of forward bottom shell plate due to slamming
<b>Sketch of damage</b>		<b>Sketch of repair</b>

<b>Notes on possible cause of damage</b>		<b>Notes on repairs</b>
<ol style="list-style-type: none"> <li>1. Heavy weather.</li> <li>2. Poor design for slamming.</li> <li>3. Poor operation, i.e. negligence of heavy ballast.</li> </ol>		<ol style="list-style-type: none"> <li>1. Deformed bottom shell plating should be faired in place, or partly cropped and renewed if considered necessary.</li> <li>2. Bottom shell plating should be reinforced by stiffeners.</li> </ol>

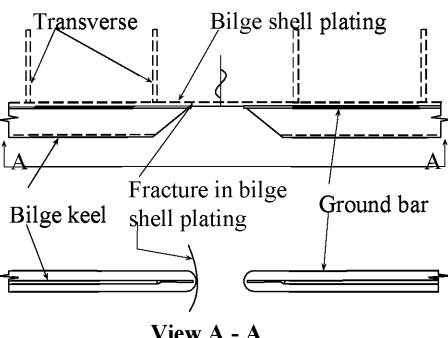
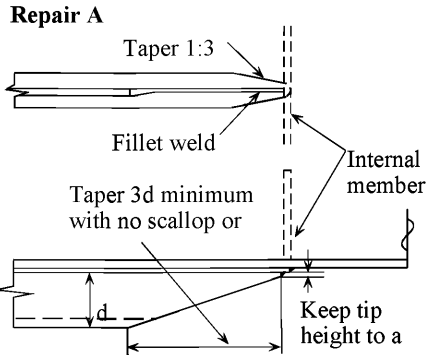
<b>BULK CARRIERS</b>		<b>Guidelines for Surveys, Assessment and Repair of Hull Structure</b>
<b>Part 1</b>	<b>Cargo hold region</b>	<b>Example No.</b>
<b>Area 5</b>	<b>Double bottom structure including hopper</b>	<b>17</b>
<b>Detail of damage</b>		Fractures in shell plating at the termination of bilge keel
<b>Sketch of damage</b>

<b>Sketch of repair</b> <p><b>Repair A</b></p>

<b>Notes on possible cause of damage</b> <ol style="list-style-type: none"> <li>Poor design causing stress concentration.</li> </ol>		<b>Notes on repairs</b> <ol style="list-style-type: none"> <li>Fractured plating is to be cropped and renewed.</li> <li>Reduction of stress concentration of the bilge keel end should be considered.           <p><b>Repair A:</b> Modification of the detail of end</p> <p><b>Repair B:</b> New internal stiffeners</p> <p><b>Repair C:</b> Continuous ground bar (in connection with <b>Repair A</b>)</p> </li> <li>Instead of <b>Repair A</b> or <b>B</b> continuous ground bar and bilge keel should be considered.</li> </ol>

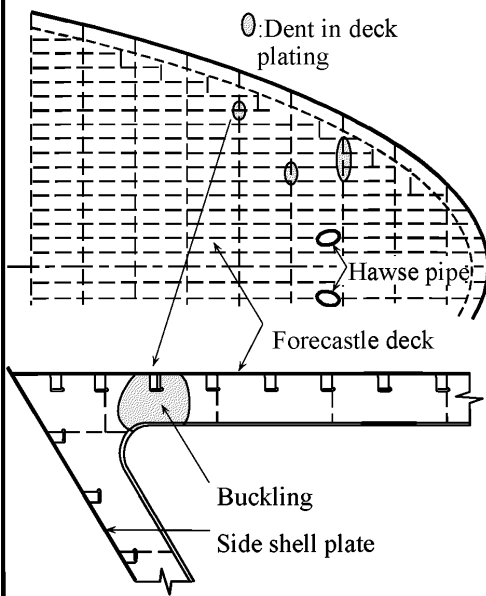
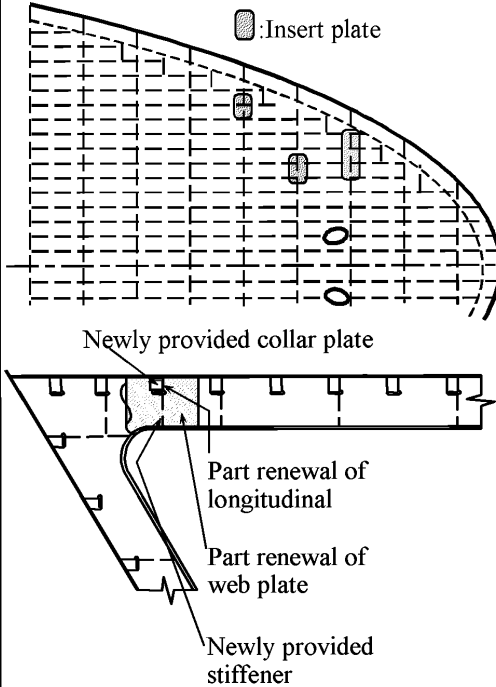
<b>BULK CARRIERS</b>		<b>Guidelines for Surveys, Assessment and Repair of Hull Structure</b>
<b>Part 2</b>	<b>Fore and aft end regions</b>	<b>Example No.</b>
<b>Area 1</b>	<b>Fore end structure</b>	<b>1</b>
<b>Detail of damage</b>		Deformation of forecastle deck
<b>Sketch of damage</b>		<b>Sketch of repair</b>

<b>Notes on possible cause of damage</b>		<b>Notes on repairs</b>
<ol style="list-style-type: none"> <li>1. Green sea on deck.</li> <li>2. Insufficient strength.</li> </ol>		<ol style="list-style-type: none"> <li>1. Deformed structure should be cropped and renewed.</li> <li>2. Additional stiffeners on web of beam should be considered for reinforcement.</li> </ol>

- 3.3.1** Fractures of a minor nature may be veed-out and rewelded. Where cracking is more extensive, the structure is to be cropped and renewed. In the case of fractures caused by sea loads, increased thickness of plating and/or design modification to reduce stress concentrations should be considered (See **Examples 1, 2 and 6**).

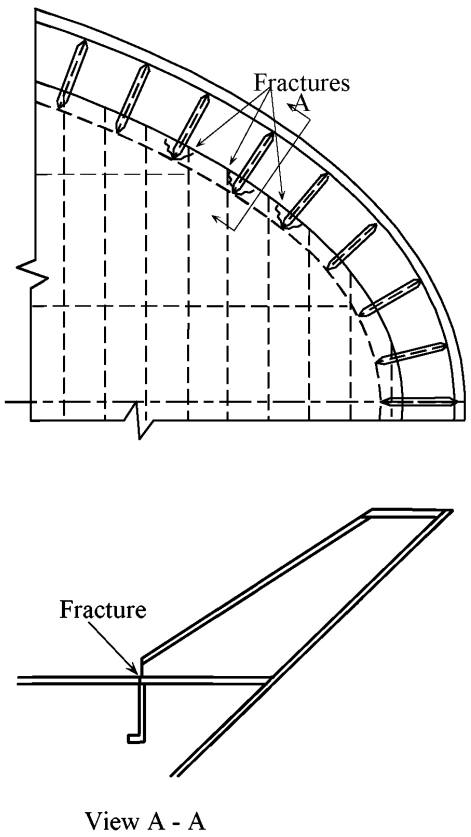
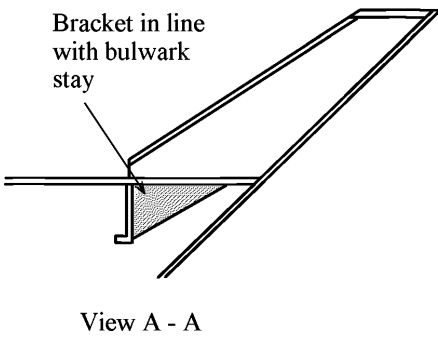
<b>BULK CARRIERS</b>		<b>Guidelines for Surveys, Assessment and Repair of Hull Structure</b>
<b>Part 2</b>	<b>Fore and aft end regions</b>	<b>Example No.</b>
<b>Area 1</b>	<b>Fore end structure</b>	<b>2</b>
<b>Detail of damage</b>		Fractures in forecastle deck plating at bulwark
<b>Sketch of damage</b>		<b>Sketch of repair</b>

<p>Fractures</p> <p>Fracture</p> <p>View A - A</p>

<p>Bracket in line with bulwark stay</p> <p>View A - A</p>
<b>Notes on possible cause of damage</b>		<b>Notes on repairs</b>
<ol style="list-style-type: none"> <li>1. Bow flare effect in heavy weather.</li> <li>2. Stress concentration due to poor design.</li> </ol>		<ol style="list-style-type: none"> <li>1. Fractured deck plating should be cropped and renewed.</li> <li>2. Bracket in line with the bulwark stay to be fitted to reduce stress concentration.</li> </ol>

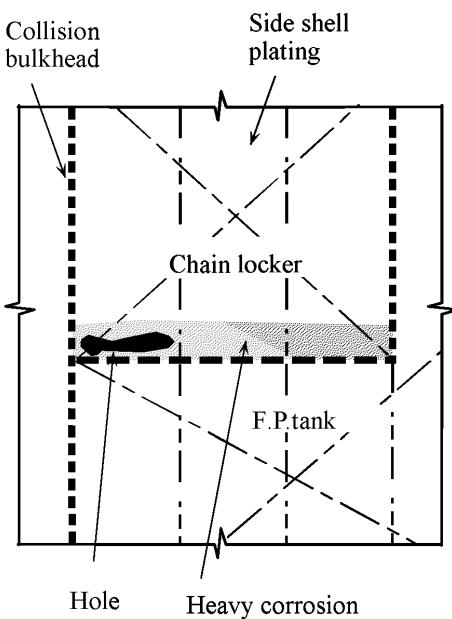
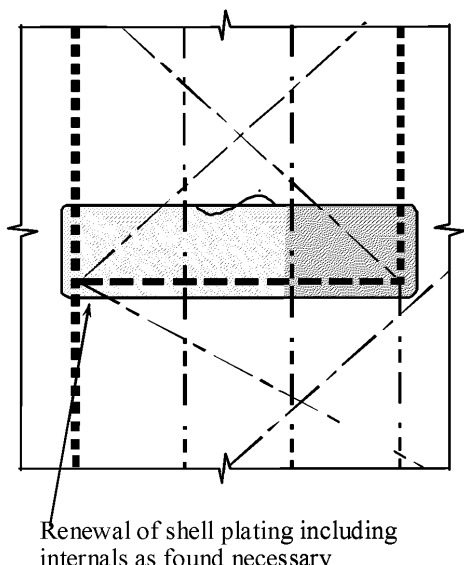
<b>BULK CARRIERS</b>		<b>Guidelines for Surveys, Assessment and Repair of Hull Structure</b>
<b>Part 2</b>	<b>Fore and aft end regions</b>	<b>Example No.</b>
<b>Area 1</b>	<b>Fore end structure</b>	<b>3</b>
<b>Detail of damage</b>		Fractures in side shell plating in way of chain locker
<b>Sketch of damage</b>

<b>Notes on possible cause of damage</b> <ol style="list-style-type: none"> <li>Heavy corrosion in region where mud is accumulated.</li> </ol>		<b>Notes on repairs</b> <ol style="list-style-type: none"> <li>Corroded plating should be cropped and renewed.</li> <li>Protective coating should be applied.</li> </ol>

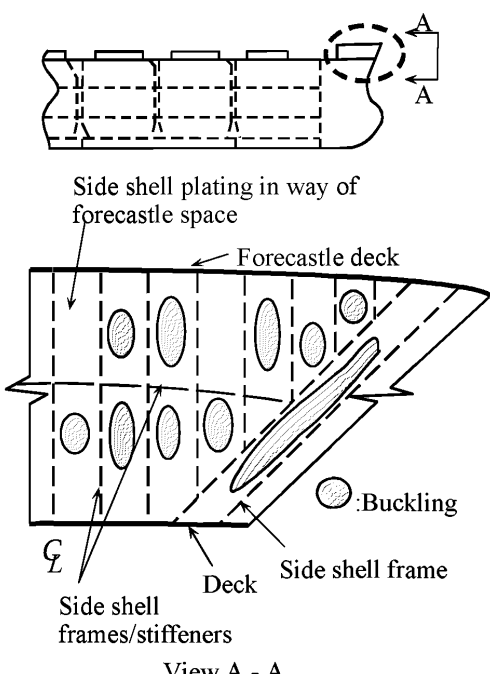
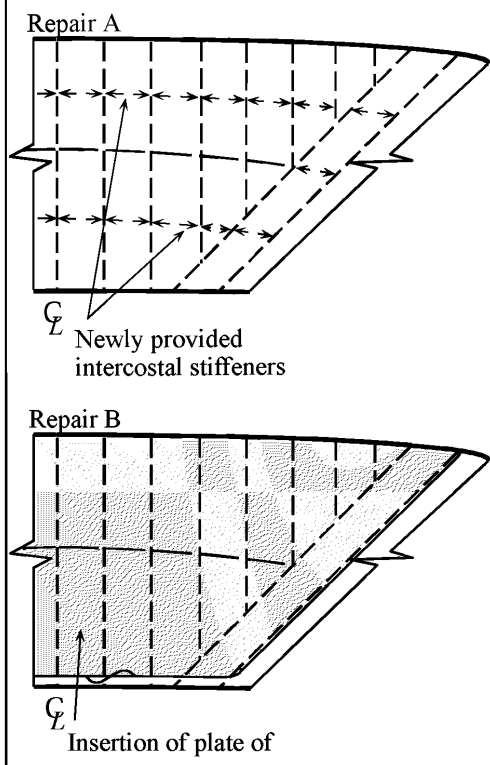
<b>BULK CARRIERS</b>		<b>Guidelines for Surveys, Assessment and Repair of Hull Structure</b>
<b>Part 2</b>	<b>Fore and aft end regions</b>	<b>Example No.</b>
<b>Area 1</b>	<b>Fore end structure</b>	<b>4</b>
<b>Detail of damage</b>		Deformation of side shell plating in way of forecastle space
<b>Sketch of damage</b>

<b>Notes on possible cause of damage</b> <ol style="list-style-type: none"> <li>1. Heavy weather.</li> <li>2. Insufficient strength.</li> </ol>		<b>Notes on repairs</b> <ol style="list-style-type: none"> <li>1. Deformed part should be cropped and part renewed.</li> <li>2. <b>Repair A</b> Additional stiffeners between existing stiffeners should be considered. <b>Repair B</b> Insertion of plate of increased thickness with additional stiffeners.</li> </ol>

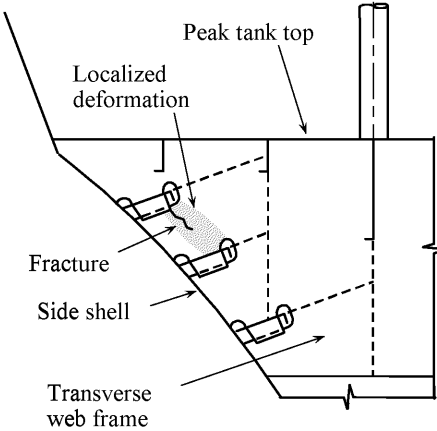
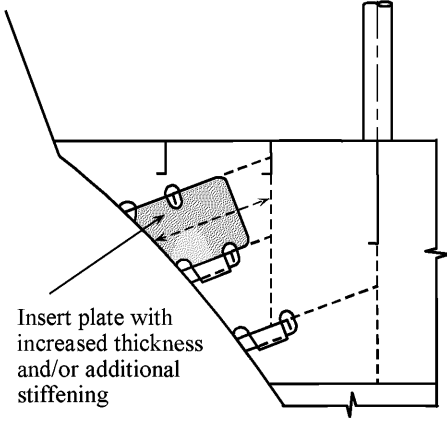
<b>BULK CARRIERS</b>		<b>Guidelines for Surveys, Assessment and Repair of Hull Structure</b>
<b>Part 2</b>	<b>Fore and aft end regions</b>	<b>Example No.</b>
<b>Area 1</b>	<b>Fore end structure</b>	<b>5</b>
<b>Detail of damage</b>	Fracture and deformation of bow transverse web in way of cut-outs for side longitudinals	
<b>Sketch of damage</b>		<b>Sketch of repair</b>

<b>Notes on possible cause of damage</b>		<b>Notes on repairs</b>
<ol style="list-style-type: none"> <li>1. Localized material wastage in way of coating failure at cut-outs and sharp edges due to working of the structure.</li> <li>2. Dynamic seaway loading in way of bow flare.</li> </ol>		<ol style="list-style-type: none"> <li>1. Sufficient panel strength to be provided to absorb the dynamic loads enhanced by bow flare shape.</li> </ol>

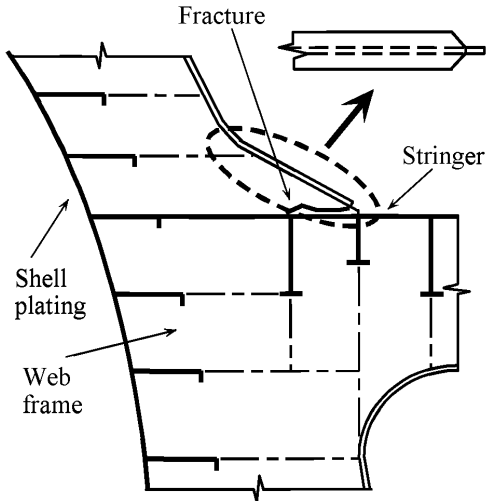
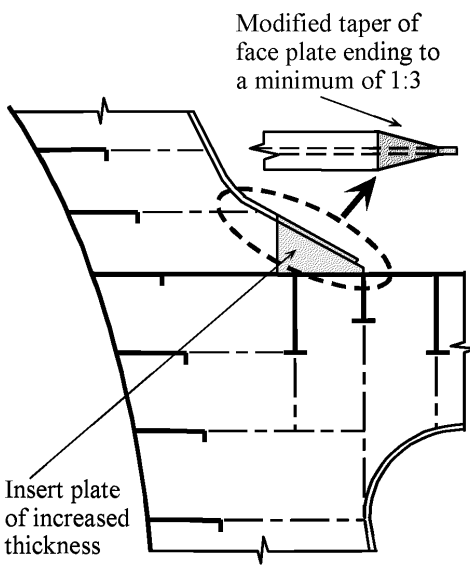
<b>BULK CARRIERS</b>		<b>Guidelines for Surveys, Assessment and Repair of Hull Structure</b>
<b>Part 2</b>	<b>Fore and aft end regions</b>	<b>Example No.</b>
<b>Area 1</b>	<b>Fore end structure</b>	<b>6</b>
<b>Detail of damage</b>	Fractures at toe of web frame bracket connection to stringer platform bracket	
<b>Sketch of damage</b>

<b>Notes on possible cause of damage</b> <ol style="list-style-type: none"> <li>1. Inadequate bracket forming the web frame connection to the stringer.</li> <li>2. Localized material wastage in way of coating failure at bracket due to flexing of the structure.</li> <li>3. Dynamic seaway loading in way of bow flare.</li> </ol>		<b>Notes on repairs</b> <ol style="list-style-type: none"> <li>1. Adequate soft nose bracket endings with a face plate taper of at least 1 : 3 to be provided.</li> </ol>
