**РОССИЙСКИЙ МОРСКОЙ РЕГИСТР СУДОХОДСТВА**  
**RUSSIAN MARITIME REGISTER OF SHIPPING**

**IACS PROCEDURAL REQUIREMENTS,  
UNIFIED INTERPRETATIONS  
AND RECOMMENDATIONS**

## **GENERAL DRY CARGO SHIPS**

Guidelines for  
Surveys, Assessment and Repair  
of Hull Structure

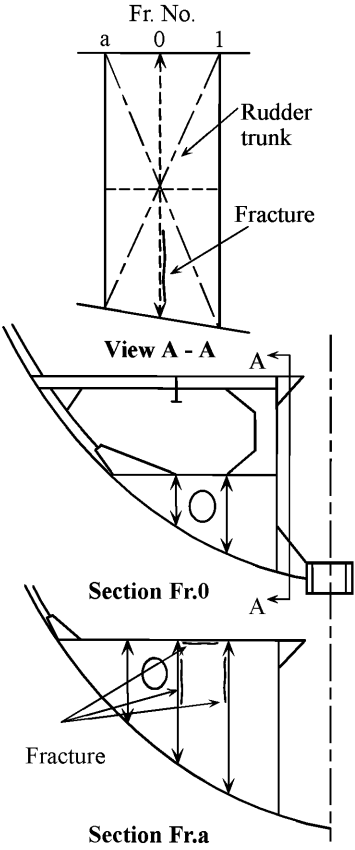
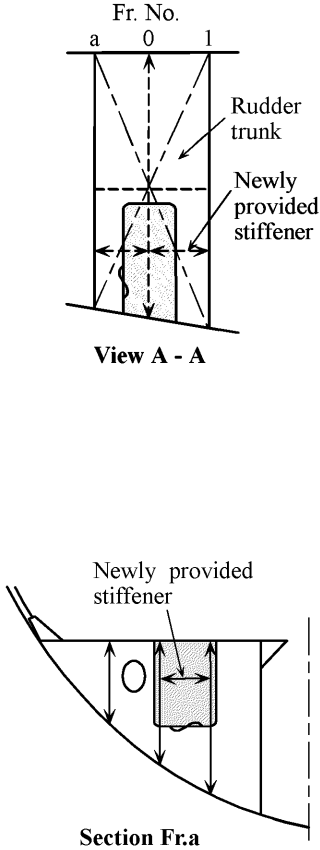
<b>BULK CARRIERS</b>		<b>Guidelines for Surveys, Assessment and Repair of Hull Structure</b>
<b>Part 2</b>	<b>Fore and aft end regions</b>	<b>Example No.</b>
<b>Area 2</b>	<b>Aft end structure</b>	<b>1</b>
<b>Detail of damage</b> Fractures in bulkhead in way of rudder trunk		
<b>Sketch of damage</b>

<b>Notes on possible cause of damage</b> 1. Vibration.		<b>Notes on repairs</b> 1. The fractured plating should be cropped and renewed. 2. Natural frequency of the plate between stiffeners should be changed, e.g. reinforcement by additional stiffeners.

**3.3.2** In order to prevent recurrence of damages suspected to be caused by main engine or propeller excited vibration, the cause of the vibration should be ascertained and additional reinforcements provided as found necessary (See **Examples 1** and **2**).

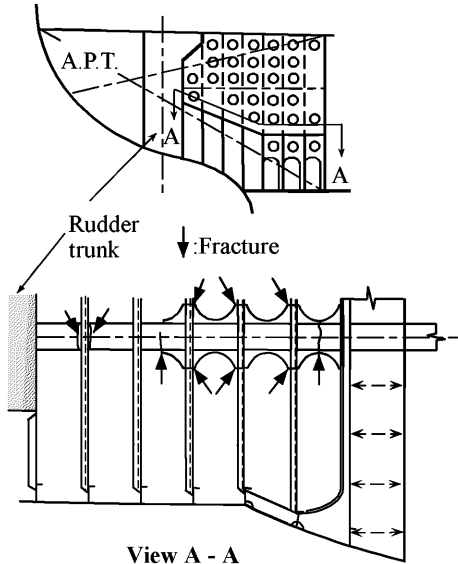
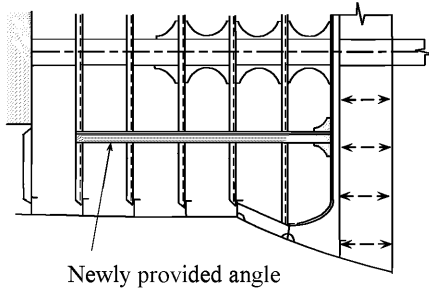
<b>BULK CARRIERS</b>		<b>Guidelines for Surveys, Assessment and Repair of Hull Structure</b>
<b>Part 2</b>	<b>Fore and aft end regions</b>	<b>Example No.</b>
<b>Area 2</b>	<b>Aft end structure</b>	<b>2</b>
<b>Detail of damage</b>	Fractures at the connection of floors and girders/side brackets	
<b>Sketch of damage</b>

<b>Notes on possible cause of damage</b> 1. Vibration.		<b>Notes on repairs</b> 1. The fractured plating should be cropped and renewed. 2. Natural frequency of the panel should be changed, e.g. reinforcement by additional strut.

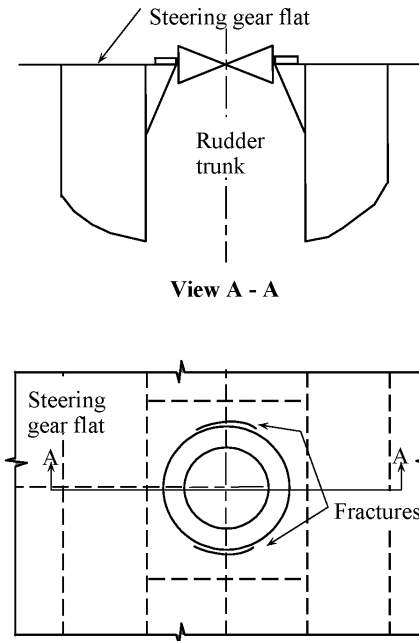
<b>BULK CARRIERS</b>		<b>Guidelines for Surveys, Assessment and Repair of Hull Structure</b>
<b>Part 2</b>	<b>Fore and aft end regions</b>	<b>Example No.</b>
<b>Area 2</b>	<b>Aft end structure</b>	<b>3-a</b>
<b>Detail of damage</b>	Fractures in flat where rudder carrier is installed in steering gear room	
<b>Sketch of damage</b>

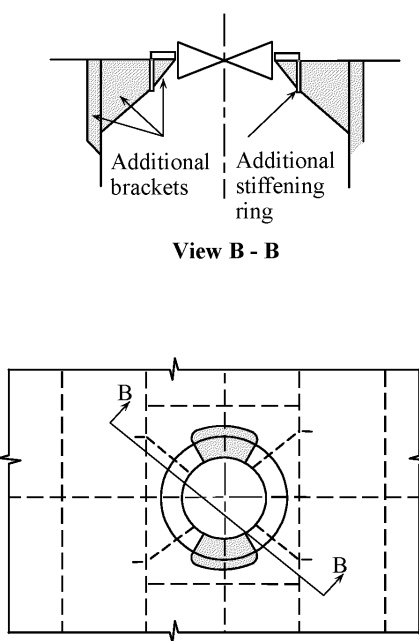
<b>Sketch of repair</b>

<b>Notes on possible cause of damage</b> 1. Inadequate design.		<b>Notes on repairs</b> 1. Fractured plating should be cropped and renewed. 2. Additional brackets and stiffening ring should be fitted for reinforcement.

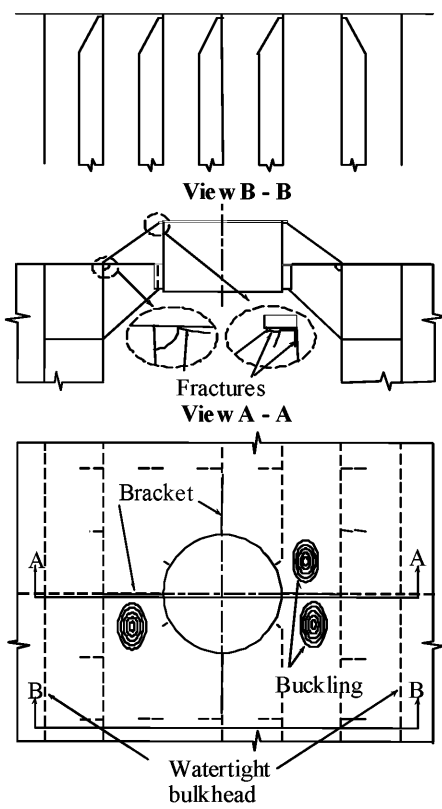
<b>BULK CARRIERS</b>		<b>Guidelines for Surveys, Assessment and Repair of Hull Structure</b>
<b>Part 2</b>	<b>Fore and aft end regions</b>	<b>Example No.</b>
<b>Area 2</b>	<b>Aft end structure</b>	<b>3-b</b>
<b>Detail of damage</b>	Fractures in steering gear foundation brackets and deformed deck plate	
<b>Sketch of damage</b>

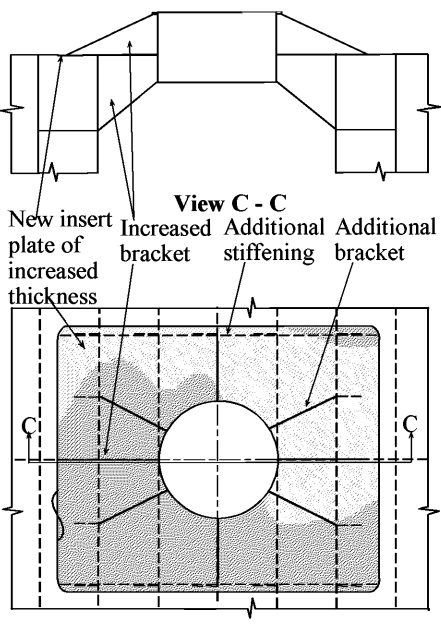
<b>Sketch of repair</b>

<b>Notes on possible cause of damage</b> <ol style="list-style-type: none"> <li>1. Insufficient deck strengthening (missing base plate).</li> <li>2. Insufficient strengthening of steering gear foundation.</li> <li>3. Bolts of steering gear were not sufficiently pre-loaded.</li> </ol>		<b>Notes on repairs</b> <ol style="list-style-type: none"> <li>1. New insert base plate of increased plate thickness.</li> <li>2. Additional longitudinal stiffening at base plate edges.</li> <li>3. Additional foundation brackets above and under deck (star configuration).</li> </ol>

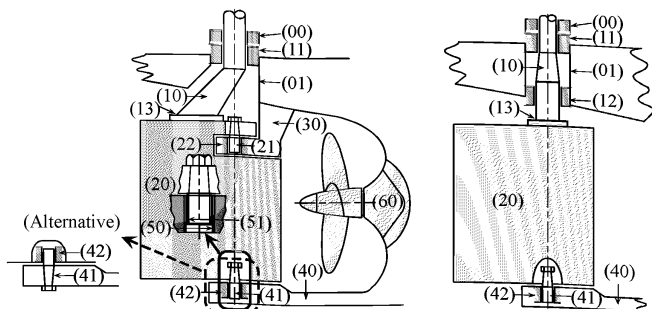
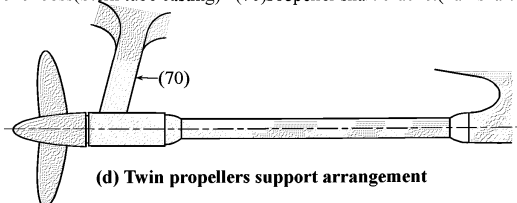
**Figure 1 Nomenclature for stern frame, rudder arrangement and propeller shaft support**

(a) Rudders supported by sole piece

| (50) Bush | (51) Sleeve (Liner) | | |
| (60) Propeller boss (Stern tube casting) | (70) Propeller shaft bracket (Tail shaft strut) | | |

(d) Twin propellers support arrangement

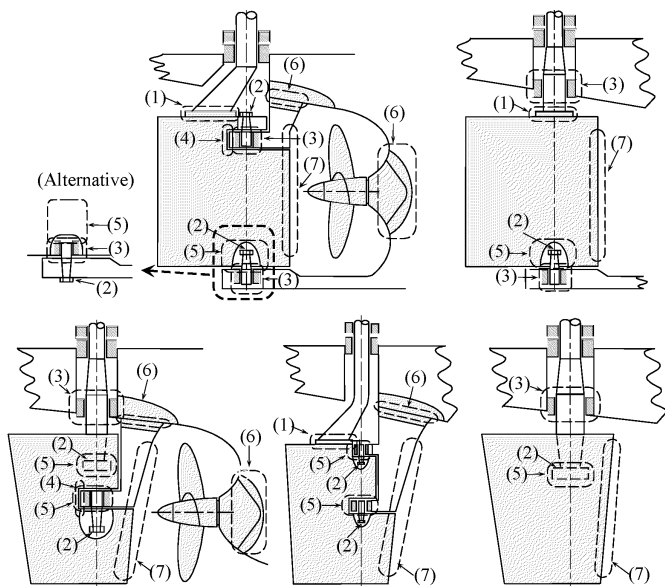
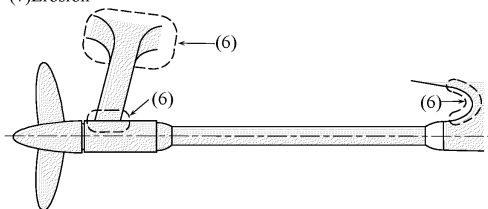
**Figure 2 Potential problem areas**

**Damage to look for:**

- (1) Fractures and loose coupling bolts
- (2) Loose nut
- (3) Wear (excessive bearing clearance)
- (4) Fractures in way of pintle cutout
- (5) Fractures in way of removable access plate
- (6) Fractures
- (7) Erosion

- 1.6 Pre-existing manufacturing internal defects in cast pieces may lead to fatigue cracking.
- 1.7 A summary of potential problem areas is shown in **Figure 2**.

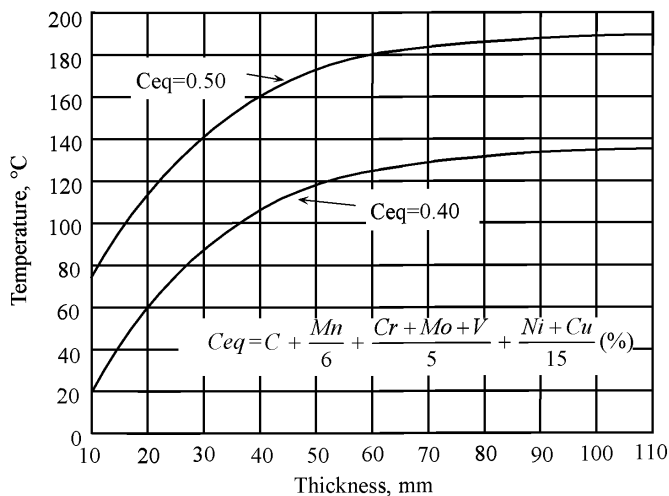
**Diagram 1 Preheating temperature**

**3.2.5** As a guide, the preheating temperature can be obtained from **Diagram 1** using the plate thickness and carbon equivalent of the thicker structure.

**3.2.4** For the fractures at the connection between plating and cast pieces an adequate preheating is necessary. The preheating temperature is to be determined taking into account the following parameters:

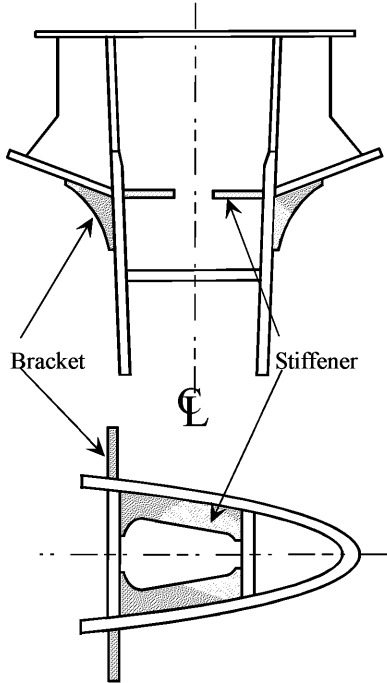
<b>BULK CARRIERS</b>		<b>Guidelines for Surveys, Assessment and Repair of Hull Structure</b>
<b>Part 2</b>	<b>Fore and aft end regions</b>	<b>Example No.</b>
<b>Area 3</b>	<b>Stern frame, rudder arrangement and propeller shaft support</b>	<b>1</b>
<b>Detail of damage</b>	Fractures in rudder horn along bottom shell plating	
<b>Sketch of damage</b>		<b>Sketch of repair</b>

<b>Notes on possible cause of damage</b>		<b>Notes on repairs</b>
1. Insufficient strength due to poor design.		1. Fractured plating to be veed-out and rewelded. 2. Fractured plating to be cropped and renewed if considered necessary. 3. Reinforcement should be considered if considered necessary.

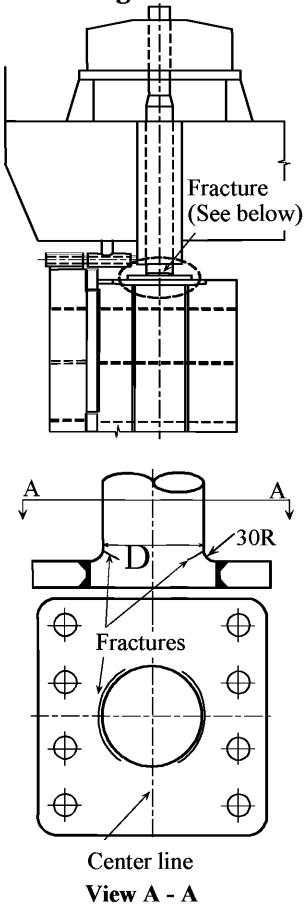
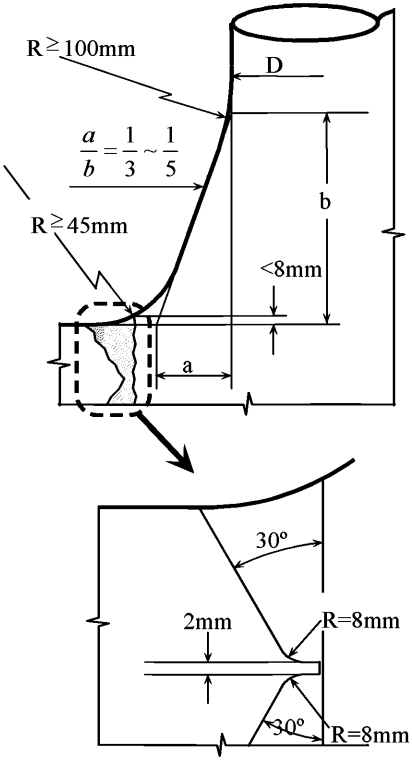
BULK CARRIERS	Guidelines for Surveys, Assessment and Repair of Hull Structure	
Part 2	Fore and aft end regions	Example No.
Area 3	Stern frame, rudder arrangement and propeller shaft support	2
Detail of damage		Fractures in rudder stock
<p><b>Sketch of damage</b></p>

<p>Fracture (See below)</p> <p>Center line View A - A</p>		<p><b>Sketch of repair</b></p>

<p><math>R \geq 100\text{mm}</math></p> <p><math>\frac{a}{b} = \frac{1}{3} \sim \frac{1}{5}</math></p> <p><math>R \geq 45\text{mm}</math></p> <p><math>D</math></p> <p><math>b</math></p> <p><math>&lt;8\text{mm}</math></p> <p><math>a</math></p> <p><math>30^\circ</math></p> <p><math>2\text{mm}</math></p> <p><math>R=8\text{mm}</math></p> <p><math>30^\circ</math></p> <p><math>R=8\text{mm}</math></p>
<p><b>Notes on possible cause of damage</b></p> <ol style="list-style-type: none"> <li>Inadequate design for stress concentration in rudder stock.</li> </ol>		<p><b>Notes on repairs</b></p> <ol style="list-style-type: none"> <li>Modification of detail design of rudder stock to reduce the stress concentration.</li> </ol>

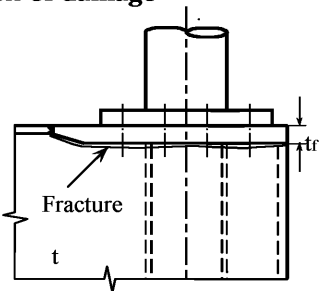
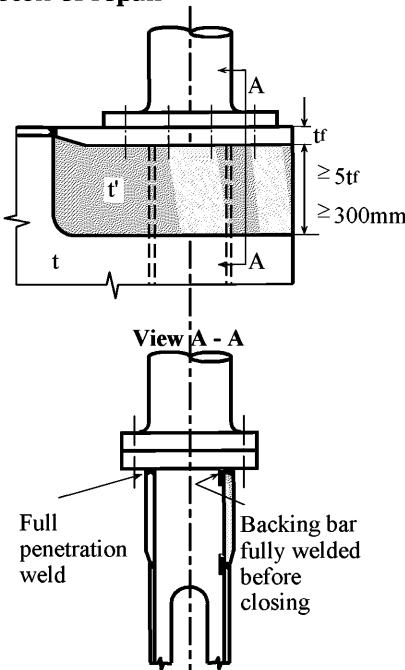
<b>BULK CARRIERS</b>		<b>Guidelines for Surveys, Assessment and Repair of Hull Structure</b>
<b>Part 2</b>	<b>Fore and aft end regions</b>	<b>Example No.</b>
<b>Area 3</b>	<b>Stern frame, rudder arrangement and propeller shaft support</b>	<b>3</b>
<b>Detail of damage</b>		Fractures in connection of palm plate to rudder blade
<b>Sketch of damage</b>		<b>Sketch of repair</b>

<p>View A - A</p> <p>Full penetration weld</p> <p>Backing bar fully welded before closing</p> <p><math>t</math> = plate thickness, mm  <math>tf</math> = actual flange thickness, mm  <math>t = \frac{tf}{3} + 5</math>, mm, where <math>tf \leq 50</math> mm  <math>t = 3\sqrt{tf}</math>, mm, where <math>tf \geq 50</math> mm</p>
<b>Notes on possible cause of damage</b>		<b>Notes on repairs</b>
<ol style="list-style-type: none"> <li>Inadequate connection between palm plate and rudder blade plating (insufficient plating thickness and/or insufficient fillet weld).</li> </ol>		<ol style="list-style-type: none"> <li>Modification of detail design of the connection by increasing the plate thickness and full penetration welding.</li> </ol>

- 2.2.4 Fractures should be looked for at the transition radius between rudder stock and horizontal coupling (palm) plate, and the connection between horizontal coupling plate and rudder blade in case of horizontal coupling. Typical fractures are shown in **Examples 1** and **2**. Fatigue fractures should be looked for at the palm plate itself in case of loosened or lost coupling bolts.

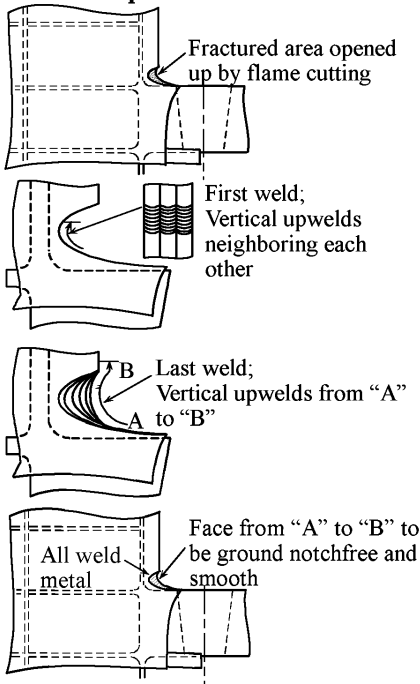
BULK CARRIERS	Guidelines for Surveys, Assessment and Repair of Hull Structure	
Part 2	Fore and aft end regions	Example No.
Area 3	Stern frame, rudder arrangement and propeller shaft support	4
Detail of damage	Fractures in rudder plating of semi-spade rudder (short fracture with end located forward of the vertical web)	
Sketch of damage		Sketch of repair

Notes on possible cause of damage		Notes on repairs
<ol style="list-style-type: none"> <li>1. Stress concentration due to inadequate local design and/or fabrication notches in way of the butt weld between cast piece and plating.</li> </ol>		<ol style="list-style-type: none"> <li>1. Grooving-out and welding of the fracture is not always adequate (metallurgical notch in way of a high stressed area).</li> <li>2. In the proposed repair procedure the metallurgical notches are shifted into a zone exposed to lower stresses.</li> <li>3. After welding a modification of the radius according to the proposal in <b>Example 5</b> is to be carried out.</li> <li>4. In case of very small crack it can be ground off by increasing the radius.</li> </ol>

In case of longer fatigue fractures starting in the lower and/or upper corners of the pintle recess of semi-spade rudders that propagate over a longer distance into the plating, thorough check of the internal structures has to be carried out. The fractured parts of the plating and of the internal structures, if necessary, have to be replaced by insert plates. A proper welding connection between the insert plate and the internal stiffening structure is very important (See **Examples 4 and 5**).

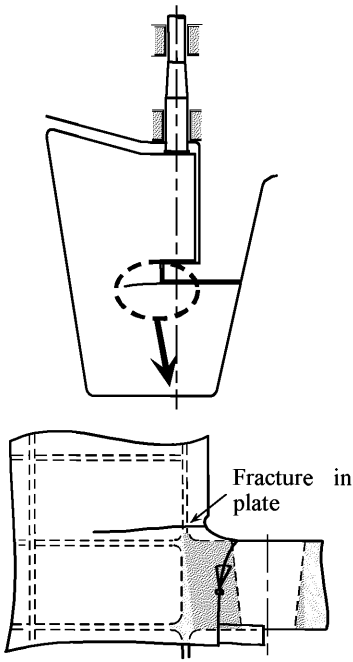
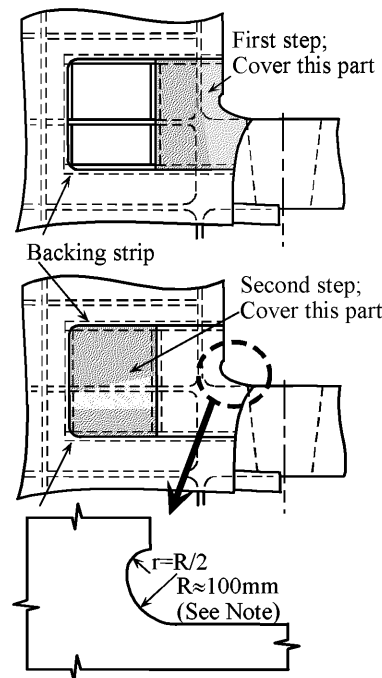
<b>GENERAL CARGO SHIPS</b>		<b>Guidelines for Surveys, Assessment and Repair of Hull Structure</b>
<b>Part 2</b>	<b>Fore and aft end regions</b>	<b>Example No.</b>
<b>Area 3</b>	<b>Stern frame, rudder arrangement and propeller shaft support</b>	<b>5</b>
<b>Detail of damage</b>	Fractures in rudder plating of semi-spade rudder extending beyond the vertical web	
<b>Sketch of damage</b>

<p>Note: R should be considered according to local detail</p>
<b>Notes on possible cause of damage</b> <ol style="list-style-type: none"> <li>1. Stress concentration due to inadequate local design and/or fabrication notches in way of the butt weld between cast piece and plating.</li> </ol>		<b>Notes on repairs</b> <ol style="list-style-type: none"> <li>1. Fractured plating is to be cut-out.</li> <li>2. Internal structures are to be checked.</li> <li>3. Cut-out is to be closed by an insert plating according to the sketch (welding only from one side is demonstrated).</li> <li>4. Modification of the radius.</li> <li>5. In case of a new cast piece, connection with the plating is to be shifted outside the high stress area.</li> </ol>

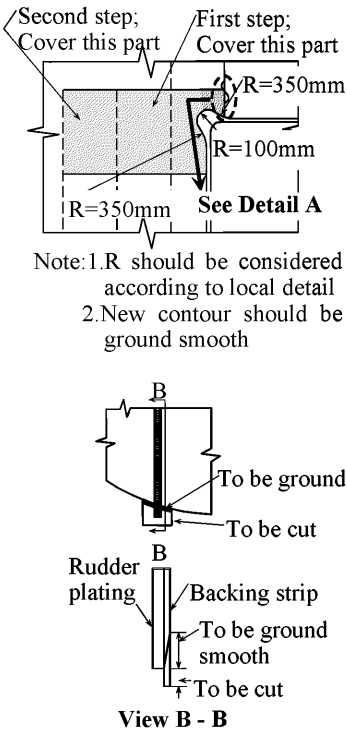
<b>BULK CARRIERS</b>		<b>Guidelines for Surveys, Assessment and Repair of Hull Structure</b>
<b>Part 2</b>	<b>Fore and aft end regions</b>	<b>Example No.</b>
<b>Area 3</b>	<b>Stern frame, rudder arrangement and propeller shaft support</b>	<b>6</b>
<b>Detail of damage</b>	Fractures in rudder plating of semi-spade rudder in way of pintle cutout	
<b>Sketch of damage</b>

<p>Note: 1. R should be considered according to local detail 2. New contour should be ground smooth</p>
<b>Notes on possible cause of damage</b> <ol style="list-style-type: none"> <li>1. Inadequate design for stress concentration in way of pintle bearing (<b>Fracture A</b>).</li> <li>2. Imperfection in welding seam (<b>Fracture B</b>).</li> </ol>		<b>Notes on repairs</b> <ol style="list-style-type: none"> <li>1. Fractured part to be cropped off.</li> <li>2. Repair by two insert plates of modified, stress releasing contour. For the vertical seam no backing strip is used 100mm off contour, welding from both sides, to be ground after welding.</li> <li>3. Variant (See <b>Detail A</b>): Repair as mentioned under 2 with the use of backing strip for the complete vertical seam. After welding backing strip partly removed by grinding.</li> </ol>

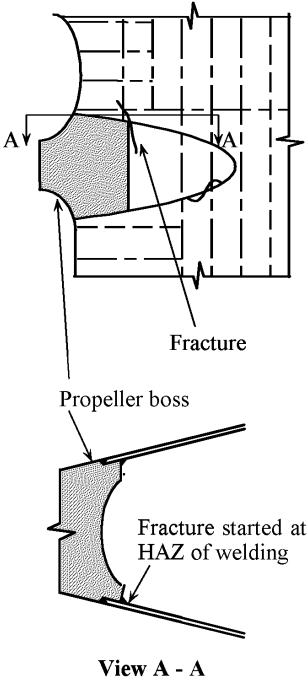
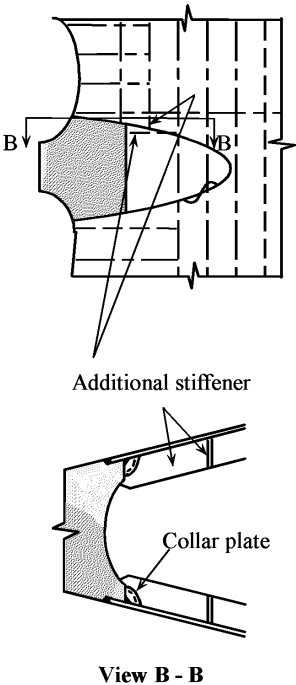
<b>BULK CARRIERS</b>		<b>Guidelines for Surveys, Assessment and Repair of Hull Structure</b>
<b>Part 2</b>	<b>Fore and aft end regions</b>	<b>Example No.</b>
<b>Area 3</b>	<b>Stern frame, rudder arrangement and propeller shaft support</b>	<b>7</b>
<b>Detail of damage</b> Fractures in side shell plating at the connection to propeller boss		
<b>Sketch of damage</b>		<b>Sketch of repair</b>

<p>Fracture</p> <p>Propeller boss</p> <p>Fracture started at HAZ of welding</p> <p><b>View A - A</b></p>

<p>Additional stiffener</p> <p>Collar plate</p> <p><b>View B - B</b></p>
<b>Notes on possible cause of damage</b>		<b>Notes on repairs</b>
<ol style="list-style-type: none"> <li>1. Fatigue fracture due to vibration.</li> </ol>		<ol style="list-style-type: none"> <li>1. Fractured side shell plating is to be cropped and part renewed.</li> <li>2. Additional stiffeners are to be provided.</li> <li>3. Collar plate is to be provided.</li> </ol>

Repair examples for propeller boss and stern tube are shown in **Examples 7 and 8**. Regarding the welding reference is made to **3.1.4**, **3.2.4** and **3.2.5**.

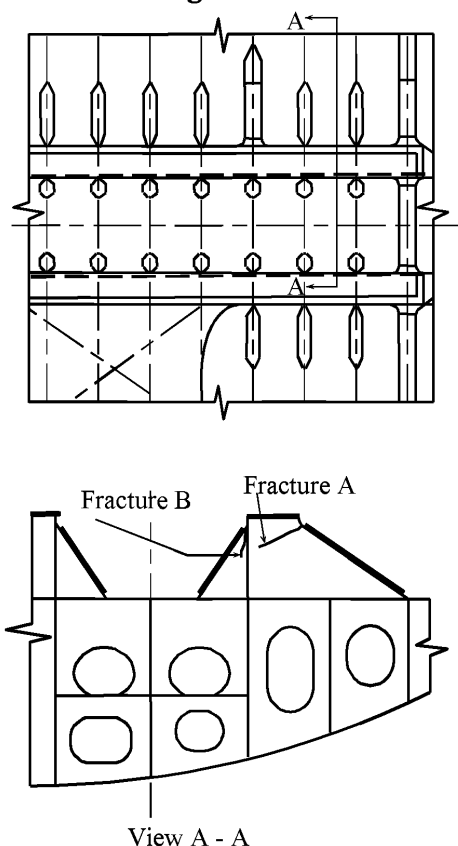
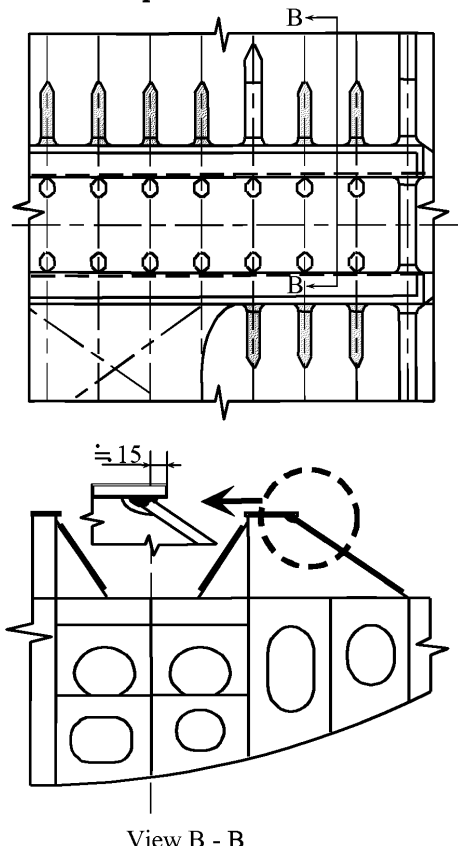
<b>BULK CARRIERS</b>	<b>Guidelines for Surveys, Assessment and Repair of Hull Structure</b>	
<b>Part 3</b>	<b>Machinery and accommodation spaces</b>	<b>Example No.</b>
<b>Area 1</b>	<b>Engine room structure</b>	<b>1</b>
<b>Detail of damage</b> Fractures in brackets at main engine foundation		
<b>Sketch of damage</b>

View A - A		<b>Sketch of repair</b>

View B - B
<b>Notes on possible cause of damage</b> <ol style="list-style-type: none"> <li>1. Vibration of main engine.</li> <li>2. Insufficient strength of brackets at main engine foundation.</li> <li>3. Insufficient pre-load bolts.</li> </ol>		<b>Notes on repairs</b> <ol style="list-style-type: none"> <li>1. Fractures are to be veed-out and rewelded.</li> <li>2. New modified brackets at main engine foundation.</li> <li>3. Or insert pieces and additional flanges to increase section modulus of the brackets.</li> </ol>

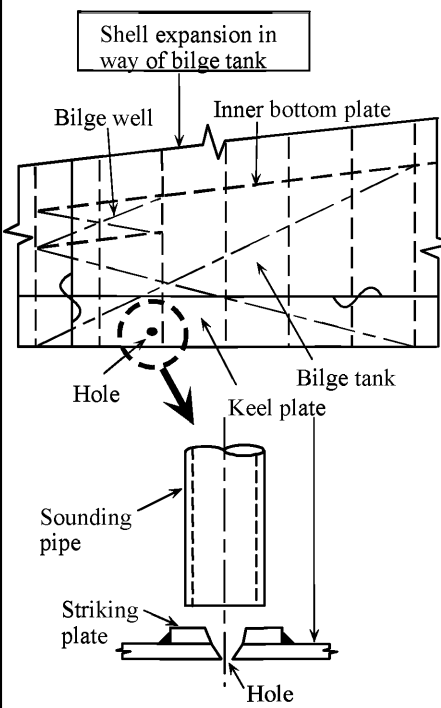
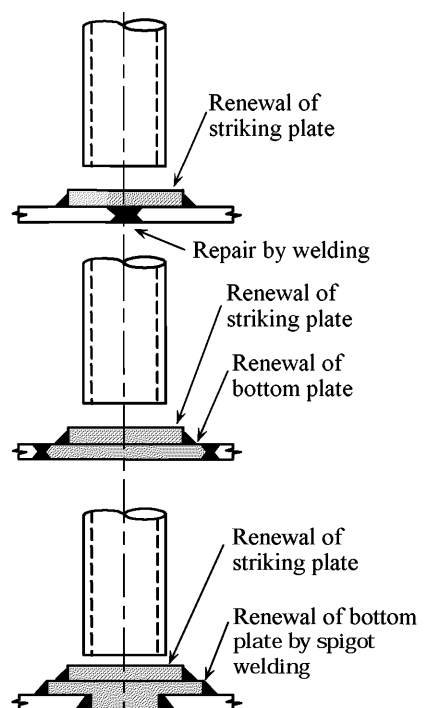
<b>BULK CARRIERS</b>		<b>Guidelines for Surveys, Assessment and Repair of Hull Structure</b>	
<b>Part 3</b>	<b>Machinery and accommodation spaces</b>	<b>Example No.</b>	
<b>Area 1</b>	<b>Engine room structure</b>	<b>2</b>	
<b>Detail of damage</b>		Corrosion in bottom plating under sounding pipe in way of bilge storage tank in engine room	
<b>Sketch of damage</b>

<b>Notes on possible cause of damage</b> 1. Heavy corrosion of bottom plating under sounding pipe.		<b>Notes on repairs</b> 1. Corroded striking plating should be renewed. 2. Bottom plate should be repaired depending on the condition of corrosion. (Note) Repair by spigot welding can be applied to the structure only when the stress level is considerably low. Generally this procedure cannot be applied to the repair of bottom plating of ballast tanks in cargo hold region.

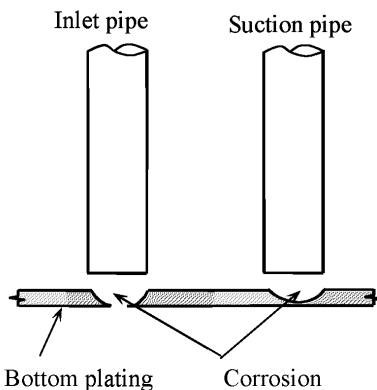
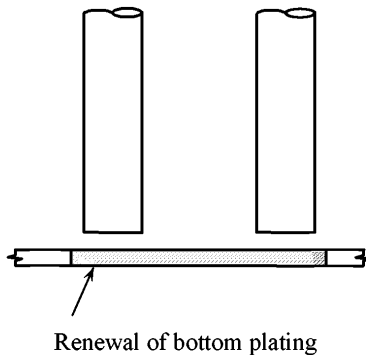
<b>BULK CARRIERS</b>		<b>Guidelines for Surveys, Assessment and Repair of Hull Structure</b>	
<b>Part 3</b>	<b>Machinery and accommodation spaces</b>		<b>Example No.</b>
<b>Area 1</b>	<b>Engine room structure</b>		<b>3</b>
<b>Detail of damage</b>	Corrosion in bottom plating under inlet/suction/pipe in way of bilge tank in engine room		
<b>Sketch of damage</b>		<b>Sketch of repair</b>

<b>Notes on possible cause of damage</b> 1. Heavy corrosion of bottom plating under the inlet/suction pipe.		<b>Notes on repairs</b> 1. Corroded bottom plating is to be cropped and part renewed. Thicker plate is preferable. 2. Replacement of pipe end by enlarged conical opening (similar to suction head in ballast tank) is preferable.

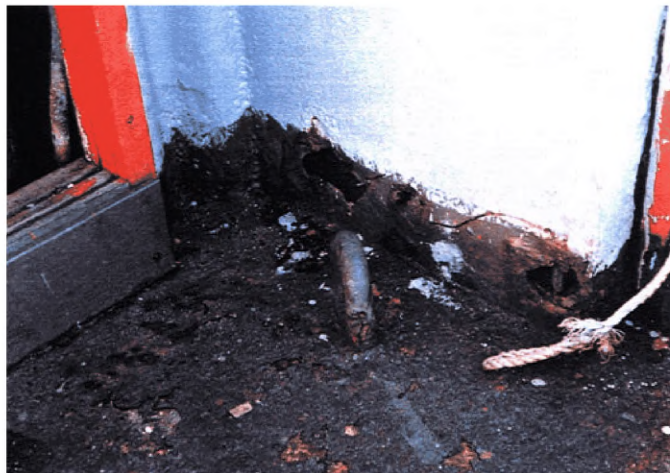
**Photograph 1** Corroded accommodation house side structure

Severe corrosion may be found in exposed deck plating and deck house side structure adjacent to the deck plating where water is liable to accumulate (See **Photograph 1**). Corrosion may also be found in accommodation bulkheads around cutout for fittings, such as doors, side scuttles, ventilators, etc., where proper maintenance of the area is relatively difficult. Deterioration of the bulkheads including fittings may impair the integrity of weathertightness.

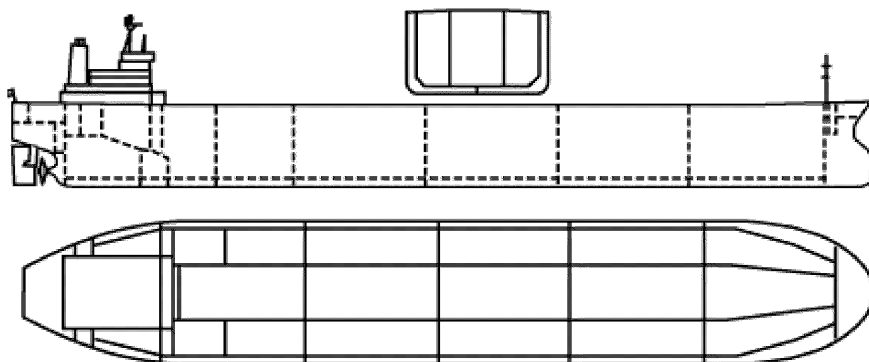
**Figure 1**      **General view of a typical double hull oil tanker (150,000 DWT and greater)**

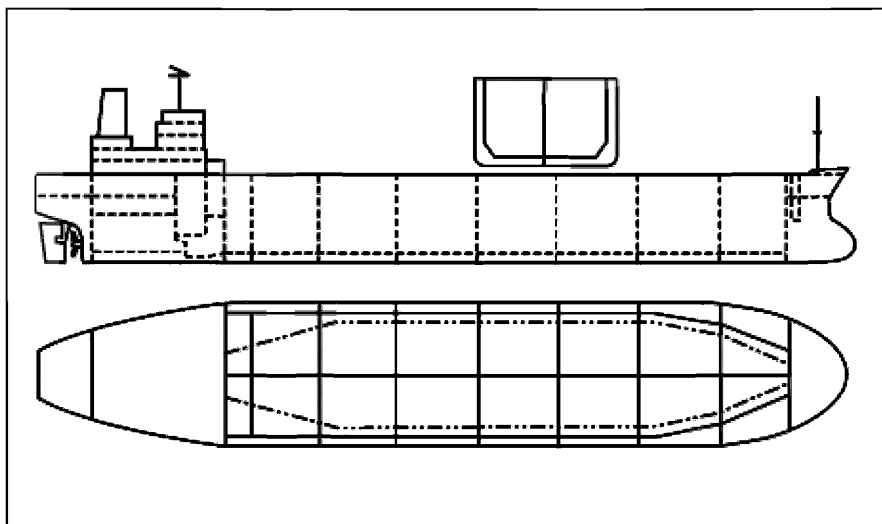
**Figure 2** General view of a typical double hull oil tanker (150,000 DWT or less)

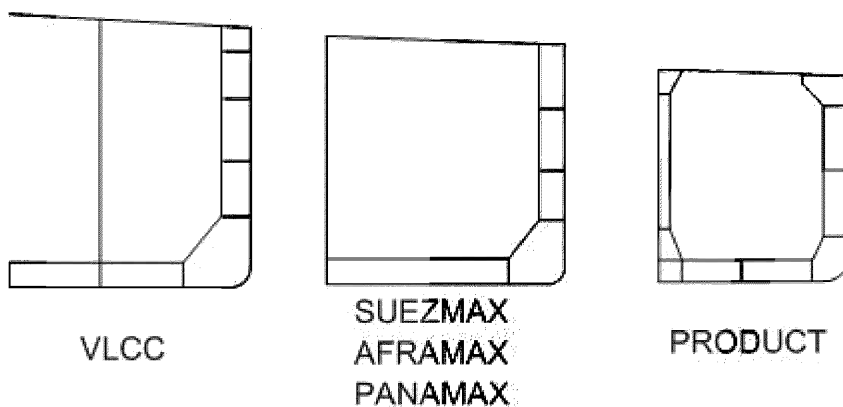
**Figure 3** Categories of Bulkhead Configurations

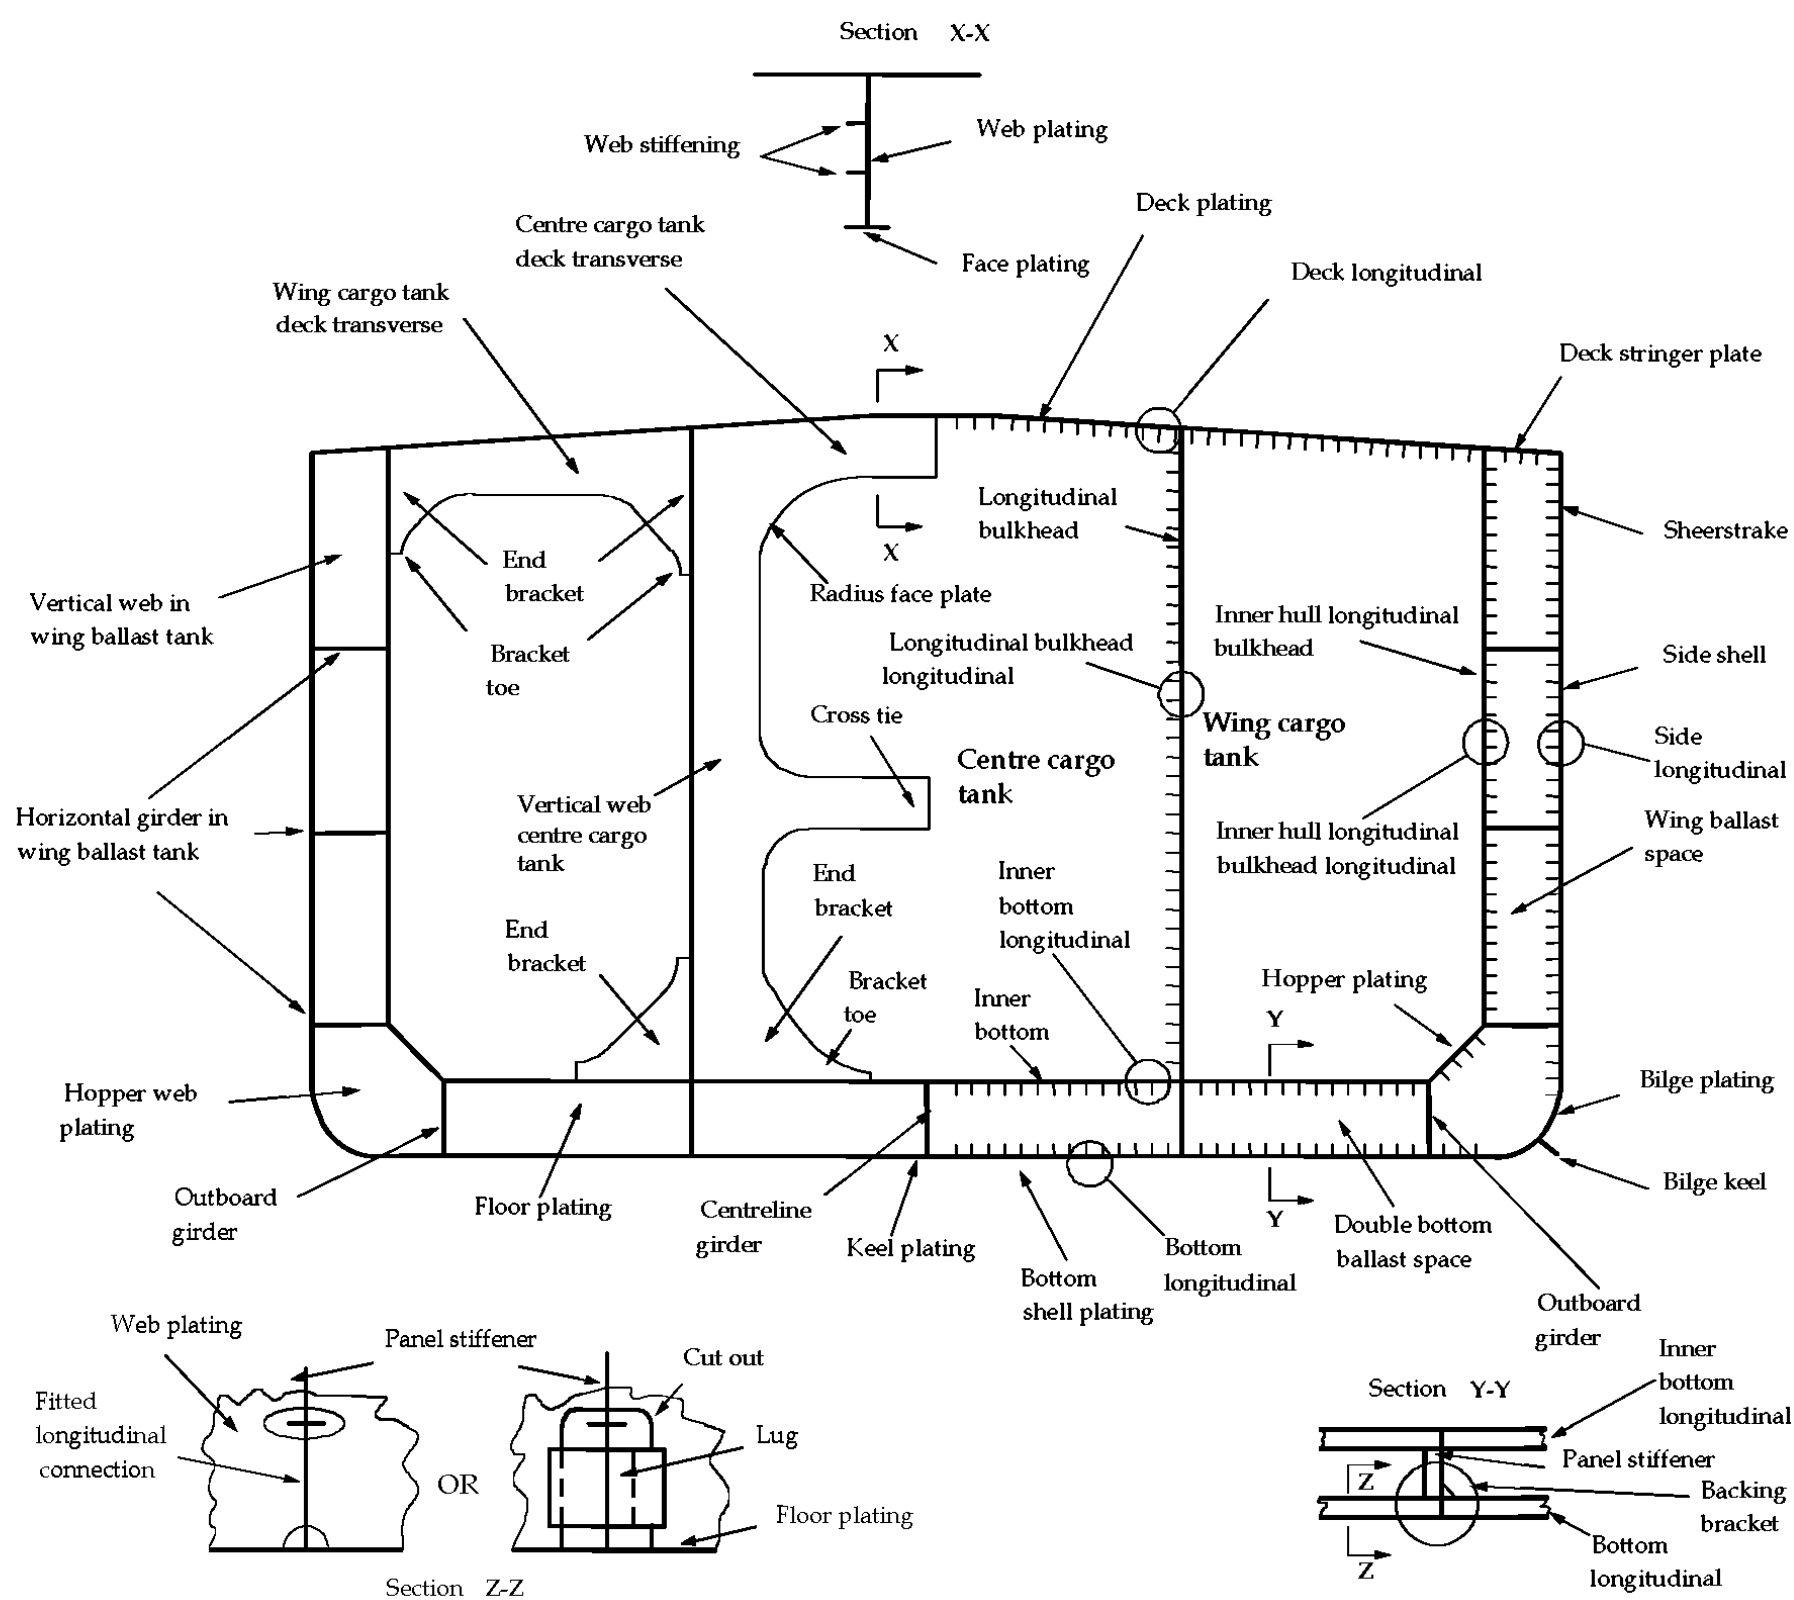
**Figure 4** Typical midship section of a double hull oil tanker with two longitudinal bulkheads including nomenclature

Figures 4 to 6 show the typical nomenclature used for the midship section and transverse bulkhead.

**3.2.1** For clarity of definition and reporting of survey data, it is recommended that standard nomenclature for structural elements be adopted. A typical midship section is illustrated in **Figures 4 to 6**. These figures show the generally accepted nomenclature.

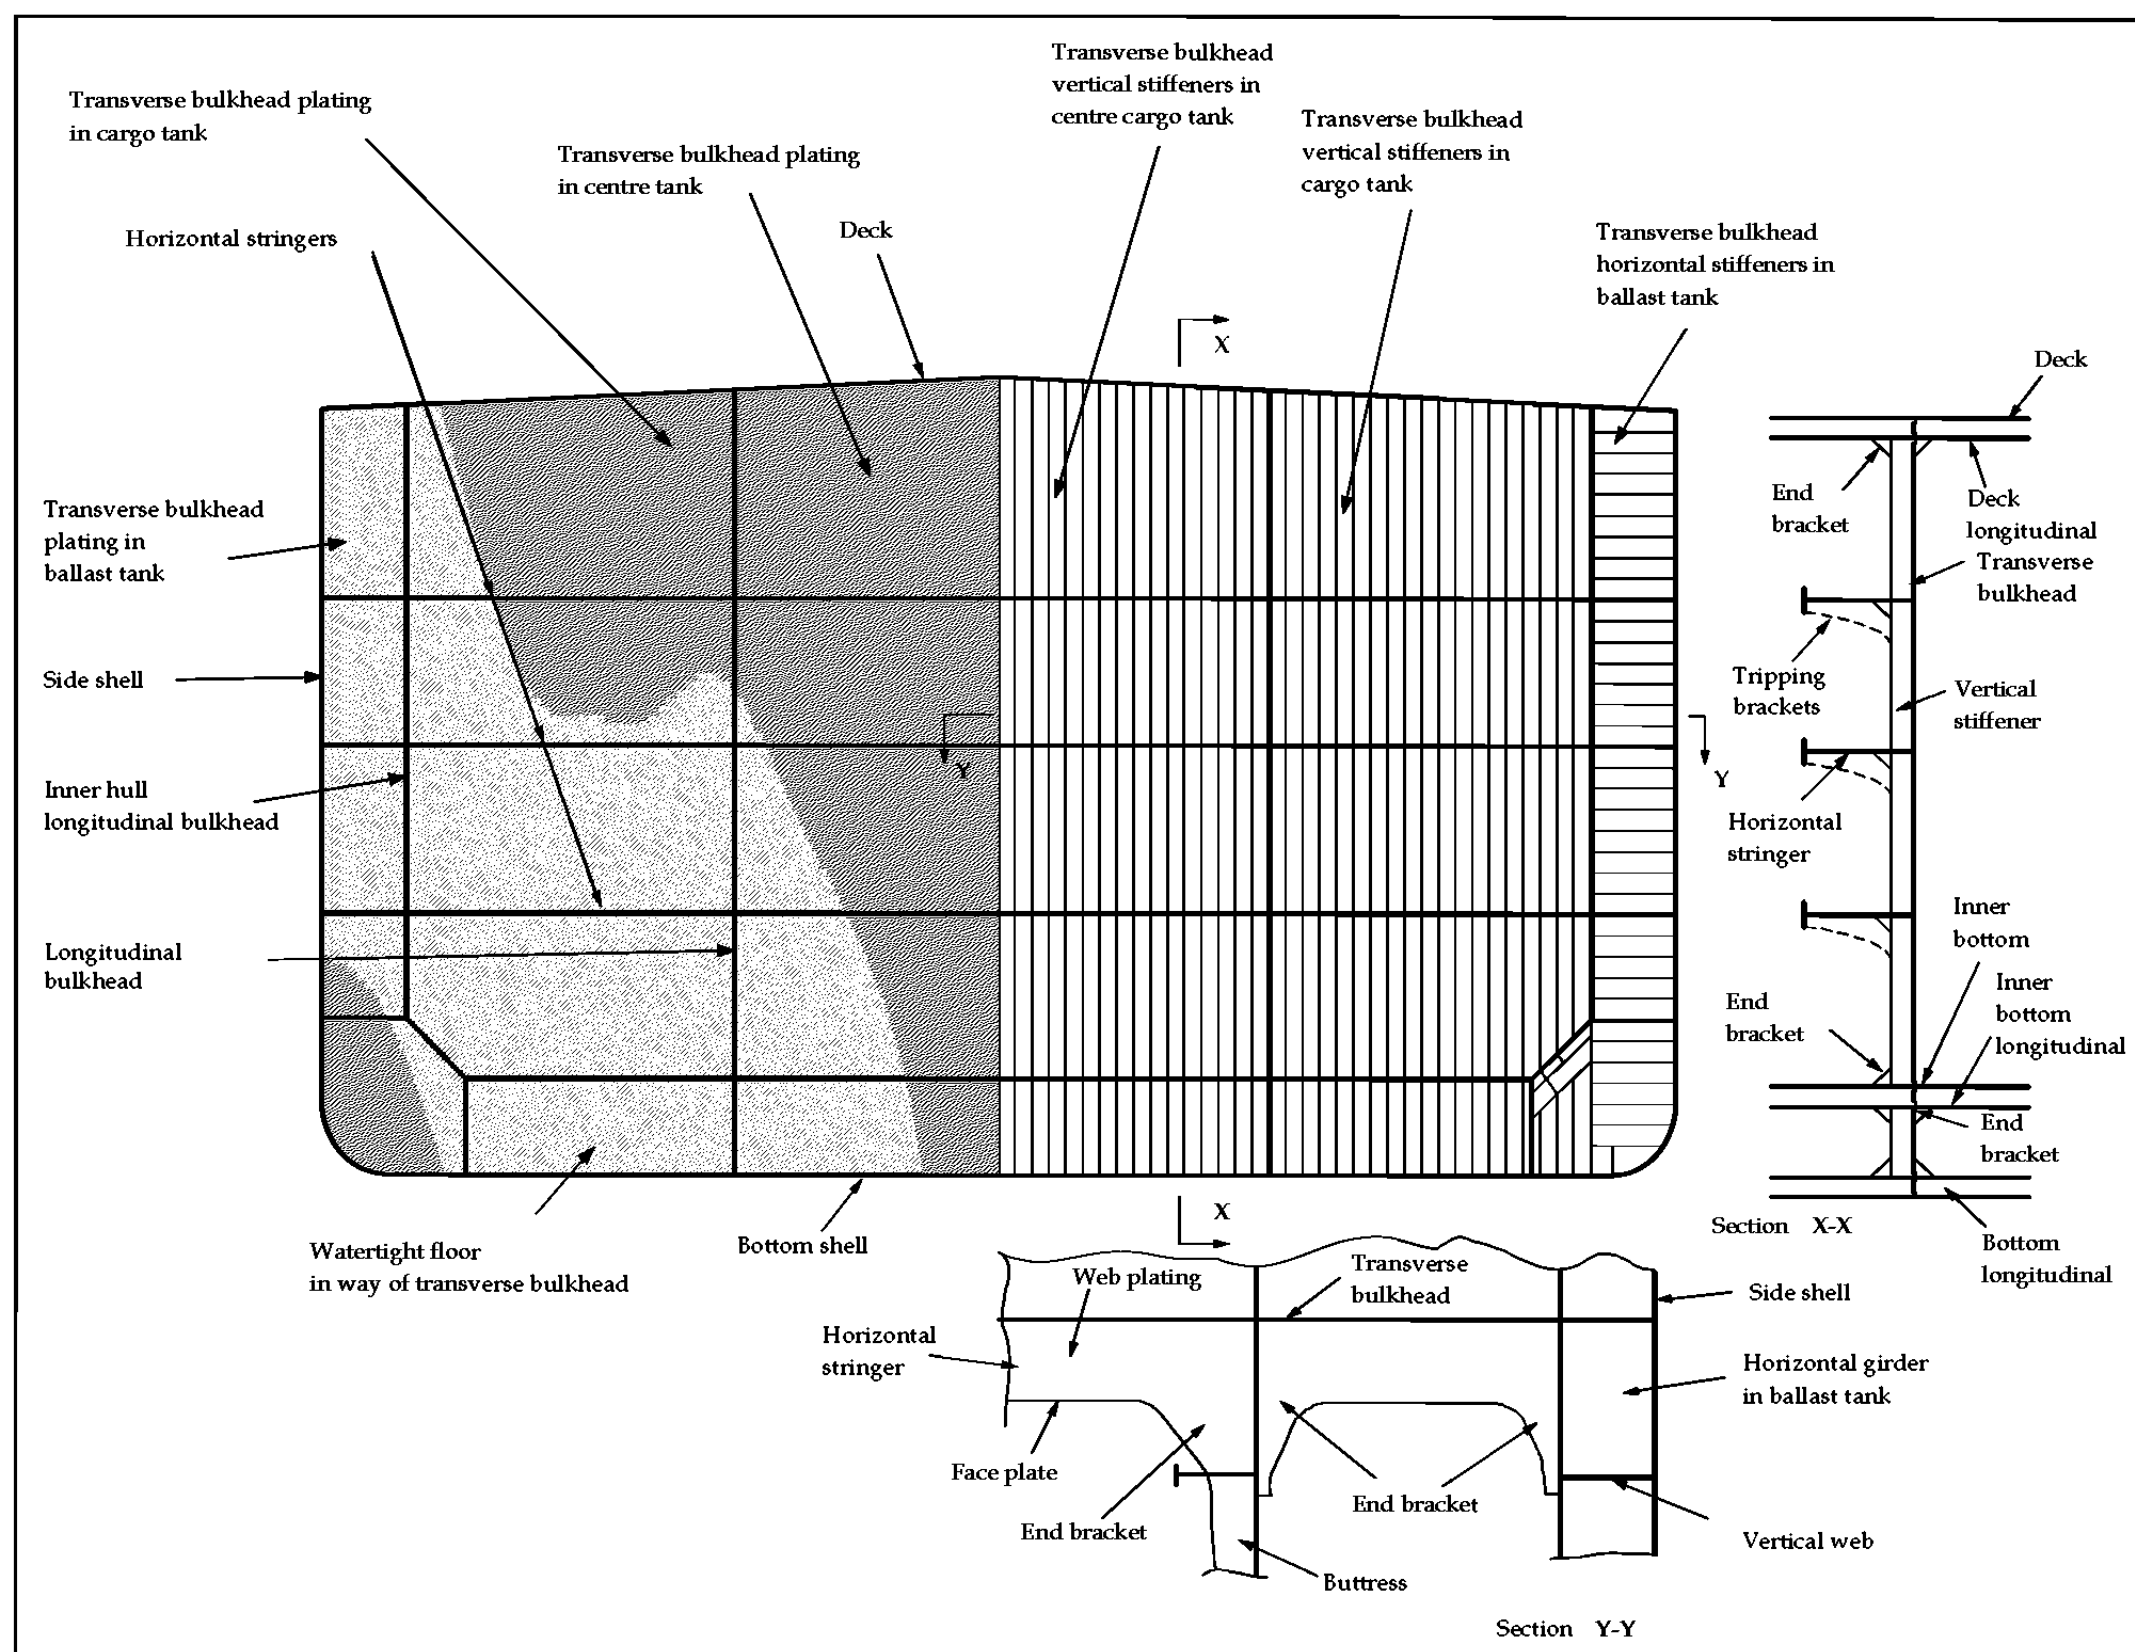
**Figure 5 Double Hull Tanker – Typical Transverse Bulkhead**

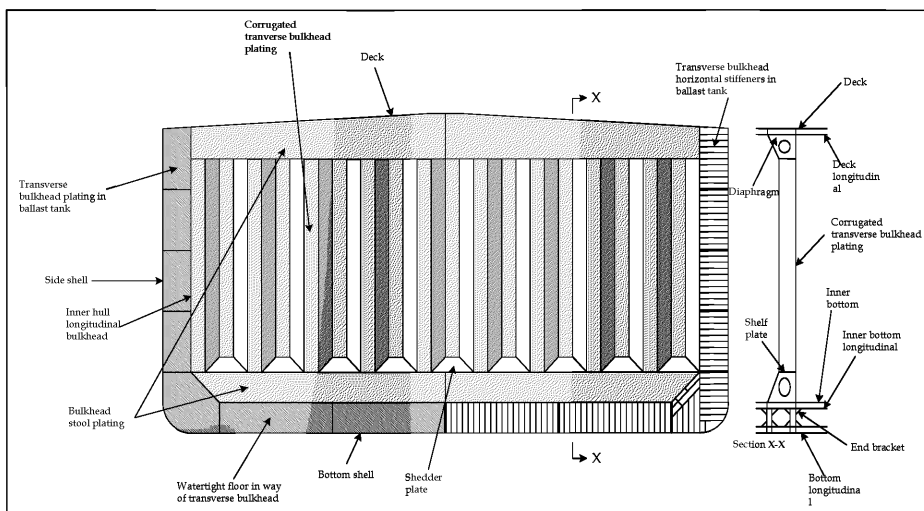
**Figure 6 Corrugated Transverse Bulkhead Nomenclature**

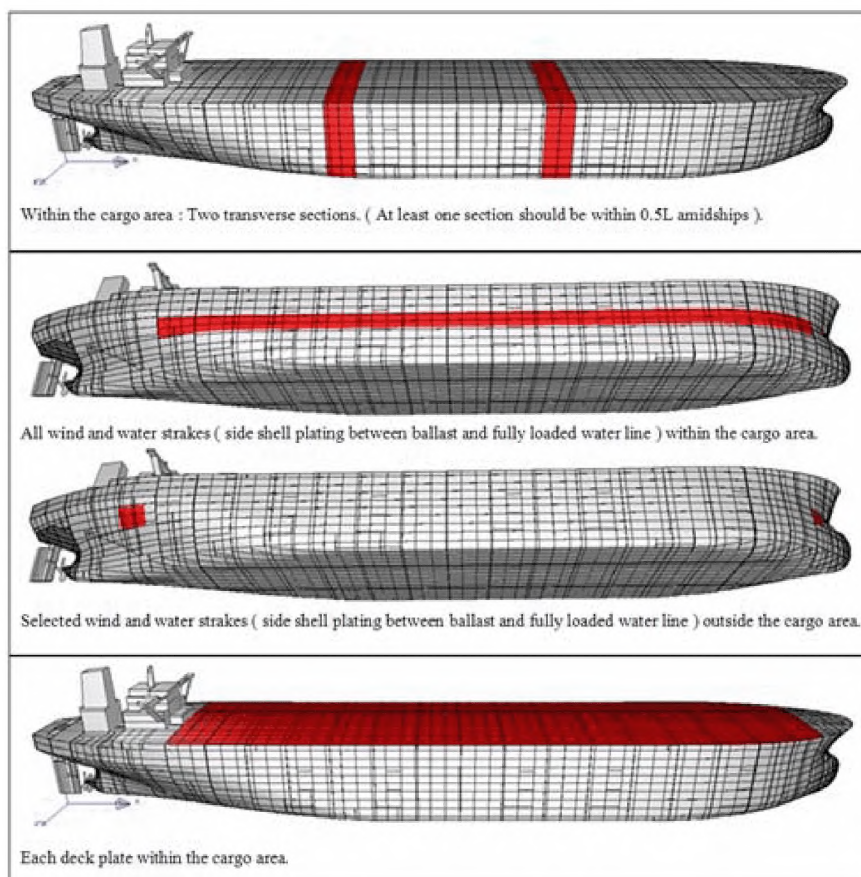
**Figure 7** Example of Transverse Sections of Shell Plating and Main Deck Thickness Measurement Requirements for an oil tanker 15 years of age.

**2.4.2** The Special Survey concentrates on close-up surveys in association with thickness measurements and is aimed at detecting fractures, buckling, corrosion and other types of structural deterioration. See Figure 7.

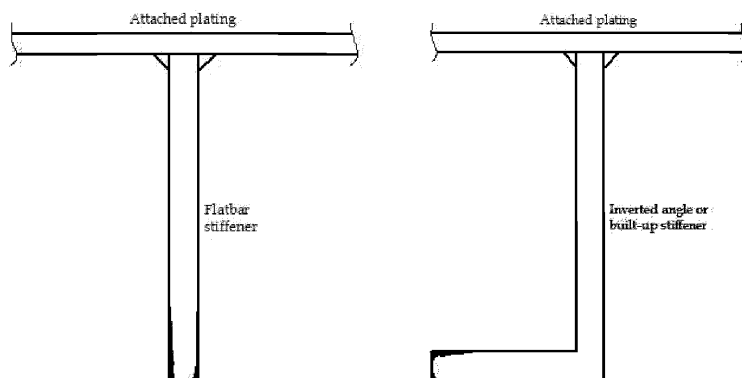
Edge corrosion is defined as local corrosion at the free edges of plates, stiffeners, primary support members and around openings. An example of edge corrosion is shown in Figure 9.

**Figure 9 Edge Corrosion**

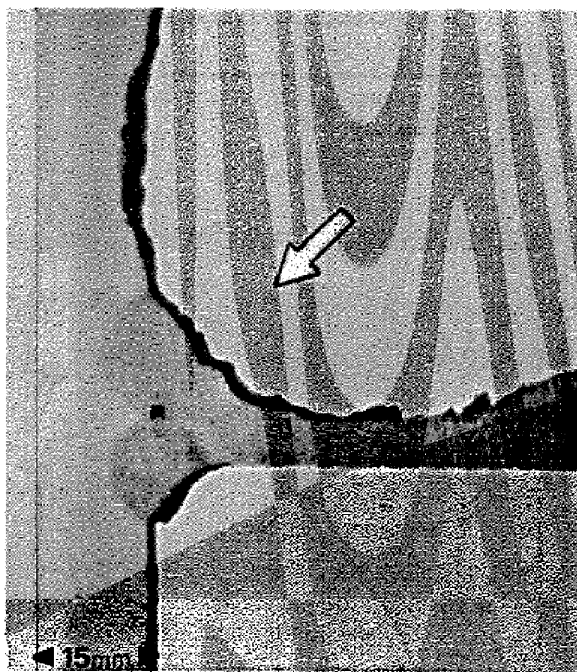
**Figure 10 Detail of Necking Effect**

- Necking occurs at the junction of the longitudinal bulkhead plating and longitudinals. The deflection of the bulkhead plating and longitudinals due to reverse, cyclic loading from cargo oil and water ballast plus the accumulated mixtures of water, mud and scale at their junctures accelerates the corrosion rate. As the steel thins and weakens, the flexing consequently increases and hence corrosion accelerates (see Figure 10). The similar necking effect could also occur in the transverse bulkhead plating and stiffeners, or in the inner bottom plating and longitudinals inside the double bottom space. In the coated water ballast tanks, the plating is the principally affected area due to local corrosion in way of coating failure.

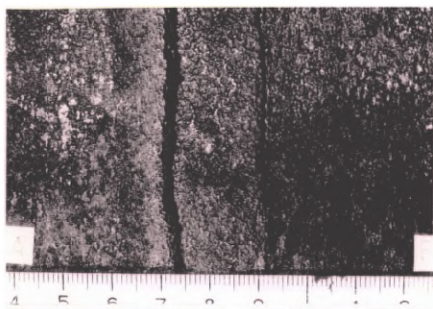
**Photograph 1**  
Grooving corrosion of welding of bottom plating

**4.1.2** Severe grooving along welding of bottom plating is often found (See **Photographs 1** and **2**). This grooving can be accelerated by poor maintenance of the protective coating and/or sacrificial anodes fitted to the bottom plating.

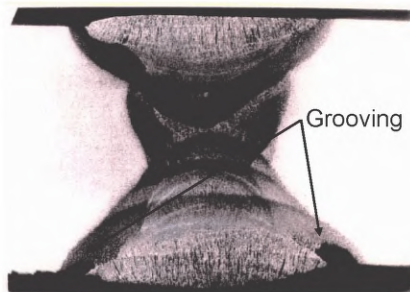
**Photograph 2**  
Section of the grooving shown in Photograph 1
