**РОССИЙСКИЙ МОРСКОЙ РЕГИСТР СУДОХОДСТВА**  
**RUSSIAN MARITIME REGISTER OF SHIPPING**

**IACS PROCEDURAL REQUIREMENTS,  
UNIFIED INTERPRETATIONS  
AND RECOMMENDATIONS**

## **GENERAL DRY CARGO SHIPS**

Guidelines for  
Surveys, Assessment and Repair  
of Hull Structure

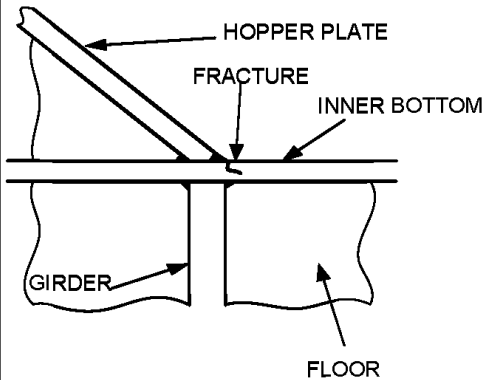
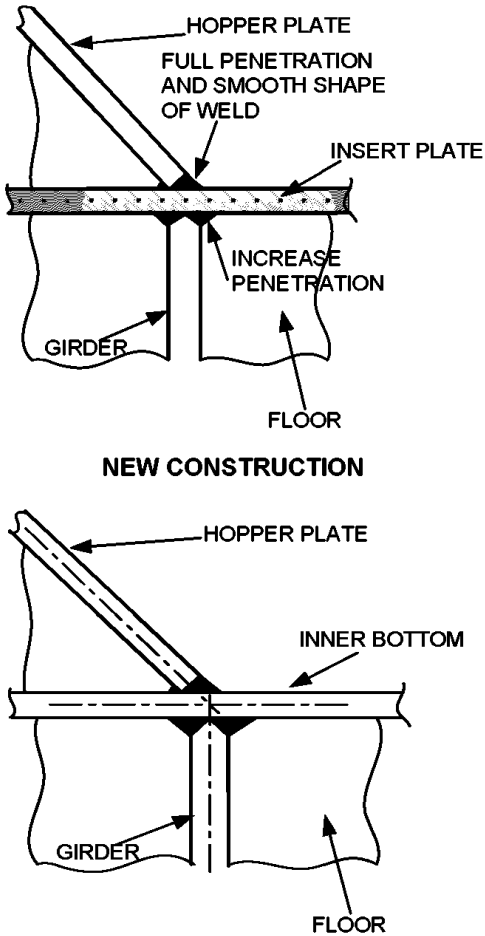
OIL Tankers		Guidelines for Surveys, Assessment and Repair of Hull Structure
Group 1	Cargo area	Example No.
	Hopper and double bottom ballast tank	1
Detail of damage	Fracture on the inner bottom plating at the connection of hopper plate to inner bottom	
<b>Sketch of damage</b>

<p><b>Notes:</b> Plate midlines intersect</p>
<b>Factors which may have caused damage</b> <ol style="list-style-type: none"> <li>1. Stress concentration at juncture of hopper plate to inner bottom.</li> <li>2. Insufficient welding connection.</li> <li>3. Misalignment between hopper plate, inner bottom and girder.</li> </ol>		<b>Notes on repairs</b> See Sketch.

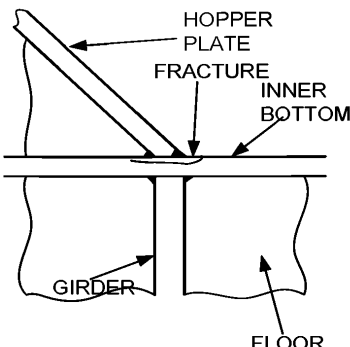
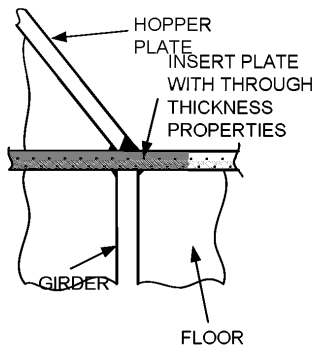
OIL Tankers		Guidelines for Surveys, Assessment and Repair of Hull Structure	
Group 1	Cargo area	Example No.	
	Hopper and double bottom ballast tank	2	
Detail of damage		Fracture at connection of bilge hopper plate and inner bottom	
Sketch of damage		Sketch of repair

<p><b>Notes:</b> Plate midlines intersect</p>	
<b>Factors which may have caused damage</b> 1. Stress concentration at the knuckle.		<b>Notes on repairs</b> See Sketch.

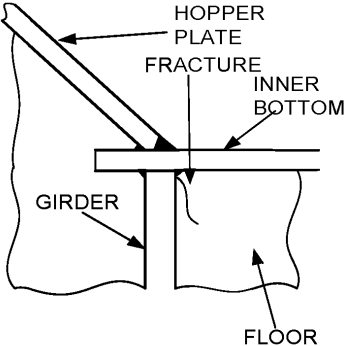
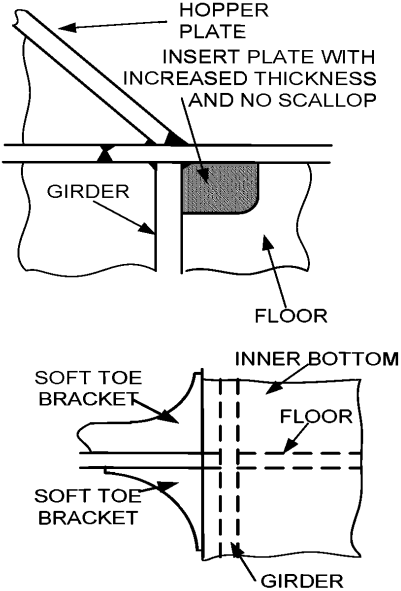
OIL Tankers		Guidelines for Surveys, Assessment and Repair of Hull Structure	
Group 1	Cargo area	Example No.	
	Hopper and double bottom ballast tank	3	
Detail of damage		Fracture at connection of bilge hopper plate and inner bottom	
Sketch of damage		Sketch of repair

<p><b>Notes:</b> Plate midlines intersect</p>	
<b>Factors which may have caused damage</b> 1. Stress concentration at the knuckle.		<b>Notes on repairs</b> See Sketch.

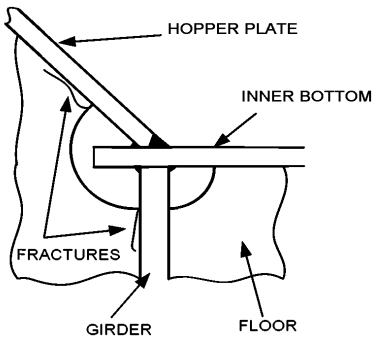
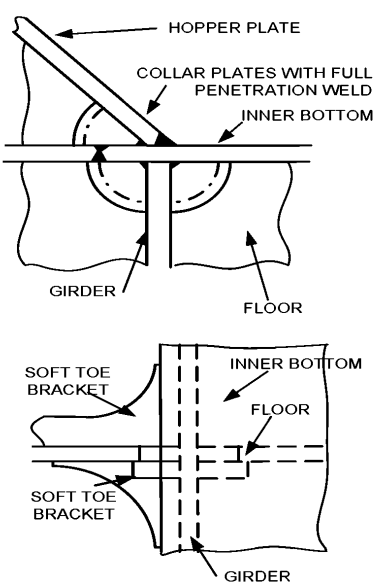
OIL Tankers		Guidelines for Surveys, Assessment and Repair of Hull Structure	
Group 1	Cargo area	Example No.	
	Hopper and double bottom ballast tank	4	
Detail of damage		Fracture at connection of bilge hopper plate and inner bottom	
Sketch of damage		Sketch of repair

<p>Notes: Plate midlines intersect</p>	
Factors which may have caused damage		Notes on repairs	
1. Stress concentration at the knuckle.		See Sketch.

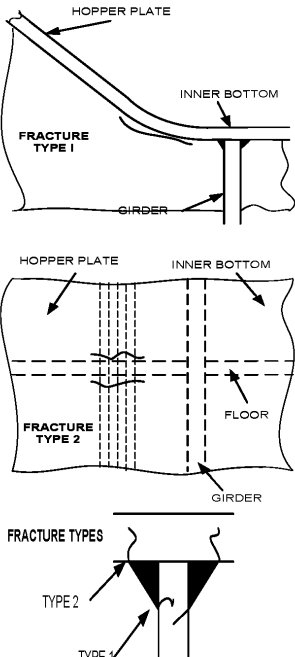
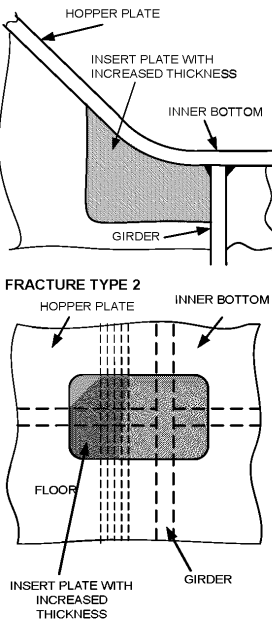
OIL Tankers		Guidelines for Surveys, Assessment and Repair of Hull Structure	
Group 1	Cargo area	Example No.	
	Hopper and double bottom ballast tank	5	
Detail of damage	Fractured floor and inner bottom plate in way of juncture of inner bottom to hopper plate		
Sketch of damage		Sketch of repair

Factors which may have caused damage		Notes on repairs	
<p>1. Misalignment. The three mid-lines do not cross at the same joint. This misalignment produces an out-of-plane deformation of inner bottom plate in way of knuckle line.</p> <p>2. Stress concentration at connection between floor and inner bottom plate.</p> <p>3. Static and dynamic load of ballast water.</p>		<p>See Sketch.</p>

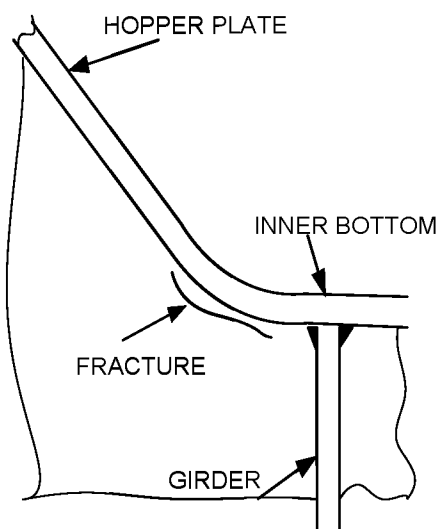
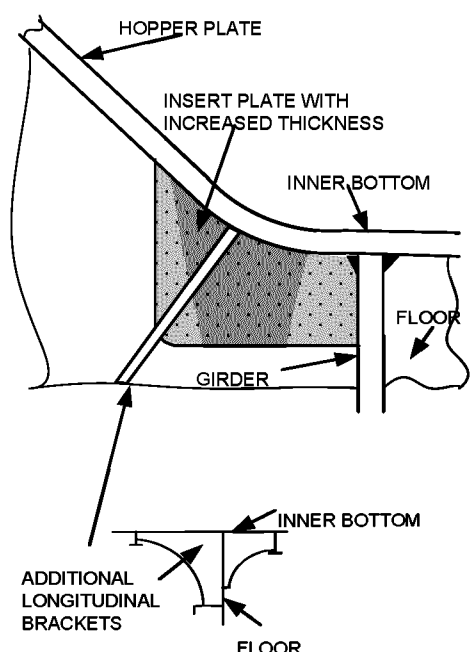
OIL Tankers		Guidelines for Surveys, Assessment and Repair of Hull Structure
Group 1	Cargo area	Example No.
	Hopper and double bottom ballast tank	6
Detail of damage		Fracture at connection of bilge hopper plate and web frame
<b>Sketch of damage</b>

<b>Factors which may have caused damage</b> 1. Stress concentration due to reduction of effective flange area at curved plate.		<b>Notes on repairs</b> See Sketch.

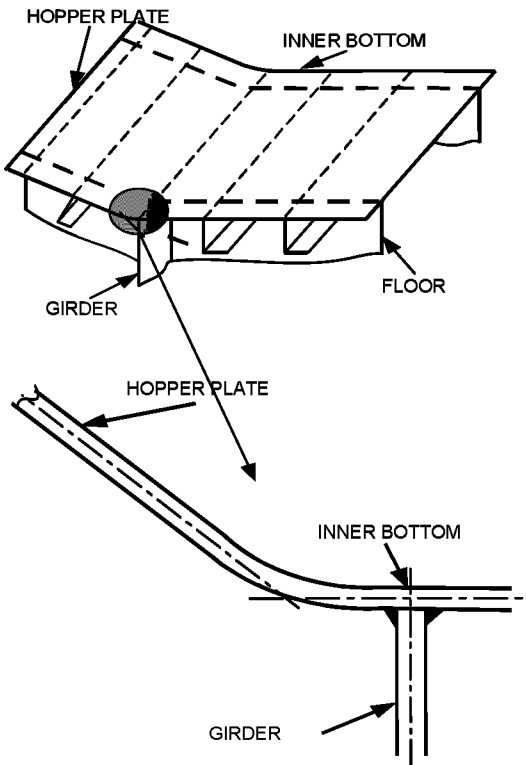
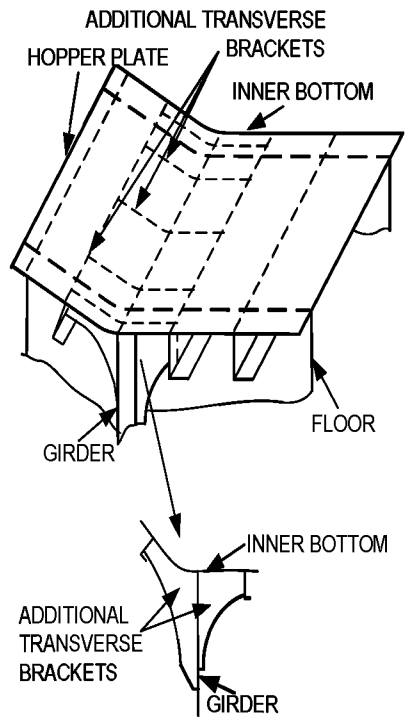
OIL Tankers		Guidelines for Surveys, Assessment and Repair of Hull Structure
Group 1	Cargo area	Example No.
	Hopper and double bottom ballast tank	7
Detail of damage	Rounded hopper plate deformation in way of the floor	
Sketch of damage

Factors which may have caused damage	<p>1. Misalignment. The three midlines do not cross at the same joint. This misalignment produces an out-of-plane deformation in knuckled plate in the vicinity of floor.</p> <p>2. Insufficient stiffening between floors.</p>	
Notes on repairs	See Sketch.

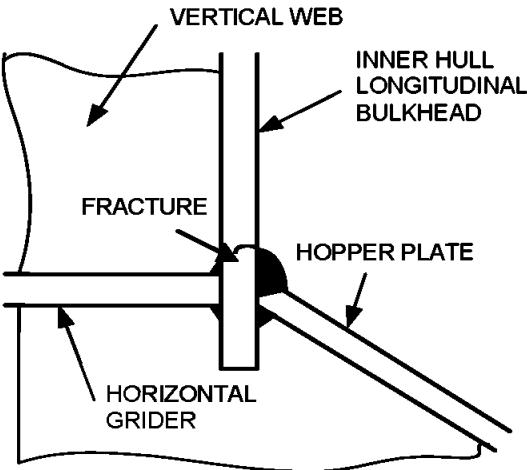
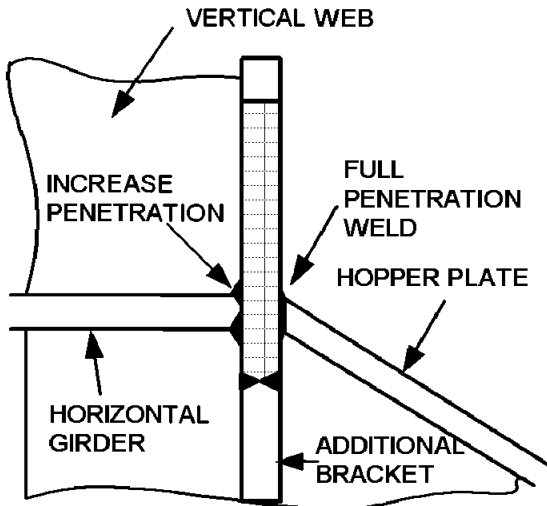
OIL Tankers Guidelines for Surveys, Assessment and Repair of Hull Structure		
Group 1	Cargo area	Example No.
	Wing cargo tank	8
Detail of damage	Fracture at the connection of hopper plate to outside longitudinal bulkhead.	
Sketch of damage		Sketch of repair

<b>Factors which may have caused damage</b> <ol style="list-style-type: none"><li>1. Stress concentration at junction of hopper plate to outside longitudinal bulkhead.</li><li>2. Insufficient welding connection and/or incorrect shape of the weld toe.</li><li>3. Misalignment between hopper plate, outside longitudinal bulkhead and side stringer.</li></ol>		<b>Notes on repairs</b> <p>See Sketch.</p>

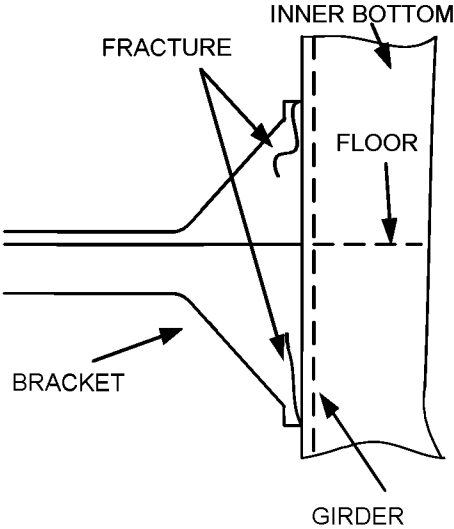
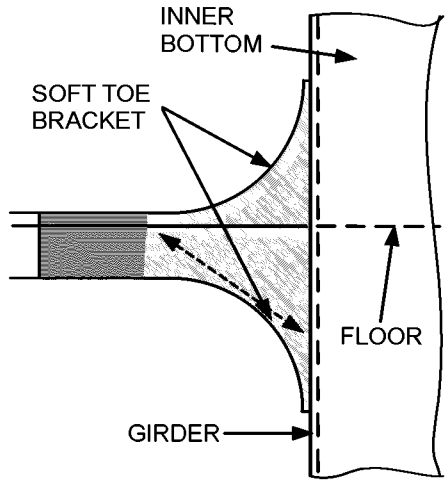
OIL Tankers		Guidelines for Surveys, Assessment and Repair of Hull Structure
Group 1	Cargo area	Example No.
	Hopper and double bottom ballast tank	9
Detail of damage		Fracture in gusset plate in line with inner bottom
<b>Sketch of damage</b>

<p><b>Notes:</b> Bracket radii as large as practicable. Bracket same thickness as inner bottom stiffener. Toe height should be small as possible while still allowing return weld (wrapped weld).</p>
<b>Factors which may have caused damage</b> <ol style="list-style-type: none"> <li>1. Stress concentration due to small radius and abrupt toe.</li> <li>2. Insufficient welding.</li> <li>3. Insufficient sectional area (thickness x breadth) of the connecting bracket.</li> </ol>		<b>Notes on repairs</b> See Sketch.

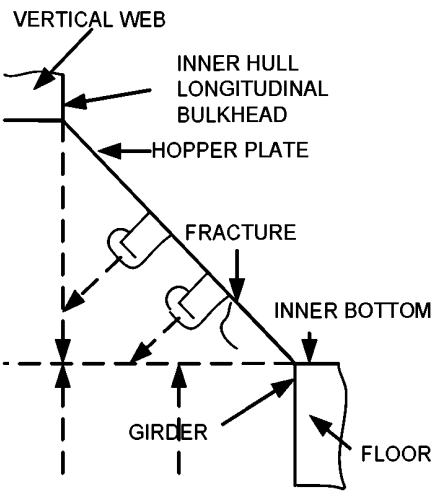
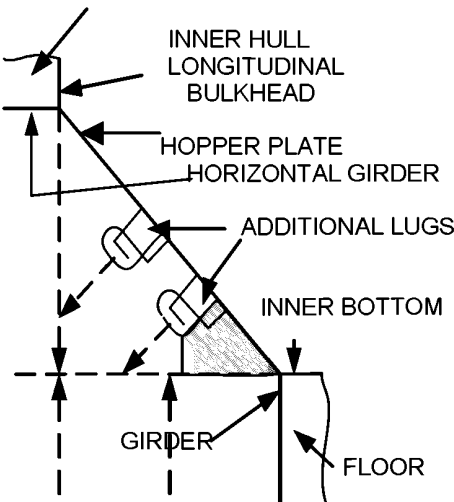
OIL Tankers		Guidelines for Surveys, Assessment and Repair of Hull Structure
Group 1	Cargo area	Example No. 10
	Hopper ballast tank	
Detail of damage		Fracture in way of cut-out in hopper plate
<b>Sketch of damage</b>

<b>Factors which may have caused damage</b> 1. Stress concentration due to no collar plate.		<b>Notes on repairs</b> See Sketch.

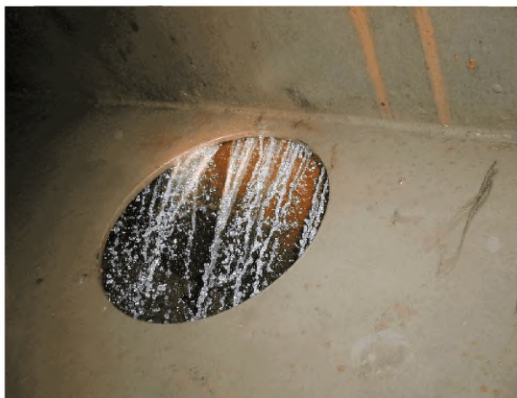
**Photograph 1 Side shell fracture in way of horizontal stringer weld**

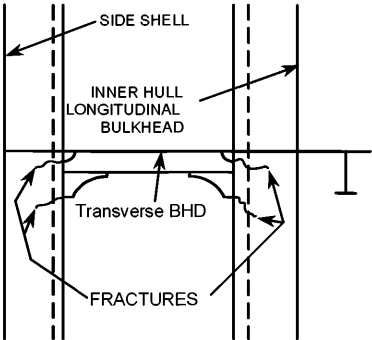
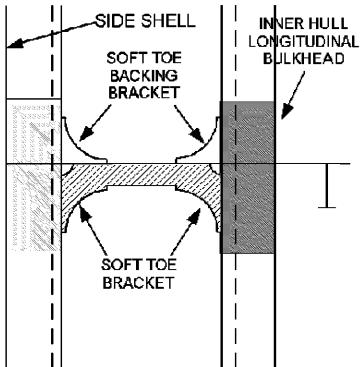
OIL Tankers		Guidelines for Surveys, Assessment and Repair of Hull Structure	
Group 2	Cargo area	Example No.	
	Wing ballast tank	1	
Detail of damage		Crack in way of connection of longitudinals to transverse bulkhead	
Sketch of damage		Sketch of repair

<b>Factors which may have caused damage</b> <ol style="list-style-type: none"> <li>1. Asymmetrical connection of bracket without backing bracket.</li> <li>2. Relative deflection of adjoining transverse web against transverse bulkhead.</li> <li>3. Additional biaxial bending stresses due to asymmetry of the angle bar longitudinal instead of symmetric T section.</li> <li>4. Dynamic load in the vicinity of the water line.</li> <li>5. Large upstand at bracket toe.</li> </ol>		<b>Notes on repairs</b> See Sketch.

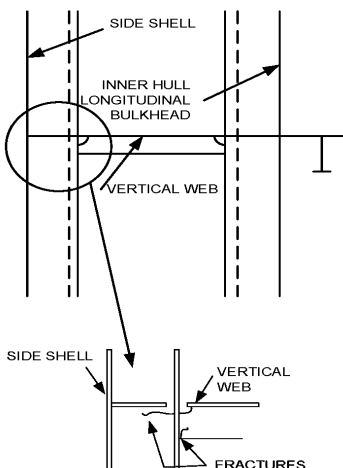
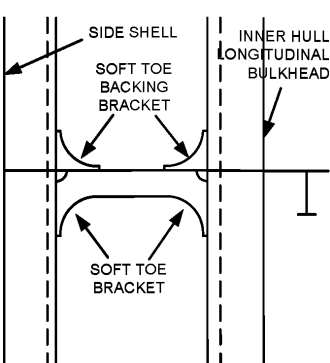
OIL Tankers		Guidelines for Surveys, Assessment and Repair of Hull Structure
Group 2	Cargo area	Example No.
	Wing ballast tank	2
Detail of damage		Crack in way of connection of longitudinals to transverse webs
Sketch of damage		Sketch of repair

<b>Factors which may have caused damage</b> <ol style="list-style-type: none"> <li>1. Asymmetrical connection of flat bar stiffener resulting in high peak stresses at the heel of the stiffener.</li> <li>2. Insufficient area of connection of longitudinal to web.</li> <li>3. High bending stresses in the longitudinal.</li> <li>4. Additional biaxial bending stresses due to asymmetry of the longitudinal (angle bar instead of symmetric T bar).</li> <li>5. Stress concentration at the square angles at heel and toe of the connections.</li> <li>6. High shear stress in the transverse web.</li> </ol>		<b>Notes on repairs</b> See Sketch.

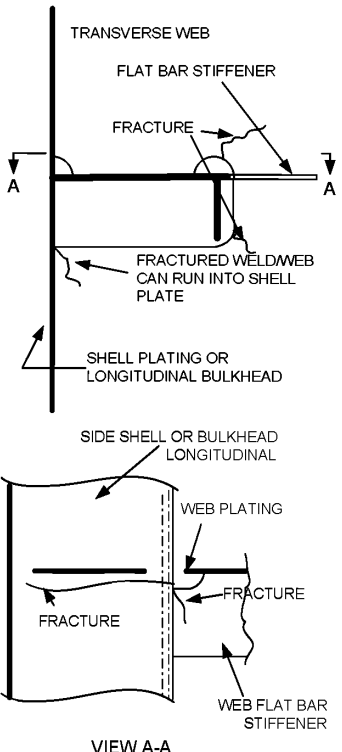
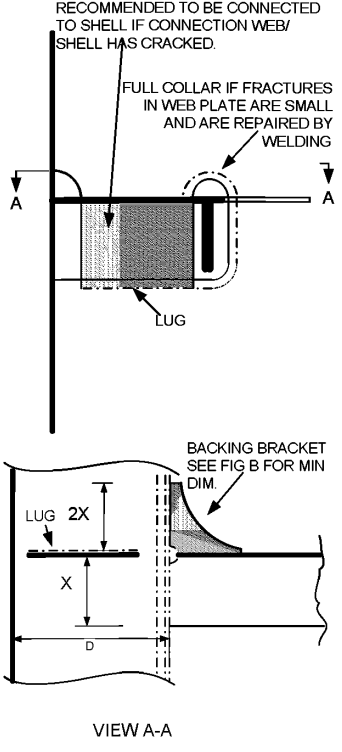
OIL Tankers		Guidelines for Surveys, Assessment and Repair of Hull Structure	
Group 2	Cargo area	Example No.	
	Wing ballast tank	3	
Detail of damage		Fracture in way of web and flat bar stiffener at cut outs for longitudinal stiffener connections.	
Sketch of damage		Sketch of repair

<p>Insert longitudinal.</p>	
<b>Factors which may have caused damage</b> <ol style="list-style-type: none"> <li>1. Asymmetrical connection of flat bar stiffener resulting in high peak stress at heel of the stiffener under fatigue loading.</li> <li>2. Insufficient area of connection of longitudinal to web plate.</li> <li>3. Defective weld at return around the plate thickness.</li> <li>4. High localized corrosion at areas of stress concentrations such as flat bar stiffener connections, corners of cut out for longitudinal and connection of web to shell at cut outs.</li> <li>5. High shear stress in web of the transverse.</li> <li>6. Dynamic seaway loads/motions.</li> </ol>		<b>Notes on repairs</b> <p>See Sketch.</p> <p>May also fit a double bracket to avoid fracture from toe.</p>

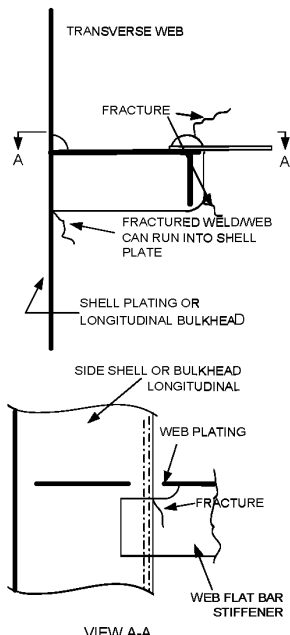
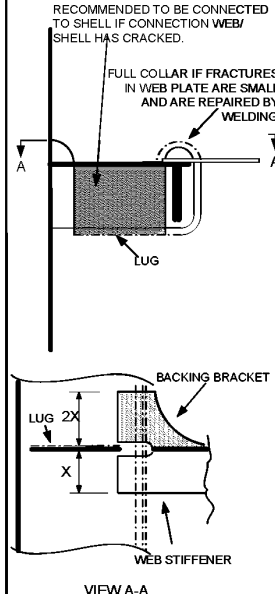
OIL Tankers		Guidelines for Surveys, Assessment and Repair of Hull Structure	
Group 2	Cargo area	Example No.	
	Wing ballast tank	4	
Detail of damage		Fracture in way of web and flat bar stiffener at cut outs for longitudinal stiffener connections as Example 3 but with faceplate attached to underside of web. Flat bar lap welded.	
Sketch of damage		Sketch of repair

<p>Insert web plate.</p>	
<b>Factors which may have caused damage</b> <ol style="list-style-type: none"> <li>1. Asymmetrical connection of flat bar stiffener resulting in high peak stress at heel of the stiffener under fatigue loading.</li> <li>2. Fabricated longitudinal with welding onto exposed edge of the web resulting in poor fatigue strength of the connection of the longitudinal to the flat bar.</li> <li>3. Insufficient area of connection of longitudinal to web plate.</li> <li>4. Defective weld at return around the plate thickness.</li> <li>5. High localized corrosion at areas of stress concentrations such as flat bar stiffener connections, corners of cut out for longitudinal and connection of lug to shell at cut outs.</li> <li>6. High shear stress in web of the transverse.</li> <li>7. Dynamic seaway loads/motions.</li> </ol>		<b>Notes on repairs</b> See Sketch. <ol style="list-style-type: none"> <li>1. May also fit a double bracket to avoid fracture from toe.</li> </ol>

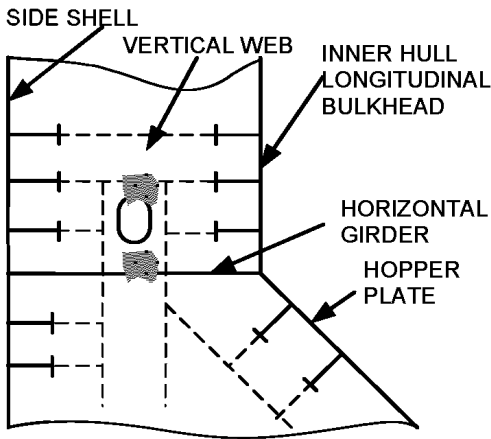
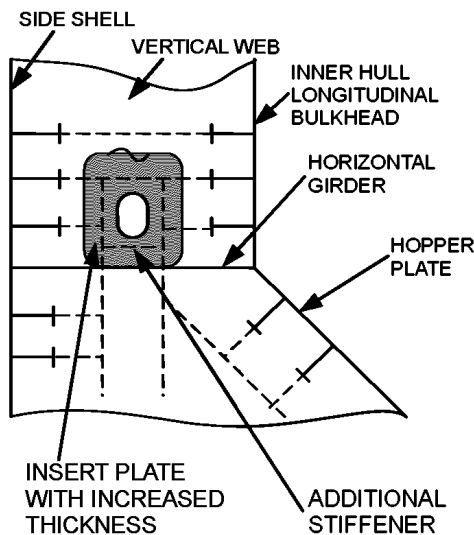
OIL Tankers		Guidelines for Surveys, Assessment and Repair of Hull Structure	
Group 2	Cargo area	Example No.	
	Wing ballast tank	5	
Detail of damage		Buckling in way of side web panels above hopper horizontal girder	
Sketch of damage		Sketch of repair

<b>Factors which may have caused damage</b> 1. High shear stress in the transverse web. 2. Insufficient buckling strength.		<b>Notes on repairs</b> See Sketch.

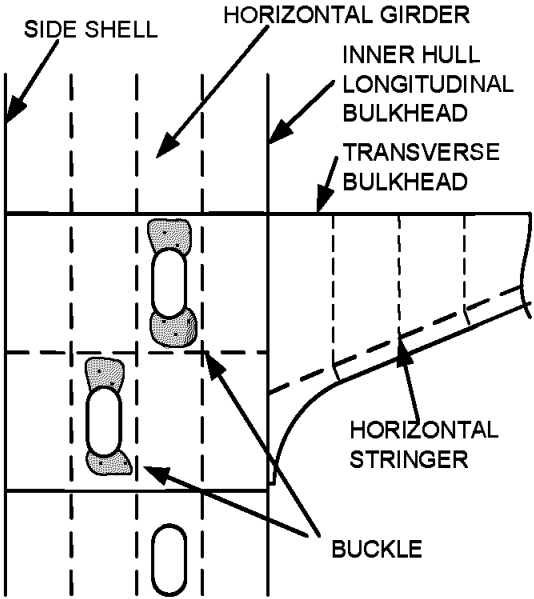
OIL Tankers		Guidelines for Surveys, Assessment and Repair of Hull Structure	
Group 2	Cargo area		Example No.
	Wing ballast tank		6
Detail of damage		Panels of side horizontal girders in way of transverse bulkhead	
<b>Sketch of damage</b>

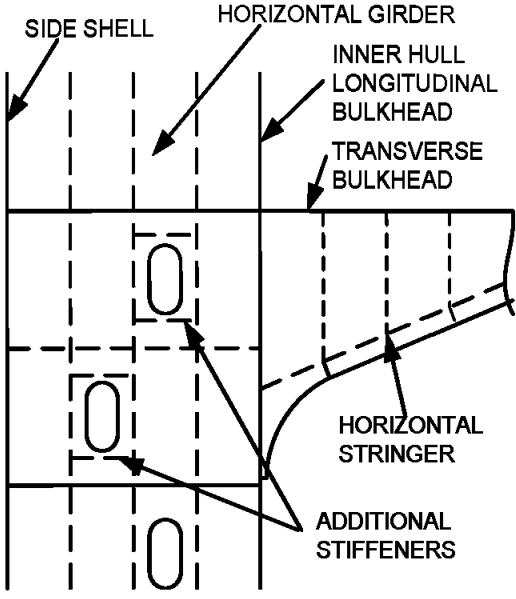
<b>Sketch of repair</b>

<b>Factors which may have caused damage</b> 1. High shear or compressive stress in the stringer. 2. Insufficient buckling strength.		<b>Notes on repairs</b> See Sketch.

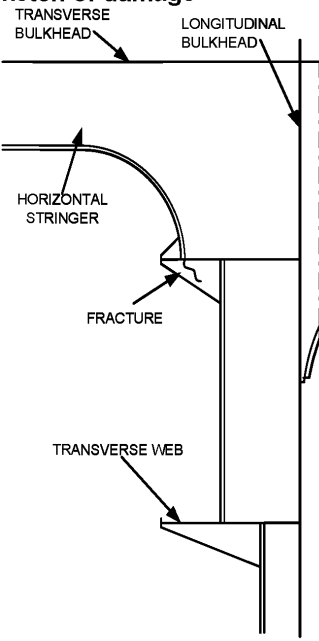
OIL Tankers		Guidelines for Surveys, Assessment and Repair of Hull Structure	
Group 2	Cargo area	Example No.	
	Wing ballast tank	7	
Detail of damage		Fracture at connection of horizontal stringers to transverse web frames and horizontal girders	
<b>Sketch of damage</b>

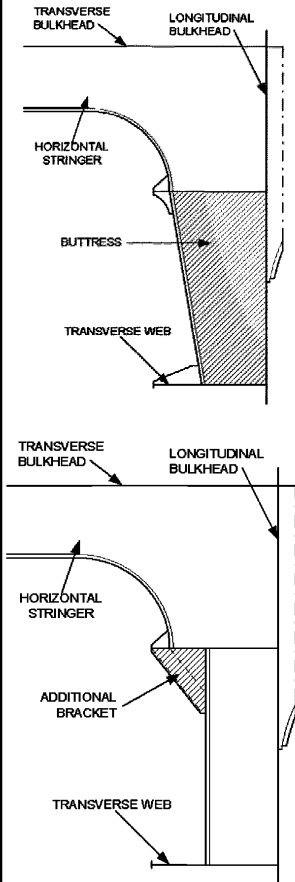
<b>Sketch of repair</b>

<b>Factors which may have caused damage</b> 1. Stress concentration due to discontinuous structure. 2. High shear stress in the horizontal stringer.		<b>Notes on repairs</b> See Sketch.

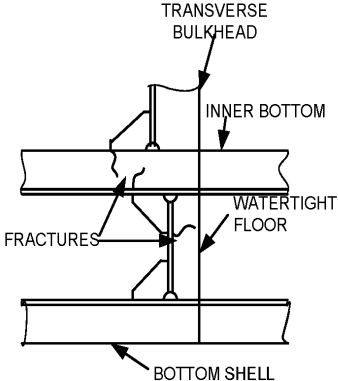
OIL Tankers		Guidelines for Surveys, Assessment and Repair of Hull Structure
Group 3	Cargo area	Example No.
	Bottom ballast tank	1
Detail of damage		Cracks in way of longitudinals connected to watertight floors
Sketch of damage		Sketch of repair

<p>TRANSVERSE BULKHEAD</p> <p>INNER BOTTOM</p> <p>FRACTURES</p> <p>WATERTIGHT FLOOR</p> <p>BOTTOM SHELL</p>

(a) Fractures in the inner bottom longitudinals and the bottom longitudinals in way of the intersection with the watertight floors below the transverse bulkhead stools.

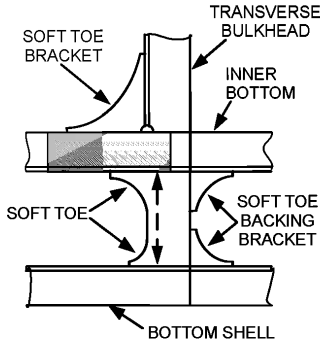
<p>SOFT TOE BRACKET</p> <p>TRANSVERSE BULKHEAD</p> <p>INNER BOTTOM</p> <p>SOFT TOE</p> <p>SOFT TOE BACKING BRACKET</p> <p>BOTTOM SHELL</p>
<b>Factors which may have caused damage</b> <ol style="list-style-type: none"> <li>1. Asymmetrical connection of bracket in association with a backing bracket, which is too small.</li> <li>2. Relative deflection between adjacent floor and transverse bulkhead.</li> <li>3. Inadequate shape of the brackets.</li> <li>4. High stresses in the inner bottom longitudinal and the floor stiffener.</li> </ol>		<b>Notes on repairs</b> See Sketch.

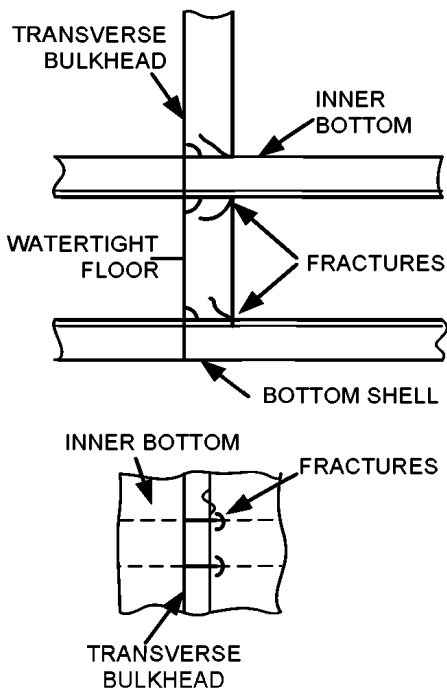
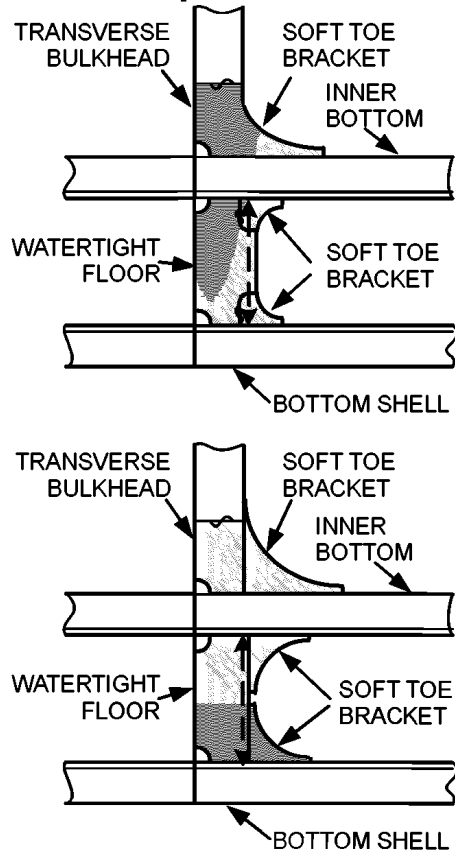
OIL Tankers		Guidelines for Surveys, Assessment and Repair of Hull Structure	
Group 3	Cargo area	Example No.	
	Bottom ballast tank	2	
Detail of damage		Fracture in way of stiffeners at connection of inner bottom and bottom shell to transverse bulkhead and floors.	
Sketch of damage		Sketch of repair

<b>Factors which may have caused damage</b> <ol style="list-style-type: none"> <li>1. Misalignment between bulkhead stiffener and inner bottom longitudinal.</li> <li>2. High stress concentration.</li> </ol>		<b>Notes on repairs</b> <p>See Sketch.</p> <ol style="list-style-type: none"> <li>1. If tank top plating is fractured, part crop and insert.</li> <li>2. Proper alignment between bulkhead stiffener and inner bottom longitudinal is critical for successful repair.</li> <li>3. Soft backing brackets may also be added.</li> </ol>

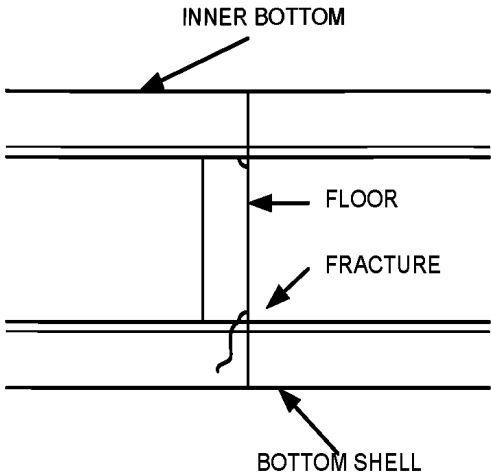
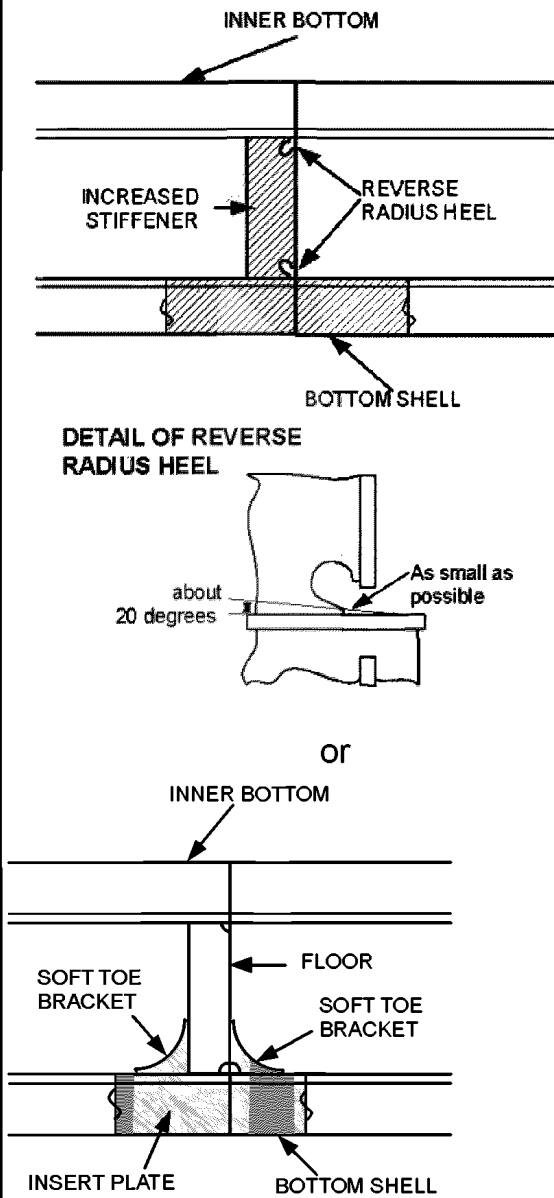
OIL Tankers		Guidelines for Surveys, Assessment and Repair of Hull Structure	
Group 3	Cargo area	Example No.	
	Bottom ballast tank	3	
Detail of damage		Connection of longitudinals to ordinary floors.	
Sketch of damage		Sketch of repair

<b>Factors which may have caused damage</b> 1. Asymmetrical connection. 2. Relative deflection of adjacent floor to transverse bulkhead.		<b>Notes on repairs</b> See Sketch.

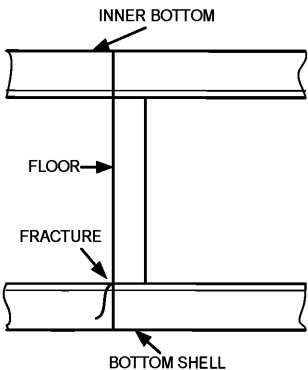
OIL Tankers Guidelines for Surveys, Assessment and Repair of Hull Structure		
Group 3	Cargo area	Example No.
	Bottom ballast tank	4
Detail of damage	Connection of longitudinals to ordinary floors	
Sketch of damage

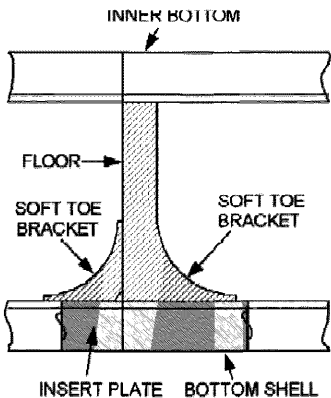
Sketch of repair

Factors which may have caused damage	<p>1. Stress concentration at the connection of bottom longitudinal and stiffener on floor.</p>	
Notes on repairs	<p>See Sketch.</p> <ol style="list-style-type: none"> <li>1. Butt welds in bottom longitudinal should be kept clear of the soft toe bracket toes.</li> <li>2. If possible soft toe bracket and vertical stiffener should be integral.</li> </ol>

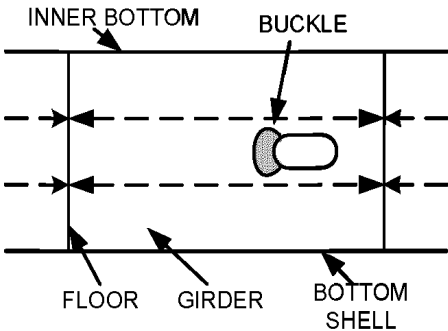
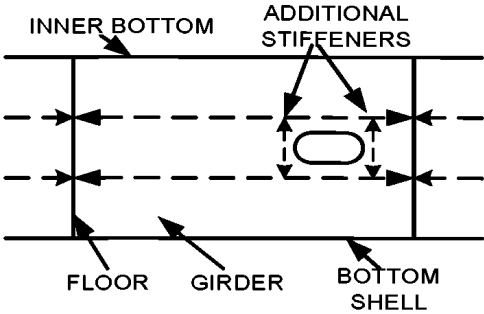
OIL Tankers		Guidelines for Surveys, Assessment and Repair of Hull Structure	
Group 3	Cargo area	Example No. ....	
	Bottom ballast tank	5	
Detail of damage		Panels of bottom girders in way of openings.	
Sketch of damage		Sketch of repair

<b>Factors which may have caused damage</b> 1. High shear or compressive stress in the side girder. 2. Insufficient buckling strength.		<b>Notes on repairs</b> See Sketch.

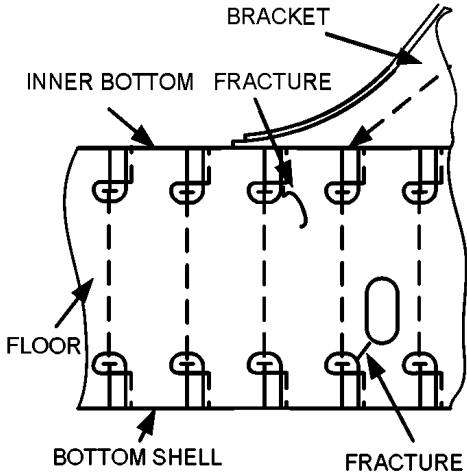
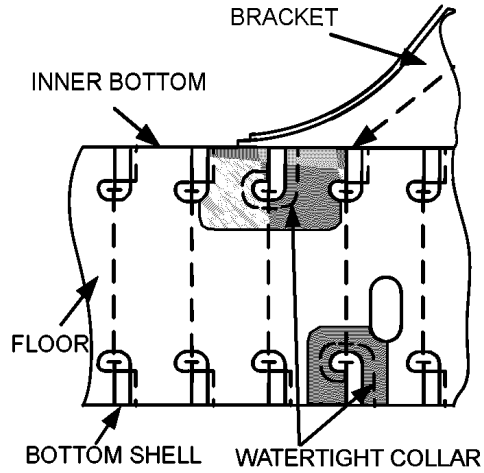
OIL Tankers		Guidelines for Surveys, Assessment and Repair of Hull Structure	
Group 3	Cargo area	Example No.	
	Bottom ballast tank	6	
Detail of damage		Cut-outs on floors	
Sketch of damage		Sketch of repair

<p><b>Above for relatively small fractures.</b></p>

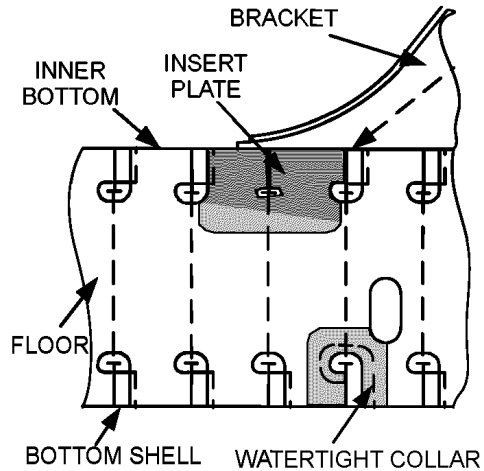
<p><b>Above method for larger fractures.</b></p>	
<b>Factors which may have caused damage</b> <ol style="list-style-type: none"> <li>1. High stress in the vicinity of the transverse web frame bracket toe.</li> <li>2. Lack of material between manhole and cut-out for bottom longitudinals.</li> </ol>		<b>Notes on repairs</b> <ol style="list-style-type: none"> <li>1. Top sketch: Gouge and reweld fractures then fit WT collars.</li> <li>2. Bottom sketch: As an alternative to rewelding and fitting collar, crop and insert.</li> </ol>

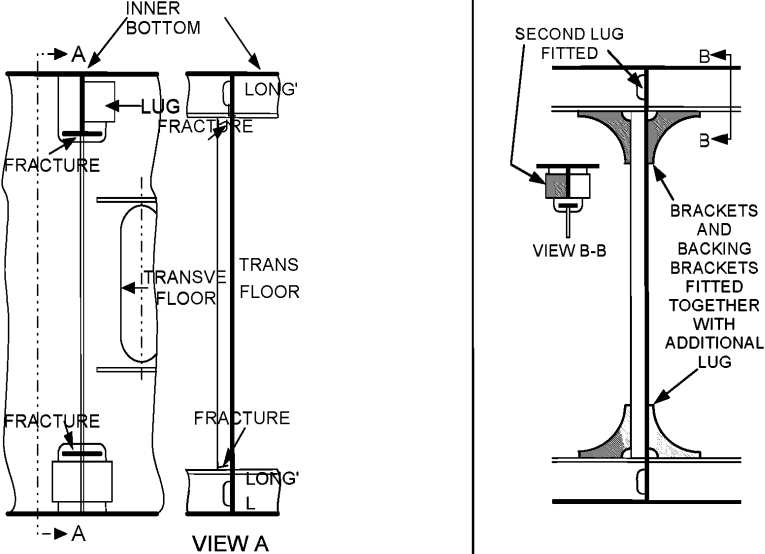
OIL Tankers		Guidelines for Surveys, Assessment and Repair of Hull Structure
Group 3	Cargo area	Example No.
	Bottom ballast tank	7
Detail of damage	Fractured stiffener connection to bottom and inner bottom longitudinals.	
Sketch of damage

Factors which may have caused damage	<p>1. Asymmetric connection leading to high local stresses at the connection of vertical stiffeners of the transverse floors to the inner and outer bottom longitudinals.</p> <p>2. Wide slot for longitudinal leads to inefficient lug connection.</p> <p>3. Sharp corners or flame-cut edges producing a notch effect.</p> <p>4. Incomplete/defective weld at stiffener connection to the longitudinals.</p> <p>5. Dynamic sea way loads/ship motions.</p>	
Notes on repairs	See Sketch.

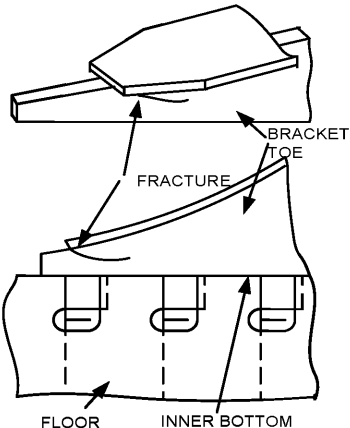
OIL Tankers		Guidelines for Surveys, Assessment and Repair of Hull Structure
Group 4	Cargo area	Example No.
	Web Frame in cargo tank	1
Detail of damage		Fracture at toe of web frame bracket connection to inner bottom.
<b>Sketch of damage</b>

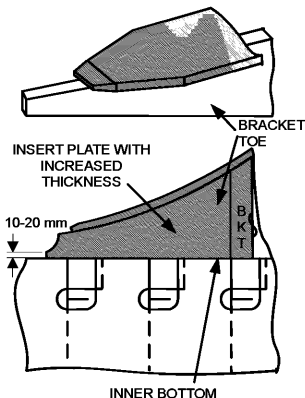
<b>Sketch of repair</b> Modify Face Taper 1. Breadth taper 20 degrees. 2. Breadth at toe as small as practical. 3. Thickness taper 1 in 3 to 10mm.

<b>Factors which may have caused damage</b> 1. Inadequate tapering the toe end. 2. Insufficient tapering of flange. 3. Lateral flexing of the bracket.		<b>Notes on repairs</b> See Sketch.

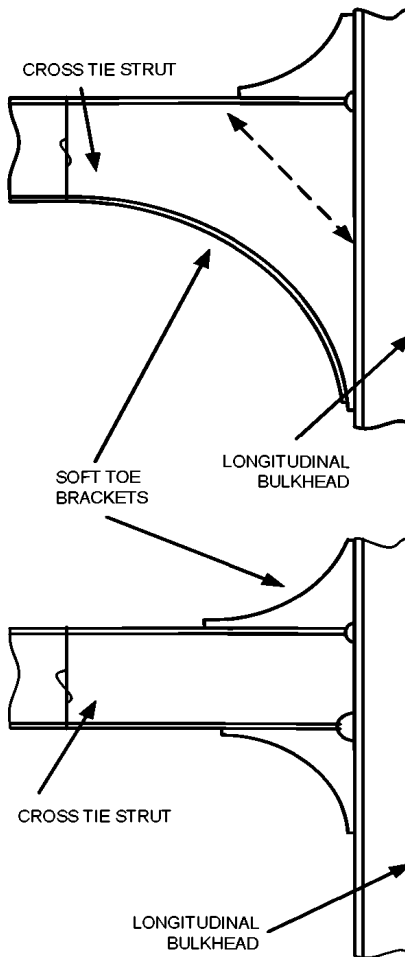
OIL Tankers		Guidelines for Surveys, Assessment and Repair of Hull Structure	
Group 4	Cargo area	Example No. ....	
	Web Frame in cargo tank	2	
Detail of damage		Cross ties and their end connections	
Sketch of damage		Sketch of repair

<b>Factors which may have caused damage</b> <ol style="list-style-type: none"> <li>1. Stress concentration due to unsuitable bracket shape at juncture of cross tie to longitudinal.</li> <li>2. Inadequate panel stiffening of web plate of cross-tie.</li> </ol>		<b>Notes on repairs</b> See Sketch.

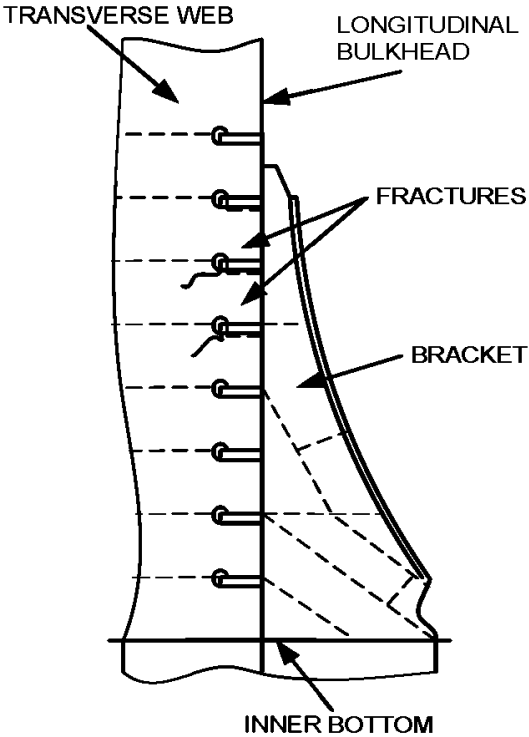
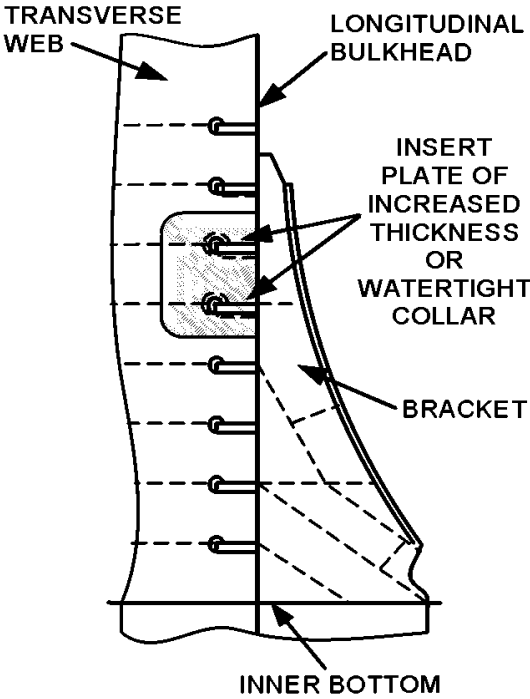
OIL Tankers		Guidelines for Surveys, Assessment and Repair of Hull Structure	
Group 4	Cargo area		Example No.
	Web Frame in cargo tank		4
Detail of damage	Cut-outs around transverse bracket end.		
Sketch of damage		Sketch of repair

Factors which may have caused damage		Notes on repairs	
1. High stresses at toe of bottom transverse end bracket. 2. Sharp corner at cut-out.		See Sketch.

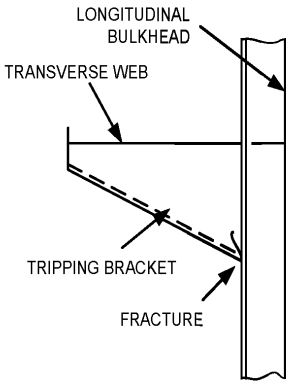
OIL Tankers		Guidelines for Surveys, Assessment and Repair of Hull Structure	
Group 4	Cargo area	Example No.	
	Web Frame in cargo tank	5	
Detail of damage		Fracture in way of connection of transverse web tripping brackets to longitudinal	
Sketch of damage		Sketch of repair

<p>LONGITUDINAL BULKHEAD</p> <p>TRANSVERSE WEB</p> <p>TRIPPING BRACKET</p> <p>FRACTURE</p>

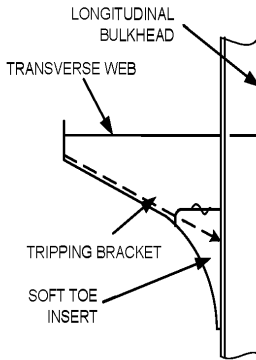
<p>LONGITUDINAL BULKHEAD</p> <p>TRANSVERSE WEB</p> <p>TRIPPING BRACKET</p> <p>SOFT TOE INSERT</p>	
Factors which may have caused damage		Notes on repairs	
<ol style="list-style-type: none"> <li>1. Hard spot at the toe of bracket.</li> <li>2. Vibration.</li> </ol>		<p>See Sketch.</p> <ol style="list-style-type: none"> <li>1. Soft bracket may be added on upper side of web, to avoid fracture at the heel.</li> </ol>

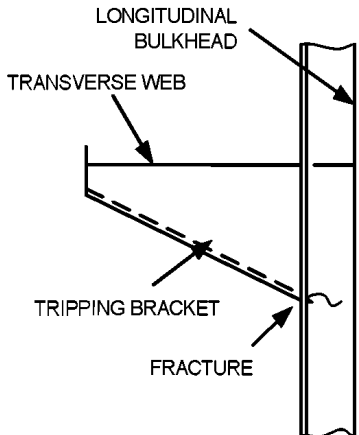
OIL Tankers		Guidelines for Surveys, Assessment and Repair of Hull Structure	
Group 4	Cargo area	Example No.	
	Web Frame in cargo tank	6	
Detail of damage		Tripping brackets modification of the bracket toe.	
Sketch of damage		Sketch of repair

<p>LONGITUDINAL BULKHEAD</p> <p>TRANSVERSE WEB</p> <p>TRIPPING BRACKET</p> <p>FRACTURE</p>

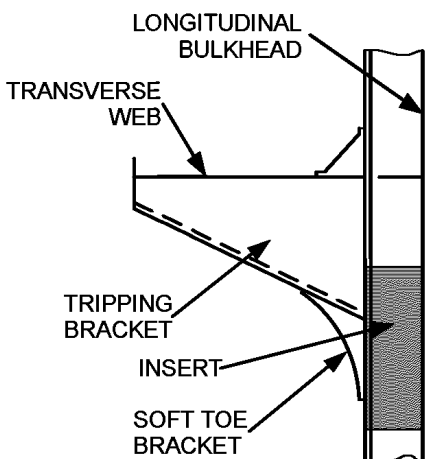
<p>LONGITUDINAL BULKHEAD</p> <p>TRANSVERSE WEB</p> <p>TRIPPING BRACKET</p> <p>INSERT</p> <p>SOFT TOE BRACKET</p>	
<b>Factors which may have caused damage</b> <ol style="list-style-type: none"> <li>1. Stress concentrations at toe of bracket.</li> <li>2. High stress in longitudinal.</li> </ol>		<b>Notes on repairs</b> <p>See Sketch.</p> <ol style="list-style-type: none"> <li>1. Soft bracket may be added on upper side of web, to avoid fracture at the heel.</li> </ol>

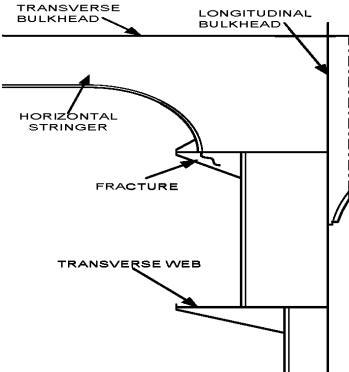
OIL Tankers			Guidelines for Surveys, Assessment and Repair of Hull Structure
Group 5	Cargo area		Example No.
	Transverse Bulkhead in cargo tank		1
Detail of damage	Fracture in way of connection of transverse bulkhead stringer to transverse web frames and longitudinal bulkhead stringer		
Sketch of damage

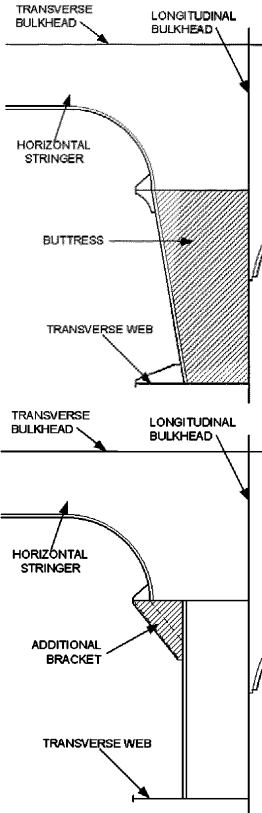
Sketch of repair

Factors which may have caused damage	<ol style="list-style-type: none"> <li>1. Stress concentration due to discontinuous structure.</li> <li>2. High shear stress in the horizontal stringer.</li> </ol>		
Notes on repairs	See Sketch.

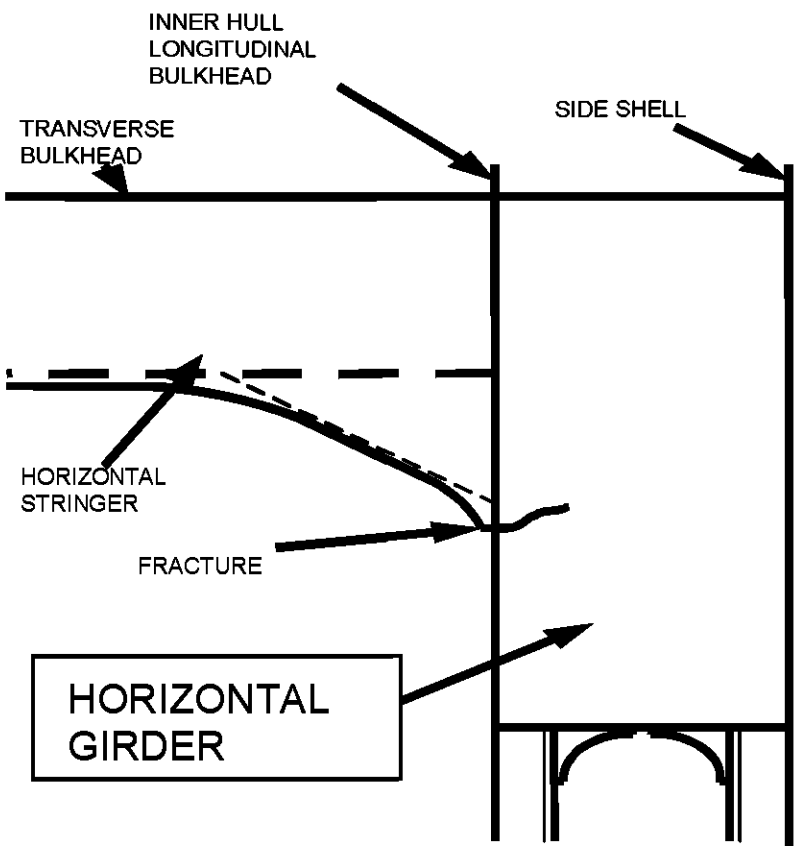
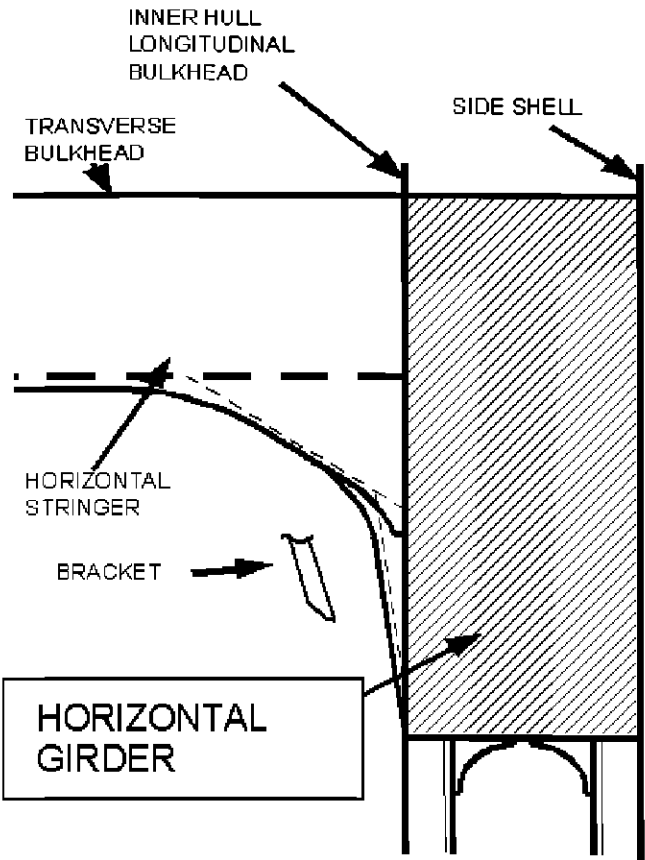
OIL Tankers		Guidelines for Surveys, Assessment and Repair of Hull Structure	
Group 5	Cargo area		Example No.
	Transverse Bulkhead in cargo tank		2
Detail of damage		Horizontal stringer in way of longitudinal BHD cracked	
Sketch of damage		Sketch of repair

Factors which may have caused damage		Notes on repairs	
1. Misalignment between bracket end and side girder in wing tank.		See Sketch.

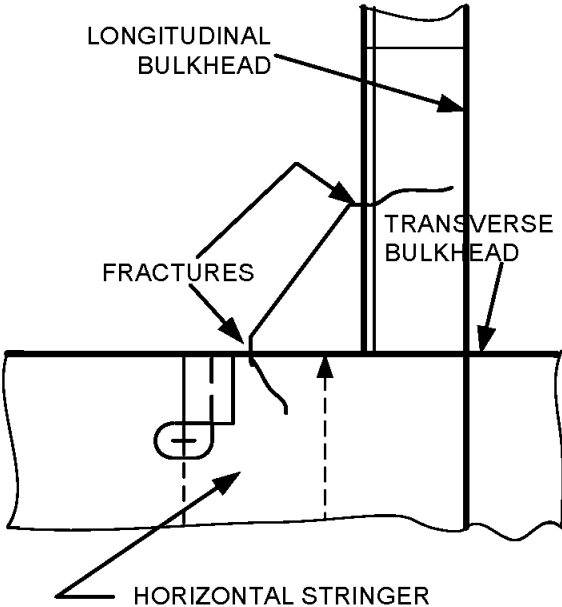
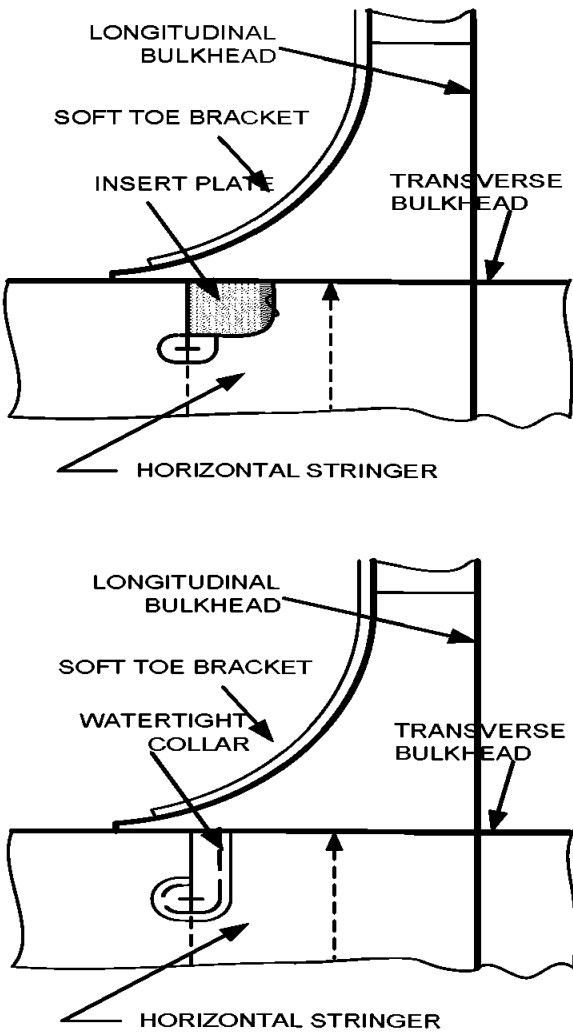
OIL Tankers		Guidelines for Surveys, Assessment and Repair of Hull Structure	
Group 5	Cargo area		Example No.
	Transverse Bulkhead in cargo tank		3
Detail of damage		Connection of longitudinals to horizontal stringers.	
Sketch of damage		Sketch of repair

Factors which may have caused damage		Notes on repairs	
<div>1. Stress concentration due to inadequate shape of the bracket.</div> <div>2. Relative deflection of adjoining transverse web against transverse bulkhead.</div>		See Sketch

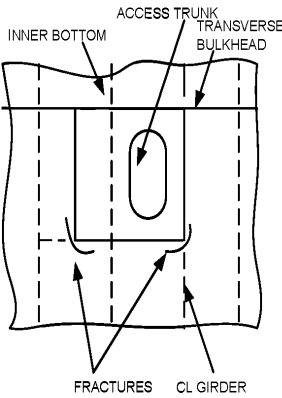
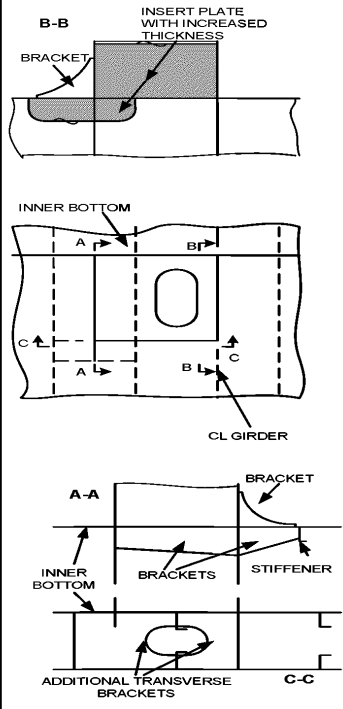
OIL Tankers		Guidelines for Surveys, Assessment and Repair of Hull Structure	
Group 5	Cargo area	Example No.	
	Transverse Bulkhead in cargo tank	4	
Detail of damage		Fractured inner bottom plate at the connection to access trunk wall	
<b>Sketch of damage</b>

<b>Sketch of repair</b>

<b>Factors which may have caused damage</b> <ol style="list-style-type: none"> <li>1. Stress concentration at the connection of trunk wall to inner bottom plate.</li> <li>2. Relative deformation between horizontal stringer fitted on transverse bulkhead and inner bottom plate.</li> <li>3. Static and dynamic load of cargo liquid.</li> </ol>		<b>Notes on repairs</b> See Sketch.
