**РОССИЙСКИЙ МОРСКОЙ РЕГИСТР СУДОХОДСТВА**  
**RUSSIAN MARITIME REGISTER OF SHIPPING**

**IACS PROCEDURAL REQUIREMENTS,  
UNIFIED INTERPRETATIONS  
AND RECOMMENDATIONS**

## **GENERAL DRY CARGO SHIPS**

Guidelines for  
Surveys, Assessment and Repair  
of Hull Structure

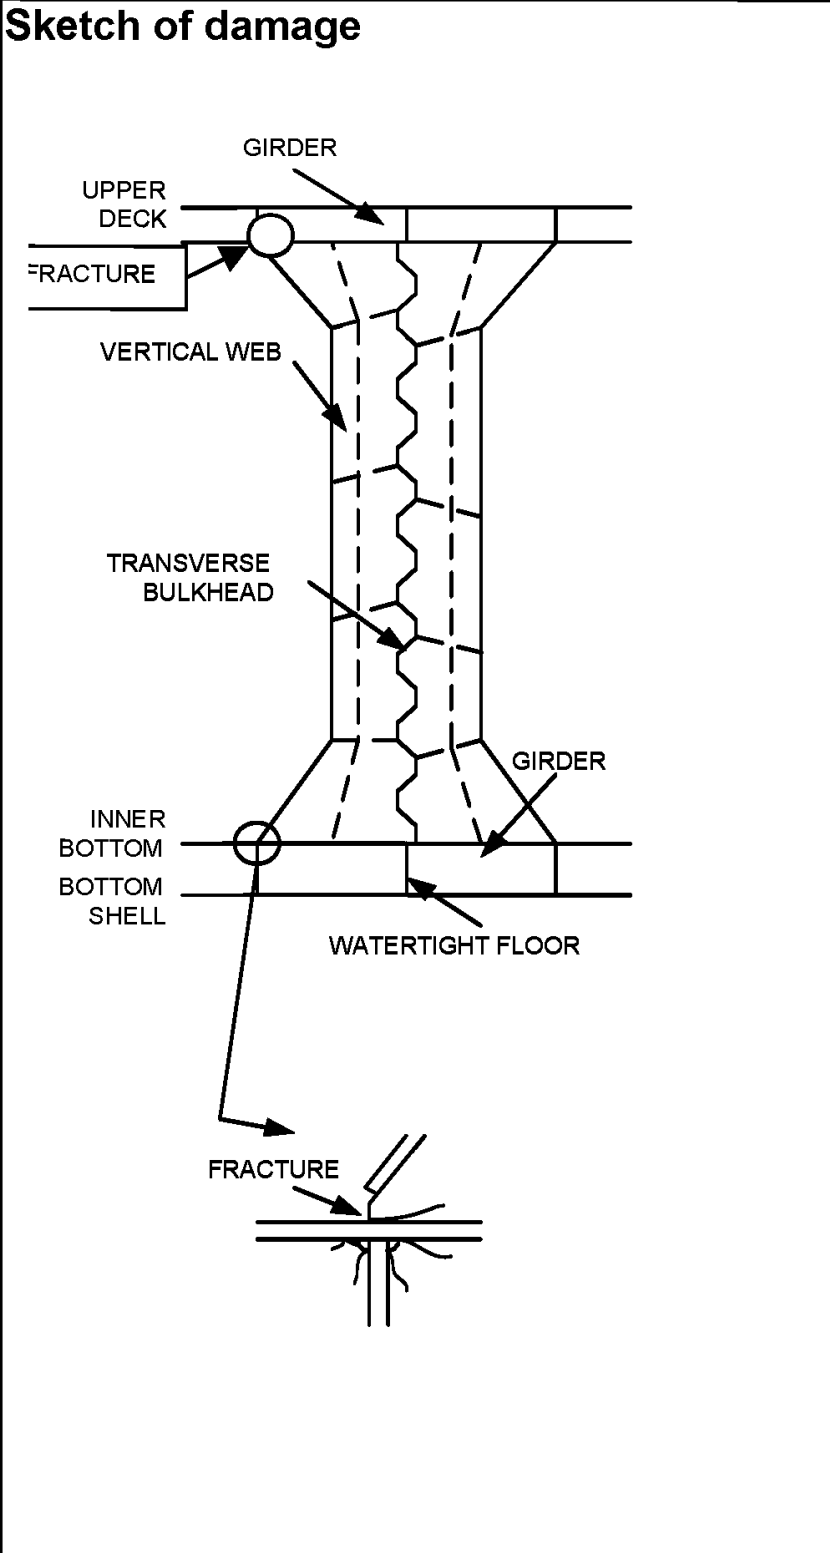
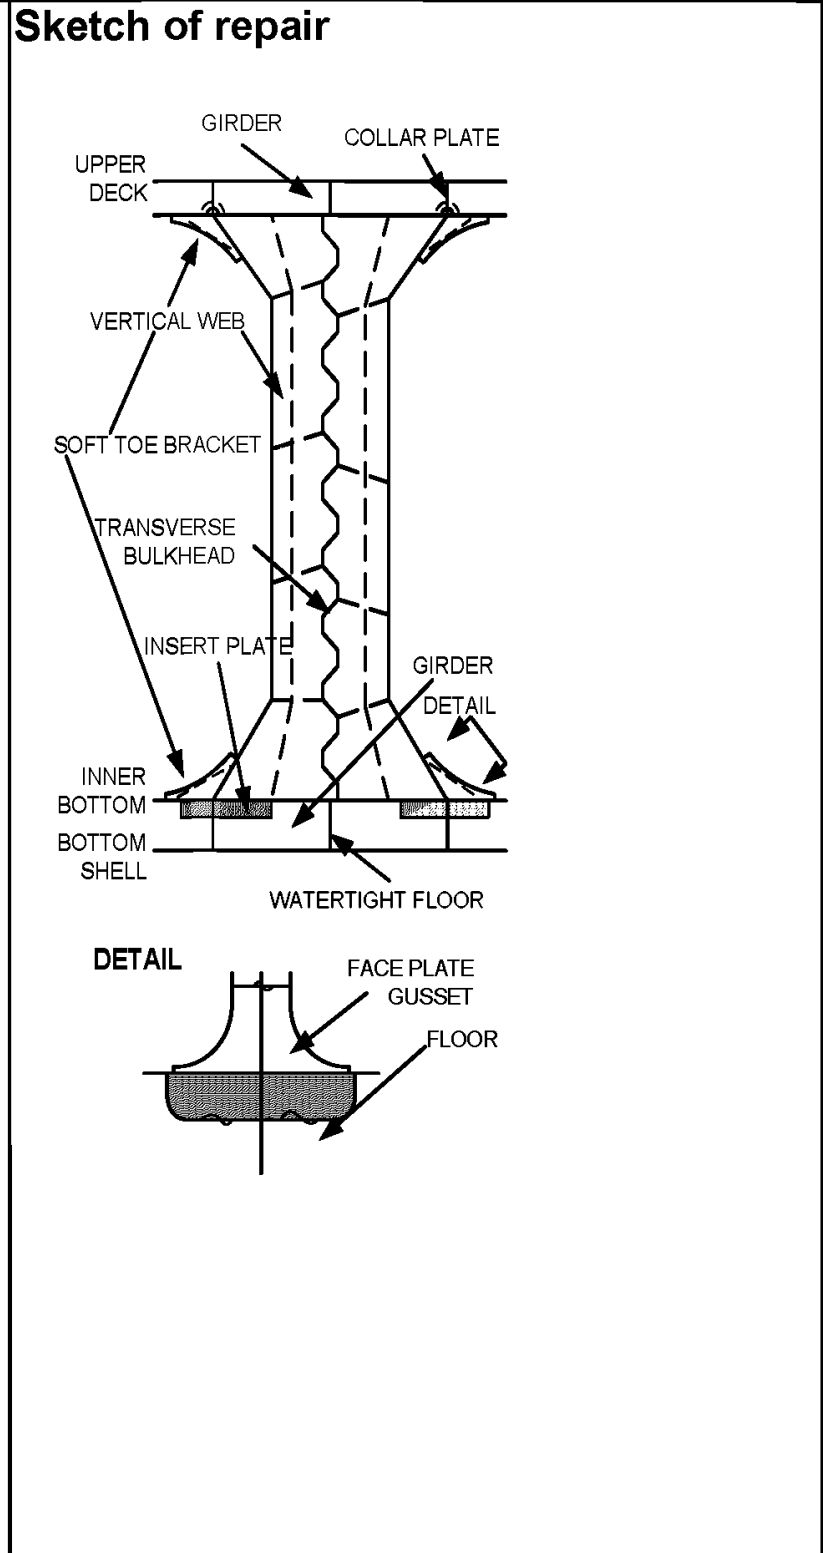
OIL Tankers		Guidelines for Surveys, Assessment and Repair of Hull Structure	
Group 5	Cargo area		Example No.
	Transverse Bulkhead in cargo tank		5
Detail of damage		Bulkhead vertical web to deck and inner bottom	
Sketch of damage		Sketch of repair

Factors which may have caused damage		Notes on repairs	
1. Stress concentration at toe of bracket due to sniped face plate and scallop in way.		See Sketch.

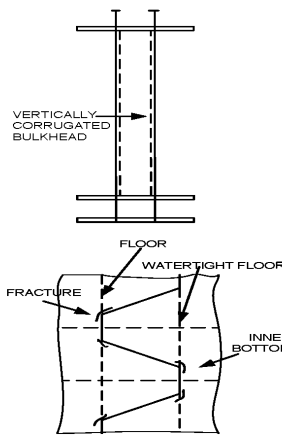
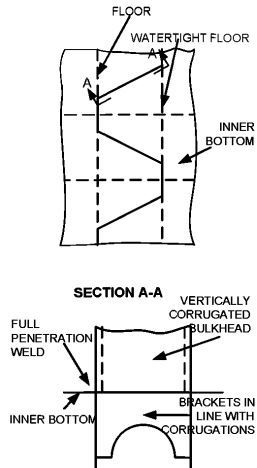
OIL Tankers		Guidelines for Surveys, Assessment and Repair of Hull Structure	
Group 5	Cargo area	Example No.	
	Transverse Bulkhead in cargo tank	6	
Detail of damage	Vertically corrugated bulkhead without stool, connection to deck and inner bottom		
Sketch of damage	<div>

</div>		
Sketch of repair	<div>

</div>		
Factors which may have caused damage	<div>1. Stress concentration due to unsupported corrugation web.</div> <div>2. High through thickness stress, lamellar tearing.</div> <div>3. Weld details and dimensions.</div> <div>4. Misalignment between face of corrugation and floor underneath.</div> <div>5. Cut-outs and scallops or air holes increasing the stress in the floor.</div> <div>6. Insufficient through thickness properties of inner bottom plate.</div>		
Notes on repairs	See Sketch.

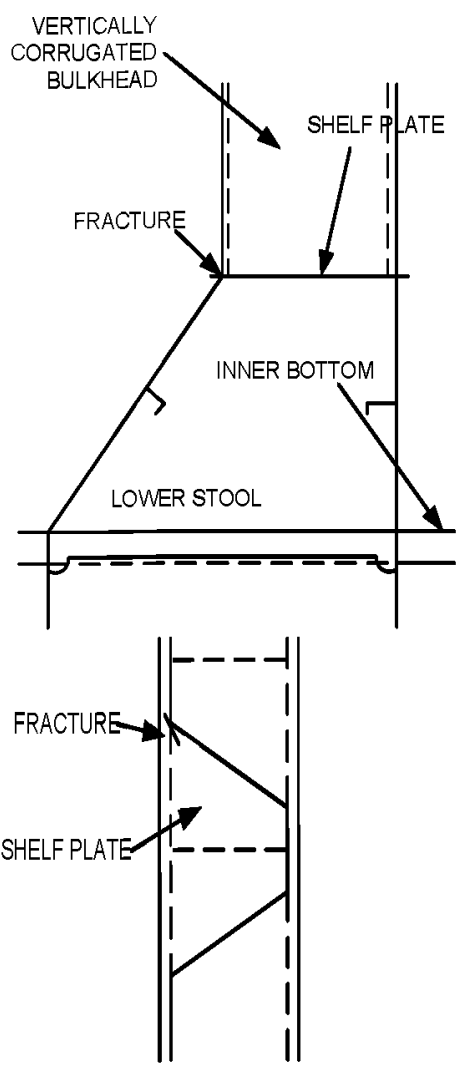
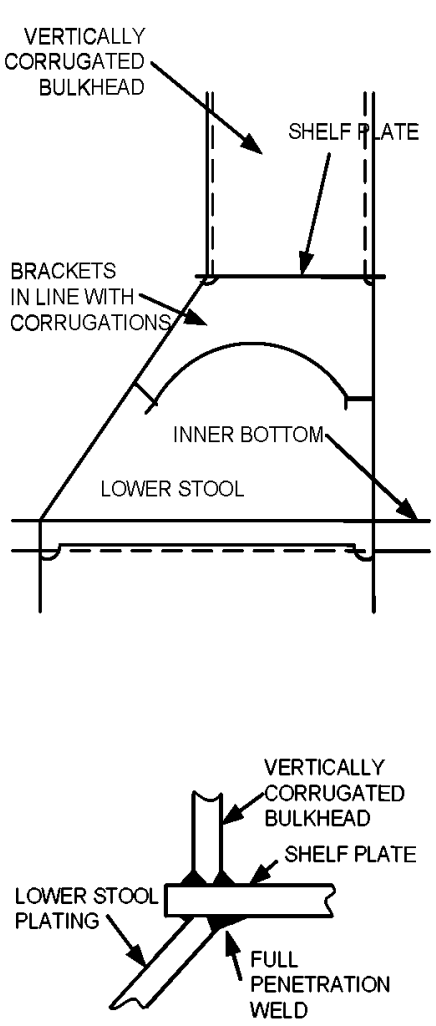
OIL Tankers		Guidelines for Surveys, Assessment and Repair of Hull Structure	
Group 5	Cargo area		Example No.
	Transverse Bulkhead in cargo tank		7
Detail of damage		Fracture at connection of vertically corrugated transverse bulkhead with stool to shelf plate and lower stool plate.	
Sketch of damage		Sketch of repair

Factors which may have caused damage		Notes on repairs	
<ol style="list-style-type: none"><li>1. Stress concentration due to unsupported corrugation web.</li><li>2. High through thickness stress, lamellar tearing.</li><li>3. Weld details and dimensions.</li><li>4. Misalignment.</li><li>5. Insufficient thickness of stool side plating in relation to corrugation flange thickness.</li></ol>		See Sketch.

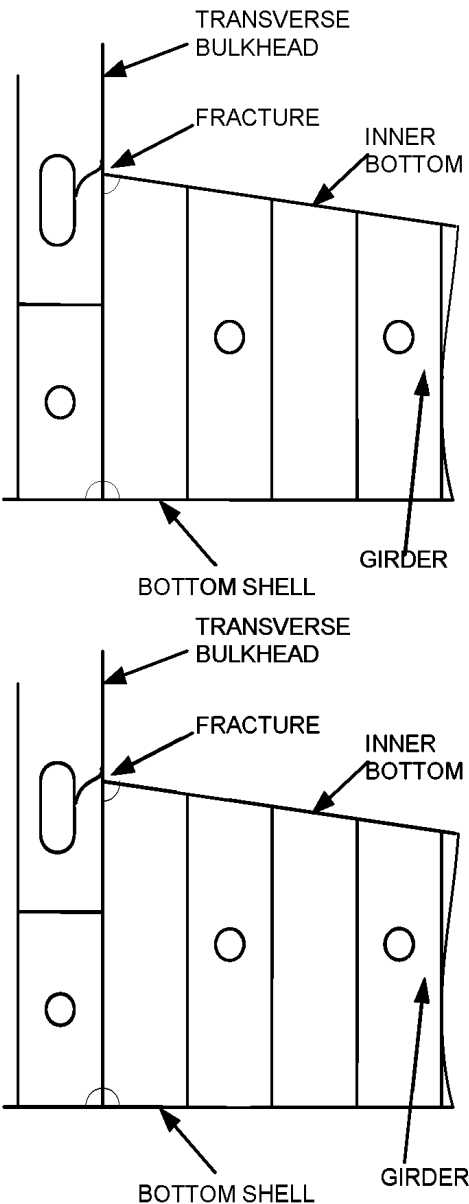
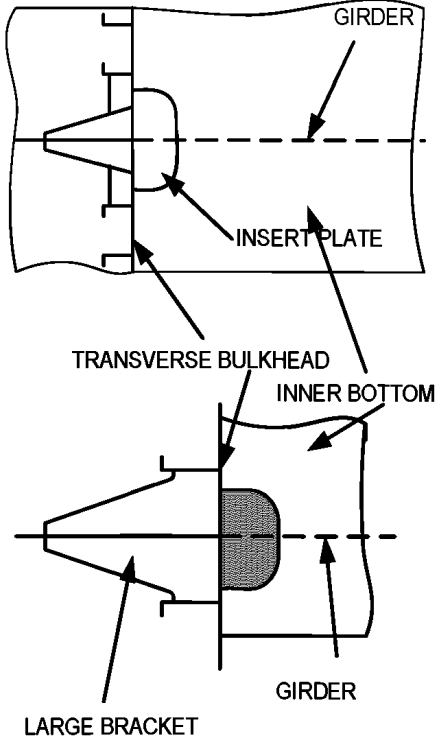
OIL Tankers		Guidelines for Surveys, Assessment and Repair of Hull Structure	
Group 5	Cargo area	Example No.	
	Transverse Bulkhead in cargo tank	9	
Detail of damage		Fracture at connection of transverse bulkhead to knuckle inner bottom/girder	
<b>Sketch of damage</b>

<b>Sketch of repair</b>

<b>Factors which may have caused damage</b> 1. High stress concentration. 2. Discontinuity of structural members at knuckle joint.		<b>Notes on repairs</b> See Sketch.

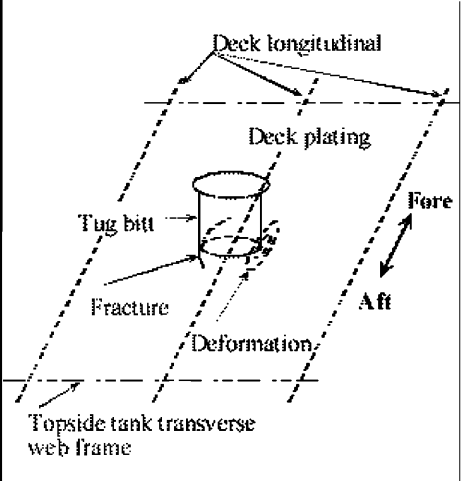
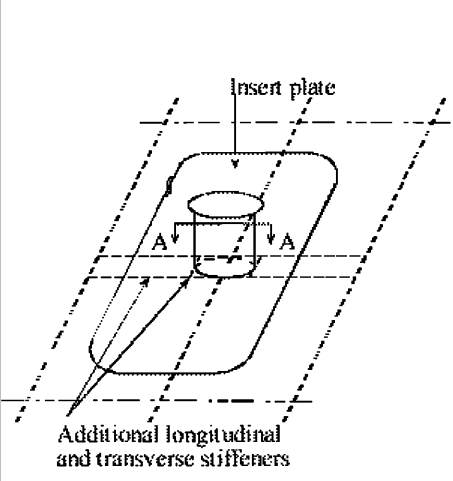
OIL Tankers		Guidelines for Surveys, Assessment and Repair of Hull Structure
Group 6	Deck Structure	Example No.
		1
<b>Detail of damage</b>	Deformed and fractured deck plating around tug bitt	
<b>Sketch of damage</b>	<div style="display: flex; justify-content: space-around;"> <div style="width: 45%;">

<p><b>View A-A</b></p> </div>	
<b>Factors which may have caused damage</b>	<b>Notes on repairs</b> <ol style="list-style-type: none"> <li>1. Insufficient strength</li> <li>1. Fractured/deformed deck plating should be cropped and part renewed.</li> <li>2. Reinforcement by stiffeners should be considered.</li> </ol>

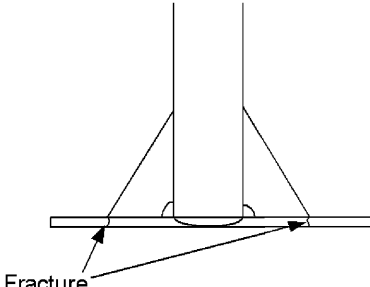
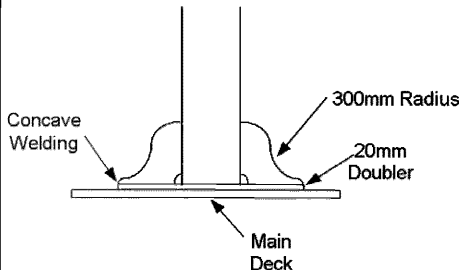
OIL Tankers		Guidelines for Surveys, Assessment and Repair of Hull Structure	
Group 6	Deck Structure		Example No.
			5
Detail of damage		Fractured deck plating in way of deck pipe support stanchions (midships)	
Sketch of damage		Sketch of repair

<b>Factors which may have caused damage</b> 1. Stanchions experience more severe relative displacements from hull girder bending.		<b>Notes on repairs</b> See Sketch.

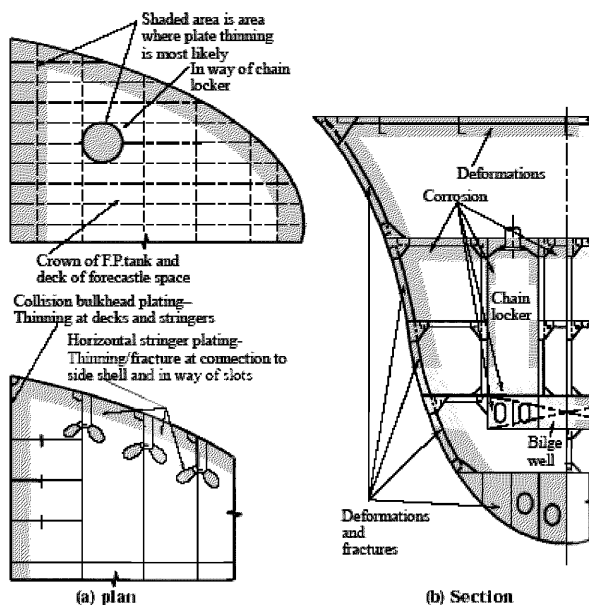
**Fig 1 Fore end structure - Potential problem areas**

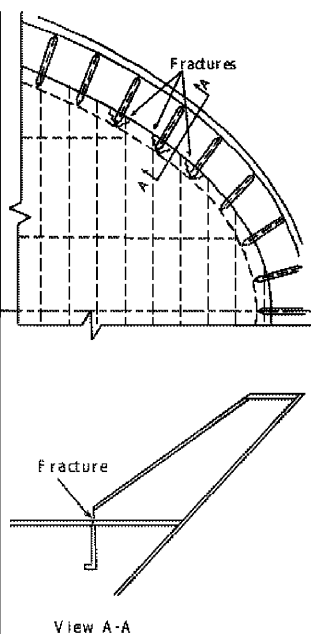
OIL Tankers			Guidelines for Surveys, Assessment and Repair of Hull Structure
Group 7	Fore region	Example No.	
Area 1	Forecastle	1	
Detail of damage	Fracture in forecastle deck plating at bulwark		
Sketch of damage		Sketch of repair

Factors which may have caused damage		Notes on repairs	
1. Bow Flare effect in heavy weather. 2. Stress concentration due to poor design.		1. Fractured deck plating should be cropped and renewed. 2. Bracket in line with the bulwark stay to be fitted to reduce stress concentration.

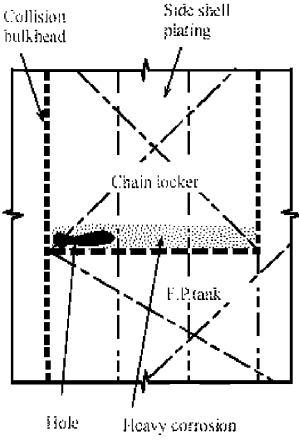
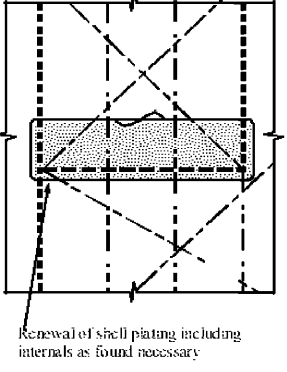
OIL Tankers Guidelines for Surveys, Assessment and Repair of Hull Structure		
Group 7	Fore region	Example No.
Area 1	Chain locker	2
Detail of damage Fractures in side shell plating in way of chain locker		
Sketch of damage		Sketch of repair

<b>Factors which may have caused damage</b> 1. Heavy corrosion in region where mud is accumulated.		<b>Notes on repairs</b> 1. Corroded plating should be cropped and renewed. 2. Protective coating should be applied.

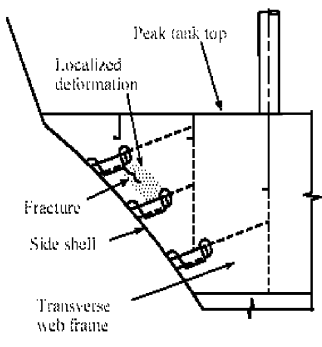
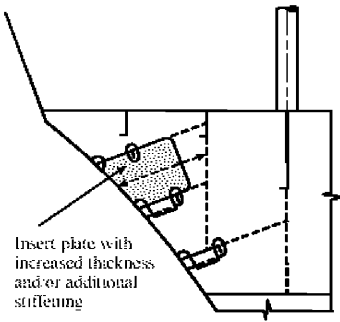
OIL Tankers Guidelines for Surveys, Assessment and Repair of Hull Structure		
Group 7	Fore region	Example No.
Area 1	Forepeak ballast tank	3
Detail of damage	Fractures and deformation of bow transverse webs in way of cut-outs for side longitudinals	
<b>Sketch of damage</b>

<b>Sketch of repair</b>

<b>Factors which may have caused damage</b> <ol style="list-style-type: none"> <li>1. Localized material wastage in way of coating failure at cut-outs and sharp edges due to working of the structure.</li> <li>2. Dynamic seaway loading in way of bow flare.</li> </ol>		<b>Notes on repairs</b> <ol style="list-style-type: none"> <li>1. Sufficient panel strength to be provided to absorb the dynamic loads enhanced by bow flare shape.</li> </ol>

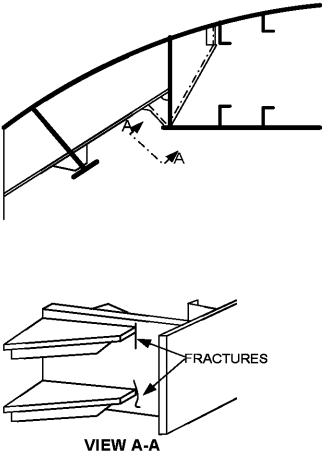
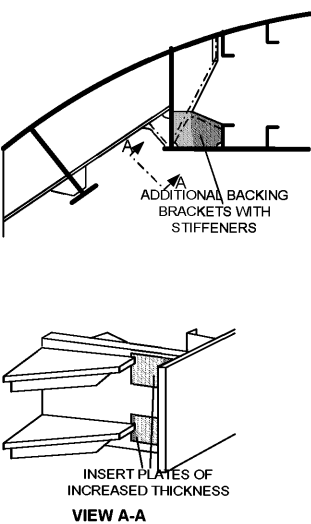
OIL Tankers Guidelines for Surveys, Assessment and Repair of Hull Structure		
Group 7	Fore region	Example No.
Area 1	Forepeak ballast tank	4
Detail of damage	Fractured vertical web at the longitudinal stiffener ending in way of the parabolic bow structure.	
<b>Sketch of damage</b>

<b>Sketch of repair</b>

<b>Factors which may have caused damage</b> <ol style="list-style-type: none"> <li>1. Stress concentrations at bracket ending due to inadequate support at bracket toes in way of connection to web frame members.</li> <li>2. Localised thinning in way of coating failure at bracket endings due to flexing of the structure.</li> <li>3. Dynamic seaway loadings at bow causing flexing at bracket endings.</li> </ol>		<b>Notes on repairs</b> See Sketch.

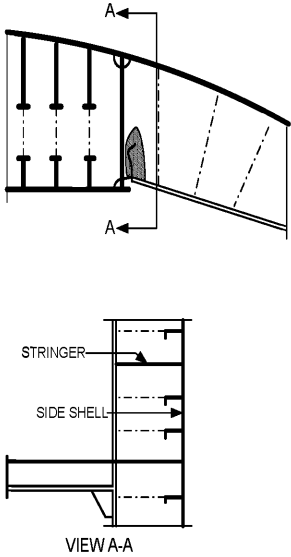
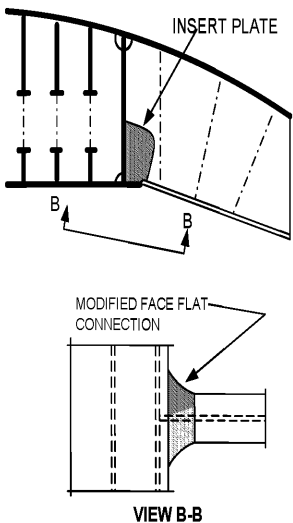
OIL Tankers		Guidelines for Surveys, Assessment and Repair of Hull Structure
Group 7	Fore region	Example No.
Area 1	Forepeak ballast tank	5
Detail of damage	Fractured stringer end connection in way of the parabolic bow structure	
<b>Sketch of damage</b>

<b>Sketch of repair</b>

<b>Factors which may have caused damage</b> <ol style="list-style-type: none"> <li>1. High stress concentration of stringer to stiff girder/deep web intersection due to discontinuity of faceplate.</li> <li>2. Localised thinning in way of coating failure at stringer connection due to flexing of the structure.</li> <li>3. Dynamic seaway loadings at bow causing flexing in way of detail.</li> </ol>		<b>Notes on repairs</b> See Sketch.

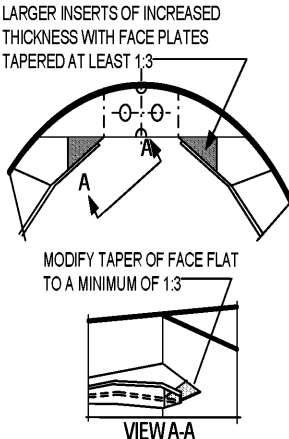
OIL Tankers		Guidelines for Surveys, Assessment and Repair of Hull Structure
Group 7	Fore region	Example No.
Area 1	Forepeak ballast tank	6
Detail of damage	Fracture at end of longitudinal at bow structure.	
<b>Sketch of damage</b>

<b>Sketch of repair</b> <p>LARGER INSERTS OF INCREASED THICKNESS WITH FACE PLATES TAPERED AT LEAST 1:3</p>

<b>Factors which may have caused damage</b> <ol style="list-style-type: none"> <li>1. Inadequate brackets forming the longitudinal endings at bow structure.</li> <li>2. Localised thinning in way of coating failure at longitudinal endings due to flexing of the structure.</li> <li>3. Dynamic seaway loadings at bow causing flexing at longitudinal endings.</li> </ol>		<b>Notes on repairs</b> See Sketch.

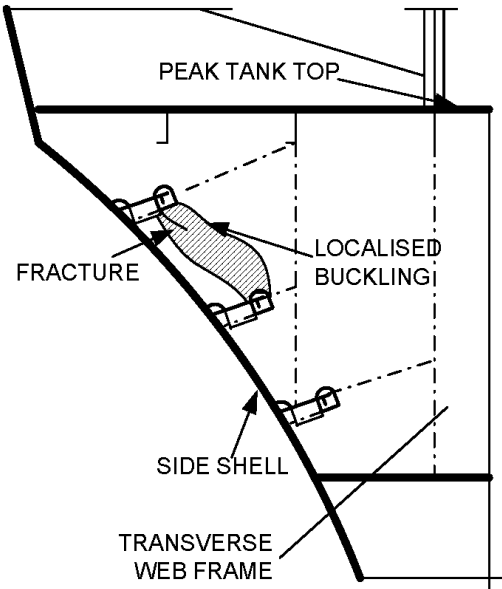
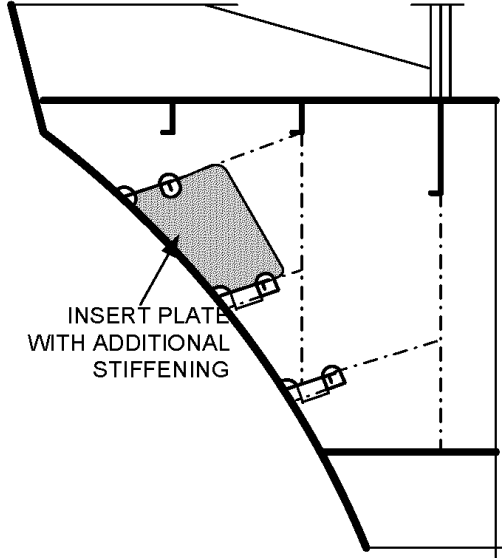
OIL Tankers		Guidelines for Surveys, Assessment and Repair of Hull Structure
Group 7	Fore region	Example No.
Area 1	Forepeak ballast tank	7
Detail of damage		Fracture and buckle of bow transverse web frame in way of longitudinal cut-outs.
Sketch of damage		Sketch of repair

<b>Factors which may have caused damage</b> <ol style="list-style-type: none"> <li>1. Localised thinning in way of coating failure at cut-outs and sharp edges due to working of the structure.</li> <li>2. Dynamic seaway loadings in way of bow flare.</li> </ol>		<b>Notes on repairs</b> See Sketch.

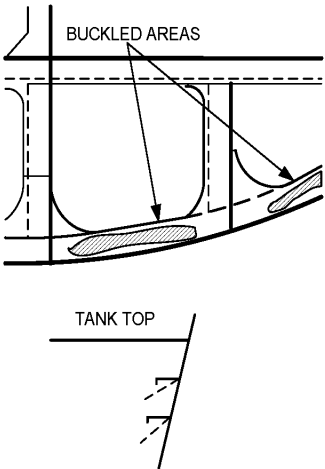
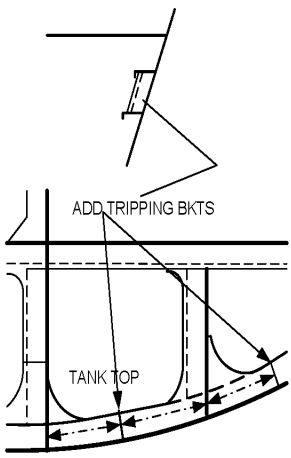
OIL Tankers		Guidelines for Surveys, Assessment and Repair of Hull Structure
Group 7	Fore region	Example No.
Area 1	Fore peak ballast tank	8
Detail of damage	Buckled and tripped breasthooks	
Sketch of damage		Sketch of repair

<b>Factors which may have caused damage</b> <ol style="list-style-type: none"> <li>1. Bow impact load.</li> <li>2. Low buckling resistance.</li> </ol>		<b>Notes on repairs</b> See Sketch.

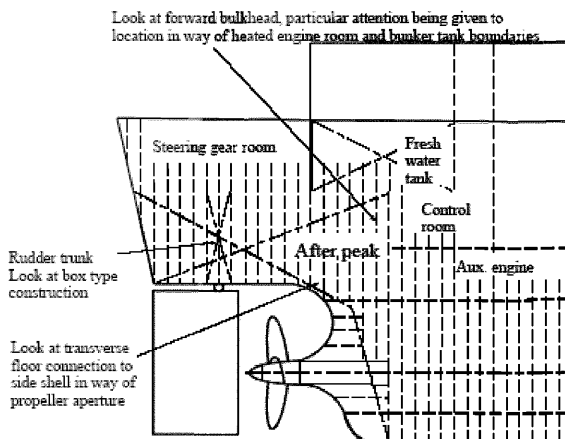
Figure 1 Aft end structure - Potential problem areas

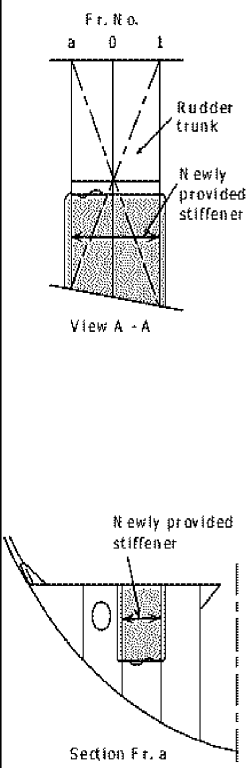
<b>Sketch of repair</b>

<b>Factors which may have caused damage</b> 1. Vibration.		<b>Notes on repairs</b> 1. The fractured plating should be cropped and renewed. 2. Natural frequency of the plate between stiffeners should be changed, e.g. reinforcement by additional stiffeners.

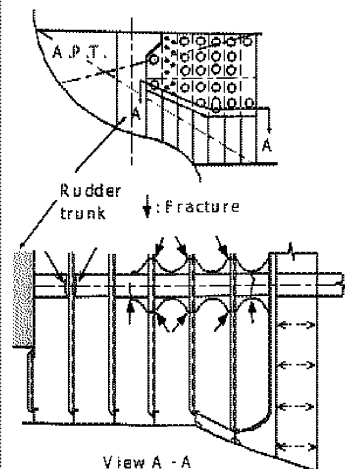
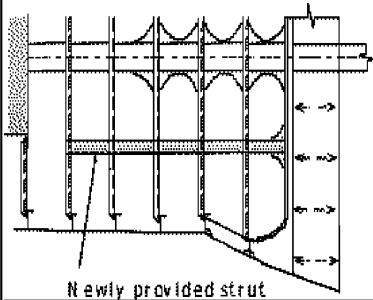
OIL Tankers		Guidelines for Surveys, Assessment and Repair of Hull Structure
Group 7	Aft region	Example No.
Area 2	Aft peak ballast tank	10
Detail of damage	Fractures at the connection of floors and girders/side brackets	
Sketch of damage	<div style="display: flex; justify-content: space-around;"> <div style="width: 45%;">

<p>View A - A</p> </div> <div style="width: 45%;">

<p>Newly provided strut</p> </div> </div>	
Factors which may have caused damage	<b>Notes on repairs</b> <ol style="list-style-type: none"> <li>1. The fractured plating should be cropped and renewed.</li> <li>2. Natural frequency of the panel should be changed, e.g. reinforcement by additional strut.</li> </ol>

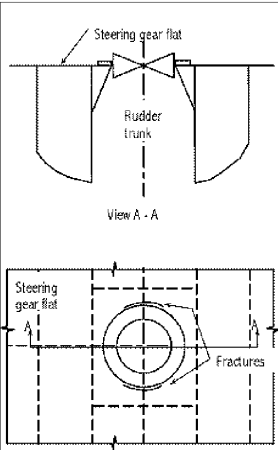
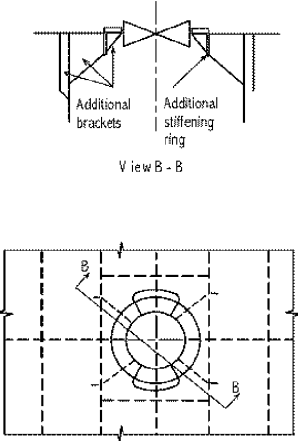
OIL Tankers Guidelines for Surveys, Assessment and Repair of Hull Structure		
Group 7	Aft region	Example No.
Area 2	Machinery space outside Engine room	11
Detail of damage	Fractures in flat where rudder carrier is installed in steering gear room	
<b>Sketch of damage</b>

<b>Sketch of repair</b>

<b>Factors which may have caused damage</b> 1. Inadequate design.		<b>Notes on repairs</b> 1. Fractured plating should be cropped and renewed. 2. Additional brackets and stiffening ring should be fitted for reinforcement.

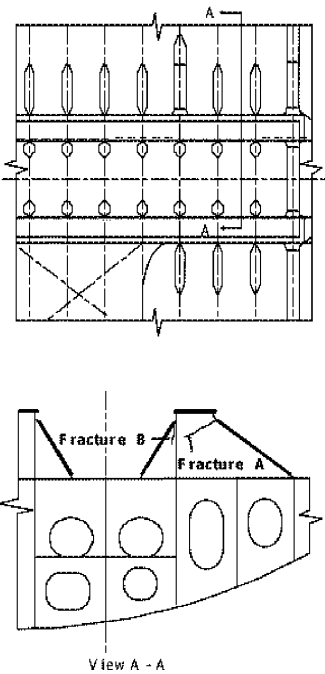
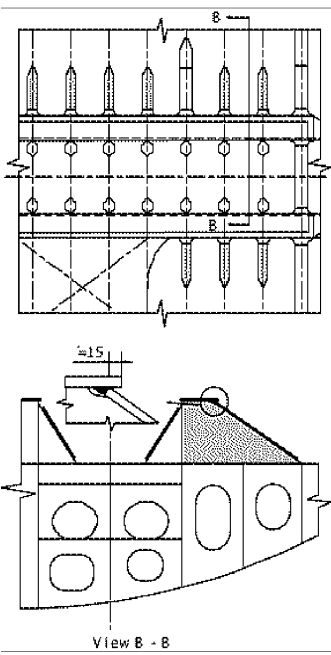
OIL Tankers		Guidelines for Surveys, Assessment and Repair of Hull Structure
Group 8	Machinery and accommodation spaces	Example No.
Area 1	Engine room	1
Detail of damage		Fractures in brackets at main engine foundation
Sketch of damage		Sketch of repair

<b>Factors which may have caused damage</b> <ol style="list-style-type: none"> <li>1. Vibration of main engine.</li> <li>2. Insufficient strength of brackets at main engine foundation.</li> <li>3. Insufficient pre-load of the bolts.</li> </ol>		<b>Notes on repairs</b> <ol style="list-style-type: none"> <li>1. Fractures may be veed-out and rewelded.</li> <li>2. New modified brackets at main engine foundation.</li> <li>3. Or insert pieces and additional flanges to increase section modulus of the brackets.</li> </ol>

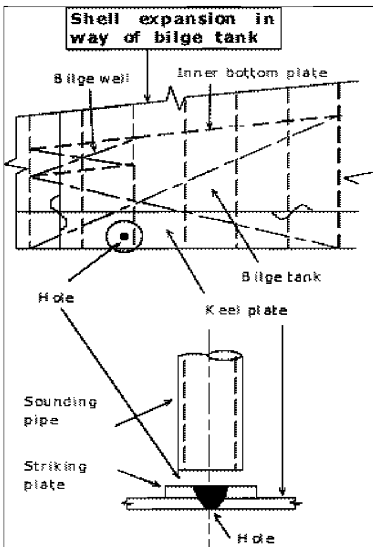
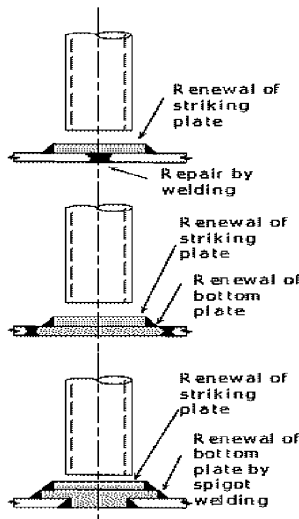
OIL Tankers		Guidelines for Surveys, Assessment and Repair of Hull Structure
Group 8	Machinery and accommodation spaces	Example No.
Area 1	Engine room	2
Detail of damage		Corrosion in bottom plating under sounding pipe in way of bilge storage tank in engine room
Sketch of damage		Sketch of repair

<b>Factors which may have caused damage</b> 1. Heavy corrosion of bottom plating under sounding pipe.		<b>Notes on repairs</b> 1. Corroded striking plating should be renewed. 2. Bottom plate should be repaired depending on the condition of corrosion.  <i>(Note):</i> Repair by spigot welding can be applied to the structure only when the stress level is considerably low. Generally this procedure cannot be applied to the repair of bottom plating of ballast tanks in cargo tank region.

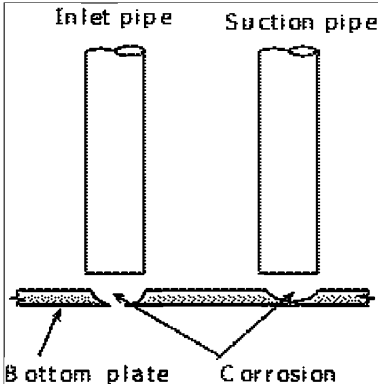
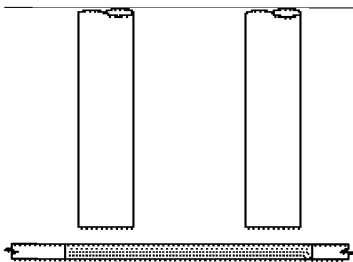
OIL Tankers		Guidelines for Surveys, Assessment and Repair of Hull Structure
Group 8	Machinery and accommodation spaces	Example No.
Area 1	Engine room	3
Detail of damage		Corrosion in bottom plating under inlet/suction/pipe in way of bilge tank in engine room
Sketch of damage		Sketch of repair

Factors which may have caused damage		Notes on repairs
<ol style="list-style-type: none"> <li>1. Heavy corrosion of bottom plating under the inlet/suction pipe.</li> </ol>		<ol style="list-style-type: none"> <li>1. Corroded bottom plate is to be cropped and part renewed. Thicker plate is preferable.</li> <li>2. Replacement of pipe end by enlarged conical opening (similar to suction head in ballast tank) is preferable.</li> </ol>

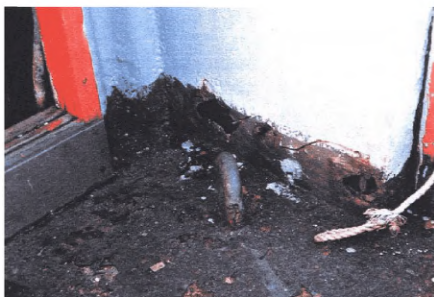
**Photograph 1 Corroded accommodation house side structure**

Severe corrosion may be found in exposed deck plating and deck house side structure adjacent to the deck plating where water is liable to accumulate (See **Photograph 1**). Corrosion may also be found in accommodation bulkheads around cut-out for fittings, such as doors, side scuttles, ventilators, etc., where proper maintenance of the area is relatively difficult. Deterioration of the bulkheads including fittings may impair the integrity of weathertightness.

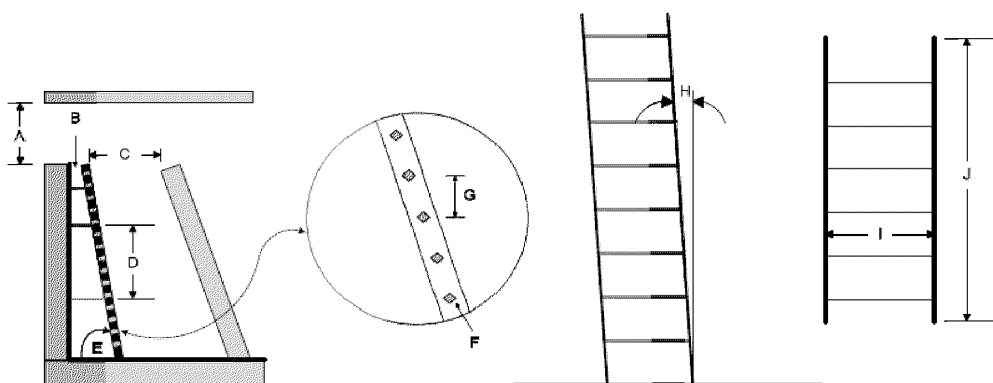
**Figure 2 Vertical Ladders (General Criteria)**

<i>Dimension</i>	<i>Recommendation</i>
A	Overhead Clearance	2130 mm (84.0 in.)
B	Ladder distance (gap accommodating toe space) from surface (at 90 degrees)	≥ 175 mm (7.0 in.) ≤ 200 mm (8.0 in.)
C	Horizontal Clearance (from ladder face and obstacles)	≥ 750 mm (29.5 in.) or ≥ 600 mm (23.5 in.) (in way of openings)
D	Distance between ladder attachments / securing devices	≤ 2.5 m (8.0 ft)
E	Ladder angle of inclination from the horizontal	80 to 90 degrees
F	Rung Design – (Can be round or square bar; where square bar is fitted, orientation should be edge up)	Square bar 25 mm (1.0 in.) x 25 mm (1.0 in.)  Round bar 25 mm (1.0 in.) diameter
G	Distance between ladder rungs (rungs evenly spaced throughout the full run of the ladder)	≥ 275 mm (11.0 in.) ≤ 300 mm (12.0 in.)
H	Skew angle	≤ 2 degrees
I	Stringer separation	400 to 450 mm (16.0 to 18.0 in.)
J	Ladder height: Ladders over 6 m (19.7 ft) require intermediate/linking platforms)	≤ 6.0 m (19.5 ft)

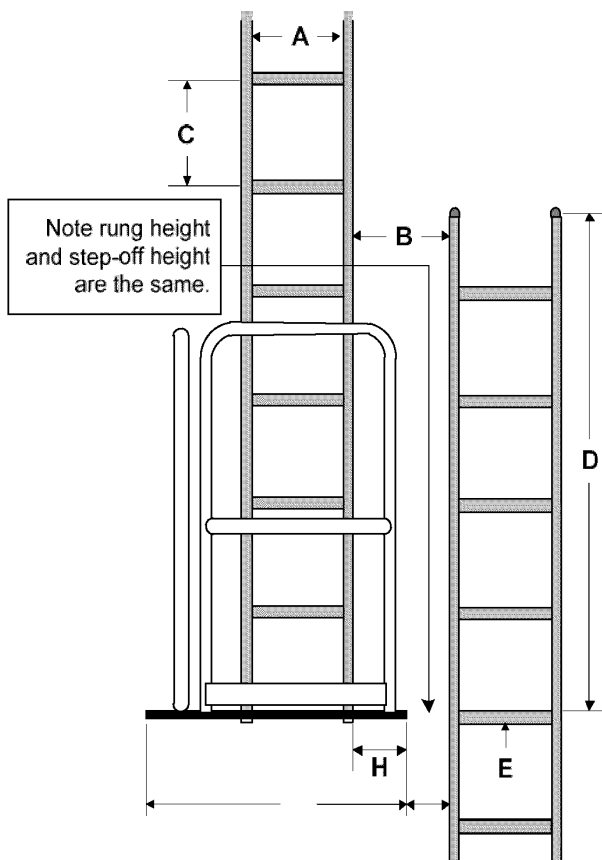
Dimension		Recommendation
A	Stringer separation	400 to 450 mm (16.0 to 18.0 in.)
B	Horizontal separation between two vertical ladders, stringer to stringer	≥ 225 mm (9 in.) ≤ 450 mm (18 in.)
C	Distance between ladder rungs (rungs evenly spaced throughout the full run of the ladder)	≥ 275 mm (11.0 in.) ≤ 300 mm (12.0 in.)
D	Stringer height above landing or intermediate platform	≥ 1350 mm (53.0 in.)
E	Rung design – (Can be round or square bar; where square bar is fitted, orientation should be edge up)	Square bar 22 mm (0.9 in.) x 22 mm (0.9 in.)  Round bar 25 mm (1.0 in.) diameter
F	Horizontal separation between ladder and platform	≥ 150 mm (6.0 in.) ≤ 300 mm (12.0 in.)
G	Landing or intermediate platform width	≥ 925 mm (36.5 in.)
H	Platform ladder to Platform ledge	≥ 75 mm (3.0 in.) ≤ 150 mm (6.0 in.)

\*Note: Left side guardrail of platform omitted for clarity.

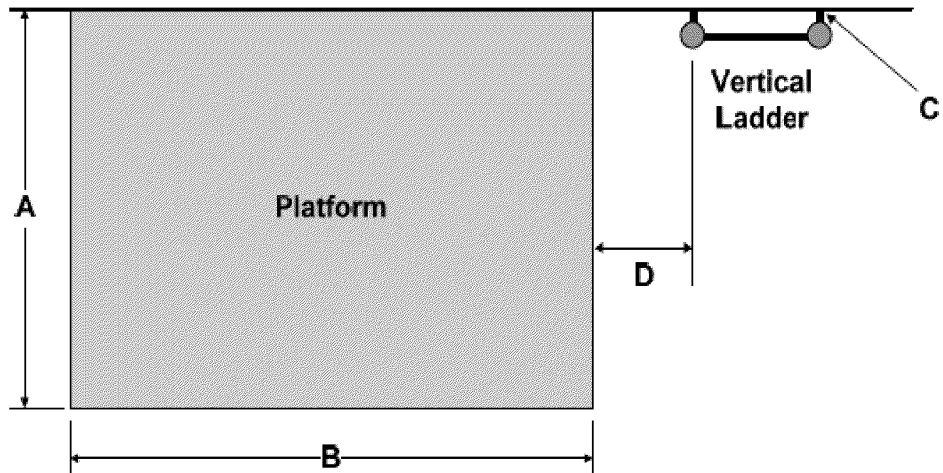
**Figure 4 Vertical Ladders to Landings (Side Mount)\***

<i>Dimension</i>		<i>Recommendation</i>
A	Platform depth	≥ 750 mm (29.5 in.)
B	Platform width	≥ 925 mm (36.5 in.)
C	Ladder distance from surface	≥ 175 mm (7.0 in.)
D	Horizontal separation between ladder and platform	≥ 150 mm (6.0 in.) and ≤ 300 mm (12.0 in.)

\* Notes: Top view. Guardrails/Handrails not shown.

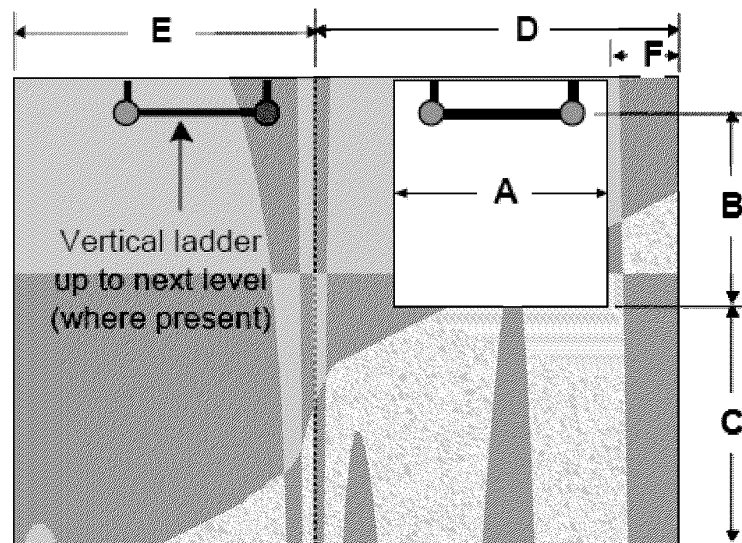
<i>Dimension</i>		<i>Recommendation</i>
A	Vertical ladder opening	≥ 750 mm (29.5 in.)
B	Distance from front of vertical ladder to back of platform opening	≥ 750 mm (29.5 in.)
C	Minimum clear standing area in front of ladder opening – Depth	≥ 750 mm (29.5 in.)
D	Minimum clear standing area in front of ladder opening – Width	≥ 925 mm (36.5 in.)
E	Additional platform width for intermediate landing (where present)	≥ 925 mm (36.5 in.)
F	Horizontal separation between ladder and platform	≥ 150 mm (6.0 in.) and ≤ 300 mm (12.0 in.)

\*Notes: Top view. Guardrails/Handrails not shown.

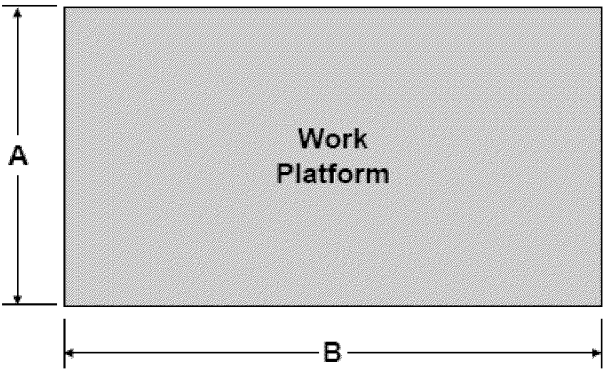
Figure 6 Work Platform Dimensions

Dimension		Recommendation
A	Work platform width	≥ 750 mm (29.5 in.)
	Work platform width (if used for standing only)	≥ 380 mm (15.0 in.)
B	Work platform length	≥ 925 mm (37.0 in.)
	Work platform length (if used for standing only)	≥ 450 mm (18.0 in.)

In addition to the recommendations for Work Platforms presented in Section 4.6 Access & Egress Design, the following recommended dimensions relating to the design of Work Platforms are presented in Figure 6 ‘Work Platform Dimensions’.

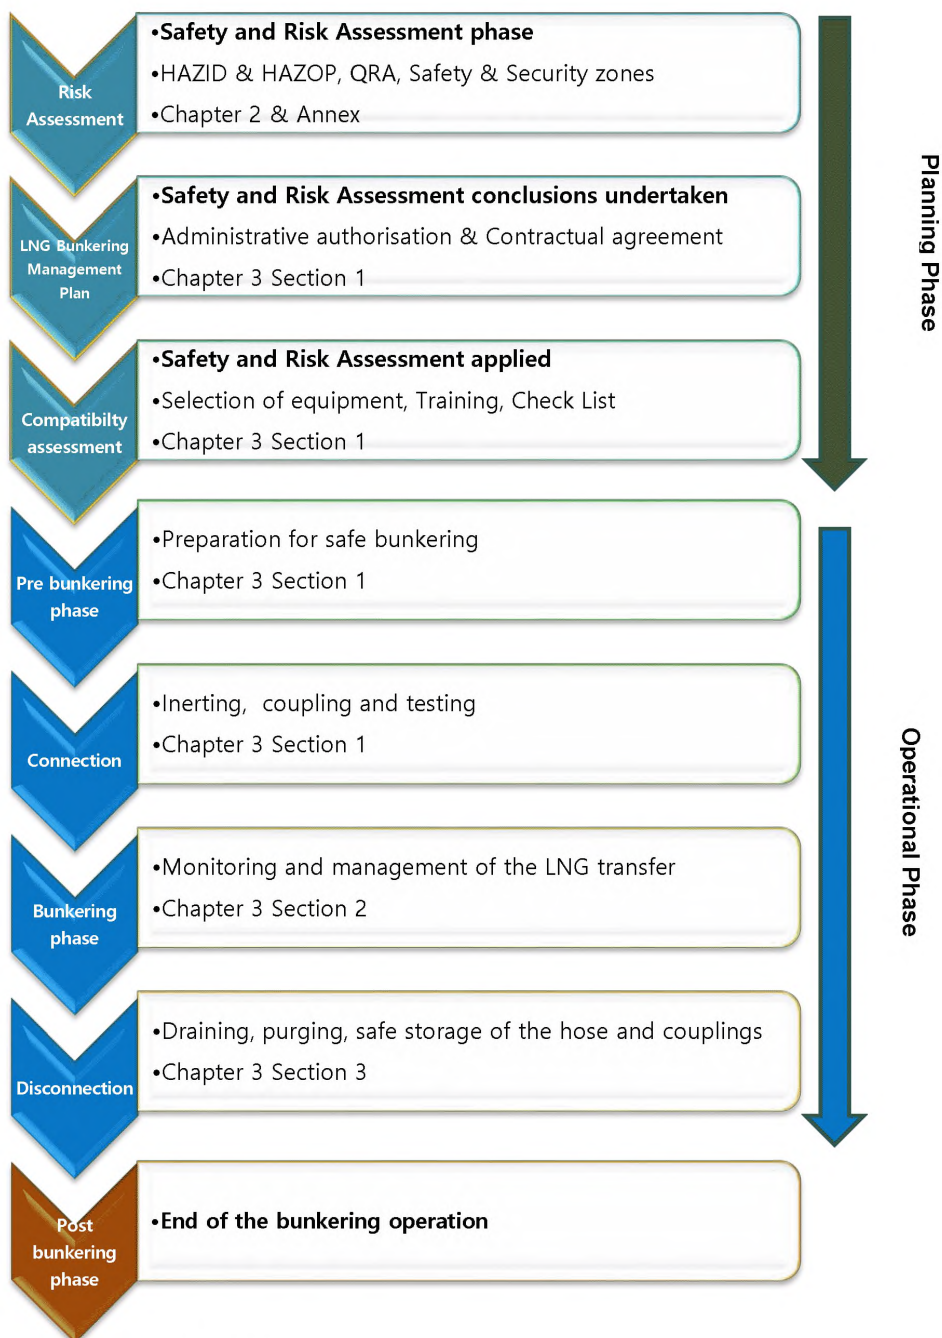
Figure 1: Bunkering process

The sequence for a bunkering operation carried out between two parties for the first time is described in the following diagram; the references identify the applicable sections of the guideline.

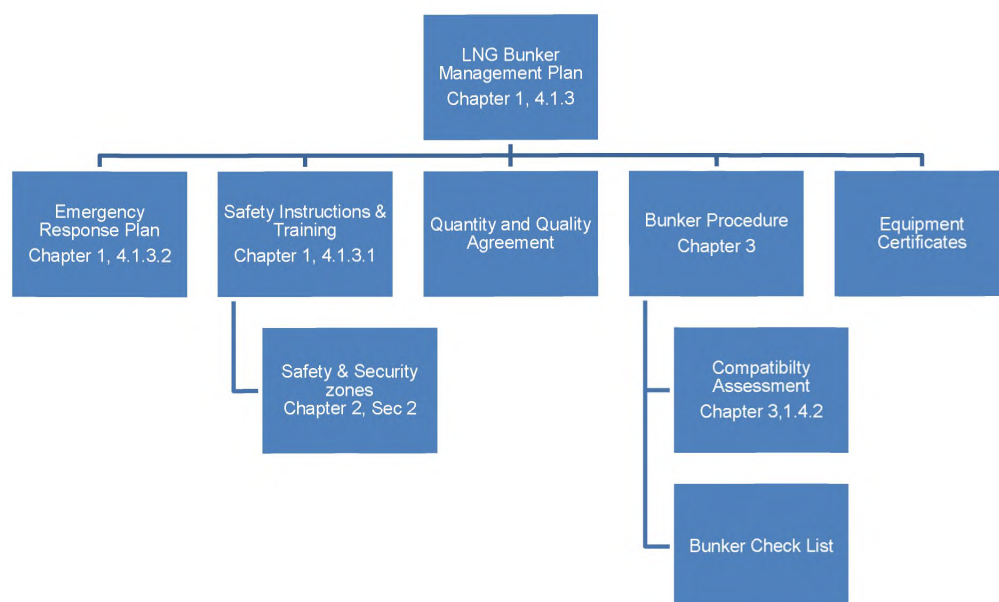
**Figure 2: Breakdown of LNGBMP content showing related sections of this guide**

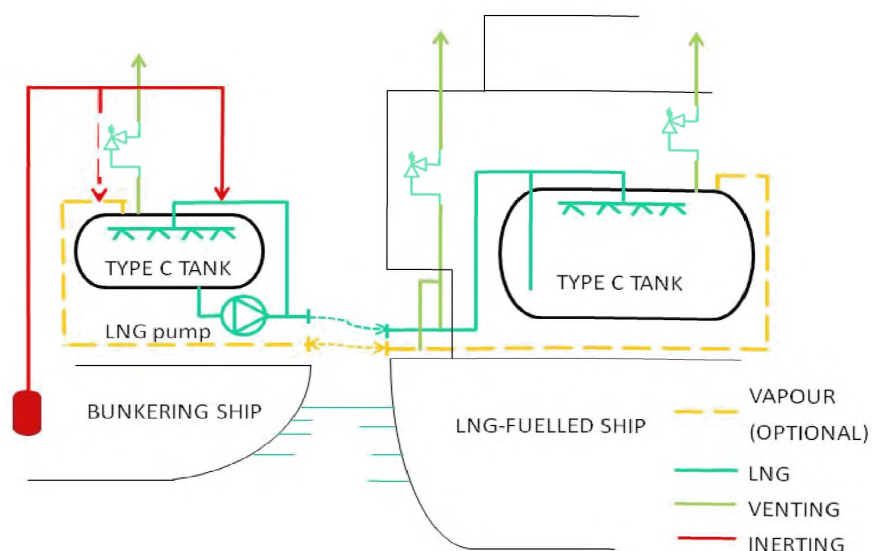
**Figure 3: Ship-to-ship bunkering - typical arrangement of bunkering ship and LNG fuelled ship with type C tank**

Note: For small scale bunker supply using Type C tanks, the LNG supply pressure may be generated by pump (as shown in the figures below) or by a Pressure Built Up unit.

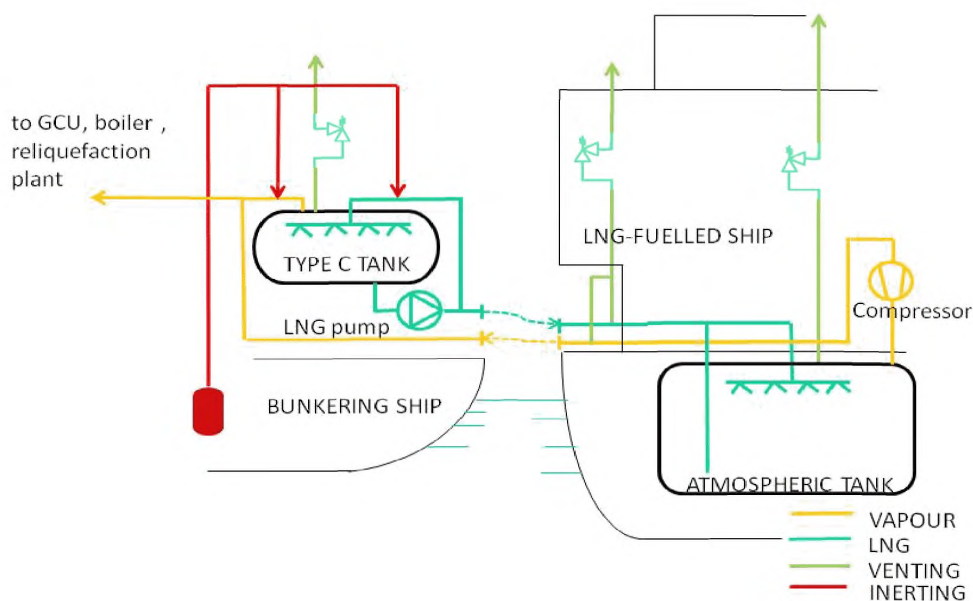
**Figure 4: Ship-to-ship bunkering - typical arrangement of bunkering ship with type C tank and LNG fuelled ship with atmospheric tank**

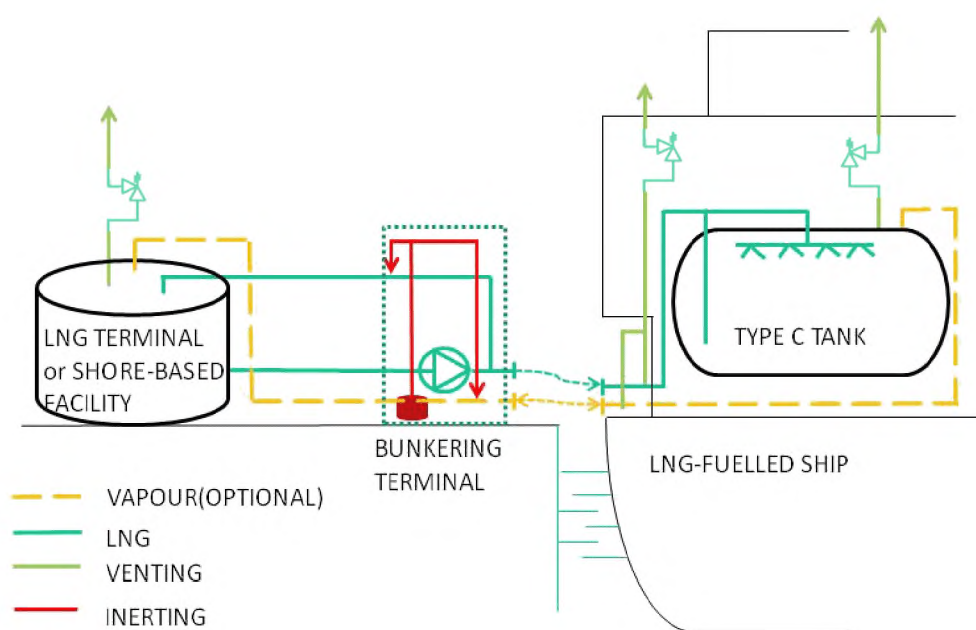
**Figure 7: Terminal to ship bunkering - typical arrangement of LNG fuelled ship with type C tank**

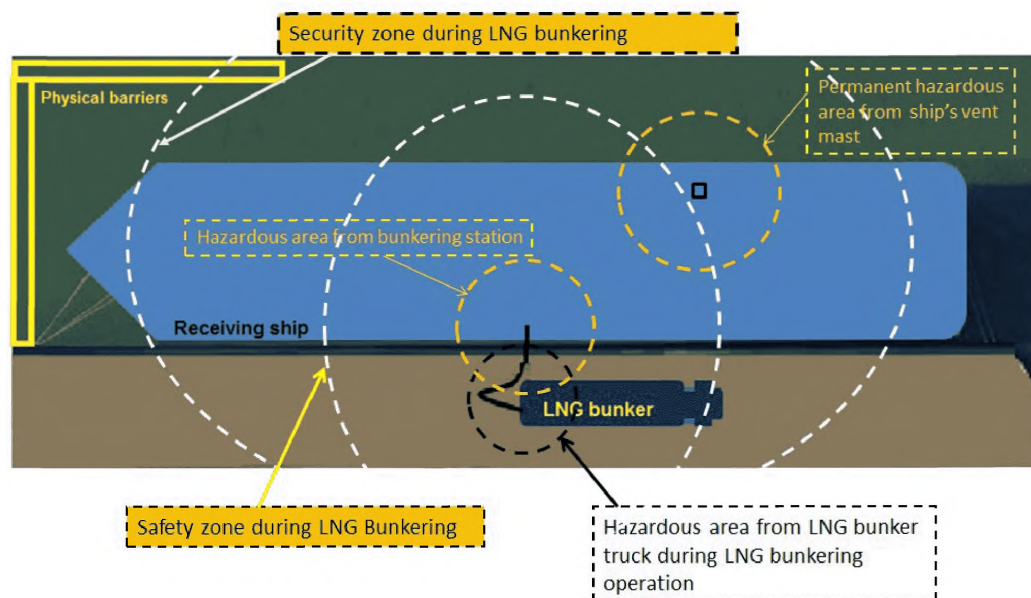
A safety zone and a security zone should be established around the bunkering operation in accordance with ISO/TS 18683. These zones are in addition to the established practice of setting hazardous area classification zones that will be required around areas with potential for explosive atmospheres such as the bunkering connections. A pictorial example of these zones is illustrated below.

The purpose of the safety zone is to set an area within which only essential personnel are allowed and potential ignition sources are controlled. Essential personnel are those required to monitor and control the bunkering operation. Similarly, the purpose of the security zone is to set an area within which ship/port traffic is monitored and controlled.

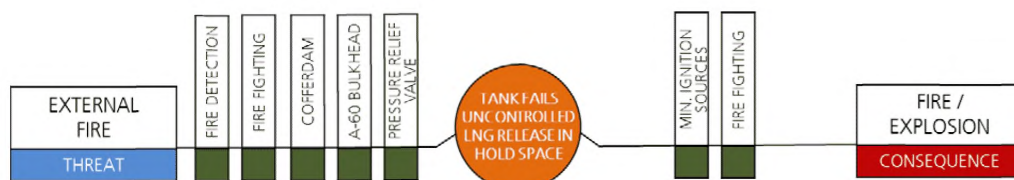
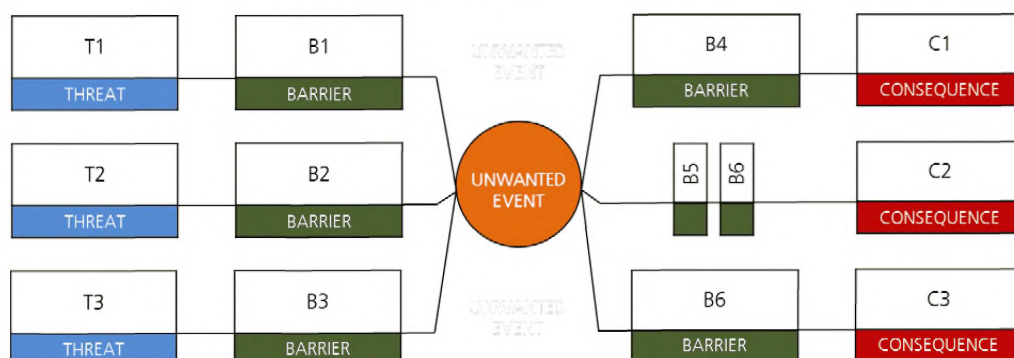
- Threat** – A cause that can potentially lead to the unwanted event.
- Barrier** – A mitigation measure that can potentially prevent the unwanted event or its consequences.
- Unwanted Event** – A situation to be avoided e.g. a release of fuel or a loss of ship propulsion.
- Consequence** – An outcome of a threat and an unwanted event not being mitigated by the barriers.

*In respect of 'mitigation measures' (i.e. barriers) those prior to the unwanted event are often referred to as preventative barriers or prevention measures.*
