**РОССИЙСКИЙ МОРСКОЙ РЕГИСТР СУДОХОДСТВА**  
**RUSSIAN MARITIME REGISTER OF SHIPPING**

**ПРИЛОЖЕНИЕ К ПРАВИЛАМ**  
**РОССИЙСКОГО МОРСКОГО РЕГИСТРА СУДОХОДСТВА**  
**УНИФИЦИРОВАННЫЕ ИНТЕРПРЕТАЦИИ**  
**И РЕКОМЕНДАЦИИ**  
**МЕЖДУНАРОДНОЙ АССОЦИАЦИИ**  
**КЛАССИФИКАЦИОННЫХ ОБЩЕСТВ**

**SUPPLEMENT TO RULES**  
**OF RUSSIAN MARITIME REGISTER OF SHIPPING**  
**IACS UNIFIED INTERPRETATIONS**  
**AND RECOMMENDATIONS**

НД № 2-020101-085-R-E

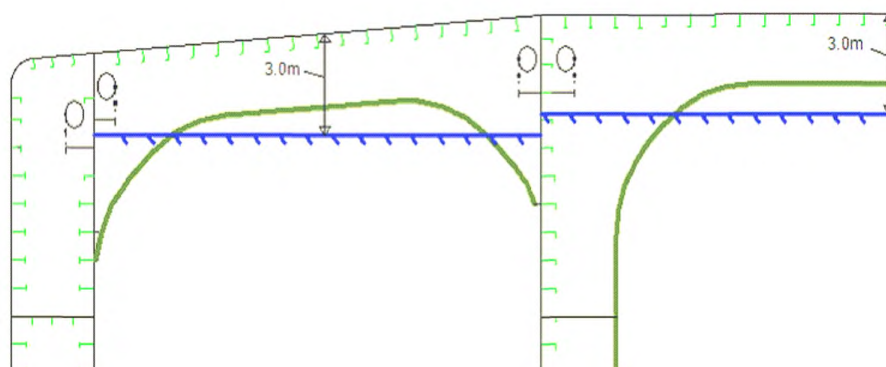
Where rafting is indicated in the ship structures access manual as the means to gain ready access to the under deck structure, the term "*similar obstructions*" referred to in the regulation includes internal structures (e.g., webs >1.5m deep) which restrict the ability to raft (at the maximum water level needed for rafting of under deck structure) directly to the nearest access ladder and hatchway to deck. When rafts or boats alone, as an alternative means of access, are allowed under the conditions specified in resolution A.744(18), permanent means of access are to be provided to allow safe entry and exit. This means:

- a) access direct from the deck via a vertical ladder and small platform fitted approximately 2m below the deck in each bay; or
- b) access to deck from a longitudinal permanent platform having ladders to deck in each end of the tank. The platform shall, for the full length of the tank, be arranged in level with, or above, the maximum water level needed for rafting of under deck structure. For this purpose, the ullage corresponding to the maximum water level is to be assumed not more than 3m from the deck plate measured at the midspan of deck transverses and in the middle length of the tank. (See Figure below). A permanent means of access from the longitudinal permanent platform to the water level indicated above is to be fitted in each bay (e.g., permanent rungs on one of the deck webs inboard of the longitudinal permanent platform).

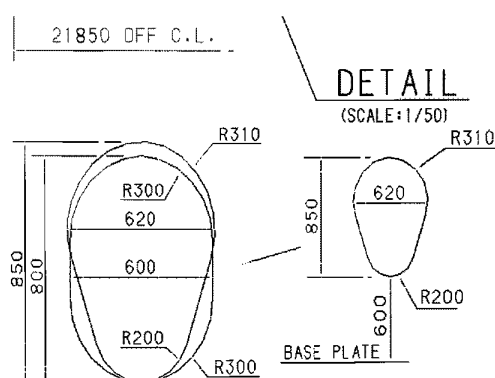
1. The minimum clear opening of not less than 600 mm x 800 mm may also include an opening with corner radii of 300 mm. An opening of 600mm in height x 800mm in width may be accepted as access openings in vertical structures where it is not desirable to make large opening in the structural strength aspects, i.e. girders and floors in double bottom tanks.
2. Subject to verification of easy evacuation of injured person on a stretcher the vertical opening 850 mm x 620 mm with wider upper half than 600 mm, while the lower half may be less than 600 mm with the overall height not less than 850 mm is considered an acceptable alternative to the traditional opening of 600 mm x 800 mm with corner radii of 300 mm.

3. If a vertical opening is at a height of more than 600 mm steps and handgrips are to be provided. In such arrangements it is to be demonstrated that an injured person can be easily evacuated.

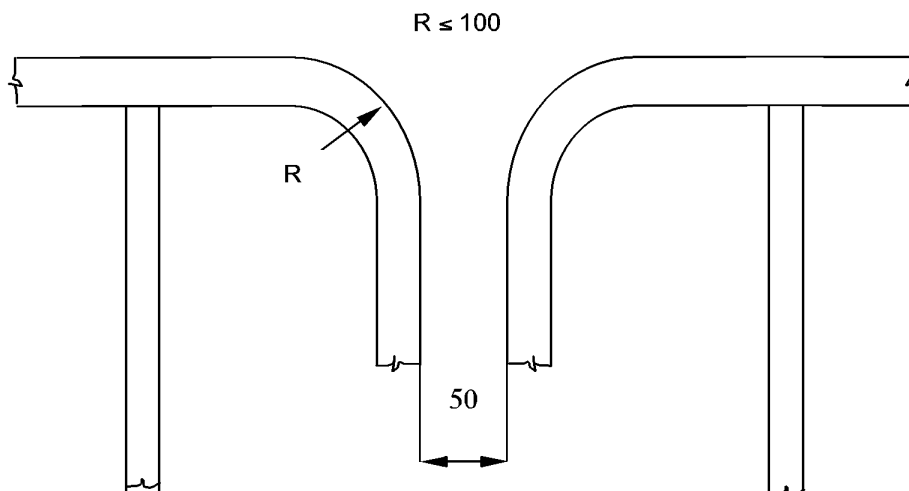
The maximum distance between the stanchion and other structural members is not to exceed 200 mm where the top and mid handrails are not connected together and 300 mm when they are connected together.

When the top and mid handrails are connected by a bent rail, the outside radius of the bent part is not to exceed 100 mm (see Figure below).

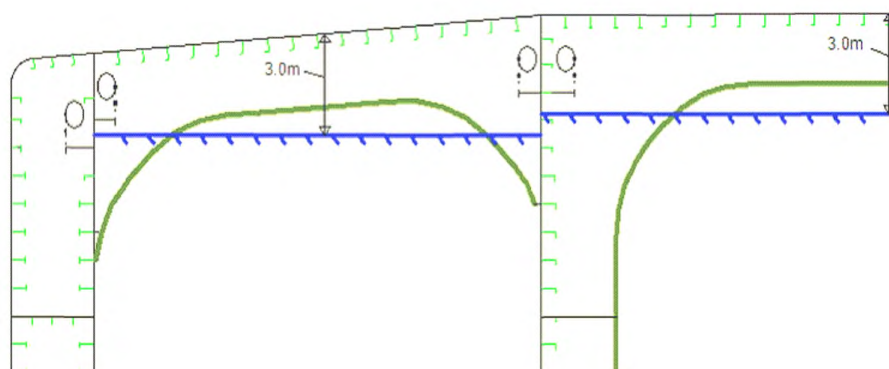
Where rafting is indicated in the ship structures access manual as the means to gain ready access to the under deck structure, the term "*similar obstructions*" referred to in the regulation includes internal structures (e.g., webs >1.5m deep) which restrict the ability to raft (at the maximum water level needed for rafting of under deck structure) directly to the nearest access ladder and hatchway to deck. When rafts or boats alone, as an alternative means of access, are allowed under the conditions specified in resolution A.744(18), A.1049(27) (2011 ESP Code), as amended, permanent means of access are to be provided to allow safe entry and exit. This means:

- a) access direct from the deck via a vertical ladder and small platform fitted approximately 2m below the deck in each bay; or
- b) access to deck from a longitudinal permanent platform having ladders to deck in each end of the tank. The platform shall, for the full length of the tank, be arranged in level with, or above, the maximum water level needed for rafting of under deck structure. For this purpose, the ullage corresponding to the maximum water level is to be assumed not more than 3m from the deck plate measured at the midspan of deck transverses and in the middle length of the tank. (See Figure below). A permanent means of access from the longitudinal permanent platform to the water level indicated above is to be fitted in each bay (e.g., permanent rungs on one of the deck webs inboard of the longitudinal permanent platform).

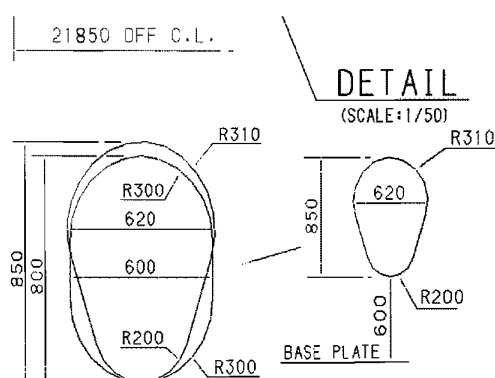
1. The minimum clear opening of not less than 600 mm x 800 mm may also include an opening with corner radii of 300 mm. An opening of 600mm in height x 800mm in width may be accepted as access openings in vertical structures where it is not desirable to make large opening in the structural strength aspects, i.e. girders and floors in double bottom tanks.
2. Subject to verification of easy evacuation of injured person on a stretcher the vertical opening 850 mm x 620 mm with wider upper half than 600 mm, while the lower half may be less than 600 mm with the overall height not less than 850 mm is considered an acceptable alternative to the traditional opening of 600 mm x 800 mm with corner radii of 300 mm.

3. If a vertical opening is at a height of more than 600 mm steps and handgrips are to be provided. In such arrangements it is to be demonstrated that an injured person can be easily evacuated.

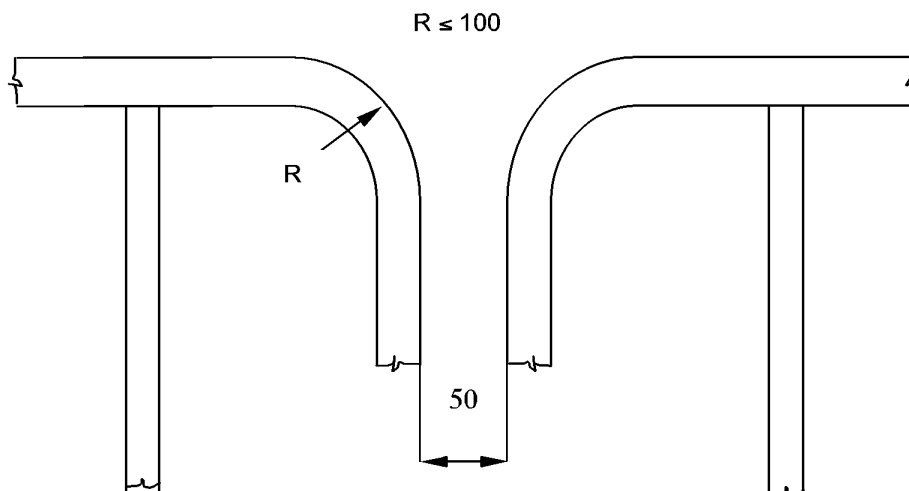
The maximum distance between the stanchion and other structural members is not to exceed 200 mm where the top and mid handrails are not connected together and 300 mm when they are connected together.

When the top and mid handrails are connected by a bent rail, the outside radius of the bent part is not to exceed 100 mm (see Figure below).

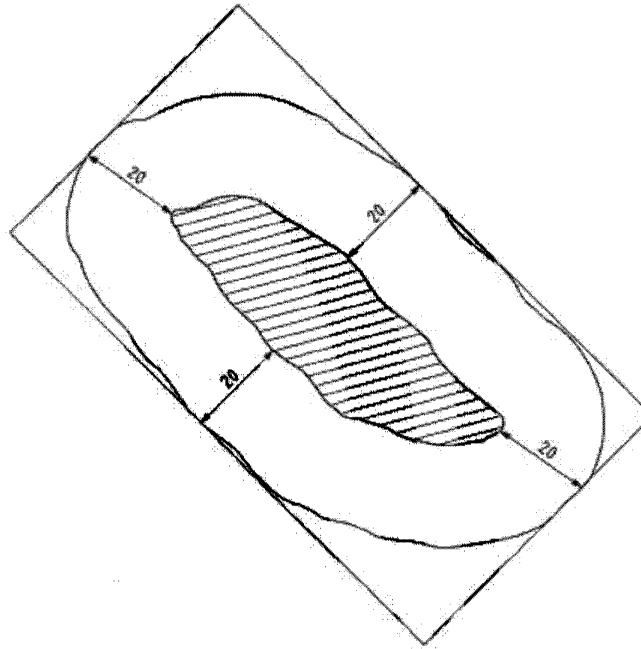
For isolated surface discontinuities, influenced area is obtained by drawing a continuous line which follows the circumference of the discontinuity at a distance of 20 mm. (Figure 1)

Figure 1 - Determination of the area influenced by an isolated discontinuity  
(Ref. Nr. EN 10163-1:2004+AC:2007 E)

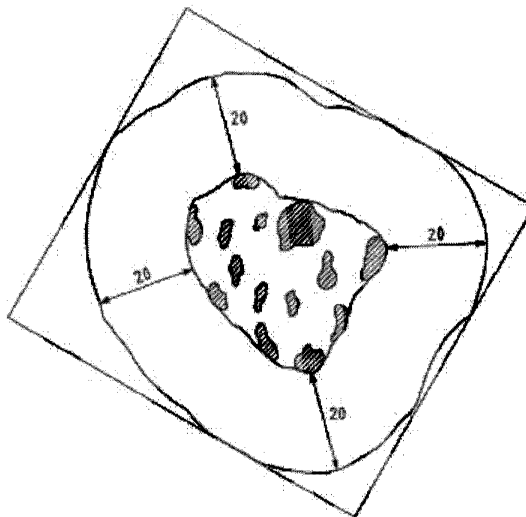
For surface discontinuities appearing in a cluster, influenced area is obtained by drawing a continuous line which follows the circumference of the cluster at a distance of 20 mm. (Figure 2)

Figure 2 - Determination of the area influenced by clustered discontinuities  
(Ref. Nr. EN 10163-1:2004+AC:2007 E)

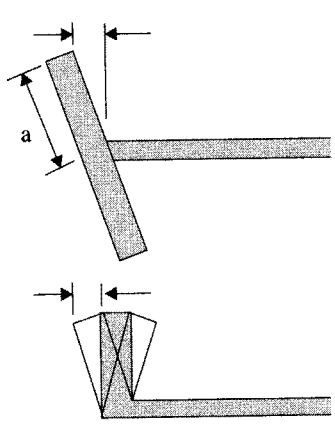
Detail	Standard	Limit	Remarks
<p>Frames and longitudinal</p>

$\pm 1.5 \text{ mm}$	$\pm 3 \text{ mm}$	per 100 mm of a
<p>Distortion of face plate</p>

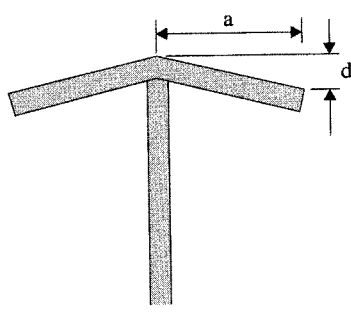
$d \leq 3 + a/100 \text{ mm}$	$d \leq 5 + a/100 \text{ mm}$	
<p>Distortion in plane of web and flange of built up longitudinal frame, transverse frame, girder and transverse web.</p>

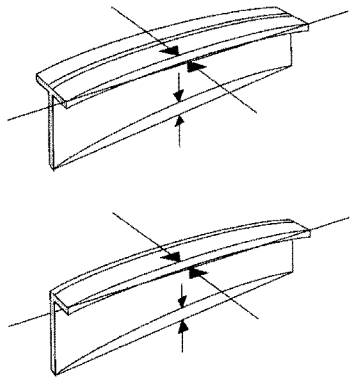
$\pm 10 \text{ mm}$	$\pm 25 \text{ mm}$	per 10 m in length

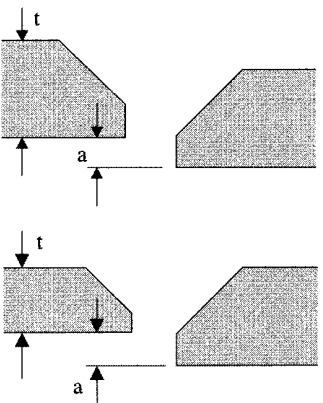
Detail	Standard	Limit	Remarks
<p>Alignment of butt welds</p>

$a \leq 0.15t$ strength member $a \leq 0.2t$ other but maximum 4.0 mm	t is the lesser plate thickness
<p>Alignment of fillet welds</p>

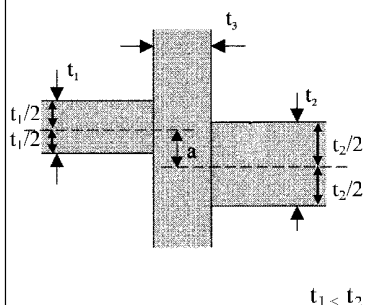
<p style="text-align: center;"><math>t_1 &lt; t_2</math></p>		Strength member and higher stress member: $a \leq t_1/3$  Other: $a \leq t_1/2$	Alternatively, heel line can be used to check the alignment.  Where $t_3$ is less than $t_1$ , then $t_3$ should be substituted for $t_1$ in the standard.
<p>Alignment of fillet welds</p>

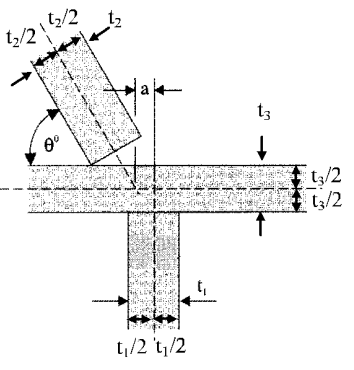
Strength member and higher stress member: $a \leq t_1/3$  Other: $a \leq t_1/2$	Alternatively, heel line can be used to check the alignment.  Where $t_3$ is less than $t_1$ , then $t_3$ should be substitute for $t_1$ in the standard.

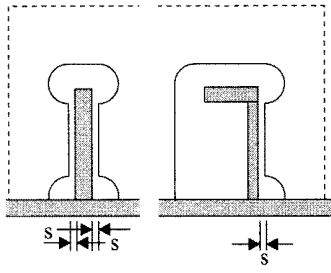
$a \leq 2.0 \text{ mm}$	$a = 5.0 \text{ mm}$	
<p>Gap around stiffener cut-out</p>

$s \leq 2.0 \text{ mm}$	$s = 3.0 \text{ mm}$

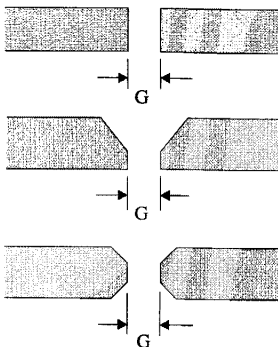
Detail	Standard	Limit	Remarks
<p>Submerged Arc Welding (SAW)</p>

$0 \leq G \leq 0.8 \text{ mm}$	$G = 2 \text{ mm}$	<p>See Note 1.</p>
<p><b>NOTE 1</b></p> <p>Different plate edge preparation may be accepted or approved by the Classification Society in accordance with URW28 or other recognized standard accepted by the Classification Society.</p> <p>For welding procedures other than manual welding, see paragraph 3.2 <u>Qualification of welding procedures</u>.</p>

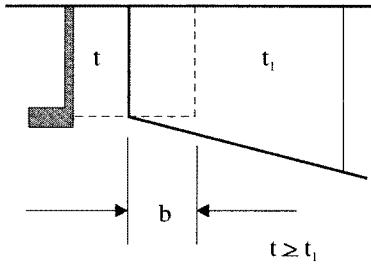
<p>When <math>3 \text{ mm} &lt; a \leq 5 \text{ mm}</math>: weld leg length to be increased by increase in gap in excess of 3 mm</p>	
	<p>When <math>5 \text{ mm} &lt; a \leq 10 \text{ mm}</math>: chamfer <math>30^\circ</math> to <math>40^\circ</math> and build up by welding with backing</p>	
	<p>When <math>a &gt; 10 \text{ mm}</math>: increase gap to about 50 mm and fit collar plate</p>

<p><math>b = (2t + 25) \text{ mm, min. } 50 \text{ mm}</math></p>	
<p>Gap between beam and frame</p>

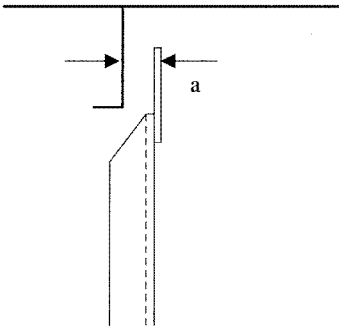
<p><math>3 \text{ mm} &lt; a \leq 5 \text{ mm}</math>: weld leg length to be increased by the same amount as increase in gap in excess of 3 mm</p> <p><math>a &gt; 5 \text{ mm}</math> release and adjust</p>

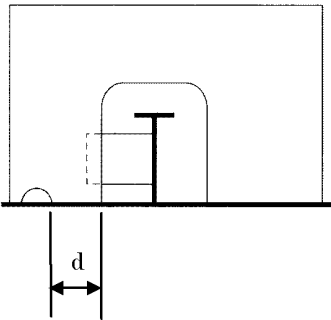
Detail	Remedial standard	Remarks
<p>Position of scallop</p>

<p>When <math>d &lt; 75</math> mm web plate to be cut between scallop and slot, and collar plate to be fitted</p>

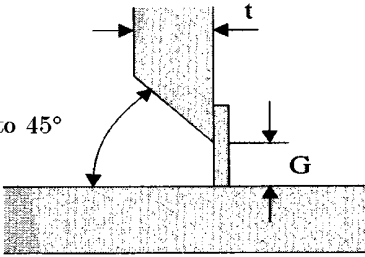
<p><math>3 \text{ mm} &lt; G \leq 5 \text{ mm}</math> – leg length increased to Rule leg + (G-2)</p>	
	<p><math>5 \text{ mm} &lt; G \leq 16 \text{ mm}</math> or <math>G \leq 1.5t</math> - chamfer by <math>30^\circ</math> to <math>45^\circ</math>, build up with welding, on one side, with backing strip if necessary, grind and weld.</p>

<p><math>G &gt; 16 \text{ mm}</math> or <math>G &gt; 1.5t</math> use insert plate of minimum width 300 mm</p>

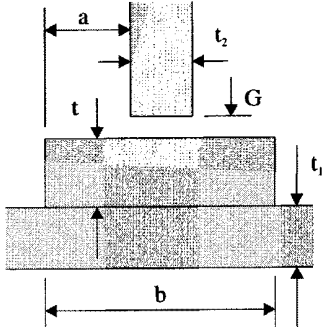
<p>Liner treatment</p>

<p> <math>t_2 \leq t \leq t_1</math>  <math>G \leq 2 \text{ mm}</math>  <math>a = 5 \text{ mm} + \text{fillet leg length}</math> </p>	<p>Not to be used in cargo area or areas of tensile stress through the thickness of the liner</p>

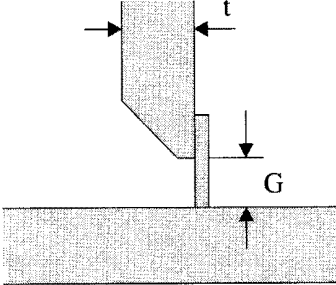
<p><math>3\text{ mm} &lt; G \leq 5\text{ mm}</math> build up weld</p>	
	<p><math>5\text{ mm} &lt; G \leq 16\text{ mm}</math> - build up with welding, with backing strip if necessary, remove backing strip if used, back gouge and back weld.</p>

<p><math>G &gt; 16\text{ mm}</math> new plate to be inserted of minimum width 300 mm</p>

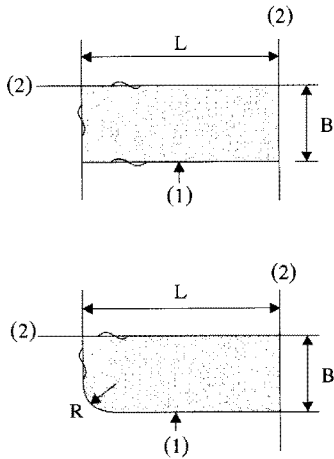
Detail	Remedial standard	Remarks
<p>Remedial by insert plate</p>

<p> <math>L = 300 \text{ mm minimum}</math>  <math>B = 300 \text{ mm minimum}</math>  <math>R = 5t \text{ mm}</math>  <math>100\text{mm minimum}</math> </p> <p> (1) seam with insert piece is to be welded first  (2) original seam is to be released and welded over for a minimum of 100 mm. </p>	
<p>Remedial of built section by insert plate</p>

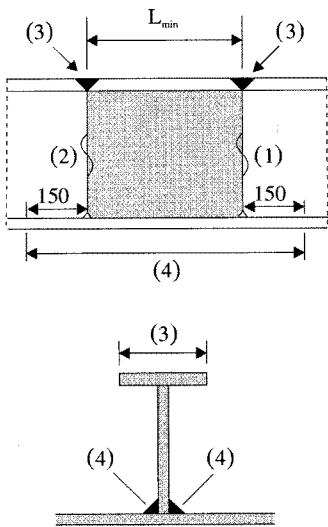
<p> <math>L_{\min} \geq 300 \text{ mm}</math> </p> <p> Welding sequence  (1) → (2) → (3) → (4) </p> <p> Web butt weld scallop to be filled during final pass (4) </p>

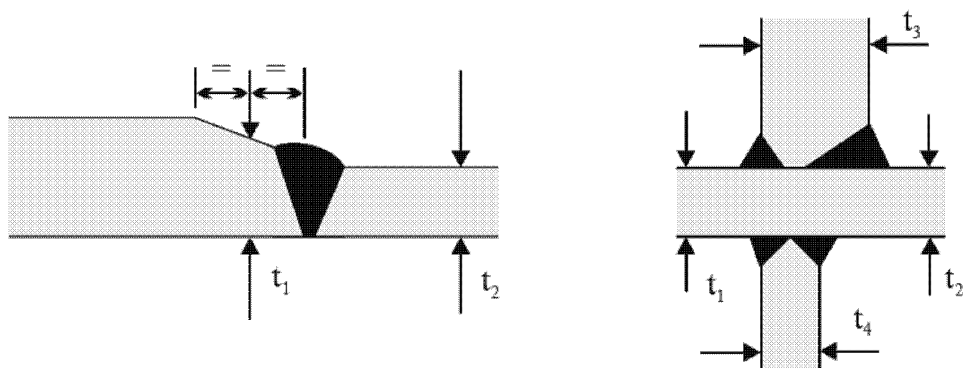
2) Combined thickness  $t_{comb} = t_1 + t_2 + t_3 + t_4$ , see figure

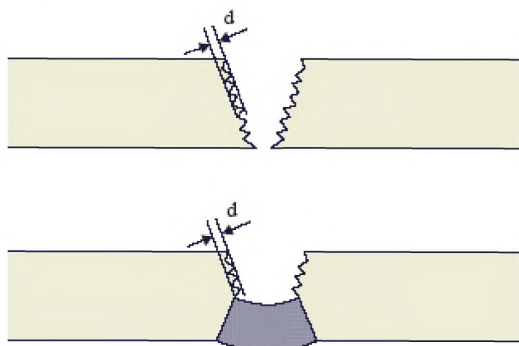
**Fig 6.1 Groove roughness**

Item	Standard	Limit	Remarks
Material Grade	Same as original or higher		See Section 4
Welding Consumables	IACS UR W17 (ref. 6)	Approval according to equivalent international standard	
Groove / Roughness	See note and Fig 6.1	$d < 1.5 \text{ mm}$	Grind smooth
Pre-Heating	See Table 5.1	Steel temperature not lower than 5°C	
Welding with water on the outside	See Section 5.3	Acceptable for normal and high strength steels	- Moisture to be removed by a heating torch
Alignment	As for new construction		
Weld Finish	IACS Recommendation 20 (ref. 10)		
NDE	IACS Recommendation 20 (ref. 10)	At random with extent to be agreed with attending surveyors

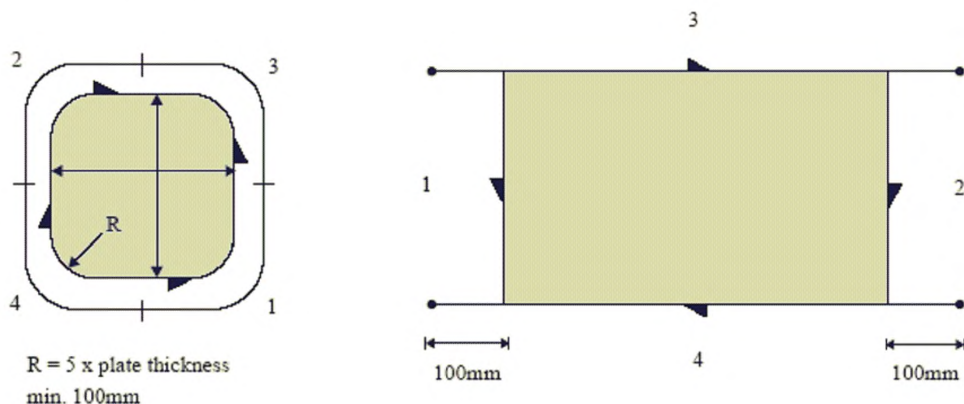
Fig 6.2 Welding sequence for inserts

Item	Standard	Limit	Remarks
Size Insert	Min. 300 x 300 mm $R = 5 \times \text{thickness}$ Circular inserts: $D_{\min} = 200 \text{ mm}$	Min. 200 x 200 mm Min $R = 100 \text{ mm}$	
Material Grade	Same as original or higher		See Section 4.
Edge Preparation	As for new construction		In case of non compliance increase the amount of NDE
Welding Sequence	See Fig 6.2 Weld sequence is $1 \rightarrow 2 \rightarrow 3 \rightarrow 4$		For primary members sequence 1 and 2 transverse to the main stress direction
Alignment	As for new construction		
Weld Finish	IACS Recommendation 20 (ref. 10)		
NDE	IACS Recommendation 20 (ref. 10)

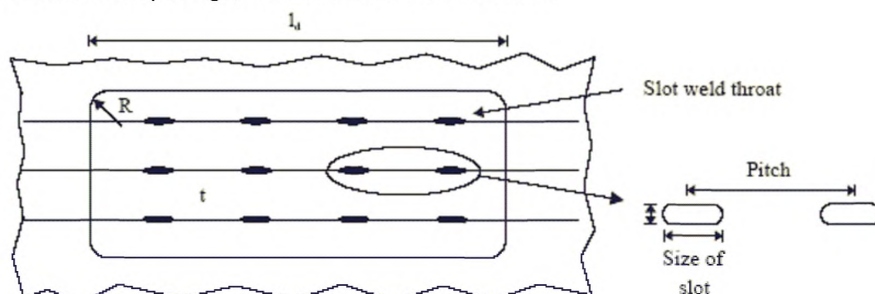
**Fig 6.3 Doublers on plates**

Local doublers are normally only allowed as temporary repairs, except as original compensation for openings, within the main hull structure.

Item	Standard	Limit	Remarks
Existing Plating		General: $t \geq 5 \text{ mm}$	For areas where existing plating is less than 5 mm plating a permanent repair by insert is to be carried out.
Extent / Size	Rounded off corners.	min 300 x 300 mm $R \geq 50 \text{ mm}$	
Thickness of Doubler (td)	$td \leq tp$ ( $tp$ = original thickness of existing plating)	$td > tp/3$	
Material Grade	Same as original plate		See Section 4
Edge Preparation	As for [newbuilding] new construction		Doublers welded on primary strength members: ( $Le$ : leg length) when $t > Le + 5 \text{ mm}$ , the edge to be tapered (1:4)
Welding	As for [newbuilding] new construction		Welding sequence similar to insert plates.
Weld Size (throat thickness)	Circumferencial and in slots: $0.6 \times td$		
Slot Welding	Normal size of slot: $(80-100) \times 2 \text{ td}$  Distance from doubler edge and between slots: $d \leq 15 \text{ td}$	Max pitch between slots 200 mm  $d_{max} = 500 \text{ mm}$	For doubler extended over several supporting elements, see Figure 6.3

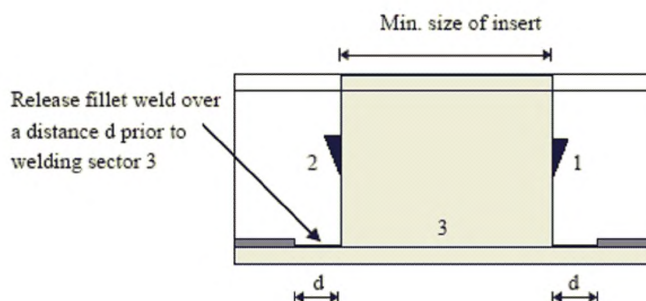
Fig 6.4 Welding sequence for inserts of stiffeners

Item	Standard	Limit	Remarks
Size Insert	Min. 300 mm	Min. 200 mm	
Material Grade	Same as original or higher		See Section 4.
Edge Preparation	As for new construction. Fillet weld stiffener web / plate to be released over min. d = 150 mm		
Welding Sequence	See Fig 6.4 Welding sequence is 1 → 2 → 3		
Alignment	As for new construction		
Weld Finish	IACS Recommendation 20 (ref. 10)		
NDE	IACS Recommendation 20 (ref. 10)

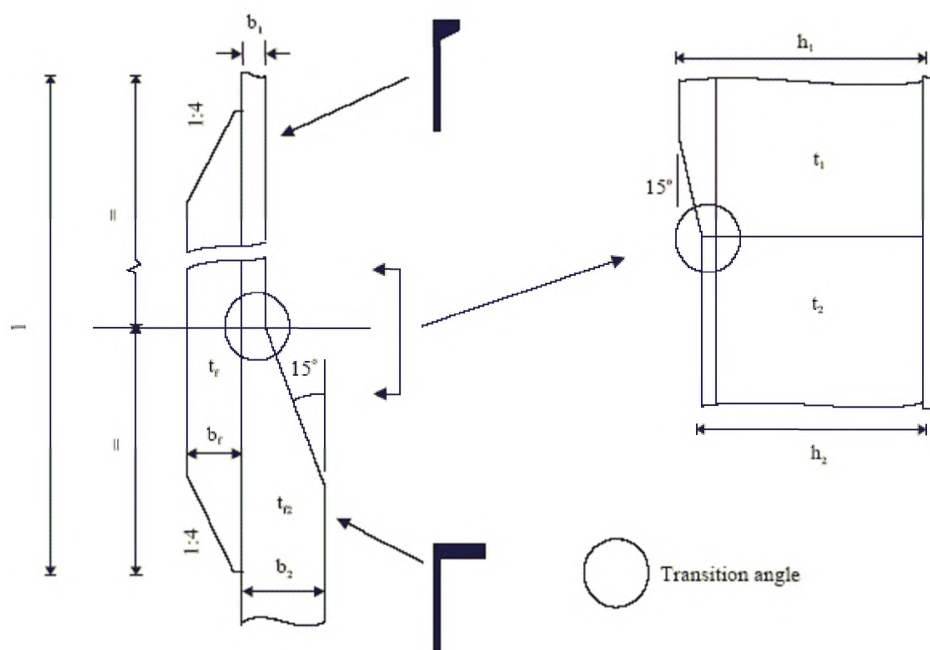
**Fig 6.5 Transition between inverted angle and bulb profile**

The application of the transition is allowed for secondary structural elements.

Item	Standard	Limit	Remarks
$(h_1 - h_2)$	$\leq 0.25 \times b_1$		
$ t_1 - t_2 $	2 mm		Without tapering transition.
Transition Angle	15 degrees		At any arbitrary section
Flanges	$t_f = t_2$ $b_f = b_2$		
Length of Flatbar	$4 \times h_1$		
Material			See Section 4.

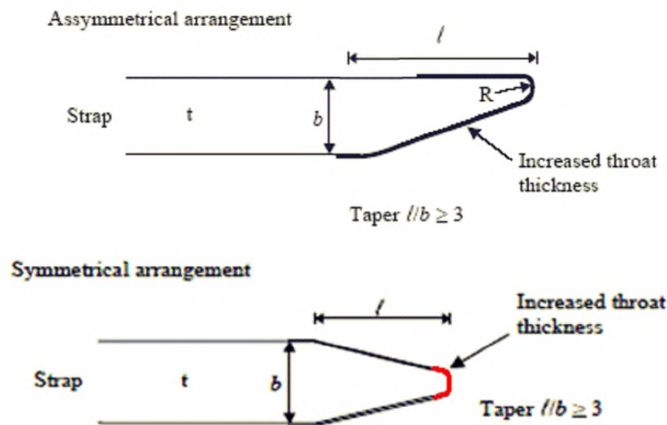
Fig 6.6 Application of Doubling Straps

- the end termination points of the straps, so that toe support is such that no isolated hard point occurs.
- in the case of application of symmetrical or asymmetrical-ended straps, the corners at the end of the tapering should be properly rounded.
- any butts between lengths of doubling straps, so that there is adequate separation of the butt weld from the primary structure below during welding, and so that a high quality root run under controlled circumstances is completed prior to completing the remainder of the weld. Ultrasonic testing should be carried out on completion to verify full penetration.

Item	Standard	Limit	Remarks
Tapering	$l/b > 3$		Special consideration to be drawn to design of strap terminations in fatigue sensitive areas.
Radius	$0.1 \times b$	min 30 mm	
Material			See paragraph 2.0 General requirement to materials.
Weld Size			Depending on number and function of straps. Throat thickness to be increased 15 % toward ends.
Welding	Welding sequence from middle towards the free ends		See sketch. For welding of lengths > 1000 mm step welding to be applied.

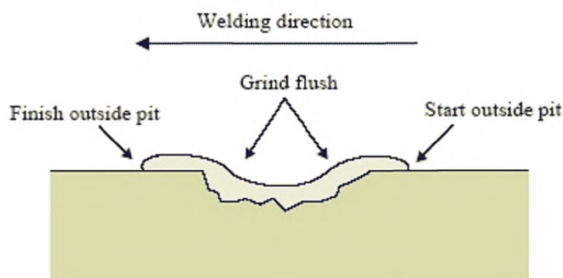
Fig 6.7 Welding of pits

Shallow pits may be filled by applying coating or pit filler. Pits can be defined as shallow when their depth is less than  $\frac{1}{3}$  of the original plate thickness.

Item	Standard	Limit	Remarks
Extent / Depth	Pits / grooves are to be welded flush with the original surface.	If deep pits or grooves are clustered together or remaining thickness is less than 6 mm, the plates should be renewed.	See also IACS Recommendation 12 (ref. 9)
Cleaning	Heavy rust to be removed		
Pre-Heating	See Table 5.1	Required when ambient temperature < 5°C	Always use propane torch or similar to remove any moisture
Welding Sequence	Reverse direction for each layer		See also IACS Recommendation 12 (ref. 9)
Weld Finish	IACS Recommendation 20 (ref. 10)		
NDE	IACS Recommendation 20 (ref. 10)	Min. 10% extent	Preferably MPI

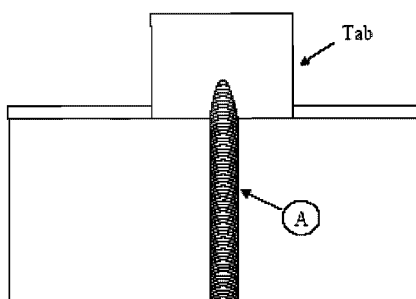
Fig 6.8.b End crack termination

Item	Standard	Limit	Remarks
Groove Preparation	$\theta = 45-60^\circ$ $r = 5 \text{ mm}$		For through plate cracks as for newbuilding. Also see Fig 6.8.d
Termination	Termination to have slope 1:3		For cracks ending on edges weld to be terminated on a tab see Fig 6.8.b
Extent	On plate max. 400 mm length. Vee out 50 mm past end of crack	On plate max 500 mm. Linear crack, not branched	
Welding Sequence	See Fig 6.8.c for sequence and direction	For cracks longer than 300 mm step-back technique should be used Fig 6.8.a	Always use low hydrogen welding consumables
Weld Finish	IACS Recommendation 20 (ref. 10)		
NDE	IACS Recommendation 20 (ref. 10)	100 % MP or PE of groove	100 % surface crack detection + UE or RE for butt joints

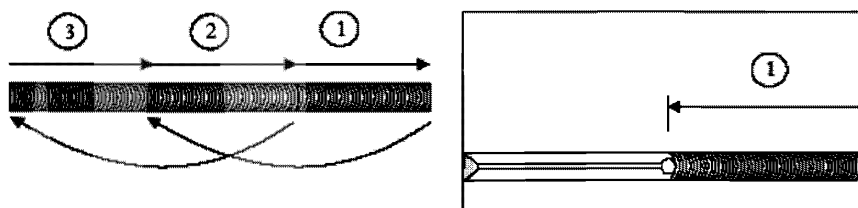
Fig 6.8.c Welding sequence for cracks with length less than 300 mm

In the event that a crack is considered weldable, either as a temporary or permanent repair, the following techniques should be adopted as far as practicable. Run-on and run-off plates should be adopted at all free edges.

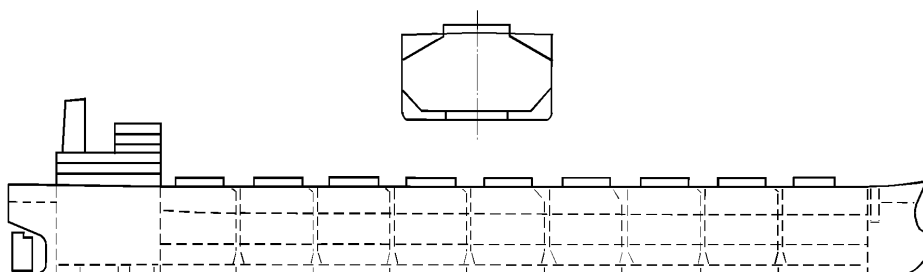
**Figure 1 General view of a typical single skin bulk carrier**

This manual gives guidelines for a bulk carrier type ship which is constructed with a single deck, single skin, double bottom, hopper side tanks and topside tanks in cargo spaces, and is intended primarily to carry dry cargo, including ore, in bulk. **Figure 1** shows the general view of a typical single skin bulk carrier with 9 cargo holds.

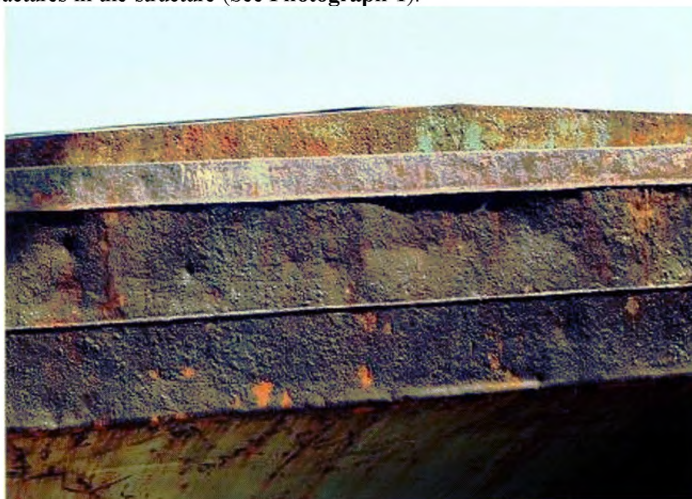
**Photograph 1**      Heavy corrosion of hatch coaming and topside tank plating vertical strake

- 3.1.1 The level of wastage of under-deck stiffeners/structure in cross deck may have to be established by means of thickness measurements. The combined effect of the marine environment and the high humidity atmosphere within cargo hold s will give rise to a high corrosion rate.
- 3.1.2 Severe corrosion of the hatch coaming plating inside cargo hold and topside tank plating vertical strake may occur due to difficult access for the maintenance of the protective coating. This may lead to fractures in the structure (See **Photograph 1**).

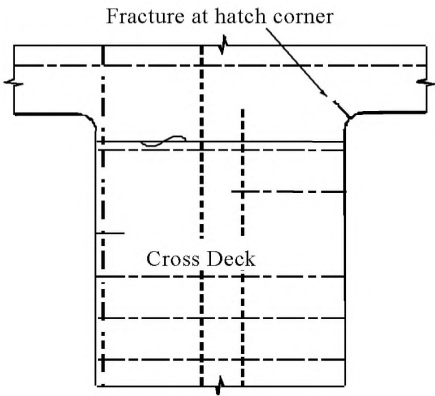
<b>BULK CARRIERS</b>		<b>Guidelines for Surveys, Assessment and Repair of Hull Structure</b>	
<b>Part 1</b>	<b>Cargo hold region</b>	<b>Example No.</b>	
<b>Area 1</b>	<b>Deck structure</b>	<b>1</b>	
<b>Detail of damage</b>		Fractures at main cargo hatch corner	
<b>Sketch of damage</b>

<b>Notes on possible cause of damage</b> <ol style="list-style-type: none"> <li>1. Stress concentration at hatch corners, i.e. radius of corner.</li> <li>2. Welded attachment of shedder plate close to edge of hatch corner.</li> <li>3. Wire rope groove.</li> </ol>		<b>Notes on repairs</b> <ol style="list-style-type: none"> <li>1. The corner plating in way of the fracture is to be cropped and renewed. If stress concentration is primary cause, insert plate should be increased thickness, enhanced steel grade and/or improved geometry. Insert plate should be continued beyond the longitudinal and transverse extent of the hatch corner radius ellipse or parabola, and the butt welds to the adjacent deck plating should be located well clear of the butts in the hatch coaming. It is recommended that the edges of the insert plate and the butt welds connecting the insert plates to the surrounding deck plating be made smooth by grinding. In this respect caution should be taken to ensure that the micro grooves of the grinding are parallel to the plate edge.</li> <li>2. If the cause of fracture is welded attachment of shedder plate, the deck connection should be left unwelded.</li> <li>3. If the cause of the fracture is wire rope groove, replacement to the original design can be accepted.</li> </ol>

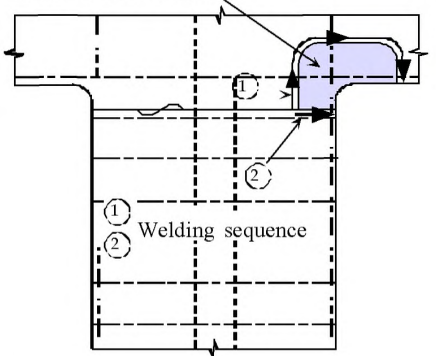
<b>Sketch of repair</b> Insert plate of enhanced steel grade and increased thickness

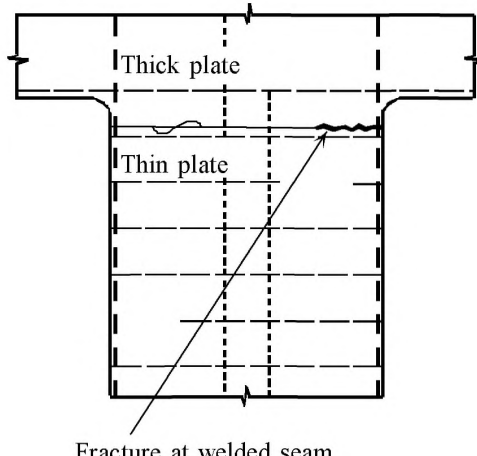
BULK CARRIERS		Guidelines for Surveys, Assessment and Repair of Hull Structure	
Part 1	Cargo hold region		Example No.
Area 1	Deck structure		2-a
Detail of damage		Fractures of welded seam between thick plate and thin plate at cross deck	
Sketch of damage		Sketch of repair

<p>Thick plate</p> <p>Thin plate</p> <p>Fracture at welded seam</p>

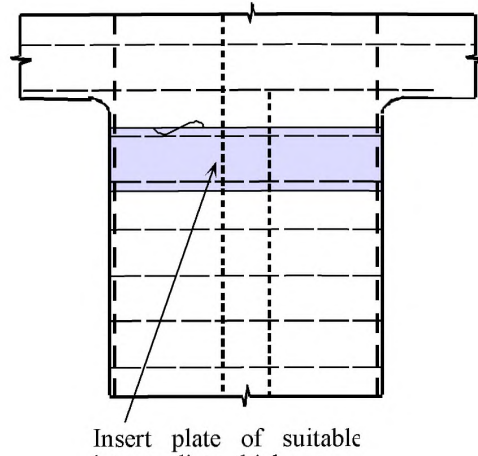
<p>Insert plate of suitable intermediate thickness</p>	
Notes on possible cause of damage		Notes on repairs	
<ol style="list-style-type: none"><li>1. Stress concentration created by abrupt change in deck plating thickness.</li><li>2. In-plane bending in cross deck strip due to torsional (longitudinal) movements of ship sides.</li><li>3. Welded seam not clear of tangent point of hatch corner.</li></ol>		<ol style="list-style-type: none"><li>1. Insert plate of intermediate thickness is recommended.</li><li>2. Smooth transition between plates (beveling) should be considered.</li></ol>

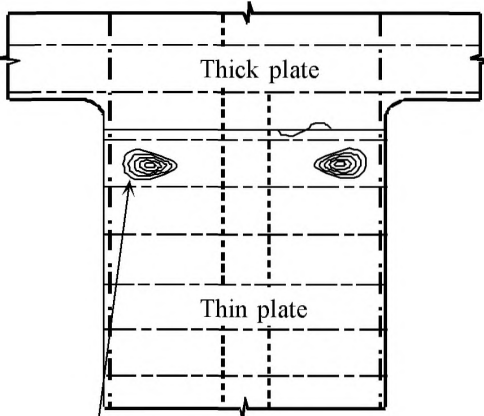
<b>BULK CARRIERS</b>		<b>Guidelines for Surveys, Assessment and Repair of Hull Structure</b>	
<b>Part 1</b>	<b>Cargo hold region</b>		<b>Example No.</b>
<b>Area 1</b>	<b>Deck structure</b>		<b>2-b</b>
<b>Detail of damage</b>		Plate buckling in thin plate near thick plate at cross deck	
<b>Sketch of damage</b>

<p>Buckling of cross deck plating (Buckling of hatch end structure should be examined. Refer to <b>Example 7-a.</b>)</p>		<b>Sketch of repair</b>

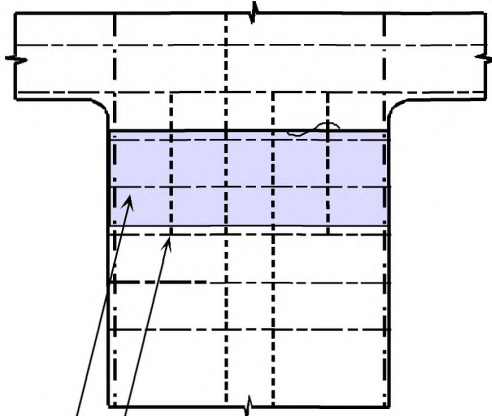
<p>Additional transverse stiffening and/or insertion of plate with suitable intermediate thickness</p>	
<b>Notes on possible cause of damage</b> <ol style="list-style-type: none"> <li>1. In-plane bending of cross deck strip due to torsional (longitudinal) movement of ship sides, often in combination with corrosion.</li> <li>2. Insufficient plate thickness and/or transverse stiffening.</li> </ol>		<b>Notes on repairs</b> <ol style="list-style-type: none"> <li>1. Transverse stiffeners extending from hatch sides towards centerline at least 10% of breadth of hatch, and/or increased plate thickness in the same area.</li> </ol>

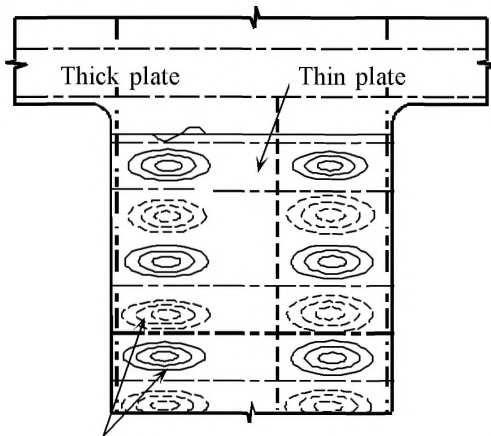
<b>BULK CARRIERS</b>		<b>Guidelines for Surveys, Assessment and Repair of Hull Structure</b>	
<b>Part 1</b>	<b>Cargo hold region</b>		<b>Example No.</b>
<b>Area 1</b>	<b>Deck structure</b>		<b>2-c</b>
<b>Detail of damage</b>		Overall buckling of cross deck plating	
<b>Sketch of damage</b>

<p>Buckling of cross deck plating (Buckling of hatch end structure should be examined. Refer to Example 7-a.)</p>		<b>Sketch of repair</b> <b>Repair A</b>

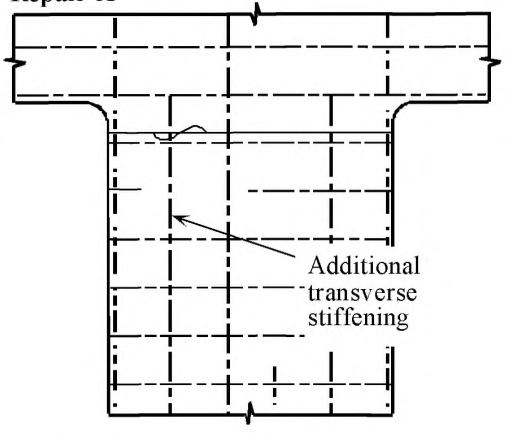
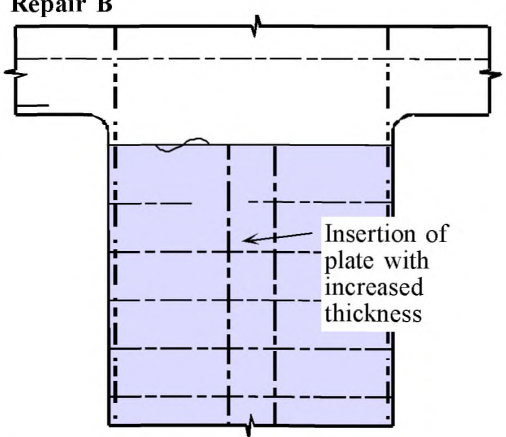
<b>Repair B</b>

<b>Notes on possible cause of damage</b> <ol style="list-style-type: none"> <li>1. Transverse compression of deck due to sea load.</li> <li>2. Transverse compression of deck due to excessive loading in two adjacent holds.</li> <li>3. Insufficient plate thickness and/or transverse stiffening.</li> </ol>		<b>Notes on repairs</b> <ol style="list-style-type: none"> <li>1. <b>Repair A</b> Plating of original thickness in combination with additional transverse stiffening.</li> <li>2. <b>Repair B</b> Insertion of plating of increased thickness.</li> </ol>

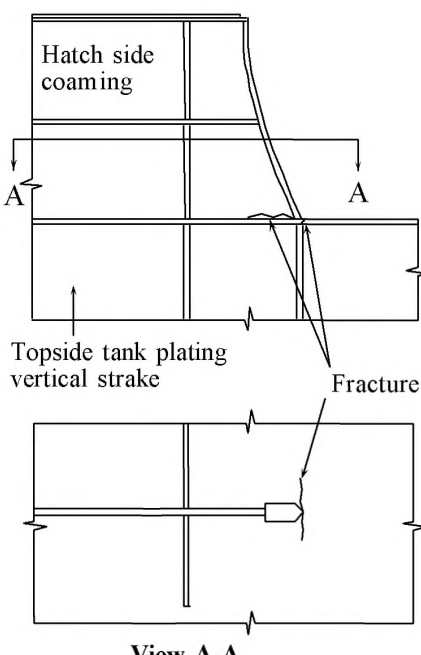
<b>BULK CARRIERS</b>		<b>Guidelines for Surveys, Assessment and Repair of Hull Structure</b>
<b>Part 1</b>	<b>Cargo hold region</b>	<b>Example No.</b>
<b>Area 1</b>	<b>Deck structure</b>	<b>3-a</b>
<b>Detail of damage</b>	Fractures in the web or in the deck at the toes of the longitudinal hatch coaming termination bracket	
<b>Sketch of damage</b>

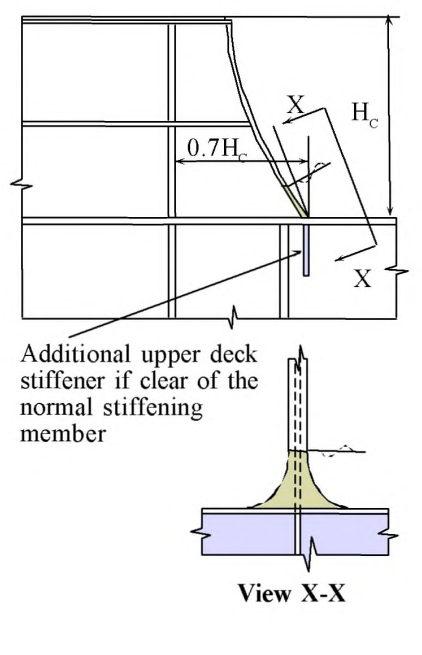
<b>Notes on possible cause of damage</b> 1. This damage is caused by stress concentrations attributed to the design of the bracket.		<b>Notes on repairs</b> 1. The design of the bracket can be altered as shown above, however, it is to be ensured that an additional under deck stiffener is provided at the toe of the termination bracket, where the toe is clear of the normal stiffening member. 2. Full penetration weld for a distance of $0.15 H_C$ from toe of side coaming termination bracket and for connection of athwartship gusset bracket to deck. 3. The fracture in deck plating to be veed-out and rewelded or deck plating cropped and part renewed as appropriate, using low hydrogen electrodes for welding.

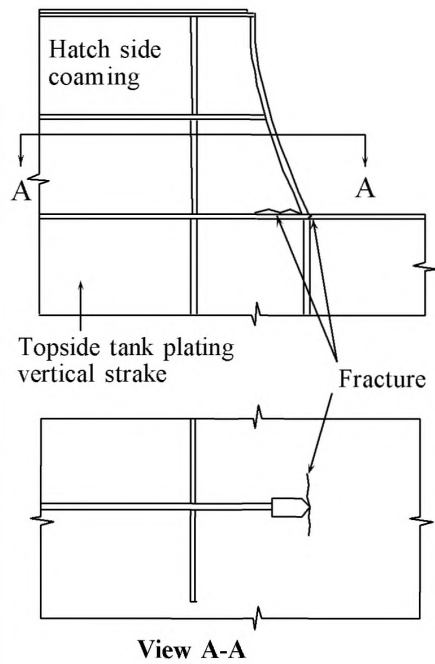
<b>BULK CARRIERS</b>		<b>Guidelines for Surveys, Assessment and Repair of Hull Structure</b>
<b>Part 1</b>	<b>Cargo hold region</b>	<b>Example No.</b>
<b>Area 1</b>	<b>Deck structure</b>	<b>3-b</b>
<b>Detail of damage</b>	Fractures in the web or in the deck at the toes of the longitudinal hatch coaming termination bracket	
<b>Sketch of damage</b>

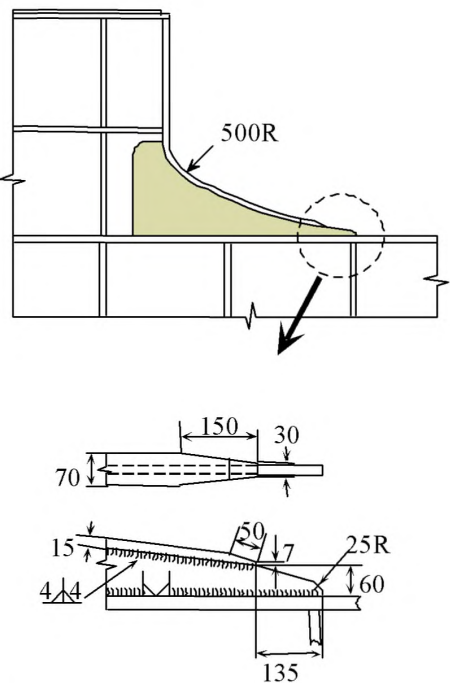
<b>Notes on possible cause of damage</b> 1. This damage is caused by stress concentrations attributed to the design of the bracket.		<b>Notes on repairs</b> 1. The design of the bracket can be altered as shown above, however, it is to be ensured that an additional under deck stiffener is provided at the toe of the termination bracket, where the toe is clear of the normal stiffening member. 2. The fracture in deck plating to be veed-out and rewelded or deck plating cropped and part renewed as appropriate, using low hydrogen electrodes for welding.

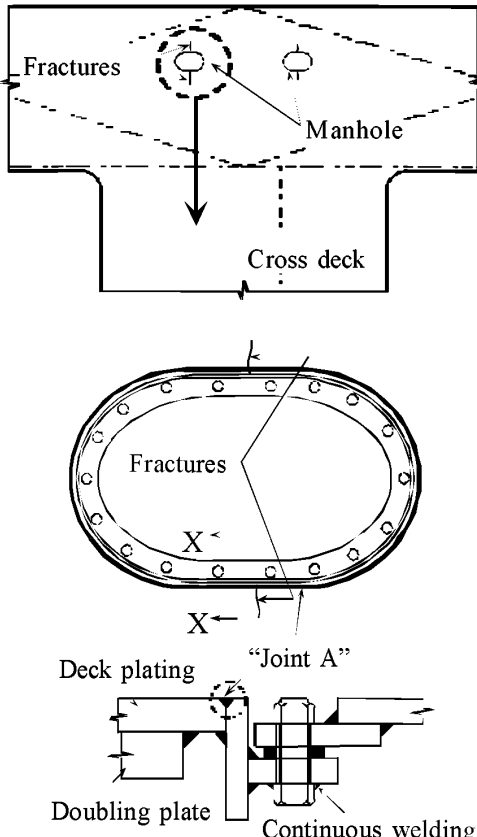
<b>BULK CARRIERS</b>		<b>Guidelines for Surveys, Assessment and Repair of Hull Structure</b>
<b>Part 1</b>	<b>Cargo hold region</b>	<b>Example No.</b>
<b>Area 1</b>	<b>Deck structure</b>	<b>4</b>
<b>Detail of damage</b>	Fractures in deck plating initiated from weld of access manhole	
<b>Sketch of damage</b>

<p>Fractures</p> <p>Manhole</p> <p>Cross deck</p> <p>Fractures</p> <p>X</p> <p>X</p> <p>Deck plating</p> <p>"Joint A"</p> <p>Doubling plate</p> <p>Continuous welding</p> <p><b>Section X-X</b></p>		<b>Sketch of repair</b>

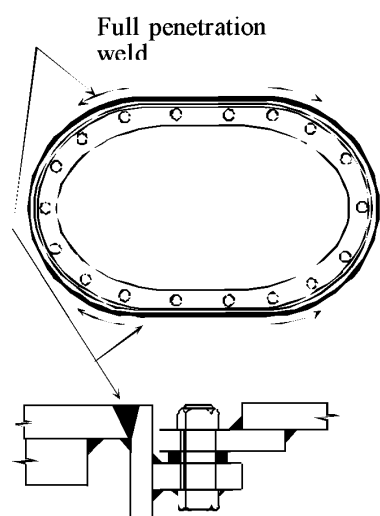
<p>Full penetration weld</p>
<b>Notes on possible cause of damage</b> <ol style="list-style-type: none"> <li>1. Heavy weather.</li> <li>2. Improper welding of joint "A".</li> </ol>		<b>Notes on repairs</b> <ol style="list-style-type: none"> <li>1. The fracture in deck plating to be veed-out and rewelded, or deck plating cropped and part renewed if considered necessary.</li> <li>2. Full penetration of joint "A" should be considered.</li> </ol>

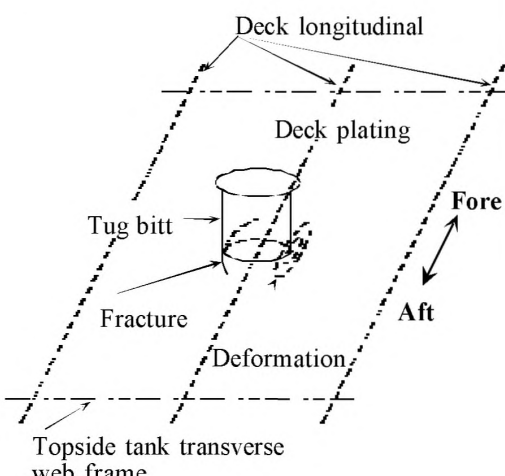
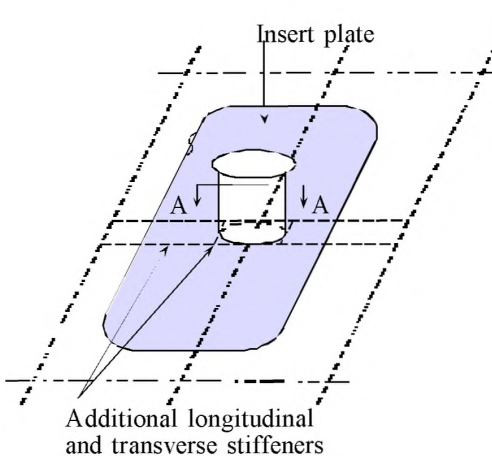
<b>BULK CARRIERS</b>		<b>Guidelines for Surveys, Assessment and Repair of Hull Structure</b>	
<b>Part 1</b>	<b>Cargo hold region</b>	<b>Example No.</b>	
<b>Area 1</b>	<b>Deck structure</b>	<b>5</b>	
<b>Detail of damage</b>		Deformed and fractured deck plating around tug bitt	
<b>Sketch of damage</b>		<b>Sketch of repair</b>

<p style="text-align: center;"><b>View A-A</b></p>	
<b>Notes on possible cause of damage</b>		<b>Notes on repairs</b>	
1. Insufficient strength		1. Fractured/deformed deck plating should be cropped and part renewed. 2. Reinforcement by stiffeners should be considered.

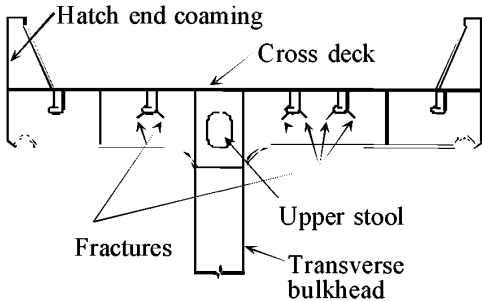
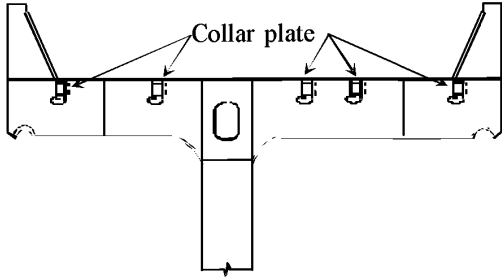
<b>BULK CARRIERS</b>		<b>Guidelines for Surveys, Assessment and Repair of Hull Structure</b>	
<b>Part 1</b>	<b>Cargo hold region</b>		<b>Example No.</b>
<b>Area 1</b>	<b>Deck structure</b>		<b>6</b>
<b>Detail of damage</b>		Fractures around cut-outs in cross deck girder	
<b>Sketch of damage</b>		<b>Sketch of repair</b>

<b>Notes on possible cause of damage</b>		<b>Notes on repairs</b>	
<ol style="list-style-type: none"> <li>1. Stress concentration at the cut-outs in cross deck girder.</li> </ol>		<ol style="list-style-type: none"> <li>1. Fractured web plate of cross deck girder to be cropped and part renewed.</li> <li>2. Collar plates to be provided.</li> </ol>

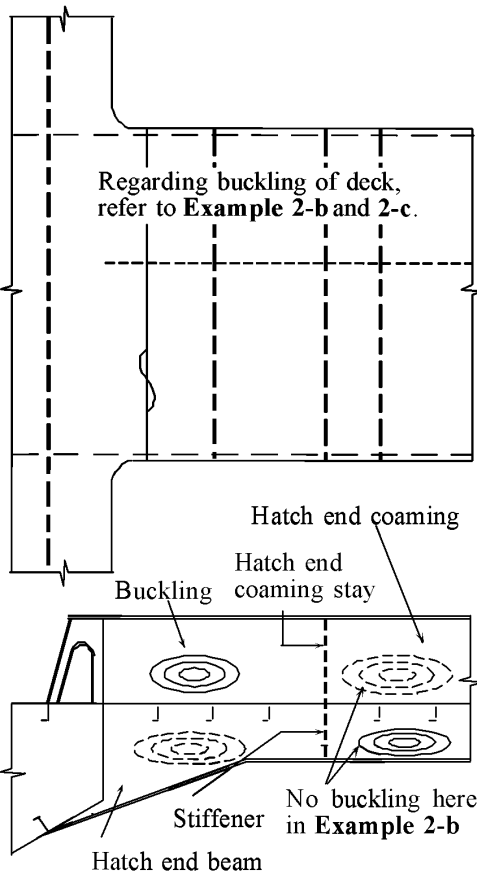
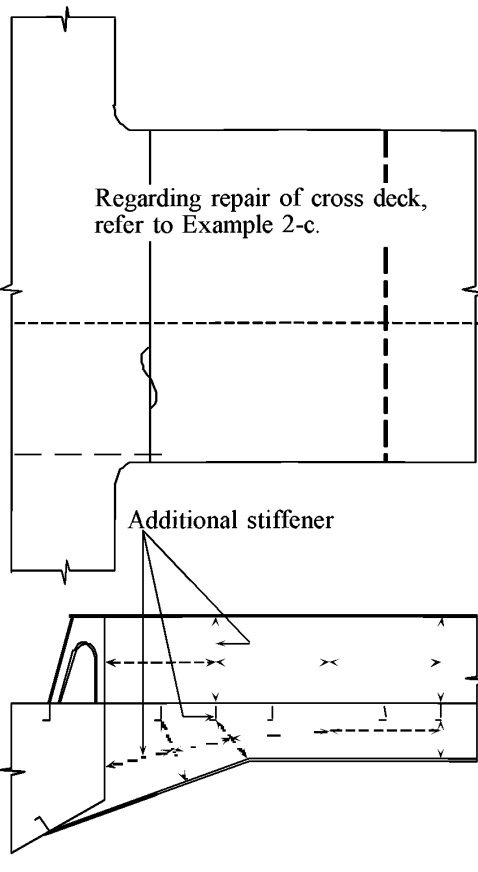
<p>Regarding buckling of deck, refer to <b>Example 2-b</b> and <b>2-c</b>.</p> <p>Hatch end coaming</p> <p>Buckling</p> <p>Hatch end coaming stay</p> <p>Stiffener</p> <p>Hatch end beam</p> <p>No buckling here in <b>Example 2-b</b></p>

<p>Regarding repair of cross deck, refer to <b>Example 2-c</b>.</p> <p>Additional stiffener</p>
<b>Notes on possible cause of damage</b>		<b>Notes on repairs</b>
<ol style="list-style-type: none"> <li>1. Additional transverse forces due to heavy seas, and torsional loading.</li> <li>2. Inadvertent overloading of cargo spaces.</li> </ol>		<ol style="list-style-type: none"> <li>1. If buckling is due to loss in strength induced by corrosion, the buckled zone to be cropped and renewed as necessary.</li> <li>2. If buckling results from inadequate strength, stiffeners should be fitted in addition to cropping and renewal of buckled zone.</li> </ol>

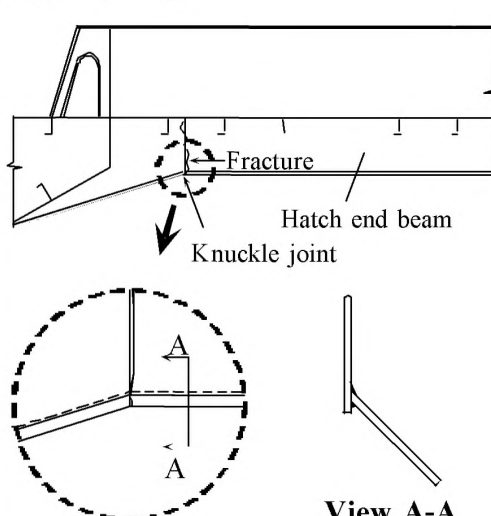
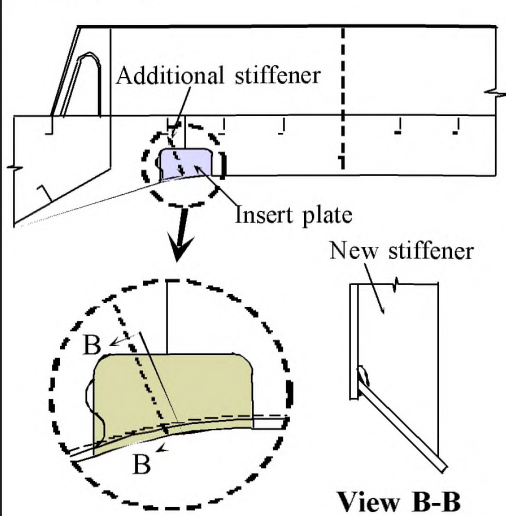
<b>Notes on possible cause of damage</b>		<b>Notes on repairs</b>
<ol style="list-style-type: none"> <li>1. Stress concentration at knuckle joint.</li> </ol>		<ol style="list-style-type: none"> <li>1. Fractured part to be cropped and renewed.</li> <li>2. Improvement to avoid stress concentration at knuckle joint should be considered.</li> </ol>

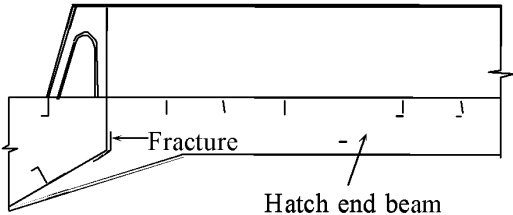
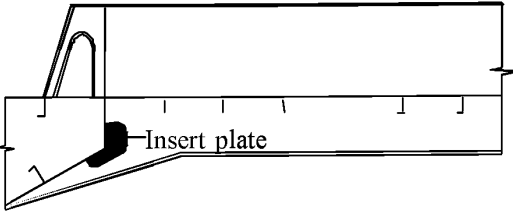
<b>Notes on possible cause of damage</b>		<b>Notes on repairs</b>	
<ol style="list-style-type: none"> <li>1. Misalignment of the hatch end beam with transverse web frame in topside tank.</li> <li>2. Stress concentration.</li> </ol>		<ol style="list-style-type: none"> <li>1. Fractured part to be cropped and renewed.</li> </ol>

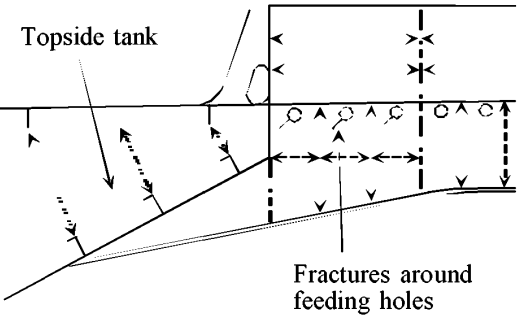
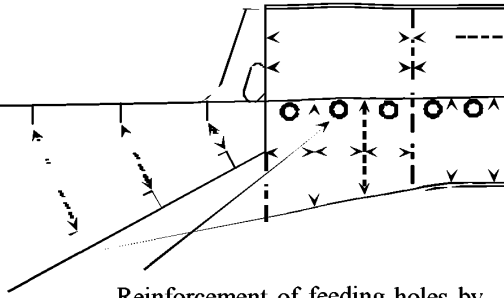
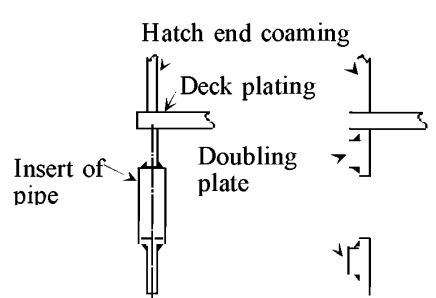
<p>Topside tank</p> <p>Fractures around feeding holes</p>

<p>Reinforcement of feeding holes by doubling plate or insert of pipe. See "Detail" below.</p>

<p>Hatch end coaming</p> <p>Deck plating</p> <p>Insert of pipe</p> <p>Doubling plate</p> <p><b>Detail</b></p>
<b>Notes on possible cause of damage</b>		<b>Notes on repairs</b>
<ol style="list-style-type: none"> <li>1. Inadequate reinforcement around feeding hole.</li> <li>2. Corrosion.</li> </ol>		<ol style="list-style-type: none"> <li>1. Fractured part to be veed-out or cropped and renewed.</li> <li>2. If the fractured part is free from corrosion, reinforcement should be considered.</li> </ol>
