**РОССИЙСКИЙ МОРСКОЙ РЕГИСТР СУДОХОДСТВА**  
**RUSSIAN MARITIME REGISTER OF SHIPPING**

**ПРИЛОЖЕНИЕ К ПРАВИЛАМ**  
**РОССИЙСКОГО МОРСКОГО РЕГИСТРА СУДОХОДСТВА**  
**УНИФИЦИРОВАННЫЕ ИНТЕРПРЕТАЦИИ**  
**И РЕКОМЕНДАЦИИ**  
**МЕЖДУНАРОДНОЙ АССОЦИАЦИИ**  
**КЛАССИФИКАЦИОННЫХ ОБЩЕСТВ**

**SUPPLEMENT TO RULES**  
**OF RUSSIAN MARITIME REGISTER OF SHIPPING**  
**IACS UNIFIED INTERPRETATIONS**  
**AND RECOMMENDATIONS**

НД № 2-020101-085-R-E

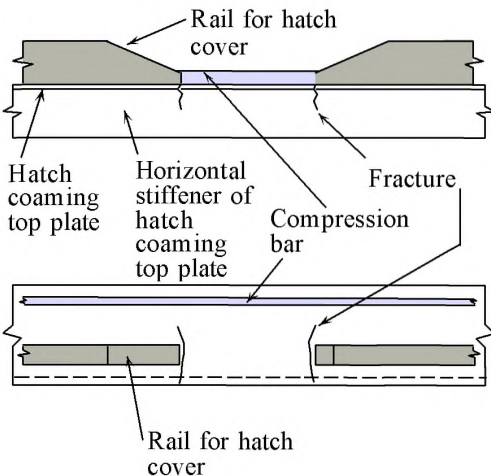
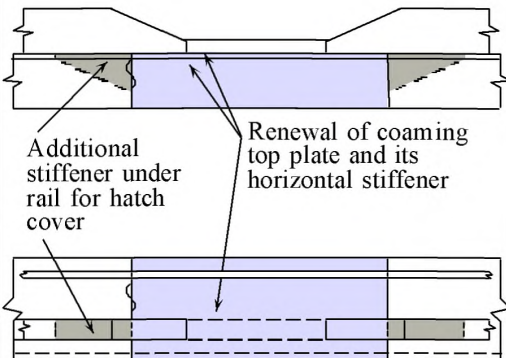
<b>Sketch of repair</b>

<b>Notes on possible cause of damage</b> <ol style="list-style-type: none"> <li>1. Stress concentration at the termination of the rail for hatch cover due to poor design.</li> </ol>		<b>Notes on repairs</b> <ol style="list-style-type: none"> <li>1. Fractured plate is to be cropped and part renewed.</li> <li>2. Thicker insert plate and/or reinforcement by additional stiffener under the top plate should be considered. Also refer to <b>Example 10-b</b>.</li> </ol>

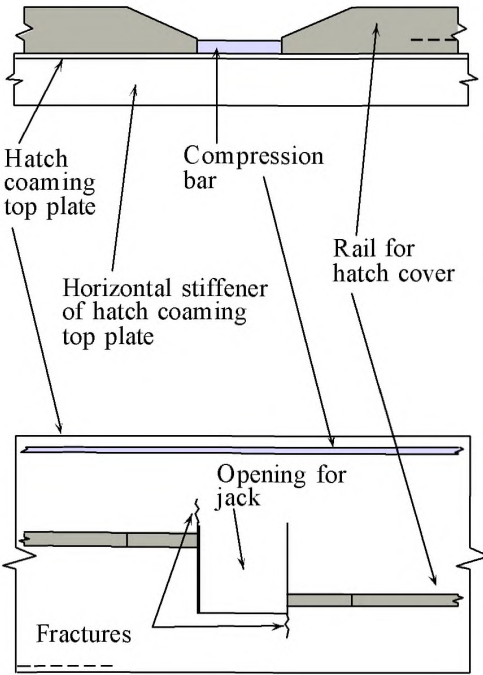
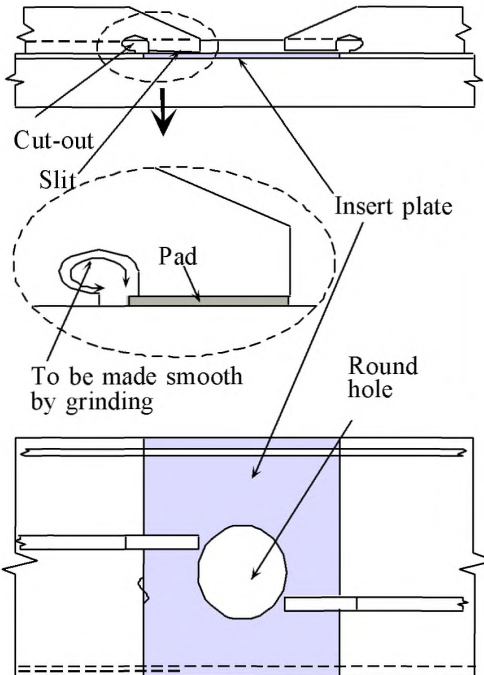
<b>Sketch of repair</b>

<b>Notes on possible cause of damage</b> 1. Stress concentration at the termination of the rail for hatch cover due to poor design of opening.		<b>Notes on repairs</b> 1. Fractured plate is to be cropped and part renewed. 2. Thicker insert plate and/or reduction of stress concentration adopting large radius should be considered. Or cut-out in the rail and detachment of the welds as shown in the above drawing should be considered in order to reduce the stress of the corner of the opening.

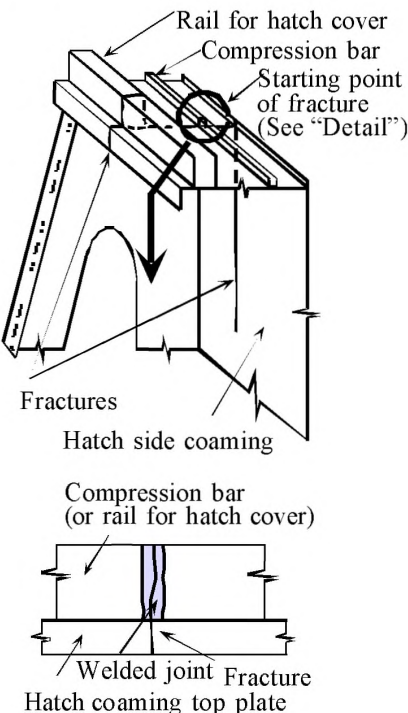
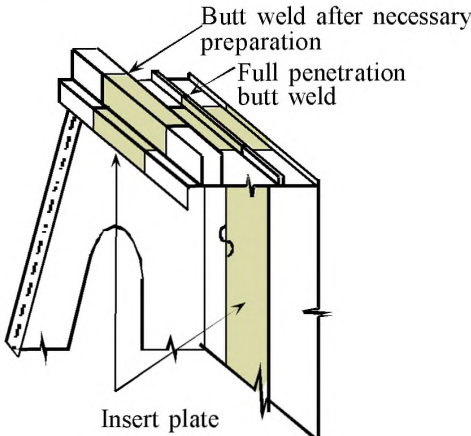
<b>Sketch of repair</b>

<b>Notes on possible cause of damage</b> <ol style="list-style-type: none"> <li>1. Heavy weather</li> <li>2. Insufficient preparation of weld of compression bar and/or rail (Although the compression bar and rail are not longitudinal strength members, they subject same longitudinal stress as longitudinal members)</li> <li>3. Crack may initiate from insufficient penetration of weld of rail for hatch cover.</li> </ol>		<b>Notes on repairs</b> <ol style="list-style-type: none"> <li>1. Loading condition of the ship and proper welding procedure should be carefully considered.</li> <li>2. Fractured structure is to be cropped and renewed if considered necessary. (Small fracture may be vee-out and rewelded.)</li> <li>3. Full penetration welding should be applied to the butt weld of compression bar and rail.</li> </ol>

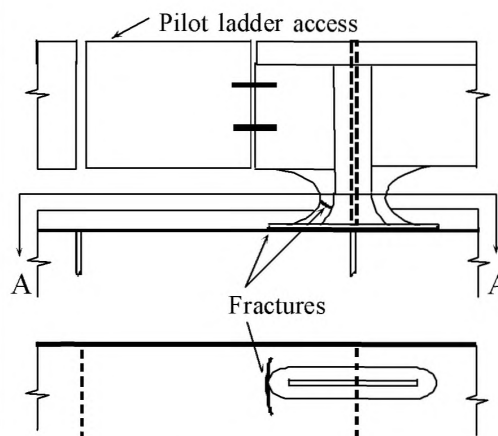
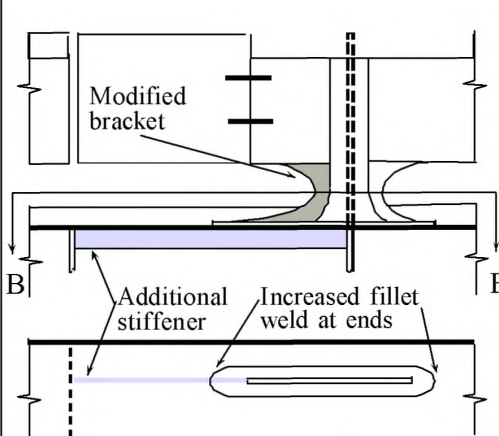
<p style="text-align: center;"><b>View A-A</b></p>		<b>Sketch of repair</b>

<p style="text-align: center;"><b>View B-B</b></p>	
<b>Notes on possible cause of damage</b> 1. Stress concentration at the termination of bulwarks.		<b>Notes on repairs</b> 1. Fractured deck plating should be cropped and part renewed. 2. Reduction of stress concentration should be considered. In the above figure gusset plate was replaced with soft type for the fracture in gusset plate and pad plate was increased. Additional stiffeners were provided for the fracture in deck plating.

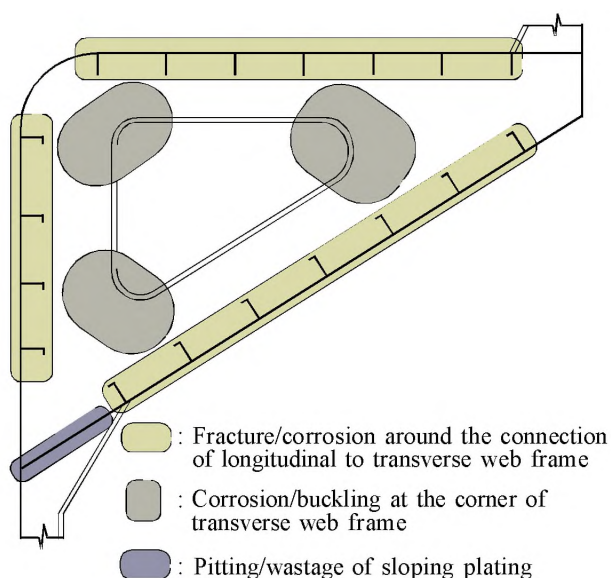
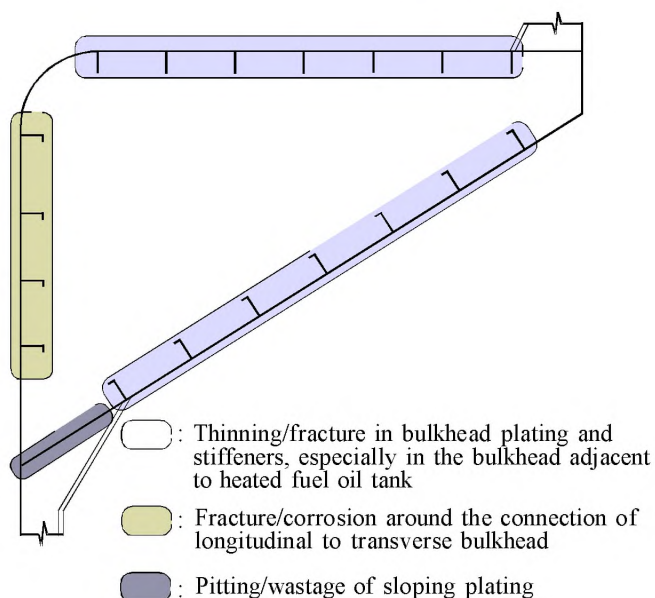
**(b) Transverse bulkhead section****Figure 1 Topside tank - Potential problem areas**

- (a) Structure in corrosive environment
    - Deck plating and deck longitudinal
    - Transverse bulkhead adjacent to heated fuel oil tank
    - Lowest part of sloping plating

- (b) Structure subject to high stress
    - Face plates and web plates of transverse at corners
    - Connection of side longitudinal to transverse
  - (c) Areas susceptible to coating breakdown

- Back side of face plate of longitudinal
    - Welded joint
    - Edge of access opening
  - (d) Areas subjected to poor drainage
    - Web of side and sloping longitudinals

**(a) Transverse web frame section**

- 2.1.2** Rate and extent of corrosion depends on the environmental conditions, and protective measures employed, such as coatings and sacrificial anodes. The following structures are generally susceptible to corrosion (See **Figure 1**).

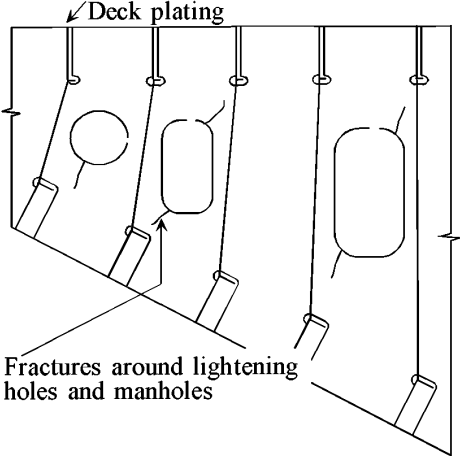
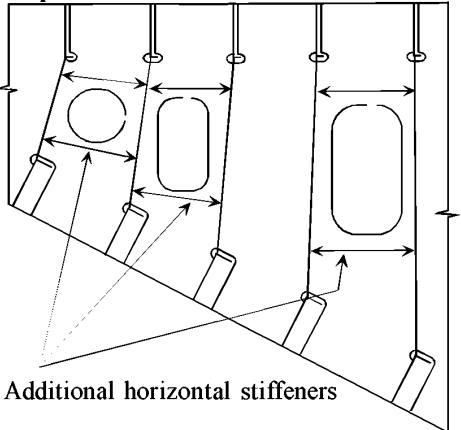
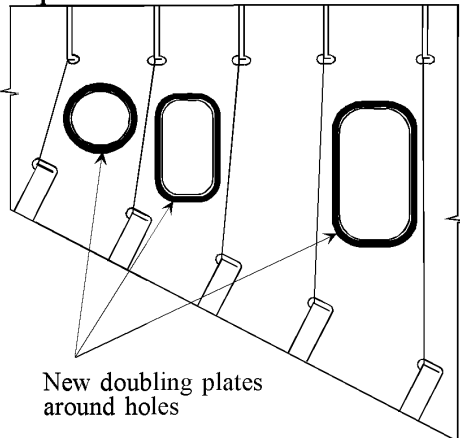
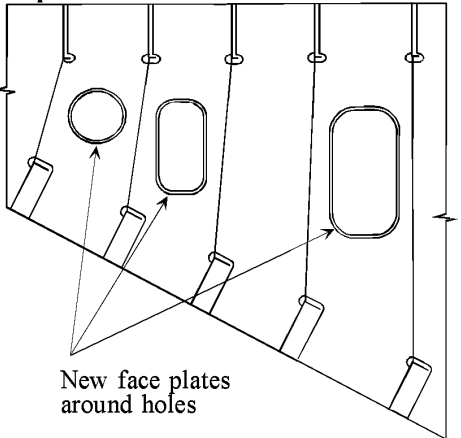
<p>Deck plating</p> <p>Fractures around lightening holes and manholes</p>		<b>Sketch of repair</b> <b>Repair A</b>

<p>Additional horizontal stiffeners</p>
<b>Repair C</b>

<p>New doubling plates around holes</p>		<b>Repair B</b>

<p>New face plates around holes</p>
<b>Notes on possible cause of damage</b> 1. General levels of corrosion and presence of stress concentration.		<b>Notes on repairs</b> 1. Corroded/fractured plate should be cropped and renewed with plating of enhanced thickness. 2. Reinforcement should be considered.

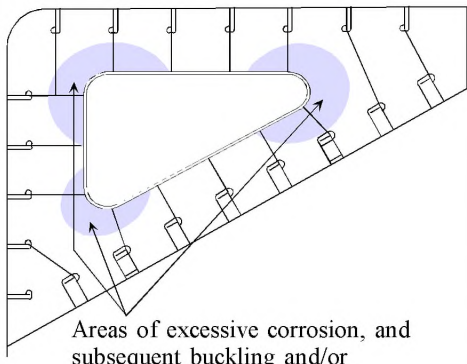
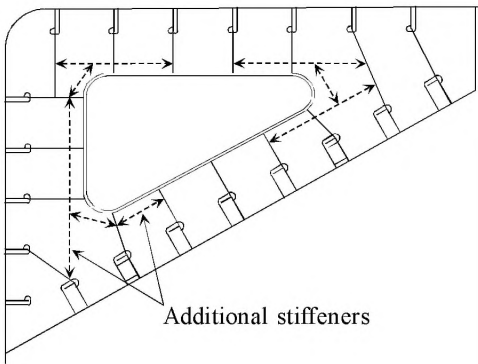
<p>Areas of excessive corrosion, and subsequent buckling and/or</p>

<p>Additional stiffeners</p>
<b>Notes on possible cause of damage</b>		<b>Notes on repairs</b>
<ol style="list-style-type: none"> <li>1. Insufficient buckling strength.</li> <li>2. Corrosion due to stress concentration at corners.</li> </ol>		<ol style="list-style-type: none"> <li>1. Buckled plating is to be cropped and parts renewed, if necessary.</li> <li>2. Additional stiffeners as shown above and/or renewal with plating of increased thickness should be considered.</li> </ol>

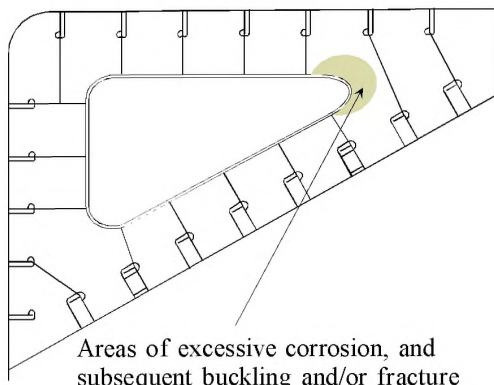
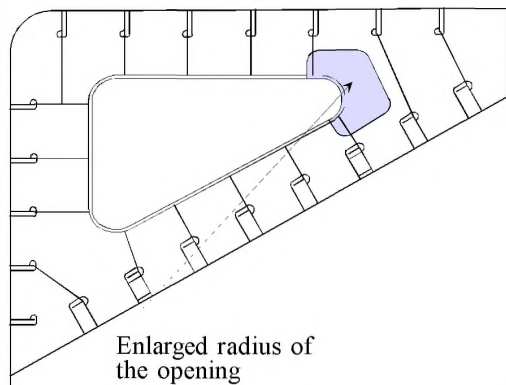
BULK CARRIERS		Guidelines for Surveys, Assessment and Repair of Hull Structure	
Part 1	Cargo hold region	Example No.	
Area 2	Topside tank structure	2-b	
Detail of damage	Thinning and subsequent buckling of web plating in the vicinity of the radii of the opening		
Sketch of damage		Sketch of repair

<p>Areas of excessive corrosion, and subsequent buckling and/or fracture</p>

<p>Enlarged radius of the opening</p>	
Notes on possible cause of damage		Notes on repairs	
1. Corrosion caused by stress concentration at the corner due to insufficient radius for the opening.		1. Corroded/buckled plating is to be cropped and parts renewed with plating of increased thickness and additional stiffeners are preferable to minimize deflection.	
		2. An attempt should be made to improve the design of the radius if felt necessary.

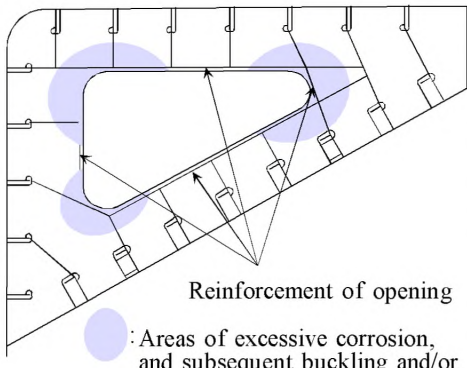
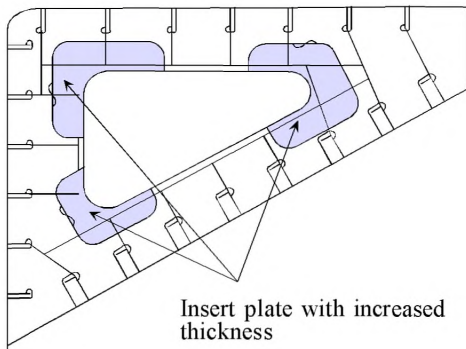
<p>Reinforcement of opening</p> <p>Areas of excessive corrosion, and subsequent buckling and/or</p>

<p>Insert plate with increased thickness</p>
<b>Notes on possible cause of damage</b>		<b>Notes on repairs</b>
1. Additional stresses at the free edge of transverse web. (In <b>Example 2-a - 2-c</b> face plate is provided for the reinforcement of the opening.)		1. Corroded/buckled plating is to be cropped and part renewed with plating of increased thickness.

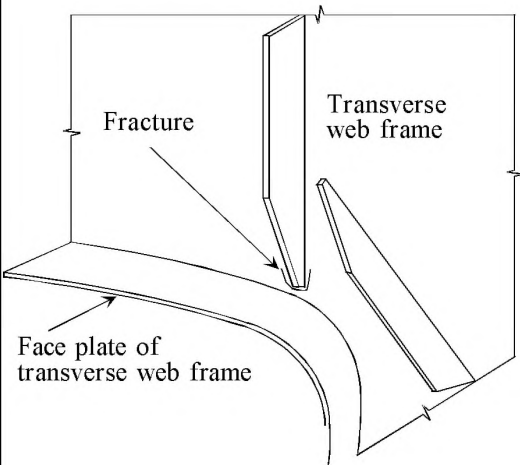
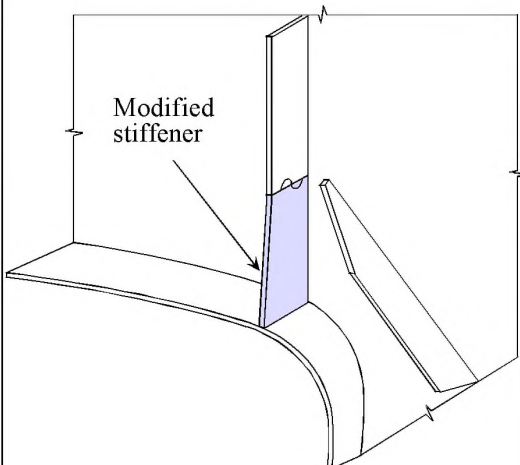
<b>Notes on possible cause of damage</b>		<b>Notes on repairs</b>	
1. Stress concentration.		1. Fracture can be veed-out and welded provided the plating is not generally corroded. If necessary, fractured plating should be cropped and renewed. 2. Excessive stress concentration at the end of stiffener should be avoided.

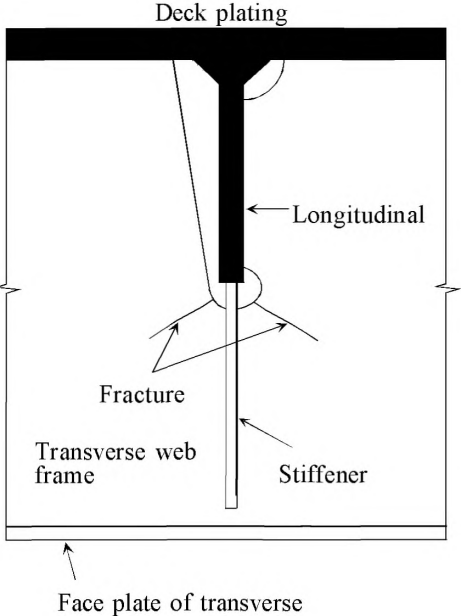
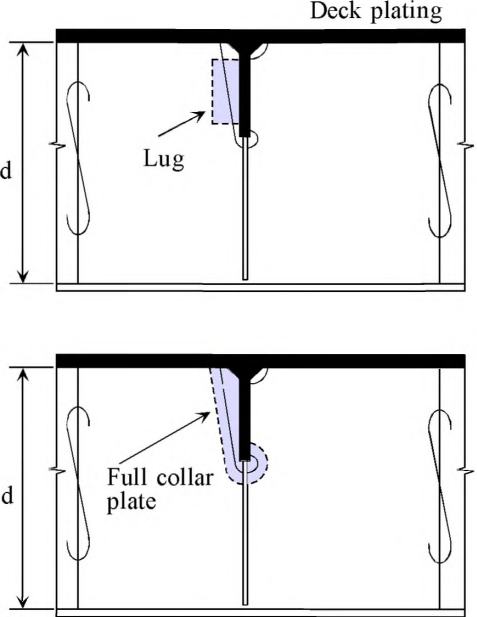
<b>Sketch of repair</b>

<p>(Note) Full collar plate where the depth of cut-out is more than 0.4 times the depth of web frame (<math>0.4d</math>) and in an areas of high shear stress</p>
<b>Notes on possible cause of damage</b> <ol style="list-style-type: none"> <li>1. Damage may be created by local shear stress concentrations due to large cut-outs for notch.</li> <li>2. Also deficient welds (fillet welds between deck longitudinal and stiffener).</li> </ol>		<b>Notes on repairs</b> <ol style="list-style-type: none"> <li>1. Crop and part renew the web plating.</li> <li>2. Close the cut-out by introducing a lug or alternatively fit a full collar plate.</li> </ol>

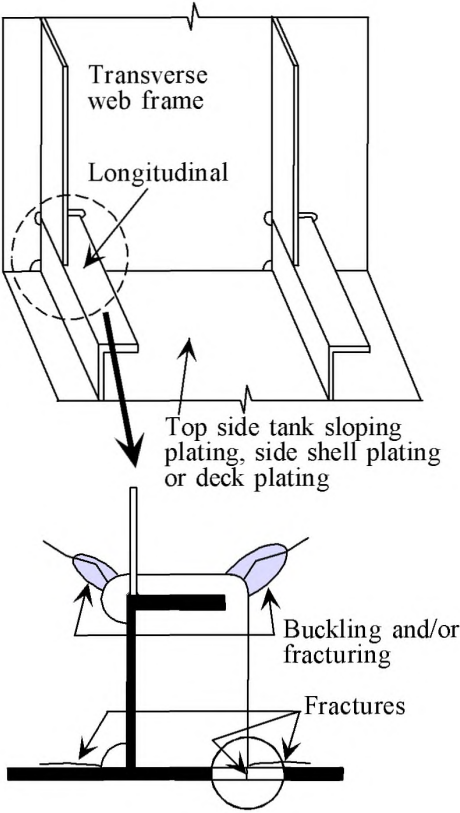
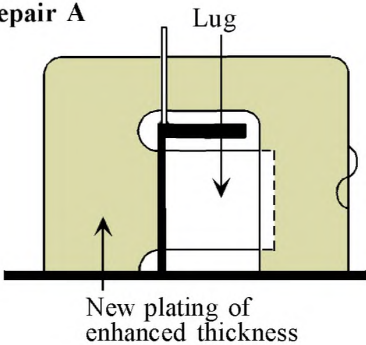
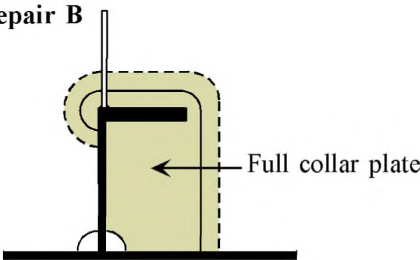
<p>Transverse web frame</p> <p>Longitudinal</p> <p>Top side tank sloping plating, side shell plating or deck plating</p> <p>Buckling and/or fracturing</p> <p>Fractures</p>		<p><b>Repair A</b></p>

<p>Lug</p> <p>New plating of enhanced thickness</p> <p><b>Repair B</b></p>

<p>Full collar plate</p>
<b>Notes on possible cause of damage</b>		<b>Notes on repairs</b>
<p>1. Damage can be caused by general levels of corrosion and presence of stress concentration associated with the presence of a cut-out.</p>		<p>1. If fractures are significant then crop and part renew the plating otherwise the fracture can be veed-out and welded provided the plating is not generally corroded.</p> <p>2. <b>Repair A</b> Lug should be considered.</p> <p>3. <b>Repair B</b> Full collar plate should be considered where the depth of cut-out is more than 0.4 times the depth of web frame and in an area of high shear stress or the existing lug proves to be ineffective.</p>

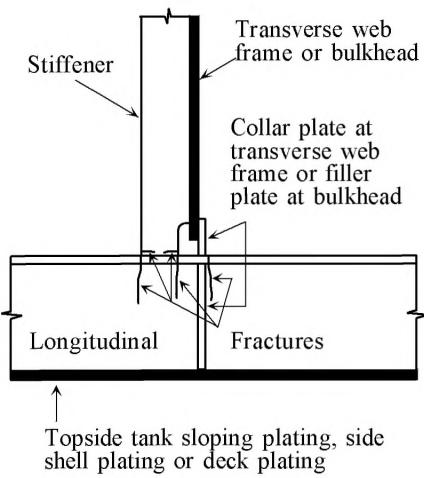
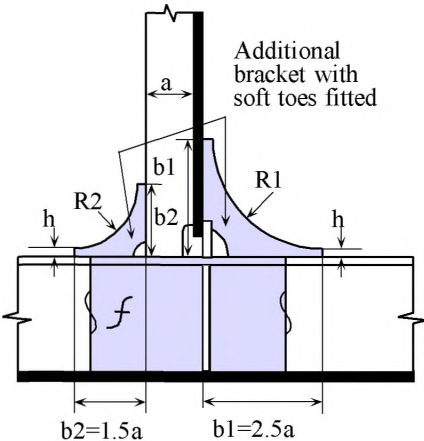
<p><math>f</math>: Where required, the longitudinal to be cropped and part renewed</p> <ol style="list-style-type: none"> <li>1. For a slope at toes max. 1:3, <math>R1=(b1-h) \times 1.6</math> and <math>R2=(b2-h) \times 1.6</math></li> <li>2. Soft toe bracket to be welded first to longitudinal</li> <li>3. Scallop in bracket to be as small as possible, recommended max. 35mm</li> <li>4. If toes of brackets are ground smooth, full penetration welds in way to be provided</li> <li>5. Maximum length to thickness ratio =50:1 for unstiffened bracket edge</li> <li>6. Toe height, <math>h</math>, to be as small as possible (10-15mm)</li> </ol>

<b>Notes on possible cause of damage</b>		<b>Notes on repairs</b>
<ol style="list-style-type: none"> <li>1. Damage can be caused by stress concentrations leading to accelerated fatigue in this region.</li> </ol>		<ol style="list-style-type: none"> <li>1. If fracture extends to over one third of the depth of the longitudinal, then crop and part renew. Otherwise the fracture can be vee-out and welded.</li> </ol>

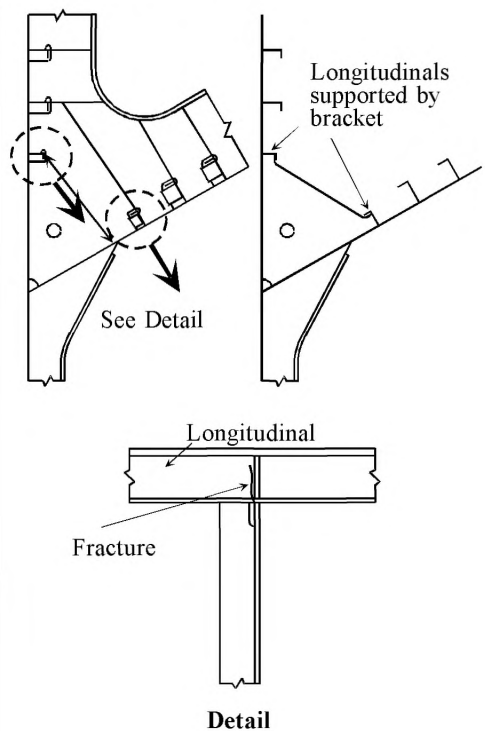
<b>Notes on possible cause of damage</b>		<b>Notes on repairs</b>
<ol style="list-style-type: none"> <li>Insufficient scantling for torsional rigidity (The lowest longitudinal is usually supported by bracket(s) as shown in the above and smaller scantling may be adopted. However, the lowest longitudinal undergoes torsion from side shell frame through bracket(s) and may suffer fracture.)</li> </ol>		<ol style="list-style-type: none"> <li>Fractured part to be cropped and renewed.</li> <li>Size of bracket should be increased</li> </ol>

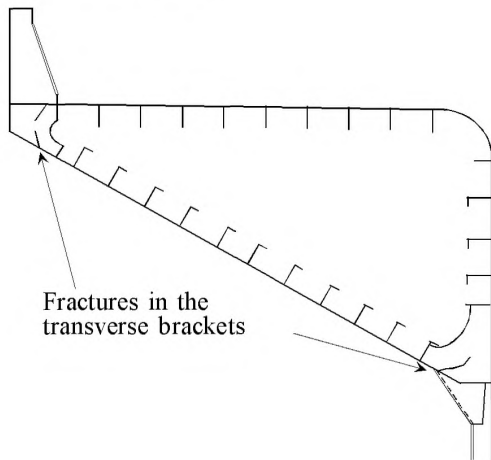
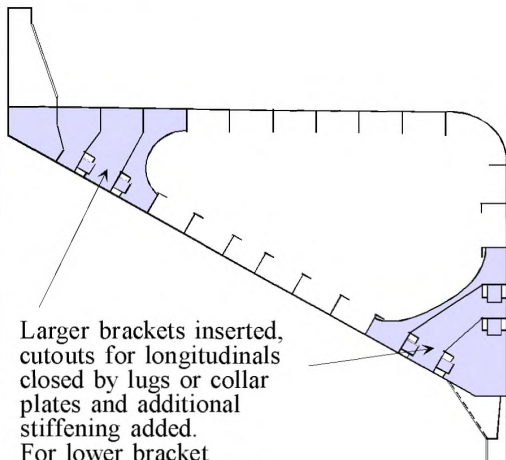
<b>BULK CARRIERS</b>		<b>Guidelines for Surveys, Assessment and Repair of Hull Structure</b>
<b>Part 1</b>	<b>Cargo hold region</b>	<b>Example No.</b>
<b>Area 2</b>	<b>Topside tank structure</b>	<b>7-a</b>
<b>Detail of damage</b>		Fractures in transverse brackets
<b>Sketch of damage</b>

<b>Notes on possible cause of damage</b>		<b>Notes on repairs</b>
<ol style="list-style-type: none"> <li>1. General levels of corrosion and presence of stress concentrations.</li> <li>2. Misalignment of the brackets with adjoining structure, e.g. side shell frame brackets and/or coaming brackets.</li> <li>3. High shear stresses due to insufficient bracket size.</li> <li>4. Inadvertent overloading.</li> </ol>		<ol style="list-style-type: none"> <li>1. If the damage is caused by misalignment with the side shell frame brackets or the hatch coaming brackets the misalignment is to be rectified and the replacement by larger brackets incorporated only if considered necessary.</li> </ol>

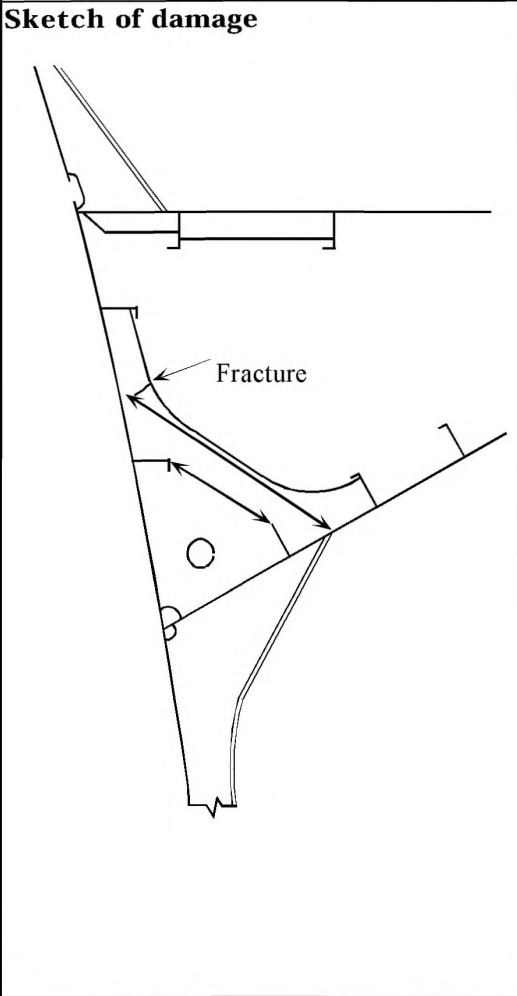
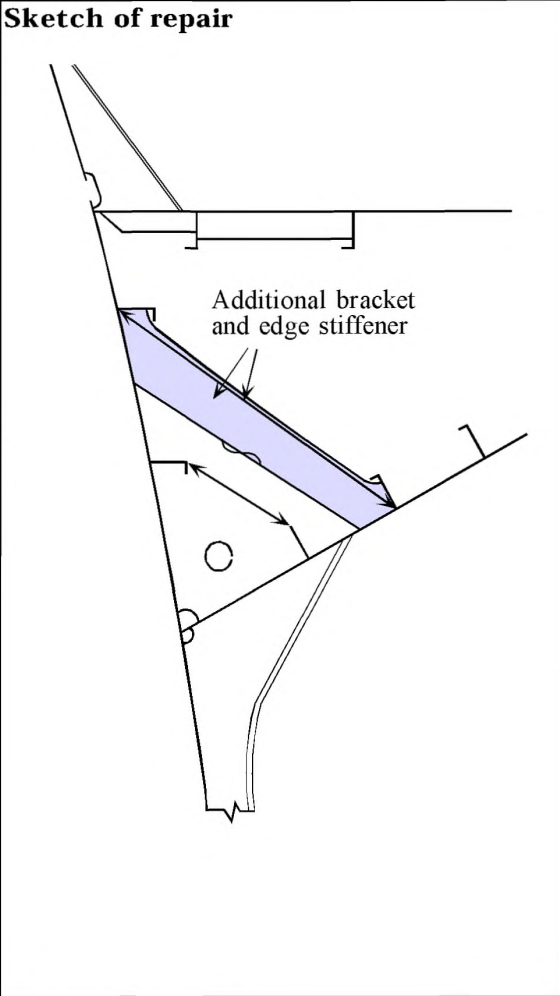
<b>Notes on possible cause of damage</b>		<b>Notes on repairs</b>	
<ol style="list-style-type: none"> <li>1. Insufficient strength.</li> <li>2. Corrosion.</li> </ol>		<ol style="list-style-type: none"> <li>1. Fractured part to be cropped and renewed.</li> <li>2. If the fractured part is free from corrosion, increased size and thickness should be considered. Partial renewal of the bracket may be accepted depending on the nature of the fracture.</li> </ol>

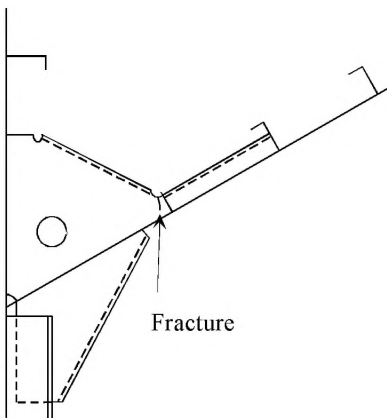
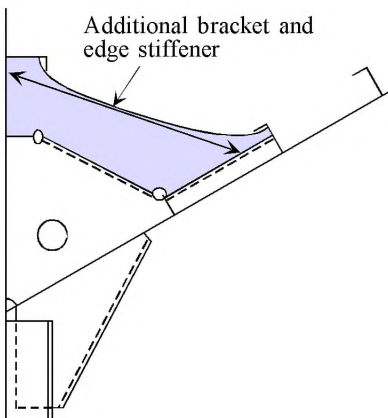
<b>Notes on possible cause of damage</b>		<b>Notes on repairs</b>
1. Stress concentration due to the shape of the bracket.		1. Cracked weld to be veed-out and rewelded.

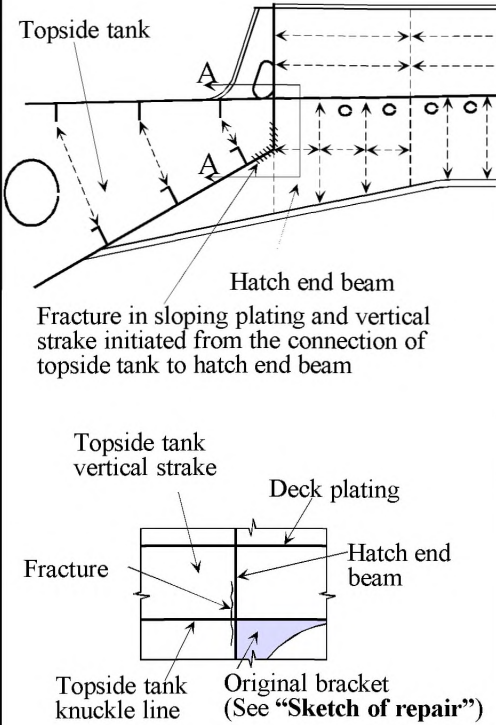
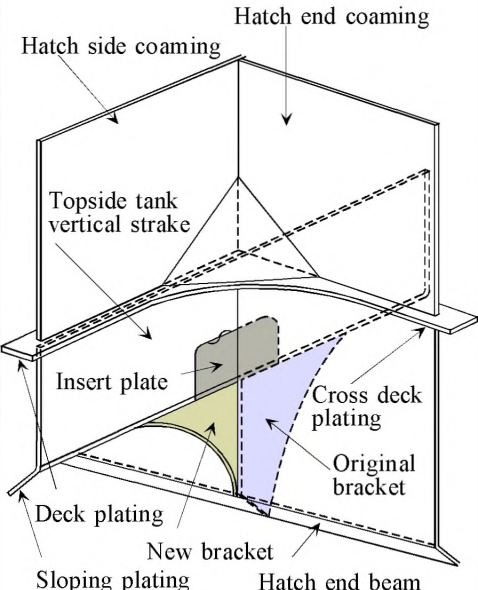
<p>Topside tank</p> <p>Hatch end beam</p> <p>Fracture in sloping plating and vertical strake initiated from the connection of topside tank to hatch end beam</p> <p>Topside tank vertical strake</p> <p>Deck plating</p> <p>Fracture</p> <p>Hatch end beam</p> <p>Topside tank knuckle line</p> <p>Original bracket (See "Sketch of repair")</p> <p><b>View A-A</b></p>

<p>Hatch side coaming</p> <p>Hatch end coaming</p> <p>Topside tank vertical strake</p> <p>Insert plate</p> <p>Cross deck plating</p> <p>Original bracket</p> <p>Deck plating</p> <p>New bracket</p> <p>Sloping plating</p> <p>Hatch end beam</p>

<b>Notes on possible cause of damage</b>		<b>Notes on repairs</b>
<ol style="list-style-type: none"> <li>1. Stress concentration at the connection of hatch end beam to topside tank.</li> </ol>		<ol style="list-style-type: none"> <li>1. Fractured part to be cropped and renewed with increased thickness.</li> <li>2. Additional bracket should be considered for reinforcement.</li> </ol>

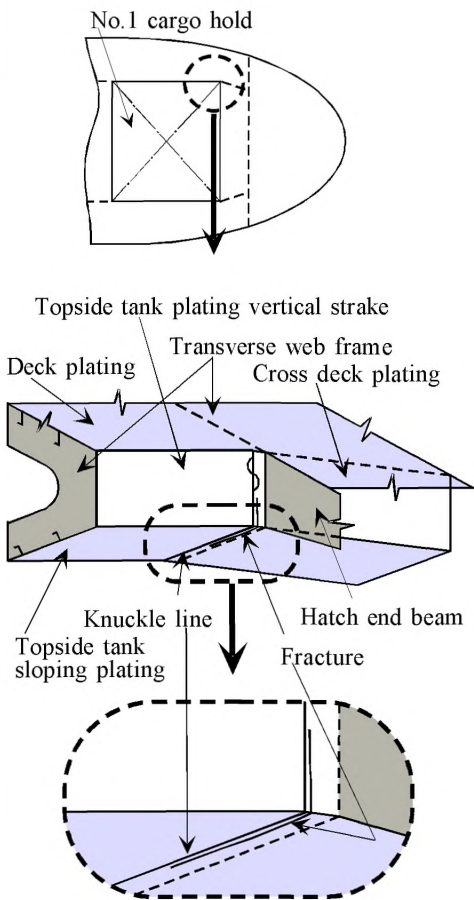
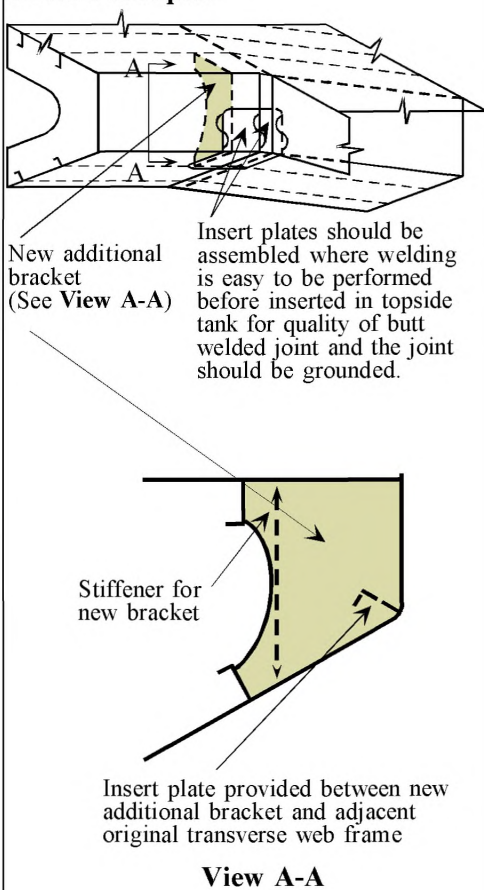
<b>BULK CARRIERS</b>		<b>Guidelines for Surveys, Assessment and Repair of Hull Structure</b>
<b>Part 1</b>	<b>Cargo hold region</b>	<b>Example No.</b>
<b>Area 2</b>	<b>Topside tank structure</b>	<b>9</b>
<b>Detail of damage</b>		Fractures in sloping plating at knuckle
<b>Sketch of damage</b>

<p>No.1 cargo hold</p> <p>Topside tank plating vertical strake</p> <p>Deck plating</p> <p>Transverse web frame</p> <p>Cross deck plating</p> <p>Knuckle line</p> <p>Topside tank sloping plating</p> <p>Hatch end beam</p> <p>Fracture</p>		<b>Sketch of repair</b>

<p>New additional bracket (See View A-A)</p> <p>Insert plates should be assembled where welding is easy to be performed before inserted in topside tank for quality of butt welded joint and the joint should be grounded.</p> <p>Stiffener for new bracket</p> <p>Insert plate provided between new additional bracket and adjacent original transverse web frame</p> <p><b>View A-A</b></p>

<b>Notes on possible cause of damage</b> 1. Insufficient strength. 2. Additional stress induced by knuckle.		<b>Notes on repairs</b> 1. Knuckle part should be reinforced appropriately.

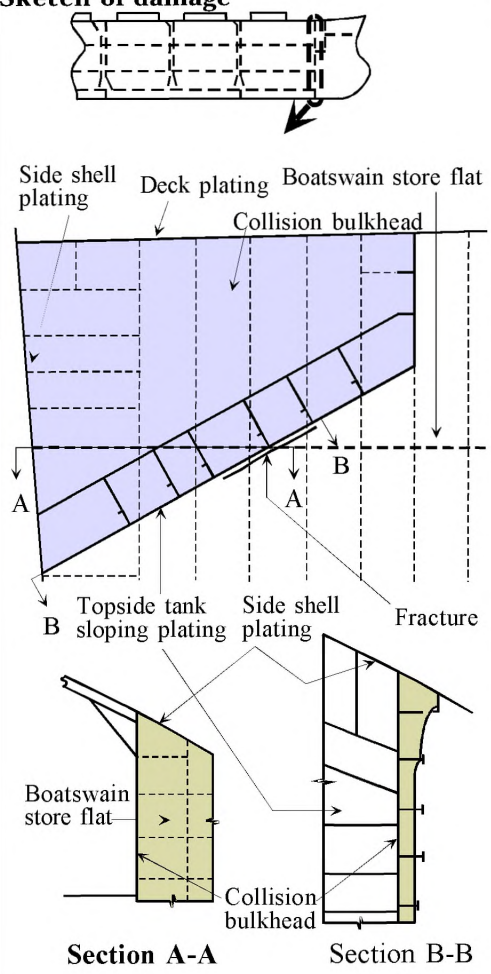
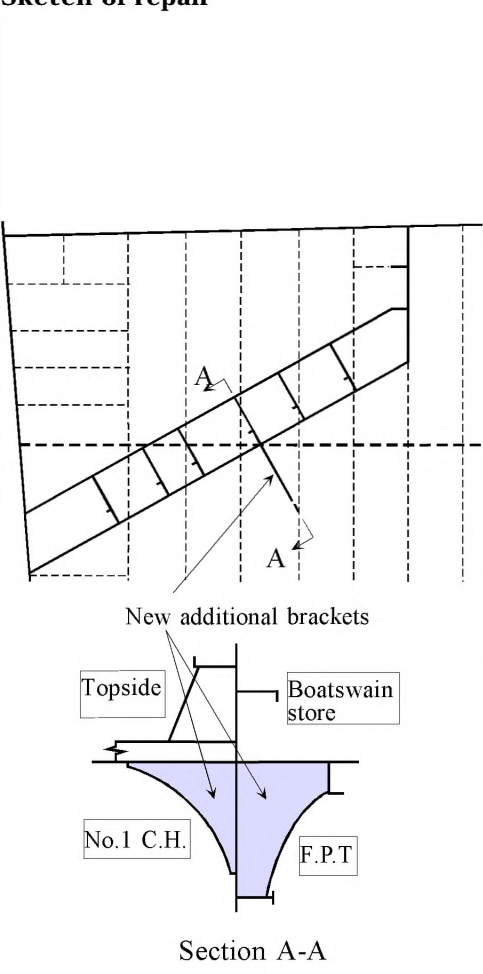
<p>Side shell plating Deck plating Boatswain store flat Collision bulkhead Fracture Topside tank sloping plating Side shell plating Boatswain store flat Collision bulkhead Section A-A Section B-B</p>

<p>New additional brackets Topside Boatswain store No.1 C.H. F.P.T. Section A-A</p>
<b>Notes on possible cause of damage</b>		<b>Notes on repairs</b>
<ol style="list-style-type: none"> <li>Damage caused by hard spot at intersection of the topside tank sloping plating and boatswain's store deck plating (fore peak tank top plating).</li> </ol>		<ol style="list-style-type: none"> <li>Fractured plates to be cropped and renewed.</li> <li>Stress concentration should be considered (Brackets were fitted on both sides for reinforcement).</li> </ol>

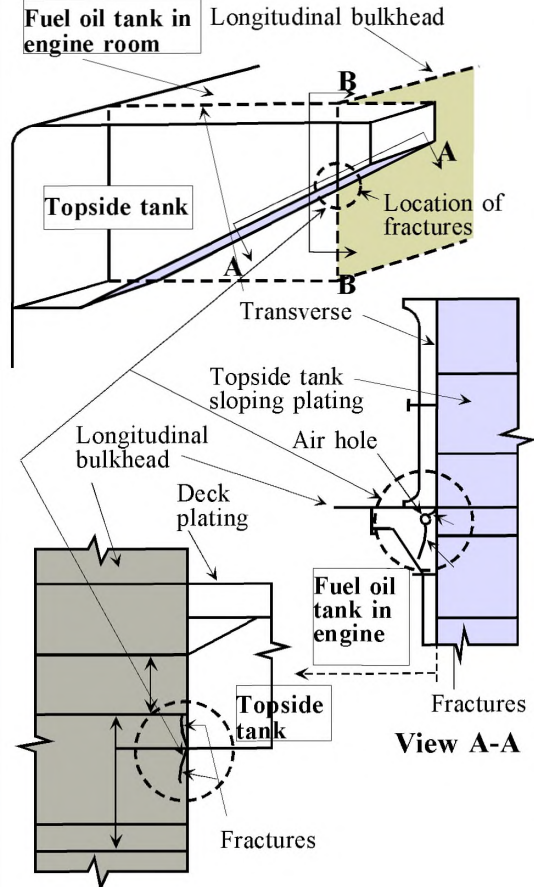
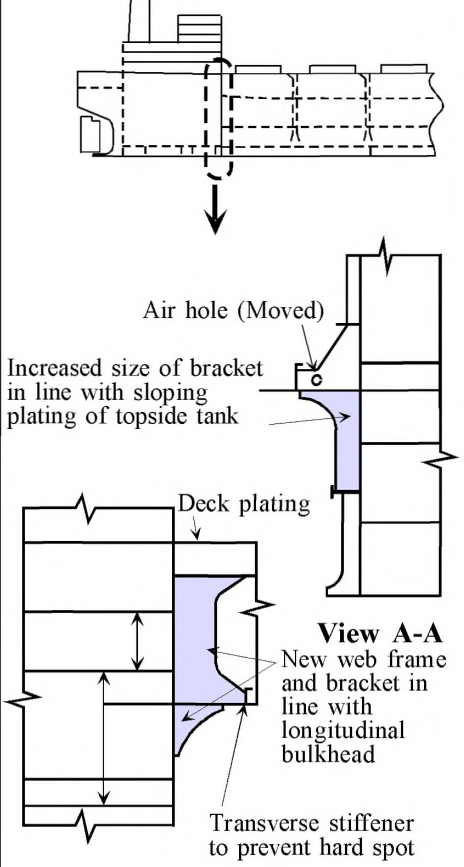
<b>Notes on possible cause of damage</b> 1. Damage caused by hard spot at intersection of the topside tank sloping plating and longitudinal bulkhead of the fuel oil tank in engine room.		<b>Notes on repairs</b> 1. Fractured plates to be cropped and renewed as necessary and reinforcement fitted as shown shaded above. The position of the air-hole to be relocated.

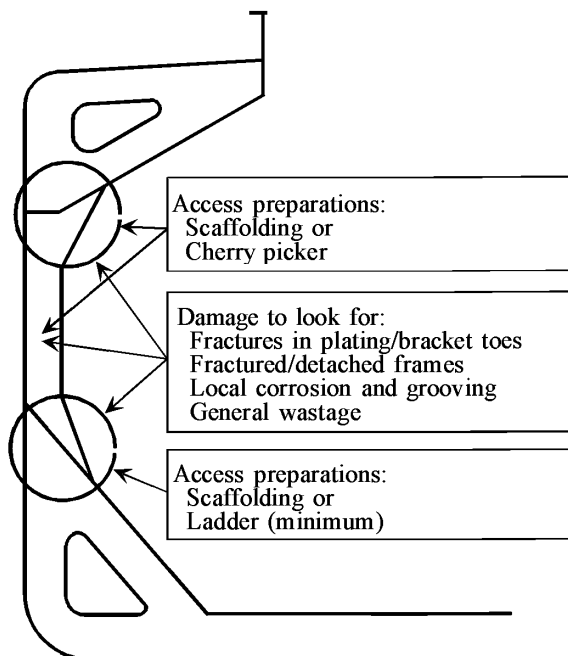
**Figure 1**  
**Side shell frame - Potential**  
**problem areas**

- 1.6 A summary of potential problem areas is shown in **Figures 1 - 4**. Examples of failure and damaged ship side structure are illustrated in **Photographs 1- 2**.

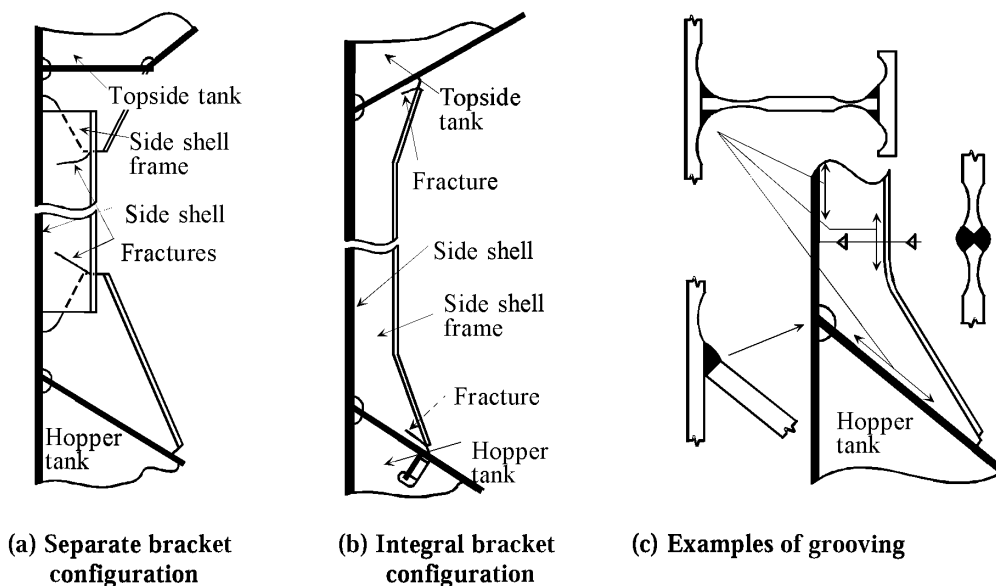
**Figure 2**      **Damages to side shell frame - Potential problem areas**

(Note) The type of bracket configuration used will, to a large extent, dictate the location and extent of fracture. Where separate brackets are employed, the fracture location is normally at the bracket toe position on the frames, whereas with integral brackets the location is at the toe position on the hopper and topside tank.

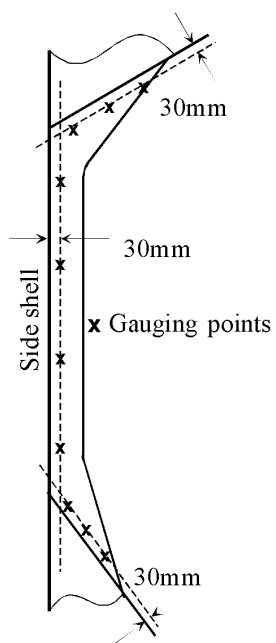
**Figure 3**  
Representative gauging locations on the side shell frame - Potential problem areas

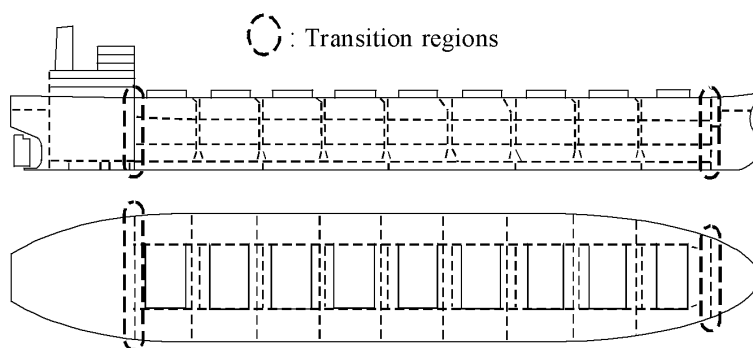
**Figure 4** Transition regions - Potential problem area

- 1.5 The structure at the transition regions at the fore and aft ends of the ship are subject to stress concentrations due to structural discontinuities. The side shell plating at the transition regions is also subject to panting. The lack of continuity of the longitudinal structure, and the increased slenderness and flexibility of the side structure, makes the structure at the transition regions more prone to fracture damages.

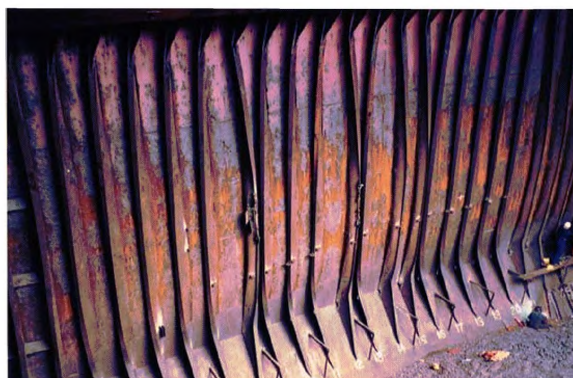
**Photograph 1** Collapsed side shell frames (See Example 4)

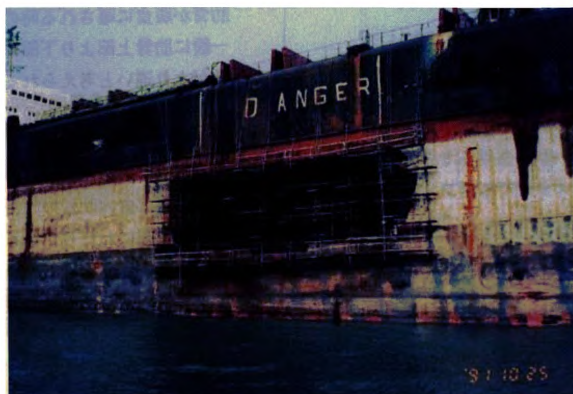
**Photograph 2** Missing side shell structure (See Examples 4 and 5)

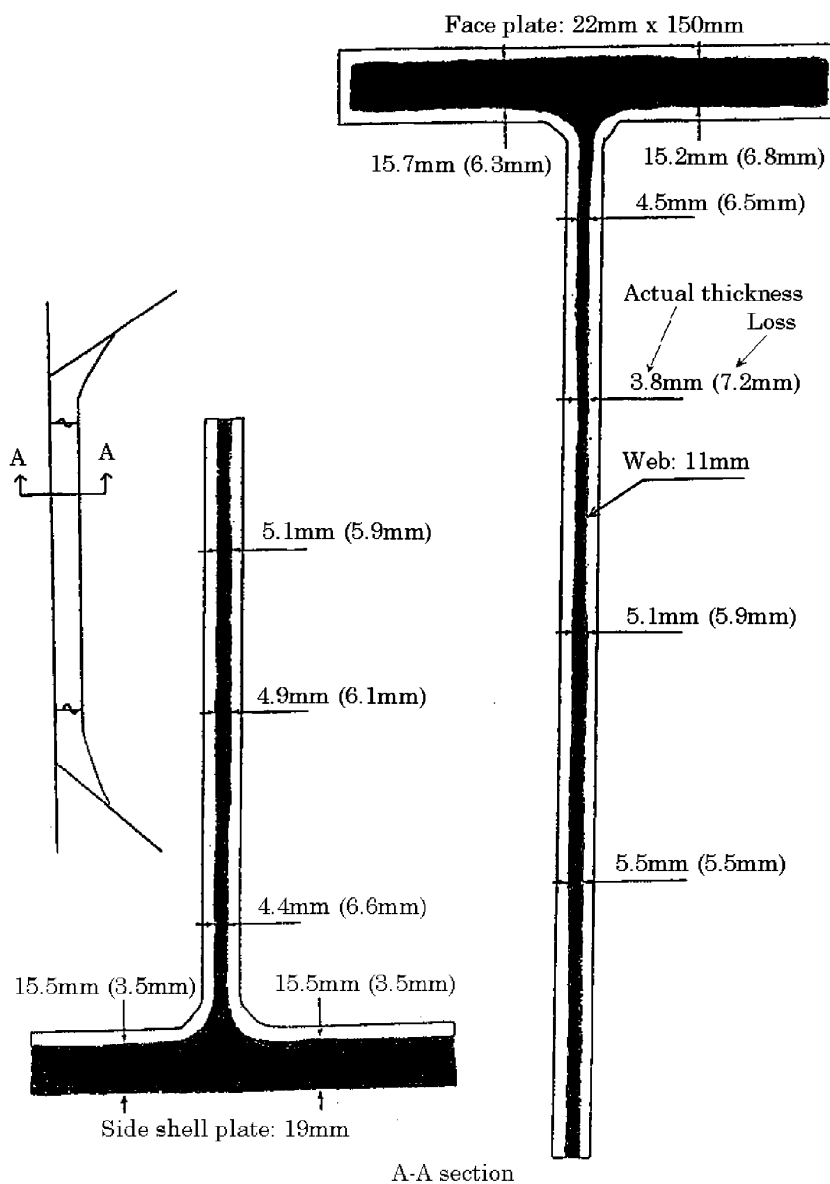
**Figure 5 Uniform corrosion of side shell frame**

- 2.1.1** Attention is drawn to the fact that side shell frames may be significantly weakened by loss of thickness although diminution and deformations may not be apparent. Inspection should be made after the removal of any scale or rust deposit. Thickness measurements may be necessary, particularly if the corrosion is smooth and uniform, to determine the condition of the structure (See **Figure 5**).

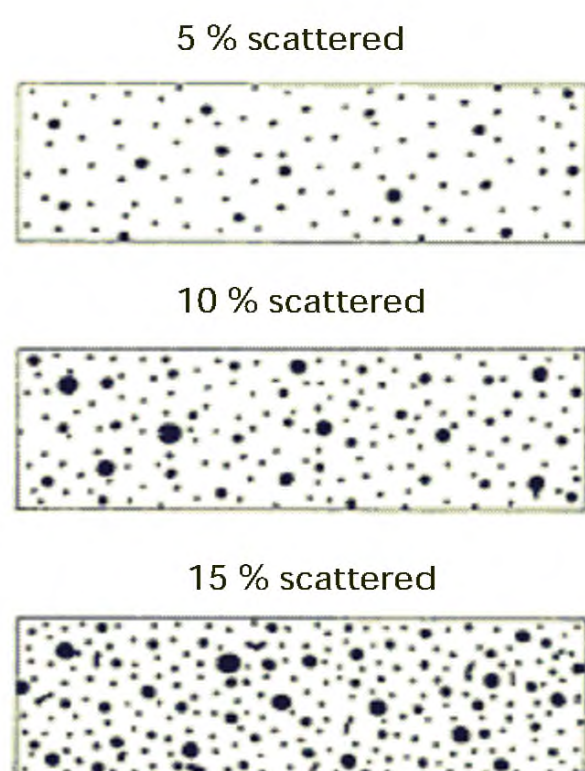
**Figure 6 Pitting intensity diagrams (from 5% to 15% intensity)**

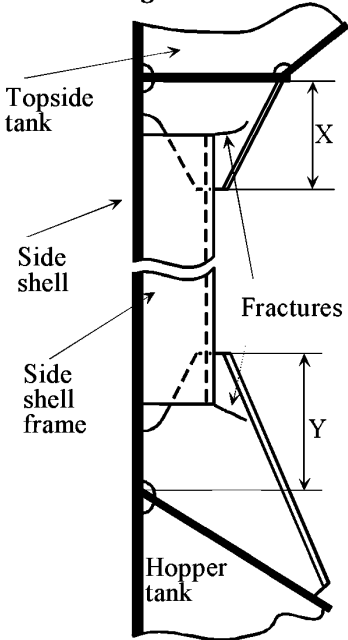
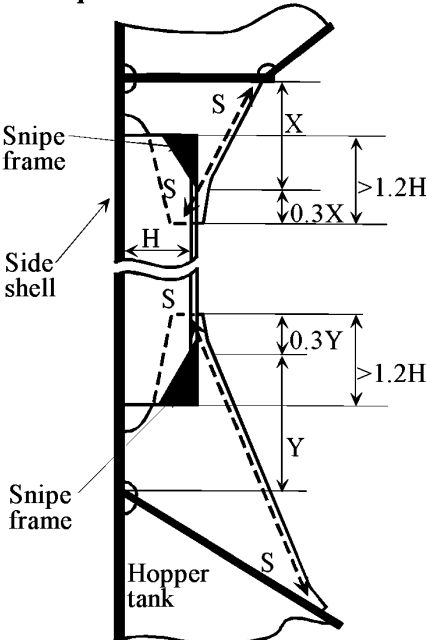
BULK CARRIERS		Guidelines for Surveys, Assessment and Repair of Hull Structure	
Part 1	Cargo hold region	Example No.	
Area 3	Cargo hold side structure	1-a	
Detail of damage		Fractures in brackets at termination of frame	
<b>Sketch of damage</b>

<p>Topside tank</p> <p>Side shell</p> <p>Side shell frame</p> <p>Fractures</p> <p>Hopper tank</p> <p>Separate bracket configuration</p>		<b>Sketch of repair</b>

<p>Snipe frame</p> <p>Side shell</p> <p>Side shell frame</p> <p>Snipe frame</p> <p>Hopper tank</p> <p>S=Snipped end</p>	
<b>Notes on possible cause of damage</b> <ol style="list-style-type: none"> <li>1. This type of damage is caused due to stress concentration.</li> </ol>		<b>Notes on repairs</b> <ol style="list-style-type: none"> <li>1. For small fractures, e. g. hairline fractures, the fracture can be veed-out, ground, examined by NDT for fractures, and rewelded.</li> <li>2. For larger/significant fractures consideration is to be given to cropping and partly renewing/renewing the frame brackets. If renewing the brackets, end of frames can be sniped to soften them.</li> <li>3. If felt prudent, soft toes are to be incorporated at the boundaries of the bracket to the hopper plating.</li> <li>4. Attention to be given to the structure in wing tanks in way of the extended bracket arm. i.e. reinforcement provided in line with the bracket.</li> </ol>

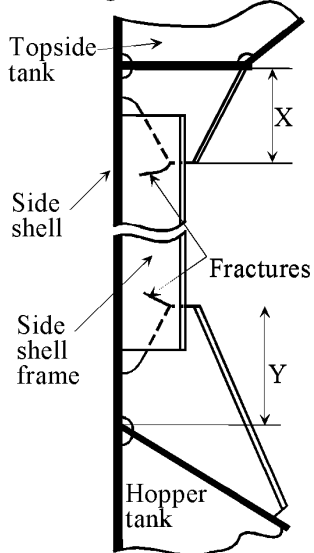
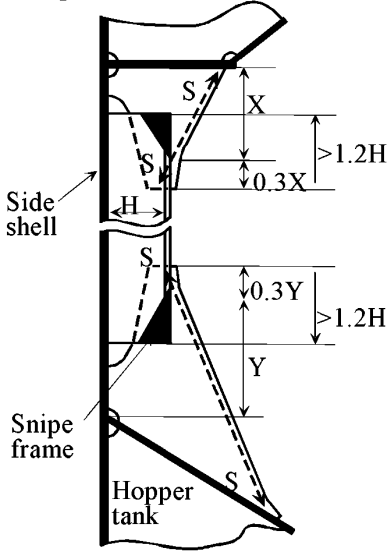
BULK CARRIERS		Guidelines for Surveys, Assessment and Repair of Hull Structure
Part 1	Cargo hold region	Example No.
Area 3	Cargo hold side structure	1-b
Detail of damage		Fractures in side shell frame at bracket's toe
<p><b>Sketch of damage</b></p>

<p><b>Separate bracket configuration</b></p>		<p><b>Sketch of repair</b></p>

<p>S=Snipped end</p>
<p><b>Notes on possible cause of damage</b></p> <ol style="list-style-type: none"> <li>1. This type of damage is caused due to stress concentration.</li> </ol>		<p><b>Notes on repairs</b></p> <ol style="list-style-type: none"> <li>1. For small fractures, e. g. hairline fractures, the fracture can be veed-out, welded up, ground, examined by NDT for fractures, and rewelded.</li> <li>2. For larger/significant fractures consideration is to be given to cropping and partly renewing/renewing the frame brackets. If renewing the brackets, end of frames can be sniped to soften them.</li> <li>3. If felt prudent, soft toes are to be incorporated at the boundaries of the bracket to the hopper plating.</li> <li>4. Attention to be given to the structure in wing tanks in way of the extended bracket arm. i.e. reinforcement provided in line with the bracket.</li> </ol>
