**РОССИЙСКИЙ МОРСКОЙ РЕГИСТР СУДОХОДСТВА**  
**RUSSIAN MARITIME REGISTER OF SHIPPING**

**ПРИЛОЖЕНИЕ К ПРАВИЛАМ**  
**РОССИЙСКОГО МОРСКОГО РЕГИСТРА СУДОХОДСТВА**  
**УНИФИЦИРОВАННЫЕ ИНТЕРПРЕТАЦИИ**  
**И РЕКОМЕНДАЦИИ**  
**МЕЖДУНАРОДНОЙ АССОЦИАЦИИ**  
**КЛАССИФИКАЦИОННЫХ ОБЩЕСТВ**

**SUPPLEMENT TO RULES**  
**OF RUSSIAN MARITIME REGISTER OF SHIPPING**  
**IACS UNIFIED INTERPRETATIONS**  
**AND RECOMMENDATIONS**

НД № 2-020101-085-R-E

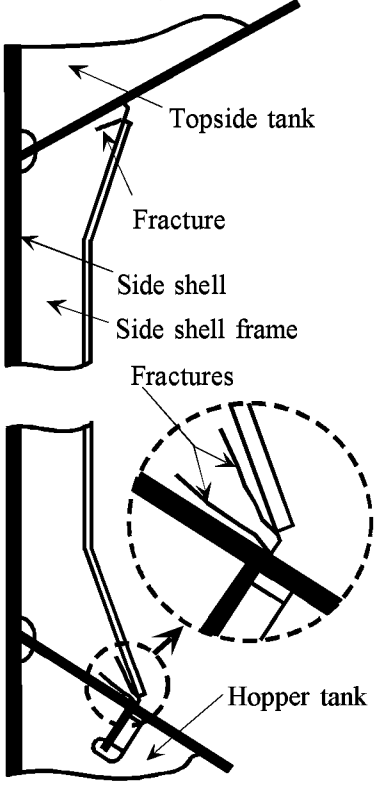
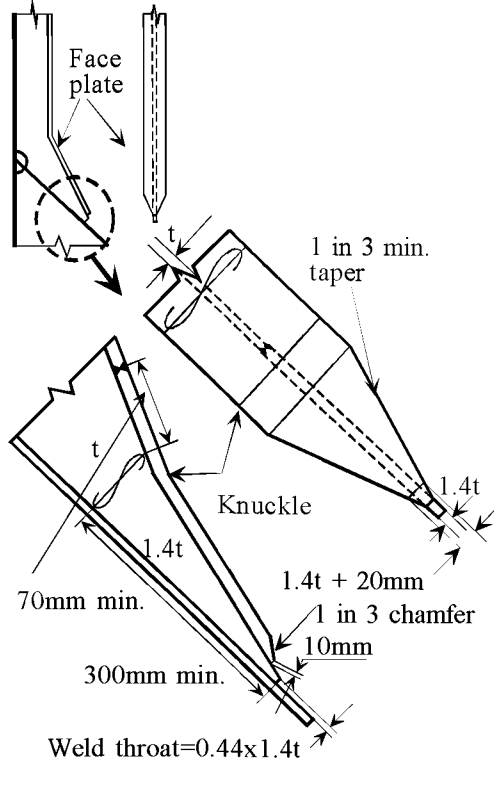
BULK CARRIERS		Guidelines for Surveys, Assessment and Repair of Hull Structure	
Part 1	Cargo hold region	Example No.	
Area 3	Cargo hold side structure	2	
Detail of damage		Fractures in side shell frame at bracket's toe	
Sketch of damage		Sketch of repair

<p>Topside tank</p> <p>Fracture</p> <p>Side shell</p> <p>Side shell frame</p> <p>Fractures</p> <p>Hopper tank</p>

<p>Face plate</p> <p>1 in 3 min. taper</p> <p>Knuckle</p> <p>1.4t</p> <p>1.4t + 20mm</p> <p>1 in 3 chamfer</p> <p>10mm</p> <p>300mm min.</p> <p>70mm min.</p> <p>Weld throat = <math>0.44 \times 1.4t</math></p>	
Notes on possible cause of damage		Notes on repairs	
<p>1. This type of damage is caused due to stress concentration.</p>		<p>1. Repair is to incorporate a design similar to the one shown on the sketch and in addition:-</p> <ol style="list-style-type: none"> <li>1.1. The arm of the bracket along the hopper/ topside plating should be increased by altering the angle of the bracket face plate. A face plate taper of 1 in 3 should be arranged.</li> <li>1.2. The local thickness of the bracket web plating over the length of the new face plate taper should be increased by about 40% above that originally fitted.</li> <li>1.3. The face plate thickness should be chamfered 1 in 3 to a thickness at its extremity.</li> <li>1.4. Welding of the new bracket toe should be based on a weld factor of 0.44 applied to the increased thickness.</li> </ol> <p>2. Attention to be given to the structure in wing tanks in way of the extended bracket arm. i.e. reinforcement provided in line with the bracket.</p>

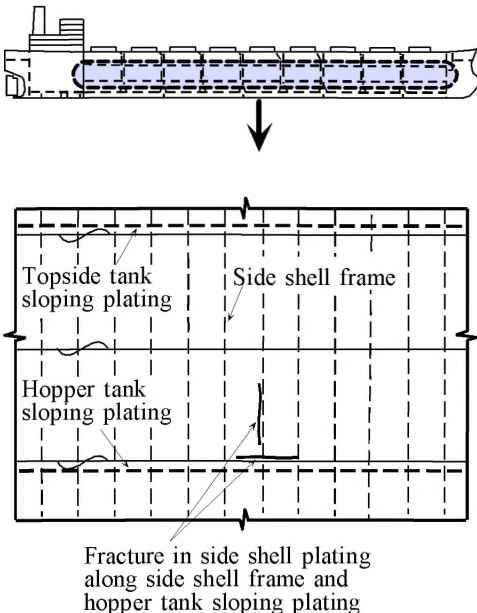
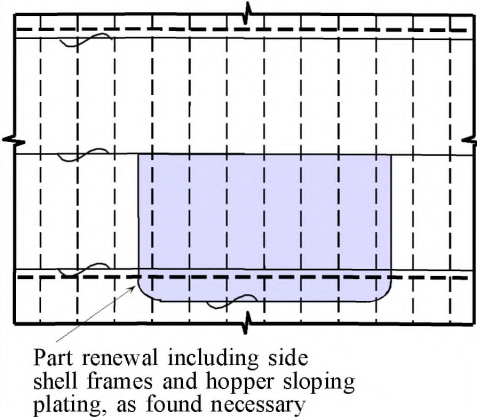
BULK CARRIERS		Guidelines for Surveys, Assessment and Repair of Hull Structure	
Part 1	Cargo hold region		Example No.
Area 3	Cargo hold side structure		3
Detail of damage		Fractures in side shell frame/lower bracket and side shell plating near hopper	
<b>Sketch of damage</b>

<b>Sketch of repair</b>

<b>Notes on possible cause of damage</b> 1. Heavy corrosion (grooving). Refer to <b>Figure 2 (c)</b> .		<b>Notes on repairs</b> 1. Sketch of repair applies when damage extends over several frames. 2. Isolated fractures may be repaired by veeing-out and rewelding. 3. Isolated cases of grooving may be repaired by build up of welding.

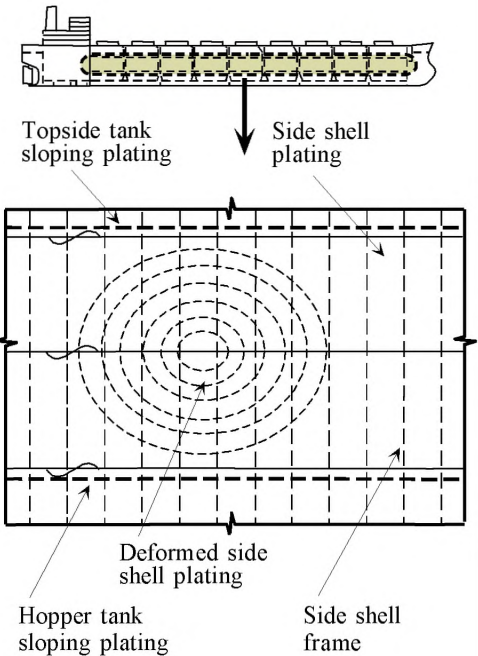
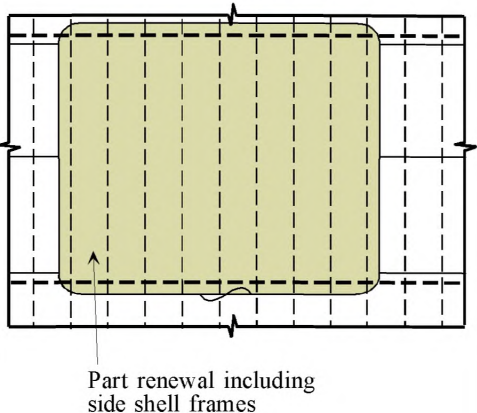
BULK CARRIERS		Guidelines for Surveys, Assessment and Repair of Hull Structure	
Part 1	Cargo hold region	Example No.	
Area 3	Cargo hold side structure	4	
Detail of damage		Deformation of side shell plating	
<b>Sketch of damage</b>

<b>Sketch of repair</b>

<b>Notes on possible cause of damage</b> <ol style="list-style-type: none"> <li>1. Insufficient stiffness of side shell frames due to buckling and/or detachment of side shell frames due to corrosion.</li> <li>2. Heavy weather.</li> </ol>		<b>Notes on repairs</b> <ol style="list-style-type: none"> <li>1. Deformed side shell plating including side shell frames should be cropped and renewed.</li> </ol>

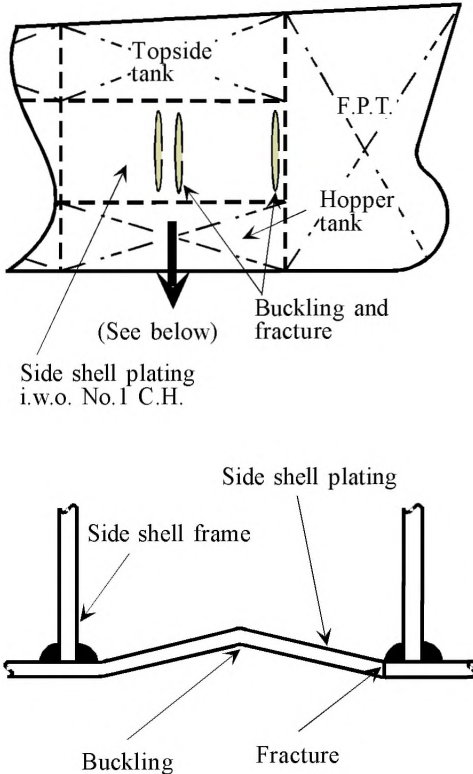
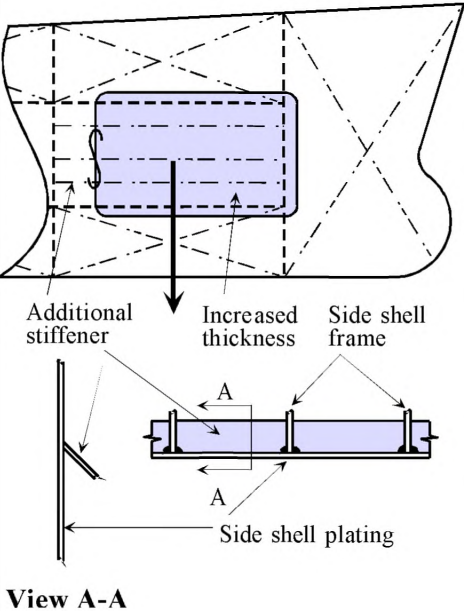
BULK CARRIERS		Guidelines for Surveys, Assessment and Repair of Hull Structure	
Part 1	Cargo hold region	Example No.	
Area 3	Cargo hold side structure	6	
Detail of damage		Buckling and fractures of side shell plating in foremost cargo hold	
<p><b>Sketch of damage</b></p>

<p><b>Sketch of repair</b></p>

<p><b>View A-A</b></p>	
<p><b>Notes on possible cause of damage</b></p> <ol style="list-style-type: none"> <li>1. Heavy weather.</li> <li>2. Insufficient buckling strength due to high tensile steel or heavy uniform corrosion.</li> <li>3. Inadequate transition structure.</li> </ol>		<p><b>Notes on repairs</b></p> <ol style="list-style-type: none"> <li>1. Buckled/fractured side shell plating is to be cropped and renewed.</li> <li>2. Reinforcement by thicker side shell plating and/or additional stiffeners should be considered.</li> </ol>

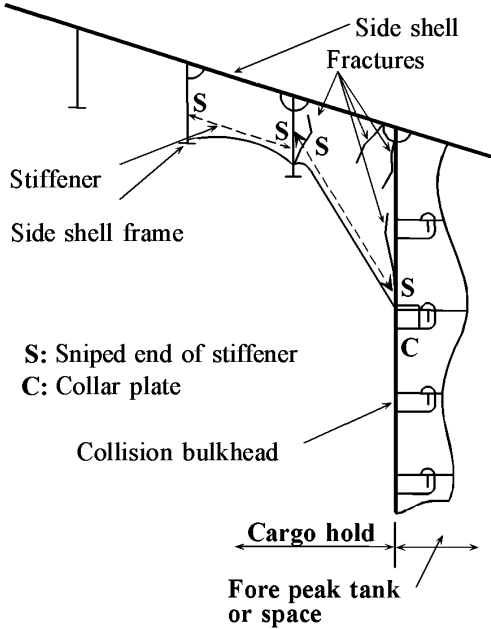
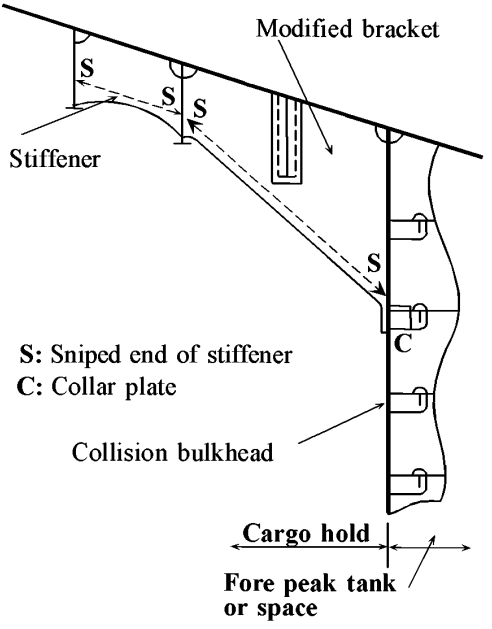
BULK CARRIERS		Guidelines for Surveys, Assessment and Repair of Hull Structure	
Part 1	Cargo hold region	Example No.	
Area 3	Cargo hold side structure	7	
Detail of damage		Fractures at the supporting brackets in way of the collision bulkhead	
Sketch of damage		Sketch of repair

<b>Notes on possible cause of damage</b> <ol style="list-style-type: none"> <li>1. Insufficient bracket size resulting in high stress due to load cantilevered from side frame.</li> <li>2. Stress concentration at toe of bracket and misalignment between bracket and stringer in fore peak tank or space.</li> </ol>		<b>Notes on repairs</b> <ol style="list-style-type: none"> <li>1. The extended bracket arm connection to the collision bulkhead is to have a soft toe, and any cut-outs for stiffeners in the fore peak tank or space are to be collared when situated in the vicinity of the bracket toe.</li> <li>2. When fractures have extended into the side shell or bulkhead plating, the plating is to be cropped and part renewed.</li> </ol>

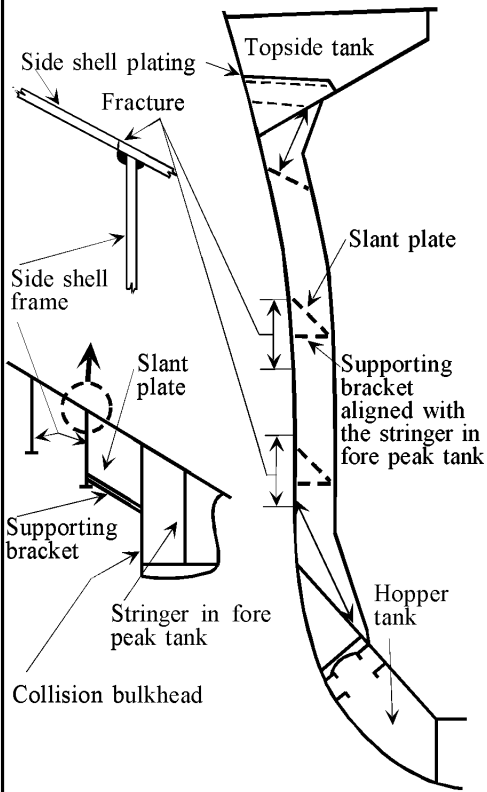
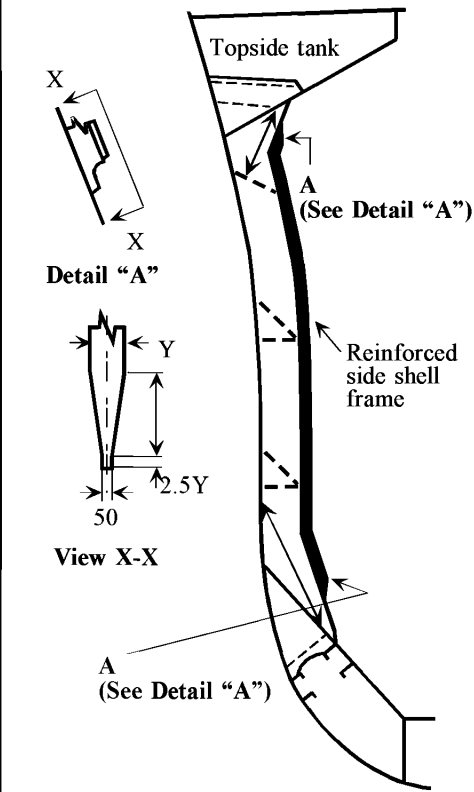
BULK CARRIERS		Guidelines for Surveys, Assessment and Repair of Hull Structure	
Part 1	Cargo hold region	Example No.	
Area 3	Cargo hold side structure	8	
Detail of damage		Fractures at the supporting brackets in way of the collision bulkhead with no side shell panting stringer in hold	
Sketch of damage		Sketch of repair

<b>Notes on possible cause of damage</b> <ol style="list-style-type: none"> <li>1. Damage caused by stress concentration leading to fatigue fracture in side shell. This has been exacerbated because of the greater flexibility of the hold structure in relation to the structure forward of the collision bulkhead.</li> </ol>		<b>Notes on repairs</b> <ol style="list-style-type: none"> <li>1. Fractured shell plates to be cropped and part renewed, and side shell frame/frames in the vicinity of the damage to be reinforced as required by the relevant Classification Society.</li> </ol>

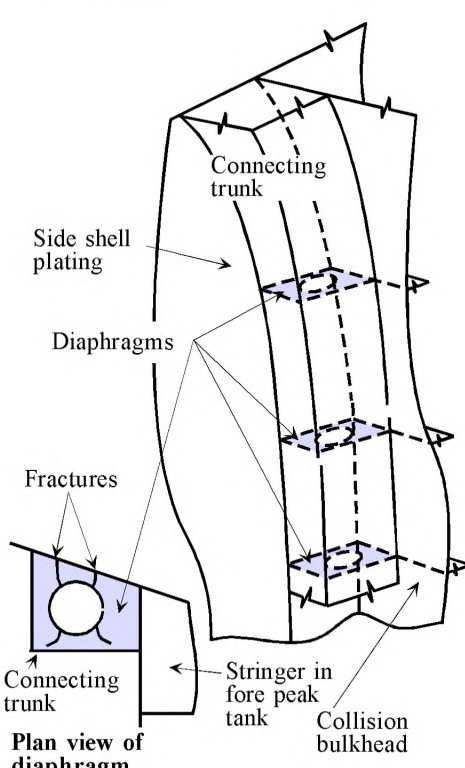
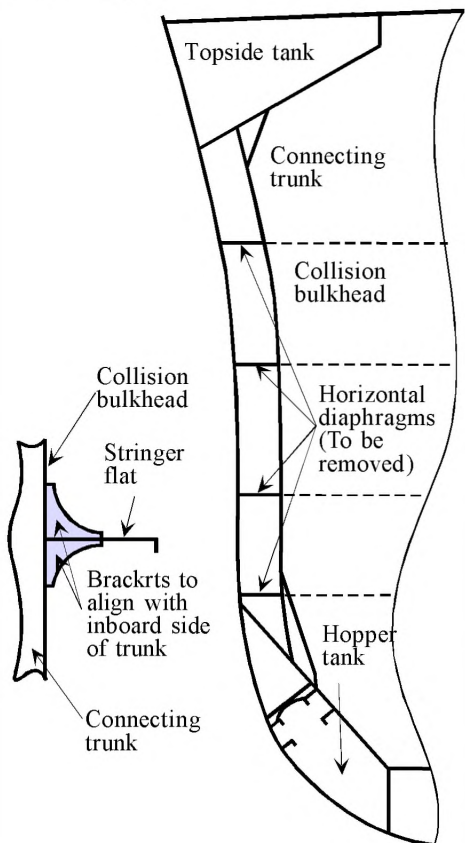
BULK CARRIERS		Guidelines for Surveys, Assessment and Repair of Hull Structure
Part 1	Cargo hold region	Example No.
Area 3	Cargo hold side structure	9
<b>Detail of damage</b>		Fractures in way of horizontal diaphragm in the connecting trunk between topside tank and hopper double bottom tank, on after side of collision bulkhead
<b>Sketch of damage</b>

<b>Sketch of repair</b>

<b>Notes on possible cause of damage</b> <ol style="list-style-type: none"> <li>Damage caused by stress concentration resulting from the discontinuity created by the trunk and diaphragm structure. This has been exacerbated because of the greater flexibility of the hold structure in relation to the trunk and structure forward of the collision bulkhead.</li> </ol>		<b>Notes on repairs</b> <ol style="list-style-type: none"> <li>Diaphragm to be removed permanently and fractured shell plated cropped and part renewed, or veed and weld as necessary in way of damage. Brackets with softened toes are to be fitted on forward side of collision bulkhead in way of stringers/flats to align with inboard side of trunk in order to remove hard-spots.</li> </ol>

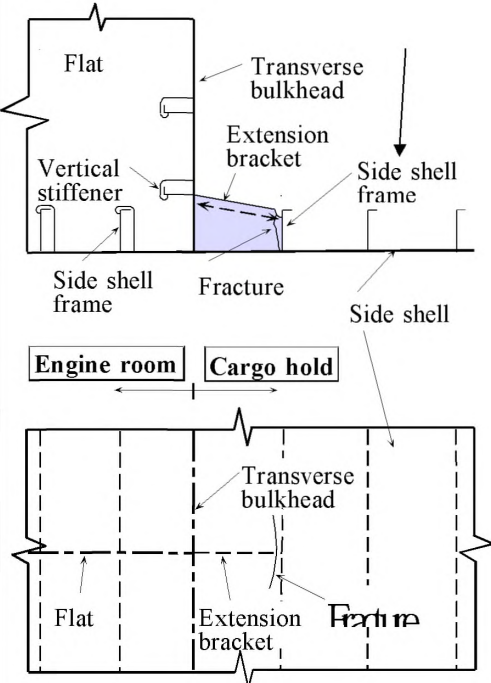
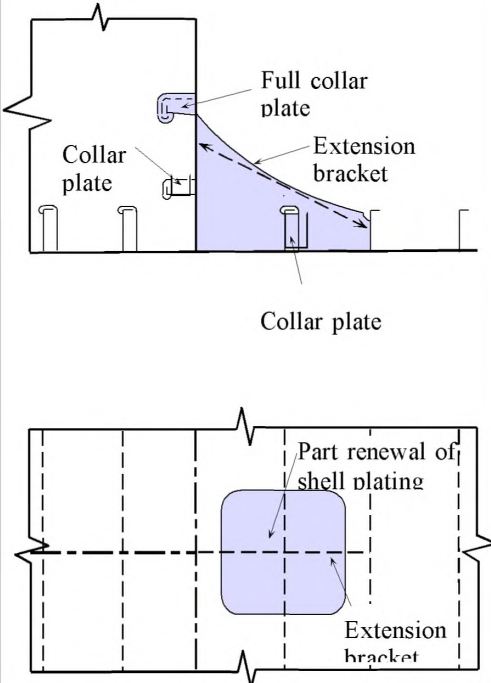
BULK CARRIERS		Guidelines for Surveys, Assessment and Repair of Hull Structure
Part 1	Cargo hold region	Example No.
Area 3	Cargo hold side structure	10
Detail of damage		Fractures in way of continuation/extension brackets in aftermost hold at the engine room bulkhead
Sketch of damage		Sketch of repair

<b>Notes on possible cause of damage</b> 1. Damage caused by stress concentration leading to fatigue fracture on side shell. This will be exacerbated because of the greater flexibility of the hold structure in relation to the engine room structure.		<b>Notes on repairs</b> 1. The fractured shell plating is to be cropped and part renewed as necessary. 2. Extension bracket is to be modified and collar plates to cut-outs in engine room flat are to be installed.

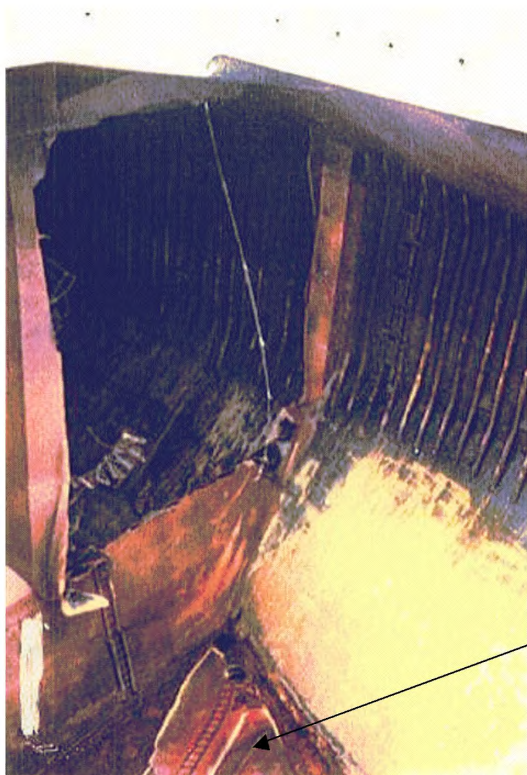
**Photograph 1**  
Collapsed and detached  
transverse bulkhead

Collapsed and detached transverse  
bulkhead on the tank top

- The filling is restricted to a level that corresponds to the dry cargo hold scantlings, in particular the transverse bulkheads scantlings, and must only be carried out in port. In no case should these cargo holds be partially filled during voyage to save time at the berth. Such filling at sea may cause sloshing resulting in catastrophic failure such as indicated in **Photograph 1**.

- 1.5** Heavy corrosion may lead to collapse of the structure under extreme load, such as indicated in **Photograph 1** if it is not rectified properly.

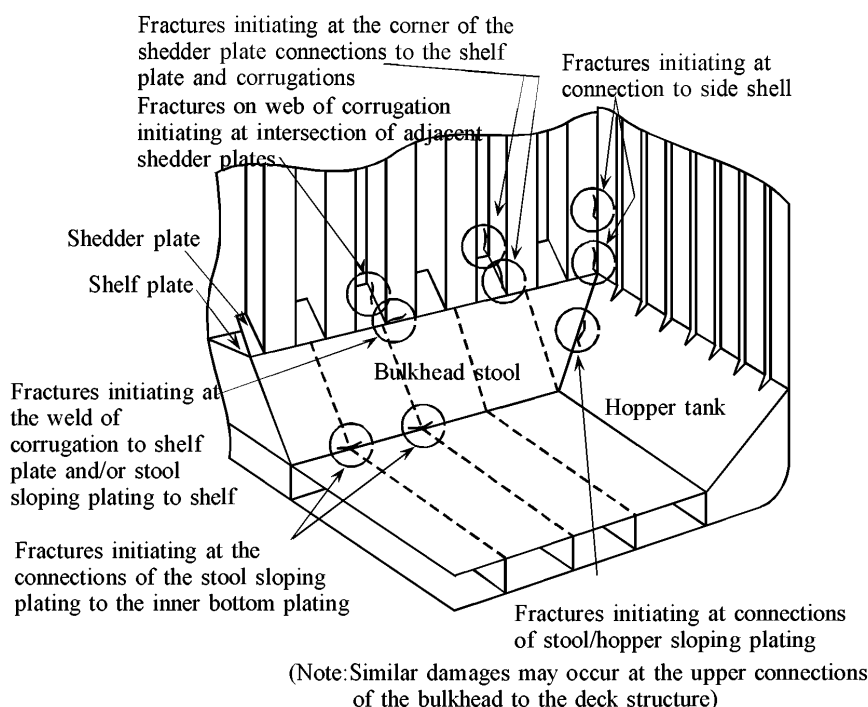
**Figure 2 Typical fracturing at the connection of transverse bulkhead structure**

**2.3.1** Fractures usually occur at the boundaries of corrugations and bulkhead stools particularly in way of shelf plates, shedder plates, deck, inner bottom, etc. (See **Figure 2**).

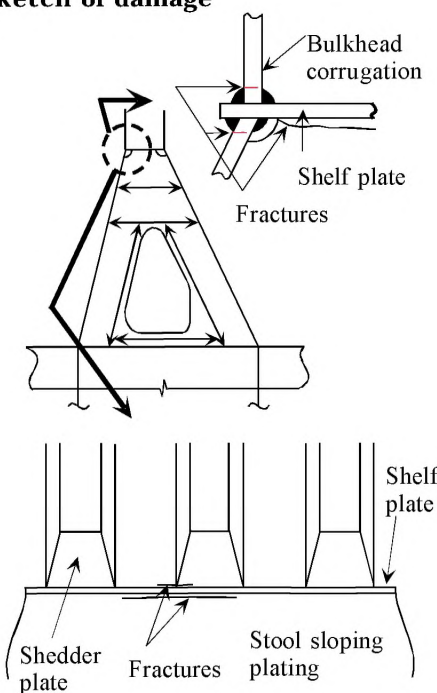
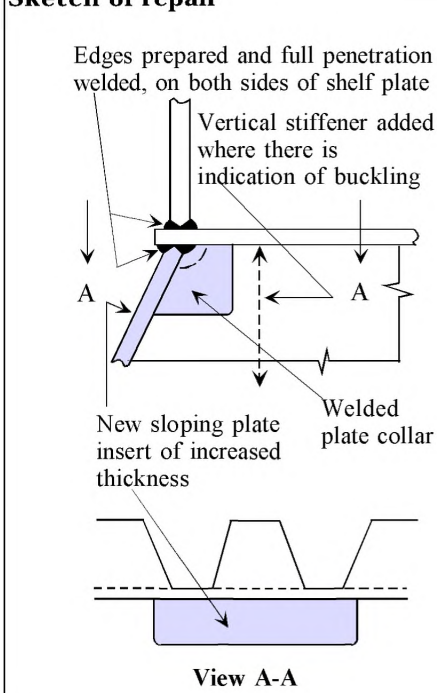
<b>BULK CARRIERS</b>		<b>Guidelines for Surveys, Assessment and Repair of Hull Structure</b>
<b>Part 1</b>	<b>Cargo hold region</b>	<b>Example No.</b>
<b>Area 4</b>	<b>Transverse bulkhead and associated structure in cargo hold</b>	<b>1-a</b>
<b>Detail of damage</b>		Fractures at weld connections to stool shelf plate
<b>Sketch of damage</b>		<b>Sketch of repair</b>

<p>The sketch of damage consists of two parts. The top part is a perspective view of a bulkhead corrugation where a shelf plate is attached. Arrows point to the 'Bulkhead corrugation', 'Shelf plate', and 'Fractures' at the weld connections. The bottom part is a plan view showing 'Shedder plate' and 'Stool sloping plating' with 'Fractures' indicated at the welds. A 'Shelf plate' is also labeled in this view.</p>

<p>The sketch of repair shows the same area after repair. The top part shows 'Edges prepared and full penetration welded, on both sides of shelf plate'. A 'Vertical stiffener added where there is indication of buckling' is shown. A 'New sloping plate insert of increased thickness' is shown in the stool sloping plating. A 'Welded plate collar' is shown at the junction. A section line 'A-A' is indicated. The bottom part is 'View A-A', showing the cross-section of the repair with the new sloping plate insert and welded plate collar.</p>

<b>Notes on possible cause of damage</b>		<b>Notes on repairs</b>
<ol style="list-style-type: none"> <li>1. Stress concentrations at welds adjacent to the scallops.</li> <li>2. Inadequate welding area connecting corrugation flange to shelf plate or similarly sloping stool plating to shelf plate.</li> <li>3. Inadequate thickness of sloping plating in relation to corrugation flange thickness.</li> <li>4. Stress concentration at knuckle of corrugation where web is not supported by bracket inside the stool.</li> </ol>		<ol style="list-style-type: none"> <li>1. Fractures to be vee-d out and rewelded.</li> <li>2. Reductions in stress concentration by fitting welded plate collars in way of the scallop.</li> <li>3. Where necessary an insert plate to be arranged in stool plating and/or diaphragm.</li> </ol>

- 3.3.1** Fractures observed at the connection between lower stool and corrugated bulkhead during hold inspection may have initiated at the weld connection of the inside diaphragms (See **Example 1**).
- 3.3.2** Misalignment between bulkhead corrugation flange and sloping stool plating may also cause fractures at the weld connection of the inside diaphragms (See **Example 2**).

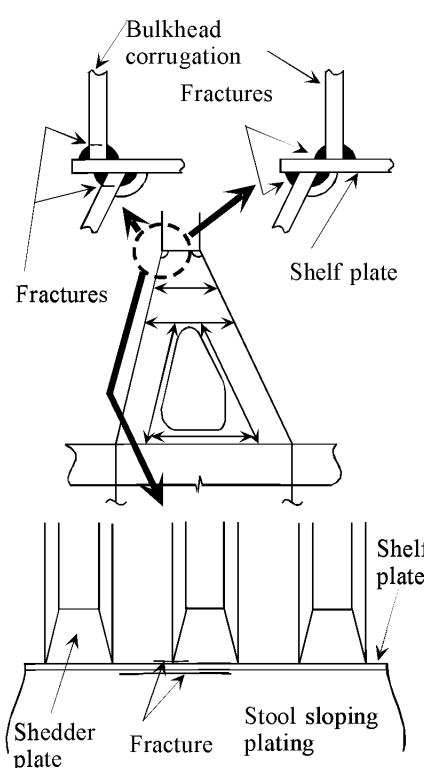
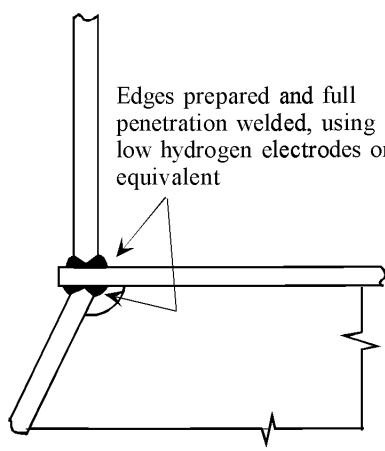
<b>BULK CARRIERS</b>		<b>Guidelines for Surveys, Assessment and Repair of Hull Structure</b>
<b>Part 1</b>	<b>Cargo hold region</b>	<b>Example No.</b>
<b>Area 4</b>	<b>Transverse bulkhead and associated structure in cargo hold</b>	<b>1-b</b>
<b>Detail of damage</b> Fractures at weld connections to stool shelf plate		
<b>Sketch of damage</b>		<b>Sketch of repair</b>

<b>Notes on possible cause of damage</b>		<b>Notes on repairs</b>
<ol style="list-style-type: none"> <li>1. Misalignment between corrugation flange and sloping stool plating.</li> <li>2. Inadequate welding area connecting corrugation flange to shelf plate or similarly sloping stool plating to shelf plate.</li> </ol>		<ol style="list-style-type: none"> <li>1. Fractures to be veed-out and rewelded.</li> <li>2. Structure to be released and misalignment rectified.</li> <li>3. Edge of the corrugated bulkhead and the stool plating on both sides of shelf plate to have full penetration welds.</li> <li>4. Where necessary an insert plate to be arranged in stool plating.</li> </ol>

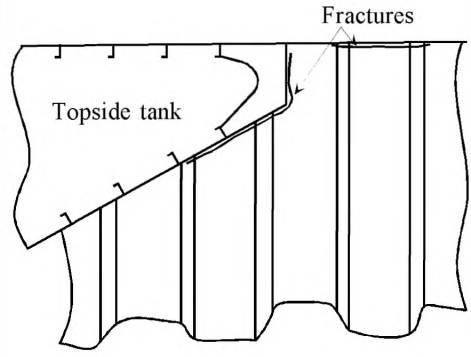
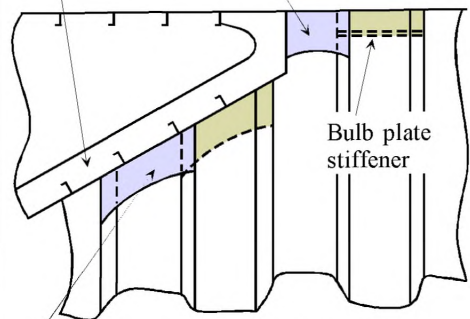
<b>BULK CARRIERS</b>		<b>Guidelines for Surveys, Assessment and Repair of Hull Structure</b>
<b>Part 1</b>	<b>Cargo hold region</b>	<b>Example No.</b>
<b>Area 4</b>	<b>Transverse bulkhead and associated structure in cargo hold</b>	<b>2</b>
<b>Detail of damage</b> Fractures at the upper boundaries to topside tanks		
<b>Sketch of damage</b>		<b>Sketch of repair</b>

<p>Fractures</p> <p>Topside tank</p>		<p>Continuous or intercostal reinforcement in line with flanges or gussets where not already fitted</p> <p>Adjacent to the topside tank either a gusset to a bulb plate stiffener may be</p>

<p>Bulb plate stiffener</p> <p>Gusset(similar gusset on the opposite</p>
<b>Notes on possible cause of damage</b>		<b>Notes on repairs</b>
<ol style="list-style-type: none"> <li>1. Damage due to poor design and/or defective welds.</li> </ol>		<ol style="list-style-type: none"> <li>1. Fractures may be veed-out and rewelded. If necessary corrugated plating cropped and renewed.</li> <li>2. It is recommended that reinforcement as shown above be incorporated, giving due consideration to the following criteria:             <ol style="list-style-type: none"> <li>2.1 It is important to have the gusset plates well aligned with the transverse structure inside the tank. Gusset plates may be joggled to obtain this alignment.</li> <li>2.2 If there is no transverse web already existing inside the topside tank and in line with the flanges of corrugation or gusset plates, reinforcement as shown above to be fitted.</li> </ol> </li> </ol>

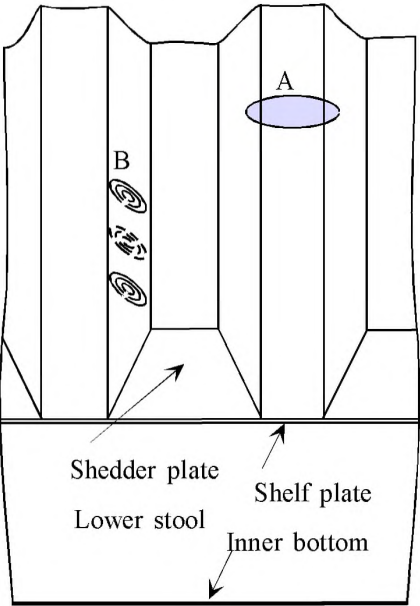
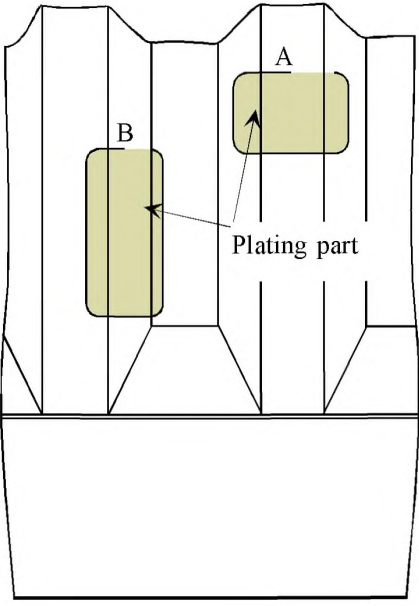
<b>BULK CARRIERS</b>		<b>Guidelines for Surveys, Assessment and Repair of Hull Structure</b>
<b>Part 1</b>	<b>Cargo hold region</b>	<b>Example No.</b>
<b>Area 4</b>	<b>Transverse bulkhead and associated structure in cargo hold</b>	<b>3</b>
<b>Detail of damage</b>		Indentation and buckling of vertical corrugation
<b>Sketch of damage</b>		<b>Sketch of repair</b>

<b>Notes on possible cause of damage</b>		<b>Notes on repairs</b>
<ol style="list-style-type: none"> <li>1. Damages by mechanical abuse during cargo handling e.g. grab damage.</li> <li>2. Damage resulting from thickness reduction by corrosion.</li> <li>3. Buckling caused by bending or shear, see locations A and B respectively above, with a minimum reduction in thickness could be caused by underdesign or overloading. If this cause is suspected, the Classification Society concerned shall be contacted before proceeding with repairs.</li> </ol>		<ol style="list-style-type: none"> <li>1. Damage by mechanical abuse If the indentation/buckling is local and of a minor nature, the plating can be faired in place. If the deformation is more pronounced and/or in association with a generalized reduction in thickness the plating is to be cropped and renewed, as shown at locations A and B above.</li> <li>2. Damage resulting from corrosion In this case thickness measurements are to be taken at mid-span and top and bottom of corrugations, and corrugations renewed or part renewed as necessary. Particular attention is to be given to the fit and alignment at corners of flanged corrugations when being partly renewed.</li> </ol>

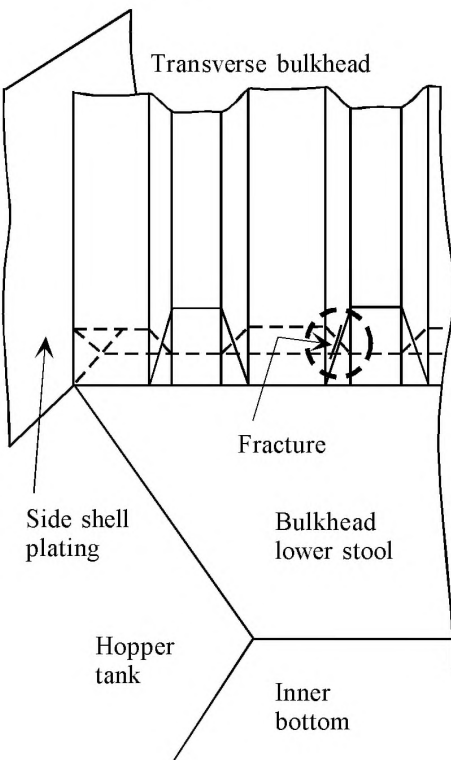
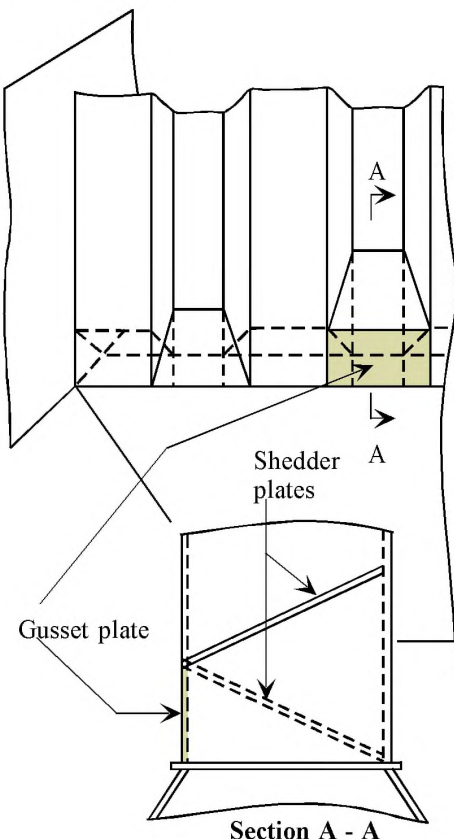
BULK CARRIERS		Guidelines for Surveys, Assessment and Repair of Hull Structure	
Part 1	Cargo hold region	Example No.	
Area 4	Transverse bulkhead and associated structure in cargo hold	4	
Detail of damage	Fractures in the web of the corrugation initiating at intersection of adjacent shedder plates		
Sketch of damage		Sketch of repair

Notes on possible cause of damage		Notes on repairs	
<p>1. Damage due to stress concentrations at intersection of shedder plates. This can be exacerbated by corrosion and reduction in thickness of the corrugation web plating.</p>		<p>1. If due to wastage, corrugation plating and shedder plates to be part renewed/renewed as necessary.</p> <p>2. Where renewals are being carried out it may be prudent to fit the extension pieces shown above to change the location of the point of intersection, and hence reduce the stress concentration.</p>

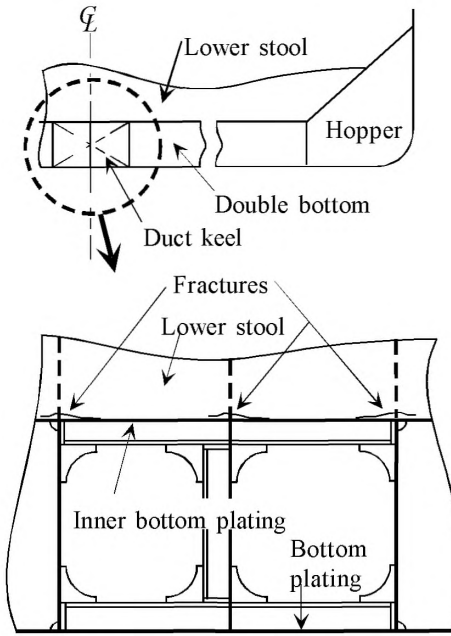
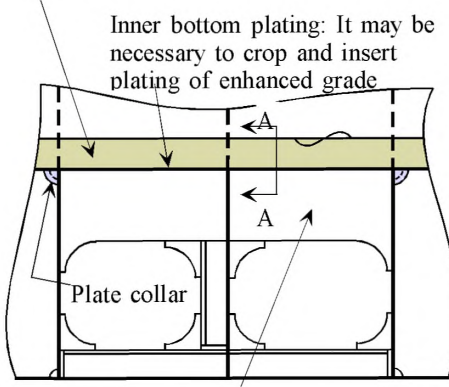
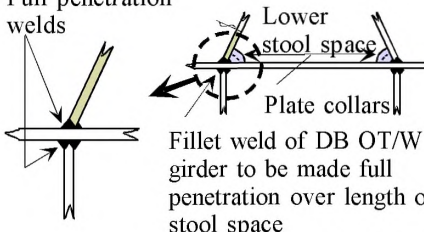
<b>BULK CARRIERS</b>		<b>Guidelines for Surveys, Assessment and Repair of Hull Structure</b>
<b>Part 1</b>	<b>Cargo hold region</b>	<b>Example No.</b>
<b>Area 4</b>	<b>Transverse bulkhead and associated structure in cargo hold</b>	<b>5</b>
<b>Detail of damage</b>	Fractures at weld connection of lower stool plating to inner bottom in way of duct keel	
<b>Sketch of damage</b>

<b>Sketch of repair</b> <p>Lower stool: Insert plate of increased</p> <p>Inner bottom plating: It may be necessary to crop and insert plating of enhanced grade</p>

<p>Increased depth of stiffener to suit arrangement of pipes in duct keel</p> <p>Full penetration welds</p>

<p>Fillet weld of DB OT/WT girder to be made full penetration over length of stool space</p> <p><b>View A - A</b></p>
<b>Notes on possible cause of damage</b> <ol style="list-style-type: none"> <li>1. This type of failure is more likely to occur at the boundaries of the ballast hold.</li> <li>2. The fractures arise because of stress concentration in way of cut-outs and exacerbated by the flexibility of the inner bottom structure in way of the duct keel.</li> </ol>		<b>Notes on repairs</b> <ol style="list-style-type: none"> <li>1. In order to prevent recurrence of the damage, the additional reinforcement shown should be fitted.</li> </ol>

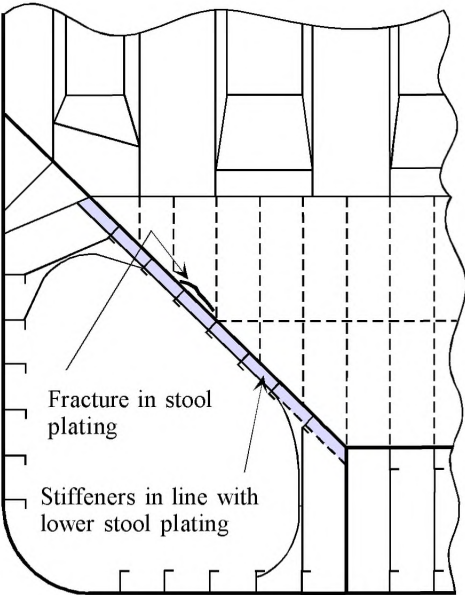
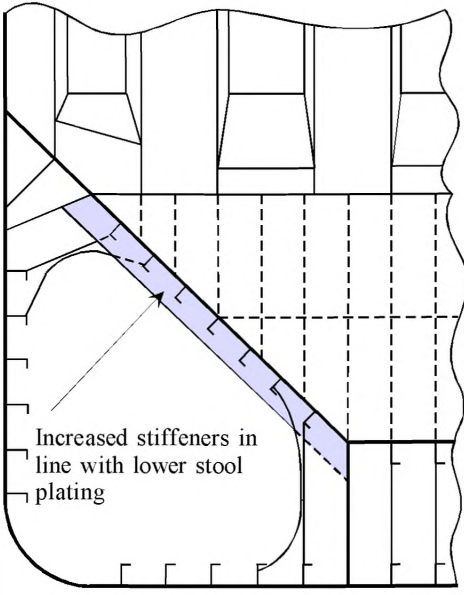
<b>BULK CARRIERS</b>		<b>Guidelines for Surveys, Assessment and Repair of Hull Structure</b>
<b>Part 1</b>	<b>Cargo hold region</b>	<b>Example No.</b>
<b>Area 4</b>	<b>Transverse bulkhead and associated structure in cargo hold</b>	<b>6</b>
<b>Detail of damage</b>		Fractures at the connection of lower stool to hopper
<b>Sketch of damage</b>		<b>Sketch of repair</b>

<b>Notes on possible cause of damage</b>		<b>Notes on repairs</b>
<ol style="list-style-type: none"> <li>1. Insufficient strength of the connection</li> <li>2. Corrosion</li> </ol>		<ol style="list-style-type: none"> <li>1. Fractured stool plating should be partly cropped and renewed (thicker plate) if considered necessary.</li> <li>2. If the damage occurred due to insufficient strength, stiffeners in line with stool plating should be increased.</li> </ol>

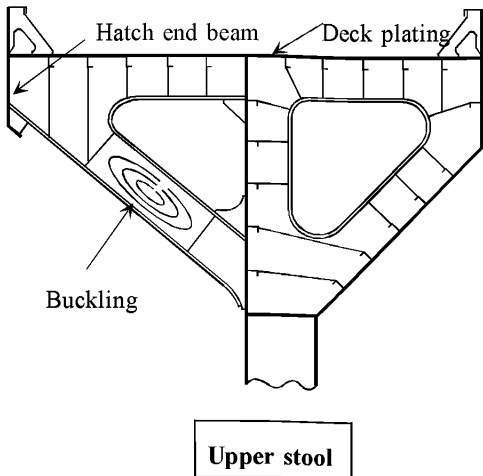
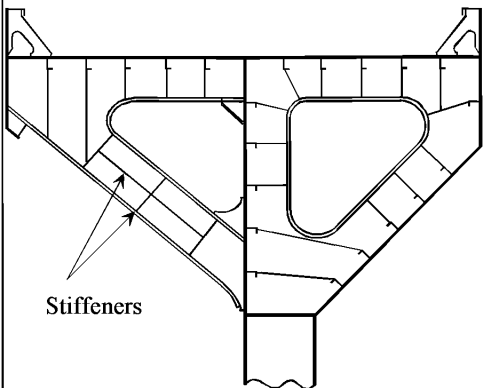
<b>BULK CARRIERS</b>			<b>Guidelines for Surveys, Assessment and Repair of Hull Structure</b>
<b>Part 1</b>	<b>Cargo hold region</b>	<b>Example No.</b>	
<b>Area 4</b>	<b>Transverse bulkhead and associated structure in cargo hold</b>	<b>7</b>	
<b>Detail of damage</b>		Buckling of strut supporting hatch end beam	
<b>Sketch of damage</b>		<b>Sketch of repair</b>

<b>Notes on possible cause of damage</b>		<b>Notes on repairs</b>	
<ol style="list-style-type: none"> <li>1. Insufficient strength</li> <li>2. Partial ballast loading in ballast cargo hold (sloshing)</li> <li>3. Corrosion</li> </ol>		<ol style="list-style-type: none"> <li>1. Deformed part to be cropped and renewed if considered necessary.</li> <li>2. If the damage occurred due to insufficient strength, appropriate reinforcement is to be considered (thicker plate/additional stiffener(s)).</li> </ol>

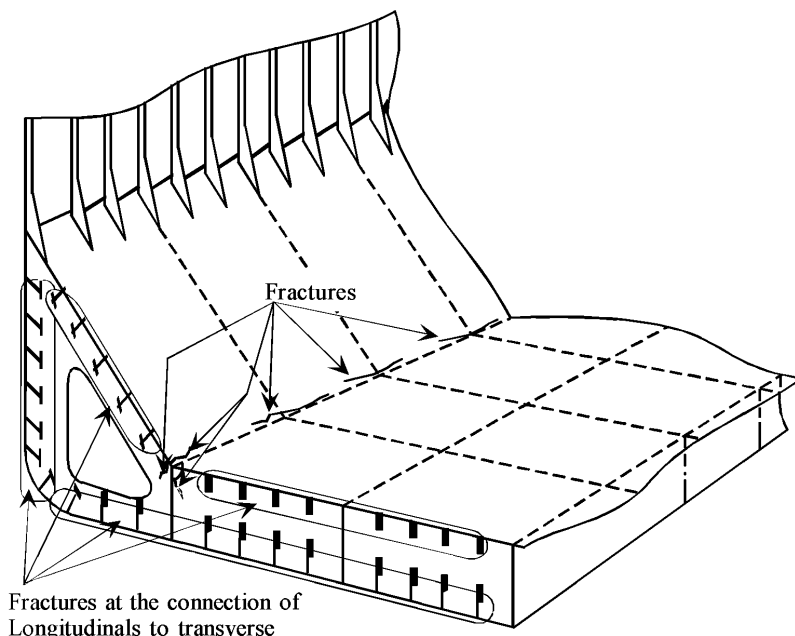
**Figure 1** Typical fractures in the connection of hopper sloping plating to inner bottom (tank top) and longitudinals to transverse (or transverse bulkhead)

**3.3.2** Fractures may occur in way of the welded or radiused knuckle between the inner bottom and hopper sloping plating if the side girder in the double bottom is not in line with the knuckle and also when the floors below have a large spacing, or when corner scallops are created for ease of fabrication. The local stress variations due to the loading and subsequent deflection may lead to the development of fatigue fractures which can be categorised as follows (See **Figure 1**).

**3.3.3** The fractures in way of connection of inner bottom plating/hopper sloping plating to stool may be caused by the cyclic deflection of the inner bottom induced by repeated loading from the sea or due to poor “through-thickness” properties of the inner bottom plating. Scallops in the underlying girders can create stress concentrations which further increase the risk of fractures. These can be categorised as follows (See **Figure 1** and **Examples**).

- (a) In way of the intersection between inner bottom and stool. These fractures often generate along the edge of the welded joint above the centre line girder, side girders, and sometimes along the duct keel sides.

- (b) Fractures in the inner bottom longitudinals and the bottom longitudinals in way of the intersection with the watertight floors below the transverse bulkhead stools in way of the ballast hold, especially in way of suction wells.

- (c) Fractures at the connection between the longitudinals and the vertical stiffeners or brackets on the floors, as well as at the corners of the duct keel.

- (d) Lamellar tearing of the inner bottom plate below the weld connection with the stool in the ballast hold caused by large bending stresses in the connection when in heavy ballast condition. The size of stool and lack of full penetration welds could also be a contributory factor, as well as poor “through-thickness” properties of the tank top plating.

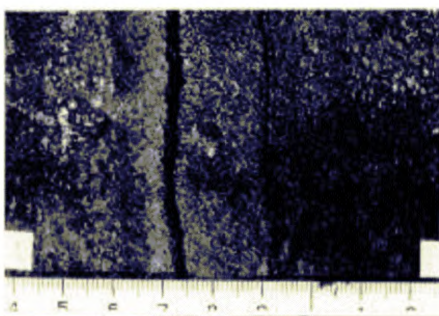
**Photograph 1**  
Grooving corrosion of welding of  
bottom plating

**4.1.2** Severe grooving along welding of bottom plating is often found (See **Photographs 1** and **2**). This grooving can be accelerated by poor maintenance of the protective coating and/or sacrificial anodes fitted to the bottom plating.

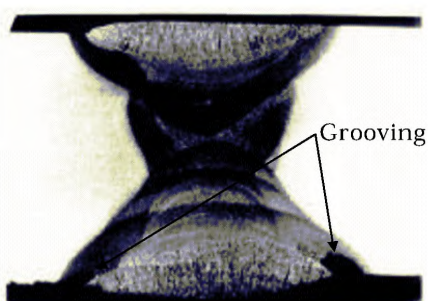
**Photograph 2**  
Section of the grooving shown in  
Photograph 1

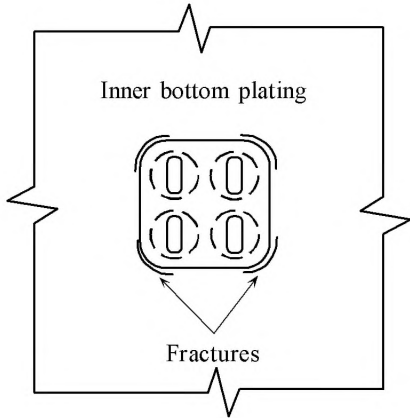
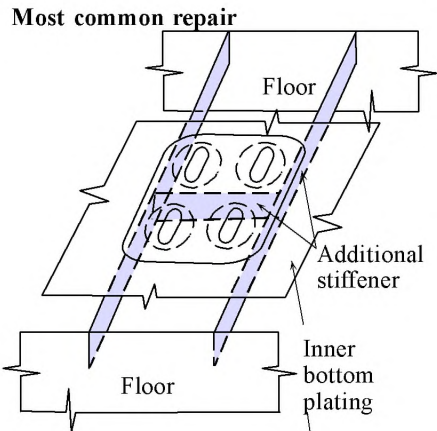
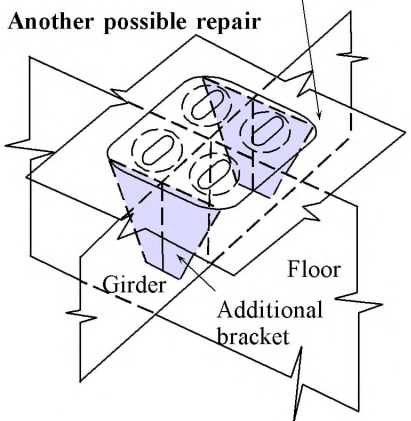
<b>BULK CARRIERS</b>		<b>Guidelines for Surveys, Assessment and Repair of Hull Structure</b>
<b>Part 1</b>	<b>Cargo hold region</b>	<b>Example No.</b>
<b>Area 5</b>	<b>Double bottom structure including hopper</b>	<b>1</b>
<b>Detail of damage</b>		Fractures in inner bottom plating around container bottom pocket
<b>Sketch of damage</b>

<b>Sketch of repair</b> <p><b>Most common repair</b></p>

<p><b>Another possible repair</b></p>

<b>Notes on possible cause of damage</b> 1. Pocket is not supported correctly by floor, longitudinal and/or stiffener.		<b>Notes on repairs</b> 1. Fractured plating should be cropped and part renewed. 2. Adequate reinforcement should be considered.

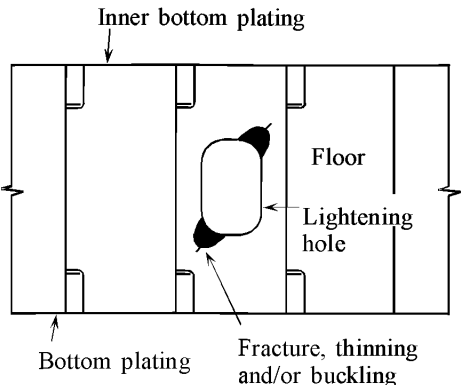
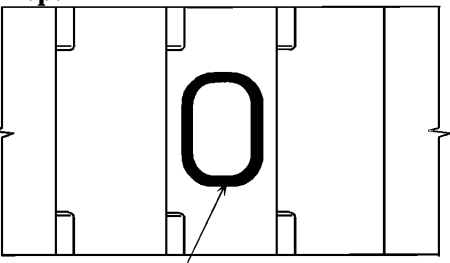
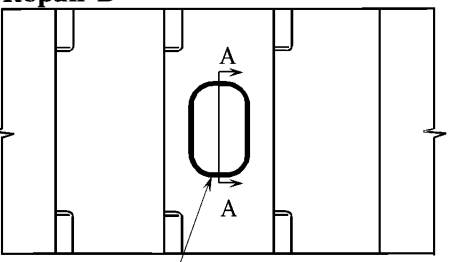
<b>BULK CARRIERS</b>		<b>Guidelines for Surveys, Assessment and Repair of Hull Structure</b>
<b>Part 1</b>	<b>Cargo hold region</b>	<b>Example No.</b>
<b>Area 5</b>	<b>Double bottom structure including hopper</b>	<b>2</b>
<b>Detail of damage</b>		Fractures, corrosion and/or buckling of floor/girder around lightening hole
<b>Sketch of damage</b>

<p>Inner bottom plating</p> <p>Floor</p> <p>Lightening hole</p> <p>Bottom plating</p> <p>Fracture, thinning and/or buckling</p>		<b>Sketch of repair</b> <b>Repair A</b>

<p>Doubling plate</p> <b>Repair B</b>

<p>Face plate</p> <p>Section A-A</p>
<b>Notes on possible cause of damage</b> <ol style="list-style-type: none"> <li>1. Insufficient strength due to lightening hole.</li> <li>2. Fracture, corrosion and/or buckling around lightening hole due to high stress.</li> </ol>		<b>Notes on repairs</b> <ol style="list-style-type: none"> <li>1. Fractured, corroded and/or buckled plating should be cropped and renewed if considered necessary.</li> <li>2. Appropriate reinforcement should be considered.</li> </ol>

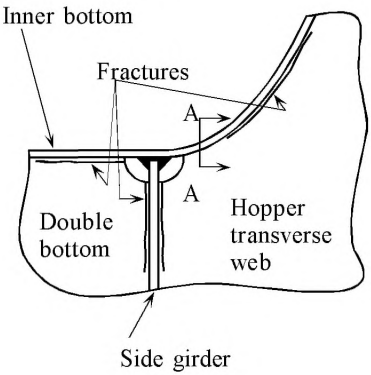
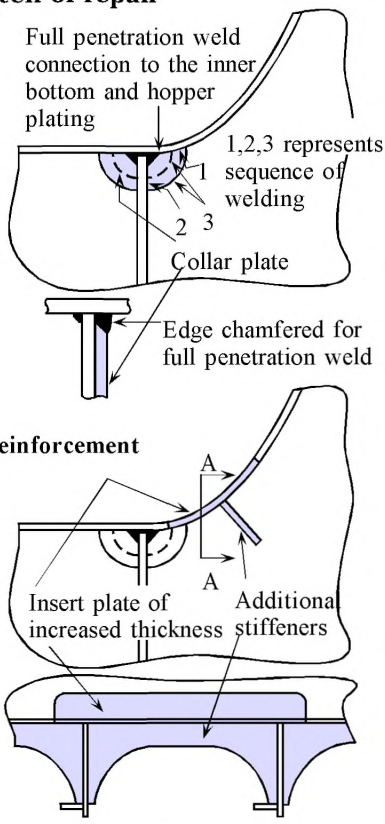
<b>BULK CARRIERS</b>		<b>Guidelines for Surveys, Assessment and Repair of Hull Structure</b>
<b>Part 1</b>	<b>Cargo hold region</b>	<b>Example No.</b>
<b>Area 5</b>	<b>Double bottom tank structure including hopper</b>	<b>3</b>
<b>Detail of damage</b>		Fractures at weld connections of floors in way of hopper/inner bottom interface (radiused knuckle)
<b>Sketch of damage</b>		<b>Sketch of repair</b>

<p><b>View A - A</b> Transverse fractures in hopper web plating into possibly extending into the hopper sloping plating</p>

<p>Inner bottom Floor or transverse web plating Fracture in the floor/web of hopper transverse ring</p>

<p><b>Reinforcement</b></p>
<b>Notes on possible cause of damage</b>		<b>Notes on repairs</b>
<ol style="list-style-type: none"> <li>1. The damage is partly due to stress concentrations at the edges of the weld created by the presence of cut-outs and local stress variations caused by the deflections in the inner bottom/hopper plating.</li> </ol>		<ol style="list-style-type: none"> <li>1. The fracture in the weld and/or plating is veed-out/cropped and renewed as appropriate.</li> <li>2. The cut-outs are eliminated by introducing suitable collar plate with emphasis on edge preparation and sequence of welding as shown above.</li> <li>3. Further reinforcements may need to be carried out as shown above, however, after consultation with the Classification Society concerned.</li> </ol>

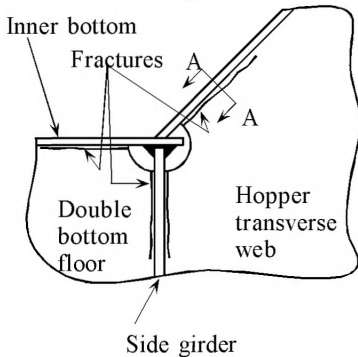
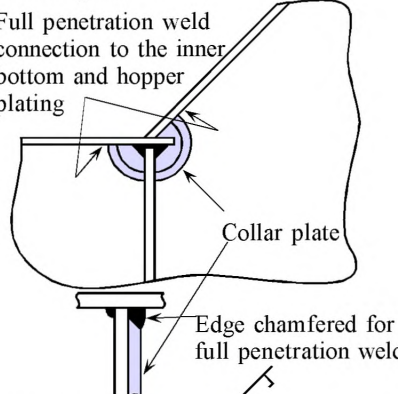
<b>BULK CARRIERS</b>		<b>Guidelines for Surveys, Assessment and Repair of Hull Structure</b>
<b>Part 1</b>	<b>Cargo hold region</b>	<b>Example No.</b>
<b>Area 5</b>	<b>Double bottom tank structure including hopper</b>	<b>4</b>
<b>Detail of damage</b>		Fractures at weld connections of floors in way of hopper/inner bottom interface (welded knuckle)
<p><b>Sketch of damage</b></p>

<p><b>View A - A</b> Transverse fractures in hopper web plating into possibly extending into the hopper sloping plating</p>

<p><b>Sketch of repair</b></p>

<p><b>Reinforcement A</b> Alternatively, may stop at longitudinals where fitted</p> <p><b>Reinforcement B</b></p> <p><b>View B - B</b></p>
<p><b>Notes on possible cause of damage</b></p> <ol style="list-style-type: none"> <li>1. The damage is partly due to stress concentration at the edges of the weld created by the presence of the deflections in the inner bottom/hopper plating.</li> </ol>		<p><b>Notes on repairs</b></p> <ol style="list-style-type: none"> <li>1. The fracture in the weld and/or plating is veed-out/cropped and renewed as appropriate.</li> <li>2. The cut-outs are eliminated by introducing suitable collar plates with emphasis on edge preparation and sequence of welding as shown above.</li> <li>3. Further reinforcements may be incorporated as shown above and depending on the judged cause of damage.</li> </ol>

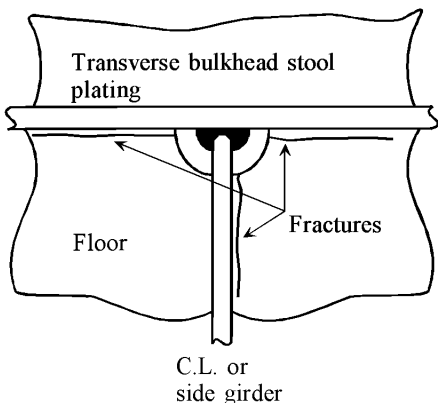
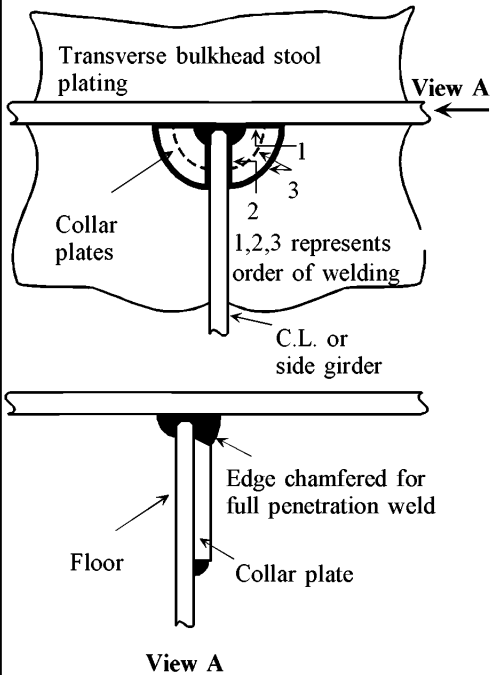
<b>BULK CARRIERS</b>		<b>Guidelines for Surveys, Assessment and Repair of Hull Structure</b>
<b>Part 1</b>	<b>Cargo hold region</b>	<b>Example No.</b>
<b>Area 5</b>	<b>Double bottom tank structure including hopper</b>	<b>5</b>
<b>Detail of damage</b>		Fractures at weld connections of floors in way of inner bottom and side girders, and plating of bulkhead stool
<b>Sketch of damage</b>		<b>Sketch of repair</b>

<p>Transverse bulkhead stool plating</p> <p>Floor</p> <p>Fractures</p> <p>C.L. or side girder</p>

<p>Transverse bulkhead stool plating</p> <p>View A</p> <p>Collar plates</p> <p>1,2,3 represents order of welding</p> <p>C.L. or side girder</p> <p>Edge chamfered for full penetration weld</p> <p>Floor</p> <p>Collar plate</p> <p>View A</p>
<b>Notes on possible cause of damage</b>		<b>Notes on repairs</b>

1. Stress concentration at the welds due to scallops.		1. The scallops will require to be fitted with welded collar plates to reduce stresses in the area.

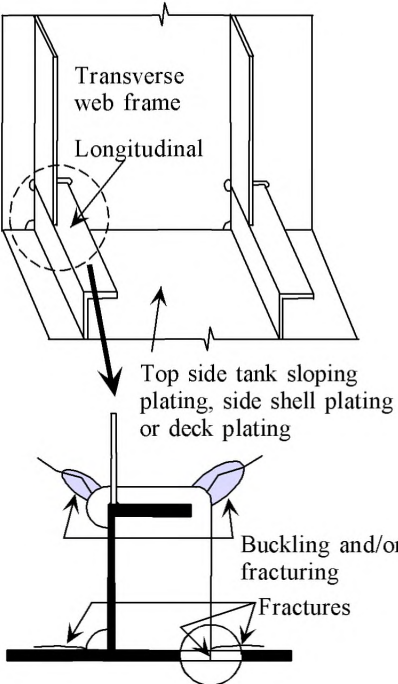
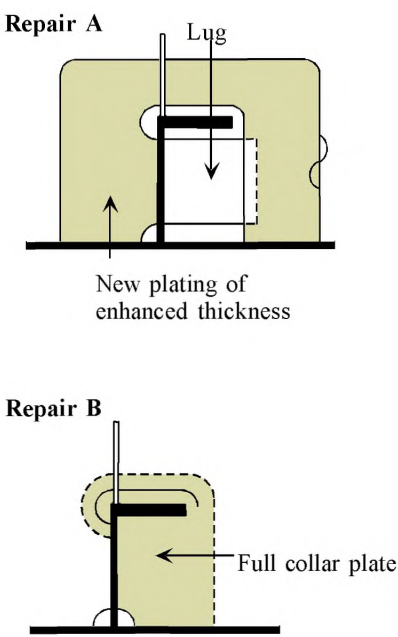
<b>BULK CARRIERS</b>		<b>Guidelines for Surveys, Assessment and Repair of Hull Structure</b>
<b>Part 1</b>	<b>Cargo hold region</b>	<b>Example No.</b>
<b>Area 5</b>	<b>Double bottom tank structure including hopper</b>	<b>6</b>
<b>Detail of damage</b>	Fractures and buckling in way of a cut-out for the passage of a longitudinal through a transverse primary member	
<b>Sketch of damage</b>

<b>Sketch of repair</b>

<b>Notes on possible cause of damage</b> 1. Damage can be caused by general levels of corrosion and presence of stress concentration associated with the presence of a cut-out.		<b>Notes on repairs</b> 1. If fractures are significant then crop and part renew the floor plating/transverse web otherwise the fracture can be vee-d out and welded provided the plating is not generally corroded. 2. <b>Repair B</b> is to be incorporated if the lug proves to be ineffective.
