**РОССИЙСКИЙ МОРСКОЙ РЕГИСТР СУДОХОДСТВА**  
**RUSSIAN MARITIME REGISTER OF SHIPPING**

**ПРИЛОЖЕНИЕ К ПРАВИЛАМ**  
**РОССИЙСКОГО МОРСКОГО РЕГИСТРА СУДОХОДСТВА**  
**УНИФИЦИРОВАННЫЕ ИНТЕРПРЕТАЦИИ**  
**И РЕКОМЕНДАЦИИ**  
**МЕЖДУНАРОДНОЙ АССОЦИАЦИИ**  
**КЛАССИФИКАЦИОННЫХ ОБЩЕСТВ**

**SUPPLEMENT TO RULES**  
**OF RUSSIAN MARITIME REGISTER OF SHIPPING**  
**IACS UNIFIED INTERPRETATIONS**  
**AND RECOMMENDATIONS**

НД № 2-020101-085-R-E

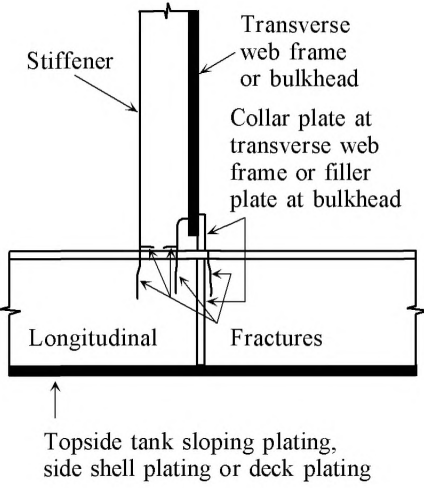
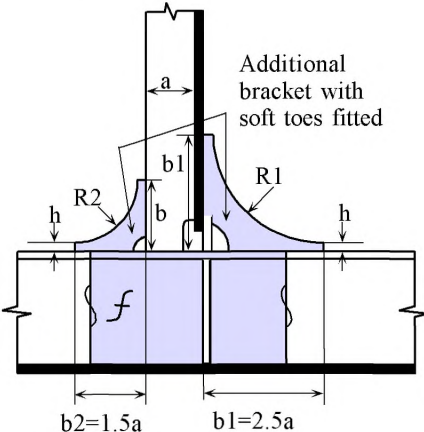
<b>BULK CARRIERS</b>		<b>Guidelines for Surveys, Assessment and Repair of Hull Structure</b>
<b>Part 1</b>	<b>Cargo hold region</b>	<b>Example No.</b>
<b>Area 5</b>	<b>Double bottom tank structure including hopper</b>	<b>7</b>
<b>Detail of damage</b>		Fractures in longitudinal at floor/transverse web frame or bulkhead
<b>Sketch of damage</b>		<b>Sketch of repair</b>

<p><math>f</math>: Where required, the longitudinal to be cropped and part renewed</p> <ol style="list-style-type: none"> <li>1. For a slope to toes max. 1:3,  <math>R1 = (b1 - h) \times 1.6</math> and <math>R2 = (b2 - h) \times 1.6</math></li> <li>2. Soft toe bracket to be welded first to longitudinal</li> <li>3. Scallop in bracket to be as small as possible, recommended max. 35mm</li> <li>4. If toes of brackets are ground smooth, full penetration welds in way to be provided</li> <li>5. Maximum length to thickness ratio = 50:1 for unstiffened bracket edge</li> <li>6. Toe height, <math>h</math>, to be as small as possible (10-15mm)</li> </ol>

<b>Notes on possible cause of damage</b>		<b>Notes on repairs</b>
<ol style="list-style-type: none"> <li>1. Damage can be caused by stress concentrations leading to accelerated fatigue in this region.</li> </ol>		<ol style="list-style-type: none"> <li>1. If fractures are not extensive e.g. hairline fractures, they can be vee-d out and welded.</li> <li>2. If fracture extends to over one third of the depth of the longitudinal then crop and part renew.</li> </ol>

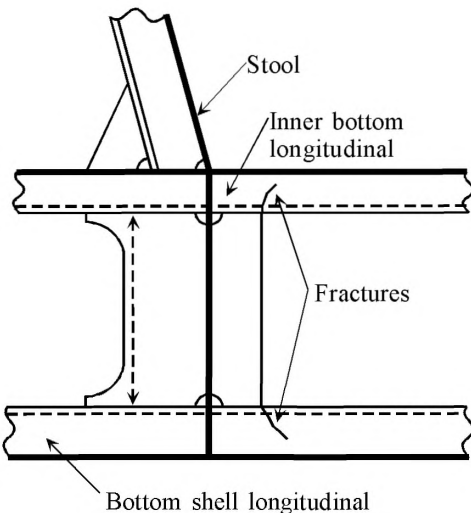
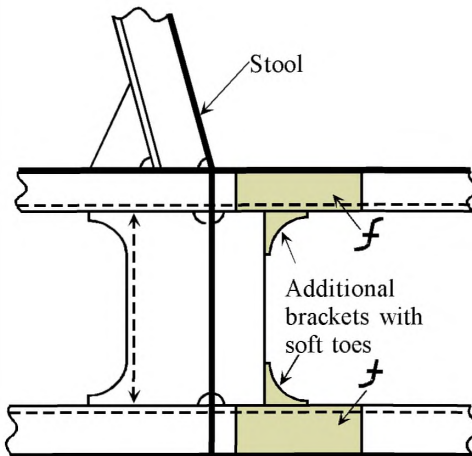
<b>BULK CARRIERS</b>		<b>Guidelines for Surveys, Assessment and Repair of Hull Structure</b>
<b>Part 1</b>	<b>Cargo hold region</b>	<b>Example No. 8</b>
<b>Area 5</b>	<b>Double bottom tank structure including hopper</b>	
<b>Detail of damage</b>	Fractures in bottom and inner bottom longitudinals in way of inner bottom and bulkhead stool boundaries	
<b>Sketch of damage</b>

<b>Sketch of repair</b>

<p><b>f</b> : Where required the longitudinal to be cropped and part renewed</p>
<b>Notes on possible cause of damage</b> 1. Damage can be caused by stress concentration leading to accelerated fatigue in this region.		<b>Notes on repairs</b> 1. If fractures are not extensive e.g. hairline fractures then these can be veed-out and welded. 2. If fracture extended to over one third of the depth of the longitudinal depth then crop and part renew.

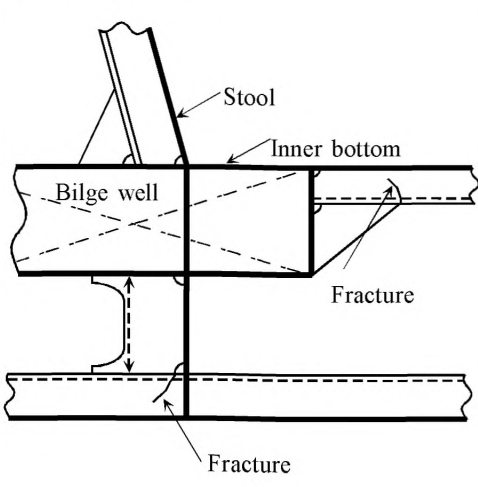
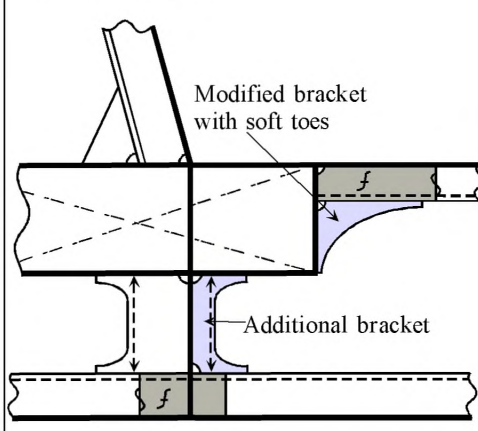
BULK CARRIERS		Guidelines for Surveys, Assessment and Repair of Hull Structure
Part 1	Cargo hold region	Example No.
Area 5	Double bottom tank structure including hopper	9
<b>Detail of damage</b>		Fractures in longitudinal in way of bilge well
<b>Sketch of damage</b>		<b>Sketch of repair</b>

<p><math>f</math>: Where required the longitudinals to be cropped and part renewed</p>
<b>Notes on possible cause of damage</b>		<b>Notes on repairs</b>
<ol style="list-style-type: none"> <li>1. Damage can be caused by stress concentrations leading to accelerated fatigue in this region.</li> </ol>		<ol style="list-style-type: none"> <li>1. If fractures are not extensive e.g. hairline fractures then these can be vee-out and welded.</li> <li>2. If the fracture extended to over one third of the depth of the longitudinal then crop and part renew.</li> </ol>

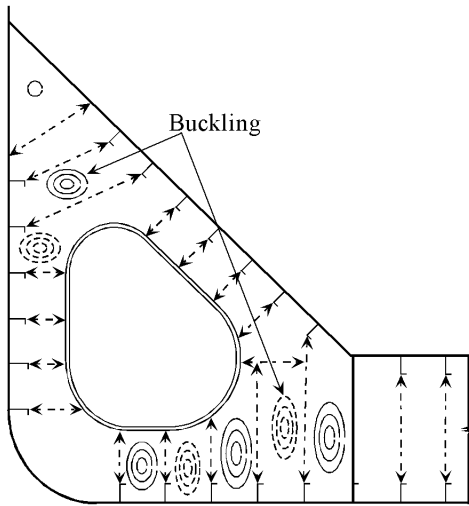
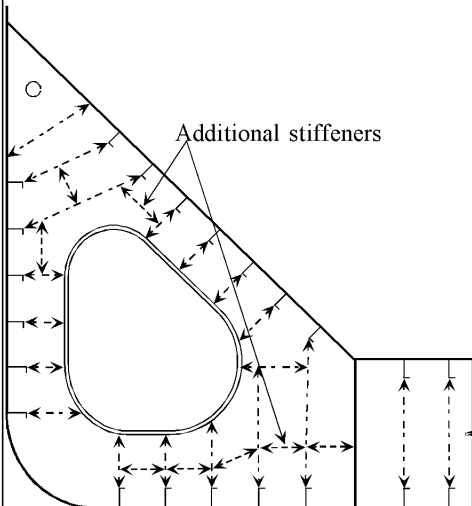
<b>BULK CARRIERS</b>		<b>Guidelines for Surveys, Assessment and Repair of Hull Structure</b>
<b>Part 1</b>	<b>Cargo hold region</b>	<b>Example No.</b>
<b>Area 5</b>	<b>Double bottom tank structure including hopper</b>	<b>10</b>
<b>Detail of damage</b>		Buckling of transverse web
<div> <div>Sketch of damage</div>

</div>
<b>Notes on possible cause of damage</b> <ol style="list-style-type: none"> <li>1. Insufficient buckling strength of transverse web plating.</li> <li>2. Corrosion of high stress area.</li> </ol>		<b>Notes on repairs</b> <ol style="list-style-type: none"> <li>1. If the buckling occurred without significant corrosion, adequate reinforcement is to be carried out.</li> <li>2. If the buckling occurred due to corrosion of high stress (shear stress) area, damaged area is to be cropped and part renewed. Adequate reinforcement and protective measures should be considered.</li> </ol>

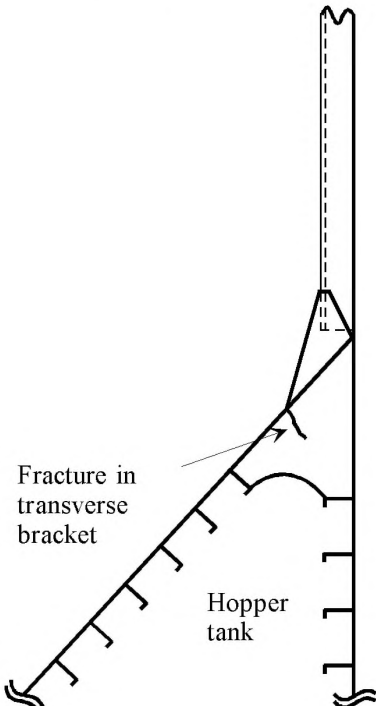
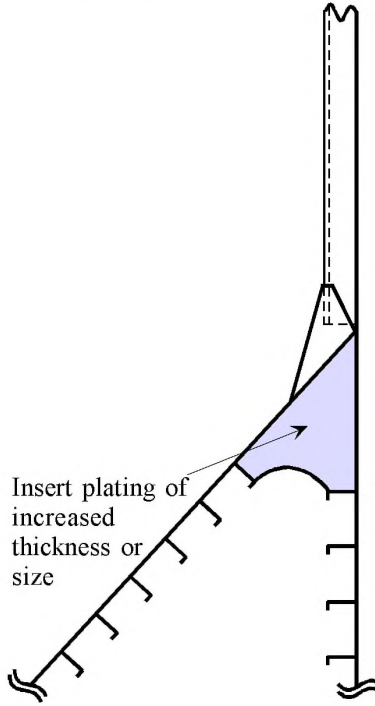
<b>BULK CARRIERS</b>	<b>Guidelines for Surveys, Assessment and Repair of Hull Structure</b>	
<b>Part 1</b>	<b>Cargo hold region</b>	<b>Example No.</b>
<b>Area 5</b>	<b>Double bottom tank structure including hopper</b>	<b>11</b>
<b>Detail of damage</b>	Fractures at weld connection of transverse brackets	
<b>Sketch of damage</b>		<b>Sketch of repair</b>

<b>Notes on possible cause of damage</b>		<b>Notes on repairs</b>
<ol style="list-style-type: none"> <li>1. General levels of corrosion and presence of stress concentration.</li> <li>2. Misalignment of the brackets with adjoining structure e.g. frame brackets.</li> <li>3. High shear stresses due to insufficient bracket.</li> <li>4. Inadvertent overloading.</li> </ol>		<ol style="list-style-type: none"> <li>1. If the damage is caused by misalignment with the frame bracket above, the misalignment is to be rectified.</li> <li>2. Replacement by a bracket of increased thickness or size should be considered.</li> </ol>

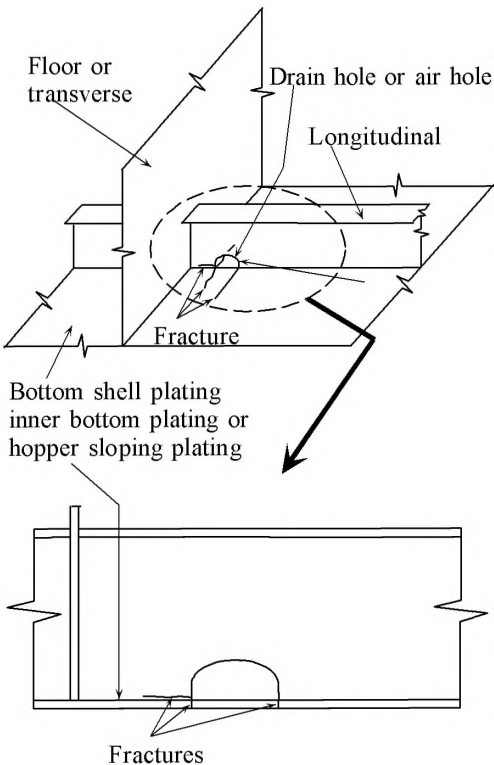
<b>BULK CARRIERS</b>		<b>Guidelines for Surveys, Assessment and Repair of Hull Structure</b>
<b>Part 1</b>	<b>Cargo hold region</b>	<b>Example No.</b>
<b>Area 5</b>	<b>Double bottom tank structure including hopper</b>	<b>12</b>
<b>Detail of damage</b>	Fractures in bottom shell/side shell/hopper sloping plating at the corner drain hole/air hole in longitudinal	
<b>Sketch of damage</b>

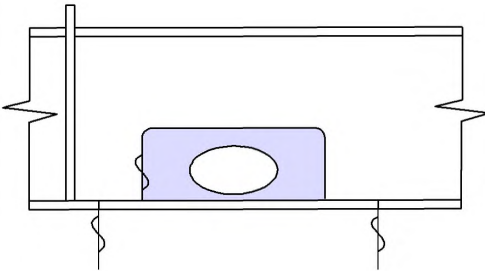
<b>Sketch of repair</b>

<b>Notes on possible cause of damage</b> 1. Stress concentration and/or corrosion due to stress concentration at the corner of drain hole/air hole.		<b>Notes on repairs</b> 1. Fractured plating should be cropped and part renewed. 2. If fatigue life is to be improved, change of drain hole/air hole shape is to be considered.

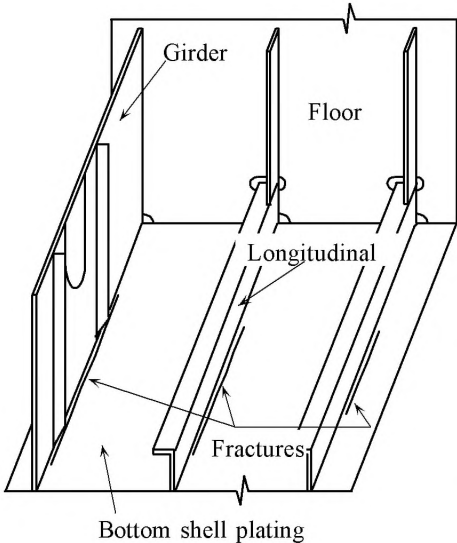
<b>BULK CARRIERS</b>		<b>Guidelines for Surveys, Assessment and Repair of Hull Structure</b>
<b>Part 1</b>	<b>Cargo hold region</b>	<b>Example No.</b>
<b>Area 5</b>	<b>Double bottom tank structure including hopper</b>	<b>13</b>
<b>Detail of damage</b>	Fractures in bottom plating along side girder and/or bottom longitudinal	
<b>Sketch of damage</b>

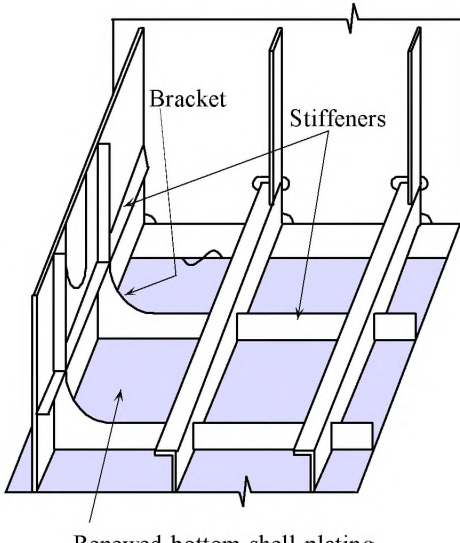
<b>Sketch of repair</b>

<b>Notes on possible cause of damage</b> 1. Vibration.		<b>Notes on repairs</b> 1. Fractured bottom shell plating should be cropped and renewed. 2. Natural frequency of the panel should be changed, e.g. reinforcement by additional stiffener/bracket.

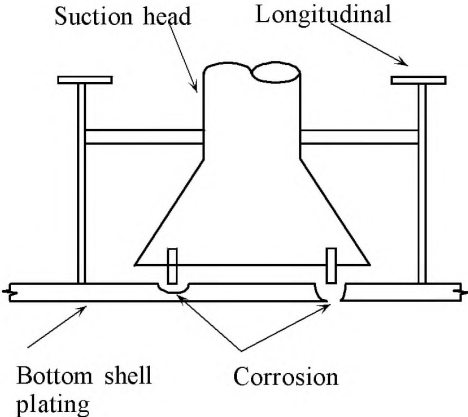
<b>BULK CARRIERS</b>		<b>Guidelines for Surveys, Assessment and Repair of Hull Structure</b>
<b>Part 1</b>	<b>Cargo hold region</b>	<b>Example No.</b>
<b>Area 5</b>	<b>Double bottom tank structure including hopper</b>	<b>14</b>
<b>Detail of damage</b>		Corrosion in bottom plating below suction head
<b>Sketch of damage</b>

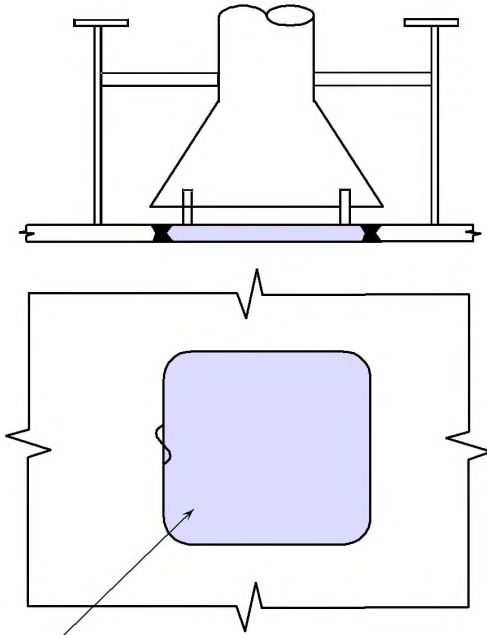
<b>Sketch of repair</b>

<p>1. Insert to have round corners 2. Non-destructive examination to be applied after welding based on the Society's rules</p>
<b>Notes on possible cause of damage</b> <ol style="list-style-type: none"> <li>1. High flow rate associated with insufficient corrosion prevention system.</li> <li>2. Galvanic action between dissimilar metals.</li> </ol>		<b>Notes on repairs</b> <ol style="list-style-type: none"> <li>1. Affected plating should be cropped and part renewed. Thicker plate and suitable beveling should be considered.</li> <li>2. If the corrosion is limited to a small area, i. e. pitting corrosion, repair by welding is acceptable.</li> </ol>

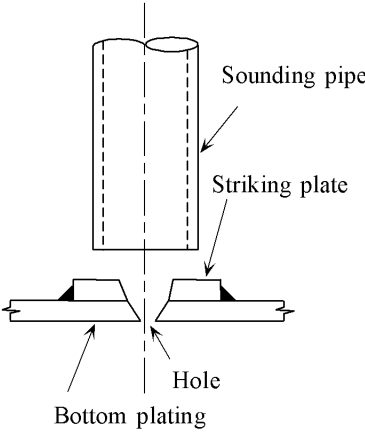
<b>BULK CARRIERS</b>		<b>Guidelines for Surveys, Assessment and Repair of Hull Structure</b>
<b>Part 1</b>	<b>Cargo hold region</b>	<b>Example No.</b>
<b>Area 5</b>	<b>Double bottom tank structure including hopper</b>	<b>15</b>
<b>Detail of damage</b> Corrosion in bottom plating below sounding pipe		
<b>Sketch of damage</b>

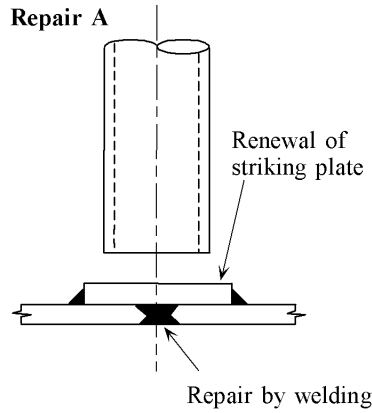
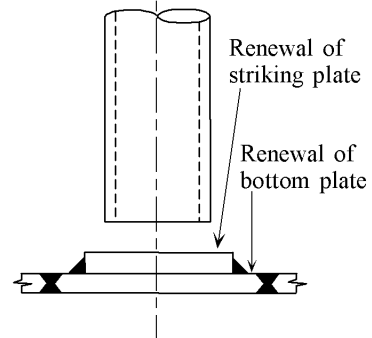
<b>Sketch of repair</b> <p><b>Repair A</b></p>

<p><b>Repair B</b></p>

<b>Notes on possible cause of damage</b> <ol style="list-style-type: none"> <li>1. Accelerated corrosion of striking plate by the striking of the weight of the sounding tape.</li> </ol>		<b>Notes on repairs</b> <ol style="list-style-type: none"> <li>1. Corroded bottom plating should be welded or partly cropped and renewed if considered necessary.</li> <li>2. Corroded striking plate should be renewed.</li> </ol>

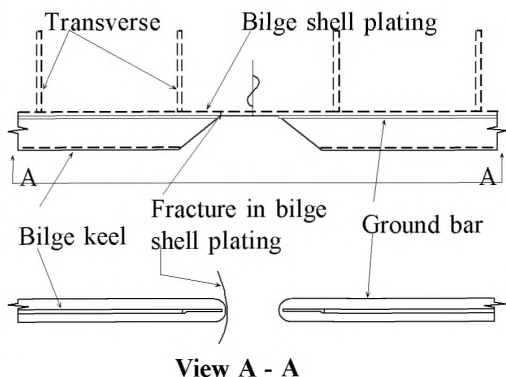
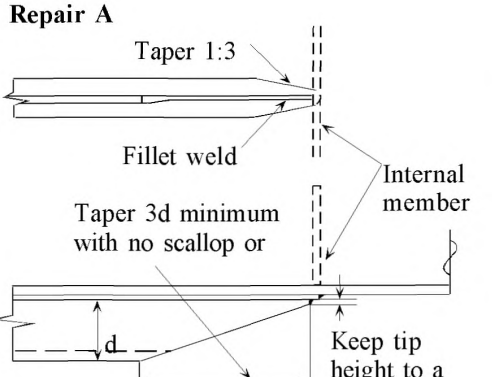
BULK CARRIERS		Guidelines for Surveys, Assessment and Repair of Hull Structure
Part 1	Cargo hold region	Example No.
Area 5	Double bottom structure including hopper	17
Detail of damage		Fractures in shell plating at the termination of bilge keel
Sketch of damage		Sketch of repair

<p>View A - A</p>		<p><b>Repair A</b></p>

<p><b>Repair B</b></p>

Notes on possible cause of damage		Notes on repairs
<ol style="list-style-type: none"> <li>Poor design causing stress concentration.</li> </ol>		<ol style="list-style-type: none"> <li>Fractured plating is to be cropped and renewed.</li> <li>Reduction of stress concentration of the bilge keel end should be considered.           <p><b>Repair A:</b> Modification of the detail of end</p> <p><b>Repair B:</b> New internal stiffeners</p> <p><b>Repair C:</b> Continuous ground bar (in connection with <b>Repair A</b>)</p> </li> <li>Instead of <b>Repair A</b> or <b>B</b> continuous ground bar and bilge keel should be considered.</li> </ol>

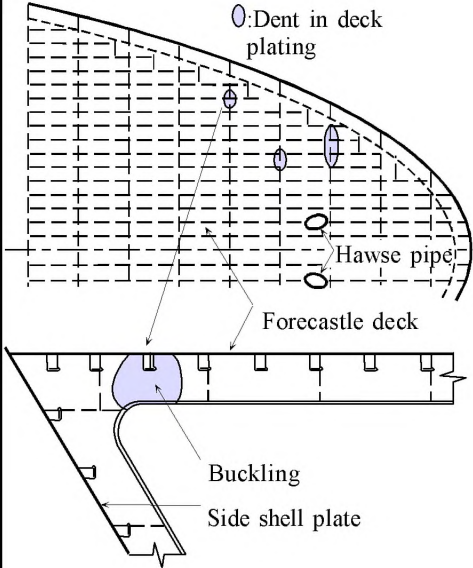
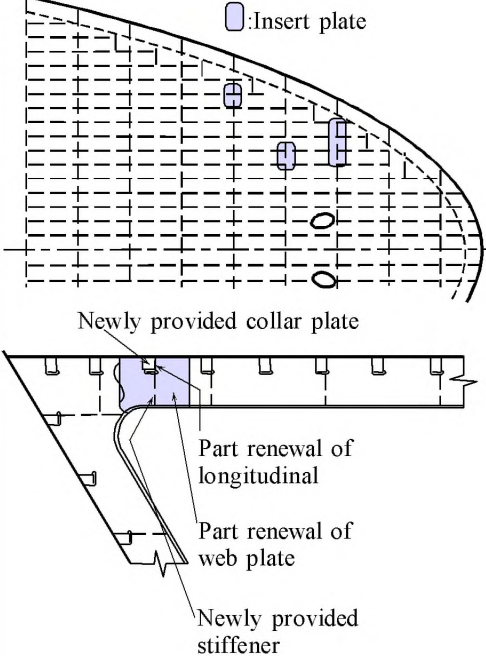
<b>BULK CARRIERS</b>		<b>Guidelines for Surveys, Assessment and Repair of Hull Structure</b>
<b>Part 2</b>	<b>Fore and aft end regions</b>	<b>Example No.</b>
<b>Area 1</b>	<b>Fore end structure</b>	<b>1</b>
<b>Detail of damage</b>		Deformation of forecastle deck
<b>Sketch of damage</b>		<b>Sketch of repair</b>

<b>Notes on possible cause of damage</b>		<b>Notes on repairs</b>
<ol style="list-style-type: none"> <li>Green sea on deck.</li> <li>Insufficient strength.</li> </ol>		<ol style="list-style-type: none"> <li>Deformed structure should be cropped and renewed.</li> <li>Additional stiffeners on web of beam should be considered for reinforcement.</li> </ol>

- 3.3.1** Fractures of a minor nature may be veed-out and rewelded. Where cracking is more extensive, the structure is to be cropped and renewed. In the case of fractures caused by sea loads, increased thickness of plating and/or design modification to reduce stress concentrations should be considered (See **Examples 1, 2 and 6**).

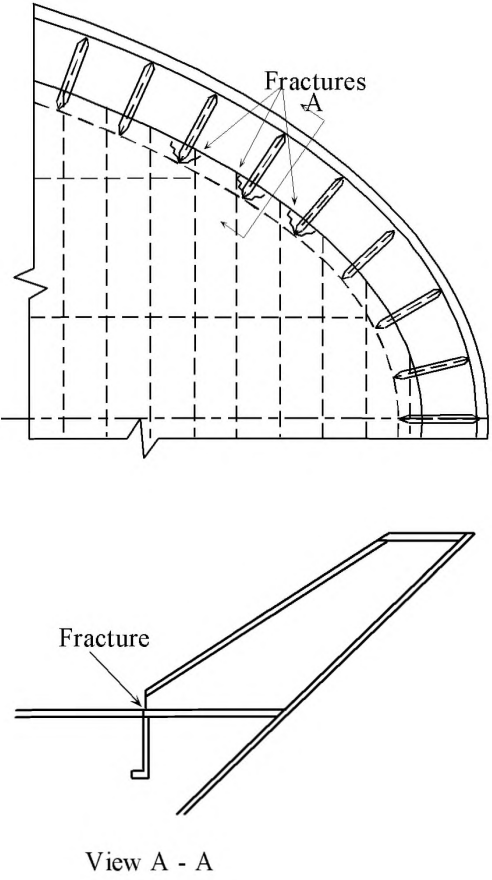
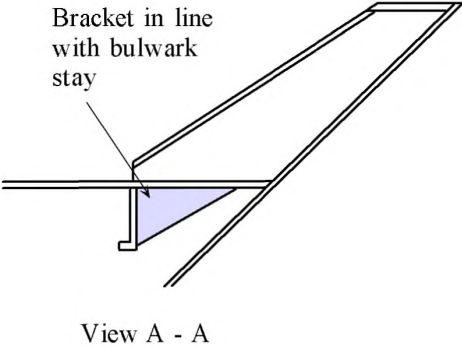
<b>BULK CARRIERS</b>		<b>Guidelines for Surveys, Assessment and Repair of Hull Structure</b>
<b>Part 2</b>	<b>Fore and aft end regions</b>	<b>Example No.</b>
<b>Area 1</b>	<b>Fore end structure</b>	<b>2</b>
<b>Detail of damage</b>		Fractures in forecastle deck plating at bulwark
<b>Sketch of damage</b>		<b>Sketch of repair</b>

<b>Notes on possible cause of damage</b>		<b>Notes on repairs</b>
<ol style="list-style-type: none"> <li>1. Bow flare effect in heavy weather.</li> <li>2. Stress concentration due to poor design.</li> </ol>		<ol style="list-style-type: none"> <li>1. Fractured deck plating should be cropped and renewed.</li> <li>2. Bracket in line with the bulwark stay to be fitted to reduce stress concentration.</li> </ol>

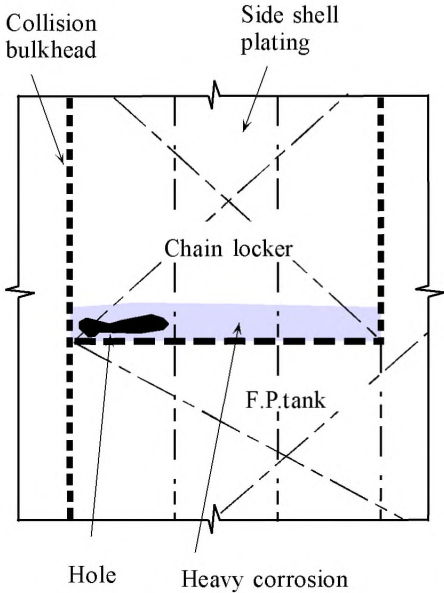
<b>BULK CARRIERS</b>		<b>Guidelines for Surveys, Assessment and Repair of Hull Structure</b>
<b>Part 2</b>	<b>Fore and aft end regions</b>	<b>Example No.</b>
<b>Area 1</b>	<b>Fore end structure</b>	<b>3</b>
<b>Detail of damage</b>		Fractures in side shell plating in way of chain locker
<b>Sketch of damage</b>

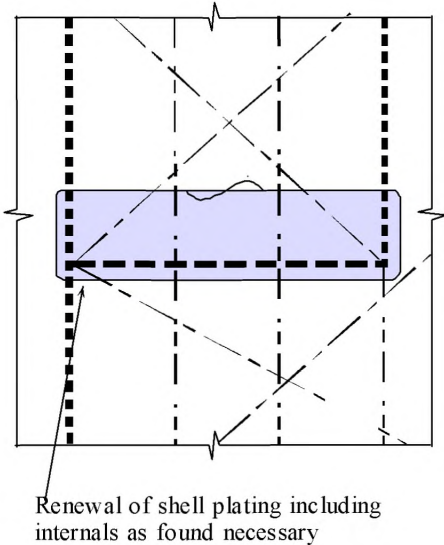
<b>Sketch of repair</b>

<b>Notes on possible cause of damage</b> <ol style="list-style-type: none"> <li>1. Heavy corrosion in region where mud is accumulated.</li> </ol>		<b>Notes on repairs</b> <ol style="list-style-type: none"> <li>1. Corroded plating should be cropped and renewed.</li> <li>2. Protective coating should be applied.</li> </ol>

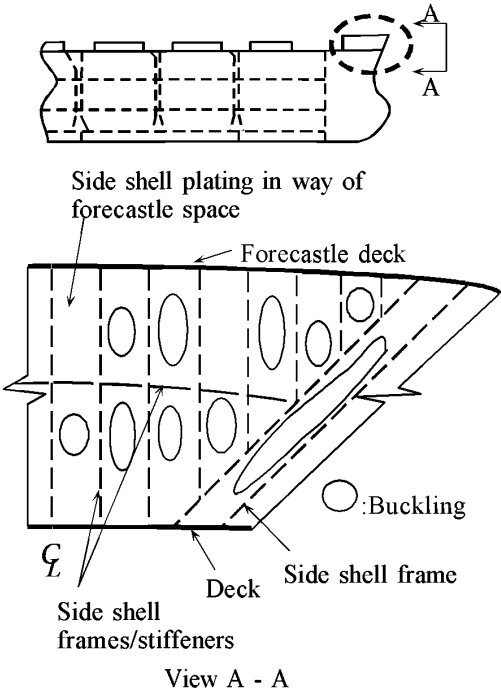
BULK CARRIERS		Guidelines for Surveys, Assessment and Repair of Hull Structure
Part 2	Fore and aft end regions	Example No.
Area 1	Fore end structure	4
Detail of damage		Deformation of side shell plating in way of forecastle space
Sketch of damage		Sketch of repair

<p>Side shell plating in way of forecastle space</p> <p>Forecastle deck</p> <p>Side shell frames/stiffeners</p> <p>Deck</p> <p>Side shell frame</p> <p>○: Buckling</p> <p>View A - A</p>

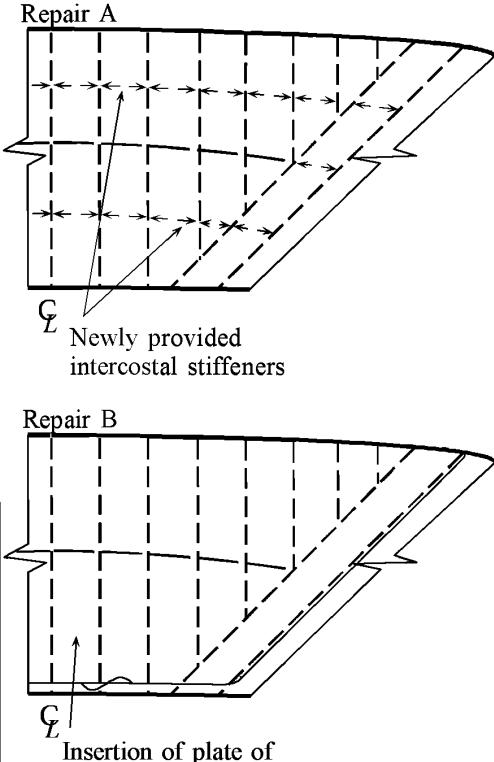
<p>Repair A</p> <p>Newly provided intercostal stiffeners</p> <p>Repair B</p> <p>Insertion of plate of</p>
Notes on possible cause of damage		Notes on repairs
<ol style="list-style-type: none"> <li>1. Heavy weather.</li> <li>2. Insufficient strength.</li> </ol>		<ol style="list-style-type: none"> <li>1. Deformed part should be cropped and part renewed.</li> <li>2. <b>Repair A</b> Additional stiffeners between existing stiffeners should be considered. <b>Repair B</b> Insertion of plate of increased thickness with additional stiffeners.</li> </ol>

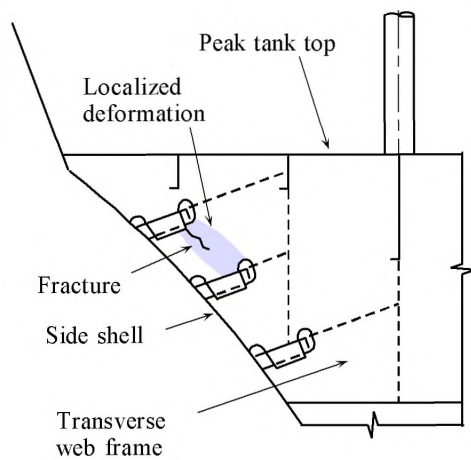
<b>BULK CARRIERS</b>		<b>Guidelines for Surveys, Assessment and Repair of Hull Structure</b>
<b>Part 2</b>	<b>Fore and aft end regions</b>	<b>Example No.</b>
<b>Area 1</b>	<b>Fore end structure</b>	<b>5</b>
<b>Detail of damage</b>		Fracture and deformation of bow transverse web in way of cut-outs for side longitudinals
<b>Sketch of damage</b>

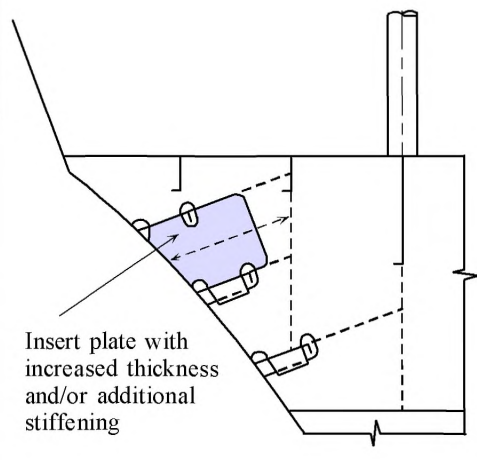
<b>Sketch of repair</b>

<b>Notes on possible cause of damage</b> <ol style="list-style-type: none"> <li>1. Localized material wastage in way of coating failure at cut-outs and sharp edges due to working of the structure.</li> <li>2. Dynamic seaway loading in way of bow flare.</li> </ol>		<b>Notes on repairs</b> <ol style="list-style-type: none"> <li>1. Sufficient panel strength to be provided to absorb the dynamic loads enhanced by bow flare shape.</li> </ol>

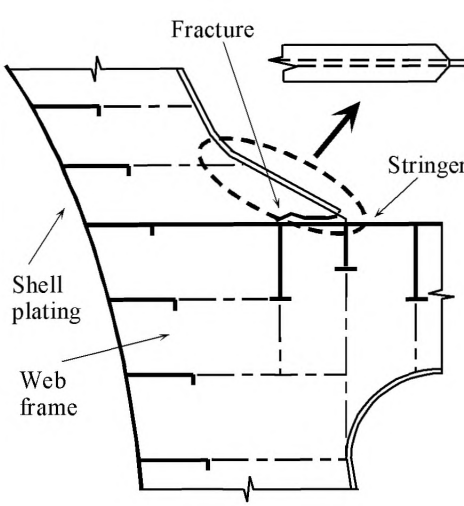
<b>BULK CARRIERS</b>		<b>Guidelines for Surveys, Assessment and Repair of Hull Structure</b>
<b>Part 2</b>	<b>Fore and aft end regions</b>	<b>Example No.</b>
<b>Area 1</b>	<b>Fore end structure</b>	<b>6</b>
<b>Detail of damage</b>		Fractures at toe of web frame bracket connection to stringer platform bracket
<b>Sketch of damage</b>

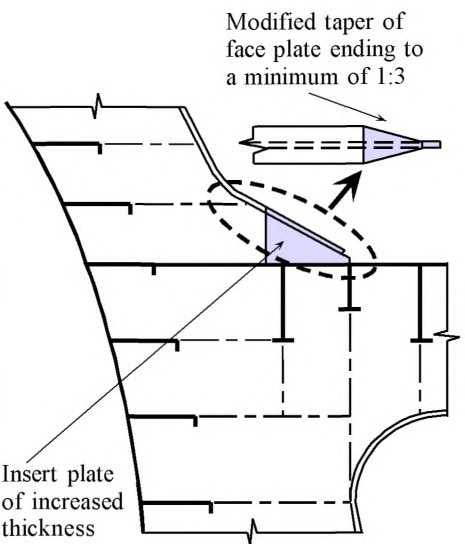
<b>Sketch of repair</b>

<b>Notes on possible cause of damage</b> <ol style="list-style-type: none"> <li>1. Inadequate bracket forming the web frame connection to the stringer.</li> <li>2. Localized material wastage in way of coating failure at bracket due to flexing of the structure.</li> <li>3. Dynamic seaway loading in way of bow flare.</li> </ol>		<b>Notes on repairs</b> <ol style="list-style-type: none"> <li>1. Adequate soft nose bracket endings with a face plate taper of at least 1 : 3 to be provided.</li> </ol>

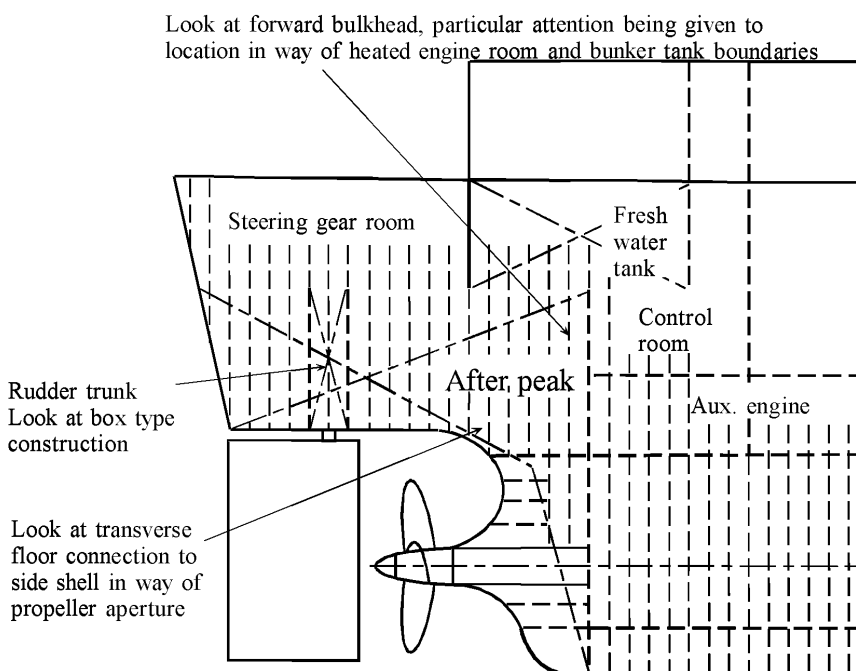
**Figure 1 Aft end structure - Potential problem areas**

- 2.3.1 Fractures in weld at floor connections and other locations in the aft peak tank and rudder trunk space can normally only be found by close-up inspection.
- 2.3.2 The structure supporting the rudder carrier may fracture and/or deform due to excessive load on the rudder. Bolts connecting the rudder carrier to the steering gear flat may also suffer damage under such load.

- 2.1.1 Wastage (and possible subsequent fractures) is more likely to be initiated at in the locations as indicated in **Figure 1**. A close-up inspection should be carried out with selection of representative thickness measurements to determine the extent of corrosion. Particular attention should be given to bunker tank boundaries and spaces adjacent to heated engine room.

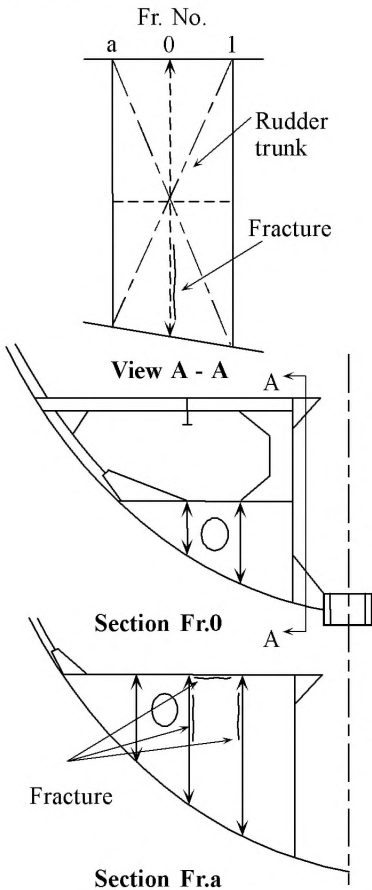
<b>BULK CARRIERS</b>		<b>Guidelines for Surveys, Assessment and Repair of Hull Structure</b>
<b>Part 2</b>	<b>Fore and aft end regions</b>	<b>Example No.</b>
<b>Area 2</b>	<b>Aft end structure</b>	<b>1</b>
<b>Detail of damage</b>		Fractures in bulkhead in way of rudder trunk
<b>Sketch of damage</b>

<p>Fr. No. a 0 l</p> <p>Rudder trunk</p> <p>Fracture</p> <p>View A - A</p> <p>Section Fr.0</p> <p>Fracture</p> <p>Section Fr.a</p>		<b>Sketch of repair</b>

**3.3.2** In order to prevent recurrence of damages suspected to be caused by main engine or propeller excited vibration, the cause of the vibration should be ascertained and additional reinforcements provided as found necessary (See **Examples 1** and **2**).

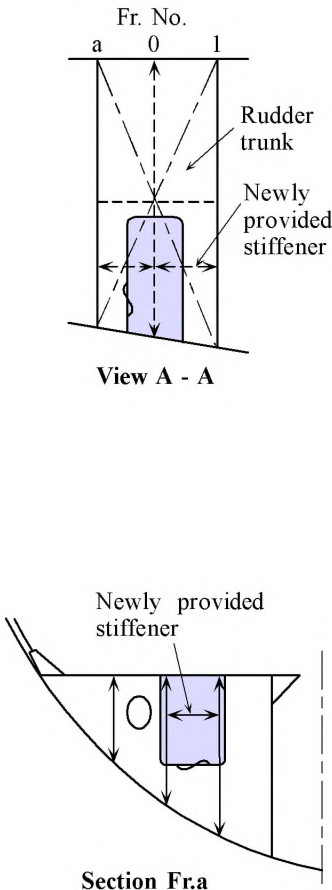
<p>Fr. No. a 0 l</p> <p>Rudder trunk</p> <p>Newly provided stiffener</p> <p>View A - A</p> <p>Newly provided stiffener</p> <p>Section Fr.a</p>
<b>Notes on possible cause of damage</b> 1. Vibration.		<b>Notes on repairs</b> 1. The fractured plating should be cropped and renewed. 2. Natural frequency of the plate between stiffeners should be changed, e.g. reinforcement by additional stiffeners.

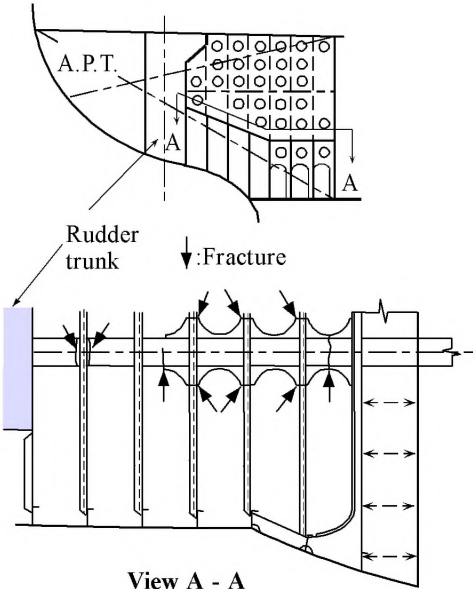
<b>BULK CARRIERS</b>		<b>Guidelines for Surveys, Assessment and Repair of Hull Structure</b>	
<b>Part 2</b>	<b>Fore and aft end regions</b>		<b>Example No.</b>
<b>Area 2</b>	<b>Aft end structure</b>		<b>2</b>
<b>Detail of damage</b>		Fractures at the connection of floors and girders/side brackets	
<b>Sketch of damage</b>

<b>Notes on possible cause of damage</b> 1. Vibration.		<b>Notes on repairs</b> 1. The fractured plating should be cropped and renewed. 2. Natural frequency of the panel should be changed, e.g. reinforcement by additional strut.

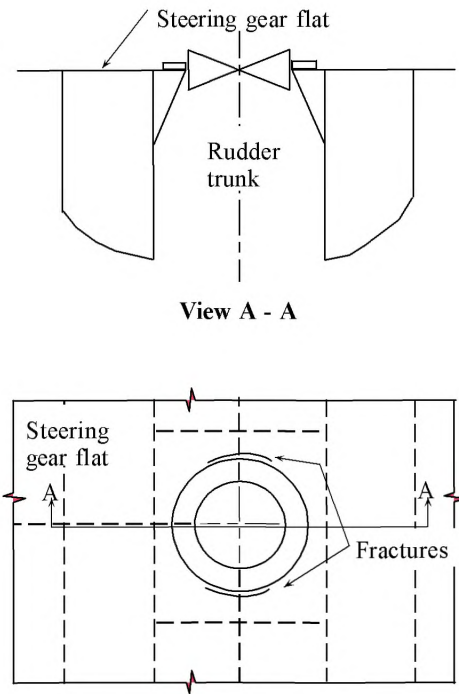
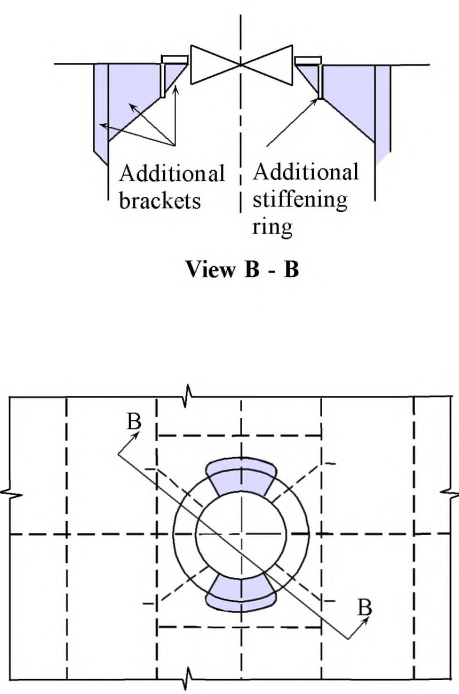
<b>BULK CARRIERS</b>		<b>Guidelines for Surveys, Assessment and Repair of Hull Structure</b>
<b>Part 2</b>	<b>Fore and aft end regions</b>	<b>Example No.</b>
<b>Area 2</b>	<b>Aft end structure</b>	<b>3-a</b>
<b>Detail of damage</b>		Fractures in flat where rudder carrier is installed in steering gear room
<b>Sketch of damage</b>		<b>Sketch of repair</b>

<p>View A - A</p>

<p>View B - B</p>
<b>Notes on possible cause of damage</b>		<b>Notes on repairs</b>
<ol style="list-style-type: none"> <li>1. Inadequate design.</li> </ol>		<ol style="list-style-type: none"> <li>1. Fractured plating should be cropped and renewed.</li> <li>2. Additional brackets and stiffening ring should be fitted for reinforcement.</li> </ol>

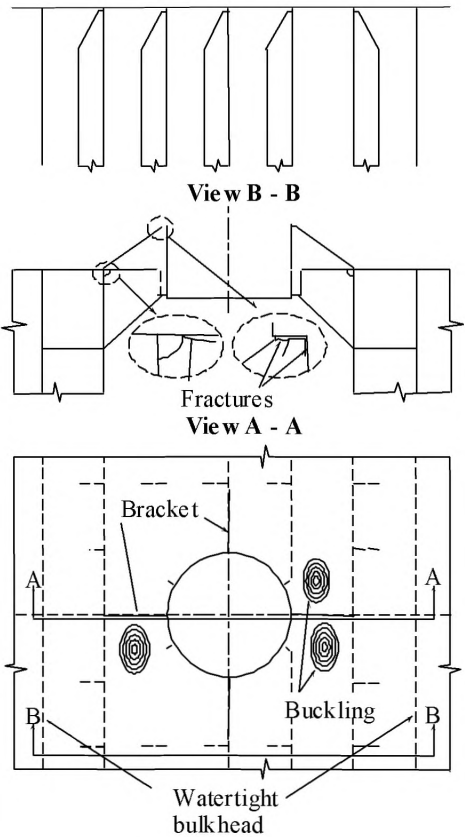
<b>BULK CARRIERS</b>		<b>Guidelines for Surveys, Assessment and Repair of Hull Structure</b>
<b>Part 2</b>	<b>Fore and aft end regions</b>	<b>Example No.</b>
<b>Area 2</b>	<b>Aft end structure</b>	<b>3-b</b>
<b>Detail of damage</b>		Fractures in steering gear foundation brackets and deformed deck plate
<b>Sketch of damage</b>

<p>View B - B</p> <p>Fractures</p> <p>View A - A</p> <p>Bracket</p> <p>Buckling</p> <p>Watertight bulkhead</p>		<b>Sketch of repair</b>

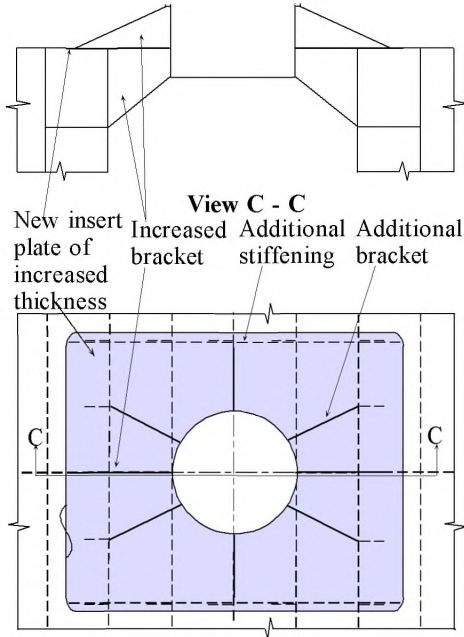
<p>View C - C</p> <p>New insert plate of increased thickness</p> <p>Increased bracket</p> <p>Additional stiffening</p> <p>Additional bracket</p>
<b>Notes on possible cause of damage</b> <ol style="list-style-type: none"> <li>1. Insufficient deck strengthening (missing base plate).</li> <li>2. Insufficient strengthening of steering gear foundation.</li> <li>3. Bolts of steering gear were not sufficiently pre-loaded.</li> </ol>		<b>Notes on repairs</b> <ol style="list-style-type: none"> <li>1. New insert base plate of increased plate thickness.</li> <li>2. Additional longitudinal stiffening at base plate edges.</li> <li>3. Additional foundation brackets above and under deck (star configuration).</li> </ol>

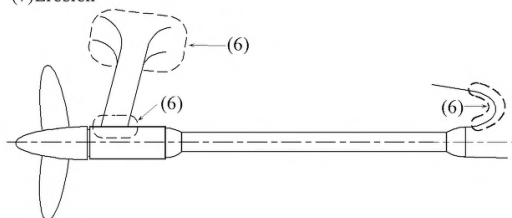
**Figure 2 Potential problem areas**

**Damage to look for:**

- (1) Fractures and loose coupling bolts
- (2) Loose nut
- (3) Wear (excessive bearing clearance)
- (4) Fractures in way of pintle cutout
- (5) Fractures in way of removable access plate
- (6) Fractures
- (7) Erosion

- 1.6 Pre-existing manufacturing internal defects in cast pieces may lead to fatigue cracking.
- 1.7 A summary of potential problem areas is shown in **Figure 2**.

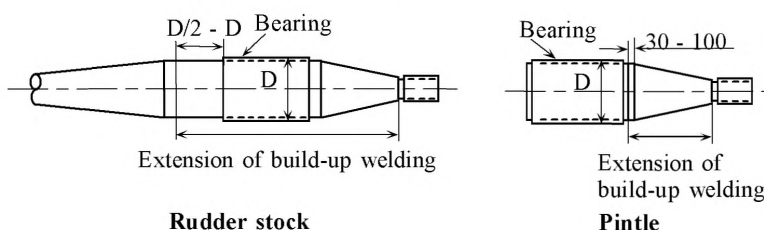
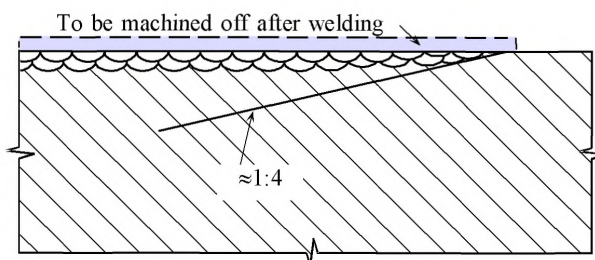
**Figure 3 Rudder stock repair by welding**

### Replacing wasted material by similar ordinary weld material

- Removal of the wasted area by machining and/or grinding, non-destructive examination for fractures (magnetic particle inspection preferred)
- Build-up welding by automatic spiral welding (turning device) according to an approved welding procedure (weld process, preheating, welding consumables, etc.)
- Extension of build-up welding over the area of **large bending moments (shafts)** according to the sketch

- Sufficient number of weld layers to compensate removed material, at least one layer in excess (heat treatment of the remaining layer)
- Transition at the end of the build-up welding according to the following sketch

- Post weld heat treatment if required in special cases (never for stainless steel cladding on ordinary steel)
- Final machining, at least two layers of welding material have to remain on the rudder stock (See the above sketch)
- Non-destructive fracture examination

- 3.1.4** Rudder stocks and/or pintles may be repaired by welding replacing wasted material by similar weld material provided its chemical composition is suitable for welding, i.e. the carbon content must usually not exceed 0.25%. The welding procedures are to be identified in function of the carbon equivalent (Ceq). After removal of the wasted area (corrosion, scratches, etc.) by machining and/or grinding the build-up welding has to be carried out by an automatic spiral welding according to an approved welding procedure. The welding has to be extended over the area of large bending moments (rudder stocks). In special cases post weld heat treatment has to be carried out according to the requirements of the Classification Society. After final machining, a sufficient number of layers of welding material have to remain on the rudder stock/pintle. A summary of the most important steps and conditions of this repair is shown in the **Figure 3**.

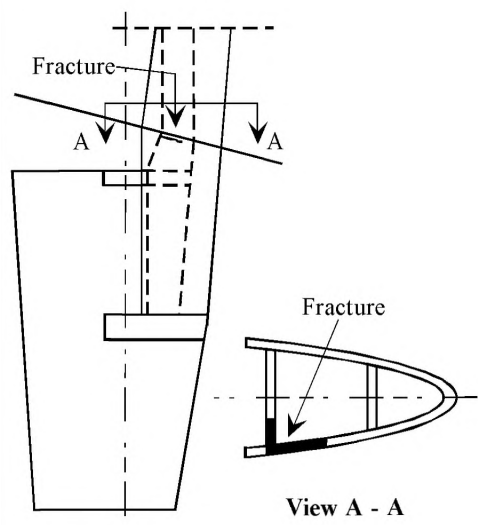
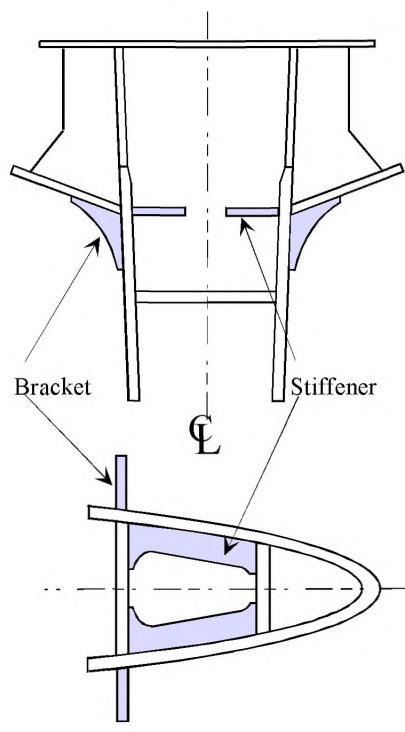
<b>BULK CARRIERS</b>		<b>Guidelines for Surveys, Assessment and Repair of Hull Structure</b>
<b>Part 2</b>	<b>Fore and aft end regions</b>	<b>Example No.</b>
<b>Area 3</b>	<b>Stern frame, rudder arrangement and propeller shaft support</b>	<b>1</b>
<b>Detail of damage</b>		Fractures in rudder horn along bottom shell plating
<b>Sketch of damage</b>

<b>Sketch of repair</b>

<b>Notes on possible cause of damage</b> <ol style="list-style-type: none"> <li>1. Insufficient strength due to poor design.</li> </ol>		<b>Notes on repairs</b> <ol style="list-style-type: none"> <li>1. Fractured plating to be veed-out and rewelded.</li> <li>2. Fractured plating to be cropped and renewed if considered necessary.</li> <li>3. Reinforcement should be considered if considered necessary.</li> </ol>

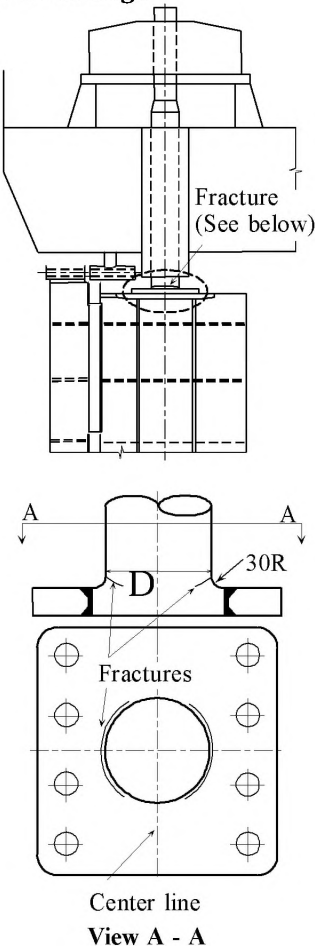
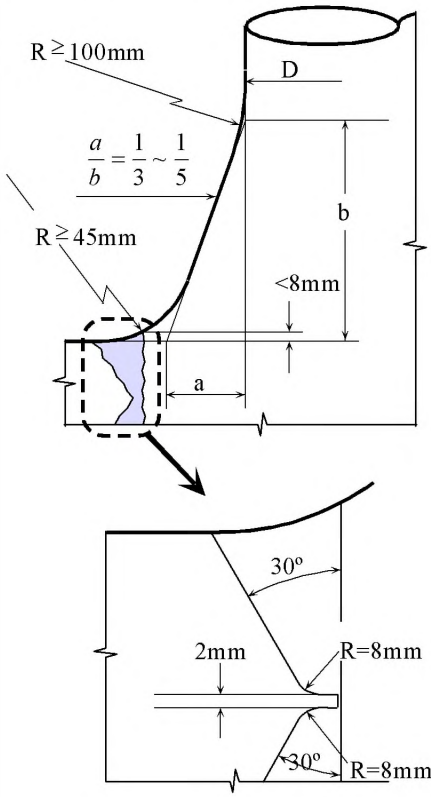
BULK CARRIERS		Guidelines for Surveys, Assessment and Repair of Hull Structure
Part 2	Fore and aft end regions	Example No.
Area 3	Stern frame, rudder arrangement and propeller shaft support	2
Detail of damage		Fractures in rudder stock
Sketch of damage		Sketch of repair

<p>Fracture (See below)</p> <p>Center line View A - A</p>

<p><math>R \geq 100\text{mm}</math></p> <p><math>\frac{a}{b} = \frac{1}{3} \sim \frac{1}{5}</math></p> <p><math>R \geq 45\text{mm}</math></p> <p><math>&lt;8\text{mm}</math></p> <p><math>30^\circ</math></p> <p><math>2\text{mm}</math></p> <p><math>R=8\text{mm}</math></p> <p><math>30^\circ</math></p> <p><math>R=8\text{mm}</math></p>
Notes on possible cause of damage		Notes on repairs
1. Inadequate design for stress concentration in rudder stock.		1. Modification of detail design of rudder stock to reduce the stress concentration.

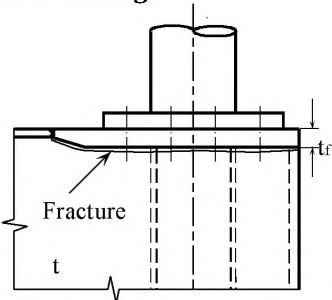
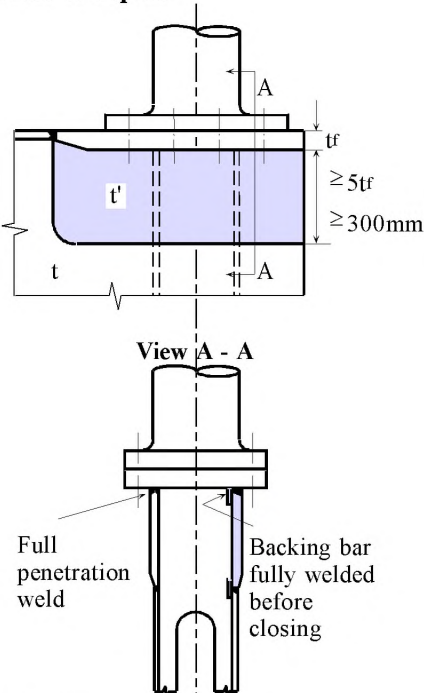
<b>BULK CARRIERS</b>		<b>Guidelines for Surveys, Assessment and Repair of Hull Structure</b>
<b>Part 2</b>	<b>Fore and aft end regions</b>	<b>Example No.</b>
<b>Area 3</b>	<b>Stern frame, rudder arrangement and propeller shaft support</b>	<b>3</b>
<b>Detail of damage</b>		Fractures in connection of palm plate to rudder blade
<b>Sketch of damage</b>		<b>Sketch of repair</b>

<p>View A - A</p> <p>Full penetration weld</p> <p>Backing bar fully welded before closing</p> <p><math>t</math> = plate thickness, mm  <math>t_f</math> = actual flange thickness, mm  <math>t = \frac{t_f}{3} + 5</math>, mm, where <math>t_f \leq 50</math> mm  <math>t = 3 \sqrt{t_f}</math>, mm, where <math>t_f \geq 50</math> mm</p>
<b>Notes on possible cause of damage</b>		<b>Notes on repairs</b>

1. Inadequate connection between palm plate and rudder blade plating (insufficient plating thickness and/or insufficient fillet weld).		1. Modification of detail design of the connection by increasing the plate thickness and full penetration welding.

**3.2.3** Short fatigue fractures starting in the lower and/or upper corners of the pintle recess of semi-spade rudders that do not propagate into vertical or horizontal stiffening structures may be repaired by gouging out and welding. The procedure according to **Example 3** should be preferred.

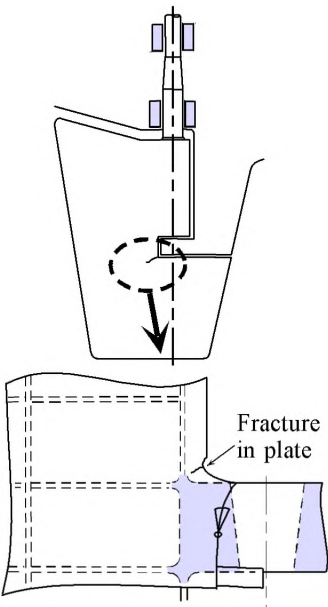
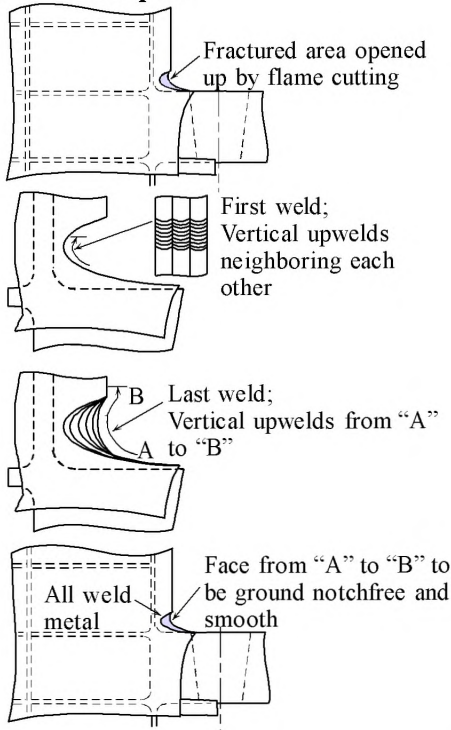
<b>BULK CARRIERS</b>		<b>Guidelines for Surveys, Assessment and Repair of Hull Structure</b>
<b>Part 2</b>	<b>Fore and aft end regions</b>	<b>Example No.</b>
<b>Area 3</b>	<b>Stern frame, rudder arrangement and propeller shaft support</b>	<b>4</b>
<b>Detail of damage</b>		Fractures in rudder plating of semi-spade rudder (short fracture with end located forward of the vertical web)
<b>Sketch of damage</b>		<b>Sketch of repair</b>

<b>Notes on possible cause of damage</b>		<b>Notes on repairs</b>
<ol style="list-style-type: none"> <li>1. Stress concentration due to inadequate local design and/or fabrication notches in way of the butt weld between cast piece and plating.</li> </ol>		<ol style="list-style-type: none"> <li>1. Grooving-out and welding of the fracture is not always adequate (metallurgical notch in way of a high stressed area).</li> <li>2. In the proposed repair procedure the metallurgical notches are shifted into a zone exposed to lower stresses.</li> <li>3. After welding a modification of the radius according to the proposal in <b>Example 5</b> is to be carried out.</li> <li>4. In case of very small crack it can be ground off by increasing the radius.</li> </ol>

In case of longer fatigue fractures starting in the lower and/or upper corners of the pintle recess of semi-spade rudders that propagate over a longer distance into the plating, thorough check of the internal structures has to be carried out. The fractured parts of the plating and of the internal structures, if necessary, have to be replaced by insert plates. A proper welding connection between the insert plate and the internal stiffening structure is very important (See **Examples 4** and **5**).

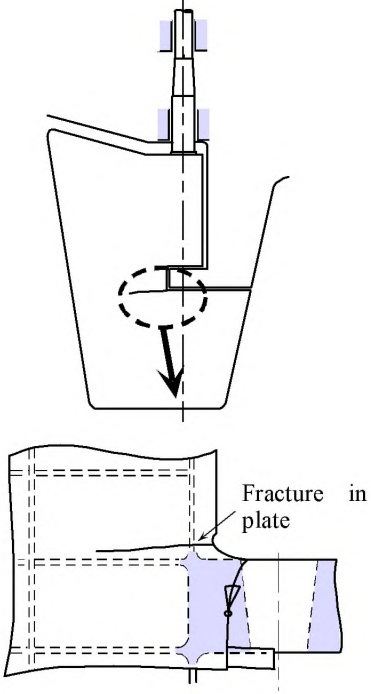
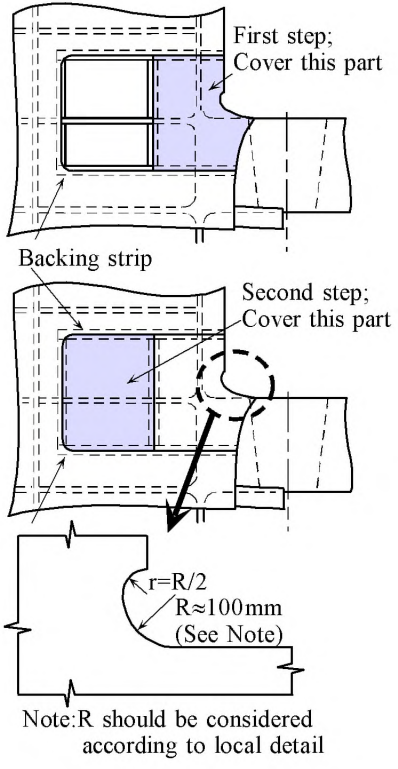
GENERAL CARGO SHIPS		Guidelines for Surveys, Assessment and Repair of Hull Structure
Part 2	Fore and aft end regions	Example No.
Area 3	Stern frame, rudder arrangement and propeller shaft support	5
<b>Detail of damage</b>		Fractures in rudder plating of semi-spade rudder extending beyond the vertical web
<b>Sketch of damage</b>		<b>Sketch of repair</b>

<b>Notes on possible cause of damage</b>		<b>Notes on repairs</b>
<ol style="list-style-type: none"> <li>1. Stress concentration due to inadequate local design and/or fabrication notches in way of the butt weld between cast piece and plating.</li> </ol>		<ol style="list-style-type: none"> <li>1. Fractured plating is to be cut-out.</li> <li>2. Internal structures are to be checked.</li> <li>3. Cut-out is to be closed by an insert plating according to the sketch (welding only from one side is demonstrated).</li> <li>4. Modification of the radius.</li> <li>5. In case of a new cast piece, connection with the plating is to be shifted outside the high stress area.</li> </ol>

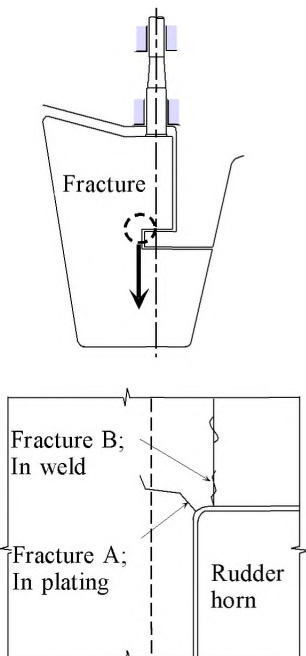
<b>BULK CARRIERS</b>		<b>Guidelines for Surveys, Assessment and Repair of Hull Structure</b>
<b>Part 2</b>	<b>Fore and aft end regions</b>	<b>Example No.</b>
<b>Area 3</b>	<b>Stern frame, rudder arrangement and propeller shaft support</b>	<b>6</b>
<b>Detail of damage</b>	Fractures in rudder plating of semi-spade rudder in way of pintle cutout	
<b>Sketch of damage</b>		<b>Sketch of repair</b>

<p>The sketch shows two views of the damage. The top view shows a fracture in the rudder plating, indicated by a dashed line and an arrow pointing to the fracture. The bottom view shows a fracture in the weld of the rudder horn, labeled 'Fracture B; In weld', and a fracture in the plating, labeled 'Fracture A; In plating'. The rudder horn is also labeled.</p>
