**РОССИЙСКИЙ МОРСКОЙ РЕГИСТР СУДОХОДСТВА**  
**RUSSIAN MARITIME REGISTER OF SHIPPING**

**ПРИЛОЖЕНИЕ К ПРАВИЛАМ**  
**РОССИЙСКОГО МОРСКОГО РЕГИСТРА СУДОХОДСТВА**  
**УНИФИЦИРОВАННЫЕ ИНТЕРПРЕТАЦИИ**  
**И РЕКОМЕНДАЦИИ**  
**МЕЖДУНАРОДНОЙ АССОЦИАЦИИ**  
**КЛАССИФИКАЦИОННЫХ ОБЩЕСТВ**

**SUPPLEMENT TO RULES**  
**OF RUSSIAN MARITIME REGISTER OF SHIPPING**  
**IACS UNIFIED INTERPRETATIONS**  
**AND RECOMMENDATIONS**

НД № 2-020101-085-R-E

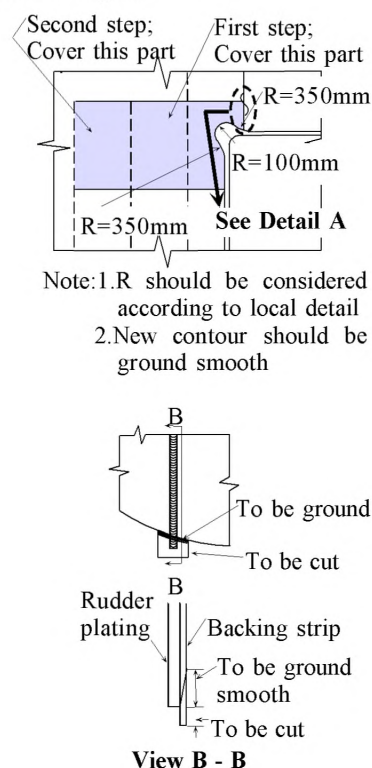
<p>The sketch shows the repair process. The top view shows the second step (cover this part) and the first step (cover this part) with radii <math>R=350\text{mm}</math> and <math>R=100\text{mm}</math>. A note states: 1.R should be considered according to local detail, 2.New contour should be ground smooth. A detail view B shows the rudder plating, backing strip, and areas to be ground smooth and cut.</p> <p><b>Note:</b> 1.R should be considered according to local detail 2.New contour should be ground smooth</p> <p><b>View B - B</b></p>

<b>Notes on possible cause of damage</b>		<b>Notes on repairs</b>
<ol style="list-style-type: none"> <li>1. Inadequate design for stress concentration in way of pintle bearing (<b>Fracture A</b>).</li> <li>2. Imperfection in welding seam (<b>Fracture B</b>).</li> </ol>		<ol style="list-style-type: none"> <li>1. Fractured part to be cropped off.</li> <li>2. Repair by two insert plates of modified, stress releasing contour. For the vertical seam no backing strip is used 100mm off contour, welding from both sides, to be ground after welding.</li> <li>3. Variant (See <b>Detail A</b>): Repair as mentioned under 2 with the use of backing strip for the complete vertical seam. After welding backing strip partly removed by grinding.</li> </ol>

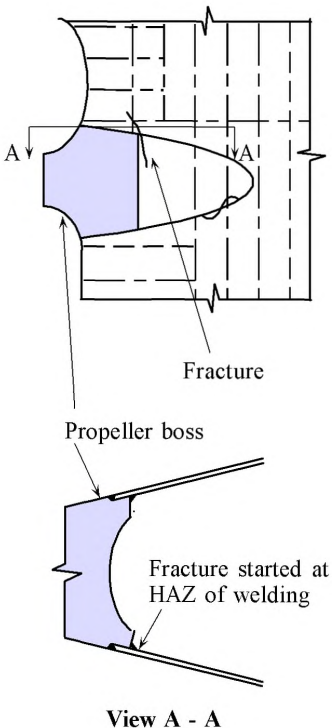
<b>BULK CARRIERS</b>		<b>Guidelines for Surveys, Assessment and Repair of Hull Structure</b>
<b>Part 2</b>	<b>Fore and aft end regions</b>	<b>Example No.</b>
<b>Area 3</b>	<b>Stern frame, rudder arrangement and propeller shaft support</b>	<b>7</b>
<b>Detail of damage</b>		Fractures in side shell plating at the connection to propeller boss
<b>Sketch of damage</b>

<p>Fracture</p> <p>Propeller boss</p> <p>Fracture started at HAZ of welding</p> <p><b>View A - A</b></p>		<b>Sketch of repair</b>

Repair examples for propeller boss and stern tube are shown in **Examples 7 and 8**. Regarding the welding reference is made to **3.1.4**, **3.2.4** and **3.2.5**.

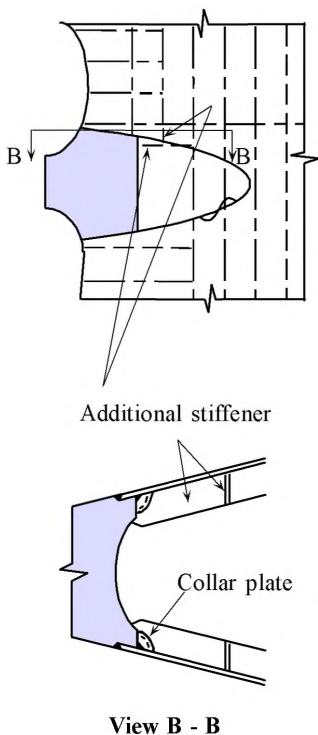
<p>Additional stiffener</p> <p>Collar plate</p> <p><b>View B - B</b></p>
<b>Notes on possible cause of damage</b> <ol style="list-style-type: none"> <li>1. Fatigue fracture due to vibration.</li> </ol>		<b>Notes on repairs</b> <ol style="list-style-type: none"> <li>1. Fractured side shell plating is to be cropped and part renewed.</li> <li>2. Additional stiffeners are to be provided.</li> <li>3. Collar plate is to be provided.</li> </ol>

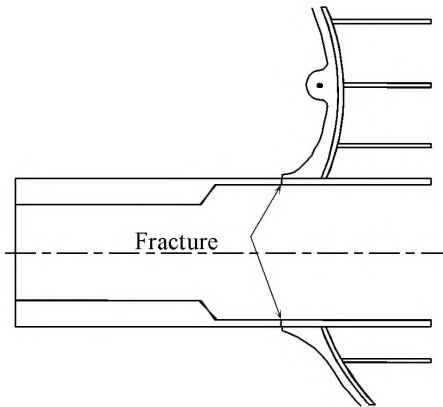
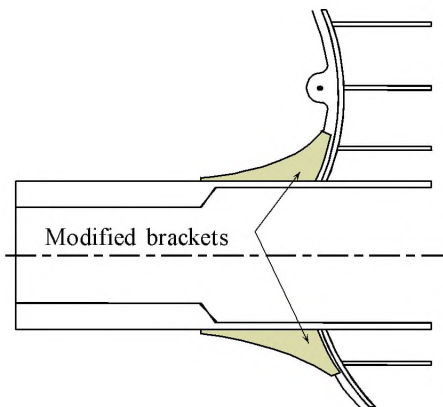
<b>BULK CARRIERS</b>		<b>Guidelines for Surveys, Assessment and Repair of Hull Structure</b>	
<b>Part 2</b>	<b>Fore and aft end regions</b>		<b>Example No.</b>
<b>Area 3</b>	<b>Stern frame, rudder arrangement and propeller shaft support</b>		<b>8</b>
<b>Detail of damage</b>		Fractures in stern tube at the connection to stern frame	
<b>Sketch of damage</b>		<b>Sketch of repair</b>

<b>Notes on possible cause of damage</b>		<b>Notes on repairs</b>	
1. Fatigue fracture due to vibration.		1. Fractured tube is to be veed-out and welded from both sides. 2. Brackets are to be replaced by modified brackets with soft transition.

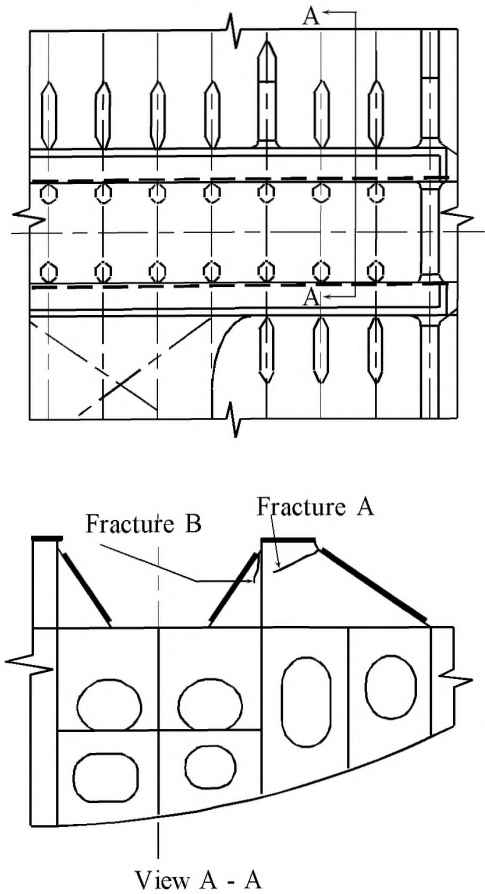
<b>BILK CARRIERS</b>	<b>Guidelines for Surveys, Assessment and Repair of Hull Structure</b>	
<b>Part 3</b>	<b>Machinery and accommodation spaces</b>	<b>Example No.</b>
<b>Area 1</b>	<b>Engine room structure</b>	<b>1</b>
<b>Detail of damage</b>		Fractures in brackets at main engine foundation
<b>Sketch of damage</b>

<p>View A - A</p>		<b>Sketch of repair</b>

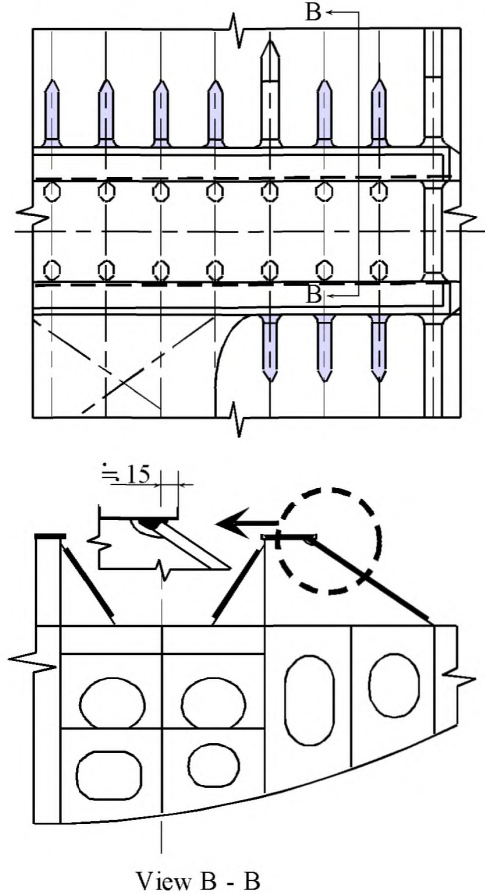
<p>View B - B</p>
<b>Notes on possible cause of damage</b> <ol style="list-style-type: none"> <li>1. Vibration of main engine.</li> <li>2. Insufficient strength of brackets at main engine foundation.</li> <li>3. Insufficient pre-load bolts.</li> </ol>		<b>Notes on repairs</b> <ol style="list-style-type: none"> <li>1. Fractures are to be veed-out and rewelded.</li> <li>2. New modified brackets at main engine foundation.</li> <li>3. Or insert pieces and additional flanges to increase section modulus of the brackets.</li> </ol>

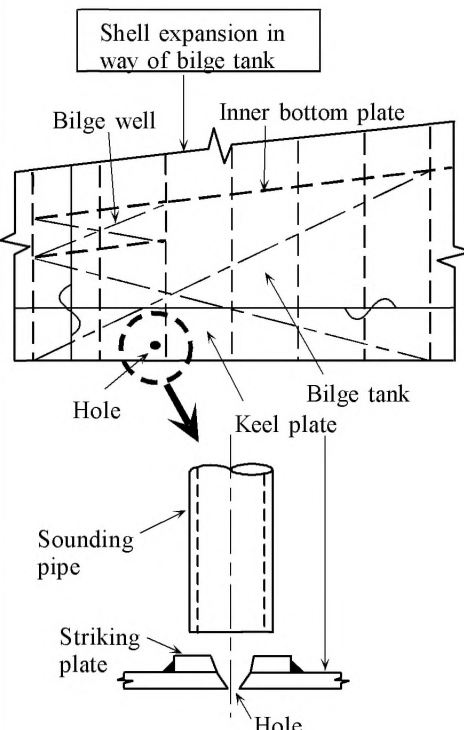
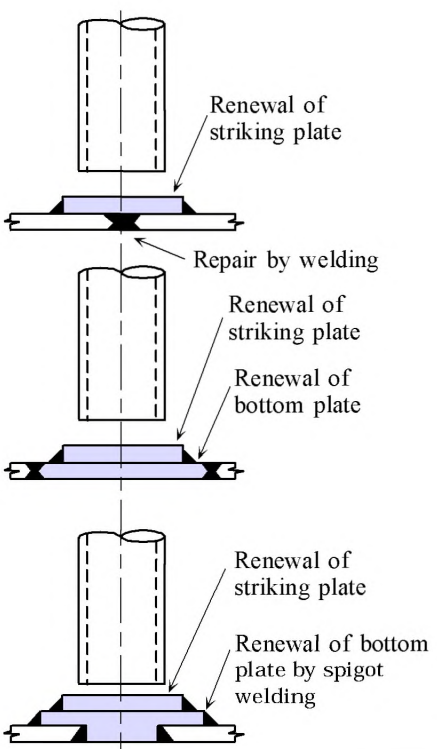
<b>BULK CARRIERS</b>		<b>Guidelines for Surveys, Assessment and Repair of Hull Structure</b>
<b>Part 3</b>	<b>Machinery and accommodation spaces</b>	<b>Example No.</b>
<b>Area 1</b>	<b>Engine room structure</b>	<b>2</b>
<b>Detail of damage</b>	Corrosion in bottom plating under sounding pipe in way of bilge storage tank in engine room	
<b>Sketch of damage</b>		<b>Sketch of repair</b>

<p>Shell expansion in way of bilge tank</p> <p>Bilge well</p> <p>Inner bottom plate</p> <p>Hole</p> <p>Keel plate</p> <p>Bilge tank plate</p> <p>Sounding pipe</p> <p>Striking plate</p> <p>Hole</p>

<p>Renewal of striking plate</p> <p>Repair by welding</p> <p>Renewal of striking plate</p> <p>Renewal of bottom plate</p> <p>Renewal of striking plate</p> <p>Renewal of bottom plate by spigot welding</p>
<b>Notes on possible cause of damage</b>		<b>Notes on repairs</b>
<ol style="list-style-type: none"> <li>Heavy corrosion of bottom plating under sounding pipe.</li> </ol>		<ol style="list-style-type: none"> <li>Corroded striking plating should be renewed.</li> <li>Bottom plate should be repaired depending on the condition of corrosion. (Note) Repair by spigot welding can be applied to the structure only when the stress level is considerably low. Generally this procedure cannot be applied to the repair of bottom plating of ballast tanks in cargo hold region.</li> </ol>

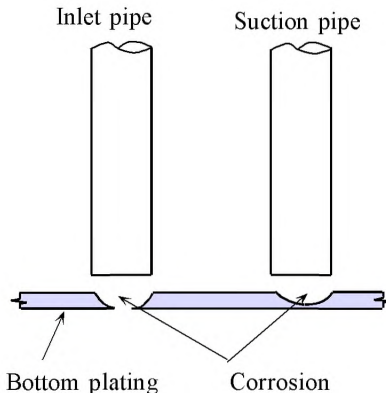
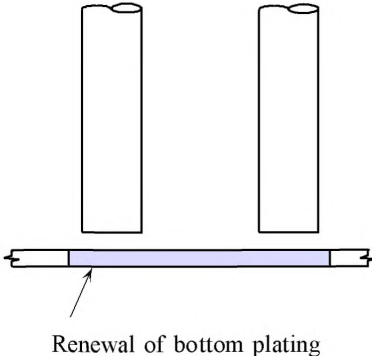
BULK CARRIERS		Guidelines for Surveys, Assessment and Repair of Hull Structure	
Part 3	Machinery and accommodation spaces	Example No.	
Area 1	Engine room structure	3	
Detail of damage	Corrosion in bottom plating under inlet/suction/pipe in way of bilge tank in engine room		
<b>Sketch of damage</b>

<b>Sketch of repair</b>

<b>Notes on possible cause of damage</b> 1. Heavy corrosion of bottom plating under the inlet/suction pipe.		<b>Notes on repairs</b> 1. Corroded bottom plating is to be cropped and part renewed. Thicker plate is preferable. 2. Replacement of pipe end by enlarged conical opening (similar to suction head in ballast tank) is preferable.

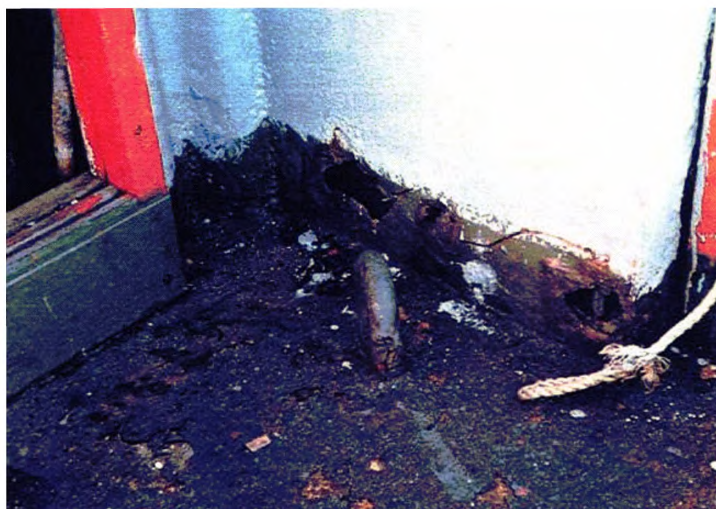
**Photograph 1** Corroded accommodation house side structure

Severe corrosion may be found in exposed deck plating and deck house side structure adjacent to the deck plating where water is liable to accumulate (See **Photograph 1**). Corrosion may also be found in accommodation bulkheads around cutout for fittings, such as doors, side scuttles, ventilators, etc., where proper maintenance of the area is relatively difficult. Deterioration of the bulkheads including fittings may impair the integrity of weathertightness.

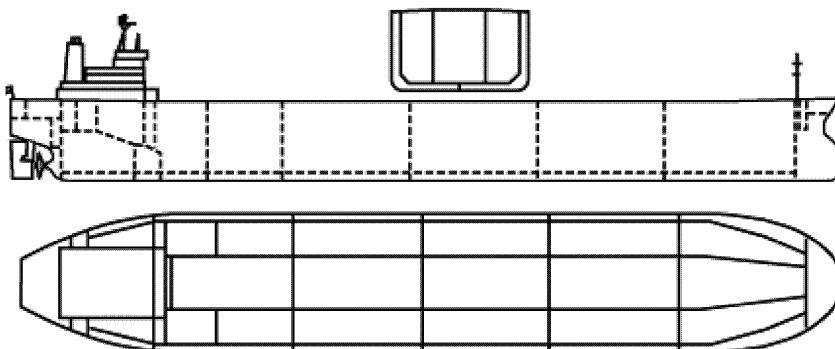
**Figure 1** General view of a typical double hull oil tanker (150,000 DWT and greater)

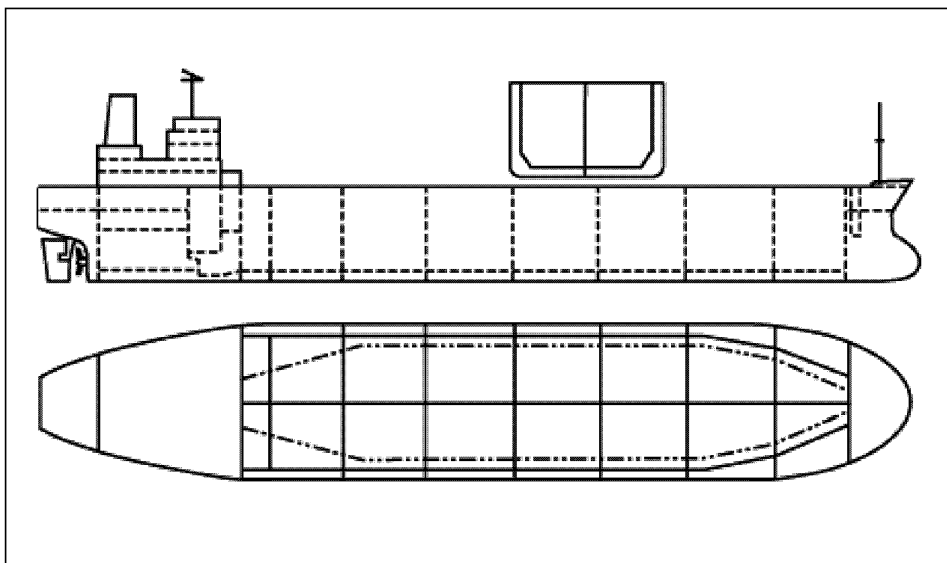
**Figure 2** General view of a typical double hull oil tanker (150,000 DWT or less)

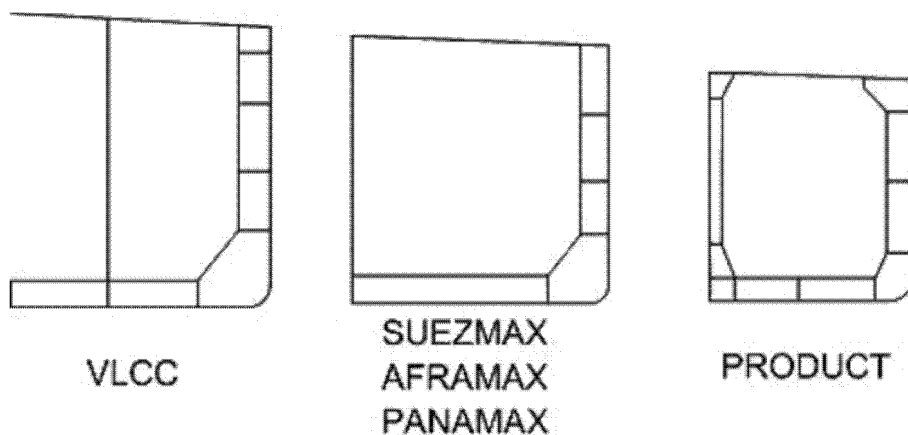
**Figure 3** Categories of Bulkhead Configurations

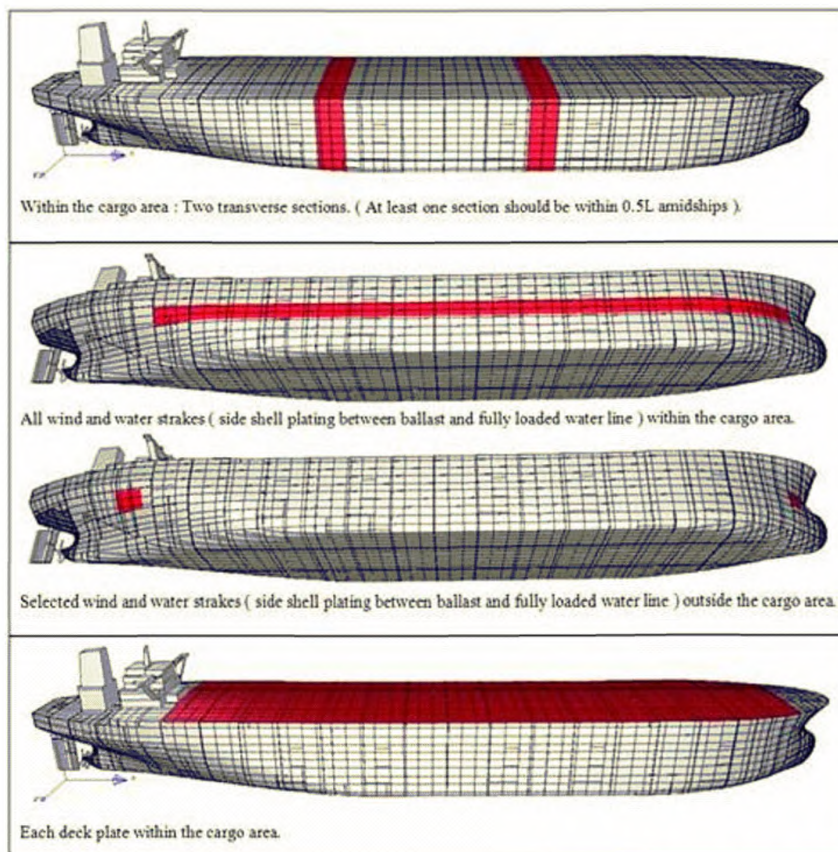
**Figure 7** Example of Transverse Sections of Shell Plating and Main Deck Thickness Measurement Requirements for an oil tanker 15 years of age.

**2.4.2** The Special Survey concentrates on close-up surveys in association with thickness measurements and is aimed at detecting fractures, buckling, corrosion and other types of structural deterioration. See Figure 7.

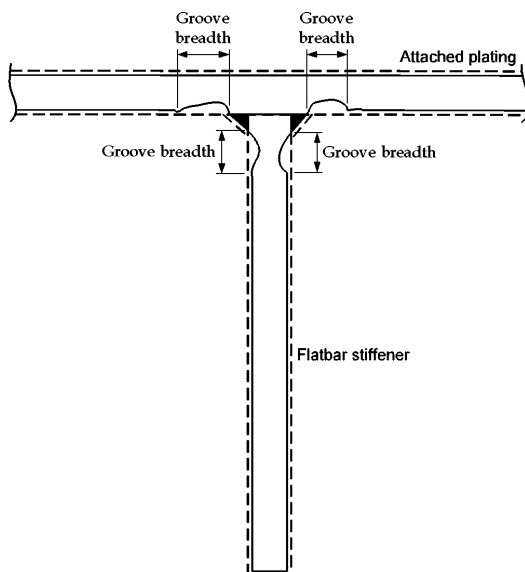
**Figure 8 Grooving Corrosion**

Grooving corrosion is often found in or beside welds, especially in the heat affected zone. This corrosion is sometimes referred to as 'inline pitting attack' and can also occur on vertical members and flush sides of bulkheads in way of flexing. The corrosion is caused by the galvanic current generated from the difference of the metallographic structure between the heat affected zone and base metal. Coating of the welds is generally less effective compared to other areas due to roughness of the surface, which exacerbates the corrosion. Grooving corrosion may lead to stress concentrations and further accelerate the corrosion process. Grooving corrosion may be found in the base material where coating has been scratched or the metal itself has been mechanically damaged. An example of grooving corrosion is shown in Figure 8.

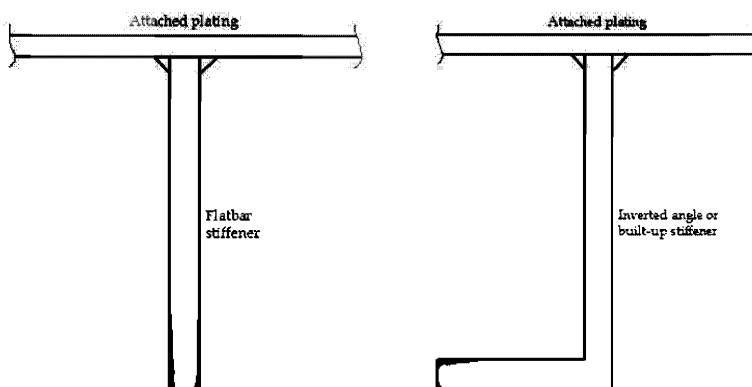
**Figure 9 Edge Corrosion**

Edge corrosion is defined as local corrosion at the free edges of plates, stiffeners, primary support members and around openings. An example of edge corrosion is shown in Figure 9.

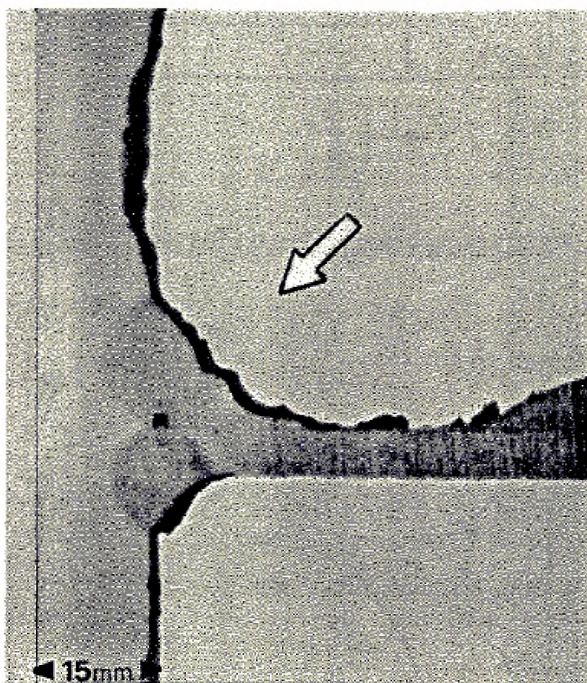
**Figure 10** Detail of Necking Effect

- Necking occurs at the junction of the longitudinal bulkhead plating and longitudinals. The deflection of the bulkhead plating and longitudinals due to reverse, cyclic loading from cargo oil and water ballast plus the accumulated mixtures of water, mud and scale at their junctures accelerates the corrosion rate. As the steel thins and weakens, the flexing consequently increases and hence corrosion accelerates (see Figure 10). The similar necking effect could also occur in the transverse bulkhead plating and stiffeners, or in the inner bottom plating and longitudinals inside the double bottom space. In the coated water ballast tanks, the plating is the principally affected area due to local corrosion in way of coating failure.

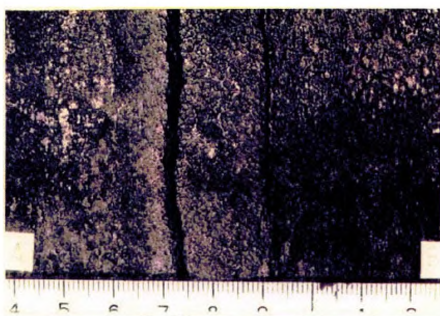
**Photograph 1**  
Grooving corrosion of welding of  
bottom plating

**4.1.2** Severe grooving along welding of bottom plating is often found (See **Photographs 1** and **2**). This grooving can be accelerated by poor maintenance of the protective coating and/or sacrificial anodes fitted to the bottom plating.

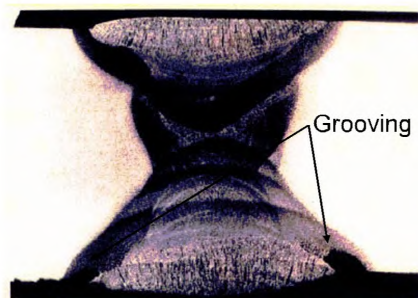
**Photograph 2**  
Section of the grooving shown in  
Photograph 1

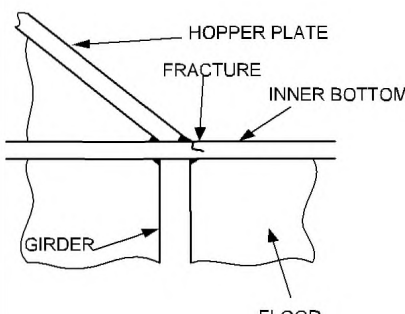
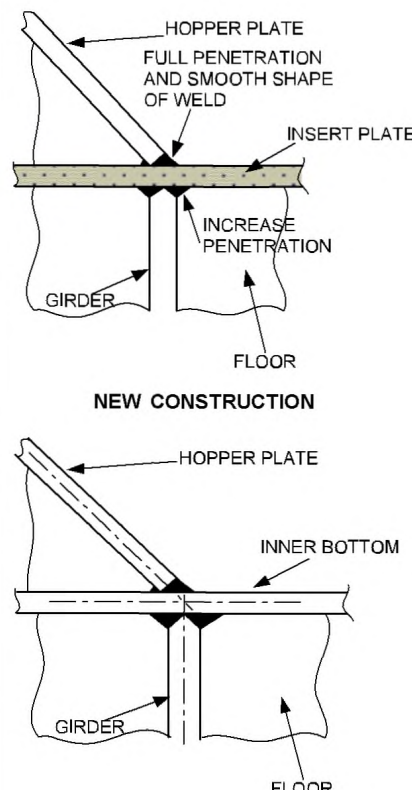
OIL Tankers		Guidelines for Surveys, Assessment and Repair of Hull Structure	
Group 1	Cargo area	Example No.	
	Hopper and double bottom ballast tank	1	
Detail of damage	Fracture on the inner bottom plating at the connection of hopper plate to inner bottom		
Sketch of damage		Sketch of repair

<p><b>NEW CONSTRUCTION</b></p>	
		<b>Notes:</b> Plate midlines intersect	
Factors which may have caused damage		Notes on repairs	
1. Stress concentration at juncture of hopper plate to inner bottom. 2. Insufficient welding connection. 3. Misalignment between hopper plate, inner bottom and girder.		See Sketch.

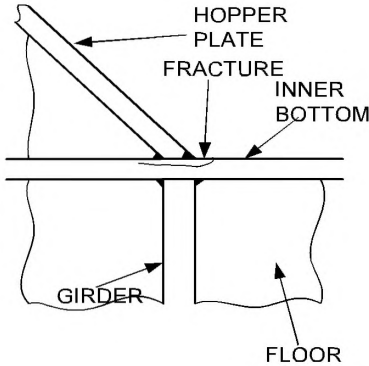
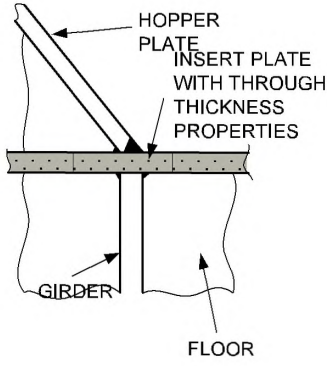
OIL Tankers		Guidelines for Surveys, Assessment and Repair of Hull Structure	
Group 1	Cargo area	Example No.	
	Hopper and double bottom ballast tank	2	
Detail of damage	Fracture at connection of bilge hopper plate and inner bottom		
Sketch of damage		Sketch of repair

Notes: Plate midlines intersect	
Factors which may have caused damage		Notes on repairs	
1. Stress concentration at the knuckle.		See Sketch.

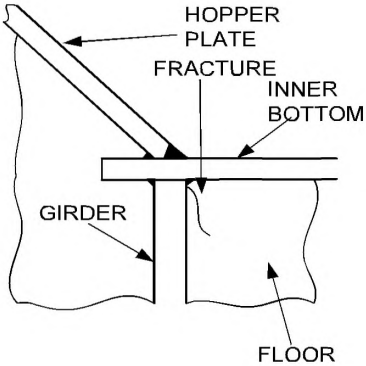
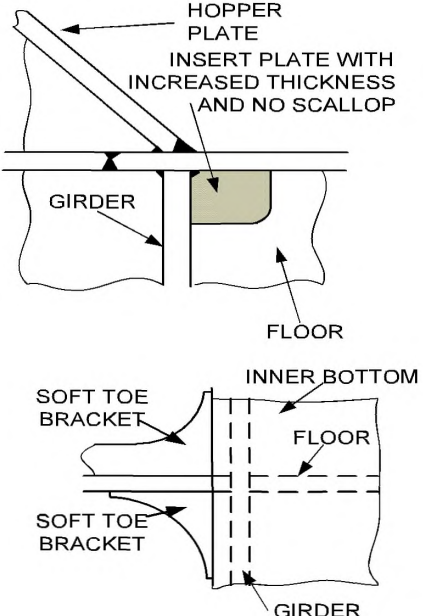
OIL Tankers		Guidelines for Surveys, Assessment and Repair of Hull Structure
Group 1	Cargo area	Example No.
	Hopper and double bottom ballast tank	3
Detail of damage		Fracture at connection of bilge hopper plate and inner bottom
Sketch of damage		Sketch of repair

<p>Notes: Plate midlines intersect</p>
<b>Factors which may have caused damage</b> 1. Stress concentration at the knuckle.		<b>Notes on repairs</b> See Sketch.

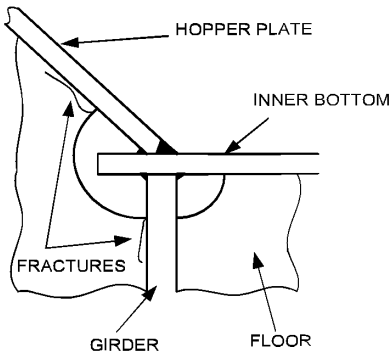
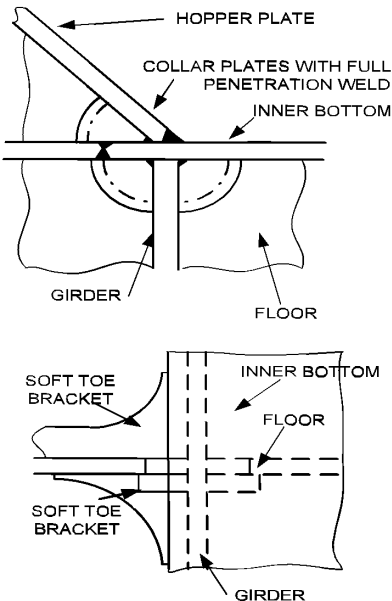
OIL Tankers		Guidelines for Surveys, Assessment and Repair of Hull Structure	
Group 1	Cargo area	Example No.	
	Hopper and double bottom ballast tank	4	
Detail of damage		Fracture at connection of bilge hopper plate and inner bottom	
Sketch of damage		Sketch of repair

<p>Notes: Plate midlines intersect</p>	
Factors which may have caused damage		Notes on repairs	
1. Stress concentration at the knuckle.		See Sketch.

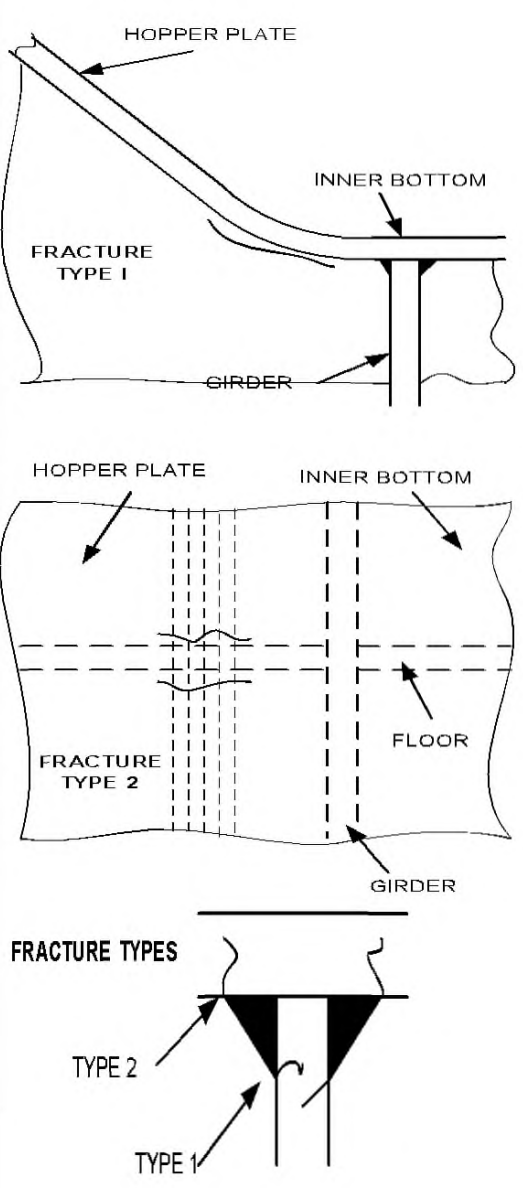
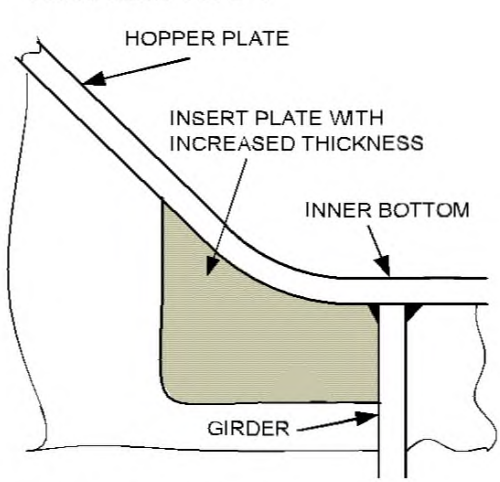
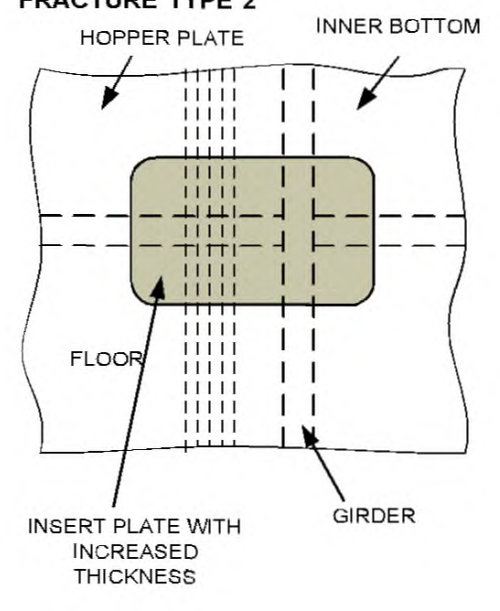
OIL Tankers		Guidelines for Surveys, Assessment and Repair of Hull Structure	
Group 1	Cargo area	Example No.	
	Hopper and double bottom ballast tank	5	
Detail of damage		Fractured floor and inner bottom plate in way of juncture of inner bottom to hopper plate	
<b>Sketch of damage</b>

<b>Sketch of repair</b> <b>FRACTURE TYPE 1</b>

<b>FRACTURE TYPE 2</b>

<b>Factors which may have caused damage</b> <ol style="list-style-type: none"> <li>1. Misalignment. The three mid-lines do not cross at the same joint. This misalignment produces an out-of-plane deformation of inner bottom plate in way of knuckle line.</li> <li>2. Stress concentration at connection between floor and inner bottom plate.</li> <li>3. Static and dynamic load of ballast water.</li> </ol>		<b>Notes on repairs</b> See Sketch.

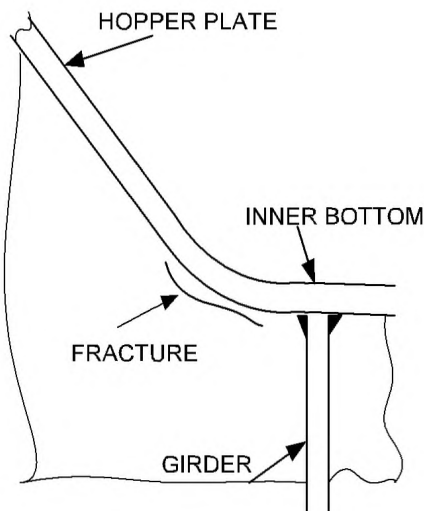
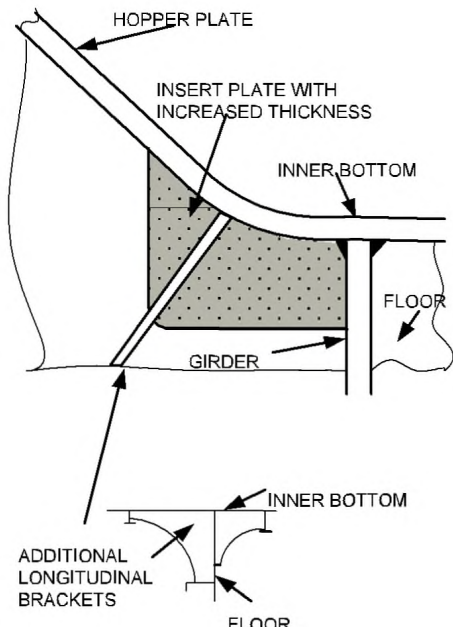
OIL Tankers		Guidelines for Surveys, Assessment and Repair of Hull Structure	
Group 1	Cargo area	Example No.	
	Hopper and double bottom ballast tank	6	
Detail of damage	Fracture at connection of bilge hopper plate and web frame		
Sketch of damage		Sketch of repair

Factors which may have caused damage		Notes on repairs	
1. Stress concentration due to reduction of effective flange area at curved plate.		See Sketch.

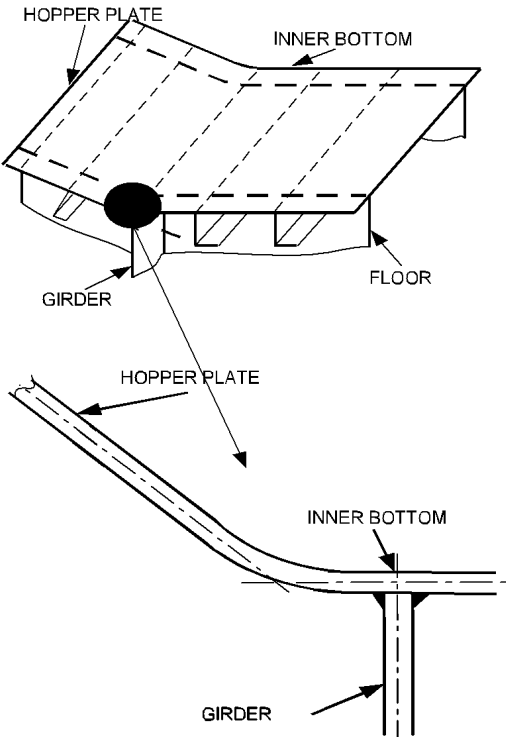
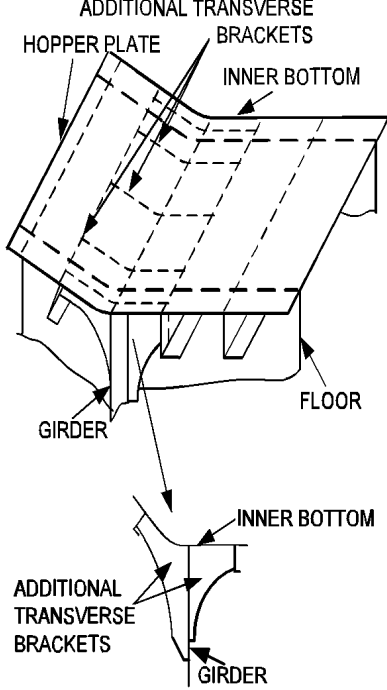
OIL Tankers		Guidelines for Surveys, Assessment and Repair of Hull Structure	
Group 1	Cargo area	Example No.	
	Hopper and double bottom ballast tank	7	
Detail of damage	Rounded hopper plate deformation in way of the floor		
Sketch of damage		Sketch of repair

<b>Factors which may have caused damage</b> 1. Misalignment. The three midlines do not cross at the same joint. This misalignment produces an out-of-plane deformation in knuckled plate in the vicinity of floor. 2. Insufficient stiffening between floors.		<b>Notes on repairs</b> See Sketch.

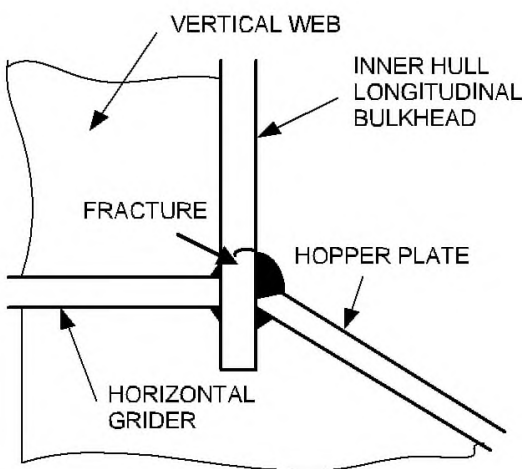
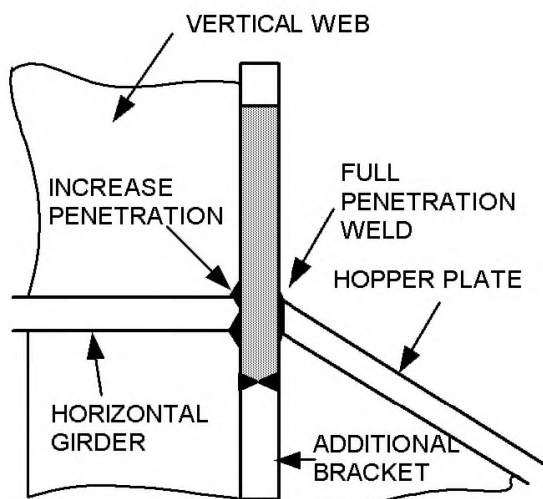
OIL Tankers		Guidelines for Surveys, Assessment and Repair of Hull Structure	
Group 1	Cargo area		Example No.
	Wing cargo tank		8
Detail of damage		Fracture at the connection of hopper plate to outside longitudinal bulkhead.	
<b>Sketch of damage</b>

<b>Sketch of repair</b>

<b>Factors which may have caused damage</b> <ol style="list-style-type: none"> <li>1. Stress concentration at junction of hopper plate to outside longitudinal bulkhead.</li> <li>2. Insufficient welding connection and/or incorrect shape of the weld toe.</li> <li>3. Misalignment between hopper plate, outside longitudinal bulkhead and side stringer.</li> </ol>		<b>Notes on repairs</b> See Sketch.

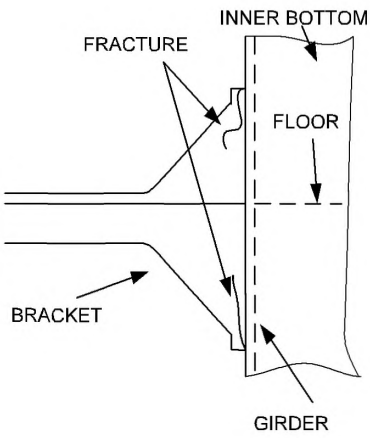
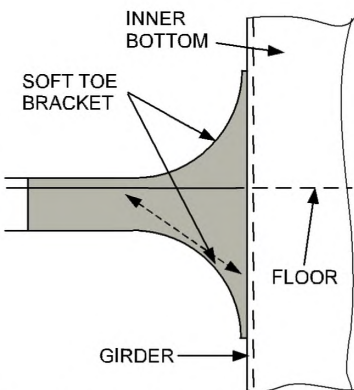
OIL Tankers		Guidelines for Surveys, Assessment and Repair of Hull Structure	
Group 1	Cargo area	Example No.	
	Hopper and double bottom ballast tank	9	
Detail of damage		Fracture in gusset plate in line with inner bottom	
Sketch of damage		Sketch of repair

<p><b>Notes:</b> Bracket radii as large as practicable. Bracket same thickness as inner bottom stiffener. Toe height should be small as possible while still allowing return weld (wrapped weld).</p>	
<b>Factors which may have caused damage</b> <ol style="list-style-type: none"> <li>1. Stress concentration due to small radius and abrupt toe.</li> <li>2. Insufficient welding.</li> <li>3. Insufficient sectional area (thickness x breadth) of the connecting bracket.</li> </ol>		<b>Notes on repairs</b> See Sketch.

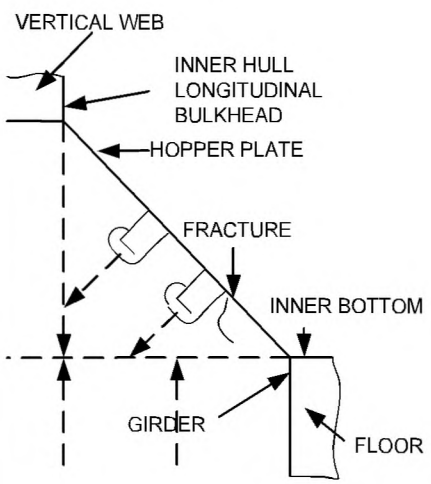
OIL Tankers		Guidelines for Surveys, Assessment and Repair of Hull Structure	
Group 1	Cargo area	Example No.	
	Hopper ballast tank	10	
Detail of damage		Fracture in way of cut-out in hopper plate	
<b>Sketch of damage</b>

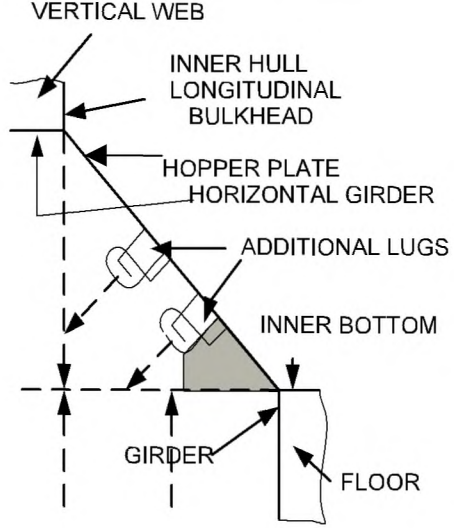
<b>Sketch of repair</b>

<b>Factors which may have caused damage</b> 1. Stress concentration due to no collar plate.		<b>Notes on repairs</b> See Sketch.

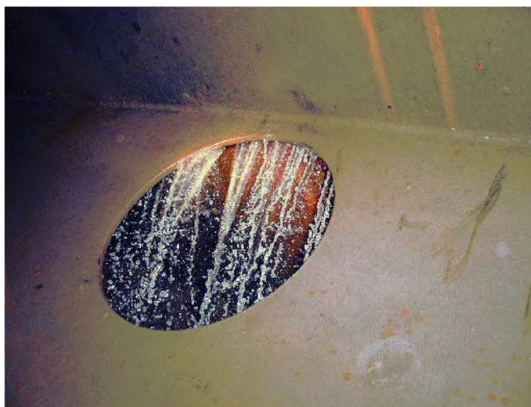
**Photograph 1 Side shell fracture in way of horizontal stringer weld**

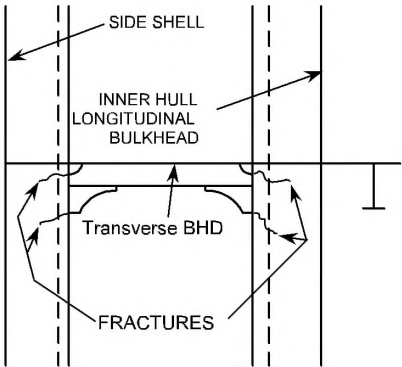
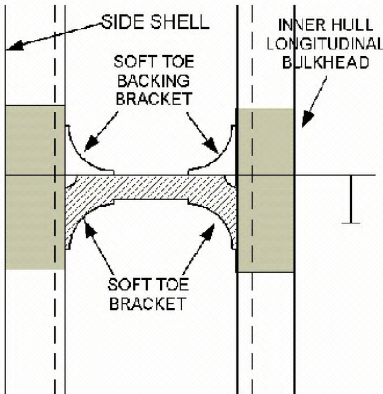
OIL Tankers		Guidelines for Surveys, Assessment and Repair of Hull Structure
Group 2	Cargo area	Example No.
	Wing ballast tank	1
Detail of damage		Crack in way of connection of longitudinals to transverse bulkhead
Sketch of damage		Sketch of repair

<b>Factors which may have caused damage</b> <ol style="list-style-type: none"> <li>1. Asymmetrical connection of bracket without backing bracket.</li> <li>2. Relative deflection of adjoining transverse web against transverse bulkhead.</li> <li>3. Additional biaxial bending stresses due to asymmetry of the angle bar longitudinal instead of symmetric T section.</li> <li>4. Dynamic load in the vicinity of the water line.</li> <li>5. Large upstand at bracket toe.</li> </ol>		<b>Notes on repairs</b> See Sketch.

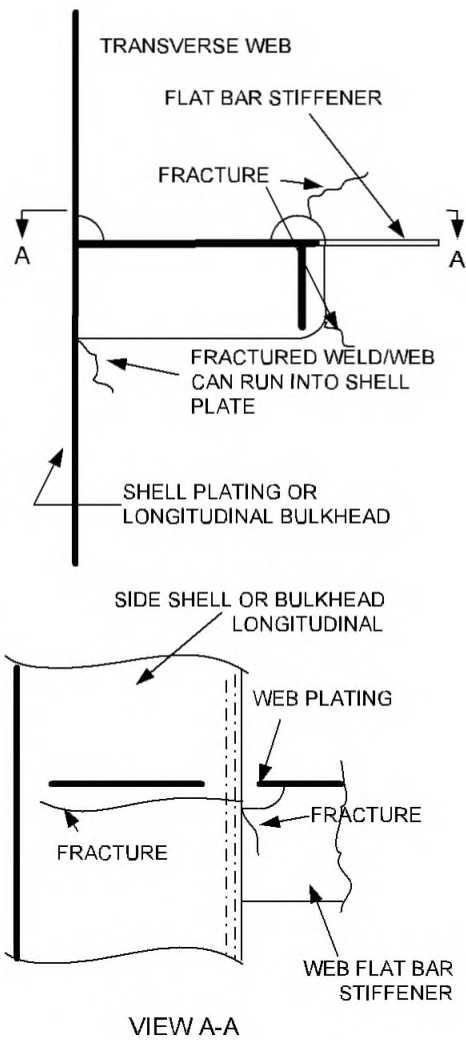
OIL Tankers Guidelines for Surveys, Assessment and Repair of Hull Structure		
Group 2	Cargo area	Example No.
	Wing ballast tank	3
Detail of damage	Fracture in way of web and flat bar stiffener at cut outs for longitudinal stiffener connections.	
<b>Sketch of damage</b>

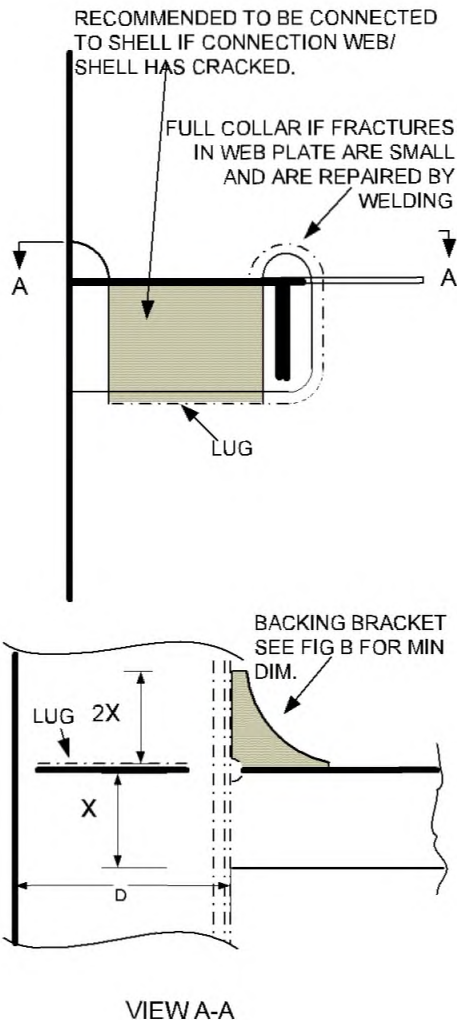
<b>Sketch of repair</b>

<p>Insert longitudinal.</p>
<b>Factors which may have caused damage</b> <ol style="list-style-type: none"> <li>1. Asymmetrical connection of flat bar stiffener resulting in high peak stress at heel of the stiffener under fatigue loading.</li> <li>2. Insufficient area of connection of longitudinal to web plate.</li> <li>3. Defective weld at return around the plate thickness.</li> <li>4. High localized corrosion at areas of stress concentrations such as flat bar stiffener connections, corners of cut out for longitudinal and connection of web to shell at cut outs.</li> <li>5. High shear stress in web of the transverse.</li> <li>6. Dynamic seaway loads/motions.</li> </ol>		<b>Notes on repairs</b> See Sketch. May also fit a double bracket to avoid fracture from toe.

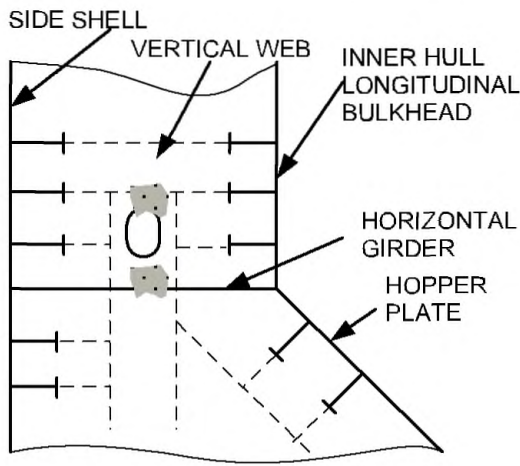
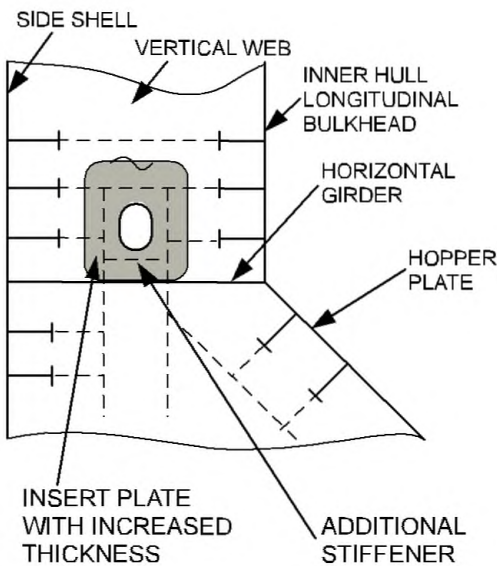
OIL Tankers		Guidelines for Surveys, Assessment and Repair of Hull Structure	
Group 2	Cargo area	Example No.	
	Wing ballast tank	5	
Detail of damage		Buckling in way of side web panels above hopper horizontal girder	
Sketch of damage		Sketch of repair

<b>Factors which may have caused damage</b> 1. High shear stress in the transverse web. 2. Insufficient buckling strength.		<b>Notes on repairs</b> See Sketch.

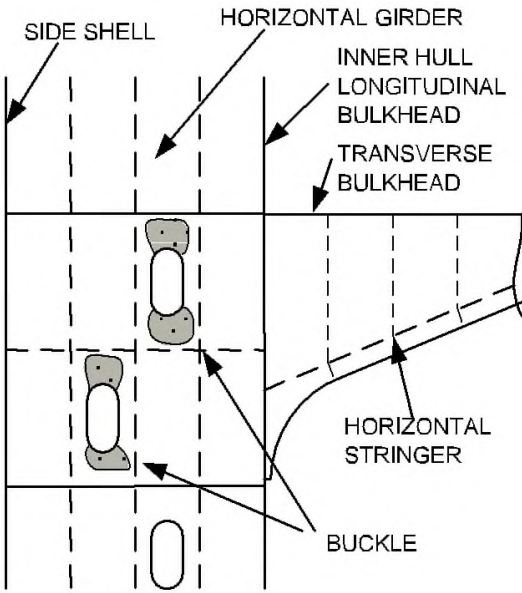
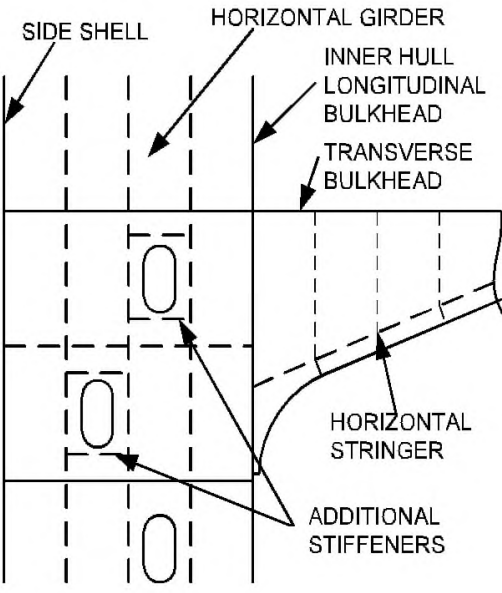
OIL Tankers		Guidelines for Surveys, Assessment and Repair of Hull Structure	
Group 2	Cargo area		Example No.
	Wing ballast tank		6
Detail of damage	Panels of side horizontal girders in way of transverse bulkhead		
Sketch of damage		Sketch of repair

Factors which may have caused damage		Notes on repairs	
1. High shear or compressive stress in the stringer. 2. Insufficient buckling strength.		See Sketch.

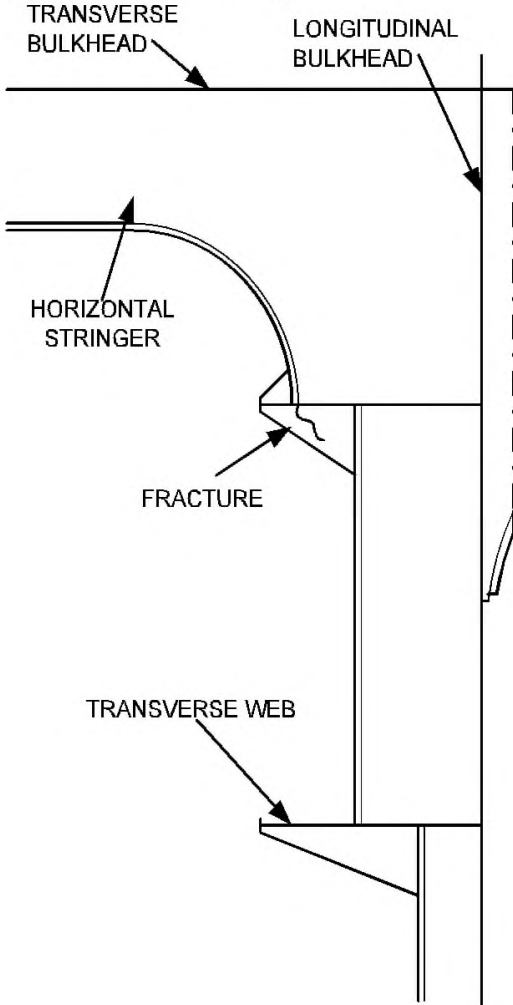
OIL Tankers		Guidelines for Surveys, Assessment and Repair of Hull Structure	
Group 2	Cargo area	Example No.	
	Wing ballast tank	7	
Detail of damage		Fracture at connection of horizontal stringers to transverse web frames and horizontal girders	
<b>Sketch of damage</b>

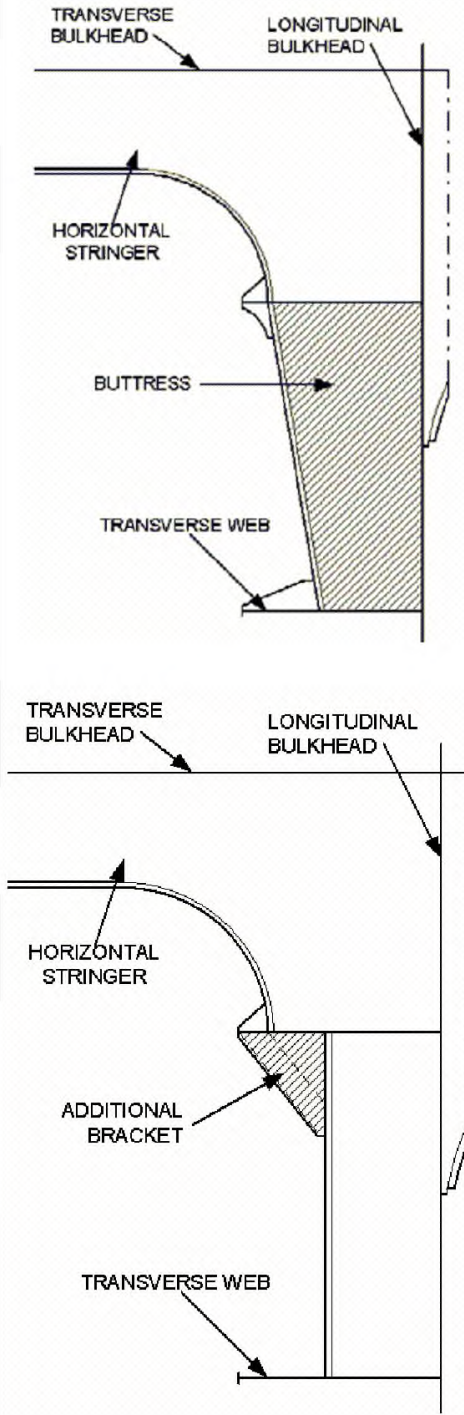
<b>Sketch of repair</b>

<b>Factors which may have caused damage</b> 1. Stress concentration due to discontinuous structure. 2. High shear stress in the horizontal stringer.		<b>Notes on repairs</b> See Sketch.

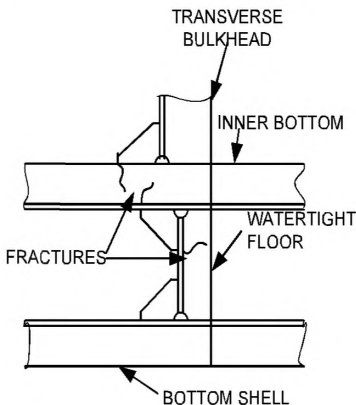
OIL Tankers		Guidelines for Surveys, Assessment and Repair of Hull Structure	
Group 3	Cargo area	Example No.	
	Bottom ballast tank	1	
Detail of damage		Cracks in way of longitudinals connected to watertight floors	
<b>Sketch of damage</b>

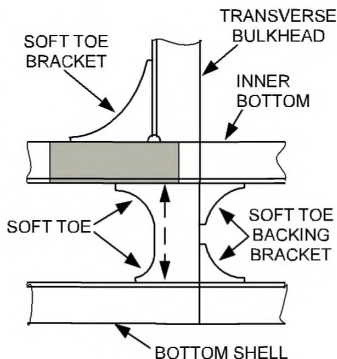
<b>Sketch of repair</b>

<b>Factors which may have caused damage</b> <ol style="list-style-type: none"> <li>1. Asymmetrical connection of bracket in association with a backing bracket, which is too small.</li> <li>2. Relative deflection between adjacent floor and transverse bulkhead.</li> <li>3. Inadequate shape of the brackets.</li> <li>4. High stresses in the inner bottom longitudinal and the floor stiffener.</li> </ol>		<b>Notes on repairs</b> See Sketch.

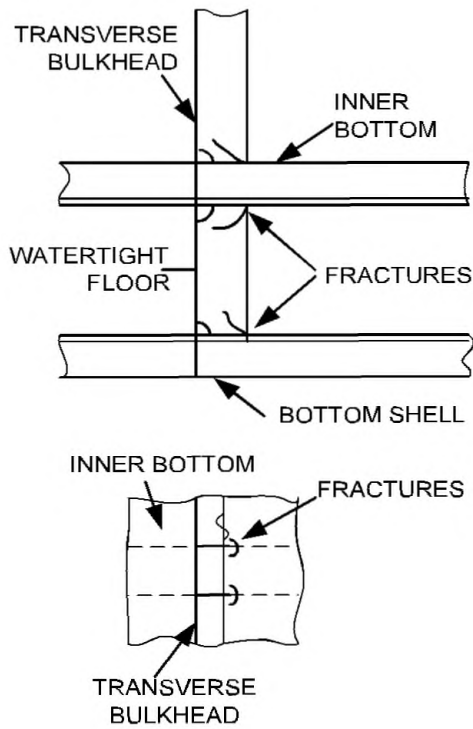
OIL Tankers		Guidelines for Surveys, Assessment and Repair of Hull Structure	
Group 3	Cargo area	Example No.	
	Bottom ballast tank	2	
Detail of damage		Fracture in way of stiffeners at connection of inner bottom and bottom shell to transverse bulkhead and floors.	
Sketch of damage		Sketch of repair

<p>The sketch shows a cross-section of the hull structure. A vertical line represents the TRANSVERSE BULKHEAD. Horizontal lines represent the INNER BOTTOM, WATERTIGHT FLOOR, and BOTTOM SHELL. Arrows point to the connection points where fractures have occurred. A separate detail view shows the INNER BOTTOM and TRANSVERSE BULKHEAD with dashed lines indicating the fracture locations.</p>

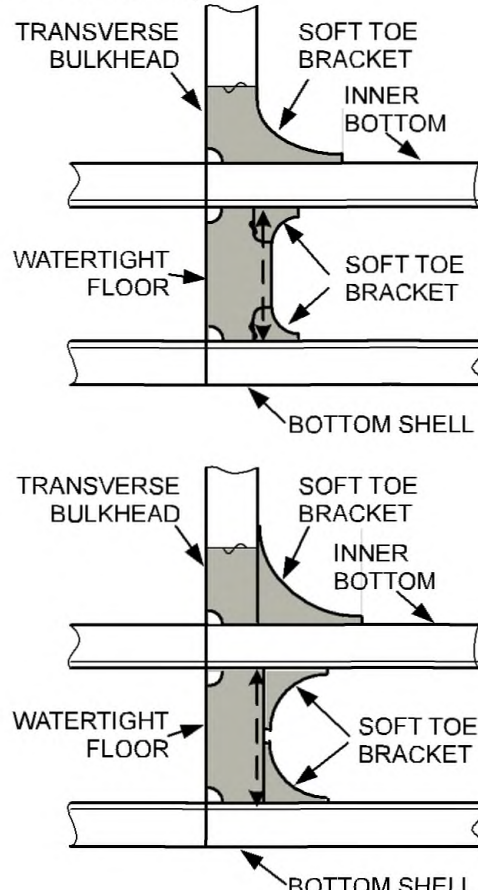
<p>The sketch shows the same cross-section as the damage sketch, but with repair components added. SOFT TOE BRACKETS are shown as curved plates welded to the inner bottom and bottom shell, reinforcing the connection to the TRANSVERSE BULKHEAD and WATERTIGHT FLOOR.</p>

<b>Factors which may have caused damage</b> <ol style="list-style-type: none"> <li>1. Misalignment between bulkhead stiffener and inner bottom longitudinal.</li> <li>2. High stress concentration.</li> </ol>		<b>Notes on repairs</b> <p>See Sketch.</p> <ol style="list-style-type: none"> <li>1. If tank top plating is fractured, part crop and insert.</li> <li>2. Proper alignment between bulkhead stiffener and inner bottom longitudinal is critical for successful repair.</li> <li>3. Soft backing brackets may also be added.</li> </ol>
