**РОССИЙСКИЙ МОРСКОЙ РЕГИСТР СУДОХОДСТВА**  
**RUSSIAN MARITIME REGISTER OF SHIPPING**

**ПРИЛОЖЕНИЕ К ПРАВИЛАМ**  
**РОССИЙСКОГО МОРСКОГО РЕГИСТРА СУДОХОДСТВА**  
**УНИФИЦИРОВАННЫЕ ИНТЕРПРЕТАЦИИ**  
**И РЕКОМЕНДАЦИИ**  
**МЕЖДУНАРОДНОЙ АССОЦИАЦИИ**  
**КЛАССИФИКАЦИОННЫХ ОБЩЕСТВ**

**SUPPLEMENT TO RULES**  
**OF RUSSIAN MARITIME REGISTER OF SHIPPING**  
**IACS UNIFIED INTERPRETATIONS**  
**AND RECOMMENDATIONS**

НД № 2-020101-085-R-E

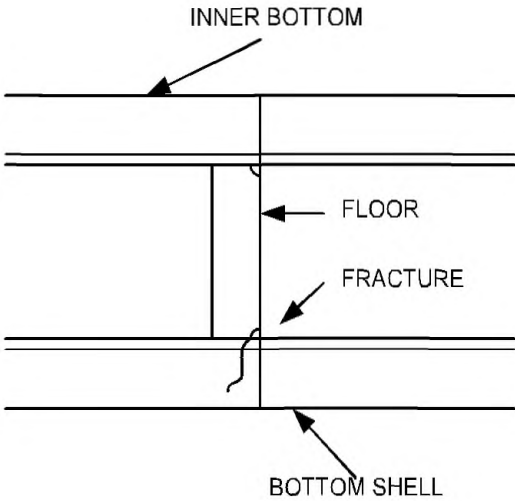
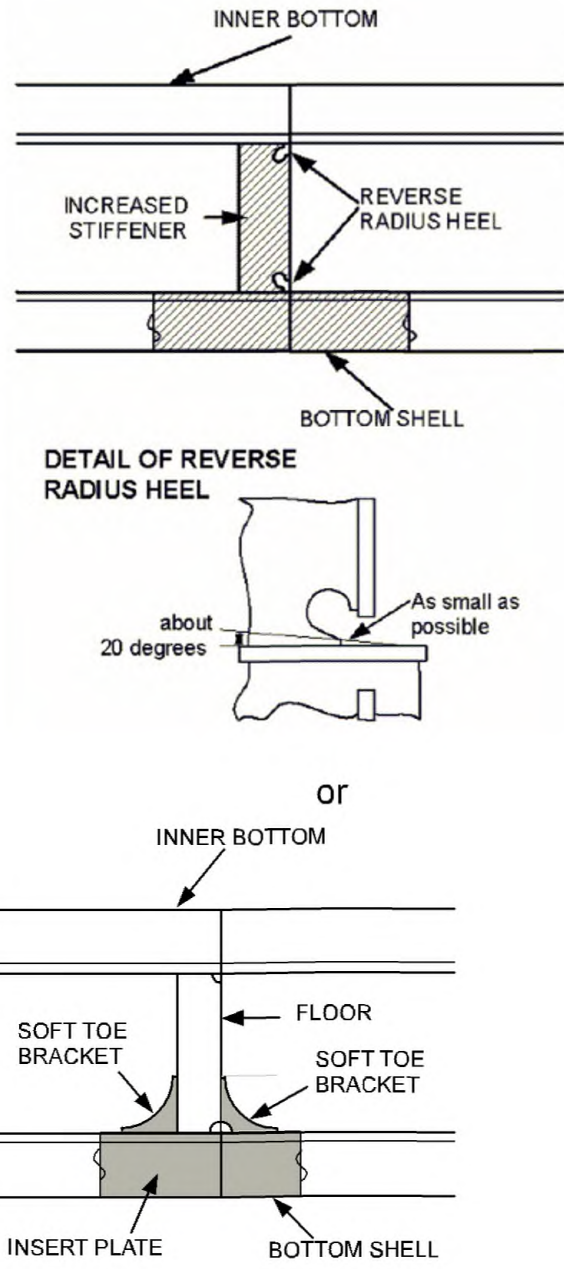
OIL Tankers		Guidelines for Surveys, Assessment and Repair of Hull Structure	
Group 3	Cargo area	Example No.	
	Bottom ballast tank	3	
Detail of damage		Connection of longitudinals to ordinary floors.	
Sketch of damage		Sketch of repair

<b>Factors which may have caused damage</b> <ol style="list-style-type: none"> <li>1. Asymmetrical connection.</li> <li>2. Relative deflection of adjacent floor to transverse bulkhead.</li> </ol>		<b>Notes on repairs</b> See Sketch.

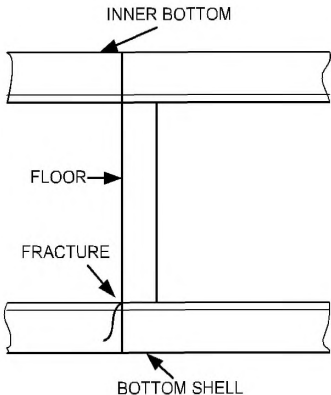
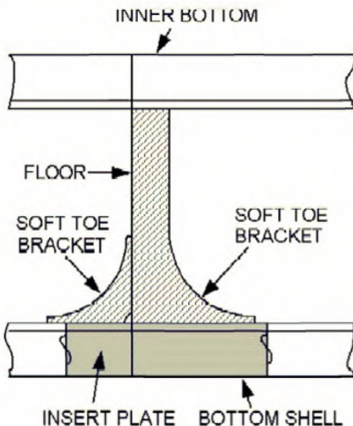
OIL Tankers		Guidelines for Surveys, Assessment and Repair of Hull Structure
Group 3	Cargo area	Example No.
	Bottom ballast tank	4
Detail of damage	Connection of longitudinals to ordinary floors	
Sketch of damage		Sketch of repair

<b>Factors which may have caused damage</b> 1. Stress concentration at the connection of bottom longitudinal and stiffener on floor.		<b>Notes on repairs</b> See Sketch. 1. Butt welds in bottom longitudinal should be kept clear of the soft toe bracket toes. 2. If possible soft toe bracket and vertical stiffener should be integral.

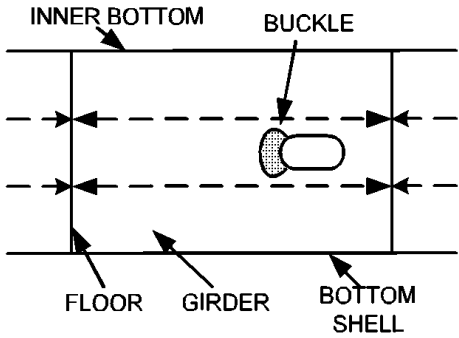
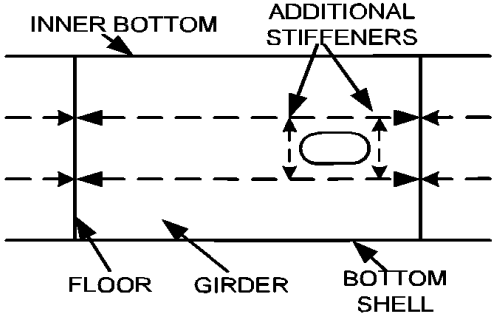
OIL Tankers		Guidelines for Surveys, Assessment and Repair of Hull Structure	
Group 3	Cargo area	Example No.	
	Bottom ballast tank	5	
Detail of damage		Panels of bottom girders in way of openings.	
Sketch of damage		Sketch of repair

<b>Factors which may have caused damage</b> 1. High shear or compressive stress in the side girder. 2. Insufficient buckling strength.		<b>Notes on repairs</b> See Sketch.

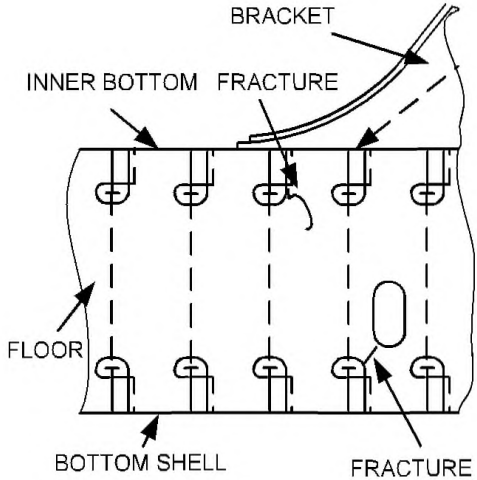
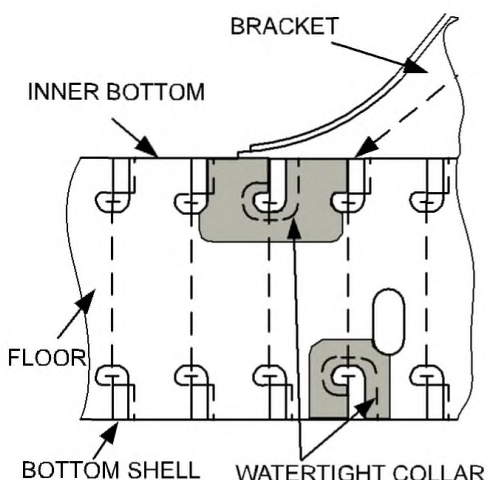
OIL Tankers		Guidelines for Surveys, Assessment and Repair of Hull Structure
Group 3	Cargo area	Example No.
	Bottom ballast tank	6
Detail of damage		Cut-outs on floors
Sketch of damage		Sketch of repair

<p><b>Above for relatively small fractures.</b></p>

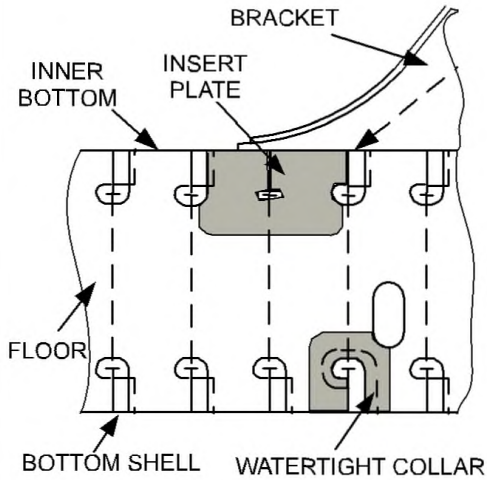
<p><b>Above method for larger fractures.</b></p>
<b>Factors which may have caused damage</b> <ol style="list-style-type: none"> <li>1. High stress in the vicinity of the transverse web frame bracket toe.</li> <li>2. Lack of material between manhole and cut-out for bottom longitudinals.</li> </ol>		<b>Notes on repairs</b> <ol style="list-style-type: none"> <li>1. Top sketch: Gouge and reweld fractures then fit WT collars.</li> <li>2. Bottom sketch: As an alternative to rewelding and fitting collar, crop and insert.</li> </ol>

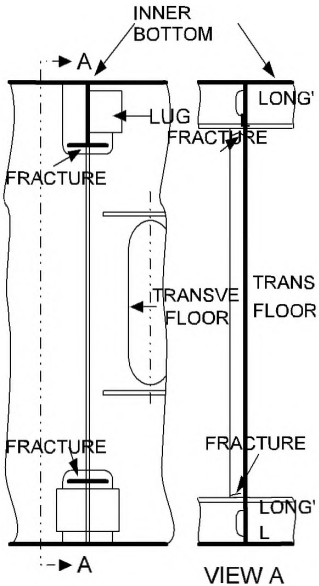
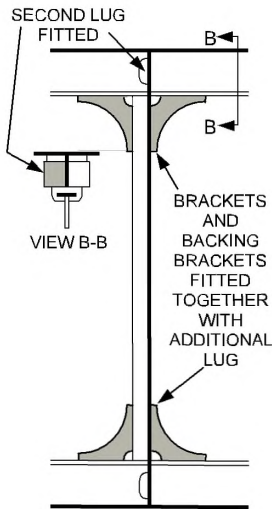
OIL Tankers		Guidelines for Surveys, Assessment and Repair of Hull Structure	
Group 3	Cargo area	Example No.	
	Bottom ballast tank	7	
Detail of damage		Fractured stiffener connection to bottom and inner bottom longitudinals.	
Sketch of damage		Sketch of repair

<b>Factors which may have caused damage</b> <ol style="list-style-type: none"> <li>1. Asymmetric connection leading to high local stresses at the connection of vertical stiffeners of the transverse floors to the inner and outer bottom longitudinals.</li> <li>2. Wide slot for longitudinal leads to inefficient lug connection.</li> <li>3. Sharp corners or flame-cut edges producing a notch effect.</li> <li>4. Incomplete/defective weld at stiffener connection to the longitudinals.</li> <li>5. Dynamic sea way loads/ship motions.</li> </ol>		<b>Notes on repairs</b> See Sketch.

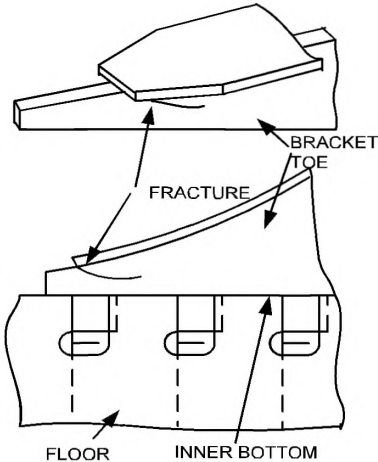
OIL Tankers		Guidelines for Surveys, Assessment and Repair of Hull Structure
Group 4	Cargo area	Example No.
	Web Frame in cargo tank	1
Detail of damage	Fracture at toe of web frame bracket connection to inner bottom.	
Sketch of damage	<div style="display: flex; justify-content: space-between;"> <div style="width: 45%;">

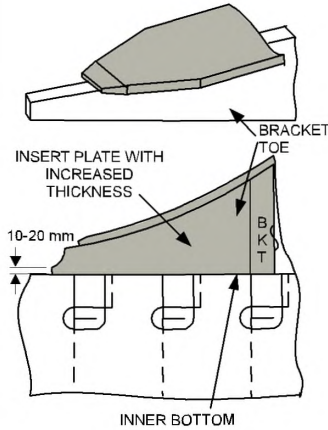
</div> <div style="width: 45%;"> <p><b>Sketch of repair</b> Modify Face Taper</p> <ol style="list-style-type: none"> <li>1. Breadth taper 20 degrees.</li> <li>2. Breadth at toe as small as practical.</li> <li>3. Thickness taper 1 in 3 to 10mm.</li> </ol>

</div> </div>	
Factors which may have caused damage	<div style="display: flex; justify-content: space-between;"> <div style="width: 45%;"> <ol style="list-style-type: none"> <li>1. Inadequate tapering the toe end.</li> <li>2. Insufficient tapering of flange.</li> <li>3. Lateral flexing of the bracket.</li> </ol> </div> <div style="width: 45%;"> <p><b>Notes on repairs</b> See Sketch.</p> </div> </div>

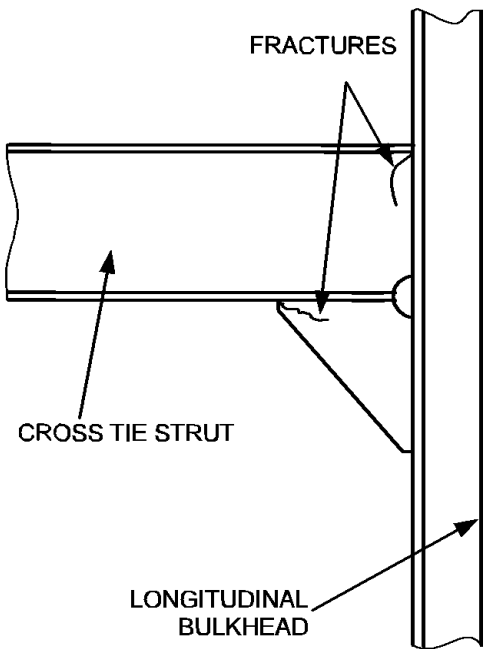
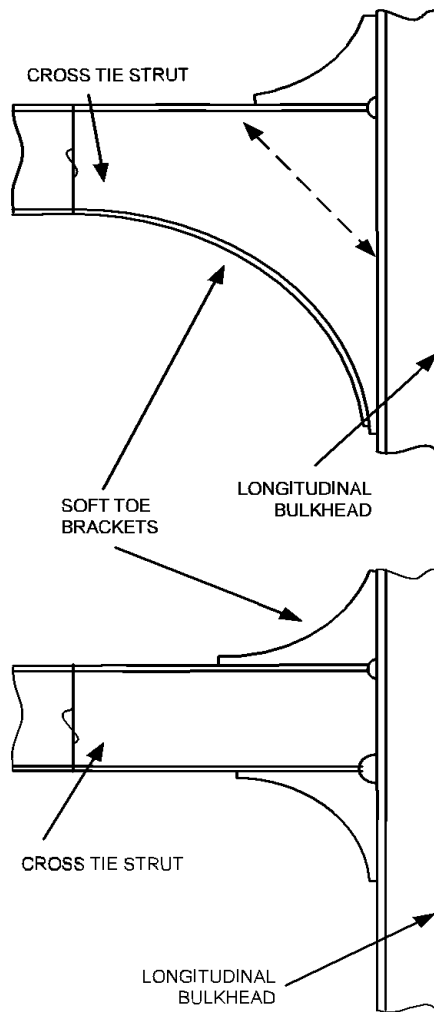
OIL Tankers Guidelines for Surveys, Assessment and Repair of Hull Structure		
Group 4	Cargo area	Example No.
	Web Frame in cargo tank	2
Detail of damage Cross ties and their end connections		
Sketch of damage		Sketch of repair

<b>Factors which may have caused damage</b> <ol style="list-style-type: none"> <li>1. Stress concentration due to unsuitable bracket shape at juncture of cross tie to longitudinal.</li> <li>2. Inadequate panel stiffening of web plate of cross-tie.</li> </ol>		<b>Notes on repairs</b> See Sketch.

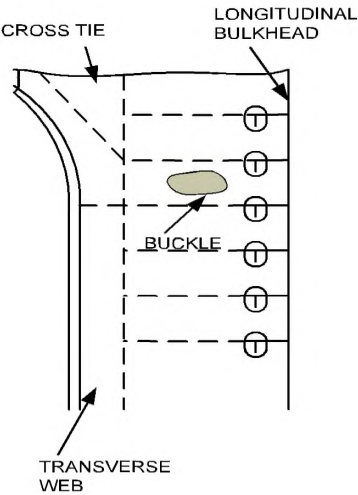
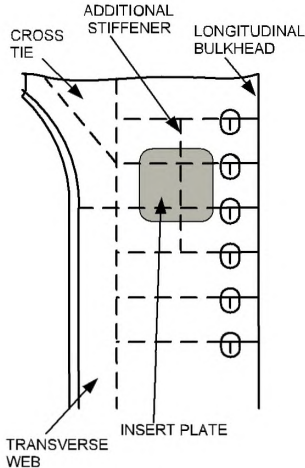
OIL Tankers		Guidelines for Surveys, Assessment and Repair of Hull Structure	
Group 4	Cargo area	Example No.	
	Web Frame in cargo tank	3	
Detail of damage		Buckled transverse web plates in way of cross tie.	
Sketch of damage		Sketch of repair

<b>Factors which may have caused damage</b> 1. Insufficient panel stiffening on transverse web.		<b>Notes on repairs</b> See Sketch. 1. Depending upon size of deformation, additional stiffeners may be sufficient.

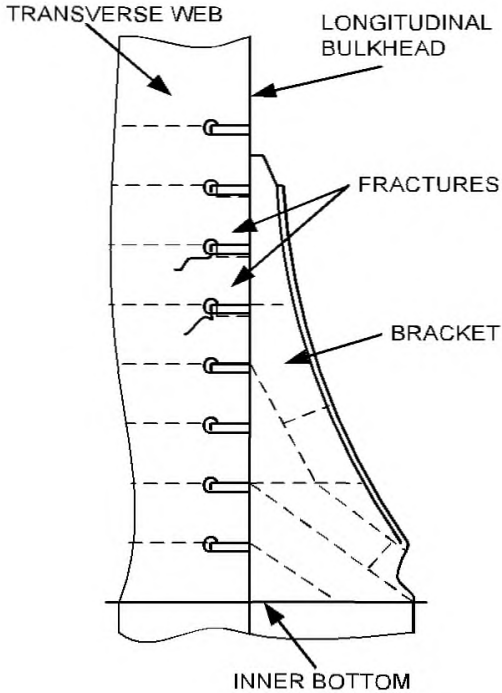
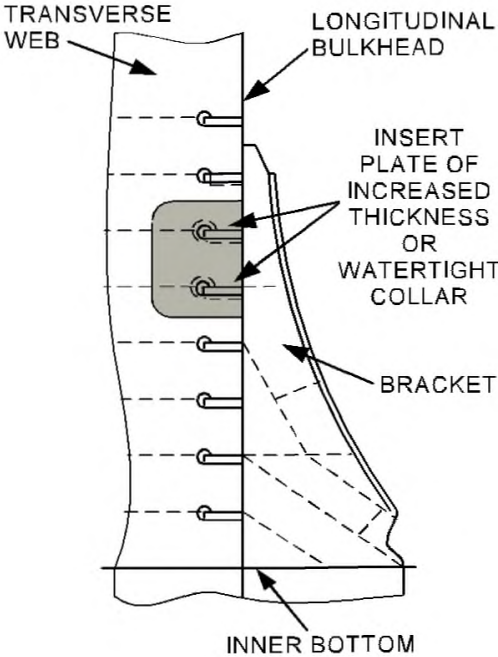
OIL Tankers		Guidelines for Surveys, Assessment and Repair of Hull Structure	
Group 4	Cargo area		Example No.
	Web Frame in cargo tank		4
Detail of damage		Cut-outs around transverse bracket end.	
Sketch of damage		Sketch of repair

Factors which may have caused damage		Notes on repairs	
1. High stresses at toe of bottom transverse end bracket. 2. Sharp corner at cut-out.		See Sketch.

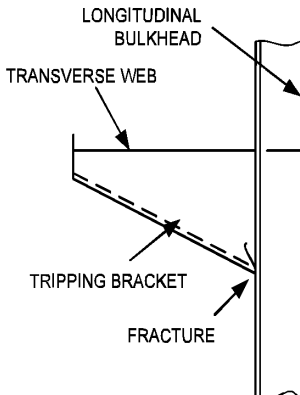
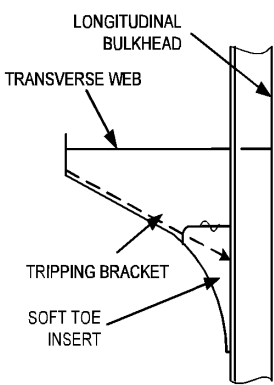
OIL Tankers		Guidelines for Surveys, Assessment and Repair of Hull Structure	
Group 4	Cargo area	Example No.	
	Web Frame in cargo tank	5	
Detail of damage	Fracture in way of connection of transverse web tripping brackets to longitudinal		
Sketch of damage		Sketch of repair

Factors which may have caused damage		Notes on repairs	
1. Hard spot at the toe of bracket. 2. Vibration.		See Sketch. 1. Soft bracket may be added on upper side of web, to avoid fracture at the heel.

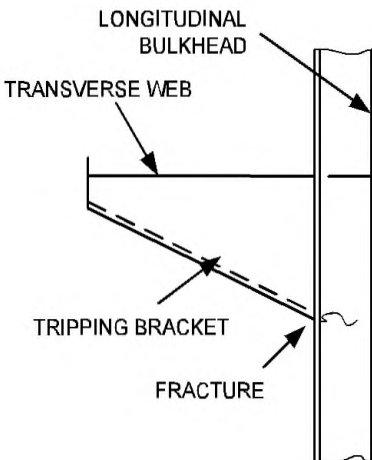
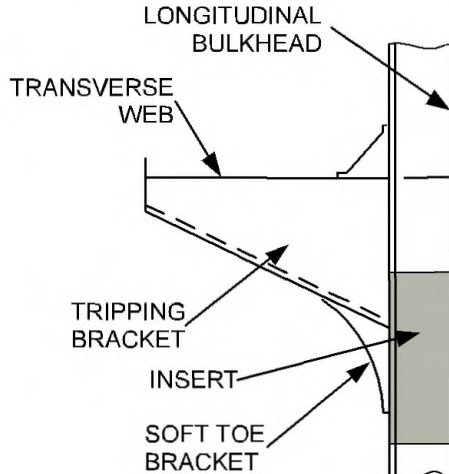
OIL Tankers		Guidelines for Surveys, Assessment and Repair of Hull Structure	
Group 4	Cargo area	Example No.	
	Web Frame in cargo tank	6	
Detail of damage		Tripping brackets modification of the bracket toe.	
Sketch of damage		Sketch of repair

<b>Factors which may have caused damage</b> 1. Stress concentrations at toe of bracket. 2. High stress in longitudinal.		<b>Notes on repairs</b> See Sketch. 1. Soft bracket may be added on upper side of web, to avoid fracture at the heel.

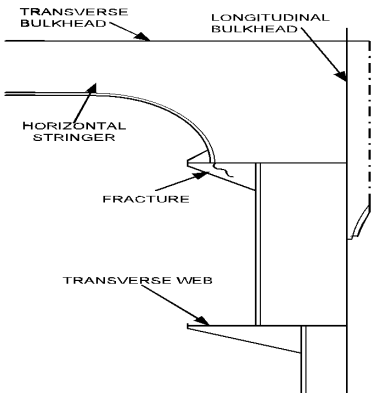
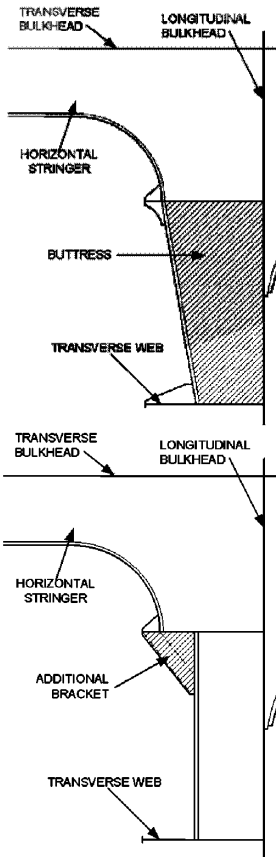
OIL Tankers		Guidelines for Surveys, Assessment and Repair of Hull Structure	
Group 5	Cargo area	Example No.	
	Transverse Bulkhead in cargo tank	1	
Detail of damage		Fracture in way of connection of transverse bulkhead stringer to transverse web frames and longitudinal bulkhead stringer	
Sketch of damage		Sketch of repair

<b>Factors which may have caused damage</b> 1. Stress concentration due to discontinuous structure. 2. High shear stress in the horizontal stringer.		<b>Notes on repairs</b> See Sketch.

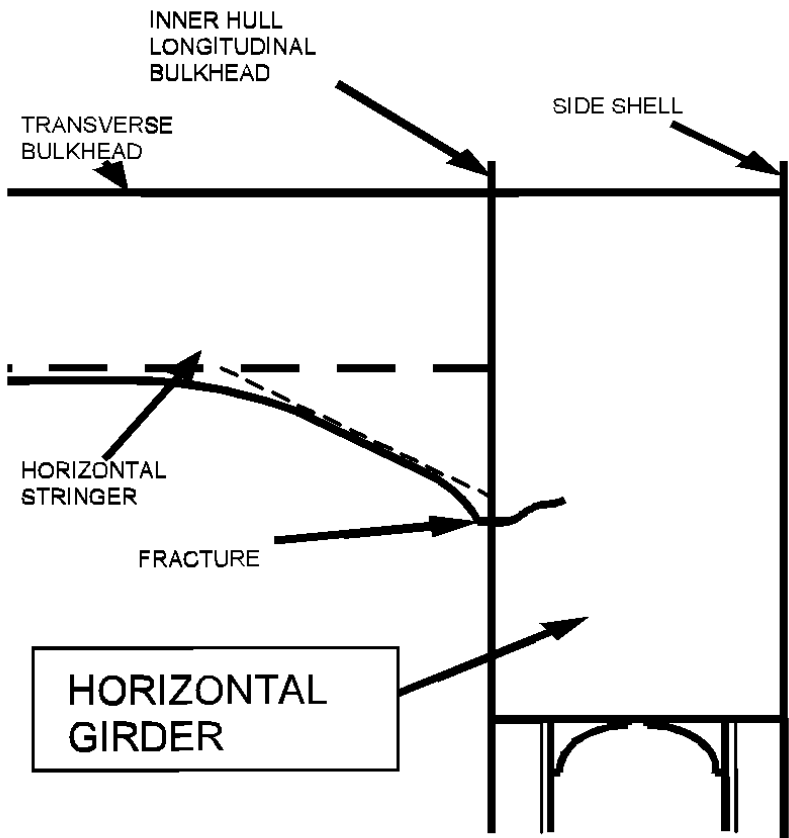
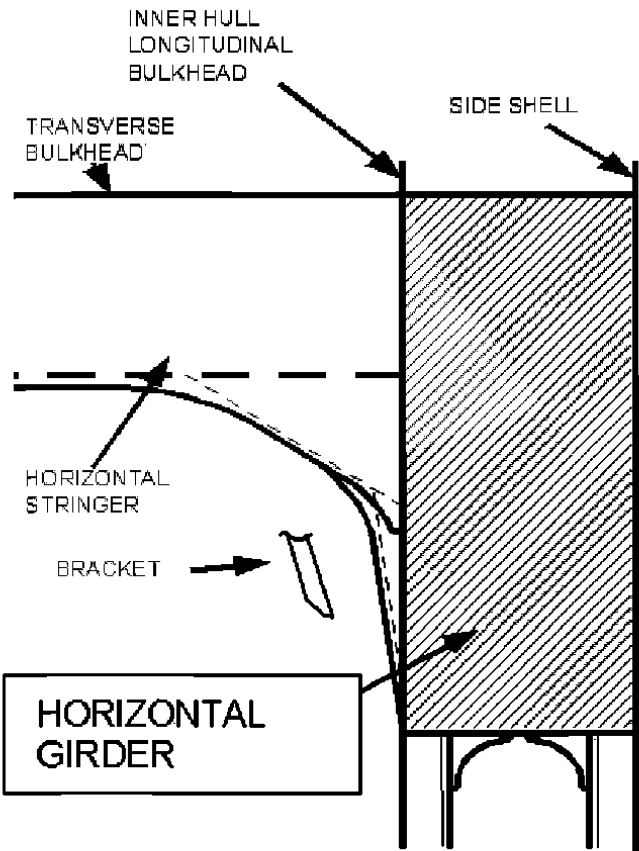
OIL Tankers		Guidelines for Surveys, Assessment and Repair of Hull Structure	
Group 5	Cargo area		Example No.
	Transverse Bulkhead in cargo tank		2
Detail of damage		Horizontal stringer in way of longitudinal BHD cracked	
Sketch of damage		Sketch of repair

Factors which may have caused damage		Notes on repairs	
1. Misalignment between bracket end and side girder in wing tank.		See Sketch.

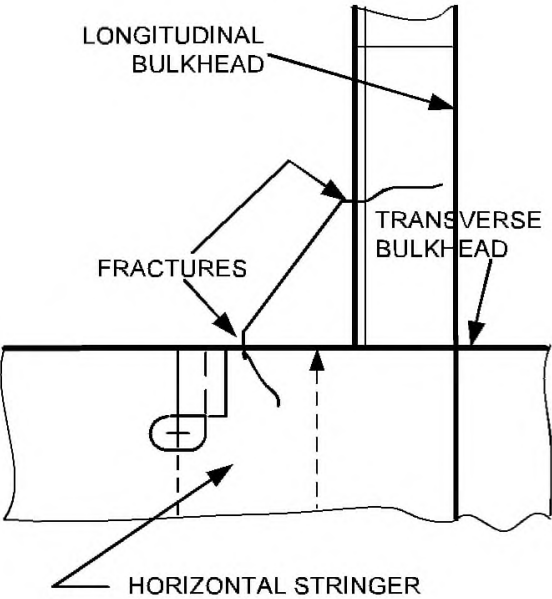
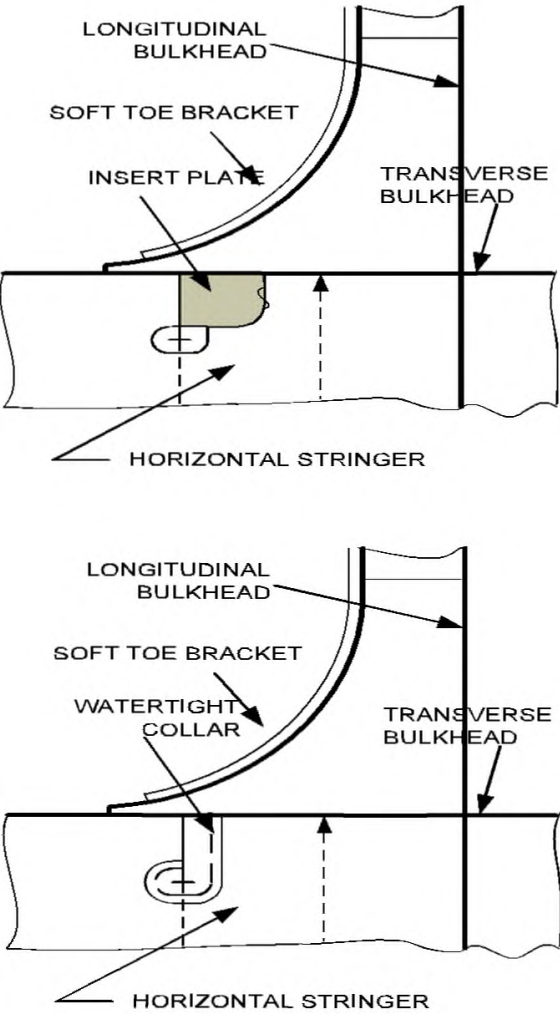
OIL Tankers		Guidelines for Surveys, Assessment and Repair of Hull Structure	
Group 5	Cargo area		Example No.
	Transverse Bulkhead in cargo tank		3
Detail of damage		Connection of longitudinals to horizontal stringers.	
Sketch of damage		Sketch of repair

Factors which may have caused damage		Notes on repairs	
<ol style="list-style-type: none"><li>1. Stress concentration due to inadequate shape of the bracket.</li><li>2. Relative deflection of adjoining transverse web against transverse bulkhead.</li></ol>		See Sketch

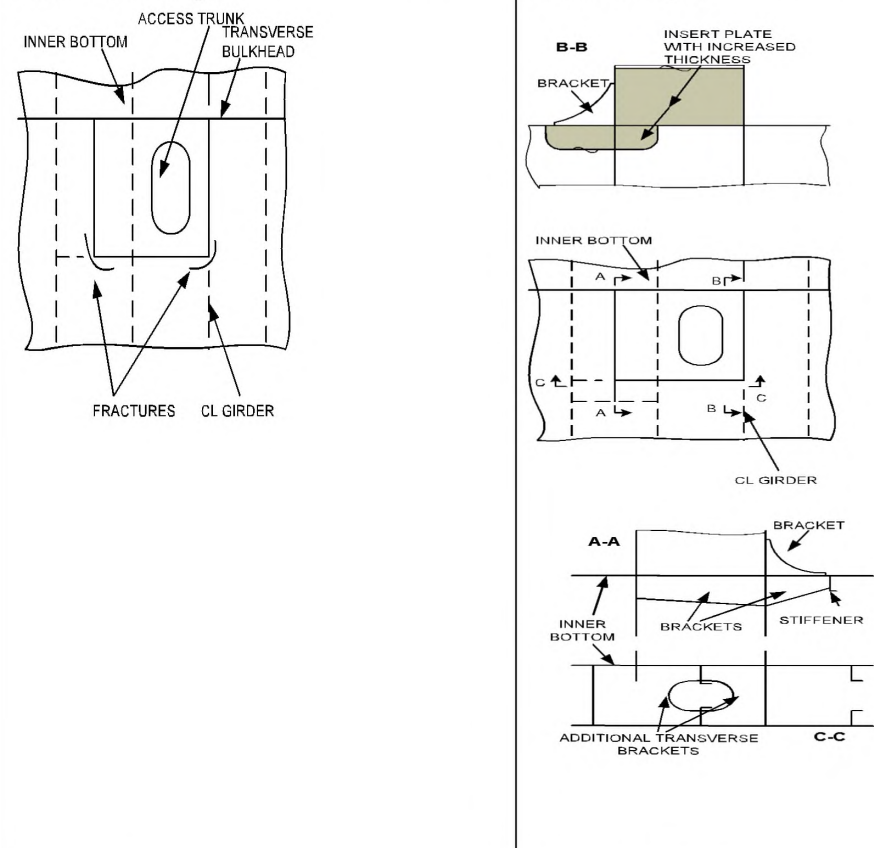
OIL Tankers		Guidelines for Surveys, Assessment and Repair of Hull Structure
Group 5	Cargo area	Example No.
	Transverse Bulkhead in cargo tank	4
Detail of damage	Fractured inner bottom plate at the connection to access trunk wall	
Sketch of damage

Factors which may have caused damage	<ol style="list-style-type: none"> <li>1. Stress concentration at the connection of trunk wall to inner bottom plate.</li> <li>2. Relative deformation between horizontal stringer fitted on transverse bulkhead and inner bottom plate.</li> <li>3. Static and dynamic load of cargo liquid.</li> </ol>	
Notes on repairs	See Sketch.

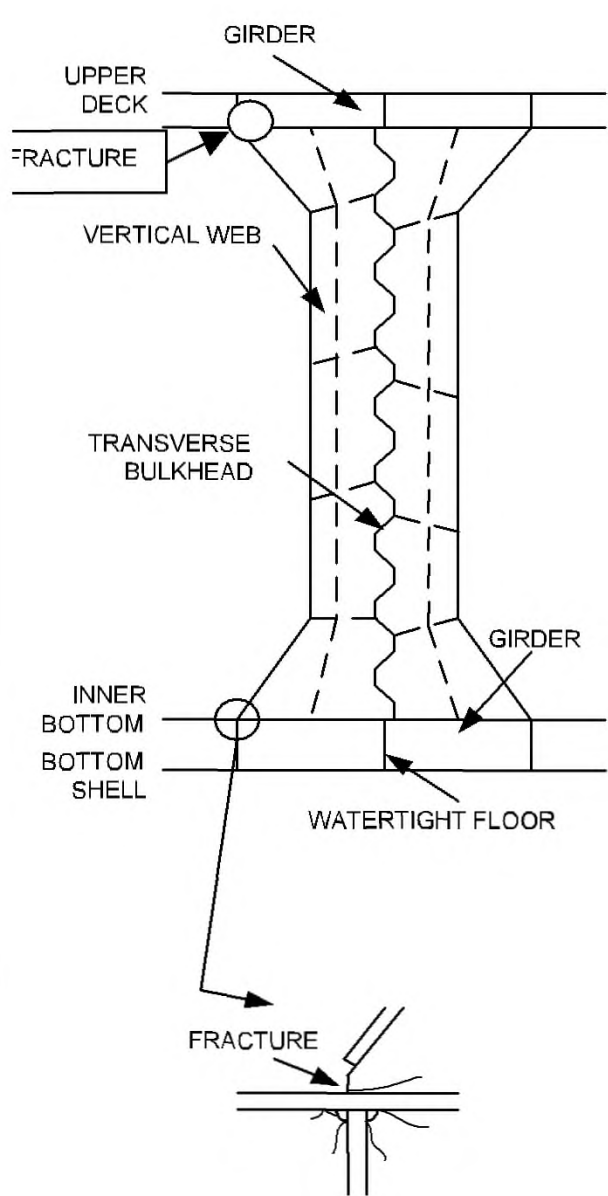
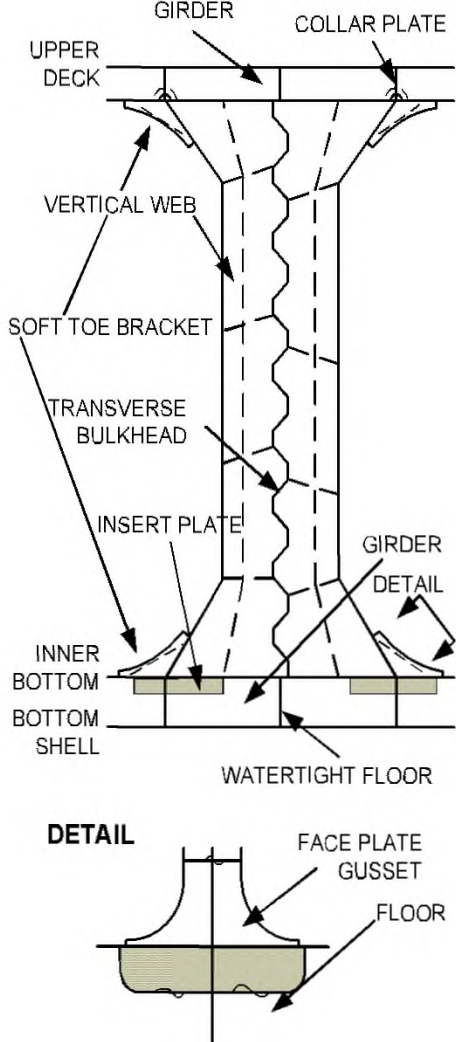
OIL Tankers		Guidelines for Surveys, Assessment and Repair of Hull Structure	
Group 5	Cargo area	Example No.	
	Transverse Bulkhead in cargo tank	5	
Detail of damage		Bulkhead vertical web to deck and inner bottom	
Sketch of damage		Sketch of repair

<b>Factors which may have caused damage</b> 1. Stress concentration at toe of bracket due to sniped face plate and scallop in way.		<b>Notes on repairs</b> See Sketch.

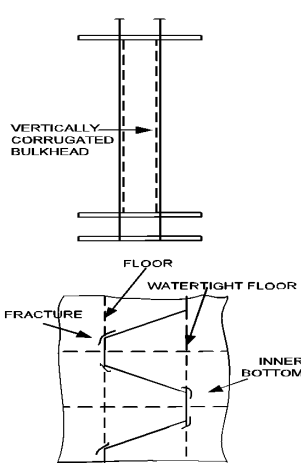
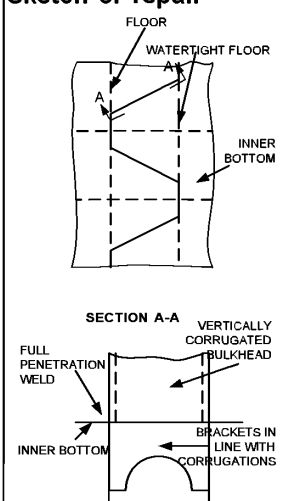
OIL Tankers		Guidelines for Surveys, Assessment and Repair of Hull Structure
Group 5	Cargo area	Example No.
	Transverse Bulkhead in cargo tank	6
Detail of damage	Vertically corrugated bulkhead without stool, connection to deck and inner bottom	
Sketch of damage	<div style="display: flex; justify-content: space-around;"> <div style="text-align: center;">

</div> </div>	
Factors which may have caused damage	<ol style="list-style-type: none"> <li>1. Stress concentration due to unsupported corrugation web.</li> <li>2. High through thickness stress, lamellar tearing.</li> <li>3. Weld details and dimensions.</li> <li>4. Misalignment between face of corrugation and floor underneath.</li> <li>5. Cut-outs and scallops or air holes increasing the stress in the floor.</li> <li>6. Insufficient through thickness properties of inner bottom plate.</li> </ol>

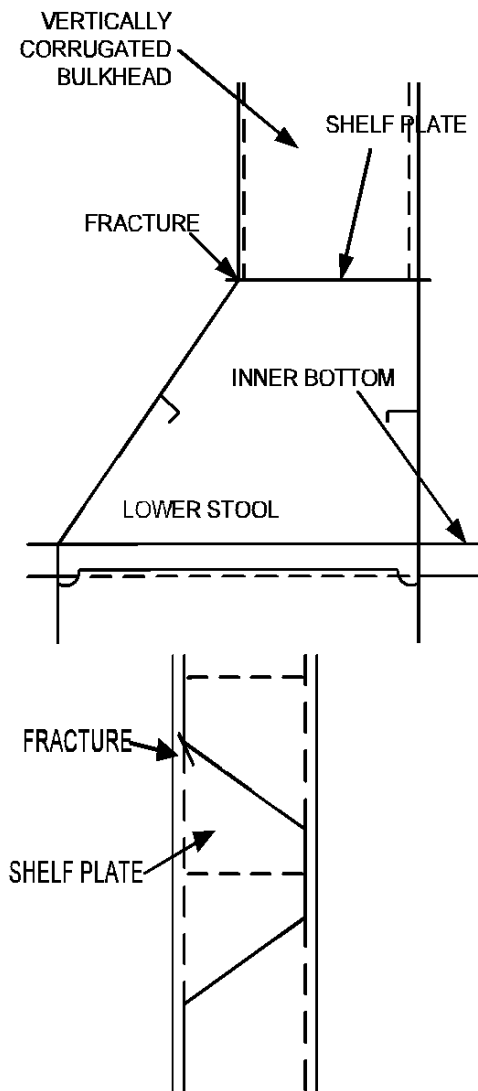
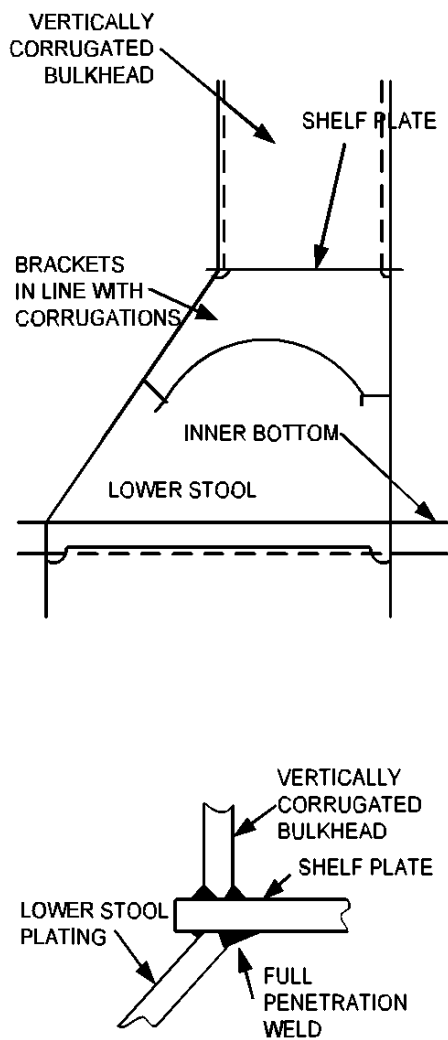
OIL Tankers		Guidelines for Surveys, Assessment and Repair of Hull Structure	
Group 5	Cargo area	Example No.	
	Transverse Bulkhead in cargo tank	7	
Detail of damage		Fracture at connection of vertically corrugated transverse bulkhead with stool to shelf plate and lower stool plate.	
Sketch of damage		Sketch of repair

<b>Factors which may have caused damage</b> <ol style="list-style-type: none"> <li>1. Stress concentration due to unsupported corrugation web.</li> <li>2. High through thickness stress, lamellar tearing.</li> <li>3. Weld details and dimensions.</li> <li>4. Misalignment.</li> <li>5. Insufficient thickness of stool side plating in relation to corrugation flange thickness.</li> </ol>		<b>Notes on repairs</b> See Sketch.

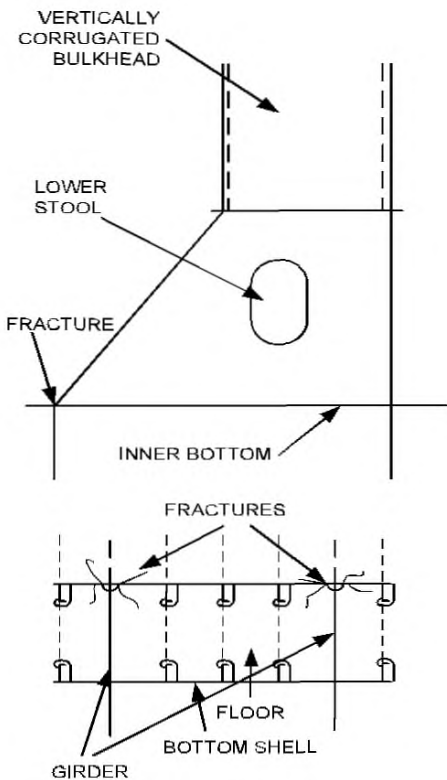
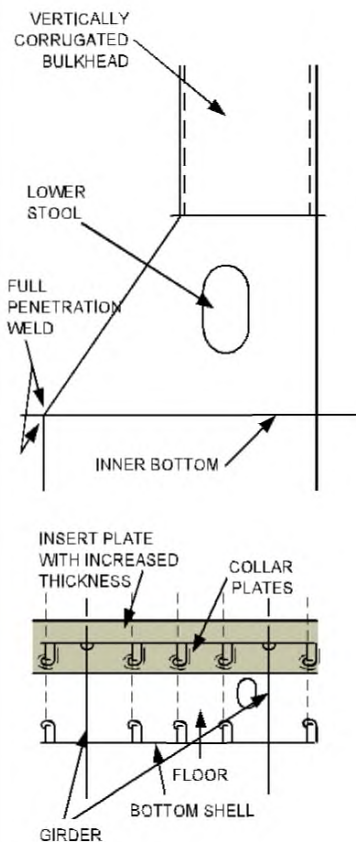
OIL Tankers		Guidelines for Surveys, Assessment and Repair of Hull Structure	
Group 5	Cargo area	Example No.	
	Transverse Bulkhead in cargo tank	8	
Detail of damage		Fracture at connection of lower stool plate to inner bottom tank. Lower stool plate connected to vertically corrugated transverse bulkhead.	
Sketch of damage		Sketch of repair

<b>Factors which may have caused damage</b> <ol style="list-style-type: none"> <li>1. Misalignment between stool side plating and floor and/or stool webs and girders of double bottom.</li> <li>2. Insufficient thickness of floor compared to stool thickness.</li> <li>3. Scallops, cut-outs, air hole reducing the connecting area too much.</li> <li>4. Weld details and dimensions.</li> <li>5. Lamellar tearing of inner bottom plating.</li> </ol>		<b>Notes on repairs</b> See Sketch.

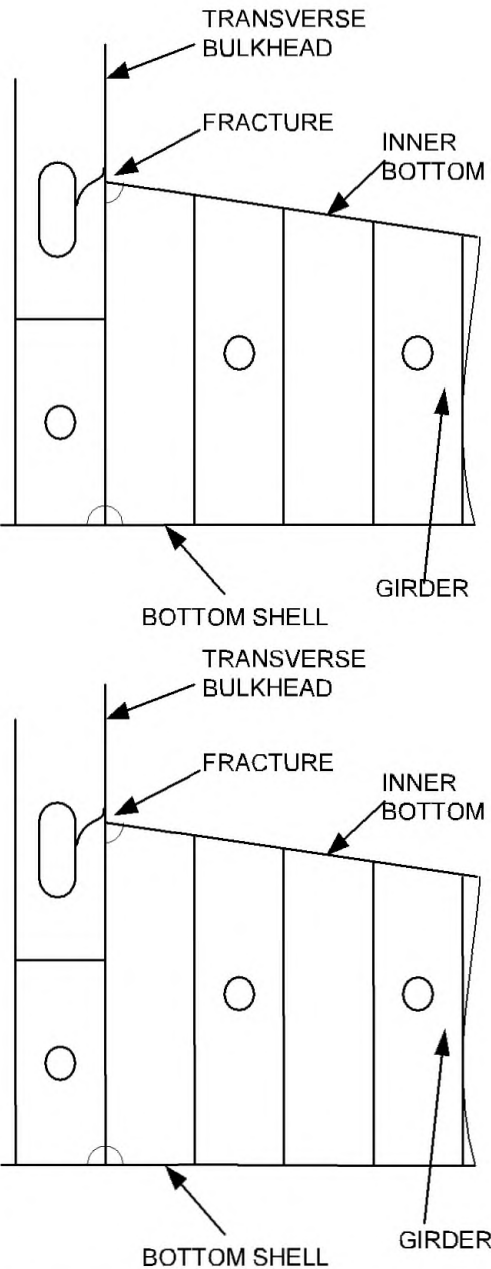
OIL Tankers		Guidelines for Surveys, Assessment and Repair of Hull Structure	
Group 5	Cargo area	Example No.	
	Transverse Bulkhead in cargo tank	9	
Detail of damage		Fracture at connection of transverse bulkhead to knuckle inner bottom/girder	
<b>Sketch of damage</b>

<b>Factors which may have caused damage</b> 1. High stress concentration. 2. Discontinuity of structural members at knuckle joint.		<b>Notes on repairs</b> See Sketch.

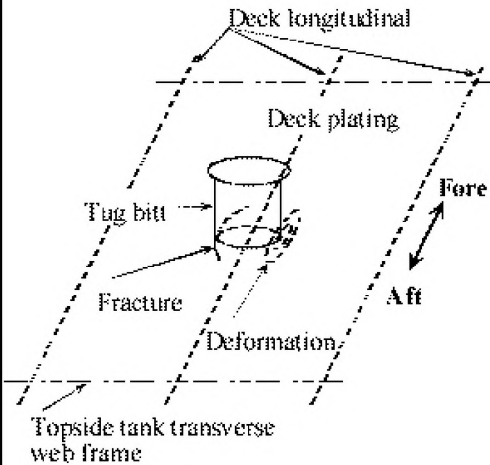
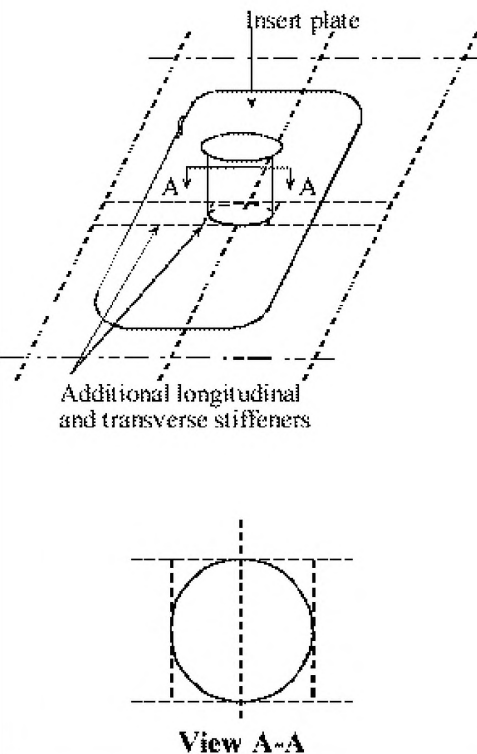
OIL Tankers		Guidelines for Surveys, Assessment and Repair of Hull Structure
Group 6	Deck Structure	Example No. 1
Detail of damage		Deformed and fractured deck plating around tug bitt
Sketch of damage		Sketch of repair

Factors which may have caused damage		Notes on repairs
1. Insufficient strength		1. Fractured/deformed deck plating should be cropped and part renewed. 2. Reinforcement by stiffeners should be considered.

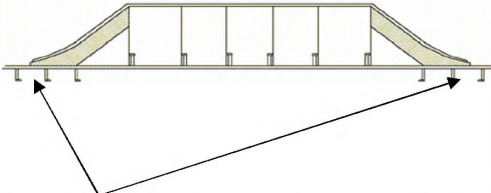
OIL Tankers		Guidelines for Surveys, Assessment and Repair of Hull Structure	
Group 6	Deck Structure	Example No.	
		2	
Detail of damage		Fracture at ends of deck transverse	
Sketch of damage		Sketch of repair

<p>Under deck transverse is to be described as mentioned in the following "Note on repairs". "Increase bracket length to end between under deck longitudinals and align end to under deck transverse."</p>	
<b>Factors which may have caused damage</b> 1. High stress due to toes bracket ending at cut out for longitudinal.		<b>Notes on repairs</b> See Sketch. 1. Increase bracket length to end between underdeck longitudinals and align end to underdeck transverse. 2. Install fitted collar rather than lapped collar. 3. Insert deck plating if fracture extends into deck.

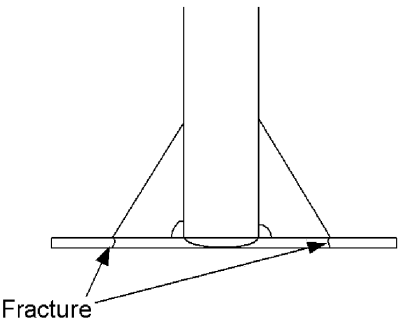
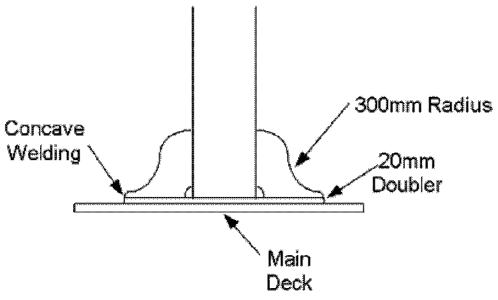
OIL Tankers		Guidelines for Surveys, Assessment and Repair of Hull Structure	
Group 6	Deck Structure	Example No.	
		5	
Detail of damage		Fractured deck plating in way of deck pipe support stanchions (midships)	
Sketch of damage		Sketch of repair

<b>Factors which may have caused damage</b> 1. Stanchions experience more severe relative displacements from hull girder bending.		<b>Notes on repairs</b> See Sketch.

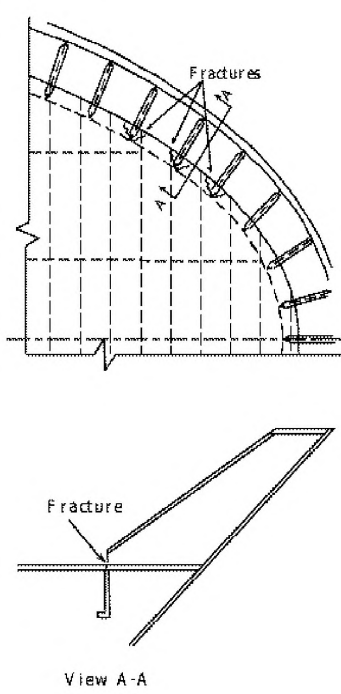
OIL Tankers		Guidelines for Surveys, Assessment and Repair of Hull Structure
Group 7	Fore region	Example No.
Area 1	Forecastle	1
Detail of damage		Fracture in forecastle deck plating at bulwark
<b>Sketch of damage</b>

<b>Factors which may have caused damage</b> 1. Bow Flare effect in heavy weather. 2. Stress concentration due to poor design.		<b>Notes on repairs</b> 1. Fractured deck plating should be cropped and renewed. 2. Bracket in line with the bulwark stay to be fitted to reduce stress concentration.

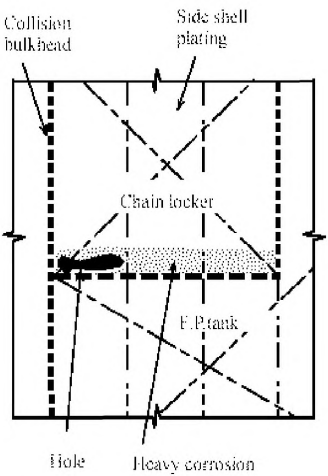
OIL Tankers		Guidelines for Surveys, Assessment and Repair of Hull Structure
Group 7	Fore region	Example No.
Area 1	Chain locker	2
Detail of damage		Fractures in side shell plating in way of chain locker
Sketch of damage		Sketch of repair

<p>Collision bulkhead</p> <p>Side shell plating</p> <p>Chain locker</p> <p>F. Plank</p> <p>Hole</p> <p>Heavy corrosion</p>

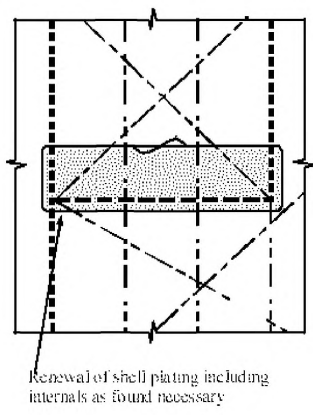
<p>Renewal of shell plating including internals as found necessary</p>
<b>Factors which may have caused damage</b> 1. Heavy corrosion in region where mud is accumulated.		<b>Notes on repairs</b> 1. Corroded plating should be cropped and renewed. 2. Protective coating should be applied.

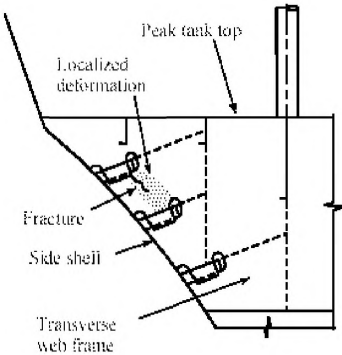
OIL Tankers		Guidelines for Surveys, Assessment and Repair of Hull Structure
Group 7	Fore region	Example No.
Area 1	Forepeak ballast tank	3
Detail of damage	Fractures and deformation of bow transverse webs in way of cut-outs for side longitudinals	
<b>Sketch of damage</b>

<b>Factors which may have caused damage</b> 1. Localized material wastage in way of coating failure at cut-outs and sharp edges due to working of the structure. 2. Dynamic seaway loading in way of bow flare.		<b>Notes on repairs</b> 1. Sufficient panel strength to be provided to absorb the dynamic loads enhanced by bow flare shape.

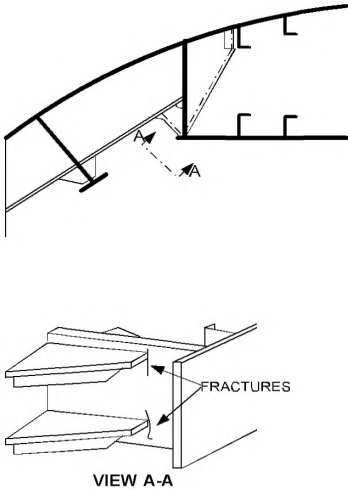
OIL Tankers		Guidelines for Surveys, Assessment and Repair of Hull Structure
Group 7	Fore region	Example No.
Area 1	Forepeak ballast tank	4
Detail of damage	Fractured vertical web at the longitudinal stiffener ending in way of the parabolic bow structure.	
<b>Sketch of damage</b>

<b>Factors which may have caused damage</b> <ol style="list-style-type: none"> <li>1. Stress concentrations at bracket ending due to inadequate support at bracket toes in way of connection to web frame members.</li> <li>2. Localised thinning in way of coating failure at bracket endings due to flexing of the structure.</li> <li>3. Dynamic seaway loadings at bow causing flexing at bracket endings.</li> </ol>		<b>Notes on repairs</b> See Sketch.

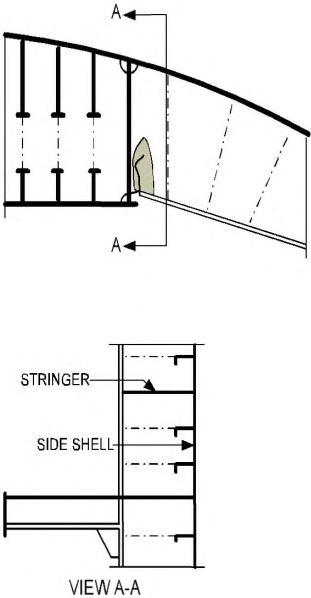
OIL Tankers		Guidelines for Surveys, Assessment and Repair of Hull Structure
Group 7	Fore region	Example No.
Area 1	Forepeak ballast tank	5
Detail of damage	Fractured stringer end connection in way of the parabolic bow structure	
<b>Sketch of damage</b>

<b>Factors which may have caused damage</b> <ol style="list-style-type: none"> <li>1. High stress concentration of stringer to stiff girder/deep web intersection due to discontinuity of faceplate.</li> <li>2. Localised thinning in way of coating failure at stringer connection due to flexing of the structure.</li> <li>3. Dynamic seaway loadings at bow causing flexing in way of detail.</li> </ol>		<b>Notes on repairs</b> See Sketch.

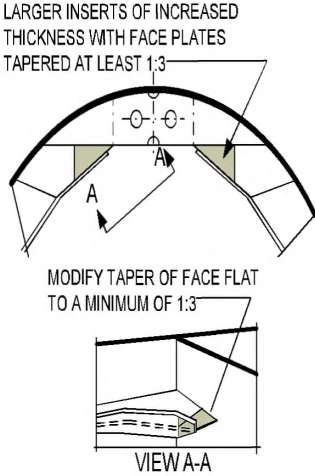
<b>Sketch of repair</b>

OIL Tankers		Guidelines for Surveys, Assessment and Repair of Hull Structure
Group 7	Fore region	Example No.
Area 1	Forepeak ballast tank	6
Detail of damage	Fracture at end of longitudinal at bow structure.	
<b>Sketch of damage</b>

<b>Factors which may have caused damage</b> <ol style="list-style-type: none"> <li>1. Inadequate brackets forming the longitudinal endings at bow structure.</li> <li>2. Localised thinning in way of coating failure at longitudinal endings due to flexing of the structure.</li> <li>3. Dynamic seaway loadings at bow causing flexing at longitudinal endings.</li> </ol>		<b>Notes on repairs</b> See Sketch.

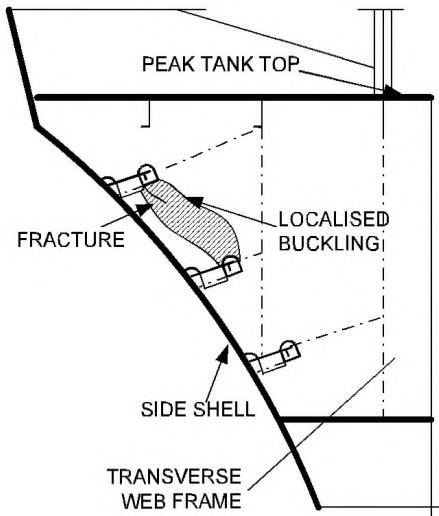
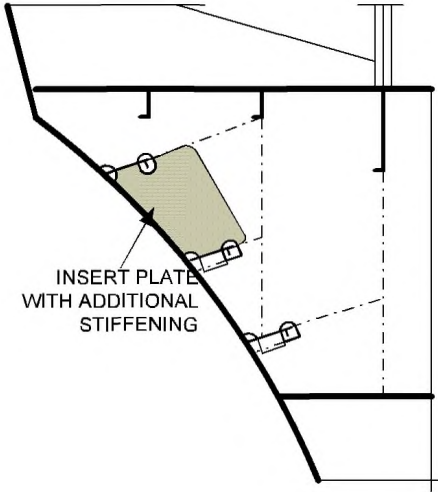
OIL Tankers		Guidelines for Surveys, Assessment and Repair of Hull Structure	
Group 7	Fore region	Example No.	
Area 1	Forepeak ballast tank	7	
Detail of damage		Fracture and buckle of bow transverse web frame in way of longitudinal cut-outs.	
Sketch of damage		Sketch of repair

<b>Factors which may have caused damage</b> <ol style="list-style-type: none"> <li>1. Localised thinning in way of coating failure at cut-outs and sharp edges due to working of the structure.</li> <li>2. Dynamic seaway loadings in way of bow flare.</li> </ol>		<b>Notes on repairs</b> See Sketch.

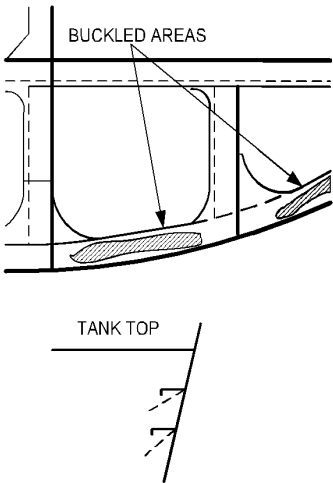
OIL Tankers		Guidelines for Surveys, Assessment and Repair of Hull Structure	
Group 7	Fore region		Example No.
Area 1	Fore peak ballast tank		8
Detail of damage		Buckled and tripped breasthooks	
Sketch of damage		Sketch of repair

<p>The sketch shows a cross-section of the fore peak ballast tank. The top structure is labeled 'BUCKLED AREAS' with arrows pointing to the deformed sections. Below the tank, the 'TANK TOP' is indicated with a line pointing to the bottom structure.</p>

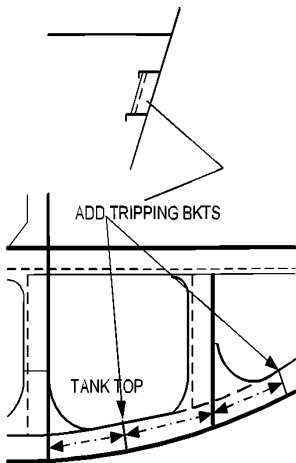
<p>The sketch shows the same cross-section as the damage sketch, but with repairs. 'ADD TRIPPING BKTS' (brackets) are shown being added to the top structure. The 'TANK TOP' is also labeled, pointing to the bottom structure.</p>	
<b>Factors which may have caused damage</b> 1. Bow impact load. 2. Low buckling resistance.		<b>Notes on repairs</b> See Sketch.

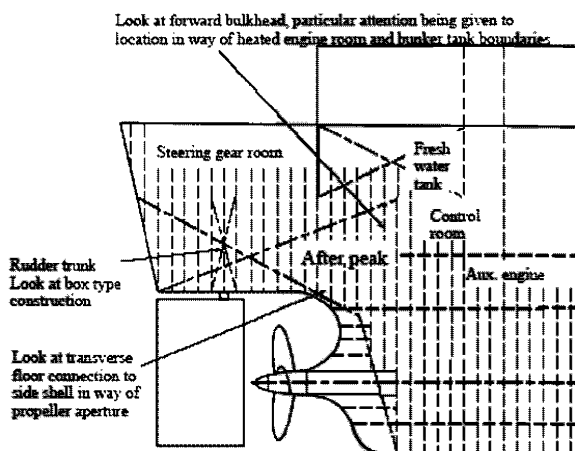
**2.3.1** Fractures in weld at floor connections and other locations in the aft peak tank and rudder trunk space can normally only be found by close-up survey.

**2.3.2** The structure supporting the rudder carrier may fracture and/or deform due to excessive load on the rudder. Bolts connecting the rudder carrier to the steering gear flat may also suffer damage under such load.

Figure 1 Aft end structure - Potential problem areas

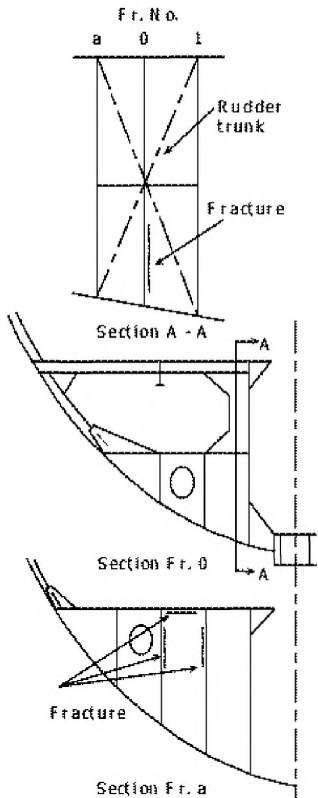
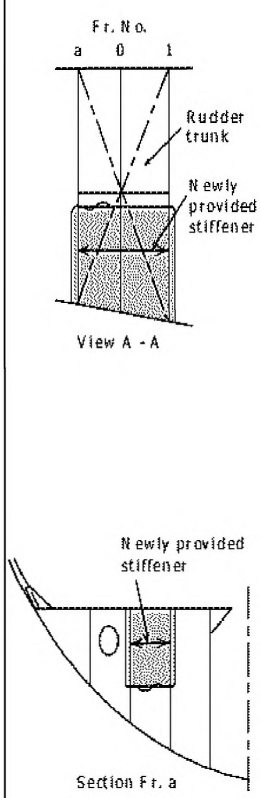
OIL Tankers		Guidelines for Surveys, Assessment and Repair of Hull Structure	
Group 7	Aft region		Example No.
Area 2	Aft peak ballast tank		9
Detail of damage		Fractures in bulkhead in way of rudder trunk	
<b>Sketch of damage</b>

<b>Factors which may have caused damage</b> 1. Vibration.		<b>Notes on repairs</b> 1. The fractured plating should be cropped and renewed. 2. Natural frequency of the plate between stiffeners should be changed, e.g. reinforcement by additional stiffeners.

3.3.2 In order to prevent recurrence of damages suspected to be caused by main engine or propeller excited vibration, the cause of the vibration should be ascertained and additional reinforcements provided as found necessary (See Examples 9 and 10).

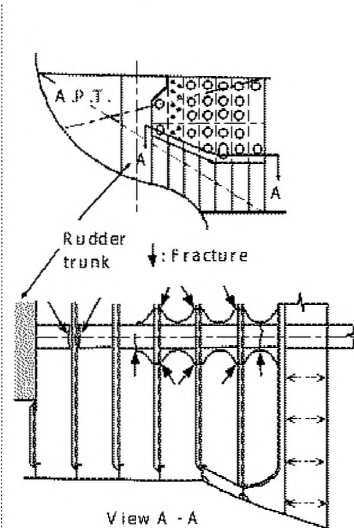
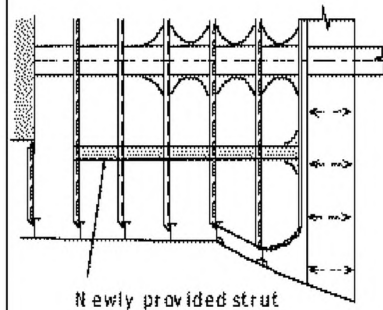
OIL Tankers		Guidelines for Surveys, Assessment and Repair of Hull Structure	
Group 7	Aft region	Example No.	
Area 2	Aft peak ballast tank	10	
Detail of damage		Fractures at the connection of floors and girders/side brackets	
Sketch of damage		Sketch of repair

<p>View A - A</p>

<p>Newly provided strut</p>	
Factors which may have caused damage		Notes on repairs	
1. Vibration.		1. The fractured plating should be cropped and renewed. 2. Natural frequency of the panel should be changed, e.g. reinforcement by additional strut.

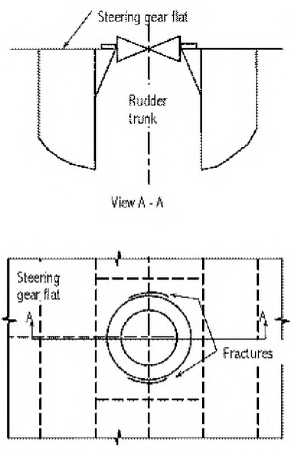
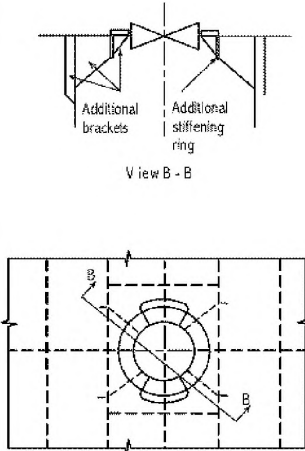
OIL Tankers		Guidelines for Surveys, Assessment and Repair of Hull Structure	
Group 7	Aft region	Example No.	
Area 2	Machinery space outside Engine room	11	
Detail of damage	Fractures in flat where rudder carrier is installed in steering gear room		
Sketch of damage		Sketch of repair

Factors which may have caused damage		Notes on repairs	
1. Inadequate design.		1. Fractured plating should be cropped and renewed. 2. Additional brackets and stiffening ring should be fitted for reinforcement.

**3.3.4** Fractured structure which supports rudder carrier is to be cropped, and renewed, and may have to be reinforced (See Examples 11 and 12).
