**РОССИЙСКИЙ МОРСКОЙ РЕГИСТР СУДОХОДСТВА**  
**RUSSIAN MARITIME REGISTER OF SHIPPING**

**ПРИЛОЖЕНИЕ К ПРАВИЛАМ**  
**РОССИЙСКОГО МОРСКОГО РЕГИСТРА СУДОХОДСТВА**  
**УНИФИЦИРОВАННЫЕ ИНТЕРПРЕТАЦИИ**  
**И РЕКОМЕНДАЦИИ**  
**МЕЖДУНАРОДНОЙ АССОЦИАЦИИ**  
**КЛАССИФИКАЦИОННЫХ ОБЩЕСТВ**

**SUPPLEMENT TO RULES**  
**OF RUSSIAN MARITIME REGISTER OF SHIPPING**  
**IACS UNIFIED INTERPRETATIONS**  
**AND RECOMMENDATIONS**

НД № 2-020101-085-R-E

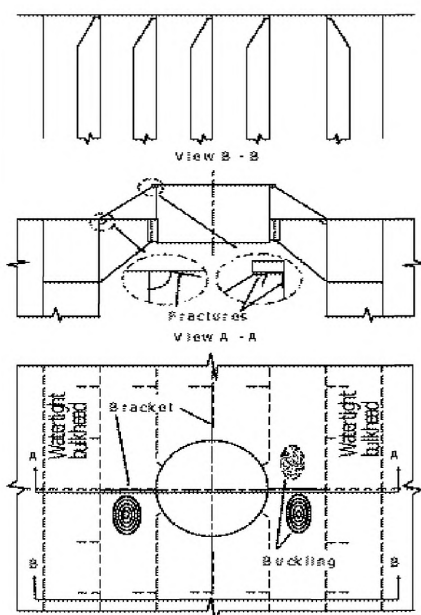
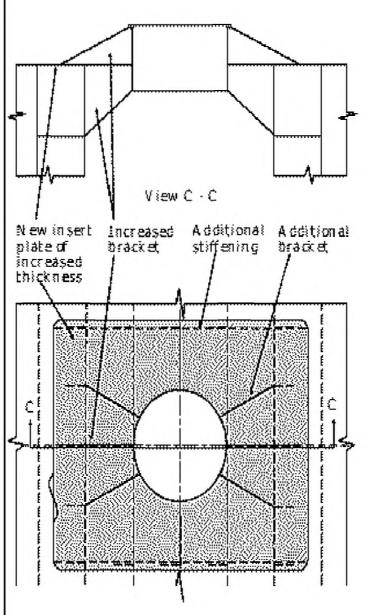
OIL Tankers		Guidelines for Surveys, Assessment and Repair of Hull Structure
Group 7	Aft region	Example No.
Area 2	Machinery space outside engine room	12
Detail of damage	Fractures in steering gear foundation brackets and deformed deck plate	
Sketch of damage		Sketch of repair

<b>Factors which may have caused damage</b> <ol style="list-style-type: none"> <li>1. Insufficient deck strengthening (missing base plate).</li> <li>2. Insufficient strengthening of steering gear foundation.</li> <li>3. Bolts of steering gear were not sufficiently pre-loaded.</li> </ol>		<b>Notes on repairs</b> <ol style="list-style-type: none"> <li>1. New insert base plate of increased plate thickness.</li> <li>2. Additional longitudinal stiffening at base plate edges.</li> <li>3. Additional foundation brackets above and under deck (star configuration).</li> </ol>

**3.3.4** Fractured structure which supports rudder carrier is to be cropped, and renewed, and may have to be reinforced (See Examples 11 and 12).

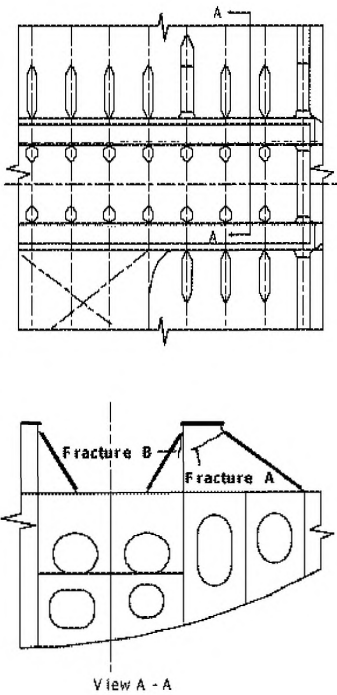
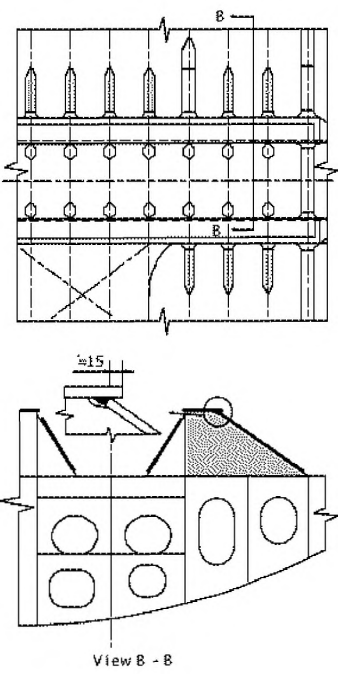
OIL Tankers		Guidelines for Surveys, Assessment and Repair of Hull Structure
Group 8	Machinery and accommodation spaces	Example No.
Area 1	Engine room	1
Detail of damage		Fractures in brackets at main engine foundation
Sketch of damage		Sketch of repair

<p>View A - A</p>

<p>View B - B</p>
<b>Factors which may have caused damage</b> <ol style="list-style-type: none"> <li>1. Vibration of main engine.</li> <li>2. Insufficient strength of brackets at main engine foundation.</li> <li>3. Insufficient pre-load of the bolts.</li> </ol>		<b>Notes on repairs</b> <ol style="list-style-type: none"> <li>1. Fractures may be veed-out and rewelded.</li> <li>2. New modified brackets at main engine foundation.</li> <li>3. Or insert pieces and additional flanges to increase section modulus of the brackets.</li> </ol>

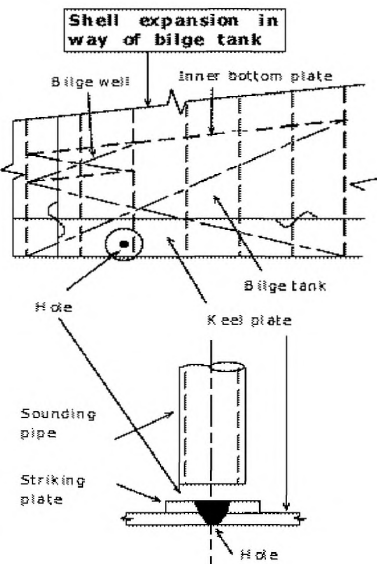
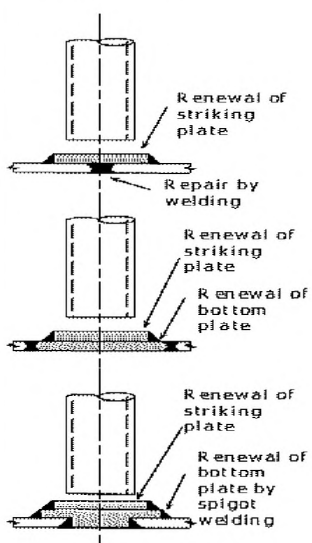
OIL Tankers		Guidelines for Surveys, Assessment and Repair of Hull Structure	
Group 8	Machinery and accommodation spaces		Example No.
Area 1	Engine room		2
Detail of damage		Corrosion in bottom plating under sounding pipe in way of bilge storage tank in engine room	
<b>Sketch of damage</b>

<b>Sketch of repair</b>

<b>Factors which may have caused damage</b> 1. Heavy corrosion of bottom plating under sounding pipe.		<b>Notes on repairs</b> 1. Corroded striking plating should be renewed. 2. Bottom plate should be repaired depending on the condition of corrosion.  <b>(Note):</b> Repair by spigot welding can be applied to the structure only when the stress level is considerably low. Generally this procedure cannot be applied to the repair of bottom plating of ballast tanks in cargo tank region.

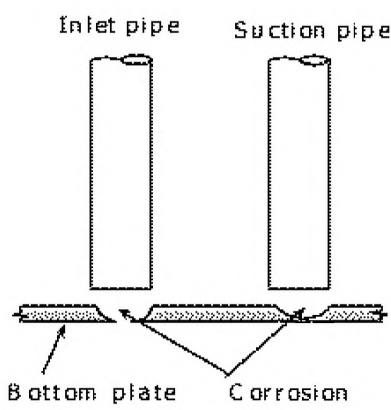
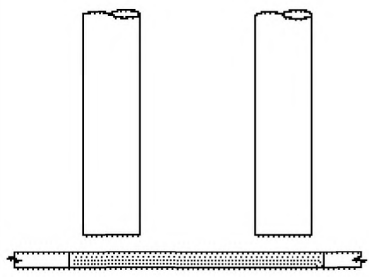
OIL Tankers		Guidelines for Surveys, Assessment and Repair of Hull Structure	
Group 8	Machinery and accommodation spaces		Example No.
Area 1	Engine room		3
Detail of damage		Corrosion in bottom plating under inlet/suction/pipe in way of bilge tank in engine room	
<b>Sketch of damage</b>

<b>Sketch of repair</b>

<b>Factors which may have caused damage</b> 1. Heavy corrosion of bottom plating under the inlet/suction pipe.		<b>Notes on repairs</b> 1. Corroded bottom plate is to be cropped and part renewed. Thicker plate is preferable. 2. Replacement of pipe end by enlarged conical opening (similar to suction head in ballast tank) is preferable.

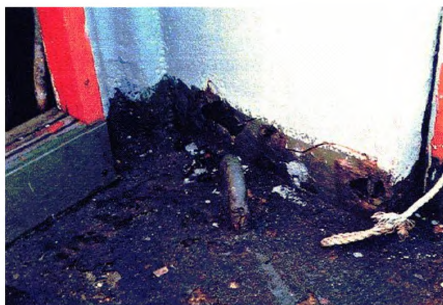
**Photograph 1 Corroded accommodation house side structure**

Severe corrosion may be found in exposed deck plating and deck house side structure adjacent to the deck plating where water is liable to accumulate (See **Photograph 1**). Corrosion may also be found in accommodation bulkheads around cut-out for fittings, such as doors, side scuttles, ventilators, etc., where proper maintenance of the area is relatively difficult. Deterioration of the bulkheads including fittings may impair the integrity of weathertightness.

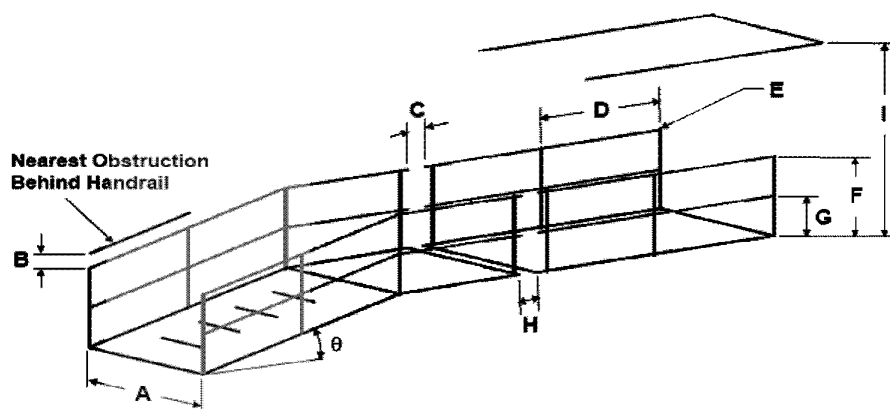
- 1 Toeboard omitted for clarity
- 2 The walkway width may be diminished to ≥ 500 mm around a walkway structure web frames

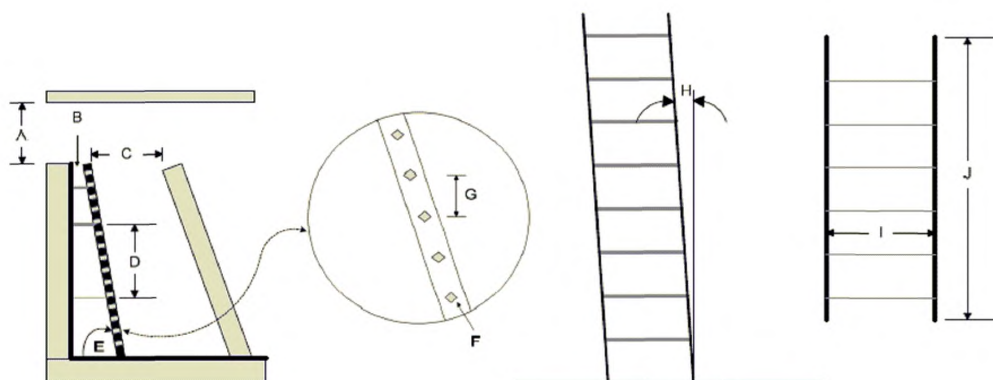
**Figure 2 Vertical Ladders (General Criteria)**

<i>Dimension</i>		<i>Recommendation</i>
A	Overhead Clearance	2130 mm (84.0 in.)
B	Ladder distance (gap accommodating toe space) from surface (at 90 degrees)	≥ 175 mm (7.0 in.) ≤ 200 mm (8.0 in.)
C	Horizontal Clearance (from ladder face and obstacles)	≥ 750 mm (29.5 in.) or ≥ 600 mm (23.5 in.) (in way of openings)
D	Distance between ladder attachments / securing devices	≤ 2.5 m (8.0 ft)
E	Ladder angle of inclination from the horizontal	80 to 90 degrees
F	Rung Design – (Can be round or square bar; where square bar is fitted, orientation should be edge up)	Square bar 25 mm (1.0 in.) x 25 mm (1.0 in.)  Round bar 25 mm (1.0 in.) diameter
G	Distance between ladder rungs (rungs evenly spaced throughout the full run of the ladder)	≥ 275 mm (11.0 in.) ≤ 300 mm (12.0 in.)
H	Skew angle	≤ 2 degrees
I	Stringer separation	400 to 450 mm (16.0 to 18.0 in.)
J	Ladder height: Ladders over 6 m (19.7 ft) require intermediate/linking platforms)	≤ 6.0 m (19.5 ft)

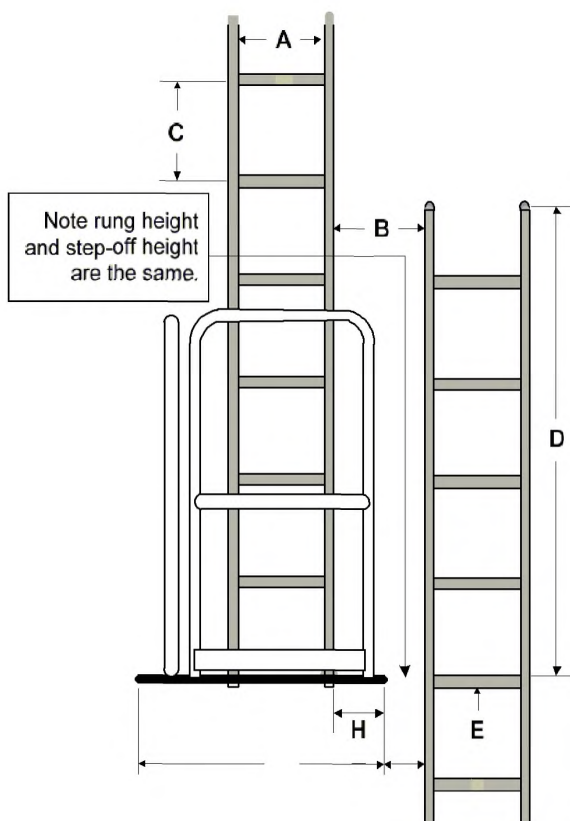
<i>Dimension</i>		<i>Recommendation</i>
A	Stringer separation	400 to 450 mm (16.0 to 18.0 in.)
B	Horizontal separation between two vertical ladders, stringer to stringer	≥ 225 mm (9 in.) ≤ 450 mm (18 in.)
C	Distance between ladder rungs (rungs evenly spaced throughout the full run of the ladder)	≥ 275 mm (11.0 in.) ≤ 300 mm (12.0 in.)
D	Stringer height above landing or intermediate platform	≥ 1350 mm (53.0 in.)
E	Rung design – (Can be round or square bar; where square bar is fitted, orientation should be edge up)	Square bar 22 mm (0.9 in.) x 22 mm (0.9 in.)  Round bar 25 mm (1.0 in.) diameter
F	Horizontal separation between ladder and platform	≥ 150 mm (6.0 in.) ≤ 300 mm (12.0 in.)
G	Landing or intermediate platform width	≥ 925 mm (36.5 in.)
H	Platform ladder to Platform ledge	≥ 75 mm (3.0 in.) ≤ 150 mm (6.0 in.)

\*Note: Left side guardrail of platform omitted for clarity.

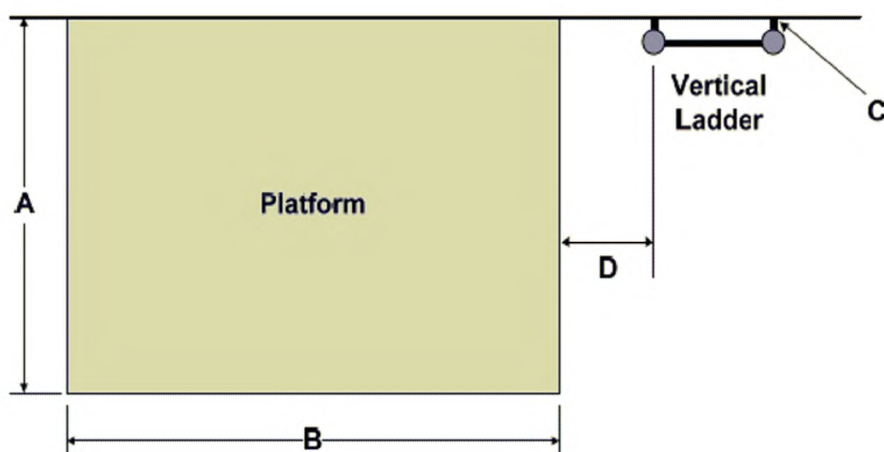
<i>Dimension</i>		<i>Recommendation</i>
A	Platform depth	≥ 750 mm (29.5 in.)
B	Platform width	≥ 925 mm (36.5 in.)
C	Ladder distance from surface	≥ 175 mm (7.0 in.)
D	Horizontal separation between ladder and platform	≥ 150 mm (6.0 in.) and ≤ 300 mm (12.0 in.)

\* Notes: Top view. Guardrails/Handrails not shown.

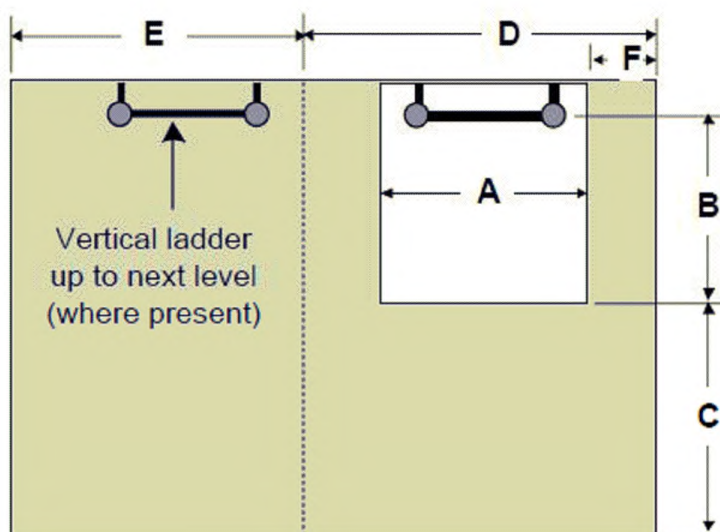
<i>Dimension</i>	<i>Recommendation</i>
A	Vertical ladder opening	≥ 750 mm (29.5 in.)
B	Distance from front of vertical ladder to back of platform opening	≥ 750 mm (29.5 in.)
C	Minimum clear standing area in front of ladder opening – Depth	≥ 750 mm (29.5 in.)
D	Minimum clear standing area in front of ladder opening – Width	≥ 925 mm (36.5 in.)
E	Additional platform width for intermediate landing (where present)	≥ 925 mm (36.5 in.)
F	Horizontal separation between ladder and platform	≥ 150 mm (6.0 in.) and ≤ 300 mm (12.0 in.)

\*Notes: Top view. Guardrails/Handrails not shown.

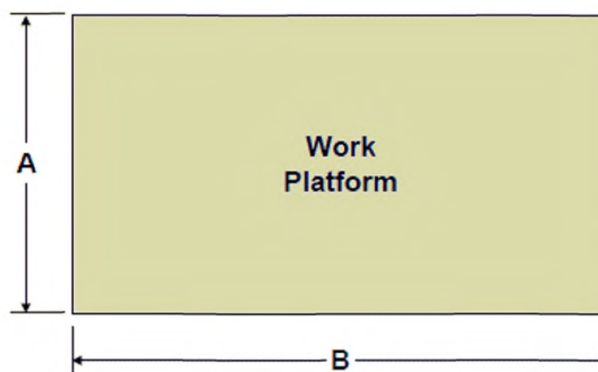
**Figure 6 Work Platform Dimensions**

<i>Dimension</i>		<i>Recommendation</i>
A	Work platform width	≥ 750 mm (29.5 in.)
	Work platform width (if used for standing only)	≥ 380 mm (15.0 in.)
B	Work platform length	≥ 925 mm (37.0 in.)
	Work platform length (if used for standing only)	≥ 450 mm (18.0 in.)

In addition to the recommendations for Work Platforms presented in Section 4.6 Access & Egress Design, the following recommended dimensions relating to the design of Work Platforms are presented in Figure 6 'Work Platform Dimensions'.
