**ПРИЛОЖЕНИЕ К ПРАВИЛАМ И РУКОВОДСТВАМ
РОССИЙСКОГО МОРСКОГО РЕГИСТРА СУДОХОДСТВА**

**SUPPLEMENT TO RULES AND GUIDELINES
OF RUSSIAN MARITIME REGISTER OF SHIPPING**

GENERAL DRY CARGO SHIPS

Guidelines for
Surveys, Assessment and Repair
of Hull Structure

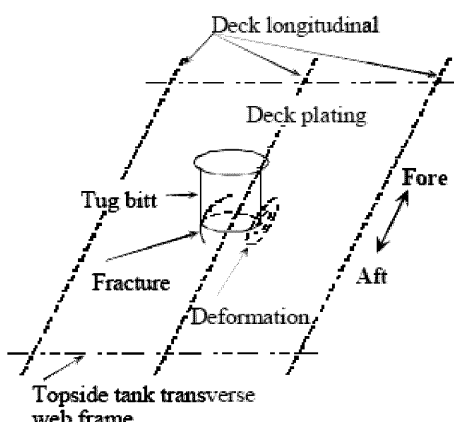
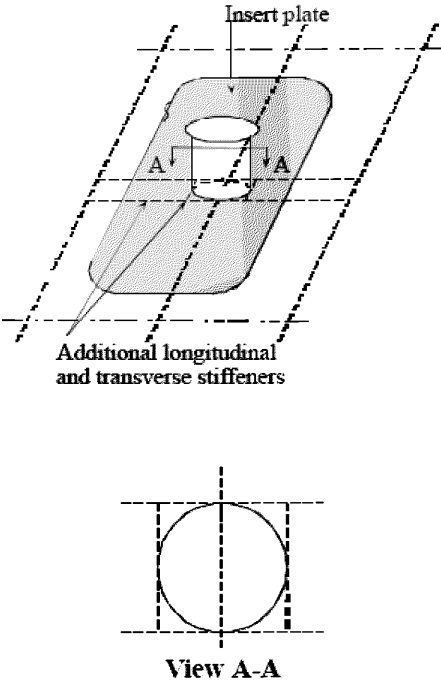
GENERAL DRY CARGO SHIPS		Guidelines for Surveys, Assessment and Repair of Hull Structure
Part 1	Cargo hold region	Example No.
Area 1	Upper deck structure	3-d
Detail of damage		Deformed and fractured deck plating around tug bitt
Sketch of damage		Sketch of repair

Notes on possible cause of damage		Notes on repairs
1. <u>Insufficient strength.</u>		1. <u>Fractured/deformed deck plating should be cropped and part renewed.</u> 2. <u>Reinforcement by stiffeners should be considered.</u>

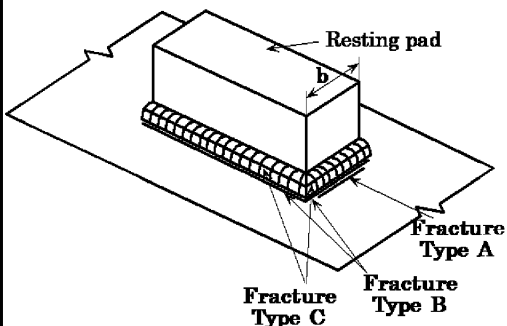
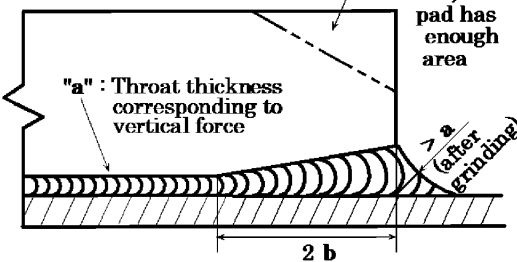
GENERAL DRY CARGO SHIPS		Guidelines for Surveys, Assessment and Repair of Hull Structure
Part 1	Cargo hold region	Example No.
Area 1	Upper deck structure	8
Detail of damage Fractures in hatch coaming top plate around resting pad		
Sketch of damage		Sketch of repair

<p>Fracture Type A: Starting in way of the undercut or HAZ of the transverse fillet weld and propagating in the top plating.</p> <p>Fracture Type B: Starting in way of the undercut or HAZ of the longitudinal fillet weld and propagating in the top plating.</p> <p>Fracture Type C: Starting and propagating in fillet weld</p>		<p>Repair for "Fracture Type A" Note: Cut, if the pad has enough area</p>

<p>Repair for "Fracture Type B"</p>

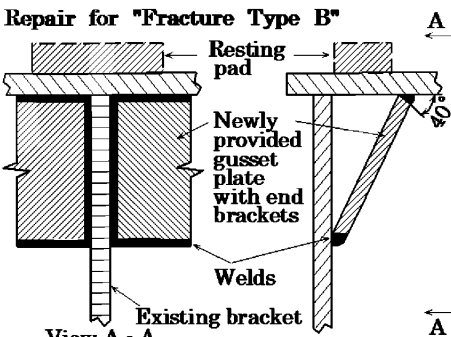
Notes on possible cause of damage		Notes on repairs
<ol style="list-style-type: none"> Fracture Type A: Inappropriate transition from the hatch coaming top plating to the resting pad in respect to longitudinal stresses. Fracture Type B: Insufficient support of the resting pad below the top plating. Fracture Type C: Insufficient throat thickness of the fillet weld in relation to the vertical forces. 		<ol style="list-style-type: none"> Fracture Type A: Modification of the transverse fillet weld according to the sketch; in some cases smoothing of the transition by grinding is acceptable. Fracture Type B: Strengthening of the structures below the top plating according to the sketch. Fracture Type C: Increasing the throat thickness corresponding to the acting vertical forces.

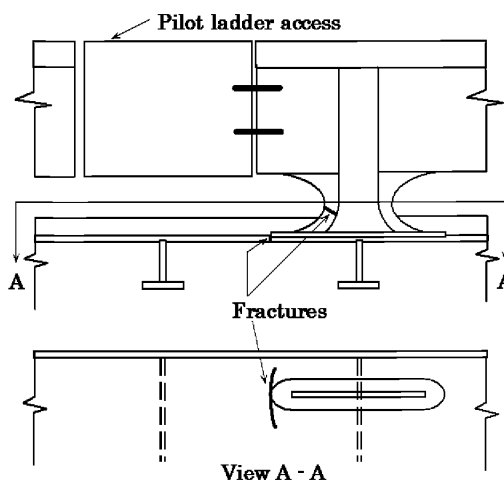
GENERAL DRY CARGO SHIPS		Guidelines for Surveys, Assessment and Repair of Hull Structure
Part 1	Cargo hold region	Example No.
Area 1	Upper deck structure	9
Detail of damage Fracture in deck plating at the pilot ladder access of bulwarks		
Sketch of damage		Sketch of repair

<p>Pilot ladder access</p> <p>Fractures</p> <p>View A - A</p>

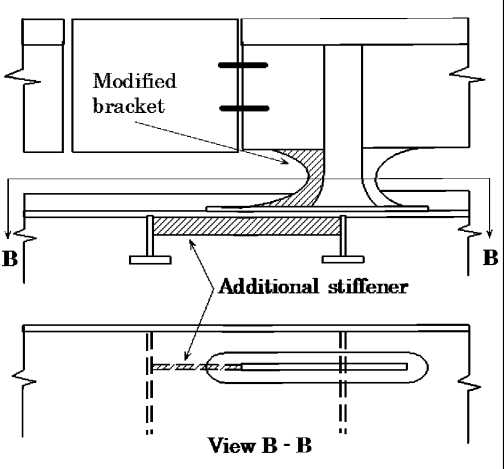
<p>Modified bracket</p> <p>Additional stiffener</p> <p>View B - B</p>
Notes on possible cause of damage 1. Stress concentration at the termination of bulwarks.		Notes on repairs 1. Fractured deck plating should be cropped and part renewed. 2. Reduction of stress concentration should be considered. In the above figure gusset plate was replaced with soft type for the fracture in gusset plate and pad plate was increased. Additional stiffeners were provided for the fracture in deck plating.

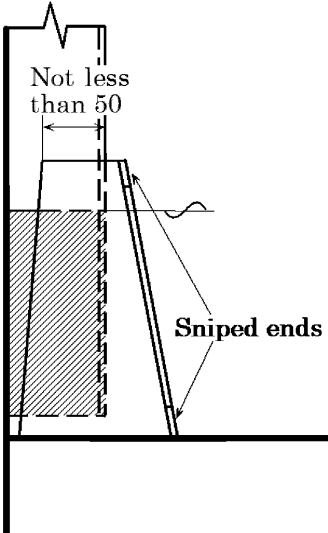
GENERAL DRY CARGO SHIPS		Guidelines for Surveys, Assessment and Repair of Hull Structure
Part 1	Cargo hold region	Example No.
Area 2	Side structure	1
Detail of damage	Fracture in side shell frame at lower bracket	
Sketch of damage	<div style="display: flex; justify-content: space-around;"> <div style="text-align: center;">

<p>Side Shell</p><p>Fracture</p><p>Inner bottom</p> </div> <div style="text-align: center;">

<p>Not less than 50</p><p>Sniped ends</p> </div> </div>	
Notes on possible cause of damage	<p>1. This type of damage is caused due to stress concentration.</p>	
Notes on repairs	<p>1. For small fractures, e. g. hairline fractures, the fracture can be veed-out, welded up, ground, examined by NDT for fractures, and rewelded. For larger/significant fractures consideration is</p> <p>2. to be given to cropping and partly renewing/ renewing the frame brackets. If renewing the brackets, end of frames can be sniped to soften them.</p> <p>If felt prudent, soft toes are to be incorporated</p> <p>3. at the boundaries of the bracket to the inner bottom plating.</p>

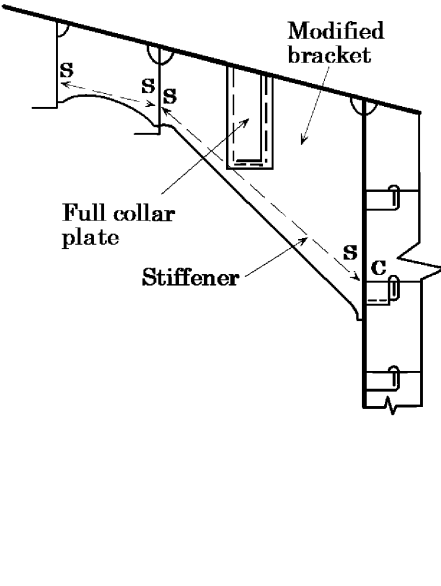
Sketch of repair

Notes on possible cause of damage <ol style="list-style-type: none"> 1. Insufficient bracket size resulting in high stress due to load cantilevered from side frame. 2. Stress concentration at toe of bracket and misalignment between bracket and stringer in fore peak tank or space. 		Notes on repairs <ol style="list-style-type: none"> 1. The extended bracket arm connection to the collision bulkhead is to have a soft toe, and any cut-outs for stiffeners in the fore peak tank or space are to be collared when situated in the vicinity of the bracket toe. When fractures have extended into the side shell or bulkhead plating, the plating is to be cropped and part renewed. 2. shell or bulkhead plating, the plating is to be cropped and part renewed.

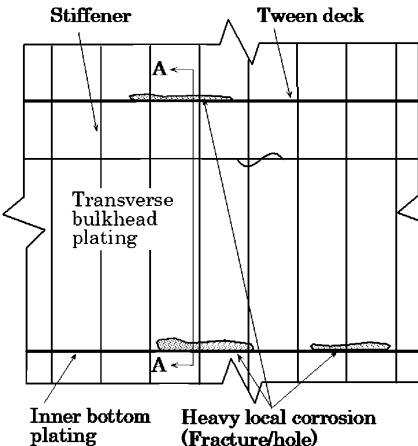
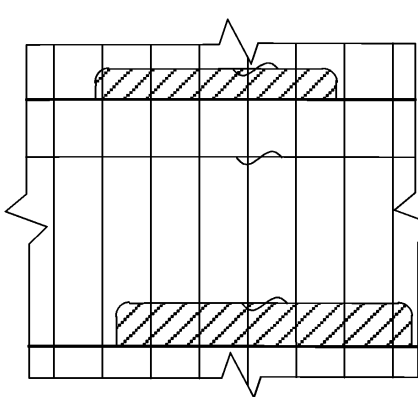
GENERAL DRY CARGO SHIPS		Guidelines for Surveys, Assessment and Repair of Hull Structure
Part 1	Cargo hold region	Example No.
Area 3	Transverse bulkhead structure	1
Detail of damage Corrosion along inner bottom or tween deck plating		
Sketch of damage		Sketch of repair

<p>Note: Regarding "View A-A", refer to Example 2 of Area 2 of this part</p>

Notes on possible cause of damage 1. Heavy corrosion including grooving along inner bottom plating or tween deck due to poor drainage.		Notes on repairs 1. The extent of the renewal should be determined carefully. If the renewal plate (original thickness) is welded to thin plate (corroded plate), it may cause stress concentration and cause fracture. 2. Protective coating should be applied.

- 2.1.1 Heavy wastage along the boundaries at ship's sides and at transverse bulkheads may occur as a result of seawater accumulated from wet cargo due to poor drainage. Such damages are related to those suffered at the lower end of side structures and transverse bulkhead structures (See **Area 2, Example 2** and **Area 3, Example 1**).

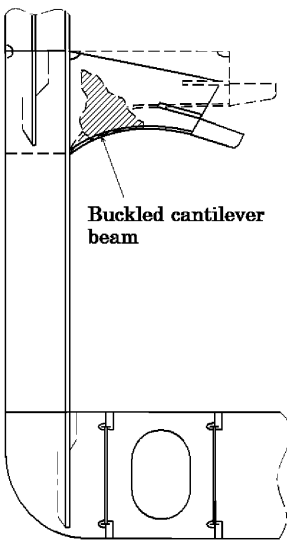
GENERAL DRY CARGO SHIPS		Guidelines for Surveys, Assessment and Repair of Hull Structure	
Part 1	Cargo hold region	Example No.	
Area 4	Tween deck structure	1	
Detail of damage	Sagging of deck panel/buckling of cantilever beam		
Sketch of damage		Sketch of repair

<p>Buckled cantilever beam</p>

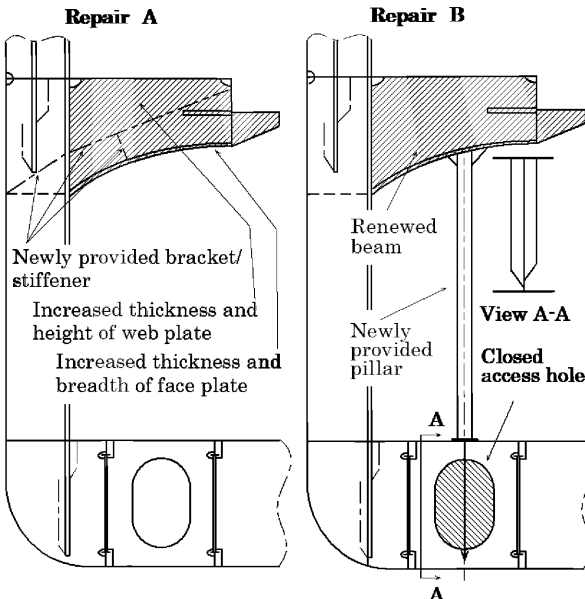
<p>Repair A</p> <p>Newly provided bracket/stiffener</p> <p>Increased thickness and height of web plate</p> <p>Increased thickness and breadth of face plate</p> <p>Repair B</p> <p>Renewed beam</p> <p>Newly provided pillar</p> <p>View A-A</p> <p>Closed access hole</p>	
Notes on possible cause of damage 1. Poor design, overloading and/or excessive inertia force caused in heavy weather.		Notes on repairs 1. The affected structures are to be cropped and renewed. 2. Repair A: Reinforcement should be considered by increased scantlings of beam and/or additional stiffeners. 3. Repair B: Pillars may be provided for reinforcement subject to the approval of the owner. In such a case, reinforcement of the floor under the pillar should be considered. (In the above example, access hole was closed.)

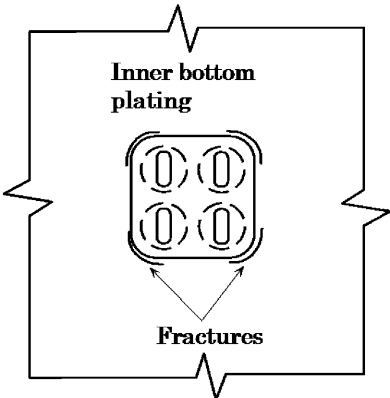
GENERAL DRY CARGO SHIPS		Guidelines for Surveys, Assessment and Repair of Hull Structure
Part 1	Cargo hold region	Example No.
Area 5	Double bottom structure	1
Detail of damage	Fractures in inner bottom plating around container bottom pocket	
Sketch of damage	<div style="display: flex; justify-content: space-around;"> <div style="width: 45%;">

</div> </div>	
Notes on possible cause of damage 1. Pocket is not supported correctly by floor, longitudinal and/or stiffener.		Notes on repairs 1. Fractured plating should be cropped and part renewed. 2. Adequate reinforcement should be considered.

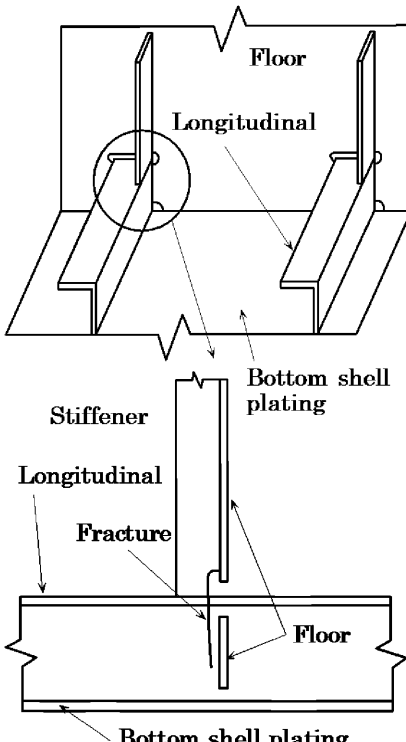
GENERAL DRY CARGO SHIPS		Guidelines for Surveys, Assessment and Repair of Hull Structure
Part 1	Cargo hold region	Example No.
Area 5	Double bottom structure	3-a
Detail of damage	Fractures at the connection of bottom/inner bottom longitudinal to floor stiffener	
<p>Sketch of damage</p>

<p>Note: same damage may occur at similar connection to inner bottom plating</p>		<p>Sketch of repair</p>

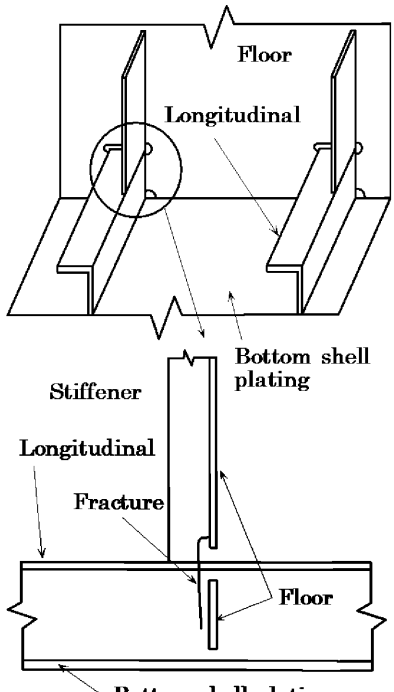
GENERAL DRY CARGO SHIPS		Guidelines for Surveys, Assessment and Repair of Hull Structure
Part 1	Cargo hold region	Example No.
Area 5	Double bottom structure	3-b
Detail of damage	Fractures at the connection of bottom/inner bottom longitudinal to floor stiffener	
<p>Sketch of damage</p>

<p>Note: same damage may occur at similar connection to inner bottom plating</p>		<p>Sketch of repair</p>

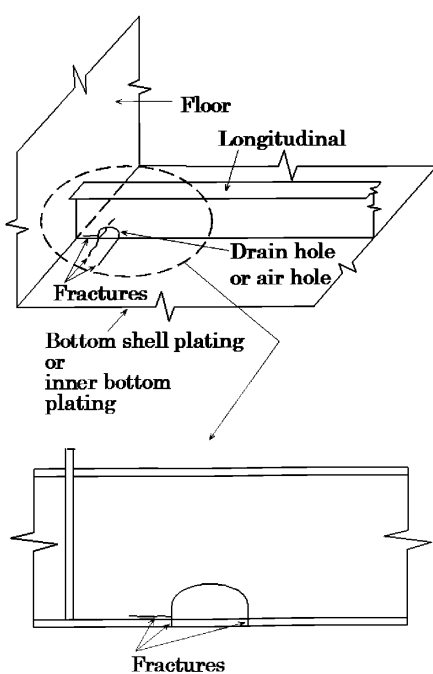
GENERAL DRY CARGO SHIPS		Guidelines for Surveys, Assessment and Repair of Hull Structure
Part 1	Cargo hold region	Example No.
Area 5	Double bottom structure	5
Detail of damage	Fractures in bottom shell plating/inner bottom plating at the corner drain hole/air hole in longitudinal	
Sketch of damage		Sketch of repair

<p>Diagram illustrating the damage: A 3D perspective view shows the floor, longitudinal plating, a drain hole or air hole, and fractures in the bottom shell plating or inner bottom plating. A cross-sectional view below shows the fractures at the corner of the drain hole.</p>

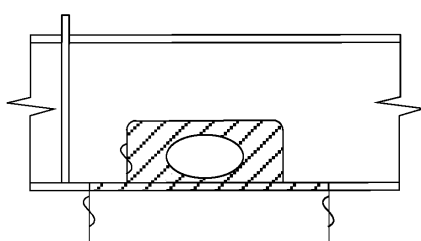
<p>Diagram illustrating the repair: A cross-sectional view shows the damaged area shaded and a new plate being installed.</p>
Notes on possible cause of damage		Notes on repairs
<ol style="list-style-type: none"> 1. Stress concentration and/or corrosion due to stress concentration at the corner of drain hole/air hole. 		<ol style="list-style-type: none"> 1. Fractured plating should be cropped and part renewed. 2. If fatigue life is to be improved, change of drain hole/air hole shape is to be considered.

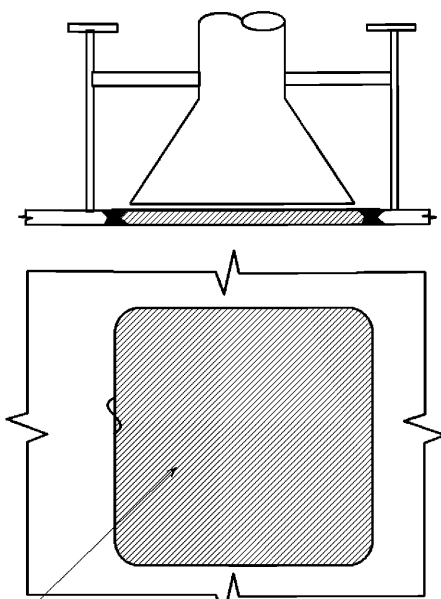
<p>1. Insert to have round corners</p> <p>2. Non-destructive examination to be applied after welding based on the Society's rules</p>
Notes on possible cause of damage <ol style="list-style-type: none"> 1. High flow rate associated with insufficient corrosion prevention system. 2. Galvanic action between dissimilar metals 		Notes on repairs <ol style="list-style-type: none"> 1. Affected plating should be cropped and part renewed. Thicker plate and suitable beveling should be considered. 2. If the corrosion is limited to a small area, i.e. pitting corrosion, repair by welding is acceptable.

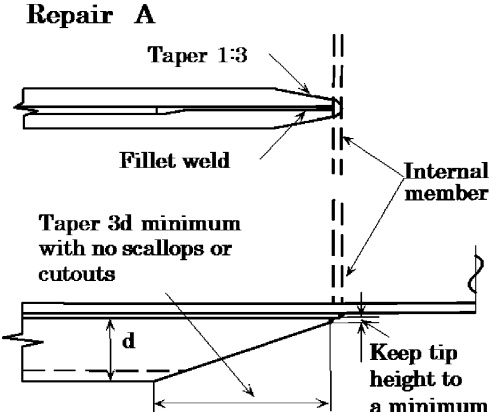
<p>Repair A</p>

Notes on possible cause of damage 1. Poor design causing stress concentration.		Notes on repairs 1. Fractured plating is to be cropped and renewed. 2. Reduction of stress concentration of the bilge keel end should be considered. Repair A: Modification of the detail of end Repair B: New internal stiffeners Instead of Repair A or B continuous ground bar and bilge keel should be considered. 3.

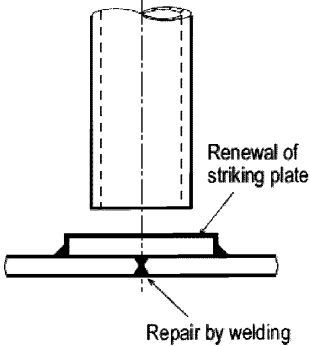
<p>Repair A</p>

Notes on possible cause of damage		Notes on repairs
<ol style="list-style-type: none"> 1. Accelerated corrosion of striking plate by the striking of the weight of the sounding tape. 		<ol style="list-style-type: none"> 1. Corroded bottom plating should be welded or partly cropped and renewed if considered necessary. 2. Corroded striking plate should be renewed.

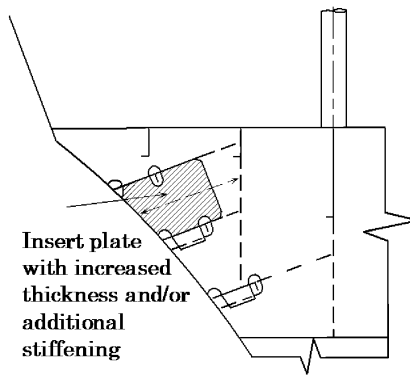
Sketch of repair

Notes on possible cause of damage 1. Localized material wastage in way of coating failure at cut-outs and sharp edges due to working of the structure. 2. Dynamic seaway loading in way of bow flare.		Notes on repairs 1. Sufficient panel strength to be provided to absorb the dynamic loads enhanced by bow flare shape.

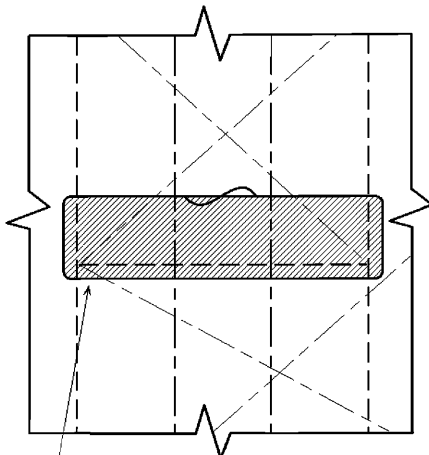
GENERAL DRY CARGO SHIPS		Guidelines for Surveys, Assessment and Repair of Hull Structure
Part 2	Fore and aft end regions	Example No.
Area 1	Fore end structure	3
Detail of damage	Fracture in side shell plating in way of chain locker	
Sketch of damage		Sketch of repair

<p>Renewal of shell plating including internals as found necessary</p>
Notes on possible cause of damage		Notes on repairs
<ol style="list-style-type: none"> 1. Heavy corrosion in region where mud is accumulated. 		<ol style="list-style-type: none"> 1. Corroded plating should be cropped and renewed. 2. Protective coating should be applied.

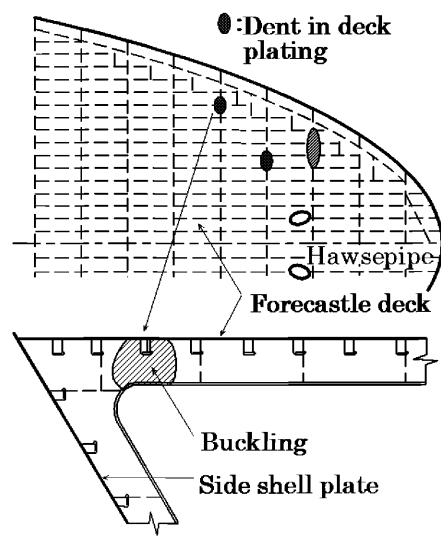
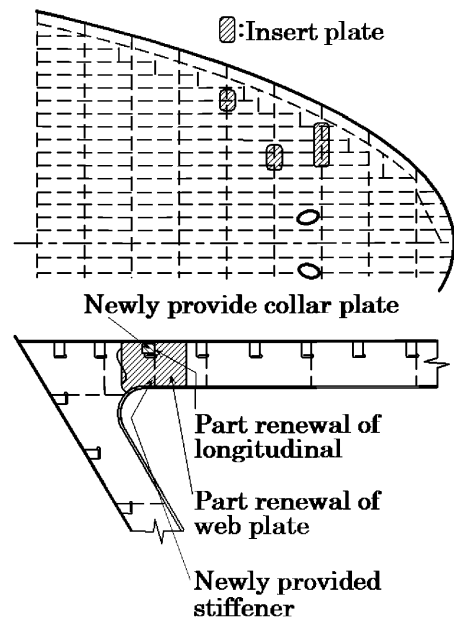
GENERAL DRY CARGO SHIPS		Guidelines for Surveys, Assessment and Repair of Hull Structure	
Part 2	Fore and aft end regions	Example No.	
Area 1	Fore end structure	4	
Detail of damage		Deformation of forecastle deck	
Sketch of damage		Sketch of repair

Notes on possible cause of damage		Notes on repairs	
<ol style="list-style-type: none">1. Green sea on deck.2. Insufficient strength.		<ol style="list-style-type: none">1. Deformed structure should be cropped and renewed.2. Additional stiffeners on web of beam should be considered for reinforcement.

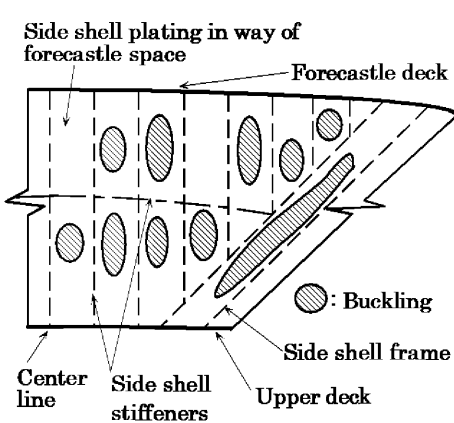
GENERAL DRY CARGO SHIPS		Guidelines for Surveys, Assessment and Repair of Hull Structure
Part 2	Fore and aft end regions	Example No.
Area 1	Fore end structure	5
Detail of damage		Deformation of side shell plating in way of forecastle space
<p>Sketch of damage</p>

<p>Side shell plating in way of forecastle space</p> <p>Forecastle deck</p> <p>Center line</p> <p>Side shell stiffeners</p> <p>Upper deck</p> <p>Side shell frame</p> <p>○: Buckling</p>		<p>Sketch of repair</p> <p>Repair A</p>

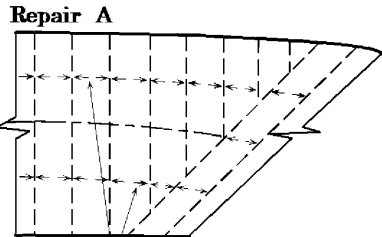
<p>Center line</p> <p>Newly provided longitudinal stiffeners</p> <p>Repair B</p>

<p>Center line</p> <p>Insertion of plate of increased thickness</p>
<p>Notes on possible cause of damage</p> <ol style="list-style-type: none"> 1. Heavy weather. 2. Insufficient strength. 		<p>Notes on repairs</p> <ol style="list-style-type: none"> 1. Deformed part should be cropped and part renewed. 2. Repair A Additional stiffeners between existing stiffeners should be considered. Repair B Insertion of plate of increased thickness with additional stiffeners

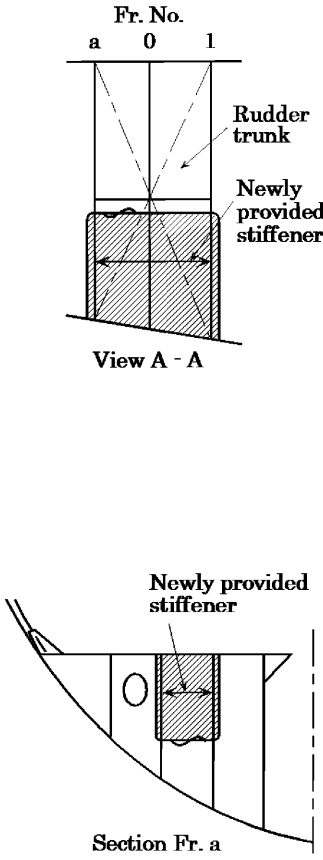
GENERAL DRY CARGO SHIPS		Guidelines for Surveys, Assessment and Repair of Hull Structure
Part 2	Fore and aft end regions	Example No.
Area 2	Aft end structure	1
Detail of damage	Fractures in <u>longitudinal</u> bulkhead in way of rudder trunk	
Sketch of damage

Sketch of repair

Notes on possible cause of damage 1. Vibration.		Notes on repairs 1. The fractured plating should be cropped and renewed. 2. Natural frequency of the plate between stiffeners should be changed, e.g. reinforcement by additional stiffeners.

- 3.3.1 Repairs of main engines and propeller excited vibration damage should be made by returning the structure to its original condition. In order to prevent recurrence of the damage the cause of the vibration should be ascertained and additional reinforcements provided as found necessary (See **Examples 1 and 2**).
- 3.3.2 Fractured structure which supports the rudder carrier is to be cropped and renewed, and may have to be reinforced (See **Example 3**).

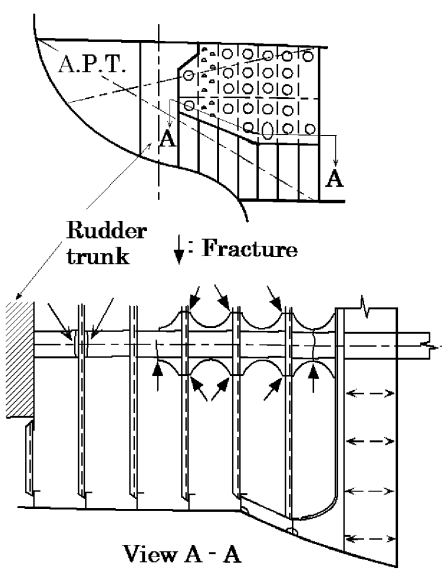
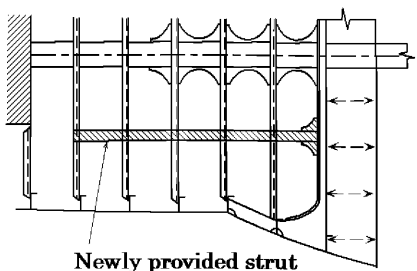
GENERAL DRY CARGO SHIPS		Guidelines for Surveys, Assessment and Repair of Hull Structure
Part 2	Fore and aft end regions	Example No.
Area 2	Aft end structure	2
Detail of damage		Fractures at the connection of floors and girders/side brackets
Sketch of damage

<p>View A - A</p>		Sketch of repair

<p>Newly provided strut</p>
Notes on possible cause of damage 1. Vibration.		Notes on repairs 1. The fractured plating should be cropped and renewed. 2. Natural frequency of the panel should be changed, e.g. reinforcement by additional strut.

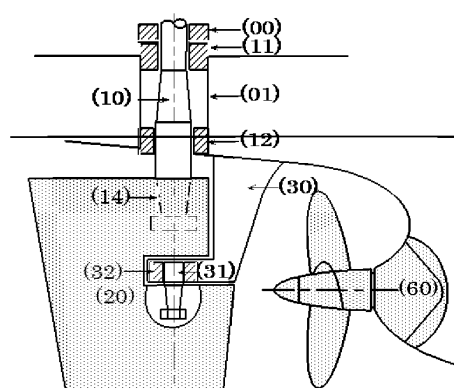
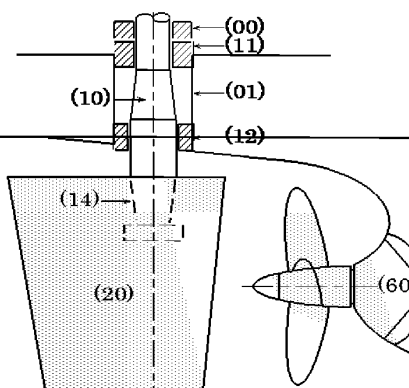
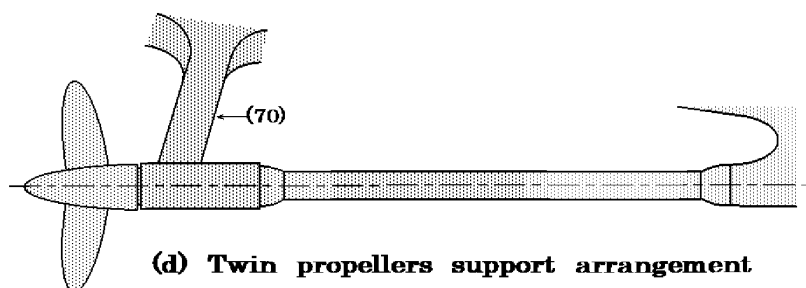
(a) Rudders supported by sole piece

Nomenclature

- (00) Rudder carrier
- (01) Rudder trunk
- (10) Rudder stock
- (11) Carrier bearing
- (12) Neck bearing
- (13) Horizontal coupling (Flange coupling)
- (14) Cone coupling
- (20) Rudder blade
- (21) Upper pintle
- (22) Upper pintle bearing
- (30) Rudder horn
- (31) Horn pintle
- (32) Horn pintle bearing
- (40) Sole piece
- (41) Bottom pintle
- (42) Bottom pintle bearing
- (50) Bush
- (51) Sleeve (Liner)
- (60) Propeller boss (Stern tube casting)
- (70) Propeller shaft bracket (Tail shaft strut)

(b) Semi-spade rudder (or Mariner rudder)

(c) Spade rudder

(d) Twin propellers support arrangement

Figures and/or Photographs - Area 3	
No.	Title
Figure 1	Nomenclature for stern frame, rudder arrangement and propeller shaft support
Figure 2	Potential problem areas
Photograph 1	Fractured rudder due to corrosion in rudder plating
Figure 3	Rudder stock repair by welding
Diagram 1	Preheating temperature

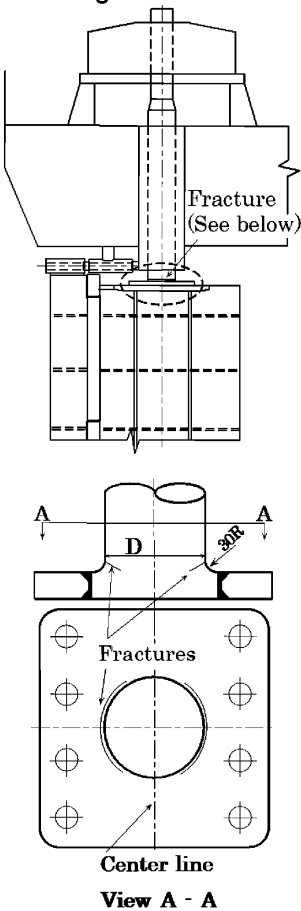
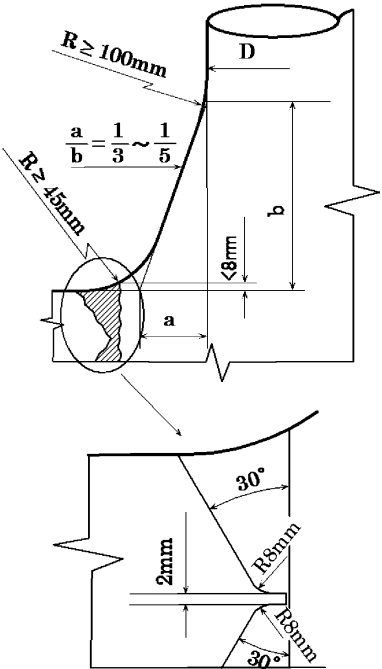
GENERAL DRY CARGO SHIPS		Guidelines for Surveys, Assessment and Repair of Hull Structure
Part 2	Fore and aft end regions	Example No.
Area 3	Stern frame, rudder arrangement and propeller shaft support	1
Detail of damage		Fracture in rudder stock
Sketch of damage		Sketch of repair

<p>Fracture (See below)</p> <p>Center line View A - A</p>

Notes on possible cause of damage		Notes on repairs
1. Inadequate design for stress concentration in rudder stock.		1. Modification of detail design of rudder stock to reduce the stress concentration.

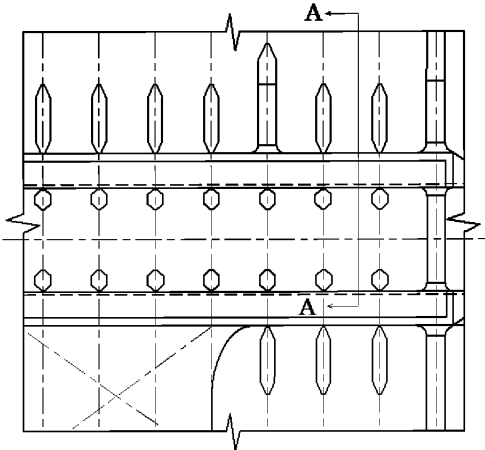
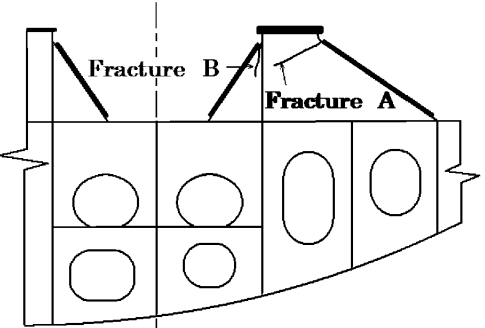
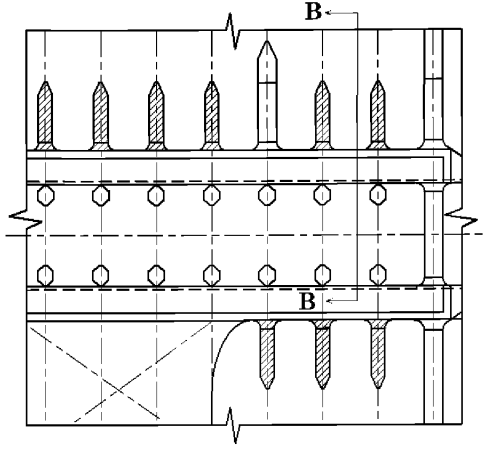
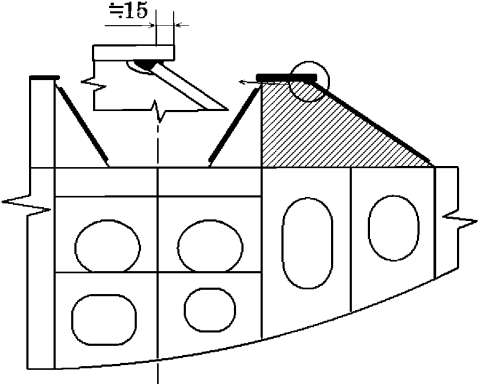
GENERAL DRY CARGO SHIPS		Guidelines for Surveys, Assessment and Repair of Hull Structure	
Part 3	Machinery and accommodation spaces	Example No.	
Area 1	Engine room structure	1	
Detail of damage		Fractures in brackets at main engine foundation	
Sketch of damage		Sketch of repair

<p>View B - B</p>	
Notes on possible cause of damage		Notes on repairs	
<ol style="list-style-type: none"> 1. Vibration of main engine. 2. Insufficient strength of brackets at main engine foundation. 3. Insufficient pre-load of the bolts. 		<ol style="list-style-type: none"> 1. Fractures may be veed-out and rewelded. 2. New modified brackets at main engine foundation. Or insert pieces and additional flanges to increase section modulus of the brackets.

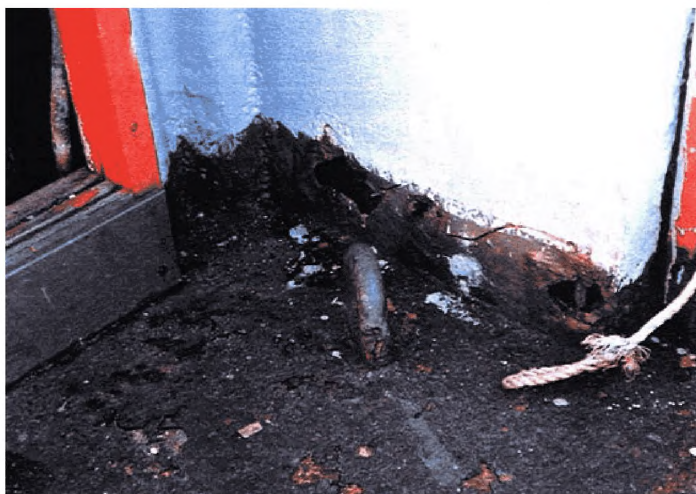
Photograph 1 Corroded accommodation house structure

The main damage is corrosion which may cause serious problems since the structure is relatively thin. Serious corrosion may be found in exposed deck plating and its adjoining accommodation house structure where water is liable to collect (See **Photograph 1**). Corrosion is also found in accommodation bulkheads where fittings such as doors, side scuttles, ventilators, etc. are fitted and proper maintenance of the area is relatively difficult. Deterioration of the bulkheads including fittings may impair the integrity of weathertightness.

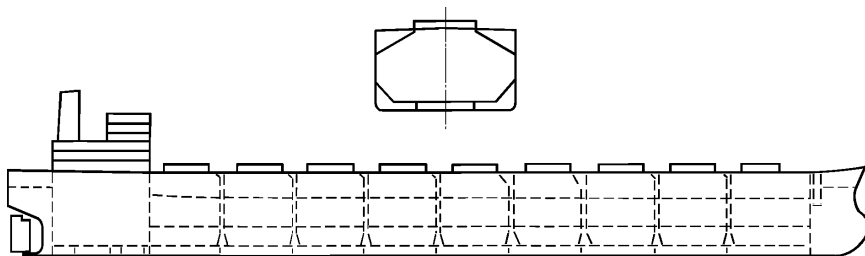
Figure 1 General view of a typical single skin bulk carrier

This manual gives guidelines for a bulk carrier type ship which is constructed with a single deck, single skin, double bottom, hopper side tanks and topside tanks in cargo spaces, and is intended primarily to carry dry cargo, including ore, in bulk. **Figure 1** shows the general view of a typical single skin bulk carrier with 9 cargo holds.

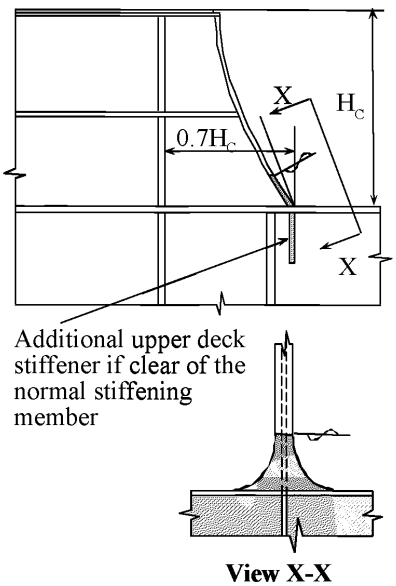
BULK CARRIERS		Guidelines for Surveys, Assessment and Repair of Hull Structure	
Part 1	Cargo hold region		Example No.
Area 1	Deck structure		3-a
Detail of damage		Fractures in the web or in the deck at the toes of the longitudinal hatch coaming termination bracket	
Sketch of damage

Notes on possible cause of damage 1. This damage is caused by stress concentrations attributed to the design of the bracket.		Notes on repairs 1. The design of the bracket can be altered as shown above, however, it is to be ensured that an additional under deck stiffener is provided at the toe of the termination bracket, where the toe is clear of the normal stiffening member. 2. Full penetration weld for a distance of $0.15 H_C$ from toe of side coaming termination bracket and for connection of athwartship gusset bracket to deck. 3. The fracture in deck plating to be veed-out and rewelded or deck plating cropped and part renewed as appropriate, using low hydrogen electrodes for welding.

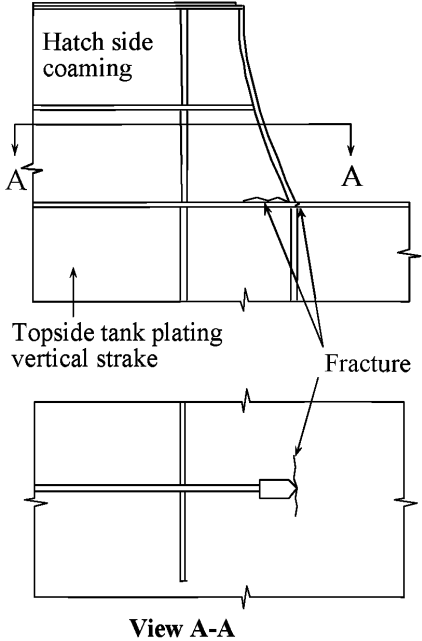
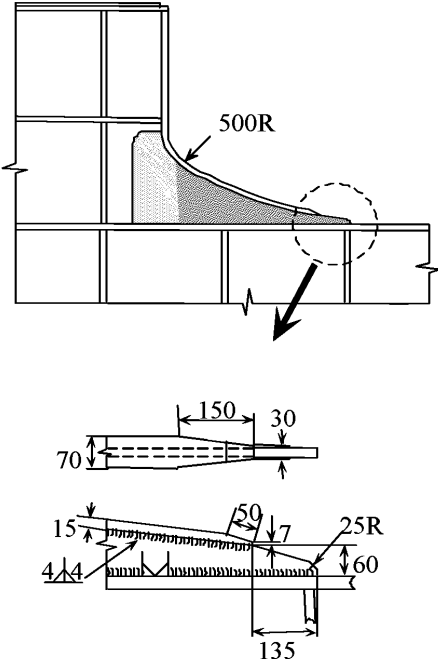
BULK CARRIERS		Guidelines for Surveys, Assessment and Repair of Hull Structure
Part 1	Cargo hold region	Example No.
Area 1	Deck structure	3-b
Detail of damage		Fractures in the web or in the deck at the toes of the longitudinal hatch coaming termination bracket
Sketch of damage

<p>Hatch side coaming</p> <p>Topside tank plating vertical strake</p> <p>Fracture</p> <p>View A-A</p>		Sketch of repair

<p>500R</p> <p>150 30 70 15 50 7 25R 60 135 4 4</p>
Notes on possible cause of damage 1. This damage is caused by stress concentrations attributed to the design of the bracket.		Notes on repairs 1. The design of the bracket can be altered as shown above, however, it is to be ensured that an additional under deck stiffener is provided at the toe of the termination bracket, where the toe is clear of the normal stiffening member. 2. The fracture in deck plating to be veed-out and rewelded or deck plating cropped and part renewed as appropriate, using low hydrogen electrodes for welding.

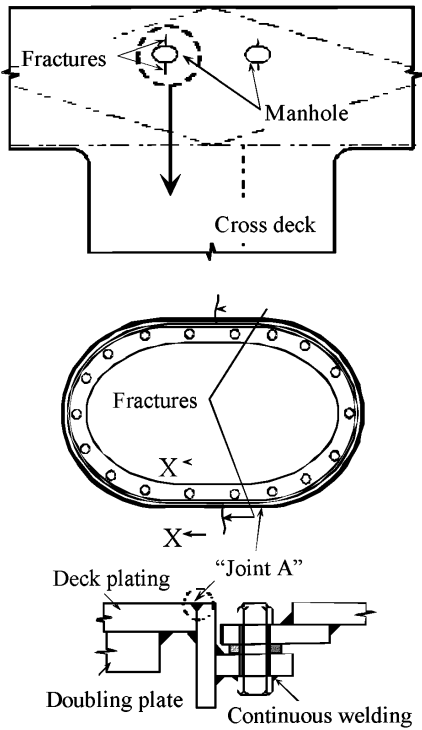
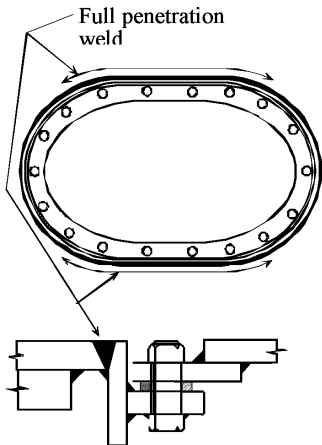
BULK CARRIERS		Guidelines for Surveys, Assessment and Repair of Hull Structure
Part 1	Cargo hold region	Example No.
Area 1	Deck structure	4
Detail of damage		Fractures in deck plating initiated from weld of access manhole
Sketch of damage		Sketch of repair

<p>Fractures</p> <p>Manhole</p> <p>Cross deck</p> <p>Fractures</p> <p>X-X</p> <p>Deck plating</p> <p>"Joint A"</p> <p>Doubling plate</p> <p>Continuous welding</p> <p>Section X-X</p>

<p>Full penetration weld</p>
Notes on possible cause of damage <ol style="list-style-type: none"> 1. Heavy weather. 2. Improper welding of joint "A". 		Notes on repairs <ol style="list-style-type: none"> 1. The fracture in deck plating to be veed-out and rewelded, or deck plating cropped and part renewed if considered necessary. 2. Full penetration of joint "A" should be considered.

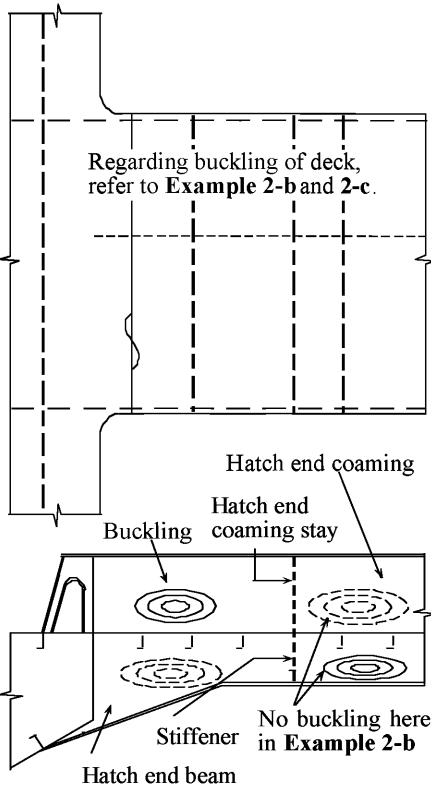
BULK CARRIERS Guidelines for Surveys, Assessment and Repair of Hull Structure		
Part 1	Cargo hold region	Example No.
Area 1	Deck structure	7-a
Detail of damage Buckling of hatch coaming and hatch end beam		
Sketch of damage		Sketch of repair

<p>Regarding buckling of deck, refer to Example 2-b and 2-c.</p> <p>Hatch end coaming</p> <p>Buckling</p> <p>Hatch end coaming stay</p> <p>Stiffener</p> <p>Hatch end beam</p> <p>No buckling here in Example 2-b</p>

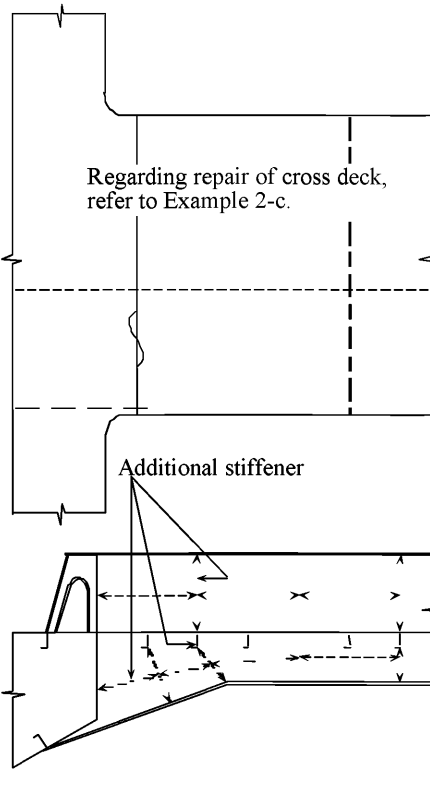
<p>Regarding repair of cross deck, refer to Example 2-c.</p> <p>Additional stiffener</p>
Notes on possible cause of damage <ol style="list-style-type: none"> 1. Additional transverse forces due to heavy seas, and torsional loading. 2. Inadvertent overloading of cargo spaces. 		Notes on repairs <ol style="list-style-type: none"> 1. If buckling is due to loss in strength induced by corrosion, the buckled zone to be cropped and renewed as necessary. 2. If buckling results from inadequate strength, stiffeners should be fitted in addition to cropping and renewal of buckled zone.

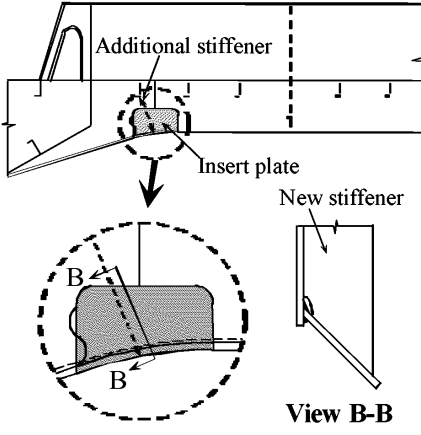
<p>Additional stiffener</p> <p>Insert plate</p> <p>New stiffener</p> <p>View B-B</p>
Notes on possible cause of damage 1. Stress concentration at knuckle joint.		Notes on repairs 1. Fractured part to be cropped and renewed. 2. Improvement to avoid stress concentration at knuckle joint should be considered.

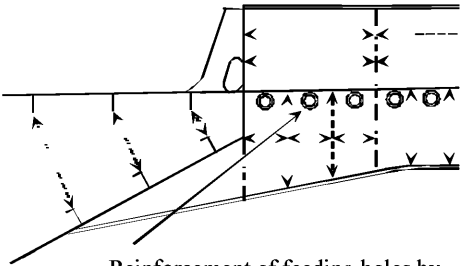
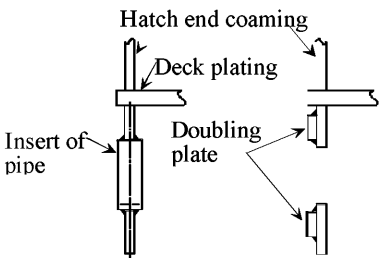
Sketch of repair

Detail
Notes on possible cause of damage <ol style="list-style-type: none"> 1. Inadequate reinforcement around feeding hole. 2. Corrosion. 		Notes on repairs <ol style="list-style-type: none"> 1. Fractured part to be vee-d-out or cropped and renewed. 2. If the fractured part is free from corrosion, reinforcement should be considered.

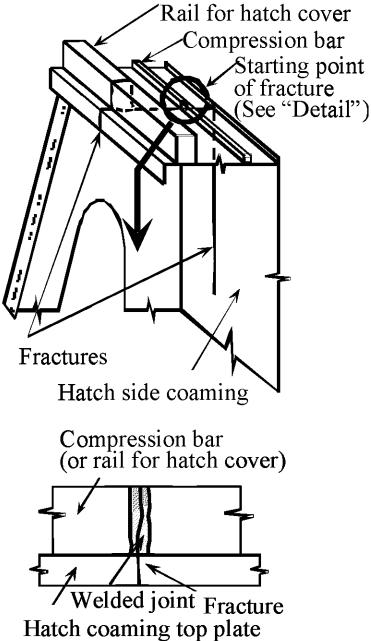
BULK CARRIERS		Guidelines for Surveys, Assessment and Repair of Hull Structure
Part 1	Cargo hold region	Example No.
Area 1	Deck structure	11
Detail of damage		Fractures in hatch coaming top plate initiated from butt weld of compression bar
Sketch of damage

<p>Labels in sketch: Rail for hatch cover, Compression bar, Starting point of fracture (See "Detail"), Fractures, Hatch side coaming, Compression bar (or rail for hatch cover), Welded joint, Fracture, Hatch coaming top plate.</p> <p>Detail</p>		Sketch of repair

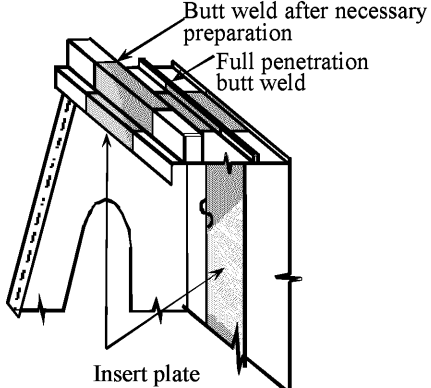
<p>Labels in sketch: Butt weld after necessary preparation, Full penetration butt weld, Insert plate.</p>
Notes on possible cause of damage <ol style="list-style-type: none"> 1. Heavy weather 2. Insufficient preparation of weld of compression bar and/or rail (Although the compression bar and rail are not longitudinal strength members, they subject same longitudinal stress as longitudinal members) 3. Crack may initiate from insufficient penetration of weld of rail for hatch cover. 		Notes on repairs <ol style="list-style-type: none"> 1. Loading condition of the ship and proper welding procedure should be carefully considered. 2. Fractured structure is to be cropped and renewed if considered necessary. (Small fracture may be vee-d-out and rewelded.) 3. Full penetration welding should be applied to the butt weld of compression bar and rail.

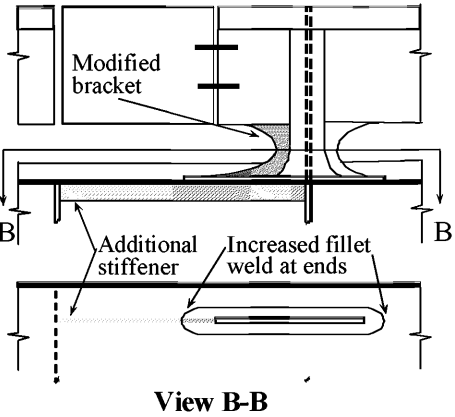
Sketch of repair

Notes on possible cause of damage 1. Stress concentration at the termination of bulwarks.		Notes on repairs 1. Fractured deck plating should be cropped and part renewed. 2. Reduction of stress concentration should be considered. In the above figure gusset plate was replaced with soft type for the fracture in gusset plate and pad plate was increased. Additional stiffeners were provided for the fracture in deck plating.

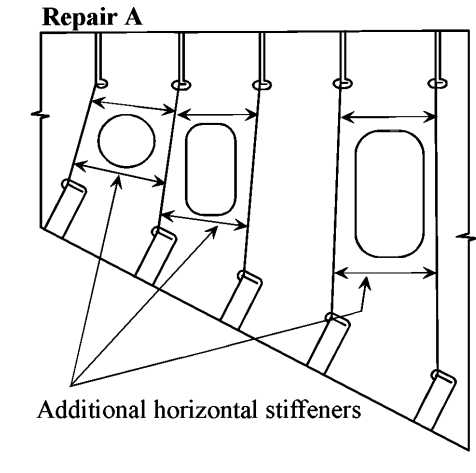
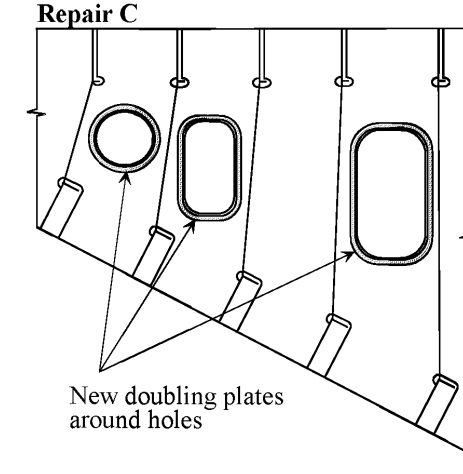
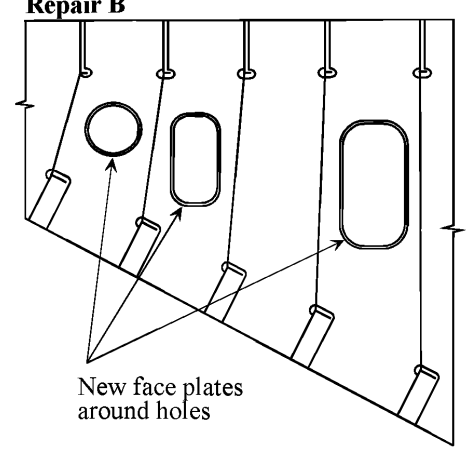
BULK CARRIERS		Guidelines for Surveys, Assessment and Repair of Hull Structure
Part 1	Cargo hold region	Example No.
Area 2	Topside tank structure	1
Detail of damage		Fractures around unstiffened lightening holes and manholes in wash bulkhead
Sketch of damage		Sketch of repair

Notes on possible cause of damage		Notes on repairs
<ol style="list-style-type: none"> General levels of corrosion and presence of stress concentration. 		<ol style="list-style-type: none"> Corroded/fractured plating should be cropped and renewed with plating of enhanced thickness. Reinforcement should be considered.

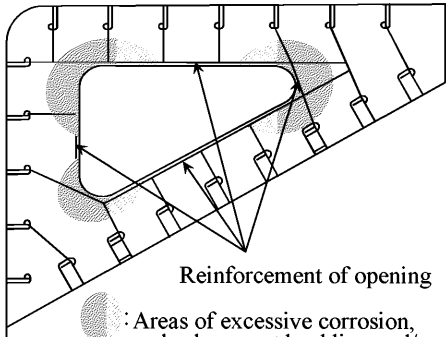
BULK CARRIERS		Guidelines for Surveys, Assessment and Repair of Hull Structure	
Part 1	Cargo hold region	Example No.	
Area 2	Topside tank structure	2-c	
Detail of damage		Thinning and subsequent buckling of web plating in the vicinity of the radii of the opening	
Sketch of damage		Sketch of repair

<p>Reinforcement of opening</p> <p>: Areas of excessive corrosion, and subsequent buckling and/or</p>

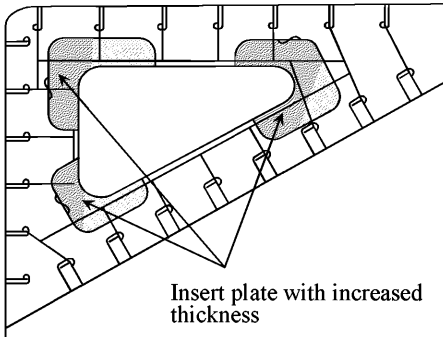
<p>Insert plate with increased thickness</p>	
Notes on possible cause of damage		Notes on repairs	
1. Additional stresses at the free edge of transverse web. (In Example 2-a - 2-c face plate is provided for the reinforcement of the opening.)		1. Corroded/buckled plating is to be cropped and part renewed with plating of increased thickness.

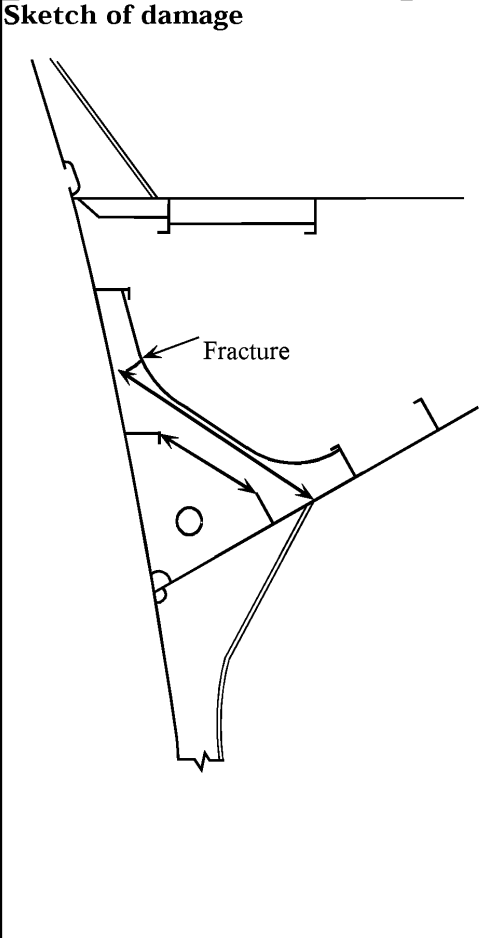
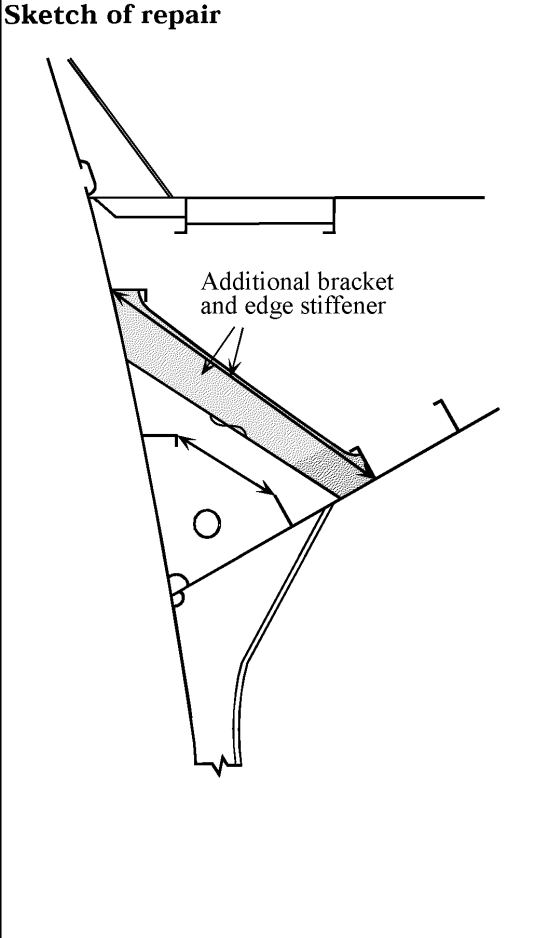
BULK CARRIERS		Guidelines for Surveys, Assessment and Repair of Hull Structure	
Part 1	Cargo hold region		Example No.
Area 2	Topside tank structure		7-b
Detail of damage		Fractures in transverse bracket	
Sketch of damage		Sketch of repair

Notes on possible cause of damage		Notes on repairs	
<div>1. Insufficient strength.</div> <div>2. Corrosion.</div>		<div>1. Fractured part to be cropped and renewed.</div> <div>2. If the fractured part is free from corrosion, increased size and thickness should be considered. Partial renewal of the bracket may be accepted depending on the nature of the fracture.</div>

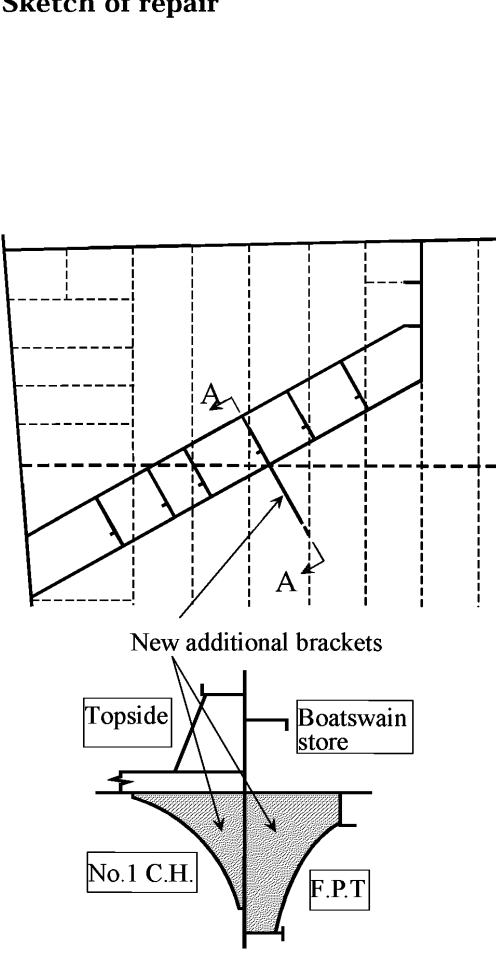
BULK CARRIERS		Guidelines for Surveys, Assessment and Repair of Hull Structure
Part 1	Cargo hold region	Example No.
Area 2	Topside tank structure	10
Detail of damage		Fractures in way of collision bulkhead at intersection with topside tank structure in foremost cargo hold
Sketch of damage		Sketch of repair

<p>Section A-A Section B-B</p>

<p>Section A-A</p>
Notes on possible cause of damage		Notes on repairs
<ol style="list-style-type: none"> Damage caused by hard spot at intersection of the topside tank sloping plating and boatswain's store deck plating (fore peak tank top plating). 		<ol style="list-style-type: none"> Fractured plates to be cropped and renewed. Stress concentration should be considered (Brackets were fitted on both sides for reinforcement).

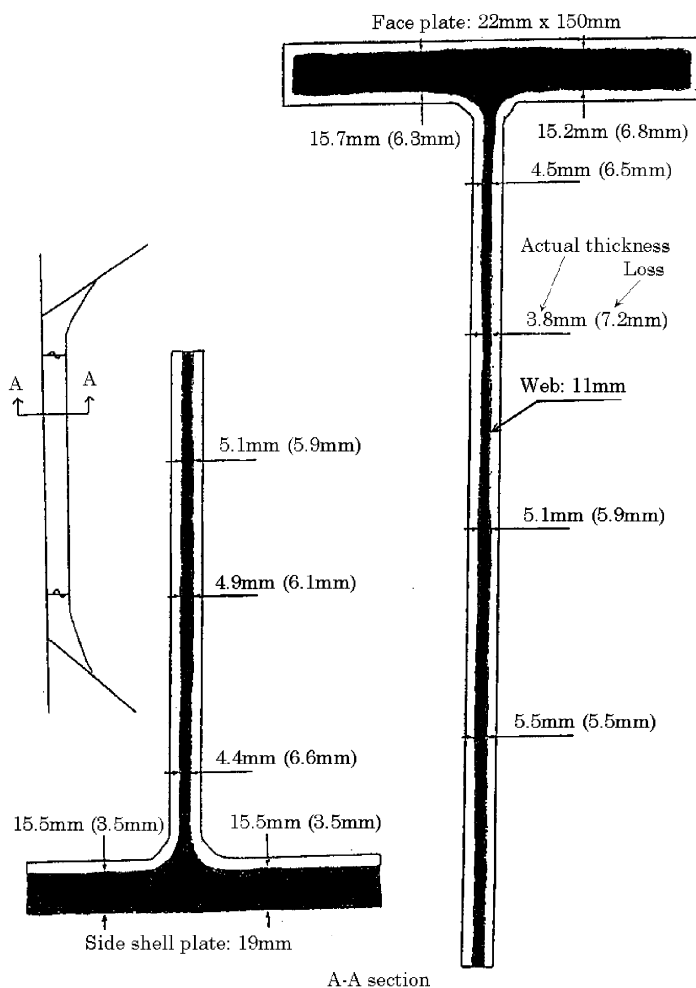
Figure 5 Uniform corrosion of side shell frame

- 2.1.1** Attention is drawn to the fact that side shell frames may be significantly weakened by loss of thickness although diminution and deformations may not be apparent. Inspection should be made after the removal of any scale or rust deposit. Thickness measurements may be necessary, particularly if the corrosion is smooth and uniform, to determine the condition of the structure (See **Figure 5**).
