**ПРИЛОЖЕНИЕ К ПРАВИЛАМ И РУКОВОДСТВАМ
РОССИЙСКОГО МОРСКОГО РЕГИСТРА СУДОХОДСТВА**

**SUPPLEMENT TO RULES AND GUIDELINES
OF RUSSIAN MARITIME REGISTER OF SHIPPING**

GENERAL DRY CARGO SHIPS

Guidelines for
Surveys, Assessment and Repair
of Hull Structure

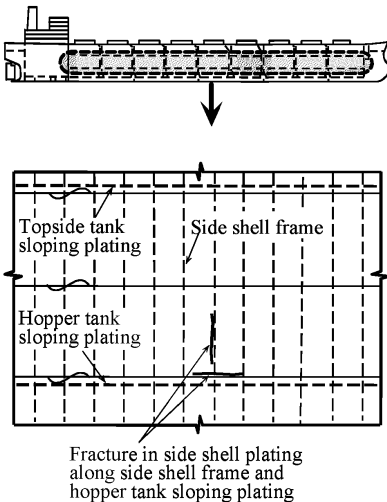
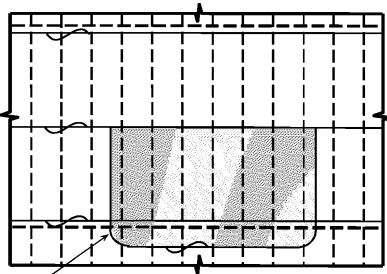
BULK CARRIERS		Guidelines for Surveys, Assessment and Repair of Hull Structure
Part 1	Cargo hold region	Example No.
Area 3	Cargo hold side structure	3
Detail of damage	Fractures in side shell frame/lower bracket and side shell plating near hopper	
Sketch of damage		Sketch of repair

<p>Fracture in side shell plating along side shell frame and hopper tank sloping plating</p>

<p>Part renewal including side shell frames and hopper sloping plating, as found necessary</p>
Notes on possible cause of damage		Notes on repairs
<ol style="list-style-type: none"> 1. Heavy corrosion (grooving). Refer to Figure 2 (c). 		<ol style="list-style-type: none"> 1. Sketch of repair applies when damage extends over several frames. 2. Isolated fractures may be repaired by veeing-out and rewelding. 3. Isolated cases of grooving may be repaired by build up of welding.

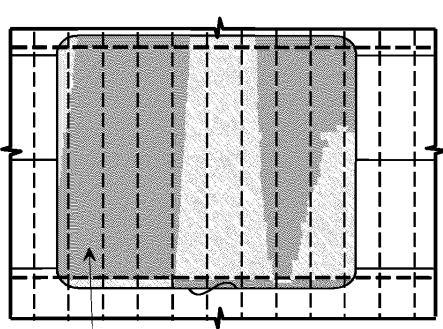
BULK CARRIERS		Guidelines for Surveys, Assessment and Repair of Hull Structure
Part 1	Cargo hold region	Example No.
Area 3	Cargo hold side structure	4
Detail of damage		Deformation of side shell plating
Sketch of damage		Sketch of repair

Notes on possible cause of damage		Notes on repairs
<ol style="list-style-type: none"> 1. Insufficient stiffness of side shell frames due to buckling and/or detachment of side shell frames due to corrosion. 2. Heavy weather. 		<ol style="list-style-type: none"> 1. Deformed side shell plating including side shell frames should be cropped and renewed.

Photograph 1 Collapsed side shell frames (See Example 4)

Photograph 2 Missing side shell structure (See Examples 4 and 5)

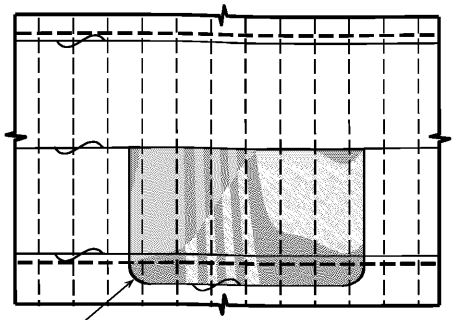
BULK CARRIERS		Guidelines for Surveys, Assessment and Repair of Hull Structure	
Part 1	Cargo hold region	Example No.	
Area 3	Cargo hold side structure	5	
Detail of damage		Adverse effect of corrosion on the frame of forward/afterward hold	
Sketch of damage		Sketch of repair

<p>Side shell frame of forward/afterward hold</p> <p>Detached side shell frame</p> <p>Consequence of heavy corrosion</p> <p>Side shell plating</p> <p>Side shell frame</p> <p>"a"</p> <p>"b"</p>

<ol style="list-style-type: none"> 1. Part renewal including side shell frames and hopper plating, as found necessary 2. Deep penetration welding at the connections of side shell frames to side shell plating 	
Notes on possible cause of damage <ol style="list-style-type: none"> 1. Heavy corrosion (grooving) of side shell frame along side shell plating and difference of throat thickness "a" from "b". (Since original throat thickness of "a" is usually smaller than that of "b", if same welding procedure is applied, the same corrosion has a more severe effect on "a", and may cause collapse and/or detachment of side shell frame.) 		Notes on repairs <ol style="list-style-type: none"> 1. Sketch of repair applies when damage extends over several frames. 2. Isolated fractures may be repaired by veeing-out and rewelding. 3. Isolated cases of grooving may be repaired by build up of welding.

shell plating is oblique to frames, may result in fracture and buckling of the shell plating as shown in **Example 5**.

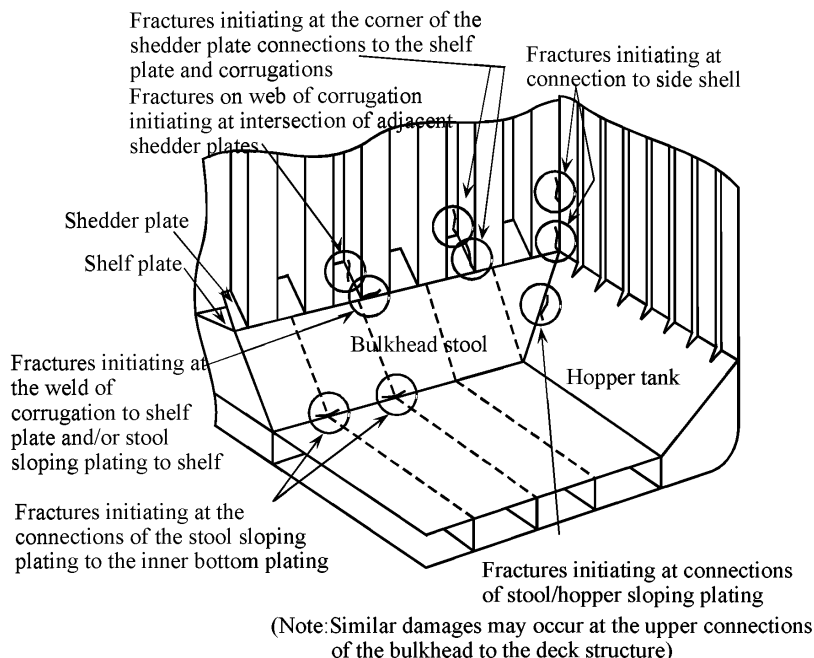
Figure 2 Typical fracturing at the connection of transverse bulkhead structure

2.3.1 Fractures usually occur at the boundaries of corrugations and bulkhead stools particularly in way of shelf plates, shedder plates, deck, inner bottom, etc. (See **Figure 2**).

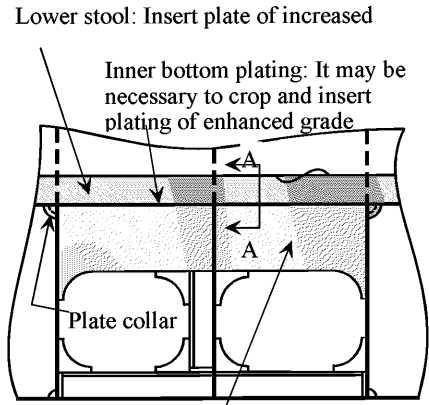
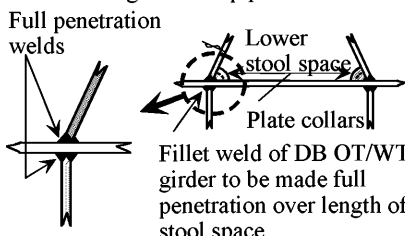
Sketch of repair <p>Lower stool: Insert plate of increased</p> <p>Inner bottom plating: It may be necessary to crop and insert plating of enhanced grade</p>

<p>Increased depth of stiffener to suit arrangement of pipes in duct keel</p> <p>Full penetration welds</p>

<p>View A - A</p>
Notes on possible cause of damage <ol style="list-style-type: none"> 1. This type of failure is more likely to occur at the boundaries of the ballast hold. 2. The fractures arise because of stress concentration in way of cut-outs and exacerbated by the flexibility of the inner bottom structure in way of the duct keel. 		Notes on repairs <ol style="list-style-type: none"> 1. In order to prevent recurrence of the damage, the additional reinforcement shown should be fitted.

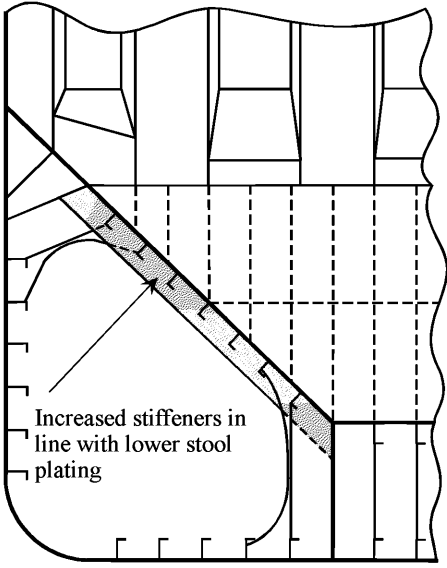
BULK CARRIERS	Guidelines for Surveys, Assessment and Repair of Hull Structure	
Part 1	Cargo hold region	Example No.
Area 4	Transverse bulkhead and associated structure in cargo hold	6
Detail of damage	Fractures at the connection of lower stool to hopper	
Sketch of damage		Sketch of repair

Notes on possible cause of damage		Notes on repairs
<ol style="list-style-type: none"> 1. Insufficient strength of the connection 2. Corrosion 		<ol style="list-style-type: none"> 1. Fractured stool plating should be partly cropped and renewed (thicker plate) if considered necessary. 2. If the damage occurred due to insufficient strength, stiffeners in line with stool plating should be increased.

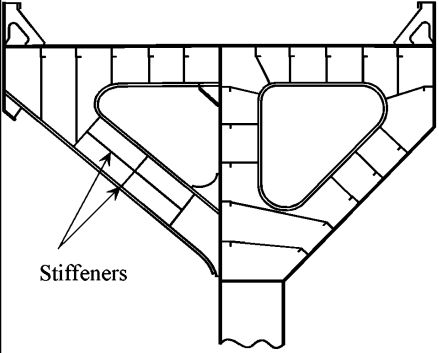
BULK CARRIERS		Guidelines for Surveys, Assessment and Repair of Hull Structure	
Part 1	Cargo hold region	Example No.	
Area 4	Transverse bulkhead and associated structure in cargo hold	7	
Detail of damage		Buckling of strut supporting hatch end beam	
Sketch of damage		Sketch of repair

Notes on possible cause of damage <ol style="list-style-type: none"> 1. Insufficient strength 2. Partial ballast loading in ballast cargo hold (sloshing) 3. Corrosion 		Notes on repairs <ol style="list-style-type: none"> 1. Deformed part to be cropped and renewed if considered necessary. 2. If the damage occurred due to insufficient strength, appropriate reinforcement is to be considered (thicker plate/additional stiffener(s)).

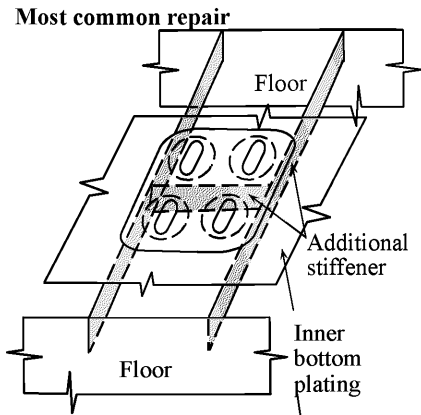
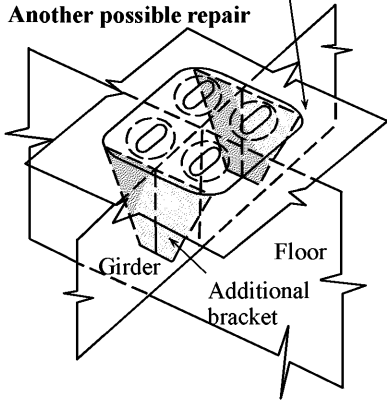
BULK CARRIERS	Guidelines for Surveys, Assessment and Repair of Hull Structure	
Part 1	Cargo hold region	Example No.
Area 5	Double bottom structure including hopper	1
Detail of damage	Fractures in inner bottom plating around container bottom pocket	
Sketch of damage

Sketch of repair <p>Most common repair</p>

<p>Another possible repair</p>

Notes on possible cause of damage 1. Pocket is not supported correctly by floor, longitudinal and/or stiffener.		Notes on repairs 1. Fractured plating should be cropped and part renewed. 2. Adequate reinforcement should be considered.

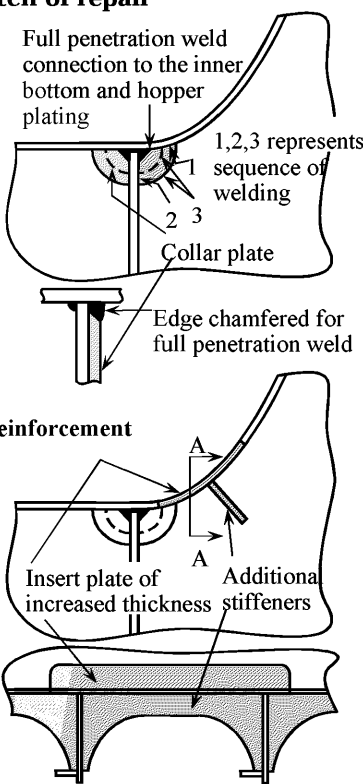
BULK CARRIERS		Guidelines for Surveys, Assessment and Repair of Hull Structure	
Part 1	Cargo hold region	Example No.	
Area 5	Double bottom tank structure including hopper	3	
Detail of damage		Fractures at weld connections of floors in way of hopper/inner bottom interface (radiused knuckle)	
Sketch of damage		Sketch of repair

<p>View A - A</p> <p>Transverse fractures in hopper web plating into possibly extending into the hopper sloping plating</p>

<p>Reinforcement</p> <p>Insert plate of increased thickness</p> <p>Additional stiffeners</p>	
Notes on possible cause of damage		Notes on repairs

1. The damage is partly due to stress concentrations at the edges of the weld created by the presence of cut-outs and local stress variations caused by the deflections in the inner bottom/hopper plating.		1. The fracture in the weld and/or plating is veed-out/cropped and renewed as appropriate.

2. The cut-outs are eliminated by introducing suitable collar plate with emphasis on edge preparation and sequence of welding as shown above.	
		3. Further reinforcements may need to be carried out as shown above, however, after consultation with the Classification Society concerned.

- (e) If the damage is confined to areas below the ballast holds and the knuckle connection is of a radiused type, then in addition to rectifying the damage (i.e. weld or crop and renew), consideration is to be given to fitting further reinforcement, e.g. longitudinals or scarfing brackets, in the vicinity of the upper tangent point of the radius.

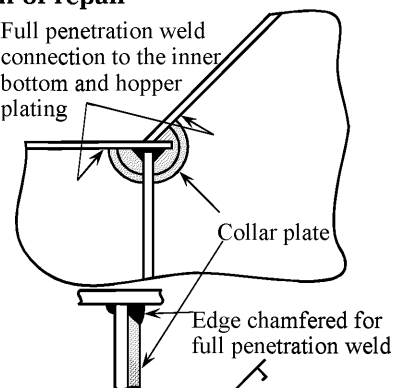
BULK CARRIERS		Guidelines for Surveys, Assessment and Repair of Hull Structure
Part 1	Cargo hold region	Example No.
Area 5	Double bottom tank structure including hopper	4
Detail of damage	Fractures at weld connections of floors in way of hopper/inner bottom interface (welded knuckle)	
Sketch of damage

View A - A Transverse fractures in hopper web plating into possibly extending into the hopper sloping plating		Sketch of repair

Reinforcement A Alternatively, may stop at longitudinals where fitted Intermediate brackets (i.e. between floors) Reinforcement B Scarfing brackets View B - B Face plate of transverse Inner bottom
Notes on possible cause of damage 1. The damage is partly due to stress concentration at the edges of the weld created by the presence of the deflections in the inner bottom/hopper plating.		Notes on repairs 1. The fracture in the weld and/or plating is veed-out/cropped and renewed as appropriate. 2. The cut-outs are eliminated by introducing suitable collar plates with emphasis on edge preparation and sequence of welding as shown above. 3. Further reinforcements may be incorporated as shown above and depending on the judged cause of damage.

- (a) Where the fracture is confined to the weld, the weld is to be veed-out and renewed using full penetration welding, with low hydrogen electrodes or equivalent.

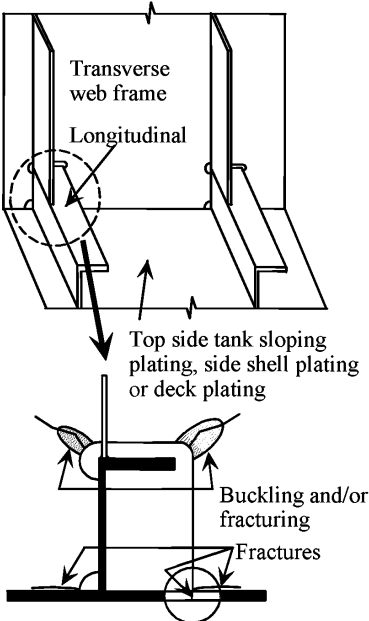
BULK CARRIERS		Guidelines for Surveys, Assessment and Repair of Hull Structure
Part 1	Cargo hold region	Example No.
Area 5	Double bottom tank structure including hopper	6
Detail of damage		Fractures and buckling in way of a cut-out for the passage of a longitudinal through a transverse primary member
Sketch of damage

Sketch of repair <div style="text-align: center;"> Repair A

New plating of enhanced thickness </div> <div style="text-align: center;"> Repair B

Full collar plate </div>
Notes on possible cause of damage 1. Damage can be caused by general levels of corrosion and presence of stress concentration associated with the presence of a cut-out.		Notes on repairs 1. If fractures are significant then crop and part renew the floor plating/transverse web otherwise the fracture can be veed-out and welded provided the plating is not generally corroded. 2. Repair B is to be incorporated if the lug proves to be ineffective.

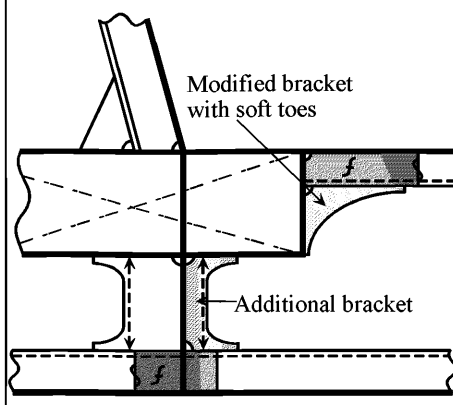
BULK CARRIERS	Guidelines for Surveys, Assessment and Repair of Hull Structure	
Part 1	Cargo hold region	Example No.
Area 5	Double bottom tank structure including hopper	9
Detail of damage	Fractures in longitudinal in way of bilge well	
Sketch of damage	<div style="display: flex; justify-content: space-between;"> <div style="width: 48%;">

<p>\mathcal{f}: Where required the longitudinals to be cropped and part renewed</p> </div> </div>	
Notes on possible cause of damage	Notes on repairs <ol style="list-style-type: none"> 1. Damage can be caused by stress concentrations leading to accelerated fatigue in this region. 1. If fractures are not extensive e.g. hairline fractures then these can be veed-out and welded. 2. If the fracture extended to over one third of the depth of the longitudinal then crop and part renew.

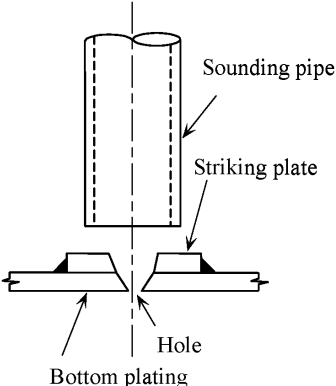
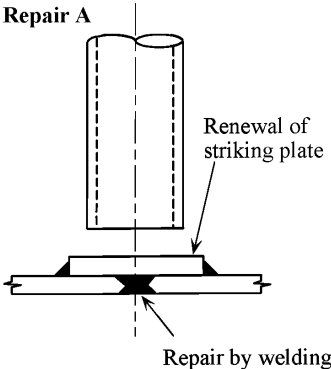
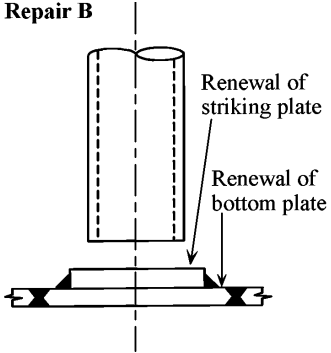
BULK CARRIERS		Guidelines for Surveys, Assessment and Repair of Hull Structure
Part 1	Cargo hold region	Example No.
Area 5	Double bottom tank structure including hopper	15
Detail of damage Corrosion in bottom plating below sounding pipe		
Sketch of damage

Sketch of repair <div style="margin-top: 20px;"> Repair A

</div> <div style="margin-top: 20px;"> Repair B

</div>
Notes on possible cause of damage <ol style="list-style-type: none"> 1. Accelerated corrosion of striking plate by the striking of the weight of the sounding tape. 		Notes on repairs <ol style="list-style-type: none"> 1. Corroded bottom plating should be welded or partly cropped and renewed if considered necessary. 2. Corroded striking plate should be renewed.

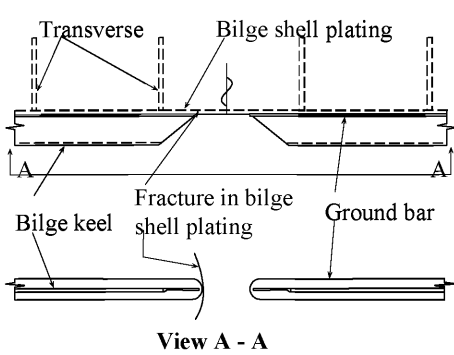
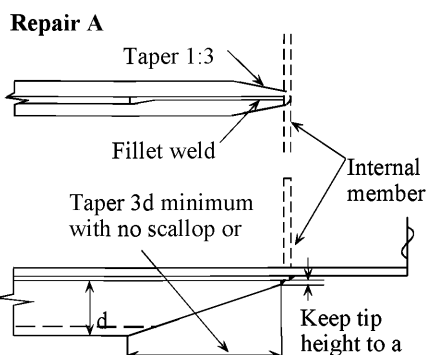
BULK CARRIERS		Guidelines for Surveys, Assessment and Repair of Hull Structure
Part 1	Cargo hold region	Example No.
Area 5	Double bottom structure including hopper	17
Detail of damage		Fractures in shell plating at the termination of bilge keel
Sketch of damage

<p>View A - A</p>		Sketch of repair <p>Repair A</p>

<p>Repair B</p>

Notes on possible cause of damage <ol style="list-style-type: none"> Poor design causing stress concentration. 		Notes on repairs <ol style="list-style-type: none"> Fractured plating is to be cropped and renewed. Reduction of stress concentration of the bilge keel end should be considered. <p>Repair A: Modification of the detail of end</p> <p>Repair B: New internal stiffeners</p> <p>Repair C: Continuous ground bar (in connection with Repair A)</p> Instead of Repair A or B continuous ground bar and bilge keel should be considered.

- (a) Fractures or distortion in bilge keels must be promptly repaired. Fractured butt welds should be repaired using full penetration welds and proper welding procedures. The bilge keel is subjected to the same level of longitudinal hull girder stress as the bilge plating, fractures in the bilge keel can propagate into the shell plating.
- (b) Termination of bilge keel requires proper support by internal structure. This aspect should be taken into account when cropping and renewing damaged parts of a bilge keel (See **Example 17**).

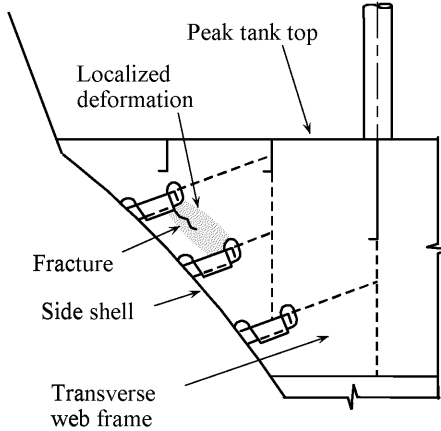
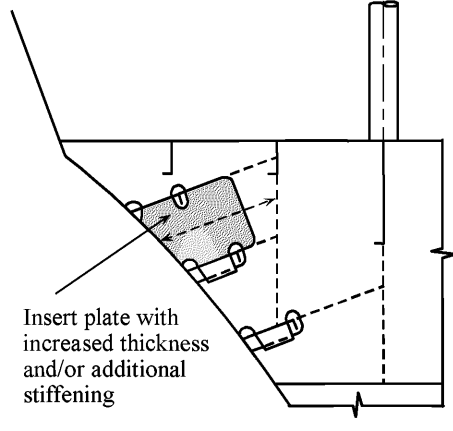
BULK CARRIERS		Guidelines for Surveys, Assessment and Repair of Hull Structure
Part 2	Fore and aft end regions	Example No.
Area 1	Fore end structure	5
Detail of damage	Fracture and deformation of bow transverse web in way of cut-outs for side longitudinals	
Sketch of damage		Sketch of repair

Notes on possible cause of damage		Notes on repairs
<ol style="list-style-type: none"> 1. Localized material wastage in way of coating failure at cut-outs and sharp edges due to working of the structure. 2. Dynamic seaway loading in way of bow flare. 		<ol style="list-style-type: none"> 1. Sufficient panel strength to be provided to absorb the dynamic loads enhanced by bow flare shape.

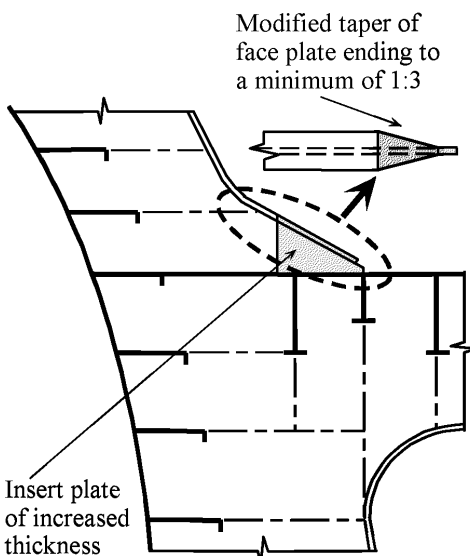
Sketch of repair

Notes on possible cause of damage <ol style="list-style-type: none"> 1. Inadequate bracket forming the web frame connection to the stringer. 2. Localized material wastage in way of coating failure at bracket due to flexing of the structure. 3. Dynamic seaway loading in way of bow flare. 		Notes on repairs <ol style="list-style-type: none"> 1. Adequate soft nose bracket endings with a face plate taper of at least 1 : 3 to be provided.

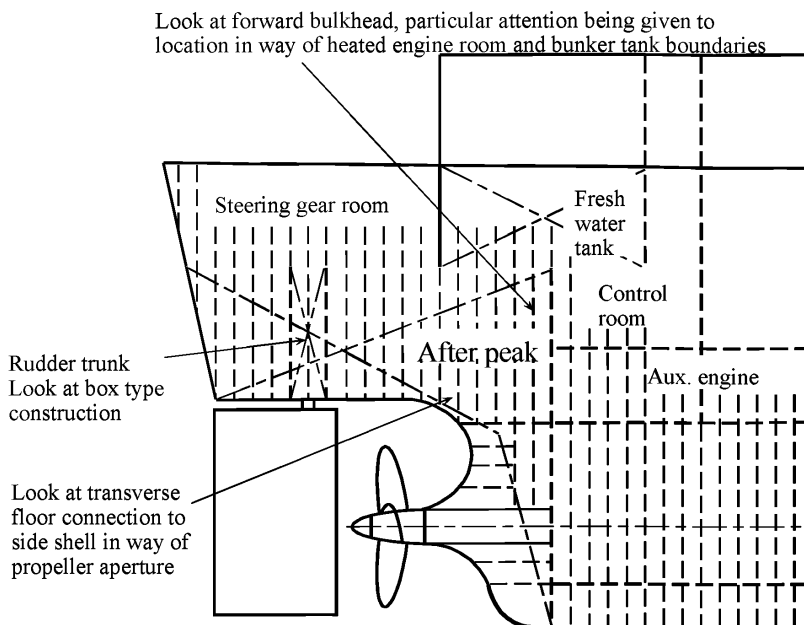
Figure 1 Aft end structure - Potential problem areas

- 2.1.1 Wastage (and possible subsequent fractures) is more likely to be initiated at in the locations as indicated in **Figure 1**. A close-up inspection should be carried out with selection of representative thickness measurements to determine the extent of corrosion. Particular attention should be given to bunker tank boundaries and spaces adjacent to heated engine room.

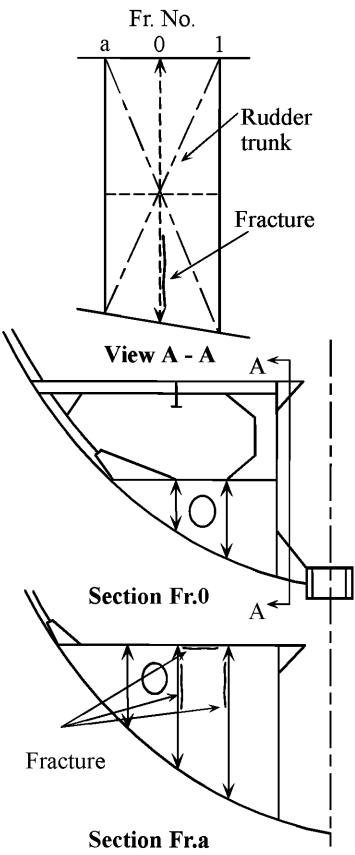
BULK CARRIERS		Guidelines for Surveys, Assessment and Repair of Hull Structure
Part 2	Fore and aft end regions	Example No.
Area 2	Aft end structure	1
Detail of damage Fractures in bulkhead in way of rudder trunk		
Sketch of damage

3.3.2 In order to prevent recurrence of damages suspected to be caused by main engine or propeller excited vibration, the cause of the vibration should be ascertained and additional reinforcements provided as found necessary (See **Examples 1** and **2**).

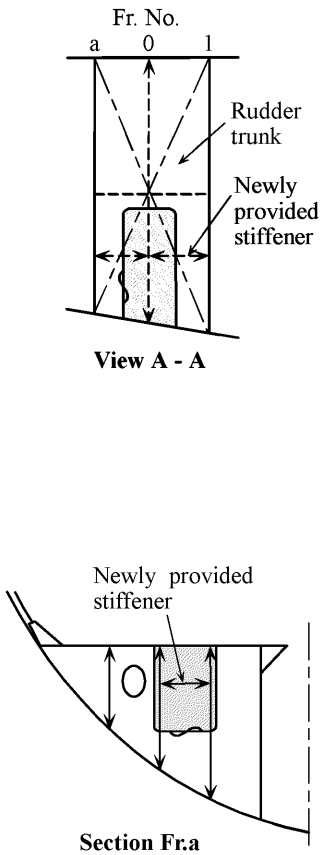
Sketch of repair

Notes on possible cause of damage 1. Vibration.		Notes on repairs 1. The fractured plating should be cropped and renewed. 2. Natural frequency of the plate between stiffeners should be changed, e.g. reinforcement by additional stiffeners.

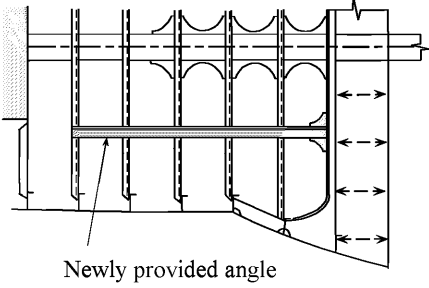
Sketch of repair

Notes on possible cause of damage 1. Vibration.		Notes on repairs 1. The fractured plating should be cropped and renewed. 2. Natural frequency of the panel should be changed, e.g. reinforcement by additional strut.

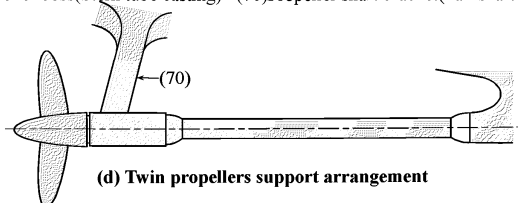
(d) Twin propellers support arrangement

Figure 1 Nomenclature for stern frame, rudder arrangement and propeller shaft support

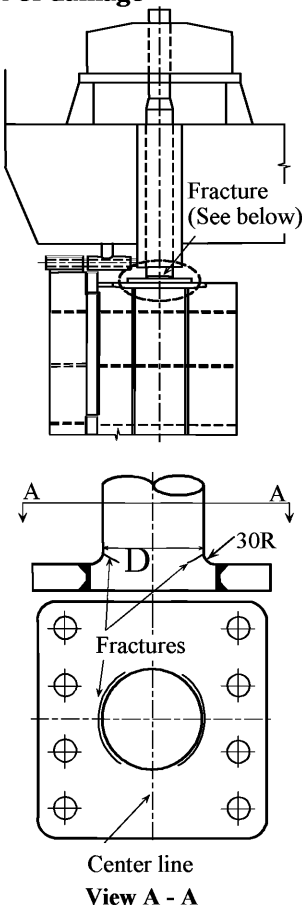
BULK CARRIERS	Guidelines for Surveys, Assessment and Repair of Hull Structure	
Part 2	Fore and aft end regions	Example No.
Area 3	Stern frame, rudder arrangement and propeller shaft support	2
Detail of damage		Fractures in rudder stock
<p>Sketch of damage</p>

<p>Fracture (See below)</p> <p>Center line View A - A</p>		<p>Sketch of repair</p>

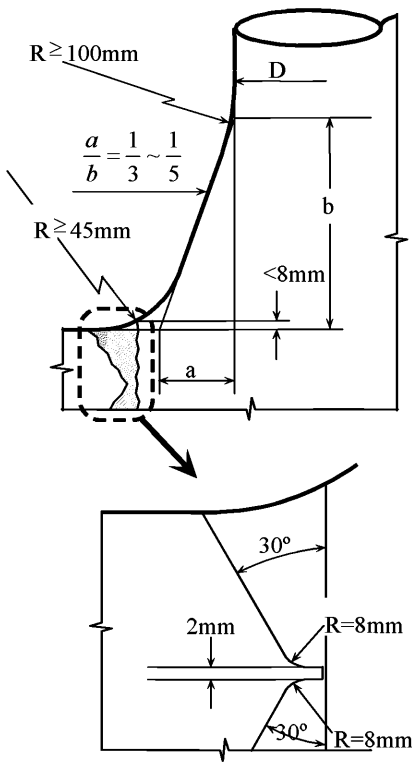
<p>$R \geq 100\text{mm}$</p> <p>$\frac{a}{b} = \frac{1}{3} \sim \frac{1}{5}$</p> <p>$R \geq 45\text{mm}$</p> <p>$D$</p> <p>$b$</p> <p>$<8\text{mm}$</p> <p>$a$</p> <p>$30^\circ$</p> <p>$2\text{mm}$</p> <p>$R=8\text{mm}$</p> <p>$30^\circ$</p> <p>$R=8\text{mm}$</p>
<p>Notes on possible cause of damage</p> <ol style="list-style-type: none"> Inadequate design for stress concentration in rudder stock. 		<p>Notes on repairs</p> <ol style="list-style-type: none"> Modification of detail design of rudder stock to reduce the stress concentration.

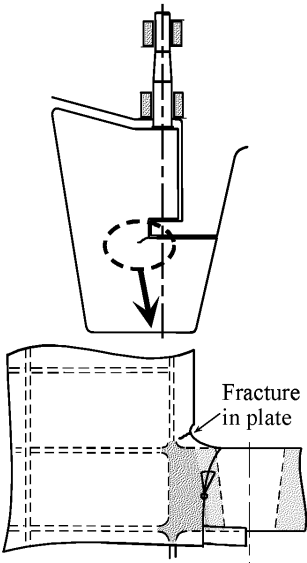
BULK CARRIERS		Guidelines for Surveys, Assessment and Repair of Hull Structure
Part 2	Fore and aft end regions	Example No.
Area 3	Stern frame, rudder arrangement and propeller shaft support	4
Detail of damage	Fractures in rudder plating of semi-spade rudder (short fracture with end located forward of the vertical web)	
Sketch of damage		Sketch of repair

Notes on possible cause of damage		Notes on repairs
<ol style="list-style-type: none"> 1. Stress concentration due to inadequate local design and/or fabrication notches in way of the butt weld between cast piece and plating. 		<ol style="list-style-type: none"> 1. Grooving-out and welding of the fracture is not always adequate (metallurgical notch in way of a high stressed area). 2. In the proposed repair procedure the metallurgical notches are shifted into a zone exposed to lower stresses. 3. After welding a modification of the radius according to the proposal in Example 5 is to be carried out. 4. In case of very small crack it can be ground off by increasing the radius.

- 2.2.2 Fractures should be looked for at weld connection between rudder horn, propeller boss and propeller shaft brackets, and stern frame.
- 2.2.3 Fractures should be looked for at the upper and lower corners in way of the pintle recess in case of semi-spade rudders. Typical fractures are shown in **Examples 3** to **5**.

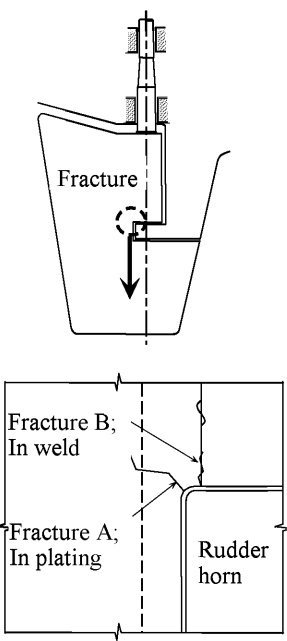
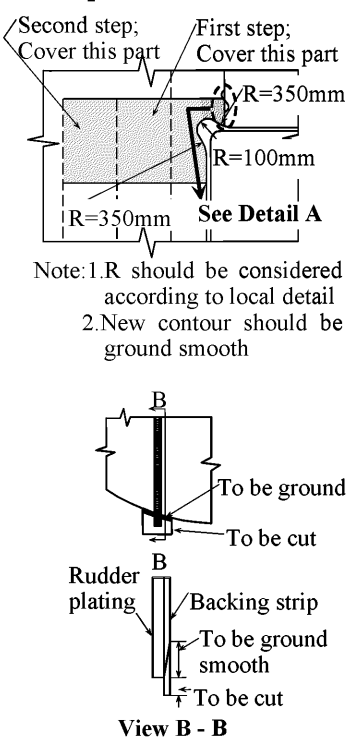
BULK CARRIERS		Guidelines for Surveys, Assessment and Repair of Hull Structure
Part 2	Fore and aft end regions	Example No.
Area 3	Stern frame, rudder arrangement and propeller shaft support	6
Detail of damage	Fractures in rudder plating of semi-spade rudder in way of pintle cutout	
Sketch of damage

Sketch of repair

<p>Note: 1. R should be considered according to local detail 2. New contour should be ground smooth</p>
Notes on possible cause of damage <ol style="list-style-type: none"> 1. Inadequate design for stress concentration in way of pintle bearing (Fracture A). 2. Imperfection in welding seam (Fracture B). 		Notes on repairs <ol style="list-style-type: none"> 1. Fractured part to be cropped off. 2. Repair by two insert plates of modified, stress releasing contour. For the vertical seam no backing strip is used 100mm off contour, welding from both sides, to be ground after welding. 3. Variant (See Detail A): Repair as mentioned under 2 with the use of backing strip for the complete vertical seam. After welding backing strip partly removed by grinding.

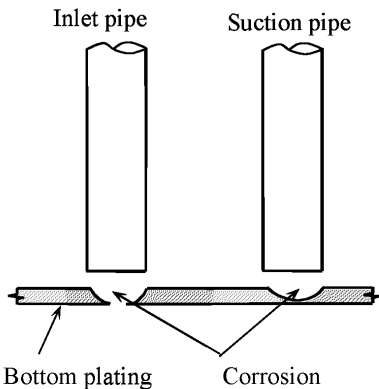
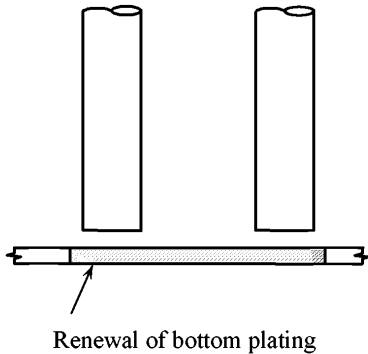
BULK CARRIERS	Guidelines for Surveys, Assessment and Repair of Hull Structure	
Part 3	Machinery and accommodation spaces	Example No.
Area 1	Engine room structure	3
Detail of damage	Corrosion in bottom plating under inlet/suction/pipe in way of bilge tank in engine room	
Sketch of damage

Sketch of repair

Notes on possible cause of damage <ol style="list-style-type: none"> Heavy corrosion of bottom plating under the inlet/suction pipe. 		Notes on repairs <ol style="list-style-type: none"> Corroded bottom plating is to be cropped and part renewed. Thicker plate is preferable. Replacement of pipe end by enlarged conical opening (similar to suction head in ballast tank) is preferable.

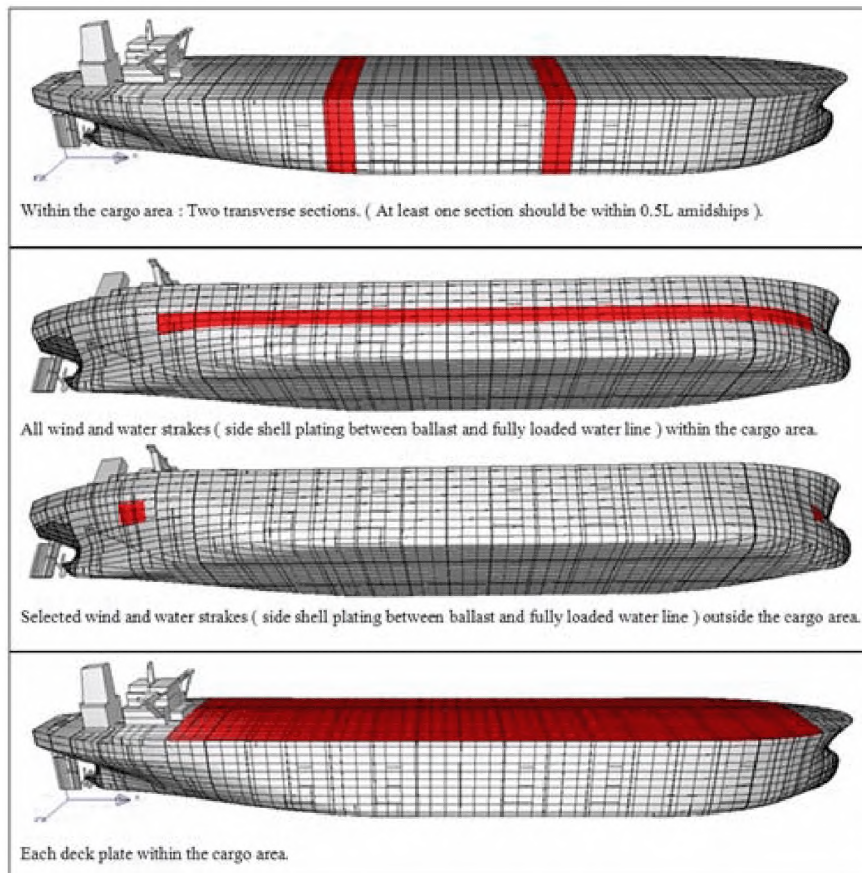
Figure 7 Example of Transverse Sections of Shell Plating and Main Deck Thickness Measurement Requirements for an oil tanker 15 years of age.

2.4.2 The Special Survey concentrates on close-up surveys in association with thickness measurements and is aimed at detecting fractures, buckling, corrosion and other types of structural deterioration. See Figure 7.

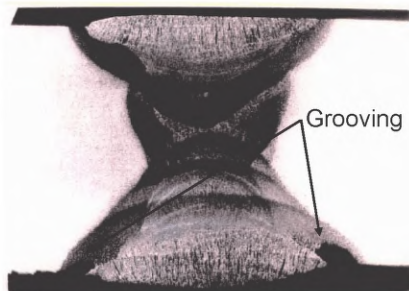
Photograph 2
Section of the grooving shown in Photograph 1

4.1.2 Severe grooving along welding of bottom plating is often found (See **Photographs 1** and **2**). This grooving can be accelerated by poor maintenance of the protective coating and/or sacrificial anodes fitted to the bottom plating.

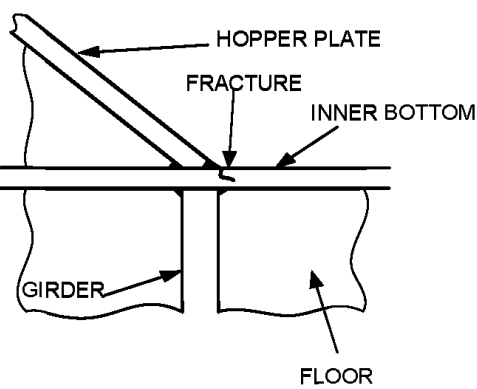
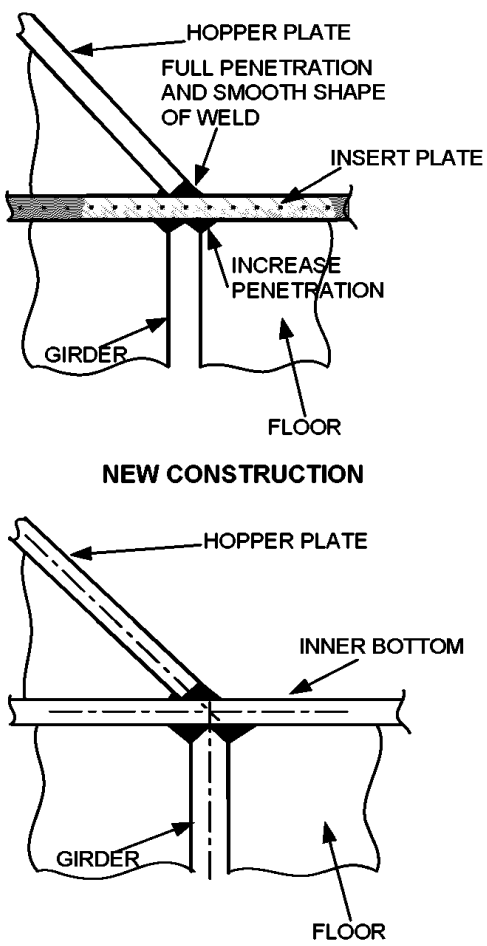
OIL Tankers		Guidelines for Surveys, Assessment and Repair of Hull Structure
Group 1	Cargo area	Example No.
	Hopper and double bottom ballast tank	1
Detail of damage	Fracture on the inner bottom plating at the connection of hopper plate to inner bottom	
Sketch of damage

Sketch of repair

<p>Notes: Plate midlines intersect</p>
Factors which may have caused damage <ol style="list-style-type: none"> 1. Stress concentration at juncture of hopper plate to inner bottom. 2. Insufficient welding connection. 3. Misalignment between hopper plate, inner bottom and girder. 		Notes on repairs See Sketch.

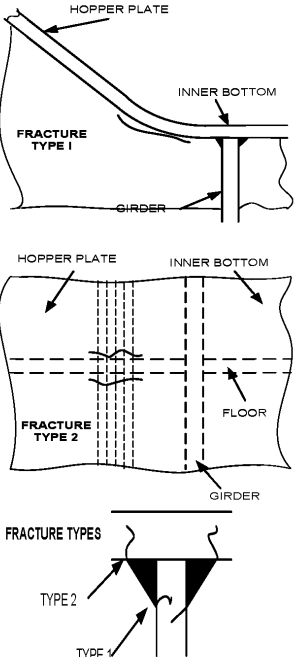
OIL Tankers		Guidelines for Surveys, Assessment and Repair of Hull Structure	
Group 1	Cargo area	Example No.	
	Hopper and double bottom ballast tank	5	
Detail of damage		Fractured floor and inner bottom plate in way of juncture of inner bottom to hopper plate	
Sketch of damage

Sketch of repair FRACTURE TYPE 1

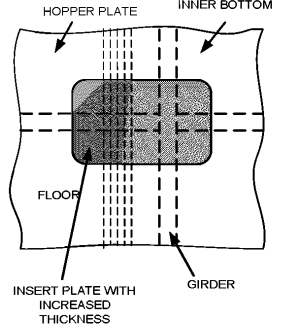
FRACTURE TYPE 2

Factors which may have caused damage <ol style="list-style-type: none"> 1. Misalignment. The three mid-lines do not cross at the same joint. This misalignment produces an out-of-plane deformation of inner bottom plate in way of knuckle line. 2. Stress concentration at connection between floor and inner bottom plate. 3. Static and dynamic load of ballast water. 		Notes on repairs See Sketch.

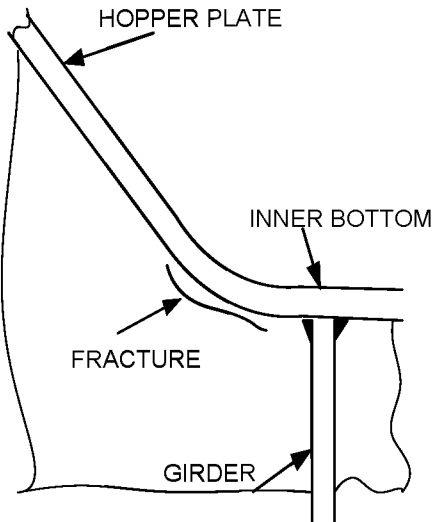
OIL Tankers		Guidelines for Surveys, Assessment and Repair of Hull Structure
Group 1	Cargo area	Example No.
	Hopper and double bottom ballast tank	6
Detail of damage		Fracture at connection of bilge hopper plate and web frame
Sketch of damage

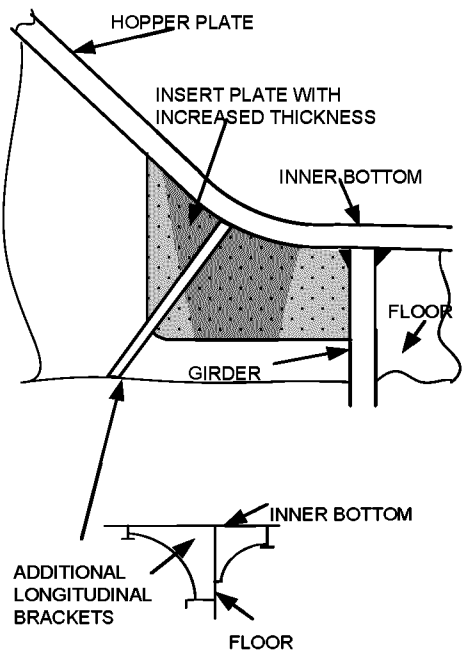
Sketch of repair

Factors which may have caused damage 1. Stress concentration due to reduction of effective flange area at curved plate.		Notes on repairs See Sketch.

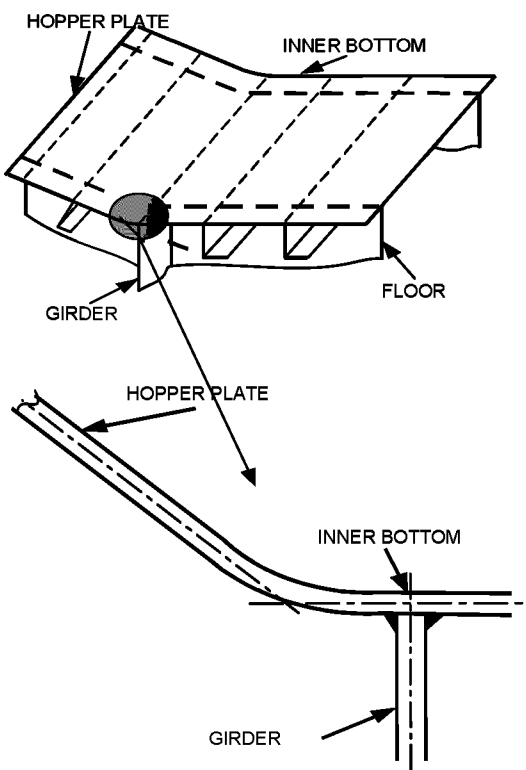
OIL Tankers		Guidelines for Surveys, Assessment and Repair of Hull Structure
Group 1	Cargo area	Example No.
	Hopper and double bottom ballast tank	7
Detail of damage		Rounded hopper plate deformation in way of the floor
Sketch of damage

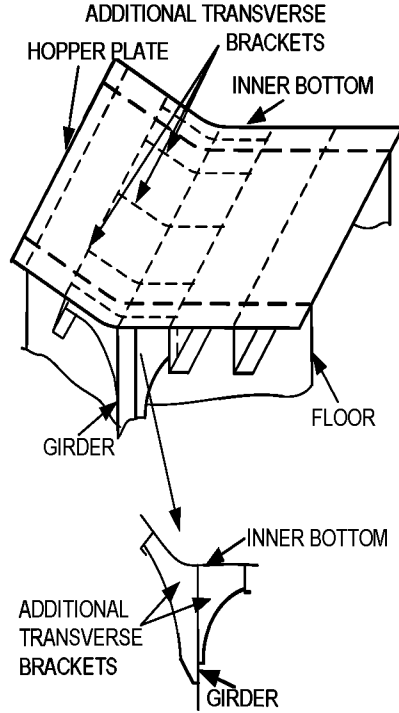
Sketch of repair

Factors which may have caused damage <ol style="list-style-type: none"> 1. Misalignment. The three midlines do not cross at the same joint. This misalignment produces an out-of-plane deformation in knuckled plate in the vicinity of floor. 2. Insufficient stiffening between floors. 		Notes on repairs See Sketch.

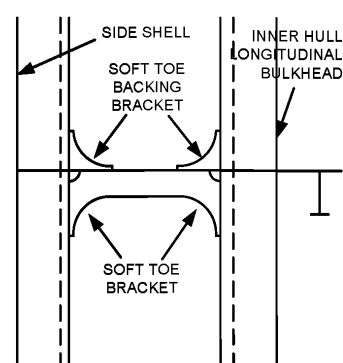
Sketch of repair

Factors which may have caused damage <ol style="list-style-type: none"> 1. Asymmetrical connection of flat bar stiffener resulting in high peak stresses at the heel of the stiffener. 2. Insufficient area of connection of longitudinal to web. 3. High bending stresses in the longitudinal. 4. Additional biaxial bending stresses due to asymmetry of the longitudinal (angle bar instead of symmetric T bar). 5. Stress concentration at the square angles at heel and toe of the connections. 6. High shear stress in the transverse web. 		Notes on repairs See Sketch.

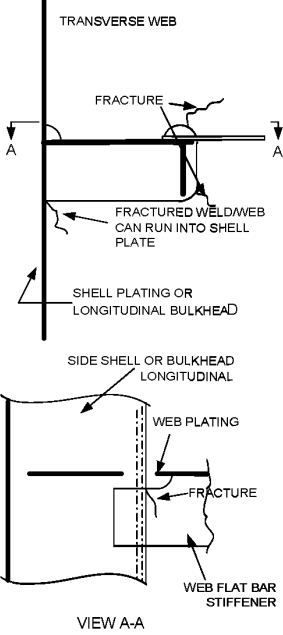
OIL Tankers		Guidelines for Surveys, Assessment and Repair of Hull Structure
Group 2	Cargo area	Example No.
	Wing ballast tank	4
Detail of damage	Fracture in way of web and flat bar stiffener at cut outs for longitudinal stiffener connections as Example 3 but with faceplate attached to underside of web. Flat bar lap welded.	
Sketch of damage	<div data-bbox="171 425 760 1222">

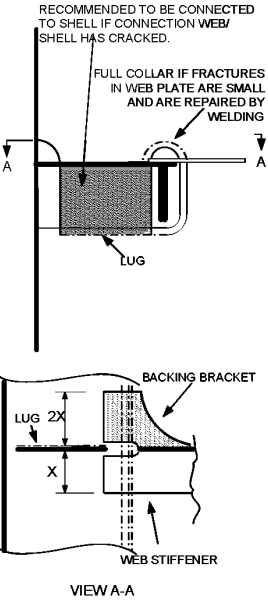
<p>Insert web plate.</p> </div>	
Factors which may have caused damage	<ol style="list-style-type: none"> 1. Asymmetrical connection of flat bar stiffener resulting in high peak stress at heel of the stiffener under fatigue loading. 2. Fabricated longitudinal with welding onto exposed edge of the web resulting in poor fatigue strength of the connection of the longitudinal to the flat bar. 3. Insufficient area of connection of longitudinal to web plate. 4. Defective weld at return around the plate thickness. 5. High localized corrosion at areas of stress concentrations such as flat bar stiffener connections, corners of cut out for longitudinal and connection of lug to shell at cut outs. 6. High shear stress in web of the transverse. 7. Dynamic seaway loads/motions.

Notes on repairs	<p>See Sketch.</p> <ol style="list-style-type: none"> 1. May also fit a double bracket to avoid fracture from toe.

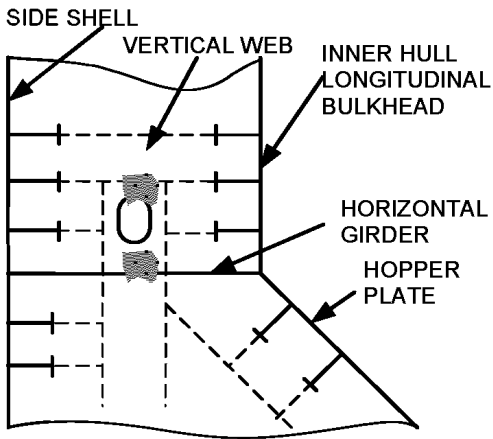
OIL Tankers		Guidelines for Surveys, Assessment and Repair of Hull Structure	
Group 2	Cargo area	Example No.	
	Wing ballast tank	5	
Detail of damage		Buckling in way of side web panels above hopper horizontal girder	
Sketch of damage

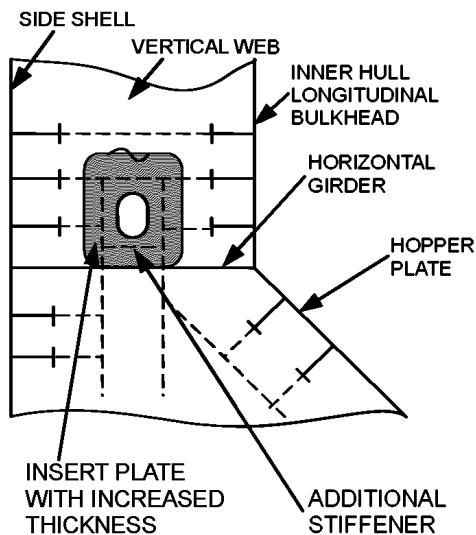
Sketch of repair

Factors which may have caused damage <ol style="list-style-type: none"> 1. High shear stress in the transverse web. 2. Insufficient buckling strength. 		Notes on repairs See Sketch.

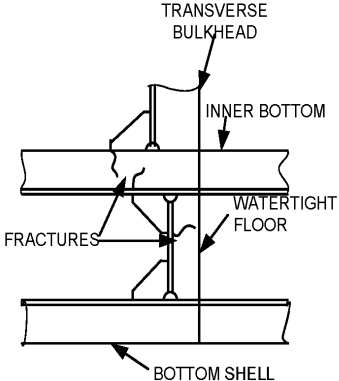
OIL Tankers		Guidelines for Surveys, Assessment and Repair of Hull Structure
Group 3	Cargo area	Example No.
	Bottom ballast tank	1
Detail of damage		Cracks in way of longitudinals connected to watertight floors
Sketch of damage		Sketch of repair

<p>TRANSVERSE BULKHEAD</p> <p>INNER BOTTOM</p> <p>FRACTURES</p> <p>WATERTIGHT FLOOR</p> <p>BOTTOM SHELL</p>

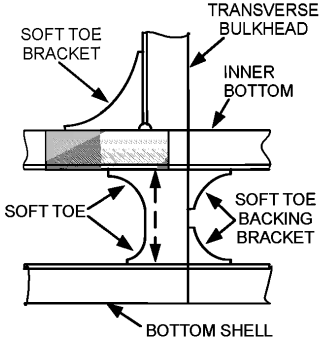
<p>TRANSVERSE BULKHEAD</p> <p>INNER BOTTOM</p> <p>SOFT TOE BRACKET</p> <p>SOFT TOE</p> <p>SOFT TOE BACKING BRACKET</p> <p>BOTTOM SHELL</p>
Factors which may have caused damage <ol style="list-style-type: none"> 1. Asymmetrical connection of bracket in association with a backing bracket, which is too small. 2. Relative deflection between adjacent floor and transverse bulkhead. 3. Inadequate shape of the brackets. 4. High stresses in the inner bottom longitudinal and the floor stiffener. 		Notes on repairs See Sketch.

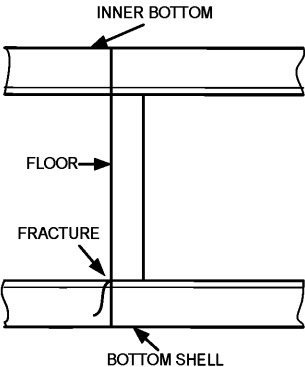
OIL Tankers Guidelines for Surveys, Assessment and Repair of Hull Structure		
Group 3	Cargo area	Example No.
	Bottom ballast tank	4
Detail of damage	Connection of longitudinals to ordinary floors	
Sketch of damage

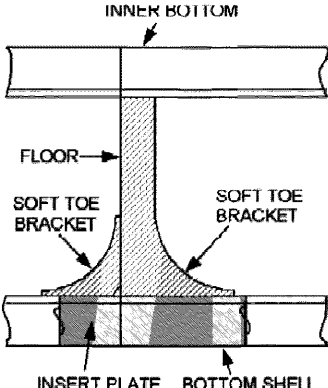
Sketch of repair

Factors which may have caused damage	<p>1. Stress concentration at the connection of bottom longitudinal and stiffener on floor.</p>	
Notes on repairs	<p>See Sketch.</p> <ol style="list-style-type: none"> 1. Butt welds in bottom longitudinal should be kept clear of the soft toe bracket toes. 2. If possible soft toe bracket and vertical stiffener should be integral.

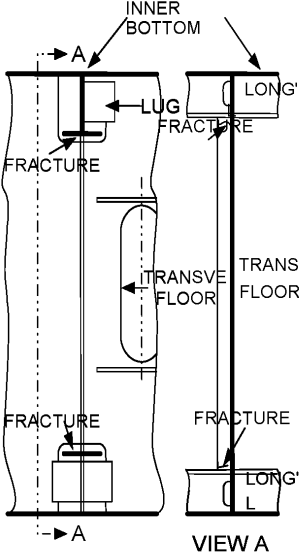
OIL Tankers		Guidelines for Surveys, Assessment and Repair of Hull Structure
Group 3	Cargo area	Example No.
	Bottom ballast tank	7
Detail of damage	Fractured stiffener connection to bottom and inner bottom longitudinals.	
Sketch of damage

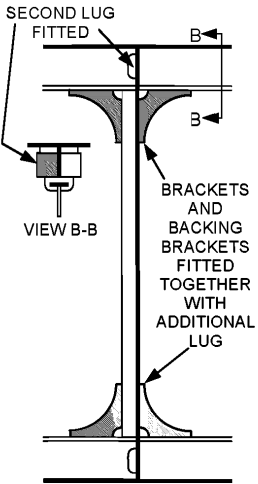
Sketch of repair

Factors which may have caused damage <ol style="list-style-type: none"> 1. Asymmetric connection leading to high local stresses at the connection of vertical stiffeners of the transverse floors to the inner and outer bottom longitudinals. 2. Wide slot for longitudinal leads to inefficient lug connection. 3. Sharp corners or flame-cut edges producing a notch effect. 4. Incomplete/defective weld at stiffener connection to the longitudinals. 5. Dynamic sea way loads/ship motions. 		Notes on repairs See Sketch.

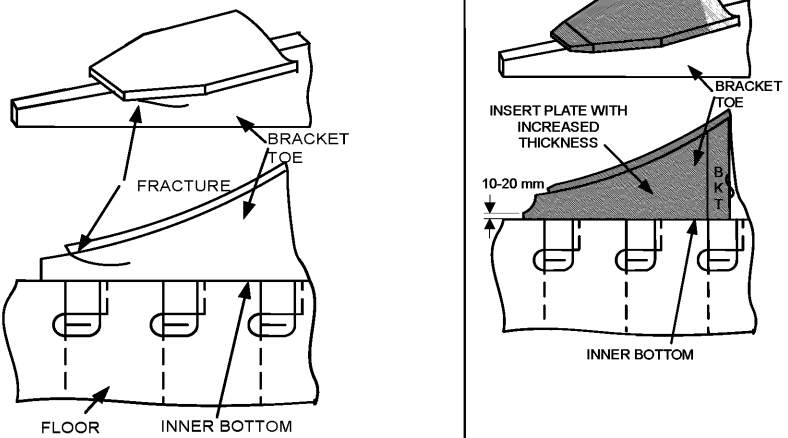
OIL Tankers		Guidelines for Surveys, Assessment and Repair of Hull Structure
Group 4	Cargo area	Example No.
	Web Frame in cargo tank	1
Detail of damage		Fracture at toe of web frame bracket connection to inner bottom.
Sketch of damage		<p>Sketch of repair Modify Face Taper 1. Breadth taper 20 degrees. 2. Breadth at toe as small as practical. 3. Thickness taper 1 in 3 to 10mm.</p>

Factors which may have caused damage		Notes on repairs
1. Inadequate tapering the toe end. 2. Insufficient tapering of flange. 3. Lateral flexing of the bracket.		See Sketch.

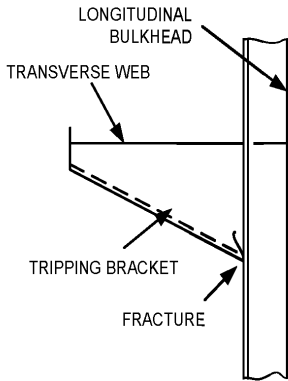
OIL Tankers		Guidelines for Surveys, Assessment and Repair of Hull Structure	
Group 4	Cargo area	Example No.	
	Web Frame in cargo tank	5	
Detail of damage		Fracture in way of connection of transverse web tripping brackets to longitudinal	
Sketch of damage		Sketch of repair

<p>LONGITUDINAL BULKHEAD</p> <p>TRANSVERSE WEB</p> <p>TRIPPING BRACKET</p> <p>FRACTURE</p>

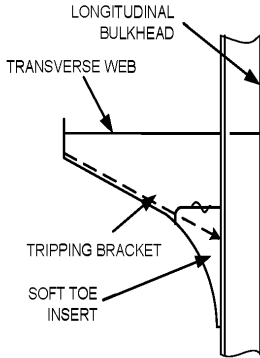
<p>LONGITUDINAL BULKHEAD</p> <p>TRANSVERSE WEB</p> <p>TRIPPING BRACKET</p> <p>SOFT TOE INSERT</p>	
Factors which may have caused damage		Notes on repairs	
<ol style="list-style-type: none"> 1. Hard spot at the toe of bracket. 2. Vibration. 		<p>See Sketch.</p> <ol style="list-style-type: none"> 1. Soft bracket may be added on upper side of web, to avoid fracture at the heel.

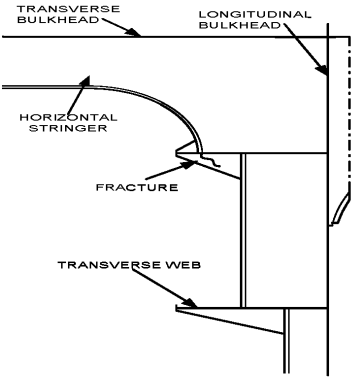
OIL Tankers		Guidelines for Surveys, Assessment and Repair of Hull Structure
Group 5	Cargo area	Example No.
	Transverse Bulkhead in cargo tank	1
Detail of damage	Fracture in way of connection of transverse bulkhead stringer to transverse web frames and longitudinal bulkhead stringer	
Sketch of damage	<div style="display: flex; justify-content: space-between;"> <div style="width: 48%;">

</div> </div>	
Factors which may have caused damage	<ol style="list-style-type: none"> 1. Stress concentration due to discontinuous structure. 2. High shear stress in the horizontal stringer. 	
Notes on repairs	See Sketch.
