**ПРИЛОЖЕНИЕ К ПРАВИЛАМ И РУКОВОДСТВАМ
РОССИЙСКОГО МОРСКОГО РЕГИСТРА СУДОХОДСТВА**

**SUPPLEMENT TO RULES AND GUIDELINES
OF RUSSIAN MARITIME REGISTER OF SHIPPING**

GENERAL DRY CARGO SHIPS

Guidelines for
Surveys, Assessment and Repair
of Hull Structure

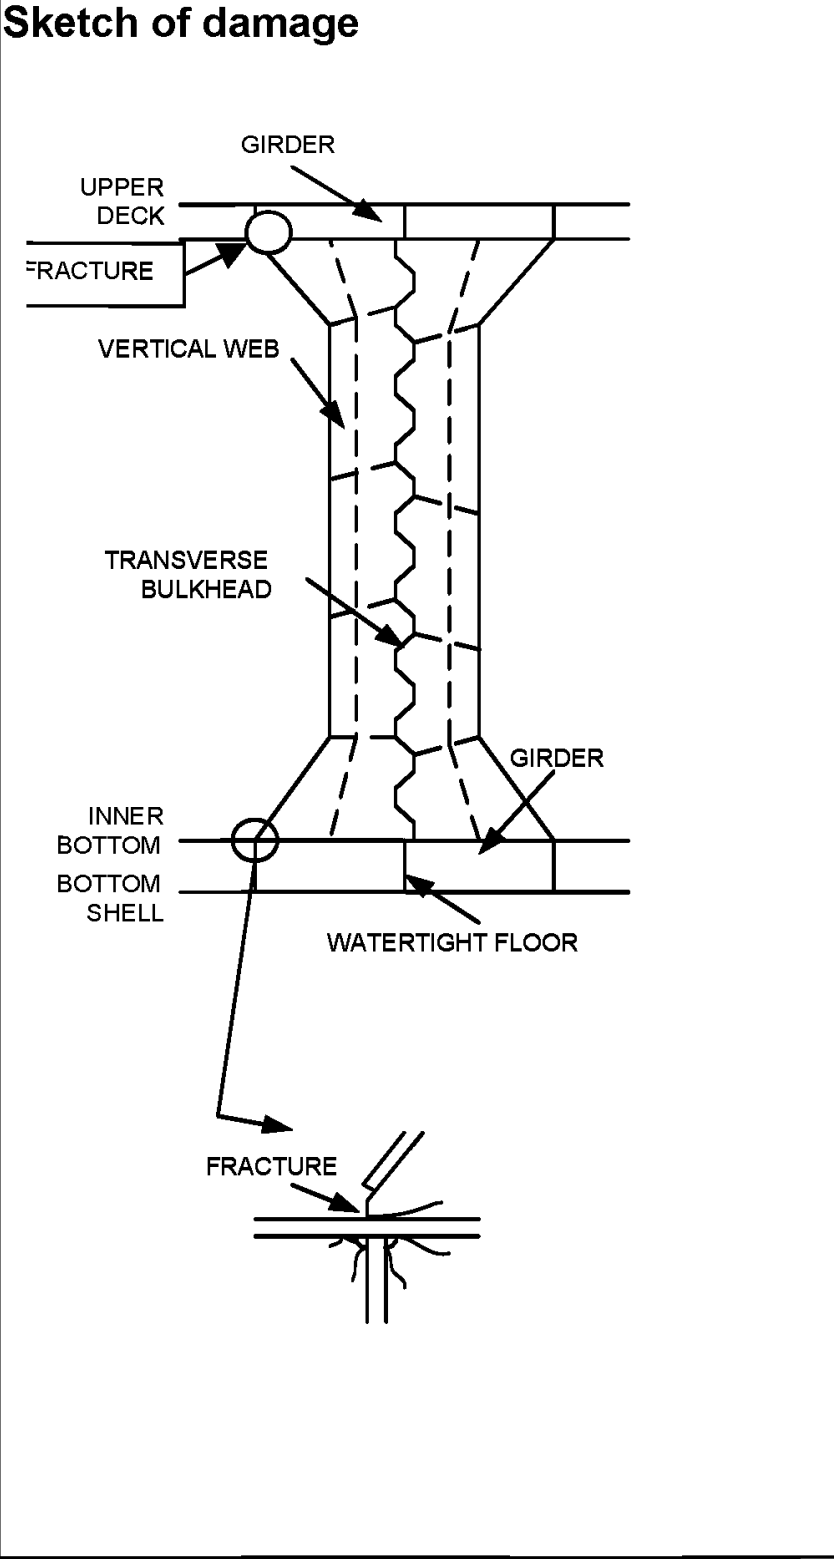
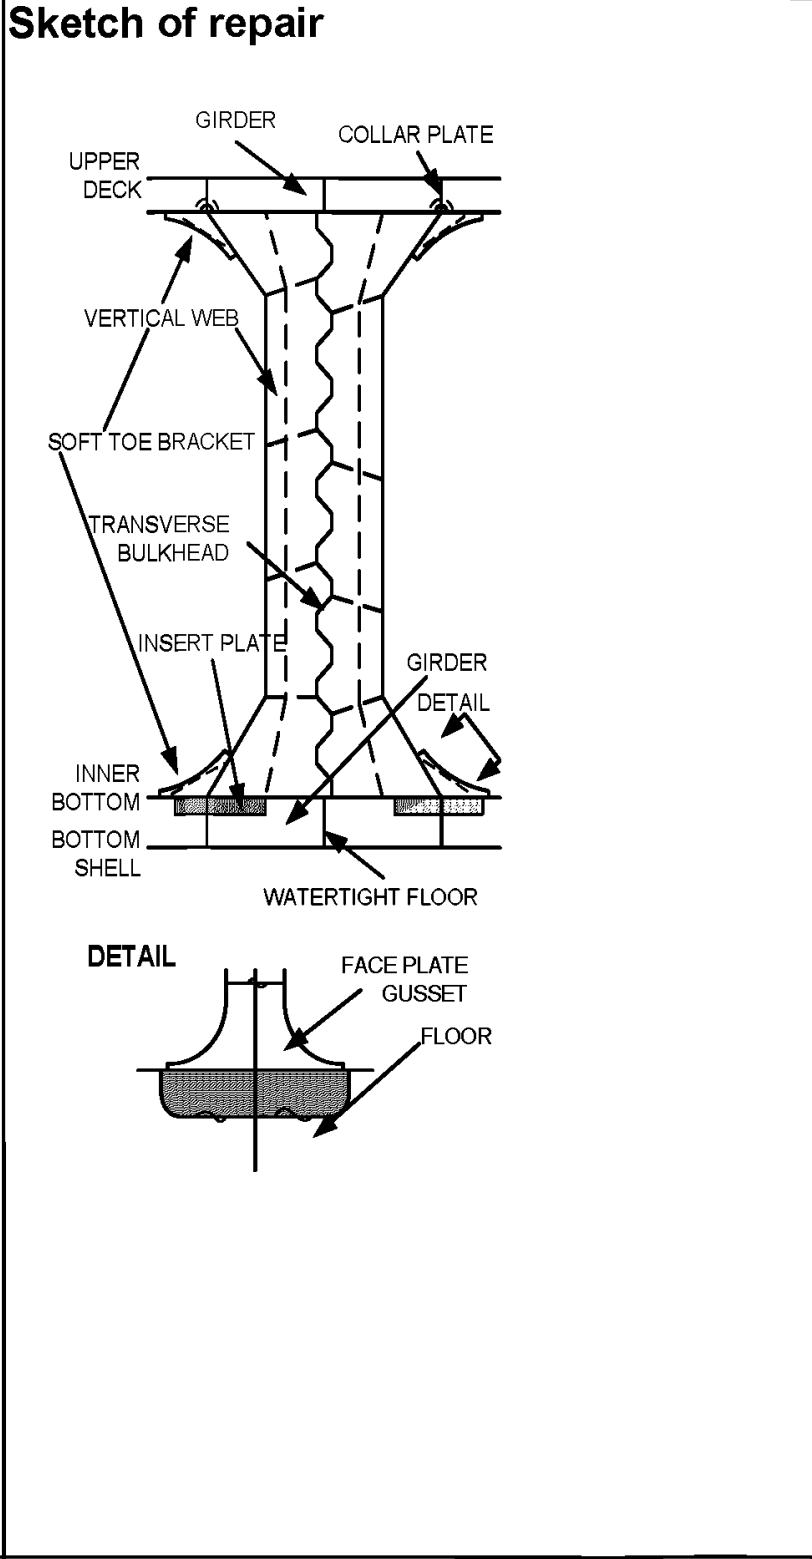
OIL Tankers		Guidelines for Surveys, Assessment and Repair of Hull Structure	
Group 5	Cargo area		Example No.
	Transverse Bulkhead in cargo tank		5
Detail of damage		Bulkhead vertical web to deck and inner bottom	
Sketch of damage		Sketch of repair

Factors which may have caused damage		Notes on repairs	
1. Stress concentration at toe of bracket due to sniped face plate and scallop in way.		See Sketch.

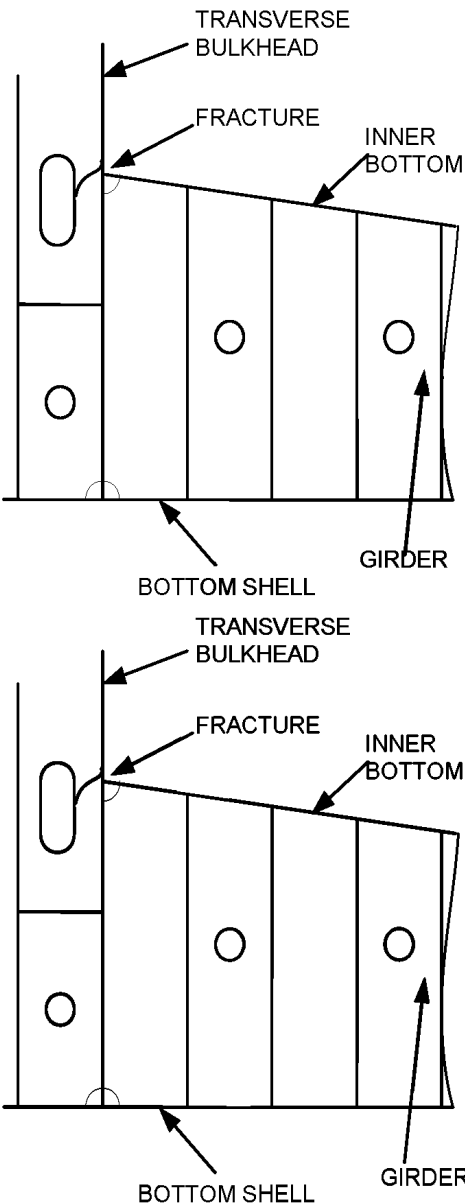
OIL Tankers		Guidelines for Surveys, Assessment and Repair of Hull Structure	
Group 5	Cargo area	Example No.	
	Transverse Bulkhead in cargo tank	9	
Detail of damage		Fracture at connection of transverse bulkhead to knuckle inner bottom/girder	
Sketch of damage

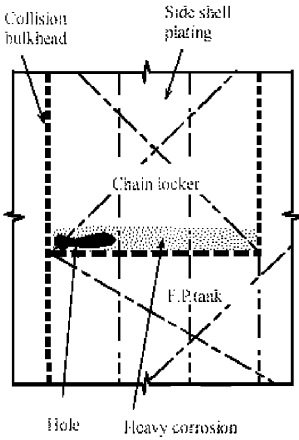
OIL Tankers			Guidelines for Surveys, Assessment and Repair of Hull Structure		
Group 7		Fore region		Example No.	
Area 1		Chain locker		2	
Detail of damage		Fractures in side shell plating in way of chain locker			
Sketch of damage		Sketch of repair

Factors which may have caused damage		Notes on repairs			
1. Heavy corrosion in region where mud is accumulated.		1. Corroded plating should be cropped and renewed. 2. Protective coating should be applied.

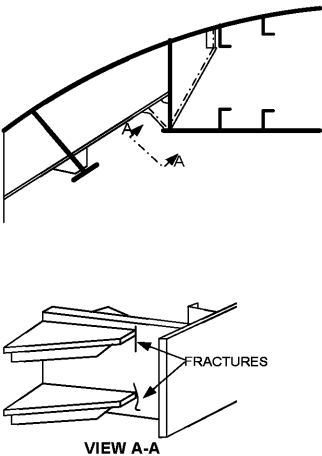
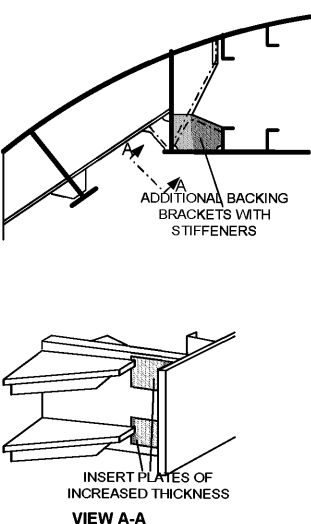
OIL Tankers Guidelines for Surveys, Assessment and Repair of Hull Structure		
Group 7	Fore region	Example No.
Area 1	Forepeak ballast tank	4
Detail of damage	Fractured vertical web at the longitudinal stiffener ending in way of the parabolic bow structure.	
Sketch of damage

Sketch of repair

Factors which may have caused damage <ol style="list-style-type: none"> 1. Stress concentrations at bracket ending due to inadequate support at bracket toes in way of connection to web frame members. 2. Localised thinning in way of coating failure at bracket endings due to flexing of the structure. 3. Dynamic seaway loadings at bow causing flexing at bracket endings. 		Notes on repairs See Sketch.

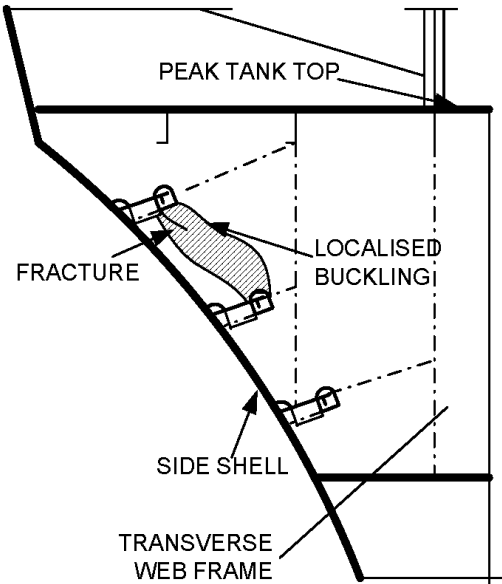
OIL Tankers		Guidelines for Surveys, Assessment and Repair of Hull Structure	
Group 7	Fore region		Example No.
Area 1	Forepeak ballast tank		7
Detail of damage		Fracture and buckle of bow transverse web frame in way of longitudinal cut-outs.	
Sketch of damage		Sketch of repair

Factors which may have caused damage <ol style="list-style-type: none"> 1. Localised thinning in way of coating failure at cut-outs and sharp edges due to working of the structure. 2. Dynamic seaway loadings in way of bow flare. 		Notes on repairs See Sketch.

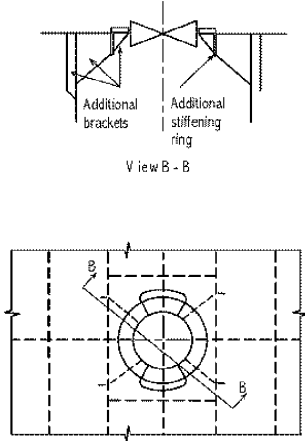
OIL Tankers Guidelines for Surveys, Assessment and Repair of Hull Structure		
Group 7	Aft region	Example No.
Area 2	Machinery space outside Engine room	11
Detail of damage	Fractures in flat where rudder carrier is installed in steering gear room	
Sketch of damage

Sketch of repair

Factors which may have caused damage 1. Inadequate design.		Notes on repairs 1. Fractured plating should be cropped and renewed. 2. Additional brackets and stiffening ring should be fitted for reinforcement.

3.3.4 Fractured structure which supports rudder carrier is to be cropped, and renewed, and may have to be reinforced (See Examples 11 and 12).

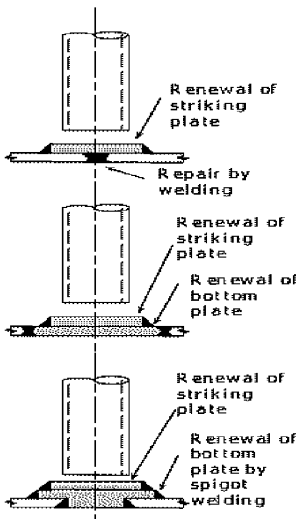
OIL Tankers		Guidelines for Surveys, Assessment and Repair of Hull Structure
Group 8	Machinery and accommodation spaces	Example No.
Area 1	Engine room	2
Detail of damage		Corrosion in bottom plating under sounding pipe in way of bilge storage tank in engine room
Sketch of damage

Sketch of repair

Factors which may have caused damage 1. Heavy corrosion of bottom plating under sounding pipe.		Notes on repairs 1. Corroded striking plating should be renewed. 2. Bottom plate should be repaired depending on the condition of corrosion. <i>(Note):</i> Repair by spigot welding can be applied to the structure only when the stress level is considerably low. Generally this procedure cannot be applied to the repair of bottom plating of ballast tanks in cargo tank region.

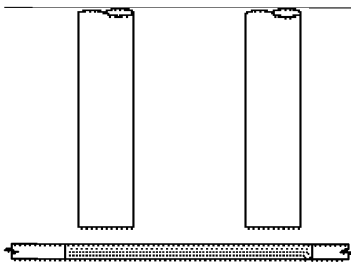
OIL Tankers		Guidelines for Surveys, Assessment and Repair of Hull Structure
Group 8	Machinery and accommodation spaces	Example No.
Area 1	Engine room	3
Detail of damage		Corrosion in bottom plating under inlet/suction/pipe in way of bilge tank in engine room
Sketch of damage		Sketch of repair

Factors which may have caused damage		Notes on repairs
<ol style="list-style-type: none"> 1. Heavy corrosion of bottom plating under the inlet/suction pipe. 		<ol style="list-style-type: none"> 1. Corroded bottom plate is to be cropped and part renewed. Thicker plate is preferable. 2. Replacement of pipe end by enlarged conical opening (similar to suction head in ballast tank) is preferable.

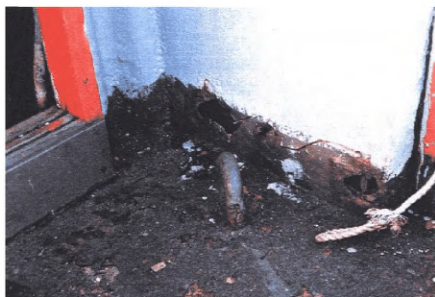
Photograph 1 Corroded accommodation house side structure

Severe corrosion may be found in exposed deck plating and deck house side structure adjacent to the deck plating where water is liable to accumulate (See **Photograph 1**). Corrosion may also be found in accommodation bulkheads around cut-out for fittings, such as doors, side scuttles, ventilators, etc., where proper maintenance of the area is relatively difficult. Deterioration of the bulkheads including fittings may impair the integrity of weathertightness.

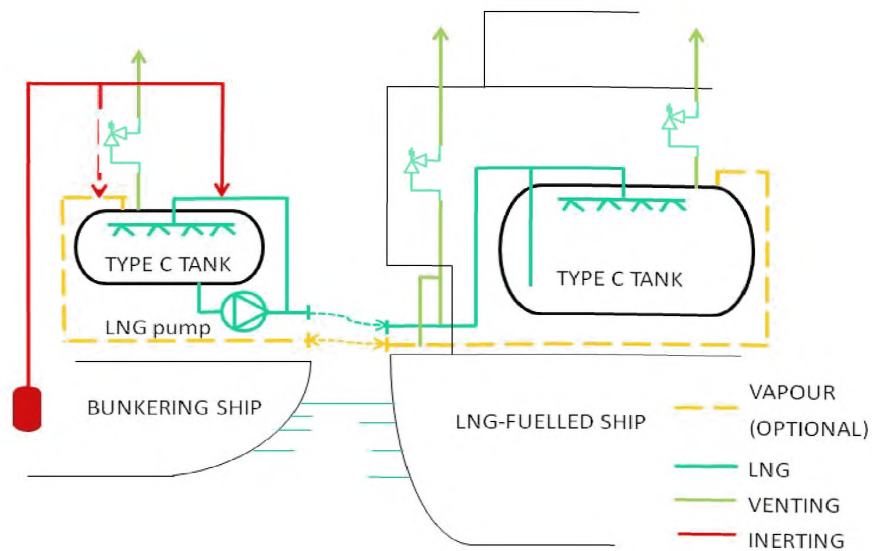
Note: For small scale bunker supply using Type C tanks, the LNG supply pressure may be generated by pump (as shown in the figures below) or by a Pressure Built Up unit.

Figure 3: Ship-to-ship bunkering - typical arrangement of bunkering ship and LNG fuelled ship with type C tank

Bunkering facility				
		Type C tank			Atmospheric tank	
		Bunker ship	Tank truck	Shore-based facility	Bunker ship	Shore-based facility
Receiving ship	Type C tank	Fig.3	Fig.6	(*)	(*)	Fig.7
	Atmospheric tank	Fig.4	(*)	(*)	Fig.5	(*)

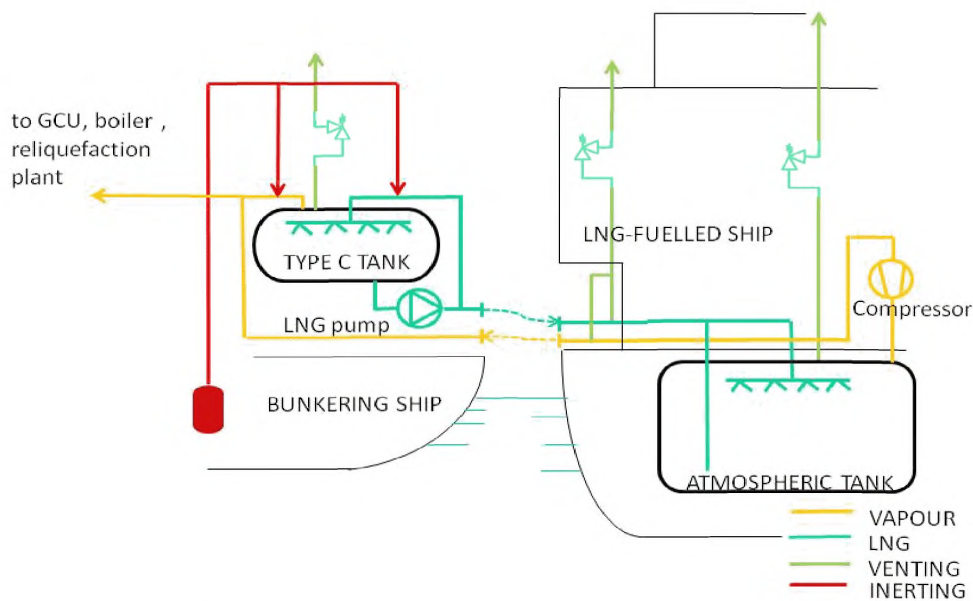
Figure 4: Ship-to-ship bunkering - typical arrangement of bunkering ship with type C tank and LNG fuelled ship with atmospheric tank

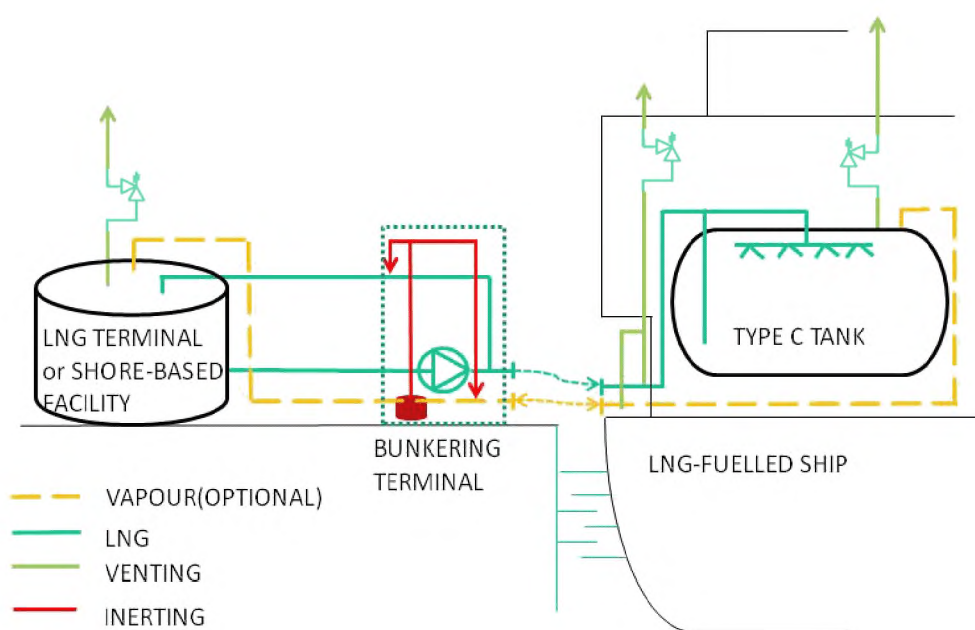
Figure 7: Terminal to ship bunkering - typical arrangement of LNG fuelled ship with type C tank

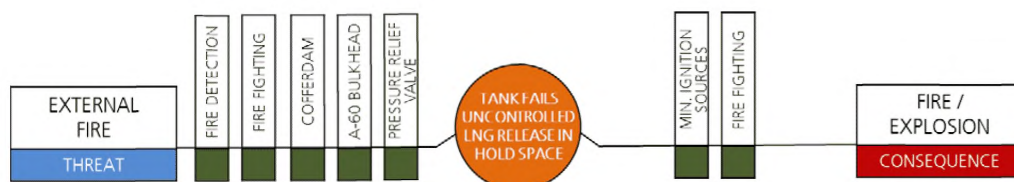
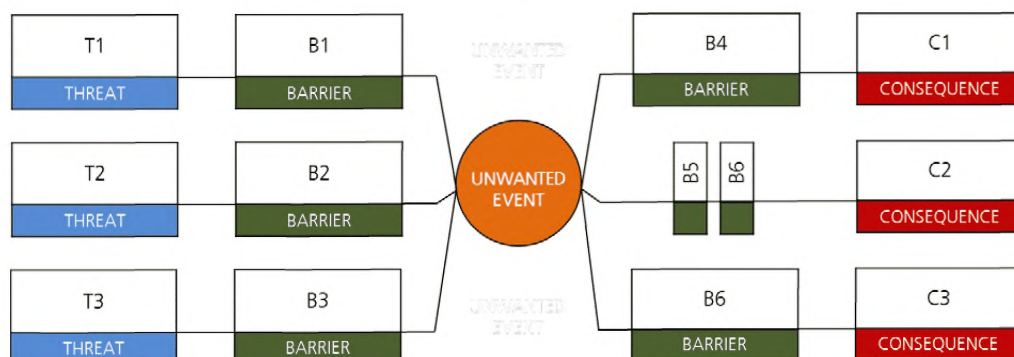
- Threat** – A cause that can potentially lead to the unwanted event.
- Barrier** – A mitigation measure that can potentially prevent the unwanted event or its consequences.
- Unwanted Event** – A situation to be avoided e.g. a release of fuel or a loss of ship propulsion.
- Consequence** – An outcome of a threat and an unwanted event not being mitigated by the barriers.

In respect of 'mitigation measures' (i.e. barriers) those prior to the unwanted event are often referred to as preventative barriers or prevention measures.
